**ENSHAM RESOURCES PTY LIMITED**

**ENSHAM COAL PROJECT  
YONGALA MINE**

**ENVIRONMENTAL MANAGEMENT  
OVERVIEW STRATEGY  
NOVEMBER 1992**

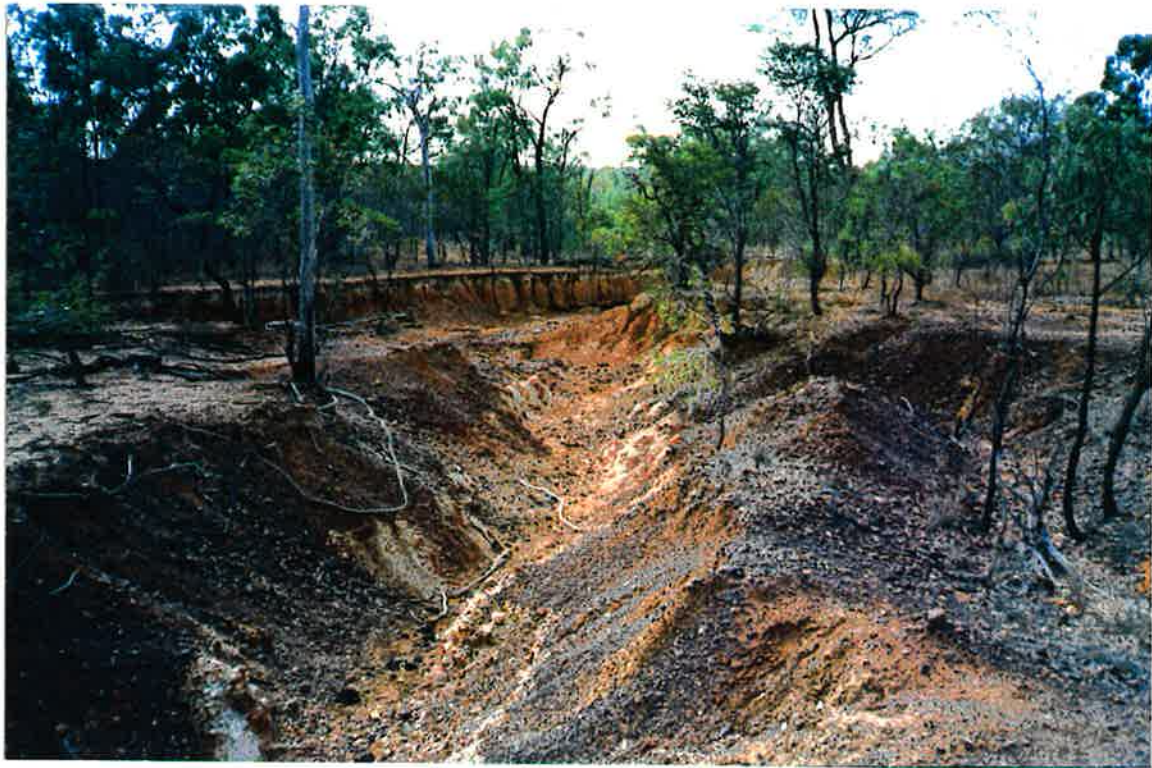
Deep gullying associated with dispersive soils

As indicated in Appendix 3 the proposed mine area is currently in a seriously degraded state, primarily due to overstocking and lack of management of run-off in the dispersive soil areas. There is a lack of grass cover generally, some extensive local areas of scalds, and gully erosion on drainage channels leading into Boggy Creek. The Boggy Creek channel is subject to erosion during flow events. Mining, by effectively destocking areas surrounding the active pit, will promote recovery of the grass cover in these areas. The access road construction will effectively treat the drainage gullies it traverses and greatly retard further erosion in those gullies. However, existing gullies and scalds will remain and those not disturbed by mining operations will extend naturally with time.

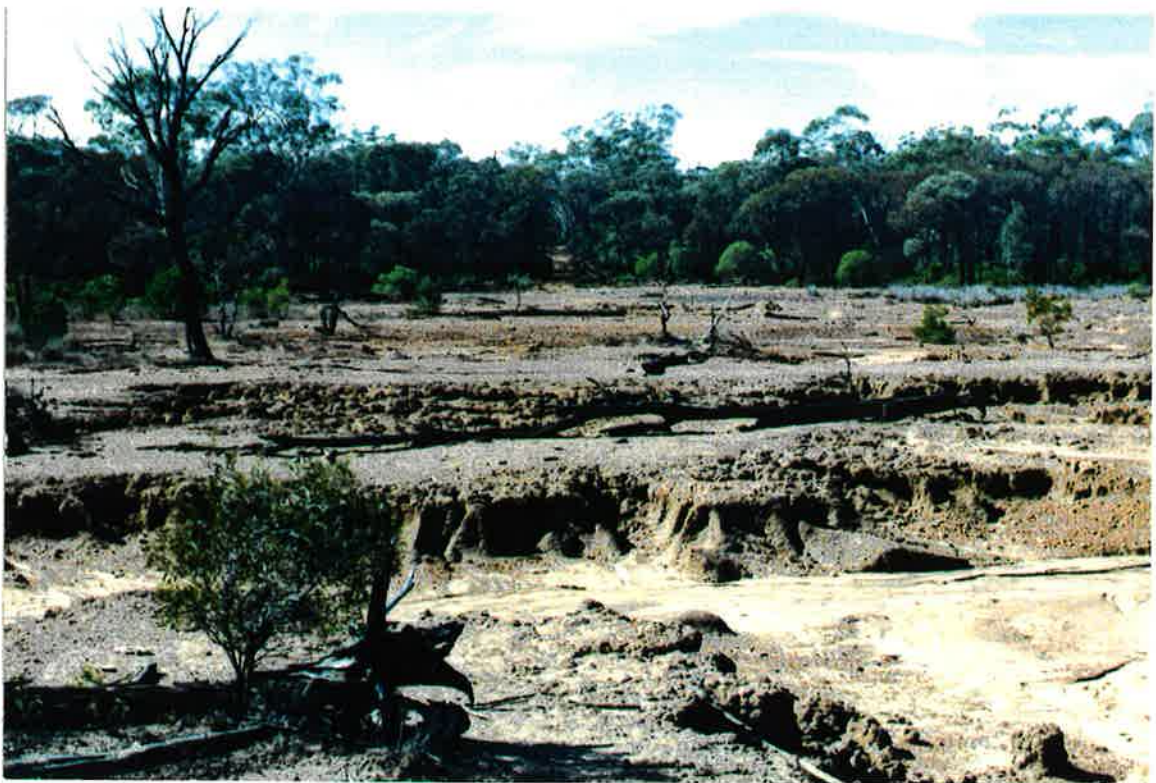
Scald area with severe sheet erosion

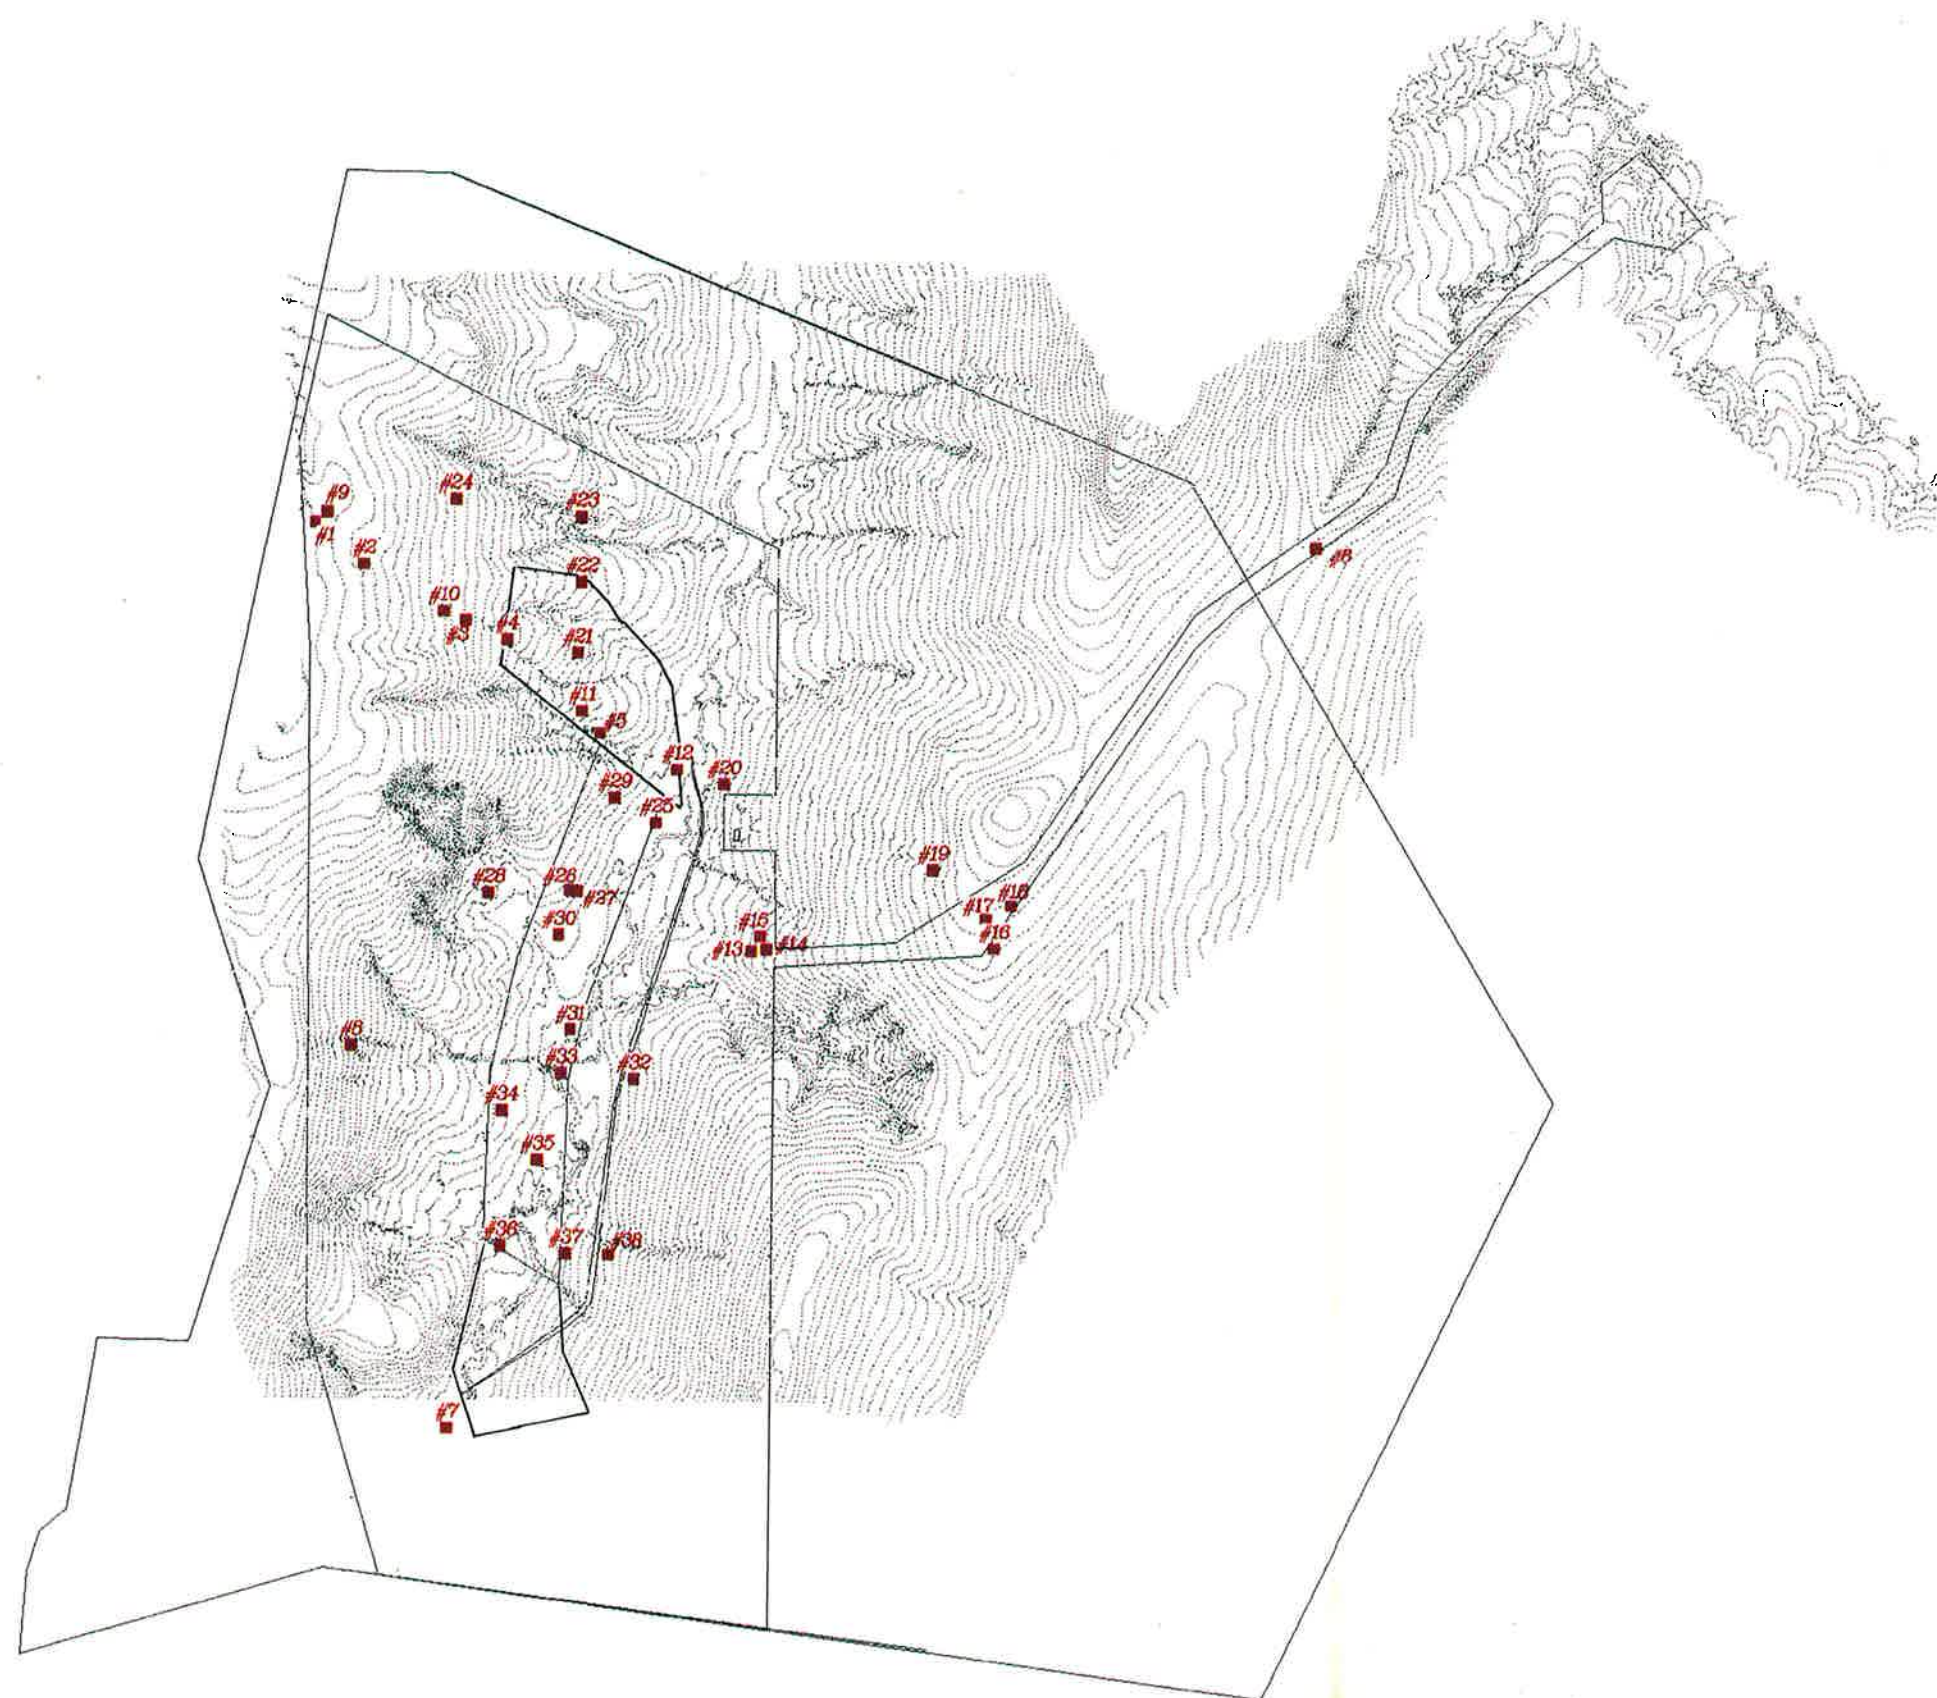
FIG. 13

**SITE INSPECTION/  
SOIL SAMPLING LOCATIONS**

Soil and land unit characteristics were recorded throughout the area of interest, details of which are included in Annexure A. A total of 39 sites were inspected, the locations of which are shown on Figure 14. Soil profiles were described and sampled from backhoe pits. As is usual practice in carrying out a reconnaissance soil/site survey, numerous additional observations were made en-route between sites, noting vegetation types, surface conditions (soil colour, rockiness, colour of termite mounds etc.) all of which are reasonable indicators of soil type.

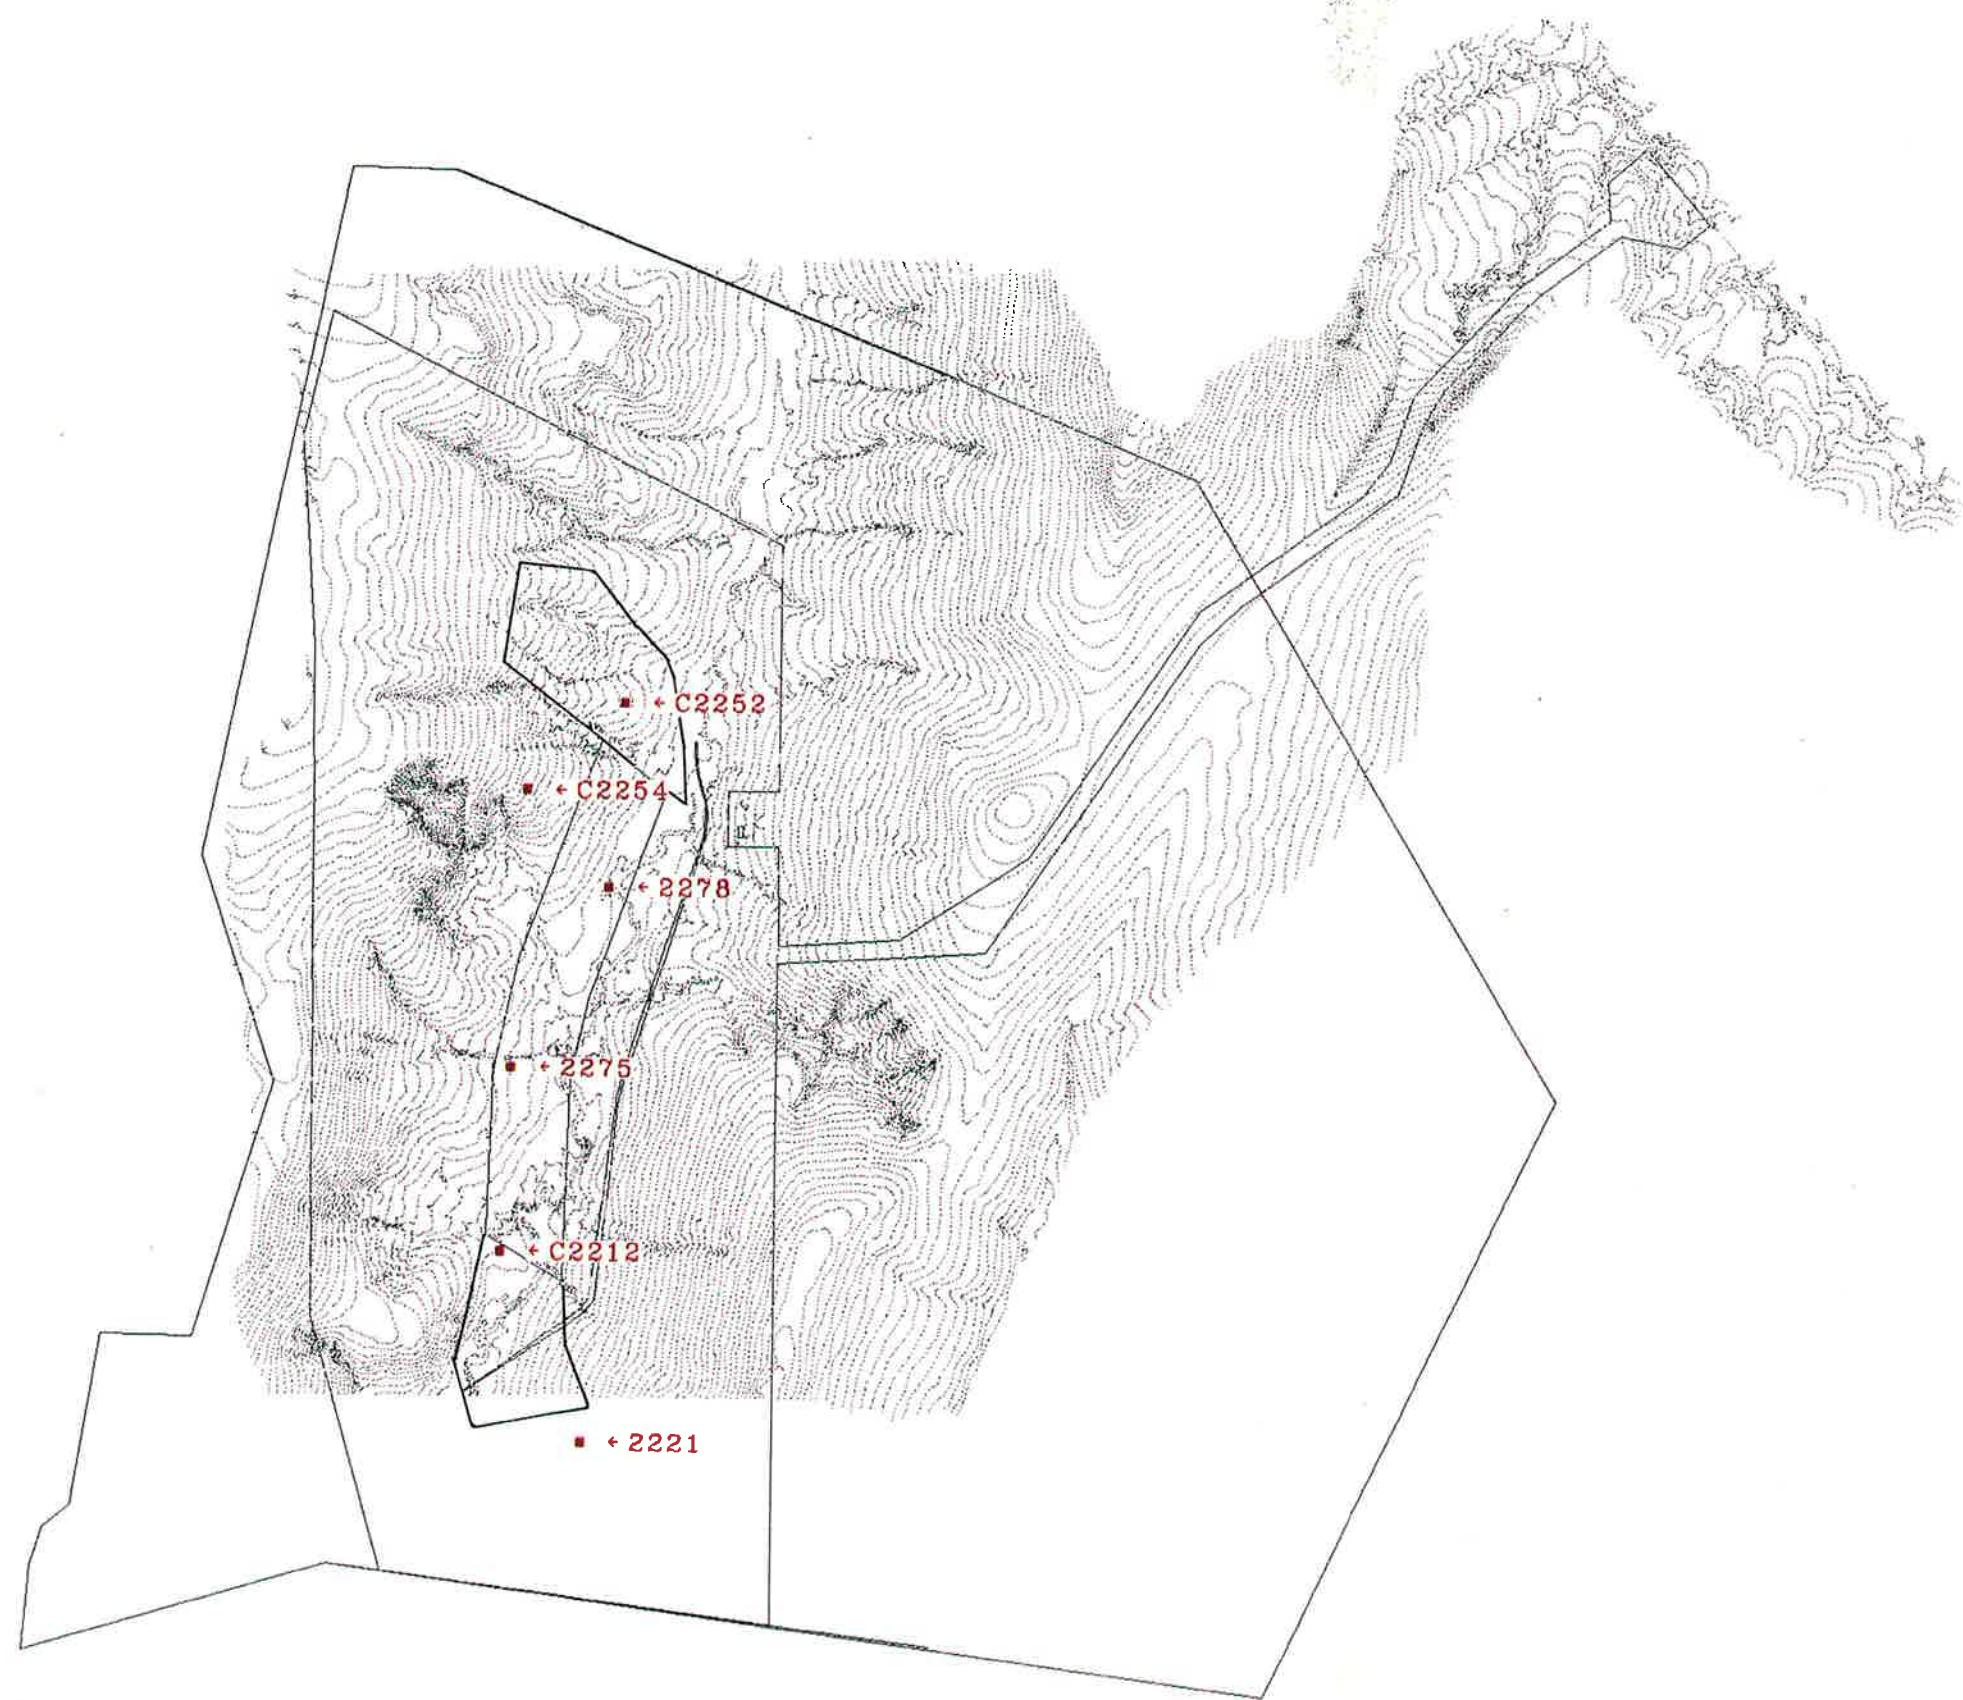
FIG. 17

**BOREHOLE LOCATIONS OF  
GEOCHEMICALLY SAMPLED  
CORES**
