PROGRESSIVE REHABILITATION CLOSURE PLAN FOR EPML00841513 *COMMODORE MINE PRCP*

Title of the project	Commodore Coal Mine
Document title	Commodore Mine PRCP
Version number	V0.3
Document ID number	PRCP Commodore Coal Mine ML50151
Date of submission	5 April 2022
Tenure number(s)	ML50151
EA holders name	Millmerran Power Partners *
EA holders contact details	Millmerran Power Partners* c/- Millmerran Power Management Pty Ltd Level 26, 400 George Street BRISBANE QLD 4000 Tel: + 61-7 3001 7177
Prepared by	Leticia Tolson – Civil Mining & Environment Coordinator
Reviewed by	Joel Rickuss – External Resources Manager

PRCP FOR EPML00841513

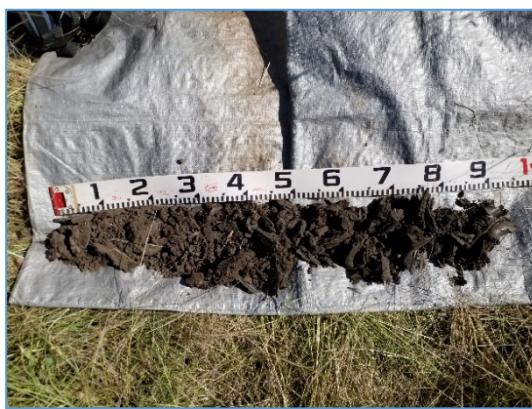
Photographs 1 and 2 are representative of natural soils at the mine. Samples were collected during the 2020 rehabilitation monitoring assessment⁵.

Photograph 1. Black vertisol soil profile sampled during 2020 rehabilitation monitoring at analogue transect AN5.

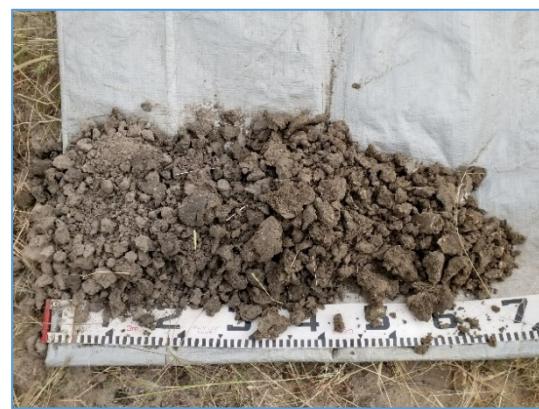
Photograph 2. Grey vertisol soil profile sampled during 2020 rehabilitation monitoring at analogue transect AN5.

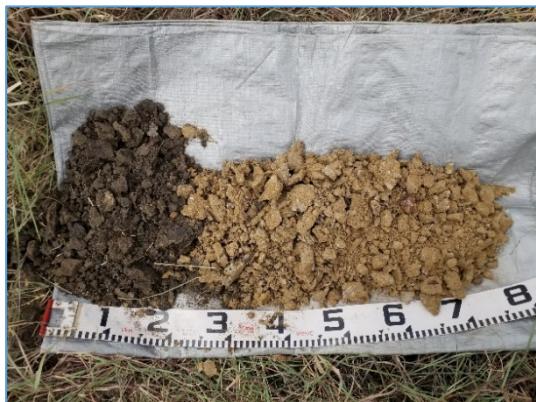
Photograph 3. Yellowish brown spoil material below topsoil at monitoring transect CD13.

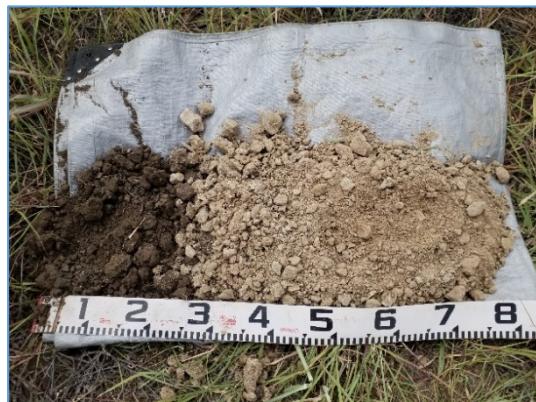
Photograph 4. Pale brown spoil material below topsoil at monitoring transect CD16.

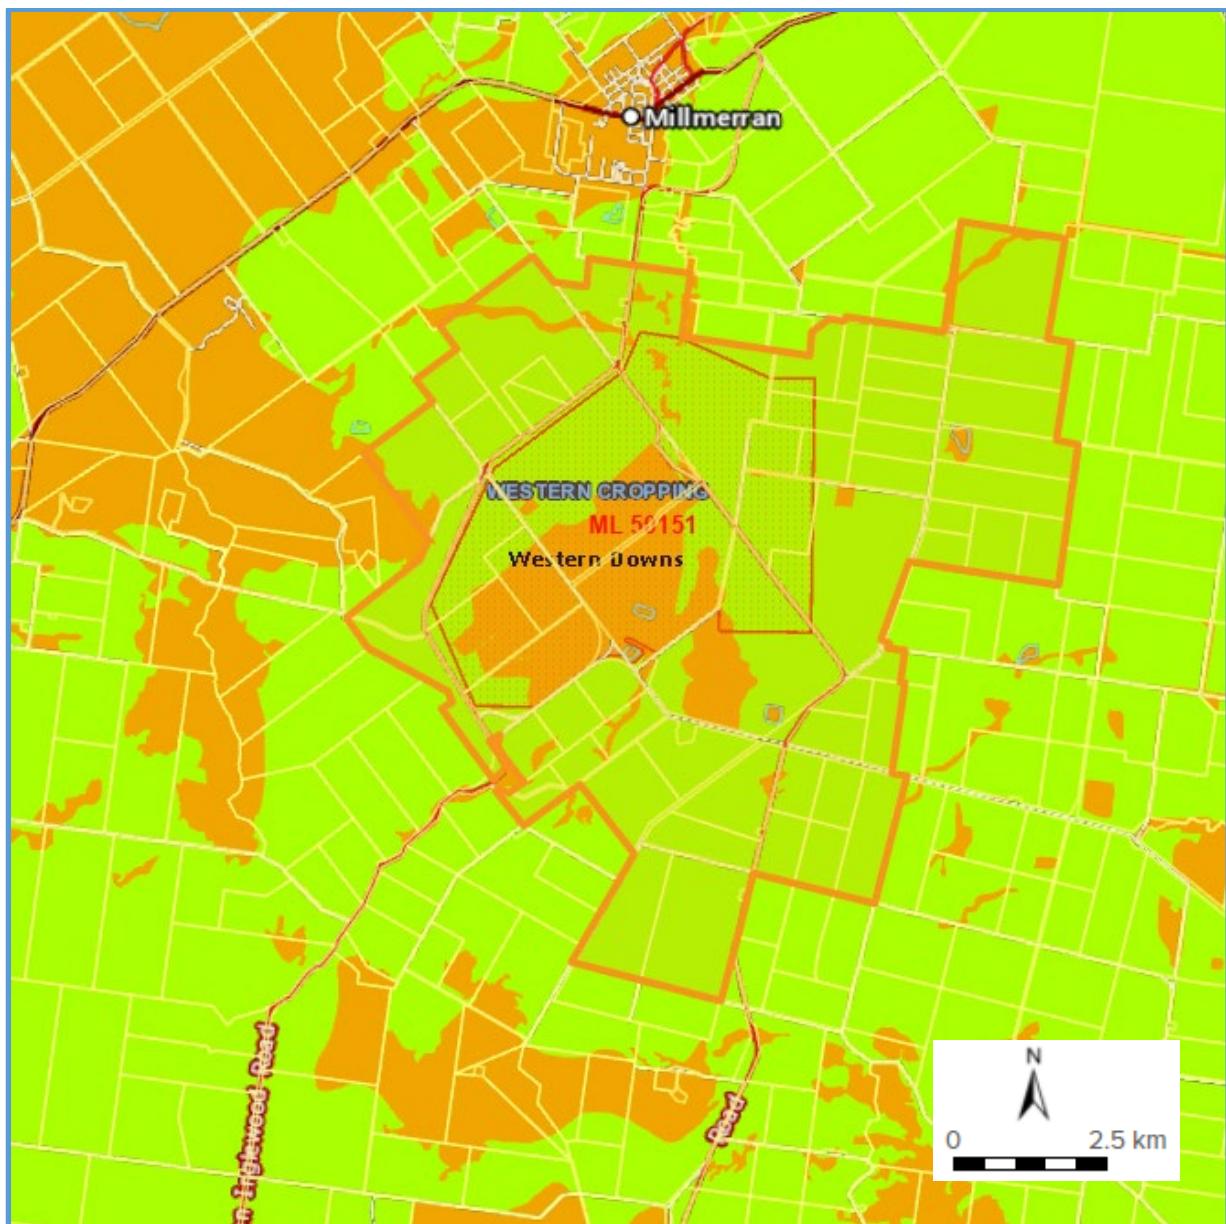
Figure 20 - Western Downs SCL Areas around Commodore Mine

The mine is surrounded by Western Downs Strategic Cropping Land (SCL). See **Figure 20 - Western Downs SCL Areas around Commodore Mine**. SCL areas are in green, and orange is Western Downs zone of the Western Cropping areas (QLD Globe, 2021).

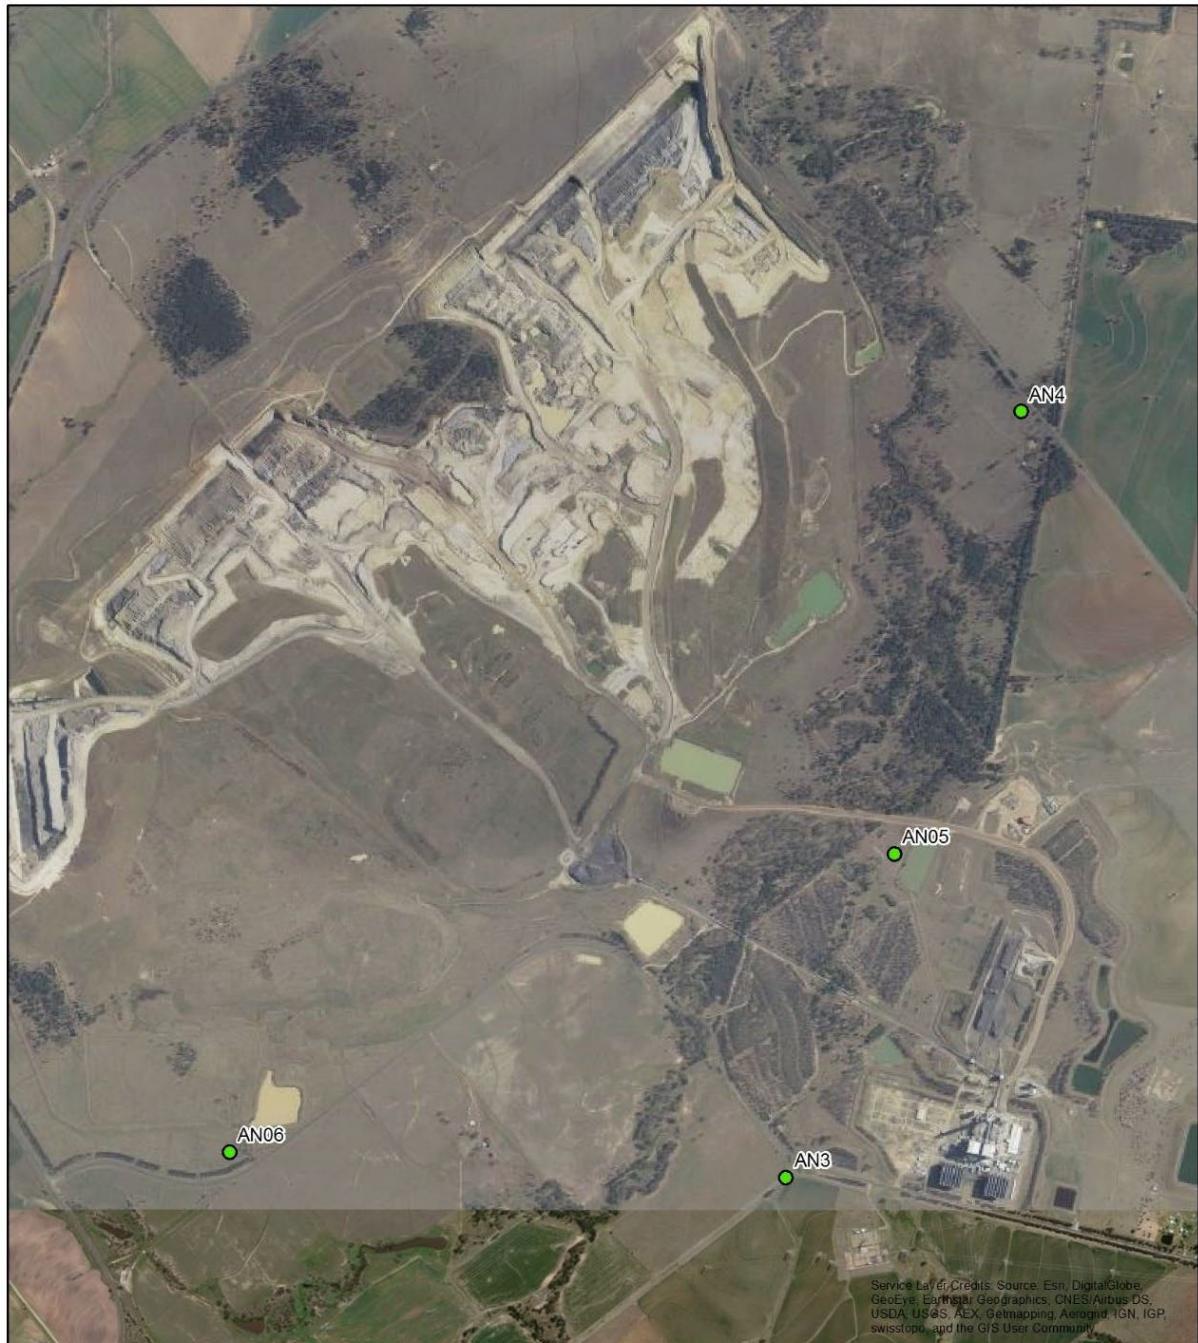
Commodore Coal Rehabilitation Monitoring - Analogue Transects

Date: 21/06/19
GDA94 (MGA56) Source(s): Landloch, Downer

AN6 was also established in 2018 as another replacement of the recently deleted AN2 and is situated on a flat area of pasture, on the outer boundary of the project area.

The transect has remained relatively unchanged since establishment and it has a range of pasture grasses including Rhodes grass, Queensland bluegrass, setaria species, barbed wire grass and windmill grass, with moderate to low weed cover.

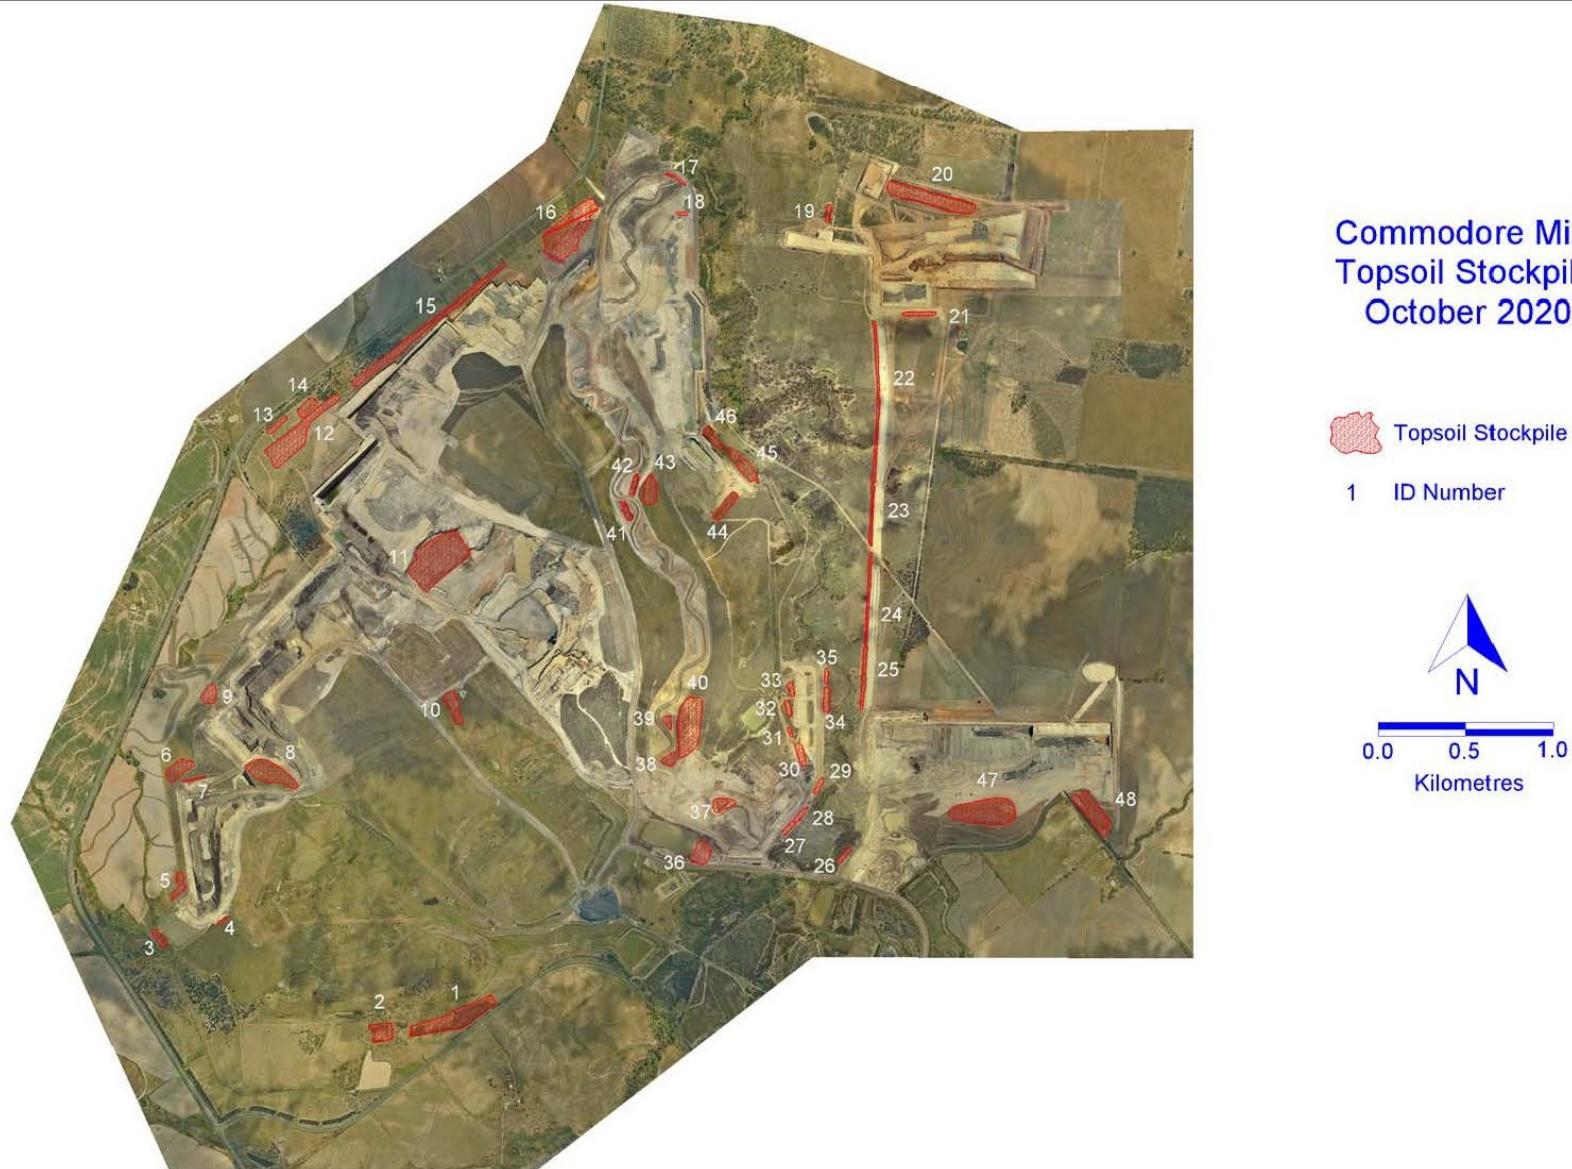
Figure 41 - Locations of topsoil stockpiles at Commodore Coal mine.

Information about current stockpile materials (2021) and their locations was provided by the mine contractor. Stockpile volumes are provided in Table 26 and locations are displayed in Figure 41.

Table 26 - Summary of stockpiled topsoil materials and volumes for rehabilitation.
