***Peabody Energy Ltd***

***Updated Feasibility Level Geotechnical Study for  
Codrilla***

**Date:** 23<sup>rd</sup> March, 2012  
**Project No:** 001047  
**Report No:** IMC1397

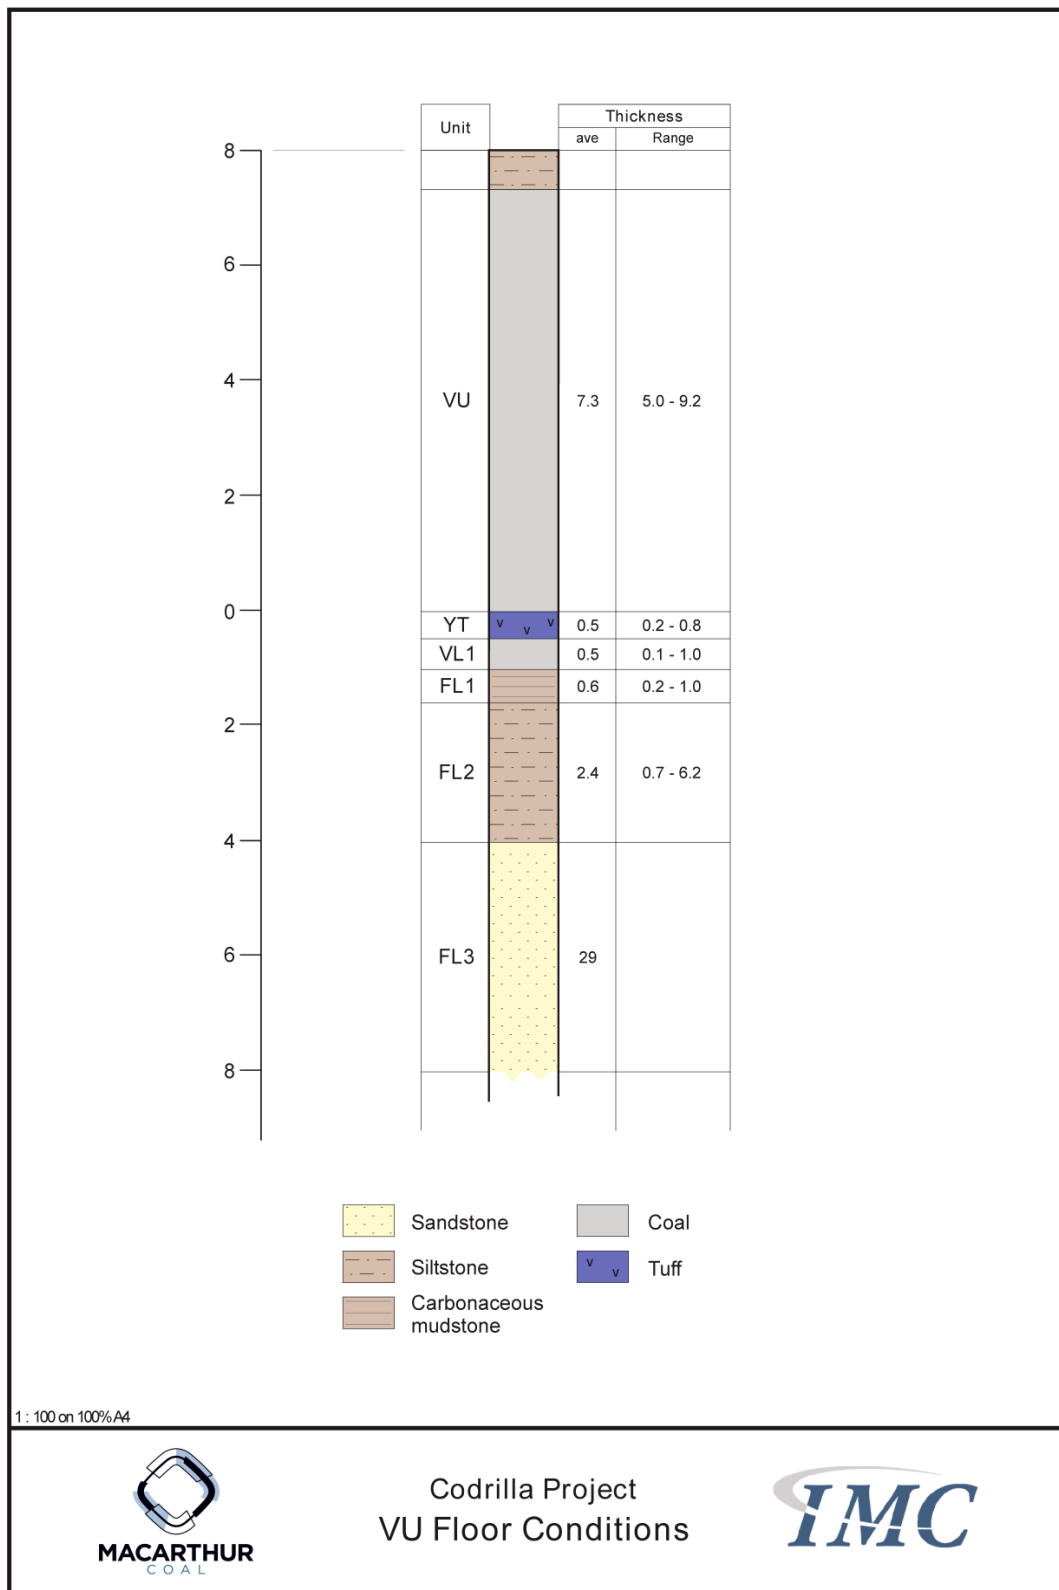
**Figure 6-6: VU Floor Conditions**

The VU Seam is the principal target seam and will form the mining floor in the opencut pit. Consequently the VU Seam floor has been examined in some detail. The overlying lessser seams would be mined as transient parting operations and hence floor conditions for individual upper seams have not been addressed. The floor sequence for the VU Seam is illustrated in the representative section shown in Figure 6-6.

Laboratory testing on floor samples indicated a UCS value of 9.9 MPa for Unit FL1; with an average slake durability of 75.7%, ranging from 29.4% to 96.3%. Other tests were on weathered samples and these showed a reduction in strength to around 2.5 MPa for all three floor units, with a corresponding reduction in durability to 22.5% on average.

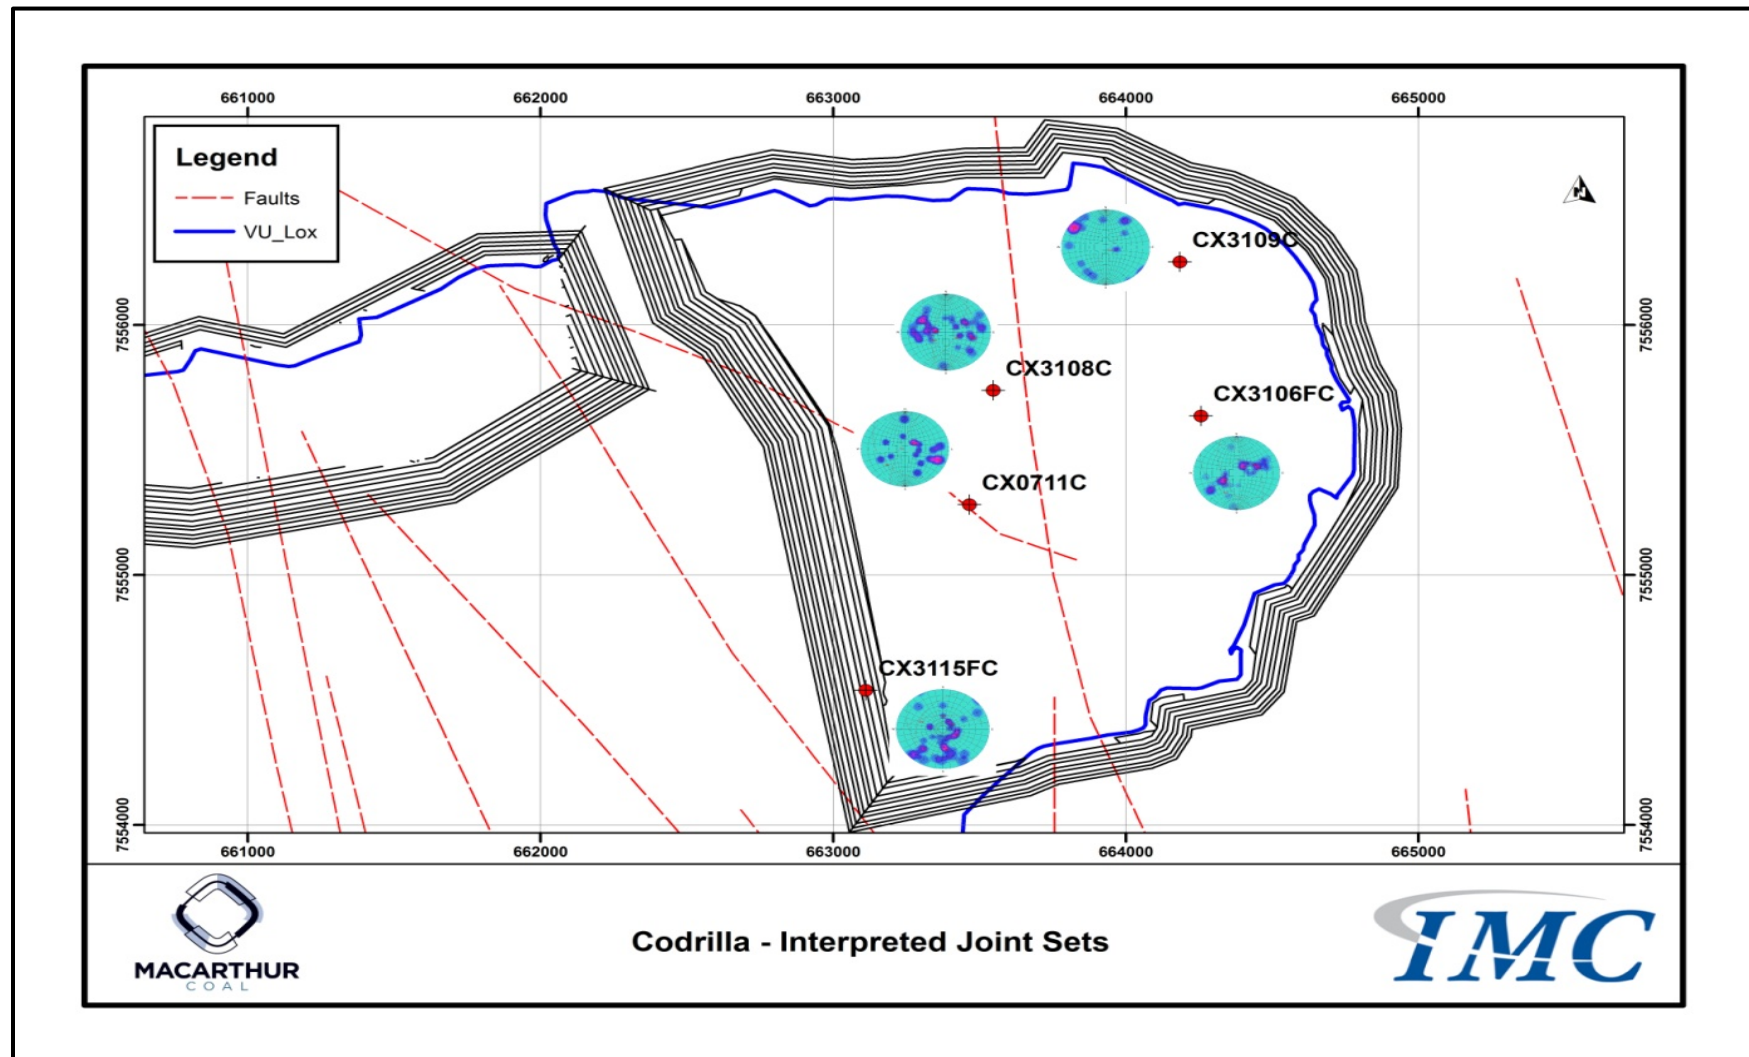
Figure 8-11: Interpreted Joint Sets – Stereonet Layout Plan

Figure 8-11 presents a site plan showing the stereonets of the major joint sets interpreted from each borehole. An analysis of joints for each borehole is presented in Section 8.7.

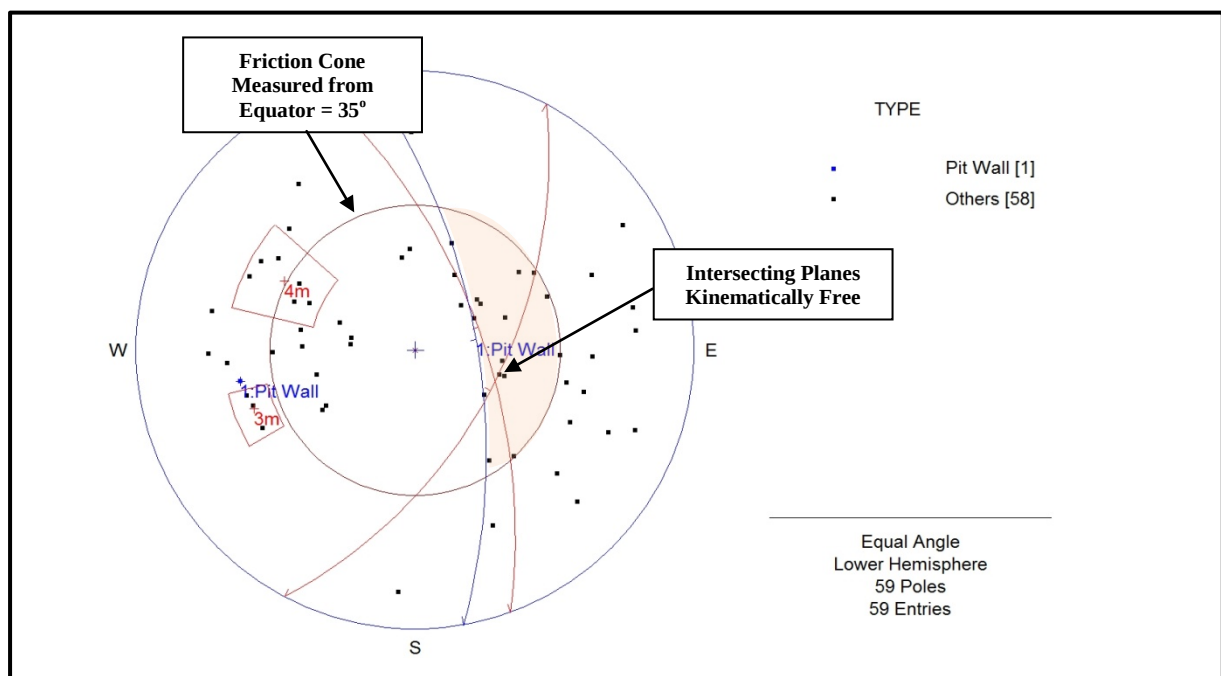
**Figure 9-3: Wedge Failure Kinematic Scenario Example**

Similarly, for wedge failure analysis, the intersection of structure planes which daylight on the pit face, inside the friction cone, are kinematically free to move.

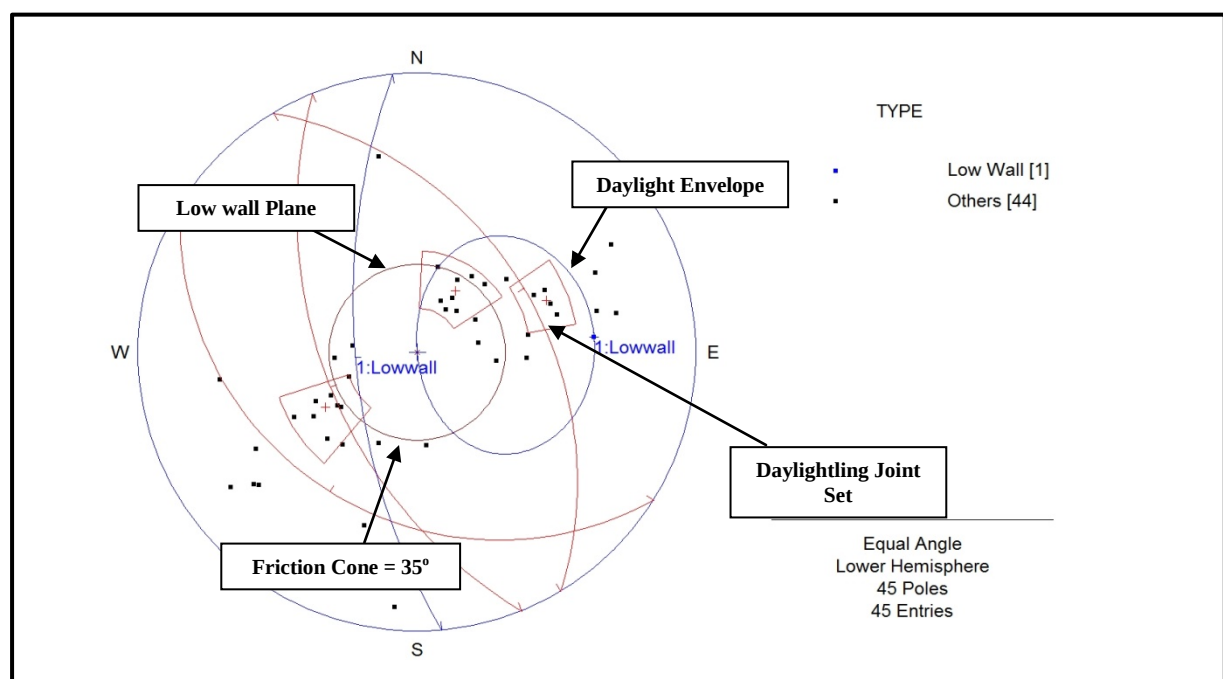
Figure 9-8: Planar Kinematic Scenario – Low wall East

The low wall east case showed that one joint set could have the potential to form planar failure configurations, with also the possibility of random joint configurations.

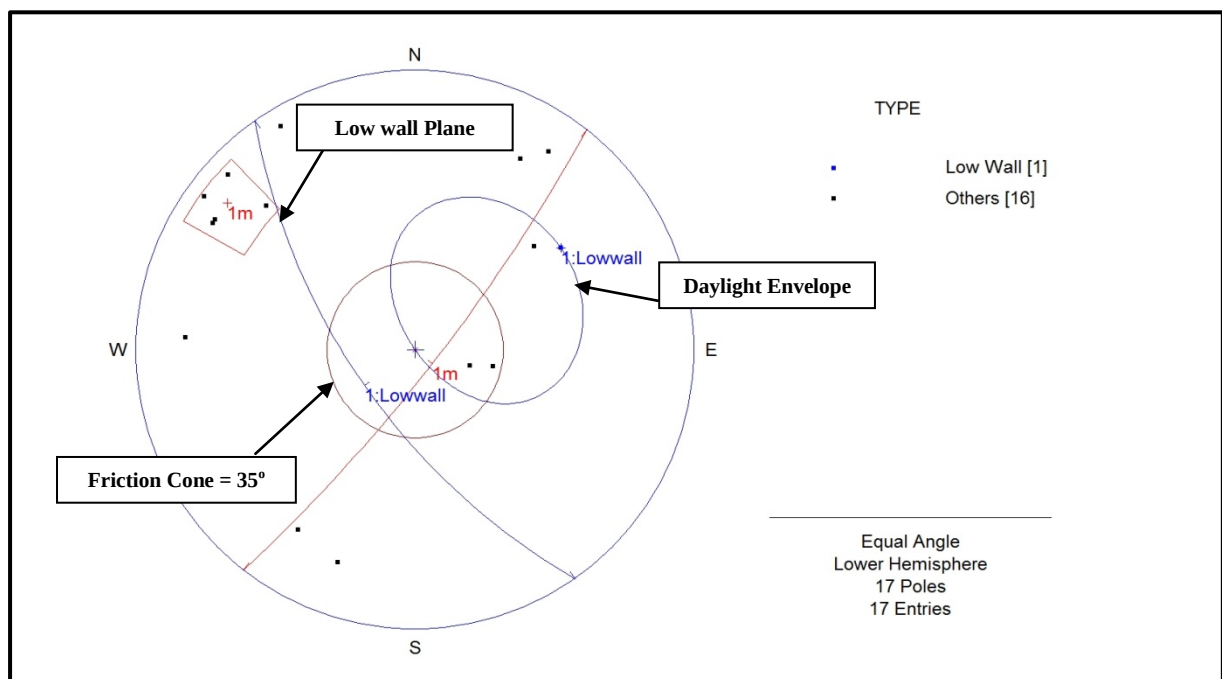
Both cases showed that interpreted joint sets were unlikely to form planar failure configurations, based on the available data; however the analyses showed the possibility for planar configurations from random joint orientations for the low wall south-east case.

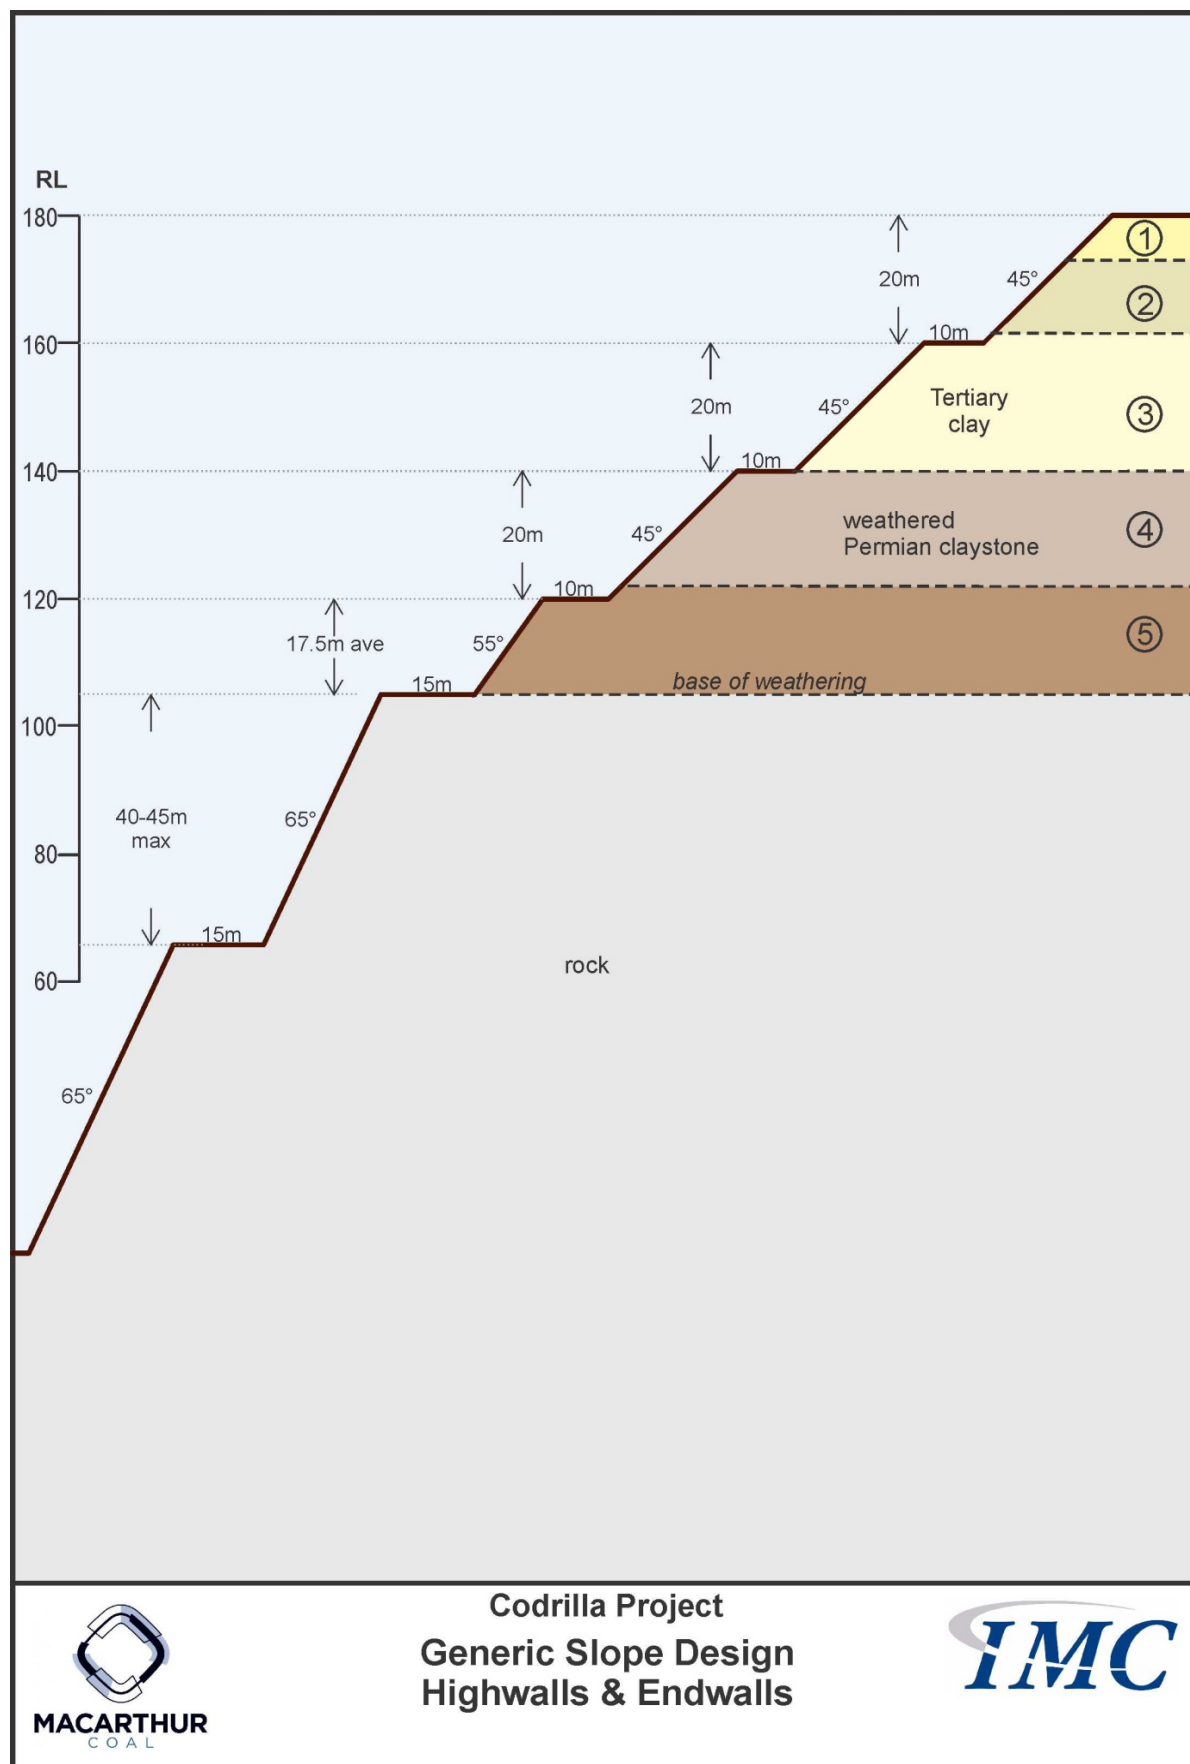
Figure 10-1: Generic Slope Design

Based on the results of the slope stability modeling, it is concluded that the proposed bench configurations for the generic design provides an adequate degree of stability against mass failure of the Tertiary and weathered Permian clays. This part of the design, down to the base of Unit 5, is applicable to all slopes. The full generic design including the weathered Permian rock (Unit 5) and fresh Permian rock is applicable to all highwall and endwall slopes not subject to structural disturbance, and where there is not an adverse dip in the face (refer Figure 10-1). The design however is not applicable to boxcut - low walls.
