***Peabody Energy Ltd***

***Updated Feasibility Level Geotechnical Study for  
Codrilla***

**Date:** 23<sup>rd</sup> March, 2012  
**Project No:** 001047  
**Report No:** IMC1397

**IMC Mining Group Pty Ltd**  
Level 40, Riverside Centre  
123 Eagle Street  
GPO Box 2579  
BRISBANE QLD 4000

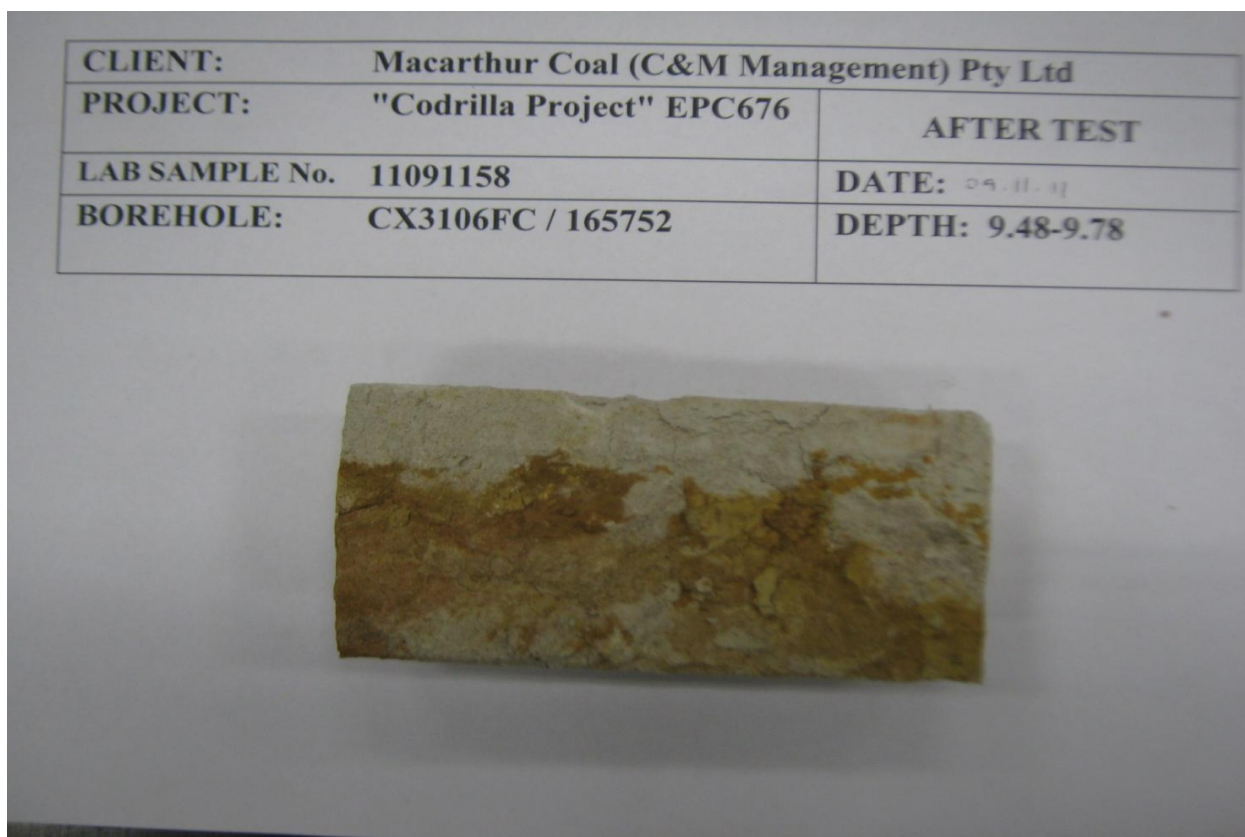
| <b>Client Id.:</b> CX3106FC / 165752 | <b>Depth (m):</b> 9.48-9.78 |

| <b>Description:</b> SILTY SAND - grey & yellow | |

| Sample Type: Single Individual Undisturbed Specimen | Remarks: Tested as Received |

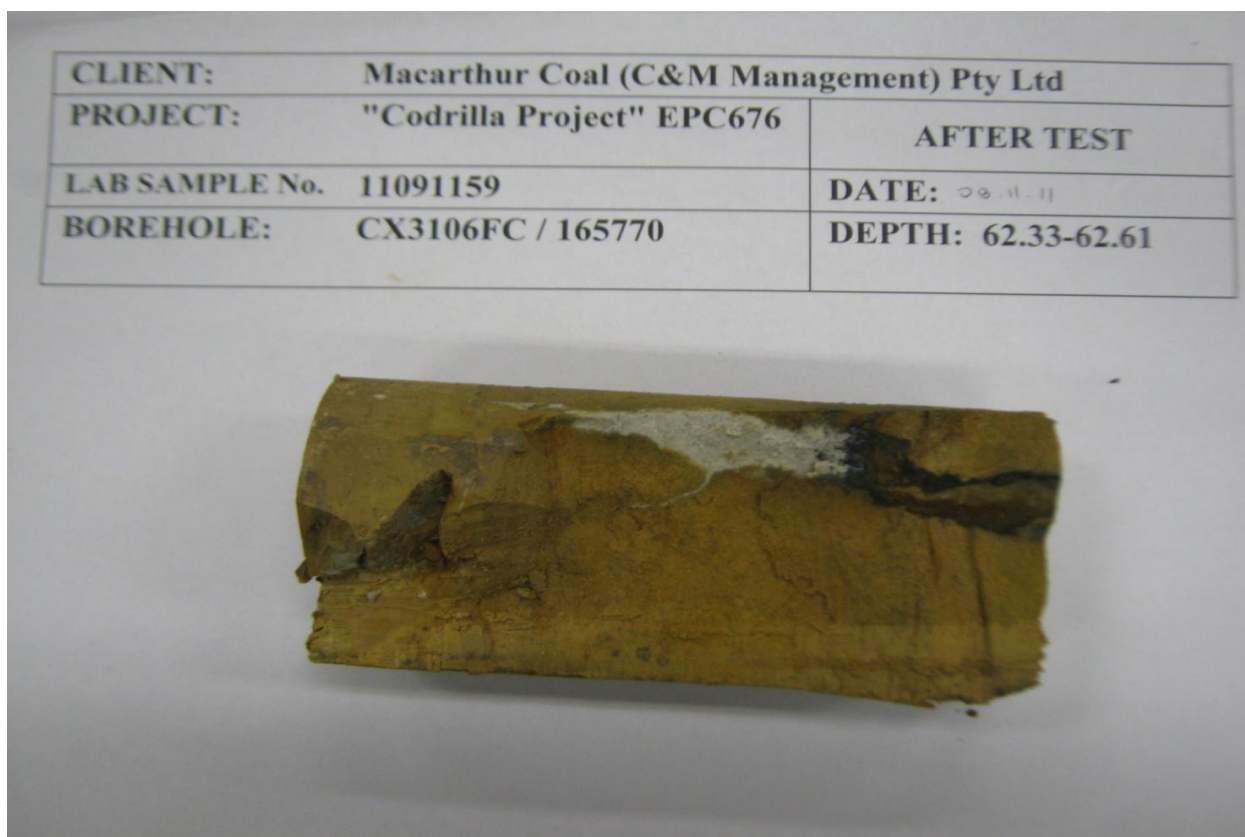
| <b>Client Id.:</b> CX3106FC / 165770 | <b>Depth (m):</b> 62.33-62.61 |

| <b>Description:</b> SILTSTONE - yellow-brown | |

| Sample Type: Single Individual Undisturbed Specimen | Remarks: Tested as Received |
