# Capricorn Stone Products Pty Ltd

## Progressive Rehabilitation Closure Plan

Capricorn Stone Products Pty Ltd – Progressive Rehabilitation  
Closure Plan - Capricorn Sandstone Quarries, 227 Power  
Station Road, Stanwell QLD 4702

**20 January 2023**

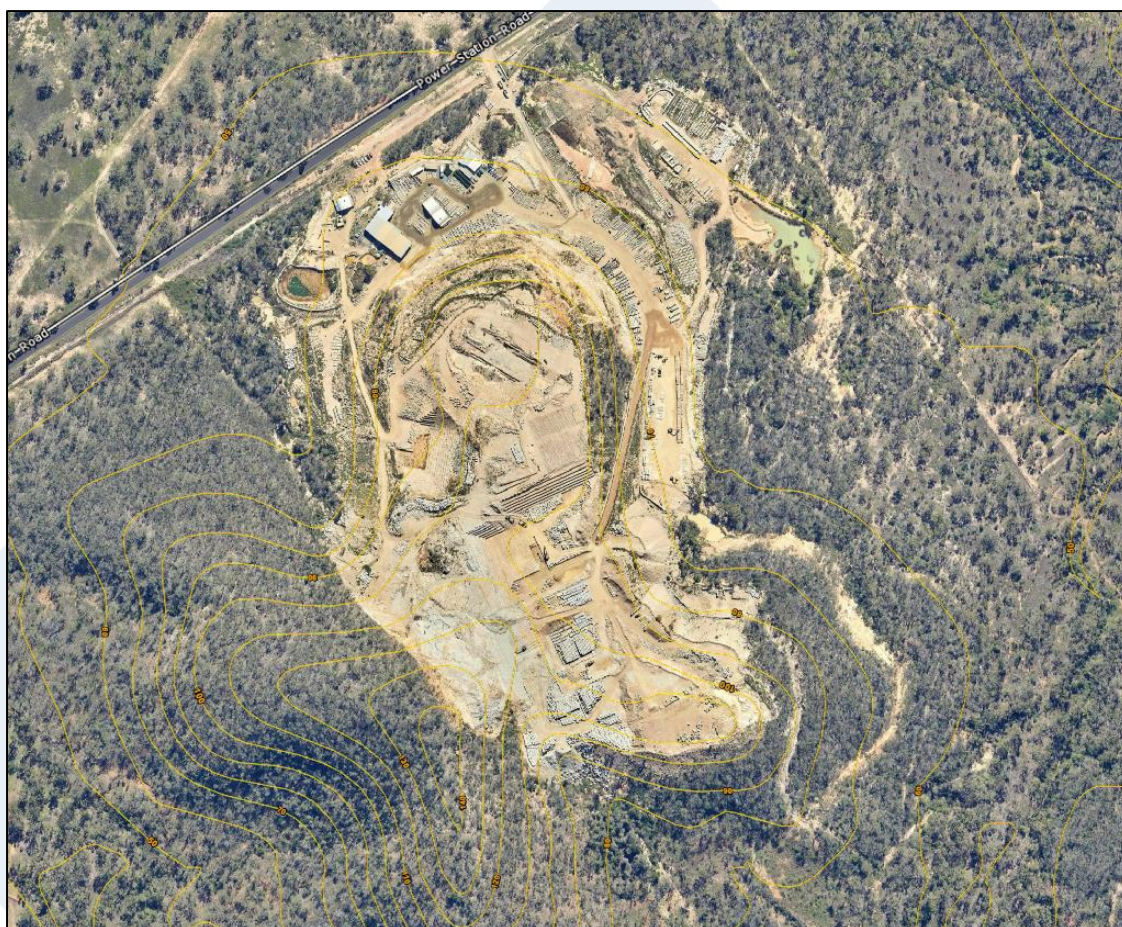
Figure 1. Topography around the site (image QLD Globe ©).

The site consists of a sandstone outcrop which rises to an elevation of approximately 140 m at the eastern side of the activity down to 60 m on the western side of the activity (Figure 1).

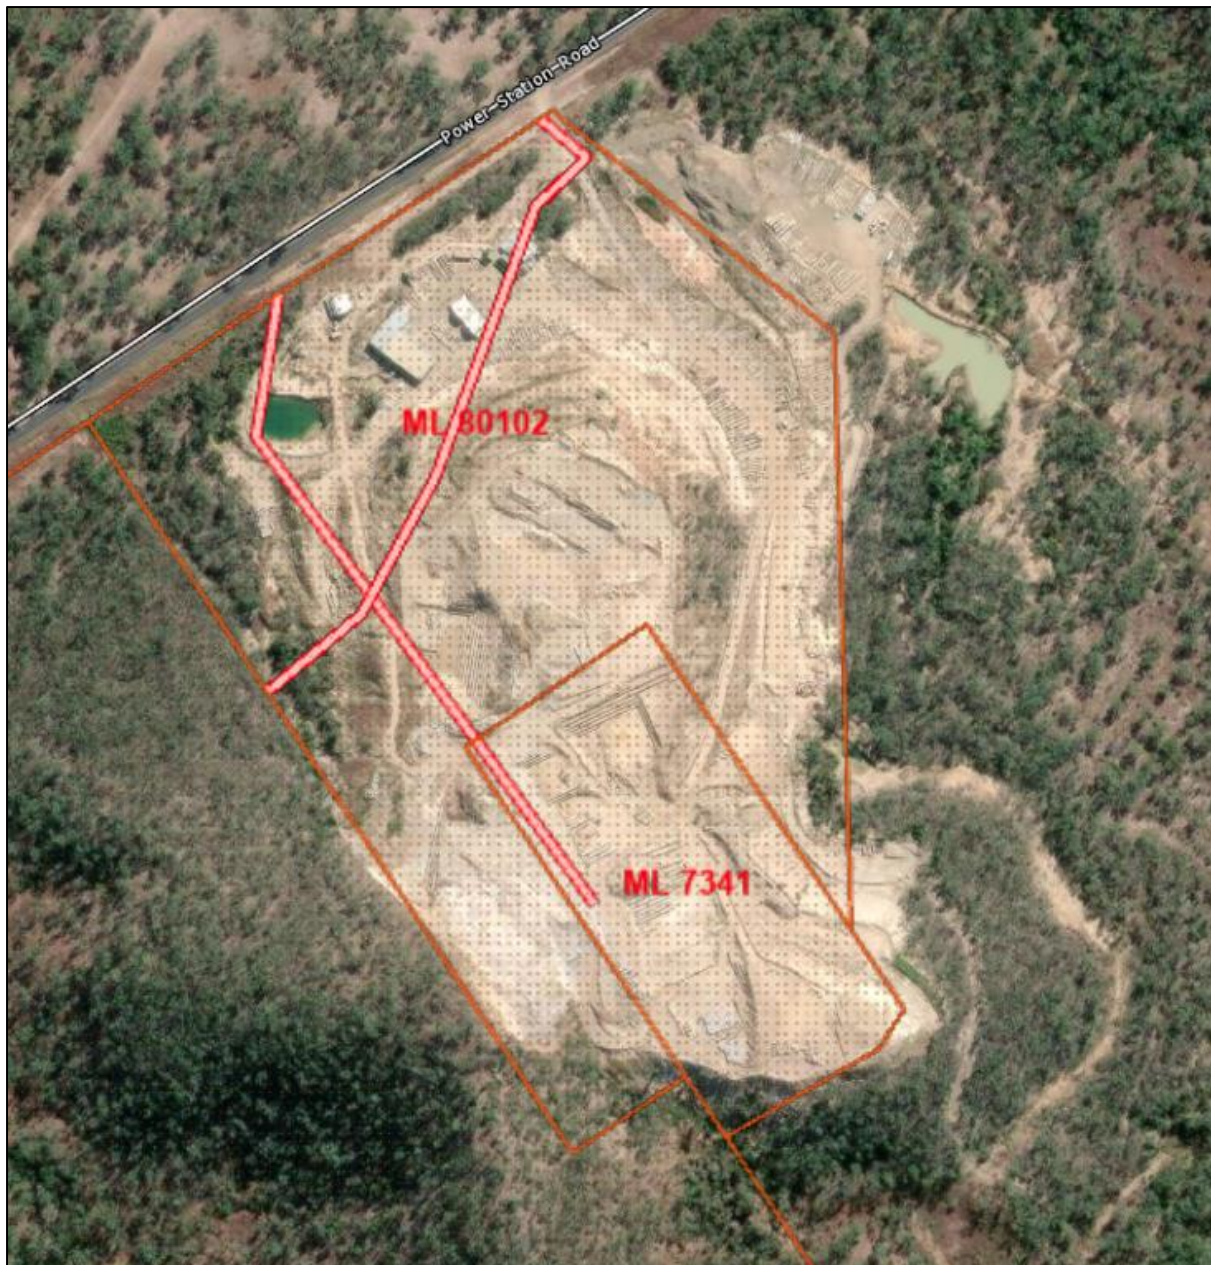
Figure 8. Mining leases at the site (Image QLD Globe ©).

The mining leases on the subject parcels of land are ML 80102 (18.84 ha) and ML 7341 (5.97 ha). The extent of these leases can be seen in Figure 8.

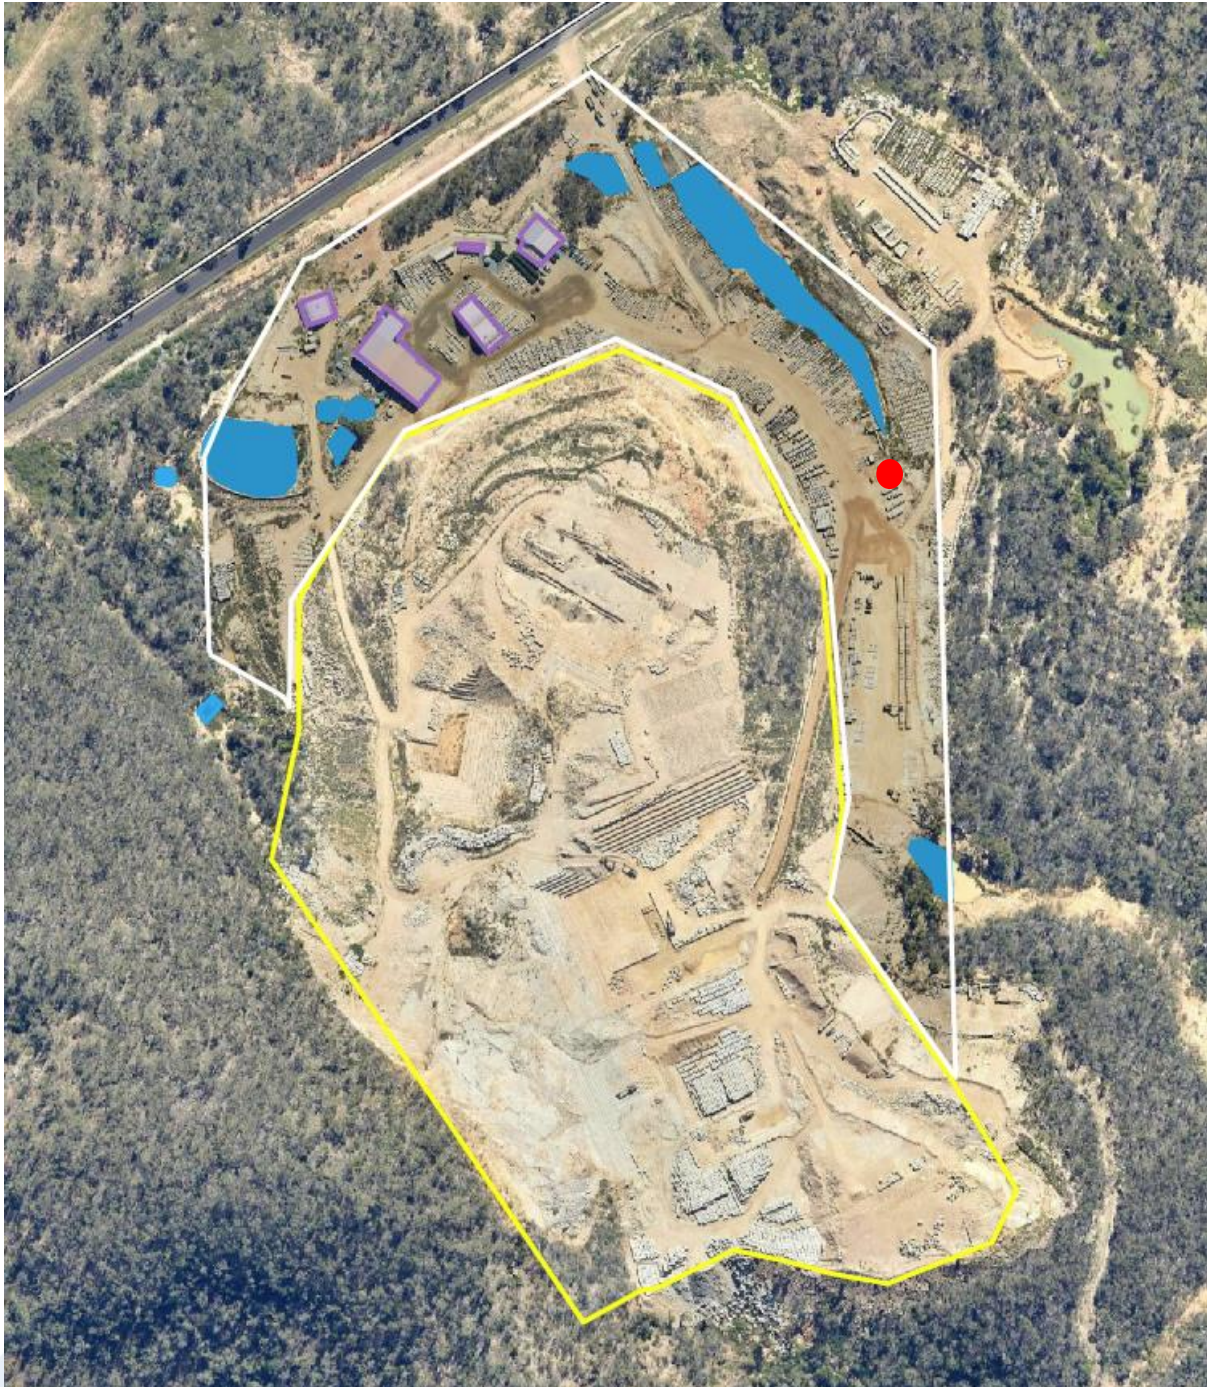
Figure 9. Approximate locations of stormwater management dams (blue polygons), buildings (purple polygons), lay down areas (white polygon), extraction area (yellow polygon) and minor fuel storage (red circle) (Image QLD Globe ©).

The location of these items as well as the approximate location of the extraction and laydown areas can be seen in Figure 9.

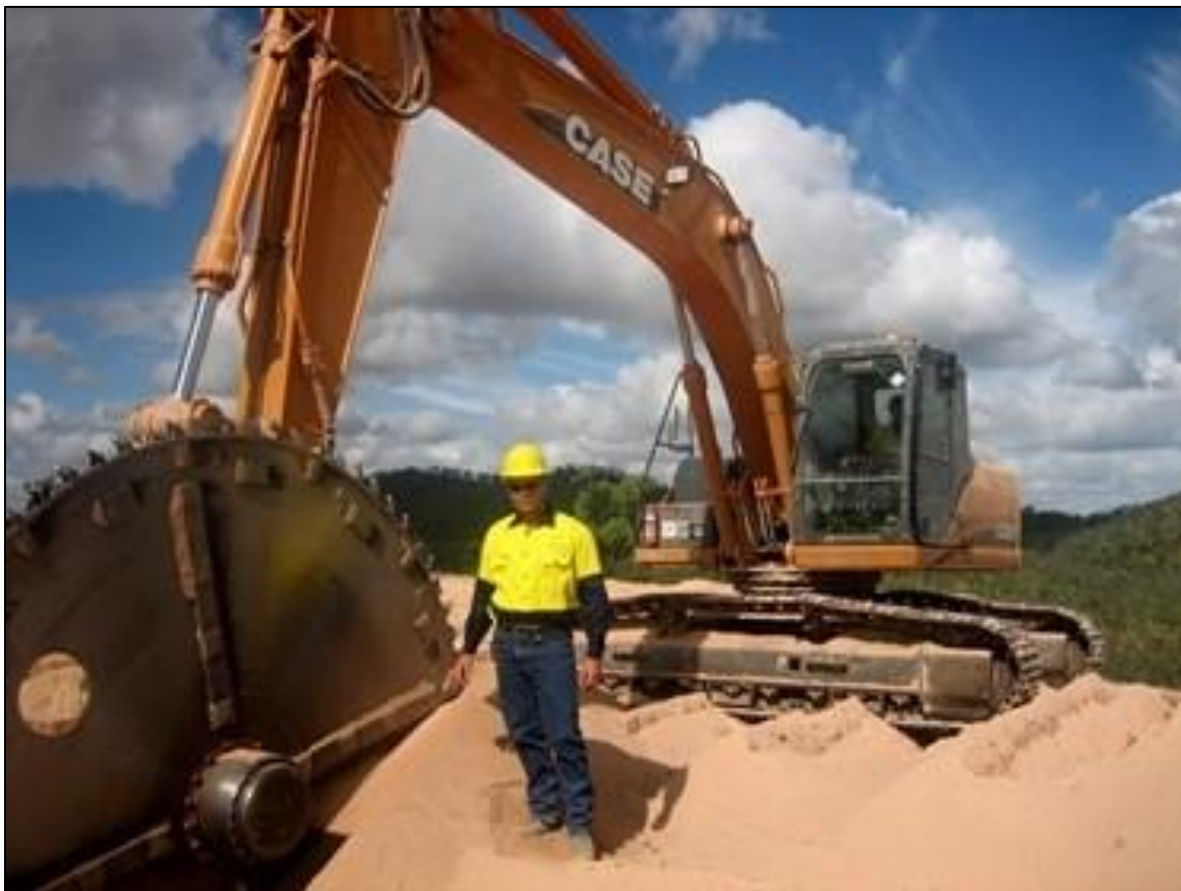
*Figure 10. Excavator mounted saw.*

The mining operation consist of mechanically sawing sandstone blocks from the hillside. There are no chemical processes used at any point in the mining process. The resource being extracted exists as a sandstone outcrop rising to approximately 140 m. As such there is no interference with any aquifers (saline or otherwise) and there is no interaction with acid forming rock or acid sulphate soils. Given these characteristics, there are no waste rock dumps, heap leach pads, contaminated water storages, tailings dams, pits, voids or any other hazardous features associated with the mine.

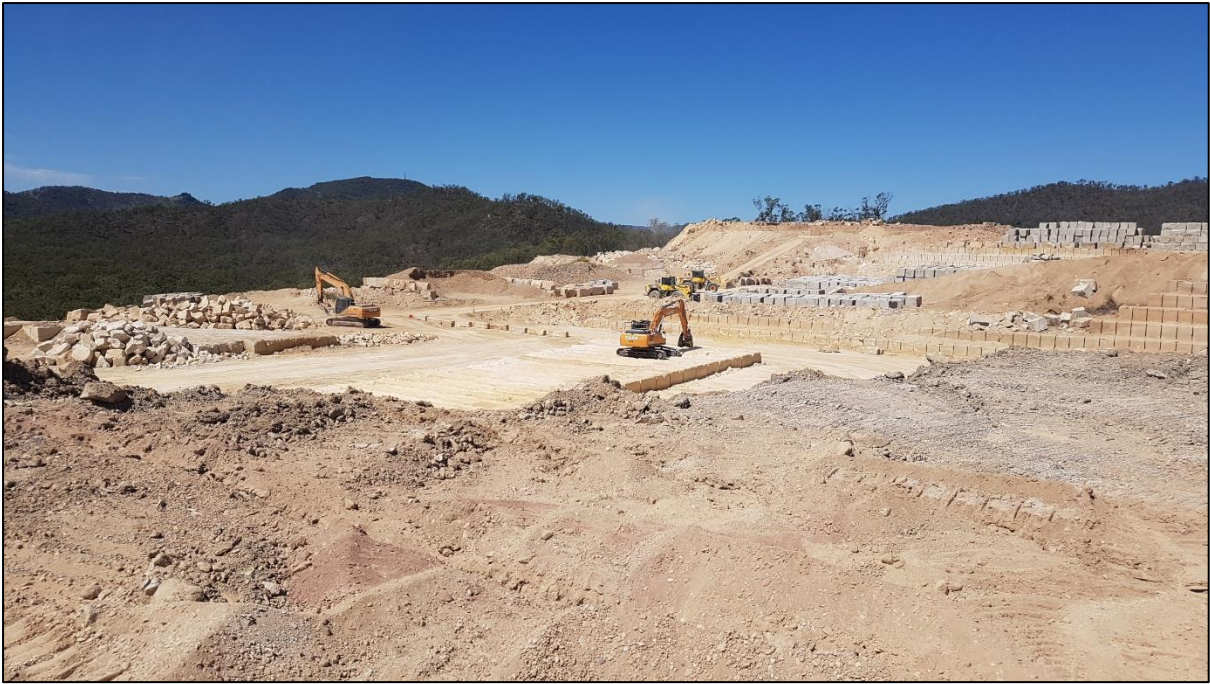
*Figure 11. Excavator mounted saw cutting blocks at the site.*

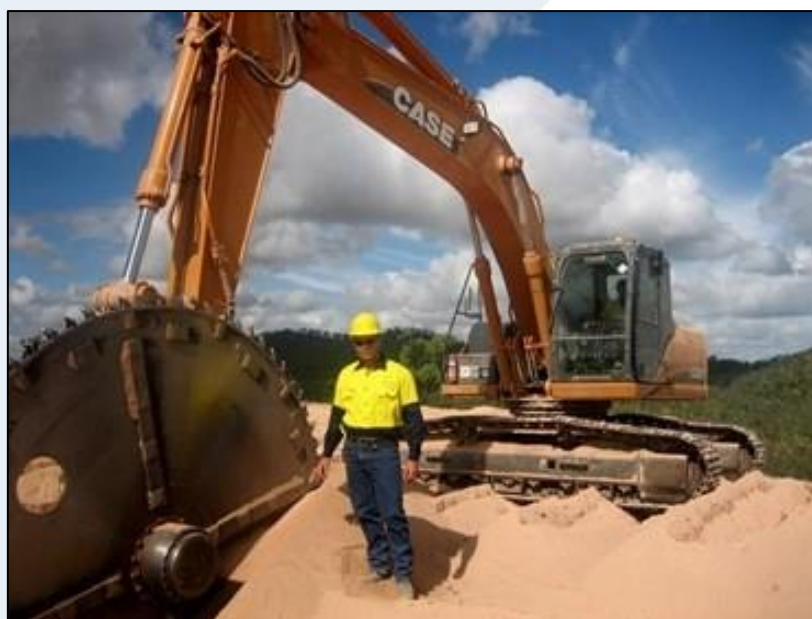
*Figure 2. Excavator mounted stone saw.*

When Roy Gough and his son Reece reopened the quarry in 1994 the blocks were cut with Fantini chainsaws, then drilled underneath to extract the blocks. CSP has come a long way since then with substantial investments in excavator mounted cutting wheels (see Figure 2). These have enabled CSP to significantly improve efficiency whilst dramatically reducing physical workloads on employees concurrently.

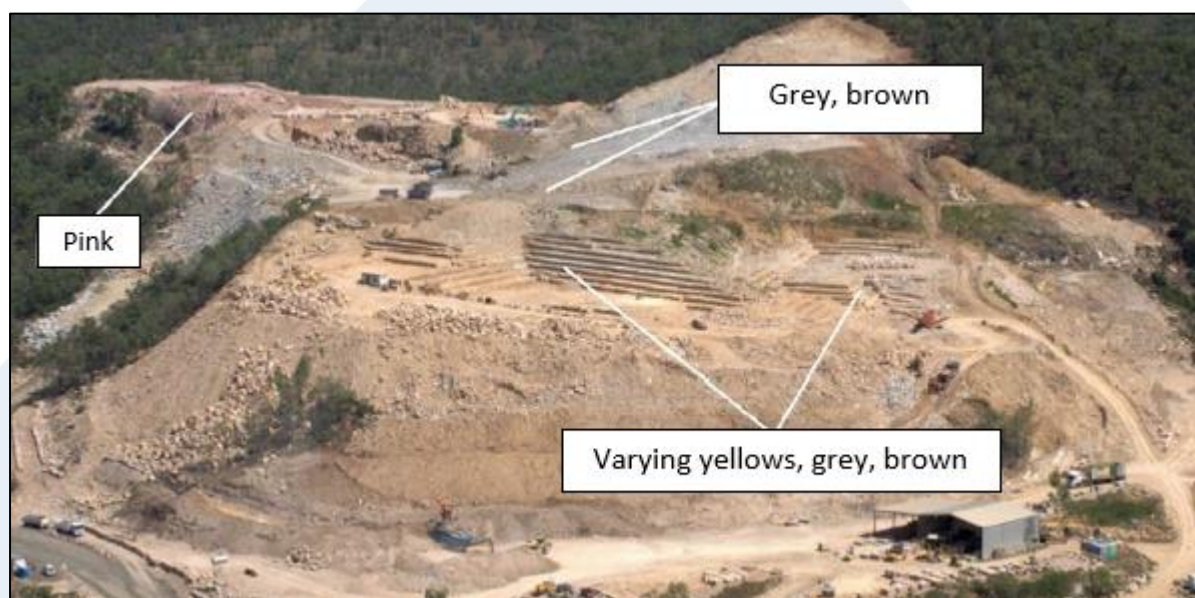
Figure 10. Variability of product across Capricorn Sandstone Quarries.

Mining operations at Capricorn Sandstone Quarries are somewhat unusual, in that they provide a high value but low volume commodity. The sandstone that is extracted on site is not a homogenous resource. The characteristics of the stone is highly variable across the site (see Figure 10) and demand for stone with certain features can vary significantly from a temporal point of view. This characteristic means that mining is not performed on a progressive basis, as consumer demand dictates when and where extraction is occurring on site. Essentially, this results in the entire site being active for the entire life of the mine. The non-progressive nature of mining activities on the site precludes progressive rehabilitation of the site. Rehabilitation of a dormant area only to reopen extractive activities at a later date would be both economically and environmentally irresponsible.

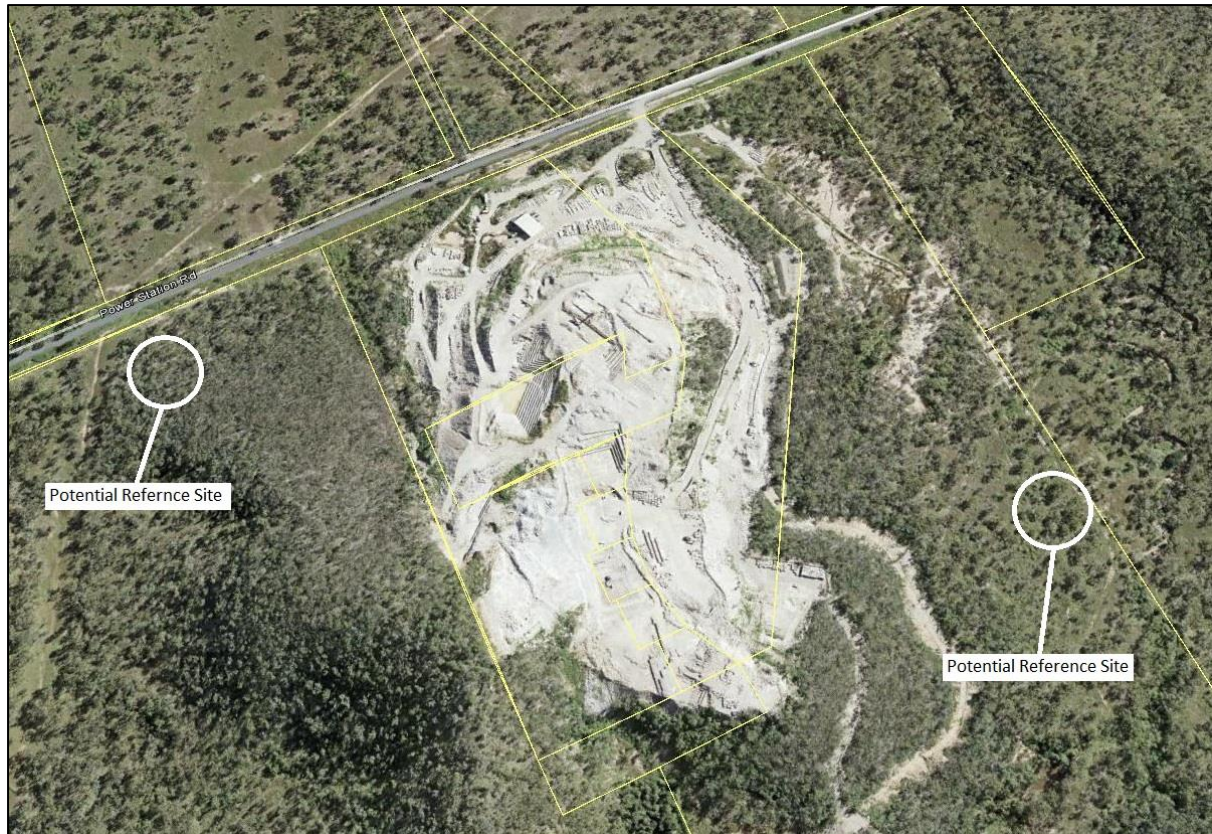
*Figure 13. Potential rehabilitation reference sites.*

- Potential Reference Site A = Lat. -23.5019 and Long. 150.3398.
- Potential Reference Site B = Lat. -23.5024 and Long. 150.3490.

These potential reference sites will be evaluated for suitability at an appropriate time in the future, closer to activation of rehabilitation actions.

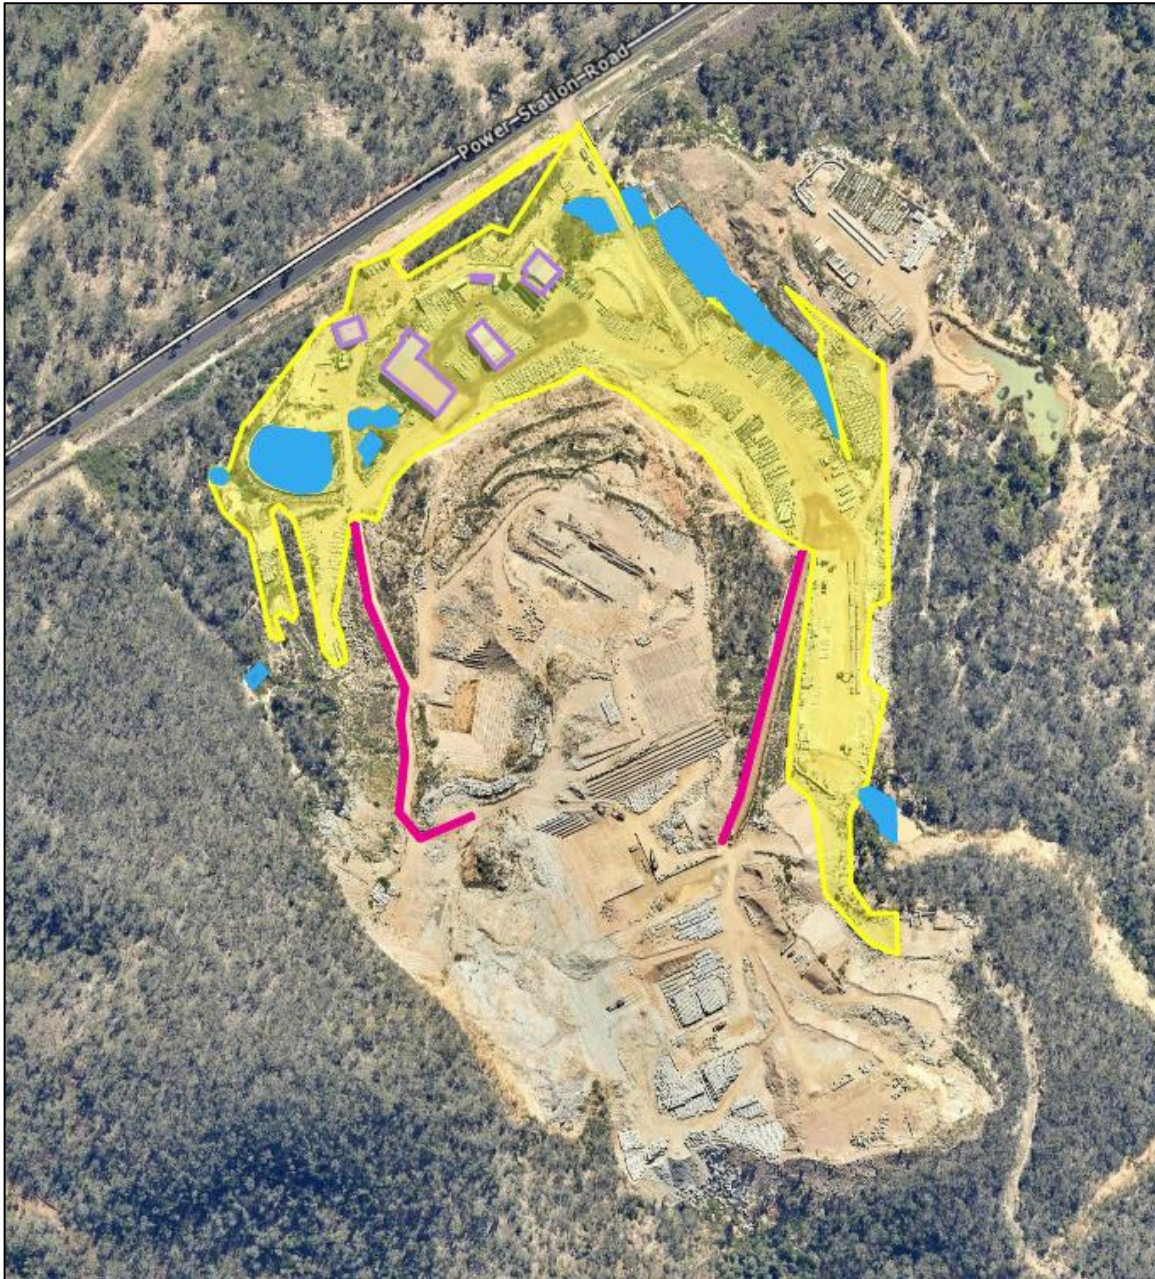
The size of the area to be retained by the landholder post mining for potential future industrial use without additional rehabilitation is approximately 7.90 ha.

*Figure 1. Areas and locations of infrastructure to be retained by the landholder. Yellow polygons are set down areas, blue polygons are dams, purple polygons are administration, workshop, processing and staff amenities and red lines are roads*

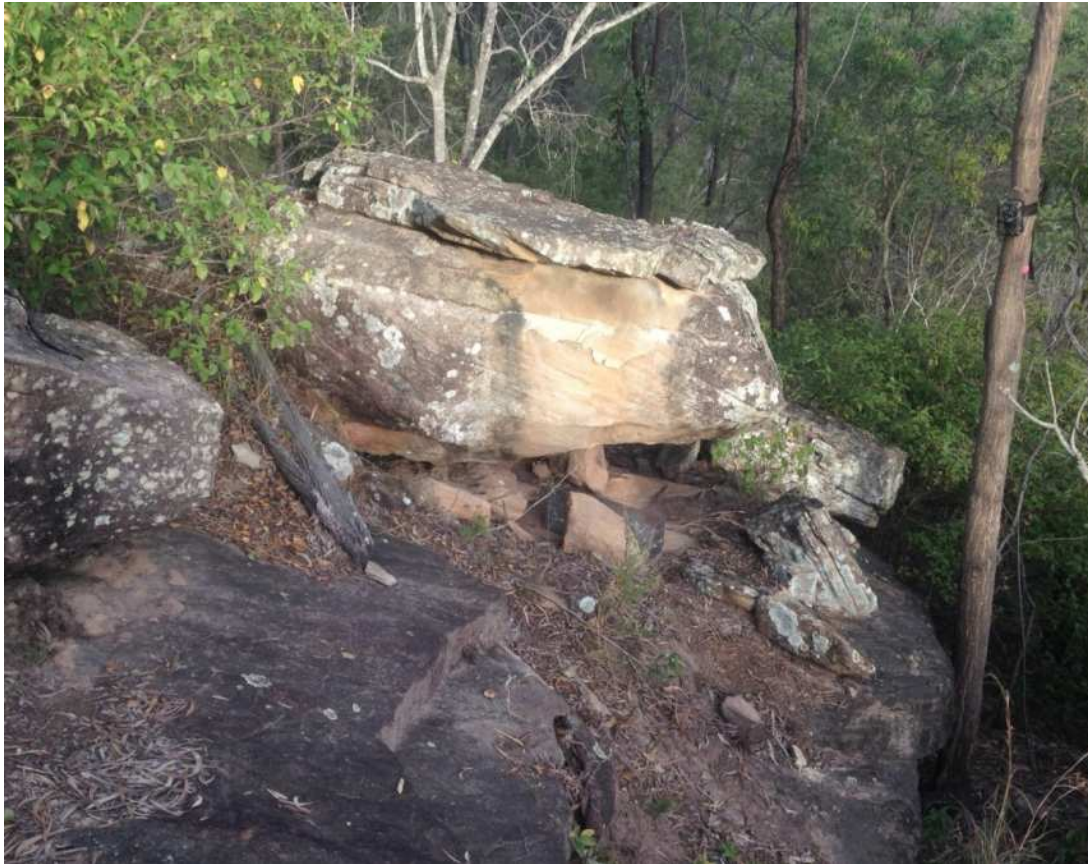
Figure 6: High quality denning and shelter habitat was present on the elevated slopes within the proposed MLA

The elevated rocky areas contained high quality denning and shelter habitat for the northern quoll, particularly around the top of the hill currently being mined, which is shown as the 120 metre topography contour in Figure 5. Habitat quality was highest on the eastern side, with an abundance of rocky crevices, overhangs and boulder piles, and where infestation of the weeds, Lantana (*Lantana camara*) and Rubber Vine (*Cryptostegia grandiflora*) was less severe (Figure 6).

This area was subject to targeted survey for northern quoll, with 5 infrared cameras, 11 large Elliott traps and 23 quoll-sized wire cages deployed around rocky denning habitat and along the easterly-aspect sandstone slope. Cameras were deployed for 4 consecutive nights, while cages and Elliott traps were set for 3 nights.

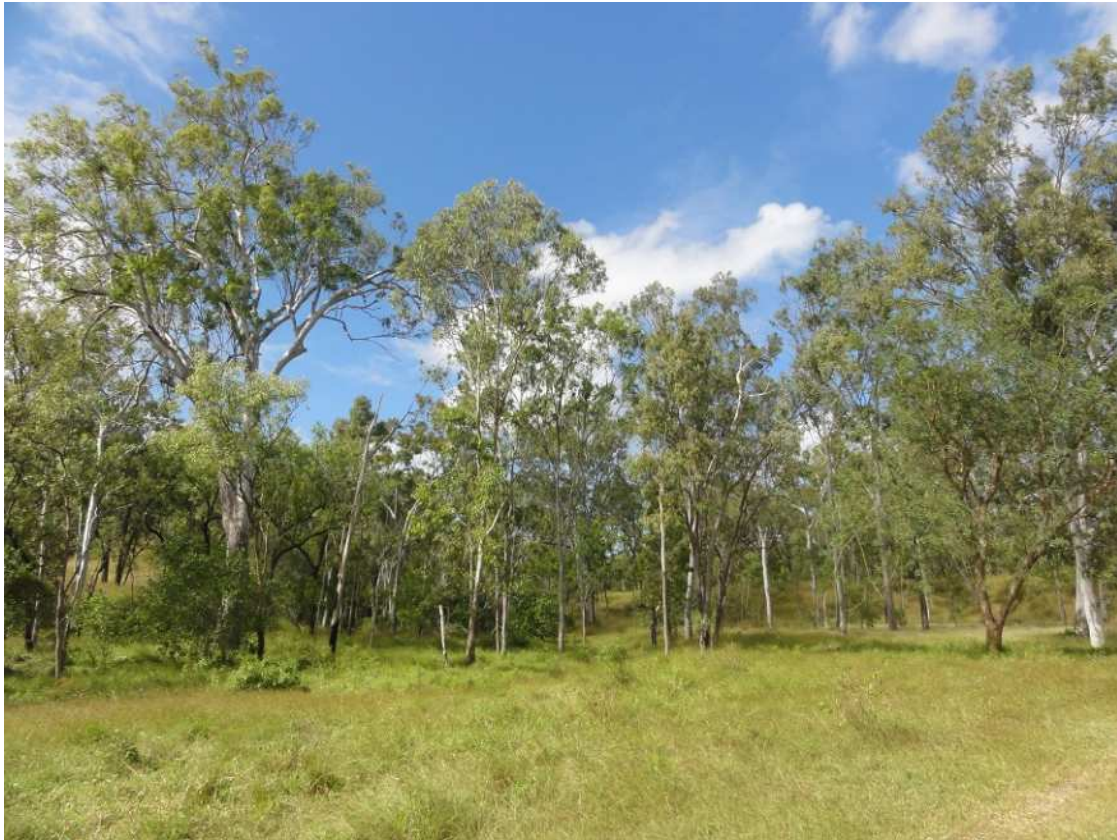
Figure 7: The alluvial plains supported open eucalypt woodland that constitutes suitable habitat for koala

There were small areas of alluvial eucalypt open woodland near the western boundary within the proposed MLA, which were dominated by *Eucalyptus tereticornis* (Queensland Blue Gum) to a height of 25 to 30 metres (refer Figure 7). These areas provided the highest quality koala habitat, and targeted searches for koala were concentrated in this area. The alluvial plains were also the most likely area to support red goshawk nesting trees, as this species is generally recorded as nesting in the largest tree within 1 km of permanent water.

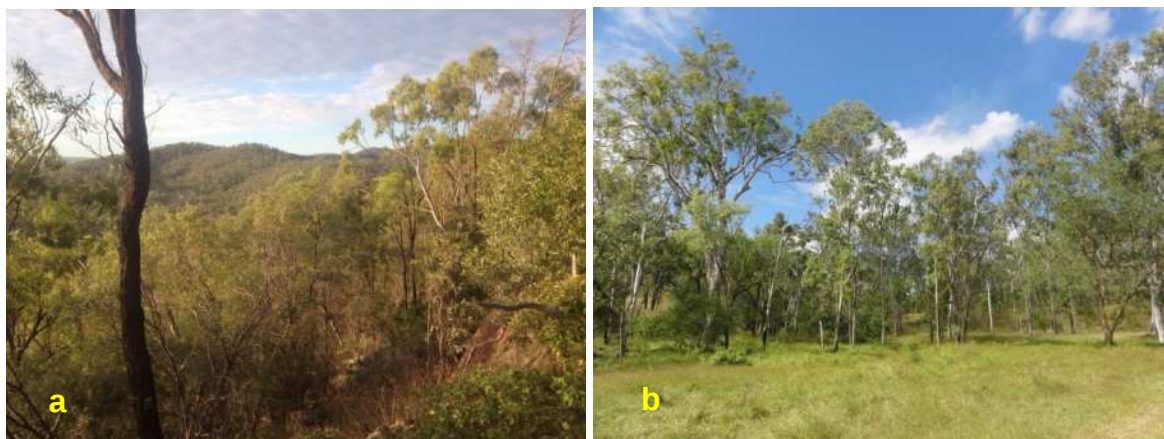
Figure 1 Koala habitat is present throughout the proposed MLA in the form of a) *E. crebra* dominated woodland on rocky slopes and b) *E. tereticornis* open woodland on alluvial plains

The vegetation communities within the proposed MLA include *Eucalyptus crebra*/*Acacia rhodoxylon* co-dominant woodland on sandstone ridges and slopes, with lower slopes and undulating hills dominated by *E. crebra* woodland interspersed with *Corymbia citriodora*, *C. erythrophloia* and *C. clarksoniana*. There are also limited areas of alluvial plains containing tall *Eucalyptus tereticornis*. All of these species, with the exception of *A. rhodoxylon* are known koala food trees.

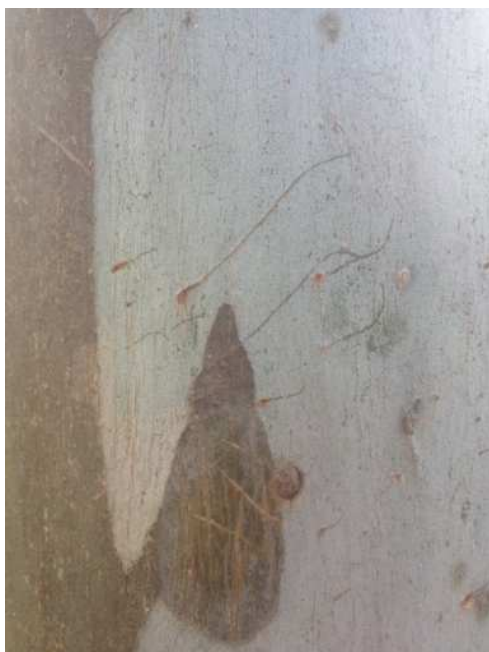
Figure 2 Claw scratches on *E. tereticornis* in the proposed MLA, with two longer fingers. These are most likely from a large varanid (goanna)

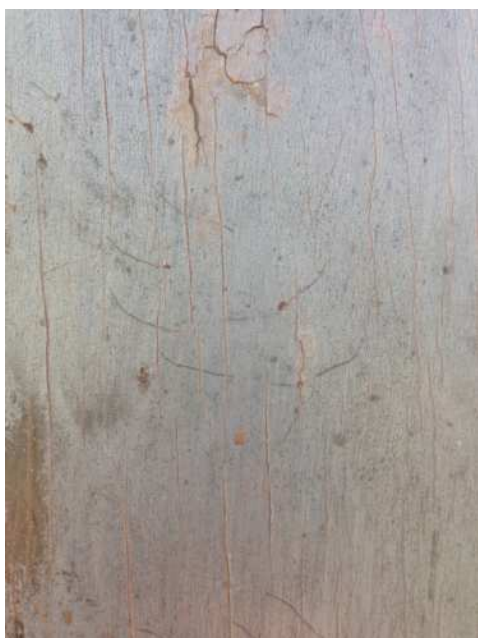
Figure 3 Claw scratches with four fingers and an opposing thumb, most likely left by a possum or glider
