# Progressive Rehabilitation and Closure Plan

## Wards Well Mine

| <b>Document title</b> | Progressive Rehabilitation and Closure Plan |
| <b>Version number</b> | V3.0 |

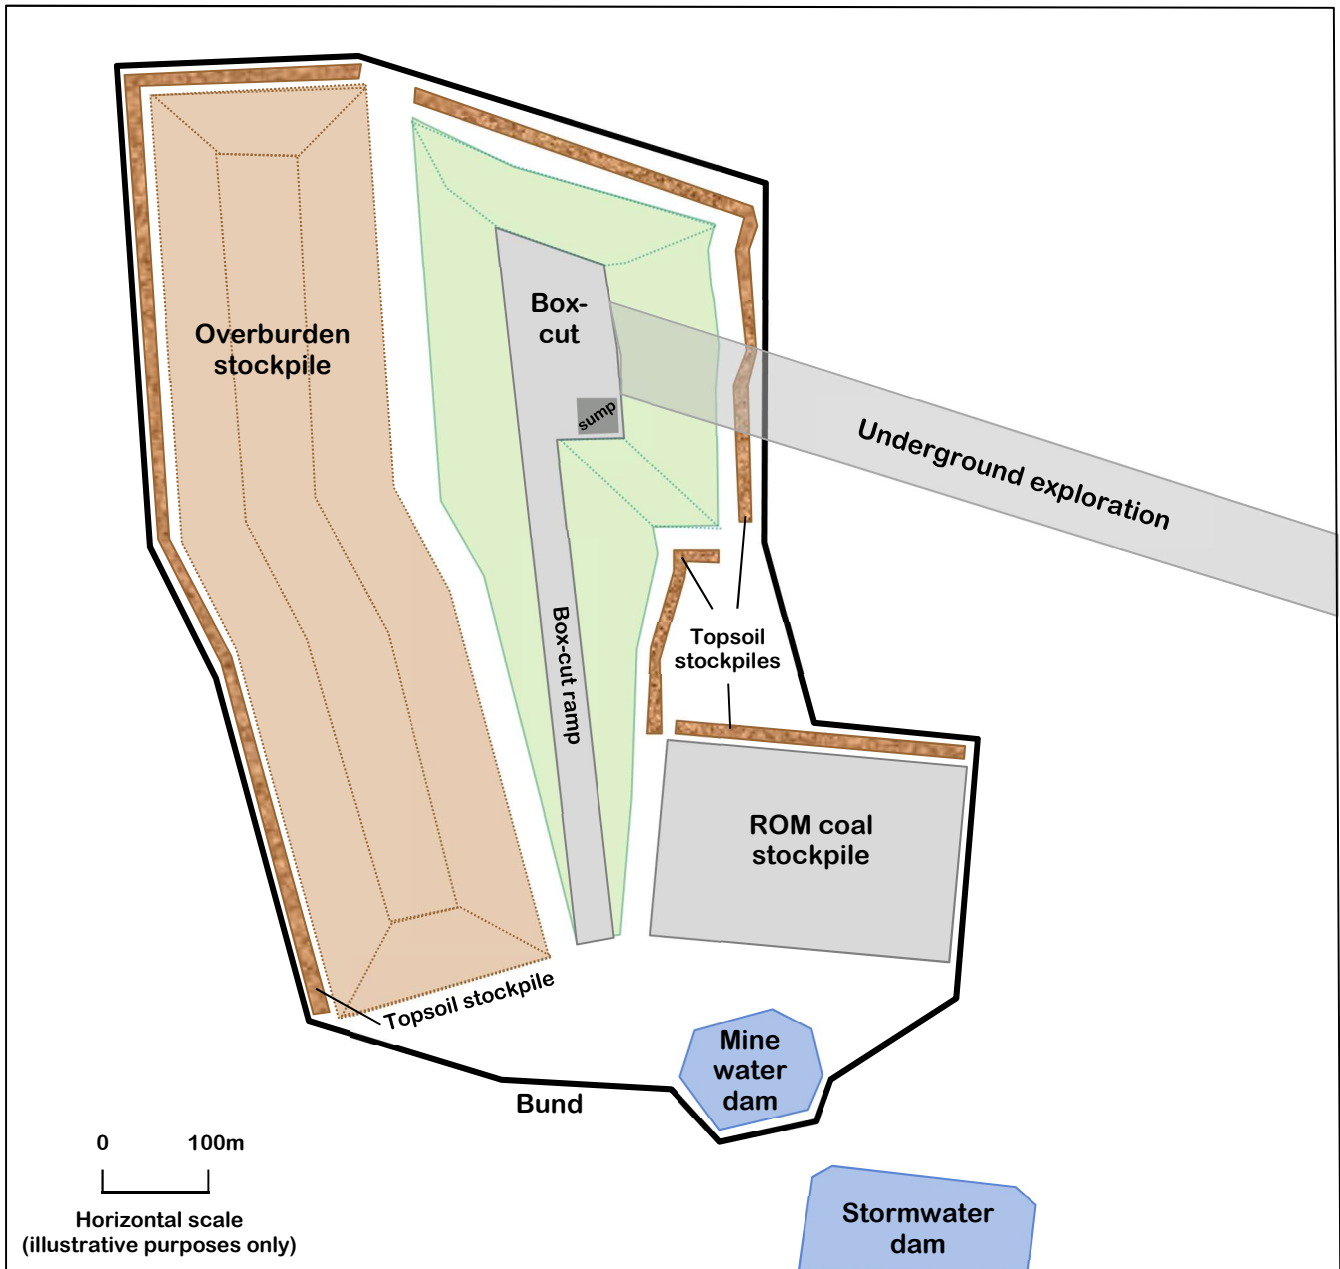
**Figure 4: Wards Well conceptual bulk sample layout**

Figure 4 further schematically illustrates the conceptual bulk sample layout with reference to some of the primary mine features and maintained infrastructure.

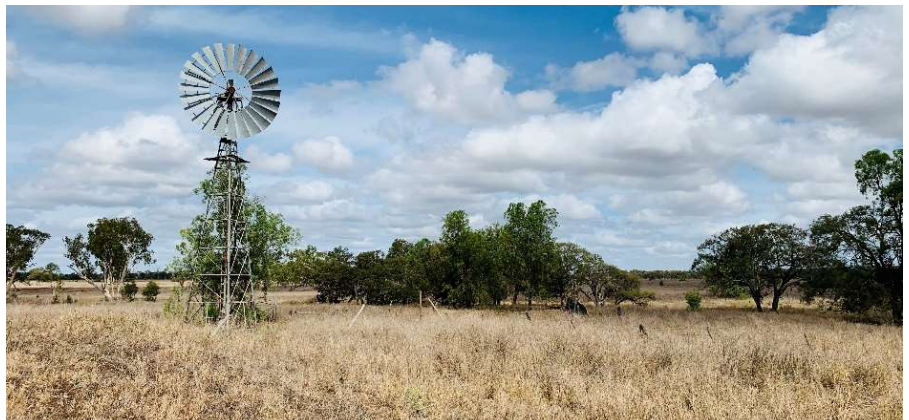
**Figure 5: General site topography at Wards Well**

The site's topographical features are consistent with the regional landscape and consist of level plains and gently undulating plains and rises. The slope across the majority of the site is between 1-2%, sloping gently towards the southwest (Figure 5). Steeper slopes up to 11% exist in the far north and on the south-eastern parts of the site. Within the footprint of the Wards Well area, the highest ground elevations lie within the north-west (about RL380) with the lowest in the middle of the area toward the western boundary (about RL310).

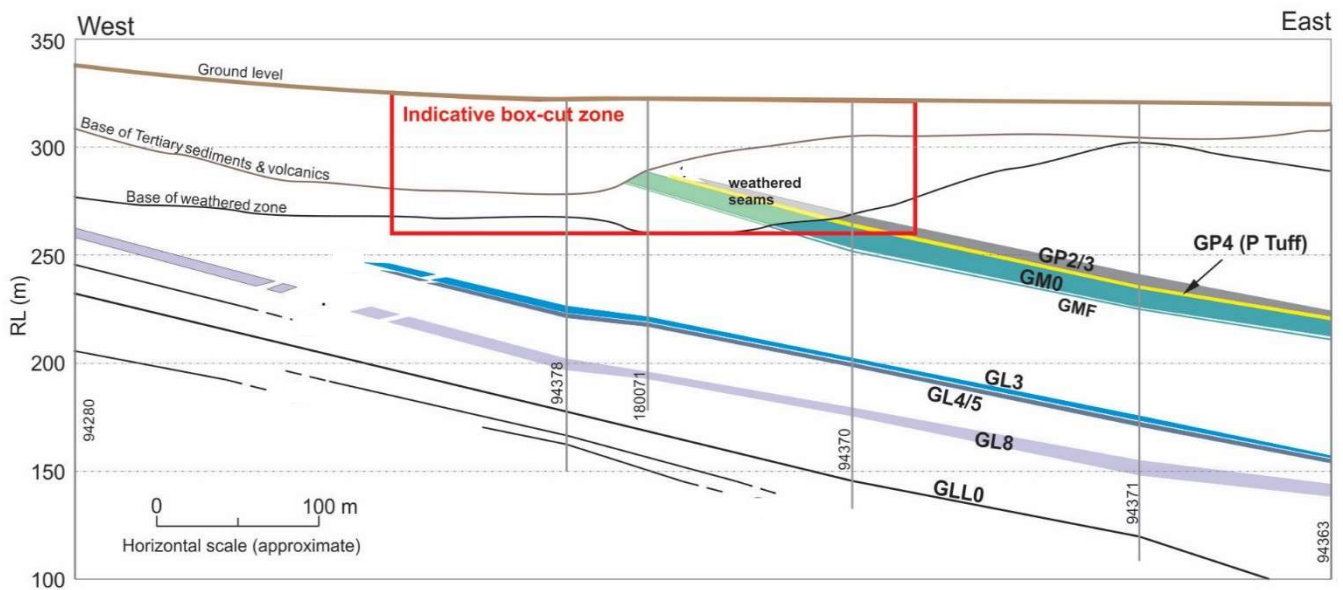
**Figure 6: Geological cross-section from west to east through the Wards Well box-cut**

Geological units in the box-cut area are diagrammatically shown in a geological cross-section from west to east through the box-cut (Figure 6). The coal measures are overlain by Tertiary sediments and weathered and fresh Permian.

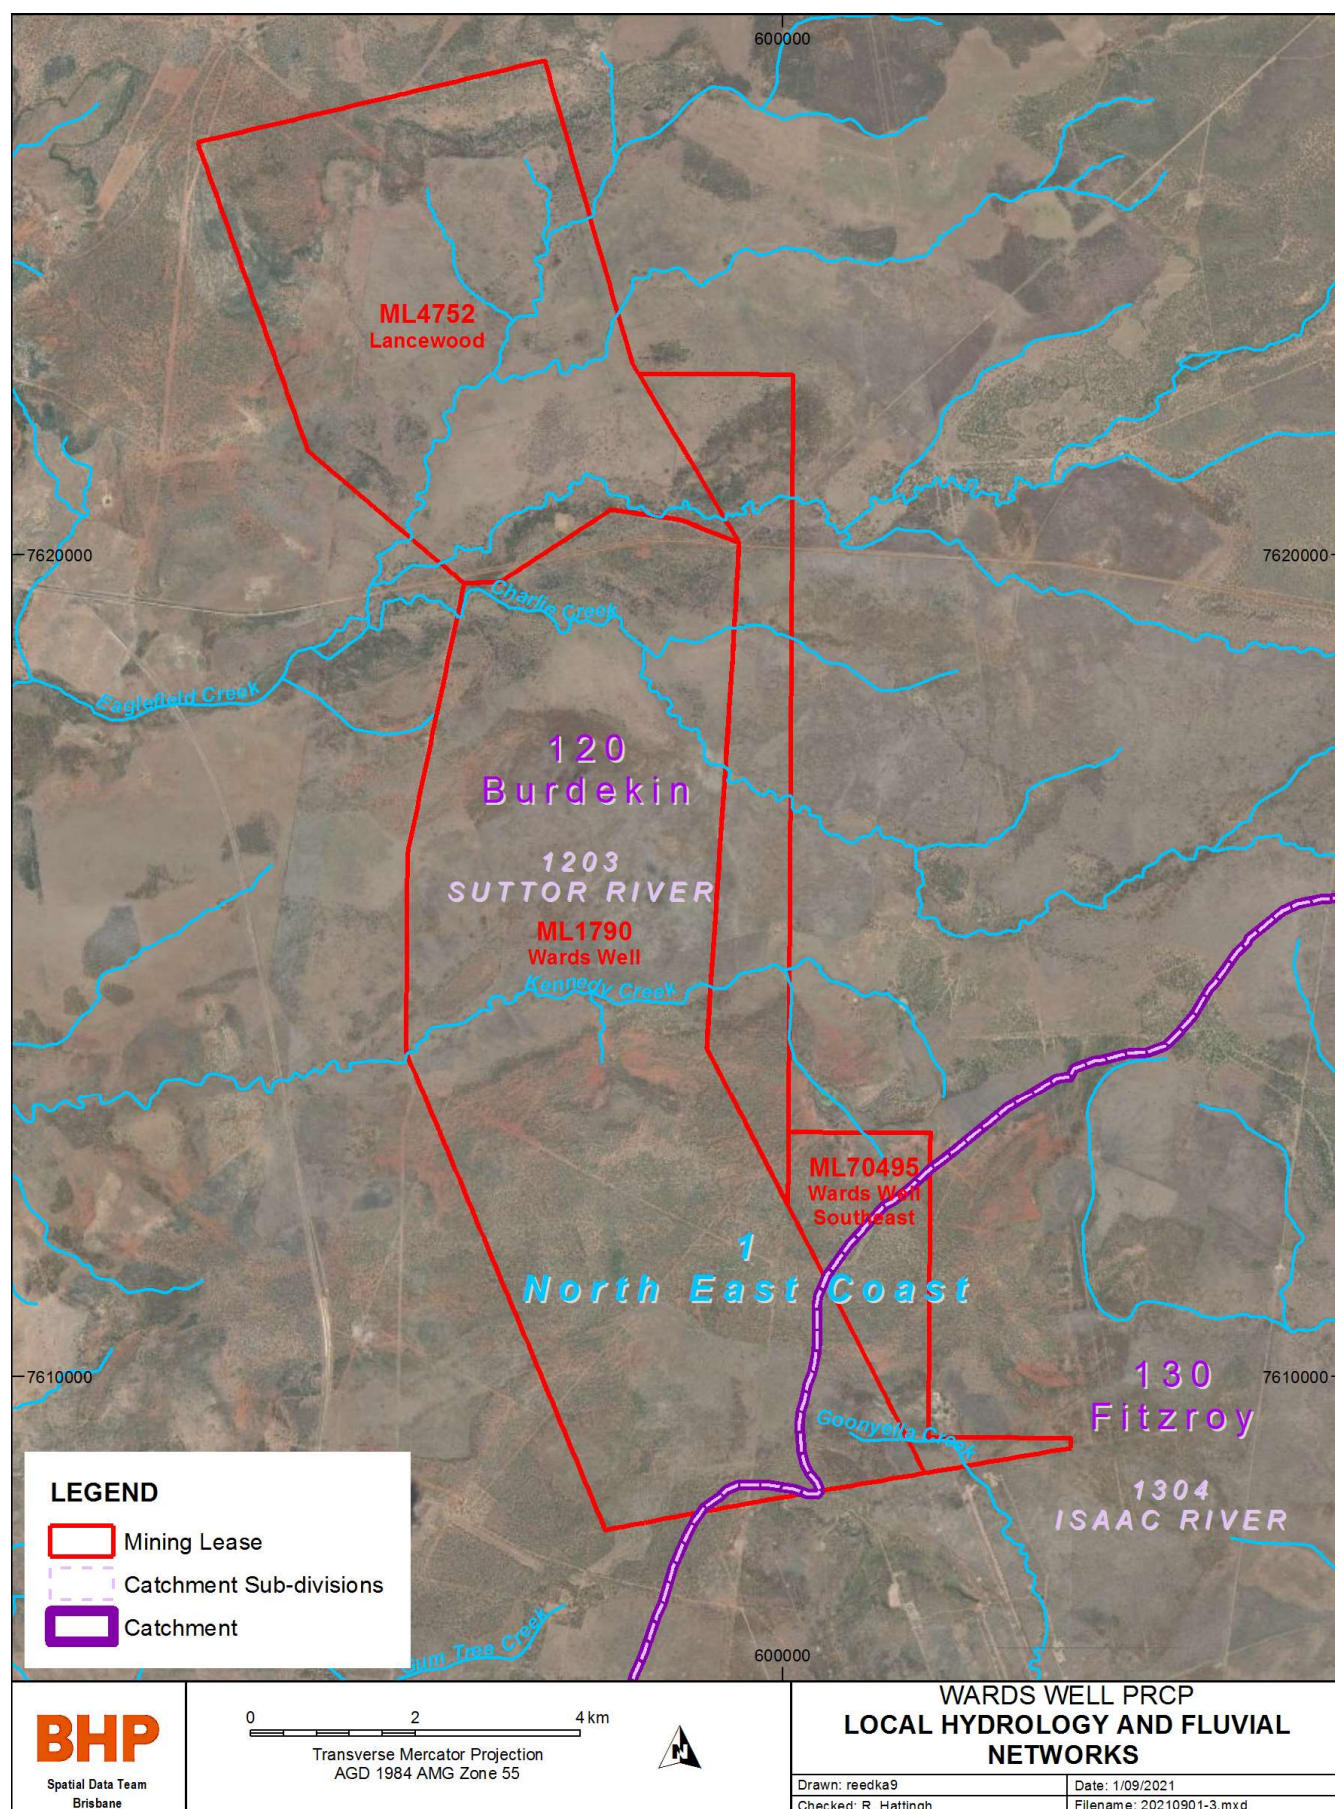
Figure 8: Wards Well fluvial networks and basins

Figure 8<sup>10</sup> illustrates the location of the basins and mining leases.

The location of the approved box-cut and bulk sampling activities under the EA are located on ML4752, which is entirely located within the Burdekin Basin. The area of the approved activities predominantly slopes towards the south/south-west towards an unnamed ephemeral tributary of Eaglefield Creek.

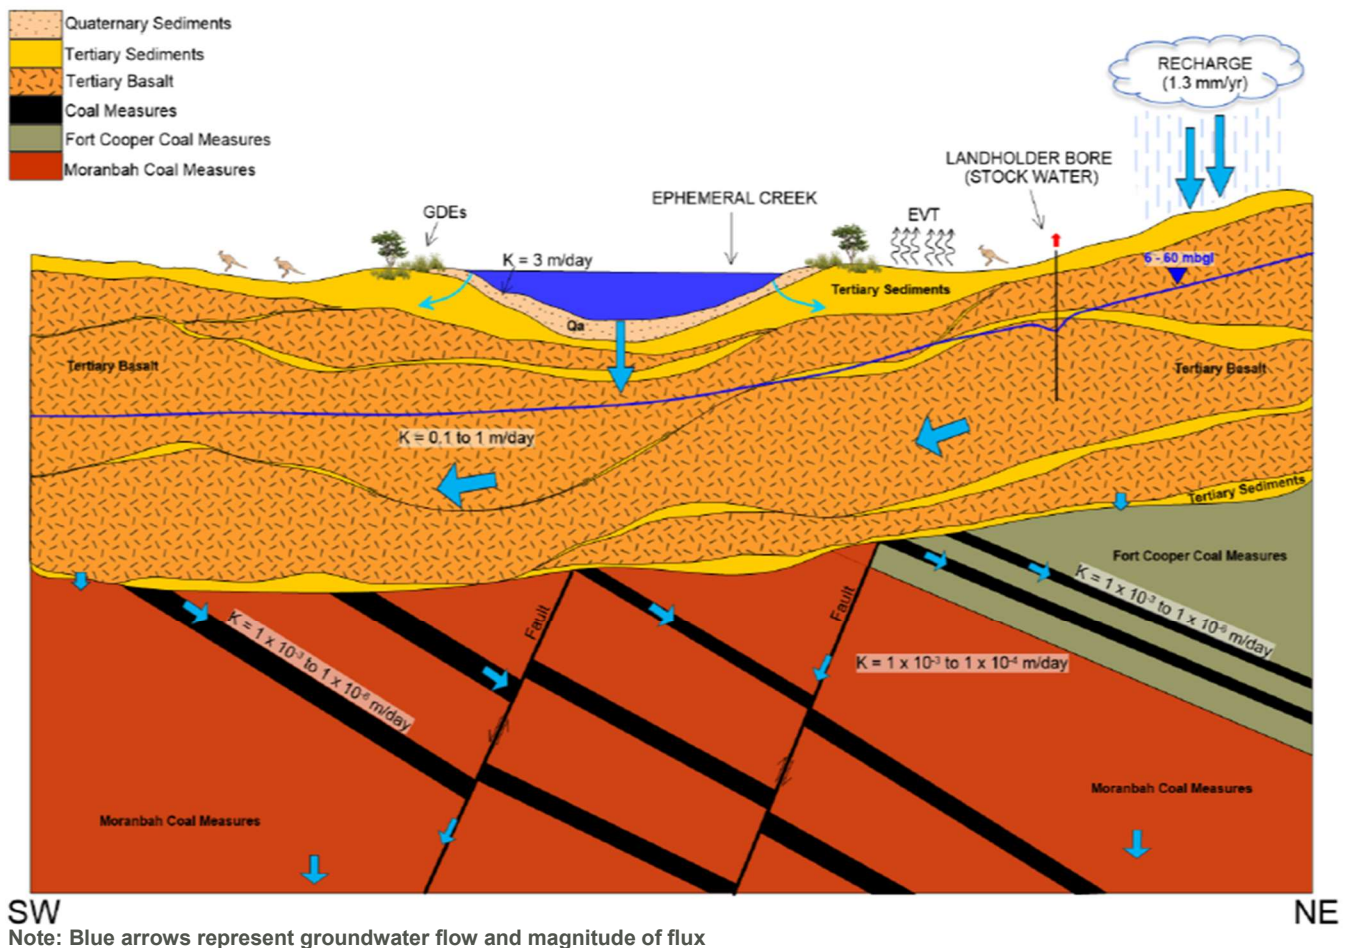
**Figure 9: Wards Well baseline hydrogeological conceptual model (Golder, 2020)**

A baseline hydrogeological conceptual model<sup>11</sup> illustrating the above hydrostratigraphic units and groundwater flows is illustrated in Figure 9.

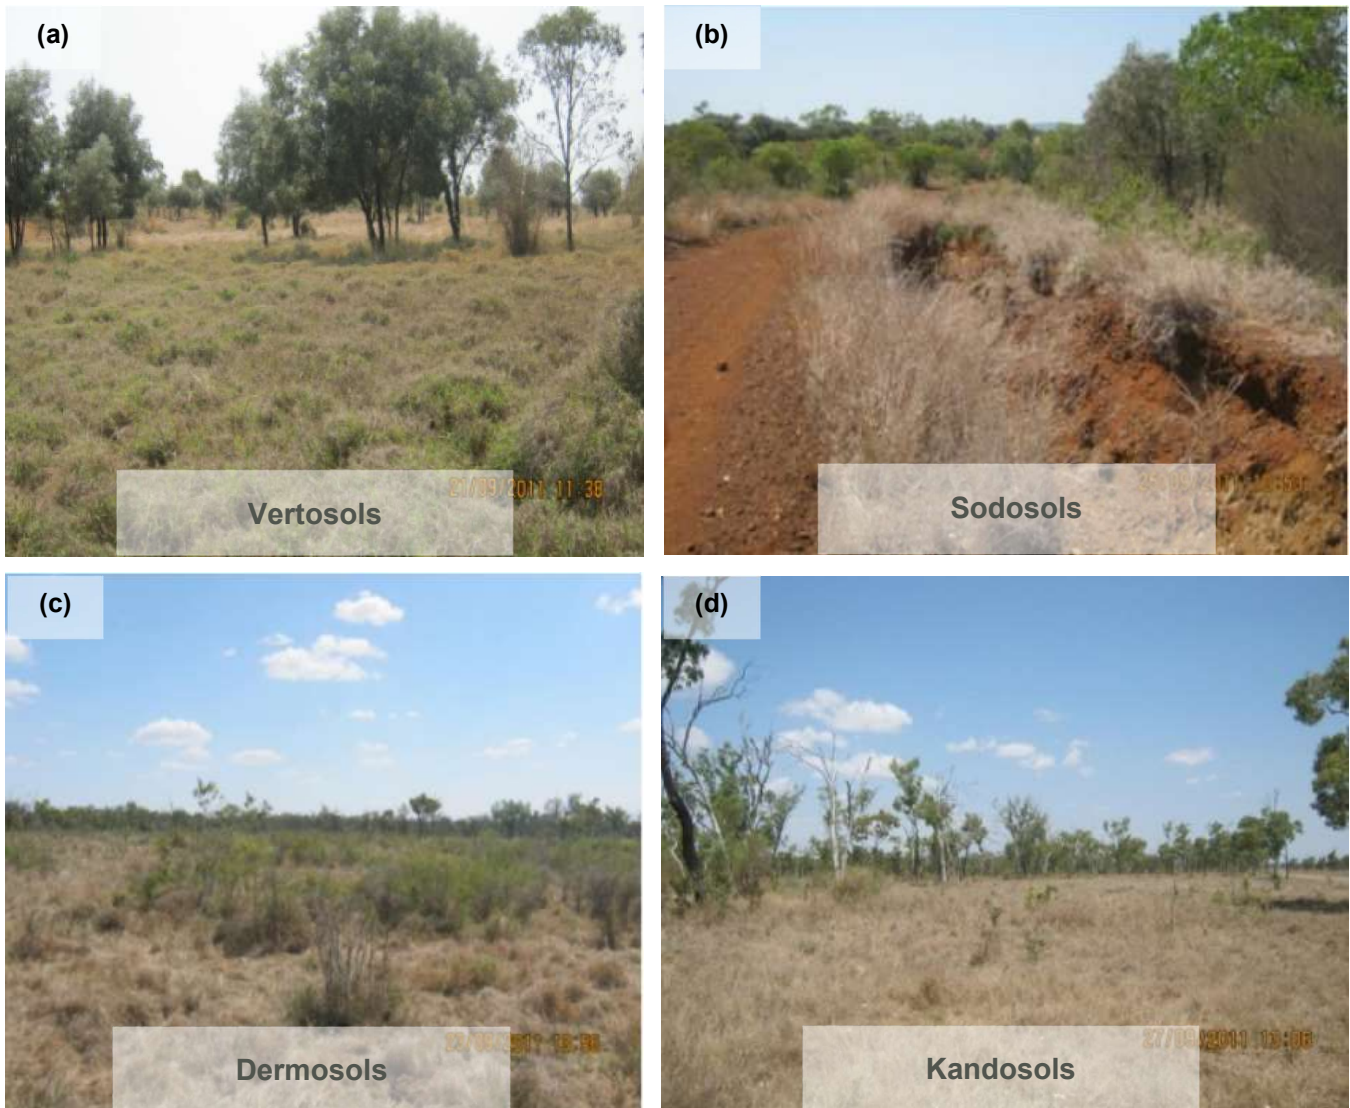
**Figure 12: Areas in Wards Well that are characteristic of the local soil types and associated vegetation - (a) Brigalow and grasslands with cattle grazing on cracking clay Vertosols; b) Ironbark, Brigalow and erosion-prone areas on Sodosols; c) Low shrubs and grassland with cattle grazing on Dermosols and d) Open grasslands with remnant vegetation and cattle grazing on Kandosols**

Figure 12 illustrates various areas in Wards Well that are characteristic of the local soil types and associated vegetation.

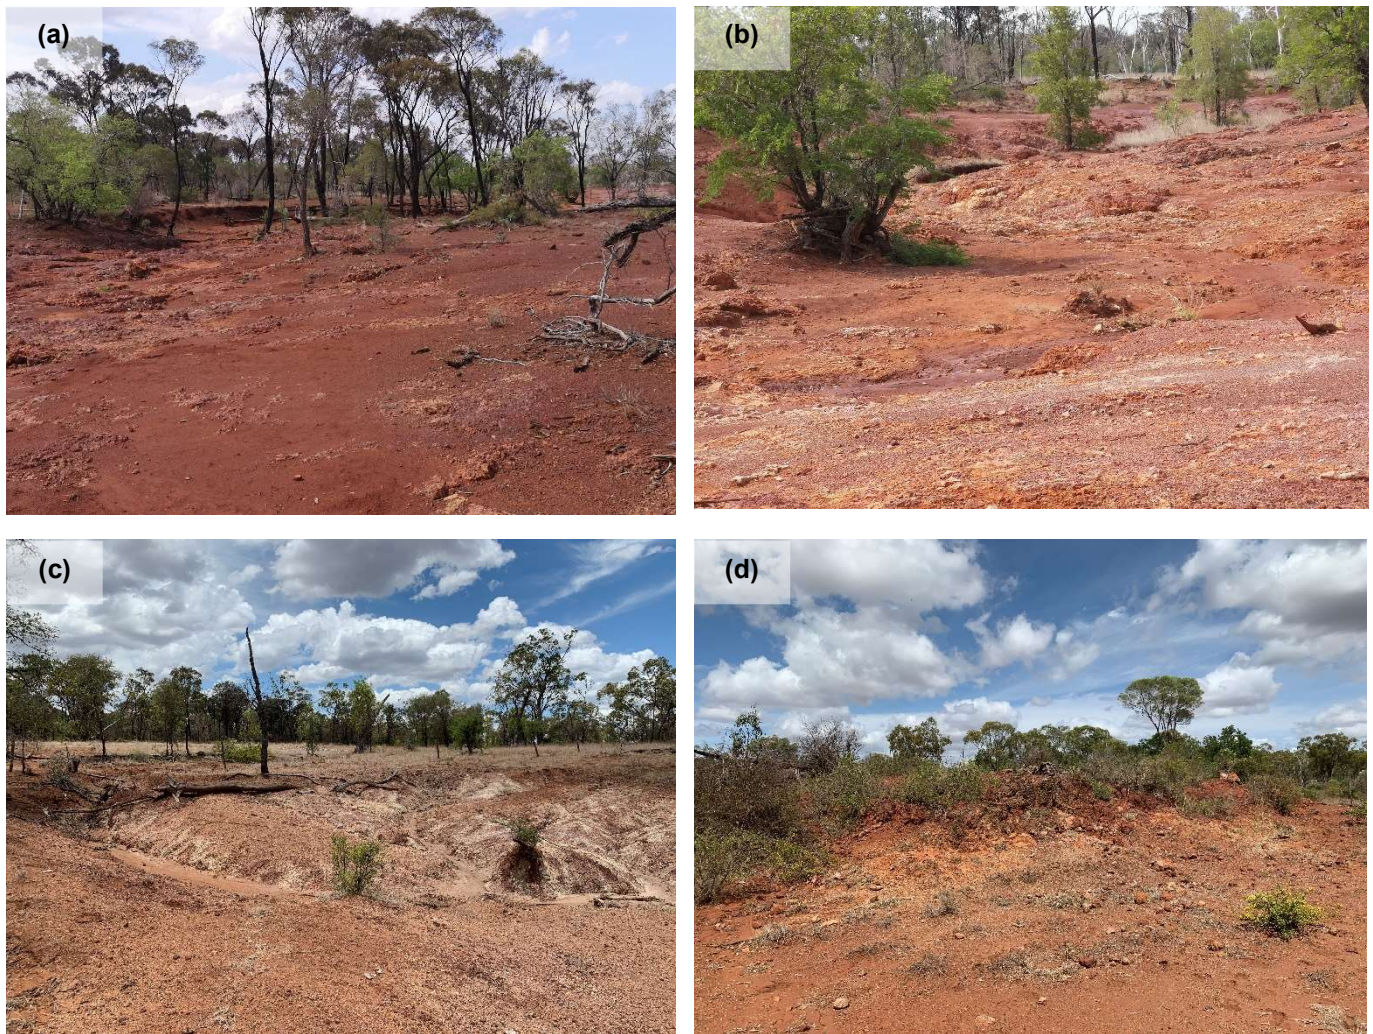
**Figure 13: Evidence of surface erosion due to existing grazing activities and historical land clearance in the Wards Well area - a) Sheet erosion adjacent to creek; b) Stream bank erosion; c) Sheet erosion leading to flow concentrating features and d) Stream bank erosion**

The regional topography is dominated by flat to gently sloping landforms which is consistent with the landscape at Wards Well. In the context of land stability, erosion is isolated to areas of the landscape where land use has exposed soil types with limited erosion resistance. Pre-mining surface erosion in drainage areas and creek crossings is evident across the site and is mainly associated with existing grazing activities and historically cleared areas. During the soil survey, erosion was noted at 16 of the 98 sample locations and on all four soil types. Erosion was most prevalent on Sodosols in the north-east of Wards Well and will have a tendency to be unstable if not ameliorated post-disturbance. Stream bank erosion was also identified within drainage lines, and sheet erosion on land adjacent to dirt tracks (Figure 13).

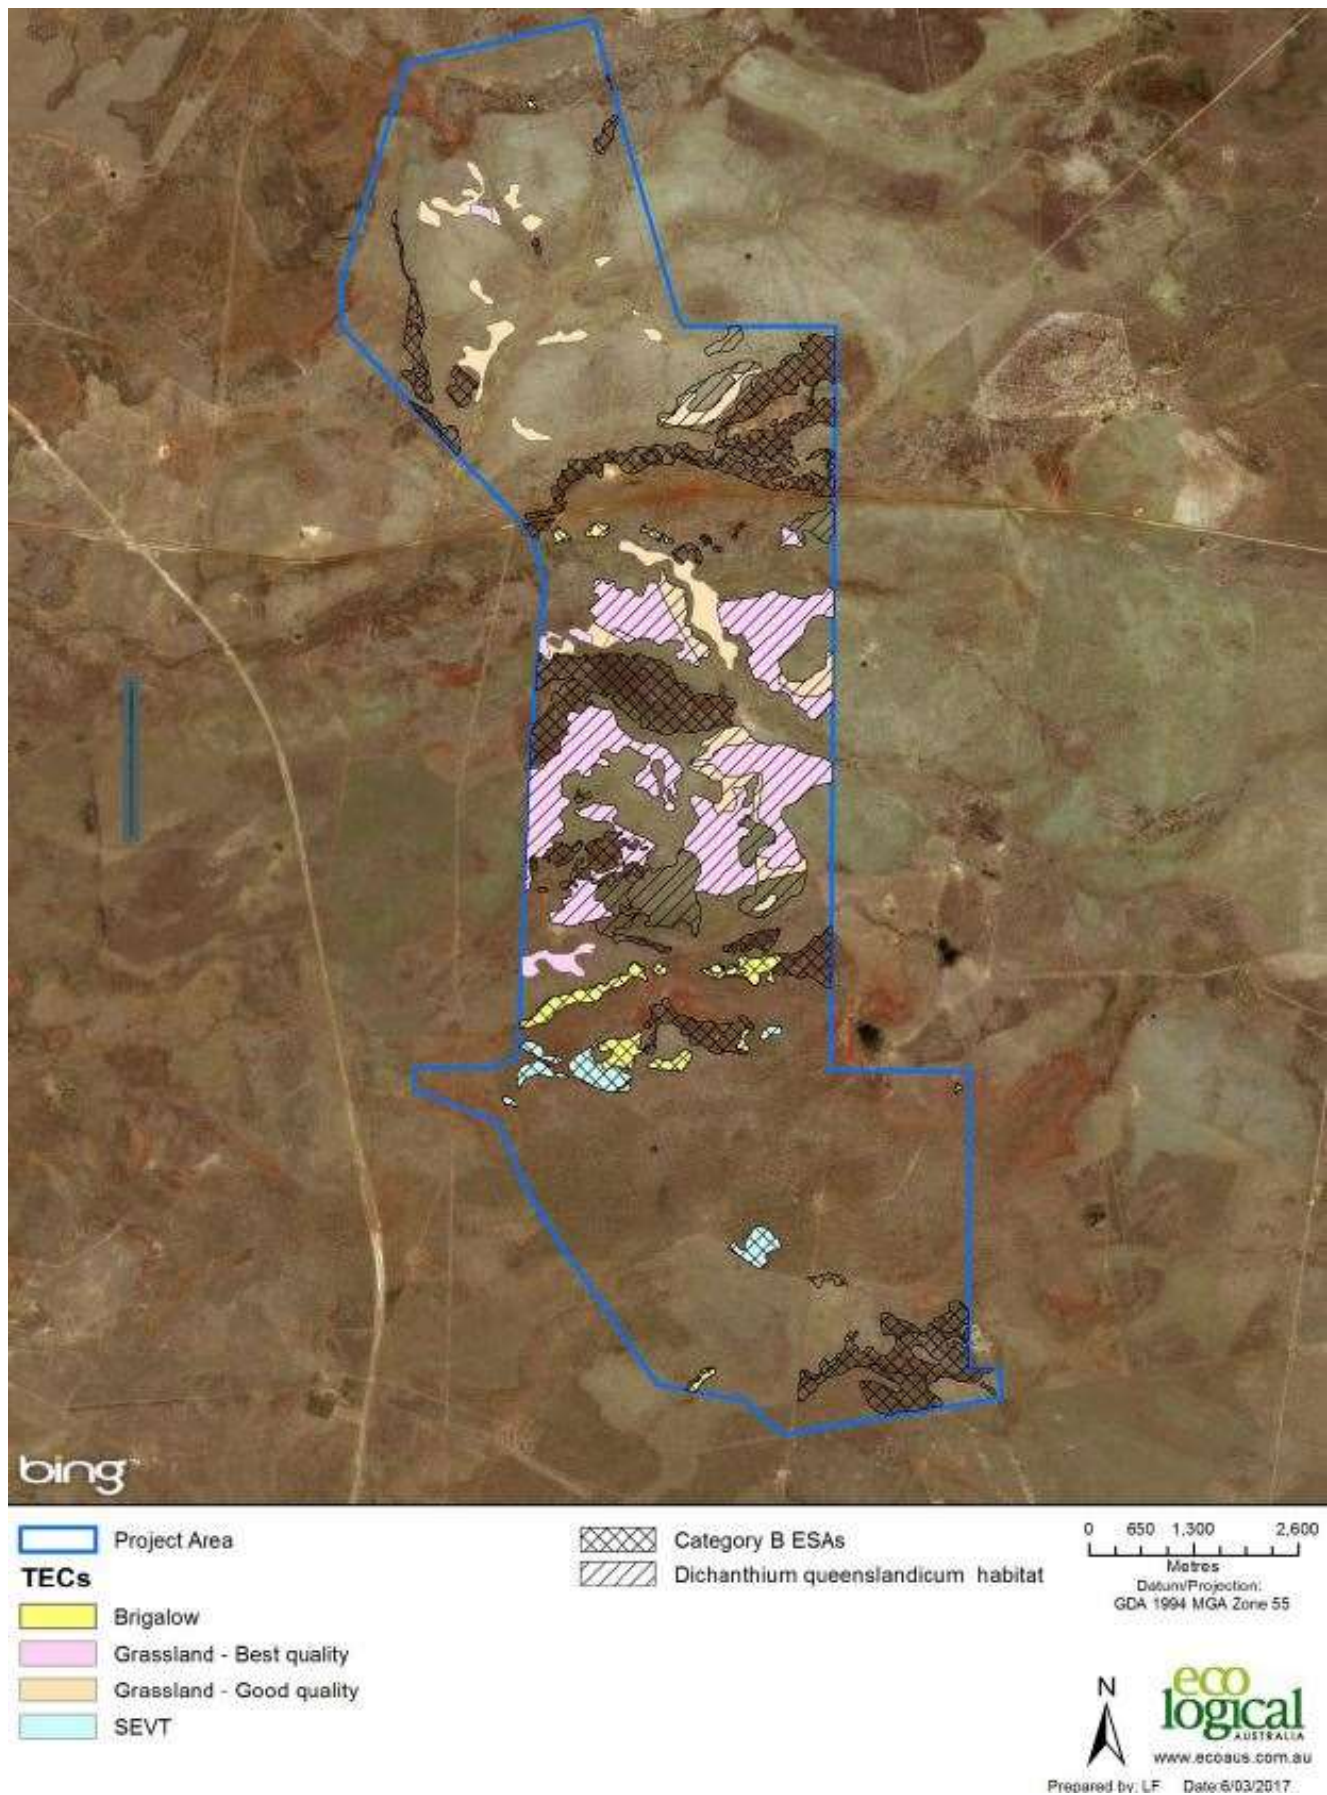
Figure 14: Wards Well Threatened Ecological Communities mapping

The Brigalow TEC was identified in small patches across the site, within a total area of 91.2ha (Figure 14). Natural Grasslands dominate the centre and north of the area - patches meeting the key diagnostic and condition threshold of the TEC in good quality were identified within an area of 234.0ha and best quality within 552.4ha (Figure 14). SEVT TEC was identified in small patches in the south, within an area of 57.5ha (Appendix 6) (Figure 14)<sup>16</sup>.

Figure 3 indicates the initial mapping of Category B ESAs associated with Endangered REs as approved under the EA and includes a 500m shaded buffer area; Figure 14 indicates updated ESA mapping from ground-truthed surveys (Appendix 5 and Appendix 6).

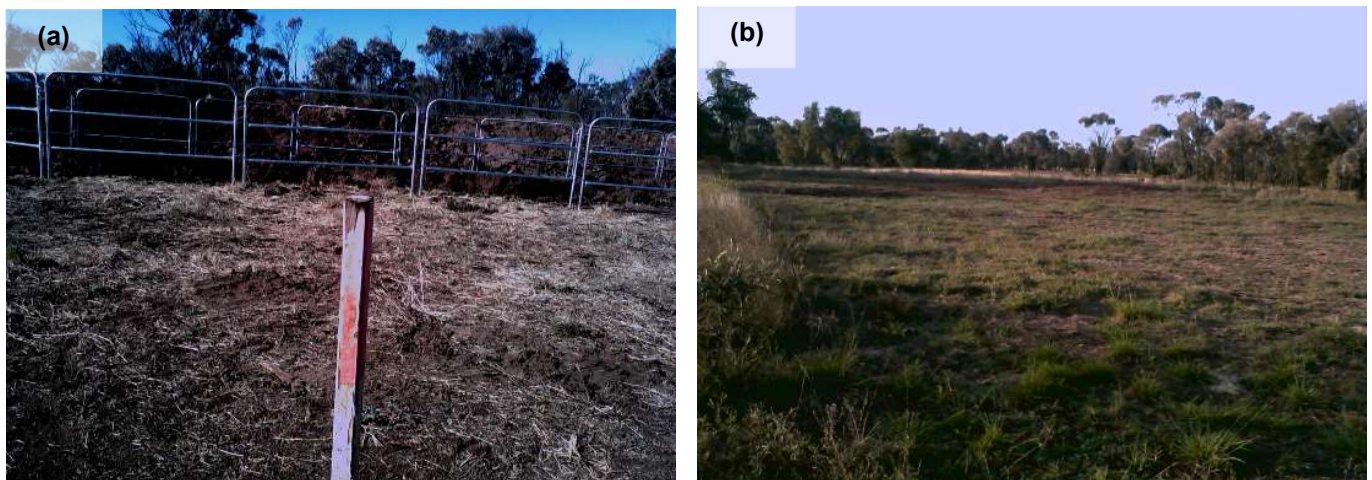
**Figure 17: Wards Well drill site ML1790 DB12 before and after rehabilitation – a) prepared for drilling, and b) rehabilitated**

The existing rehabilitation of drill sites – and the subsequent trajectory towards achievement of milestone criteria, has been determined based on a combination of aerial imagery analysis before and after approved drilling programs, as well as by field visits which have indicated the self-regeneration of pastures on rehabilitated drill sites (Figure 17b).

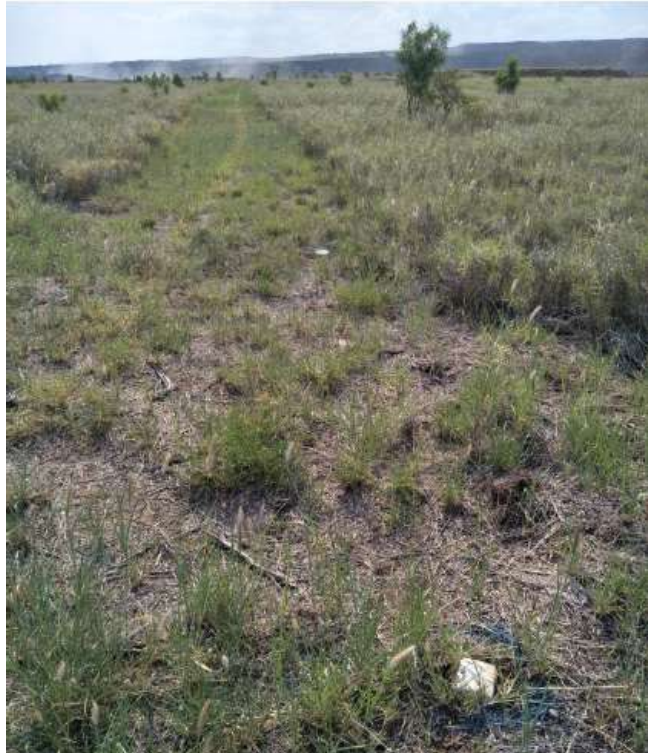
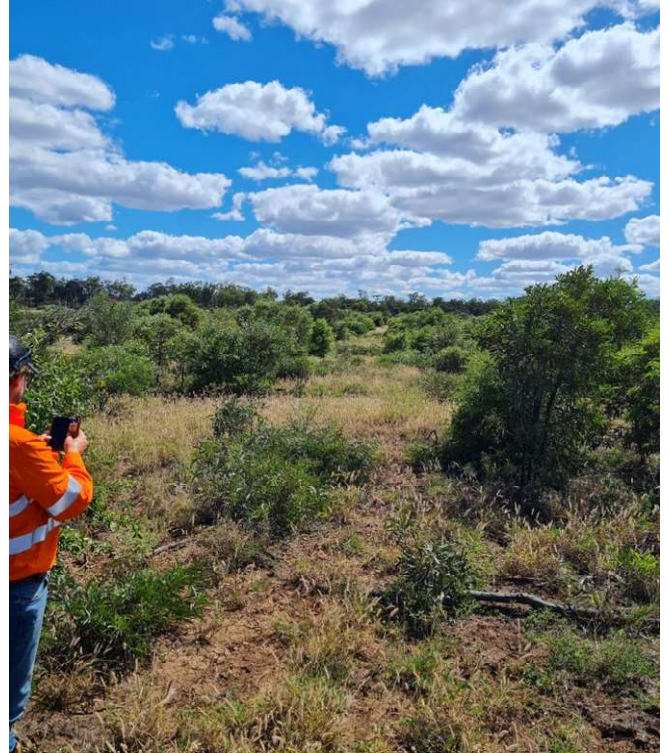
**Figure 18: Wards Well seismic activities – comparison on slashing and natural regeneration re-growth**

BHP Coal has adopted a minimal disturbance approach for line preparation for 3D seismic programs. Where possible, slashing-only is adopted as the preferred practice, leaving grass at 10cm high (Figure 18a).

**a) Slashed seismic lines**

**b) Re-growth (natural regeneration) through seismic lines**

Due to the minimal disturbance approach when undertaking seismic assessments, the rehabilitation process for seismic disturbance is 'natural regeneration.' This approach is illustrated for grassland vegetation and regrowth vegetation at Wards Well in Figure 18(b). The seismic activities do not disturb the ground or topsoil layer, and therefore no soil rehabilitation is required. Furthermore, as the existing vegetation is only slashed, the vegetation and plant species disturbed reshoot from their stable root bases. The same species are therefore present after seismic activities as prior to disturbance, negating the need for any revegetation activities.

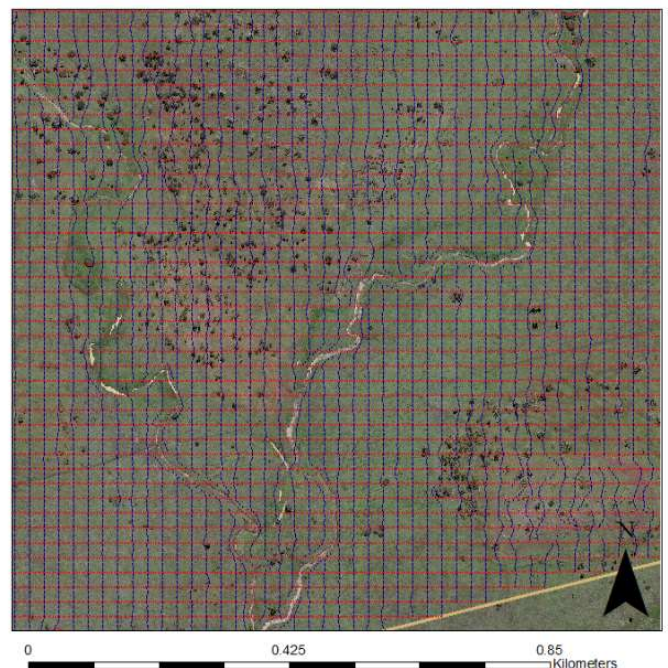
**Figure 19: Example 3D seismic program – minimal disturbance approach**

Seismic programs are typically 50m x 50m grid patterns with 3m wide paths. The grid lines are accessed by light vehicles and a medium sized seismic vehicle. Figure 19 depicts the results of 3D seismic at Wards Well, indicating where creeks and specific vegetation was avoided by vehicle tracks (blue); the red points were receivers which had the option of being hand carried, enabling the points to be positioned as designed without disturbance.

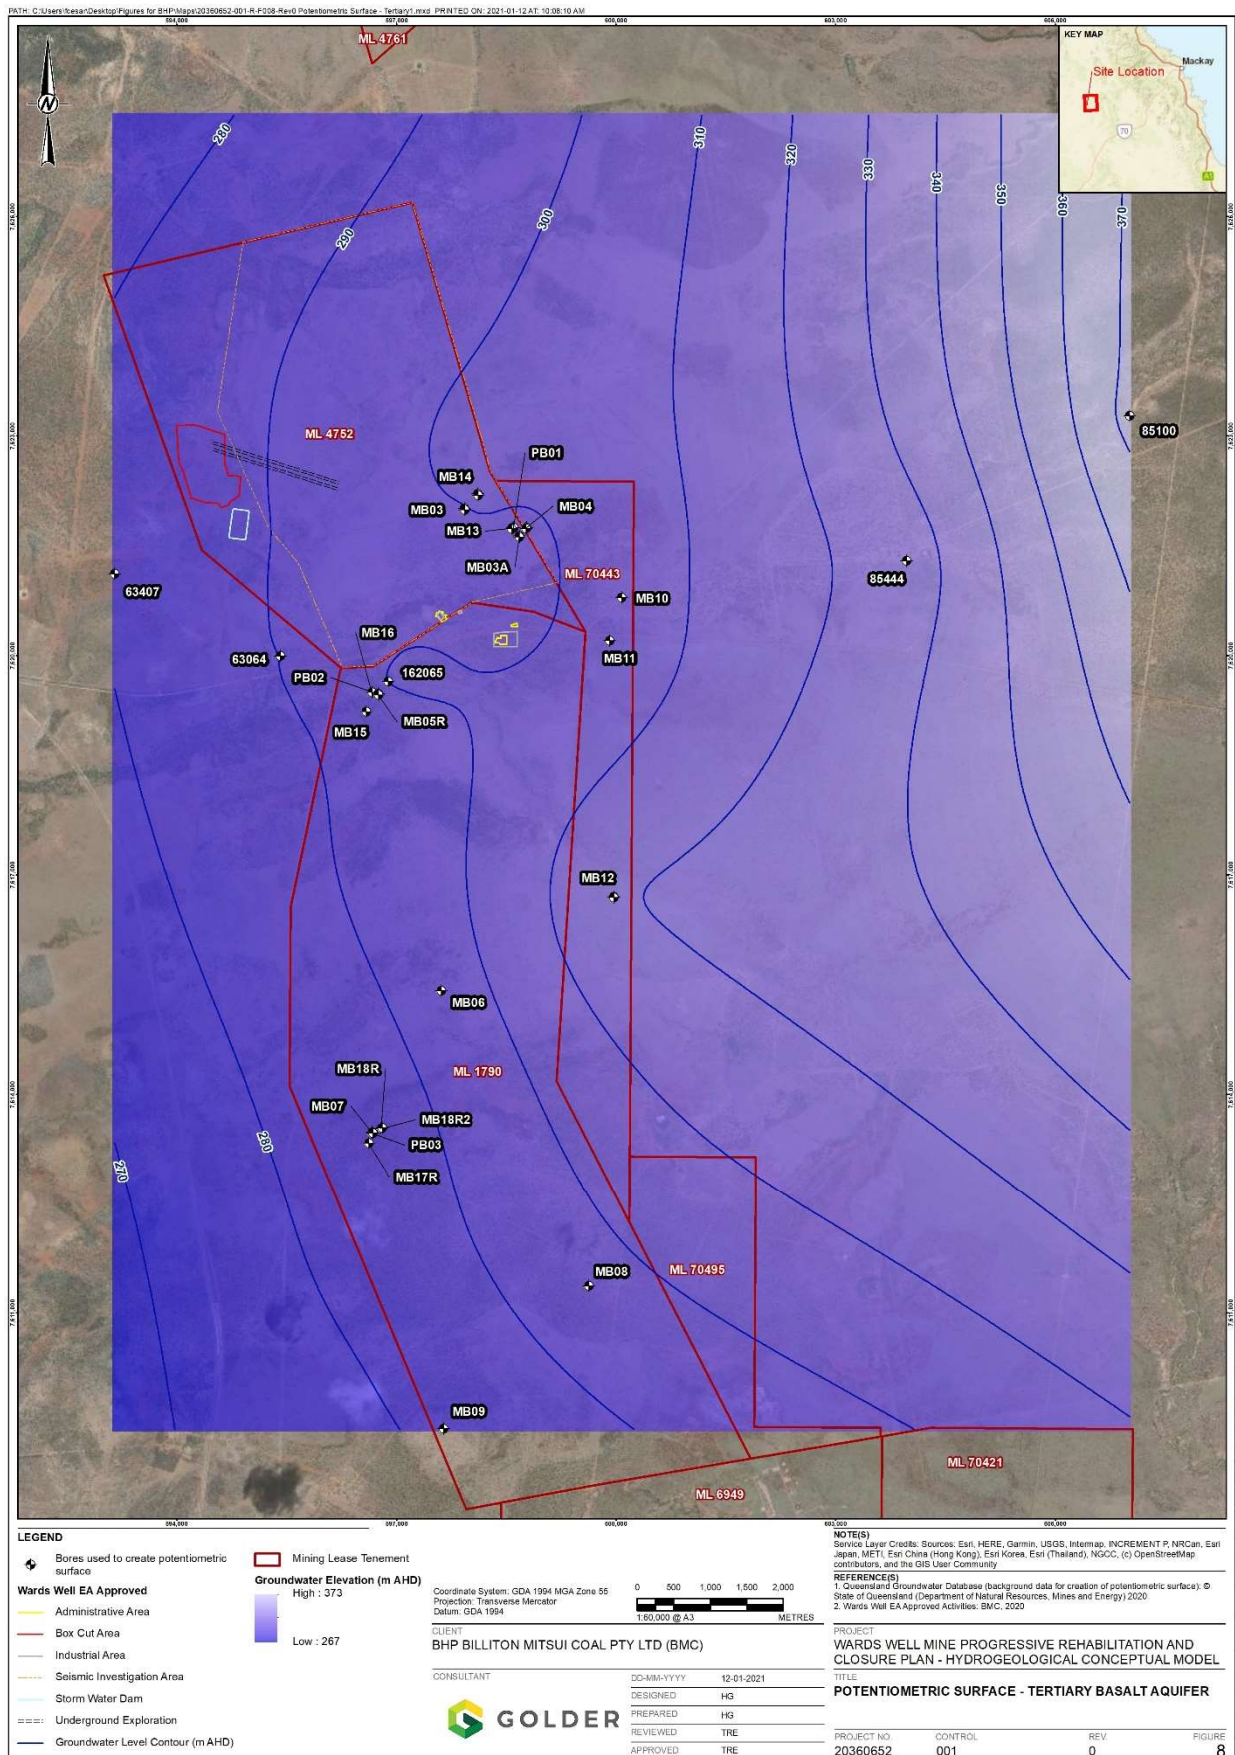
Figure 20: Potentiometric surface-tertiary aquifer for Wards Well area

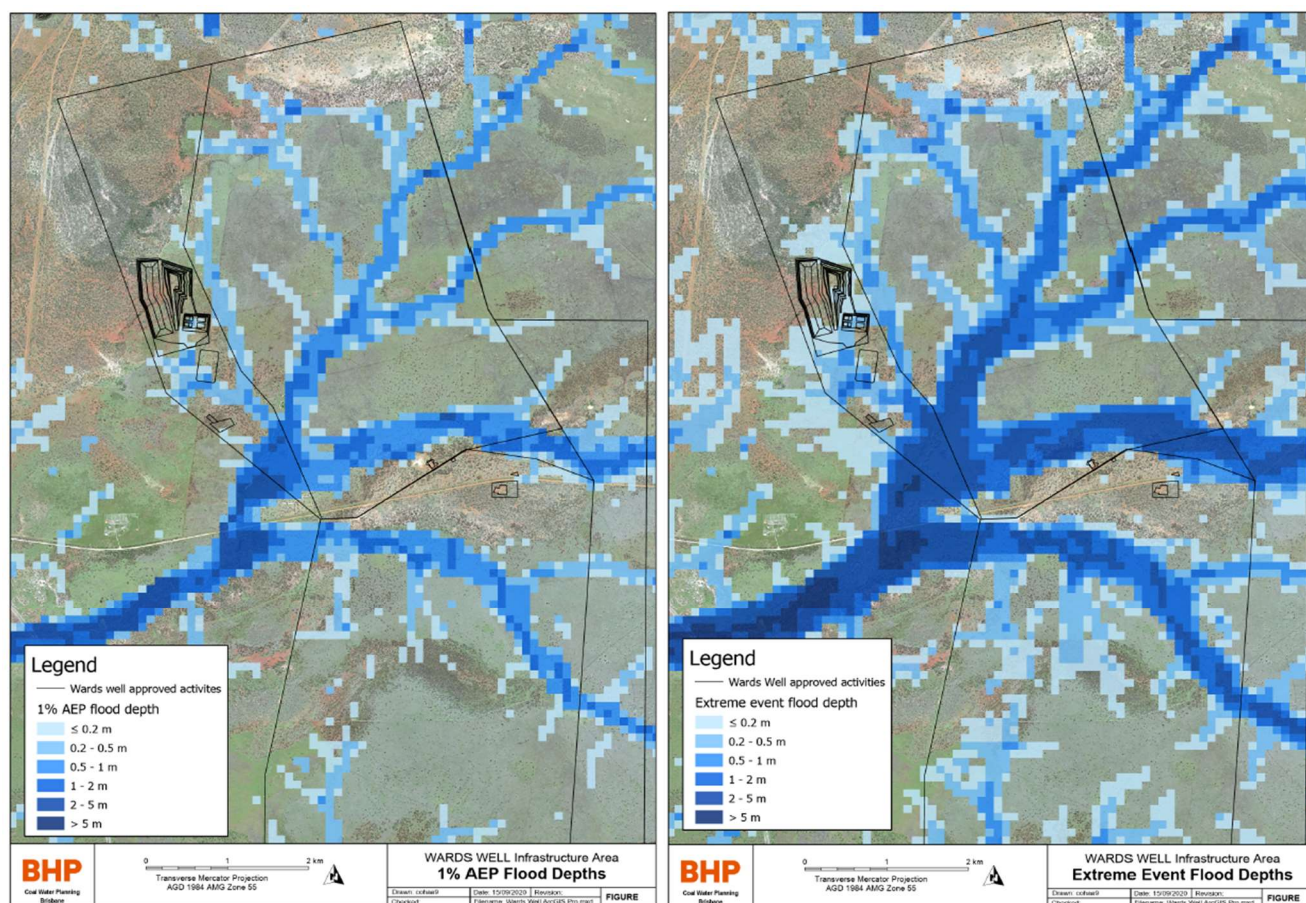
Figure 22: DNRME 1% AEP flood depths (left) and extreme event flood depths (right)

- The DNRME flood mapping (Figure 22) indicates only limited impact to the undisturbed and seismic areas from a 1% AEP flood event, with no flood impact on the box-cut area. The Extreme Event flood impact is predicted to be limited to  $\leq 0.2\text{m}$  flood depth on the south-east of the backfilled box-cut (noting the final landform level will be 0.6m above existing surface and therefore will not be subject to flood inundation);
- The approved activities do not require diversion or interruption of creeks or streams; and
- There are no fourth order or higher streams present on the Wards Well mining area.

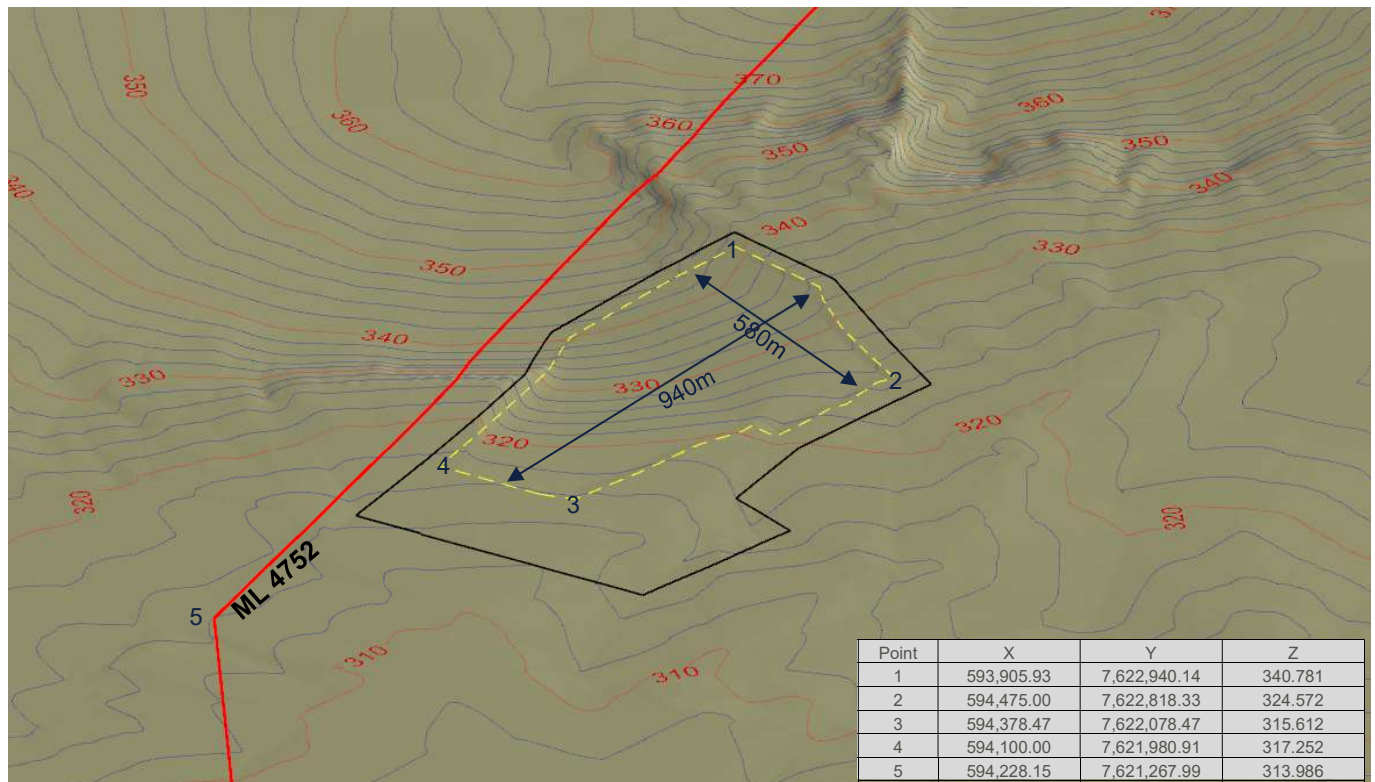
**Figure 23: 3D post-mining landform design – 2m contours, outline of box-cut and overburden stockpile area and key co-ordinates**

The approved activities on-site will result in a final landform virtually unchanged from the pre-mining landform, with only a minor height increase in the box-cut and overburden stockpile area. The 3D post-mining landform design with 2m contours is shown in Figure 23. The black outline represents the black outline of the bulk sample disturbance area as shown in Figure 3; and the yellow dash outline is the box-cut and overburden stockpile area which is approximately 0.6m higher than the pre-mining landform. All area outside of the yellow outline is not altered from the pre-mining landform.

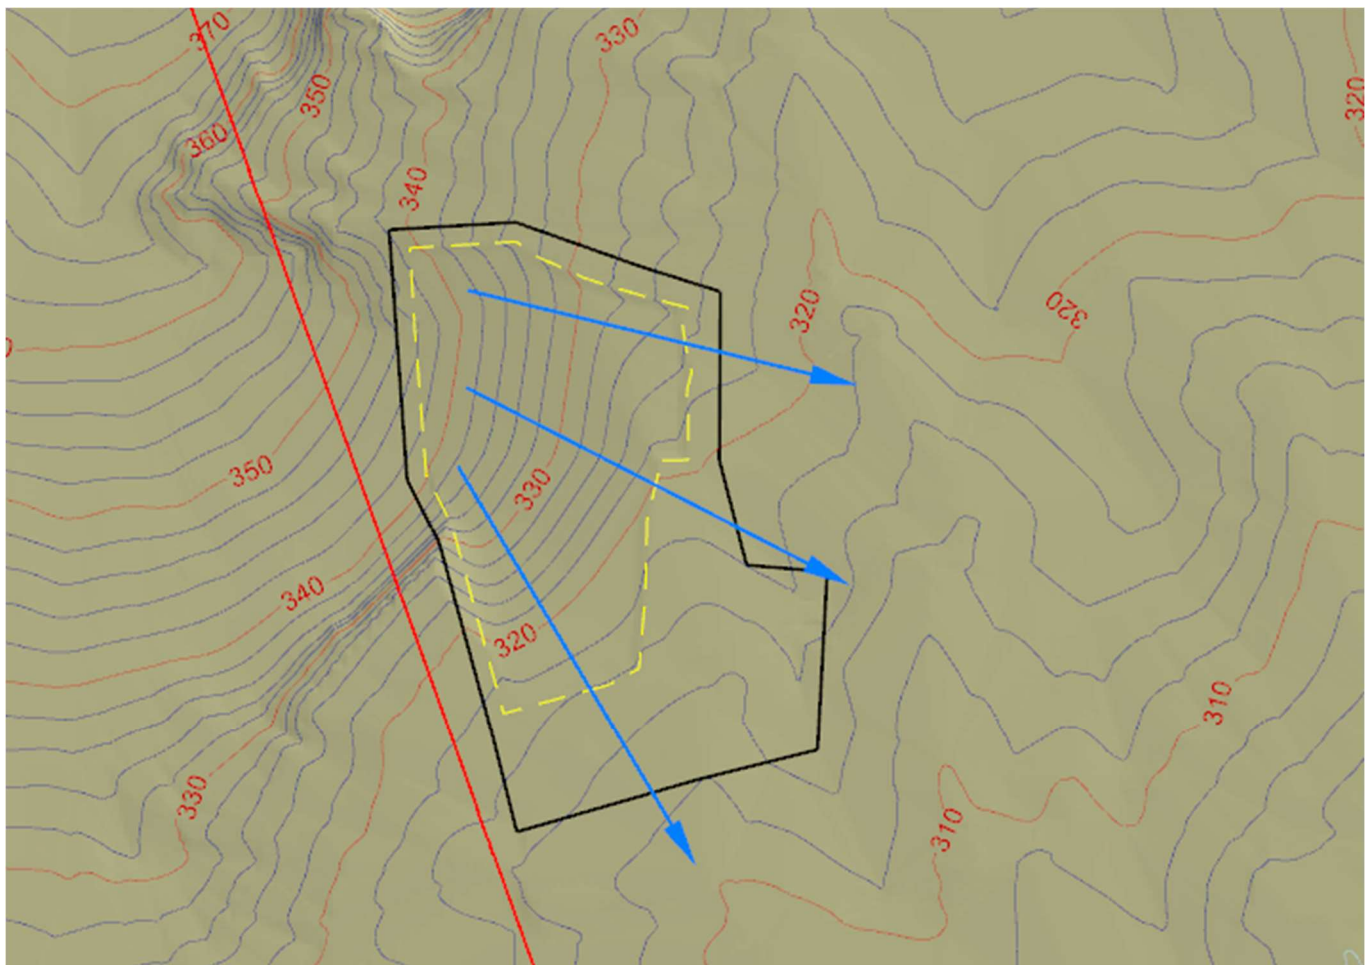
Figure 24: Indicative surface water flow direction of bulk sample area – 2m contours and outline of box-cut and overburden stockpile area

The surface water flow of the bulk sample area is shown in Figure 24.

The black outline represents the bulk sample disturbance area as shown in Figure 3. The final landform will replicate the pre-mining landform except for the box-cut and overburden stockpile area which is an average height of 0.6m above the pre-mining landform (within the yellow dash outline). The ROM pad and dam areas may be slightly altered from the pre-mining levels after the final reshape. The landform will be free-draining and water-shedding and there will be no changes to the pre-mining water flow which directs water towards the south to Eaglefield Creek.

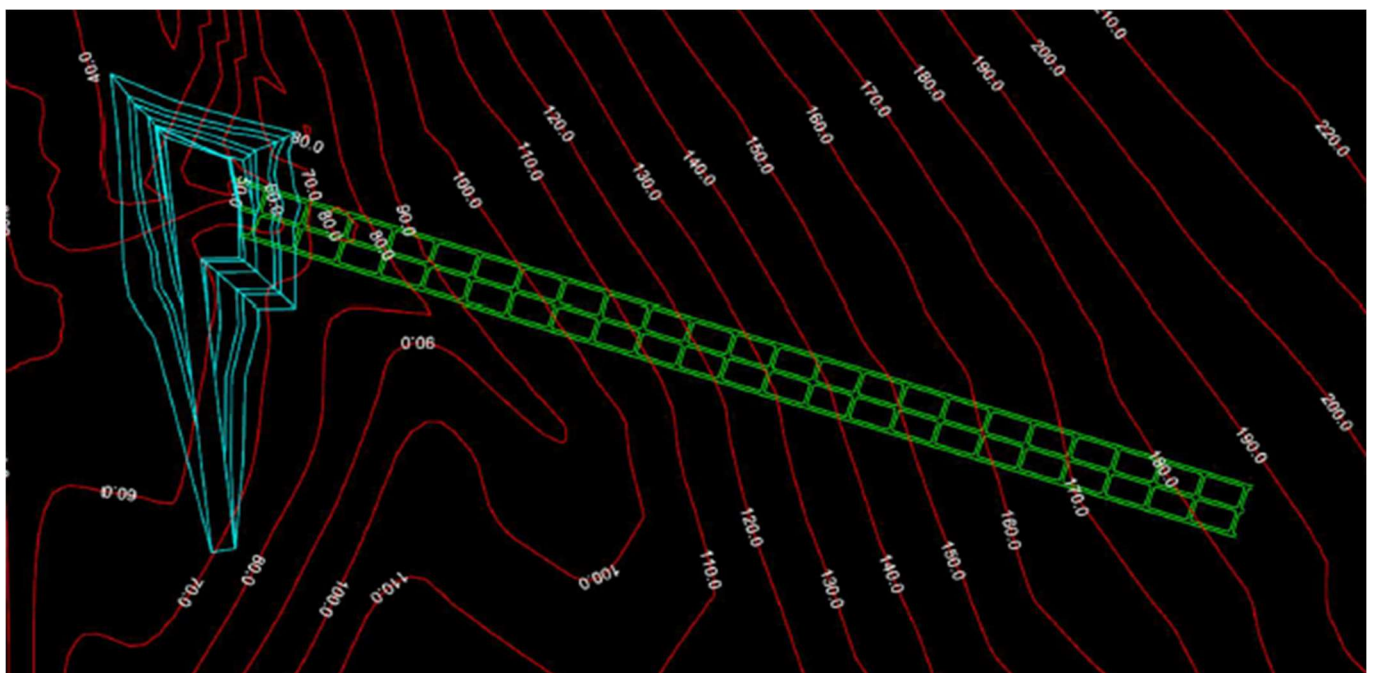
Figure 25: Planned layout of the Wards Well underground exploration area

Three headings are proposed (cutting width of 5.5m and height of 3.4m) and will extend 1800m with pillars 40m wide x 70m long (Figure 25). The three heading system with proposed 45.5m centre to centre spacing provides roadways for ventilation, coal clearance and access. The cut-through width will allow sufficient room for ventilation devices and storage of equipment during the mining processes.
