# Progressive Rehabilitation and Closure Plan

## Wards Well Mine

| <b>Document title</b> | Progressive Rehabilitation and Closure Plan |
| <b>Version number</b> | V3.0 |

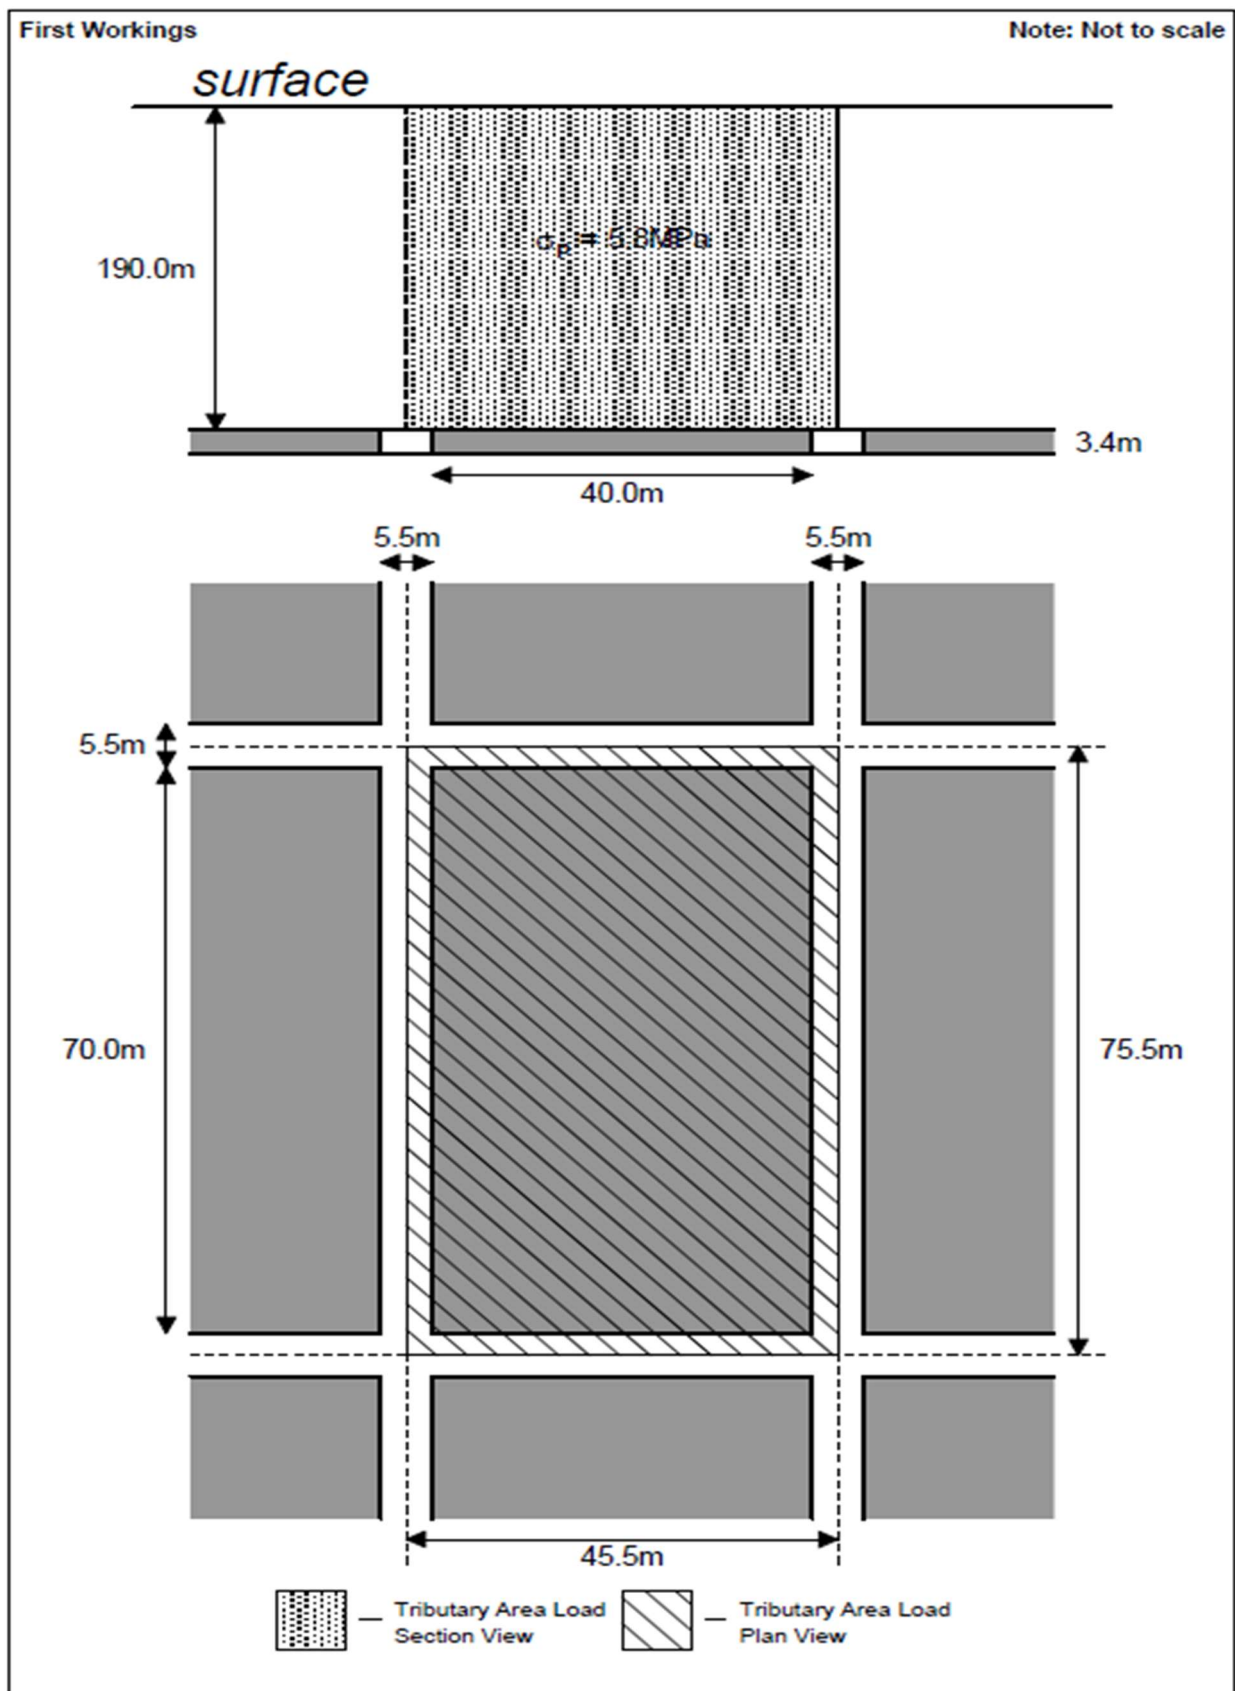
Figure 26: Geotechnical stability analysis (pillar layout, depth) for Wards Well

to the wetting and drying of soils. Therefore, no surface subsidence is expected from the underground exploration.

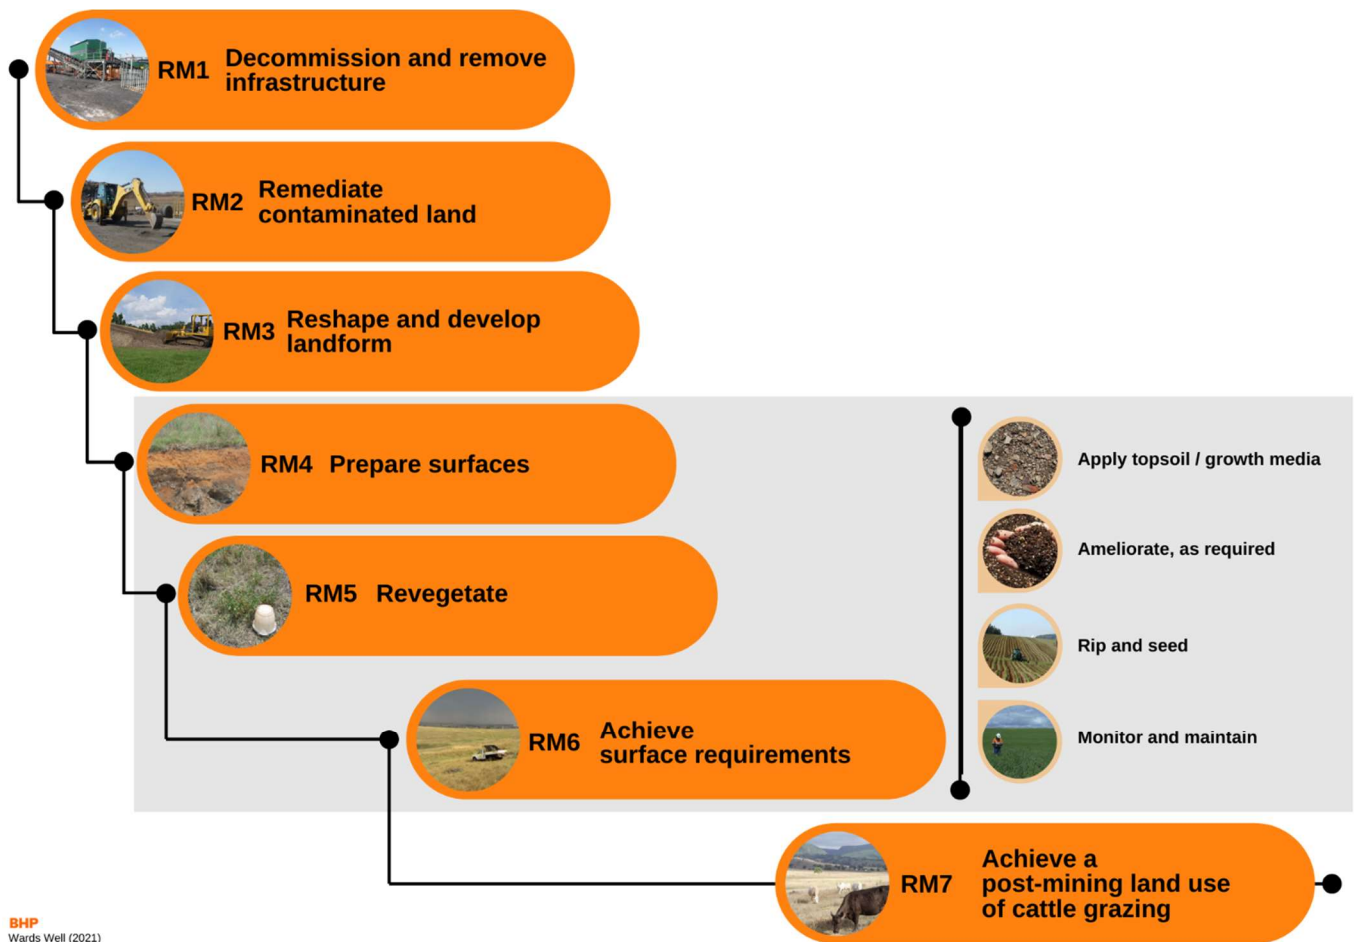
Figure 27: Summary of key rehabilitation and management practices for Wards Well

Figure 27 summarises the Wards Well rehabilitation milestones. Figure 28 provides an indicative timeline that informs the PRCP schedule. Exploration drilling are rehabilitated progressively throughout the timeline.

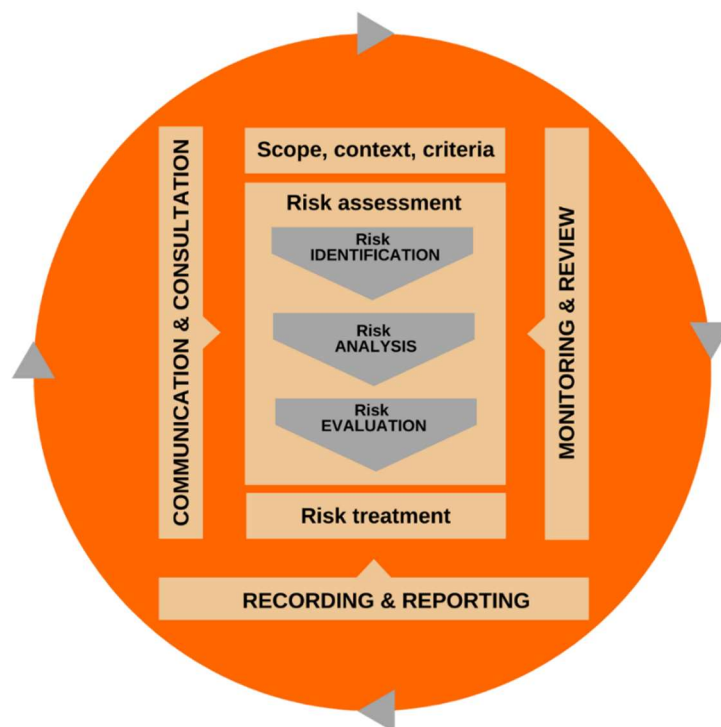
Figure 29: ISO 31000-compliant risk-based approach followed for the Wards Well PRC plan

A risk-based approach to the Wards Well PRC planning has been undertaken (Figure 29).

The risk event - a stable condition for land described as a post-mining land use not being achieved, was assessed per ISO 31000 methodology described in Figure 29 above (the full risk assessment is included in Appendix 12), where stable condition is defined as per section 111A of the EP Act:

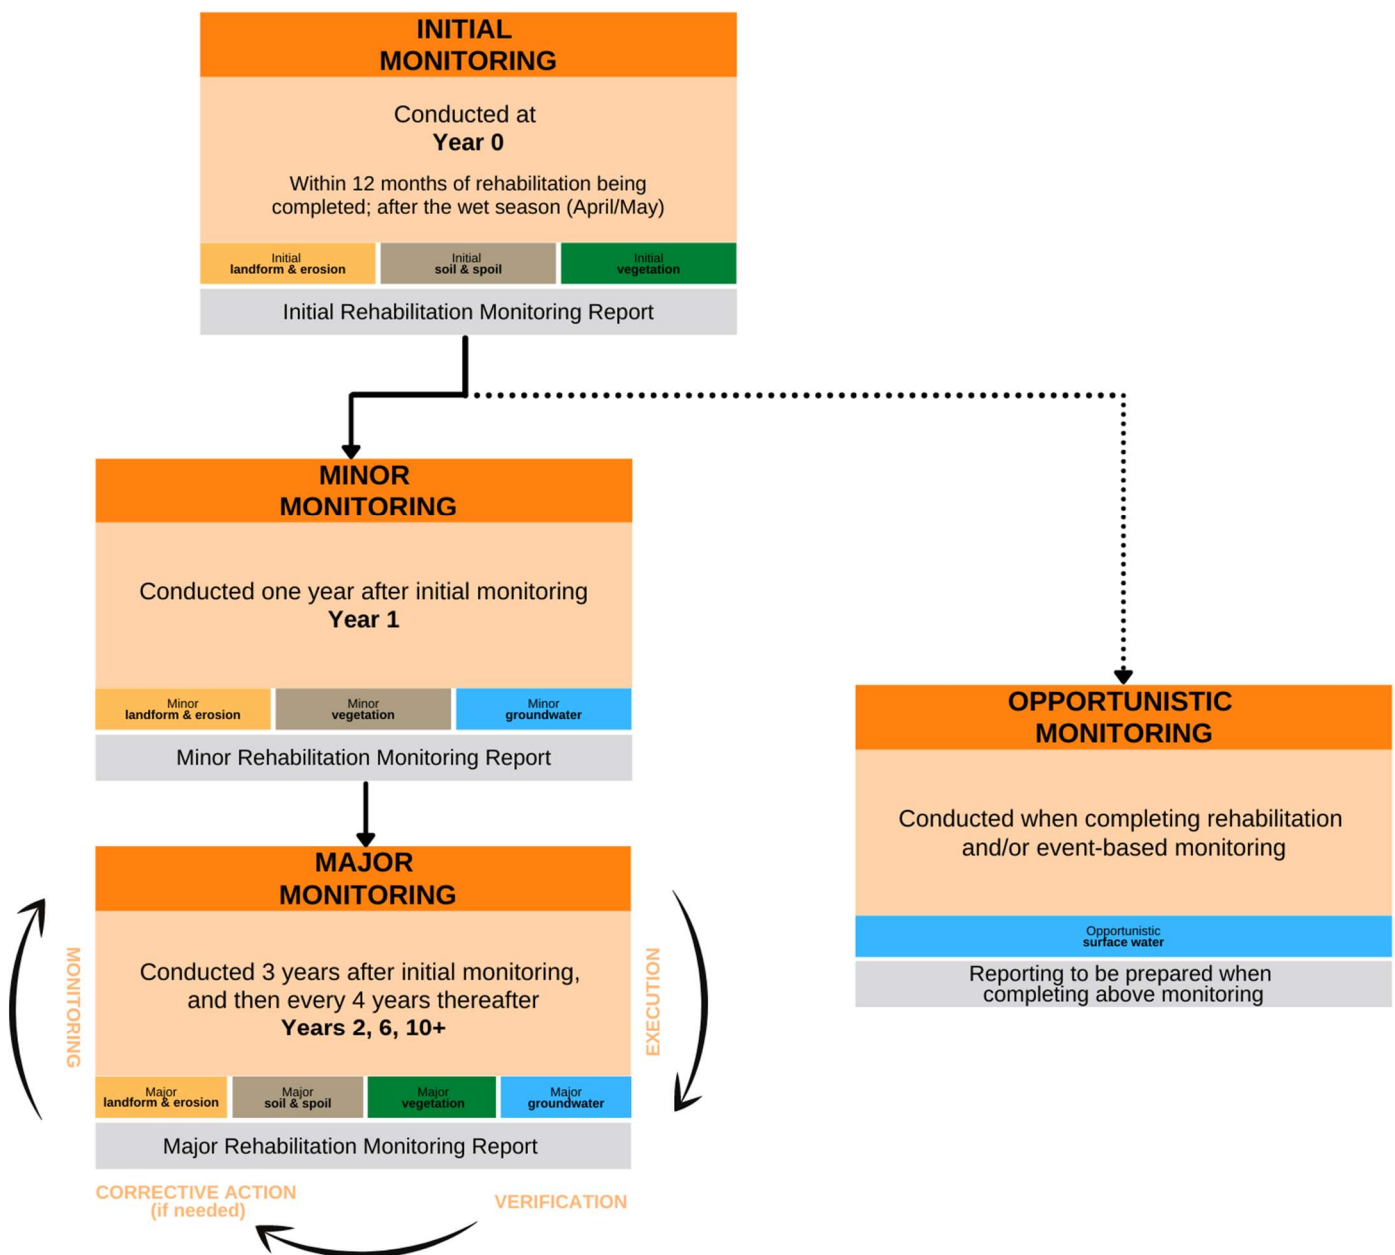
**Figure 31: Flow diagram of the Wards Well rehabilitation monitoring program**

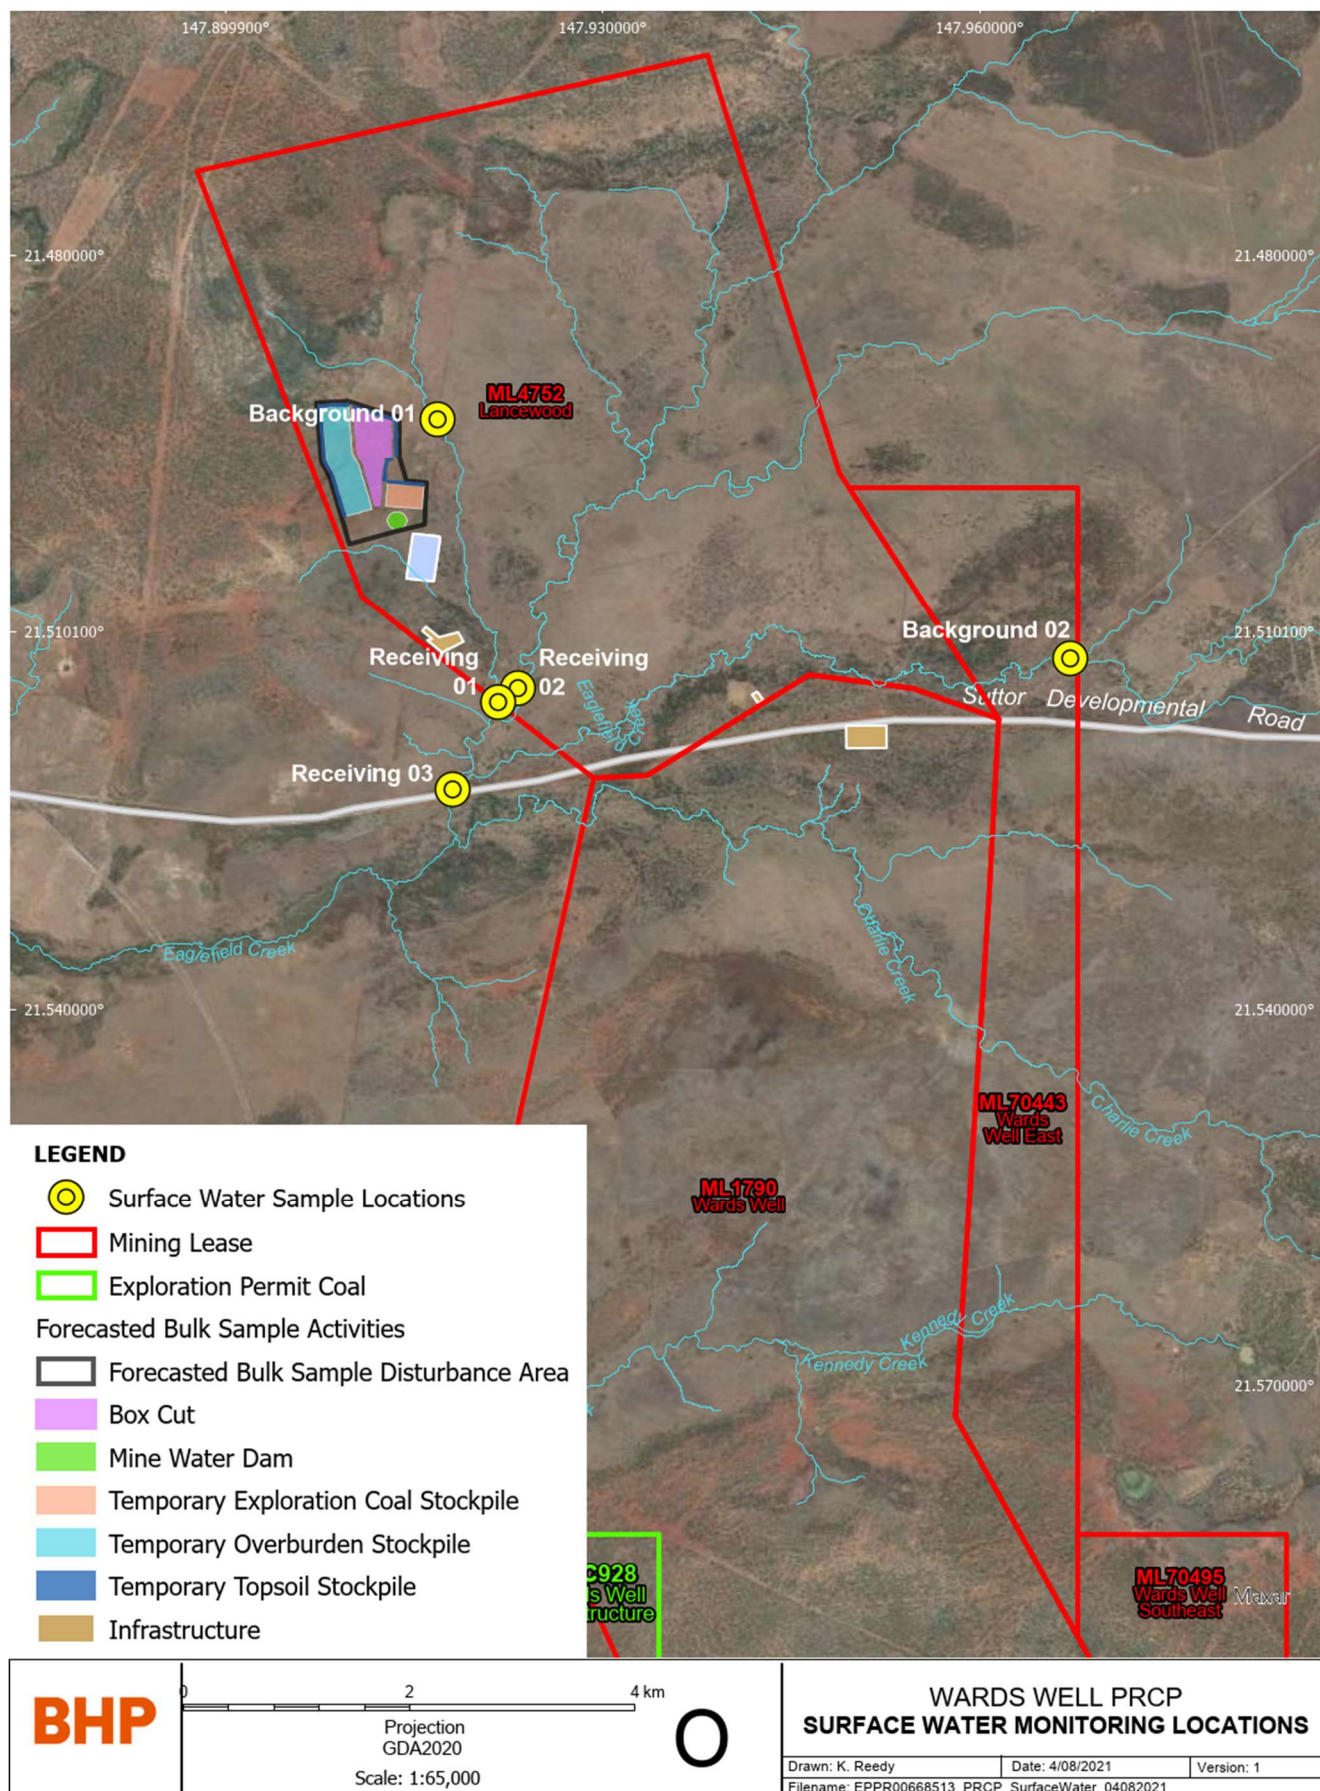
Figure 32: Wards Well rehabilitation-related surface water monitoring locations

The location of the surface water monitoring points for this opportunistic monitoring are illustrated in Figure 32 and summarised in Table 34. Other monitoring locations may be deemed necessary by BMC to demonstrate attainment of the milestone criteria – these will be identified and included in the monitoring program as rehabilitation monitoring proceeds over time.

- Independent Populations: upstream mean and downstream mean (over a maximum monitoring period of five years, sample locations shown in Figure 32, Section 8.5).
- Null Hypothesis: upstream mean = downstream mean.
- Alternative Hypothesis: upstream mean  $\neq$  downstream mean.
- Significance level: 0.1
- The statistical method to be utilised will account for the sample population size and the distribution of the data.

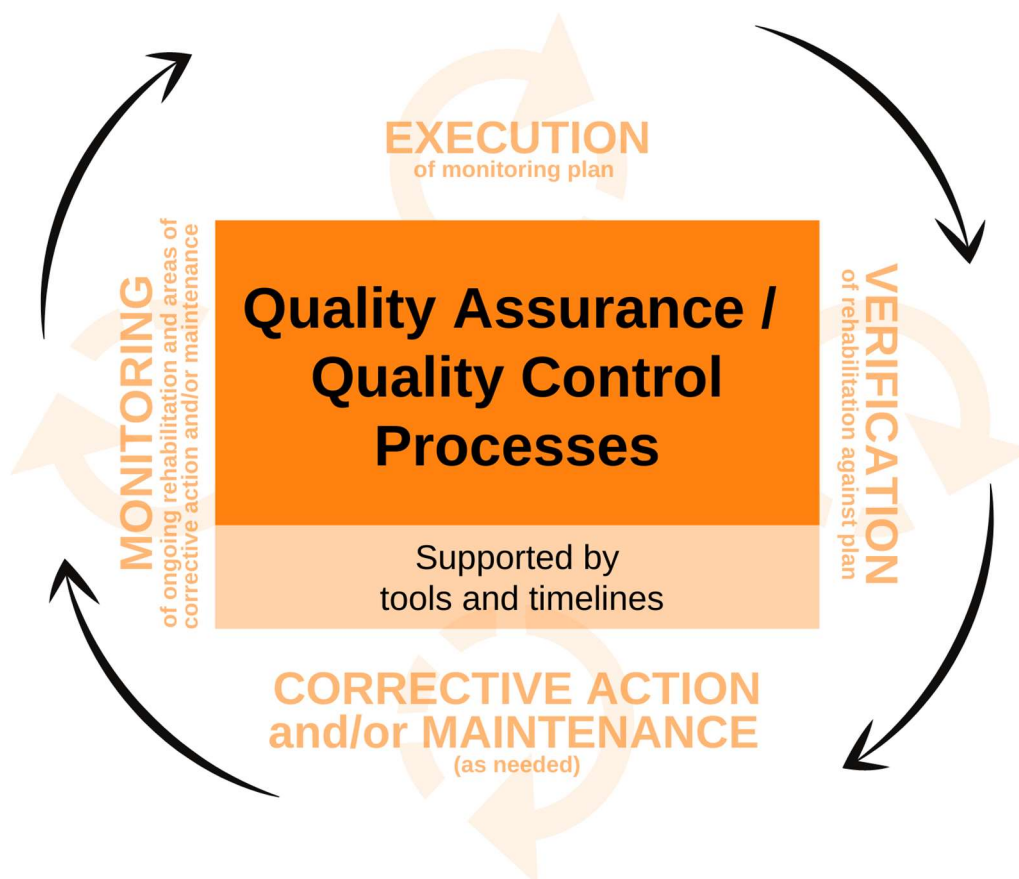
**Figure 33: Quality assurance / quality control process to be followed for ongoing rehabilitation monitoring at Wards Well**

The quality assurance and quality control (QA/QC) process to be followed as part of Wards Well's ongoing rehabilitation monitoring is illustrated in Figure 33. The process provides for initial execution of the rehabilitation in accordance with the rehabilitation measures, followed by verification of how this execution

was undertaken (again, according to these measures). Based on the verification outcomes, allowance is made for implementation of corrective action and/or maintenance, as needed. The rehabilitated areas as well as corrected and/or maintenance areas then undergo further rehabilitation monitoring; and subsequent execution of the rehabilitation measures. This process allows for a repetitive execution-verification-monitoring QA/QC approach, to ensure rehabilitation areas progress on a trajectory towards achievement of milestone criteria and eventual certification.

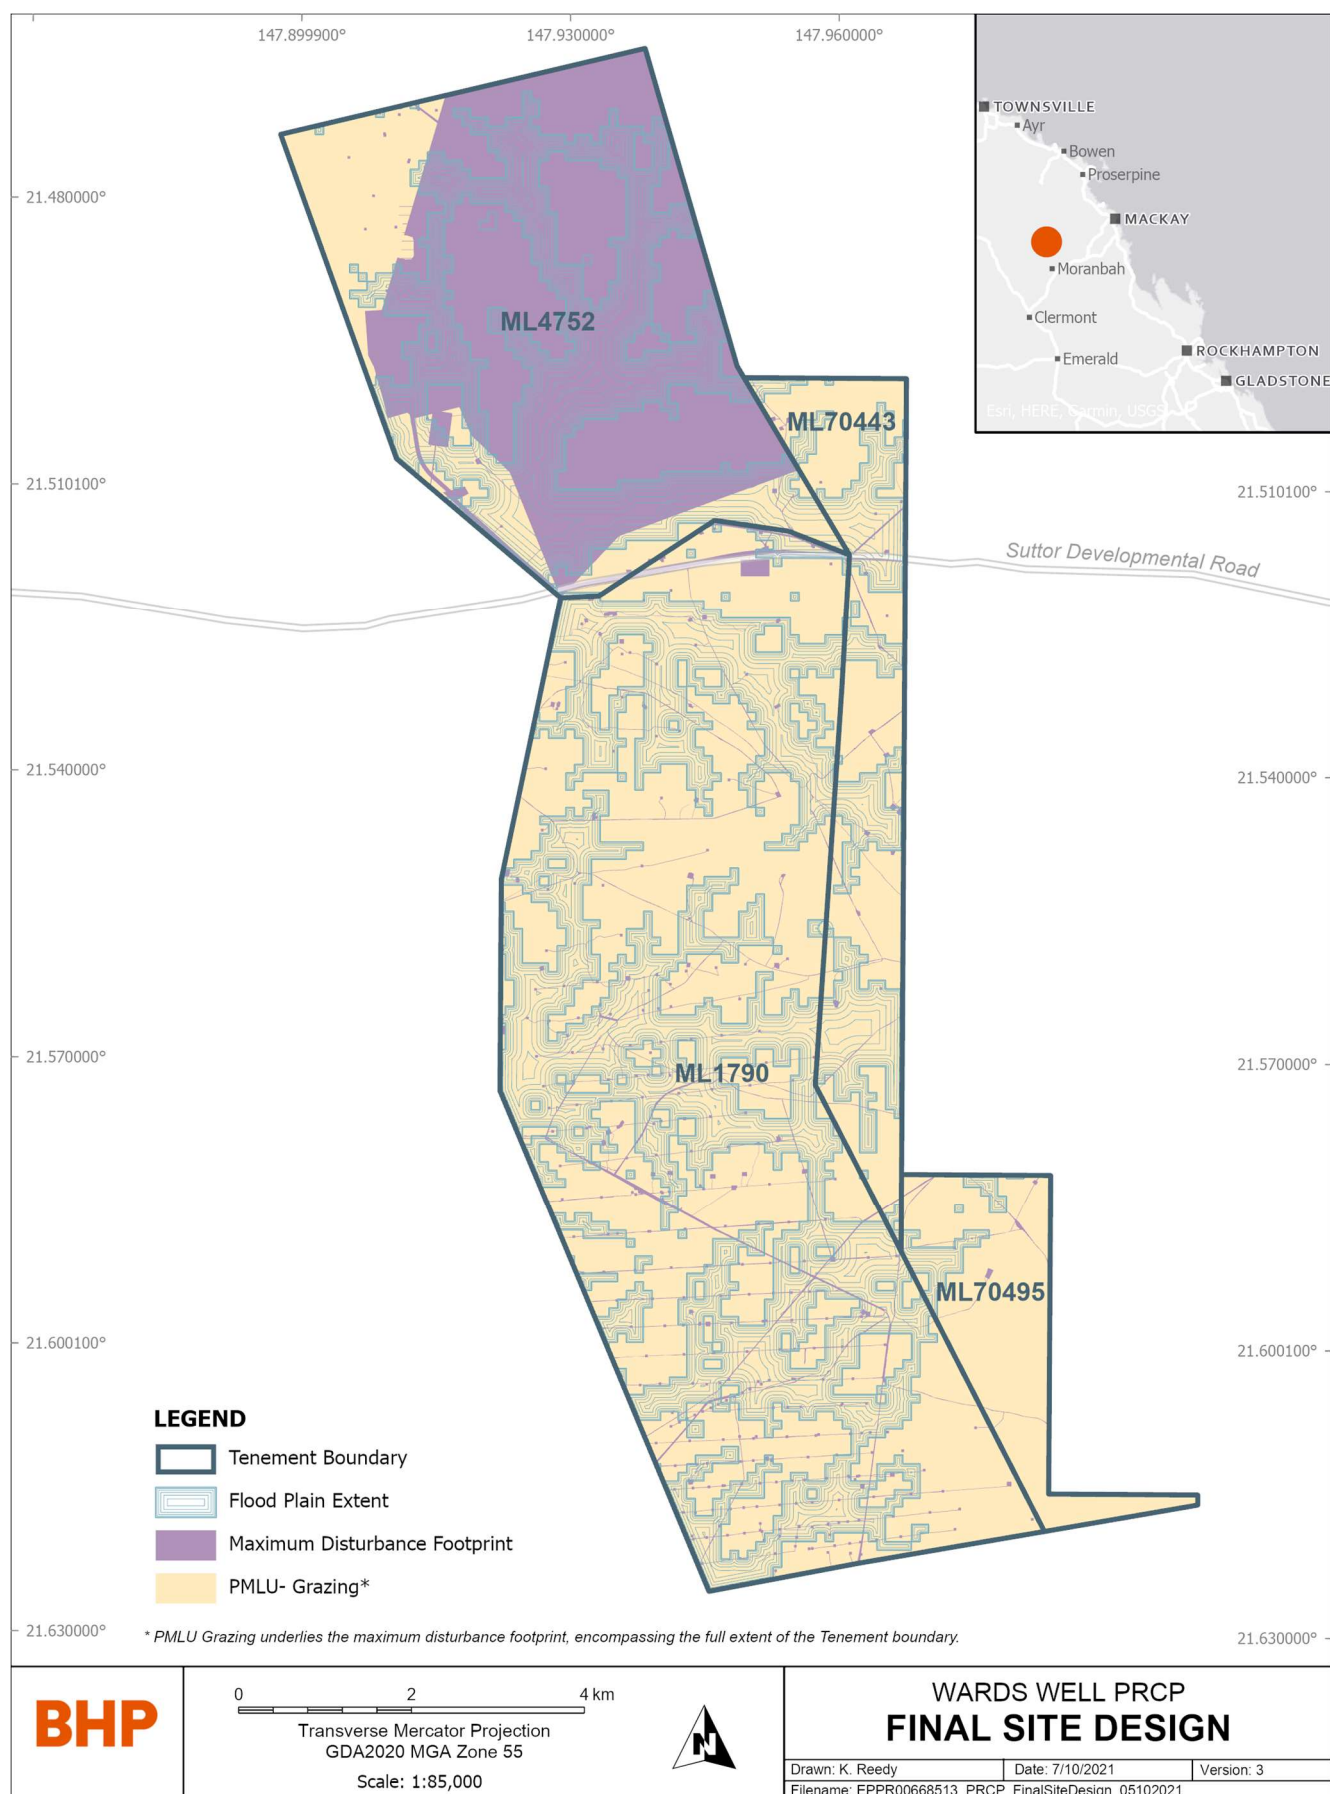
Figure 34: Wards Well final site design

The final site design for Wards Well, including maximum disturbance, tenure boundaries, the PMLU and the extreme event flood plain, is shown in Figure 34.

Pre-BHP involvement, historical exploration drilling and seismic surveys occurred outside the above areas. These historical areas are shown in the maximum disturbance footprint in the final site design map (Figure 34), as well as included in the hectares in the PRCP schedule.

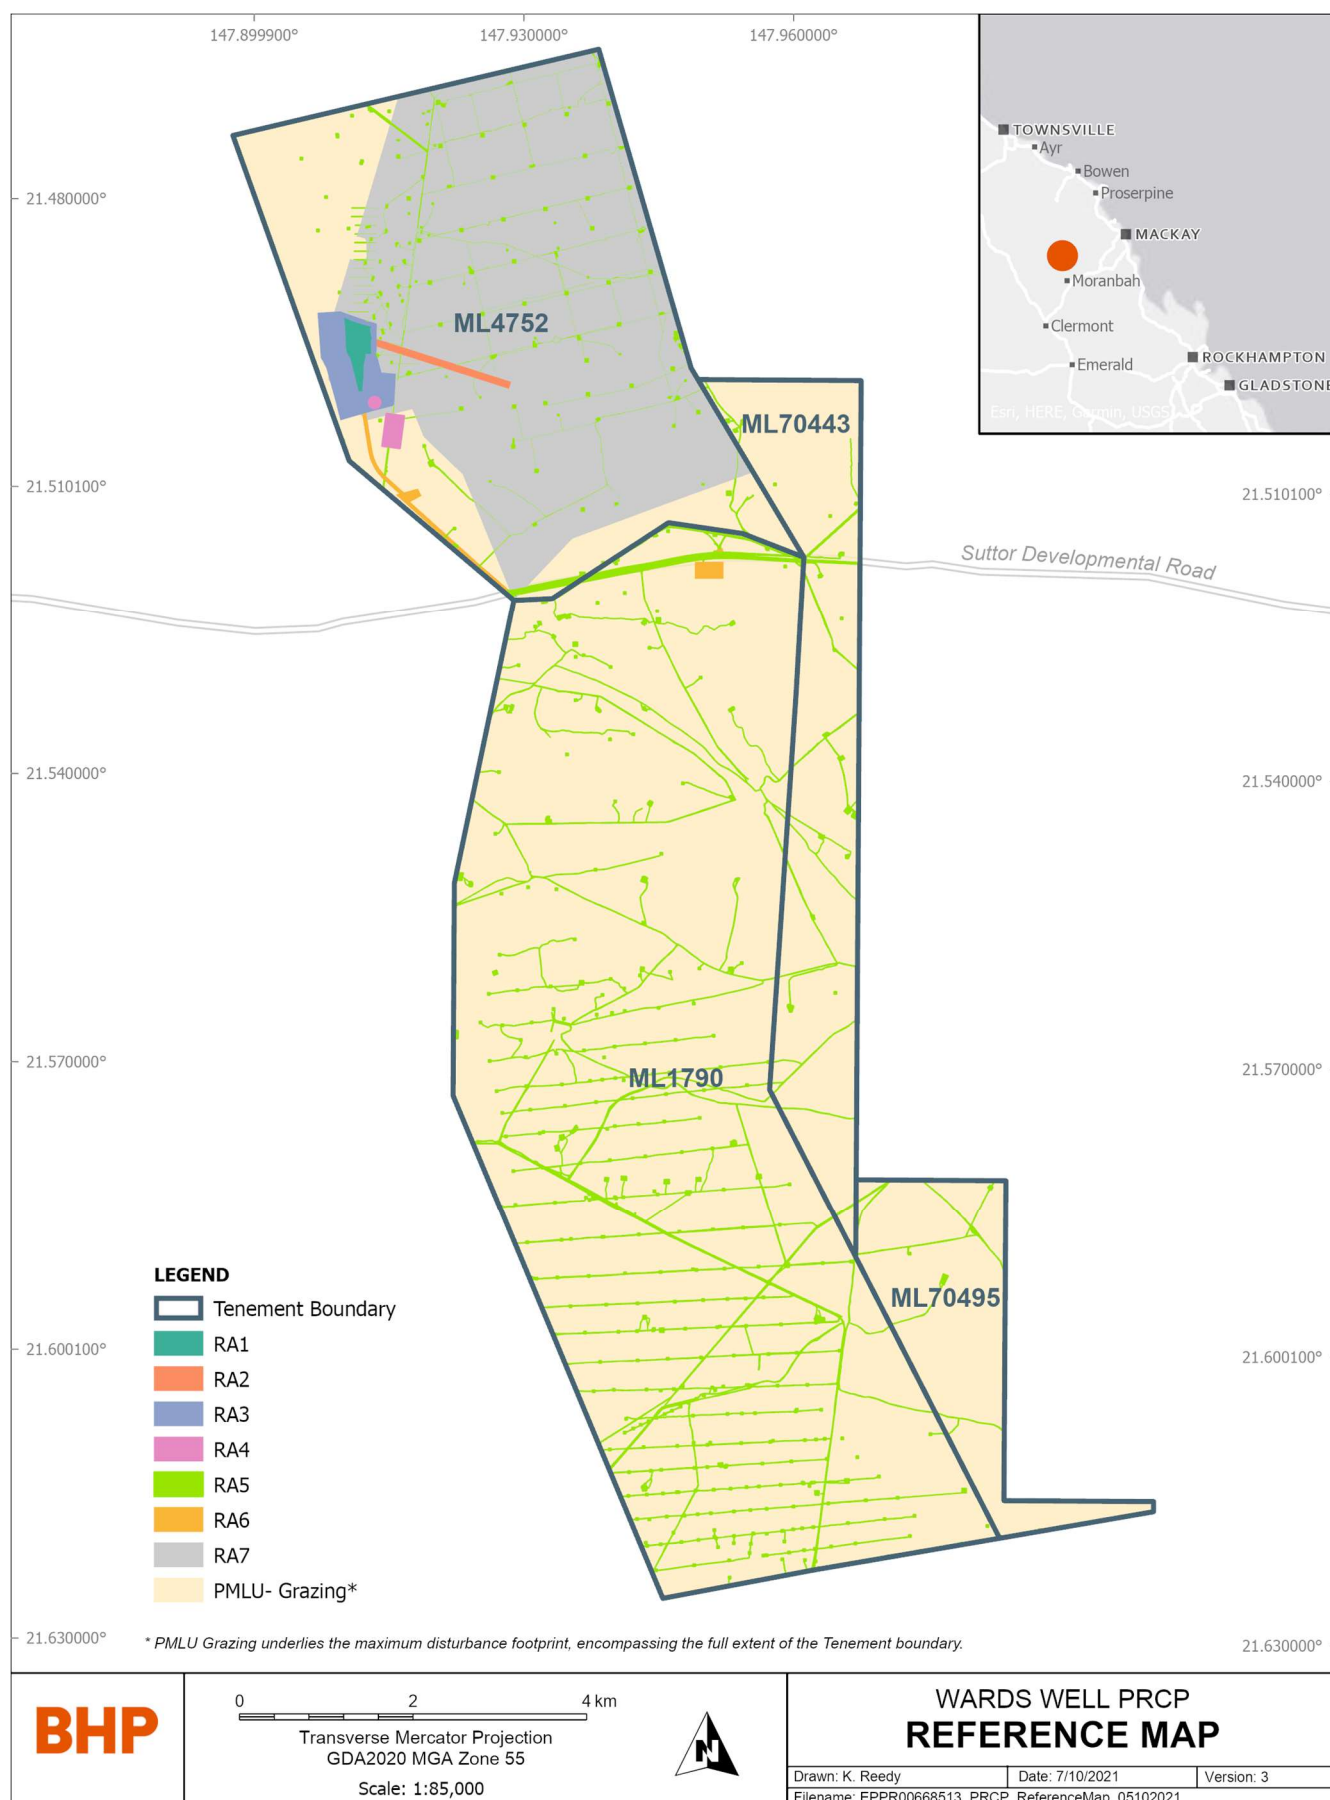
Figure 35: Wards Well reference map

The Wards Well reference map showing the rehabilitation areas is shown in Figure 35.

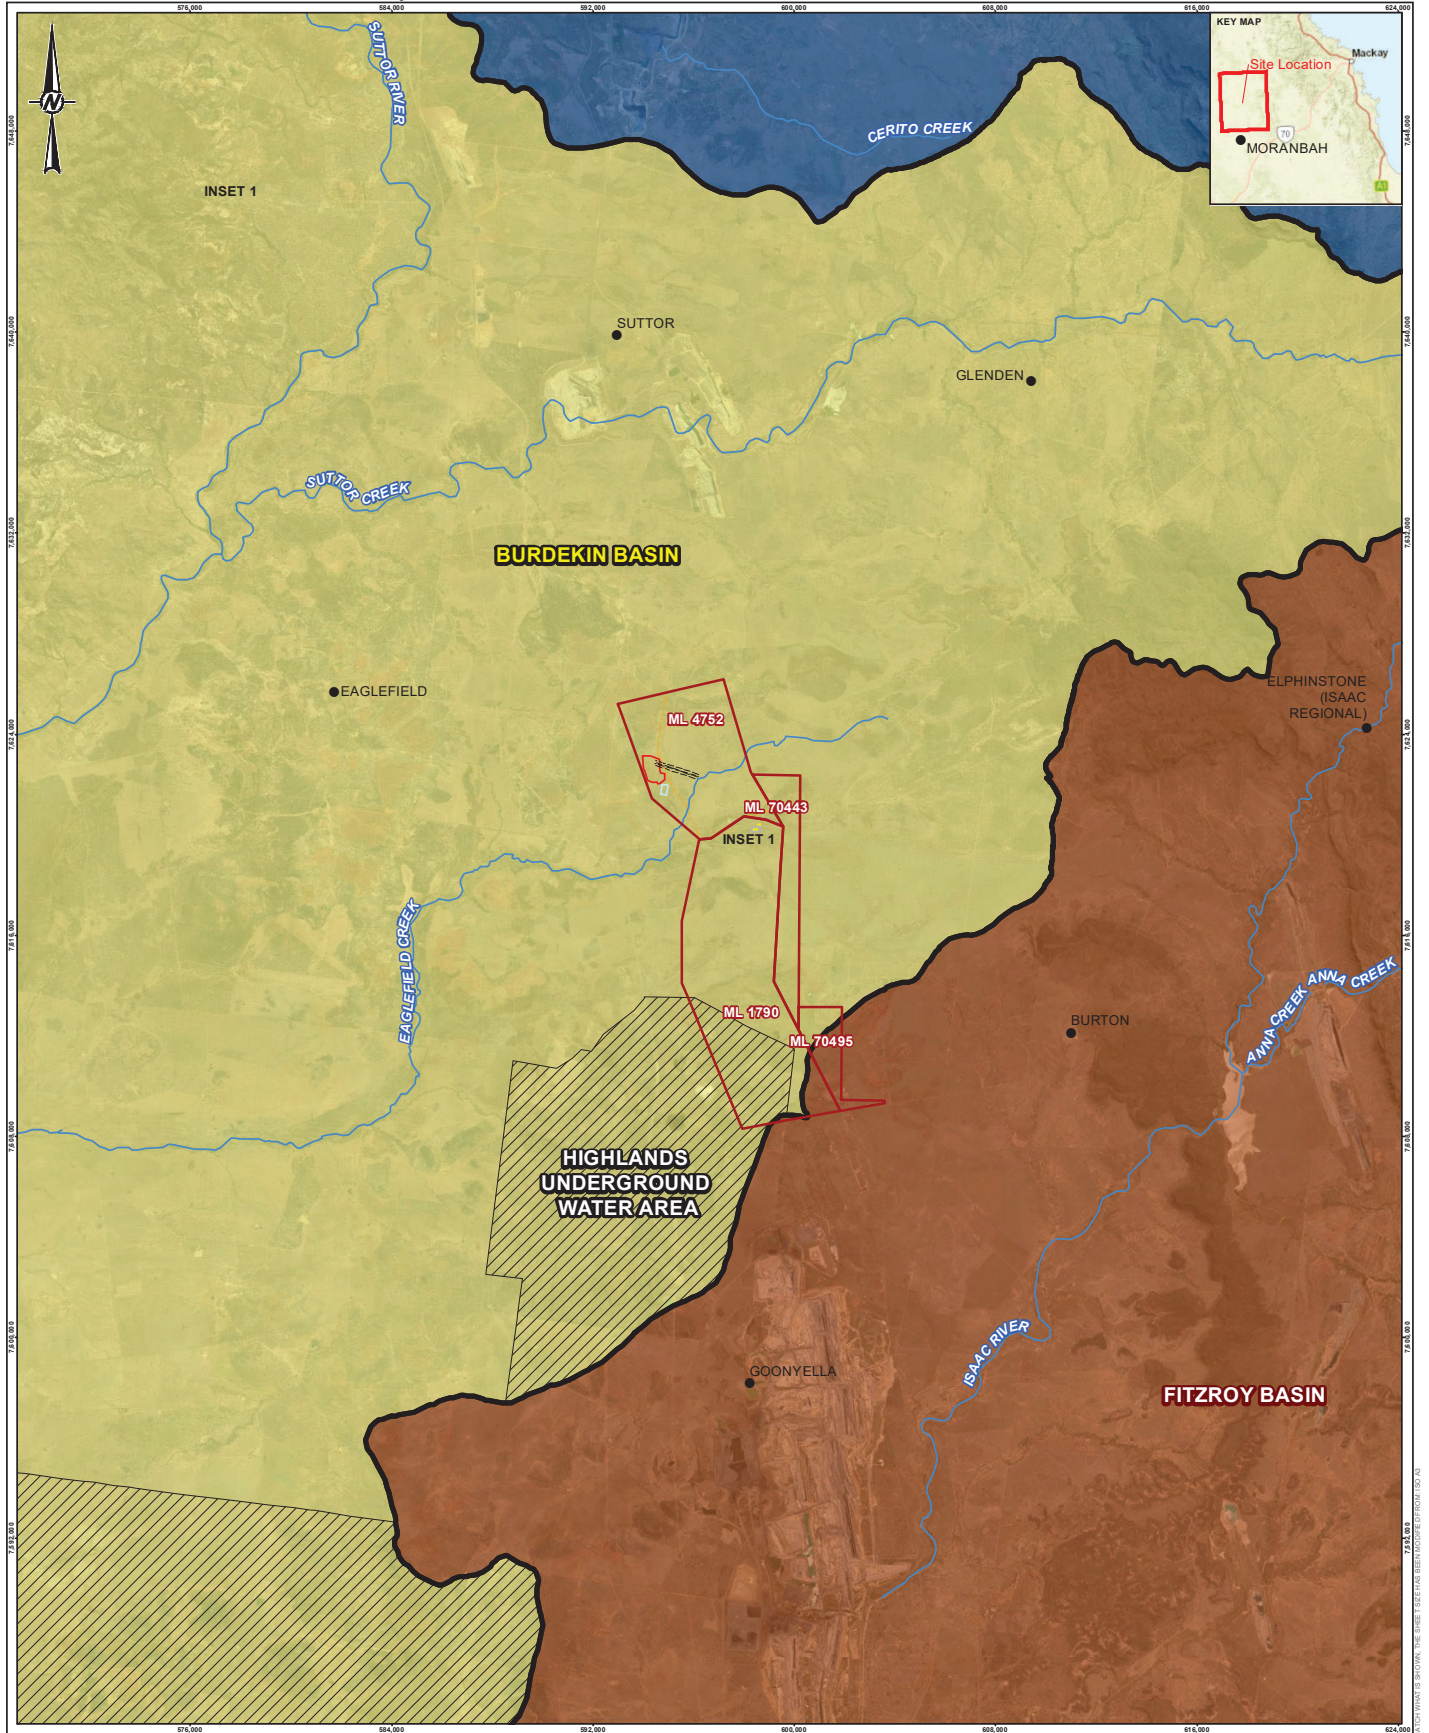
Water management areas are displayed in Figure 1.

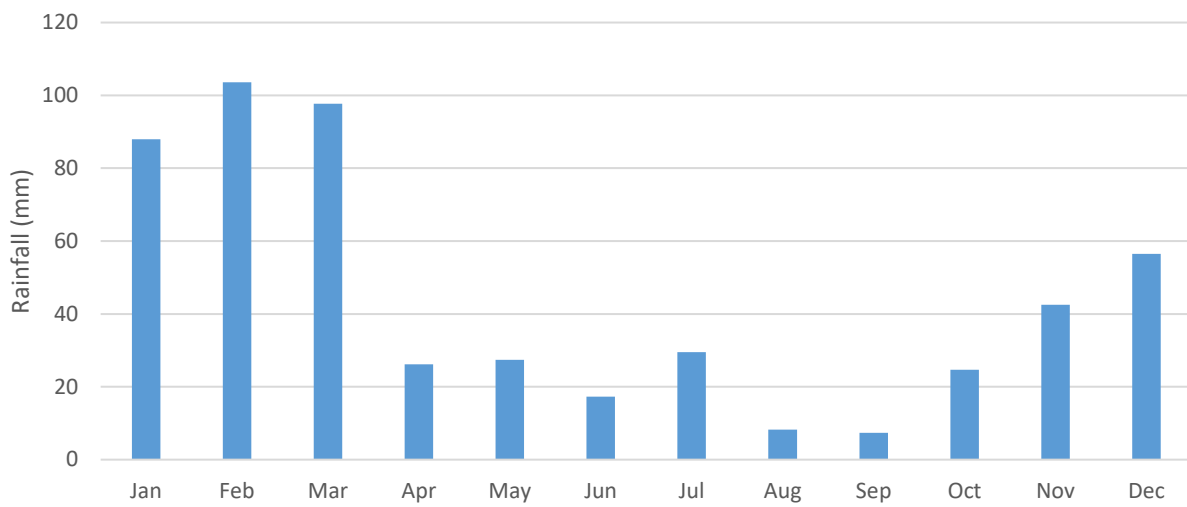
**Figure 2: Average monthly rainfall over the period 2012 to 2020 (station number 34035, BOM 2020a)**

The Central Queensland climate is classified as semi-arid and is characterised by warm, dry winters and hot, humid summers. Almost all rainfall occurs during the wet season, between the months of November and April (BOM, 2020a). Daily rainfall records since 2012 are available from the Moranbah Airport weather station (No. 34035), located approximately 50 km south of the site. The yearly distribution of average monthly rainfall is presented in Figure 2. The average annual rainfall (using rainfall data from 2012 to 2020) is approximately 529 millimetres per year (mm/yr).

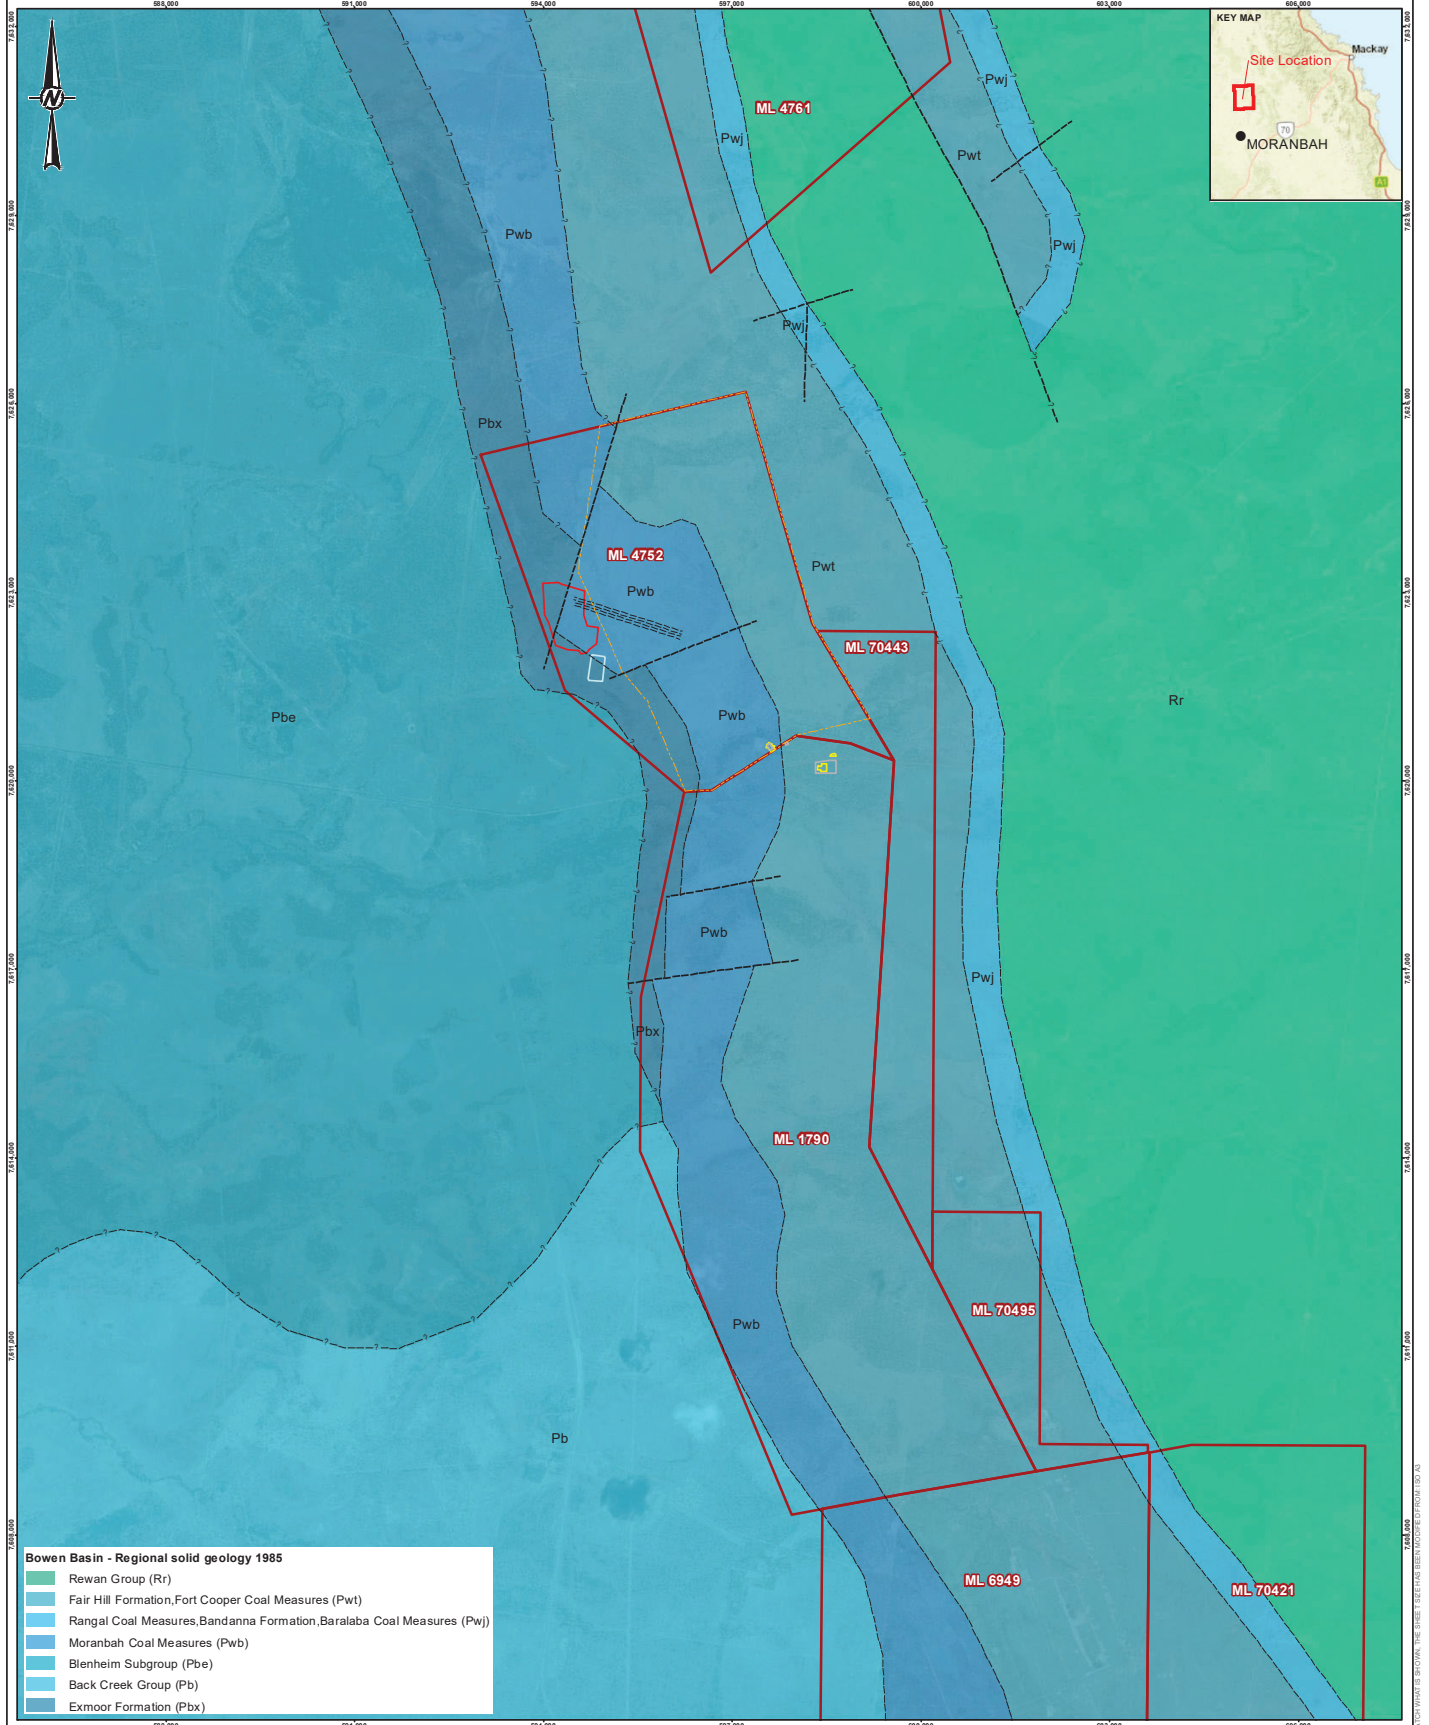
Two main fault sets have been identified at the project site during previous site investigations: normal faults striking east-west with a vertical displacement of approximately five to ten metres, and thrust faults striking north-south with approximately three metre upthrust to the east. Exploration drilling also intersected a number of normal and thrust faults located throughout the mining lease areas (AGE, 2012).

Detailed solid geology and surface geology is displayed in Figure 4 and Figure 5, respectively. Geological structures are included on Figure 4.

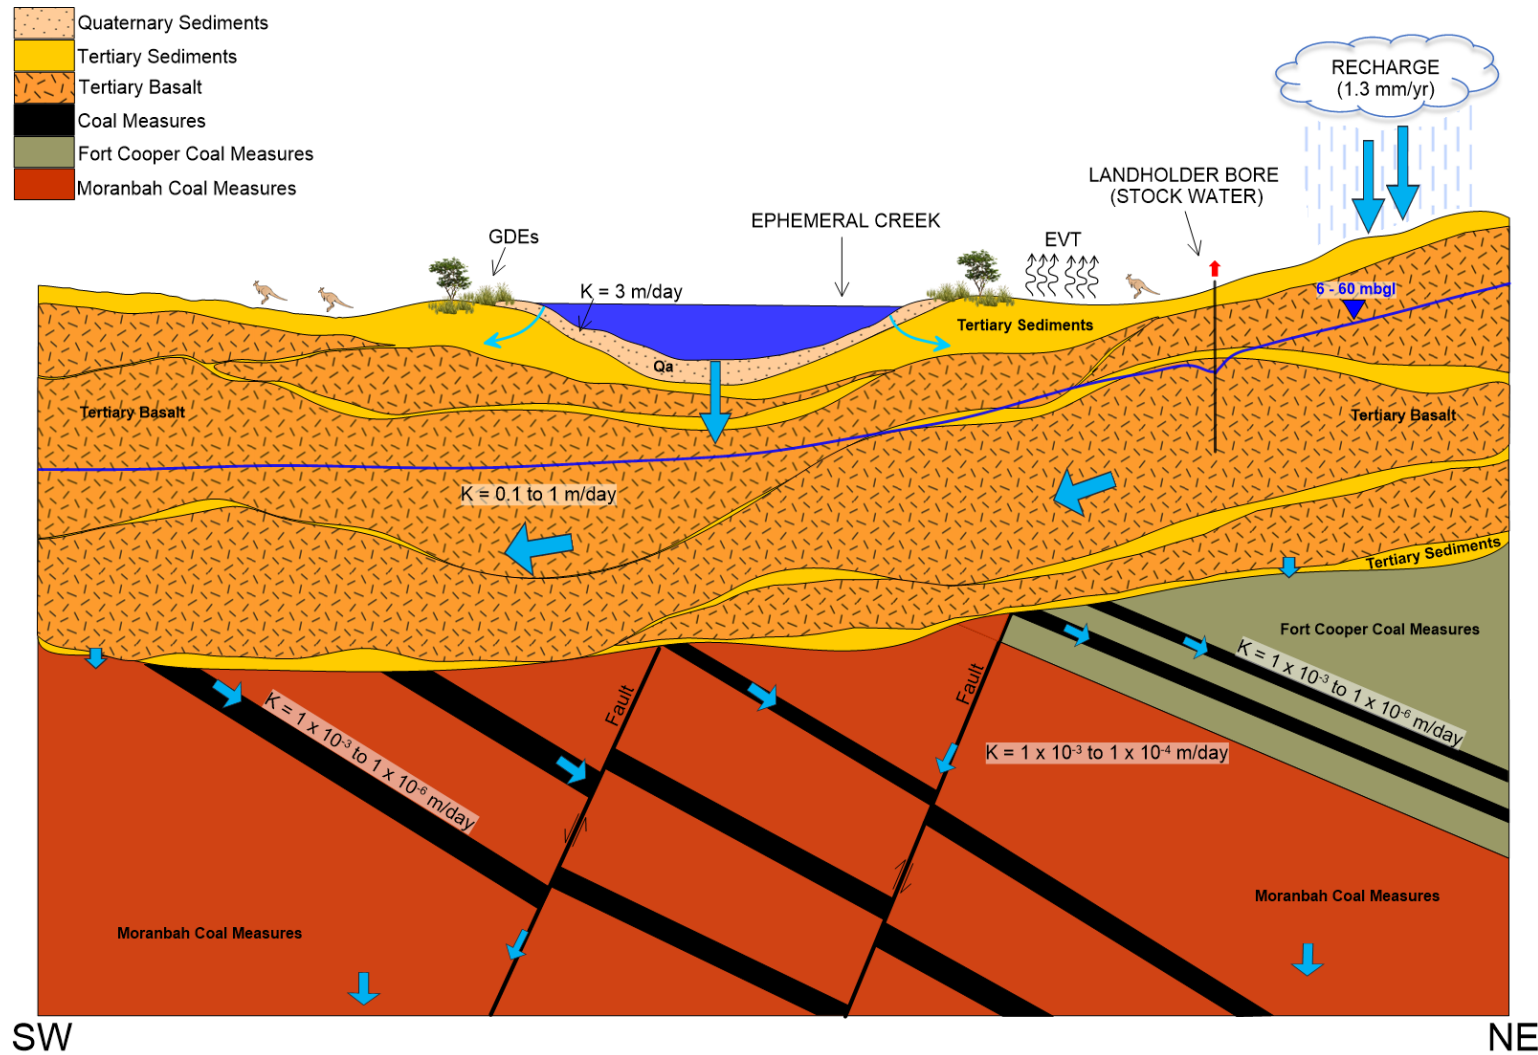
**Figure 6: Baseline Hydrogeological Conceptual Model (BHCM)** Blue arrows show likely groundwater flow directions, with the size of the arrow reflecting the magnitude of groundwater flux.

Groundwater levels in the basalt aquifer typically range between 6 m and 60 m below the ground surface, with groundwater flow in the Tertiary strata (basalts and sediments) flowing from the northeast to the southwest of the project site. Groundwater quality in the basalts is mainly sodium chloride dominated water with Total Dissolved Solids (TDS) concentrations ranging between 480 and 2900 mg/L.
