# Progressive Rehabilitation and Closure Plan

## Wards Well Mine

| <b>Document title</b> | Progressive Rehabilitation and Closure Plan |
| <b>Version number</b> | V3.0 |

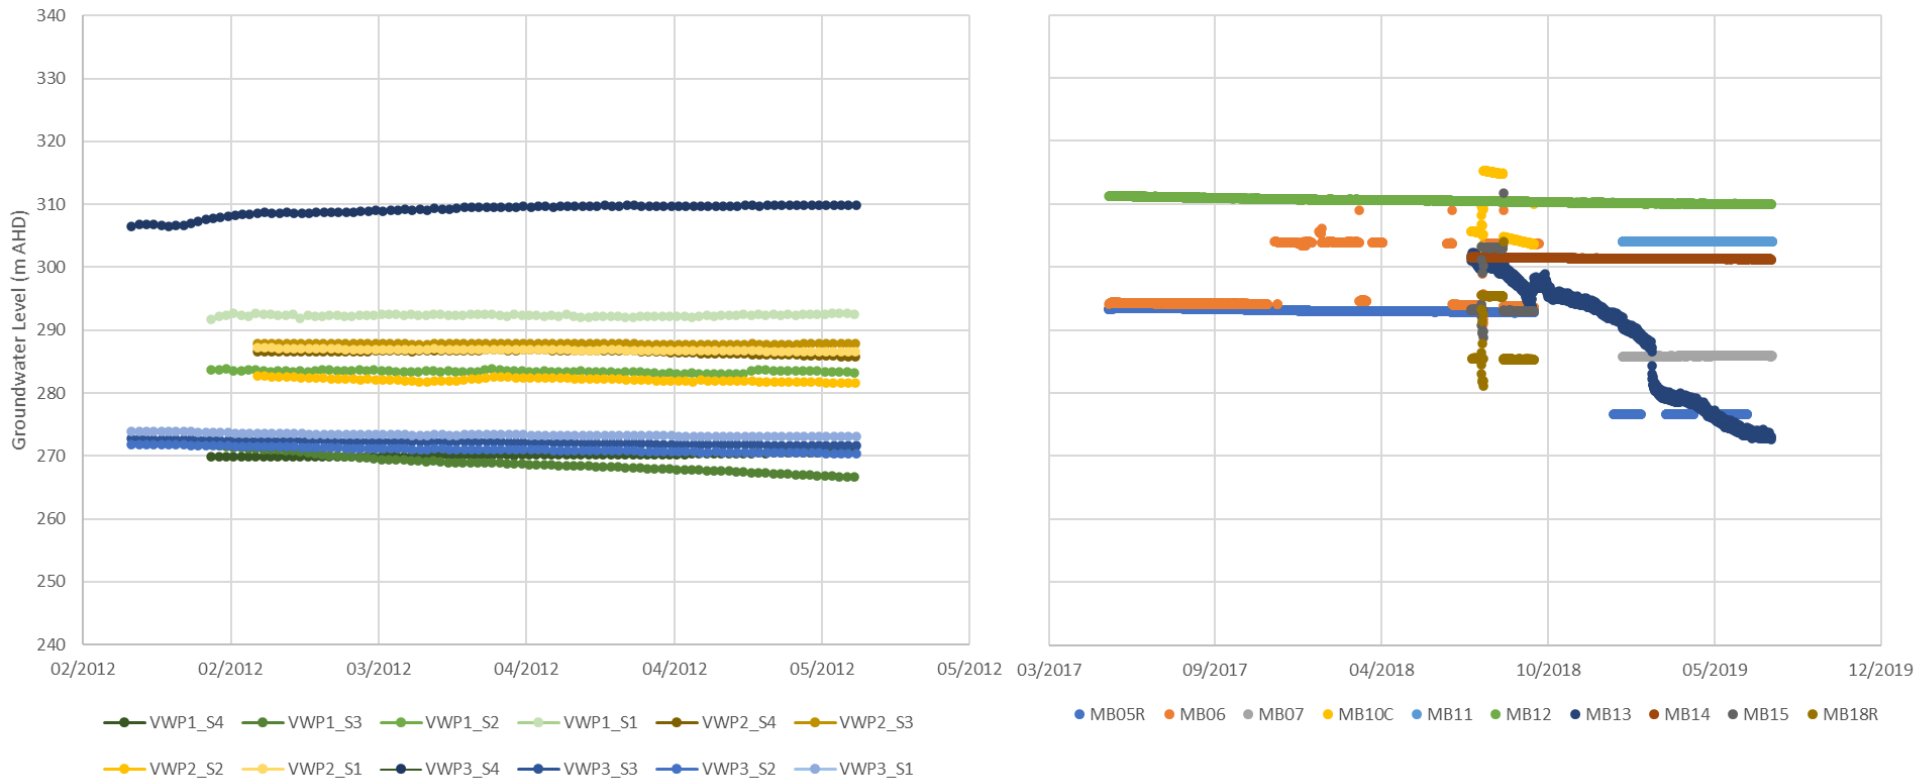
Figure 7: Groundwater Level Hydrographs. VWPs tapping Permian strata are shown on the graph to the left and monitoring bores tapping basalt and sediments shown on the right.

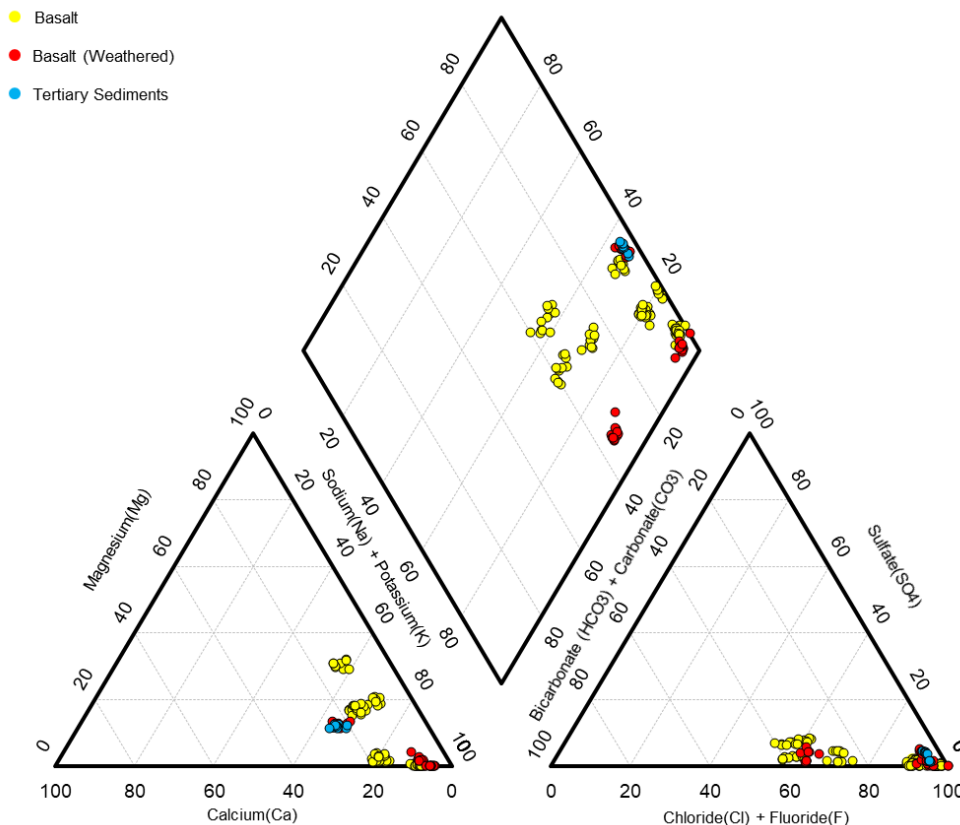
**Figure 9: Piper Plot - Tertiary Basalts Water Quality**

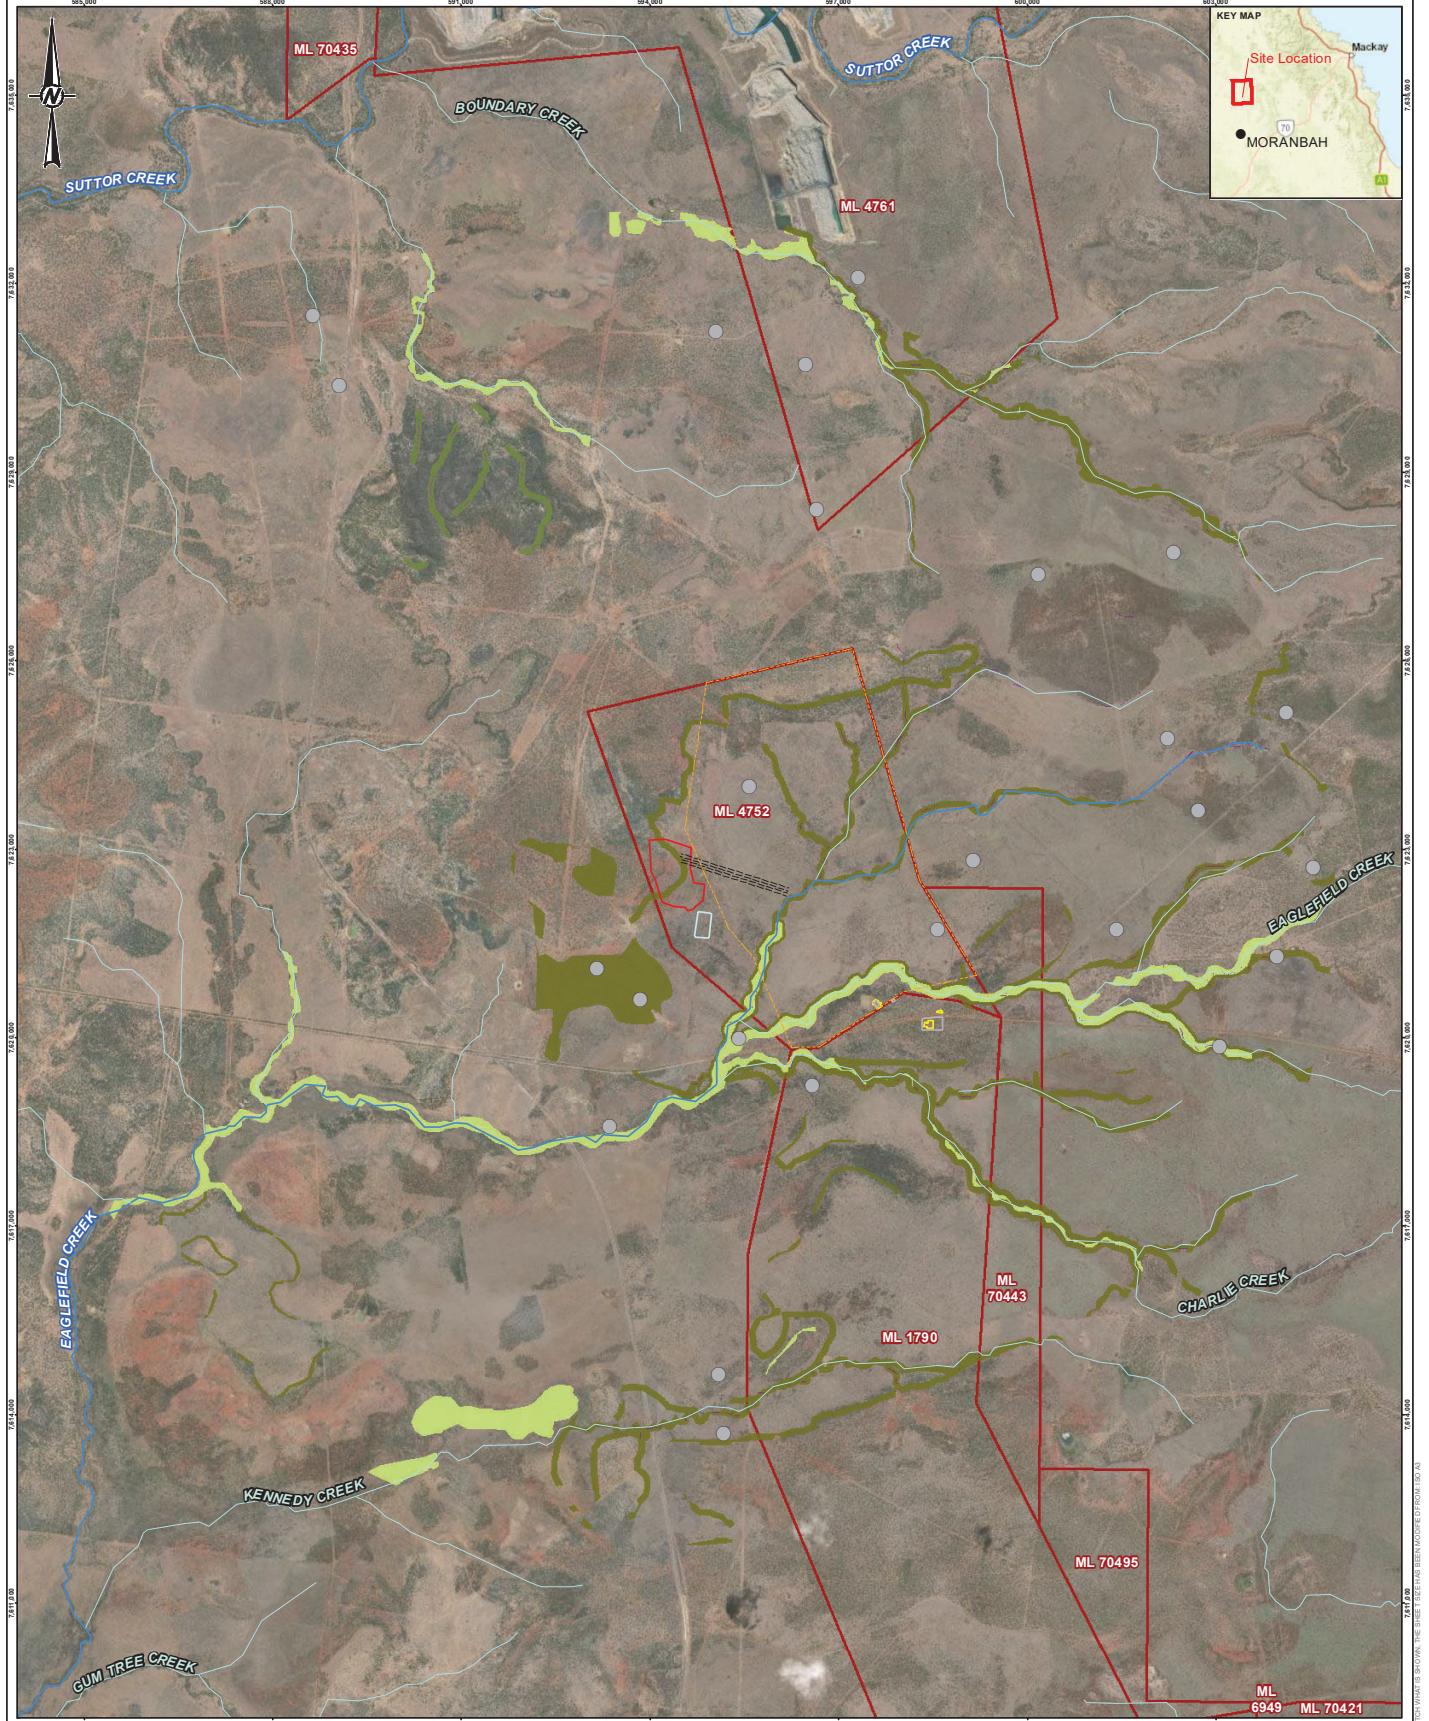
Registered groundwater bores within 10 km of the exploration box cut are displayed in Figure 10.

The distribution of GDEs within 10 km of the exploration box cut is displayed in Figure 10.

There are 16 registered groundwater bores within 10km of the box-cut (both on and off lease), which were listed as existing<sup>13</sup>. Two of the 16 bores were listed for monitoring purposes. The usage for remaining 14 existing bores was not listed, however is expected to be for stock watering or monitoring. Registered bores within 10km of the box-cut are shown on Appendix 4, Figure 10.

A review of the registered groundwater bores within 10km of the box-cut identified a total of 16 bores, which were listed as existing (Appendix 4, Figure 10<sup>11</sup>). Two of the 16 were listed for monitoring purposes. The usage of the remaining 14 existing bores was not listed, however is expected to be for stock watering or monitoring purposes.

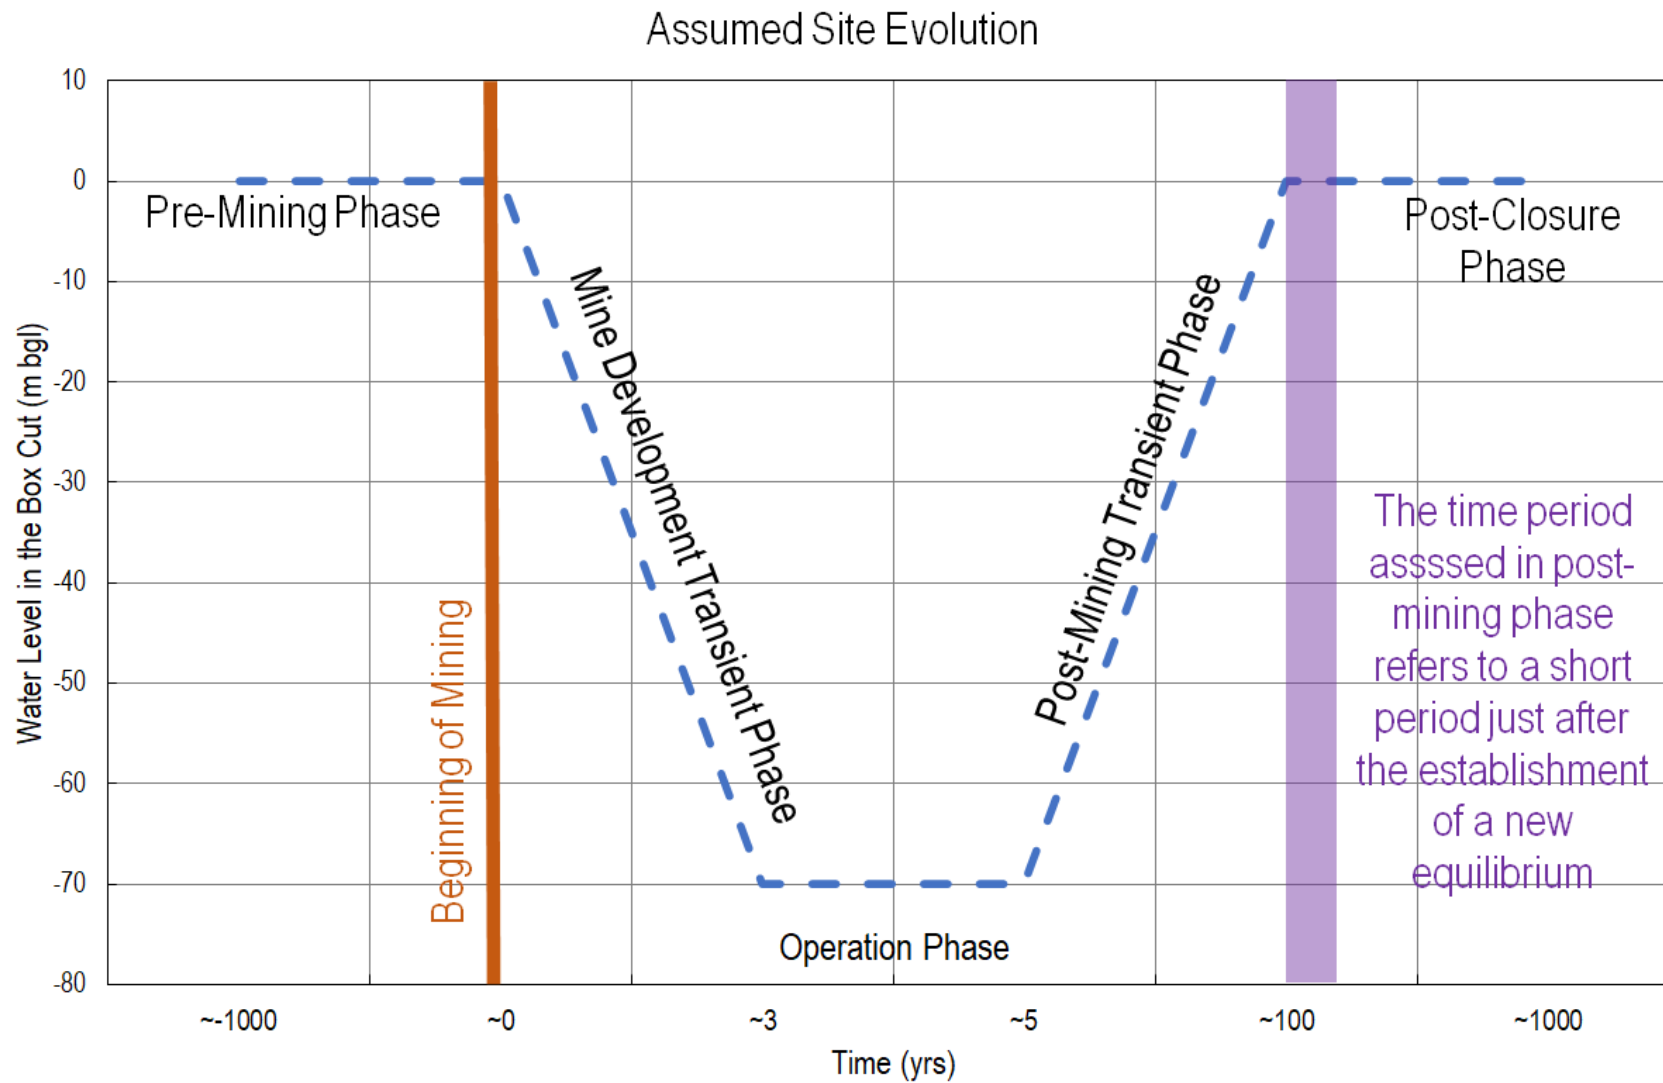
Figure 11: Assumed temporal evolution of the site (time scale is provisional). The purple rectangle shows the time period of the assessment presented in this report.

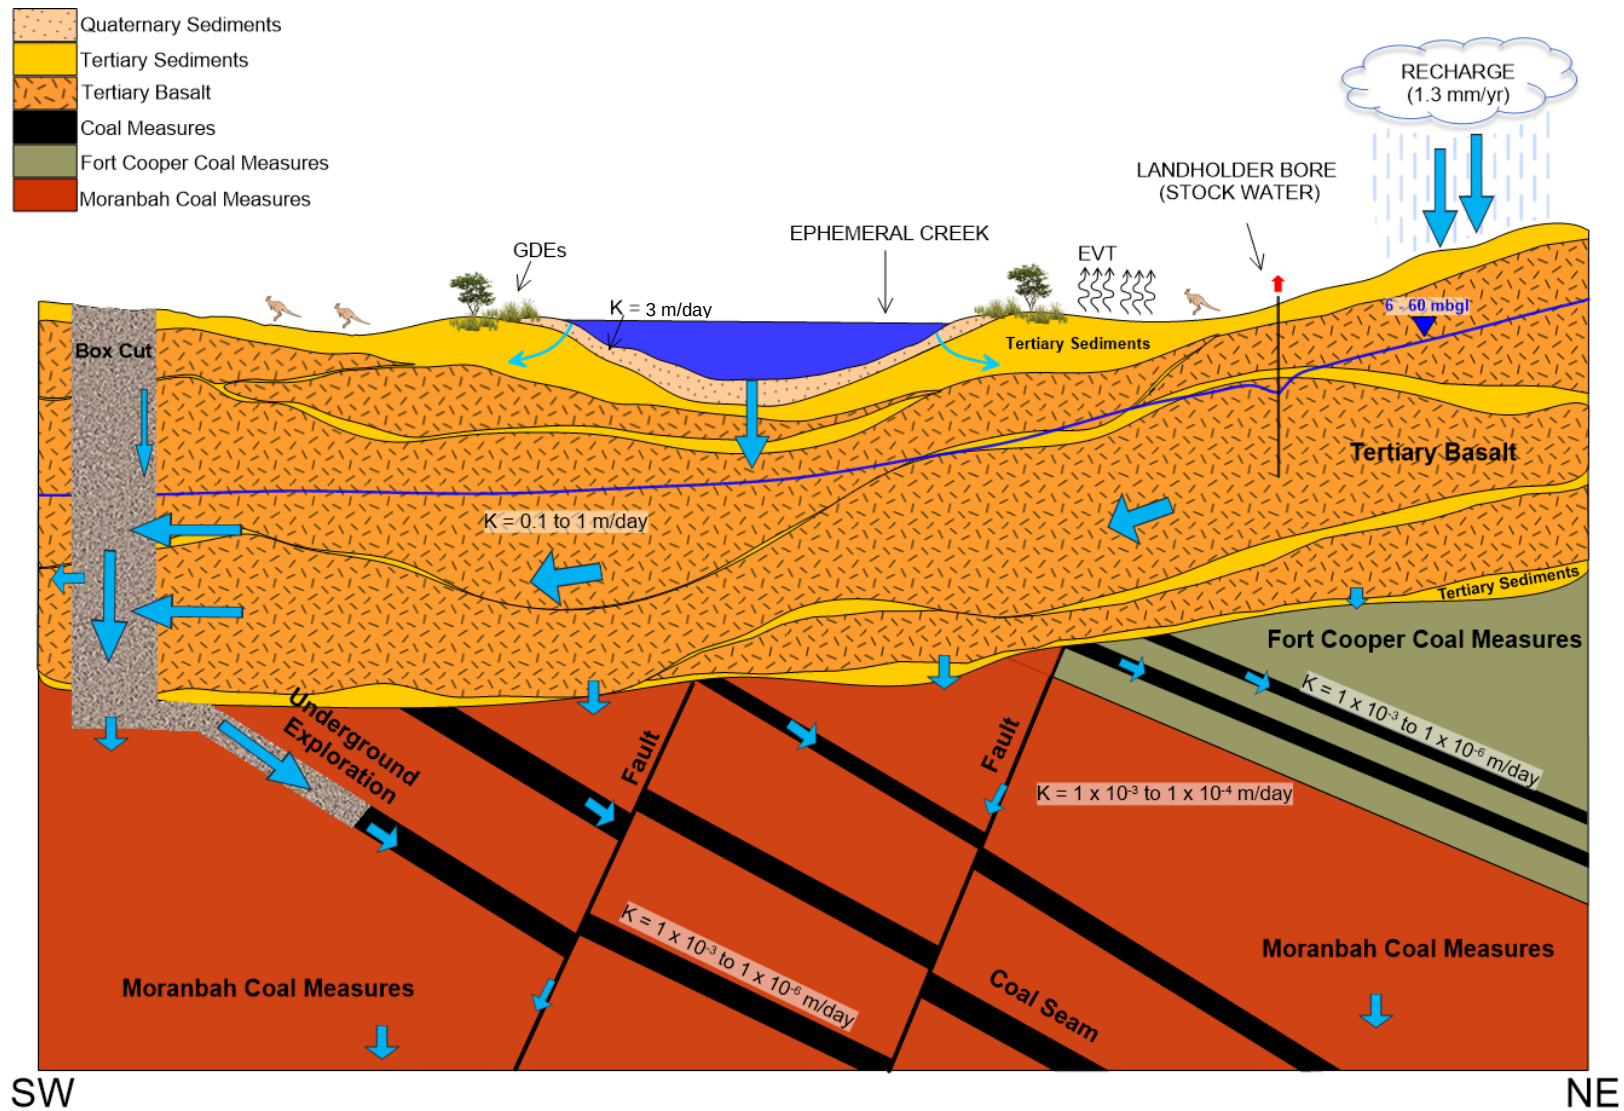
**Figure 12: Qualitative hydrogeological conceptualisation of the post-mining conditions.** Blue arrows show likely groundwater flow directions, with the size of the arrow reflecting the magnitude of groundwater flux.

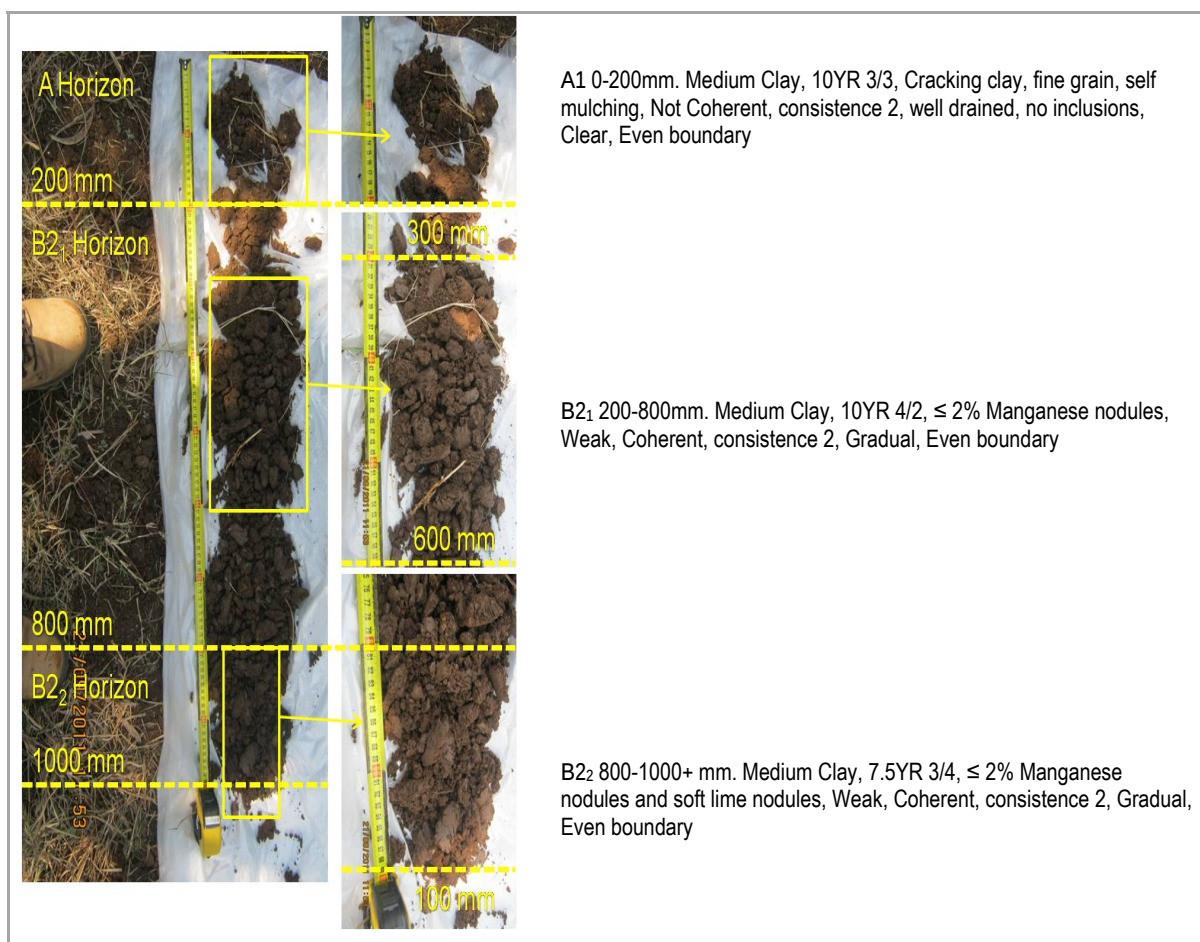
■ **Figure 3-2 3 Vertosol: Profile (Site 6)**

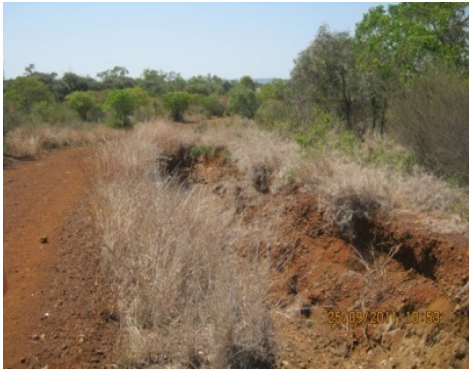
■ **Figure 3-3 Sodosol: Profile (Site 49)**

**Figure 3-3** presents a soil profile description for a Sodosol (Site 49). These Sodic Duplex and Gradational Brown Loams have a strong textural contrast between the A and B Horizons (**Table 3-6**).

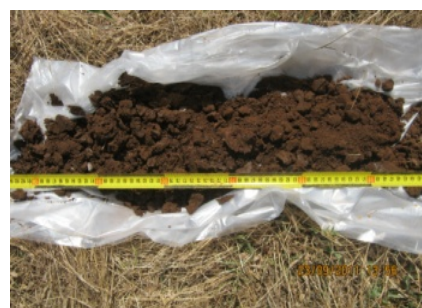
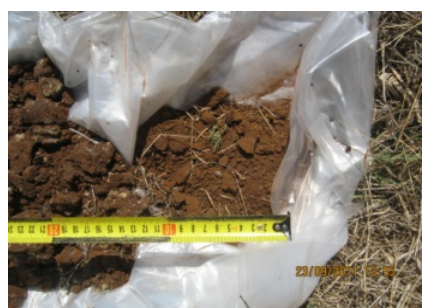
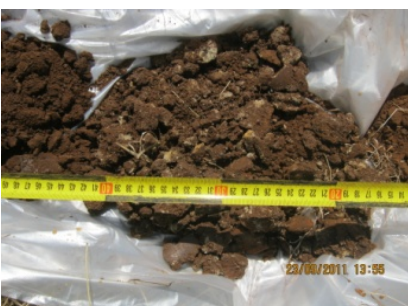
■ **Figure 3-4 Dermosol: Profile (Site 28)**

**Figure 3-4** presents a soil profile description for a Dermosol (Site 28). These Red, Brown Light to Medium Clays are well structured and poorly drained (**Table 3-9**).

A1 0-100mm. Light Clay, 7.5YR 4/4, Weak, Weakly Pedal /Apedal, consistence 2, imperfect drainage, no inclusions, clear, even boundary

B21 100-400mm. Medium Clay, 7.5Yr 4/4, ≤ 2% White mottles, Weak, Strongly Pedal, Coherent, poor drainage, consistence 2, clear, even boundary

B22 400+ mm. Medium Clay, 7.5YR 3/3, White / Black mottles, Firm / Very Firm, Strongly Pedal, Coherent, consistence 3/4, poor drainage, base of horizon not encountered.

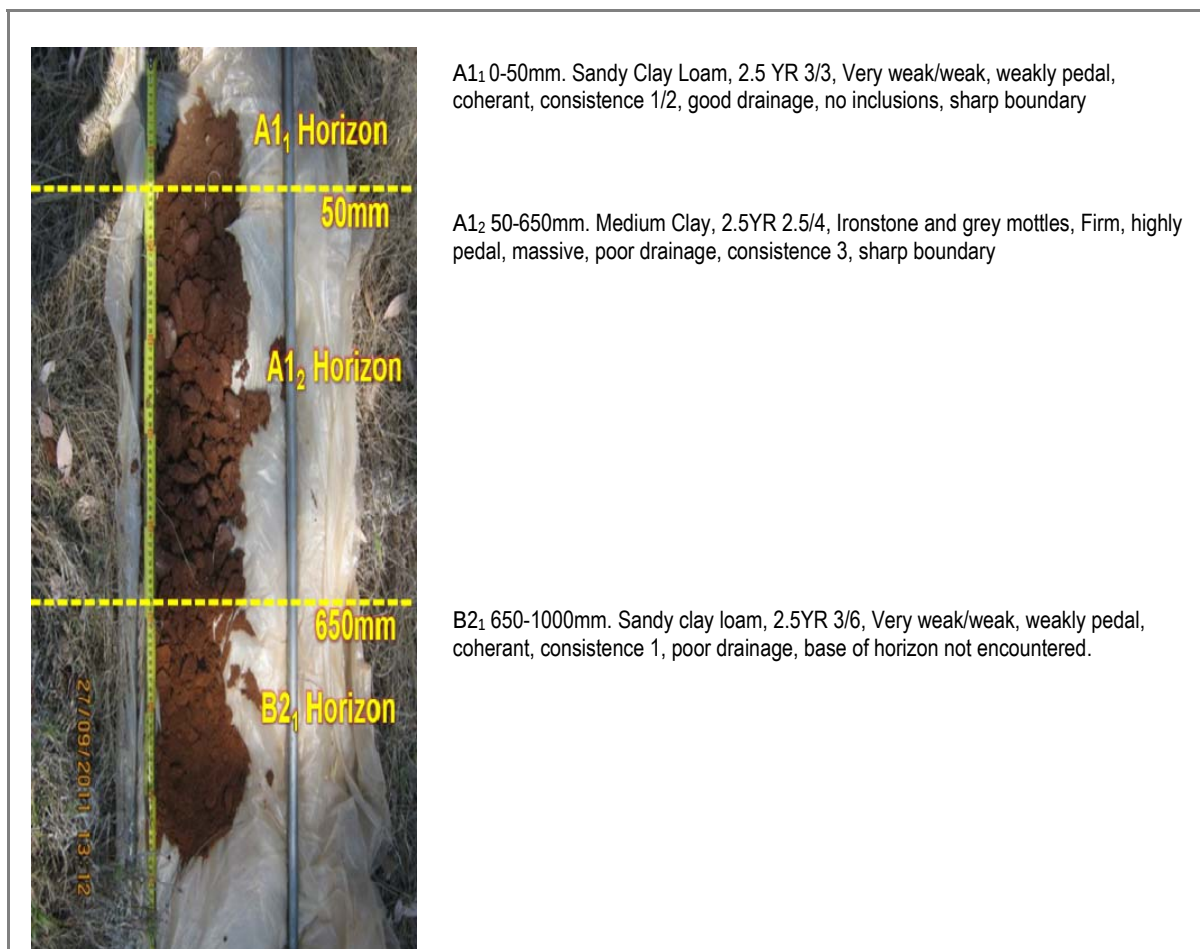
■ **Figure 3-5 Kandosol: Profile (Site 69)**

**Figure 3-5** presents a soil profile description for a Kandosol (Site 69). These Red Sandy Loams are well structured and tend to be poorly drained at depth (**Table 3-12**).

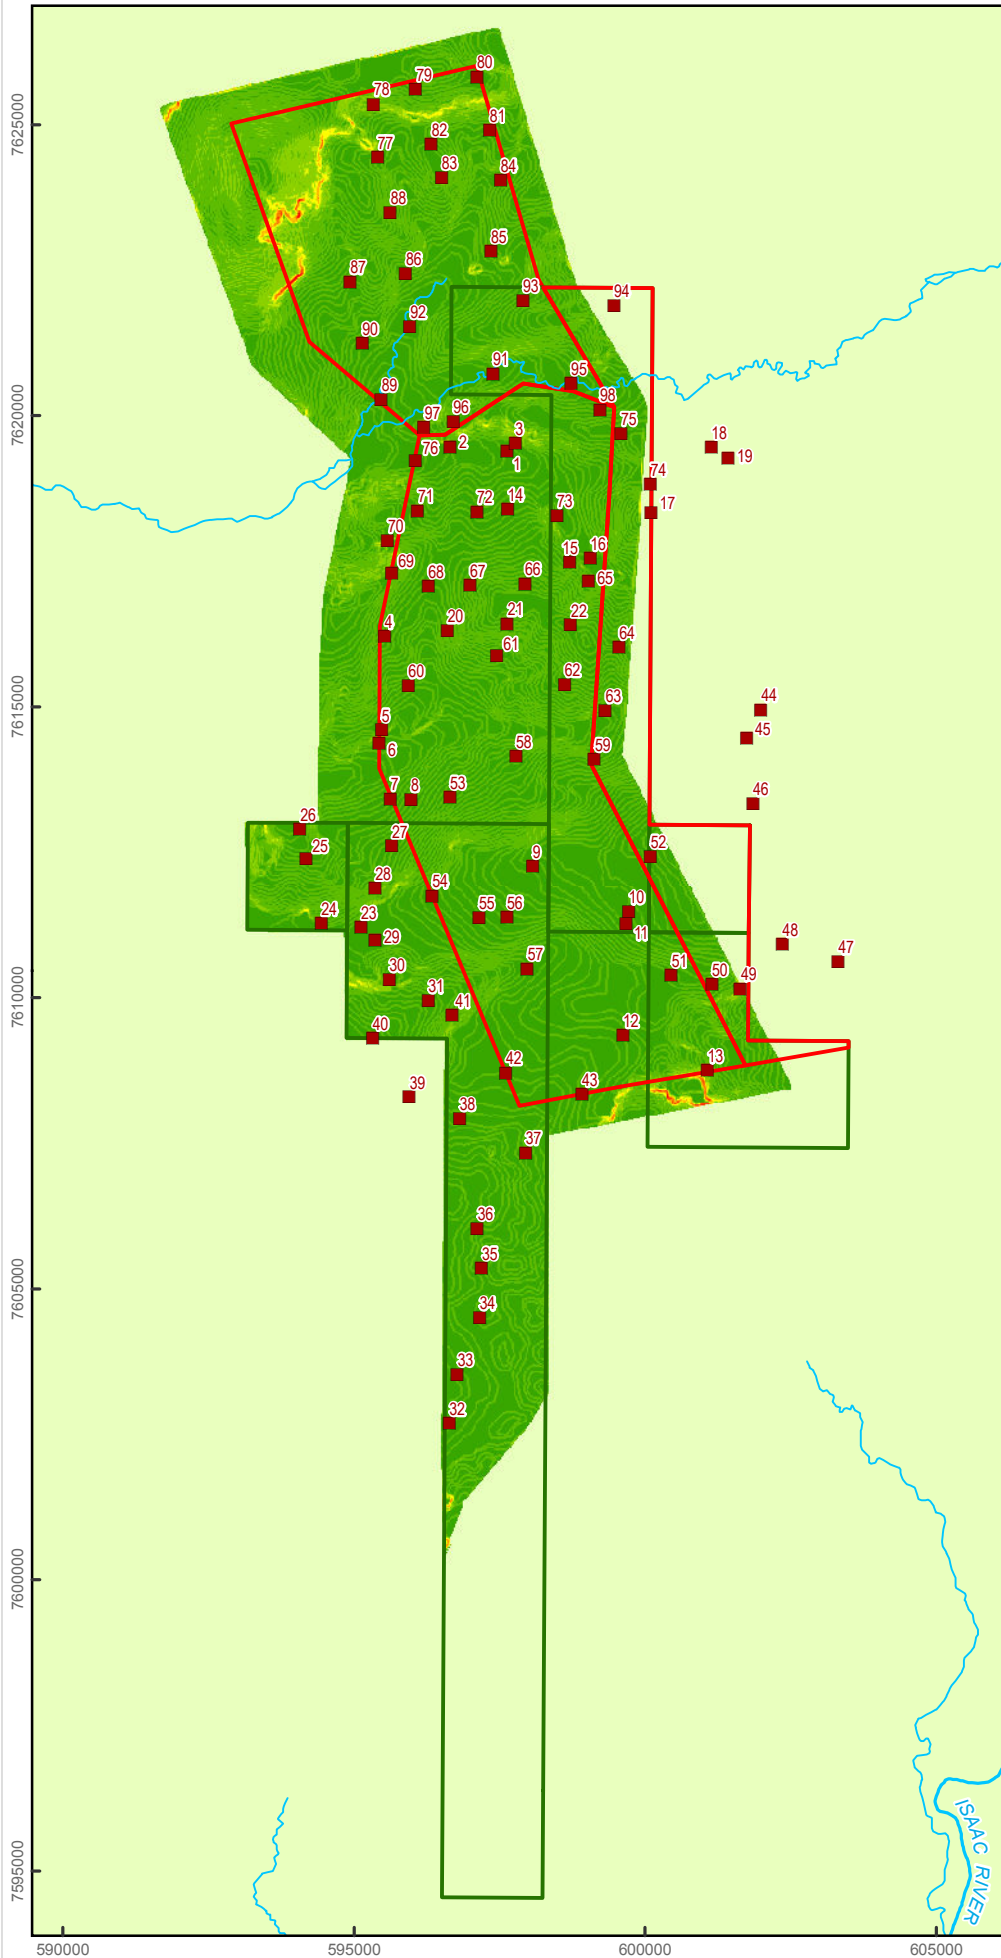
# SLOPE

The site consists of level plains and gently undulating plains and rises with slope across the majority of the site between 1-2%. Steeper slopes up to 11% exist in the far north of the site on Kandosols and on the southeast part of the site on Dermosols. These steeper slopes will present a limitation to cropping in these areas but are suitable for grazing. The map showing slope in the Project area is provided in **Figure 4-1**.

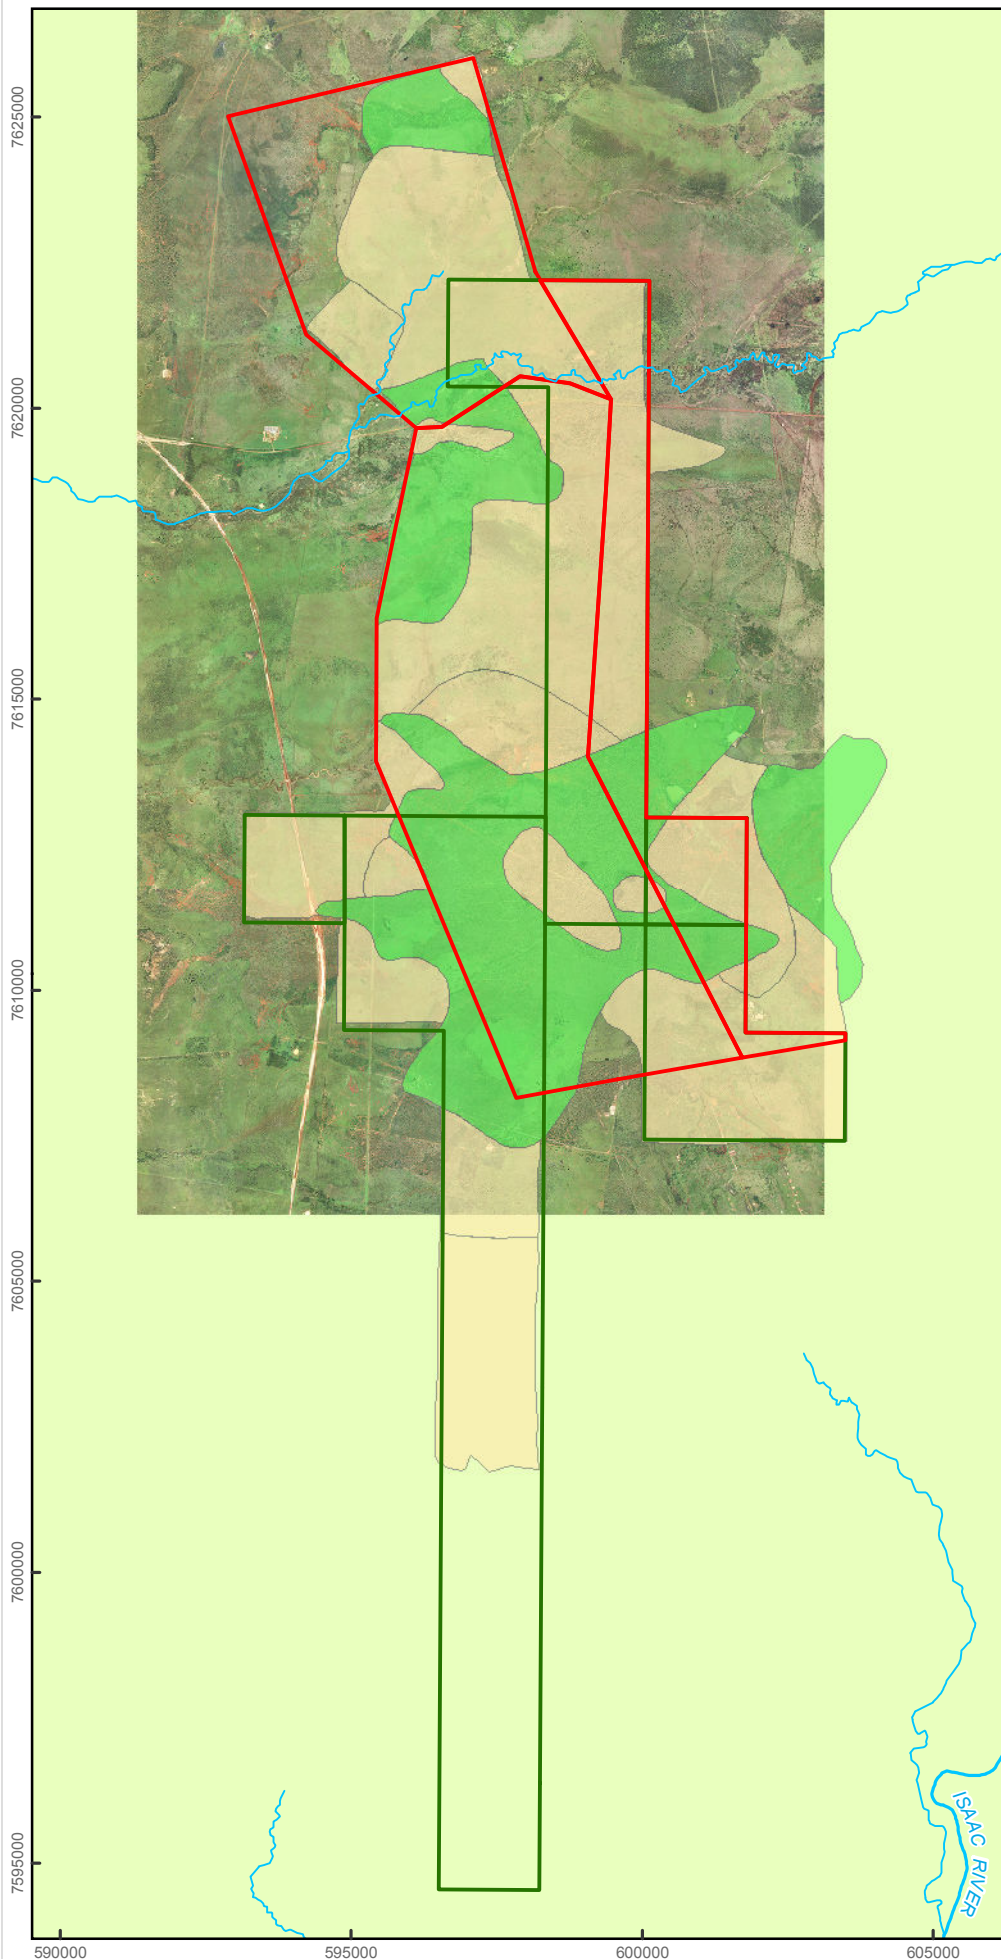
# LAND SUITABLE FOR CROPPING

- Minor Watercourse
- Major Watercourse
- Mining Lease
- Exploration Permit Coal
- Land Suitable for Cropping**
  - 3 - Cropping land with moderate limitations (Kandasols)
  - 4 - Marginal cropping land (Dermosols, Sodosols, Vertosols)

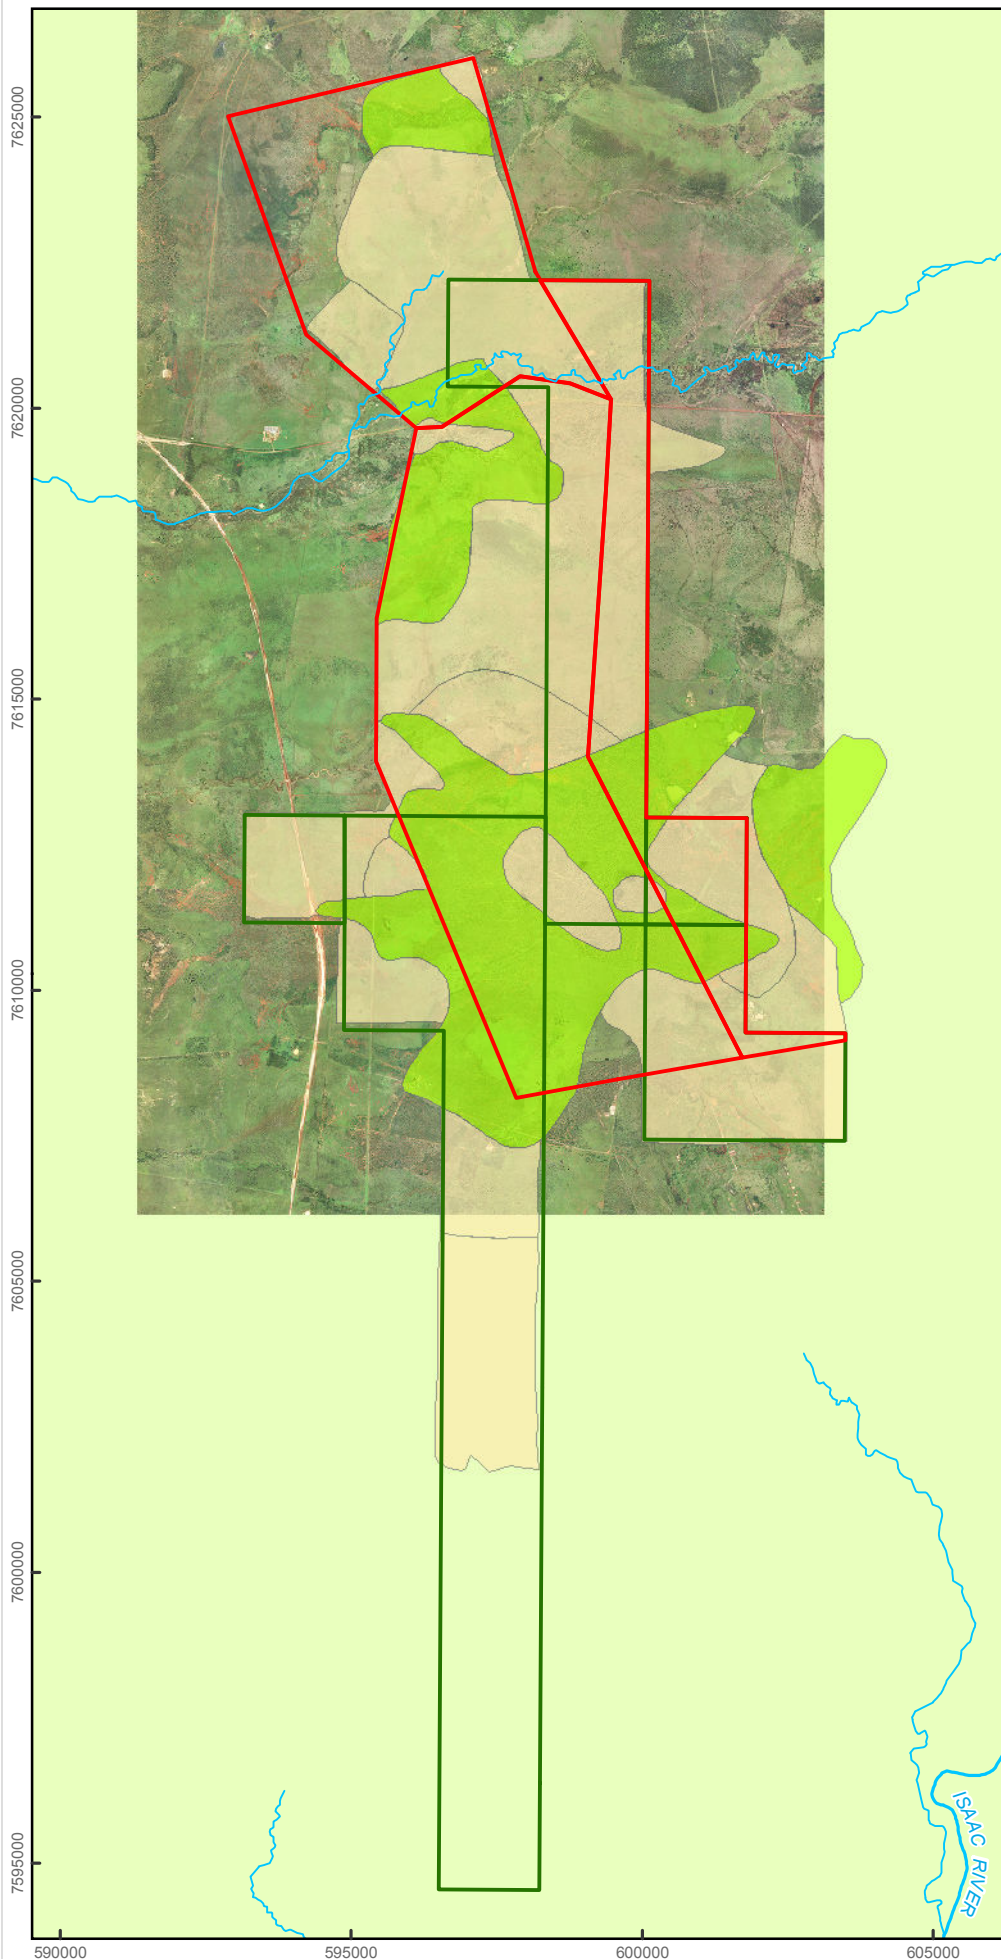
# LAND SUITABLE FOR GRAZING

- Minor Watercourse
- Major Watercourse
- Mining Lease
- Exploration Permit Coal
- Land Suitable for Grazing**
  - 2 - Suitable grazing land with minor limitations (Kandasols)
  - 3 - Suitable grazing land with moderate limitations (Dermosols, Sodosols, Vertosols)

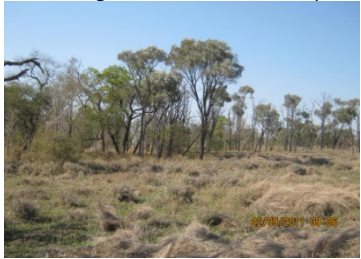
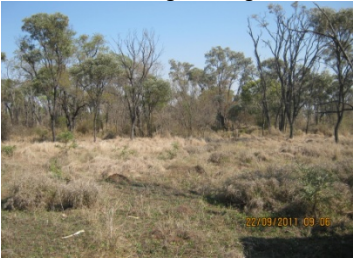
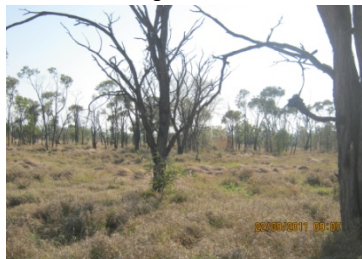
| <b>Project:</b> Wards Well | | <b>Date:</b> 22/9/2011 | | <b>Location:</b> 15 <b>Observation Type:</b> A | | | | <b>Coordinates:</b> 598820, 7617662 | | | | |
|---|---|---|---|---|---|---|---|---|---|---|---|---|
| <b>Natural Vegetation:</b> Medium density Ironbark, Acacia, Buffel grass, Brigalow | | | | | | | | <b>Land Use:</b> Grazing | | | | |
| <b>Topography:</b> Not recorded | | | <b>Surface Rock % (&gt; 60mm dia):</b> | | <b>Erosion:</b> Nil | | | <b>Drainage:</b> Nil | | | | |
| <b>Remarks:</b> | | | | | <b>ASC Mapped:</b> Vertosol | | | <b>ASC Ground Truth:</b> Brown Vertosol | | | | |

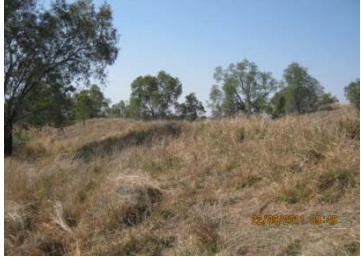
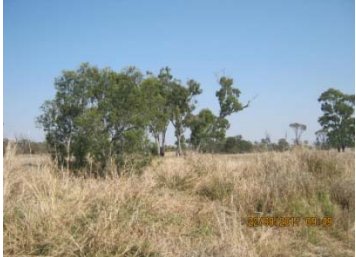
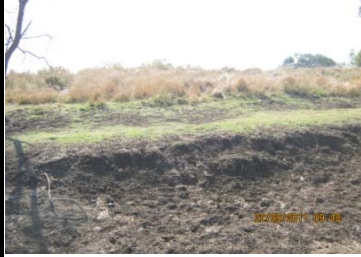
| <b>Project:</b> Wards Well | | <b>Date:</b> 22/9/2011 | | <b>Location:</b> 16 <b>Observation Type:</b> P | | | <b>Coordinates:</b> 599176,7617728 | | | | | |
|---|---|---|---|---|---|---|---|---|---|---|---|---|
| <b>Natural Vegetation:</b> Buffel grass, Acacia, River Gum | | | | | | | <b>Land Use:</b> Grazing | | | | | |
| <b>Topography:</b> Undulating (1-2%) | | | <b>Surface Rock % (&gt; 60mm dia):</b> Nil | | <b>Erosion:</b> Visible signs of erosion | | | <b>Drainage:</b> Well drained | | | | |
| <b>Remarks:</b> Creek bed | | | | | <b>ASC Mapped:</b> Vertosol | | | <b>ASC Ground Truth:</b> Vertosol | | | | |

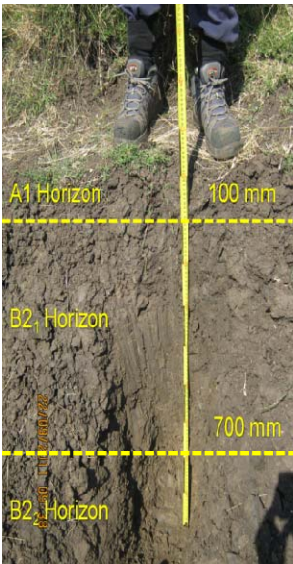
| <b>Project:</b> Wards Well | | <b>Date:</b> 22/9/2011 | | <b>Location:</b> 16 <b>Observation Type:</b> P | | | <b>Coordinates:</b> 599176,7617728 | | | | | |
|---|---|---|---|---|---|---|---|---|---|---|---|---|
| 0-100 | LC | Nil | 7.5YR 2.5/1 | | | No cracking, self-mulching crust | Weak, Weakly Pedal, Coherent | 1 | Not recorded | Gradual, Clear | A1 | No sample |
| 100-700 | MC | ≤ 30% | 7.5YR 2.5/1 | 5-10 mm diameter gravel, some mottles | | - | Weak, Weakly Pedal, Coherent | 1 | Not recorded | Gradual, Clear | B2 <sub>1</sub> | No sample |
| 700-1000+ | MC | ≤ 30% | 7.5YR 3/1 | 5-10 mm diameter gravel, some mottles | | - | Weak, Weakly Pedal, Coherent | 1 | Not recorded | Base of horizon not encountered | B2 <sub>2</sub> | No sample |

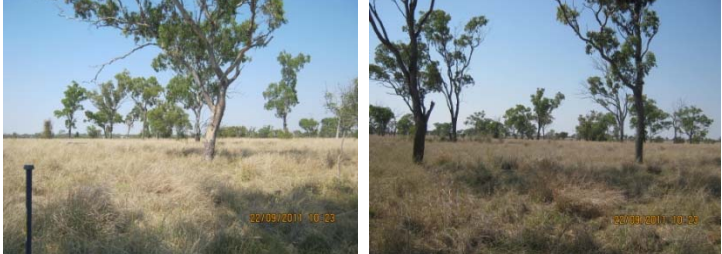
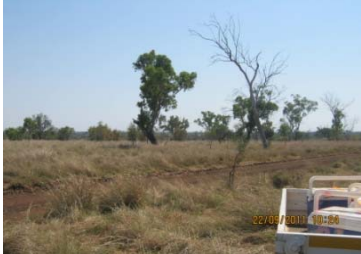
| <b>Project:</b> Wards Well | | <b>Date:</b> 22/9/2011 | | <b>Location:</b> 17 <b>Observation Type:</b> A | | <b>Coordinates:</b> 600217,7618517 | | | | | | |
|---|---|---|---|---|---|---|---|---|---|---|---|---|
| <b>Natural Vegetation:</b> Open Poplar box Woodlands | | | | | | <b>Land Use:</b> Grazing | | | | | | |
| <b>Topography:</b> ≤ 1% | | <b>Surface Rock % (&gt; 60mm dia):</b> Nil | | <b>Erosion:</b> Nil | | | <b>Drainage:</b> Imperfect | | | | | |
| <b>Remarks:</b> | | | | <b>ASC Mapped:</b> Vertosol | | | <b>ASC Ground Truth:</b> Brown Vertosol | | | | | |

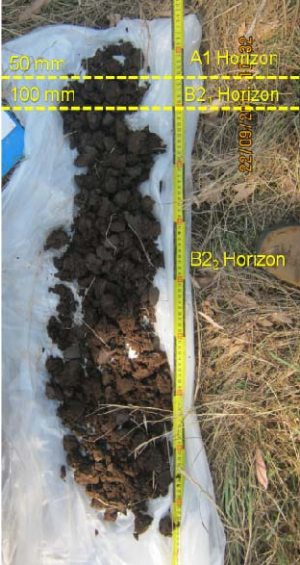
| <b>Project:</b> Wards Well | | <b>Date:</b> 22/9/2011 | | <b>Location:</b> 17 <b>Observation Type:</b> A | | <b>Coordinates:</b> 600217,7618517 | | | | | | |
|---|---|---|---|---|---|---|---|---|---|---|---|---|
| 0-50 | LC | Nil | 5YR 3/2 | Carbonate nodules | | Self mulching | Weak, Highly Pedal, Coherent | 2 | Not recorded | Gradual | A1 | No sample |
| 50-100 | MC | Nil | 5YR 3/2 | Nil | | - | Firm, Highly Pedal, Coherent | 3 | Not recorded | Gradual | B2 <sub>1</sub> | No sample |
| 100-1000 | MC | Nil | 10YR 4/4 | Nil | | - | Very Firm, Highly Pedal, Coherent | 4 | Not recorded | Base of horizon not encountered | B2 <sub>2</sub> | No sample |

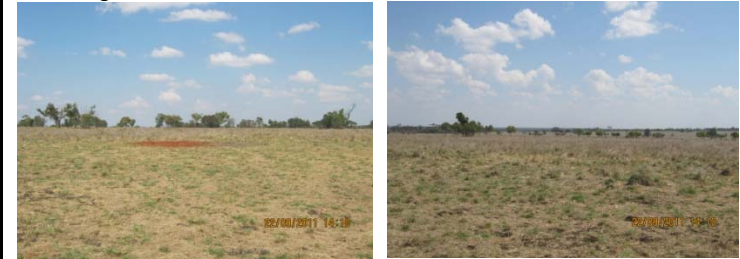
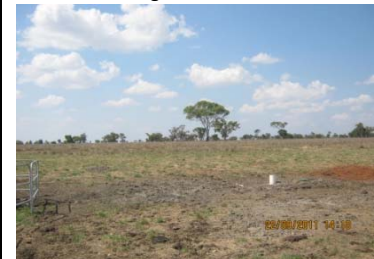
**Natural Vegetation:** Acacia and Grassland

**Land Use:** Grazing

| <b>Topography:</b> 1-2% | <b>Surface Rock % (&gt; 60mm dia):</b> Nil | <b>Erosion:</b> Nil | <b>Drainage:</b> Well drained clay |

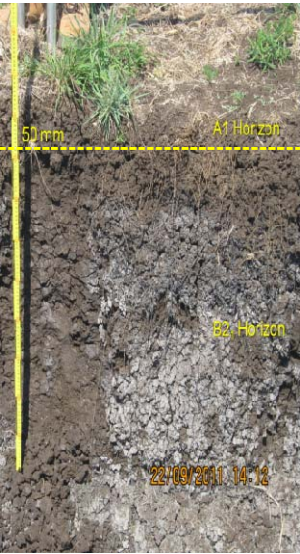
| Depth (mm) | Texture | Coarse Fraction | Munsell Colour | Inclusion | Photograph | Surface Soil Con. | Pedality | Consistence | Drainage | Boundaries | Horizons | Sample |
|---|---|---|---|---|---|---|---|---|---|---|---|---|
| 0-50 | MC | Nil | 7.5YR 3/1 | Nil | | Self-mulching crust | Weak, Highly Pedal, Coherent | 2 | Not recorded | Gradual, Even | A1 <sub>p</sub> | No sample |
| 50-1000+ | HC | ≤ 5% Gravel | 10YR 3/2 | Nil | | - | Very Firm, Weakly Pedal / Massive, Coherent | 4 | Not recorded | Base of horoizon not encountered | B2 <sub>1</sub> | No sample |

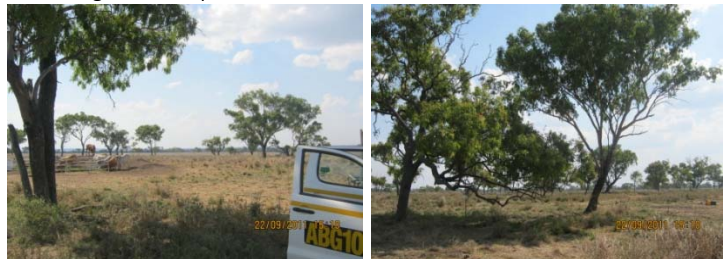
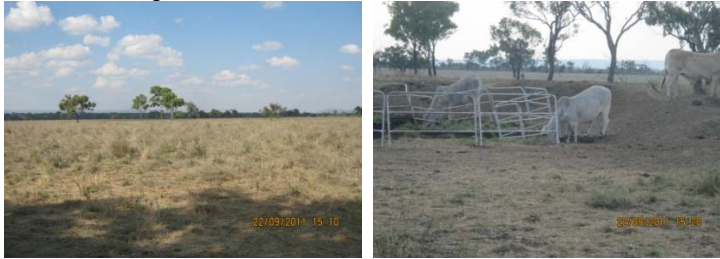
| <b>Project:</b> Wards Well | | <b>Date:</b> 22/9/2011 | | <b>Location:</b> 22 <b>Observation Type:</b> A | | | | <b>Coordinates:</b> 598838, 7616587 | | | | | |
|---|---|---|---|---|---|---|---|---|---|---|---|---|---|
| <b>Natural Vegetation:</b> Popular Box, Buffel Grass | | | | | | | | <b>Land Use:</b> Grazing | | | | | |
| <b>Topography:</b> Flat / Table top | | <b>Surface Rock % (&gt; 60mm dia):</b> Nil | | <b>Erosion:</b> Nil | | | | <b>Drainage:</b> Restricted / Poor | | | | | |
| <b>Remarks:</b> | | | | <b>ASC Mapped:</b> Vertosol | | | | <b>ASC Ground Truth:</b> Brown Vertosol | | | | | |

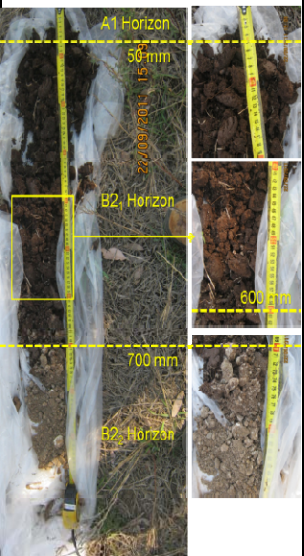
| <b>Project:</b> Wards Well | | <b>Date:</b> 22/9/2011 | | <b>Location:</b> 22 <b>Observation Type:</b> A | | | | <b>Coordinates:</b> 598838, 7616587 | | | | | |
|---|---|---|---|---|---|---|---|---|---|---|---|---|---|
| 0-50 | LC | Nil | 7.5YR 3/3 | Nil | | Self-mulching cracking clay | Very Weak, Weakly pedal / Apedal, | 1 | Restricted | Gradual, Even | A1 | 0-100 mm | |
| 50-700 | MC | Nil | 7.5YR 2.5/2 | Carbonate nodules, White mottling | | | | Weak, Stronger than weakly pedal, Coherent | 2 | Poor | Clear, Even | B2 <sub>1</sub> | 200-400 mm |
| 700-1000+ | SLC | Nil | 10YR 4/4 | Distinct white / yellow / red mottling | | | | Very Firm, Strongly Pedal, Coherent | 4 | Poor | Clear, Even | B2 <sub>2</sub> | 800-900 mm |

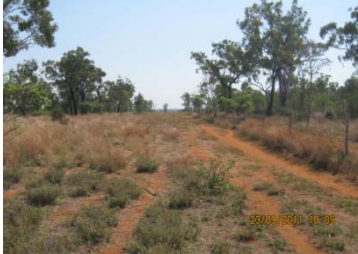
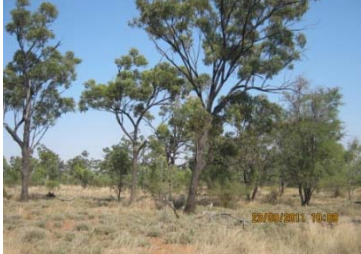
| <b>Project:</b> Wards Well | | <b>Date:</b> 23/9/2011 | | <b>Location:</b> 23 <b>Observation Type:</b> A | | | <b>Coordinates:</b> 0595233, 7611393 | | | | | |
|---|---|---|---|---|---|---|---|---|---|---|---|---|
| <b>Natural Vegetation:</b> Iron Bark, Spear Grass | | | | | | | <b>Land Use:</b> Grazing | | | | | |
| <b>Topography:</b> Close to top of slope (1-2%) | | <b>Surface Rock % (&gt; 60mm dia):</b> Nil | | <b>Erosion:</b> Nil | | | <b>Drainage:</b> Restricted | | | | | |
| <b>Remarks:</b> | | | | <b>ASC Mapped:</b> Kandosol | | | <b>ASC Ground Truth:</b> Kandosol | | | | | |

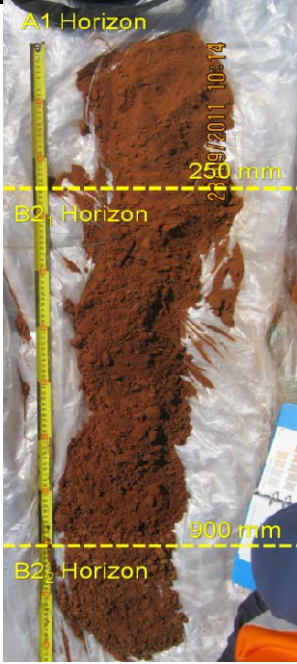
| <b>Project:</b> Wards Well | | <b>Date:</b> 23/9/2011 | | <b>Location:</b> 23 <b>Observation Type:</b> A | | | <b>Coordinates:</b> 0595233, 7611393 | | | | | |
|---|---|---|---|---|---|---|---|---|---|---|---|---|
| 0-250 | SL | Nil | 5YR 4/4 | Nil | | Hard-setting | Very Weak, Apedal | 1 | Not recorded | Clear Even | A1 | 0-100 mm |
| 250-900 | FSCL | ≤ 5% | 5YR 3/4 | Drak gray / black mottles | | - | Very Weak, Apedal / Weakly Coherent | 1 | Not recorded | Gradual Even | B2 <sub>1</sub> | 300-400 mm |
| 900-1000+ | FSCL | ≤ 80% | 5YR 3/4 | Nil | | - | Very Weak, Apedal / Weakly Coherent | 1 | Not recorded | Base of horizon not encountered | B2 <sub>2</sub> | 900-1000 mm |
