# Progressive Rehabilitation and Closure Plan

## Wards Well Mine

| <b>Document title</b> | Progressive Rehabilitation and Closure Plan |
| <b>Version number</b> | V3.0 |

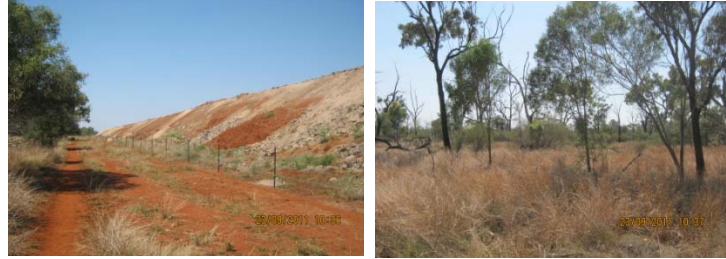
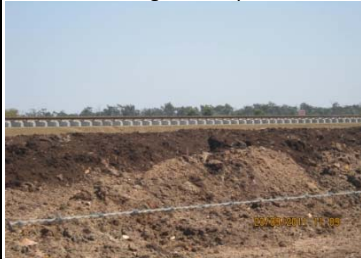
| <b>Project:</b> Wards Well | | <b>Date:</b> 23/9/2011 | | <b>Location:</b> 24 <b>Observation Type:</b> A | | | <b>Coordinates:</b> 594552,7611459 | | | | | |
|---|---|---|---|---|---|---|---|---|---|---|---|---|
| <b>Natural Vegetation:</b> Spear Grass, Ironbark | | | | | | | <b>Land Use:</b> Grazing / Railway easment | | | | | |
| <b>Topography:</b> Close to top of slope (1-2%) | | | <b>Surface Rock % (&gt; 60mm dia):</b> Nil | | <b>Erosion:</b> Nil | | | <b>Drainage:</b> Restricted | | | | |
| <b>Remarks:</b> | | | | | <b>ASC Mapped:</b> Kandosol | | | <b>ASC Ground Truth:</b> Kandosol | | | | |

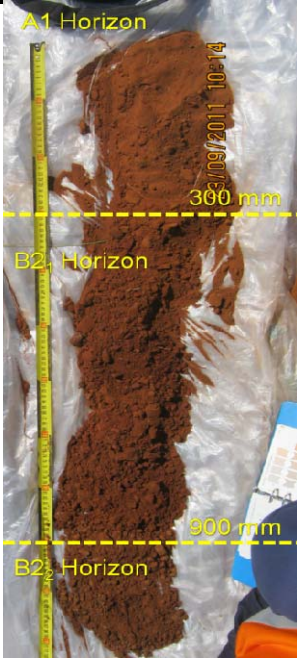
| <b>Project:</b> Wards Well | | <b>Date:</b> 23/9/2011 | | <b>Location:</b> 24 <b>Observation Type:</b> A | | | <b>Coordinates:</b> 594552,7611459 | | | | | |
|---|---|---|---|---|---|---|---|---|---|---|---|---|
| 0-300 | SL | Nil | 2.5YR 4/6 | Nil | | Hard packed, hard-setting | Very Weak, Apedal | 1 | Well | Gradual, Even | A1 <sub>1P</sub> | No sample |
| 300-900 | LC | Nil | 5YR 3/6 | Nil | | - | Very Weak, Apedal / Weakly Coherent | 1 | Poor | Gradual, Even | B2 <sub>1</sub> | No sample |
| 900+ | FSCL | ≤ 5% | 2.5YR 2.5/4 | Some mottling present | | - | Very Weak, Apedal / Weakly Coherent | 1 | Poor | Base of horizon not encountered | B2 <sub>2</sub> | No sample |

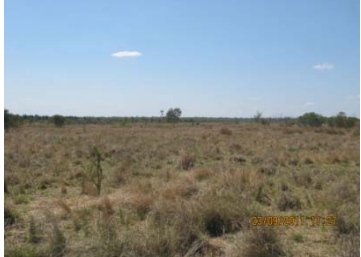
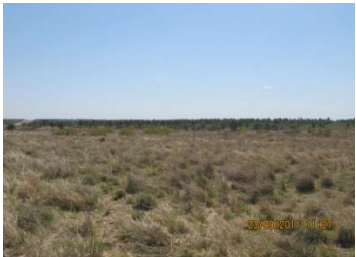
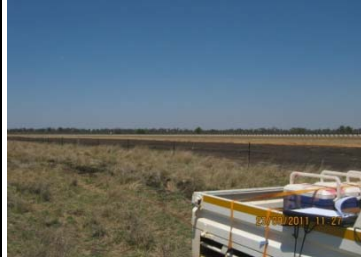
| <b>Project:</b> Wards Well | | <b>Date:</b> 23/9/2011 | | <b>Location:</b> 25 <b>Observation Type:</b> A | | | | <b>Coordinates:</b> 594285, 7612574 | | | | |
|---|---|---|---|---|---|---|---|---|---|---|---|---|
| <b>Natural Vegetation:</b> Spear Grass, Bohenia, Acacia (cleared) | | | | | | | | <b>Land Use:</b> Grazing | | | | |
| <b>Topography:</b> Old Alluvial Plain (1-2%) | | | <b>Surface Rock % (&gt; 60mm dia):</b> Nil | | <b>Erosion:</b> Nil | | | <b>Drainage:</b> Poorly drained | | | | |
| <b>Remarks:</b> | | | | | <b>ASC Mapped:</b> Vertosol | | | <b>ASC Ground Truth:</b> Vertosol | | | | |

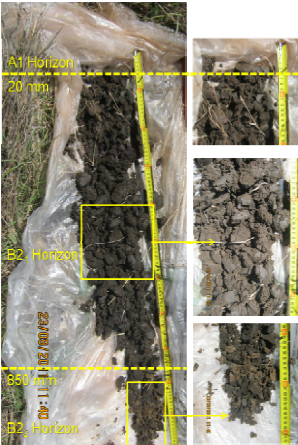
| <b>Project:</b> Wards Well | | <b>Date:</b> 23/9/2011 | | <b>Location:</b> 25 <b>Observation Type:</b> A | | | | <b>Coordinates:</b> 594285, 7612574 | | | | |
|---|---|---|---|---|---|---|---|---|---|---|---|---|
| 0-20 | LC / MC | Nil | 10YR 2/2 | Slight red / yellow mottling | | Self-mulching | Firm, Strongly Pedal, Coherent | 3 | Not recorded | Clear, Even | A1 | No sample |
| 20-80 | MC | Nil | 10YR 3/2 | Red mottles, White and orange nodules | | - | Firm, Strongly Pedal, Coherent | 3 | Not recorded | Clear, Even | B2 <sub>1</sub> | No sample |
| 850-1000 | MC | Nil | 7.5YR 3/2 | Red mottles, White and orange nodules | | - | Weak, Strongly Pedal, Coherent | 2 | Not recorded | Base of horizon not encountered | B2 <sub>2</sub> | No sample |

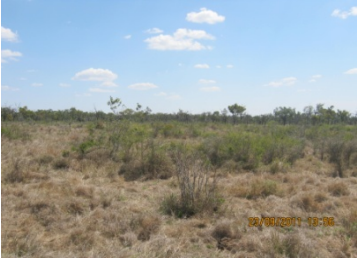
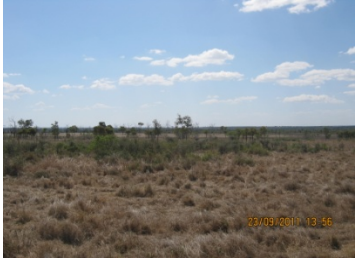
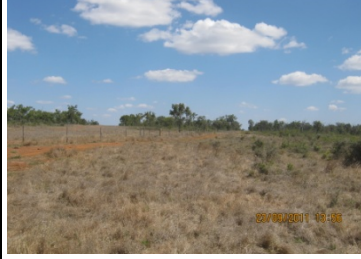
| <b>Project:</b> Wards Well | | <b>Date:</b> 23/9/2011 | | <b>Location:</b> 28 <b>Observation Type:</b> A | | | <b>Coordinates:</b> 595477, 7612063 | | | | | |
|---|---|---|---|---|---|---|---|---|---|---|---|---|
| <b>Natural Vegetation:</b> Small shrubs, Grassland, Some Ironbark | | | | | | | <b>Land Use:</b> Grazing | | | | | |
| <b>Topography:</b> Bottom of slope (1-2%) | | <b>Surface Rock % (&gt; 60mm dia):</b> Nil | | <b>Erosion:</b> Nil | | | <b>Drainage:</b> Restricted | | | | | |
| <b>Remarks:</b> Area has been previously cleared | | | | <b>ASC Mapped:</b> Kandasol | | | <b>ASC Ground Truth:</b> Brown Dermosol | | | | | |

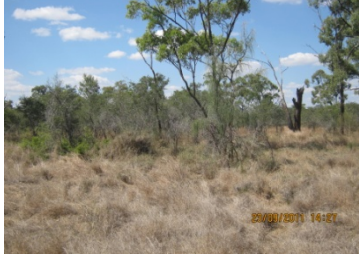
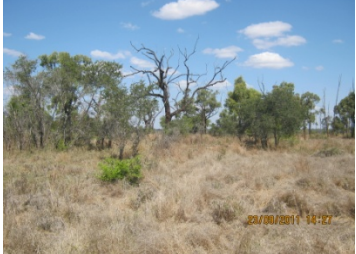
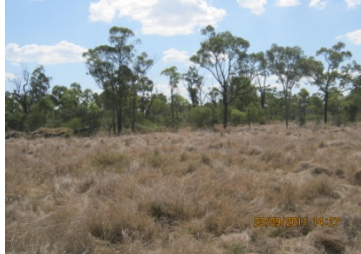
| <b>Project:</b> Wards Well | | <b>Date:</b> 23/9/2011 | | <b>Location:</b> 29 <b>Observation Type:</b> A | | | <b>Coordinates:</b> 0595478, 7611172 | | | | | |
|---|---|---|---|---|---|---|---|---|---|---|---|---|
| <b>Natural Vegetation:</b> Ironbark, Acacia, Bohenia, Buffel grass, some Popular box | | | | | | | <b>Land Use:</b> Grazing | | | | | |
| <b>Topography:</b> ≤ 1% (Table top) | | <b>Surface Rock % (&gt; 60mm dia):</b> Nil | | <b>Erosion:</b> Nil | | | | <b>Drainage:</b> Imperfect / Well | | | | |
| <b>Remarks:</b> | | | | <b>ASC Mapped:</b> Kandosol | | | | <b>ASC Ground Truth:</b> Kandosol | | | | |

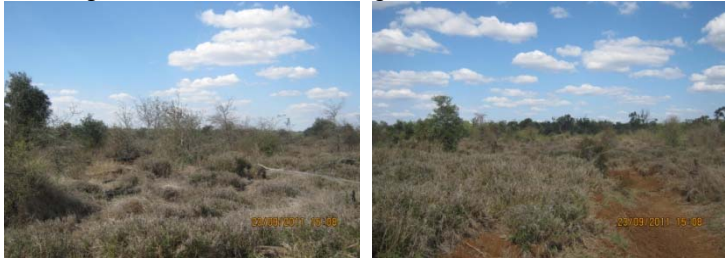
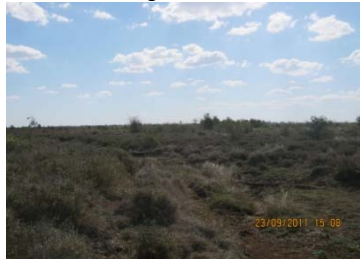
| <b>Project:</b> Wards Well | | <b>Date:</b> 23/9/2011 | | <b>Location:</b> 31 <b>Observation Type:</b> P | | | <b>Coordinates:</b> 0596389, 7610125 | | | | | |
|---|---|---|---|---|---|---|---|---|---|---|---|---|
| <b>Natural Vegetation:</b> Buffel Grass, Acacia, Brigalow | | | | | | | <b>Land Use:</b> Grazing | | | | | |
| <b>Topography:</b> Creek bed ( $\leq 1\%$ ) | | | <b>Surface Rock % (&gt; 60mm dia):</b> Nil | | <b>Erosion:</b> Approx 10% of area eroded | | | <b>Drainage:</b> Restricted | | | | |
| <b>Remarks:</b> | | | | | <b>ASC Mapped:</b> Kandosol | | | <b>ASC Ground Truth:</b> Dermosol | | | | |

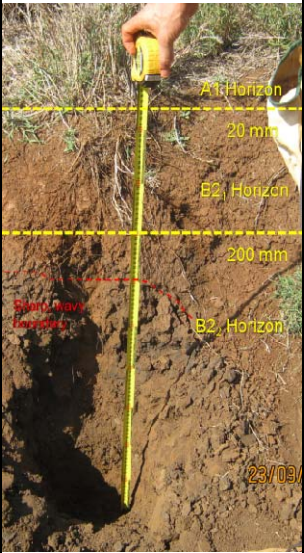
| <b>Project:</b> Wards Well | | <b>Date:</b> 23/9/2011 | | <b>Location:</b> 31 <b>Observation Type:</b> P | | | <b>Coordinates:</b> 0596389, 7610125 | | | | | |
|---|---|---|---|---|---|---|---|---|---|---|---|---|
| 0-20 | SCL | Nil | 10YR 4/4 | Nil | | Hard-setting clay | Weak / Very Weak, Weakly pedal, Coherent | 1 | Well drained | Clear, Even | A1 | No sample |
| 20-200 | LC | Nil | 10YR 3/6 | Nil | | - | Weak, Weakly pedal, Coherent | 2 | Well drained | Sharp, Wavy | B2 <sub>1</sub> | No sample |
| 200-1000+ | HC | Nil | 10YR 3/3 | Ironstone | | - | Very Firm, Weakly Pedal / Massive, Coherent | 4 | Well drained | Base of horizon not encountered | B2 <sub>2</sub> | No sample |

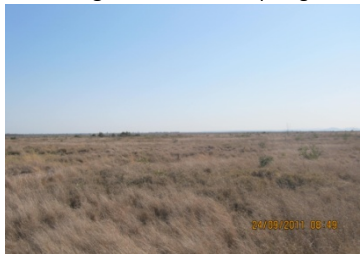
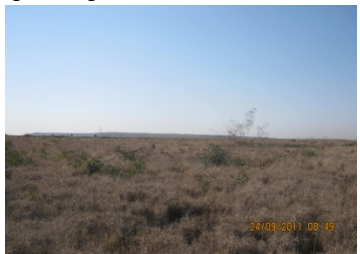
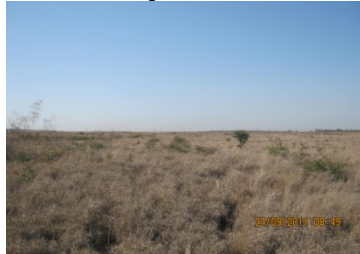
| <b>Project:</b> Wards Well | | <b>Date:</b> 24/9/2011 | | <b>Location:</b> 32 <b>Observation Type:</b> A | | | | <b>Coordinates:</b> 0596753, 7602859 | | | | |
|---|---|---|---|---|---|---|---|---|---|---|---|---|
| <b>Natural Vegetation:</b> Cleared Speargrass, Brigalow regrowth, Acacia | | | | | | | <b>Land Use:</b> Grazing | | | | | |
| <b>Topography:</b> Flat, Melonholes throughout | | <b>Surface Rock % (&gt; 60mm dia):</b> Nil | | <b>Erosion:</b> ≤ 5% of site | | | | <b>Drainage:</b> Well drained | | | | |
| <b>Remarks:</b> | | | | <b>ASC Mapped:</b> Vertosol | | | | <b>ASC Ground Truth:</b> Grey Vertosol | | | | |

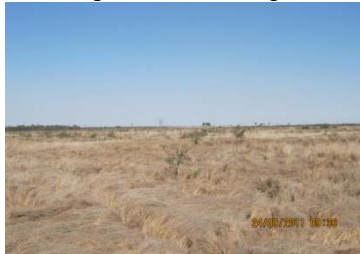
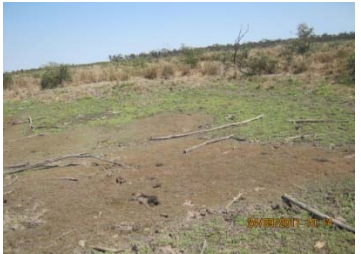
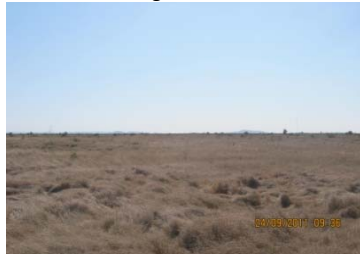
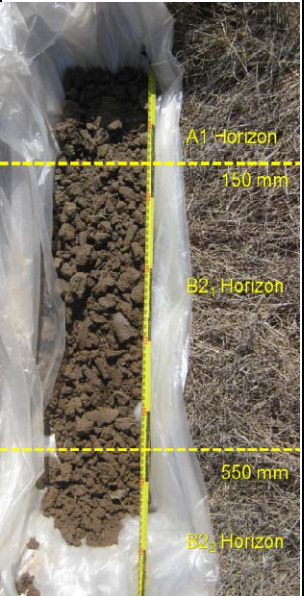
| <b>Project:</b> Wards Well | | <b>Date:</b> 27/9/2011 | | <b>Location:</b> 33 <b>Observation Type:</b> A | | <b>Coordinates:</b> 596891, 7603704 | | | | | | |
|---|---|---|---|---|---|---|---|---|---|---|---|---|
| <b>Natural Vegetation:</b> Cleared vegetation, Spear Grass | | | | | | <b>Land Use:</b> Grazing | | | | | | |
| <b>Topography:</b> Flat ( $\leq 1\%$ ), Melonholes present | | <b>Surface Rock % (&gt; 60mm dia):</b> Nil | | <b>Erosion:</b> Evidence of erosion ( $\leq 5\%$ ) | | | <b>Drainage:</b> Well drained | | | | | |
| <b>Remarks:</b> | | | | <b>ASC Mapped:</b> Vertosol | | | <b>ASC Ground Truth:</b> Brown Vertosol | | | | | |
| 0-150 | LC / MC | Nil | 10YR 3/2 | Nil | | Self-mulching cracking clay | Very firm, Highly Pedal, Coherent | 4 | Not recorded | Diffuse, Even | A1 | No sample |
| 150-550 | MC | Nil | 10YR 3/3 | Orange / red mottles | | - | Very firm, Highly Pedal, Coherent | 4 | Not recorded | Diffuse, Even | B2 <sub>1</sub> | No sample |
| 550-1000+ | MC | Nil | 10YR 3/4 | Carbonate nodules, Ironstone. Red / orange mottles | | - | Very firm, Highly Pedal, Coherent | 4 | Not recorded | base of horizon not encountered | B2 <sub>2</sub> | No sample |

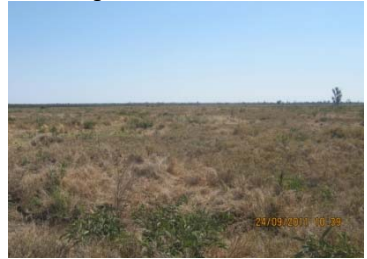
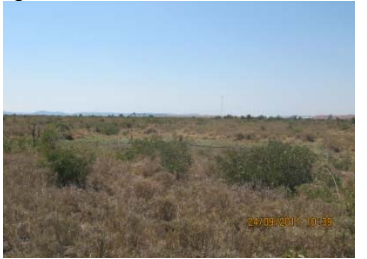
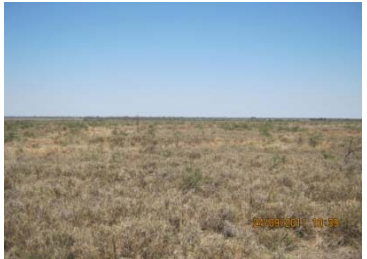
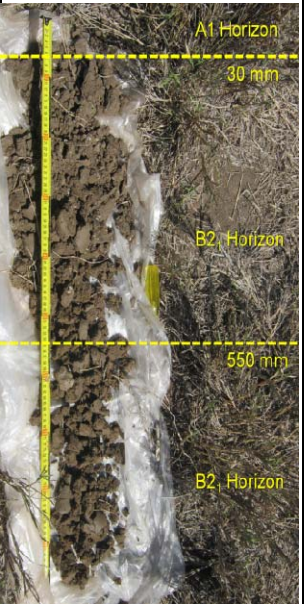
| <b>Project:</b> Wards Well | | <b>Date:</b> 24/9/2011 | | <b>Location:</b> 34 <b>Observation Type:</b> A | | | <b>Coordinates:</b> 597267, 7604679 | | | | | |
|---|---|---|---|---|---|---|---|---|---|---|---|---|
| <b>Natural Vegetation:</b> Cleared, Buffel Grass, regrowth of Acacia | | | | | | | <b>Land Use:</b> Nil | | | | | |
| <b>Topography:</b> Flat undulating, Melon holes | | | <b>Surface Rock % (&gt; 60mm dia):</b> Nil | | <b>Erosion:</b> ≤ 5% | | | <b>Drainage:</b> Imperfect | | | | |
| <b>Remarks:</b> | | | | | <b>ASC Mapped:</b> Vertosol | | | <b>ASC Ground Truth:</b> Brown Vertosol | | | | |
| 0-30 | MC | Nil | 10YR 3/2 | Nil | | Self-mulching cracking clay | Very Firm, Highly Pedal, Coherent | 4 | Not recorded | Diffuse, Even | A1 | No sample |
| 50-550 | MC | Nil | 10YR 4/2 | Carbonate nodules, Red mottles | | - | Firm, Highly Pedal, Coherent | 3 | Not recorded | Diffuse, Even | B2 <sub>1</sub> | No sample |
| 550+ | MC | Nil | 10YR 4/2 | Tree roots intercepted | | - | Weak, Highly Pedal, Coherent | 2 | Not recorded | Base of horizon not encountered | B2 <sub>1</sub> | No sample |

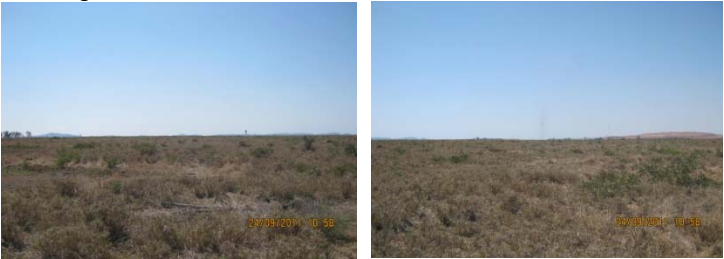
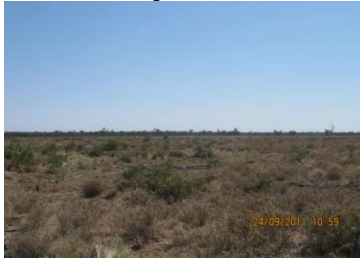
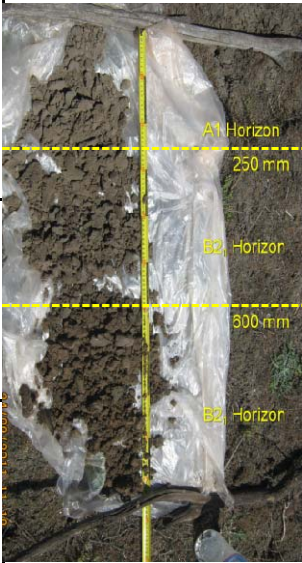
| <b>Project:</b> Wards Well | | <b>Date:</b> 24/9/2011 | | <b>Location:</b> 35 <b>Observation Type:</b> A | | | <b>Coordinates:</b> 597310, 7605530 | | | | | |
|---|---|---|---|---|---|---|---|---|---|---|---|---|
| <b>Topography:</b> Melonholes ( $\leq 1\%$ ) | | | <b>Surface Rock % (&gt; 60mm dia):</b> Nil | | <b>Erosion:</b> Nil | | | <b>Drainage:</b> Imperfect | | | | |
| <b>Remarks:</b> Sample from within melonhole | | | | | <b>ASC Mapped:</b> Vertosol | | | <b>ASC Ground Truth:</b> Vertosol | | | | |
| 0-250 | LC | Nil | 10YR 4/1 | Nil | | self-mulching, craking clay | Firm, Highly Pedal, Coherent | 3 | Imperfect | Gradual, Even | A1 | No sample |
| 250-600 | MC | Nil | 10YR 4/2 | White / Brown / Orange / Red mottles | | | Very Firm, Highly Pedal, Coherent | 4 | Imperfect | Clear, Even | B2 <sub>1</sub> | No sample |
| 600-1000+ | MC | Nil | 10YR 5/2 | Orange / Brown mottles | | | Very Firm, Highly Pedal, Coherent | 4 | Imperfect | Base of horizon not encountered | B2 <sub>2</sub> | No sample |

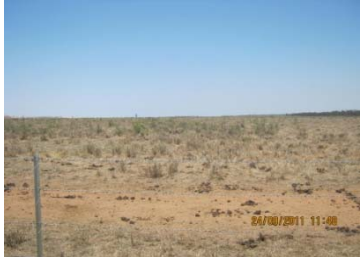
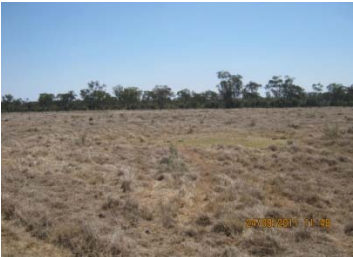
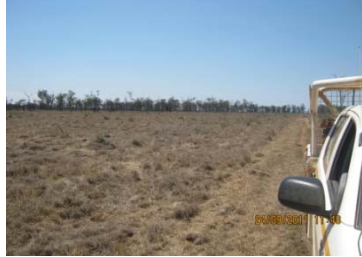
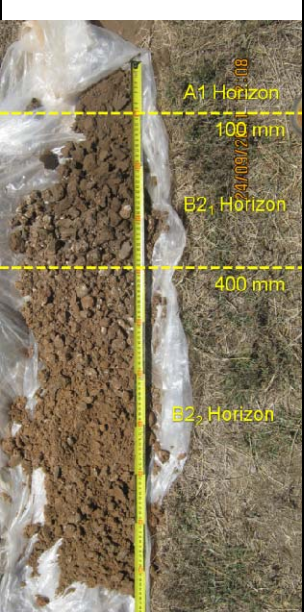
| <b>Project:</b> Wards Well | | <b>Date:</b> 24/9/2011 | | <b>Location:</b> 36 <b>Observation Type:</b> A | | | <b>Coordinates:</b> 0597230, 7606211 | | | | | |
|---|---|---|---|---|---|---|---|---|---|---|---|---|
| <b>Topography:</b> Near top ridge line ( $\leq 1\%$ ) | | | <b>Surface Rock % (&gt; 60mm dia):</b> Nil | | <b>Erosion:</b> Nil | | | <b>Drainage:</b> Restricted | | | | |
| <b>Remarks:</b> | | | | | <b>ASC Mapped:</b> Vertosol | | | <b>ASC Ground Truth:</b> Brown Dermosol | | | | |
| 0-100 | SCL | Nil | 7.5YR 3/2 | Nil | | Hard-setting | Firm, Highly Pedal, Coherent | 4 | Not recorded | Diffuse, Even | A1 | 0-100 mm |
| 100-400 | LC / MC | Nil | 7.5Yr 3/2 | Carbonate nodules, Ironstone | | - | Firm, Highly Pedal, Coherent | 4 | Not recorded | Gradual, Even | B2 <sub>1</sub> | 200-300 mm |
| 400-1000+ | MC | Nil | 7.5YR 4/3 | Carbonate nodules | | - | Firm, Highly Pedal, Coherent | 3 | Not recorded | Base of horizon not encountered | B2 <sub>2</sub> | 700-800 mm |

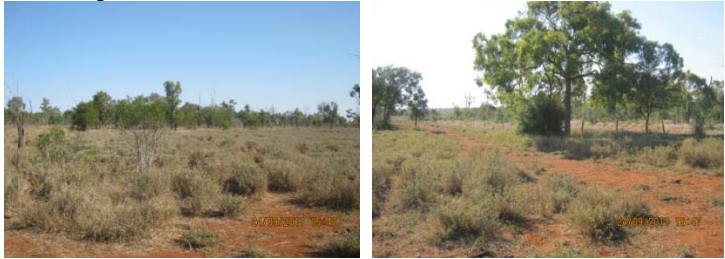
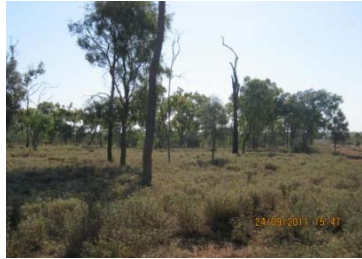
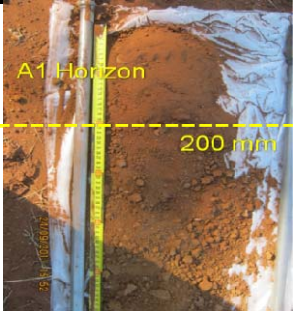
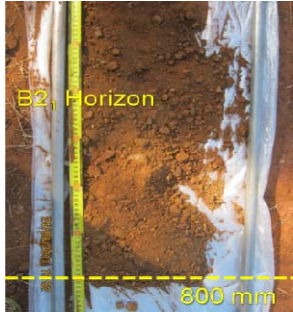
| <b>Project:</b> Wards Well | | <b>Date:</b> 41 | | <b>Location:</b> 41 <b>Observation Type:</b> A | | | | <b>Coordinates:</b> 596794, 7609884 | | | | | |
|---|---|---|---|---|---|---|---|---|---|---|---|---|--|
| <b>Topography:</b> 1-2%, Midslope | | <b>Surface Rock % (&gt; 60mm dia):</b> ≤ 1% | | <b>Erosion:</b> ≤ 5% | | | | <b>Drainage:</b> Not recorded | | | | | |
| <b>Remarks:</b> | | | | <b>ASC Mapped:</b> Kandosol | | | | <b>ASC Ground Truth:</b> Kandosol | | | | | |
| 0-200 | SL | ≤ 5% | 2.5YR 4/4 | Small Gravel (1-2 mm), ≤ 5% | | Sandy | Very Weak, Apedal | 1 | Well drained | Diffuse, Even | A1 | No sample | |
| 200-800 | SL | ≤ 5% | 2.5YR 4/6 | Medium Gravel (1-2 mm), ≤ 5% | | - | Weak, Weakly Pedal, Coherent | 2 | Well drained | Sharp, Even | B2 <sub>1</sub> | No sample | |
| 800+ | LC | ≤ 50% Horizon contain Samprolite (country rock) and is considered to be a transition layer | 5YR 5/6 | Medium - Large Gravel (1-2 mm), ≤ 50% | | - | Very Strong, Strongly Pedal, Coherent | 6 | Well drained | - | B3 | No sample | |

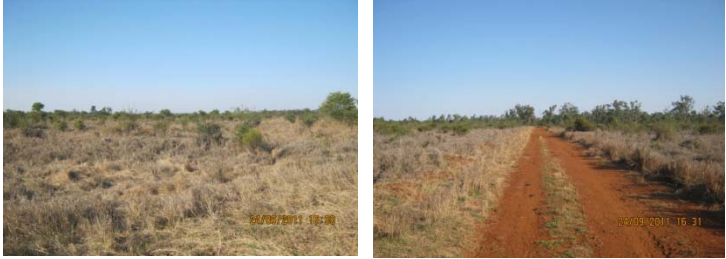
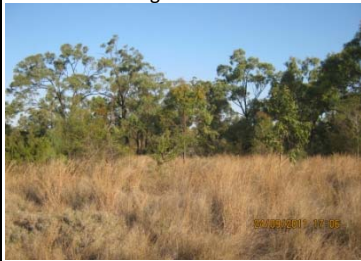
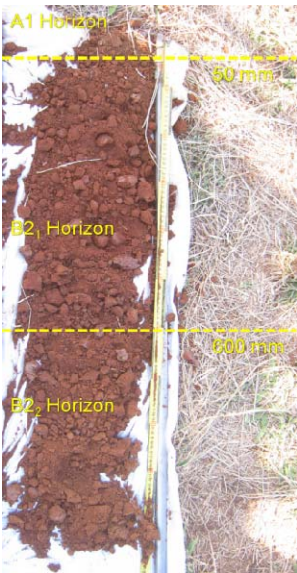
| <b>Project:</b> Wards Well | | <b>Date:</b> 24/9/2011 | | <b>Location:</b> 42 <b>Observation Type:</b> A | | | <b>Coordinates:</b> 0897721, 7608886 | | | | | |
|---|---|---|---|---|---|---|---|---|---|---|---|---|
| <b>Topography:</b> Flat | | <b>Surface Rock % (&gt; 60mm dia):</b> Nil | | <b>Erosion:</b> Nil | | | | <b>Drainage:</b> Restricted | | | | |
| <b>Remarks:</b> | | | | <b>ASC Mapped:</b> Kandosol | | | | <b>ASC Ground Truth:</b> Kandosol | | | | |
| 0-50 | SCL | Nil | 5YR 3/4 | Nil | | Firm, hardset sand | Weak, Weakly Pedal, Coherent | 2 | Not recorded | Diffuse, Even | A1 | No sample |
| 50-600 | LC | Nil | 2.5YR 3/4 | Ironstone | | - | Weak / Firm, Stronger then Weakly Pedal, Coherent | 2 | Not recorded | Diffuse, Even | B2 <sub>1</sub> | No sample |
| 600+ | MC | Nil | 4YR 3/4 | Black mottles | | - | Weak / Firm, Stronger then Weakly Pedal, Coherent | 2 | Not recorded | Base of horizon not encountered | B2 <sub>2</sub> | No sample |

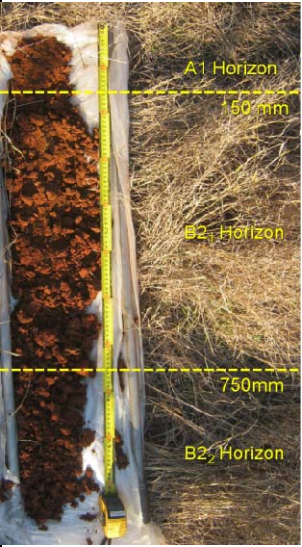
| Remarks: | | | | | ASC Mapped: Kandosol | | | ASC Ground Truth: Kandosol | | | | |
| 0-150 | SL | Nil | 2.5YR 3/3 | Nil | | Firm sand | Very Weak, Weakly Pedal, Coherent | 1 | Well drained | Gradual, Even | A1 | No sample |
| 150-750 | SCL | Nil | 5YR 3/4 | Nil | | - | Weak, Stronger than Weakly Pedal, Coherent | 2 | Imperfect | Diffuse, Even | B2 <sub>1</sub> | No sample |
| 750+ | MC | Nil | 2.5YR 3/4 | Yellow mottles | | - | Weak / Firm, Highly Pedal, Coherent | 2 / 3 | Poor drainage | Base of horizon not encountered | B2 <sub>2</sub> | No sample |

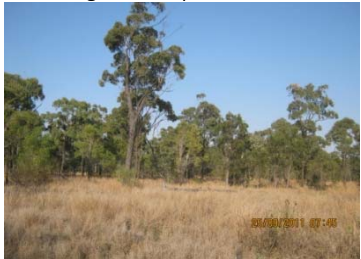
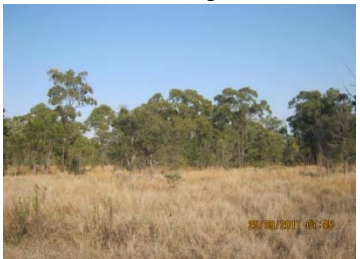
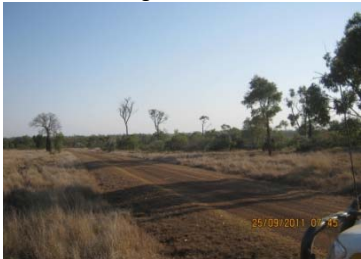
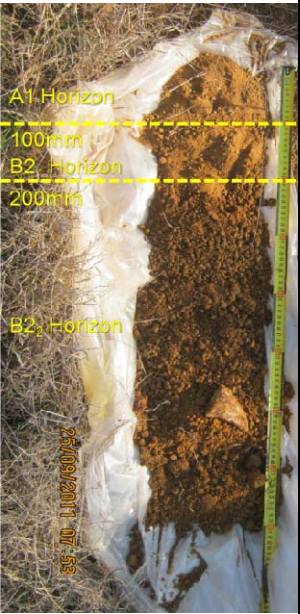
| <b>Project:</b> Wards Well | | <b>Date:</b> 25/9/2011 | | <b>Location:</b> 44 <b>Observation Type:</b> A | | | <b>Coordinates:</b> 0602107, 7615125 | | | | | |
|---|---|---|---|---|---|---|---|---|---|---|---|---|
| <b>Topography:</b> Flat, ≤ 1%, top of ridge | | | <b>Surface Rock % (&gt; 60mm dia):</b> ≤ 10% | | <b>Erosion:</b> Nil | | | <b>Drainage:</b> Poorly drained | | | | |
| <b>Remarks:</b> | | | | | <b>ASC Mapped:</b> Vertosol | | | <b>ASC Ground Truth:</b> Kandosol | | | | |
| 0-100 | SL | 20-30% | 10YR 3/6 | Nil | | Gravely, hard-setting | Loose / Very Weak, Apedal | 0 / 1 | Not recorded | Clear, Even | A1 | 0-100 mm |
| 100-200 | SL | 30% | 10YR 4/4 | Nil | | - | Very Weak, Weakly Pedal | 1 | Not recorded | Clear, Even | B2 <sub>1</sub> | 100-200 mm |
| 200-800 | SCL | 80% | 10YR 4/6 | Yellow mottles | | - | Weak, Highly Pedal, Coherent | 1 / 2 | Not recorded | Base of Horizon not encountered | B2 <sub>2</sub> | 500-600 mm |

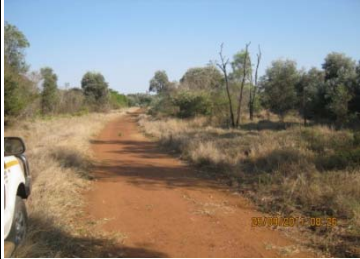
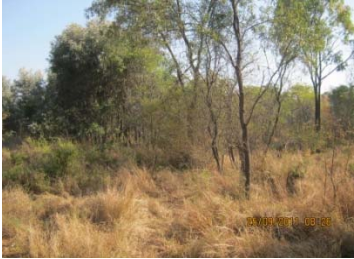
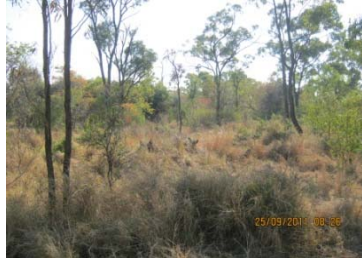
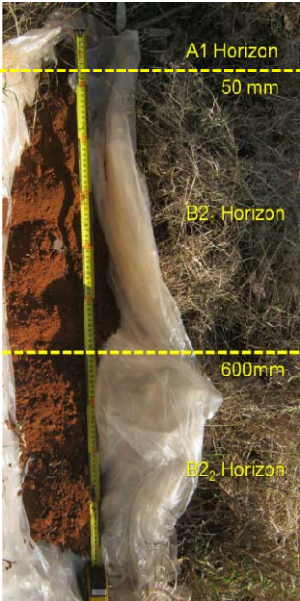
| <b>Project:</b> Wards Well | | <b>Date:</b> 25/9/2011 | | <b>Location:</b> 45 <b>Observation Type:</b> A | | <b>Coordinates:</b> 601862, 7614637 | | | | | | |
|---|---|---|---|---|---|---|---|---|---|---|---|---|
| <b>Topography:</b> ≤ 5% | | <b>Surface Rock % (&gt; 60mm dia):</b> Nil | | <b>Erosion:</b> Nil | | | <b>Drainage:</b> Not recorded | | | | | |
| <b>Remarks:</b> | | | | <b>ASC Mapped:</b> Vertosol | | | <b>ASC Ground Truth:</b> Kandosol | | | | | |
| 0-50 | SCL | ≤ 5% | 7.5YR 3/3 | Nil | | Sandy, Firm, Small gravel (2 - 5 mm) ≤ 5% | Very Weak, Apedal | 1 | Not recorded | Gradual, Even | A1 | No sample |
| 50-600 | LC | ≤ 2% Ironstone | 7.5YR 3/4 | Ironstone | | - | Weak, Weakly Pedal, Coherent | 2 | Not recorded | Gradual, Even | B2 <sub>1</sub> | No sample |
| 600-1000+ | LC | ≤ 5% Gravel | 2.5YR 3/4 | Gravel | | - | Weak, Stronger than Weakly Pedal, Coherent | 2 | Not recorded | Base of horizon not encountered | B2 <sub>2</sub> | No sample |

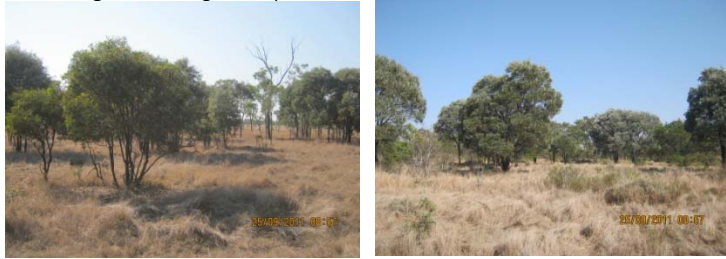
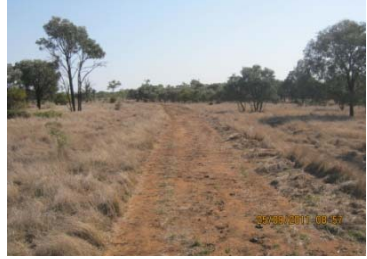
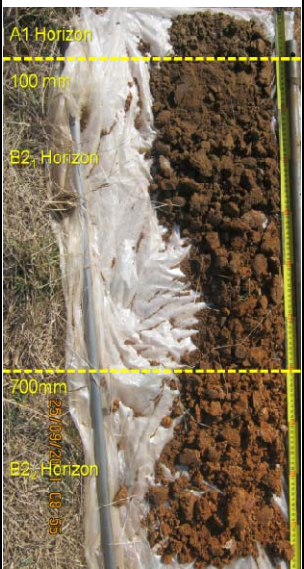
| <b>Project:</b> Wards Well | | <b>Date:</b> 25/9/2011 | | <b>Location:</b> 46 <b>Observation Type:</b> A | | | <b>Coordinates:</b> 0601972, 7613518 | | | | | |
|---|---|---|---|---|---|---|---|---|---|---|---|---|
| <b>Topography:</b> Flat (old aluvial flood plain) | | | <b>Surface Rock % (&gt; 60mm dia):</b> Nil | | <b>Erosion:</b> Nil | | | <b>Drainage:</b> Poor | | | | |
| <b>Remarks:</b> | | | | | <b>ASC Mapped:</b> Kandosol | | | <b>ASC Ground Truth:</b> Sodosol | | | | |
| 0-100 | LC | ≤ 10% | 10YR 3/2 | Nil | | hard-setting | Firm, Hghly Pedal, Coherent | 3 | Not recorded | Diffuse, Even | A1 | No sample |
| 100-700 | MC | ≤ 5% Ironstone | 10YR 2/2 | Ironstone | | - | Very Firm, Highly Pedal, Coherent | 4 | Not recorded | Gradual, Even | B2 <sub>1</sub> | No sample |
| 700-1000+ | MC | Nil | 7.5YR 6/8 | Orange / red / white mottles, Carbonate nodules | | - | Very Firm, Highly Pedal, Coherent | 4 | Not recorded | Base of horizon not encountered | B2 <sub>2</sub> | No sample |

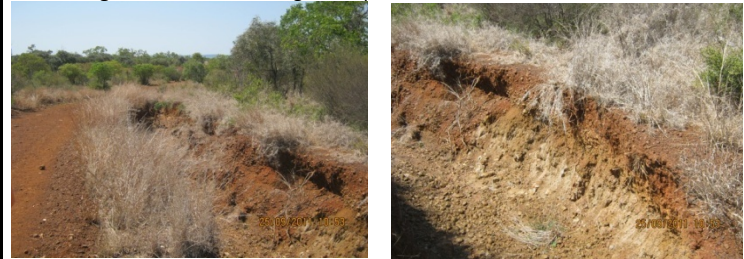
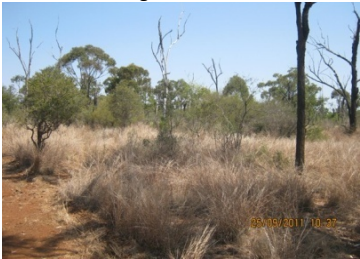
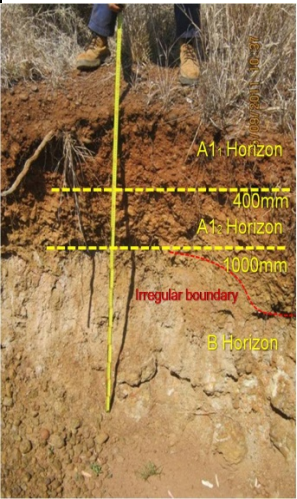
| Project: Wards Well | | Date: 25/09/11 | | Location: 49    Observation Type: E | | | Coordinates: 0601753, 7610328 | | | | | | |
|---|---|---|---|---|---|---|---|---|---|---|---|---|--|
| Topography: 1% near top | | | Surface Rock % (> 60mm dia): 50% | | Erosion: Extensive (≤ 50% of sample area) | | | Drainage: Poor | | | | | |
| Remarks: Taken in erosion channel of gravel ridge | | | | | ASC Mapped: Kandosol | | | ASC Ground Truth: Sodosol | | | | | |
| 0-400 | LC | 80% | 2.5YR 3/4 | Nil | | Hard gravel | Weak, Weakly Pedal, Coherent | 2 | Good | Clear, Even | A1 <sub>1</sub> | No sample | |
| 400-1000 | LC | 80% | 7.5YR 4/6 | Nil | | - | Weak, Weakly Pedal, Coherent | 2 | Good | Clear, Irregular | A1 <sub>2</sub> | No sample | |
| >1000 | MC / HC | Nil | 10YR 5/3 | Grey / orange mottles | | - | Weak, Weakly Pedal, Coherent | 2 | Poor | Base of horizon not encountered | B2 <sub>1</sub> | No sample | |

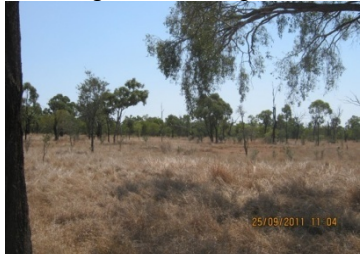
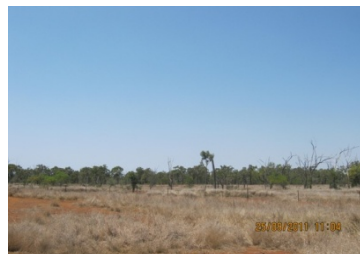
| <b>Project:</b> Wards Well | | <b>Date:</b> 25/9/2011 | | <b>Location:</b> 50 <b>Observation Type:</b> A | | | <b>Coordinates:</b> 601263, 7610410 | | | | | |
|---|---|---|---|---|---|---|---|---|---|---|---|---|
| <b>Topography:</b> 1-2% mid slope | | | <b>Surface Rock % (&gt; 60mm dia):</b> Nil | | <b>Erosion:</b> Nil | | | <b>Drainage:</b> Not recorded | | | | |
| <b>Remarks:</b> Similar to 27 & 24 | | | | | <b>ASC Mapped:</b> Kandosol | | | <b>ASC Ground Truth:</b> Kandosol | | | | |
| 0-100 | SiC | 1-5% | 7.5YR 3/4 | Nil | | sandy-hard | Loose, Apedal | 0 | Not recorded | Gradual, Even | A <sub>1</sub> | No sample |
| 100-600 | LC | Nil | 7.5YR 3/4 | Nil | | - | Loose, Apedal | 0 | Not recorded | Gradual, Even | B <sub>2</sub> <sub>1</sub> | No sample |

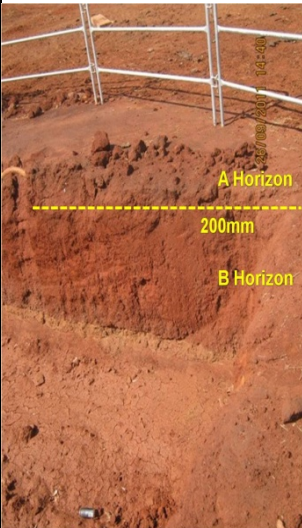
| <b>Project:</b> Wards Well | | <b>Date:</b> 26/9/2011 | | <b>Location:</b> 53 <b>Observation Type:</b> P | | | <b>Coordinates:</b> 596761, 7613627 | | | | | |
|---|---|---|---|---|---|---|---|---|---|---|---|---|
| 0-200 | SCL | 0-1% | 2.5YR 3/4 | Ironstone | | Hard packed | Very weak, Weakly pedal, Coherent | 1 | Good | Diffuse | A1 <sub>p</sub> | No sample |
| 200 - >1000 | LC/MC | Nil | 2.5YR 2.5/4 | Ironstone | | Coherent / Massive | Weak, Weakly pedal, Coherent | 2 | Good | Diffuse | B2 <sub>1</sub> | No sample |

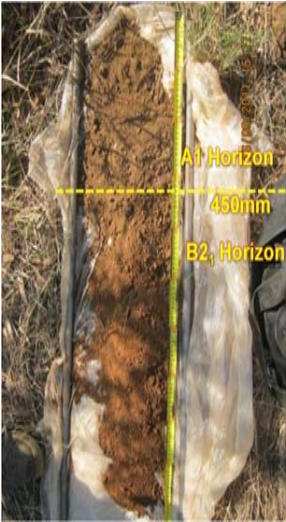
| <b>Project:</b> Wards Well | | <b>Date:</b> 26/9/2011 | | <b>Location:</b> 54 <b>Observation Type:</b> A | | | <b>Coordinates:</b> 596761, 7613627 | | | | | |
|---|---|---|---|---|---|---|---|---|---|---|---|---|
| 0-450 | MC | Nil | 10YR 2/2 | Nil | | Hard packed | Weak, Non-pedal | 2 | Not Recorded | Gradual | A1 | No sample |
| 450-1000+ | SCL | 10-20% | 7.5YR 3/3 | Ironstone | | - | Very weak, weakly pedal | 1 | Not Recorded | Base of horizon not encountered | B2 <sub>1</sub> | No sample |

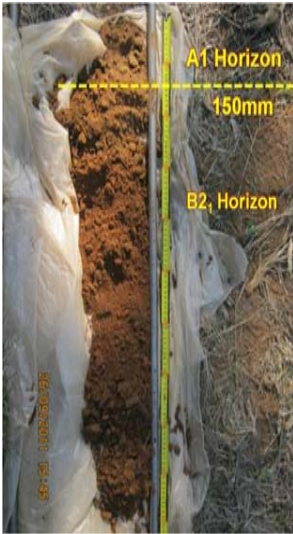
| <b>Project:</b> Wards Well | | <b>Date:</b> 26/9/2011 | | <b>Location:</b> 55 <b>Observation Type:</b> A | | | <b>Coordinates:</b> 597258, 7611552 | | | | | |
|---|---|---|---|---|---|---|---|---|---|---|---|---|
| 0-150 | SL | Nil | 7.5YR 3/4 | Nil | | Sandy Firm | Very weak, Apedal, Coherent | 1 | Good | Gradual | A1 | No sample |
| 150 - >1000 | SCL | Nil | 7.5YR 3/4 | Black / orange mottles at 950mm | | - | Weak, Weakly pedal, Coherent | 1 / 2 | Not Recorded | Base of horizon not encountered | B <sub>2</sub> <sub>1</sub> | No sample |

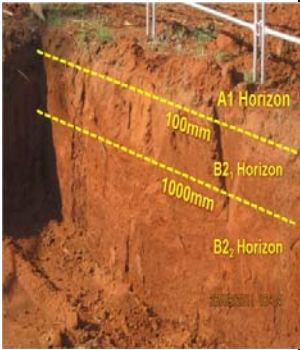
| <b>Project:</b> Wards Well | | <b>Date:</b> 26/9/2011 | | <b>Location:</b> 56 <b>Observation Type:</b> P | | | <b>Coordinates:</b> 0597741, 7611566 | | | | | |
|---|---|---|---|---|---|---|---|---|---|---|---|---|
| 0-100 | SCL | Nil | 5YR 3/3 | Nil | | Hard packed | Very weak, Apedal, Coherent | 1 | Poor | Gradual | A1 <sub>p</sub> | No sample |
| 100 - >1000 | LC | Nil | 2.5YR 3/4 | Some Ironstone | | - | Very weak, Highly pedal | 1 | Poor | Base of horizon not encountered | B2 <sub>1</sub> | No sample |
| >1000 | LC | 20% | | | | | | | | | B2 <sub>2</sub> | No sample |

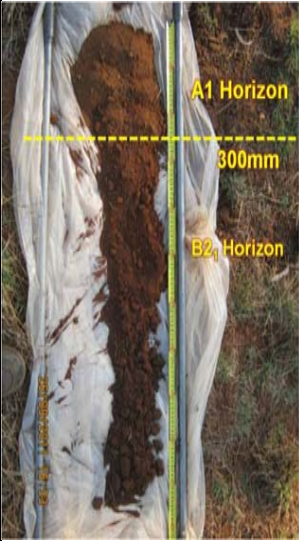
| <b>Project:</b> Wards Well | | <b>Date:</b> 26/9/2011 | | <b>Location:</b> 57 <b>Observation Type:</b> A | | | <b>Coordinates:</b> 0598090, 7610680 | | | | | |
|---|---|---|---|---|---|---|---|---|---|---|---|---|
| 0-300 | LC | Nil | 5YR 3/3 | Nil | | Hard packed | Very weak, Weakly pedal | 1 | Not recorded | Gradual | A1 | No sample |
| 300-1000 | LC/MC | Nil | 5YR 3/4 | Ironstone | | - | Very weak, Weakly pedal | 1 | Not recorded | Base of horizon not encountered | B2 <sub>1</sub> | No sample |

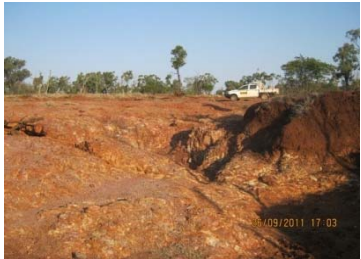
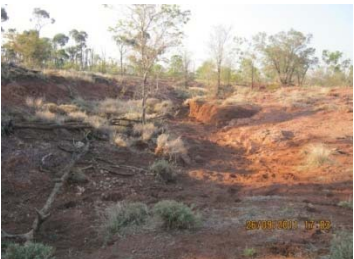
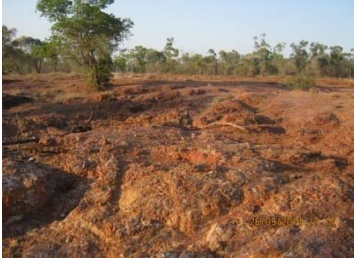
| <b>Project:</b> Wards Well | | <b>Date:</b> 26/9/2011 | | <b>Location:</b> 58 <b>Observation Type:</b> A | | | <b>Coordinates:</b> 597898, 7614327 | | | | | |
|---|---|---|---|---|---|---|---|---|---|---|---|---|
| <b>Topography:</b> <1% | | <b>Surface Rock % (&gt; 60mm dia):</b> Nil | | <b>Erosion:</b> Heavily eroded (90% of land) | | | | <b>Drainage:</b> Good | | | | |
| <b>Remarks:</b> Location is in creekbank, dry and heavily eroded (at 180cm surface is brittle/rocky | | | | <b>ASC Mapped:</b> Vertosol | | | | <b>ASC Ground Truth:</b> Demosol | | | | |

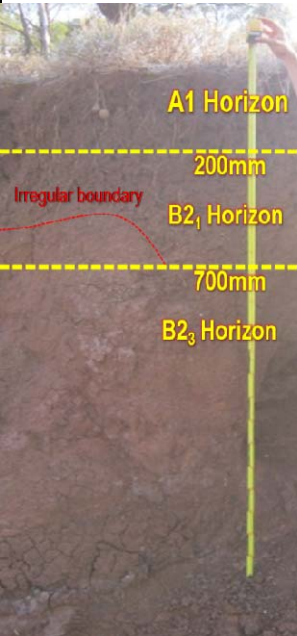
| <b>Project:</b> Wards Well | | <b>Date:</b> 26/9/2011 | | <b>Location:</b> 58 <b>Observation Type:</b> A | | | <b>Coordinates:</b> 597898, 7614327 | | | | | |
|---|---|---|---|---|---|---|---|---|---|---|---|---|
| 0-200 | LC/MC | Nil | 7.5YR 2.5/3 | Nil | | Non cracking | Very weak, Weakly pedal, Coherent | 1 | Not recorded | Gradual, Clear | A1 <sub>p</sub> | No sample |
| 200-700 | MC | <5% | 5YR 3/3 | Ironstone | | - | Very firm, Highly pedal, Coherent | 4 | Not recorded | Not recorded | B2 <sub>1</sub> | No sample |
| 700 - >1000 | MC | 50% is 5-15mm | 7.5YR 2.5/3 | Ironstone | | | Very firm, Highly pedal. Transition layer from B to C. Profile predominately B | 4 | Not recorded | Base of horizon not encountered | B2 <sub>3</sub> | No sample |

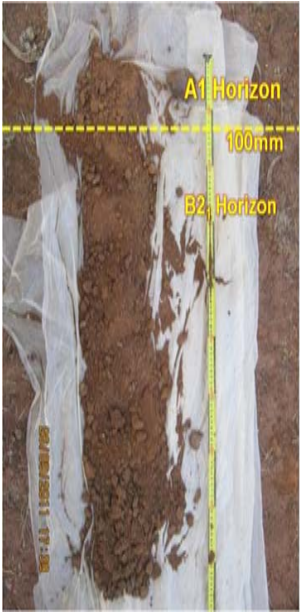
| <b>Project:</b> Wards Well | | <b>Date:</b> 26/9/2011 | | | <b>Location:</b> 59 <b>Observation Type:</b> A | | | <b>Coordinates:</b> 599246, 7614274 | | | | |
|---|---|---|---|---|---|---|---|---|---|---|---|---|
| 0-100 | SCL | 1-5% | 5YR 4/4 | Nil | | Not recorded | Very weak, Weakly pedal, Coherent | 1 | Good | Gradual | A1 | No sample |
| 100- >1000 | LC | Nil | 7.5YR 4/4 | White mottles | | - | Weak, Weakly pedal, Coherent | 2 | Poor | Gradual | B2 <sub>1</sub> | No sample |

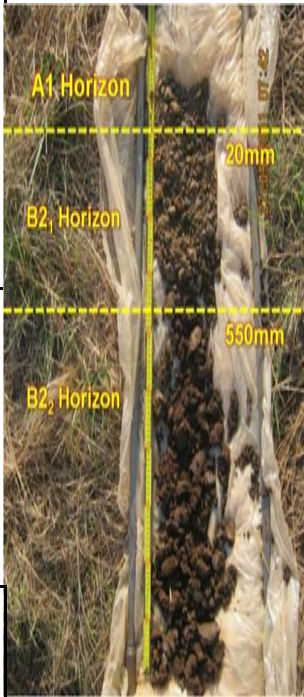
| <b>Project:</b> Wards Well | | <b>Date:</b> 27/9/2011 | | | <b>Location:</b> 60 | | | <b>Observation Type:</b> A | | | | | <b>Coordinates:</b> 0596050, 7615539 | |
|---|---|---|---|---|---|---|---|---|---|---|---|---|---|--|
| 0-20 | LC | Nil | 7.5YR | Nil | | Self Mulching | Very firm, Highly pedal | 4 | Not recorded | Sharp | A1 | 0-20 mm | | |
| 20-550 | MC | Nil | 7.5YR 3/4 | Nil | | - | Firm, Highly pedal | 3 | Poor | Sharp | B2 <sub>1</sub> | 20-300 mm | | |
| 550-1000 | SiC | 40% | 7.5YR 3/3 | White/grey mottles and some yellow mottles | | - | Very weak, Highly pedal | 1 | Good | Base of horizon not encountered | B2 <sub>2</sub> | 700-800 mm | | |

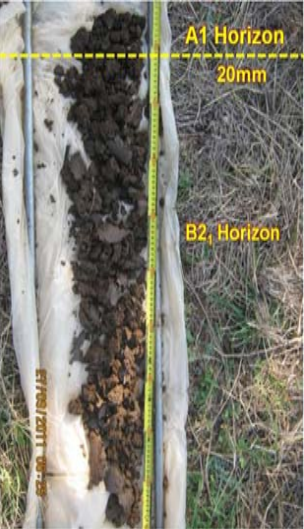
| <b>Project:</b> Wards Well | | <b>Date:</b> 27/9/2011 | | <b>Location:</b> 61 | | | <b>Observation Type:</b> A | | | <b>Coordinates:</b> 597565, 7616055 | | |
|---|---|---|---|---|---|---|---|---|---|---|---|---|
| 0-20 | LC | Nil | 7.5YR 4/4 | Nil | | Self Mulching | Firm, Highly pedal | 1 / 2 | Good | Gradual | A1 | No sample |
| 20- >1000 | MC | 1-2% 15mm | 7.5YR 3/4 | Orange / white mottles | | - | Firm, Highly pedal | 2 | Poor | Base of horizon not encountered | B2 <sub>1</sub> | No sample |

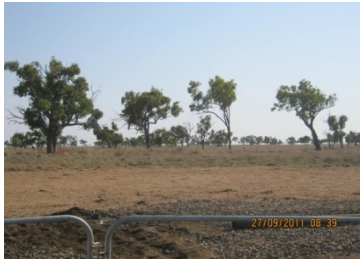
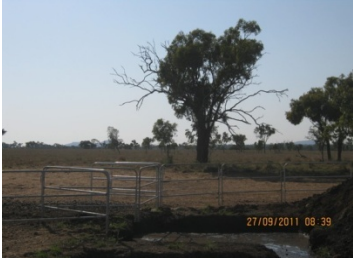
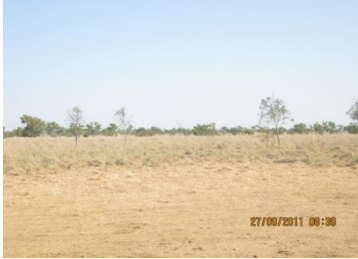
| <b>Project:</b> Wards Well | | <b>Date:</b> 27/9/2011 | | | <b>Location:</b> 62 <b>Observation Type:</b> A | | | <b>Coordinates:</b> 0598732, 7615564 | | | | |
|---|---|---|---|---|---|---|---|---|---|---|---|---|
| <b>Natural Vegetation:</b> Morton Bay Ash, Buffel Grass | | | | | | | | <b>Land Use:</b> grazing | | | | |
| <b>Topography:</b> <1% | | <b>Surface Rock % (&gt; 60mm dia):</b> Nil | | | <b>Erosion:</b> Nil | | | <b>Drainage:</b> Not recorded | | | | |
| <b>Remarks:</b> Sample location is next to proposed drill pad | | | | | <b>ASC Mapped:</b> Vertosol | | | <b>ASC Ground Truth:</b> Vertosol | | | | |

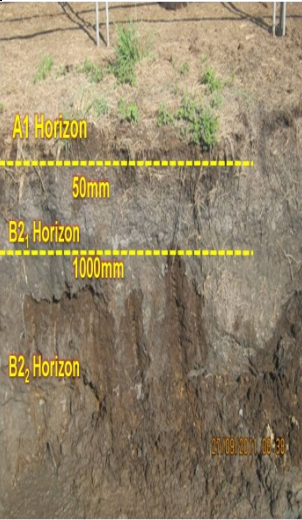
| <b>Project:</b> Wards Well | | <b>Date:</b> 27/9/2011 | | | <b>Location:</b> 62 <b>Observation Type:</b> A | | | <b>Coordinates:</b> 0598732, 7615564 | | | | |
|---|---|---|---|---|---|---|---|---|---|---|---|---|
| 0-50 | LC | Nil | 7.5YR 4/4 | Nil | | Self Mulching | Very weak, Weakly pedal | 1 | Good | Not recorded | A1 <sub>p</sub> | No sample |
| 50-1000 | MC | ≤ 5% | 7.5YR 3/3 | Black / orange mottling | | - | Weak / firm, Weakly pedal | 2 / 3 | Poor | Sharp | B2 <sub>1</sub> | No sample |
| >1000 | SCL | ≤ 40% | 10YR 5/4 | Yellow /orange mottles | - | Very weak / Weak, Weakly pedal | 1 / 2 | Not recorded | Base of horizon not encountered | B2 <sub>2</sub> | No sample | |

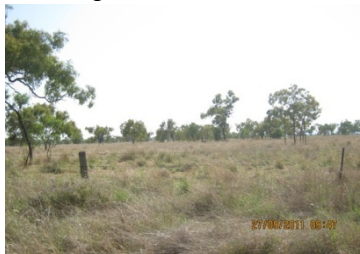
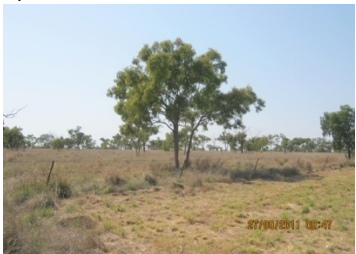
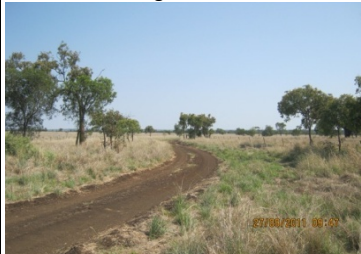
| <b>Project:</b> Wards Well | | <b>Date:</b> 27/9/2011 | | <b>Location:</b> 64 | | | <b>Observation Type:</b> A | | | <b>Coordinates:</b> 0599669, 7616198 | | | |
|---|---|---|---|---|---|---|---|---|---|---|---|---|--|
| <b>Natural Vegetation:</b> Buffel Grass, Morten Bay Grass | | | | | | | <b>Land Use:</b> Grazing | | | | | | |
| <b>Topography:</b> On top of ridge | | <b>Surface Rock % (&gt; 60mm dia):</b> Nil | | <b>Erosion:</b> Nil | | | | <b>Drainage:</b> Poor | | | | | |

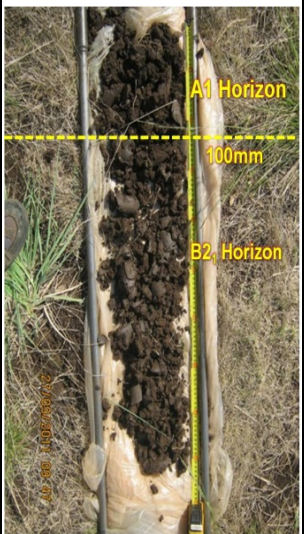
| <b>Project:</b> Wards Well | | <b>Date:</b> 27/9/2011 | | <b>Location:</b> 64 | | | <b>Observation Type:</b> A | | | <b>Coordinates:</b> 0599669, 7616198 | | | |
|---|---|---|---|---|---|---|---|---|---|---|---|---|--|
| 0-100 | MC | Nil | 10YR 3/4 | Nil | | Self Mulching | Very firm, highly pedal | 4 | Poor | Gradual, Even | A1 | No sample | |
| 100 - >1000 | MC / HC | Nil | 10YR 3/3 | Orange/brown and white mottling | | - | Very firm, highly pedal | 4 | Poor | Base of horizon not encountered | B2 <sub>1</sub> | No sample | |

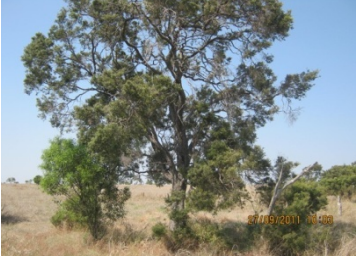
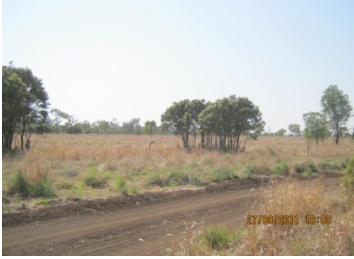
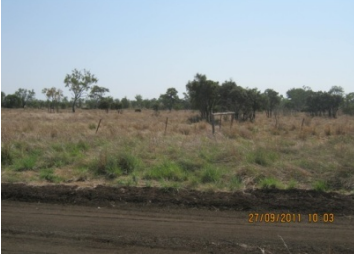
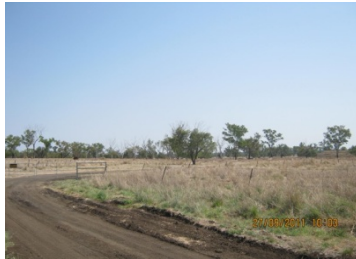
| <b>Project:</b> Wards Well | | <b>Date:</b> 27/9/2011 | | | <b>Location:</b> 65 <b>Observation Type:</b> A | | | <b>Coordinates:</b> 599143, 7617345 | | | | |
|---|---|---|---|---|---|---|---|---|---|---|---|---|
| <b>Natural Vegetation:</b> Vegetation clearing leaving Buffel Grass | | | | | | | | <b>Land Use:</b> Grazing | | | | |
| <b>Topography:</b> 1-2% bottom of slope | | | <b>Surface Rock % (&gt; 60mm dia):</b> Nil | | <b>Erosion:</b> Nil | | | <b>Drainage:</b> Poor | | | | |
| <b>Remarks:</b> Stiff Clay, auger difficult to advance, tree roots to 500mm | | | | | <b>ASC Mapped:</b> Vertosol | | | <b>ASC Ground Truth:</b> Vertosol | | | | |

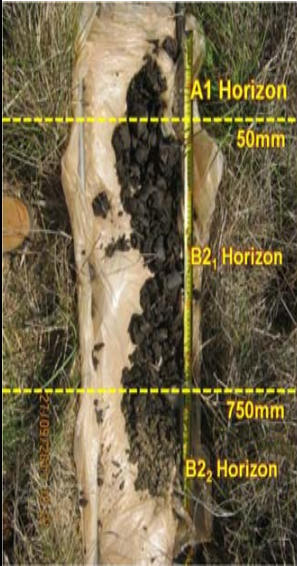
| <b>Project:</b> Wards Well | | <b>Date:</b> 27/9/2011 | | | <b>Location:</b> 65 <b>Observation Type:</b> A | | | <b>Coordinates:</b> 599143, 7617345 | | | | |
|---|---|---|---|---|---|---|---|---|---|---|---|---|
| 0-50 | MC | Nil | 7.5 YR 3/2 | Nil | | Self Mulching | Firm, Highly pedal, Coherent | 3 | Poor | Gradual | A1 | No sample |
| 50-750 | MC / HC | Nil | 10YR 3/2 | Fine Ironstone (≥ 2 mm) | | - | Firm/Very firm, Highly pedal, Coherent | 3 / 4 | Poor | Gradual | B2 <sub>1</sub> | No sample |
| 750- >1000 | SiC | 40 -50% | 7.5YR 3/3 | White/grey mottling at 750 | | | Very Weak, Stronger then Weakly Pedal, Coherent | 1 | | sharp | B2 <sub>2</sub> | |

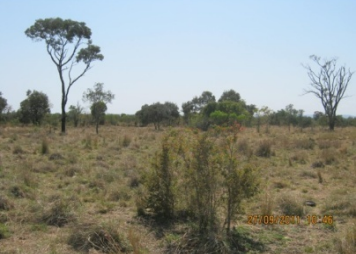
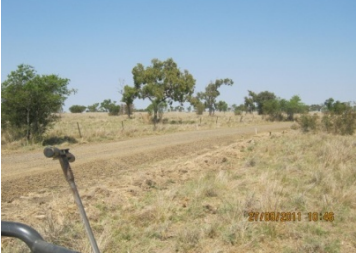
| <b>Project:</b> Wards Well | | <b>Date:</b> 27/9/2011 | | | <b>Location:</b> 66 <b>Observation Type:</b> A | | | <b>Coordinates:</b> 0598053, 7617293 | | | | |
|---|---|---|---|---|---|---|---|---|---|---|---|---|
| <b>Natural Vegetation:</b> Brigalow, Bohemia, Acacia, Morton Bay Ash | | | | | | | | <b>Land Use:</b> Grazing | | | | |
| <b>Topography:</b> 1% near top | | | <b>Surface Rock % (&gt; 60mm dia):</b> Nil | | <b>Erosion:</b> Nil | | | <b>Drainage:</b> Poor | | | | |

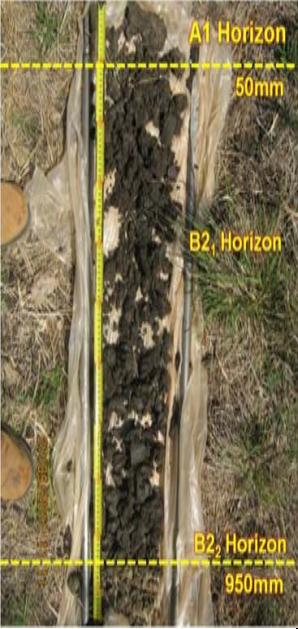
| <b>Project:</b> Wards Well | | <b>Date:</b> 27/9/2011 | | | <b>Location:</b> 66 <b>Observation Type:</b> A | | | <b>Coordinates:</b> 0598053, 7617293 | | | | |
|---|---|---|---|---|---|---|---|---|---|---|---|---|
| 0-50 | MC | Nil | 10 YR 3/2 | Nil | | Self Mulching, cracking | Very firm, highly pedal | 4 | Not recorded | Sharp | A1 | No sample |
| 50-950 | MC | Nil | 10YR 3/2 | Fine Ironstone gravel ( $\geq 2$ mm) | | - | Very firm, highly pedal | 4 | Not recorded | Sharp | B2 <sub>1</sub> | No sample |
| 950- >1000 | SiC | 50% | 10YR 4/3 | White/grey mottling | | - | Very weak, weakly pedal | 1 | Not recorded | Base of horizon not encountered | B2 <sub>2</sub> | No sample |

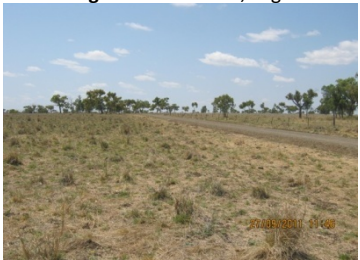
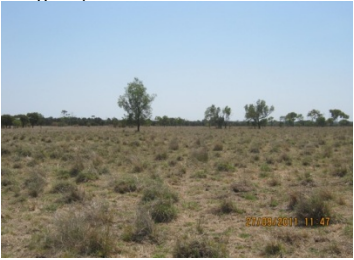
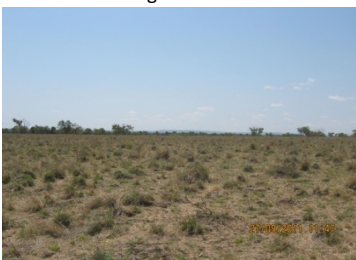
| <b>Project:</b> Wards Well | | <b>Date:</b> 27/9/2011 | | <b>Location:</b> 67 <b>Observation Type:</b> A | | | <b>Coordinates:</b> 0598053, 7617293 | | | | | |
|---|---|---|---|---|---|---|---|---|---|---|---|---|
| <b>Natural Vegetation:</b> Cleared, vegetation Buffel grass, acacia | | | | | | | <b>Land Use:</b> Grazing | | | | | |
| <b>Topography:</b> <1% | | <b>Surface Rock % (&gt; 60mm dia):</b> Nil | | <b>Erosion:</b> Nil | | | | <b>Drainage:</b> Poor | | | | |
| <b>Remarks:</b> Large cracks in surface layer | | | | <b>ASC Mapped:</b> Vertosol | | | | <b>ASC Ground Truth:</b> Vertosol | | | | |

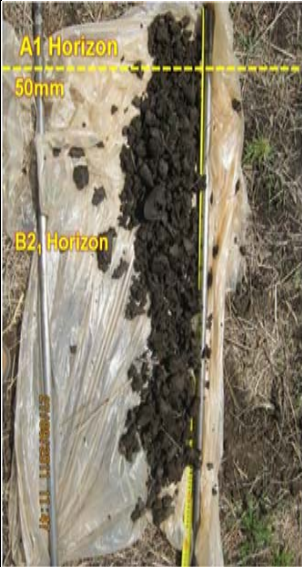
| <b>Project:</b> Wards Well | | <b>Date:</b> 27/9/2011 | | <b>Location:</b> 67 <b>Observation Type:</b> A | | | <b>Coordinates:</b> 0598053, 7617293 | | | | | |
|---|---|---|---|---|---|---|---|---|---|---|---|---|
| 0-50 | MC | Nil | 10YR 3/3 | Nil | | Self Mulching, cracking | Very firm, highly pedal, massive | 4 | Poor | Gradual | A1 | No sample |
| 50-1000 | MC | Nil | 10YR 3/3 | Orange/black mottles | | - | Very firm, highly pedal, massive | 4 | Poor | Base of horizon not encountered | B2 <sub>1</sub> | No sample |

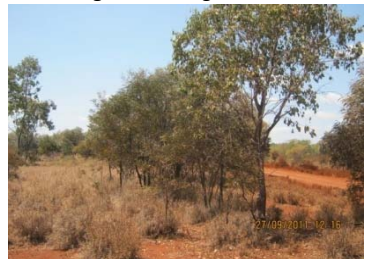
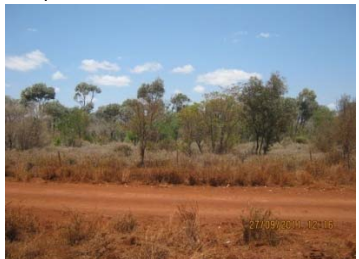
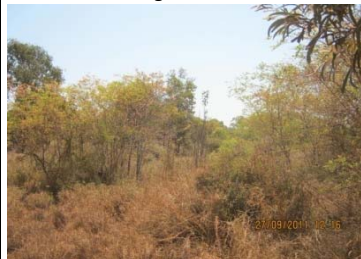
| <b>Project:</b> Wards Well | | <b>Date:</b> 27/9/2011 | | | <b>Location:</b> 68 | | | <b>Observation Type:</b> A | | | <b>Coordinates:</b> 0596388, 7617258 | | |
|---|---|---|---|---|---|---|---|---|---|---|---|---|--|
| <b>Natural Vegetation:</b> Brigalow, Buffel Grass, 1 Poplar Box | | | | | | | | <b>Land Use:</b> Grazing | | | | | |
| <b>Topography:</b> 1% mid slope | | <b>Surface Rock % (&gt; 60mm dia):</b> Nil | | | <b>Erosion:</b> Nil | | | <b>Drainage:</b> Good | | | | | |
| <b>Remarks:</b> 600-1000 is hard digging | | | | | <b>ASC Mapped:</b> Vertosol | | | <b>ASC Ground Truth:</b> Kandosol | | | | | |

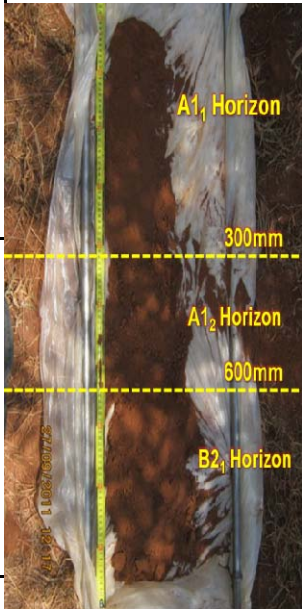
| <b>Project:</b> Wards Well | | <b>Date:</b> 27/9/2011 | | | <b>Location:</b> 68 | | | <b>Observation Type:</b> A | | | <b>Coordinates:</b> 0596388, 7617258 | | |
|---|---|---|---|---|---|---|---|---|---|---|---|---|--|
| 0-300 | SCL | Nil | 2.5 YR 2.5/4 | Nil | | Hard packed | Firm, weakly pedal | 3 | Not recorded | Gradual | A <sub>1</sub> | No sample | |
| 300-600 | SCL | 5% | 2.5YR 3/4 | Nil | | - | Weak, weakly pedal | 2 | Not recorded | Dradual | A <sub>1.5</sub> | No sample | |
| 600-1000 | SCL | Nil | 2.5YR 2.5/4 | Nil | | - | Weak, weakly pedal | 2 | Not recorded | Base of horizon not encountered | B <sub>2.1</sub> | No sample | |

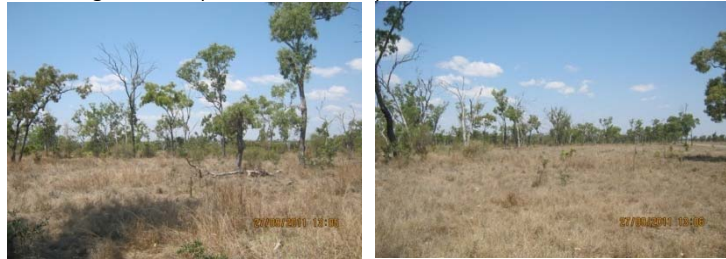
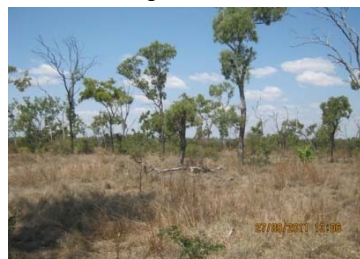
| <b>Project:</b> Wards Well | | <b>Date:</b> 27/9/2011 | | <b>Location:</b> 69 | | | <b>Observation Type:</b> A | | | <b>Coordinates:</b> 0595767, 7617473 | | |
|---|---|---|---|---|---|---|---|---|---|---|---|---|
| <b>Natural Vegetation:</b> Poplar Box, Morton Bay Ash | | | | | | | <b>Land Use:</b> Grazing | | | | | |
| <b>Topography:</b> Top of Peak | | | <b>Surface Rock % (&gt; 60mm dia):</b> Nil | | <b>Erosion:</b> Nil | | | <b>Drainage:</b> Not recorded | | | | |
| <b>Remarks:</b> 600-1000 is hard digging | | | | | <b>ASC Mapped:</b> Vertosol | | | <b>ASC Ground Truth:</b> Kandosol | | | | |

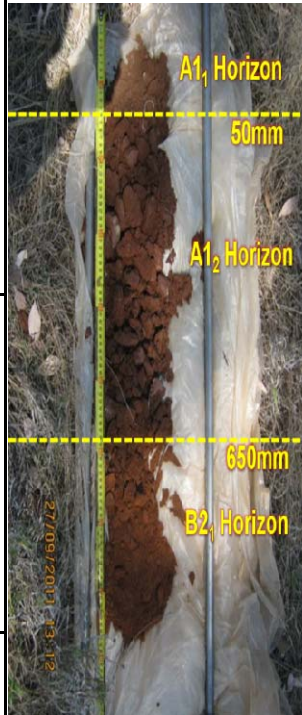
| <b>Project:</b> Wards Well | | <b>Date:</b> 27/9/2011 | | <b>Location:</b> 69 | | | <b>Observation Type:</b> A | | | <b>Coordinates:</b> 0595767, 7617473 | | |
|---|---|---|---|---|---|---|---|---|---|---|---|---|
| 0-50 | SCL | Nil | 2.5 YR 3/3 | Nil | | Hard packed | Very weak/weak, weakly pedal, coherent | 1 / 2 | Good | Sharp | A1 <sub>1</sub> | 0-50 mm |
| 50-650 | MC | Nil | 2.5YR 2.5/4 | Ironstone and grey mottles | | - | Firm, highly pedal, massive | 3 | Poor | Sharp | A1 <sub>2</sub> | 200-300 mm |
| 650-100 | SCL | Nil | 2.5YR 3/6 | Nil | | - | Very weak/weak, weakly pedal, coherent | 1 | Not recorded | Base of horizon not encountered | B1 <sub>1</sub> | 800-900 mm |

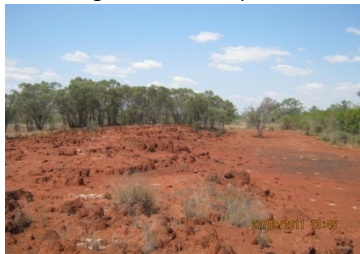
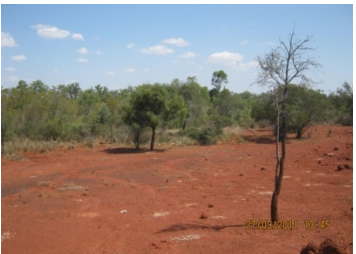
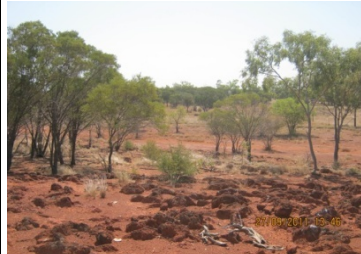
| <b>Project:</b> Wards Well | | <b>Date:</b> 27/9/2011 | | <b>Location:</b> 70 <b>Observation Type:</b> A | | | <b>Coordinates:</b> 0595691, 7618036 | | | | | |
|---|---|---|---|---|---|---|---|---|---|---|---|---|
| <b>Natural Vegetation:</b> Some spear Acacia | | | | | | | <b>Land Use:</b> None | | | | | |
| <b>Topography:</b> Top of rocky ridge | | | <b>Surface Rock % (&gt; 60mm dia):</b> Nil | | <b>Erosion:</b> Nil | | | <b>Drainage:</b> Nil | | | | |
| <b>Remarks:</b> Bore terminated at 100mm due to refusal on hard clay | | | | | <b>ASC Mapped:</b> Vertosol | | | <b>ASC Ground Truth:</b> Kandosol | | | | |

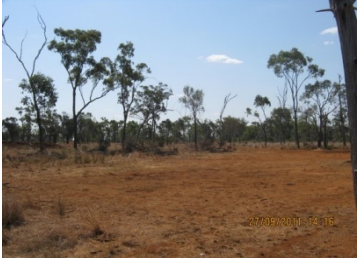
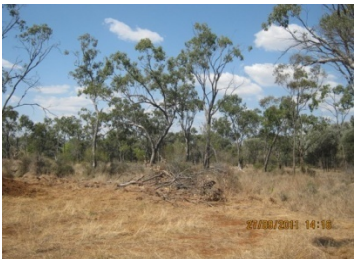
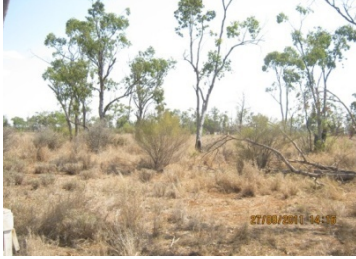
| <b>Project:</b> Wards Well | | <b>Date:</b> 27/9/2011 | | | <b>Location:</b> 71 Observation Type: A | | | <b>Coordinates:</b> 0596210, 7618561 | | | | |
|---|---|---|---|---|---|---|---|---|---|---|---|---|
| <b>Natural Vegetation:</b> Buffel Grass, Brigalow, Poplar Box, Eucalypt | | | | | | | <b>Land Use:</b> Grazing | | | | | |
| <b>Topography:</b> Flat | | <b>Surface Rock % (&gt; 60mm dia):</b> Nil | | <b>Erosion:</b> Nil | | | <b>Drainage:</b> Good | | | | | |
