# Progressive Rehabilitation and Closure Plan

## Wards Well Mine

| <b>Document title</b> | Progressive Rehabilitation and Closure Plan |
| <b>Version number</b> | V3.0 |

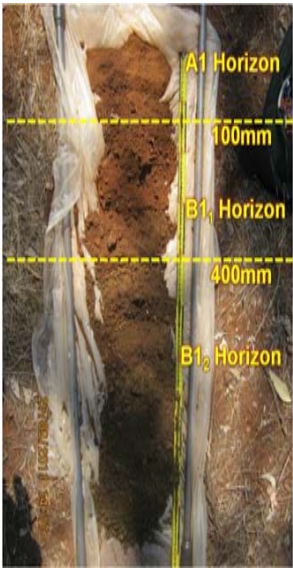
| <b>Project:</b> Wards Well | | <b>Date:</b> 27/9/2011 | | | <b>Location:</b> 71 Observation Type: A | | | <b>Coordinates:</b> 0596210, 7618561 | | | | |
|---|---|---|---|---|---|---|---|---|---|---|---|---|
| 0-100 | LC | Nil | 2.5 YR 3/3 | Nil | | Self mulching | Weak, Apedal | 2 | Not recorded | Gradual | A1 <sub>1</sub> | No sample |
| 100-400 | SC | 5% | 5YR 3/3 | Ironstone | | - | Very weak, weakly pedal | 1 | Not recorded | Sharp | B1 <sub>1</sub> | No sample |
| 400-1000 | SCL | 50% | 7.5YR 2.5/2 | Many ironstone gravels | | - | Very weak, weakly pedal | 1 | Not recorded | Base of horizon not encountered | B2 <sub>1</sub> | No sample |

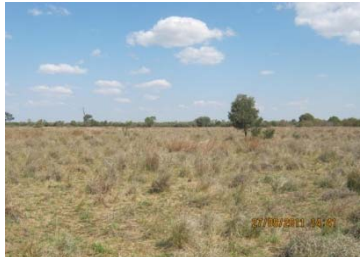
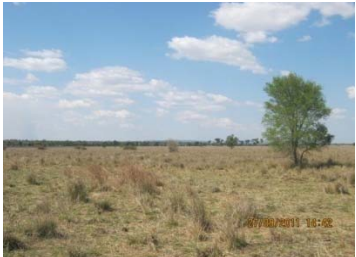
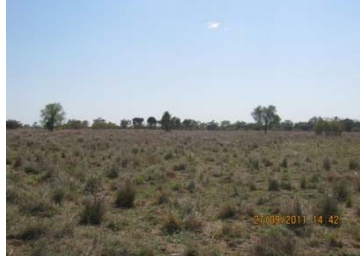
| Project: Wards Well | | Date: 27/9/2011 | | Location: 72 Observation Type: A | | Coordinates: 0597226, 7618527 | | | | | | |
|---|---|---|---|---|---|---|---|---|---|---|---|---|
| Natural Vegetation: Cleared vegetation with some Bohemia, Brigalow | | | | | | Land Use: Grazing | | | | | | |
| Topography: <1% | | Surface Rock % (> 60mm dia): Nil | | Erosion: Nil | | Drainage: Not recorded | | | | | | |
| Remarks: Hard digging | | | | ASC Mapped: Vertosol | | ASC Ground Truth: Vertosol | | | | | | |

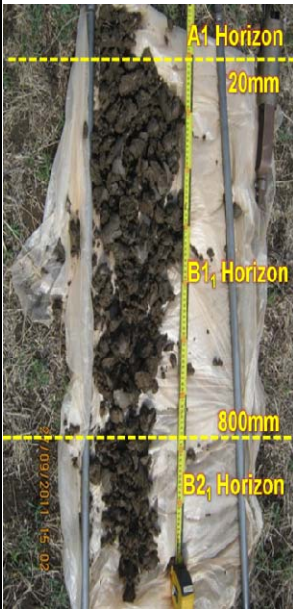
| Project: Wards Well | | Date: 27/9/2011 | | Location: 72 Observation Type: A | | Coordinates: 0597226, 7618527 | | | | | | |
|---|---|---|---|---|---|---|---|---|---|---|---|---|
| 0-20 | LC | Nil | 10 YR 3/3 | Nil | | Hard cracking clay, self mulching | Weak, weakly pedal | 2 | Good | Gradual | A1 <sub>1</sub> | No sample |
| 20-800 | MC / HC | 1% | 10YR 3/3 | Black and white mottles (ironstone) | | - | Very firm, strongly pedal | 4 | Poor | Gradual | B2 <sub>1</sub> | No sample |
| 800- >1000 | MC / HC | Nil | 10YR 3/6 | Yellow/orange mottles and ironstone | | - | Very firm, strongly pedal | 4 | Poor | Base of horizon not encountered | B2 <sub>1</sub> | No sample |

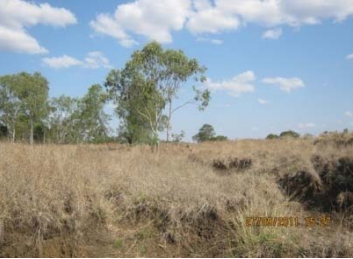
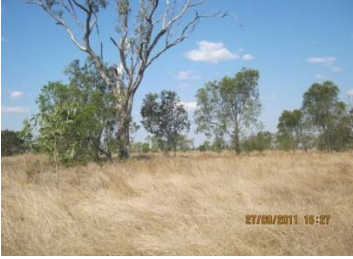
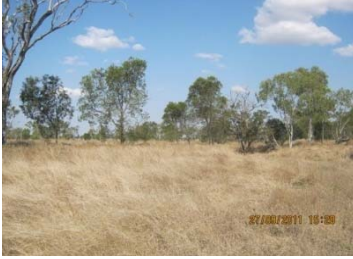
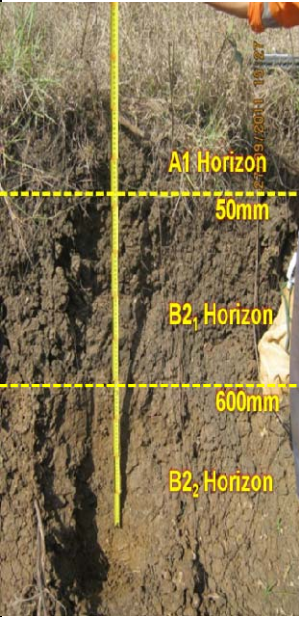
| <b>Project:</b> Wards Well | | <b>Date:</b> 27/9/2011 | | <b>Location:</b> 73 | | | | <b>Observation Type:</b> A | | | | <b>Coordinates:</b> 0598601, 7618470 | | | |
|---|---|---|---|---|---|---|---|---|---|---|---|---|--|--|--|
| <b>Topography:</b> Creek bed | | | | <b>Surface Rock % (&gt; 60mm dia):</b> Nil | | <b>Erosion:</b> 20% | | | | <b>Drainage:</b> Not recorded | | | | | |
| <b>Remarks:</b> Creek bank | | | | <b>ASC Mapped:</b> Vertosol | | | | <b>ASC Ground Truth:</b> Vertosol | | | | | | | |
| 0-50 | LC | Nil | 10YR 3/1 | Nil | | Self mulching | Loose | 0 | Not recorded | Gradual | A1 <sub>1p</sub> | No sample | | | |
| 50-600 | LC / MC | 5% | 10YR 3/2 | White mottles between 150-200mm | | Very Firm, Strongly Pedal, Coherent | 4 | Not recorded | Abrupt | B2 <sub>1</sub> | No sample | | | | |
| 600- >1000 | LC / MC | 5% | 10YR 4/3 | Ironstone | | Weak, weakly pedal, massive | 2 | Poor | Base of horizon not encountered | B2 <sub>2</sub> | No sample | | | | |

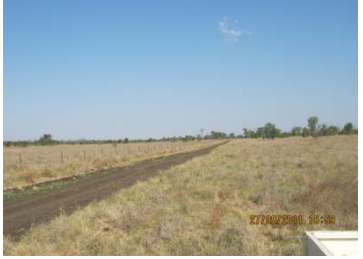
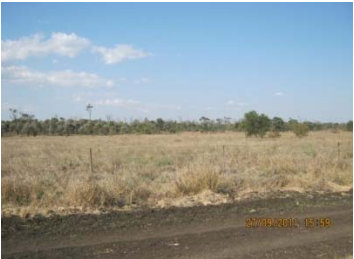
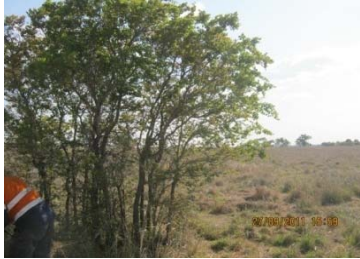
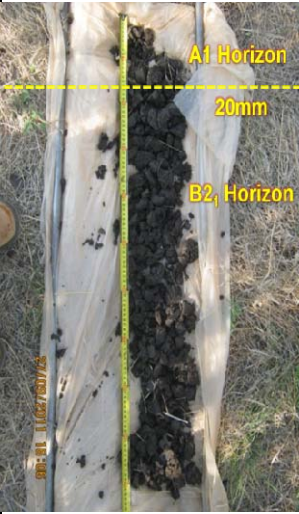
| <b>Project:</b> Wards Well | | <b>Date:</b> 27/9/2011 | | <b>Location:</b> 74 Observation Type: A | | | <b>Coordinates:</b> 0600207, 7619004 | | | | | |
|---|---|---|---|---|---|---|---|---|---|---|---|---|
| <b>Topography:</b> 1% near bottom of slope | | | <b>Surface Rock % (&gt; 60mm dia):</b> Nil | | <b>Erosion:</b> Nil | | | <b>Drainage:</b> Near creek bottom of slope | | | | |
| <b>Remarks:</b> Hard digging | | | | | <b>ASC Mapped:</b> Vertosol | | | <b>ASC Ground Truth:</b> Vertosol | | | | |
| 0-20 | LC | Nil | 10YR 3/3 | Nil | | Self mulching, hard cracking clays | Weak, Weakly pedal, Massive | 2 | Good | Gradual | A <sub>1</sub> | No sample |
| 20-1000 | MC | 1% | 10YR 3/3 | Black and white mottles | | | Very firm, strongly pedal, Massive | 4 | Poor | Abrupt | B <sub>2</sub> <sub>1</sub> | No sample |

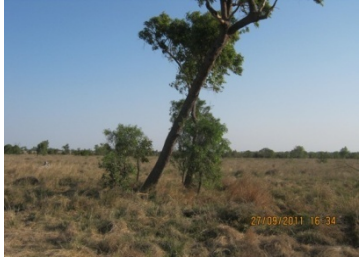
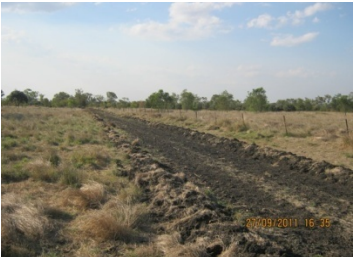
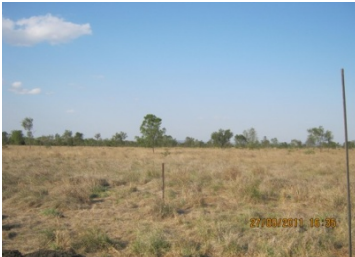
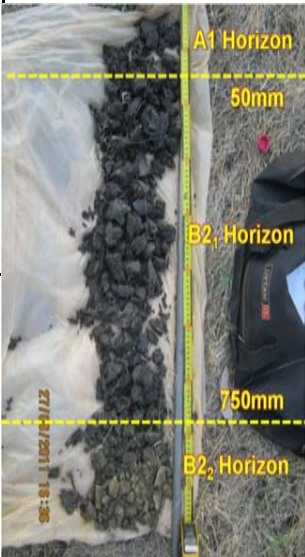
| <b>Project:</b> Wards Well | | <b>Date:</b> 27/9/2011 | | | <b>Location:</b> 75 | | | <b>Observation Type:</b> A | | | <b>Coordinates:</b> 0599700, 7619872 | | |
|---|---|---|---|---|---|---|---|---|---|---|---|---|--|
| <b>Topography:</b> 1% top of ridge (tabletop) | | <b>Surface Rock % (&gt; 60mm dia):</b> Nil | | | <b>Erosion:</b> Nil | | | <b>Drainage:</b> | | | | | |
| <b>Remarks:</b> Hard digging | | | | | <b>ASC Mapped:</b> Vertosol | | | <b>ASC Ground Truth:</b> Vertosol | | | | | |
| 0-50 | LC | Nil | 10YR 4/1 | Nil | | Self mulching, hard cracking clay | Weak / firm, highly pedal, massive | 2-3 | Poor | Gradual | A <sub>1</sub> | 0-50 mm | |
| 50-750 | MC | Nil | 10YR 4/1 | white mottles | | Very firm, highly pedal, massive | 4 | Poor | Sharp | B <sub>2</sub> <sub>1</sub> | 400-500 mm | | |
| 750 - >1000 | LC/MC | Nil | Not recorded | white/grey mottles | - | Fine, sub-angular, r | 3 | No recorded | Base of horizon not encountered | B <sub>2</sub> <sub>2</sub> | 900-1000 mm | | |

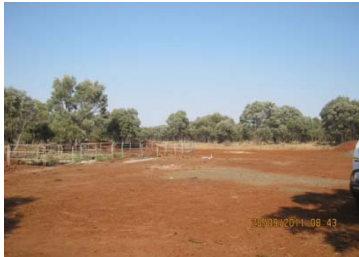
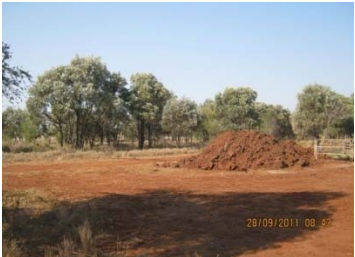
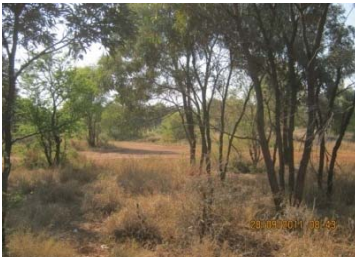
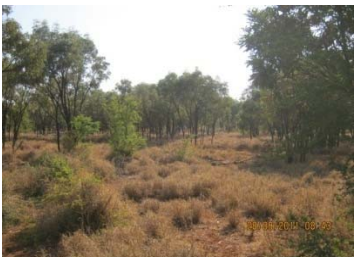
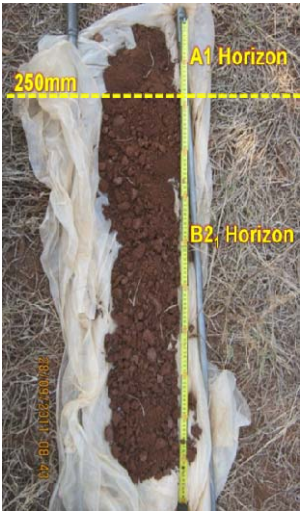
| <b>Project:</b> Wards Well | | <b>Date:</b> 28/9/2011 | | <b>Location:</b> 77 | | | <b>Observation Type:</b> A | | <b>Coordinates:</b> 0595518, 7624627 | | | | |
|---|---|---|---|---|---|---|---|---|---|---|---|---|--|
| <b>Topography:</b> <1% | | <b>Surface Rock % (&gt; 60mm dia):</b> Nil | | <b>Erosion:</b> Nil | | | | <b>Drainage:</b> Good | | | | | |
| <b>Remarks:</b> | | | | <b>ASC Mapped:</b> Kandasol | | | | <b>ASC Ground Truth:</b> Kandasol | | | | | |
| 0-250 | SL | 10% | 5YR 3/4 | Nil | | Sandy, firm, non-cracking | Very weak, weakly pedal, massive | 1 | Good | Sharp | A <sub>1</sub> | No sample | |
| 250- >1000 | SCL | Nil | 5YR 3/4 | White/black mottles, yellow mottles at 300mm | | - | Very weak, weakly pedal, massive | 1 | Good | Gradual | B <sub>2</sub> <sub>1</sub> | No sample | |

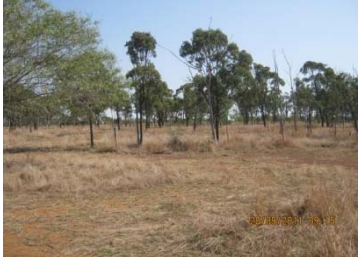
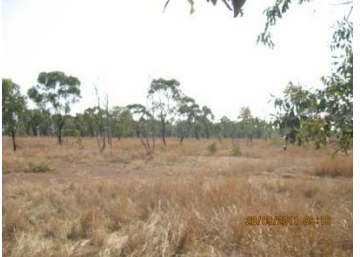
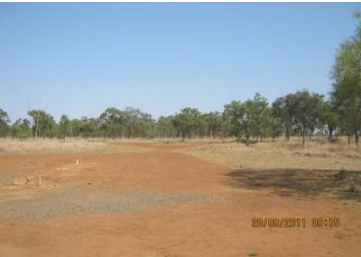
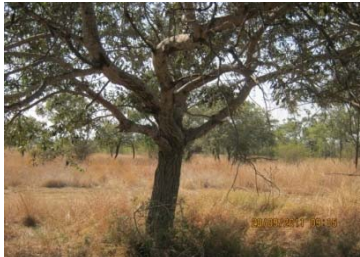
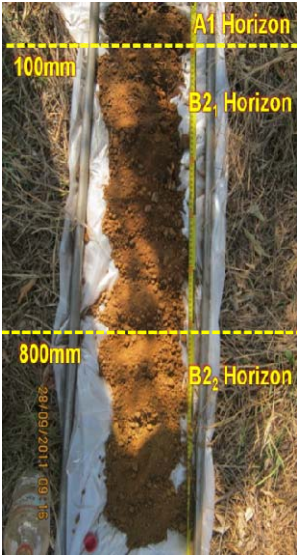
| <b>Project:</b> Wards Well | | <b>Date:</b> 28/9/2011 | | <b>Location:</b> 78 | | | <b>Observation Type:</b> A | | | <b>Coordinates:</b> 0595448, 7625536 | | | |
|---|---|---|---|---|---|---|---|---|---|---|---|---|--|
| <b>Topography:</b> Top of ridge | | <b>Surface Rock % (&gt; 60mm dia):</b> Nil | | <b>Erosion:</b> Nil | | | <b>Drainage:</b> Good | | | | | | |
| <b>Remarks:</b> Coarse fraction is black/red when broken | | | | <b>ASC Mapped:</b> Kandasol | | | <b>ASC Ground Truth:</b> Kandasol | | | | | | |
| 0-100 | SCL | 20% | 7.5YR 3/3 | Nil | | Self mulching | Very weak, weakly pedal | 1 | Not recorded | Gradual | A <sub>1</sub> | No sample | |
| 100-800 | SCL | 50% | 7.5YR 4/4 | Nil | | - | Very weak, weakly pedal | 1 | Good | Gradual | B <sub>2</sub> <sub>1</sub> | No sample | |
| 800 - >1000 | SCL | 60% | 10YR 4/6 | Nil | | - | Very weak, weakly pedal | 1 | Not recorded | Base of horizon not encountered | B <sub>2</sub> <sub>2</sub> | No sample | |

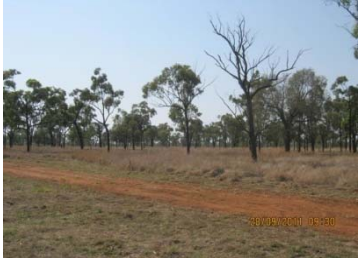
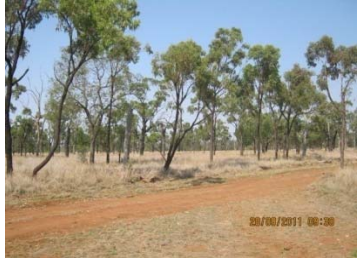
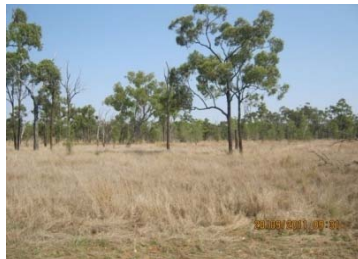
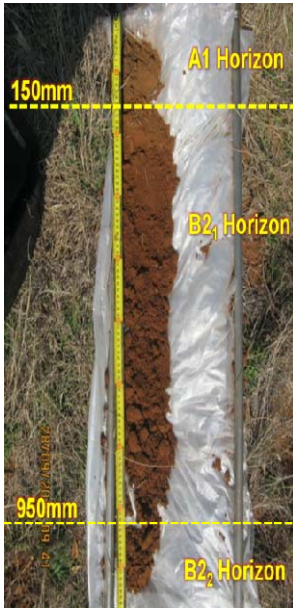
| <b>Project:</b> Wards Well | | <b>Date:</b> 28/9/2011 | | <b>Location:</b> 79 Observation Type: A | | | <b>Coordinates:</b> 0596176, 7625794 | | | | | |
|---|---|---|---|---|---|---|---|---|---|---|---|---|
| <b>Topography:</b> <1% | | <b>Surface Rock % (&gt; 60mm dia):</b> Nil | | <b>Erosion:</b> Nil | | | <b>Drainage:</b> Not recorded | | | | | |
| <b>Remarks:</b> Coarse fraction is black/red when broken | | | | <b>ASC Mapped:</b> Kandosol | | | <b>ASC Ground Truth:</b> Kandosol | | | | | |
| 0-150 | SL | Nil | 5YR 3/3 | Nil | | Hard packed sandy | Very weak, non-pedal | 1 | Good | Gradual | A1 <sub>1</sub> | No sample |
| 150-950 | SCL | Nil | 2.5YR 4/4 | Nil | | - | Very weak, weakly pedal, massive | 1 | Good | Sharp | B2 <sub>1</sub> | No sample |
| 950- >1000 | SCL | Nil | 5YR 4/4 | Ironstone | | - | Very weak, weakly pedal, massive | 1 | Poor | Base of horizon not encountered | B2 <sub>2</sub> | No sample |

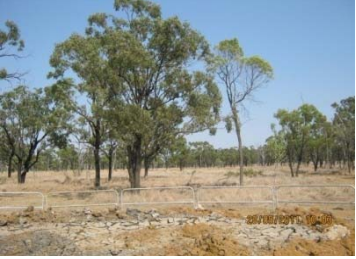
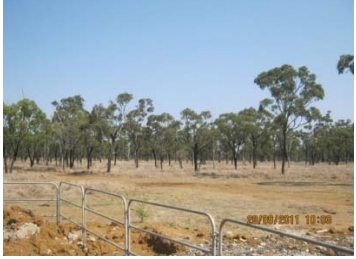
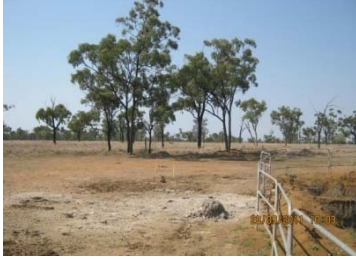
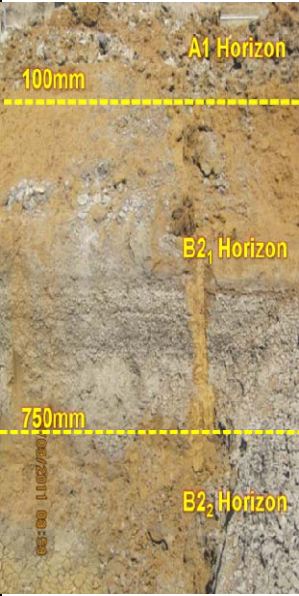
| <b>Project:</b> Wards Well | | <b>Date:</b> 28/9/2011 | | <b>Location:</b> 80 | | | <b>Observation Type:</b> P | | | <b>Coordinates:</b> 0597227, 7626006 | | |
|---|---|---|---|---|---|---|---|---|---|---|---|---|
| <b>Topography:</b> Top of ridge | | <b>Surface Rock % (&gt; 60mm dia):</b> Nil | | <b>Erosion:</b> Nil | | | | <b>Drainage:</b> Not recorded | | | | |
| <b>Remarks:</b> | | | | <b>ASC Mapped:</b> Kandasol | | | | <b>ASC Ground Truth:</b> Sodosol | | | | |
| 0-100 | SL | Nil | 10YR 3/3 | Nil | | Hard packed fine gravel | Very weak, non pedal, massive | 2 | Good | Gradual | A1 <sub>1p</sub> | No sample |
| 100-750 | SCL | Nil | 10YR 4/6 | Ironstone | | - | Weak, weakly pedal, massive | 2 | Poor | Sharp, Irregular | B2 <sub>1</sub> | No sample |
| 750 - >1000 | MC/HC | Nil | 10YR 5/4 | Grey mottles | | - | Very firm, weakly pedal, massive | 4 | Poor | Base of horizon not encountered | B2 <sub>2</sub> | No sample |

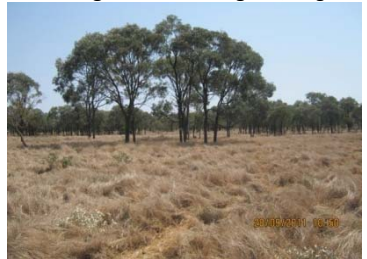
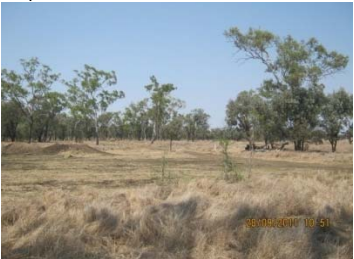
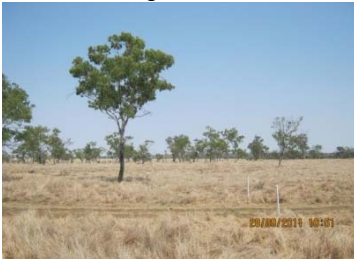
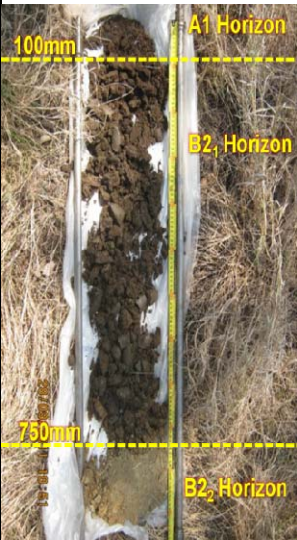
| <b>Project:</b> Wards Well | | <b>Date:</b> 28/9/2011 | | <b>Location:</b> 81 Observation Type: P | | | <b>Coordinates:</b> 0597444, 7625089 | | | | | |
|---|---|---|---|---|---|---|---|---|---|---|---|---|
| <b>Topography:</b> Flat former alluvial floodplain | | | <b>Surface Rock % (&gt; 60mm dia):</b> Nil | | <b>Erosion:</b> Nil | | | <b>Drainage:</b> Poor | | | | |
| <b>Remarks:</b> | | | | | <b>ASC Mapped:</b> Kandasol | | | <b>ASC Ground Truth:</b> Vertosol | | | | |
| 0-50 | MC | Nil | 10YR 3/3 | Nil | | Hard cracking | Firm, Weakly pedal, Massive | 3 | Good | Gradual | A1 <sub>1</sub> | No sample |
| 50-700 | MC | Nil | 10YR 3/2 | Ironstone | | - | Firm, Weakly pedal, Massive | 3 | Poor | Sharp | B2 <sub>1</sub> | No sample |
| 700- >1000 | SL | Nil | 10YR 4/3 | White, grey, orange mottles | | - | Very weak, Apedal | 1 | Good | Base of horizon not encountered | B2 <sub>2</sub> | No sample |

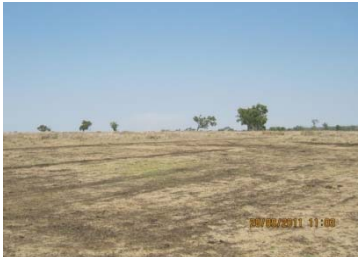
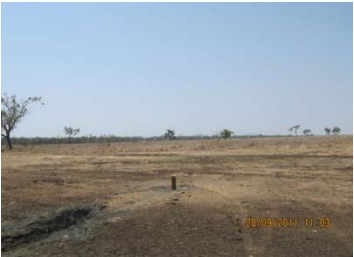
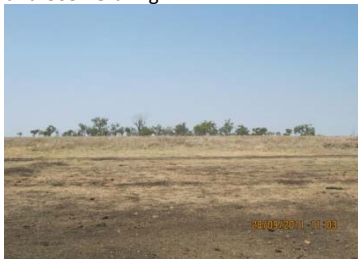
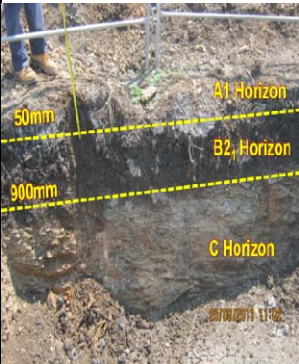
| <b>Project:</b> Wards Well | | <b>Date:</b> 28/9/2011 | | <b>Location:</b> 82 <b>Observation Type:</b> P | | | <b>Coordinates:</b> 0596439, 7624851 | | | | | |
|---|---|---|---|---|---|---|---|---|---|---|---|---|
| <b>Topography:</b> <1% | | <b>Surface Rock % (&gt; 60mm dia):</b> Nil | | <b>Erosion:</b> Nil | | | | <b>Drainage:</b> Poor | | | | |
| <b>Remarks:</b> | | | | <b>ASC Mapped:</b> Kandasol | | | | <b>ASC Ground Truth:</b> Vertosol | | | | |
| 0-50 | LC/MC | Nil | 10YR 2/2 | Nil | | Self mulching | Weak | 2 | Good | Gradual | A1 <sub>1p</sub> | No sample |
| 50-900 | MC | Nil | 10YR 3/3 | Ironstone | | - | Weak | 2 | Poor | Sharp | B2 <sub>1</sub> | No sample |
| 900-1000 | SC | Massive | 10YR 4/3 | White, grey, orange mottles | | - | Massive, Rock | 1 | Poor | Base of horizon not encountered | C | No sample |

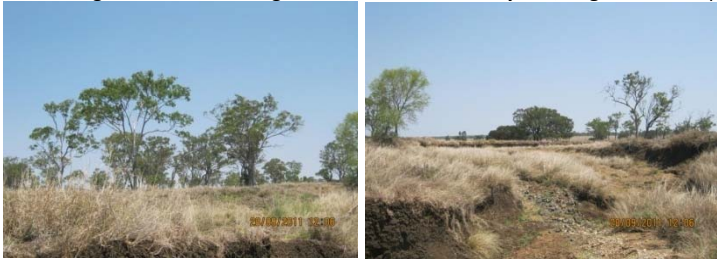
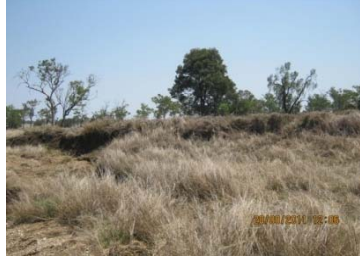
| <b>Project:</b> Wards Well | | <b>Date:</b> 28/9/2011 | | <b>Location:</b> 84 <b>Observation Type:</b> E | | | <b>Coordinates:</b> | | | | | |
|---|---|---|---|---|---|---|---|---|---|---|---|---|
| <b>Topography:</b> Low lying creek bed | | | <b>Surface Rock % (&gt; 60mm dia):</b> Nil | | <b>Erosion:</b> 20% | | | <b>Drainage:</b> Not recorded | | | | |
| <b>Remarks:</b> | | | | | <b>ASC Mapped:</b> Vertosol | | | <b>ASC Ground Truth:</b> Vertosol | | | | |

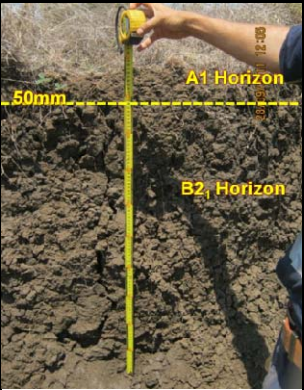
| <b>Project:</b> Wards Well | | <b>Date:</b> 28/9/2011 | | <b>Location:</b> 84 <b>Observation Type:</b> E | | | <b>Coordinates:</b> | | | | | |
|---|---|---|---|---|---|---|---|---|---|---|---|---|
| 0-50 | SC | 10% | 10YR 3/2 | Nil | | Self mulching | Weak, highly pedal, massive | 2 | Good | Sharp | A1 <sub>1p</sub> | No sample |
| 50 - >1000 | MC | Nil | 10YR 3/3 | Ironstone | | - | Very firm, highly pedal, massive | 4 | Poor | Base of horizon not encountered | B2 <sub>1</sub> | No sample |

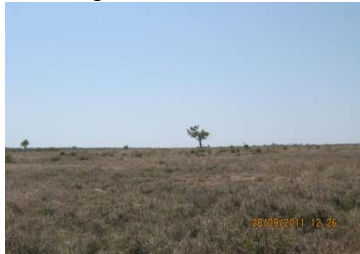
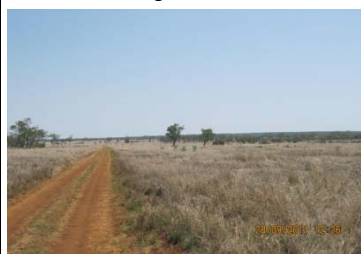
| <b>Project:</b> Wards Well | | <b>Date:</b> 28/9/2011 | | <b>Location:</b> 85 | | <b>Observation Type:</b> A | | <b>Coordinates:</b> 0597468, 7623012 | | | | |
|---|---|---|---|---|---|---|---|---|---|---|---|---|
| <b>Natural Vegetation:</b> Cleared. Buffel Grass, ironbark, Bohemia, Poplar Box | | | | | | | | <b>Land Use:</b> Grazing | | | | |
| <b>Topography:</b> 1% new top of range | | <b>Surface Rock % (&gt; 60mm dia):</b> Nil | | <b>Erosion:</b> 20% | | | | <b>Drainage:</b> Good | | | | |
| <b>Remarks:</b> | | | | <b>ASC Mapped:</b> Vertosol | | | | <b>ASC Ground Truth:</b> Brown Vertosol | | | | |

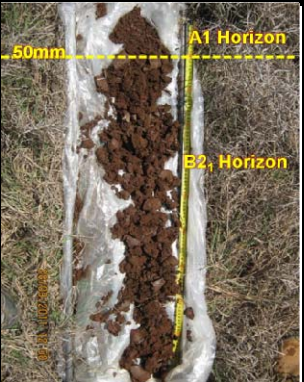
| <b>Project:</b> Wards Well | | <b>Date:</b> 28/9/2011 | | <b>Location:</b> 85 | | <b>Observation Type:</b> A | | <b>Coordinates:</b> 0597468, 7623012 | | | | |
|---|---|---|---|---|---|---|---|---|---|---|---|---|
| 0-50 | LC | Nil | 5YR 3/4 | Nil | | Self mulching | Firm, weakly pedal | 3 | Not recorded | Gradual | A1 <sub>1</sub> | No sample |
| 50 - >1000 | MC | Nil | 5YR 3/4 | Ironstone | | - | Weak, highly pedal | 2 | Not recorded | Base of horizon not encountered | B2 <sub>1</sub> | No sample |

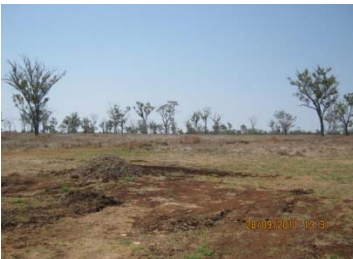
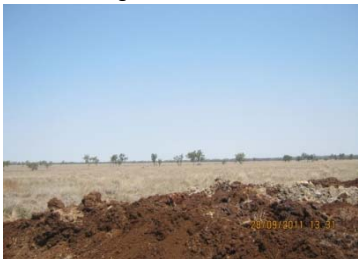
| <b>Project:</b> Wards Well | | <b>Date:</b> 28/9/2011 | | <b>Location:</b> 86 <b>Observation Type:</b> P | | | <b>Coordinates:</b> 0595998, 7622629 | | | | | |
|---|---|---|---|---|---|---|---|---|---|---|---|---|
| <b>Natural Vegetation:</b> Cleared Poplar Box | | | | | | | <b>Land Use:</b> Grazing | | | | | |
| <b>Topography:</b> 1-2% | | <b>Surface Rock % (&gt; 60mm dia):</b> Nil | | <b>Erosion:</b> Nil | | | | <b>Drainage:</b> Not recorded | | | | |
| <b>Remarks:</b> | | | | <b>ASC Mapped:</b> Vertosol | | | | <b>ASC Ground Truth:</b> Vertosol | | | | |

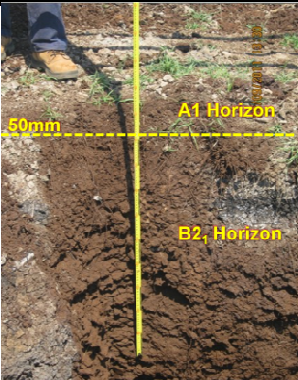
| <b>Project:</b> Wards Well | | <b>Date:</b> 28/9/2011 | | <b>Location:</b> 86 <b>Observation Type:</b> P | | | <b>Coordinates:</b> 0595998, 7622629 | | | | | |
|---|---|---|---|---|---|---|---|---|---|---|---|---|
| 0-50 | LC | Nil | 7.5YR 3/3 | Nil | | Hard cracking clay | Weak, strongly pedal | 2 | Not recorded | Gradual | A1 <sub>1p</sub> | No sample |
| 50 - >1000 | MC | 5-10% | 7.5YR 3/4 | Ironstone and orange/brown mottles | | - | Very firm, highly pedal | 4 | Not recorded | | B2 <sub>1</sub> | No sample |

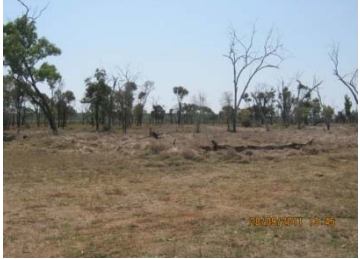
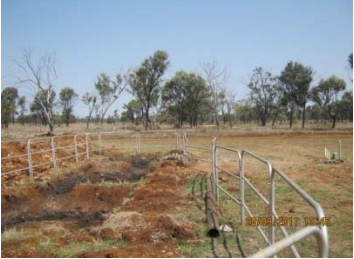
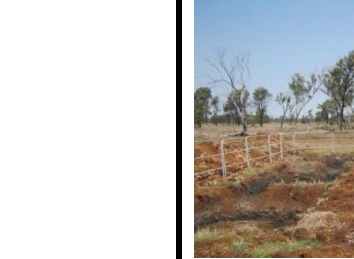
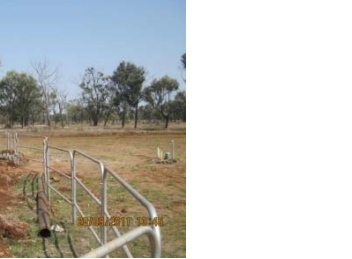
| <b>Project:</b> Wards Well | | <b>Date:</b> 28/9/2011 | | <b>Location:</b> 87 | | | <b>Observation Type:</b> P | | | <b>Coordinates:</b> 0595048, 7622481 | | |
|---|---|---|---|---|---|---|---|---|---|---|---|---|
| <b>Natural Vegetation:</b> Brigalow, Poplar Box (dead) | | | | | | | <b>Land Use:</b> Grazing | | | | | |
| <b>Topography:</b> <1% | | <b>Surface Rock % (&gt; 60mm dia):</b> Nil | | <b>Erosion:</b> Nil | | | <b>Drainage:</b> Not recorded | | | | | |
| <b>Remarks:</b> Dead trees | | | | <b>ASC Mapped:</b> Vertosol | | | <b>ASC Ground Truth:</b> Dermosol | | | | | |

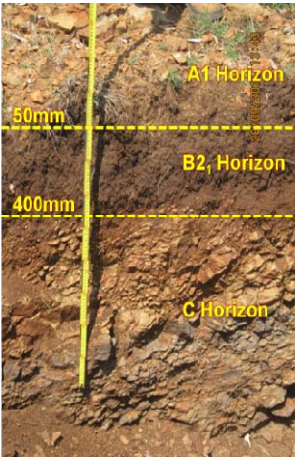
| <b>Project:</b> Wards Well | | <b>Date:</b> 28/9/2011 | | <b>Location:</b> 87 | | | <b>Observation Type:</b> P | | | <b>Coordinates:</b> 0595048, 7622481 | | |
|---|---|---|---|---|---|---|---|---|---|---|---|---|
| 0-20 | SC | 1% | 7.5YR 2.5/3 | White mottles | | Non-cracking clay | Very firm, massive | 4 | Good | Sharp | A <sub>1p</sub> | No sample |
| 20-400 | LC/MC | 0% | 7.5YR 3/3 | Ironstone | | - | Weak/firm | 2-3 | Poor | Sharp | B <sub>2</sub> <sub>1</sub> | No sample |
| 400 - >1000 | Rock | 100% | | Massive Rock | | - | Massive | 4 | Poor | Base of horizon not encountered | C | No sample |

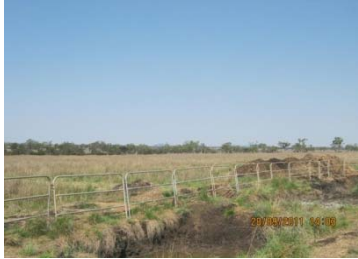
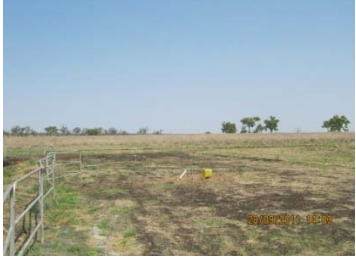
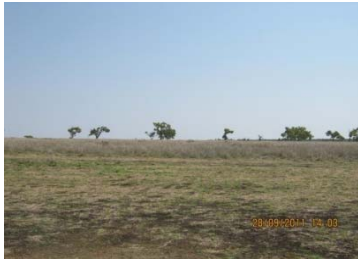
| <b>Project:</b> Wards Well | | <b>Date:</b> 28/9/2011 | | <b>Location:</b> 88 <b>Observation Type:</b> P | | | <b>Coordinates:</b> 0595737, 7623676 | | | | | |
|---|---|---|---|---|---|---|---|---|---|---|---|---|
| <b>Natural Vegetation:</b> Cleared | | | | | | | <b>Land Use:</b> Grazing | | | | | |
| <b>Topography:</b> | | <b>Surface Rock % (&gt; 60mm dia):</b> Nil | | <b>Erosion:</b> Nil | | | | <b>Drainage:</b> Not recorded | | | | |
| <b>Remarks:</b> | | | | <b>ASC Mapped:</b> Vertosol | | | | <b>ASC Ground Truth:</b> Dermosol | | | | |

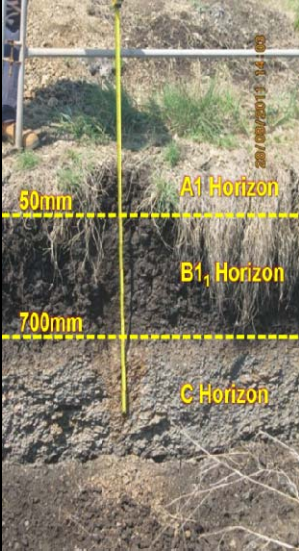
| <b>Project:</b> Wards Well | | <b>Date:</b> 28/9/2011 | | <b>Location:</b> 88 <b>Observation Type:</b> P | | | <b>Coordinates:</b> 0595737, 7623676 | | | | | |
|---|---|---|---|---|---|---|---|---|---|---|---|---|
| 0-50 | HC | 1% | 10YR 4/2 | Nil | | Very hard cracking clay | Very firm, highly pedal, massive | 4 | Good | Sharp | A <sub>1p</sub> | No sample |
| 50-700 | MC | 0% | 10YR 3/2 | White mottles | | | firm, highly pedal, massive | 3 | Poor | Sharp | B <sub>21</sub> | No sample |
| 700 - >1000 | Hard rock layer | 100% | Not recorded | Yellow/grey | | | Massive | 4 | Poor | Base of horizon not encountered | C | No sample |

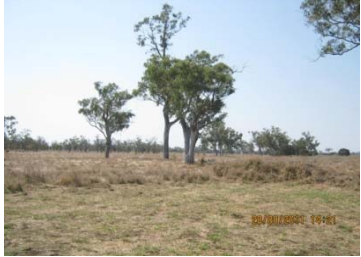
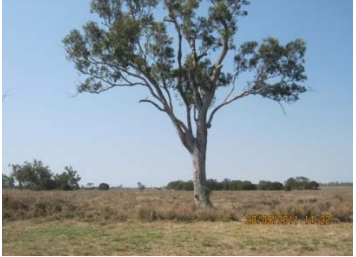
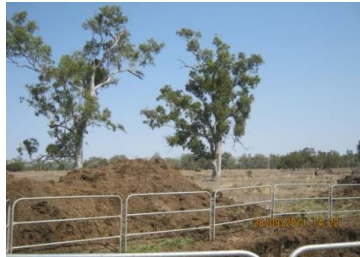
| <b>Project:</b> Wards Well | | <b>Date:</b> 28/9/2011 | | <b>Location:</b> 89 <b>Observation Type:</b> P | | | <b>Coordinates:</b> 0595582, 7620461 | | | | | |
|---|---|---|---|---|---|---|---|---|---|---|---|---|
| <b>Natural Vegetation:</b> Eucalypts | | | | | | | <b>Land Use:</b> Grazing | | | | | |
| <b>Topography:</b> <1% high area between creeks | | <b>Surface Rock % (&gt; 60mm dia):</b> Nil | | <b>Erosion:</b> Nil | | | <b>Drainage:</b> Not recorded | | | | | |
| <b>Remarks:</b> Between creeks | | | | <b>ASC Mapped:</b> Vertosol | | | <b>ASC Ground Truth:</b> Vertosol | | | | | |

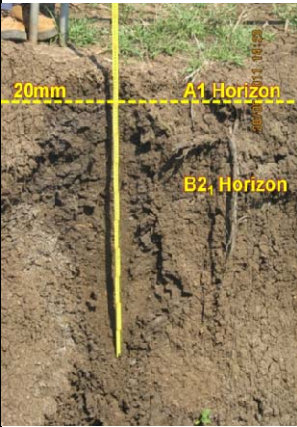
| <b>Project:</b> Wards Well | | <b>Date:</b> 28/9/2011 | | <b>Location:</b> 89 <b>Observation Type:</b> P | | | <b>Coordinates:</b> 0595582, 7620461 | | | | | |
|---|---|---|---|---|---|---|---|---|---|---|---|---|
| 0-20 | LC/MC | 1% | 10YR 3/3 | Nil | | Self mulching, roots | Firm/very firm, strongly pedal, massive | 3-4 | Good | Gradual | A1 <sub>1p</sub> | No sample |
| 20- >1000 | LC/MC | Nil | 10YR 4/3 | Grey mottles with roots and Ironstone | | - | Firm, strongly pedal, massive | 3 | Poor | Base of horizon not encountered | B2 <sub>1</sub> | No sample |

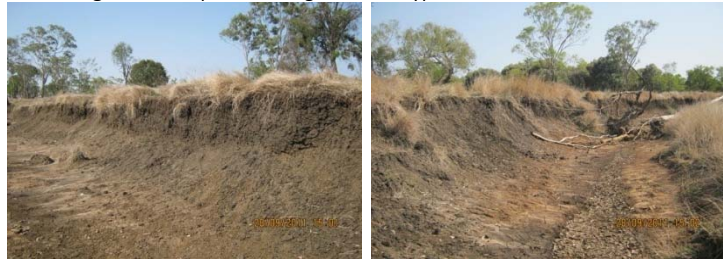
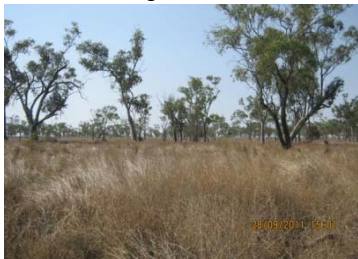
| <b>Project:</b> Wards Well | | <b>Date:</b> 28/9/2011 | | | <b>Location:</b> 91 | | | <b>Observation Type:</b> P | | | <b>Coordinates:</b> 0597501, 7620905 | | |
|---|---|---|---|---|---|---|---|---|---|---|---|---|---|
| <b>Natural Vegetation:</b> Poplar Box, brigalow, Eucalypts, Acacias | | | | | | | | <b>Land Use:</b> Grazing | | | | | |
| <b>Topography:</b> Creek bed | | | <b>Surface Rock % (&gt; 60mm dia):</b> Nil | | <b>Erosion:</b> 20-30% | | | <b>Drainage:</b> Not recorded | | | | | |
| <b>Remarks:</b> Dry creekbed | | | | | <b>ASC Mapped:</b> Vertosol | | | <b>ASC Ground Truth:</b> Vertosol | | | | | |

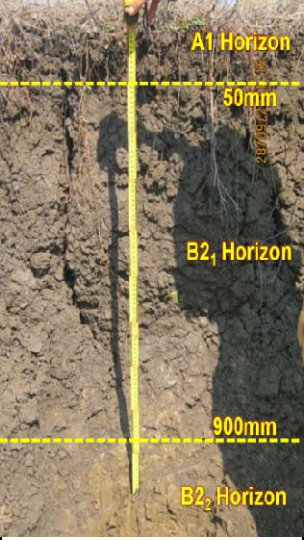
| <b>Project:</b> Wards Well | | <b>Date:</b> 28/9/2011 | | | <b>Location:</b> 91 | | | <b>Observation Type:</b> P | | | <b>Coordinates:</b> 0597501, 7620905 | | |
|---|---|---|---|---|---|---|---|---|---|---|---|---|---|
| 0-50 | LC | Nil | 10YR 4/2 | Nil | | Hard cracking clay | Firm, strongly pedal, massive | 3 | Well | Sharp | A <sub>1p</sub> | No sample | |
| 50-900 | LC/MC | Nil | 10YR 4/2 | Carbonate, Ironstone, brown maroon gravel | | | | Weak, strongly pedal, massive | 2 | Poor | Sharp | B <sub>2</sub> <sub>1</sub> | No sample |
| 900 - >1000 | MC | Nil | 10YR 4/3 | Grey gravel, carbonate | | | | Very weak/weak, strongly pedal, massive | 1-2 | | Base of horizon not encountered | B <sub>2</sub> <sub>1</sub> | No sample |

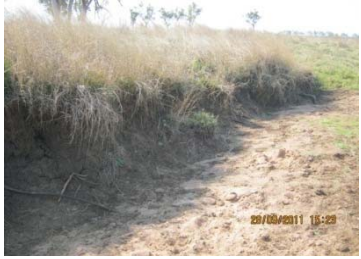
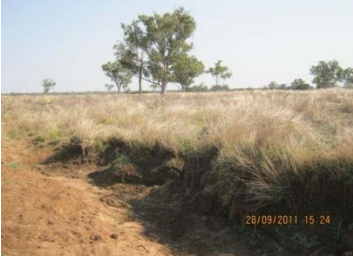
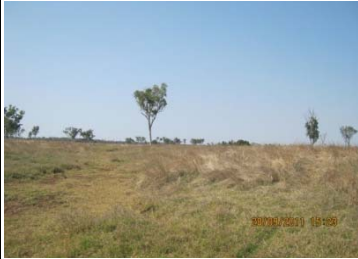
| <b>Project:</b> Wards Well | | <b>Date:</b> 28/9/2011 | | <b>Location:</b> 92 Observation Type: P | | | <b>Coordinates:</b> 0596076, 7621714 | | | | | |
|---|---|---|---|---|---|---|---|---|---|---|---|---|
| <b>Natural Vegetation:</b> Sparse Eucalypts | | | | | | | <b>Land Use:</b> Grazing | | | | | |
| <b>Topography:</b> Creek bank | | | <b>Surface Rock % (&gt; 60mm dia):</b> Nil | | <b>Erosion:</b> 10-20% | | | <b>Drainage:</b> | | | | |
| <b>Remarks:</b> Dry creekbed | | | | | <b>ASC Mapped:</b> Vertosol | | | <b>ASC Ground Truth:</b> Dermosol | | | | |

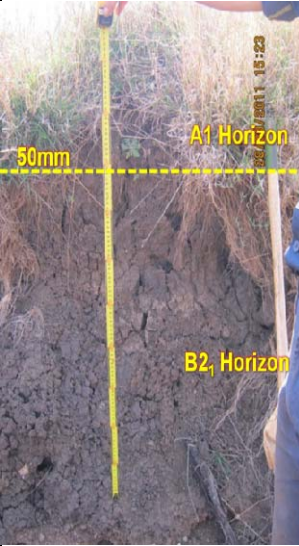
| <b>Project:</b> Wards Well | | <b>Date:</b> 28/9/2011 | | <b>Location:</b> 92 Observation Type: P | | | <b>Coordinates:</b> 0596076, 7621714 | | | | | |
|---|---|---|---|---|---|---|---|---|---|---|---|---|
| 0-50 | MC | Nil | 10YR 4/3 | Ironstone | | Self mulching | Very firm, strongly pedal, massive | 4 | Well | Sharp | A <sub>1</sub> | No sample |
| 50-1000 | MC | Nil | 10YR 3/3 | Carbonate | | - | Weak/firm, strongly pedal, massive | 2-3 | Poor | Sharp | B <sub>2</sub> | No sample |
| 1000-1050 | White rocks | 60/70% | 10YR 4/3 | Grey gravel, carbonate | | - | Weak, Massive | 3-4 | Not recorded | Base of horizon not encountered | C | No sample |

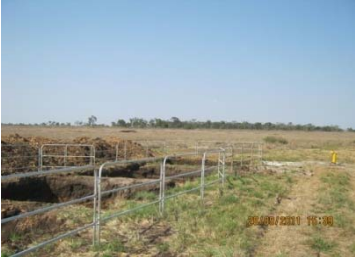
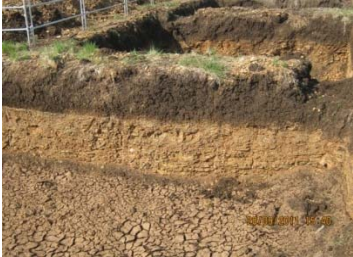
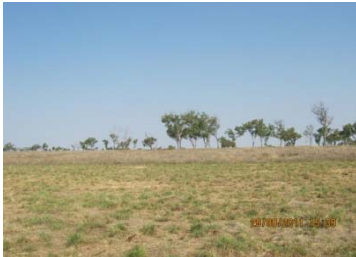
| <b>Project:</b> Wards Well | | <b>Date:</b> 28/9/2011 | | <b>Location:</b> 93 | | | <b>Observation Type:</b> | | | <b>Coordinates:</b> 598022, 7622167 | | |
|---|---|---|---|---|---|---|---|---|---|---|---|---|
| <b>Natural Vegetation:</b> vegetaion cleared, some Poplar box | | | | | | | <b>Land Use:</b> Grazing | | | | | |
| <b>Topography:</b> 1-2% | | <b>Surface Rock % (&gt; 60mm dia):</b> Nil | | <b>Erosion:</b> Nil | | | | <b>Drainage:</b> | | | | |
| <b>Remarks:</b> Dry creekbed | | | | <b>ASC Mapped:</b> Vertosol | | | | <b>ASC Ground Truth:</b> Vertosol | | | | |

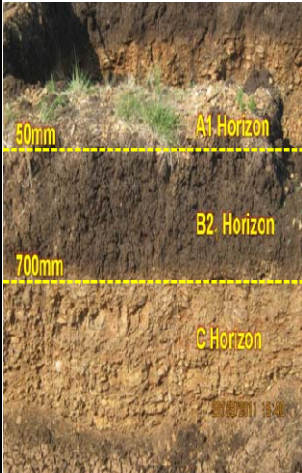
| <b>Project:</b> Wards Well | | <b>Date:</b> 28/9/2011 | | <b>Location:</b> 93 | | | <b>Observation Type:</b> | | | <b>Coordinates:</b> 598022, 7622167 | | |
|---|---|---|---|---|---|---|---|---|---|---|---|---|
| 0-50 | LC | Nil | 10YR 3/4 | Nil | | Self mulching | Weak/firm, strongly pedal, massive | 2 / 3 | Well | Sharp | A1 <sub>1p</sub> | No sample |
| 50-700 | MC | Nil | 10YR 3/3 | Orange gravel | | - | Weak, strongly pedal, massive | 2 | Poor | Sharp | B2 <sub>1</sub> | No sample |
| 700- >1000 | Rocks | 60/70% | 10YR 4/3 | | | - | Weak, Massive | 3 / 4 | None | Base of horizon not encountered | C | No sample |

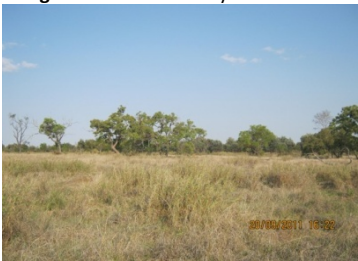
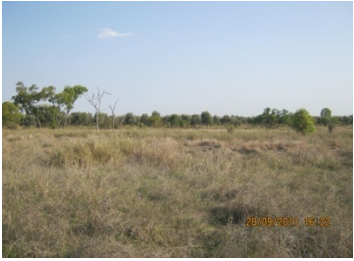
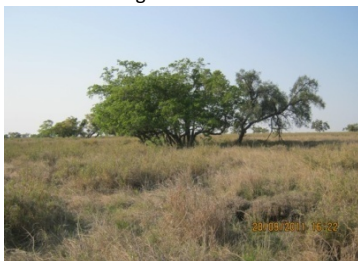
| <b>Project:</b> Wards Well | | <b>Date:</b> 28/9/2011 | | <b>Location:</b> 94 | | | <b>Observation Type:</b> A | | <b>Coordinates:</b> 0599580, 7622074 | | | | |
|---|---|---|---|---|---|---|---|---|---|---|---|---|---|
| <b>Natural Vegetation:</b> Morton Bay Ash | | | | | | | <b>Land Use:</b> Grazing | | | | | | |
| <b>Topography:</b> 1-2% | | | <b>Surface Rock % (&gt; 60mm dia):</b> Nil | | <b>Erosion:</b> Nil | | | | <b>Drainage:</b> | | | | |
| <b>Remarks:</b> Long grass up to 1.2m | | | | | <b>ASC Mapped:</b> Vertosol | | | | <b>ASC Ground Truth:</b> Vertosol | | | | |

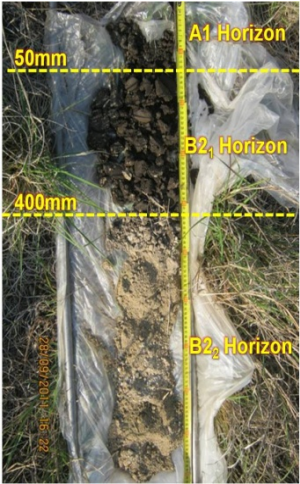
| <b>Project:</b> Wards Well | | <b>Date:</b> 28/9/2011 | | <b>Location:</b> 94 | | | <b>Observation Type:</b> A | | <b>Coordinates:</b> 0599580, 7622074 | | | | |
|---|---|---|---|---|---|---|---|---|---|---|---|---|---|
| 0-50 | LC | Nil | 10YR 3/2 | Nil | | Self mulching | Weak, strongly pedal | 2 | Good | Sharp | A <sub>1</sub> | 0-50 mm | |
| 50-400 | MC | Nil | 10YR 3/1 | Carbonate | | | | Very firm, strongly pedal | 4 | Poor | Sharp | B <sub>2</sub> <sub>1</sub> | 200-300 mm |
| 400->1000 | SL | Nil | 10YR 4/1 | Carbonate at 400mm | | | | Very weak, non pedal | 1 | Good | Base of horizon not encountered | B <sub>2</sub> <sub>2</sub> | 600-700 mm |

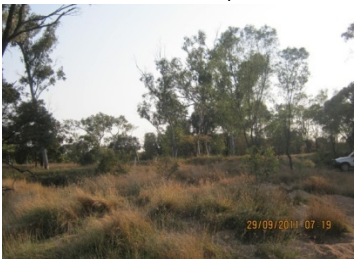
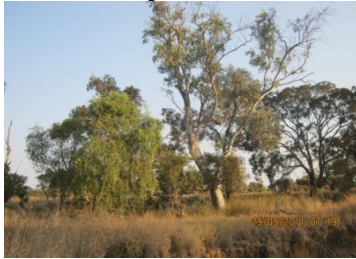
| <b>Project:</b> Wards Well | | <b>Date:</b> 29/9/2011 | | <b>Location:</b> 95 <b>Observation Type:</b> E | | | <b>Coordinates:</b> 0598841, 7620747 | | | | | |
|---|---|---|---|---|---|---|---|---|---|---|---|---|
| <b>Natural Vegetation:</b> Brigalow, Blue Gum, Buffel and Spear Grass, some Ironbark | | | | | | | <b>Land Use:</b> Grazing | | | | | |
| <b>Topography:</b> 1-2% in creek bed | | | <b>Surface Rock % (&gt; 60mm dia):</b> Nil | | <b>Erosion:</b> 20% | | | <b>Drainage:</b> Good | | | | |
| <b>Remarks:</b> In creek bed | | | | | <b>ASC Mapped:</b> Vertosol | | | <b>ASC Ground Truth:</b> Vertosol | | | | |

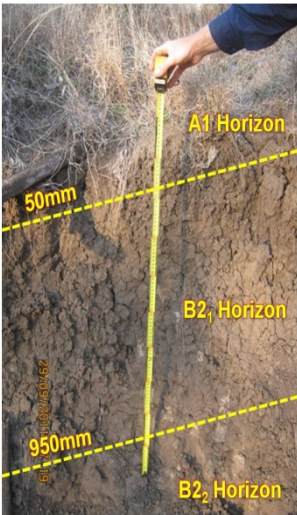
| <b>Project:</b> Wards Well | | <b>Date:</b> 29/9/2011 | | <b>Location:</b> 95 <b>Observation Type:</b> E | | | <b>Coordinates:</b> 0598841, 7620747 | | | | | |
|---|---|---|---|---|---|---|---|---|---|---|---|---|
| 0-50 | LC | Nil | 10YR 3/2 | Carbonate gravels | | Self mulching crust | Very firm, strongly pedal | 4 | Not recorded | Sharp | A <sub>1</sub> | No sample |
| 50-950 | LC | Nil | 10YR 3/3 | Carbonate gravels | | - | Very firm, strongly pedal | 4 | Not recorded | Gradual | B <sub>2</sub> <sub>1</sub> | No sample |
| 950- >1000 | MC | Nil | 10YR 4/2 | Ironstone gravels | | - | Firm, strongly pedal | 3 | Not recorded | Base of horizon not encountered | B <sub>2</sub> <sub>2</sub> | No sample |

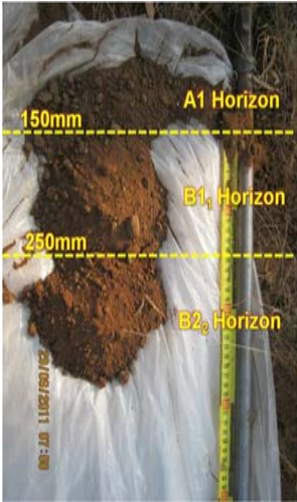
| <b>Project:</b> Wards Well | | <b>Date:</b> 29/9/2011 | | <b>Location:</b> 96 | | | <b>Observation Type:</b> E | | | <b>Coordinates:</b> 0596817, 7620084 | | | |
|---|---|---|---|---|---|---|---|---|---|---|---|---|---|
| <b>Remarks:</b> Located on rocky ridge, auger hit hard rock twice | | | | | <b>ASC Mapped:</b> Vertosol | | | <b>ASC Ground Truth:</b> Kandosol | | | | | |
| 0-150 | SL | 50% | 7.5YR 3/4 | Black and yellow gravels | | Hard packed gravel | Very weak, non pedal | 1 | Good | Sharp | A <sub>1</sub> | No sample | |
| 150-250 | SI | 50% | 5YR 4/4 | Ironstone gravel | | | Very weak, non pedal | 1 | Good | Sharp | B <sub>2</sub> | No sample | |
| 250+ | Rock | | | | | | | | | Poor | | B <sub>2</sub> | No sample |

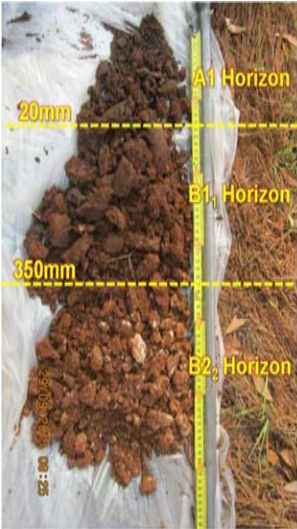
| <b>Project:</b> Wards Well | | <b>Date:</b> 29/9/2011 | | <b>Location:</b> 97 <b>Observation Type:</b> A | | | <b>Coordinates:</b> 0596317, 7619984 | | | | | |
|---|---|---|---|---|---|---|---|---|---|---|---|---|
| 0-20 | LC-MC | Nil | 5YR 3/4 | Nil | | Firm cracking surface | Very firm, strongly pedal, massive | 4 | Good | Sharp | A <sub>1</sub> | No sample |
| 20-350 | MC | Nil | 5YR 4/6 | Ironstone & carbonate gravels | | - | Weak/firm, strongly pedal | 2-3 | Poor | Sharp | B <sub>2</sub> <sub>1</sub> | No sample |
| 350-600 | Sandy clay | 70% | 5YR 4/6 | Carbonate | | - | Very weak, weakly pedal | 1 | Good | Base of horizon not encountered | B <sub>2</sub> <sub>2</sub> | No sample |

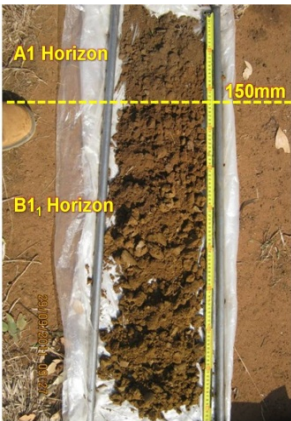
| <b>Project:</b> Wards Well | | <b>Date:</b> 29/9/2011 | | <b>Location:</b> 98 <b>Observation Type:</b> A | | | <b>Coordinates:</b> 0599337, 7620288 | | | | | |
|---|---|---|---|---|---|---|---|---|---|---|---|---|
| 0-150 | SL | Nil | 10YR 4/3 | Nil | | Sandy firm | Very weak, weakly pedal | 1 | Good | Sharp | A1 <sub>1</sub> | No sample |
| 150- >1000 | LC | Nil | 7.5YR 5/6 | Ironstone & orange gravels | | - | Fine, strongly pedal, massive | 3 | Poor | Base of horizon not encountered | B2 <sub>1</sub> | No sample |

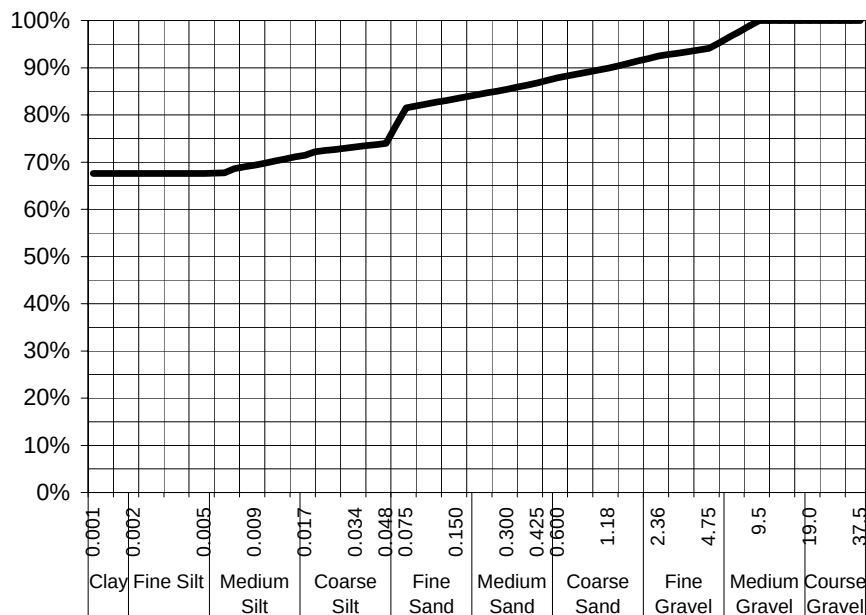
## Particle Size Distribution

**CLIENT:** Timothy Rohde **DATE REPORTED:** 26-Oct-2011  
**COMPANY:** Sinclair Knight Merz **DATE RECEIVED:** 17-Oct-2011  
**ADDRESS:** P O Box 312 Flinders Lane **REPORT NO:** EB1121537-002 / PSD  
Melbourne, Vic Australia 8009  
**PROJECT:** QEO9811 400 Wards Well - **SAMPLE ID:** WW6 20-30  
Land Resources

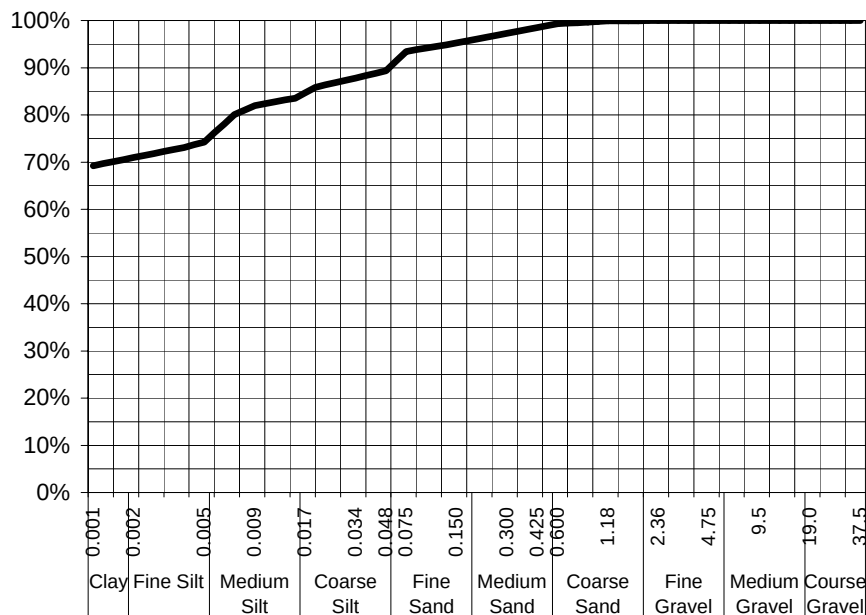
## Particle Size Distribution

**CLIENT:** Timothy Rohde **DATE REPORTED:** 26-Oct-2011  
**COMPANY:** Sinclair Knight Merz **DATE RECEIVED:** 17-Oct-2011  
**ADDRESS:** P O Box 312 Flinders Lane **REPORT NO:** EB1121537-006 / PSD  
Melbourne, Vic Australia 8009  
**PROJECT:** QEO9811 400 Wards Well - **SAMPLE ID:** WW9 800-900  
Land Resources

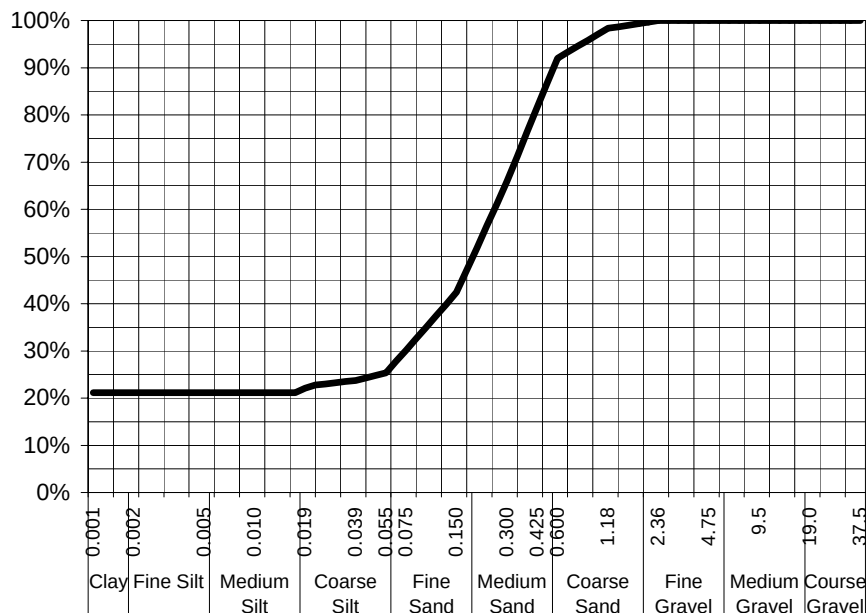
## Particle Size Distribution

**CLIENT:** Timothy Rohde **DATE REPORTED:** 26-Oct-2011  
**COMPANY:** Sinclair Knight Merz **DATE RECEIVED:** 17-Oct-2011  
**ADDRESS:** P O Box 312 Flinders Lane **REPORT NO:** EB1121537-007 / PSD  
Melbourne, Vic Australia 8009  
**PROJECT:** QEO9811 400 Wards Well - **SAMPLE ID:** WW10 0-100  
Land Resources

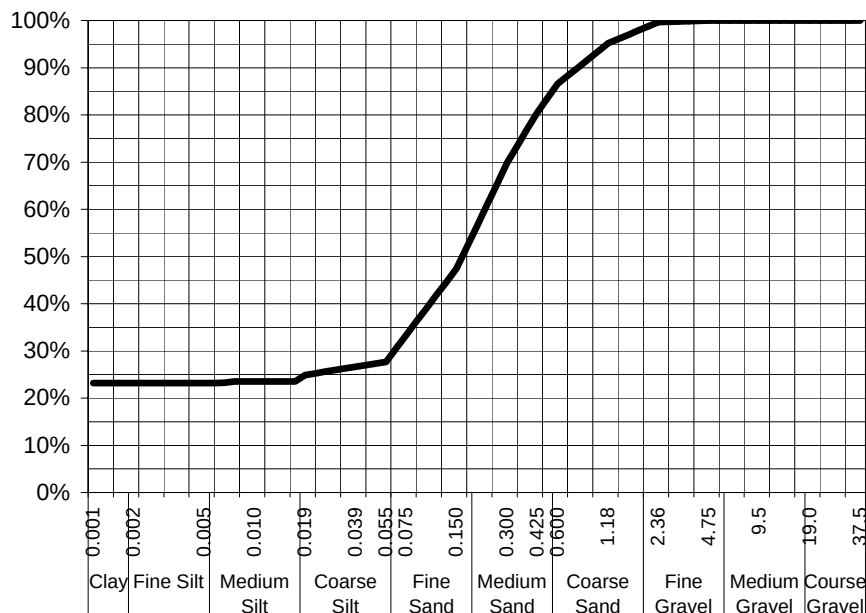
## Particle Size Distribution

**CLIENT:** Timothy Rohde **DATE REPORTED:** 26-Oct-2011  
**COMPANY:** Sinclair Knight Merz **DATE RECEIVED:** 17-Oct-2011  
**ADDRESS:** P O Box 312 Flinders Lane **REPORT NO:** EB1121537-009 / PSD  
Melbourne, Vic Australia 8009  
**PROJECT:** QEO9811 400 Wards Well - **SAMPLE ID:** WW13 1000-1100  
Land Resources

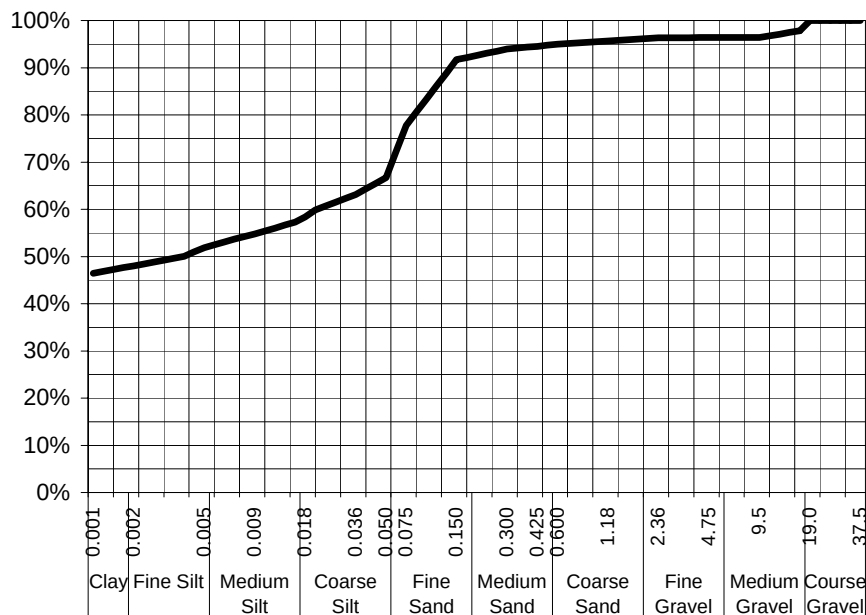
## Particle Size Distribution

**CLIENT:** Timothy Rohde **DATE REPORTED:** 26-Oct-2011  
**COMPANY:** Sinclair Knight Merz **DATE RECEIVED:** 17-Oct-2011  
**ADDRESS:** P O Box 312 Flinders Lane **REPORT NO:** EB1121537-010 / PSD  
Melbourne, Vic Australia 8009  
**PROJECT:** QEO9811 400 Wards Well - **SAMPLE ID:** WW13 0-50  
Land Resources

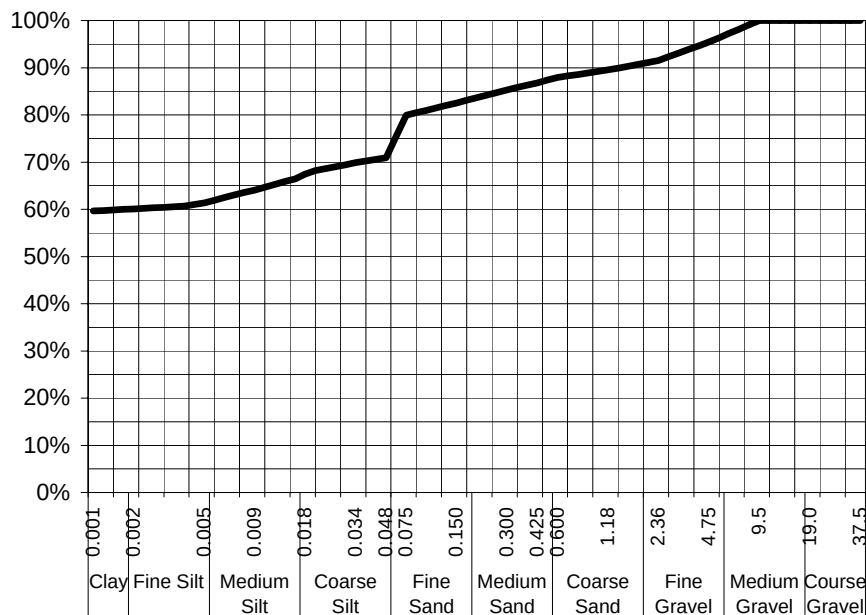
## Particle Size Distribution

**CLIENT:** Timothy Rohde **DATE REPORTED:** 26-Oct-2011  
**COMPANY:** Sinclair Knight Merz **DATE RECEIVED:** 17-Oct-2011  
**ADDRESS:** P O Box 312 Flinders Lane **REPORT NO:** EB1121537-012 / PSD  
Melbourne, Vic Australia 8009  
**PROJECT:** QEO9811 400 Wards Well - **SAMPLE ID:** WW13 70-80  
Land Resources

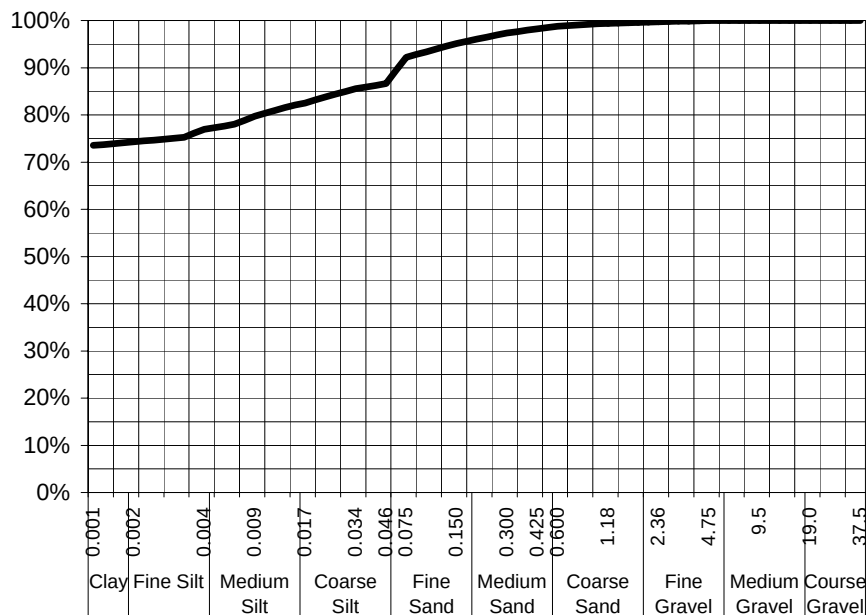
## Particle Size Distribution

**CLIENT:** Timothy Rohde **DATE REPORTED:** 26-Oct-2011  
**COMPANY:** Sinclair Knight Merz **DATE RECEIVED:** 17-Oct-2011  
**ADDRESS:** P O Box 312 Flinders Lane **REPORT NO:** EB1121537-013 / PSD  
Melbourne, Vic Australia 8009  
**PROJECT:** QEO9811 400 Wards Well - **SAMPLE ID:** WW15 0-10  
Land Resources

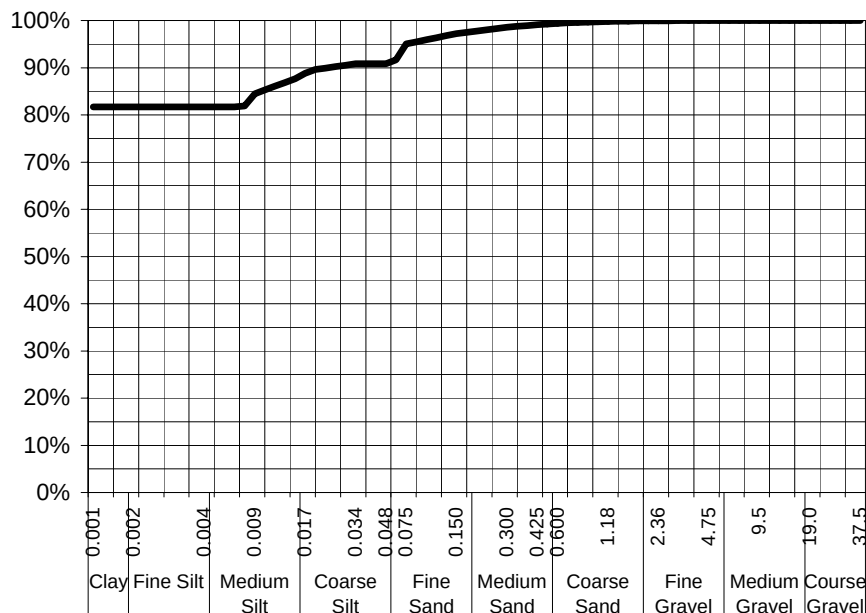
## Particle Size Distribution

**CLIENT:** Timothy Rohde **DATE REPORTED:** 26-Oct-2011  
**COMPANY:** Sinclair Knight Merz **DATE RECEIVED:** 17-Oct-2011  
**ADDRESS:** P O Box 312 Flinders Lane **REPORT NO:** EB1121537-015 / PSD  
Melbourne, Vic Australia 8009  
**PROJECT:** QEO9811 400 Wards Well - **SAMPLE ID:** WW15 90-100  
Land Resources

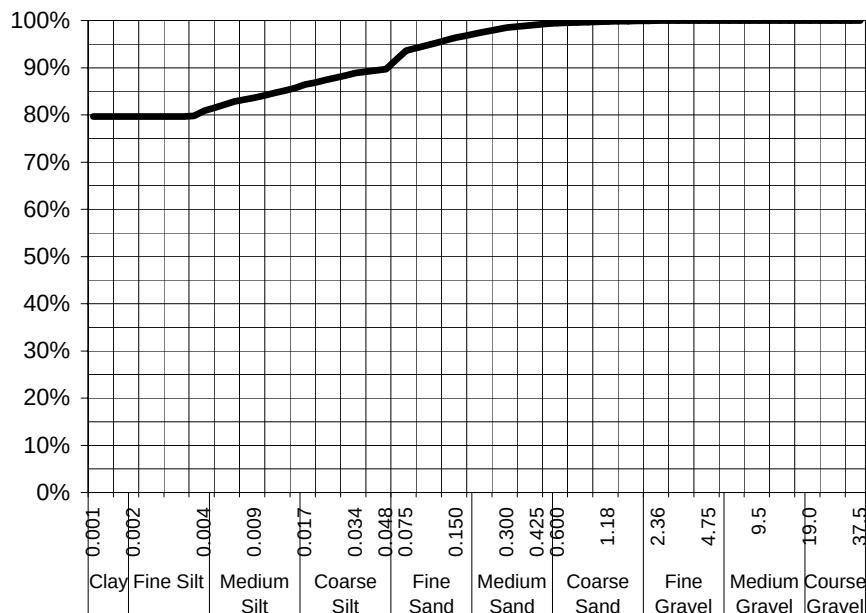
## Particle Size Distribution

**CLIENT:** Timothy Rohde **DATE REPORTED:** 26-Oct-2011  
**COMPANY:** Sinclair Knight Merz **DATE RECEIVED:** 17-Oct-2011  
**ADDRESS:** P O Box 312 Flinders Lane **REPORT NO:** EB1121537-016 / PSD  
Melbourne, Vic Australia 8009  
**PROJECT:** QEO9811 400 Wards Well - **SAMPLE ID:** WW22 0-100  
Land Resources
