# Progressive Rehabilitation and Closure Plan

## Wards Well Mine

| <b>Document title</b> | Progressive Rehabilitation and Closure Plan |
| <b>Version number</b> | V3.0 |

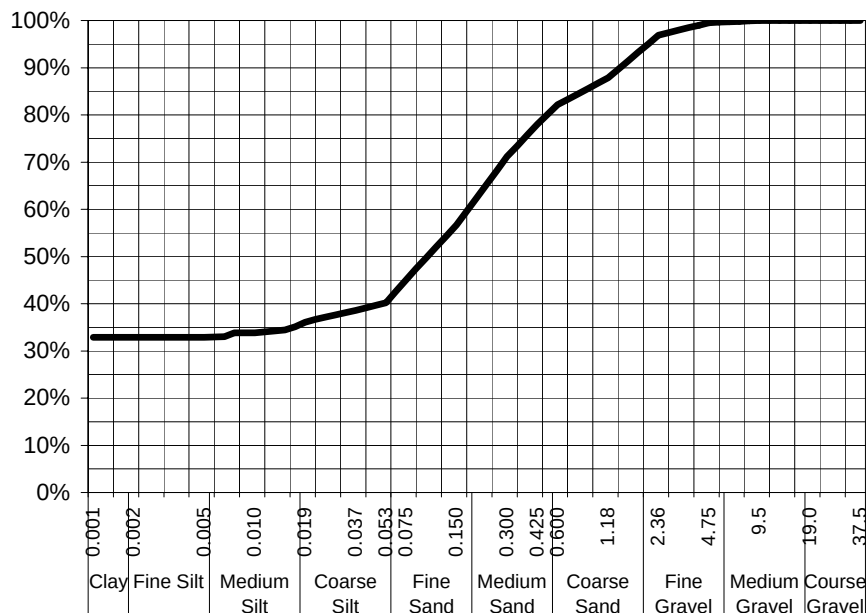
## Particle Size Distribution

**CLIENT:** Timothy Rohde **DATE REPORTED:** 26-Oct-2011  
**COMPANY:** Sinclair Knight Merz **DATE RECEIVED:** 17-Oct-2011  
**ADDRESS:** P O Box 312 Flinders Lane **REPORT NO:** EB1121537-020 / PSD  
Melbourne, Vic Australia 8009  
**PROJECT:** QEO9811 400 Wards Well - **SAMPLE ID:** WW23 300-400  
Land Resources

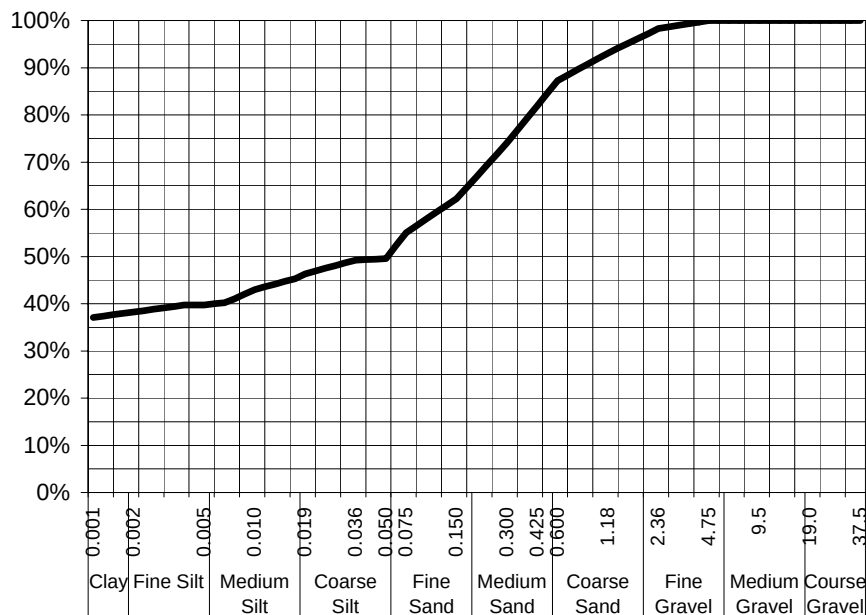
## Particle Size Distribution

**CLIENT:** Timothy Rohde **DATE REPORTED:** 26-Oct-2011  
**COMPANY:** Sinclair Knight Merz **DATE RECEIVED:** 17-Oct-2011  
**ADDRESS:** P O Box 312 Flinders Lane **REPORT NO:** EB1121537-022 / PSD  
Melbourne, Vic Australia 8009  
**PROJECT:** QEO9811 400 Wards Well - **SAMPLE ID:** WW28 0-100  
Land Resources

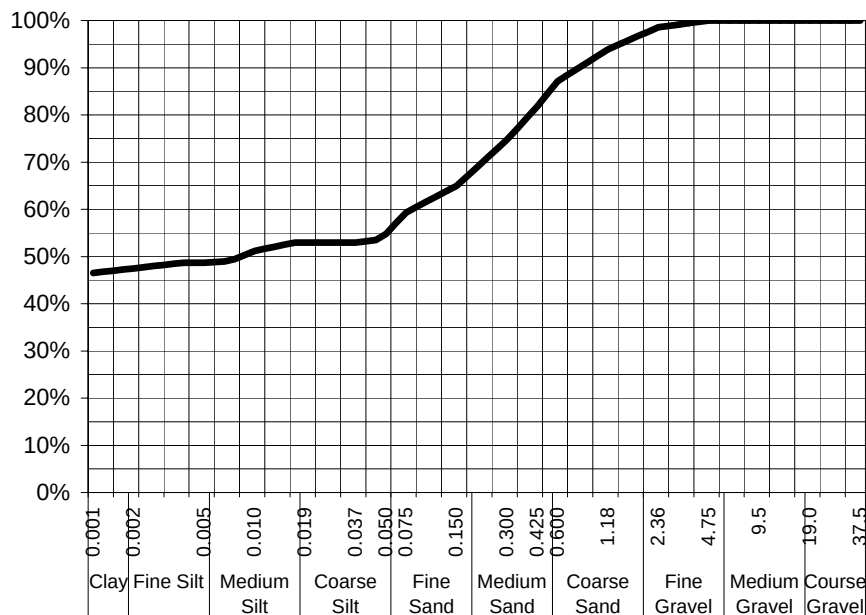
## Particle Size Distribution

**CLIENT:** Timothy Rohde **DATE REPORTED:** 26-Oct-2011  
**COMPANY:** Sinclair Knight Merz **DATE RECEIVED:** 17-Oct-2011  
**ADDRESS:** P O Box 312 Flinders Lane **REPORT NO:** EB1121537-024 / PSD  
Melbourne, Vic Australia 8009  
**PROJECT:** QEO9811 400 Wards Well - **SAMPLE ID:** WW28 700-800  
Land Resources

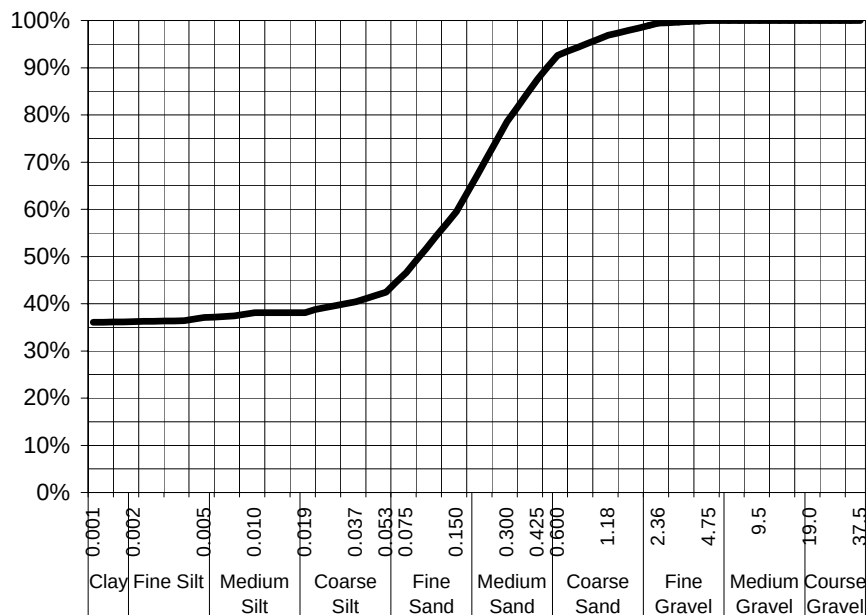
## Particle Size Distribution

**CLIENT:** Timothy Rohde **DATE REPORTED:** 26-Oct-2011  
**COMPANY:** Sinclair Knight Merz **DATE RECEIVED:** 17-Oct-2011  
**ADDRESS:** P O Box 312 Flinders Lane **REPORT NO:** EB1121537-025 / PSD  
Melbourne, Vic Australia 8009  
**PROJECT:** QEO9811 400 Wards Well - **SAMPLE ID:** WW36 0-100  
Land Resources

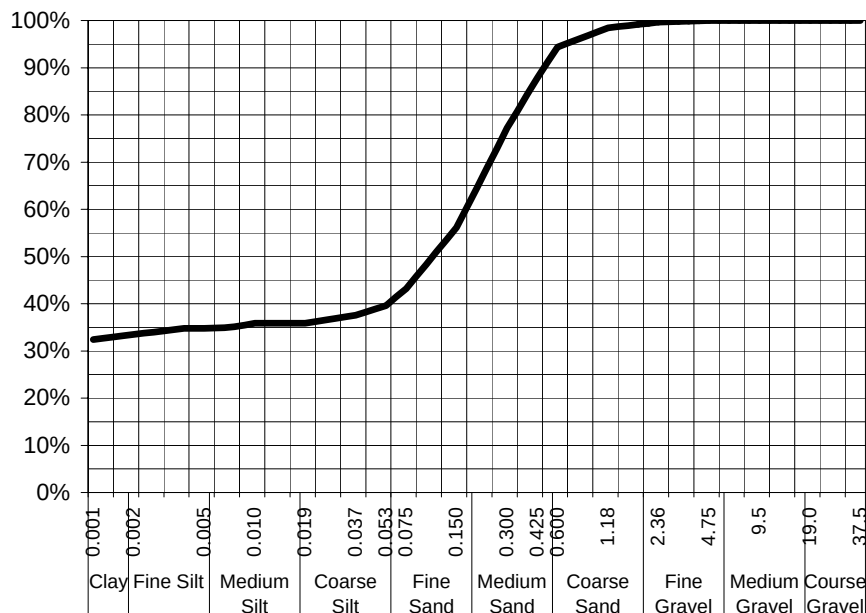
## Particle Size Distribution

**CLIENT:** Timothy Rohde **DATE REPORTED:** 26-Oct-2011  
**COMPANY:** Sinclair Knight Merz **DATE RECEIVED:** 17-Oct-2011  
**ADDRESS:** P O Box 312 Flinders Lane **REPORT NO:** EB1121537-027 / PSD  
Melbourne, Vic Australia 8009  
**PROJECT:** QEO9811 400 Wards Well - **SAMPLE ID:** WW36 700-800  
Land Resources

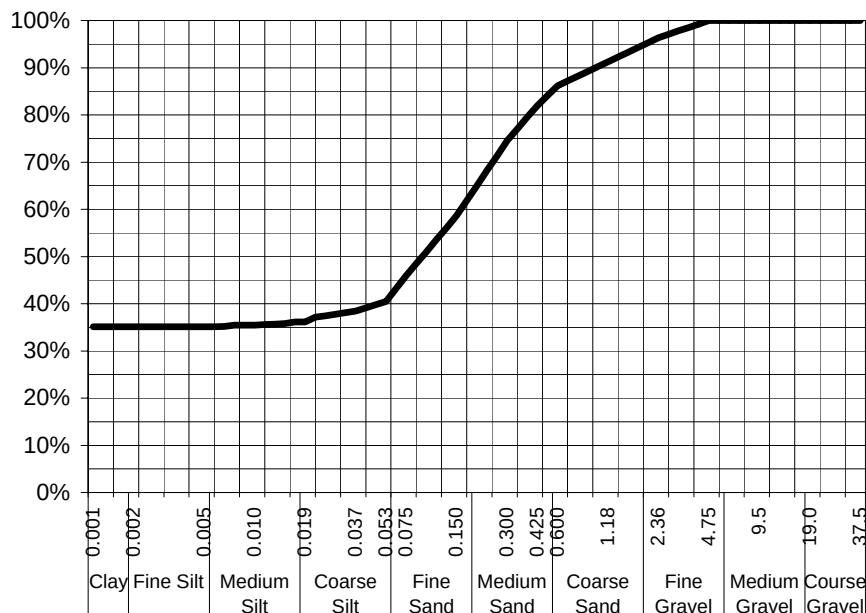
## Particle Size Distribution

**CLIENT:** Timothy Rohde **DATE REPORTED:** 26-Oct-2011  
**COMPANY:** Sinclair Knight Merz **DATE RECEIVED:** 17-Oct-2011  
**ADDRESS:** P O Box 312 Flinders Lane **REPORT NO:** EB1121537-029 / PSD  
Melbourne, Vic Australia 8009  
**PROJECT:** QEO9811 400 Wards Well - **SAMPLE ID:** WW38 500-600  
Land Resources

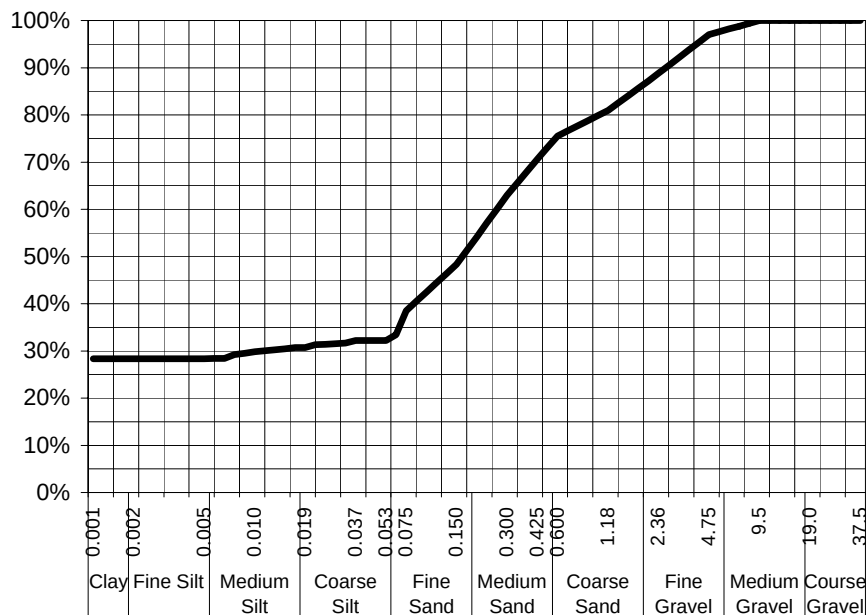
## Particle Size Distribution

**CLIENT:** Timothy Rohde **DATE REPORTED:** 26-Oct-2011  
**COMPANY:** Sinclair Knight Merz **DATE RECEIVED:** 17-Oct-2011  
**ADDRESS:** P O Box 312 Flinders Lane **REPORT NO:** EB1121537-030 / PSD  
Melbourne, Vic Australia 8009  
**PROJECT:** QEO9811 400 Wards Well - **SAMPLE ID:** WW44 0-100  
Land Resources

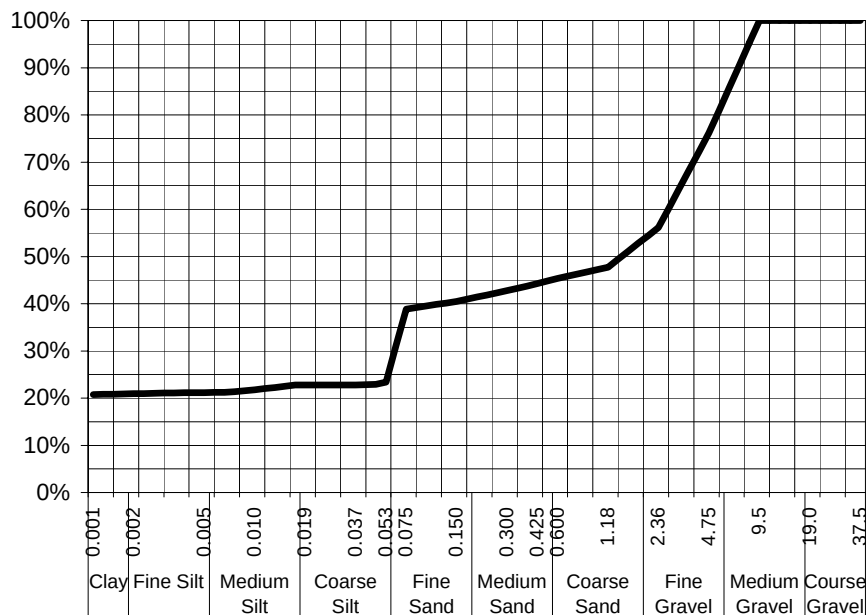
## Particle Size Distribution

**CLIENT:** Timothy Rohde **DATE REPORTED:** 26-Oct-2011  
**COMPANY:** Sinclair Knight Merz **DATE RECEIVED:** 17-Oct-2011  
**ADDRESS:** P O Box 312 Flinders Lane **REPORT NO:** EB1121537-032 / PSD  
Melbourne, Vic Australia 8009  
**PROJECT:** QEO9811 400 Wards Well - **SAMPLE ID:** WW44 500-600  
Land Resources

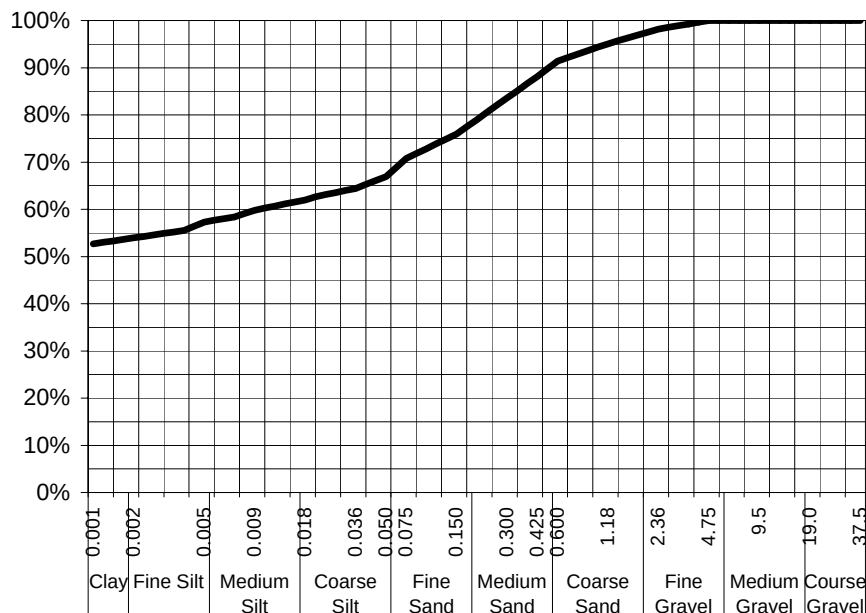
## Particle Size Distribution

**CLIENT:** Timothy Rohde **DATE REPORTED:** 26-Oct-2011  
**COMPANY:** Sinclair Knight Merz **DATE RECEIVED:** 17-Oct-2011  
**ADDRESS:** P O Box 312 Flinders Lane **REPORT NO:** EB1121537-033 / PSD  
Melbourne, Vic Australia 8009  
**PROJECT:** QEO9811 400 Wards Well - **SAMPLE ID:** WW47 0-100  
Land Resources

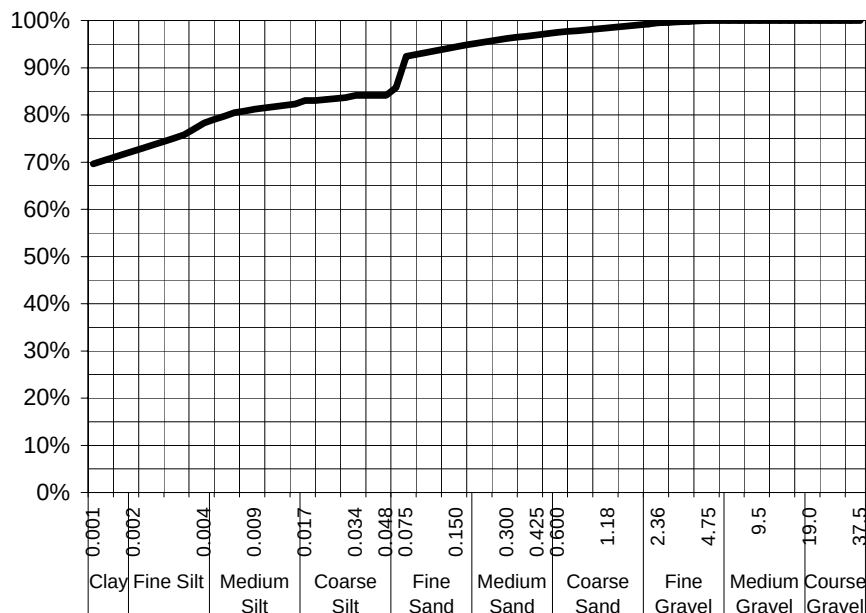
## Particle Size Distribution

**CLIENT:** Timothy Rohde **DATE REPORTED:** 26-Oct-2011  
**COMPANY:** Sinclair Knight Merz **DATE RECEIVED:** 17-Oct-2011  
**ADDRESS:** P O Box 312 Flinders Lane **REPORT NO:** EB1121537-035 / PSD  
Melbourne, Vic Australia 8009  
**PROJECT:** QEO9811 400 Wards Well - **SAMPLE ID:** WW60 0-20  
Land Resources

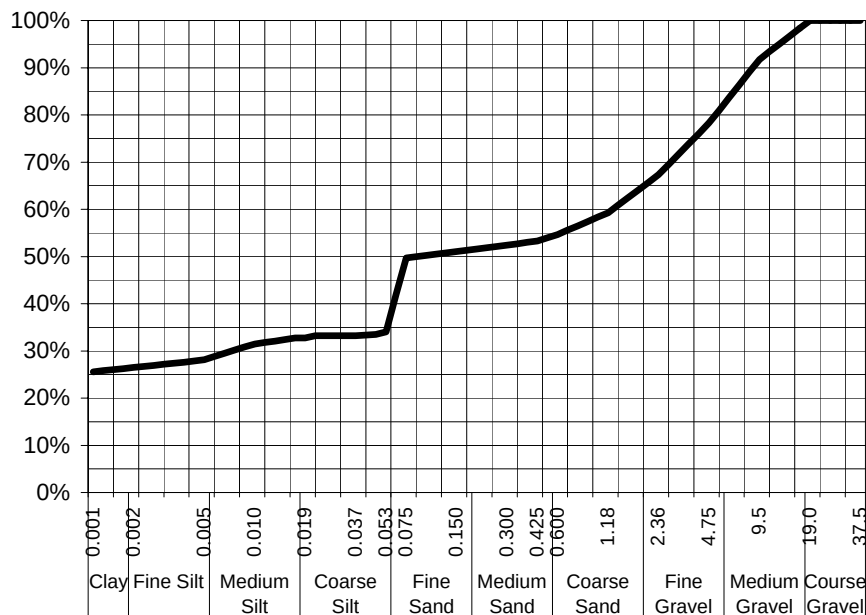
## Particle Size Distribution

**CLIENT:** Timothy Rohde **DATE REPORTED:** 26-Oct-2011  
**COMPANY:** Sinclair Knight Merz **DATE RECEIVED:** 17-Oct-2011  
**ADDRESS:** P O Box 312 Flinders Lane **REPORT NO:** EB1121537-037 / PSD  
Melbourne, Vic Australia 8009  
**PROJECT:** QEO9811 400 Wards Well - **SAMPLE ID:** WW60 700-800  
Land Resources

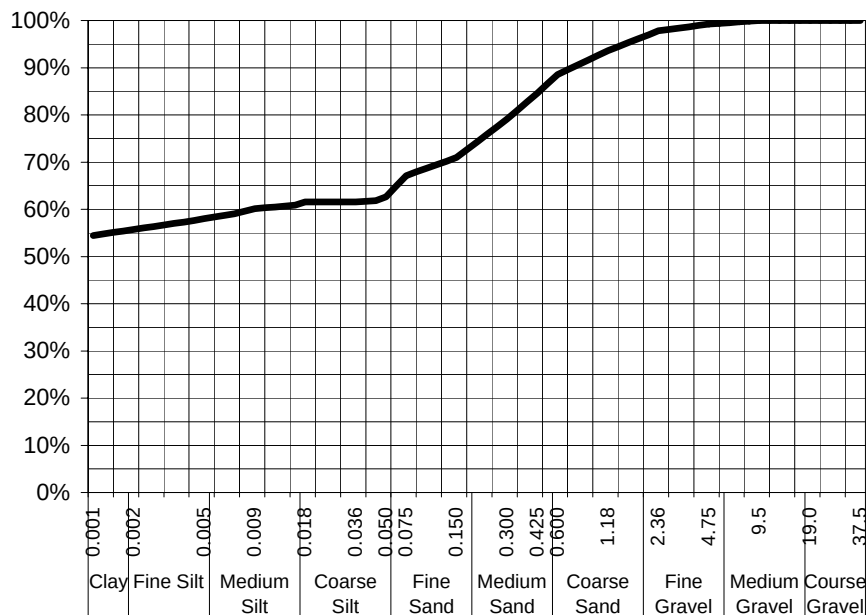
## Particle Size Distribution

**CLIENT:** Timothy Rohde **DATE REPORTED:** 26-Oct-2011  
**COMPANY:** Sinclair Knight Merz **DATE RECEIVED:** 17-Oct-2011  
**ADDRESS:** P O Box 312 Flinders Lane **REPORT NO:** EB1121537-039 / PSD  
Melbourne, Vic Australia 8009  
**PROJECT:** QEO9811 400 Wards Well - **SAMPLE ID:** WW69 200-300  
Land Resources

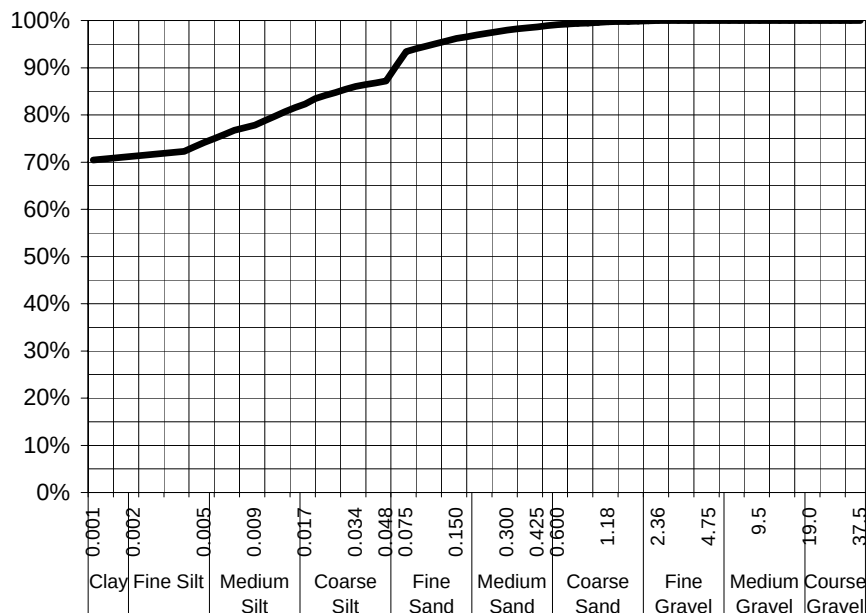
## Particle Size Distribution

**CLIENT:** Timothy Rohde **DATE REPORTED:** 26-Oct-2011  
**COMPANY:** Sinclair Knight Merz **DATE RECEIVED:** 17-Oct-2011  
**ADDRESS:** P O Box 312 Flinders Lane **REPORT NO:** EB1121537-041 / PSD  
Melbourne, Vic Australia 8009  
**PROJECT:** QEO9811 400 Wards Well - **SAMPLE ID:** WW75 0-50  
Land Resources

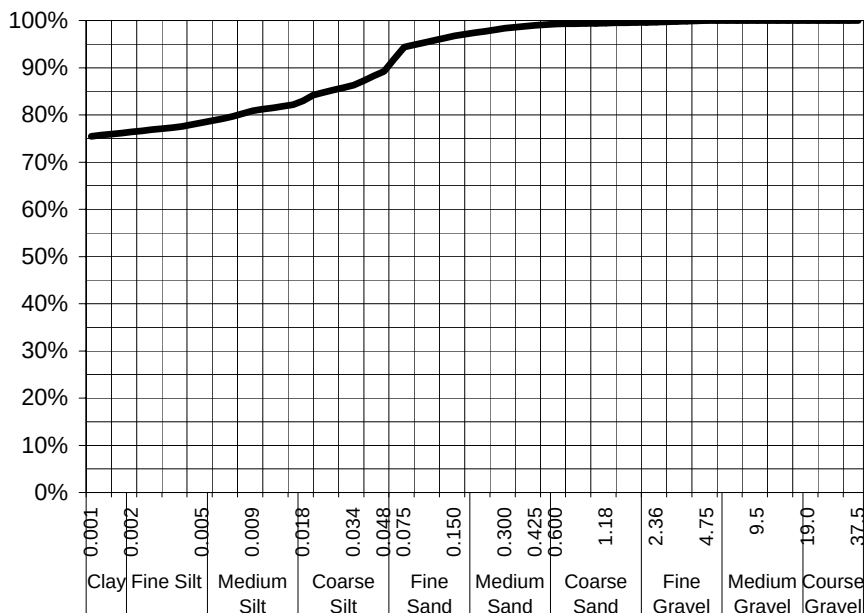
## Particle Size Distribution

**CLIENT:** Timothy Rohde **DATE REPORTED:** 26-Oct-2011  
**COMPANY:** Sinclair Knight Merz **DATE RECEIVED:** 17-Oct-2011  
**ADDRESS:** P O Box 312 Flinders Lane **REPORT NO:** EB1121537-042 / PSD  
Melbourne, Vic Australia 8009  
**PROJECT:** QEO9811 400 Wards Well - **SAMPLE ID:** WW75 400-500  
Land Resources

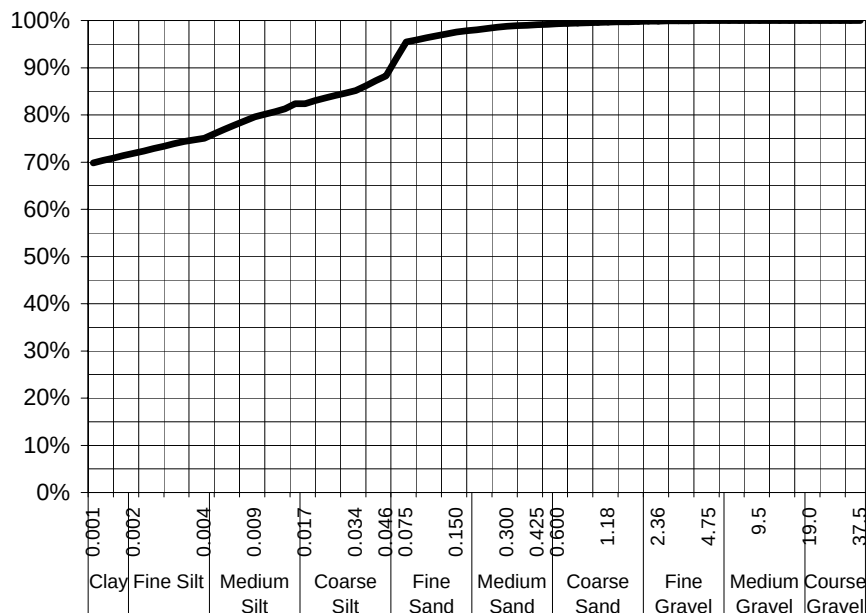
## Particle Size Distribution

**CLIENT:** Timothy Rohde **DATE REPORTED:** 26-Oct-2011  
**COMPANY:** Sinclair Knight Merz **DATE RECEIVED:** 17-Oct-2011  
**ADDRESS:** P O Box 312 Flinders Lane **REPORT NO:** EB1121537-044 / PSD  
Melbourne, Vic Australia 8009  
**PROJECT:** QEO9811 400 Wards Well - **SAMPLE ID:** WW94 0-50  
Land Resources

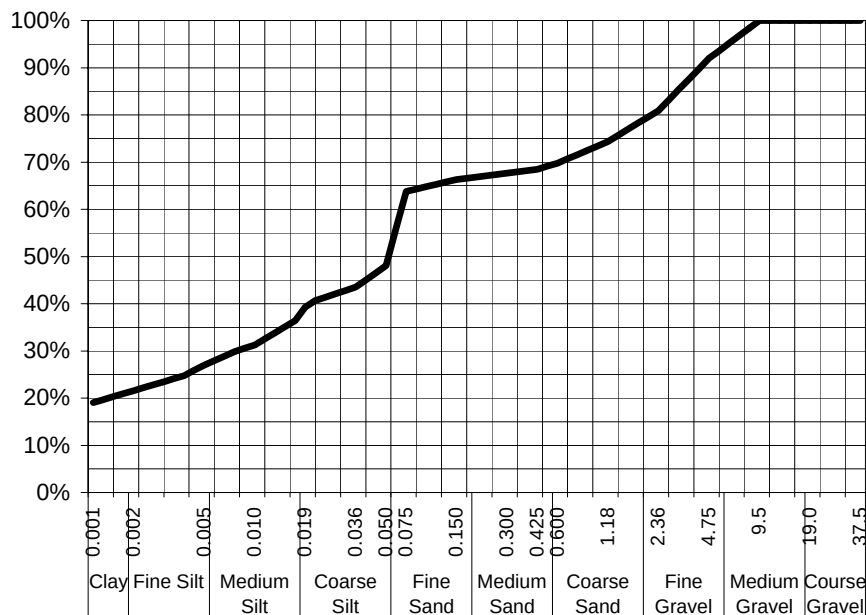
## Particle Size Distribution

**CLIENT:** Timothy Rohde **DATE REPORTED:** 26-Oct-2011  
**COMPANY:** Sinclair Knight Merz **DATE RECEIVED:** 17-Oct-2011  
**ADDRESS:** P O Box 312 Flinders Lane **REPORT NO:** EB1121537-046 / PSD  
Melbourne, Vic Australia 8009  
**PROJECT:** QEO9811 400 Wards Well - **SAMPLE ID:** WW94 600-700  
Land Resources

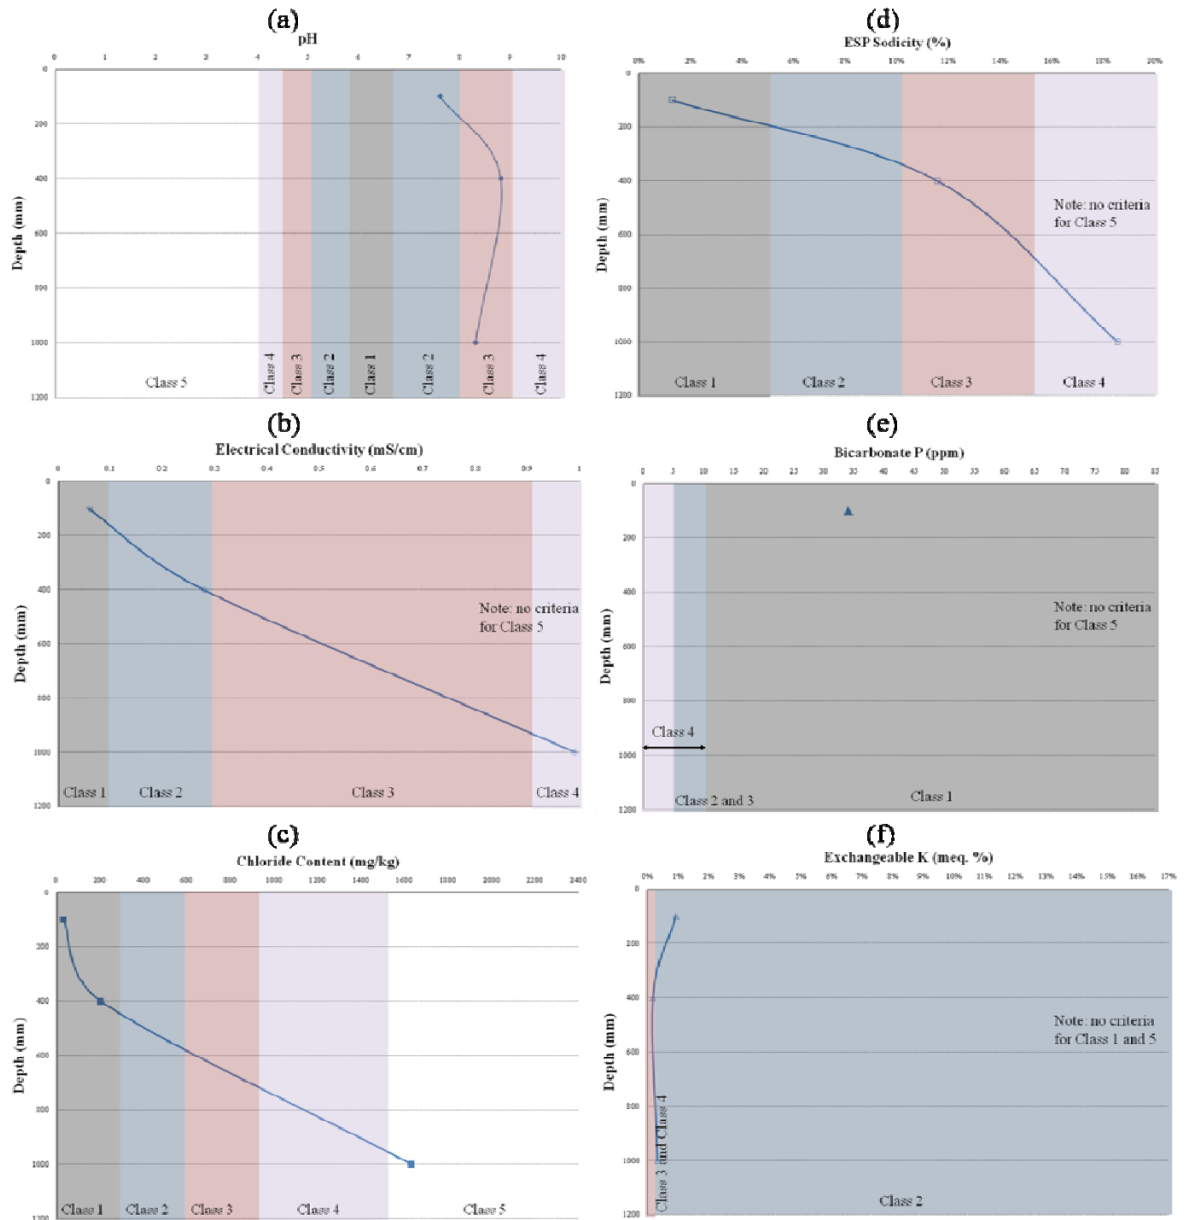
■ Figure A 1 Vertosol: Site 15 (a) pH, (b) Electrical conductivity, (c) Chloride content, (d) ESP. (e) Bicarbonate P, and (f) Exchangeable K

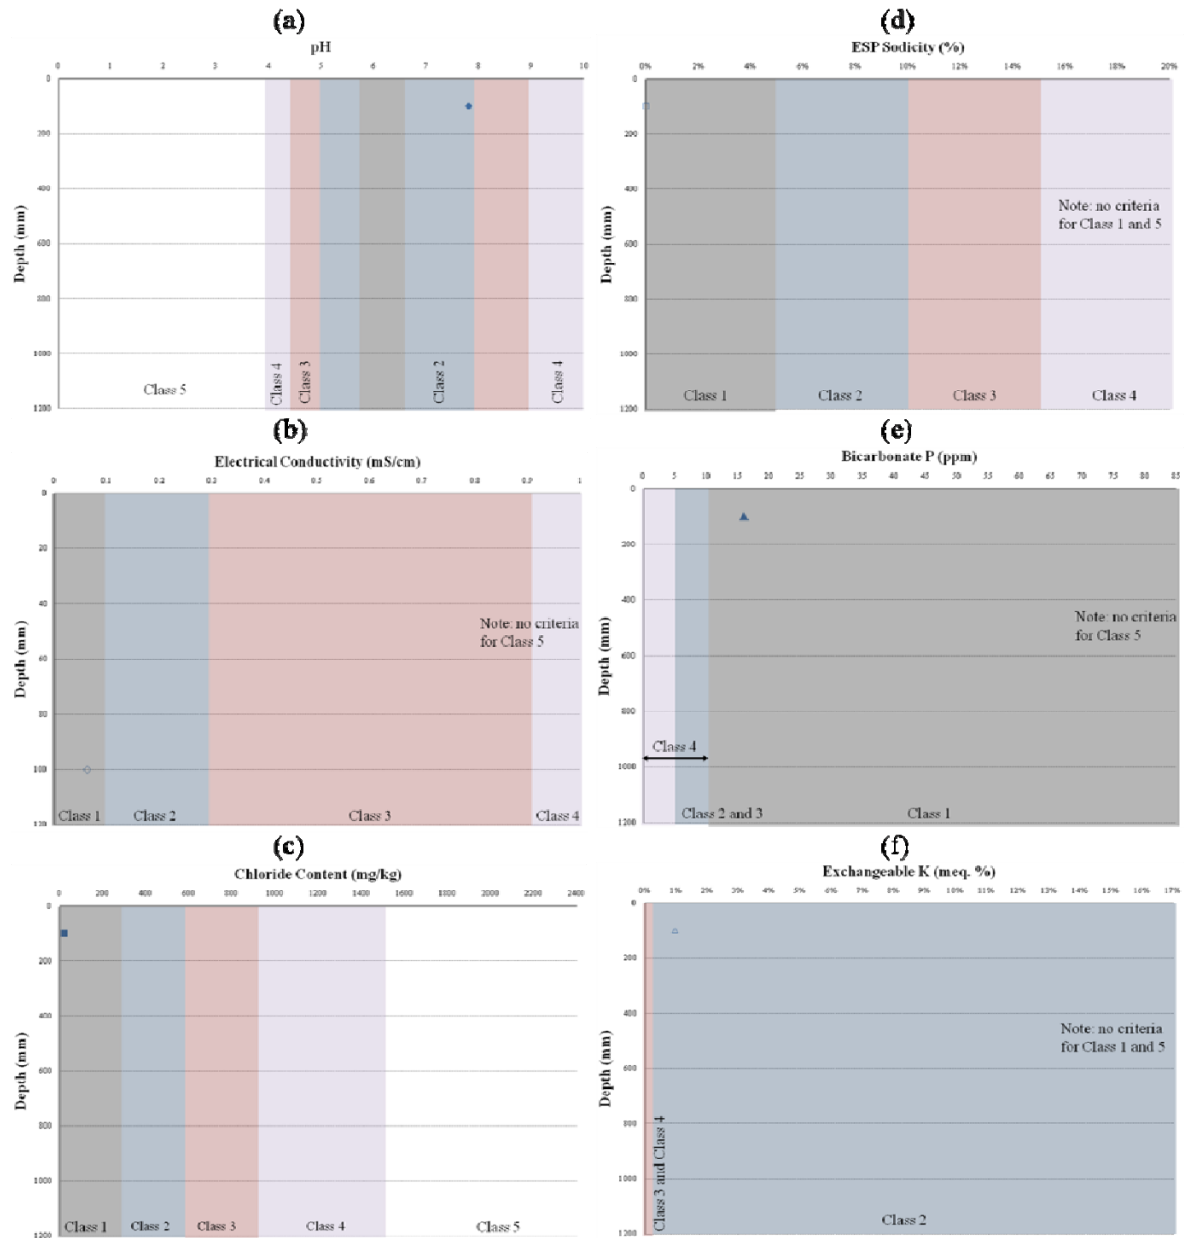
■ Figure A 2 Vertosol: Site 22 (a) pH, (b) Electrical conductivity, (c) Chloride content, (d) ESP, (e) Bicarbonate P, and (f) Exchangeable K

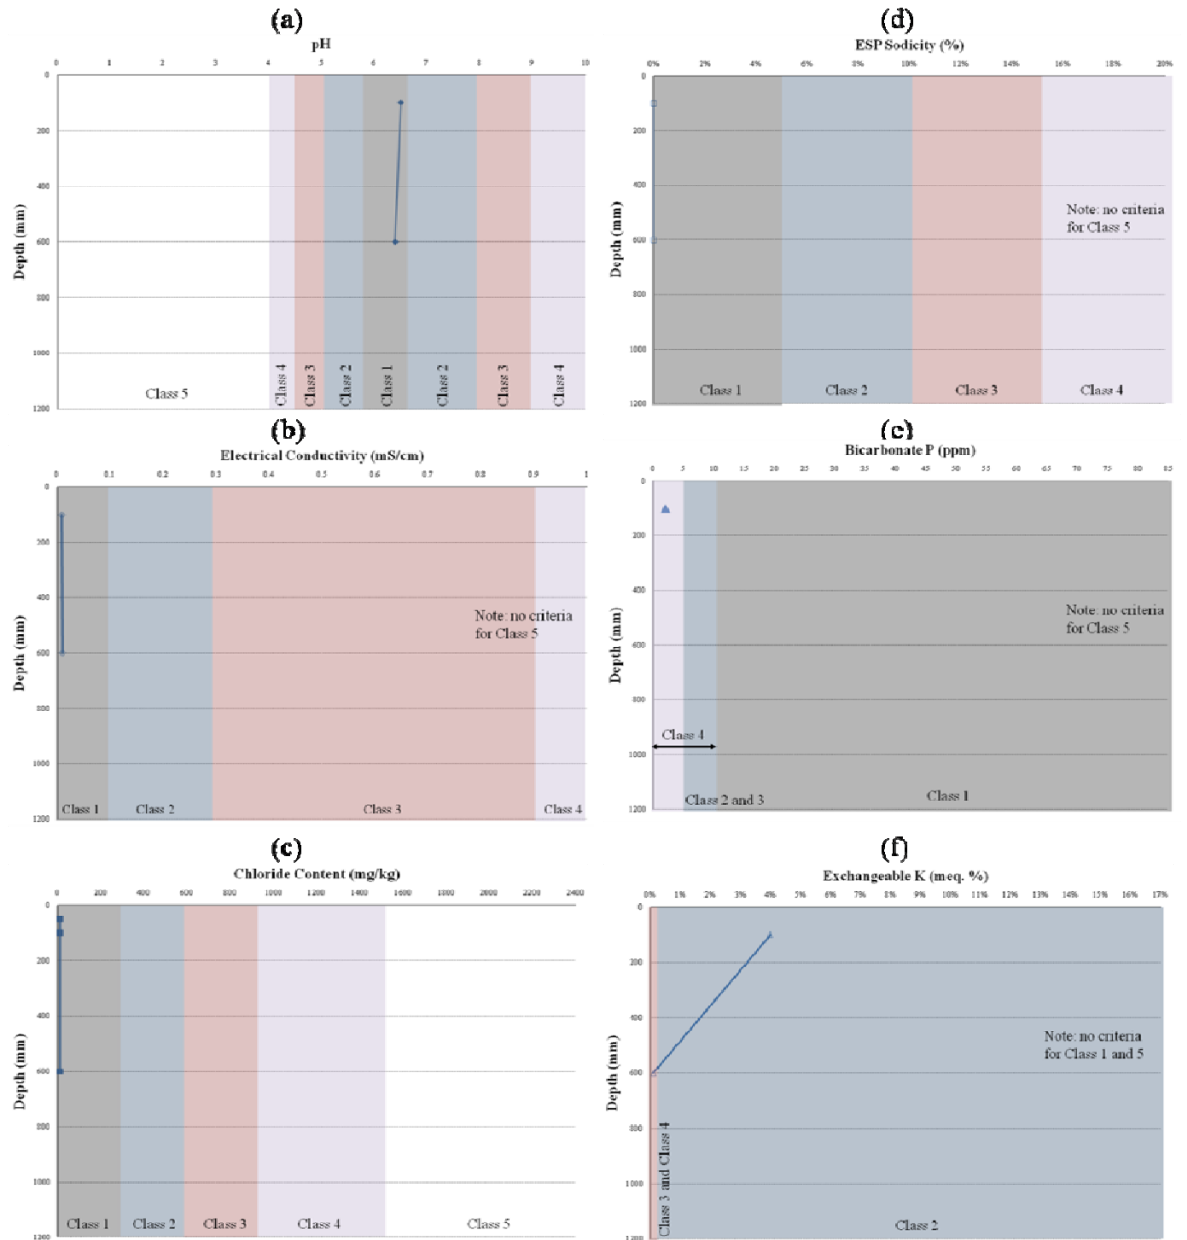
■ Figure A 3 Vertosol: Site 9 (a) pH, (b) Electrical conductivity, (c) Chloride content, (d) ESP, (e) Bicarbonate P, and (f) Exchangeable K

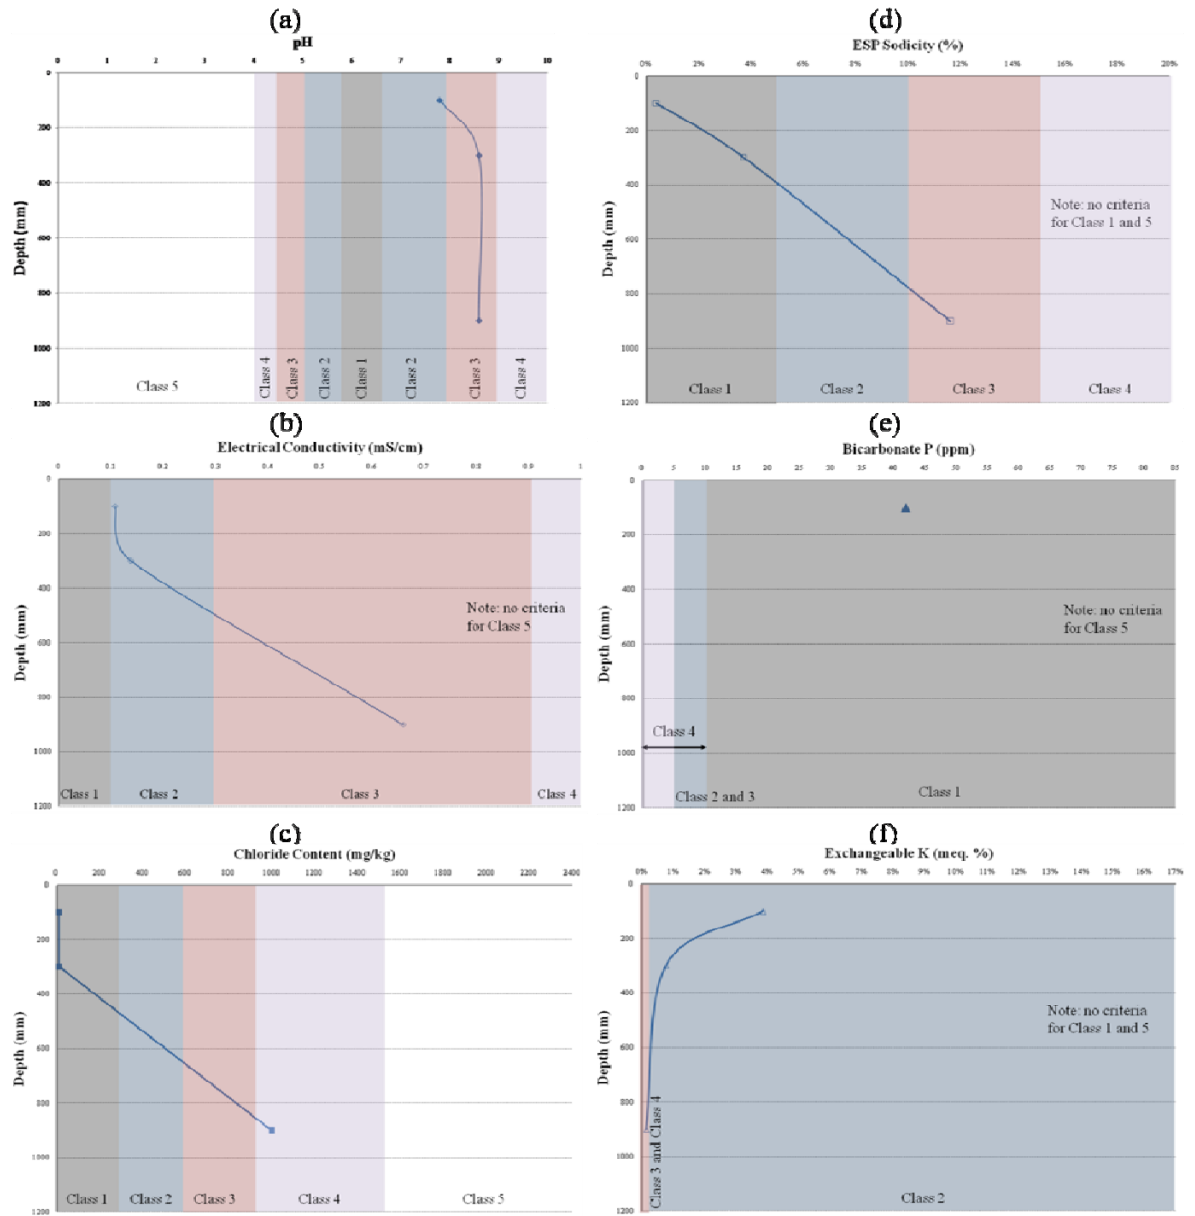
■ Figure A 4 Vertosol Site 6 (a) pH, (b) Electrical conductivity, (c) Chloride content, (d) ESP, (e) Bicarbonate P, and (f) Exchangeable K

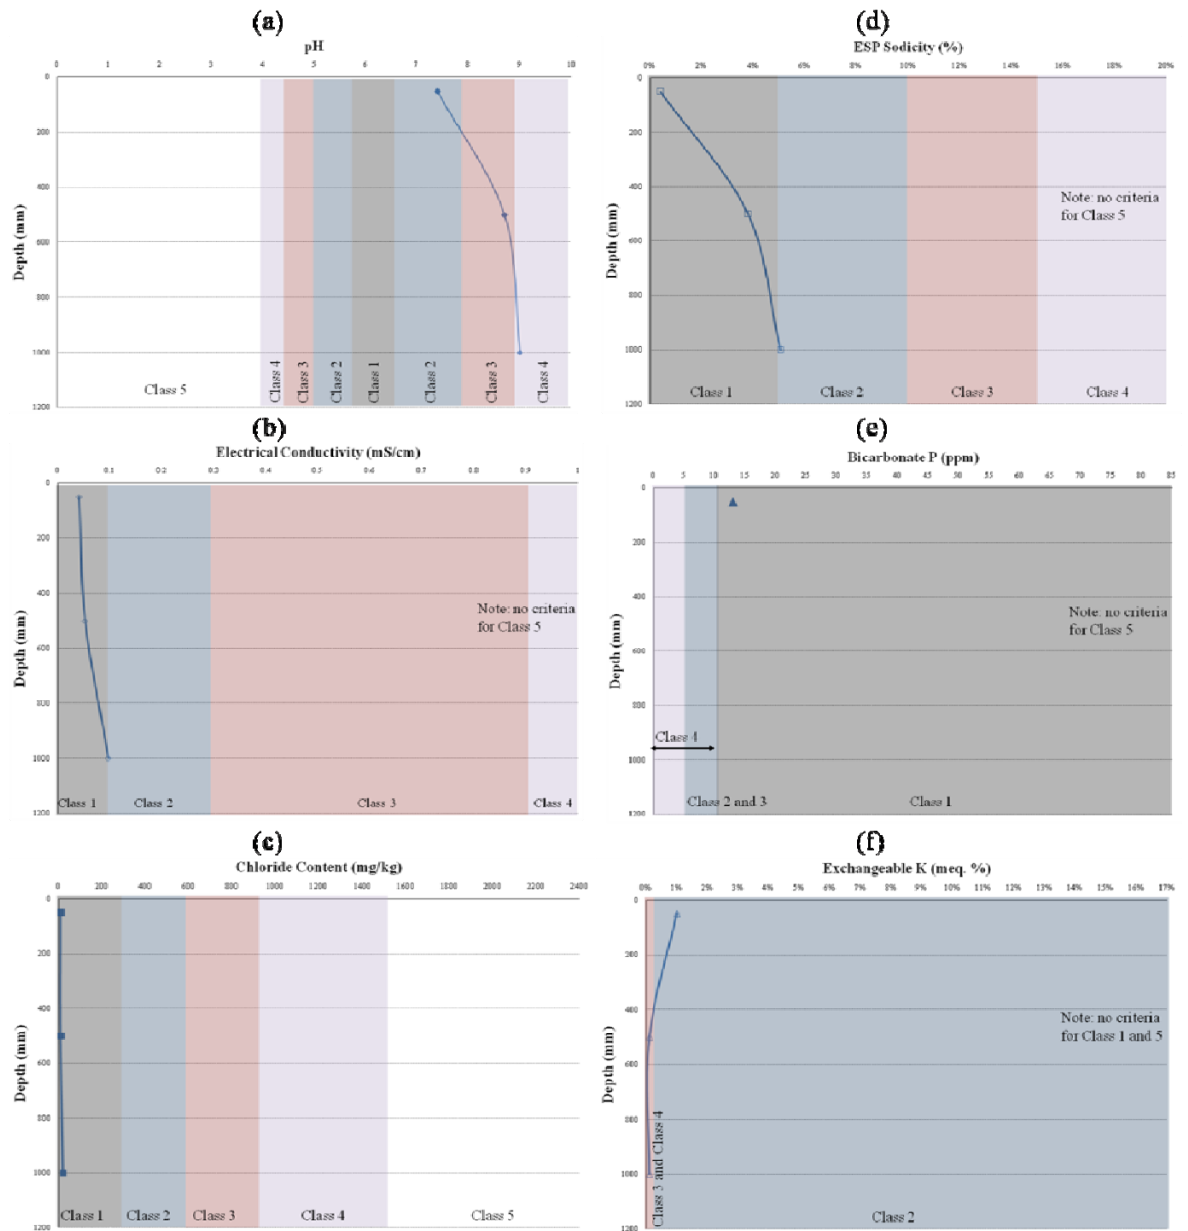
■ **Figure A 5 Vertosol: Site 75 (a) pH, (b) Electrical conductivity, (c) Chloride content, (d) ESP. (e) Bicarbonate P, and (f) Exchangeable K**

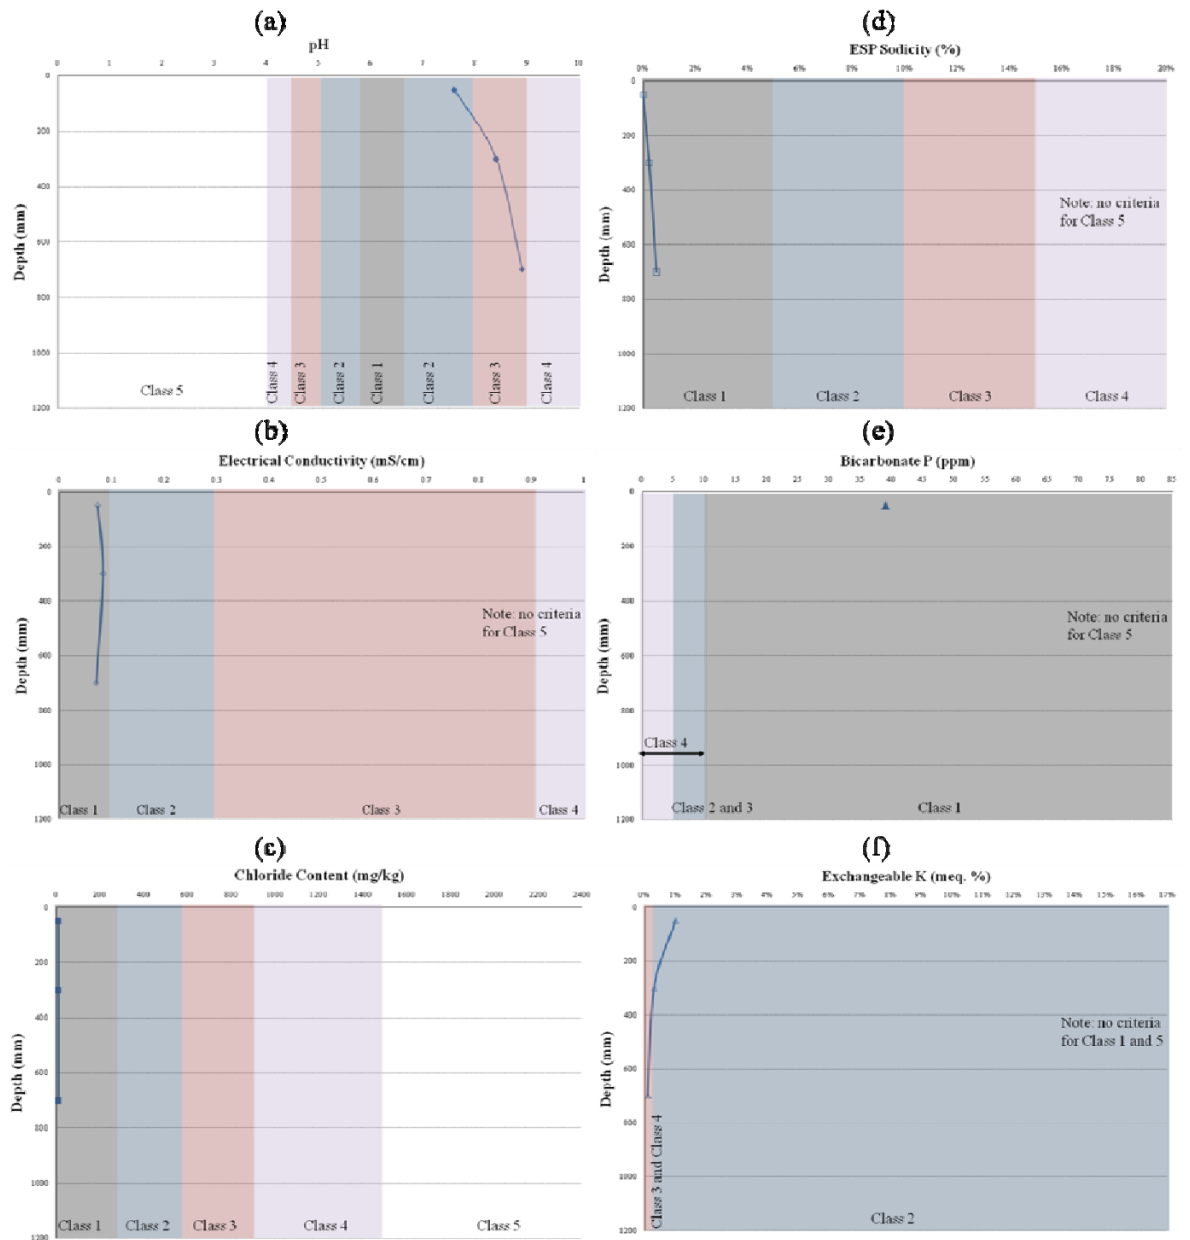
■ Figure A 6 Vertosol: Site 94 (a) pH, (b) Electrical conductivity, (c) Chloride content, (d) ESP. (e) Bicarbonate P, and (f) Exchangeable K

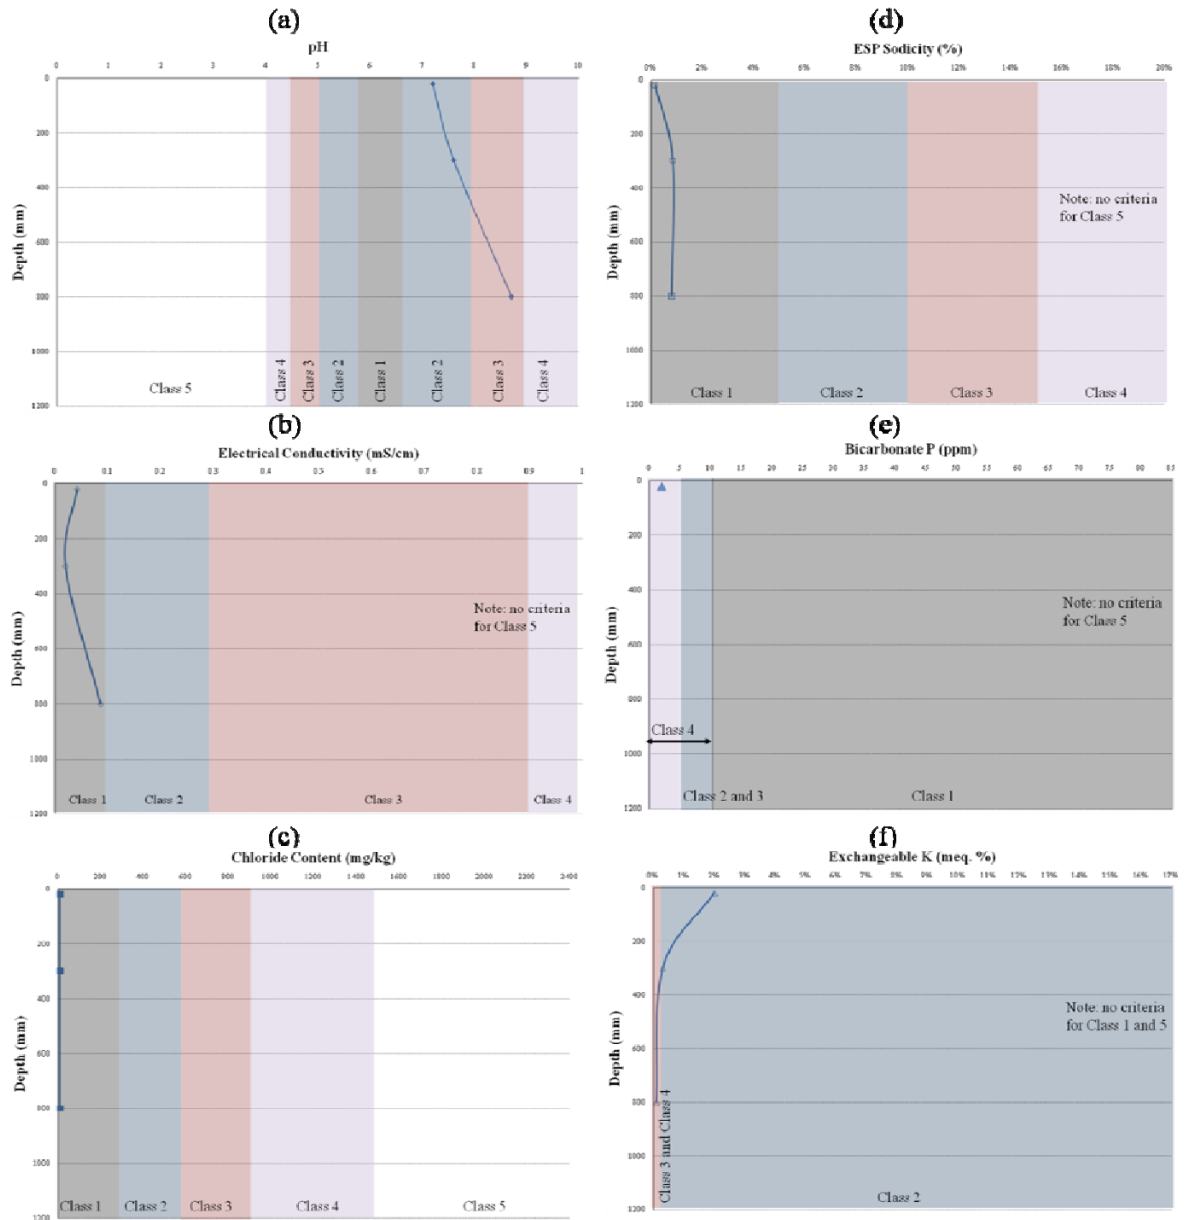
■ Figure A 7 Vertosol: Site 60 (a) pH, (b) Electrical conductivity, (c) Chloride content, (d) ESP. (e) Bicarbonate P, and (f) Exchangeable K(a) pH, (b) Electrical conductivity, (c) Chloride content, (d) ESP. (e) Bicarbonate P, and (f) Exchangeable K

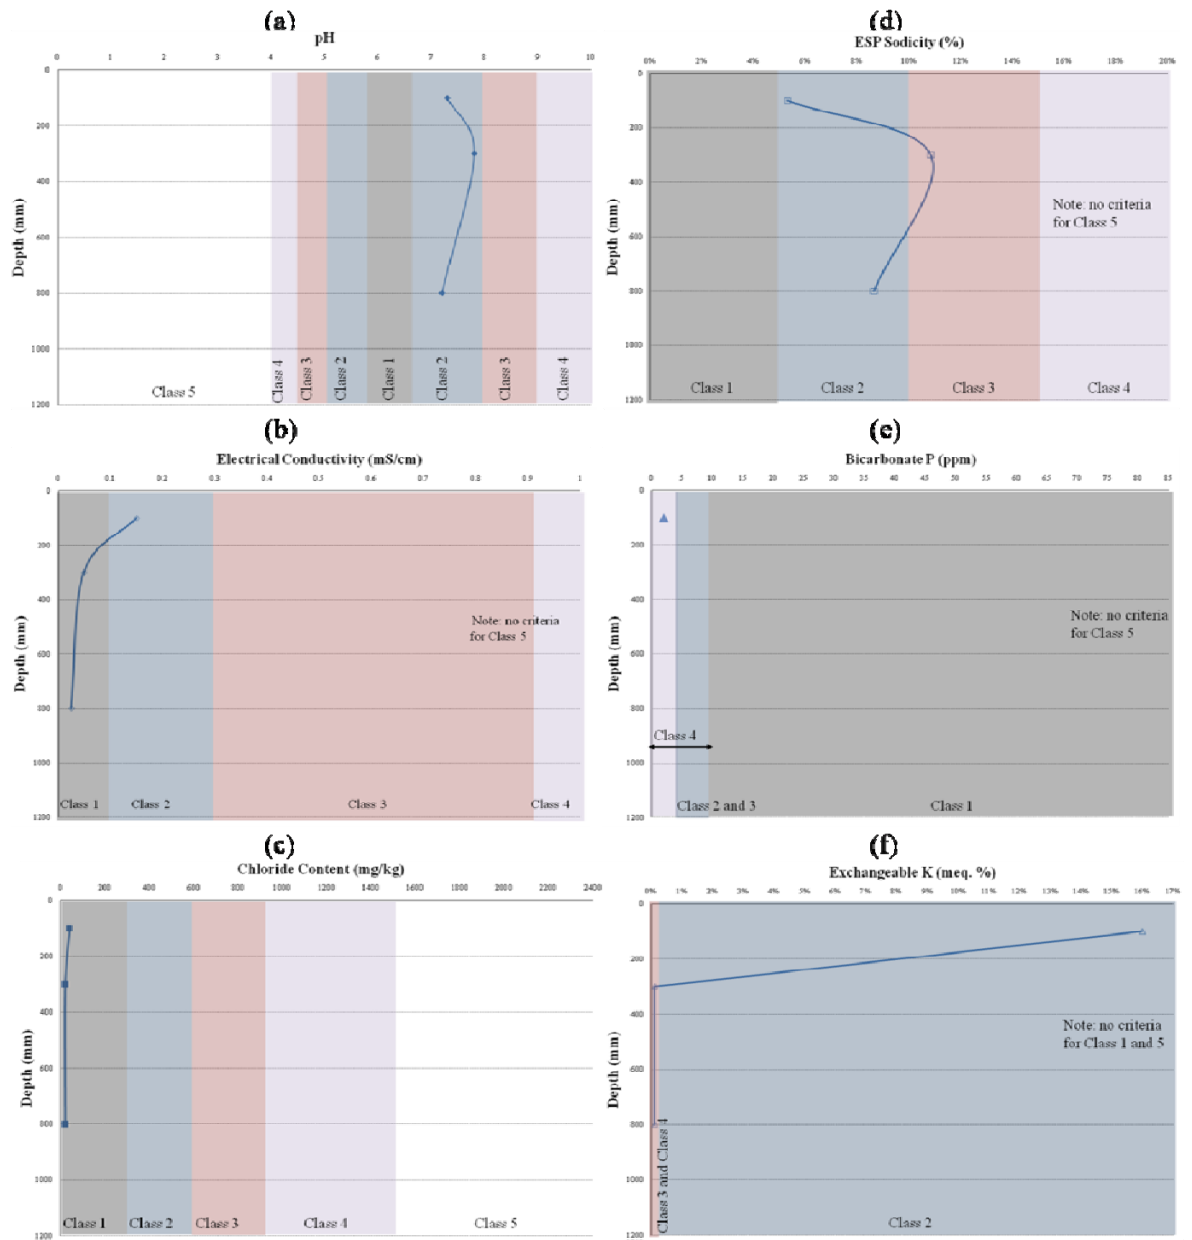
■ Figure A 8 Dermosol: Site 28 (a) pH, (b) Electrical conductivity, (c) Chloride content, (d) ESP, (e) Bicarbonate P, and (f) Exchangeable K
