# Progressive Rehabilitation and Closure Plan

## Wards Well Mine

| <b>Document title</b> | Progressive Rehabilitation and Closure Plan |
| <b>Version number</b> | V3.0 |

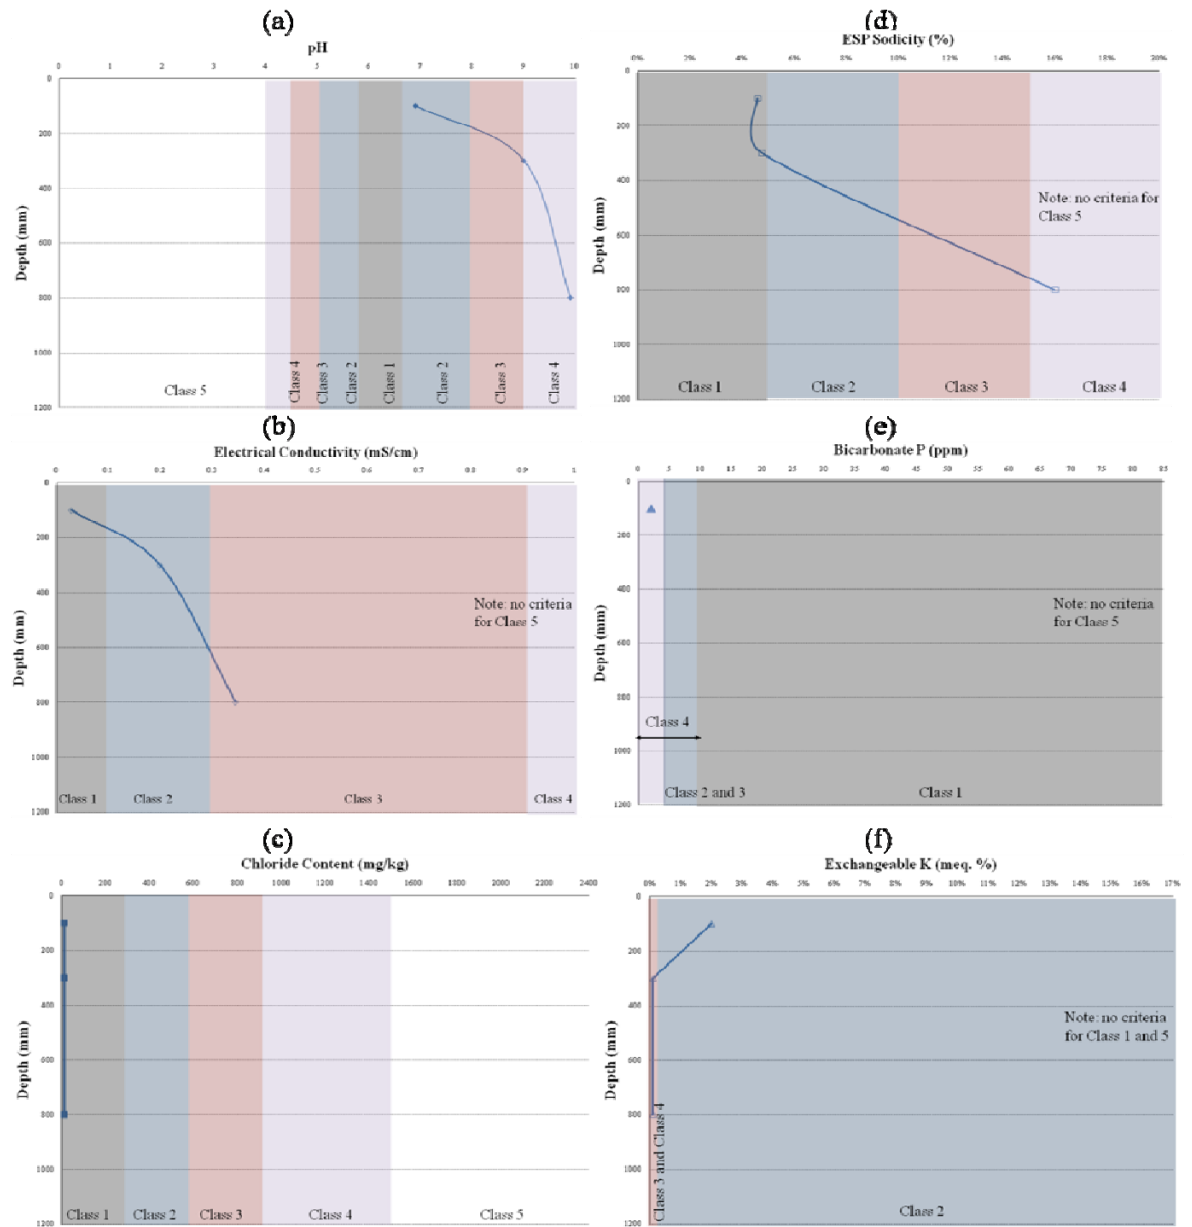
■ **Figure A 9 Dermosol: Site 36 (a) pH, (b) Electrical conductivity, (c) Chloride content, (d) ESP. (e) Bicarbonate P, and (f) Exchangeable K**

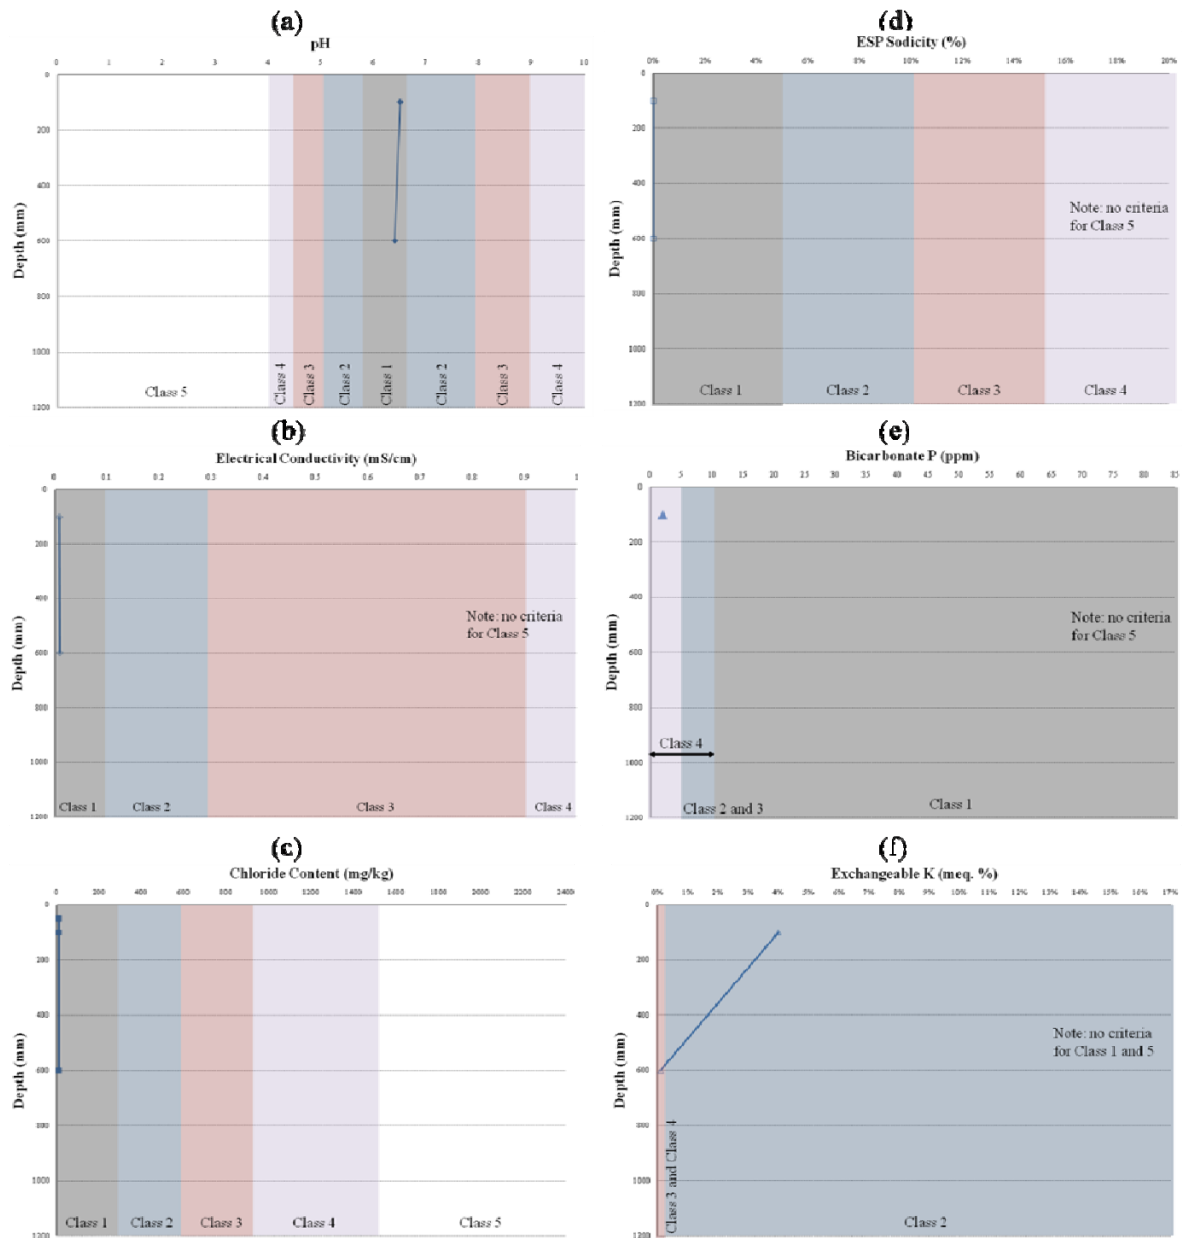
■ Figure A 10 Dermosol: Site 10 (a) pH, (b) Electrical conductivity, (c) Chloride content, (d) ESP. (e) Bicarbonate P, and (f) Exchangeable K

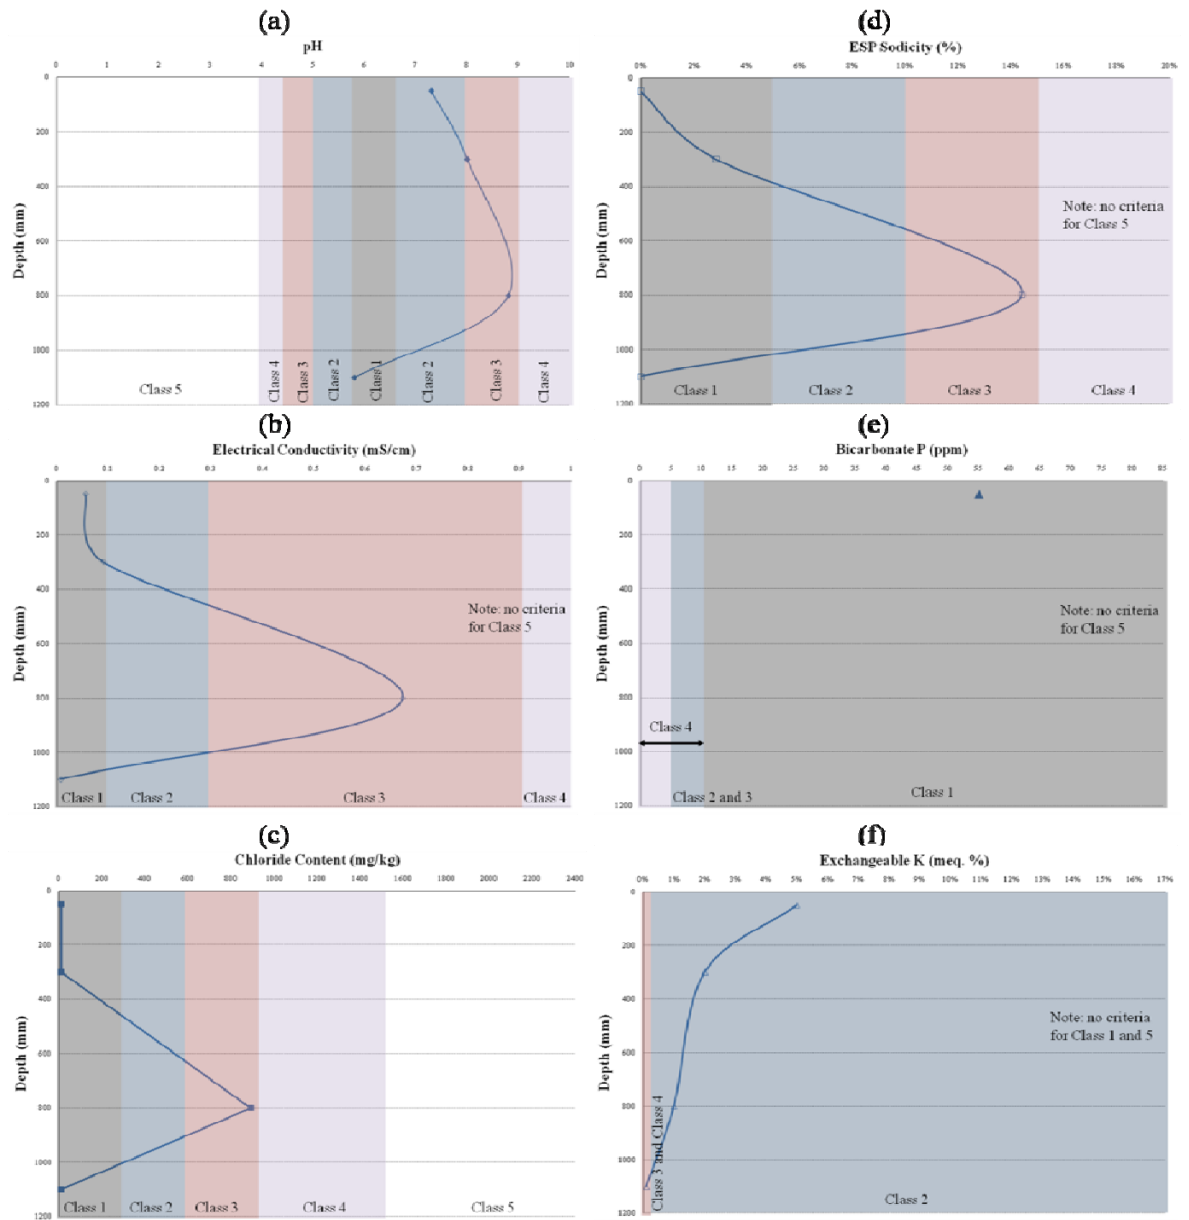
■ Figure A 11 Dermosol: Site 13 (a) pH, (b) Electrical conductivity, (c) Chloride content, (d) ESP. (e) Bicarbonate P, and (f) Exchangeable K

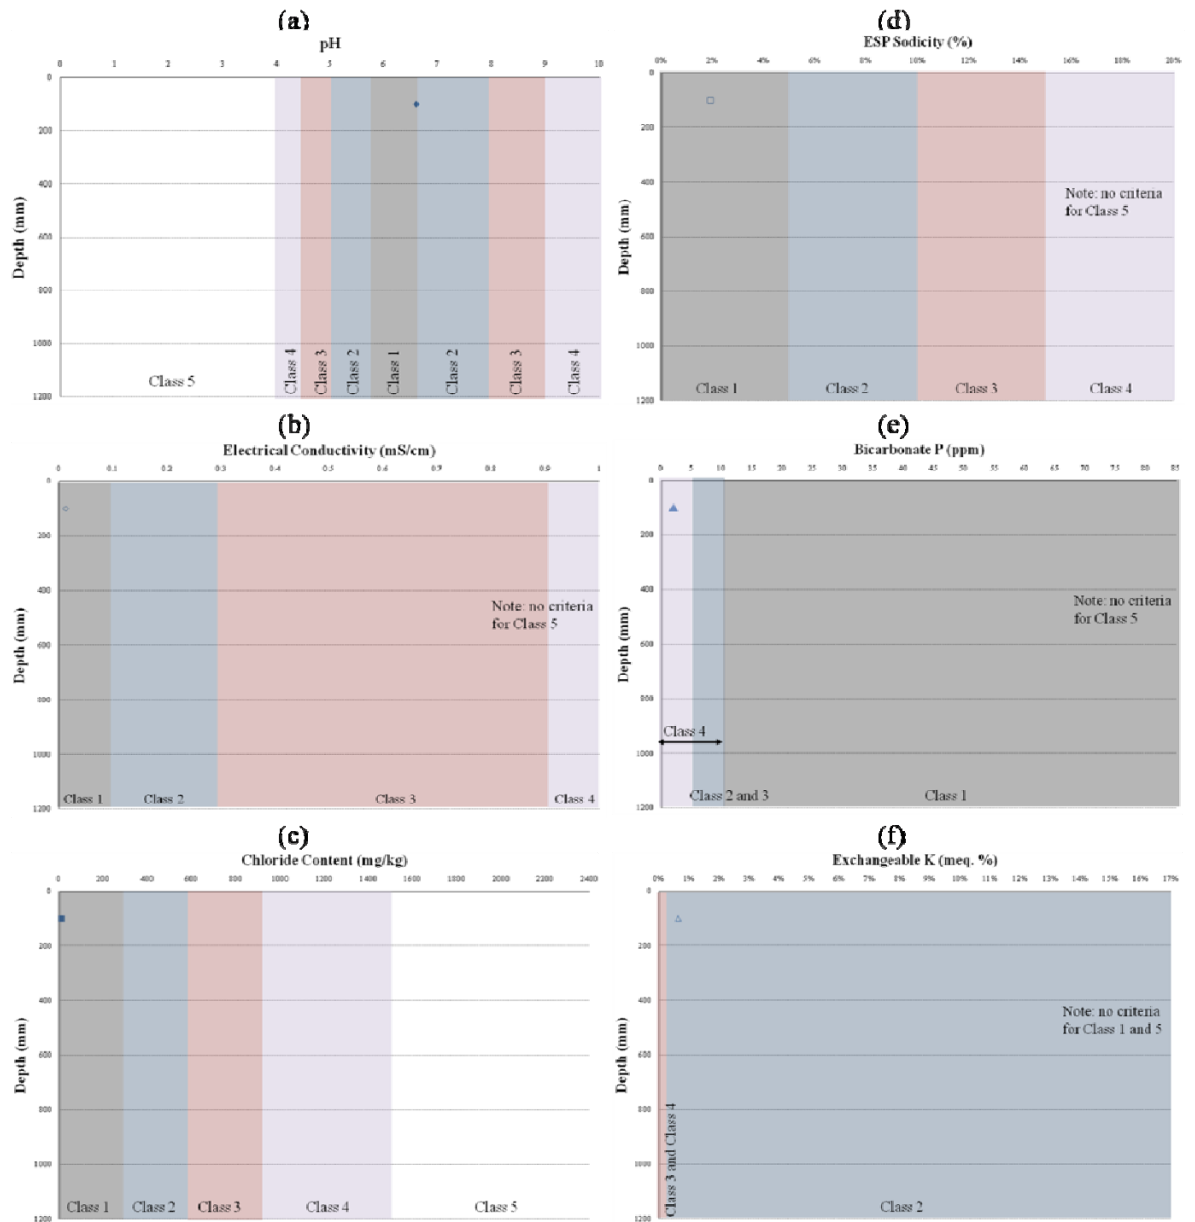
■ **Figure A 12 Dermosol: Site 47 (a) pH, (b) Electrical conductivity, (c) Chloride content, (d) ESP. (e) Bicarbonate P, and (f) Exchangeable K**

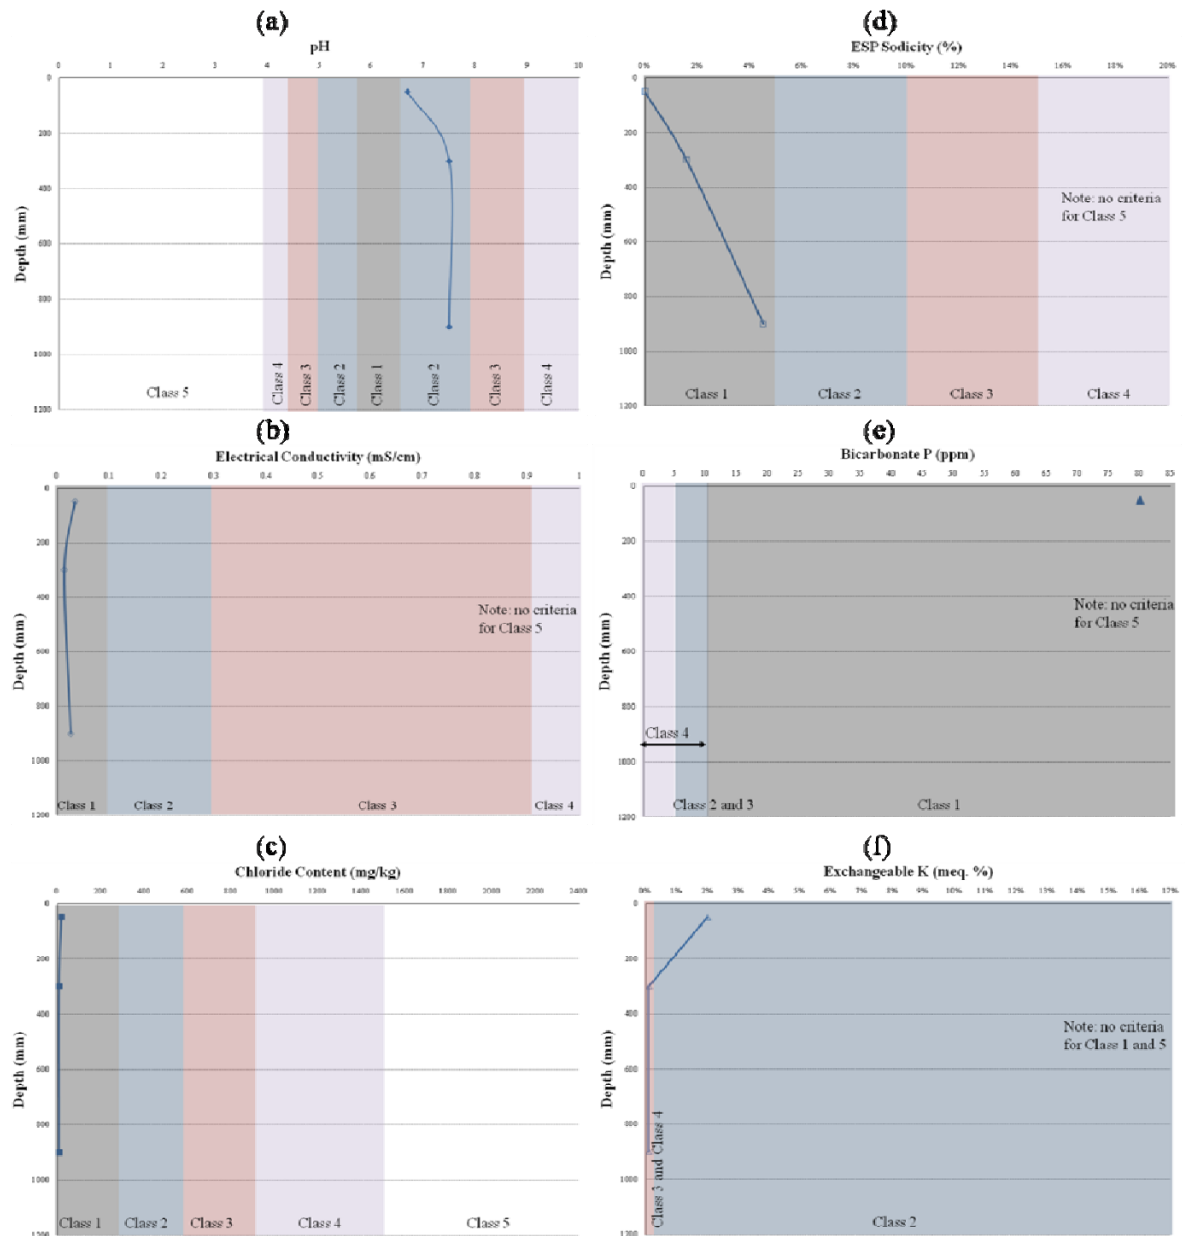
■ Figure A 13 Kandosol: Site 69 (a) pH, (b) Electrical conductivity, (c) Chloride content, (d) ESP. (e) Bicarbonate P, and (f) Exchangeable K

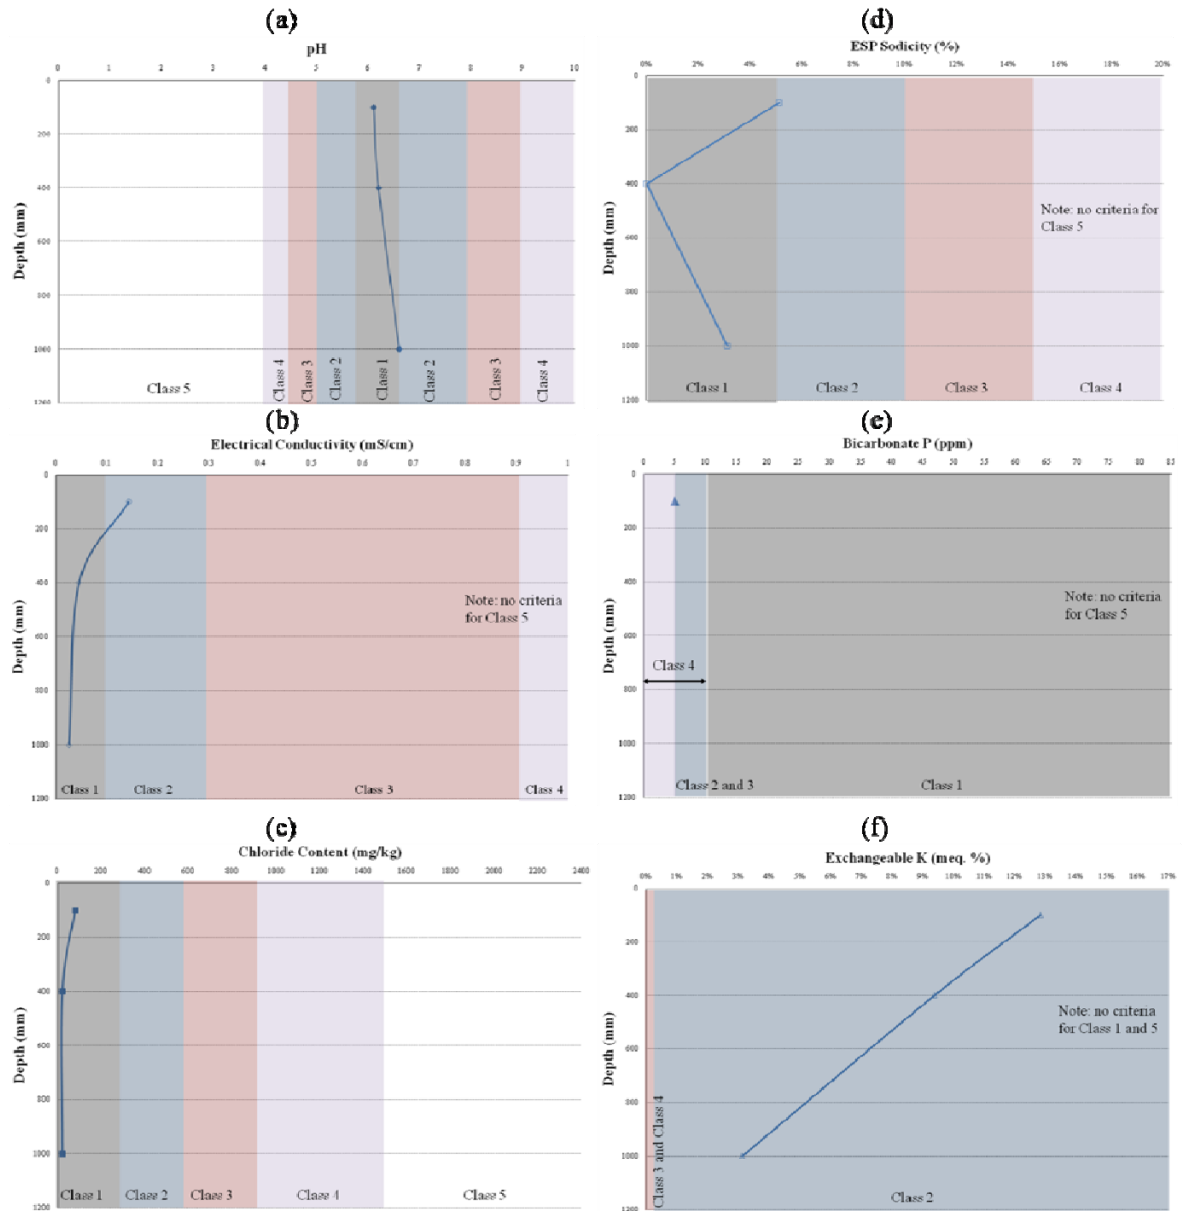
■ Figure A 14 Kandosol: Site 23 (a) pH, (b) Electrical conductivity, (c) Chloride content, (d) ESP. (e) Bicarbonate P, and (f) Exchangeable K

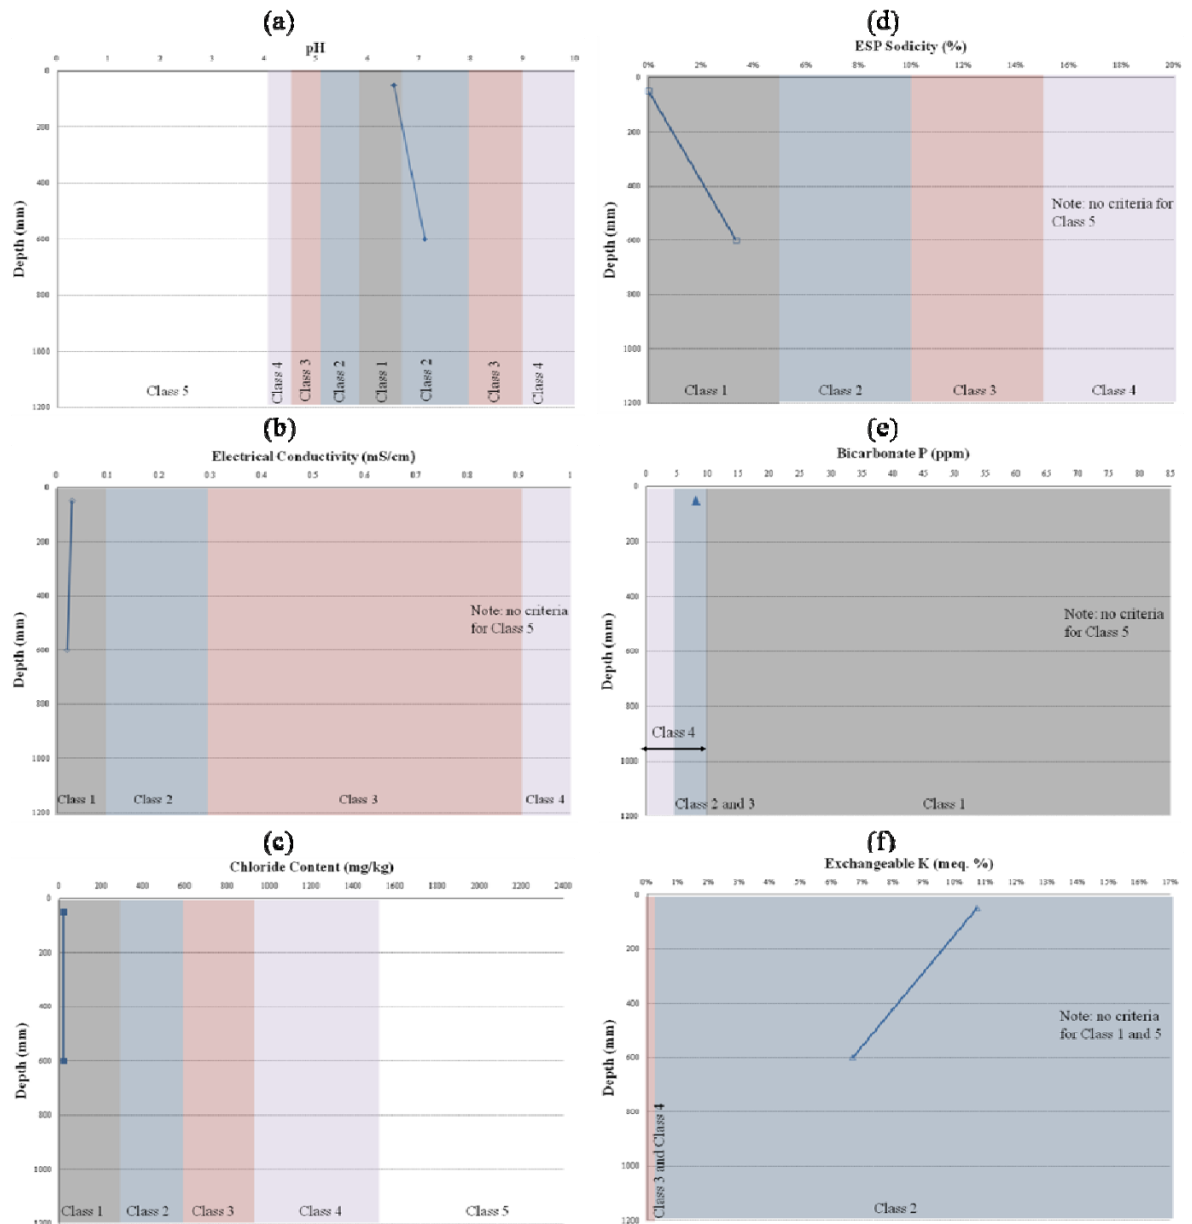
■ **Figure A 15 Kandosol: Site 38 (a) pH, (b) Electrical conductivity, (c) Chloride content, (d) ESP. (e) Bicarbonate P, and (f) Exchangeable K**

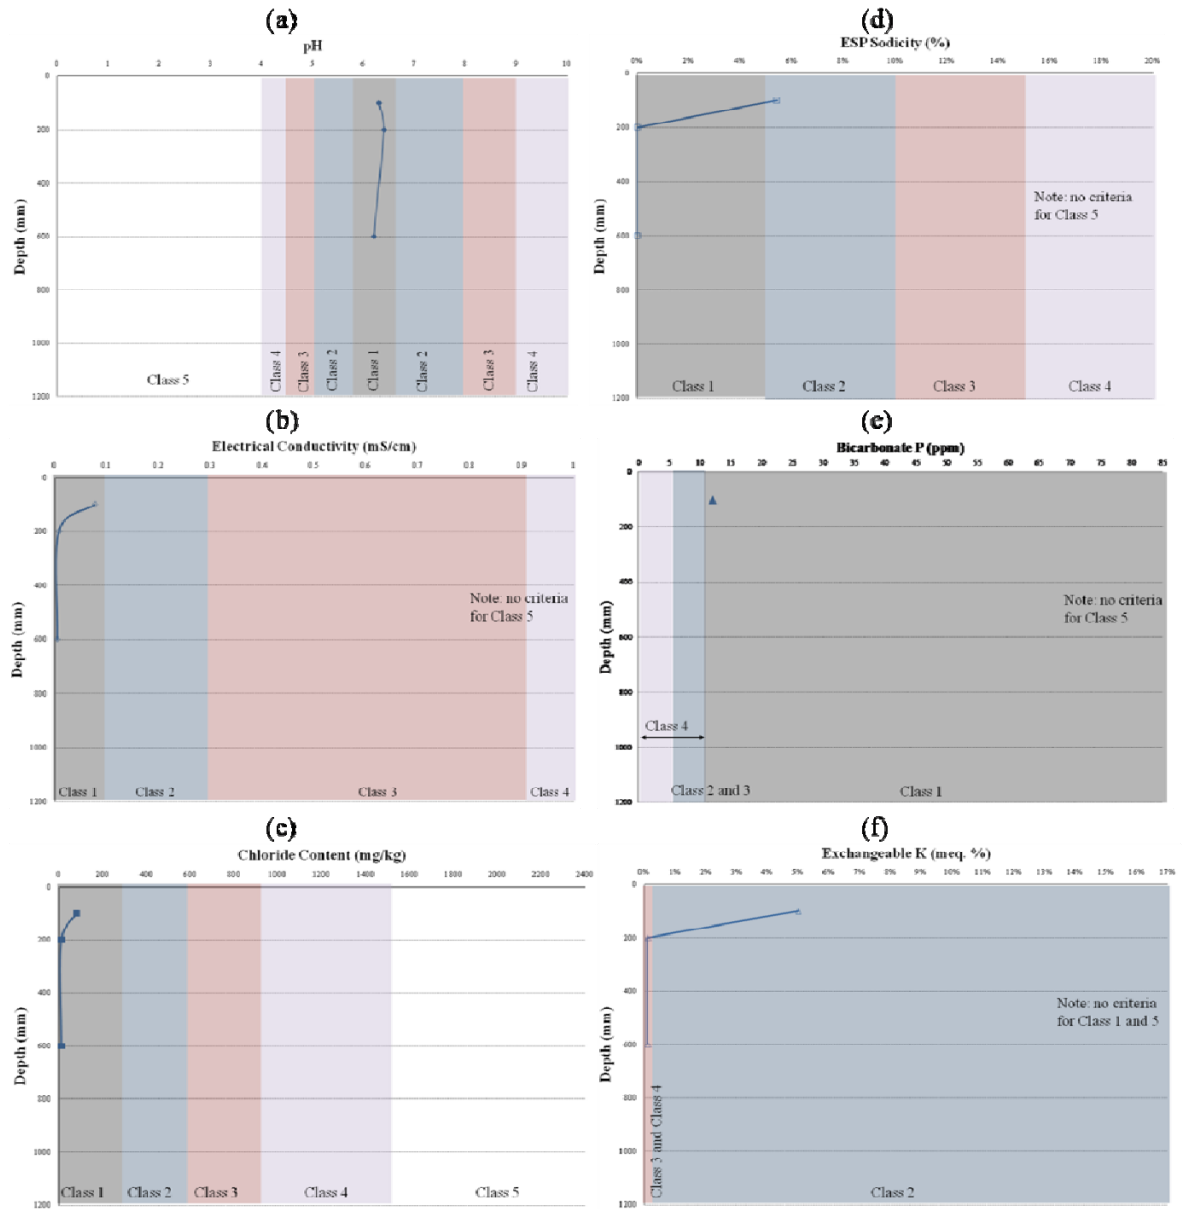
■ Figure A 16 Kandosol: Site 44 (a) pH, (b) Electrical conductivity, (c) Chloride content, (d) ESP. (e) Bicarbonate P, and (f) Exchangeable K

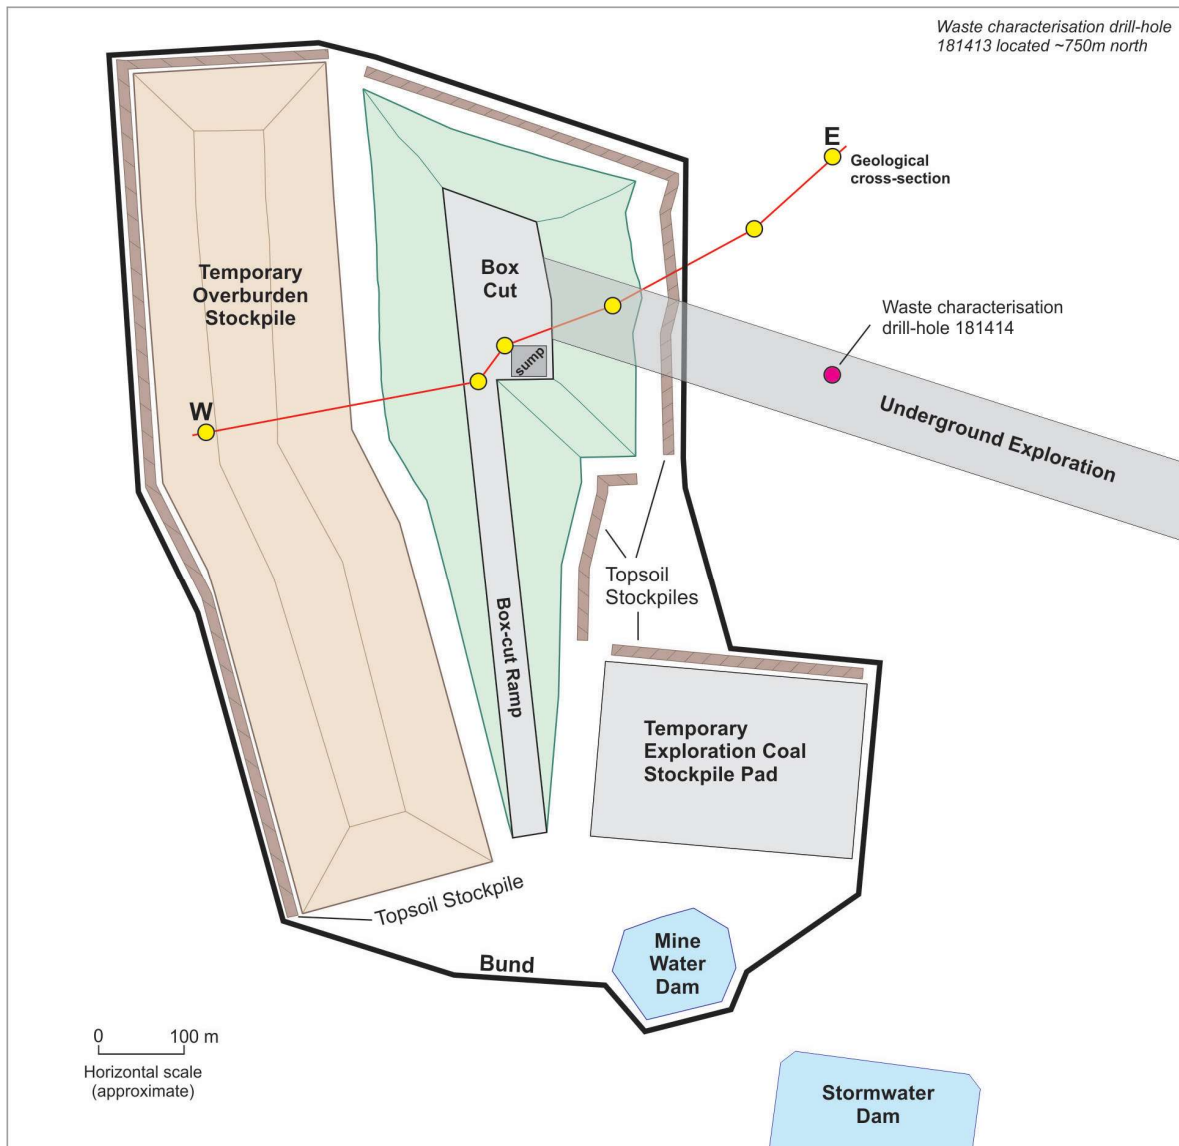
Wards Well is proposed as a future underground mining operation, however operations are currently limited to exploration activities (Environmental Authority EPPR00668513). Current approvals allow surface exploration drilling and underground exploration. The underground exploration activity will consist of up to 1,800 m of in-seam sampling in an easterly direction from a box-cut entry (Figure 1).

**Figure 1: Box-cut and exploration activity area (Refer to Figure 2 for the geological cross-section marked)**

The disturbance activities are contained within a bunded area and surface water within the bunded area flows from northwest towards the south and is captured by a Mine Water Dam (Figures 1 and 3). Surface water and sediment run-off outside of the bunded area flow from north-northwest around the outside of the bund into a Stormwater Dam located immediately south of the bunded area (Figures 1 and 3). Water from the Stormwater Dam can be used on site for exploration activities (e.g. dust suppression) or directed back into overland flow southeast towards the tributary of Eaglefield Creek.

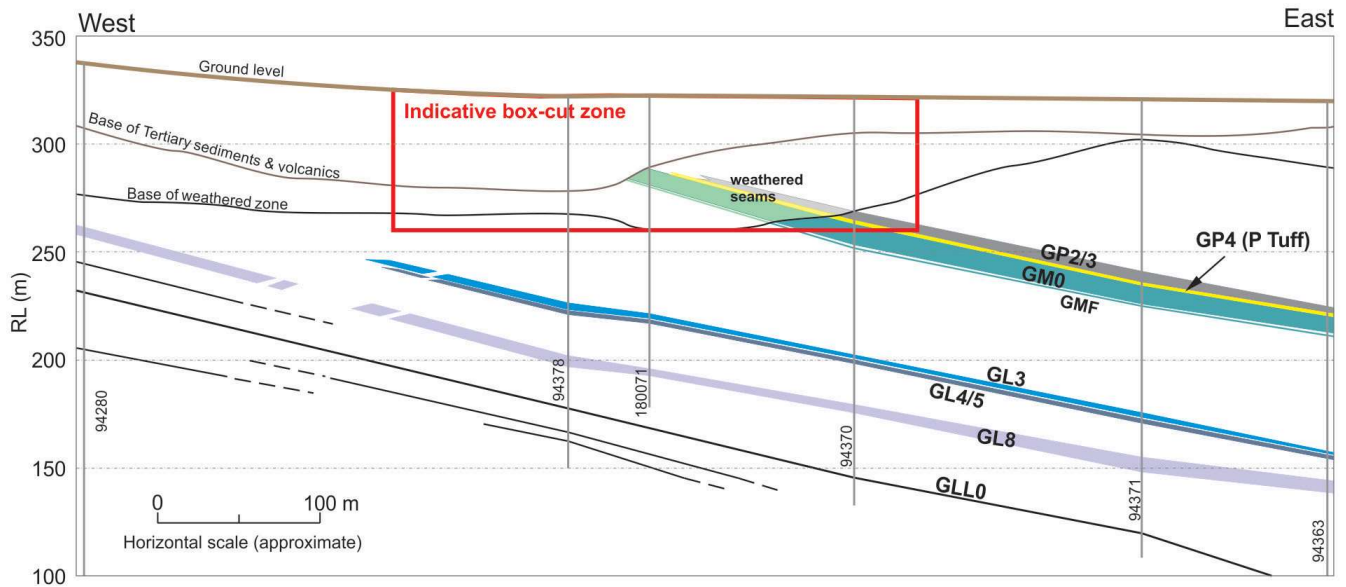
The geological units in the box-cut area are diagrammatically shown in a geological cross-section from west (left) to east (right) through the box-cut (Figure 2). The coal measures are overlain by weathered Tertiary sediments and basalt. As evident in Table 1 and Figure 2, weathered materials comprise approximately 93% of the total volume of mine (mineral) waste from the box-cut, including a proportion of weathered GP and GM seams (Figure 2)

**Figure 2: Geological cross-section through the activity area (Cross-section location shown on Figure 1)**

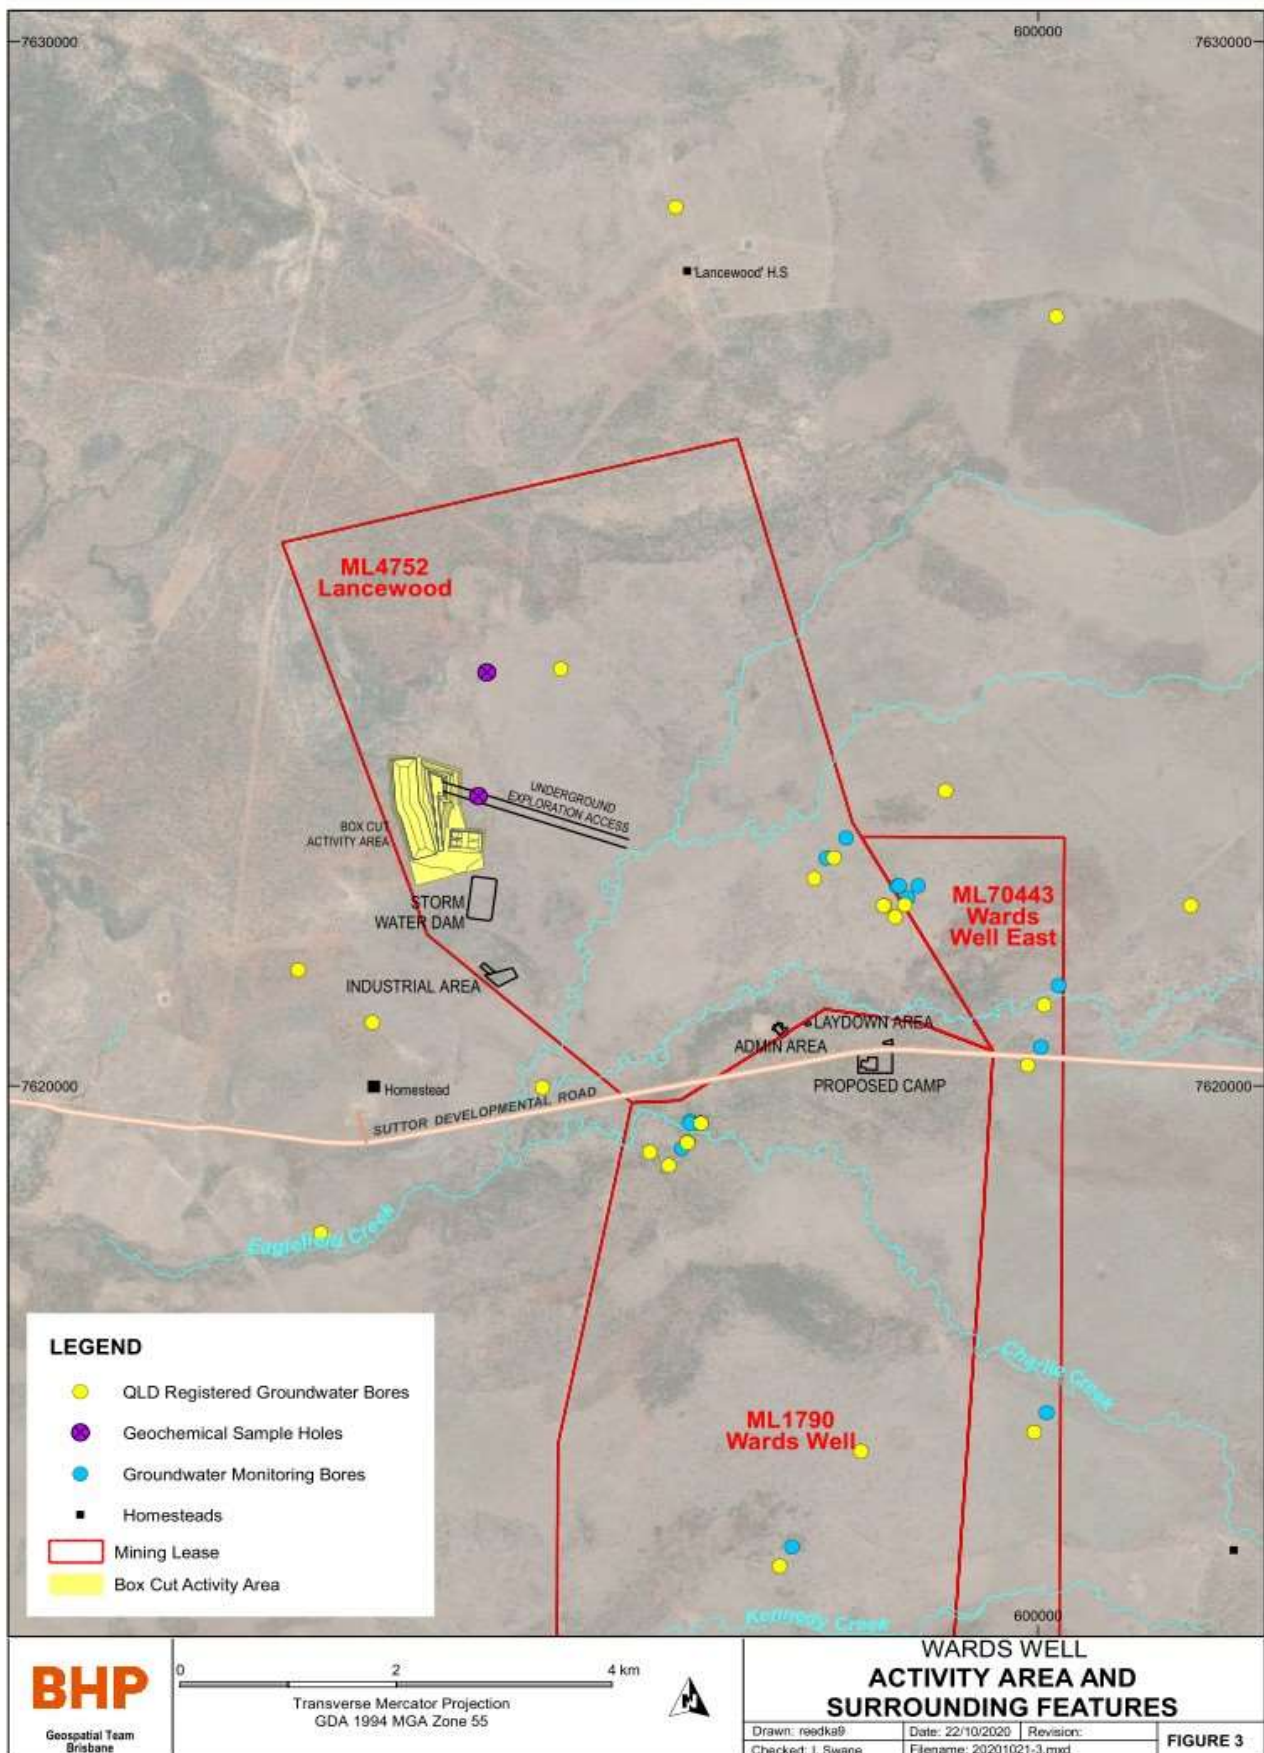
Figure 3: Locations of groundwater bores/wells in the vicinity of the activity area

The broader Wards Well area is drained by Eaglefield Creek (northern area), Charlie Creek (middle area) and Kennedy Creek (southern area) and their minor tributaries. The creek systems discharge to the northwest flowing towards the Suttor River, which is part of the Burdekin system. In each case the water courses are ephemeral. The seasonal variability in flows is evident with many months recording zero stream flow. Of direct relevance to the activity area – the focus of this report – the nearest drainage is an ephemeral northern tributary of Eaglefield Creek and is located approximately 1.2 km southeast of the activity area (Figure 3). There are no surface water features within 1 km of the activity area.

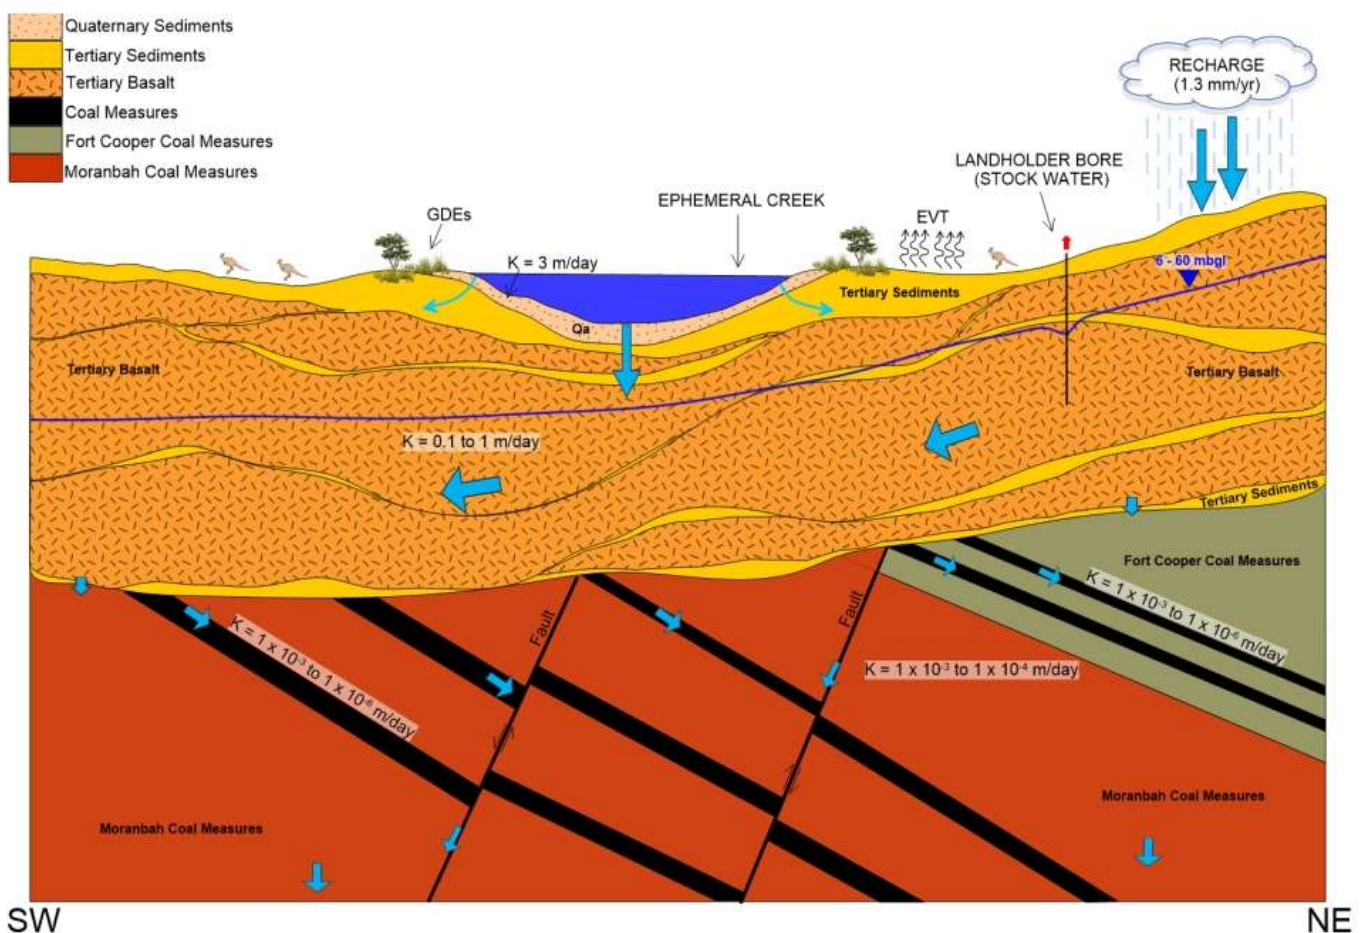
Figure 4: Hydrogeological conceptual model of the Wards Well district (Golder, 2020)

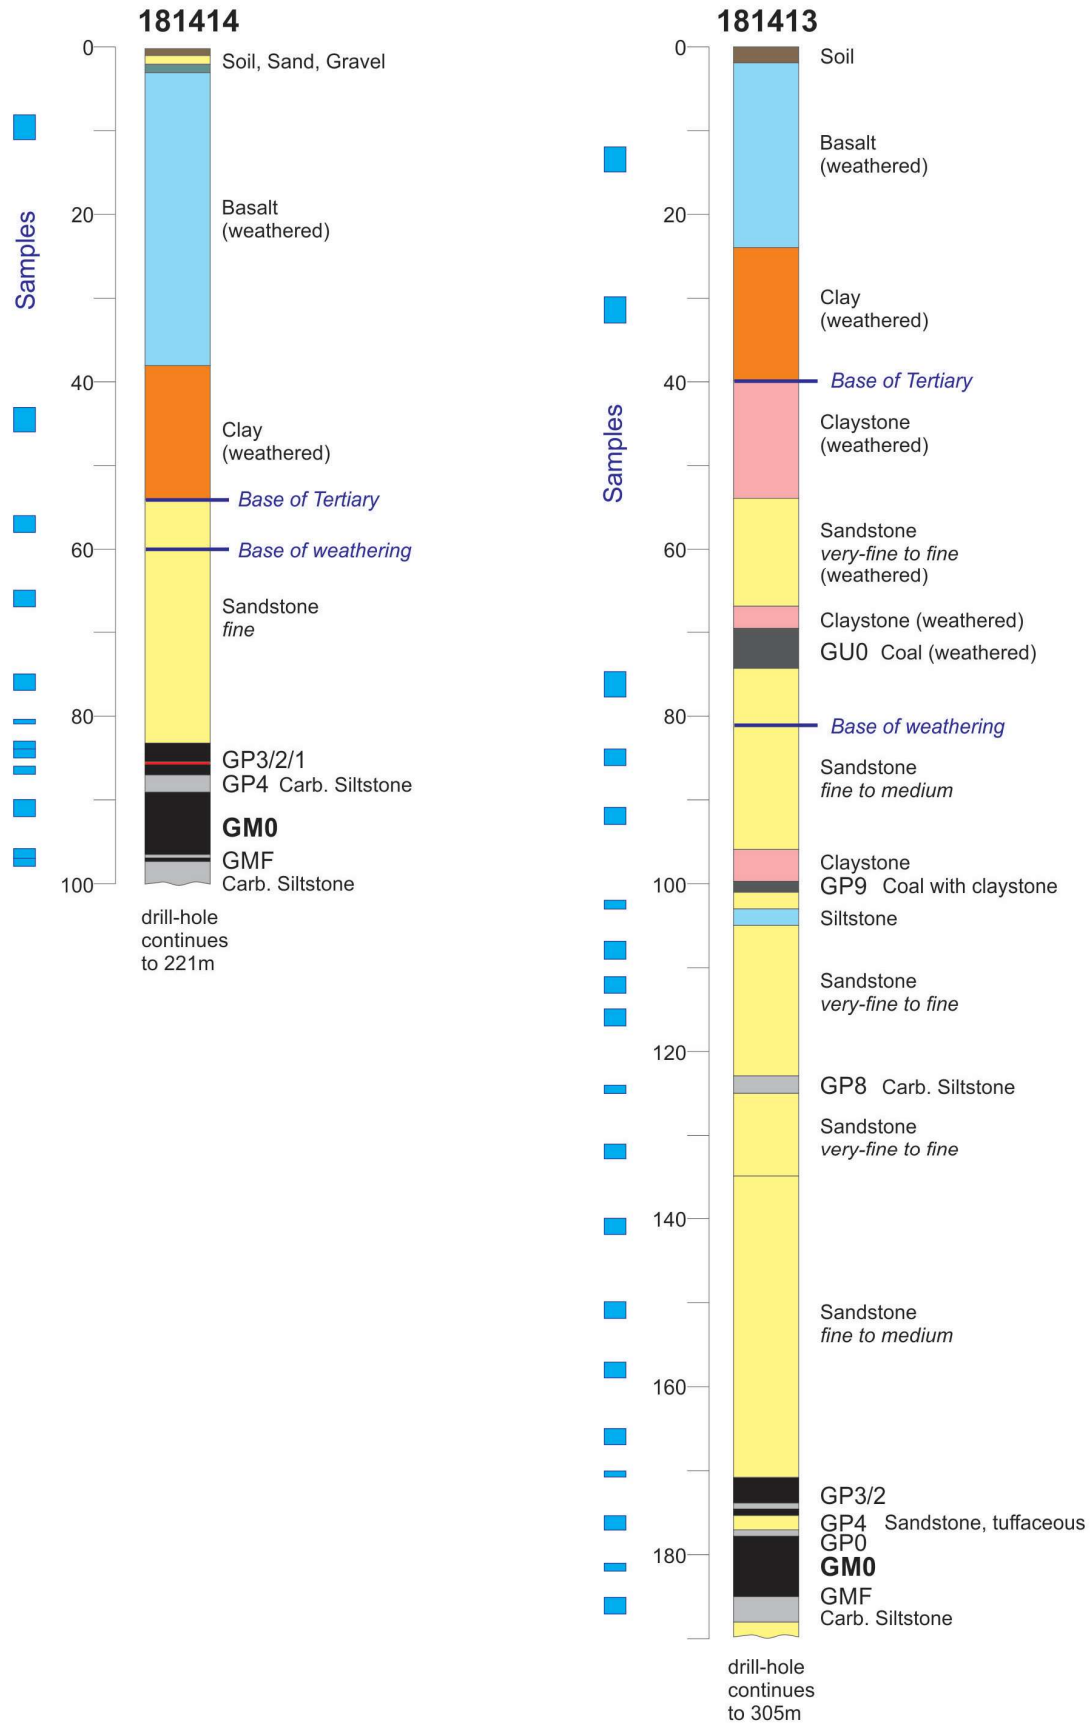
Figure 5: Stratigraphic column and sampling intervals to GMF seam from drill-holes 181413 and 181414

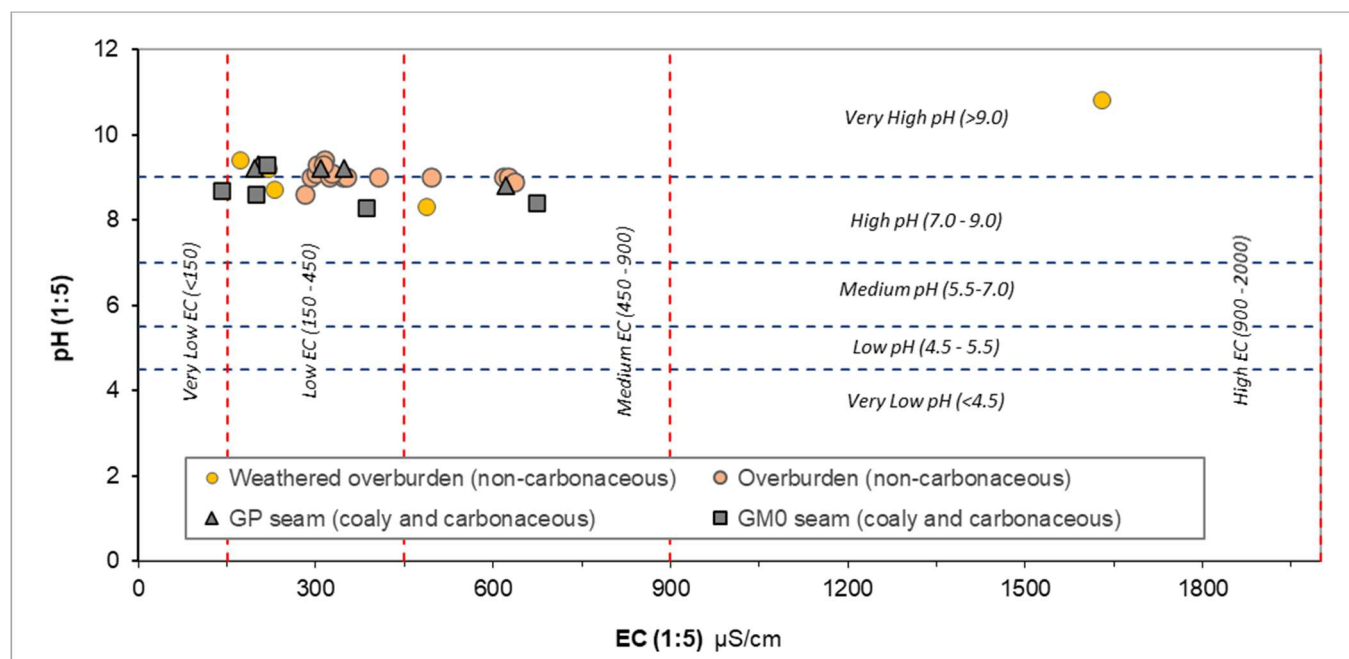
The samples had pH-neutral to alkaline soil pH<sub>1:5</sub> values ranging from pH 8.3 to 10.8 – classifying them as ‘High’ to ‘Very High’ soil pH, and generally ‘Low’ to ‘Medium’ soil electrical conductivity (EC<sub>1:5</sub>) values ranging from 140 to 1630  $\mu$ S/cm [with median, 75<sup>th</sup> and 90<sup>th</sup> percentile values of 322, 447 and 625  $\mu$ S/cm, respectively]. As evident in Figure 6 and Table 4, there is little distinction between samples of different lithology or between weathered versus fresh, or between seam samples versus overburden samples.

Figure 6: Electrical conductivity (EC) and pH

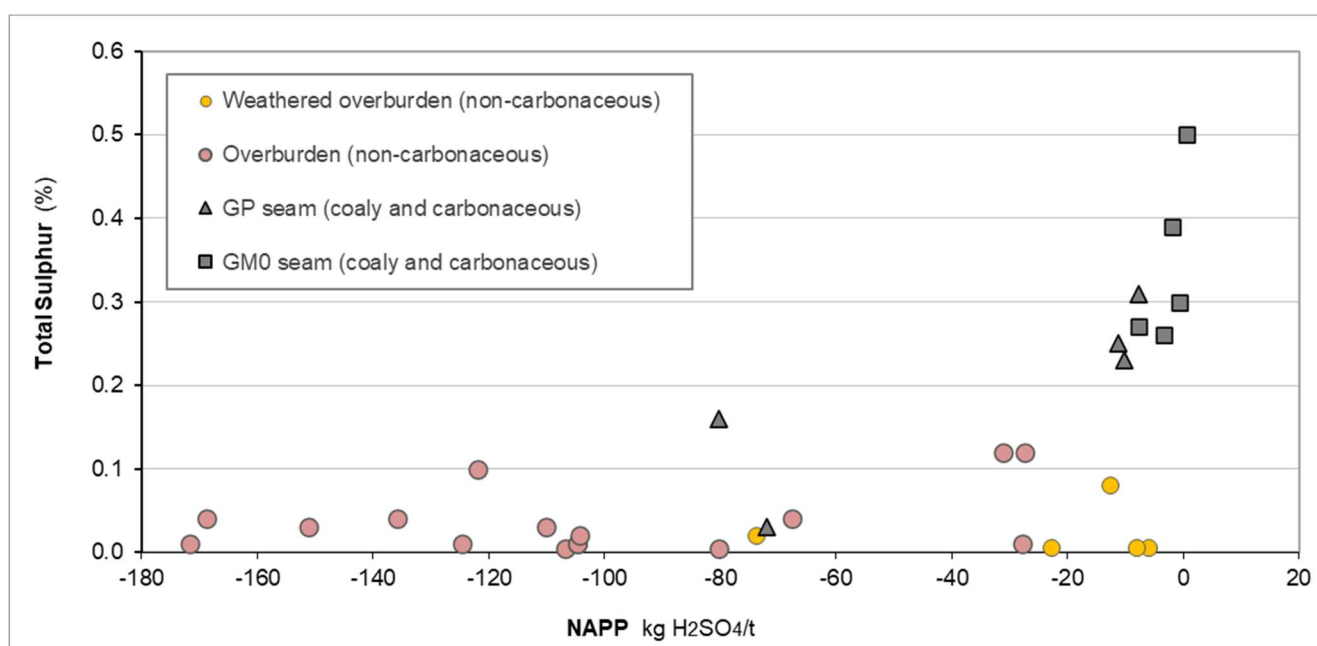
The calculated NAPP values for these samples (NAPP calculated from Scr, where available) are shown in Table 4. Based on the low MPA and generally significantly higher ANC values, the calculated NAPP values were negative for all except one sample (a GM0 seam/floor sample), indicating a greater proportion of neutralising capacity (ANC) compared to potential acidity (MPA). The NAPP values ranged from -172 to +0.5 kg H<sub>2</sub>SO<sub>4</sub>/t, with median and 75<sup>th</sup> percentile NAPP values of -68 and -9 kg H<sub>2</sub>SO<sub>4</sub>/t. As expected, the NAPP values for coaly and carbonaceous samples were generally higher (less negative) compared to non-coaly or non-carbonaceous samples. The relationship between NAPP and Total S is shown in Figure 7, which illustrates a clear increase in Total S in the coaly and carbonaceous samples compared to non-carbonaceous materials, in agreement with similar trends observed for coal deposits within the Moranbah Coal Measures.

Figure 7: Total sulphur versus NAPP

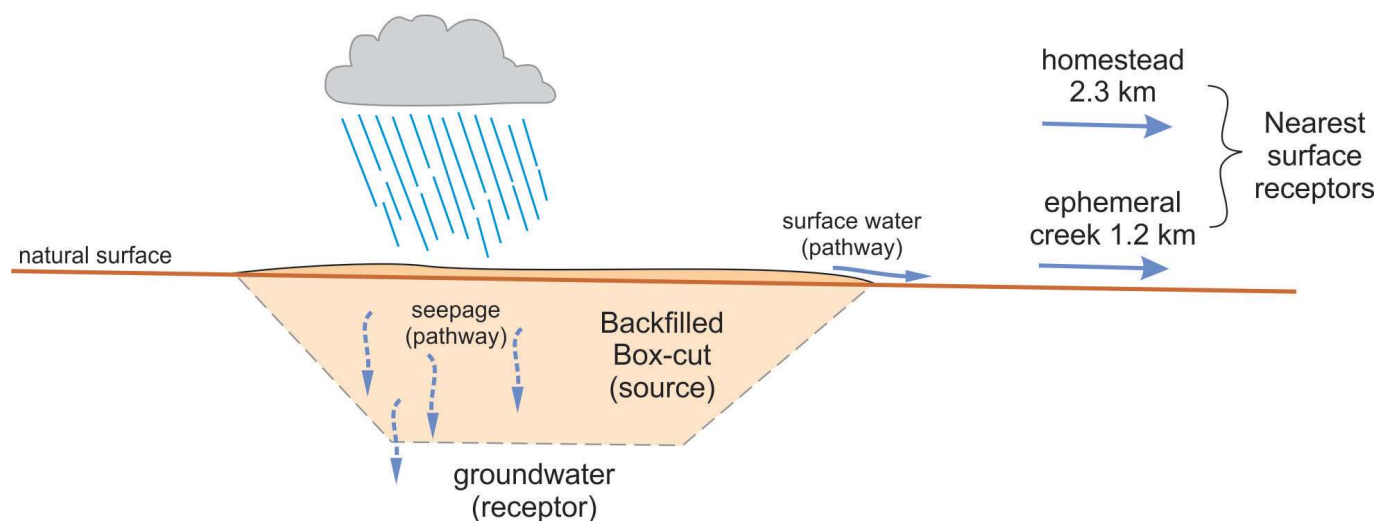
Figure 8: Source-Pathway-Receptor (SPR) conceptual site model at closure
