# Progressive Rehabilitation and Closure Plan

## Wards Well Mine

| <b>Document title</b> | Progressive Rehabilitation and Closure Plan |
| <b>Version number</b> | V3.0 |

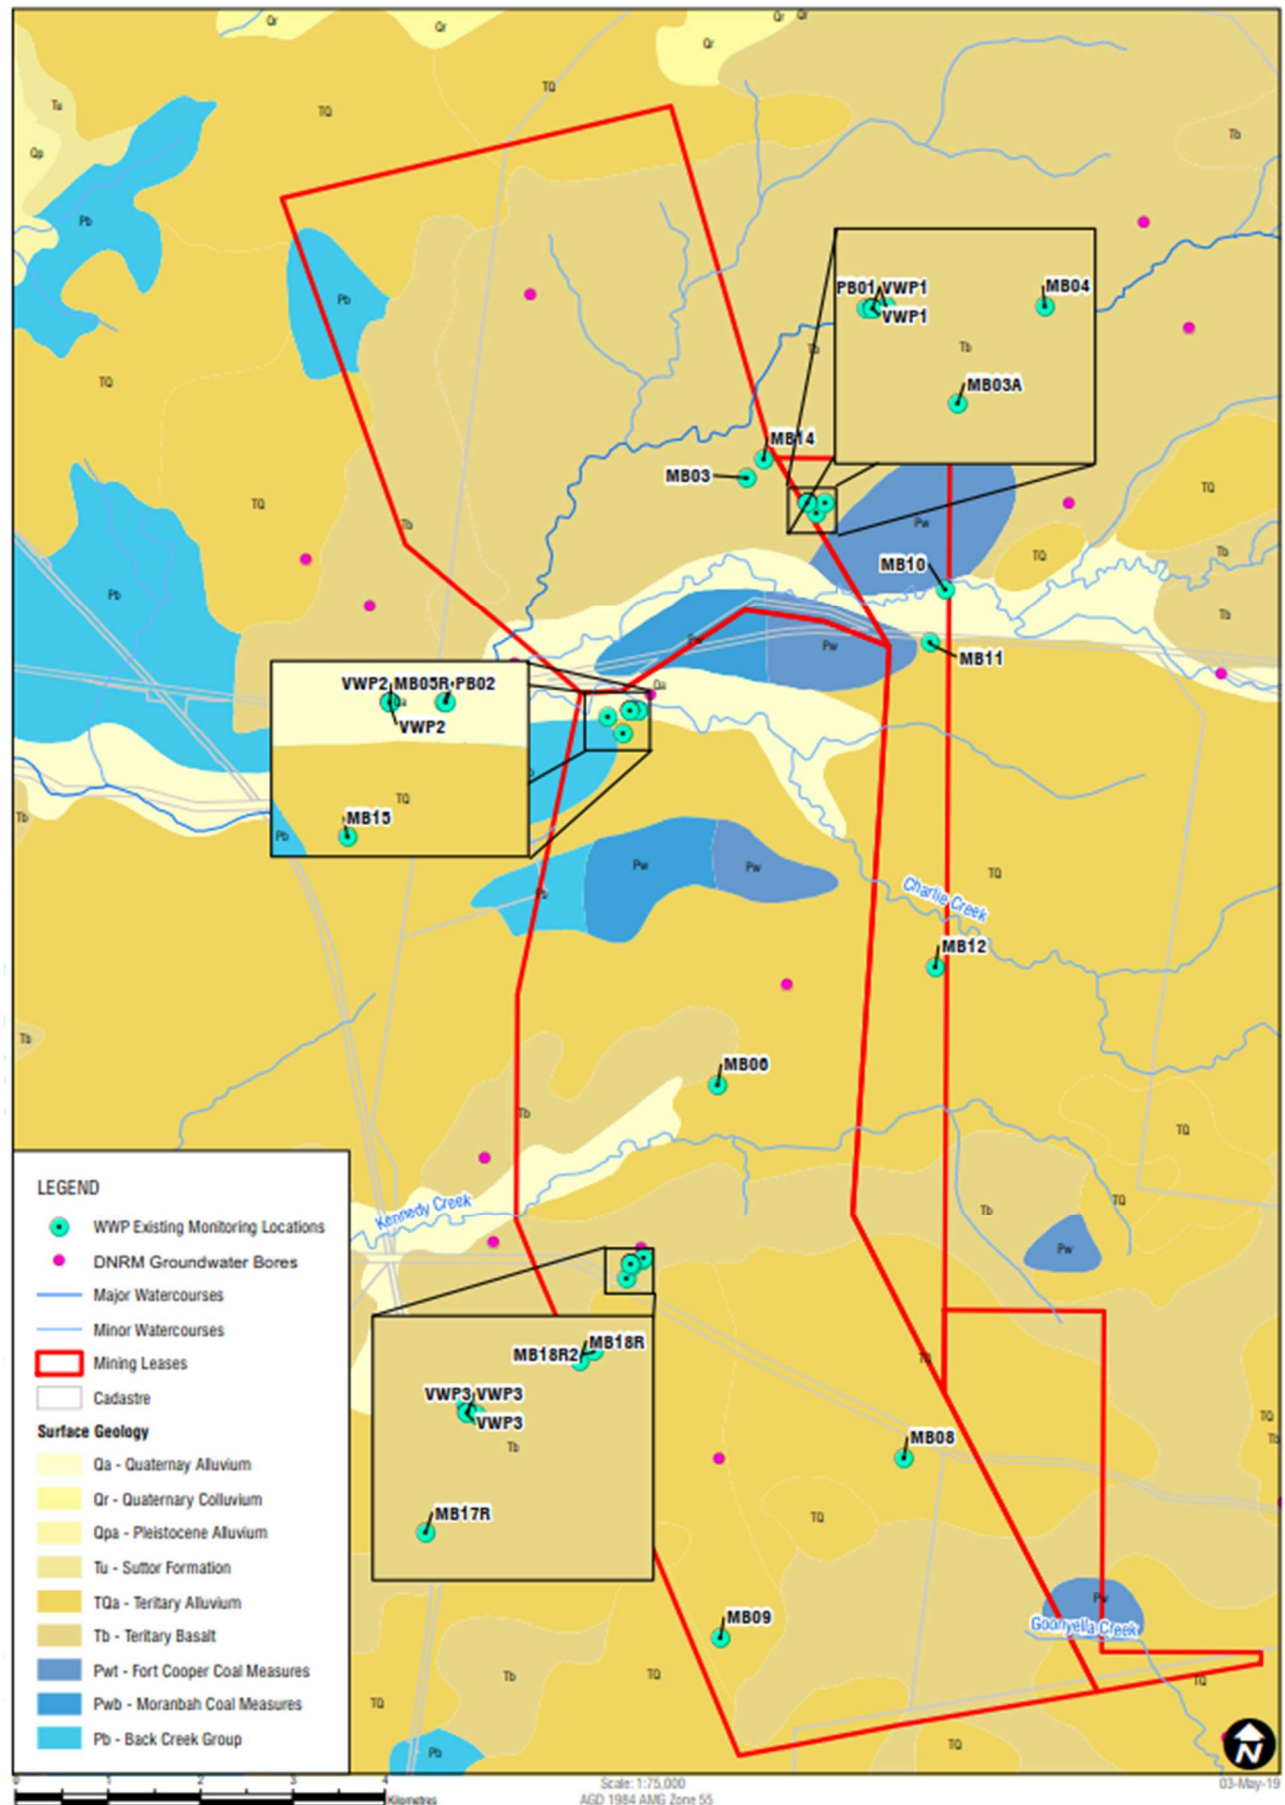
Figure 2: Wards Well Groundwater Monitoring Well Network

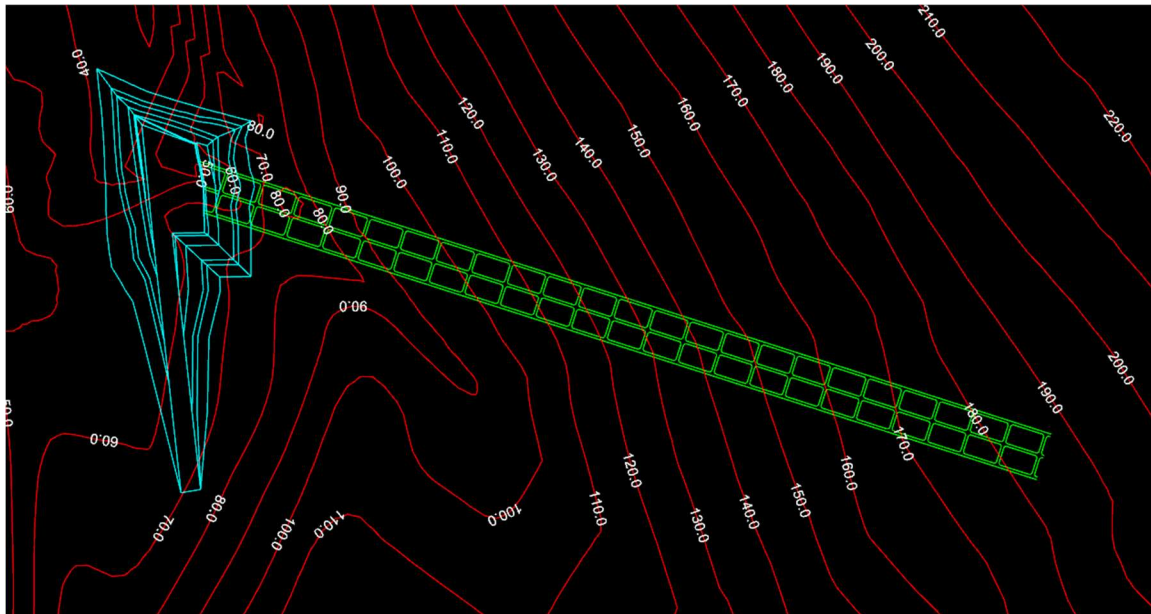
Figure 2 - Wards Well Exploration Adit Layout and Depth of Cover.

The Wards Well Exploration Adit is located on the Lancewood Mining Lease (Figure 1). As a part of mine closure provisions an assessment is required to determine if subsidence of the surface is likely to occur as a result of trial underground mining activities. The proposed underground mine comprises a 3 heading adit developed from a box cut highwall. The development will range in depth from 50m to 190m (Figure 2). The mining will take place in the Goonyella Middle seam within the Moranbah Coal Measures. The area is located in an area of reduced Tertiary sediment and basalt thickness.

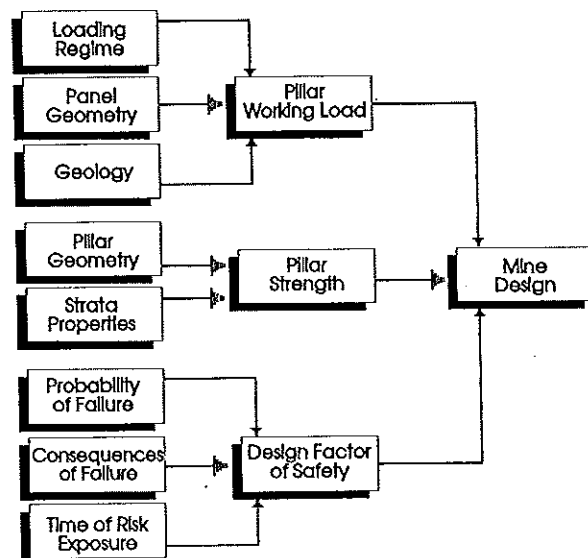
Principal Influences on Pillar Load, Strength and Factor of Safety

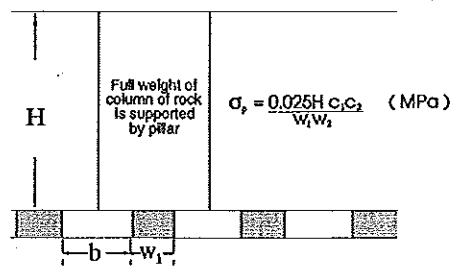
Figure 1. Tributary Area Load

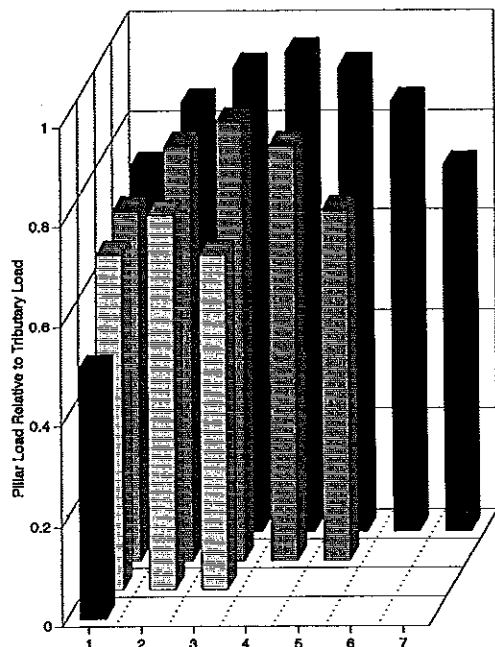
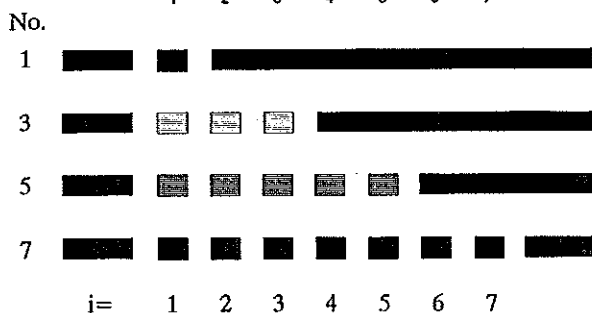
Figure 2. Panel Pillar Loading

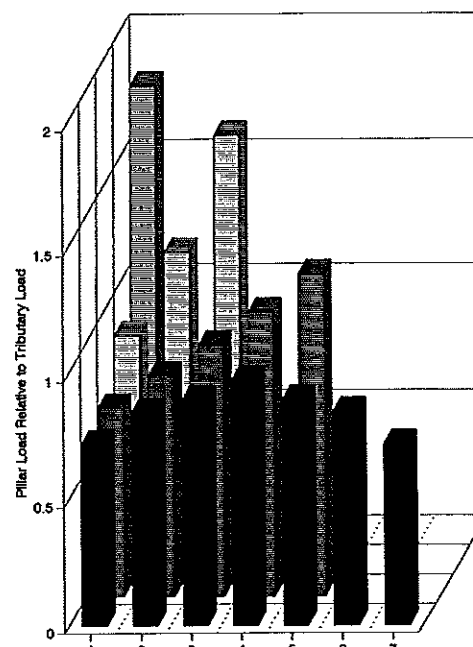
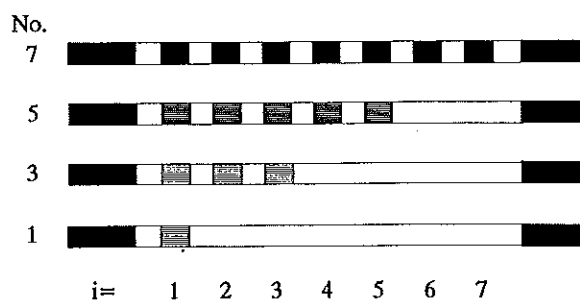
Figure 3. Abutment Loading on Standing Pillars

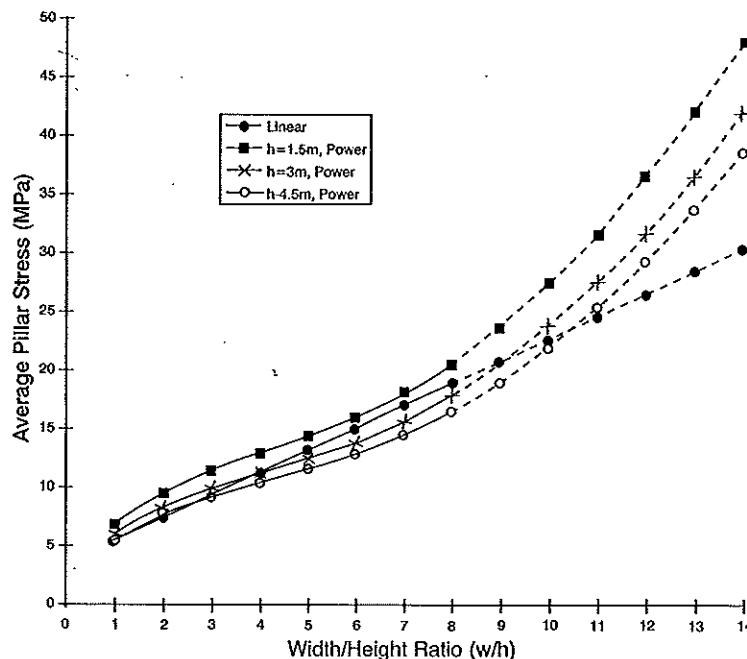
Figure 4. Strength v. Width/Height Ratio

cases, although collapsed cases carry a much higher weighting. Neither the Australian nor the South African databases contain a collapsed case above a  $w/h$  ratio of 8.2, hence there are no checks on the upper limits to which the formulae find application.

Either formula may be used up to a  $w/h$  ratio of 8 although the power law form is more flexible and preferred on the basis of statistical trends and conformity to physical principles. The power law formula is recommended for  $w/h$  ratios greater than 8 recognising, however, that there is a lack of data to validate either formula at  $w/h$  ratios greater than 8 and, especially, greater than 10.6 (upper stable case).

Close correlations were obtained in both cases, with the strength parameters for the linear and the power law formulae differing by only 5% and 3%, respectively. In all cases, a lower standard deviation was associated with the power law formulae (0.0689 to 0.0735) than the linear law formulae (0.0776 to 0.0863).

Probabilistic analysis is a far more rigorous mathematical process than curve fitting. It assigns a statistical significance to stable as well as to collapsed

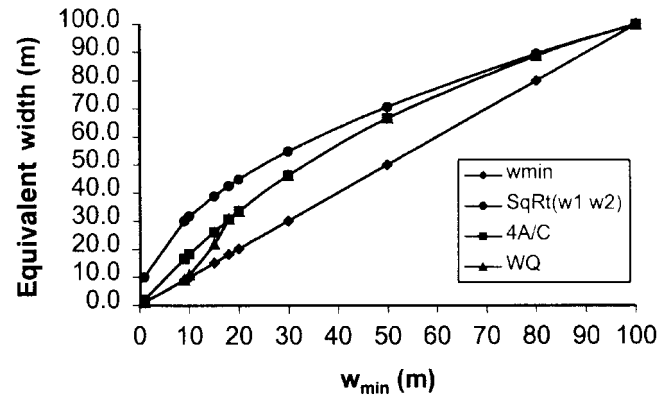
Figure 2.—Comparison of the various proposals for calculating the effective width of a 100-m-long, 3-m-high rectangular pillar.

Table 1 and figure 2 show the effects of the various approaches when applied to calculating the effective width of a 100-m-long, 3-m-high rectangular pillar.

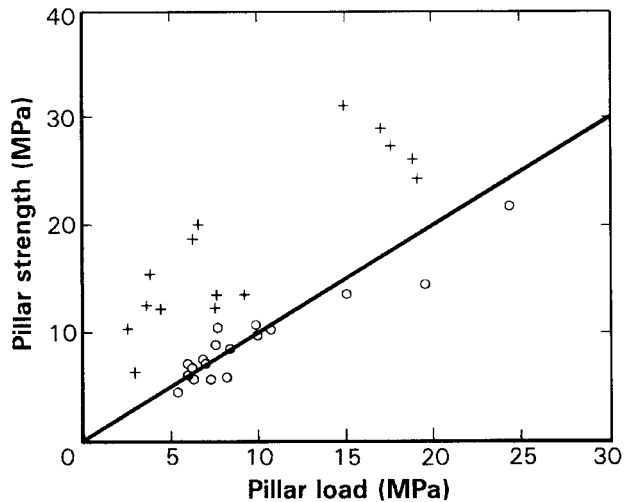
Figure 3.—Pillar strength and pillar load relationship for both the failed (o) and unfailed (+) Australian cases.

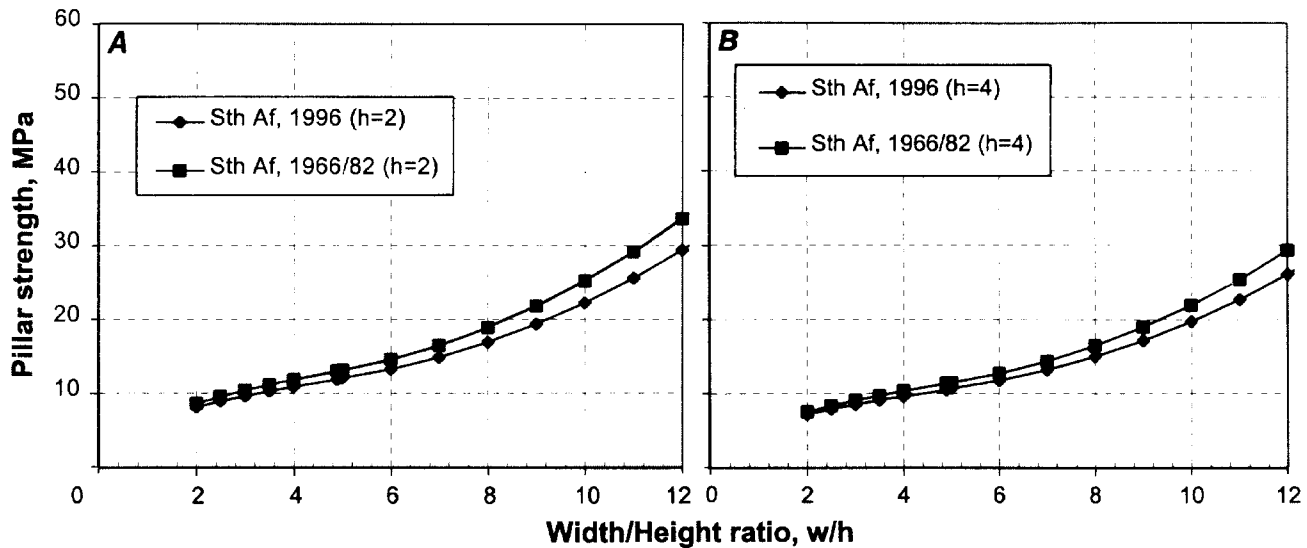
Figure 4.—Comparison between South African power formulas, 1966/82 and 1996. A,  $h = 2$  m; B,  $h = 4$  m.

Figure 4 shows the comparison between the pillar strength produced by equations 22a and 22b and that predicted by the original Salamon and Munro formula and its modified squat pillar form. In the case of a mining height of 2 m, the figure shows that for a given pillar strength, pillars designed with the

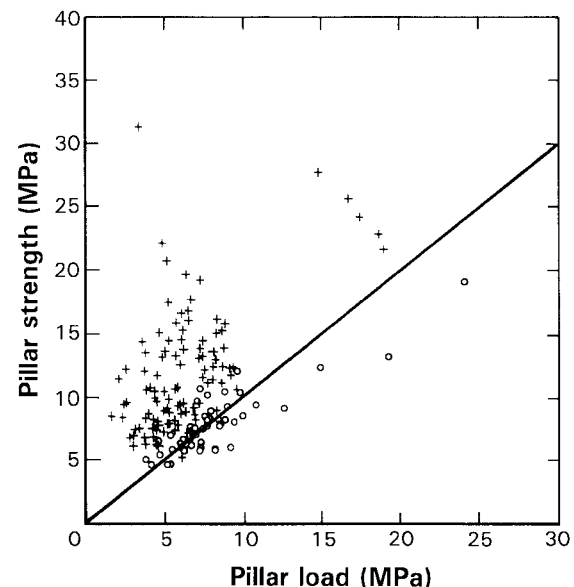
Figure 5.—The failed (o) and unfailed (+) cases in a pillar strength versus pillar load plot using the combined Australian-South African database.

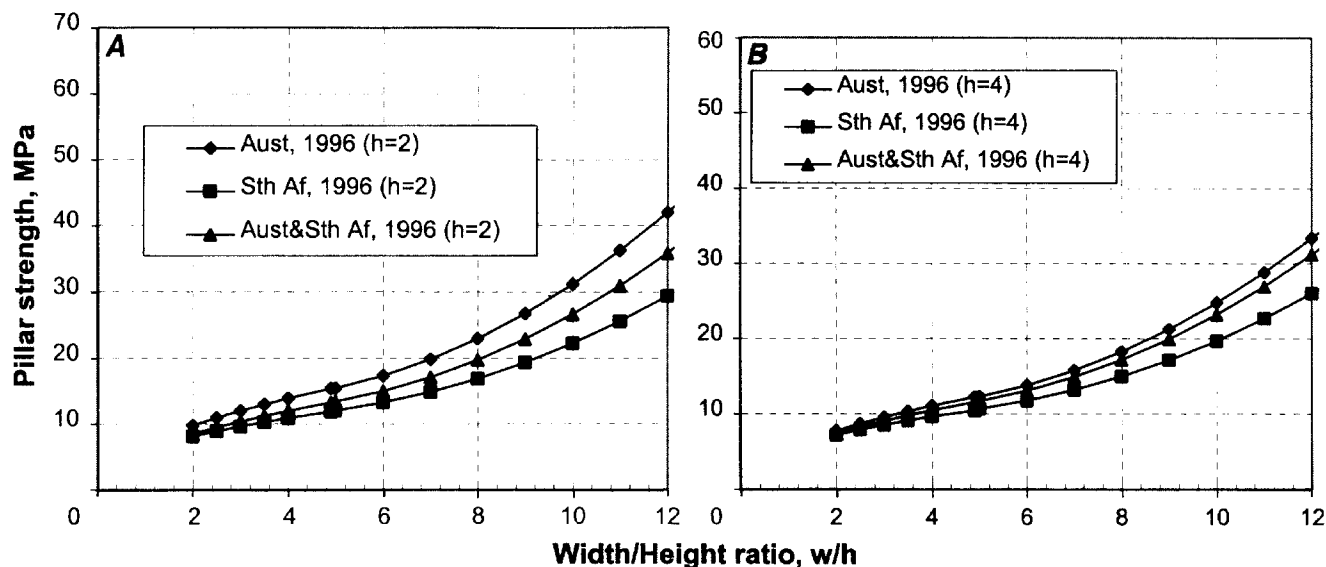
Figure 6.—Comparison between power law strength formulas derived for the Australian, South African, and combined databases. A,  $h = 2$  m; B,  $h = 4$  m.

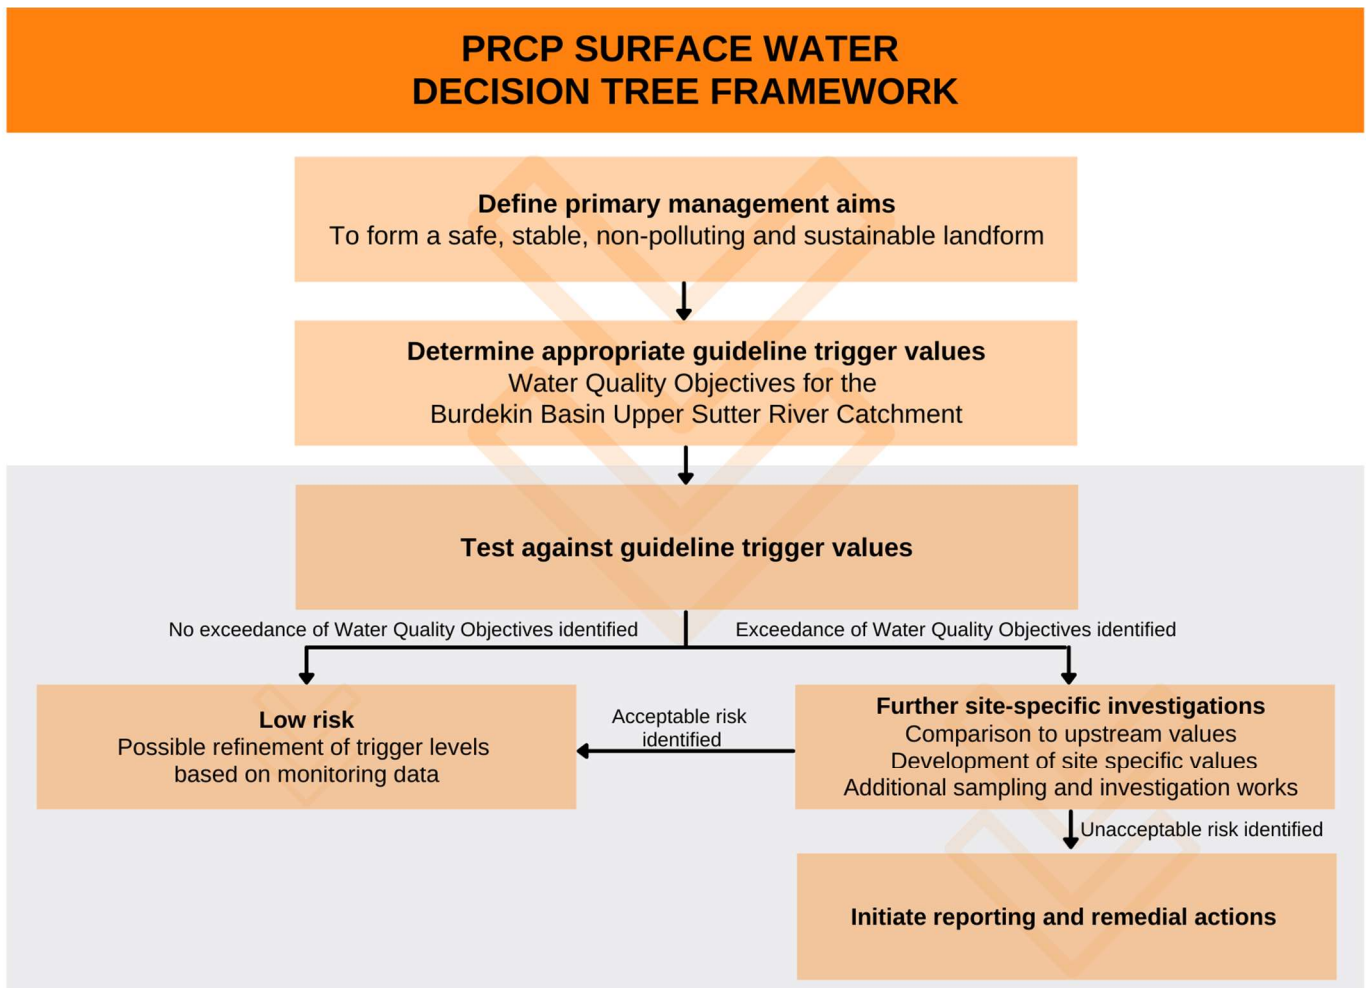
**Figure 36: Water decision tree framework (Adapted from ANZECC/ARMCANZ, 2000)**

For the purpose of the PRCP schedule, the application of the nominated water milestone criteria will follow the decision tree framework approach outlined in Section 3.3 of the ANZECC/ARMCANZ 2000 Water Quality Guidelines<sup>40</sup>, as shown below in Figure 36.

Source: Adapted from Figure 3.3 ANZECC/ARMCANZ 2000 Volume 1

In accordance with the ANZECC/ARMCANZ surface water decision tree framework and the preferential approach to the derivation of site-specific toxicant guideline values, Step 3 includes additional investigation and development of site-specific criteria where a statistical significant difference between upstream mean and receiving environment sample locations is identified. The development of site-specific criteria will be undertaken using the Commonwealth of Australia guidance: Assessing and managing water quality in temporary waters<sup>42</sup>. The aim of Step 3 is to take into consideration the specific environment in which the site is located including a more thorough investigation of the receptors and potential risks associated with any identified exceedance. This step will require suitable data sets and to be undertaken by suitably experienced persons.

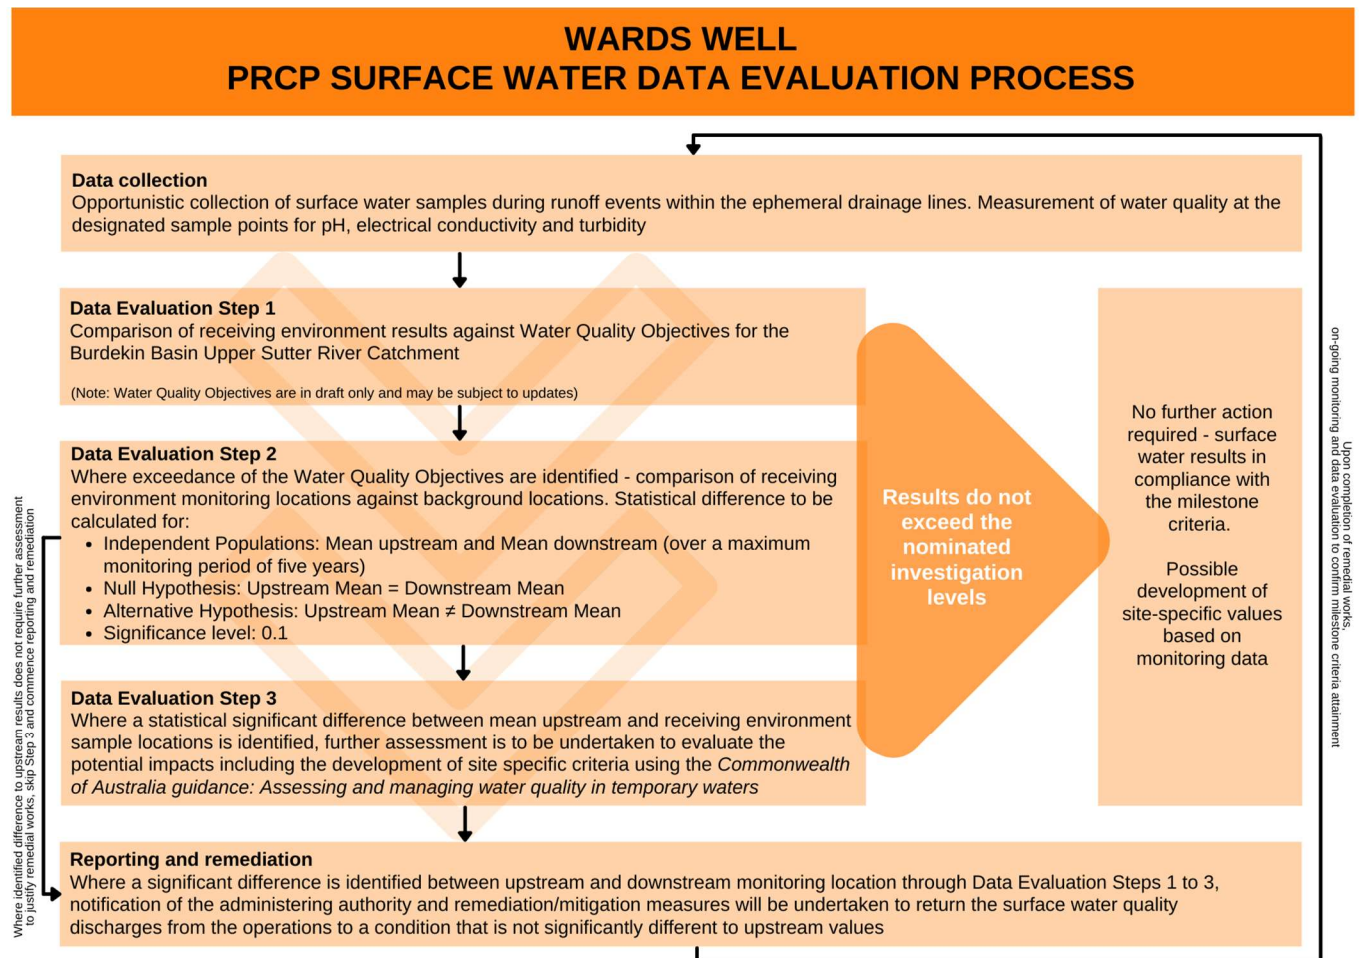
**Figure 37: Wards Well surface water data evaluation flow diagram**

Figure 37 provides a flow diagram of the approach to surface water data evaluation.

| | <ul style="list-style-type: none"> <li>• Rainfall runoff from the area is not significantly different to upstream values for the following: pH, EC and turbidity as per Appendix 13, Figure 37</li> <li>• Deep drainage from the area is not significantly different as per Appendix 13, Figure 37, to EC levels of: <ul style="list-style-type: none"> <li>– the EPP (Water) schedule documents water quality objectives for relevant groundwater chemistry zones; or</li> <li>– local water quality objectives developed in accordance with the Queensland Water Quality Guidelines</li> </ul> </li> <li>• Land suitability class <math>\leq 3</math>, or not different from pre-mining class if <math>\geq 4</math>. The assessment is to be conducted by an appropriately qualified person and completed in accordance with LSA Framework for Open-Cut Coal Mine Rehabilitation 2018 (A rule-set for land suitability assessment of sustainable beef cattle grazing on land rehabilitated after open-cut coal mining in the Bowen Basin Queensland) unless otherwise agreed in writing between the administering authority and the environmental authority holder.<br/><br/>If the land suitability class is assessed as not different from pre-mining class if <math>\geq 4</math> for all or a portion of a rehabilitation area, an assessment of reference sites must be carried out to determine if the limitation/s resulting in the class of <math>\geq 4</math> is consistent with that of reference sites.</li> <li>• Certification by an appropriately qualified person that pasture meets a pasture condition rating <math>\leq 3</math>, based on the Pasture Condition Assessment Table as per Stocktake: Balancing Supply and Demand (<a href="https://futurebeef.com.au/workshops/sustainable-grazing/stocktake-balancing-supply-demand/">https://futurebeef.com.au/workshops/sustainable-grazing/stocktake-balancing-supply-demand/</a>), as provided in Table 33.</li> </ul> |

| The following <b>Milestone Criteria</b> will demonstrate achievement of the Rehabilitation Milestones: | |
|---|---|
| RM7 | <ul style="list-style-type: none"> <li>Deep drainage from the area is not significantly different, as per Appendix 13, Figure 37, to EC levels of: <ul style="list-style-type: none"> <li>the Environmental Protection (Water and Wetland Biodiversity) Policy 2019 schedule documents water quality objectives for relevant groundwater chemistry zones; or</li> <li>local water quality objectives developed in accordance with the latest version of the Queensland Water Quality Guidelines</li> </ul> </li> </ul> |
