# Progressive Rehabilitation and Closure Plan

## WARWICK LIMESTONE MINE

**WARWICK LIMESTONE MINE –  
PROGRESSIVE REHABILITATION AND  
CLOSURE PLAN**

29 SEPTEMBER 2023

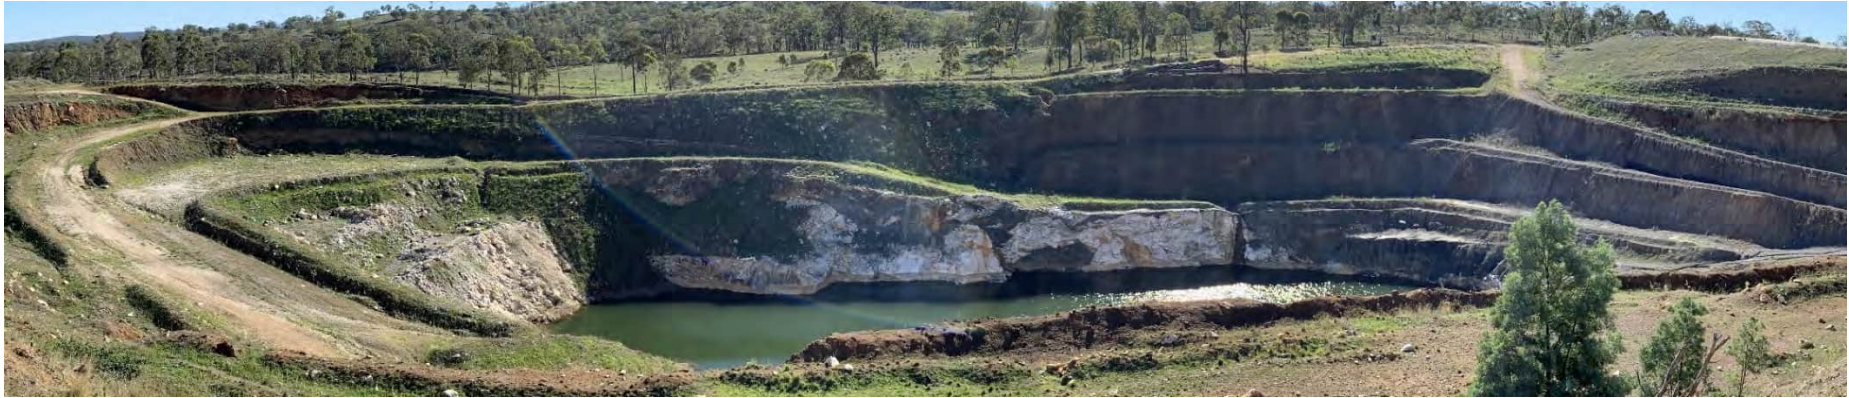
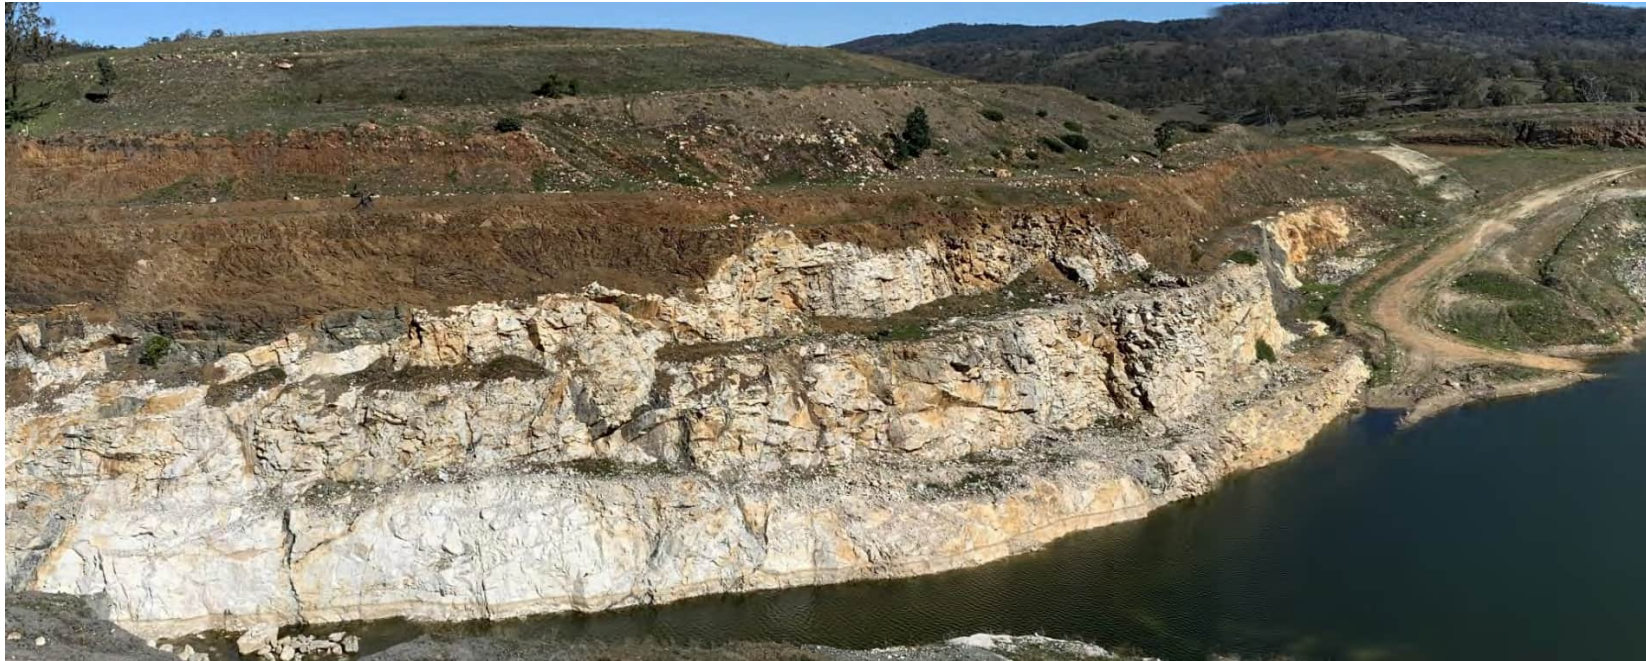
**Figure 1.** (a) North and (b) South walls at the west end of East-West pit. Waste rock dump WRD 1 is behind the crest. The west ramp (right) may be retained.

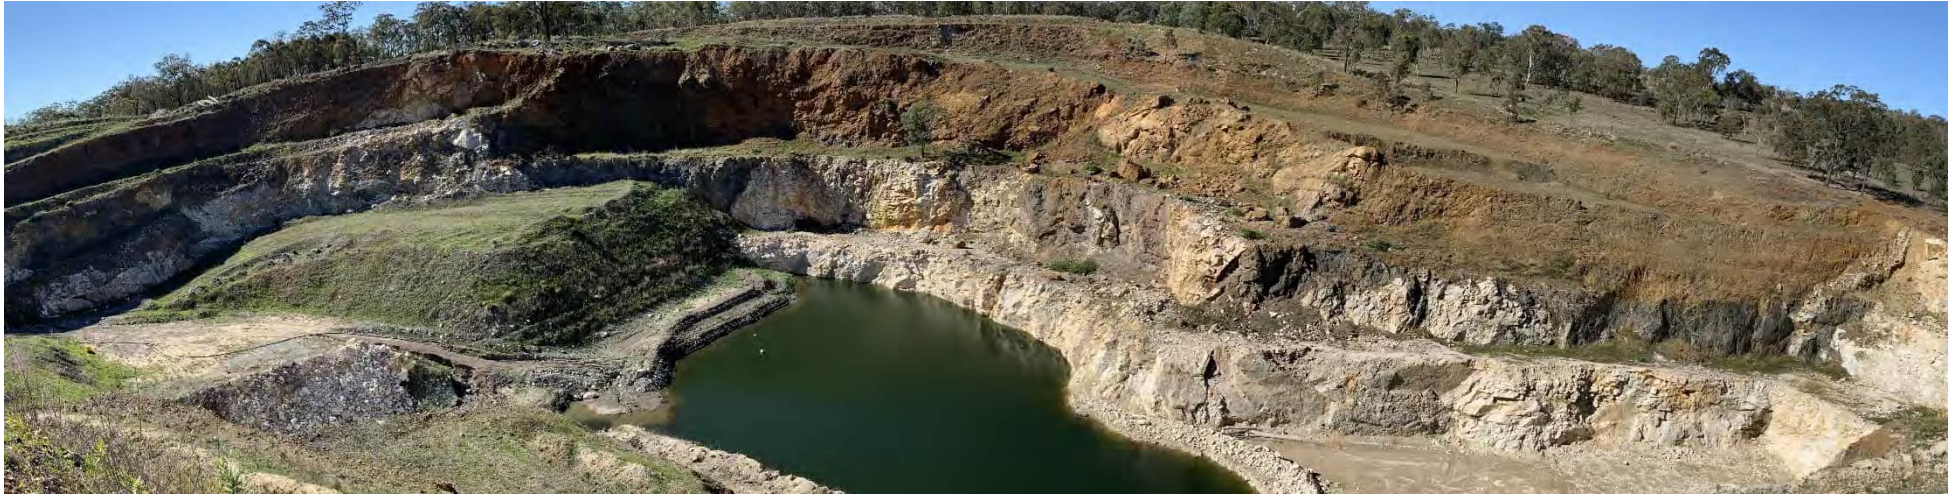
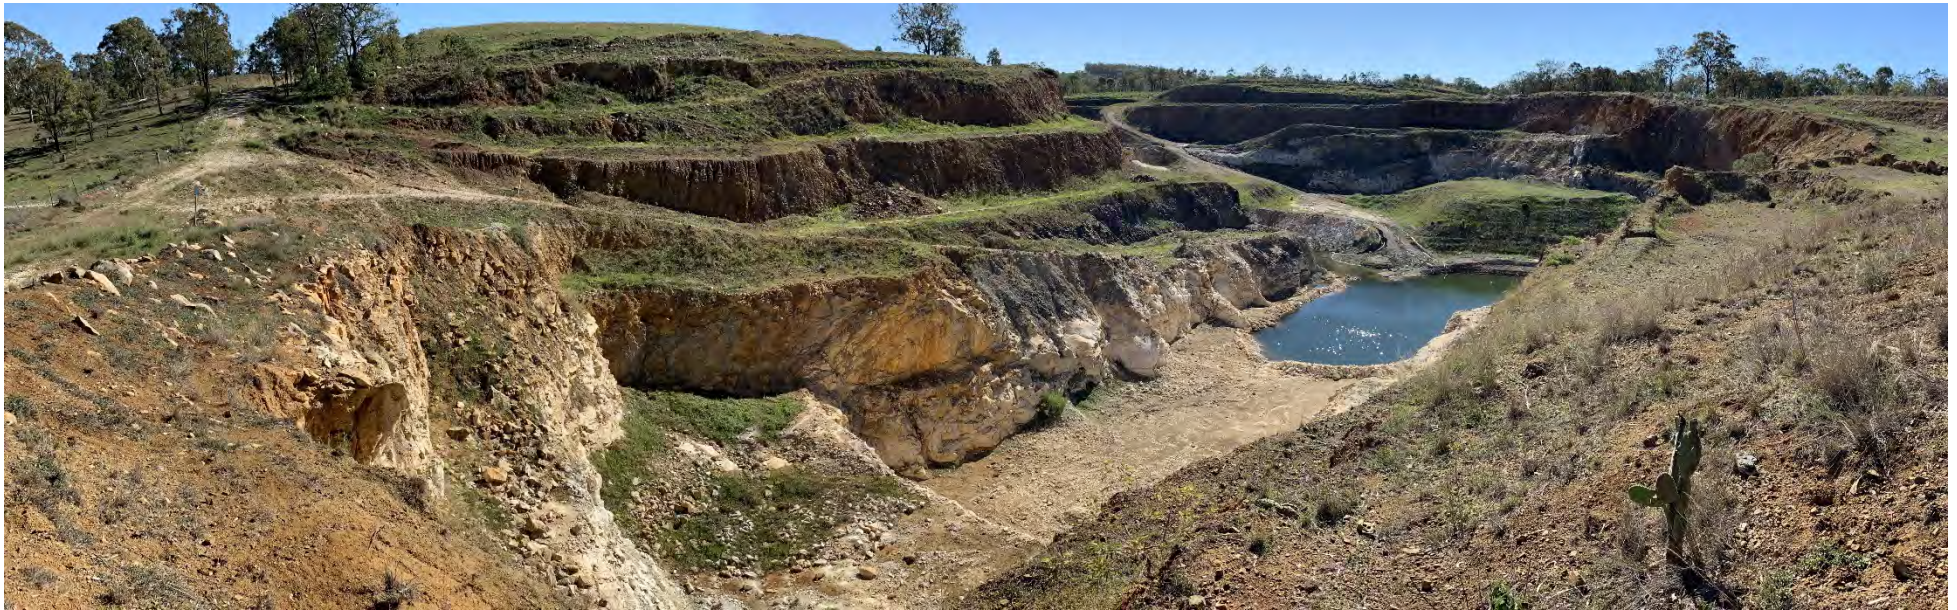
**Figure 2.** (a) Northeast and (b) Southwest walls at the south end of East-West pit. Waste rock dump WRD 1 is behind the crest.

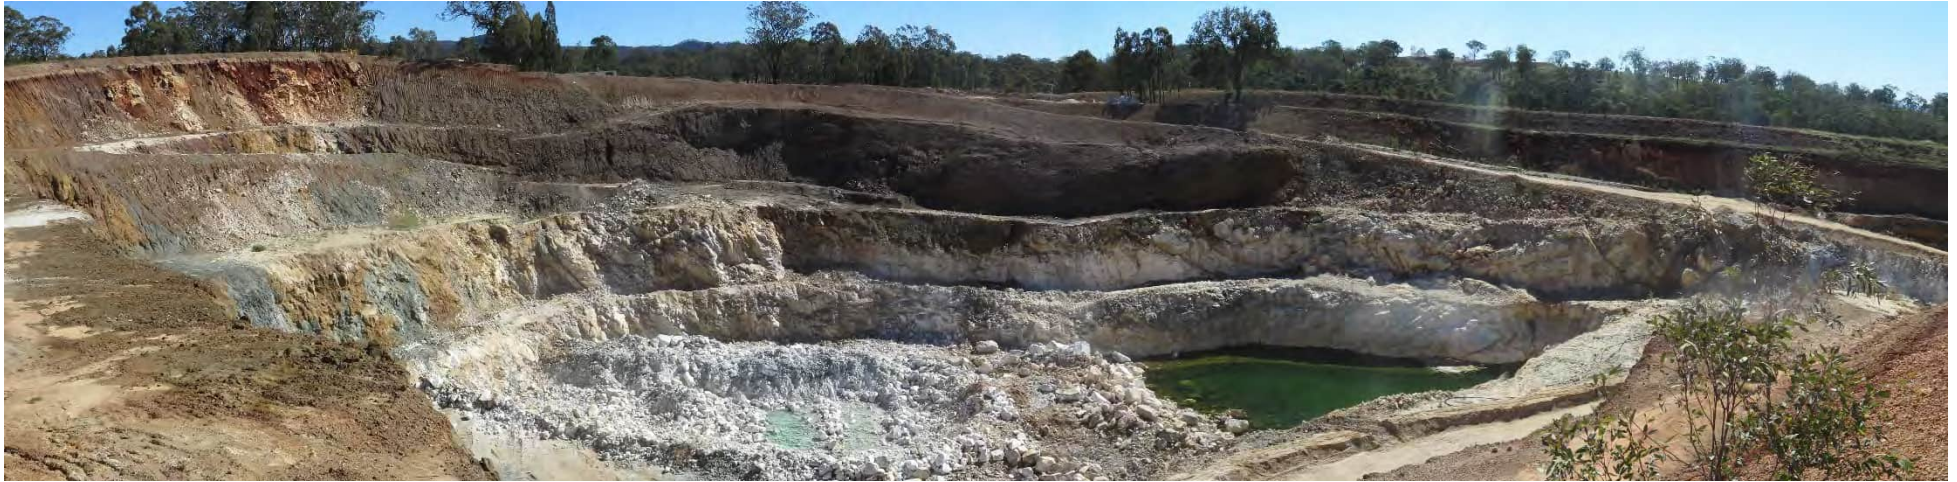
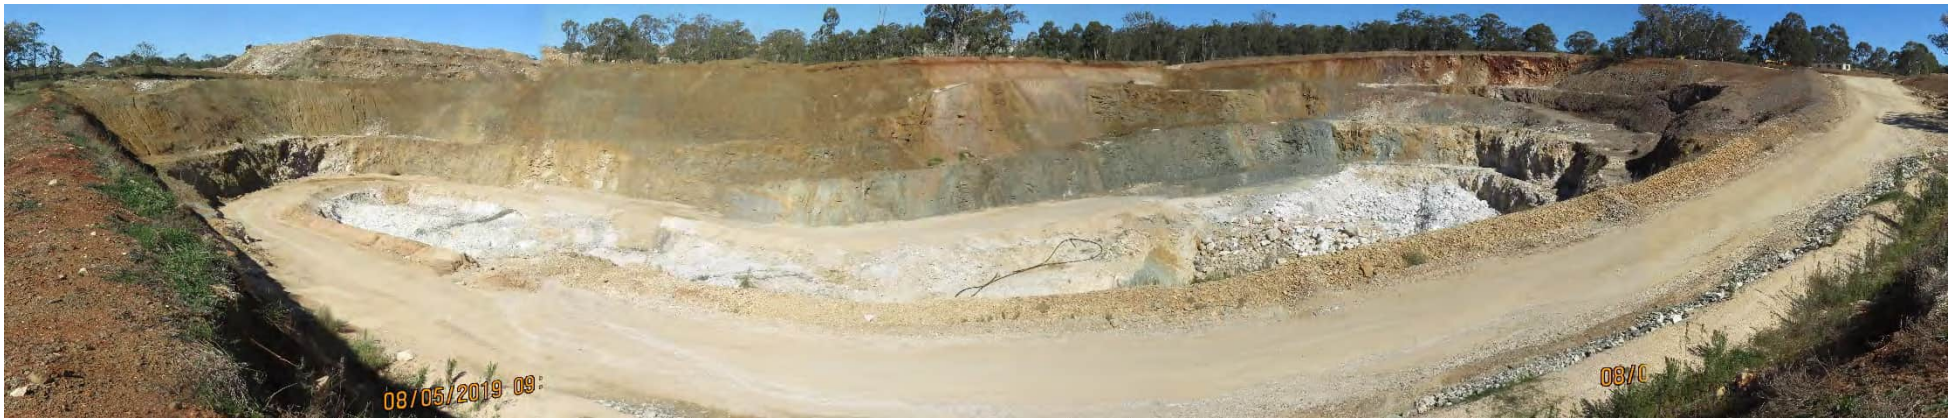
**Figure 3.** (a) North and (b) South walls of Phoenix pit. The main ramp is to be retained.

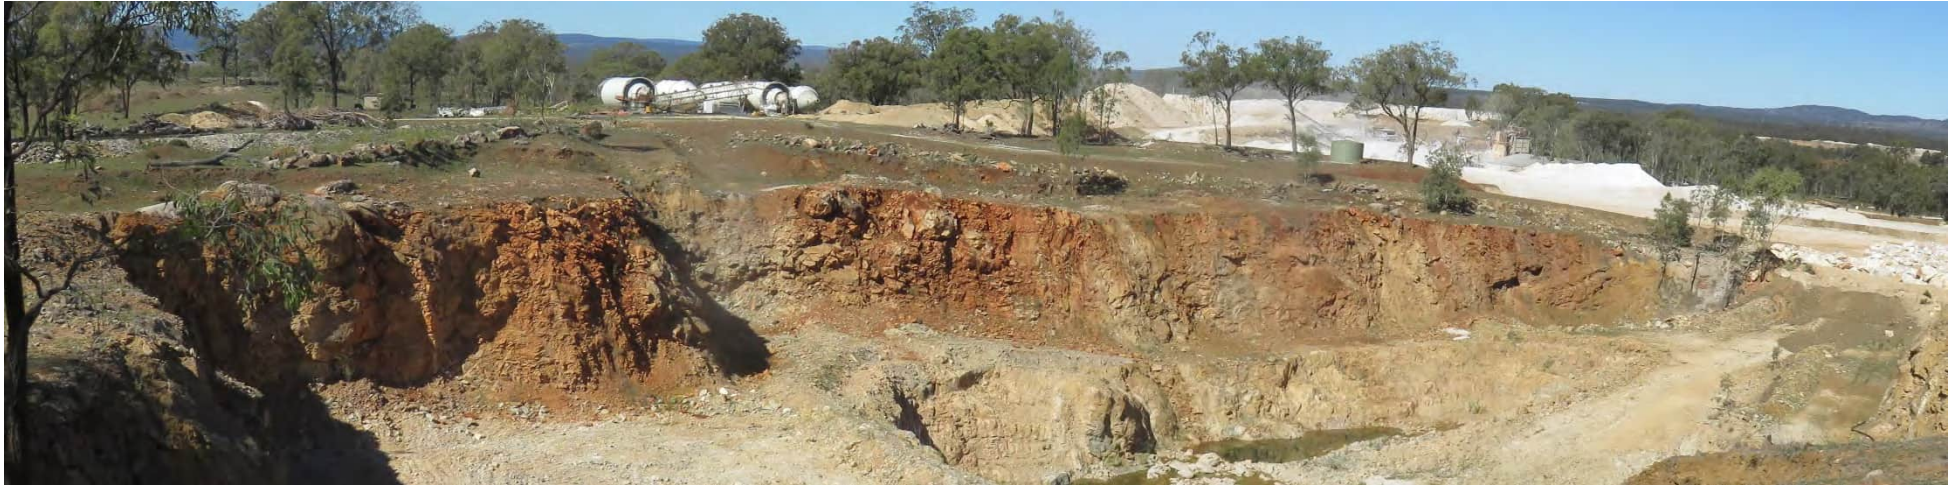
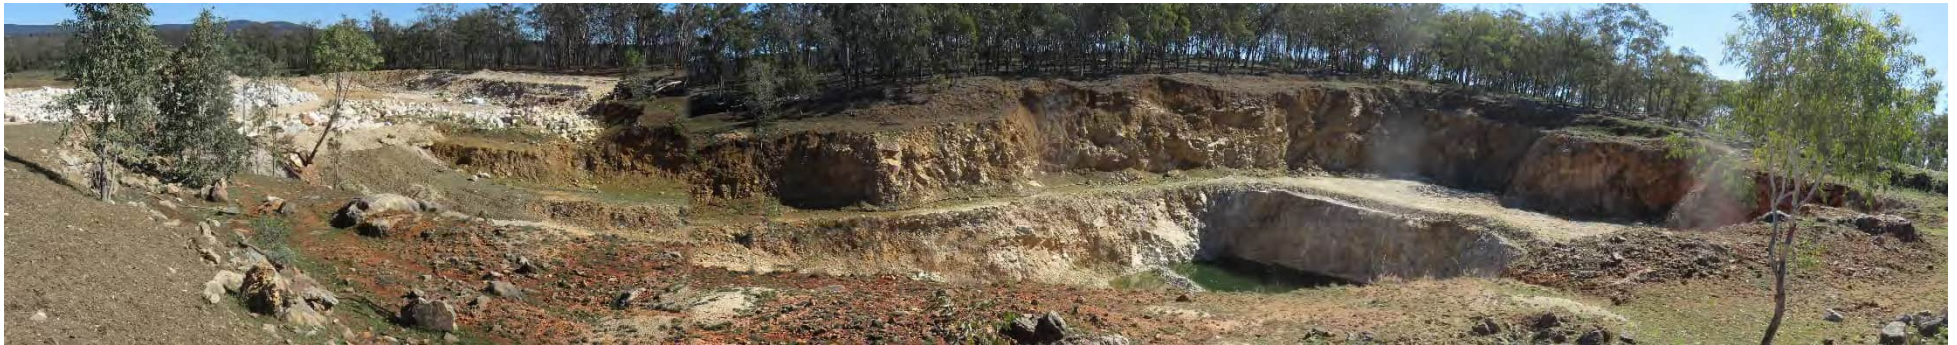
**Figure 4.** (a) East and (b) West walls of Aspinal pit. The pit to be partially filled thereby reducing the slope angles .

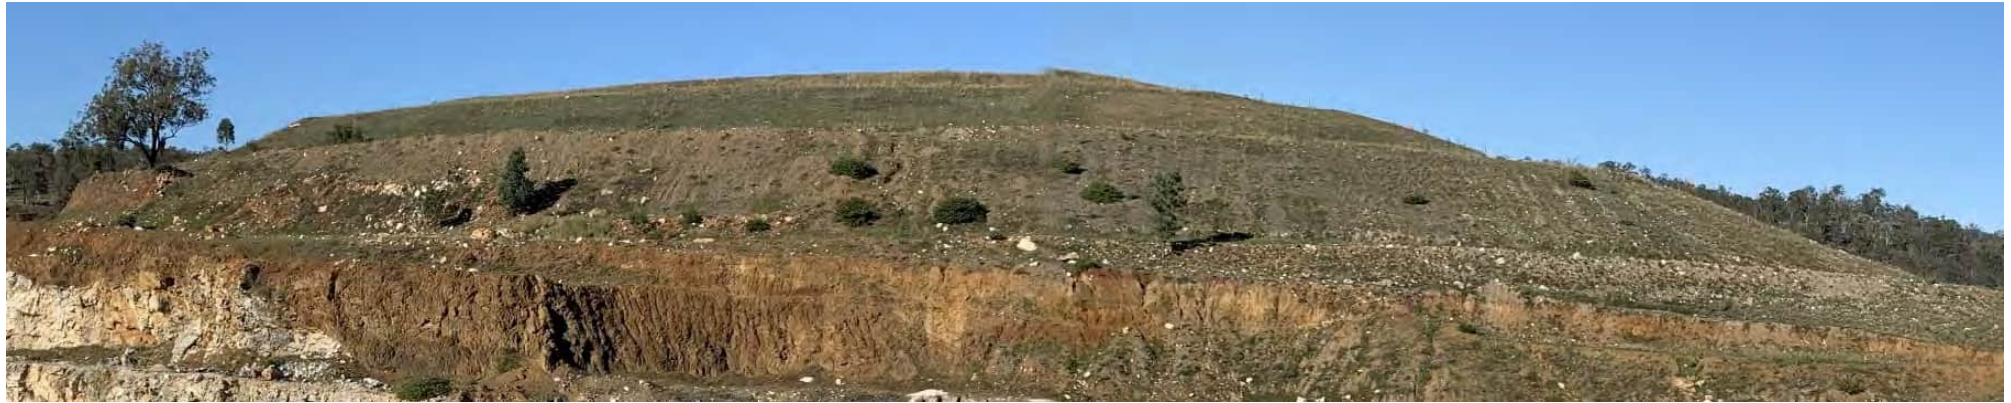
**Figure 5.** WRD 1 to the west of the East-West pit. The dump to remain in-situ. (b) The bund along the crest is inadequate as an abandonment barrier. It is to be replaced with an abandonment bund (Section 7.3.2). The bund is to tie into the bund encircling the pit at the east and west ends of the dump.

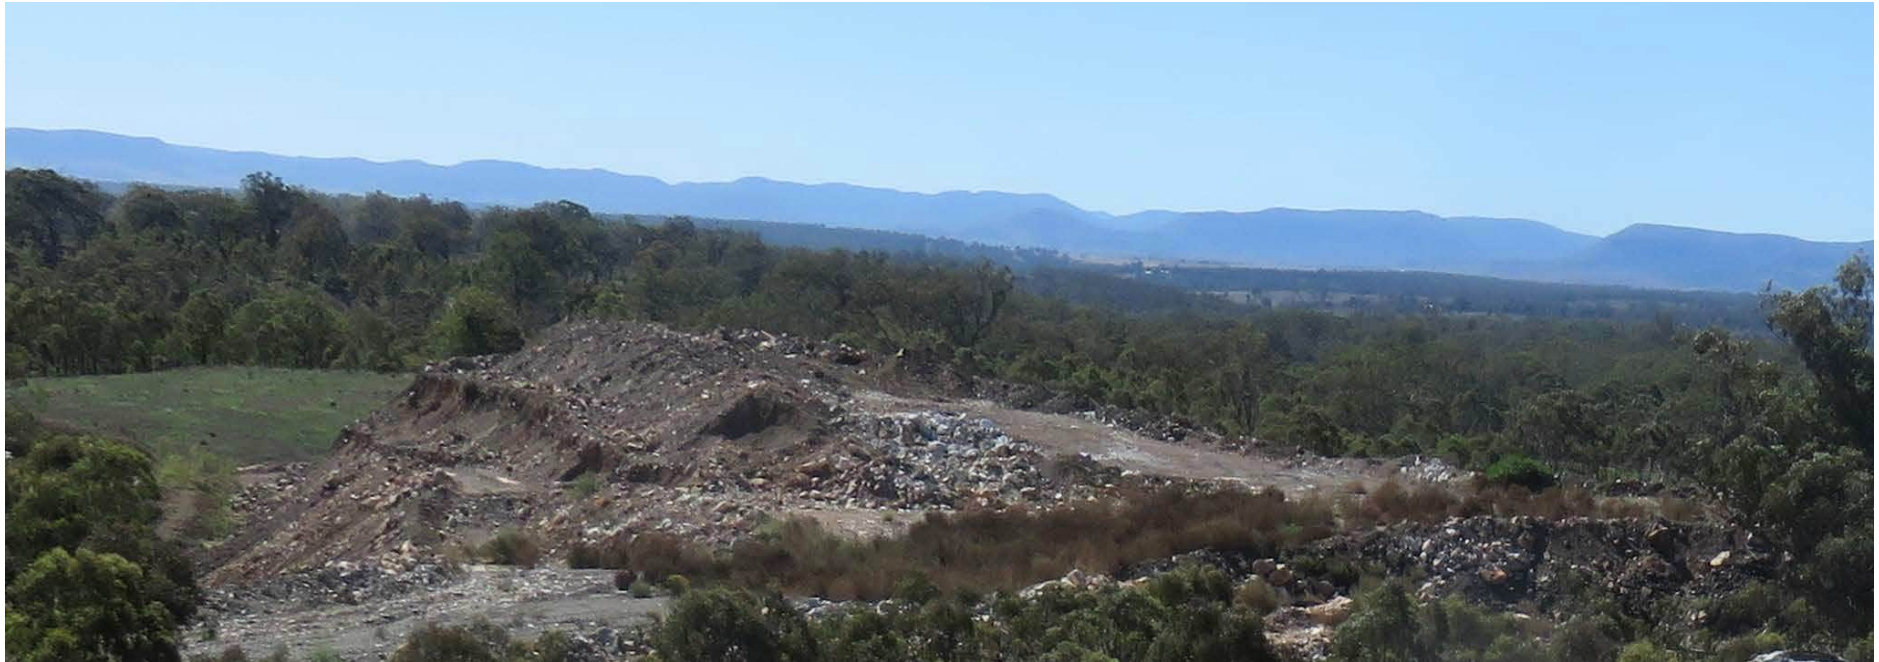
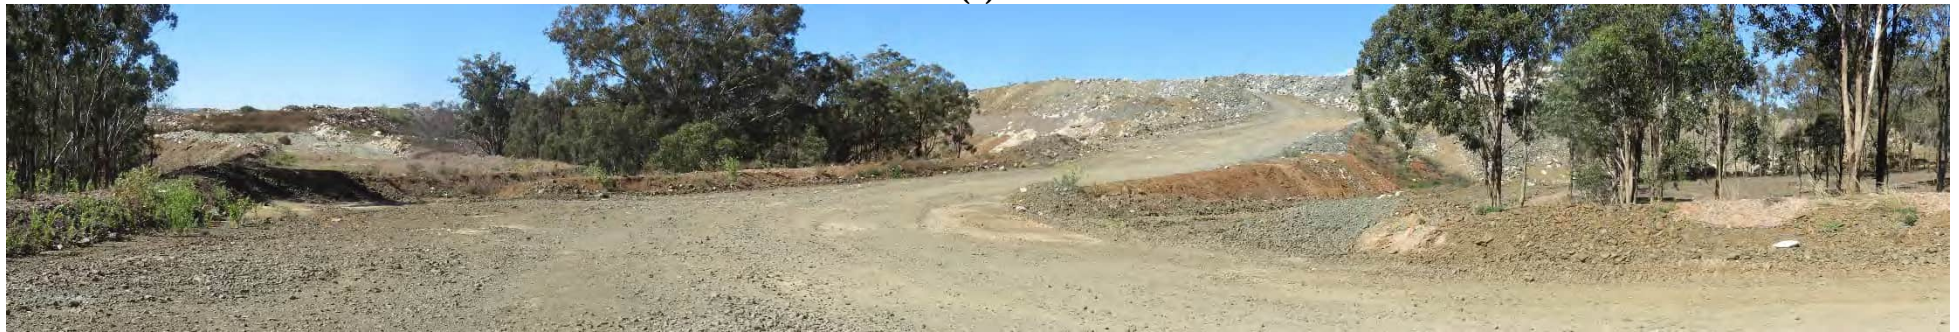
- WRD 2 is located southeast of Phoenix pit (Figure 6).
- It comprises two sections, North (Figure 6a) and South (Figure 6b). The sections are separated by  $5,600\text{-m}^2$  of natural scrub.
- Topsoil was stripped from the natural surfaces to form the footings for each section of the dump.

**Figure 6.** WRD 2 a) North section 35-m east of the Phoenix pit and b) South section 140-m south of the pit. The dump will provide rocks for the abandonment bunds. The dumps will then be graded, shaped, topsoil placed and hydroseeded.

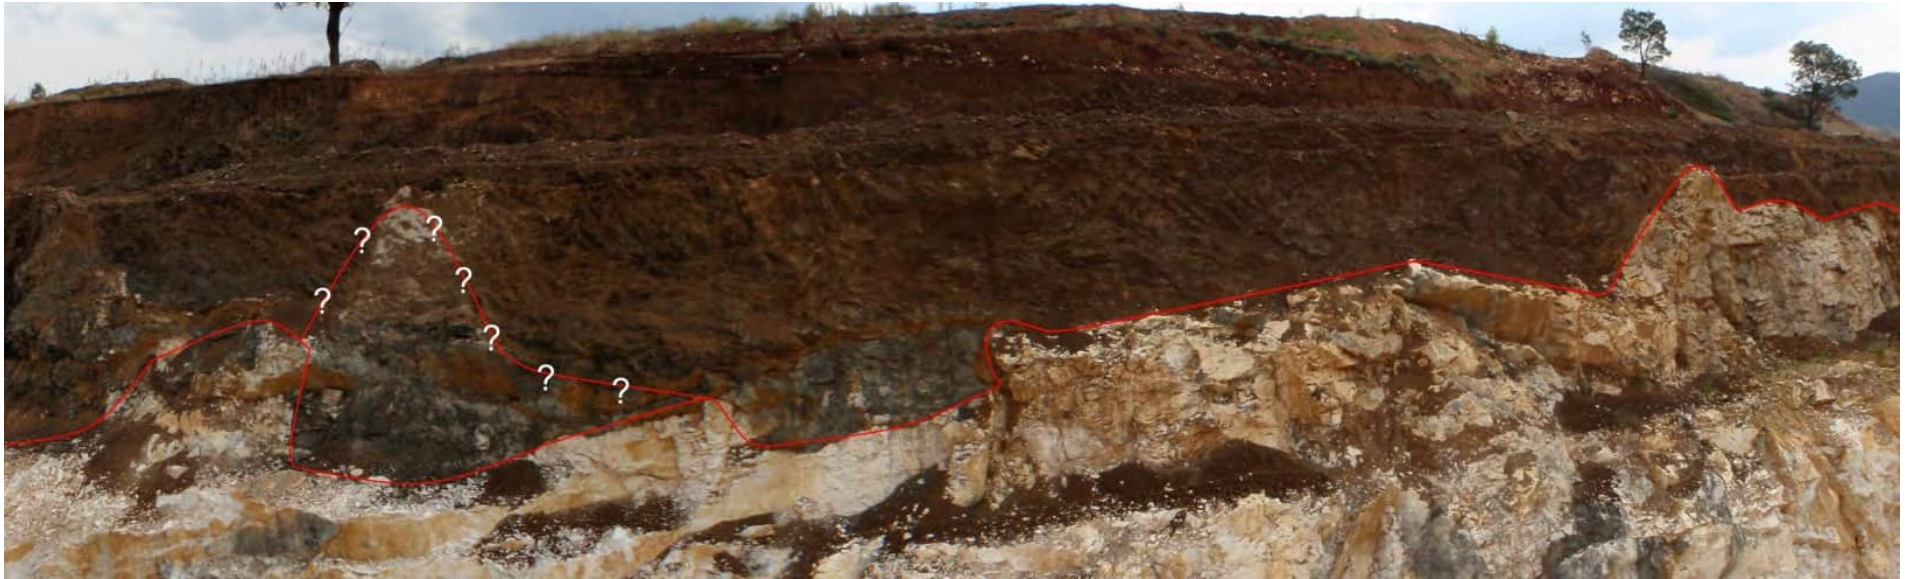
The relative proportions of the various carbonates in a particular area are a function of the degree to which alteration has occurred. Dissolution of the upper surfaces of the limestones have created karst features; predominantly an irregular upper surface (Figure 7) and dilated<sup>4</sup> joint apertures (Figure 8); the latter features being particularly evident at the east end of the East-West pit where caves are present.

**Figure 7.** Dissolution has resulted in the upper surface of the limestone being karstified hence irregular.  
Example is from the south wall at the north end of the East-West pit.

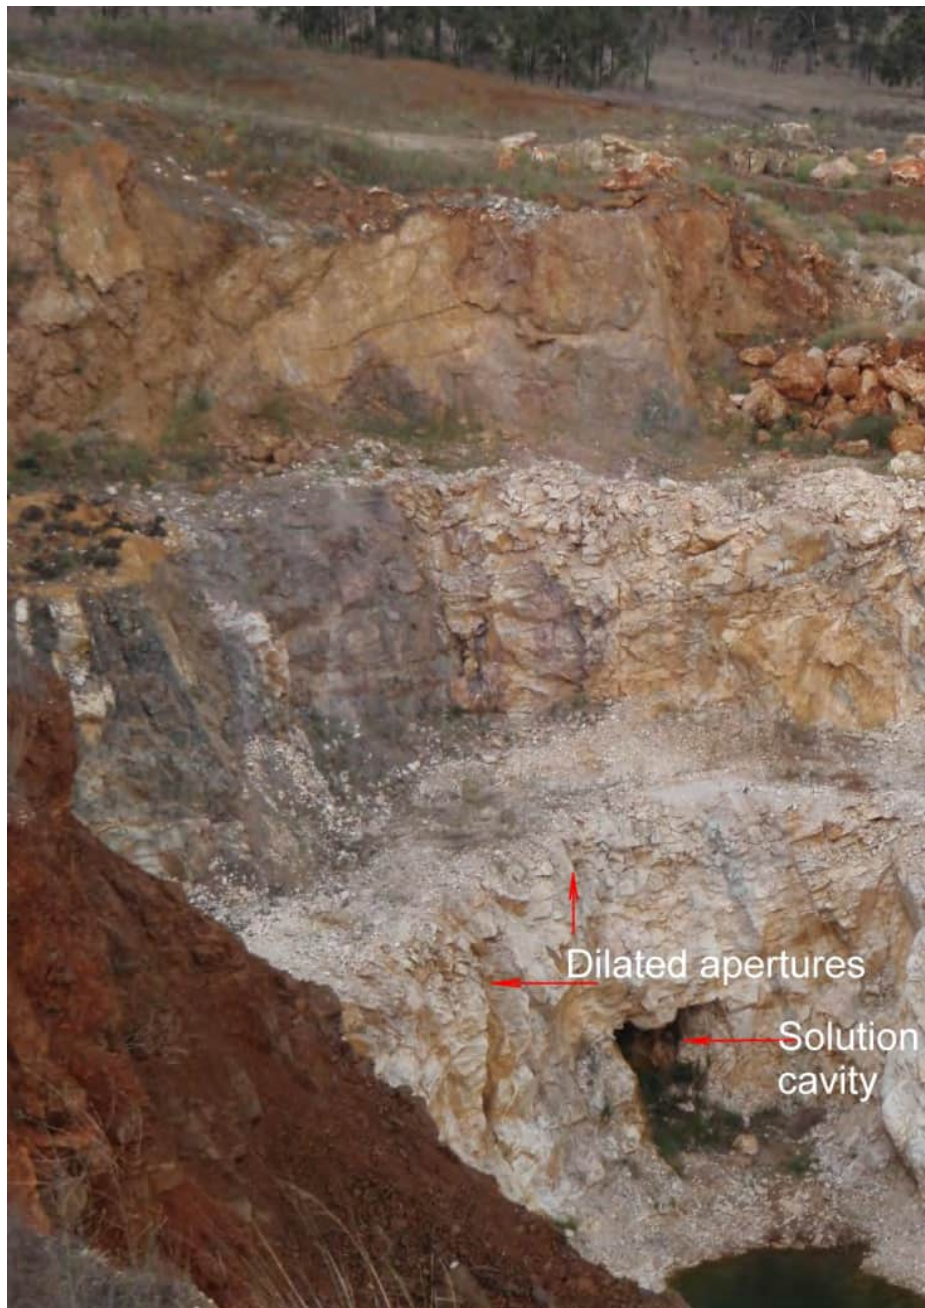
**Figure 8.** Karst features exposed in the northwest wall at the south end of the East-West pit.

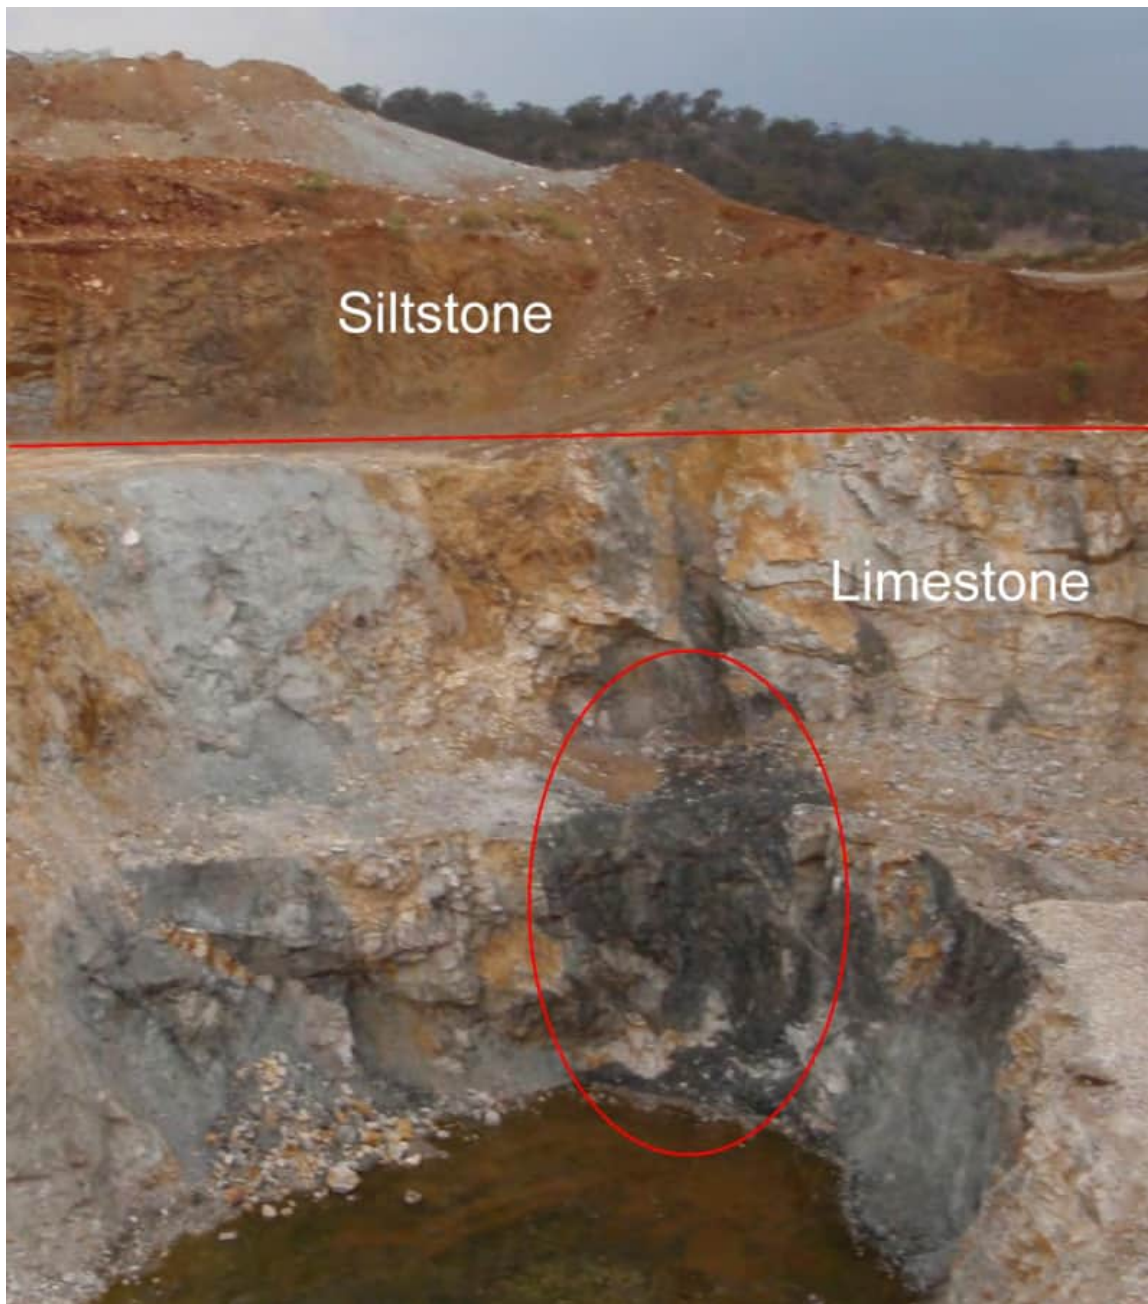
Andesites have intruded throughout the site diluting the reserves (Figure 9).

**Figure 9.** Limestone intruded by grey andesite exposed in the west wall at the north end of the East-West pit.

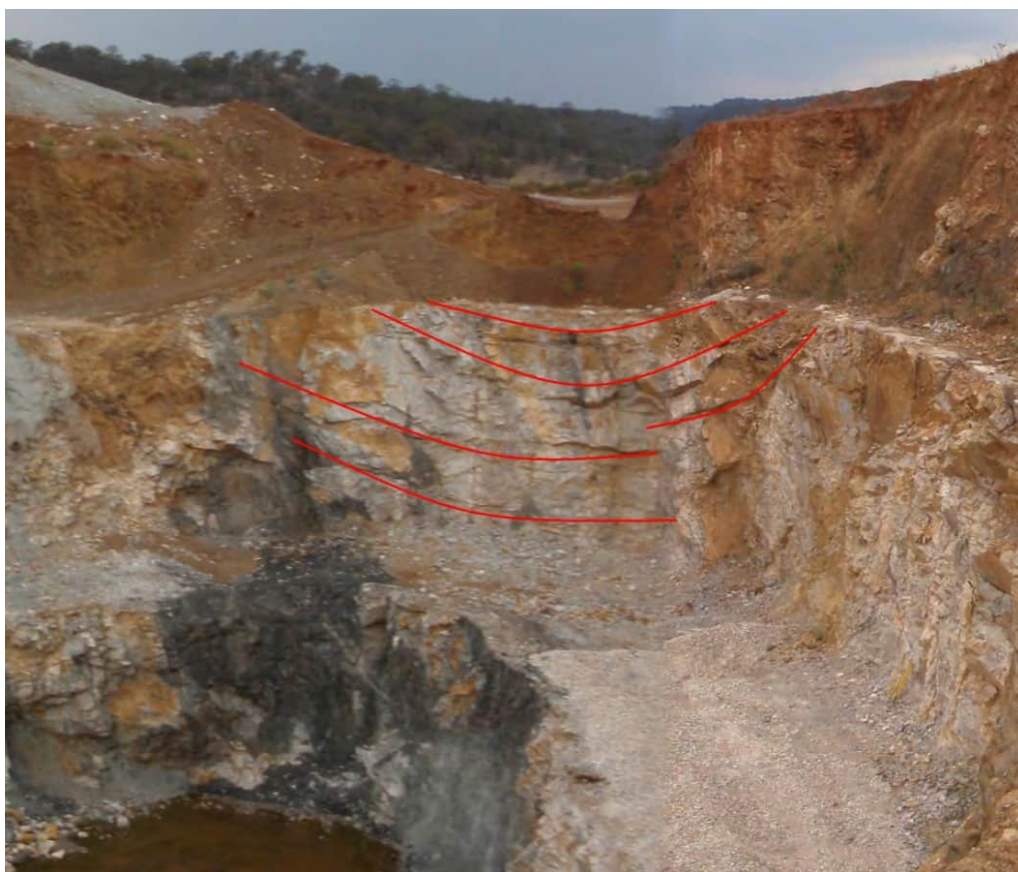
The “bent” plan view of the East-West pit is due to the rocks in the region having been folded and faulted along strike. The hinge of a downward closing synclinal fold and associated faulting can be seen in the north-west corner of this pit (Figures 10). Evidence of folding is less obvious in the other pits.

**Figure 10.** Example of synclinal fold in the upper benches at the west end of the East-West pit.

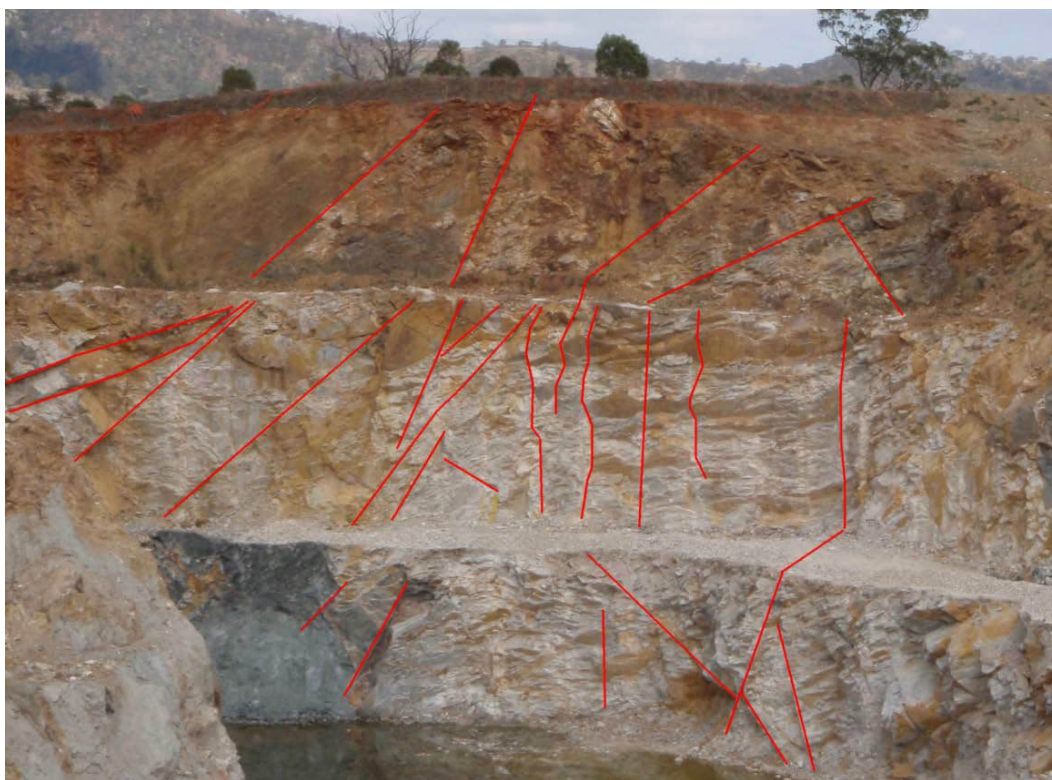
Many other less persistent faults extend across all pits (Figure 11). Many of these faults are parallel to, and likely associated with, the more persistent faults that have displaced the orebodies between pits.

**Figure 11.** Examples of faulting exposed in the upper benches at the west end of the East-West pit.

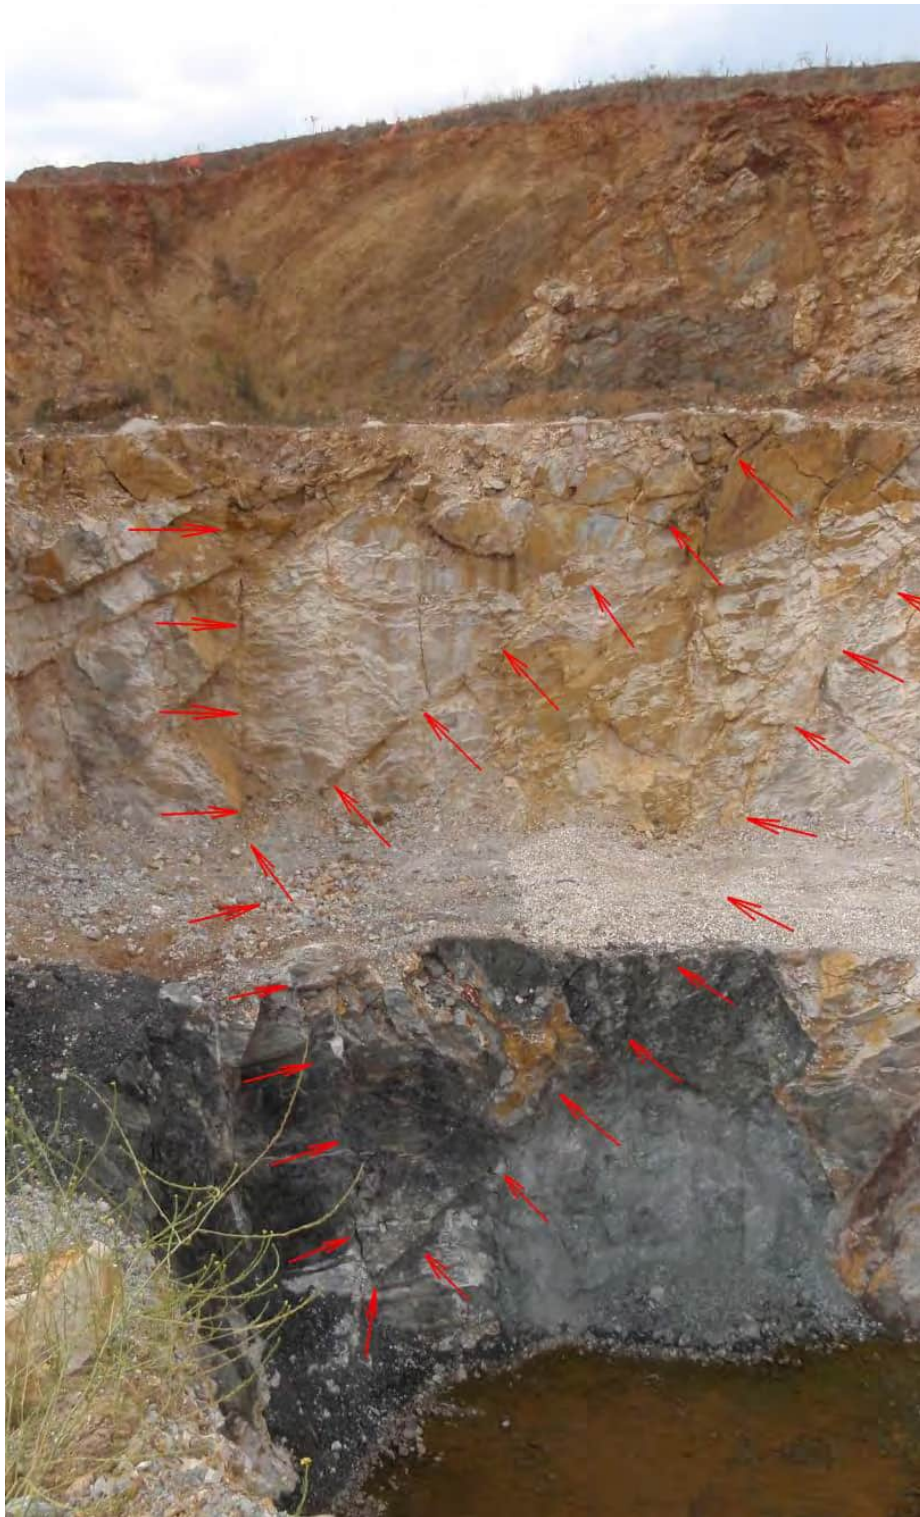
Bench scale instabilities involving intersections of two or more of the faults, or intersections of faults and jointing and/or bedding surfaces, have occurred to bench scale (Figure 12). Instabilities could extend over several benches although none of this scale has occurred to date.

**Figure 12.** Examples of traces of large wedges formed by the intersections of faults and bedding.

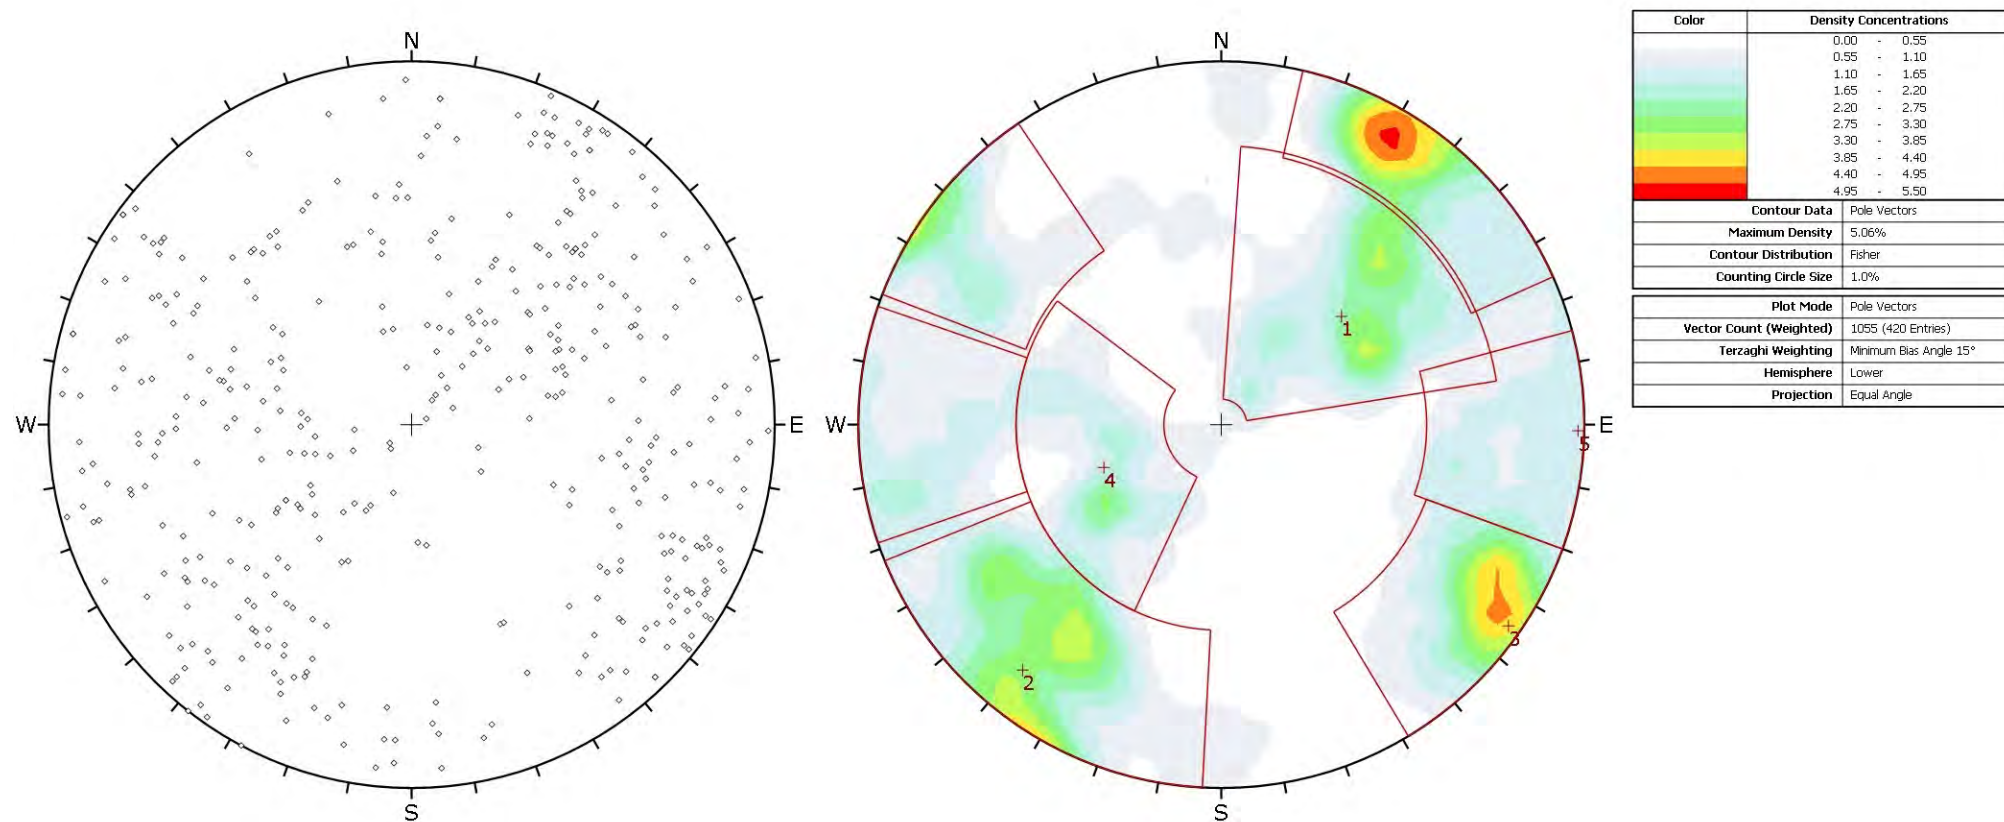
Figures 13a show the poles<sup>9</sup> to the sampled discontinuities plotted as points on a stereonet<sup>10</sup>. Figure 13b shows the poles contoured based on densities. The sets are defined as the areas of highest densities.

**Figure 13** a) Poles to the logged discontinuities plotted on a stereonet.  
b) Poles contoured to highlight five sets of discontinuities.

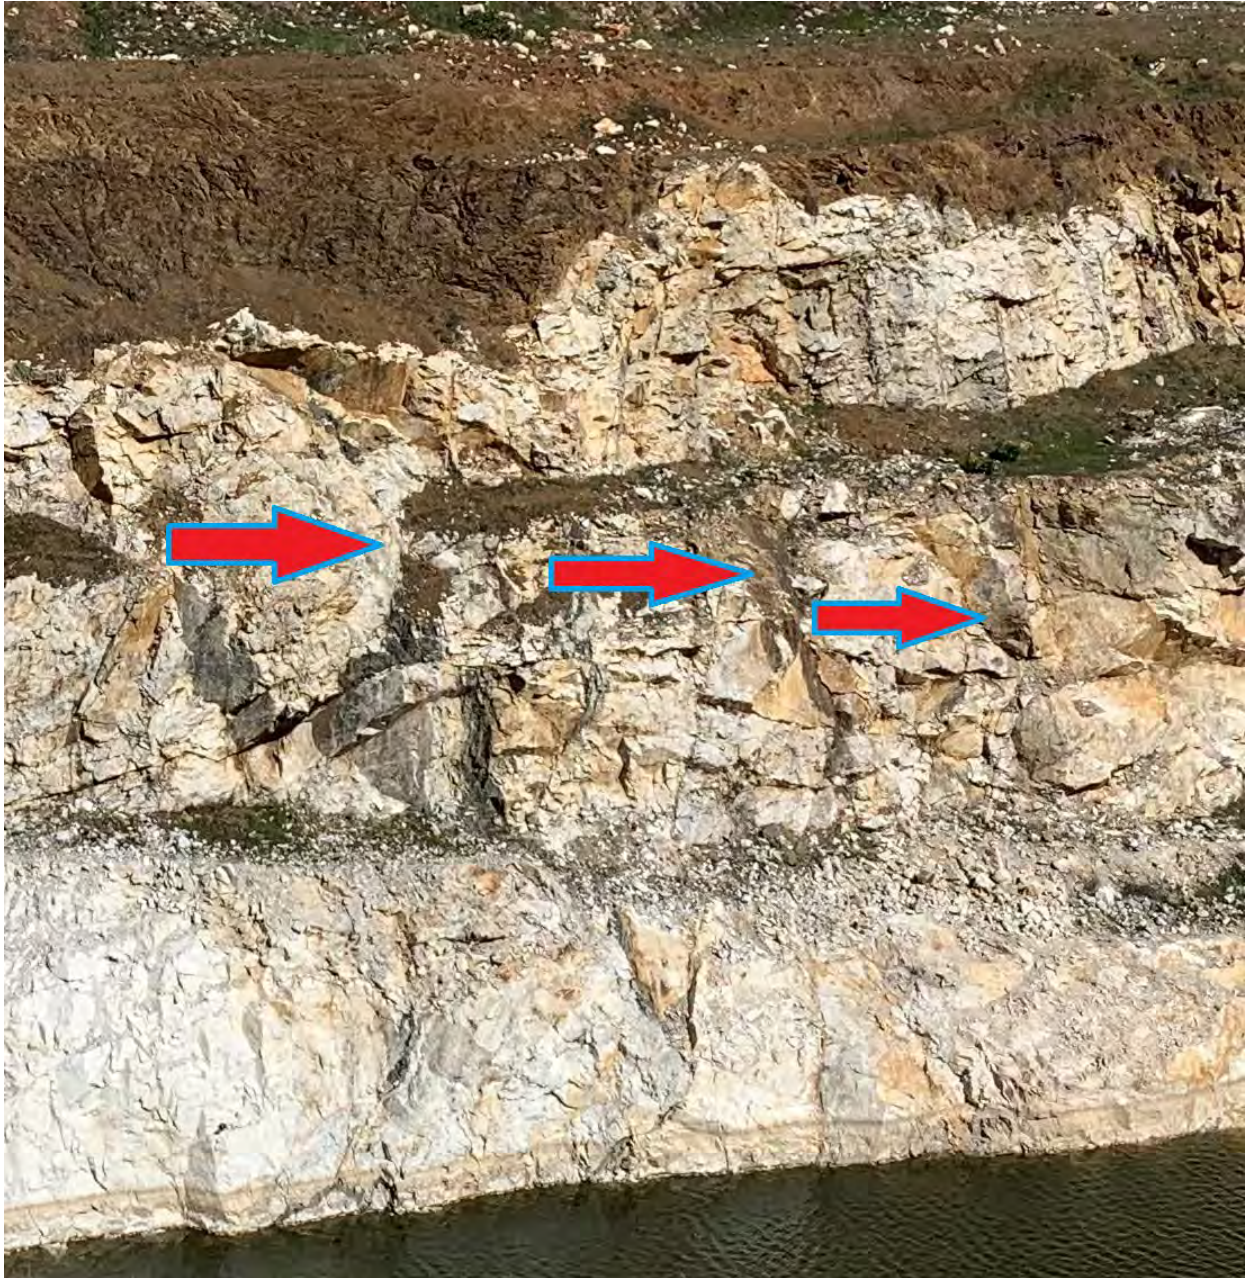
The significant fraction of moderate and greater sized rocks has contributed to the fair performances of most sections of most walls in all pits at multi-bench and overall scales<sup>16</sup>. There are however areas on every wall where spacings are significantly less than the mean values. The rock masses in these areas have lower strengths as evidenced by accelerated weathering and localised instabilities that extend over multiple benches (Figure 14).

**Figure 14.** Examples on the south wall at the west end of the East-West pit of discontinuity spacings being significantly less than the mean values. The rock masses in these areas have accelerated weathering and localised instabilities that extend over multiple benches.

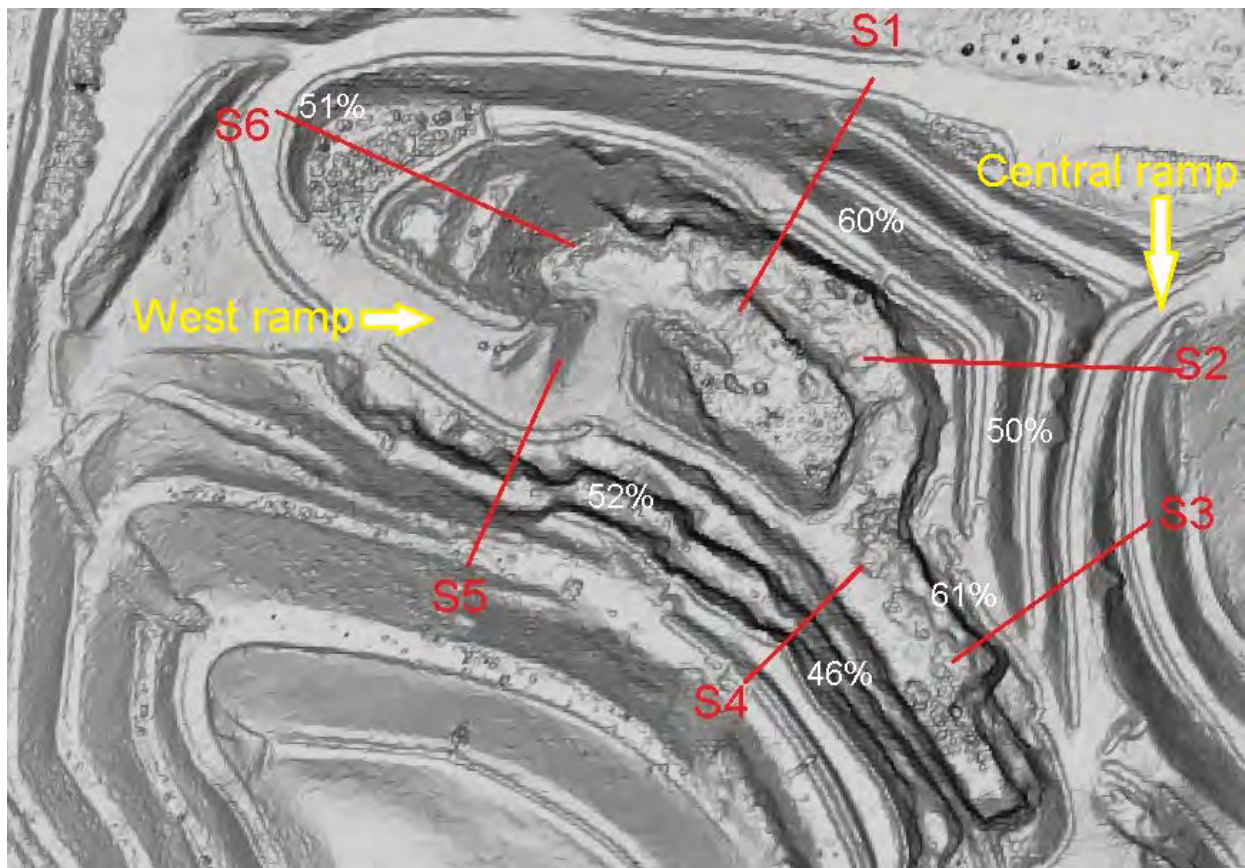
**Figure 15.** Upper bound bench scale stabilities (PoFs) at the west end of the East-West pit.
