# Progressive Rehabilitation and Closure Plan

## WARWICK LIMESTONE MINE

**WARWICK LIMESTONE MINE –  
PROGRESSIVE REHABILITATION AND  
CLOSURE PLAN**

29 SEPTEMBER 2023

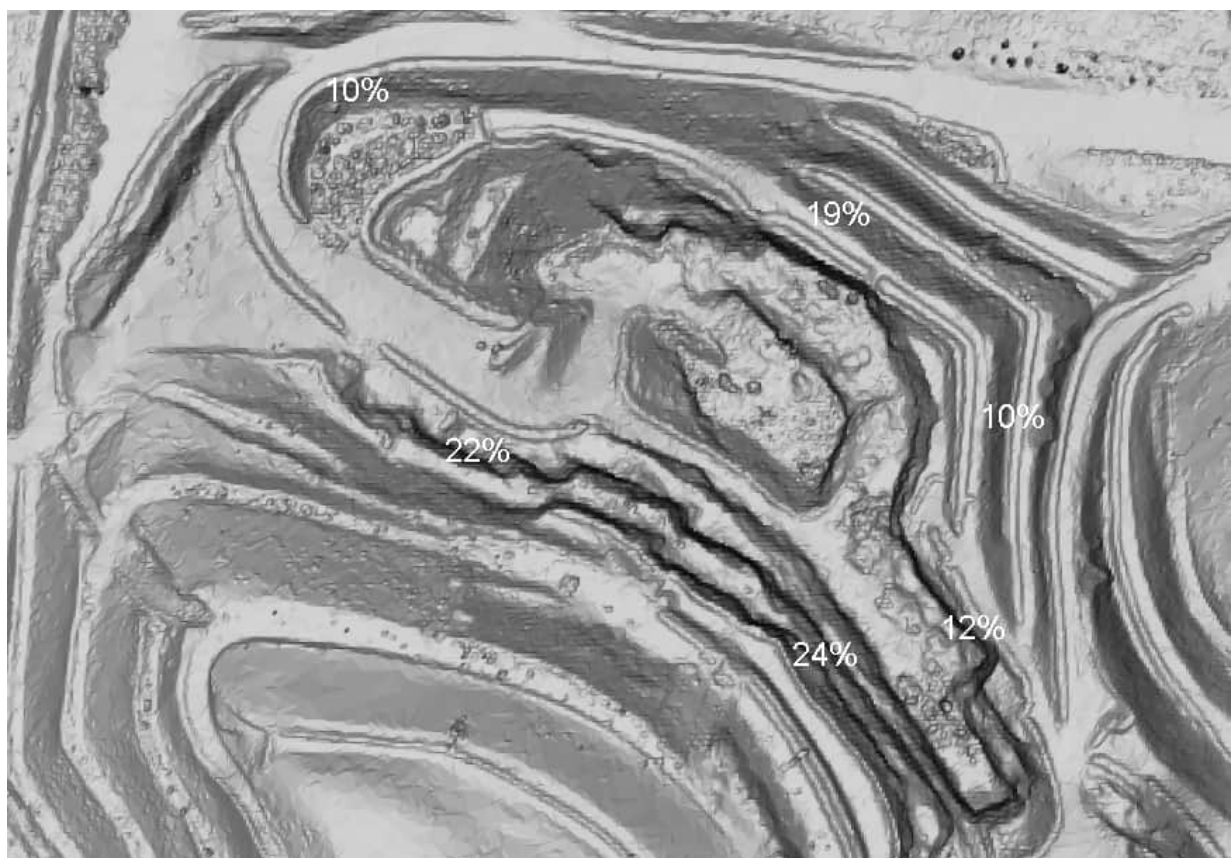
**Figure 16.** Upper bound overall scale stabilities (PoFs) at the west end of the East-West pit.

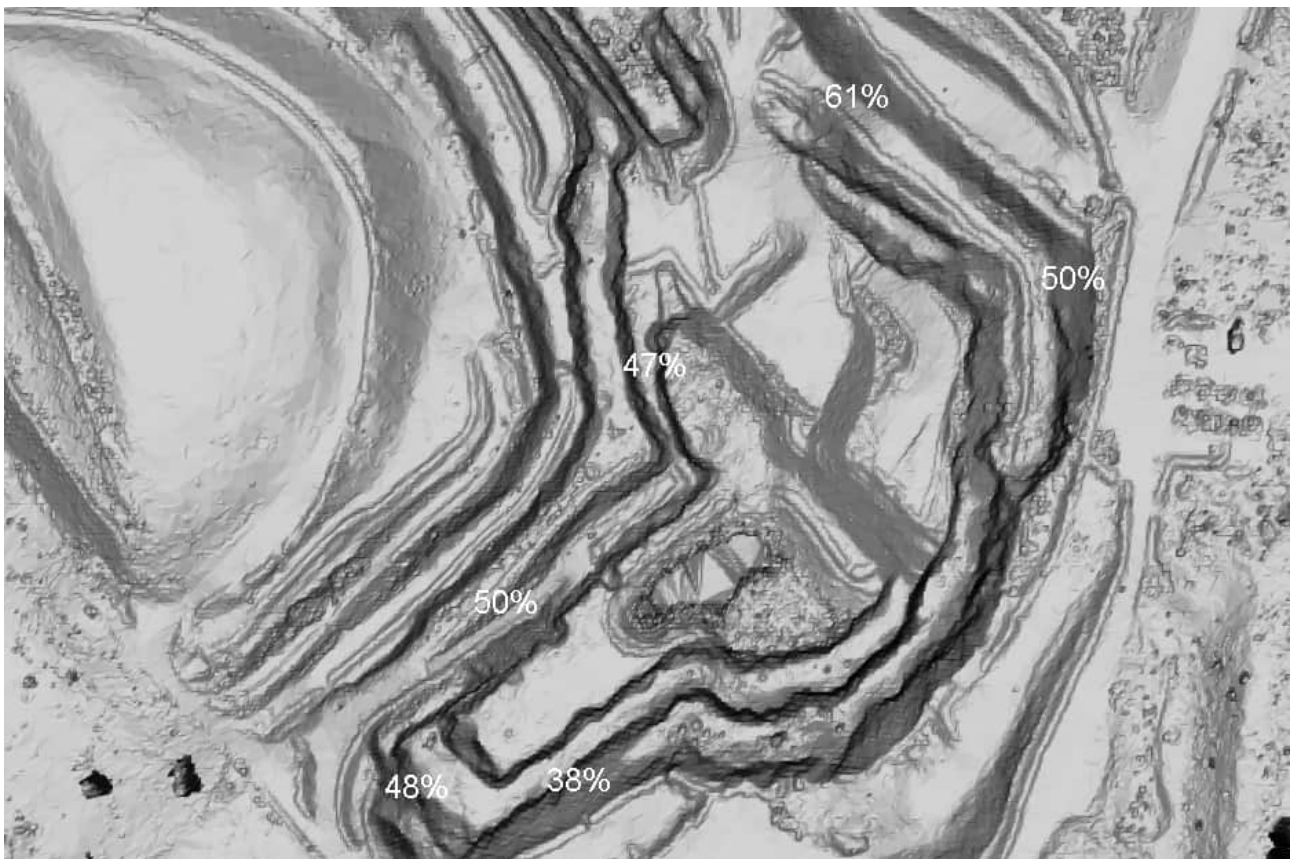
**Figure 17.** Upper bound bench scale stabilities (PoFs) at the east end of the East-West pit.

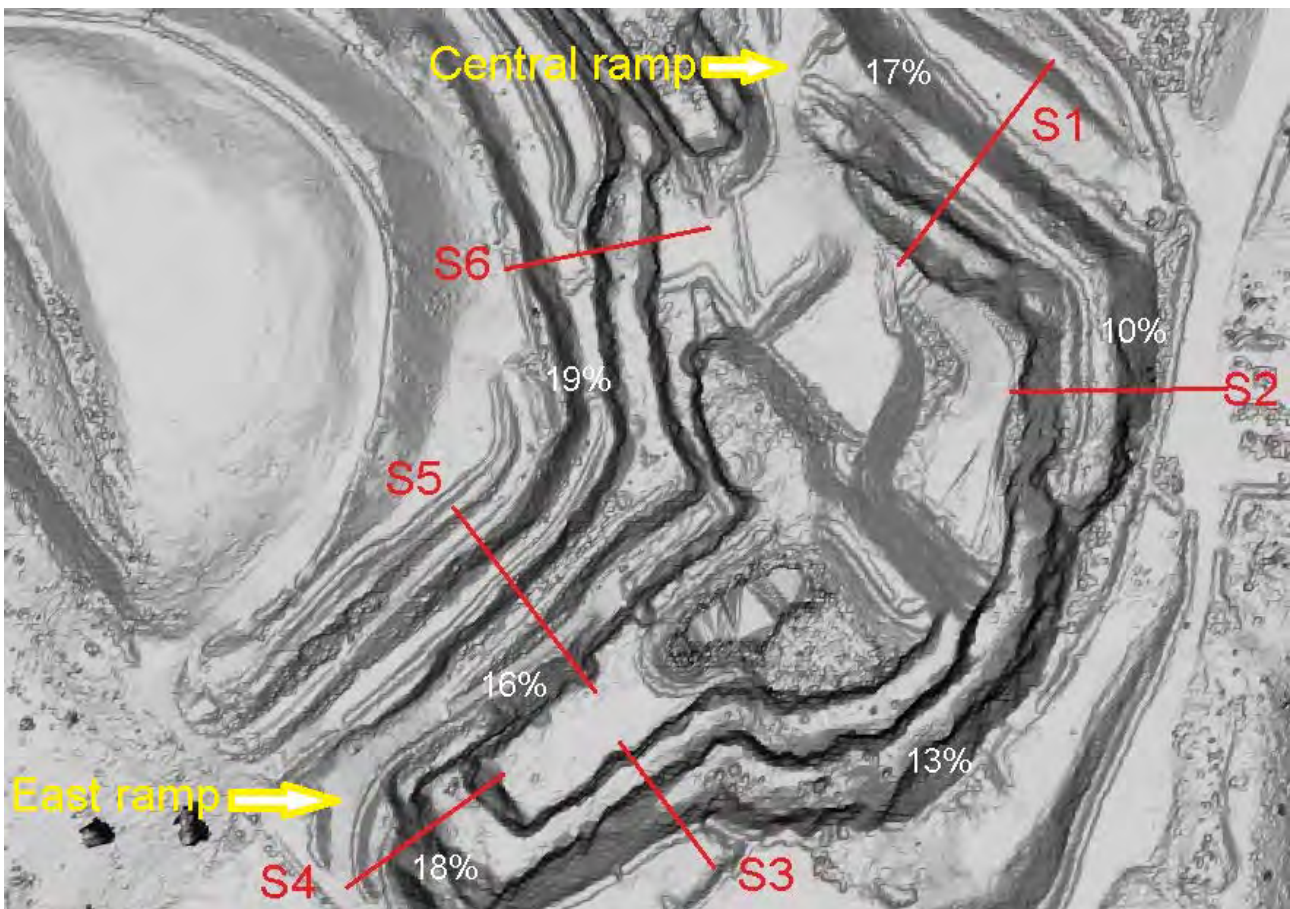
**Figure 18.** Upper bound overall scale stabilities (PoFs) at the east end of the East-West pit.

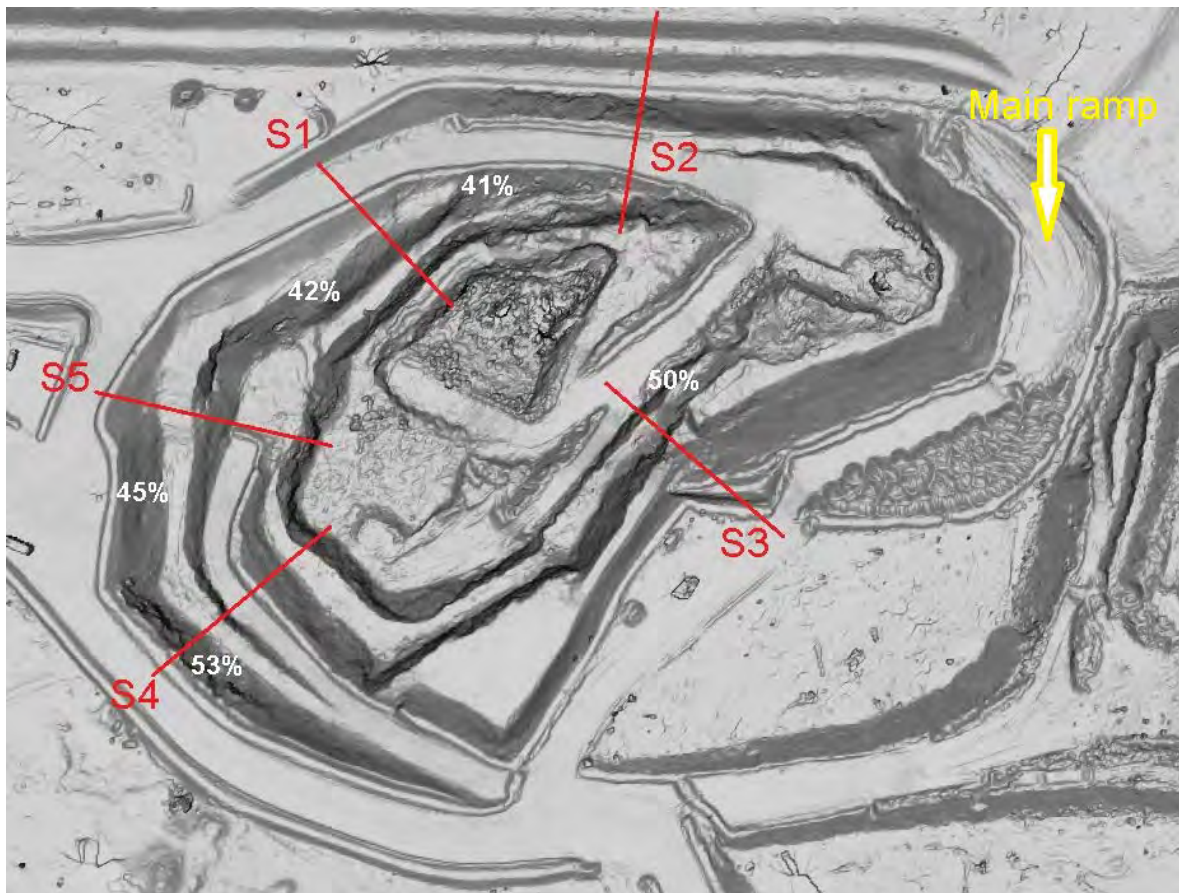
**Figure 19.** Upper bound bench scale stabilities (PoFs) around the Phoenix pit.

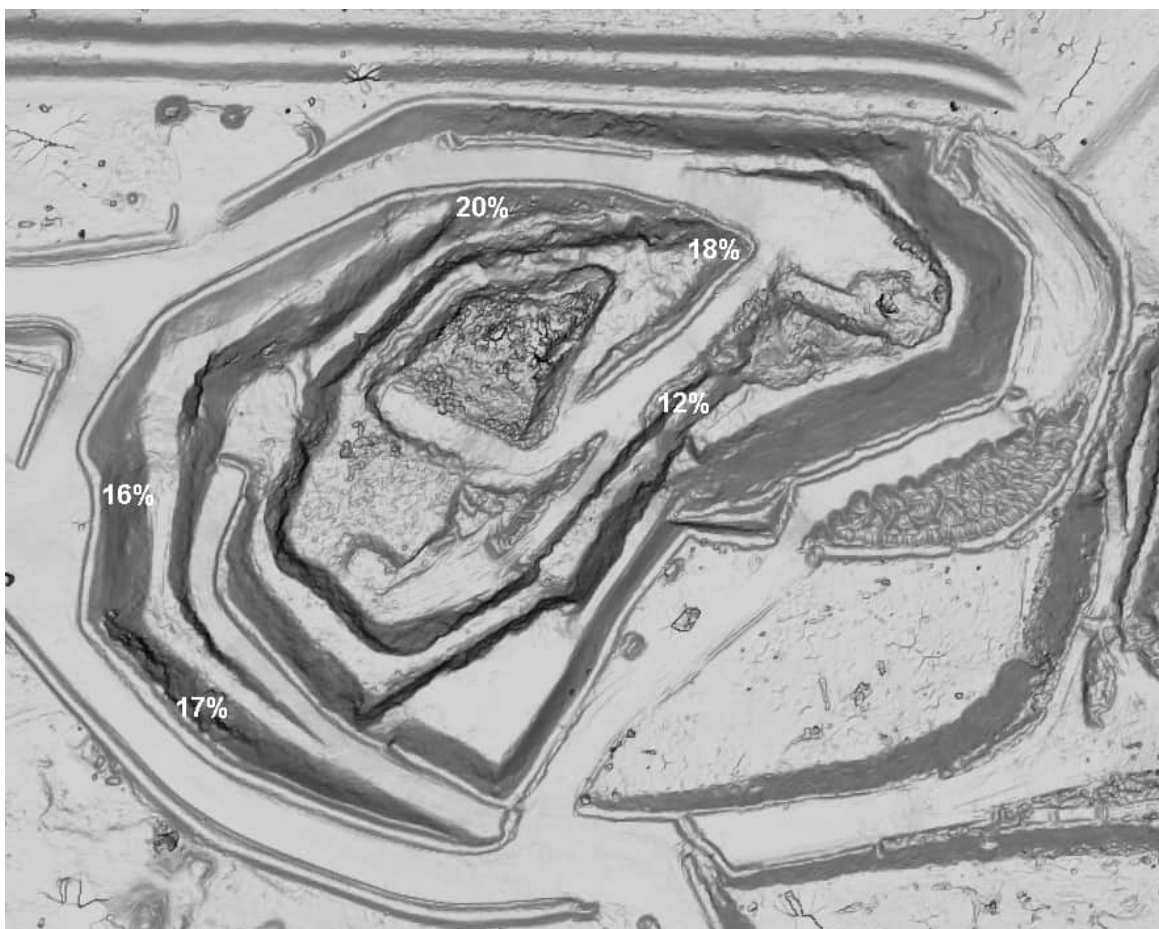
**Figure 20.** Upper bound overall scale stabilities around (PoFs) the Phoenix pit.

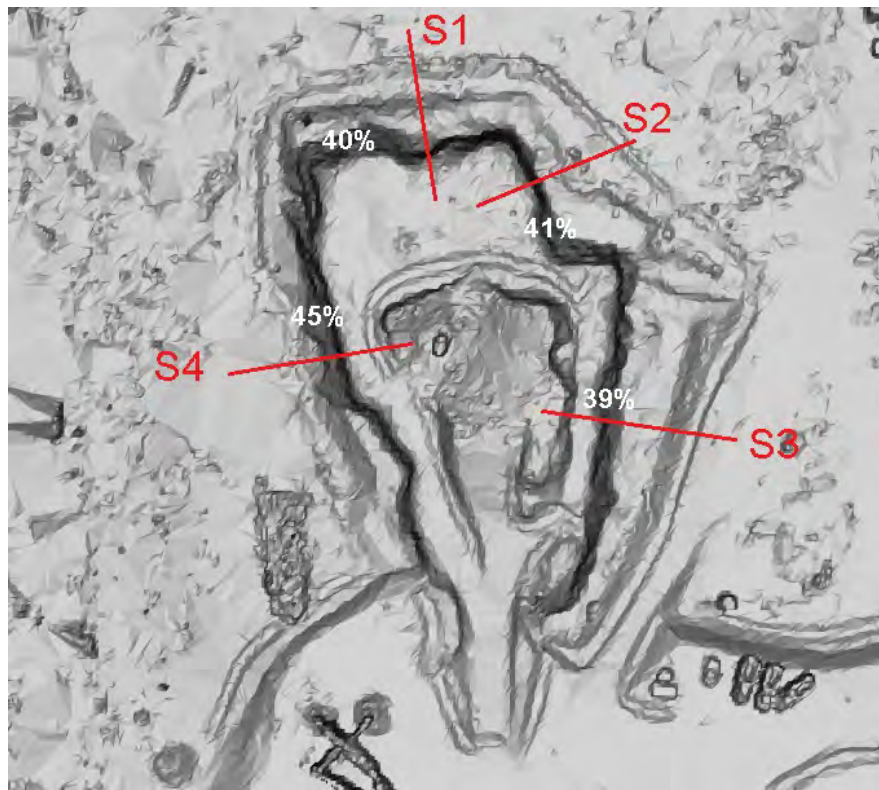
**Figure 21.** Upper bound bench scale stabilities (PoFs) around the Aspal pit.

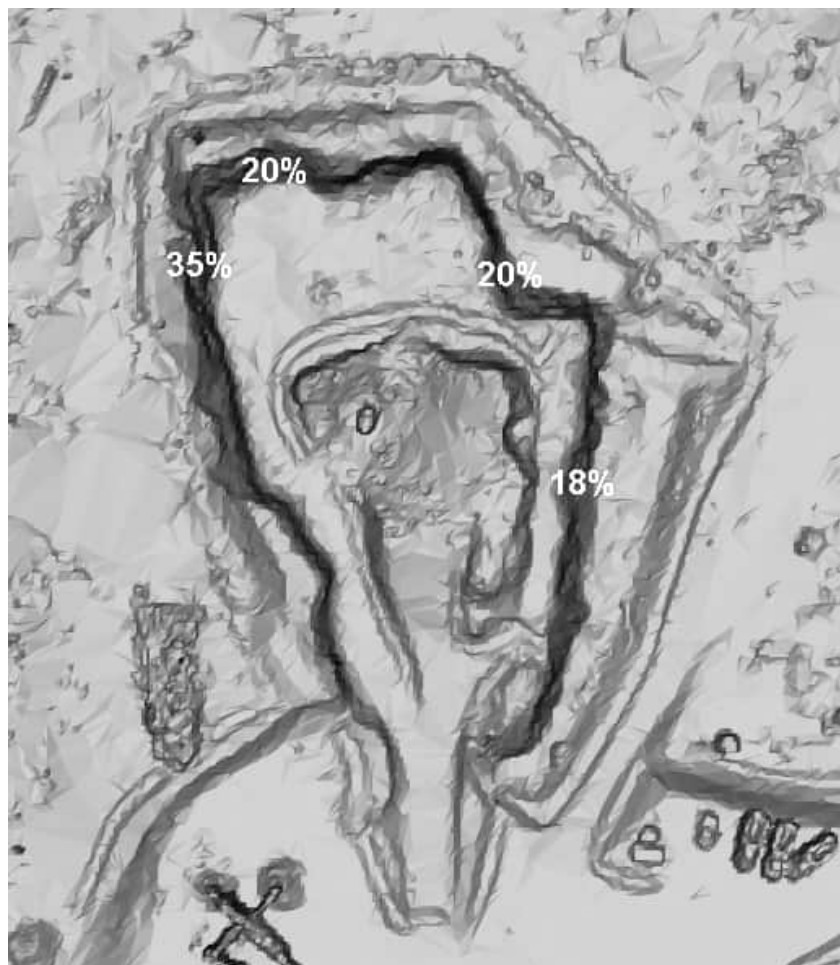
**Figure 22.** Upper bound overall scale stabilities (PoFs) around the Aspal pit.

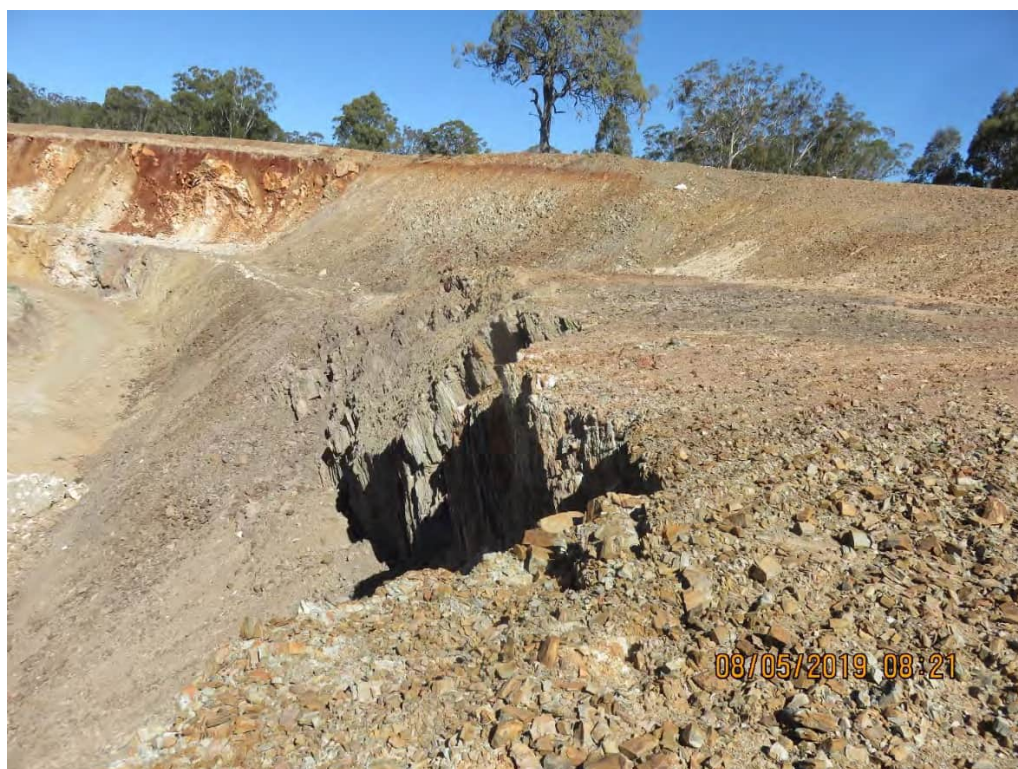
**Figure 31.** Toppling rocks on an east dipping batter on the upper bench of the Phoenix pit.

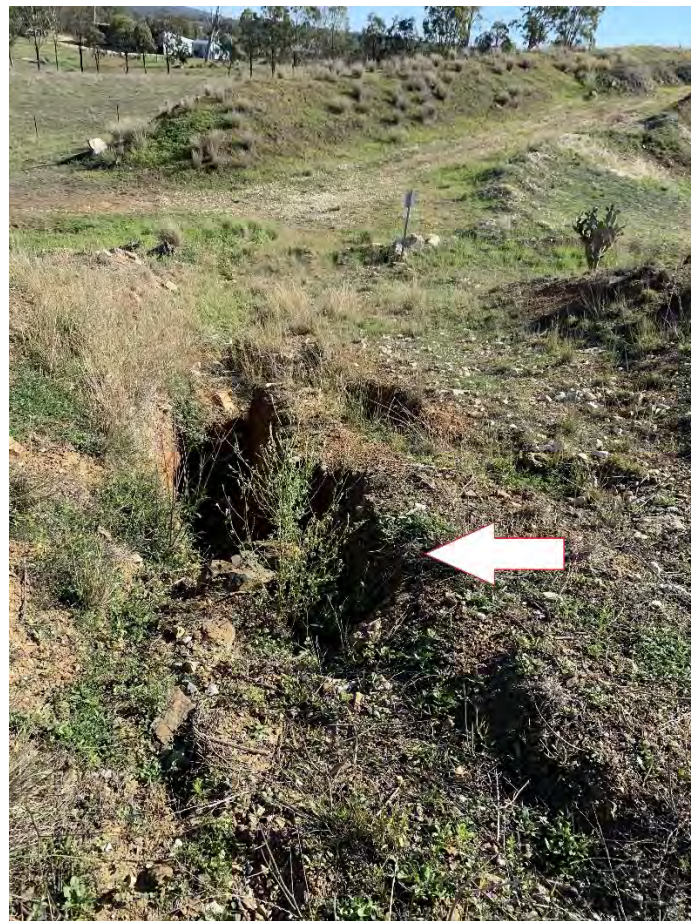
**Figure 36.** Deep gully cut by water shedding off the west end of WRD 1 is contributing to erosion of the ramp at the west end of the East-West pit. Drain will be remediated when the ramp is removed.

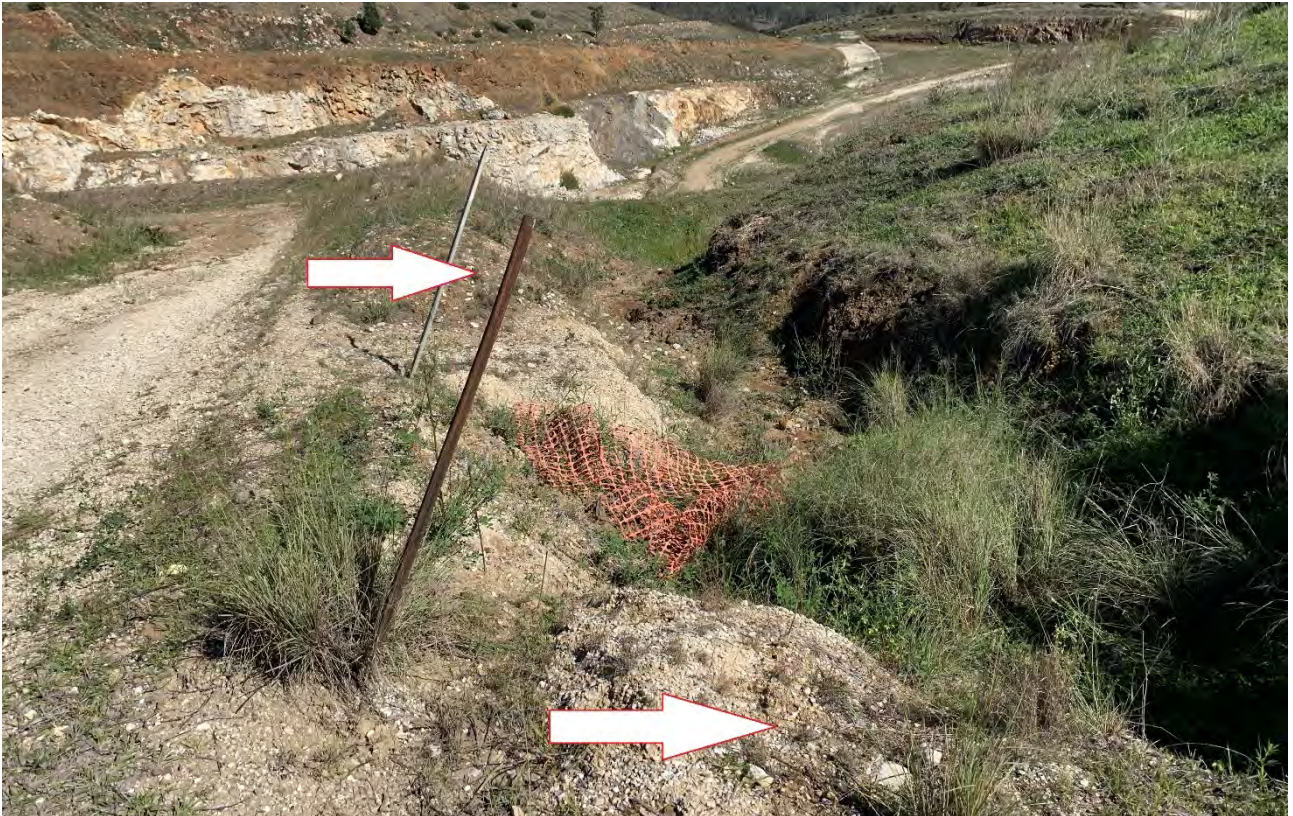
**Figure 37.** Gully cut by water shedding off the central ramp on the north wall of the East-West pit requires lining and sediment traps.

Figure 56 highlights the ramp that provides access to the upper surface of WRD 1. A shallow (0.5-m) gully has developed adjacent to the ramp (Figure 37). The ramp should be removed and the gully reinstated.

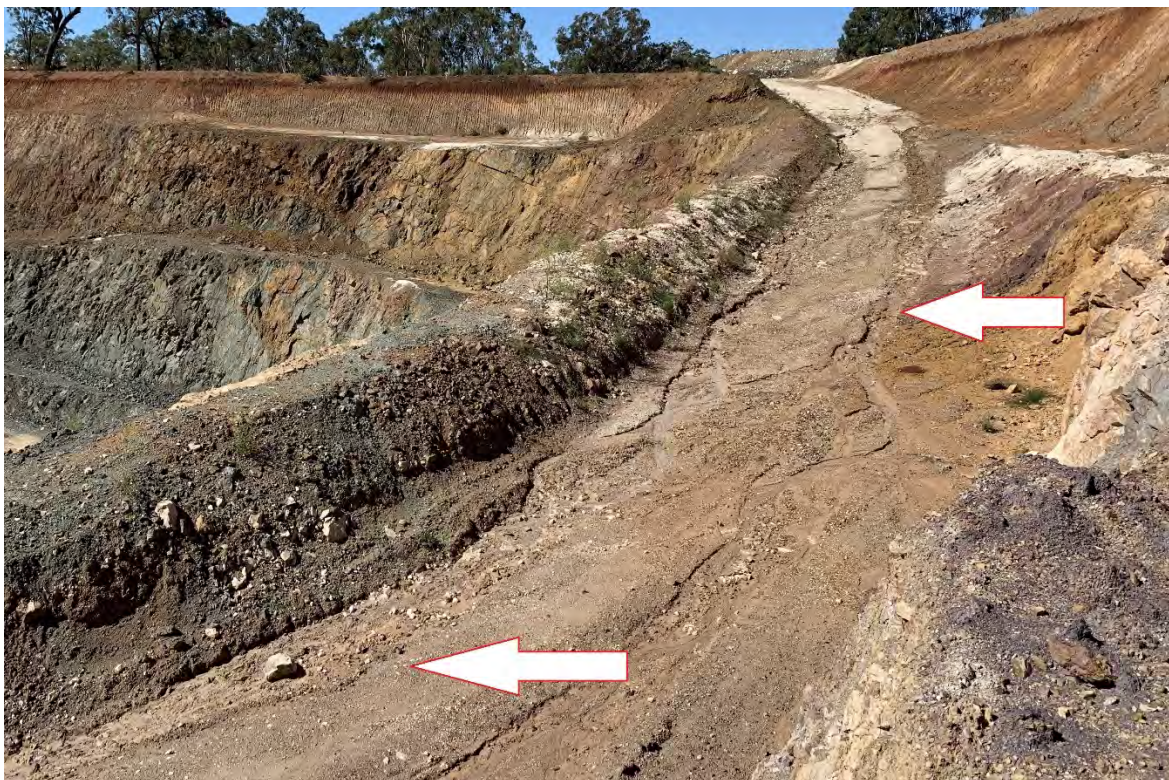
**Figure 40.** The ramp along the west end of the Phoenix pit requires ripping and drainage control to prevent shallow gullies cut by water from triggering instabilities.

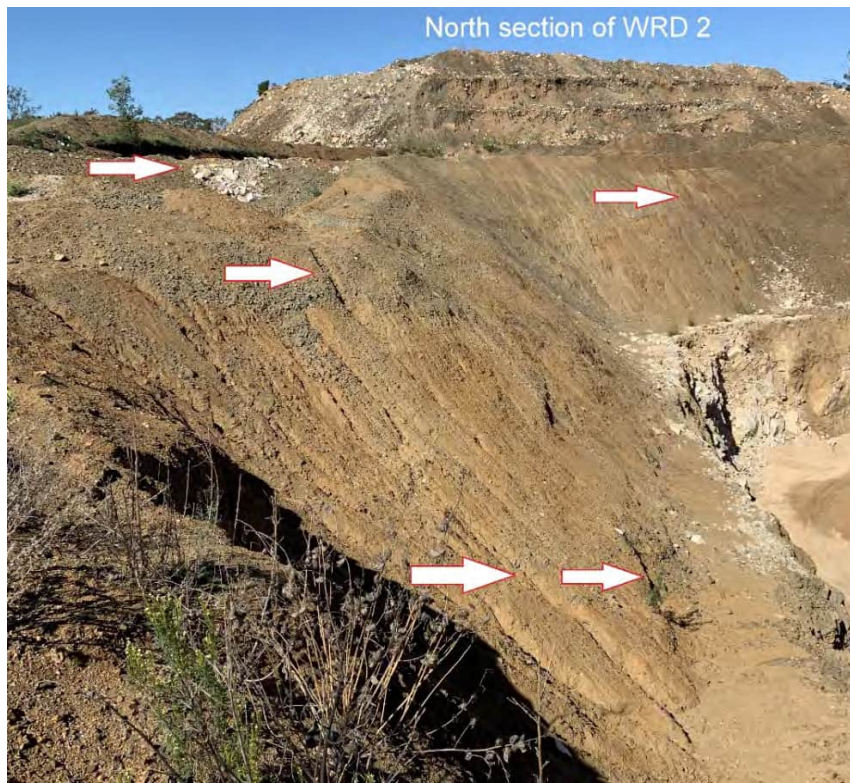
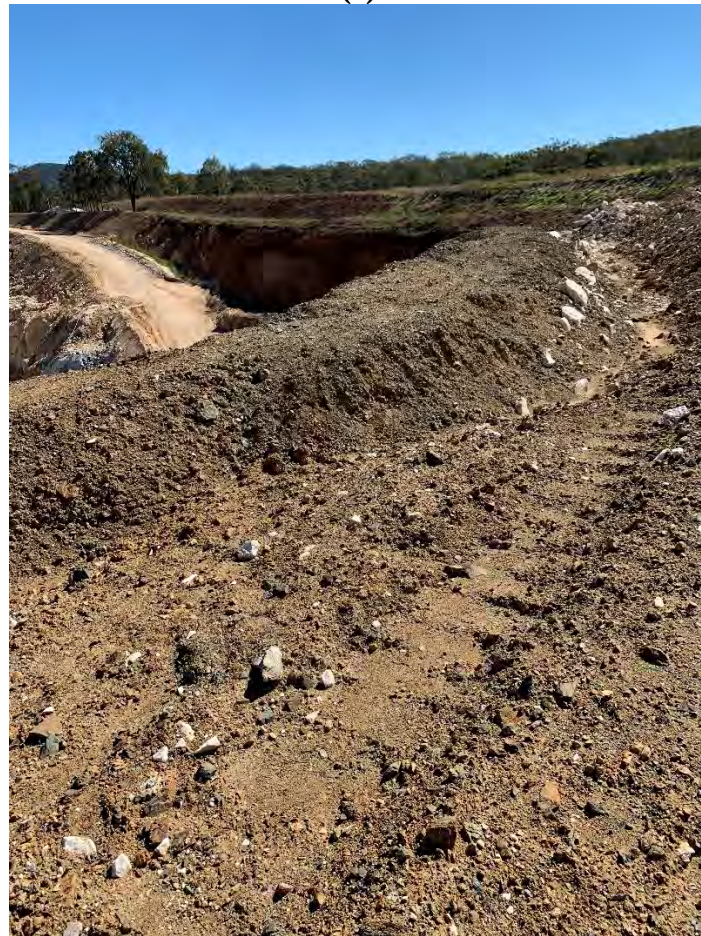
**Figure 41.** Overland flows are eroding topsoil, karst fill and extremely weathered limestones and siltstones in the upper bench at the east end of Phoenix pit (b) The bund along the crest of the is likely sufficiently high to prevent overland flows of water from flowing from behind the crest.  
Removal of the haul-road and hydroseeding is required.

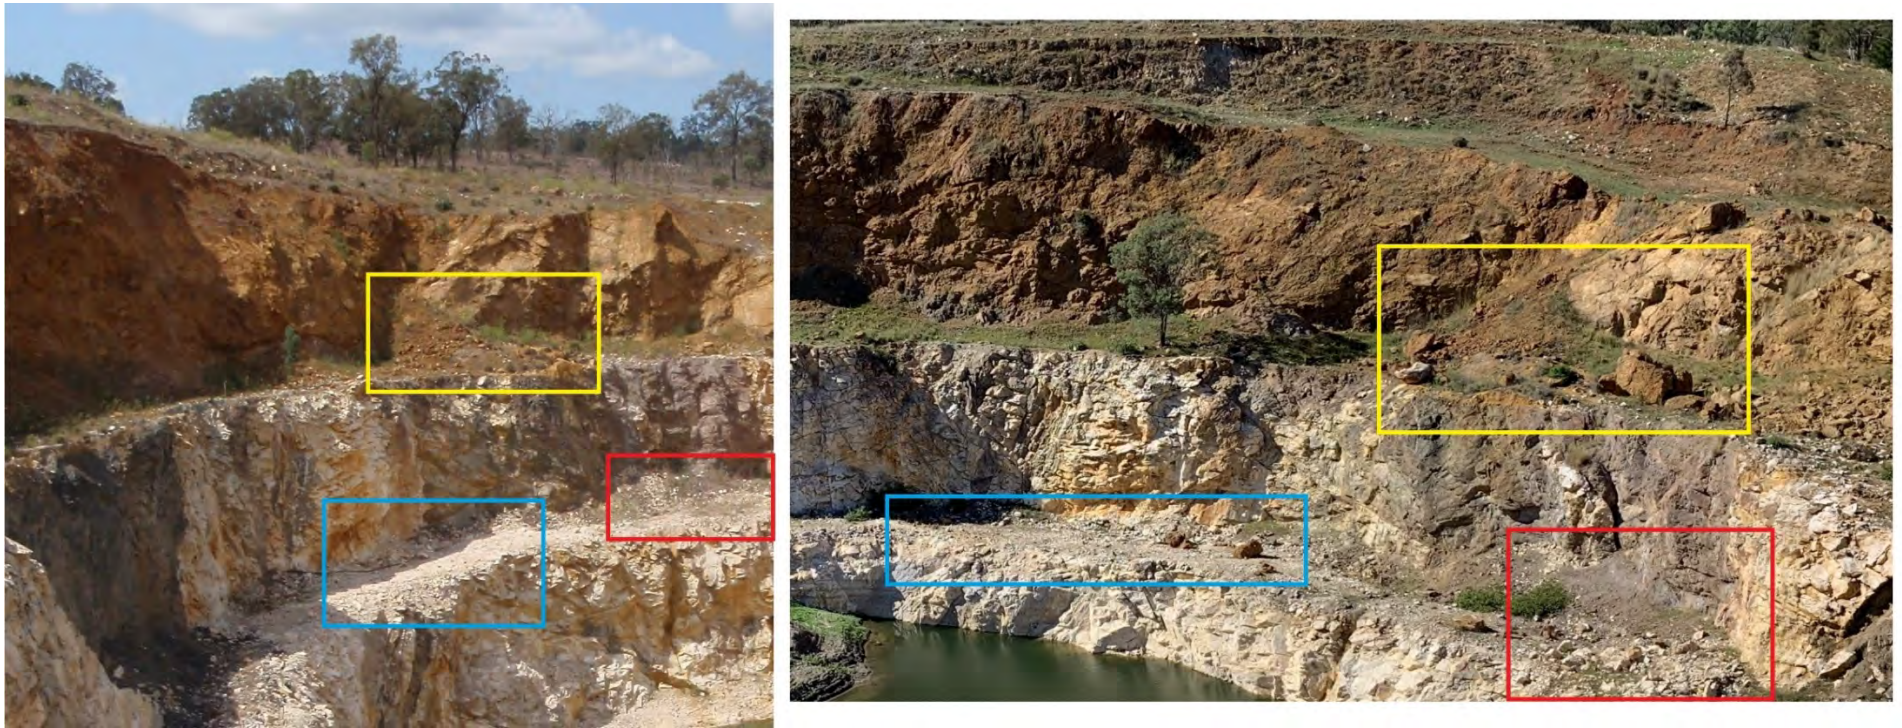
**Figure 42.** No significant differences in the volumes of rockfall debris on berms on the northeast wall at the east end of East-West pit in (left) 2004 and (right) currently.

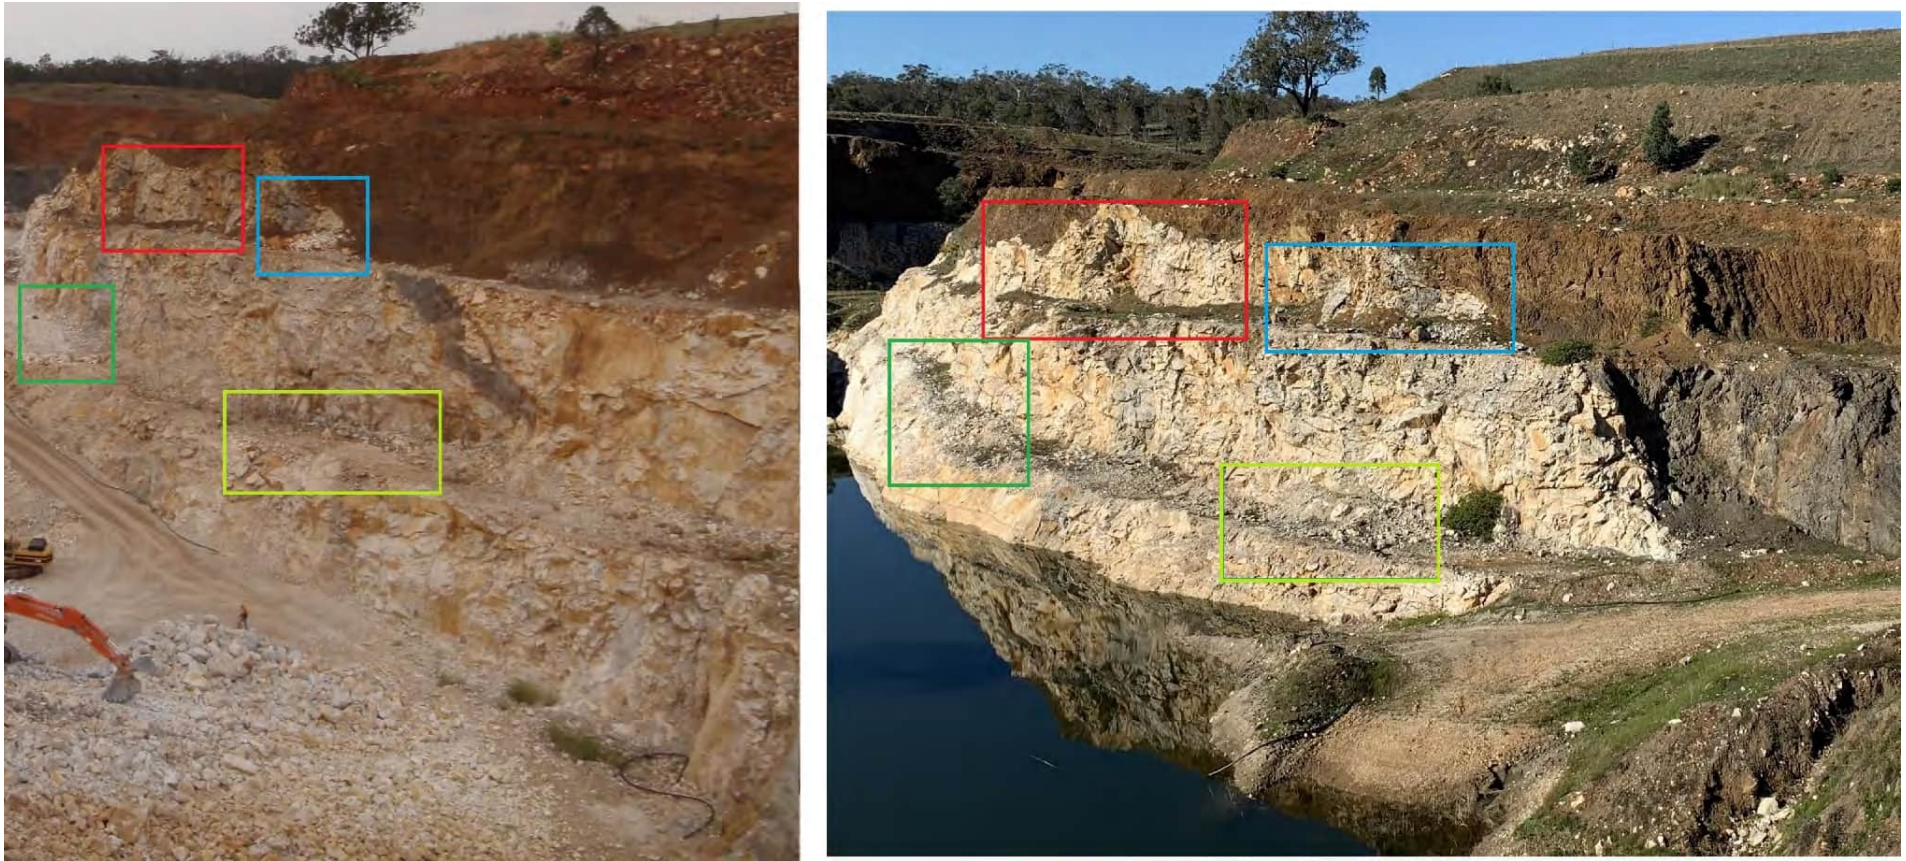
| <i>Scale of Instabilities</i> | <i>Comments</i> |
|---|---|
| Individual rocks | <p>Large volumes of rocks on most berms are evidence that rockfalls have been frequent. However, a comparison of berms from the current time with those from 15-years ago (Figures 42 to 44) indicates that a significant proportion of the falls occurred in the years soon after each batter was cut with the frequency of falls decreasing progressively afterwards. This characteristic is conducive to the frequencies remaining relatively low during the long-term.</p> |

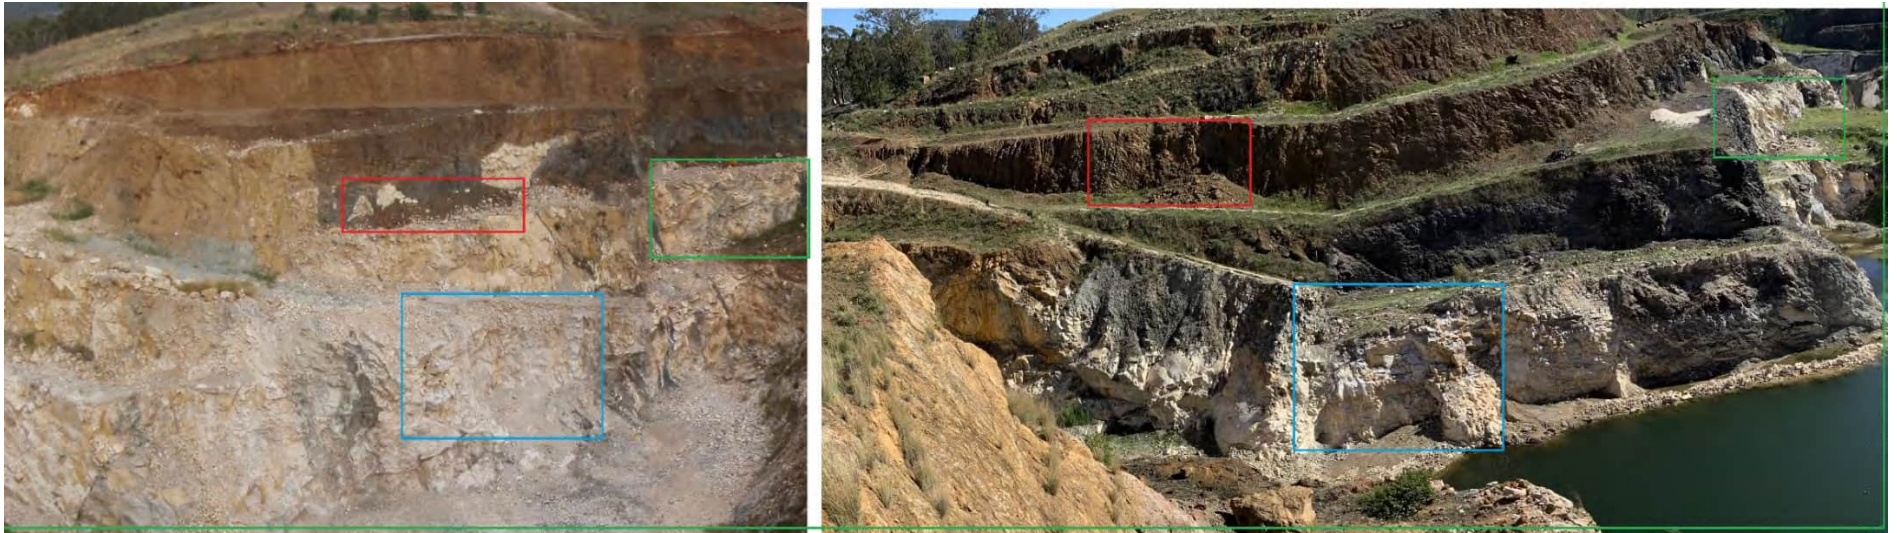
**Figure 43.** No significant differences in the volumes of rockfall debris on berms and the loss of berm widths on the south wall at the west end of East-West pit in (left) 2004 and (right) currently.

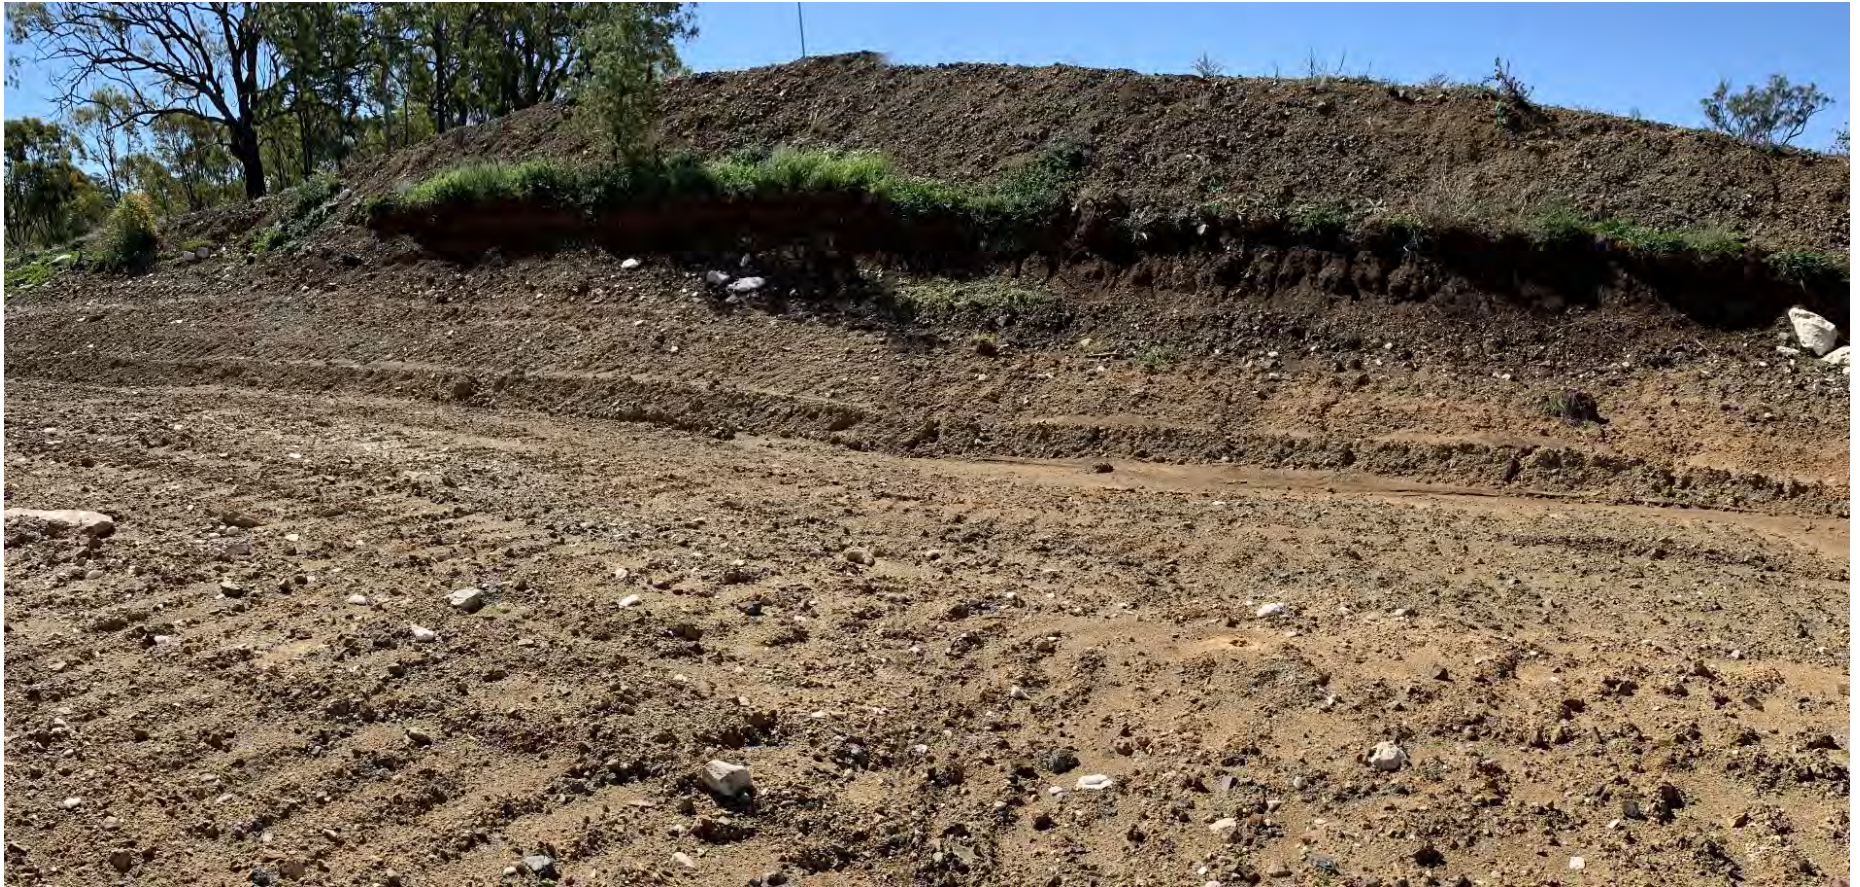
- Rocks were last placed on the dump in 2019 (Figure 46). The slopes and upper surfaces have not subsequently been contoured and no topsoil has been spread. Doing so will be required.

**Figure 46.** Upper surface of the southern section of waste rock dump 2 (WRD 2) to the southeast of Phoenix pit. The surface shaping, grading, crowning, topsoil and hydroseed.

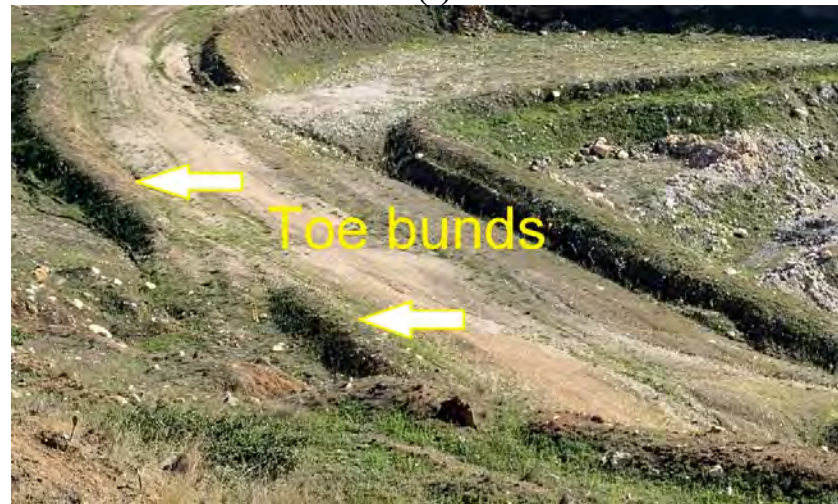
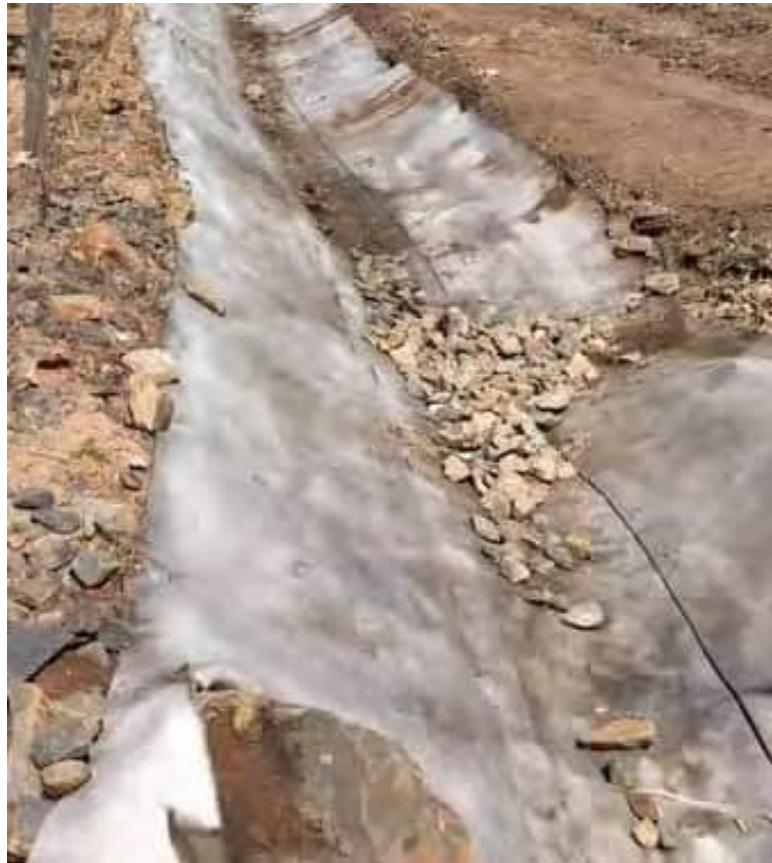
**Figure 50.** (a) If the western ramp in the East-West pit is to be retained, the heights of (b) the current toe bunds are to be increased. If the ramp is not to be retained, the surface is to be ripped and a series of low bunds are to be installed at regular intervals along contour down the inclined surface to reduce flow rates.

- Increase, to a minimum of 1.8-m, the height of the toe bund (rock traps) currently installed out from the toe of the adjacent batter (Figure 50b).
- The bund is to be continuous, unlike the current bund.
- The location of the inner toe of the bund is to coincide with the inner toe of the current bunds.
- The bund is to be constructed from rocks having the same characteristics as those used for abandonment bunds and constructed using the same procedure (Section 7.3.2).

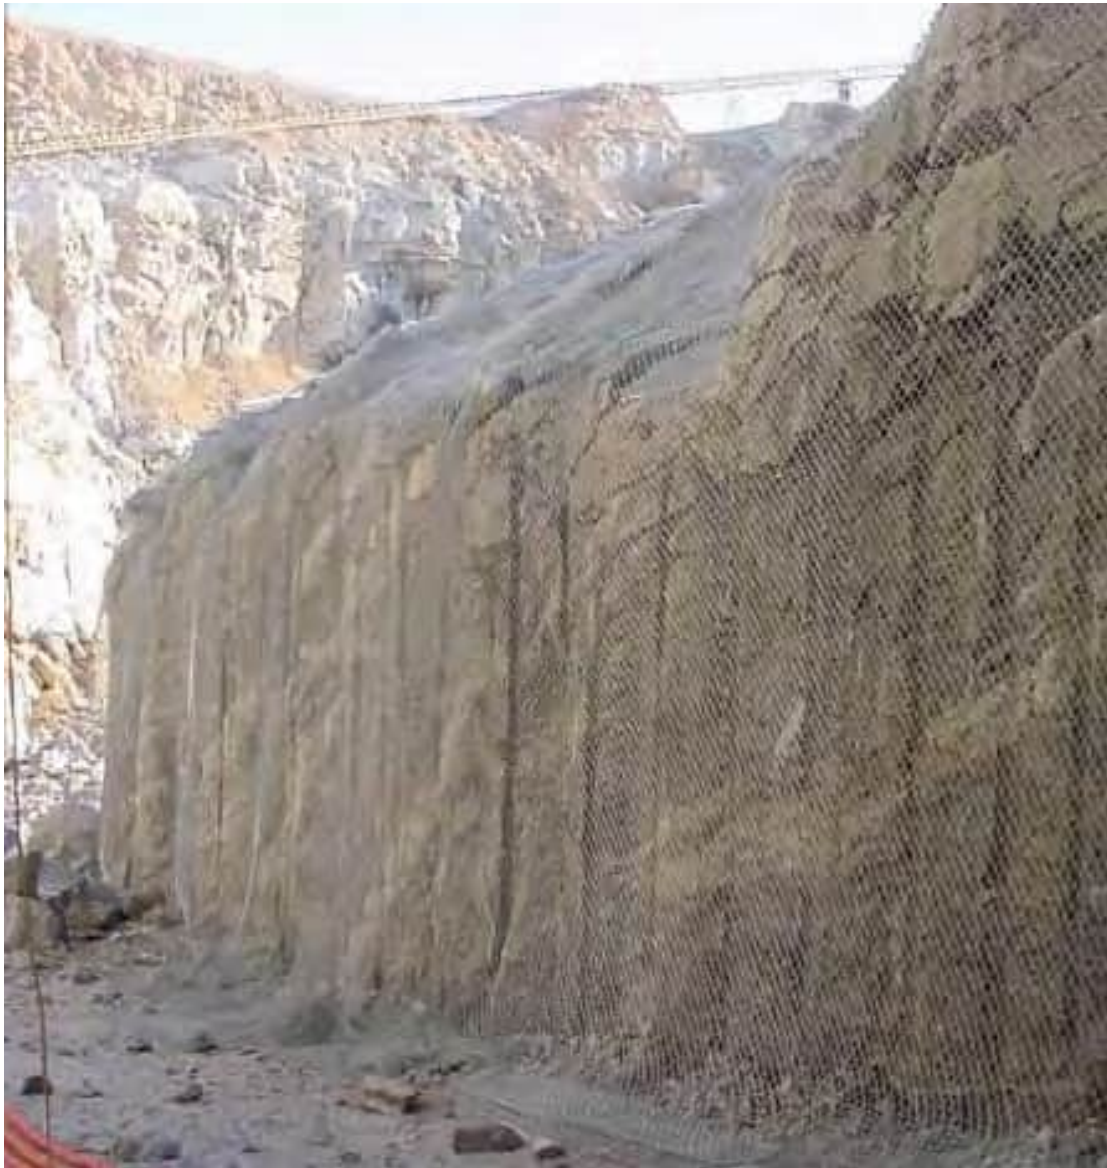
- Drains should be a minimum of 1.0-m wide and 0.3-m deep.
  - They should be filled with high permeability, coarse (no fines), durable limestones.
- Water shedding off the 550-mRL berm (Figure 52) above the batter adjacent to the central ramp is destabilising the batter below and eroding the ramp.

**Figure 52.** Water shedding off the 550-mRL berm is destabilising the 540-m to 550-mRL batter adjacent to the central ramp. Lined drains are required above and along the berm and down the batter.

- If water cannot be prevented from flowing on to the 550-mRL berm, a horizontal lined berm drain will be required to direct water to a vertical lined batter drain. The drains are to be lined with concrete canvas (Figure 51). The canvas is to be fixed securely to the surface with deep anchors.

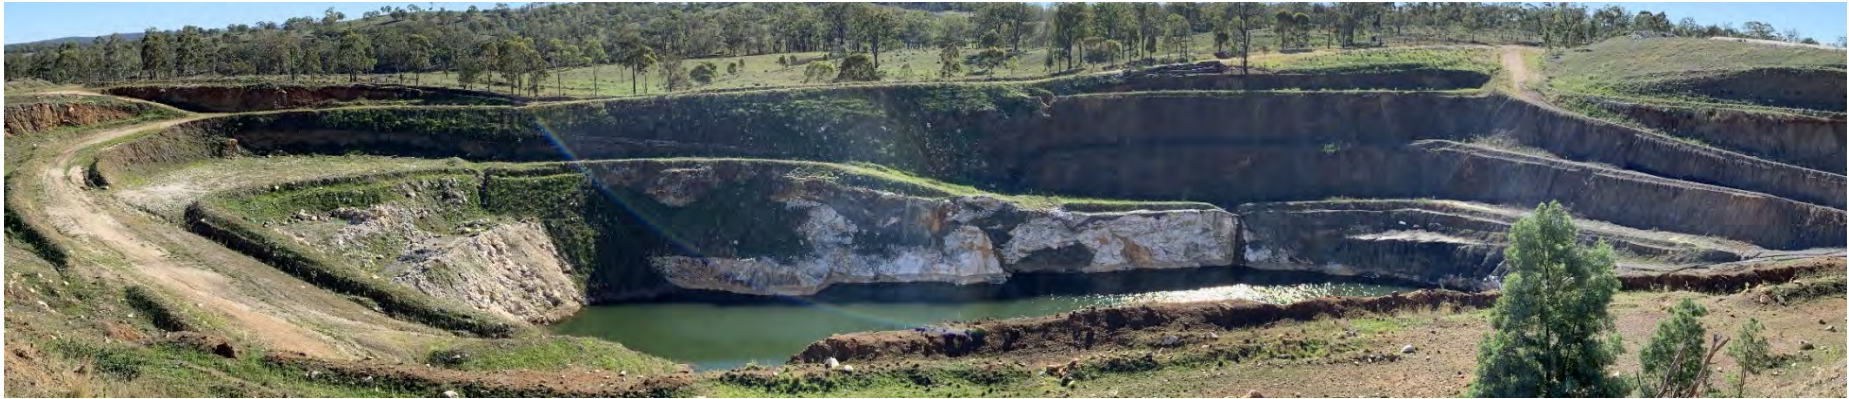
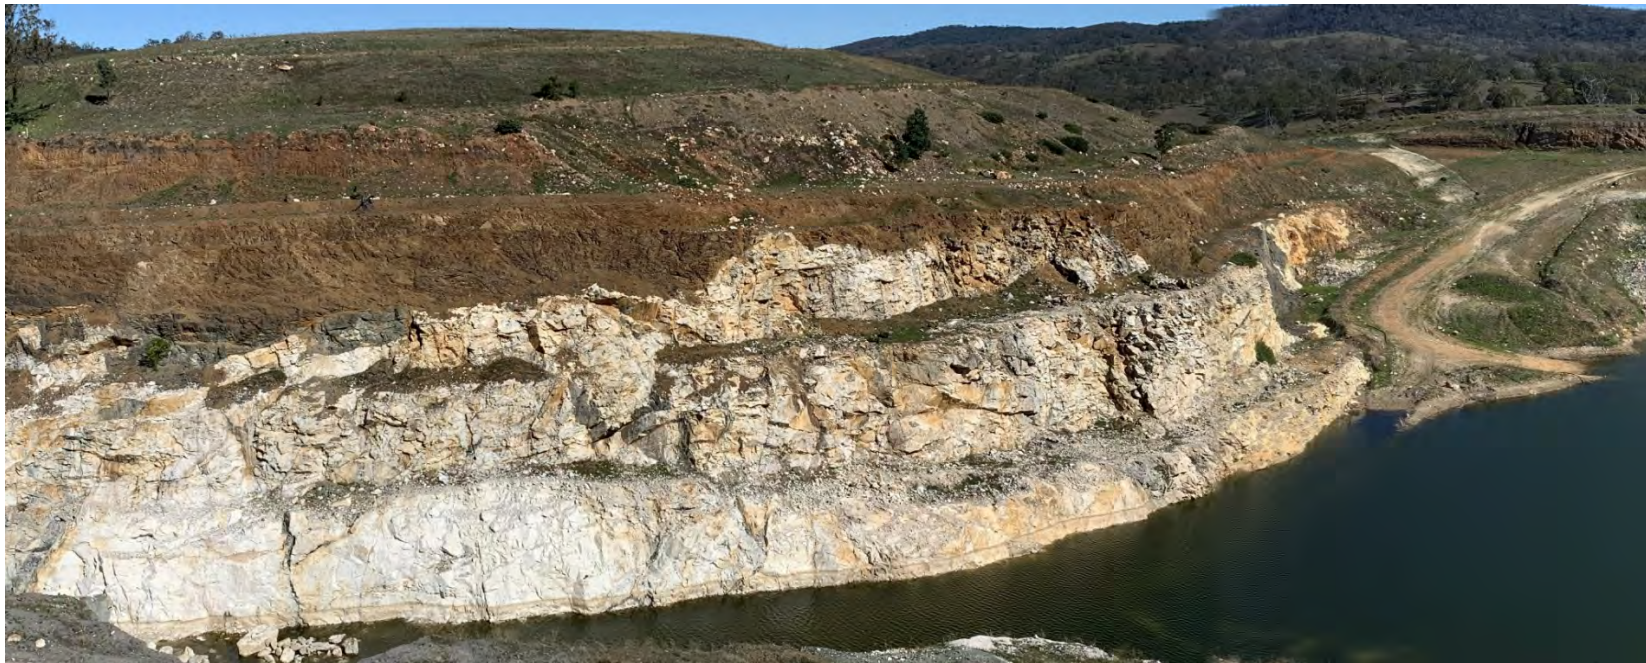
**Figure 1.** (a) North and (b) South walls at the west end of East-West pit. Waste rock dump WRD 1 is behind the crest. The west ramp (right) may be retained.
