# Progressive Rehabilitation and Closure Plan

## WARWICK LIMESTONE MINE

**WARWICK LIMESTONE MINE –  
PROGRESSIVE REHABILITATION AND  
CLOSURE PLAN**

29 SEPTEMBER 2023

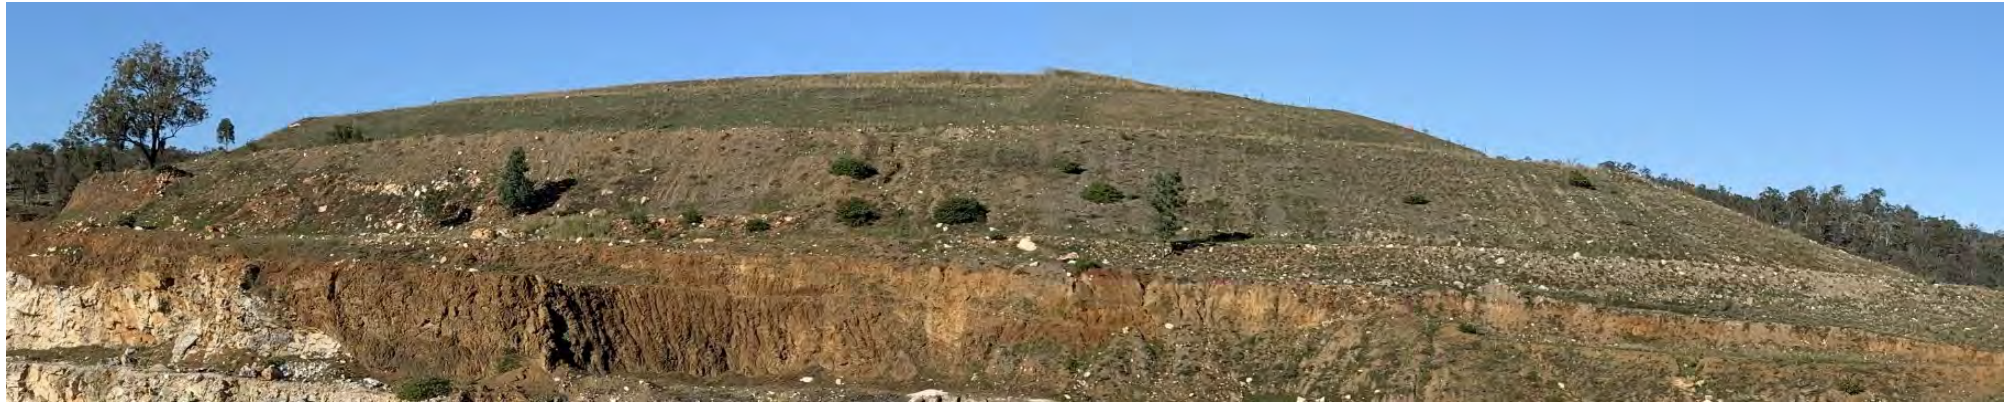
**Figure 5.** WRD 1 to the west of the East-West pit. The dump to remain in-situ. (b) The bund along the crest is inadequate as an abandonment barrier. It is to be replaced with an abandonment bund (Section 7.3.2). The bund is to tie into the bund encircling the pit at the east and west ends of the dump.

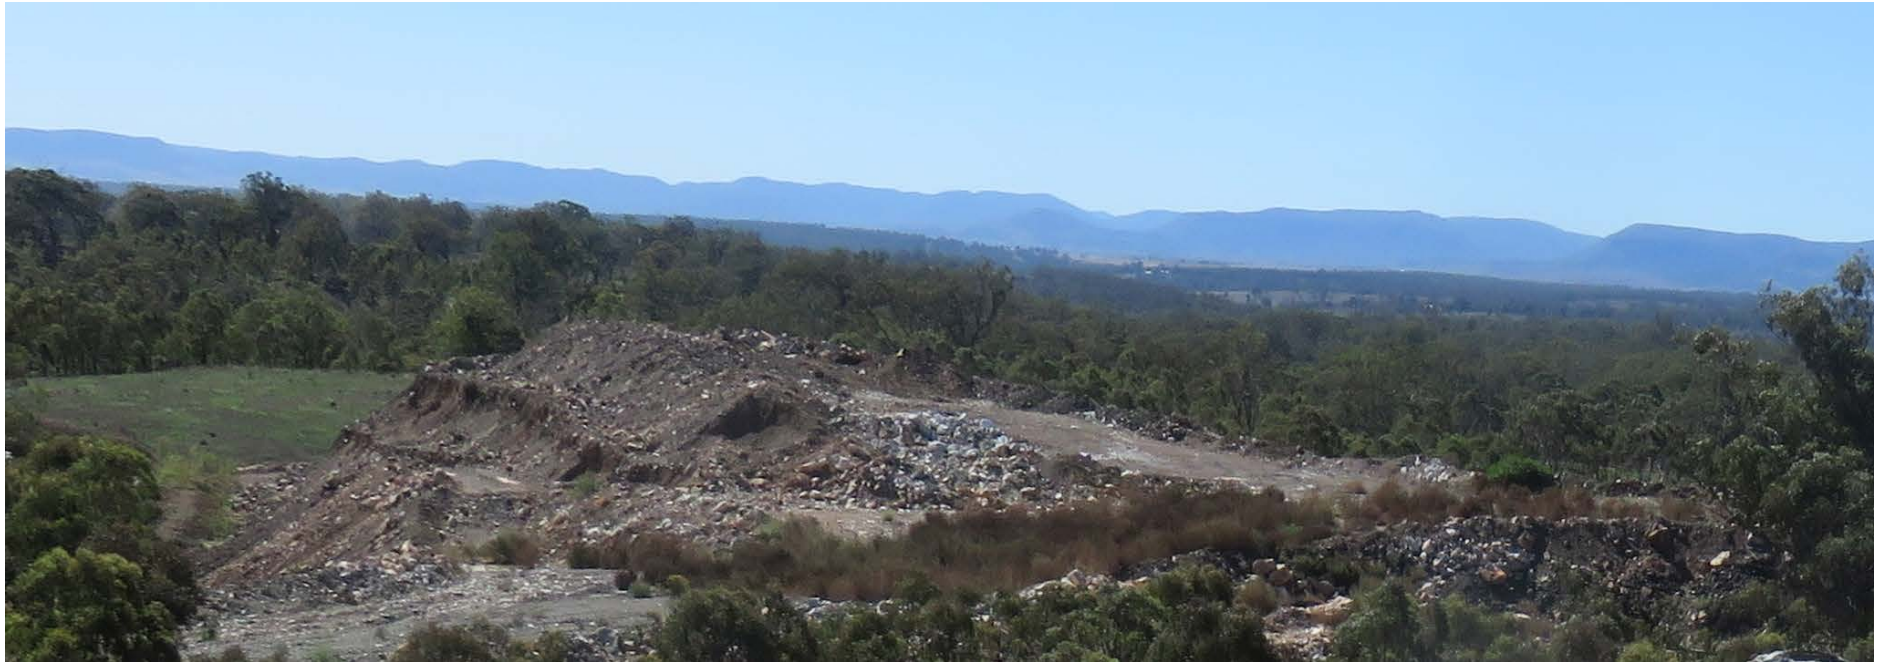
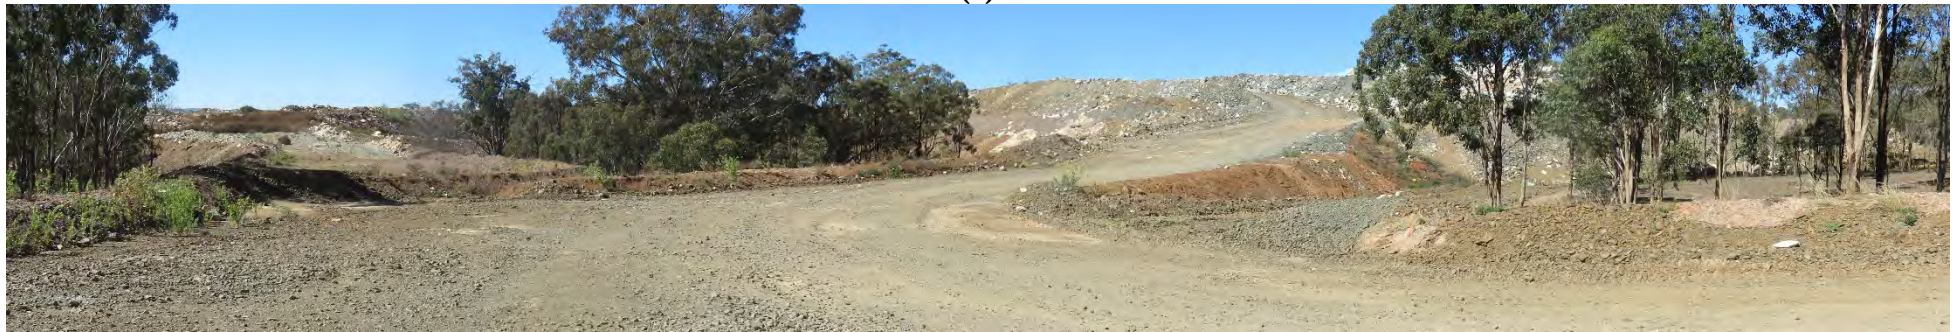
**Figure 6.** WRD 2 a) North section 35-m east of the Phoenix pit and b) South section 140-m south of the pit. The dump will provide rocks for the abandonment bunds. The dumps will then be graded, shaped, topsoil placed and hydroseeded.

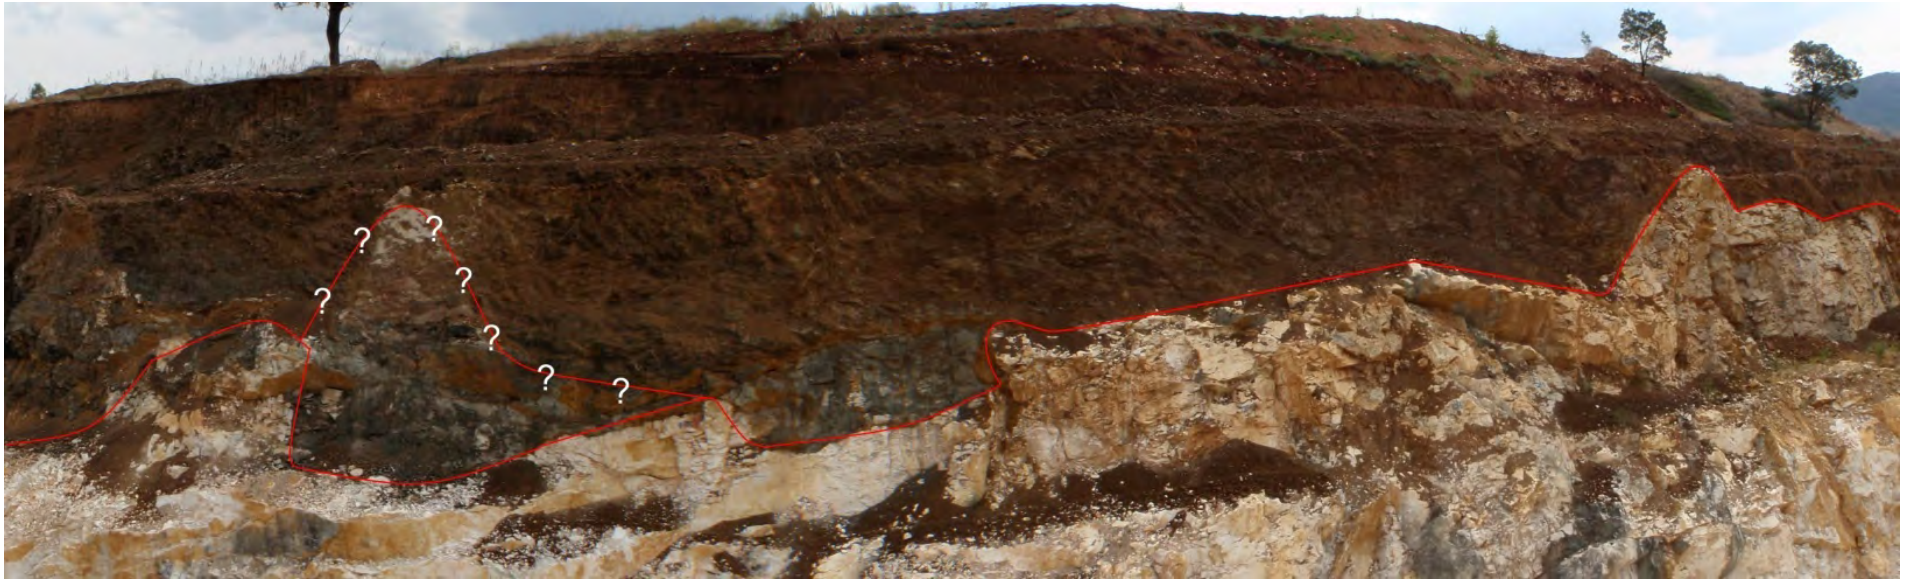
The relative proportions of the various carbonates in a particular area are a function of the degree to which alteration has occurred. Dissolution of the upper surfaces of the limestones have created karst features; predominantly an irregular upper surface (Figure 7) and dilated<sup>4</sup> joint apertures (Figure 8); the latter features being particularly evident at the east end of the East-West pit where caves are present.

**Figure 7.** Dissolution has resulted in the upper surface of the limestone being karstified hence irregular.  
Example is from the south wall at the north end of the East-West pit.

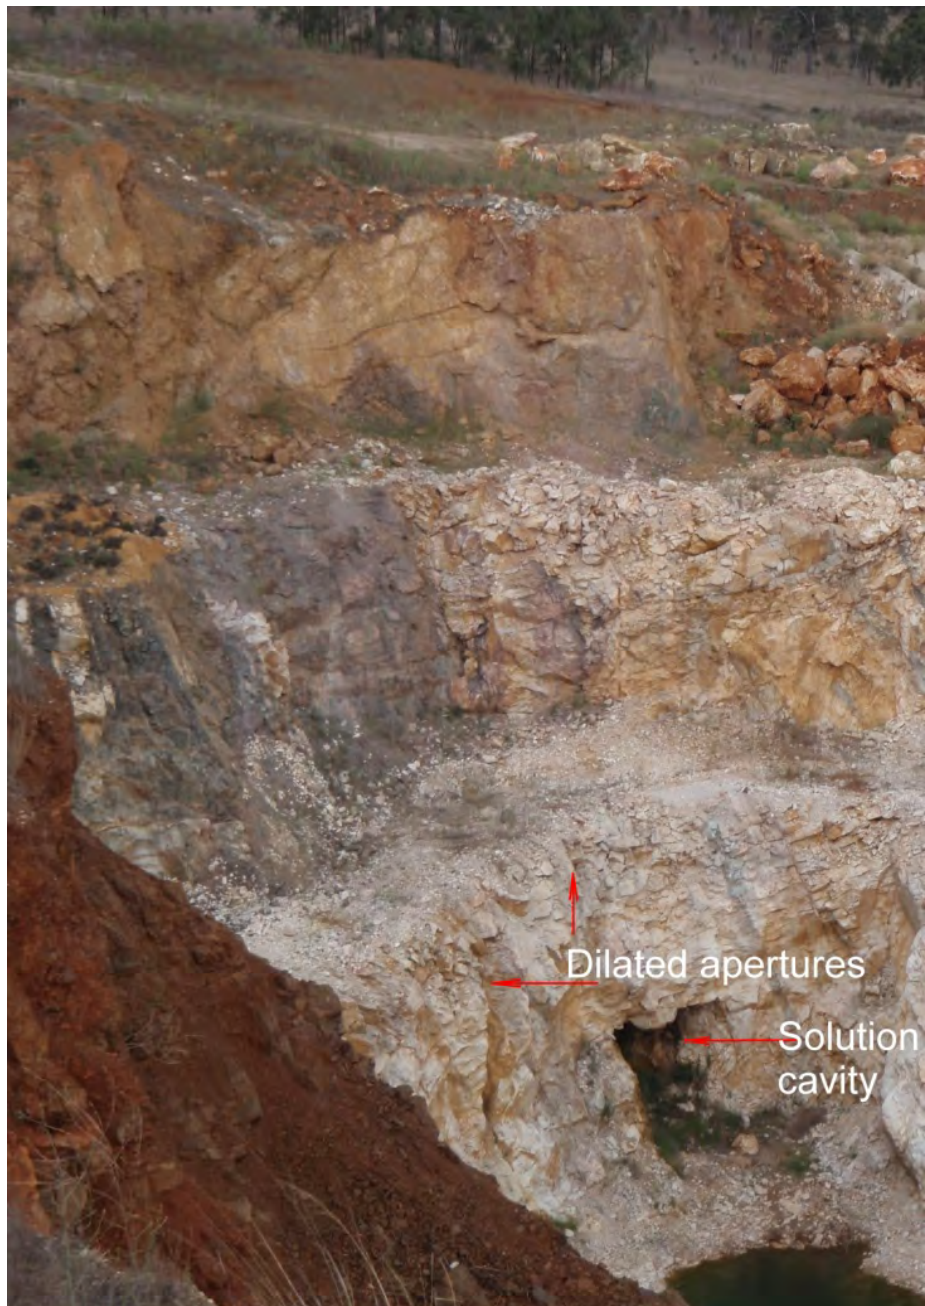
**Figure 8.** Karst features exposed in the northwest wall at the south end of the East-West pit.

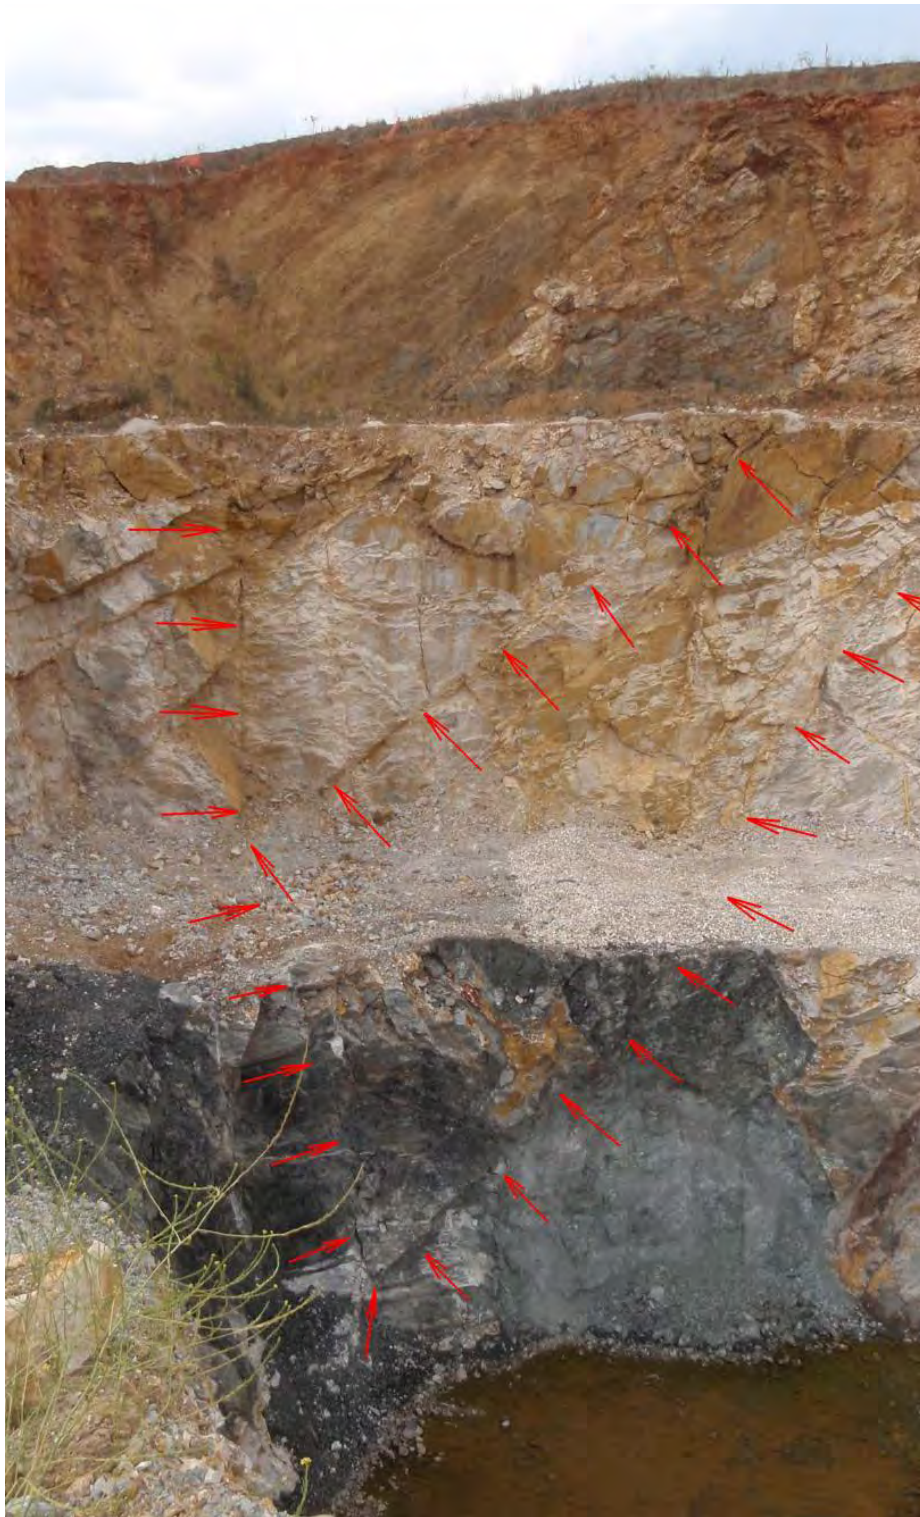
Bench scale instabilities involving intersections of two or more of the faults, or intersections of faults and jointing and/or bedding surfaces, have occurred to bench scale (Figure 12). Instabilities could extend over several benches although none of this scale has occurred to date.

**Figure 12.** Examples of traces of large wedges formed by the intersections of faults and bedding.

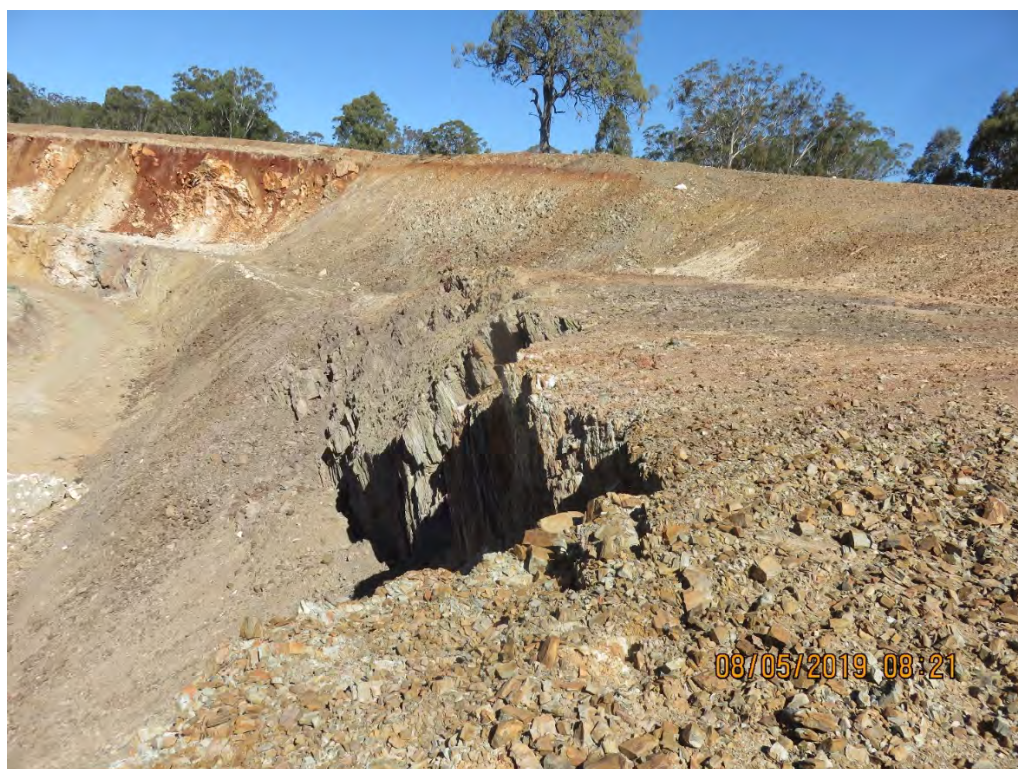
**Figure 31.** Toppling rocks on an east dipping batter on the upper bench of the Phoenix pit.

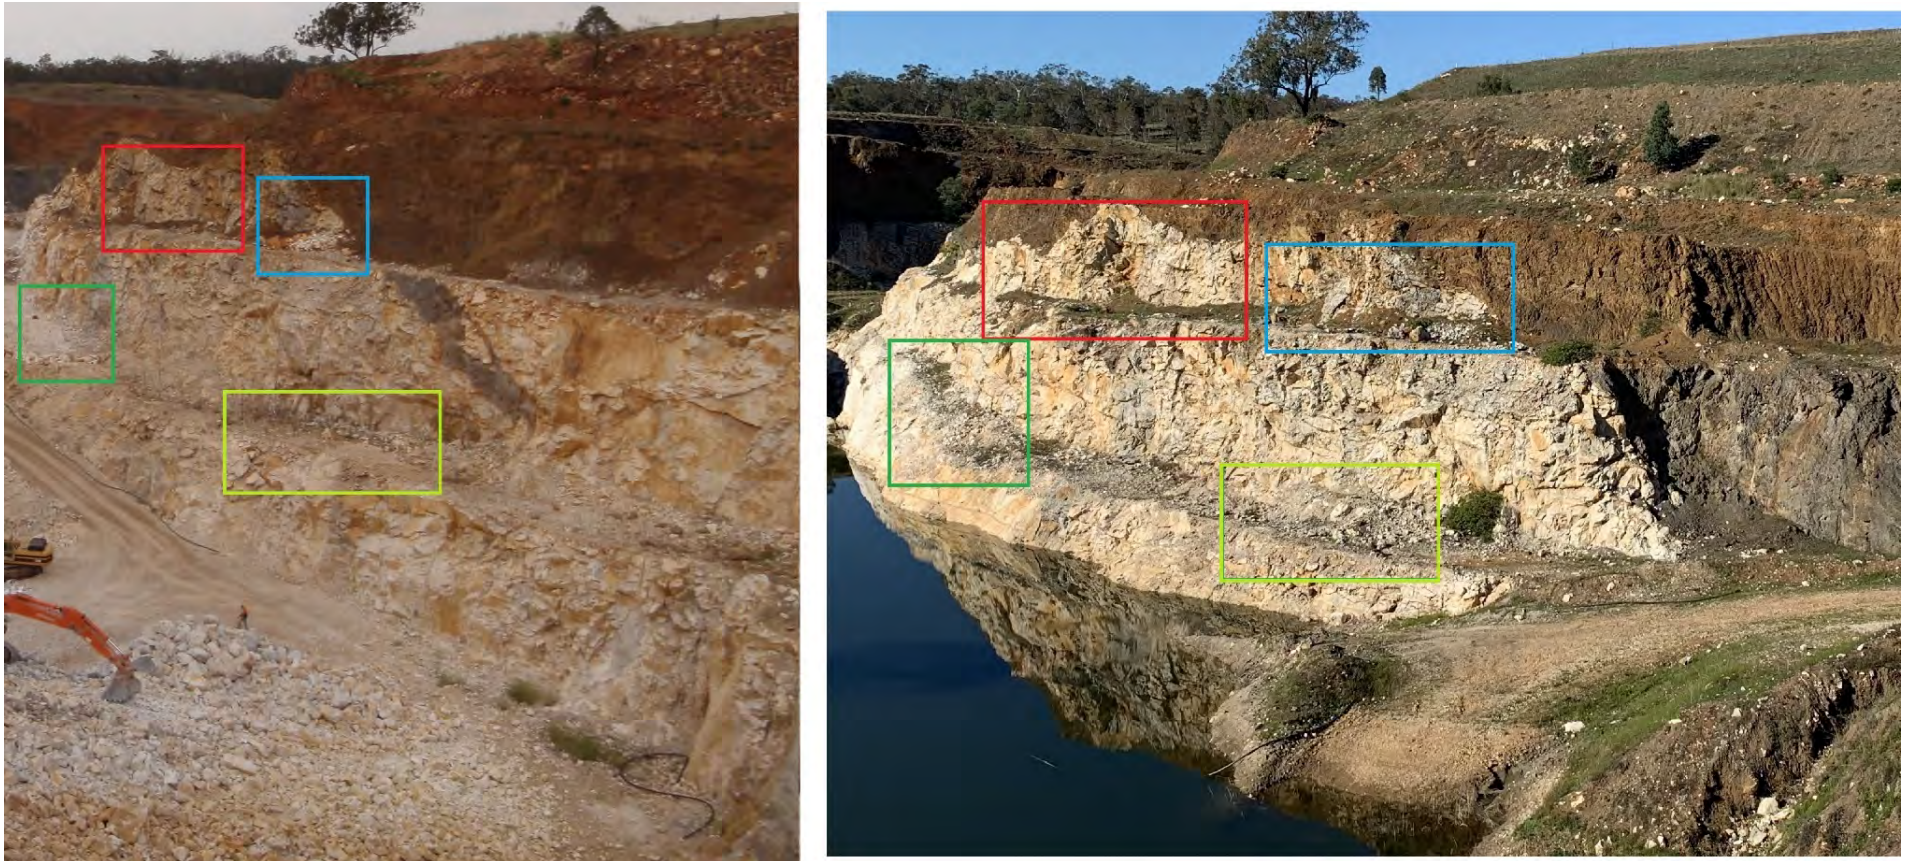
**Figure 43.** No significant differences in the volumes of rockfall debris on berms and the loss of berm widths on the south wall at the west end of East-West pit in (left) 2004 and (right) currently.

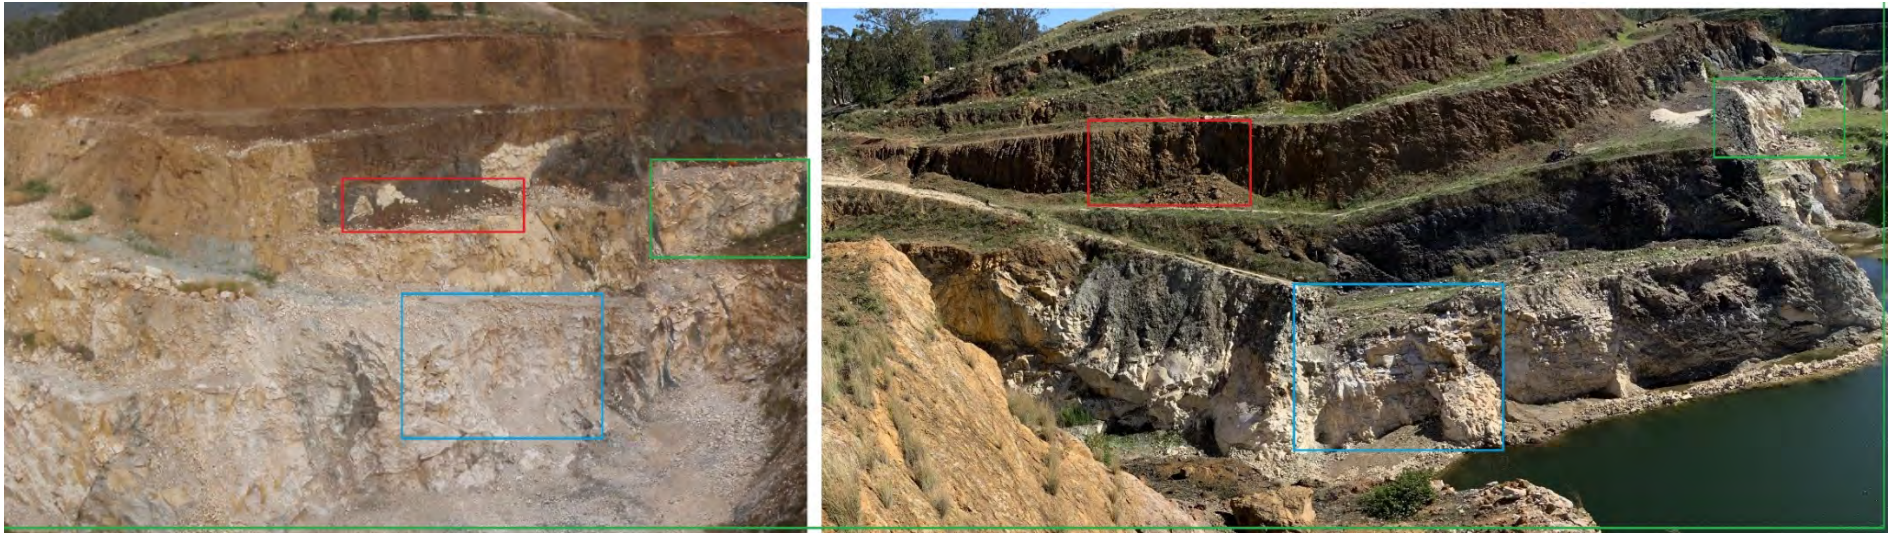
**Figure 44.** No significant differences in the volumes of rockfall debris on berms and the loss of berm widths on the southwest wall at the east end of East-West pit in (left) 2004 and (right) currently.

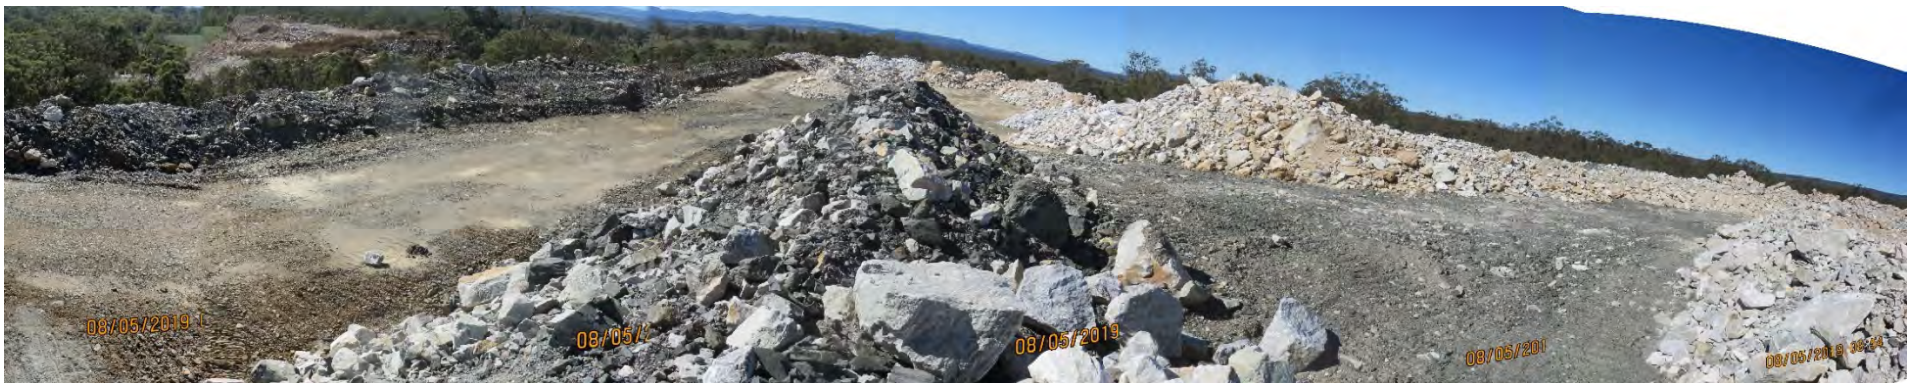
**Figure 46.** Upper surface of the southern section of waste rock dump 2 (WRD 2) to the southeast of Phoenix pit. The surface shaping, grading, crowning, topsoil and hydroseed.

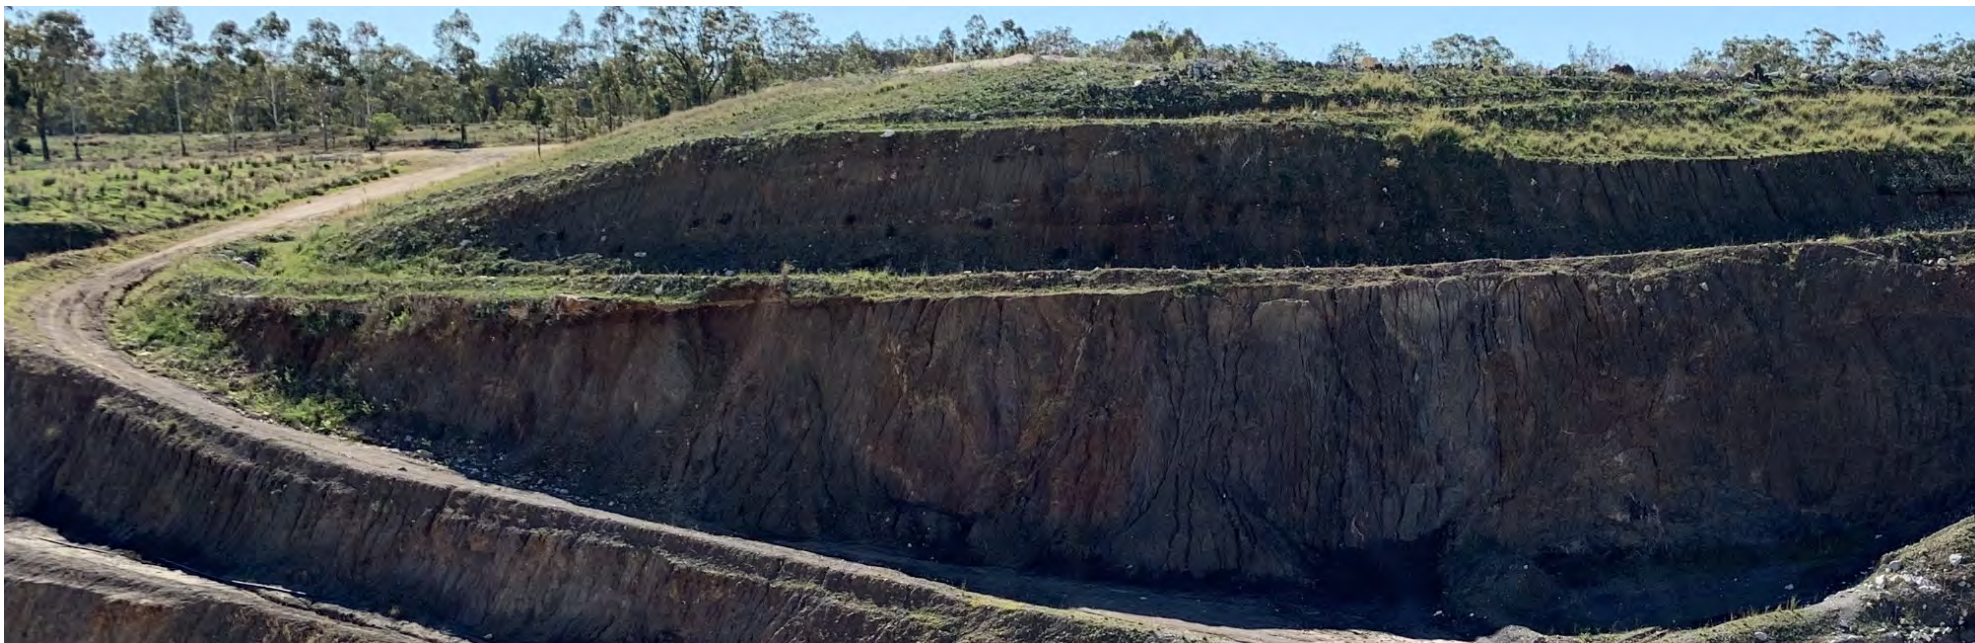
**Figure 49.** Batter adjacent to the central ramp in the East-West pit requires draped rockfall mesh and improved drainage on the ramp and 550-mRL berm above the ramp.

- East-West Pit: The central ramp on the north wall (Figure 49) and possibly the western ramp on the west wall (Figure 50).
  - Phoenix Pit: The main ramp along the east pit wall (Figure 33).

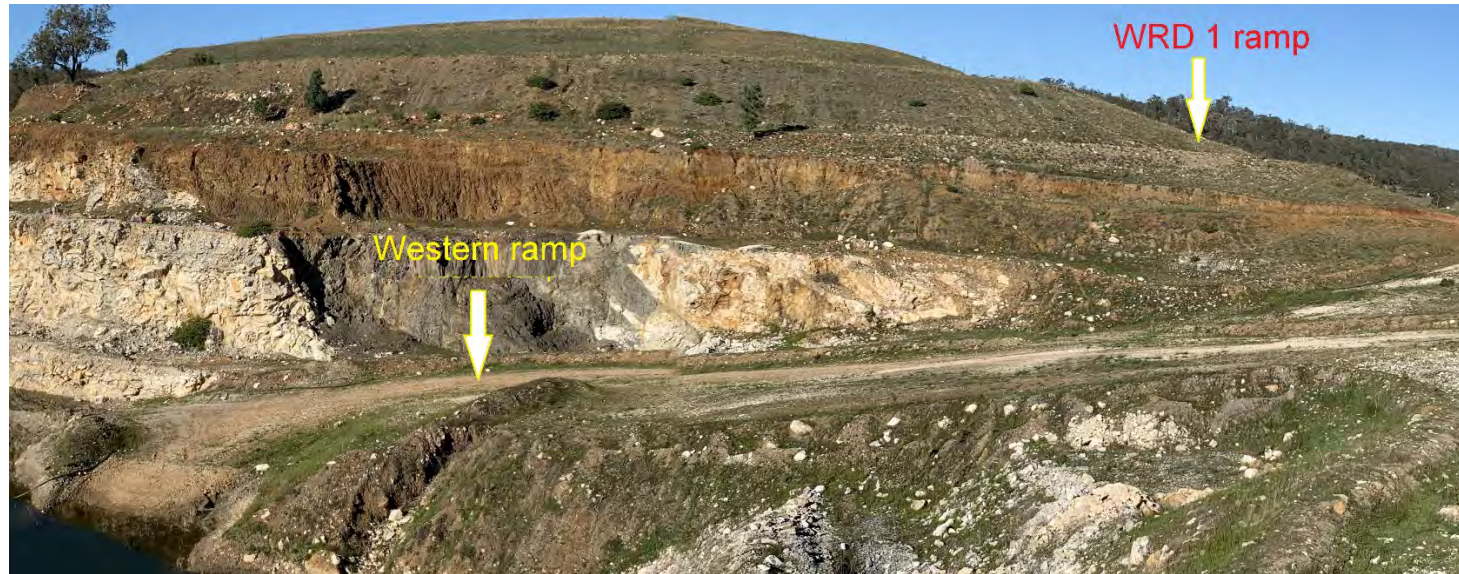
**Figure 50.** (a) If the western ramp in the East-West pit is to be retained, the heights of (b) the current toe bunds are to be increased. If the ramp is not to be retained, the surface is to be ripped and a series of low bunds are to be installed at regular intervals along contour down the inclined surface to reduce flow rates.

- Increase, to a minimum of 1.8-m, the height of the toe bund (rock traps) currently installed out from the toe of the adjacent batter (Figure 50b).
- The bund is to be continuous, unlike the current bund.
- The location of the inner toe of the bund is to coincide with the inner toe of the current bunds.
- The bund is to be constructed from rocks having the same characteristics as those used for abandonment bunds and constructed using the same procedure (Section 7.3.2).

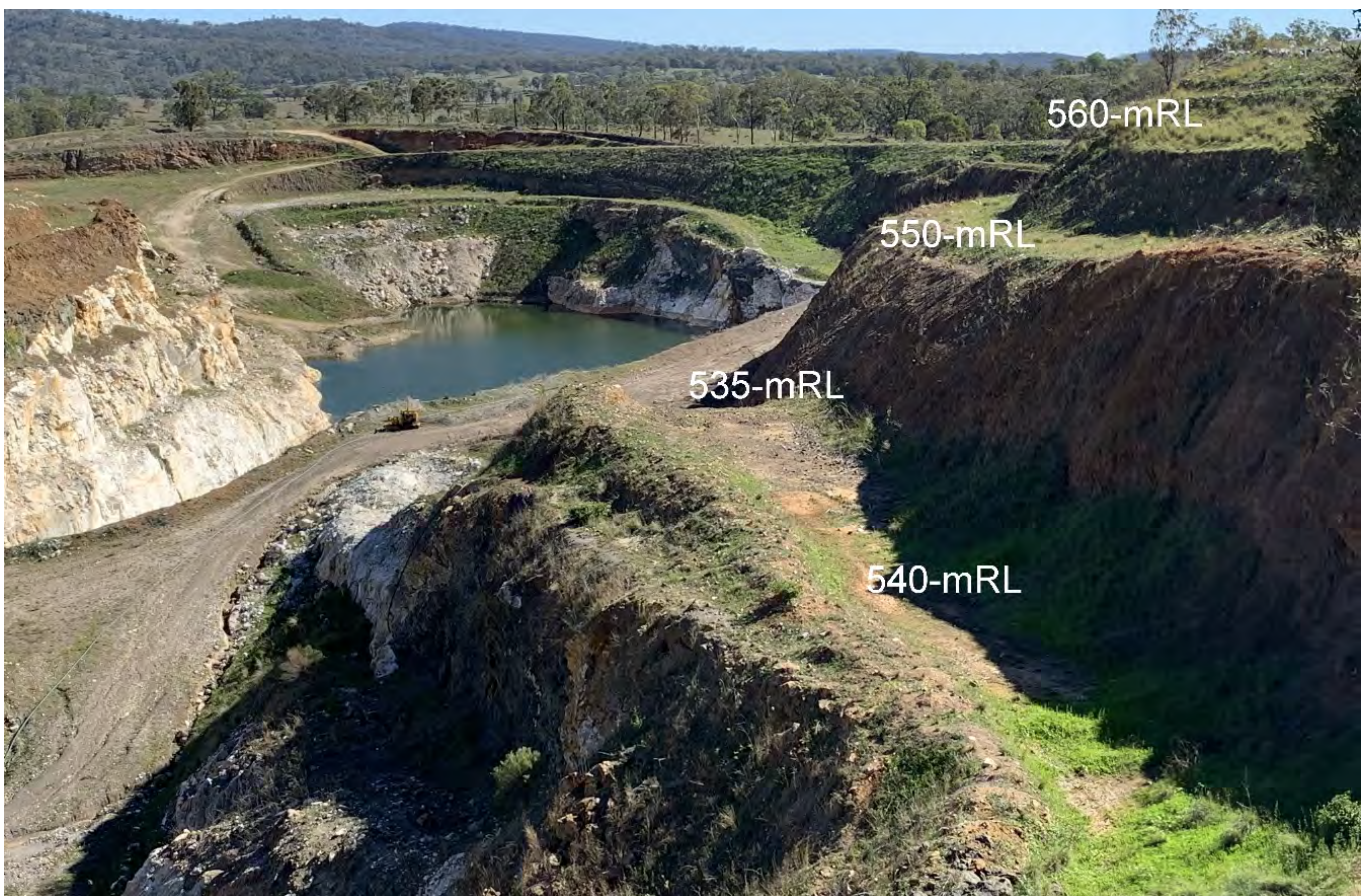
- Drains should be a minimum of 1.0-m wide and 0.3-m deep.
  - They should be filled with high permeability, coarse (no fines), durable limestones.
- Water shedding off the 550-mRL berm (Figure 52) above the batter adjacent to the central ramp is destabilising the batter below and eroding the ramp.

**Figure 52.** Water shedding off the 550-mRL berm is destabilising the 540-m to 550-mRL batter adjacent to the central ramp. Lined drains are required above and along the berm and down the batter.

- If water cannot be prevented from flowing on to the 550-mRL berm, a horizontal lined berm drain will be required to direct water to a vertical lined batter drain. The drains are to be lined with concrete canvas (Figure 51). The canvas is to be fixed securely to the surface with deep anchors.
