Part 1
Ebenezer Project
Progressive Rehabilitation Closure Plan
Environmental Authority EPML00594013

Mining Lease 4712

18 May 2023

Document ID: PRCPlp1

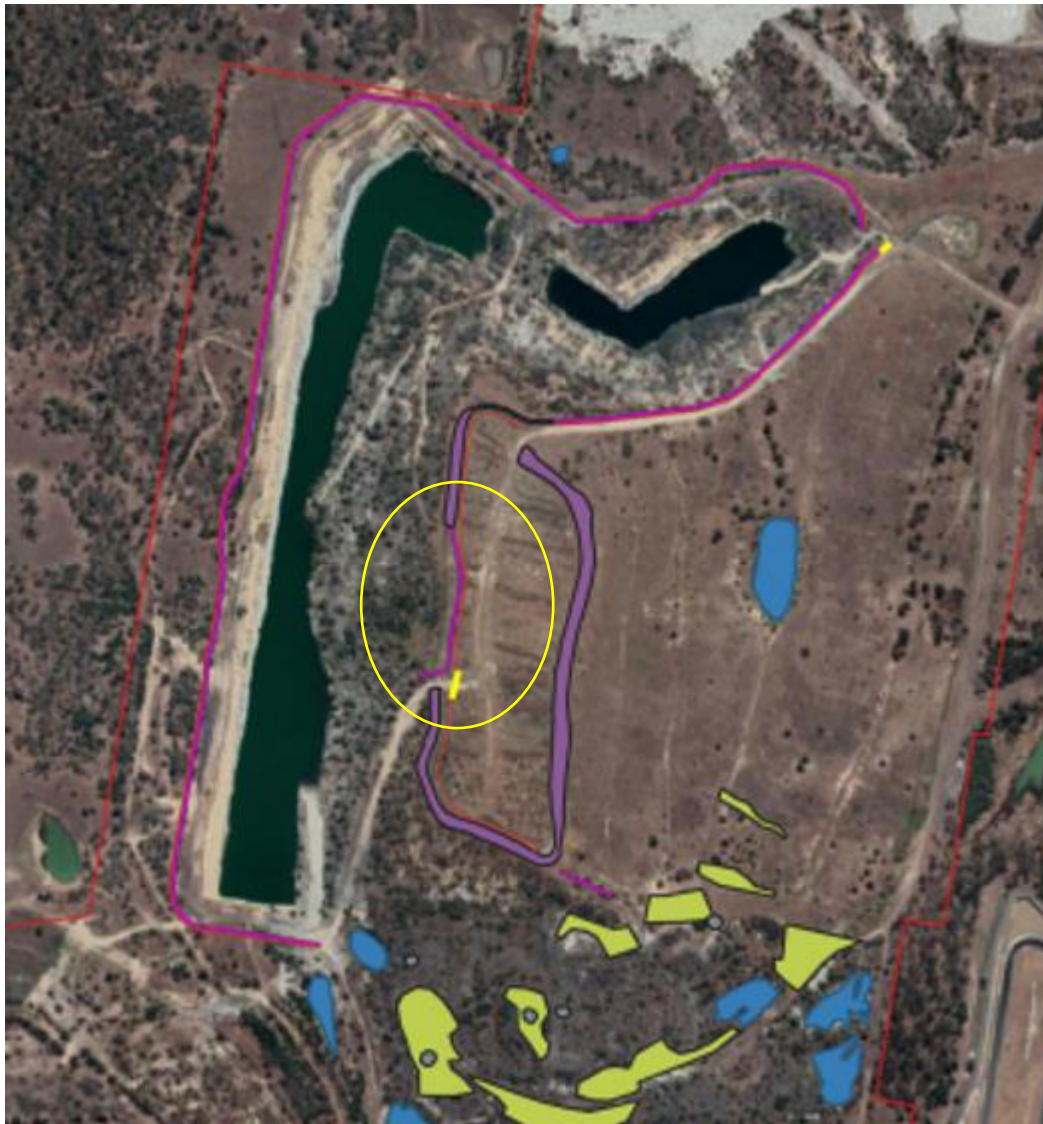
APPENDIX 2 - IMAGE 12: REALIGNMENT OF THE WESTERN BUND WALL

The bund wall located on the western side of the compost will be offset further from the crest of the low-wall due to slippage that occurred early in December 2021. The length of the realignment proposed is 270 m. The location is shown below. **Appendix 2 - Image 12** shows the approximate realignment of the western bund. A 235 m bench will be constructed to stabilise the recent failure. **Appendix 2 - Image 13** shows the slip from the top section of the low-wall batter.

- Realign perimeter bund of compost pad above recent low-wall failure (total length 270m, 5m bottom width, 1m top width and 2.5m high), place topsoil of 0.2m thickness and apply grass seed.
- Extend safety bund 100 m down slope at the southern end of Lanes Eastern Emplacement restricting access to Domain 6.
- Construct bench to stabilise crest (total length 235m).
- Construct stock fence (total length 1.6km).
- Install 3 gates to access Lanes Void Southern Ramp (Domain 3) and IBSD area (Domain 6).

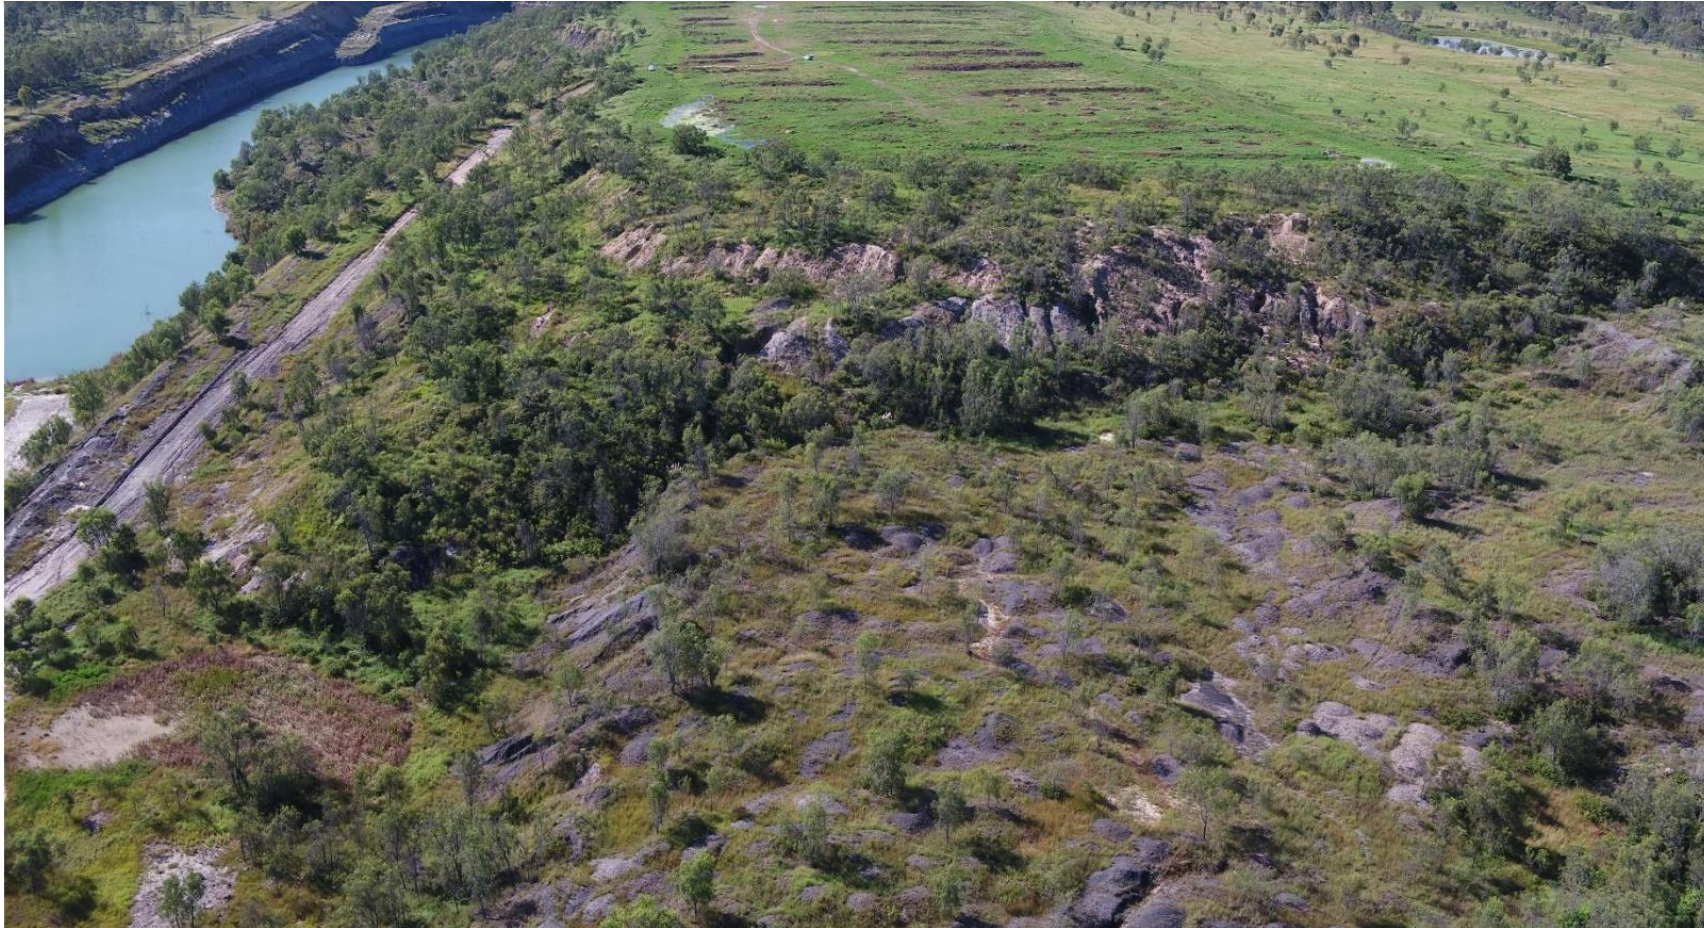
APPENDIX 2 - IMAGE 14: WESTERN SECTION OF DOMAIN 6 -IRONBARK SOUTH

The southern batter slope of the compost pad, leading down into Domain 6 (refer to **Appendix 2 - Image 14**) had experienced significant erosion due to uncontrolled stormwater flows in the past. This was abated when the perimeter bund wall was constructed around the compost pad. Vegetation has established between the bund and the crest of the southern batter.

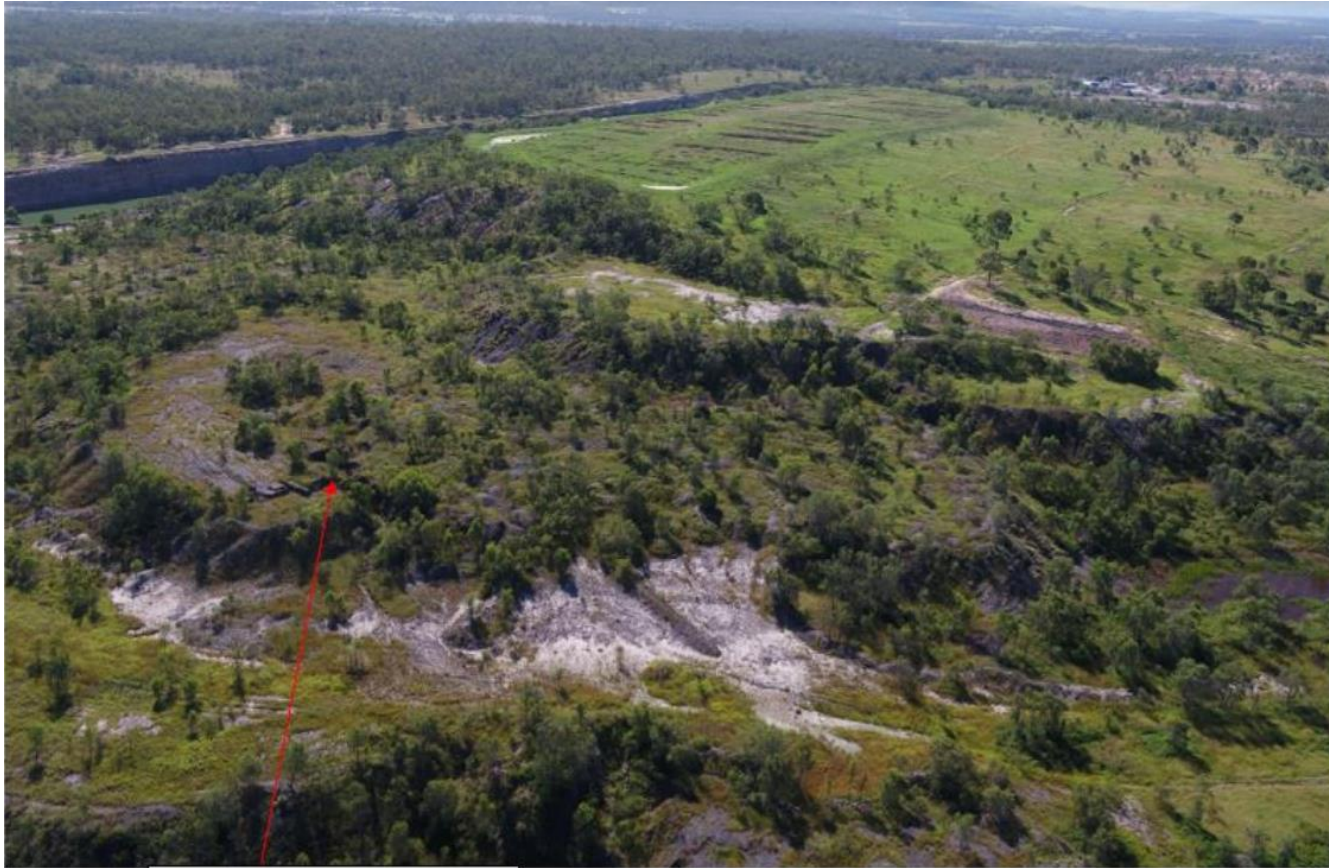
APPENDIX 2 - IMAGE 16: DEEP EROSION REQUIRING BACKFILLING AT IRONBARK SOUTH

Deep Erosion Requiring Backfilling

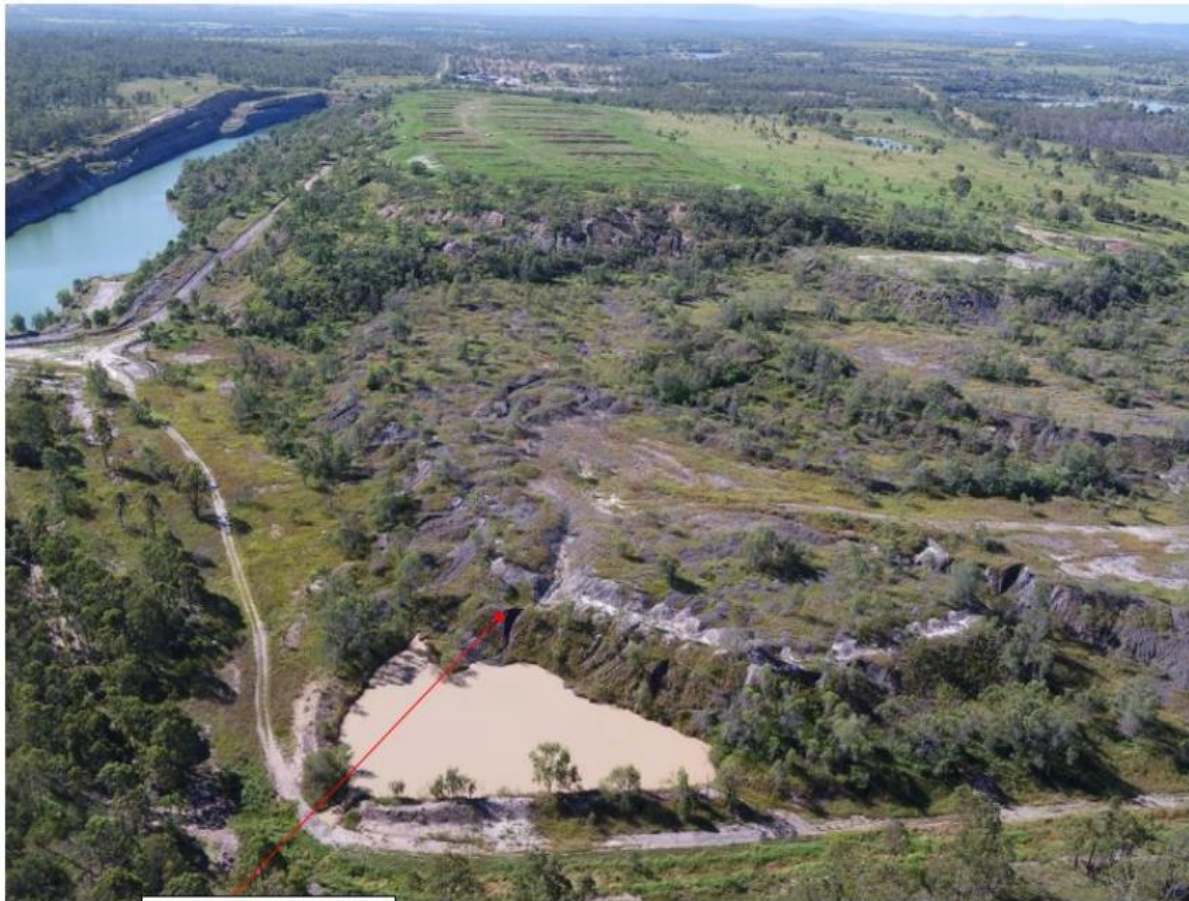
APPENDIX 2 - IMAGE 18: DRAIN REQUIRING STABILISATION IN THE SOUTH-WEST CORNER OF IRONBARK SOUTH

Drain to be stabilised

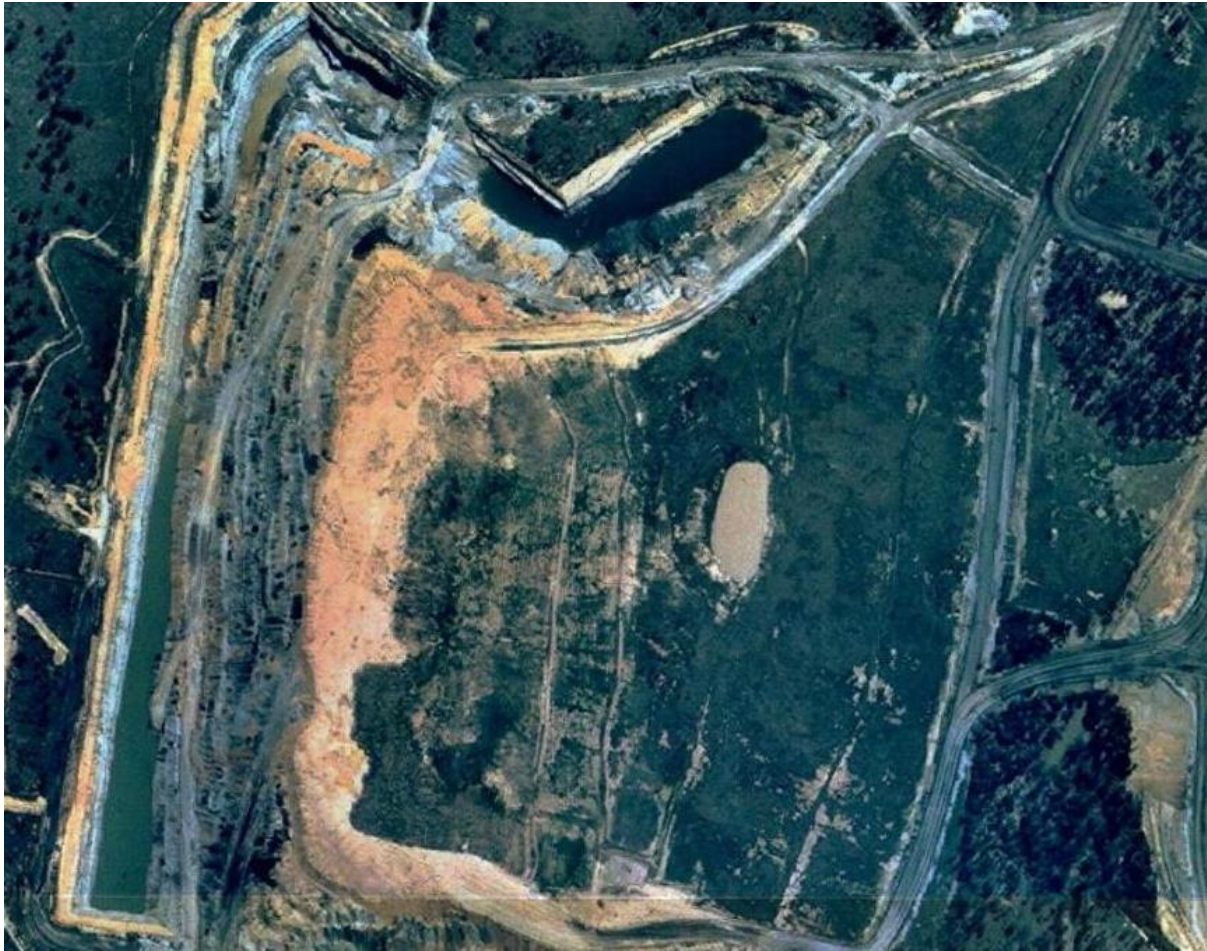
APPENDIX 2 - IMAGE 22: LOW-WALL (27/10/1997)

Whilst it is apparent that the low-wall is eroding and images obtained from Qld Globe provide a before and after view of a failure in the low-wall that occurred sometime before 6 July 2007 (refer to **Appendix 2 - Image 24** with **Appendix 2 - Image 22** and **Appendix 2 - Image 23** showing the state of the low -wall prior to the failure in 2007) (QLD Government, 2022a). There is no intention to stabilise the batter slope by reducing the angle of repose.

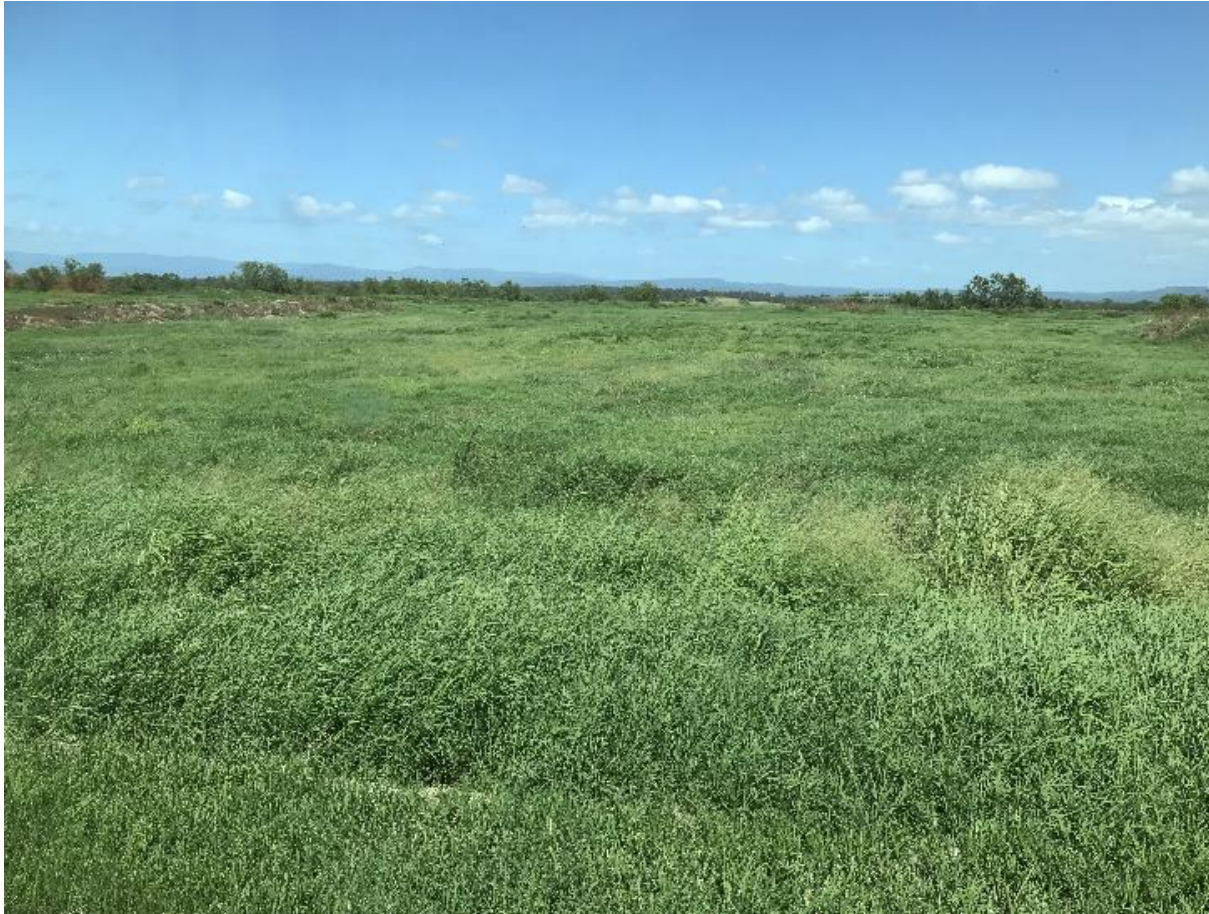
APPENDIX 2 - IMAGE 28: GRASS COVER OVER COMPOST AREA WITHIN DOMAIN 4 (06/02/2022)

The area known as Lanes Eastern Emplacement has been grazed since completion. The grass coverage on this area meets the acceptance criteria (refer to **Appendix 2 - Image 28** showing grass cover on top of compost pad surface on 06.02.2022). No further work is planned expect for at three locations where some channel and sheet erosion has occurred (refer to **Appendix 2 - Image 10**). There has also been natural regrowth of native trees since completion of the rehabilitation.

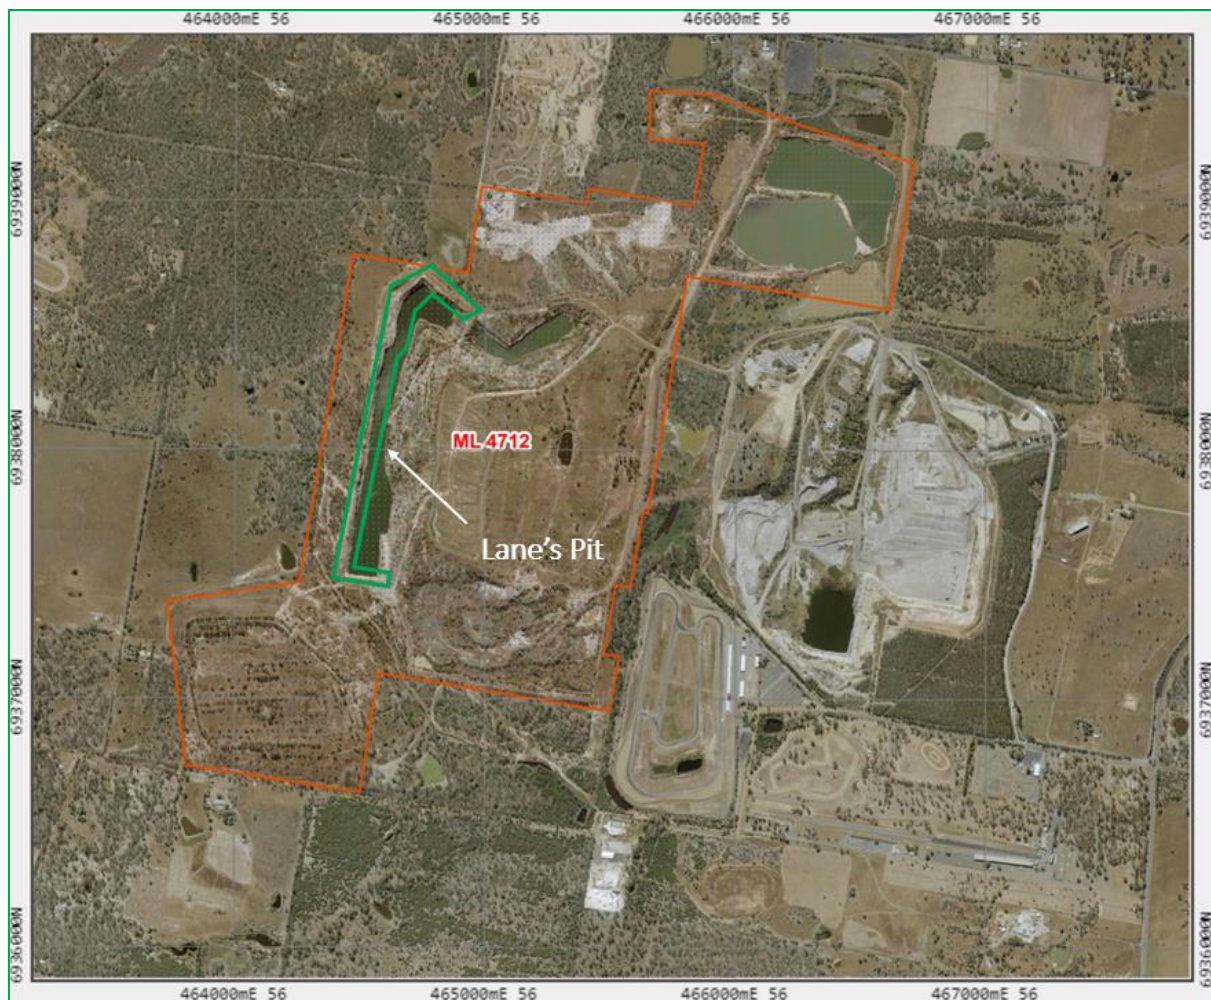
Figure 2. Location of the Highwall and Endwall Requiring Assessment (green polygon)

There are two current mining voids in Ebenezer Mines. The highwalls and associated endwalls to be assessed are along the western side of the Lane’s Pit, which was a previous opencut void and currently ponding with water, refer to Figure 2.

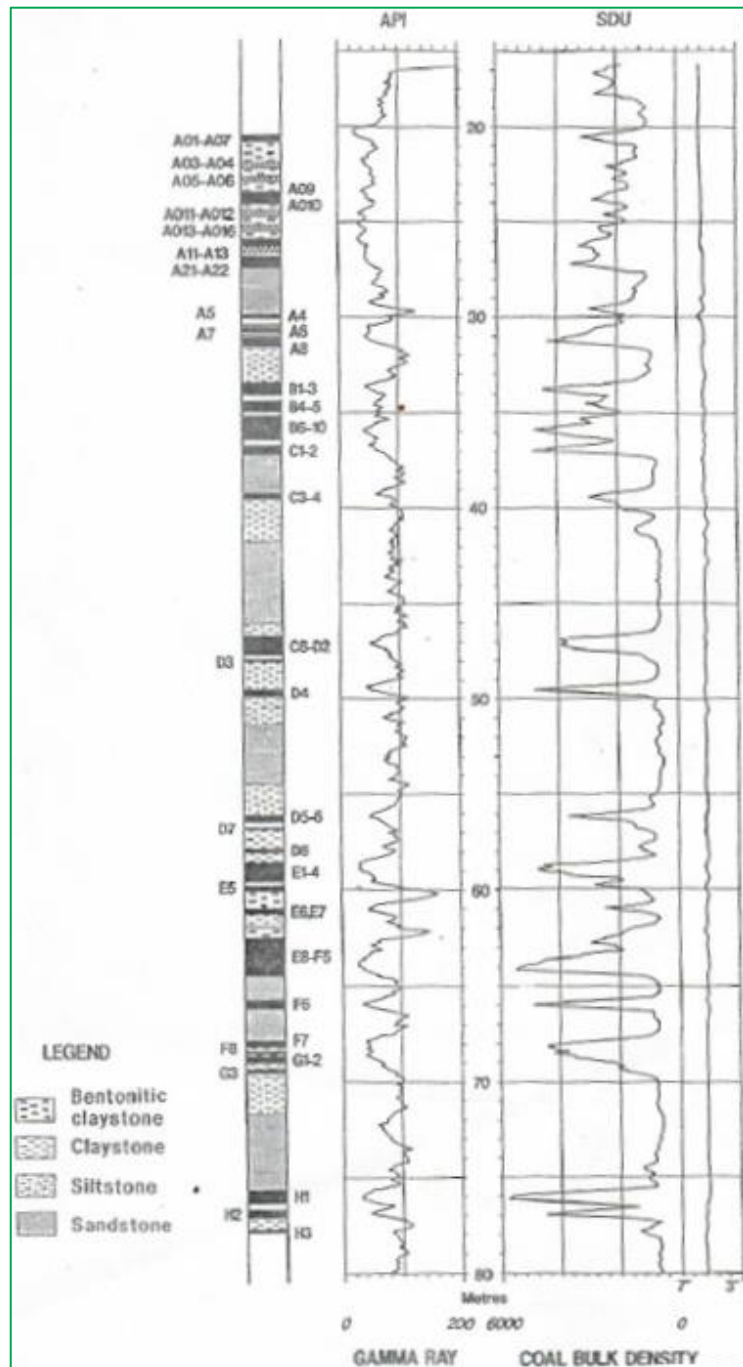
Figure 5: Generalised stratigraphic column (taken from scan0141.pdf)

provided in the dataset (file name: scan0141.pdf) identifies the presence of bentonitic claystone interbedded within the A and E coal plys, see Figure 5. Bentonitic clays have very high plasticity and very low frictional strength. These geomechanical properties have resulted in slope failures on floor dips as shallow as 4°.

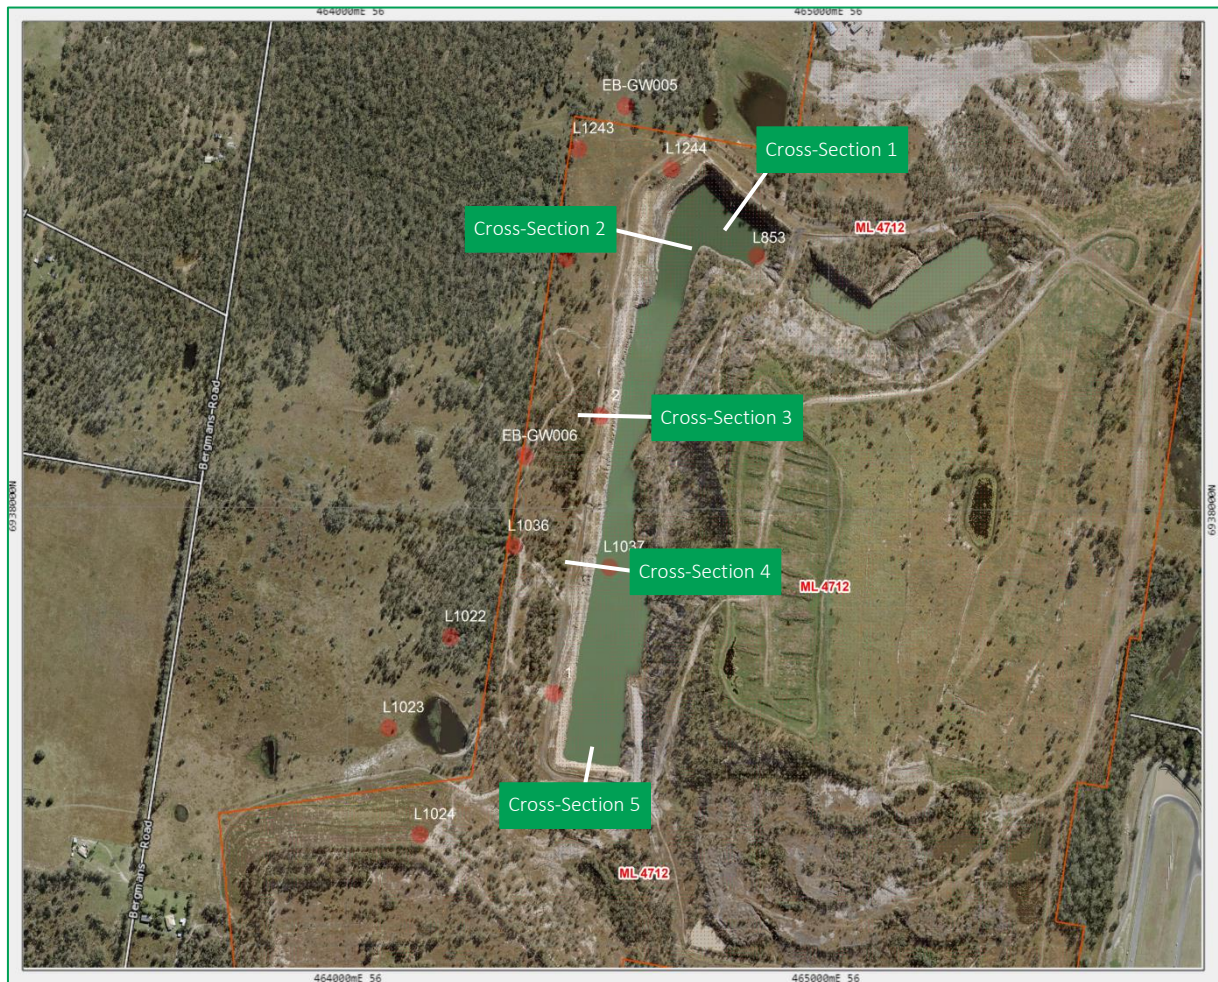
Figure 6: Plan of Cross-Sections 1 to 5

The results of the analyses, as discussed above, are presented in Table 4. Cross-Sections 1 through 4 returned results with an FOS of greater than 1.5 for all scenarios. Cross-Section 5 returned results between 1.2 and 1.5. Read & Stacey (2009) indicates that an FOS of 1.1 is approximately equivalent to a 30 per cent likelihood of slope failure. An FOS of ≥ 1.5 is approximately equivalent to a ≤ 5 per cent likelihood of failure.

The results indicate that the current slope geometries along the highwall and northern endwall satisfy the long-term requirements for slope stability. The southern endwall did not achieve the recommended minimum FOS of 1.5; however, as this is an endwall, the wall is restrained by the three-dimensional (3D) confinement of the highwall and the lowwall. With this consideration, it is likely that the 3D FOS could be in excess of the recommended minimum of 1.5.

An alternative approach to mitigating the risk of wall failure is to reduce the likelihood of a failure causing harm to people, property, or wildlife. To achieve this, Wanless have proposed to construct a safety bund (5 m bottom width, 2.5 m high and 1 m top width) and a five-strand wire fence (four strands of barbed wire with one strand at the top of plain wire) around Lane's Pit at an approximate distance of 40 m from the crest edge.

The bund and stock fence proposed by Wanless is considered to be an appropriate control measure to reduce the likelihood that people would be present at the highwall during a failure event.
