**COPPABELLA COAL MINE  
SOUTH ARM DIVERSION SALINE SEEPAGE MONITORING  
REPORT**

March 2017

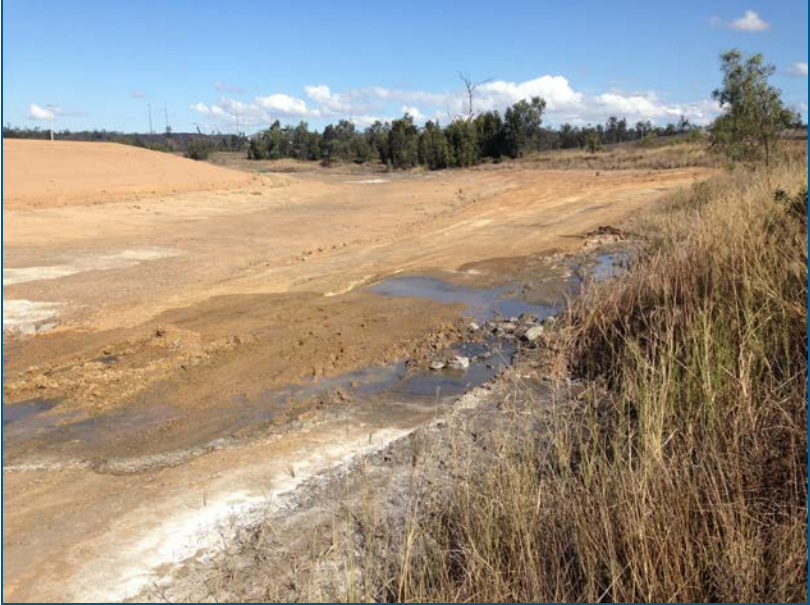
| Soak 2 – Photo Point 1 – July 14 | Soak 2 – Photo Point 1 – Aug 14 | Soak 2 – Photo Point 1 – Dec 14 (post remediation) |

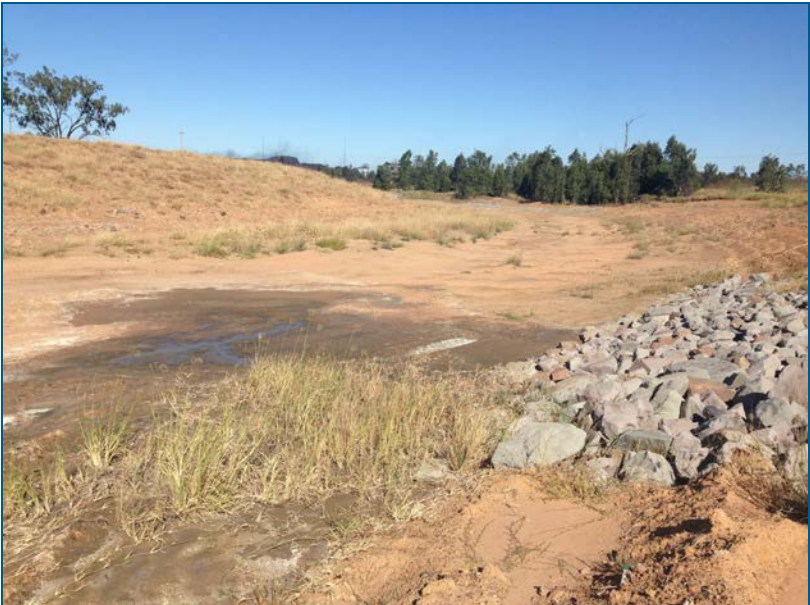
| Soak 2 – Photo Point 1 – July 14 | Soak 2 – Photo Point 1 – Aug 14 | Soak 2 – Photo Point 1 – Dec 14 (post remediation) |
|---|---|---|
| Soak 2 – Photo Point 1 – May 15 | Saline Seepage North Bank Down Stream 2 (SSNDS2) – Feb 16 | Saline Seepage North Bank Down Stream 2 (SSNDS2) – Feb 17 |
