**COPPABELLA COAL MINE**

**CHPP AREA – IMPLEMENTATION REPORT**

EROSION AND SEDIMENT CONTROL IMPLEMENTATION AND MONITORING PLAN  
December 2015

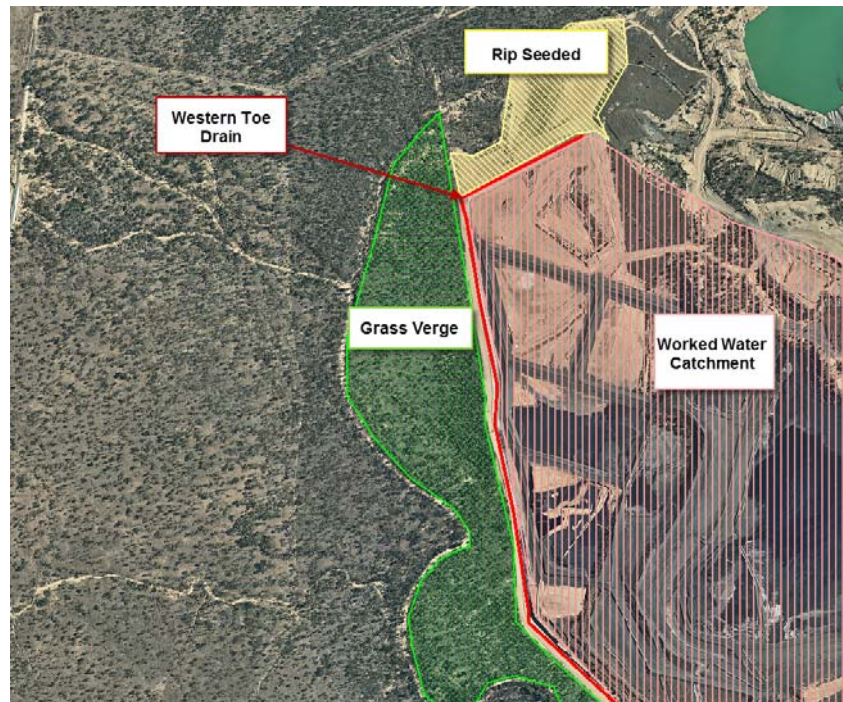
Figure 1 – Revised ESCP for Area 1 - CHPP

The extent of Area 1 as seen in the original ESC Implementation plan in March (Figure 10) has changed slightly as the western toe drain around the Co-disposal area was built for life of mine as per Figure 1 below.

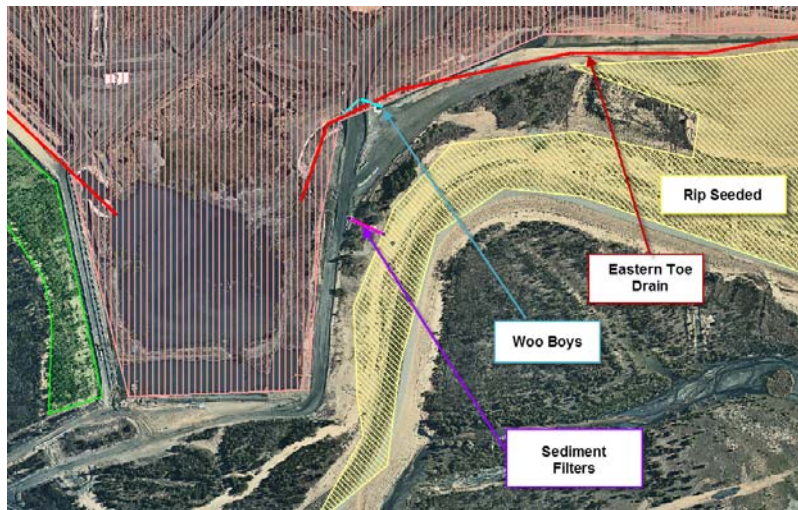
Figure 4 – Revised CHPP ESCP

Area 2 (Figure 10) is located adjacent to the Return water dam. The small ESCP catchment area is predominantly dominated by an access road. Minor changes to the original implementation plan have occurred over the period and are seen in figure 4, and discussed below.

- The road way has been Permian rocked capped for all weather access.
  - This was completed, however it was identified that additional controls would be required as mud from Moxi tires was transferring to the new surface.
- 2014 rehabilitation of the South Arm diversion was re-ripped and seeded during 2015 to encourage further growth in the area.

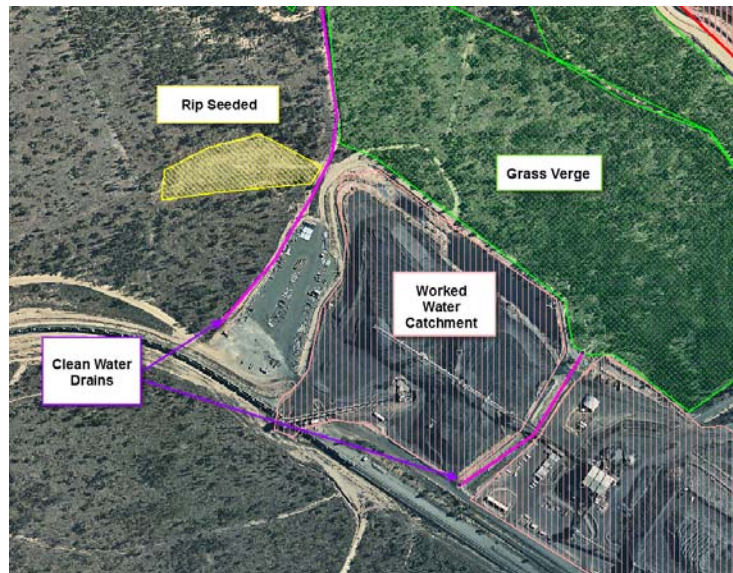
Figure 7 – Area 3 ESCP

Area 3 (Figure 10) is located around the CHPP building and is predominantly focused around the segregation of worked and ESCP water. Details of area 3 are highlighted in Figure 7, and discussed below.

- The topsoil stockpile has been seeded as seen in Figure 7
- Worked water catchments have been sheeted and drain into worked water structure and the catchment minimised as seen in Figure 7
