# Rehabilitation of the Dawson Dam, Moura, Queensland

for  
WestSide Corporation

10<sup>th</sup> October 2017

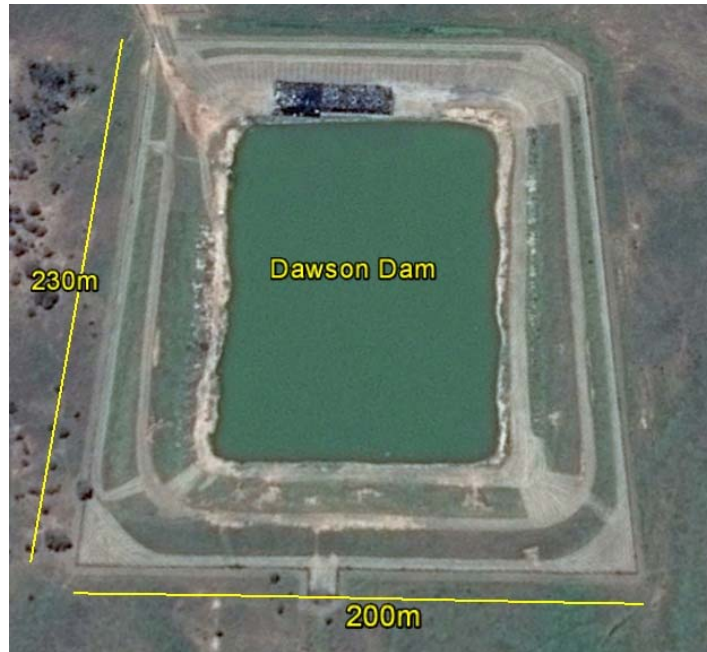
The dam is approximately 200 x 230m and empty of water even though the Google Earth shot shows water (Figure 1). This is because the Google Earth image comes from 2015. It was constructed using a cut and fill approach, using the soil from the cutting process to create the dam walls.

**Figure 1** Dawson Dam near Moura, QLD (Google Earth snapshot, accessed on 10 August 2017 but image taken in 2015, hence the presence of water in the dam)

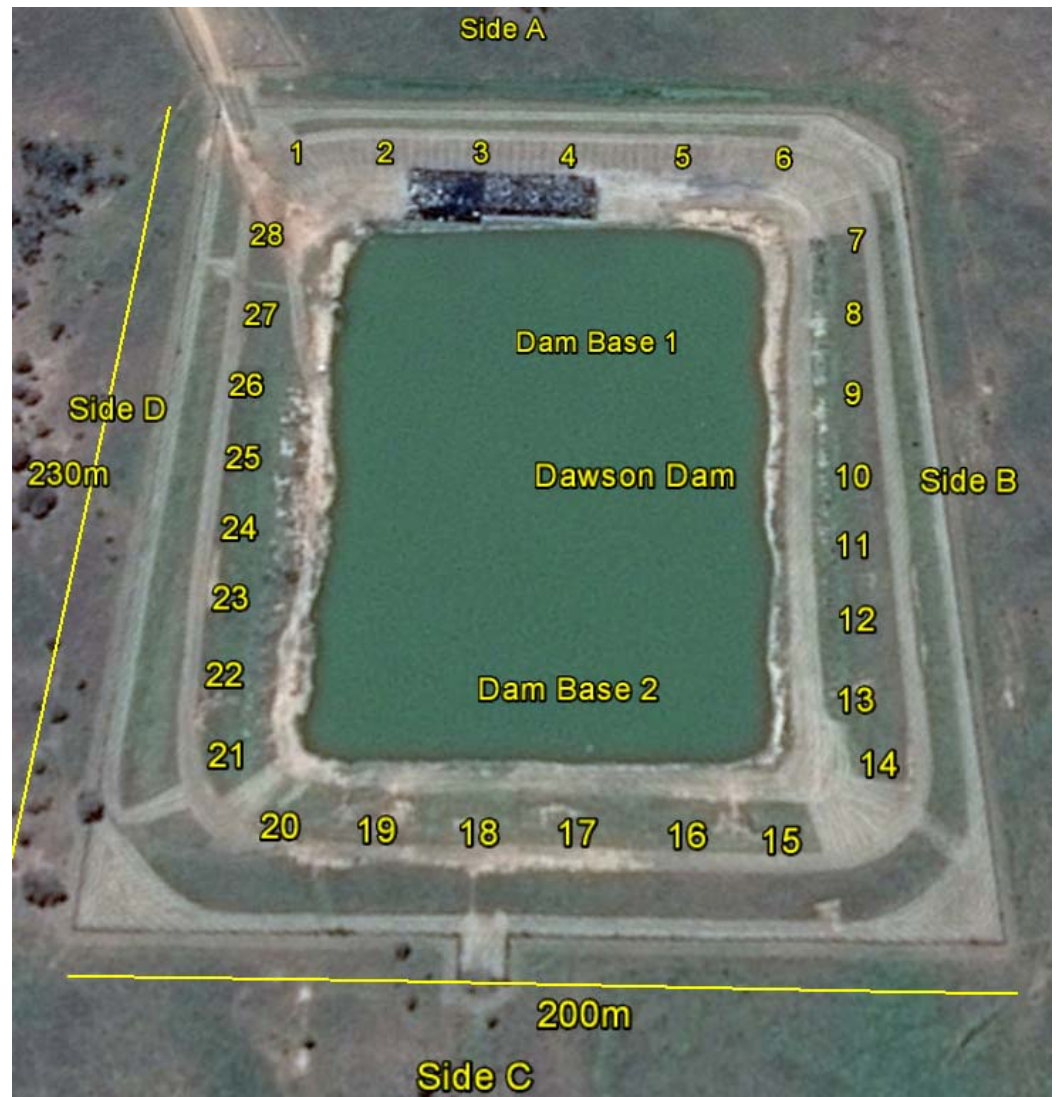
Two samples were taken from the dam base and 28 samples from the dam walls (Figure 5) and were then field assessed using the methods described in the previous section.

Figure 5 Sampling sites for the Dawson Dam

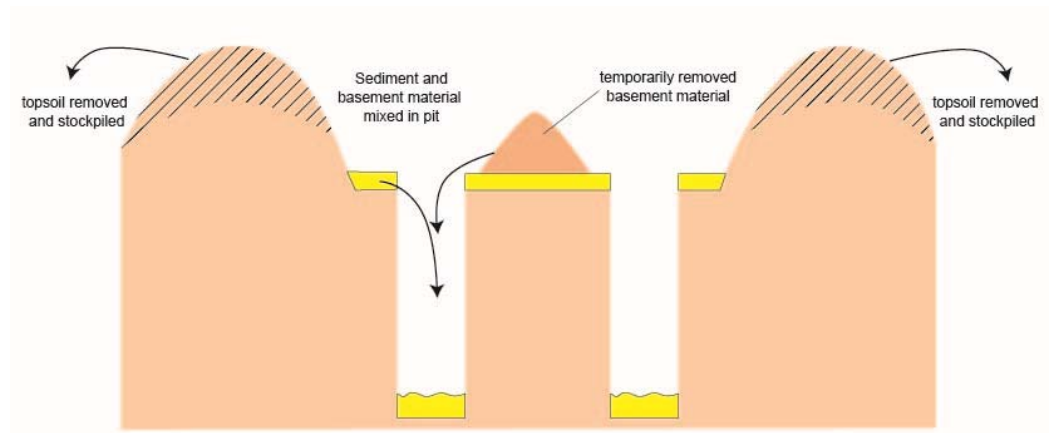
Pits, 3-10m in depth, were dug into the base of the dam. The sediment was mixed with the soil taken from the pits and relocated in a pit (Figure 10).

**Figure 10** Cross section of the Dawson Dam showing the mix and bury process

The contaminated soil were placed at a depth sufficient to ensure that the subsequent profile reconstruction would cover saline material to a depth of  $\approx 2\text{m}$  so as to provide adequate protection for pasture re-establishment.

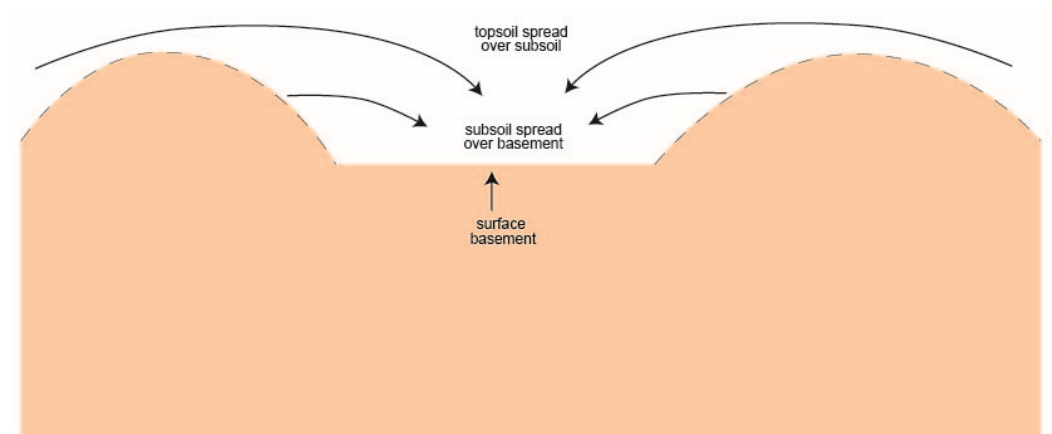
After the mix and bury process was completed, materials from the dam walls were spread over the top of the reformed basement surface (Figure 11).

**Figure 11** Cross section of the Dawson dam showing the spreading of the dam wall materials over the reformed basement

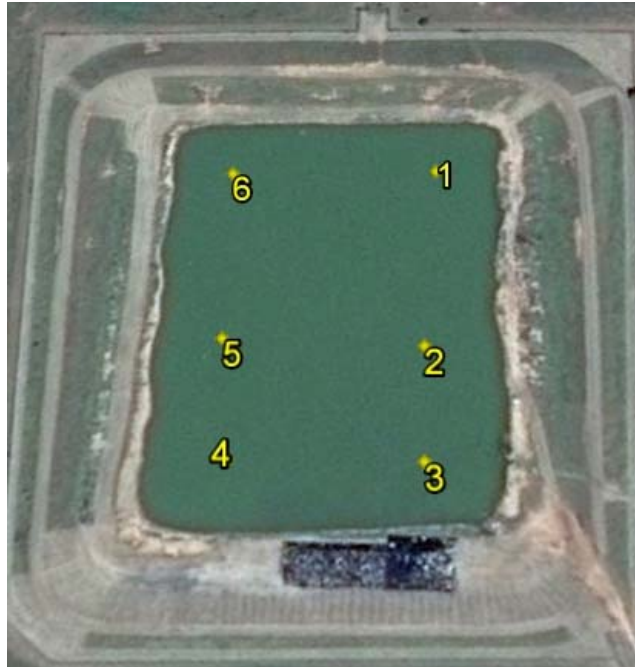
After the basement layer was reformed, six samples were taken from a depth of 0-10cm as shown in Figure 22.

**Figure 22 Location of sampling sites in the reformed basement before deep ripping**

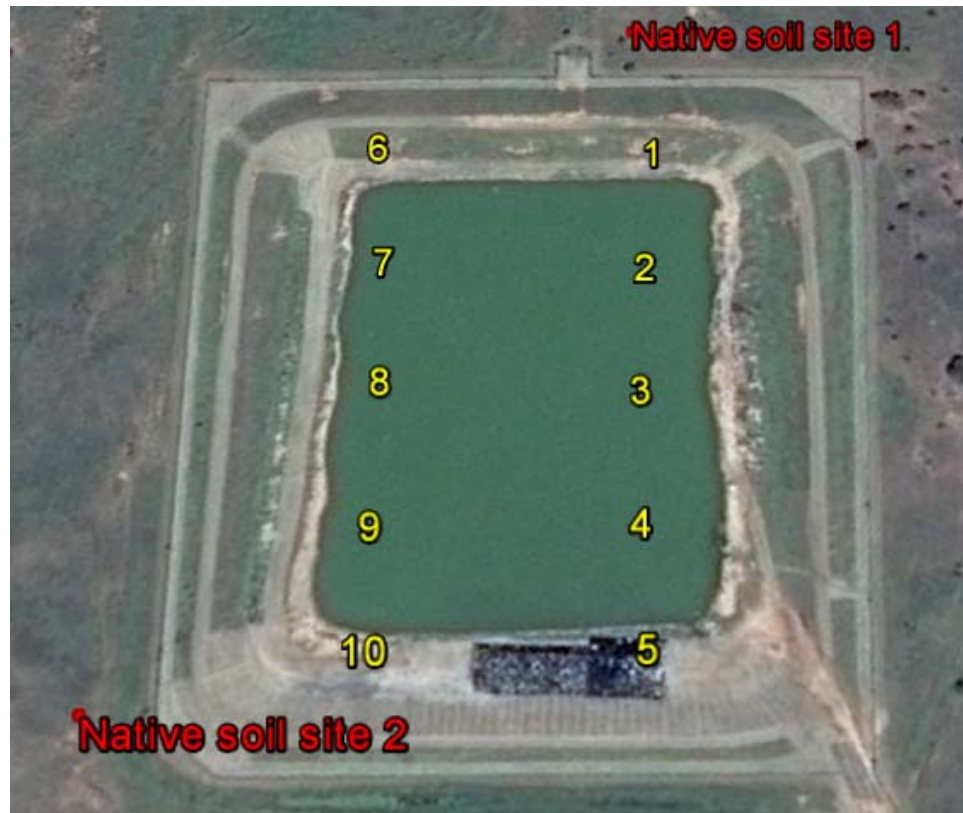
After completing the earthworks but before applying gypsum, ten samples were taken from the 0-10cm depth in the rehabilitated area (Figure 23).

**Figure 23 Location of soil sampling sites in rehabilitated topsoil of dam site**

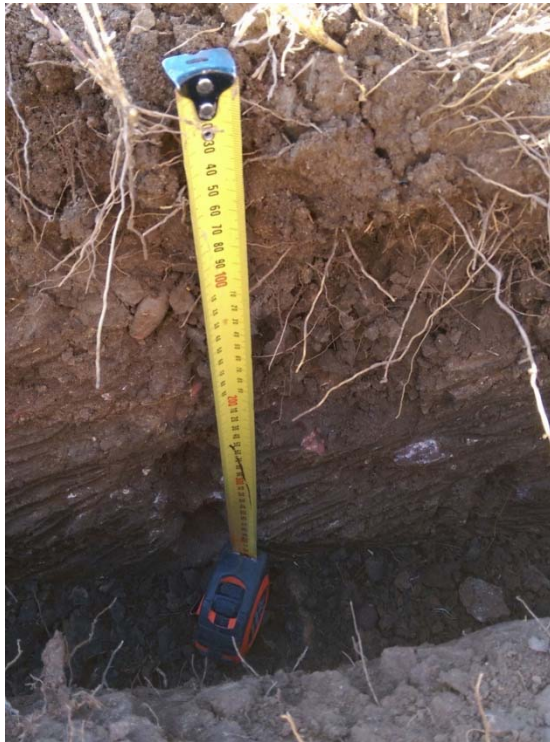
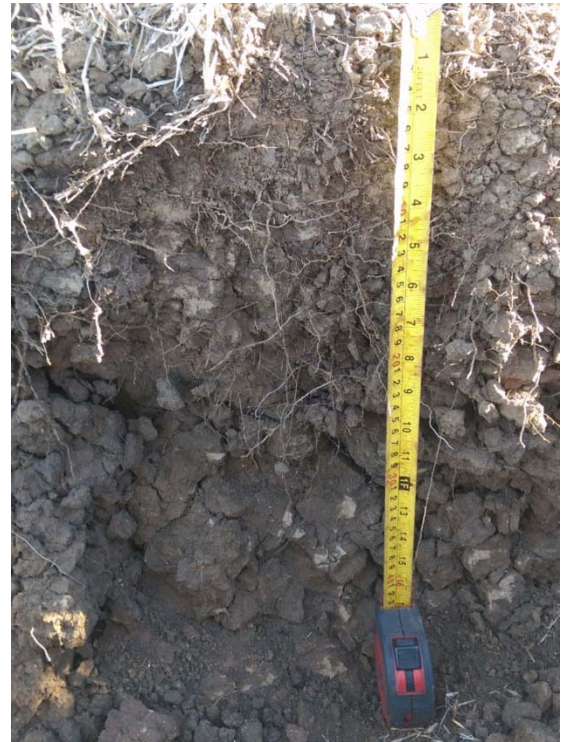
Preliminary assessment (Arris, 2016) of two adjacent native soils (Figure 24) indicated that the topsoils were low in nitrogen, phosphorus, and sulphur but were adequate to high in potassium (Table 10). The topsoil pH (H<sub>2</sub>O) values were 8 and 7.7 which could limit some sensitive pasture species. This is compounded by pH values of 9 and 8.8 in the subsoil. The soils had marginal salinity in the topsoil and high salinity in the subsoils. The topsoils were not sodic but the northern subsoil was sodic and the southern subsoil was marginally sodic (Table 11).

**Figure 24 Native soil profiles (a) north of dam and (b) south of dam**
