# Torres Strait Island Regional Council

## Saibai Sewage Treatment Plant

### Part 1: Condition Assessment

Revision B

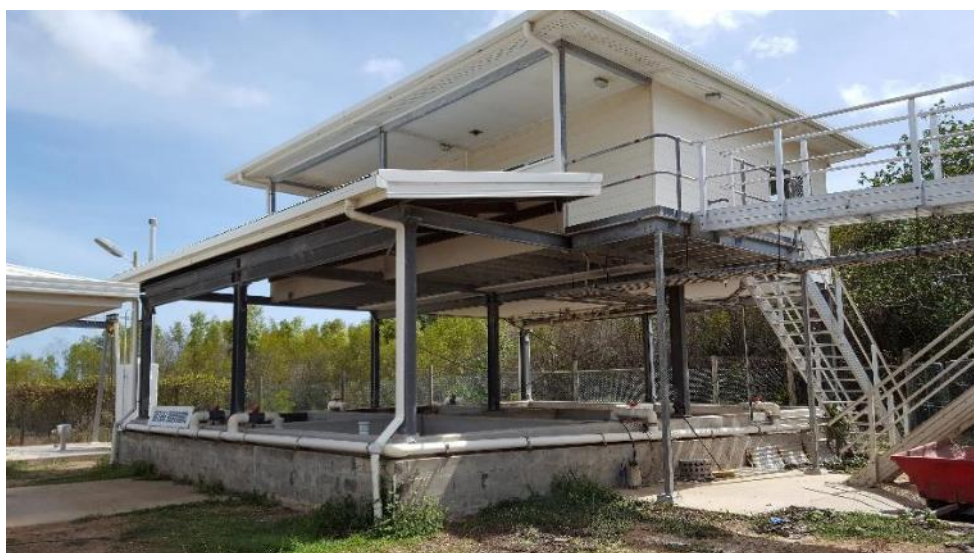
The existing admin building was in good condition and had recently been upgraded in 2012. The following issues were identified: -

1. The outdoor air-conditioning units and associated supports and frames have corroded and will likely need to be replaced; and
2. Algal growth on the walls and roof.

Figure 3 – Admin Building over Drying Beds

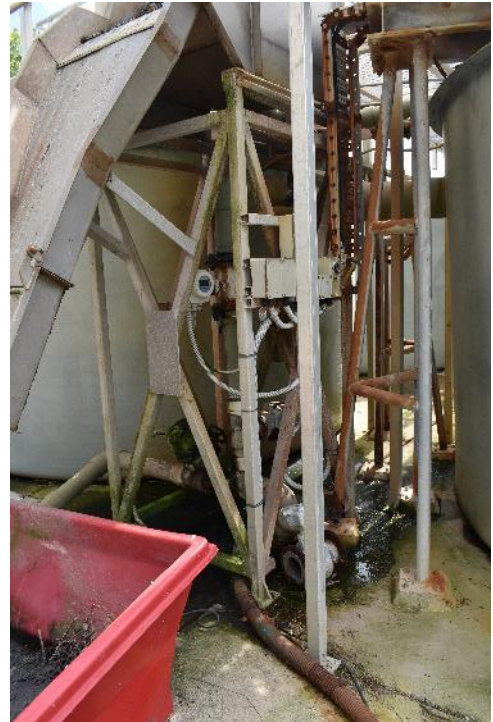
The Static Screen was installed in 2008, the condition of the static screen appeared to have deteriorated significantly since the last assessment (2016). The following issues were identified: -

1. Severe buildup of slime, grit, rags and other putrescible due to lack of maintenance e.g. sprays, cleaning etc. leading to regular overflow of the screen;
2. A section of the STP influent pipeline is in poor condition with severe corrosion on flanges, bolts etc. resulting in leaks and release of raw sewage onto the ground;
3. Leaks were observed on the back and underside of the screening unit due to corrosion around welds and connections;
4. Flowmeter was not in operation and bypass valve actuator was covered in slime/algae preventing the position indication from being read (access to control valves is poor);
5. Screenings collection trailer was damaged (wheels fallen off); and
6. Sump grate was missing.

Figure 6 – Inlet Works Area

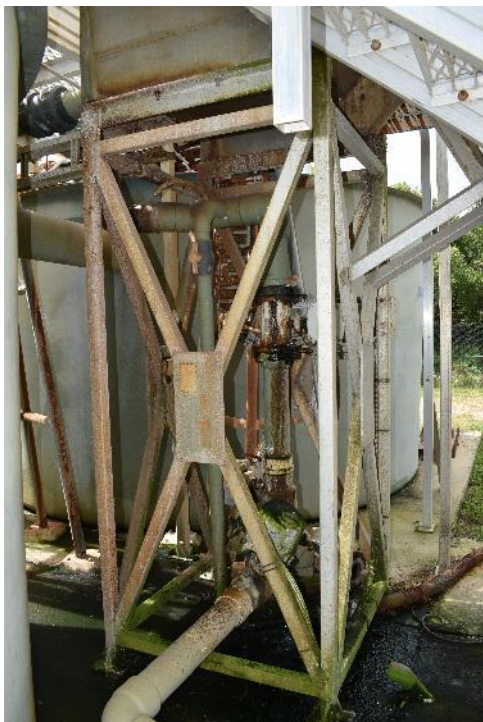
Figure 7 – Inlet Works Area

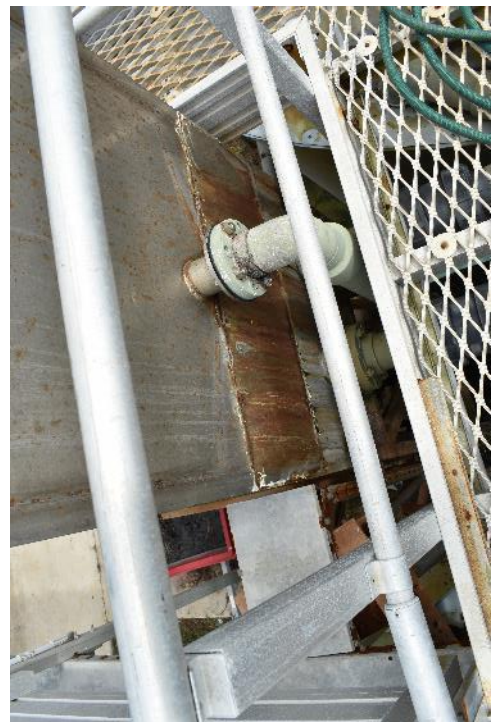
Figure 8 – Inlet Works Area

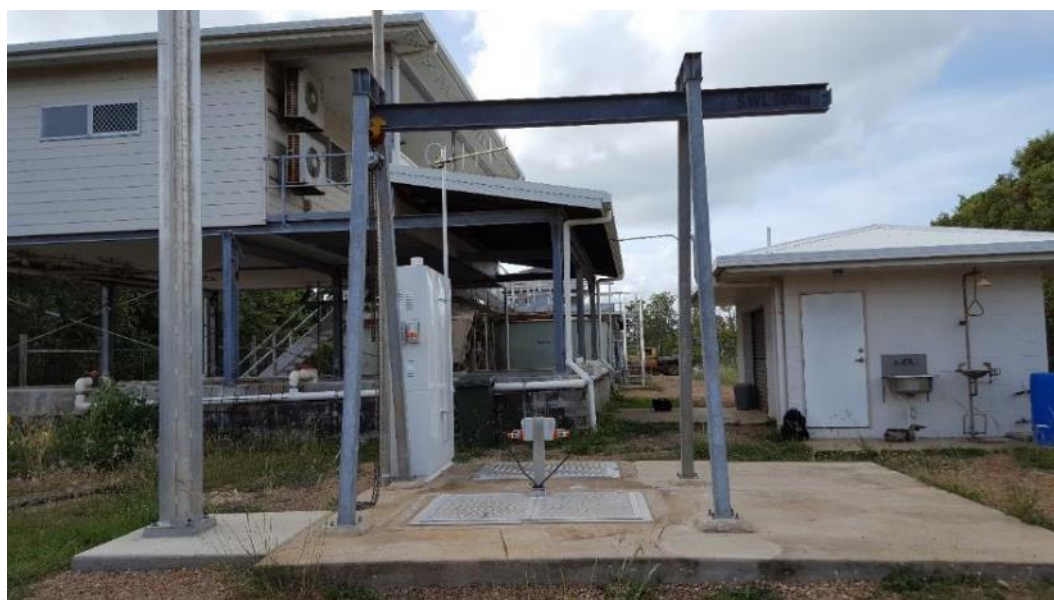
Sewage Pump Station 1 (SPS 1) is located at the southern end of the treatment plant and delivers flows into the STP based on the level in the wet well. The SPS Manhole and Wet wells were installed in 2001 and remained in a serviceable condition with some corrosion evident around the invert of the inlet in the receiving manhole. All other components (lids, pumps, instrumentation, electrical, RTU etc.) were upgraded in 2016 and are in good condition.

Figure 12 - Sewage Pump Station 1

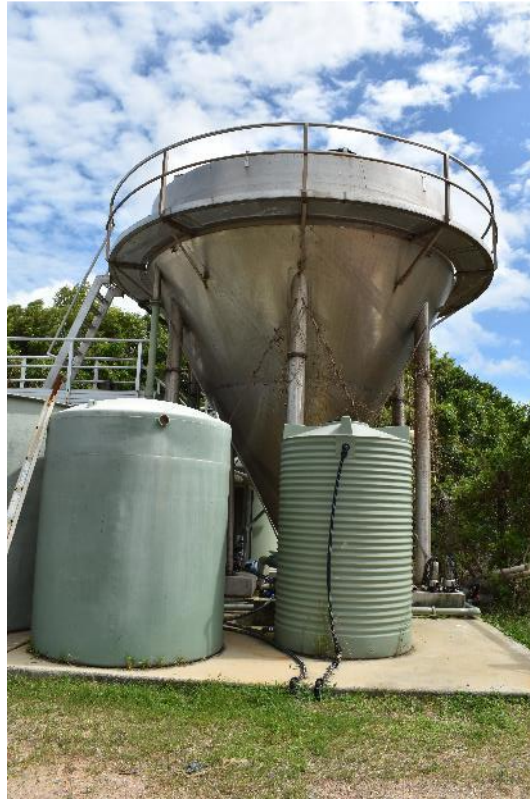
All assets in the service water system appeared to be in serviceable condition, however, some operational issues were identified during the site visit, including the installation and operation of the service water systems. There are currently two service water tanks and booster pump systems located on the treatment plant site which are: -

Figure 13 - STP Service Water Tank (Booster set is located under the clarifier)

1. Flow from the reticulation network through an RPZ into the Service Water storage tank at the front of the plant (Figure 13);
2. Booster pump set draws from the Service Water Storage tank and the supplies service water network (hose reels, safety shower and eyewash) based on loss of pressure in the network;
3. SPS Service Water tank (Figure 15) fills via a connection taken off the service water network; and
4. SPS booster pump supplies the hose reel adjacent (Figure 15).

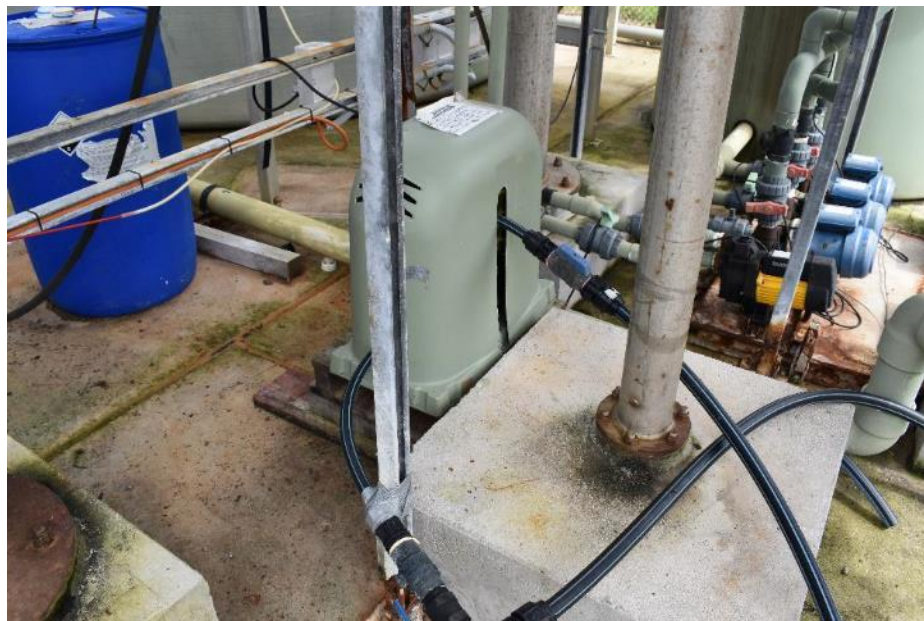
Figure 14 - STP Service Water Booster Pump (Located underneath the clarifier)

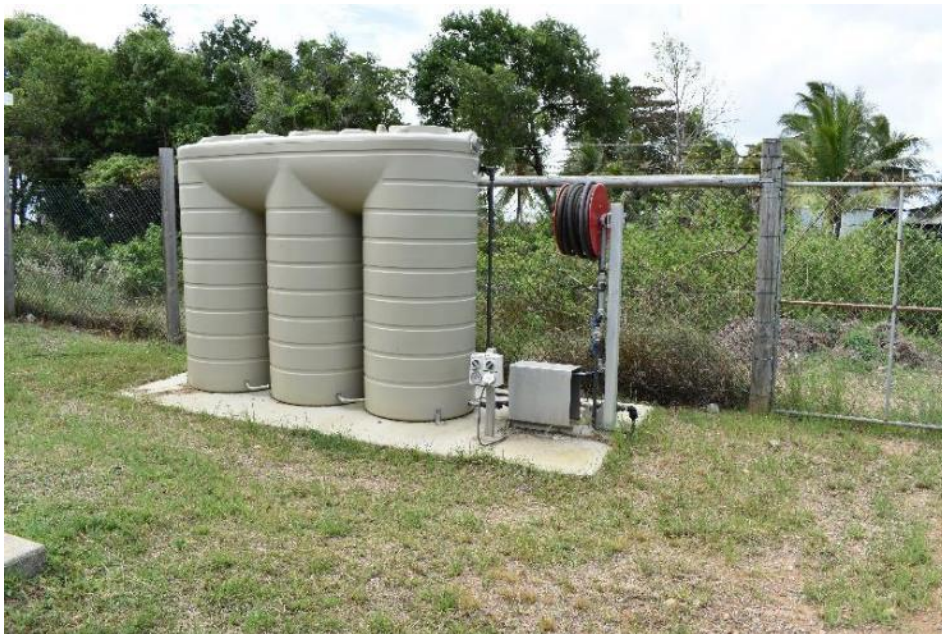
Figure 15 - SPS 1 Service Water System
