# ***Environmental Evaluation Report: March 2016***

for  
**Incitec Pivot Limited**  
***trading as Southern Cross Fertilisers***

## ENVIRONMENTAL REPORT

SITE INSPECTIONS: 8-9 July 2015,  
16 March 2016

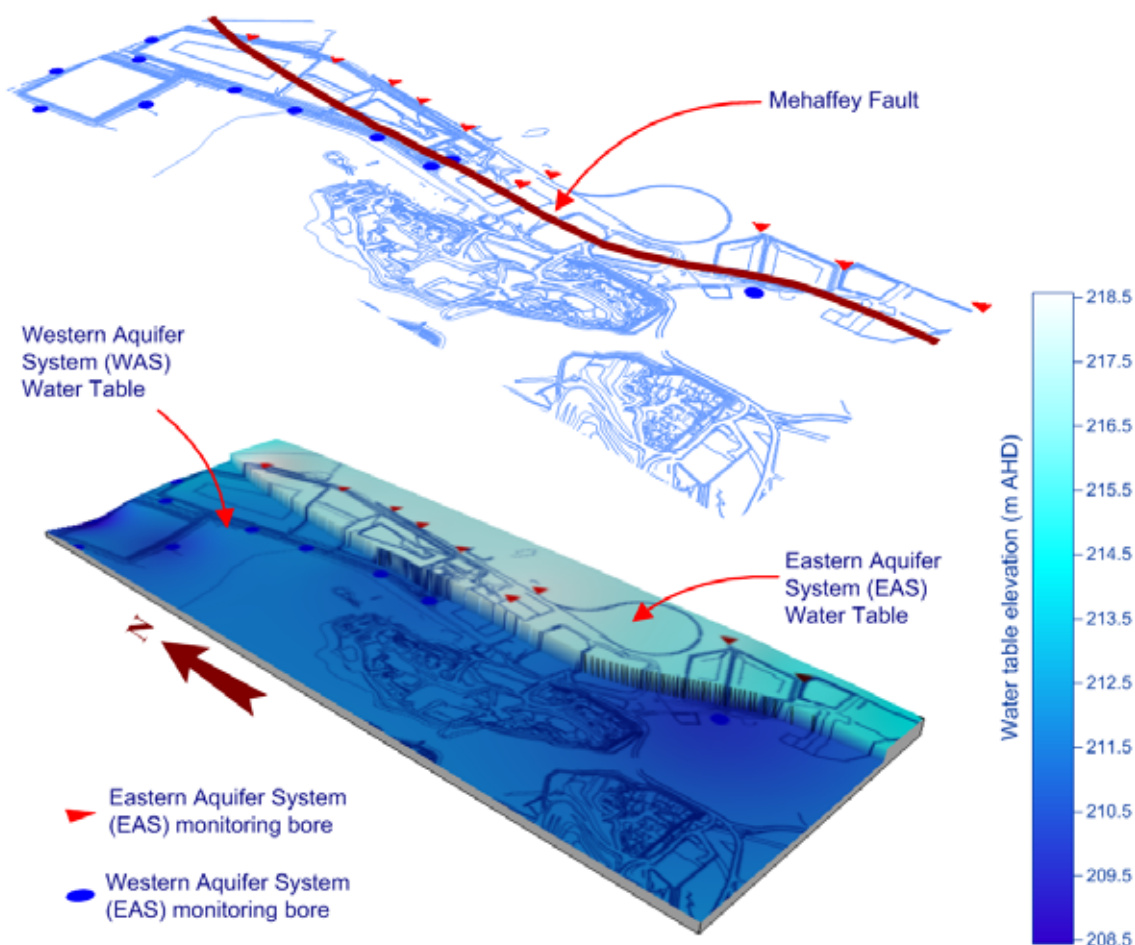
The variation in depth of the water table on both sides of the Mehaffey Fault is clearly identifiable within Figure E2 below.

**Figure E2: 3-Dimensional representation of the GSF area water table with the Mehaffey Fault forming a hydrogeological barrier boundary**

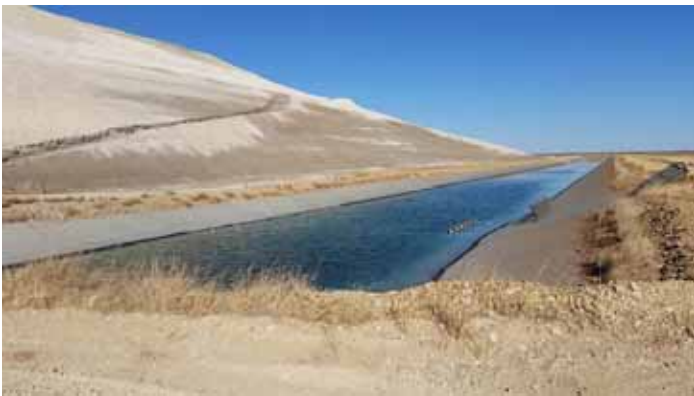
Image 2: North end of Cell 4B gypsum stockpile revealing a lined surge ditch.

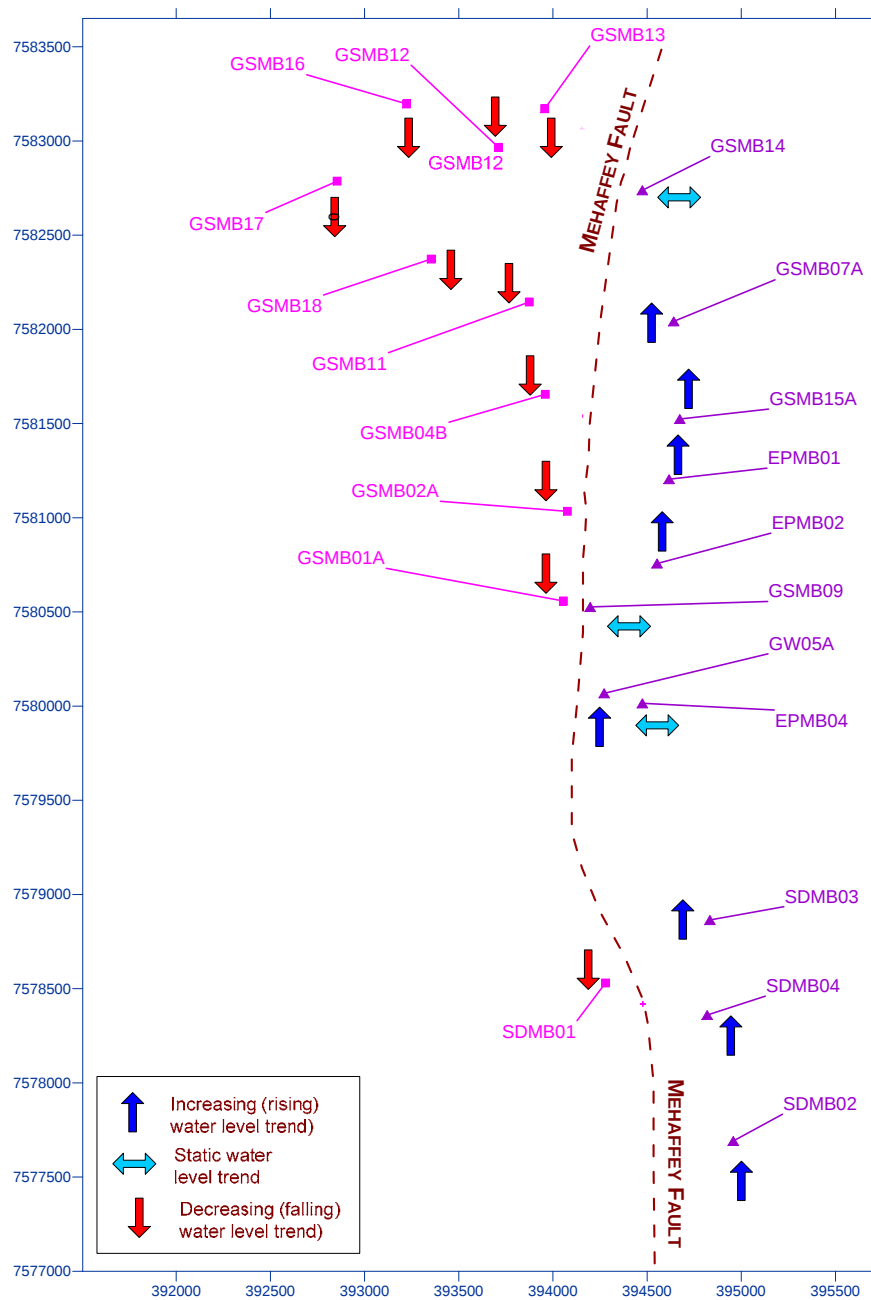
Hydrograph analysis shows that the water levels in monitoring bores in the WAS to the west of the Mehaffey Fault (including the southerly SDBM bores down hydraulic gradient from the GSF) all exhibit declining water level trends in response to local groundwater extraction whereas the water level trends in bores in the EAS east of the fault are relatively static to slightly rising. The trend directions in the GSF monitoring bores are mapped in Figure 8.

**FIGURE 8. GSF Monitoring Bores Water Level Trend Directions**

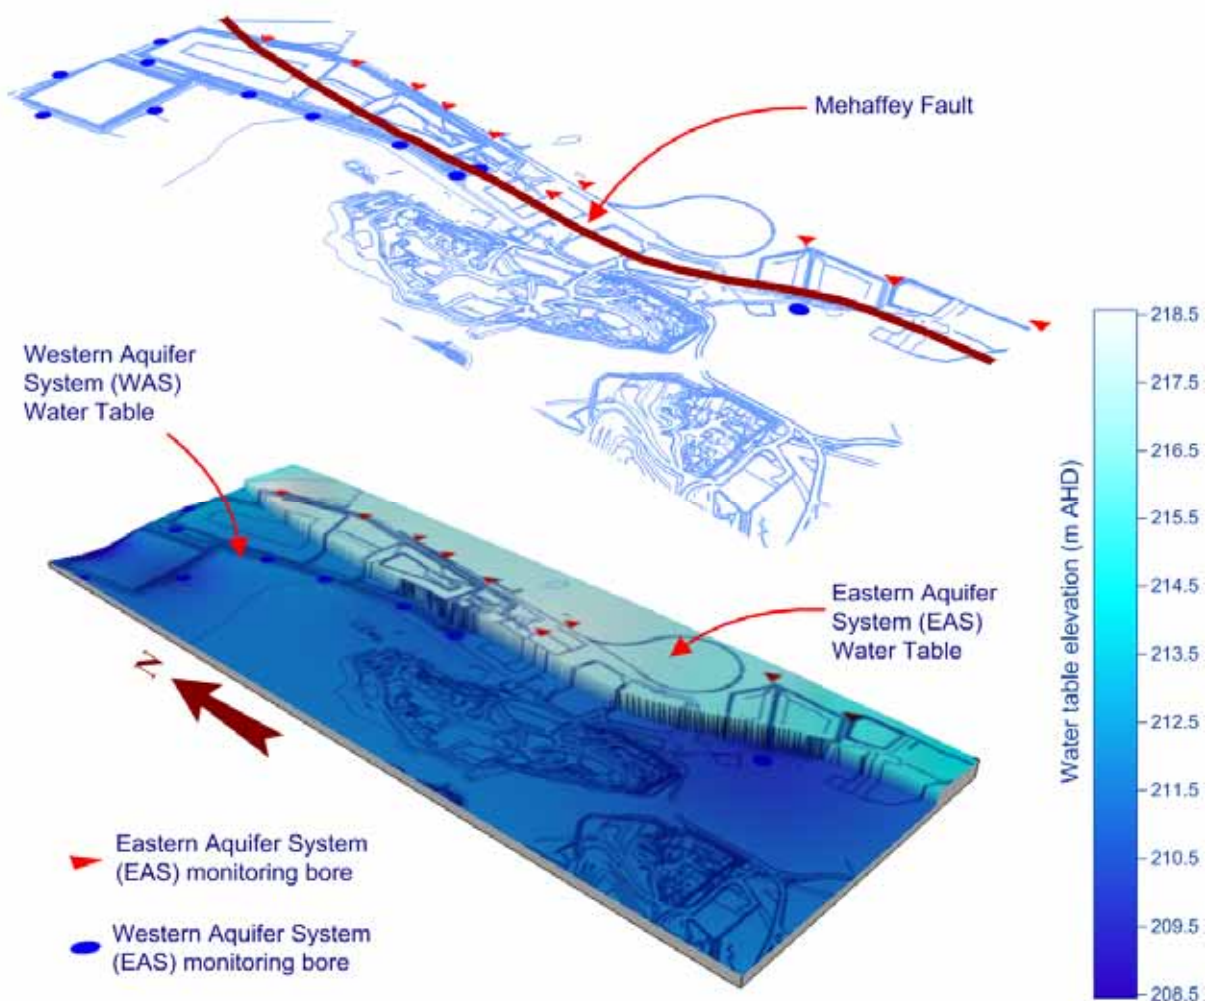
**FIGURE 10. Three-dimensional representation of the water table on both sides of the Mehaffey Fault with the fault acting as a hydrogeological barrier boundary**

The hydrogeological data specifically the large hydraulic head differential across the Mehaffey Fault and the significantly different water level trends indicates the Mehaffey Fault forms a reasonably effective hydrogeological barrier boundary that provides a high degree of hydraulic separation between the groundwater flow systems on either of the fault, at least in the vicinity of the Phosphate Hill mine.

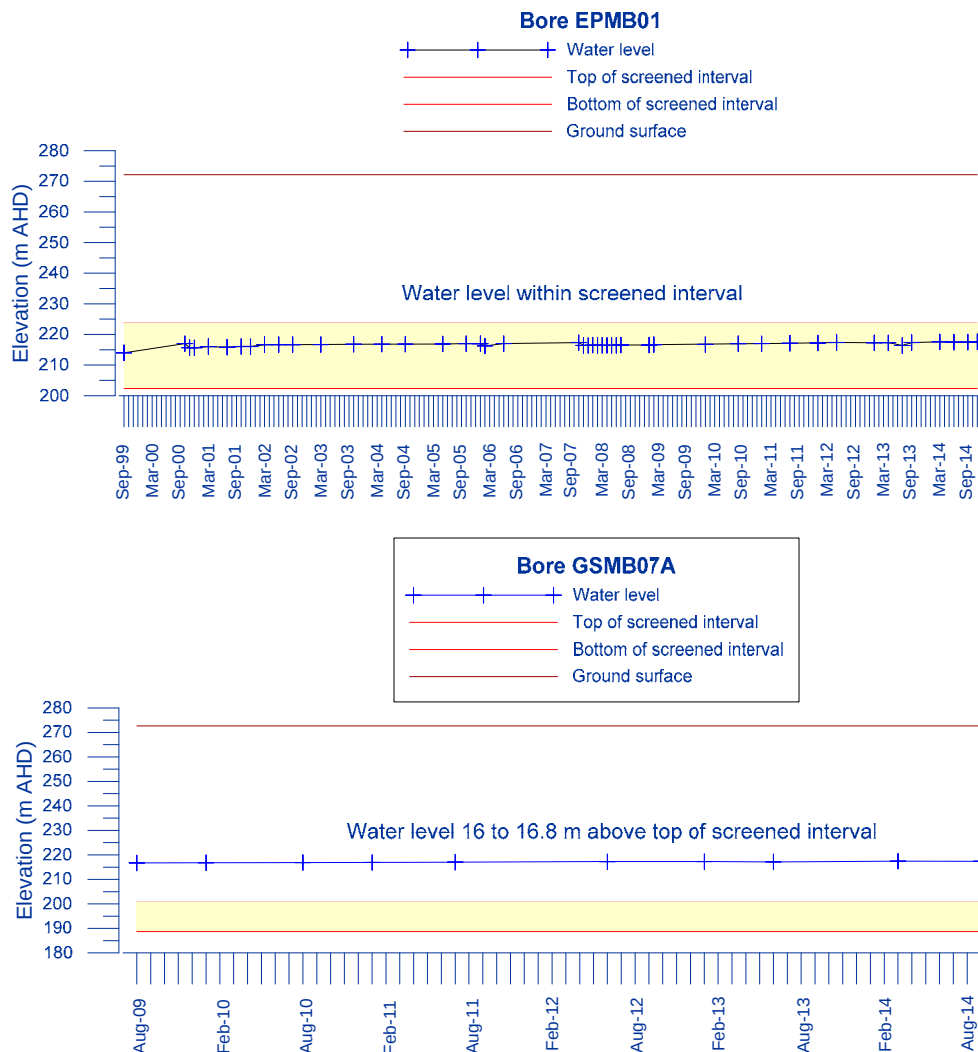
The water levels in 13 of the 17 bores were within the screened interval but groundwater was significantly above the top of the screened interval in three bores, namely GSMB07A, GSMB02A and GSMB04B. Example plots for bores where the standing water level was within the screened interval and where the water level was significantly above the top of the screened interval are shown in Figure 11.

**Figure 11. Example bore hydrographs with water table within and above screened intervals**

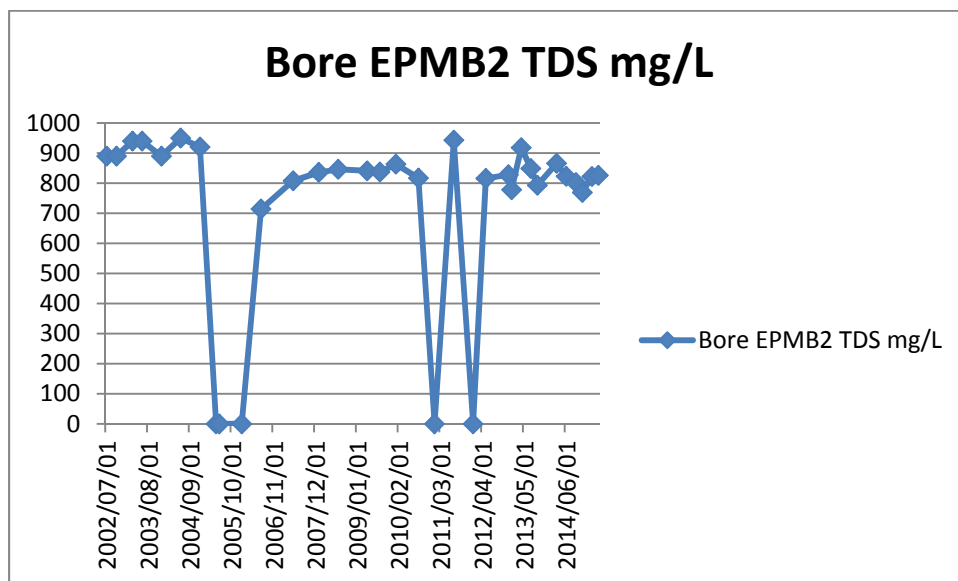
Further south-east of Gypsum Stockpile Facility (NO trend evident)

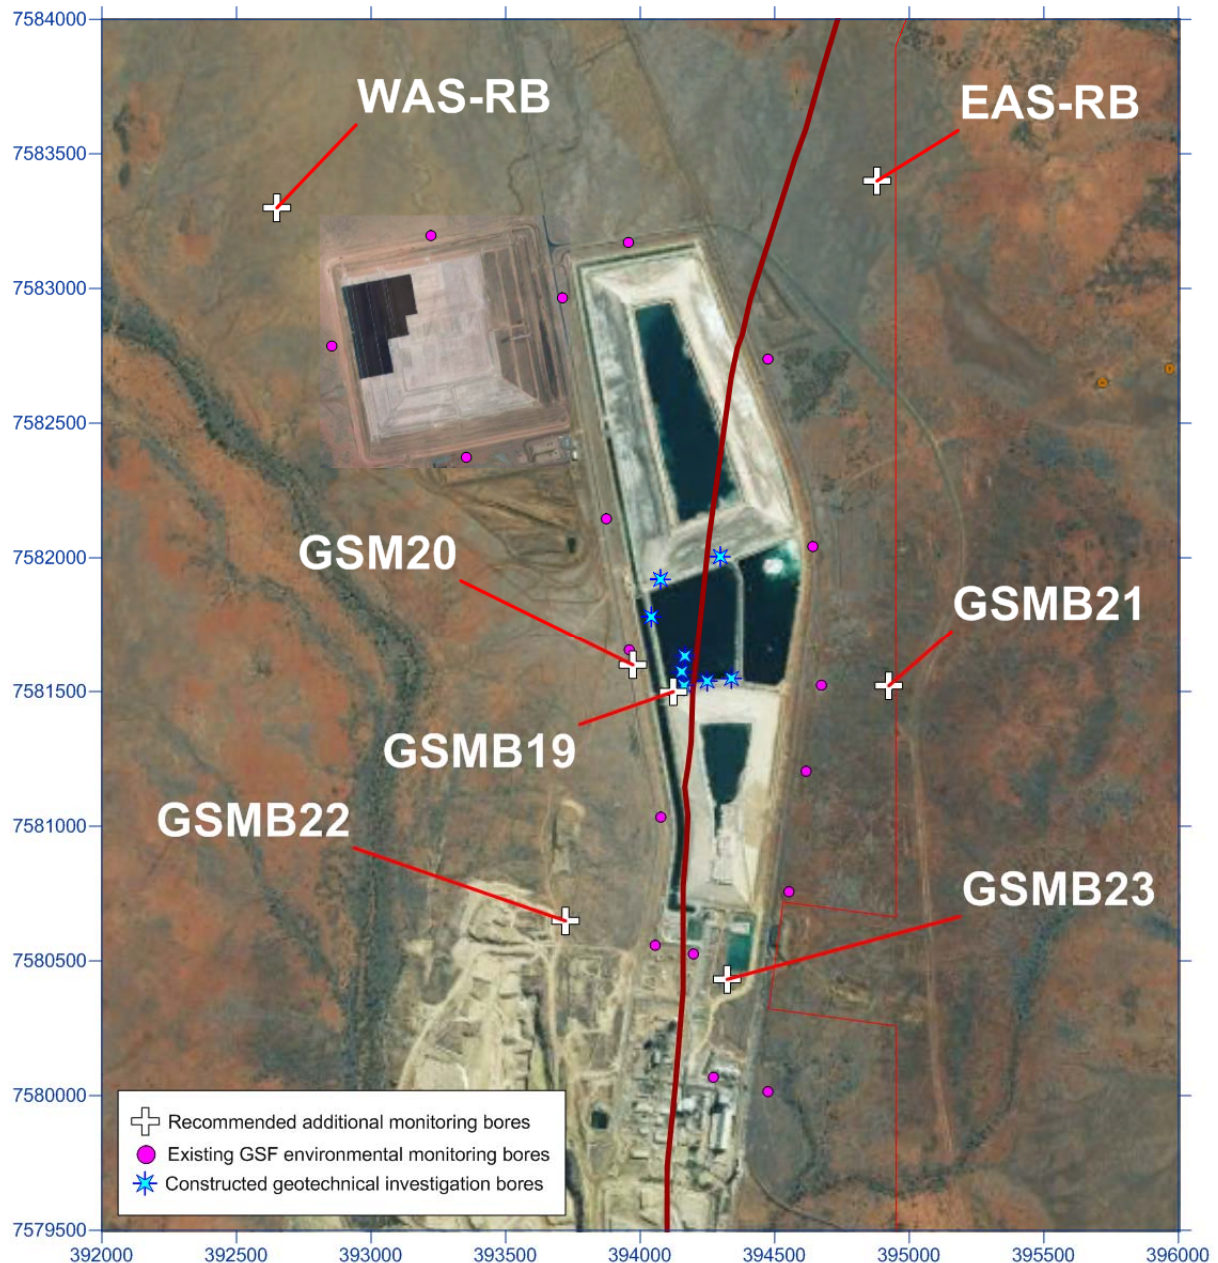
## ***Proposed New Groundwater Monitoring Bores Objectives and Constraints***

Background: Need for a EAS reference bore up-hydraulic gradient from GSF identified by C&R (2015) and supported by our review.
