ENSHAM RESOURCES PTY LTD

# STAGE 3 GEOTECHNICAL ASSESSMENT

FEBRUARY 2019

Ensham Resources Pty Ltd

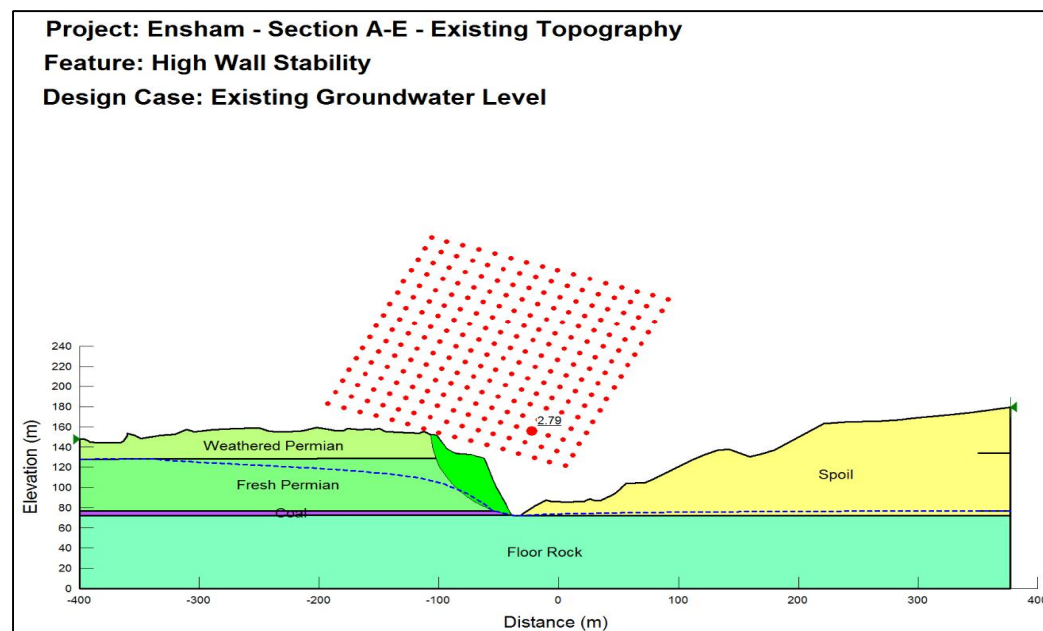
Figure 4-3: SLOPE/W Results for Typical Section A-E, Dry Pit – Current Configuration FOS = 2.79

Two sections have been modelled to assess the current stability of the pits which do not contain water and the pits which do hold water. The model results indicate that the weathered and fresh Permian materials exposed in the pit walls cut at grades typically encountered in A to E-pits have an overall FOS of >1.5 and are expected to be long-term stable in their current condition based on limit equilibrium analyses, with the exceptions noted above.

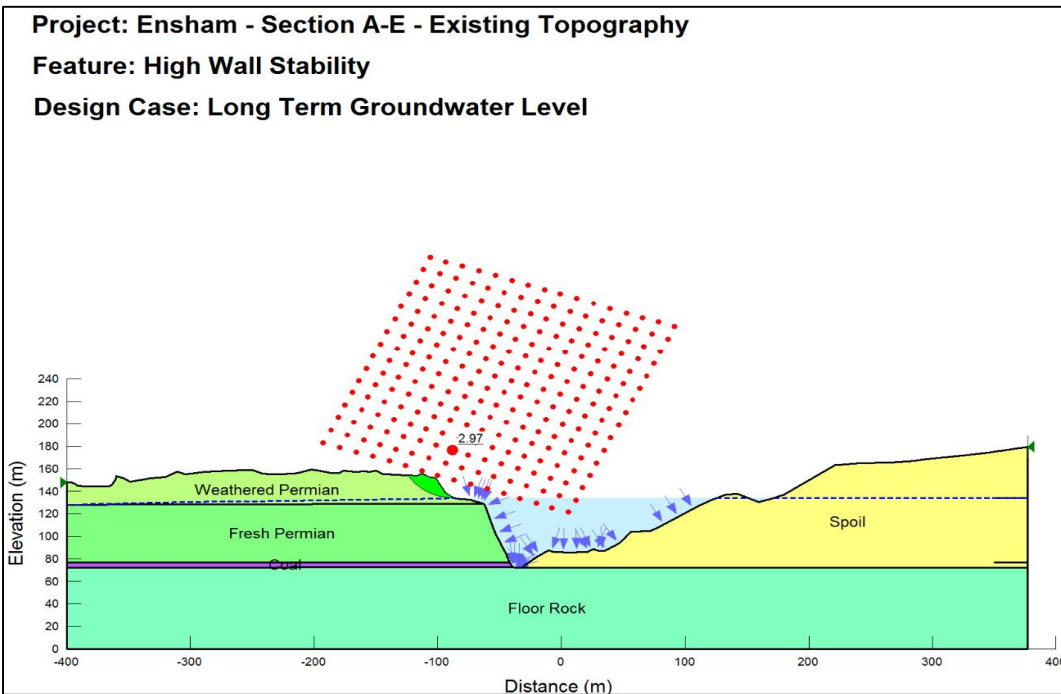
Figure 4-7: SLOPE/W Results for Typical Section A-E – Long-term FOS = 2.97

The SLOPE/W results for the long-term overall FOS for the representative rock wall sections are shown in Figure 4-7. It is noted that the actual FOS could be lower due to the impact discontinuities/faulting in the rocks, low durability rock, possible reduction in rock strength due to increased moisture content, as well as the impact of wave action from water in the pits which could not be modelled during this assessment. The models have included the long-term groundwater conditions. A long-term FOS of 1.5 has been adopted for overall stability analyses.

The model results indicate that the weathered and fresh Permian materials exposed in the rock walls cut at grades typically encountered in A to E-pits have FOS of  $>1.5$  and are expected to be long-term stable under the groundwater conditions modelled except indicated in the previous section.

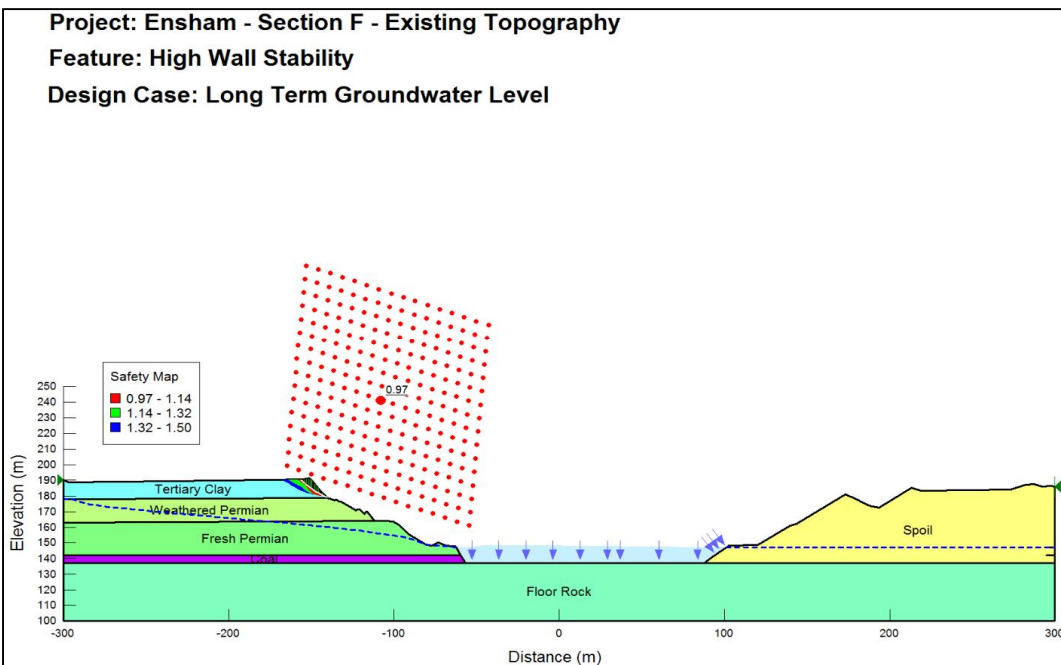
Figure 4-8: SLOPE/W Results for Typical Section F – Long-term FOS=0.97

The model results indicate that failures in the overall rock mass are not expected through the weathered and fresh Permian materials exposed in the rock walls with grades typically encountered in F-pit. The Tertiary clay soils have a FOS of 1 to <1 and would not be considered stable as shown on Figure 4-8. The model shows that regrading of these materials would improve their long-term stability (FOS – 1.5).

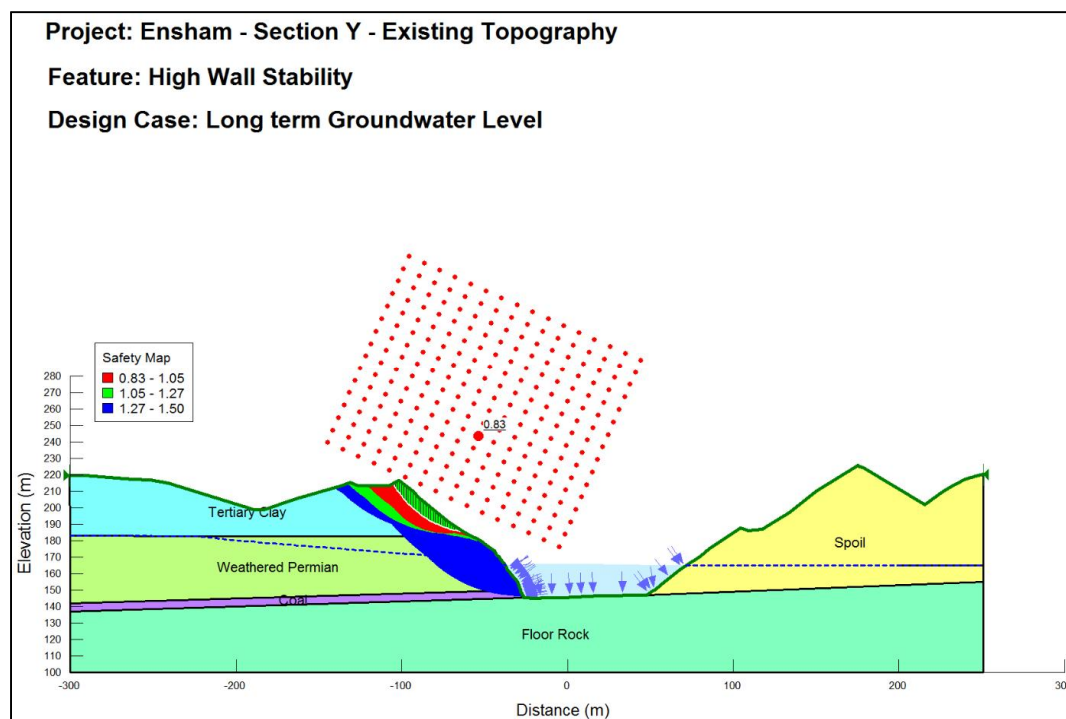
Figure 4-9: SLOPE/W Results for Typical Section Y – Long-term FOS=0.83

The model results in Figure 4-9 indicate that the overall stability of the weathered Permian materials exposed in the pit walls with grades typically encountered in Y-pit are marginally short-term stable in their current condition with FOS of 1.27. The Tertiary clay soils in their current state have a FOS of 1 to <1. The model shows that regrading of Permian and Tertiary materials would improve their long-term stability.

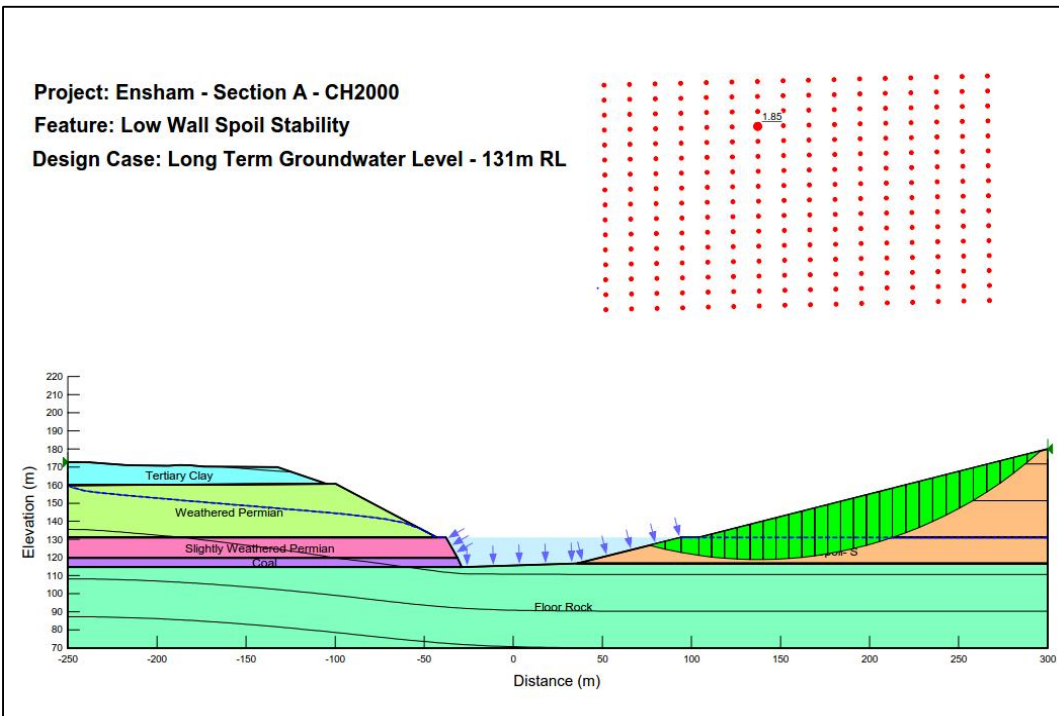
Figure 4-21: SLOPE/W Results for Regraded Spoil Section Previously Flooded, FOS=1.85

A further model was run for the scenario where pits have been flooded historically resulting in saturation of the spoil. According to Simmons and McManus (2004), a saturated strength mode in spoil is not reversible, even after free water has been drained from the void space due to slaking, softening, and weakening that occurs during saturation. This model utilises saturated spoil parameters for the full profile of the spoil material. The results for this simulation are included in Figure 4-21.

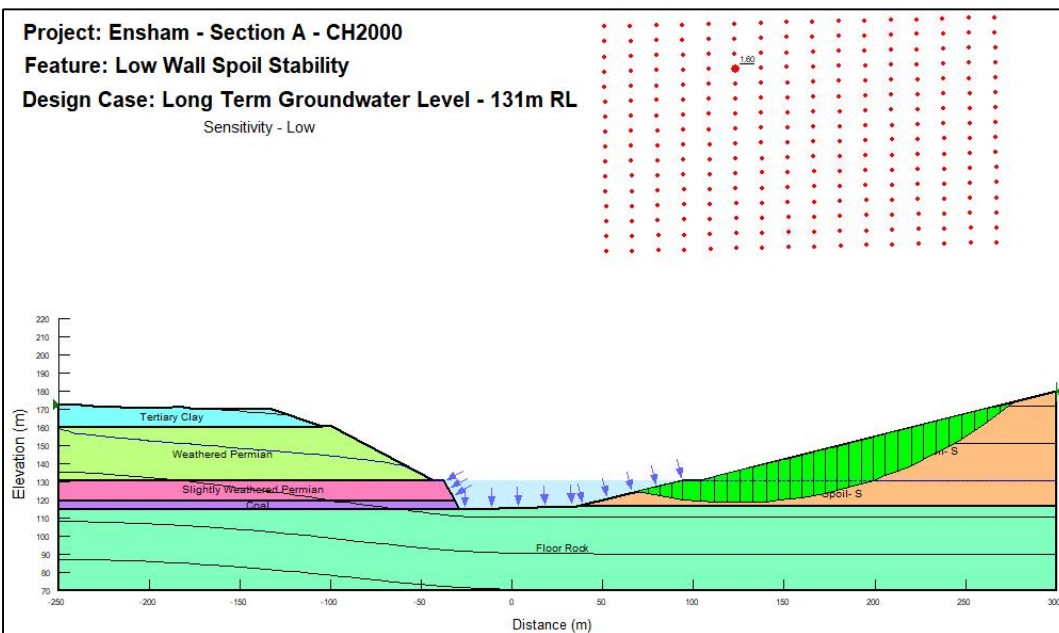
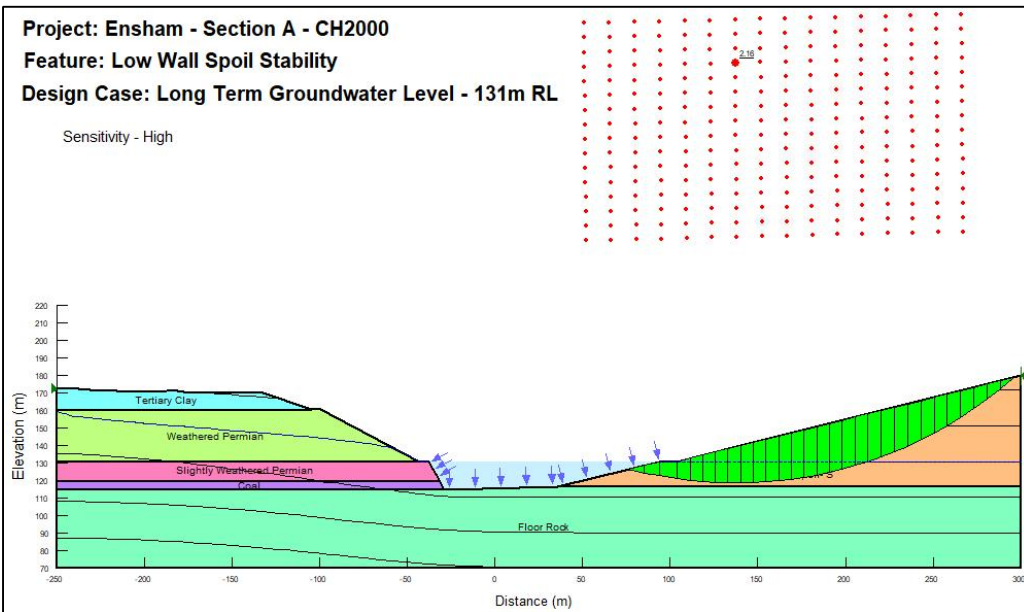
Sensitivity analyses using lower and higher spoil parameters as in indicated in Table 4-5 were performed and the results shown on Figure 4-22 and Figure 4-23. The FOS values were greater than 1.5 and therefore, acceptable.

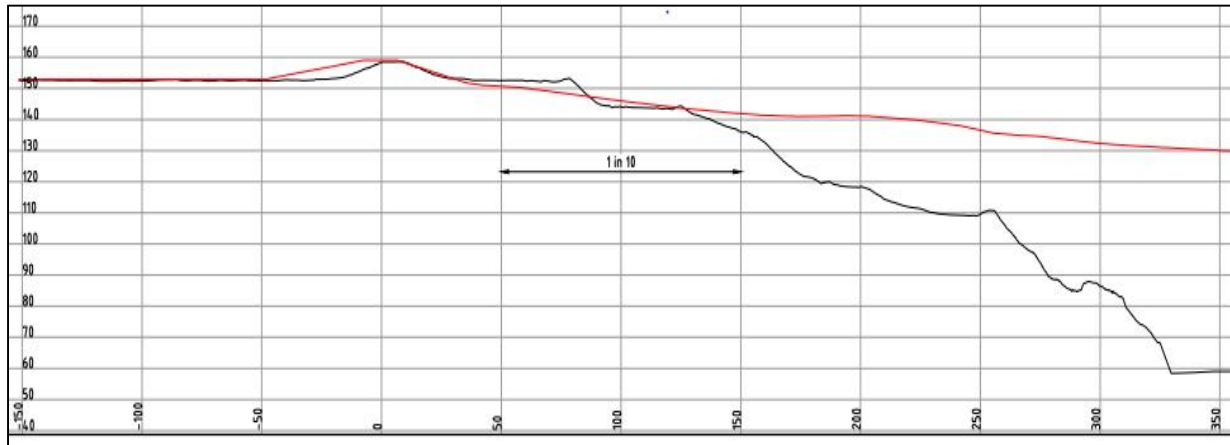
Figure 4-26: Option 1 levee Ch 2500 - B Pit critical section infill profile (red line represents final landform)

In order to achieve a materials balance for the Option 1 landform, the B Pit will be substantially backfilled in the vicinity of the previously identified critical section of levee adjacent to the B Pit endwall. A section has been taken through this area reflecting the final landform profile, and is included in Figure 4-26 below. This section indicates spoil infill for almost the full depth of pit, with 10% (1V:10H) gradient slopes away from the levee. The spoil fill will substantially stabilise the levee / pit interface and will eliminate seepage considerations, hence no seepage or stability analysis has been undertaken for this area.

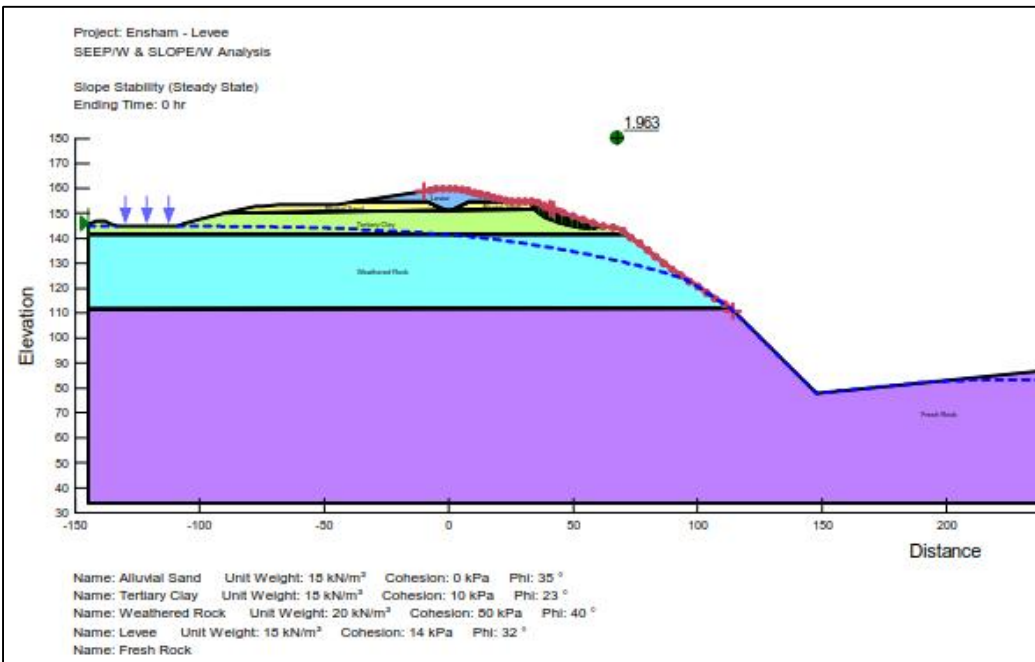
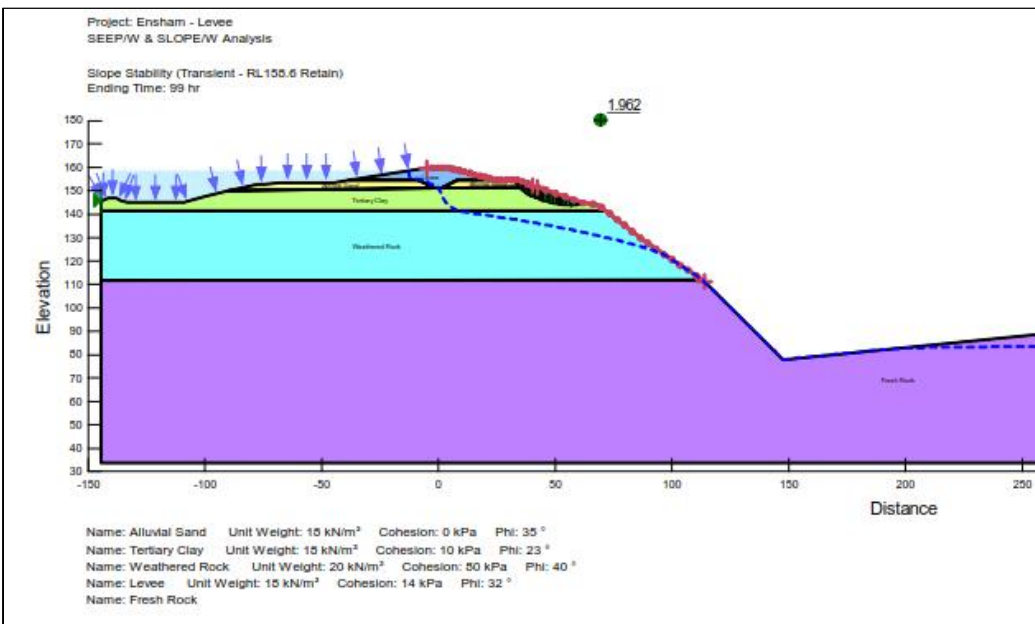
A single cross section at Ch 3400 has been taken along the C Pit levee alignment for analysis, where the levee is closest to the residual void edge based on the final Option 1 landform. This area of the levee was referred to as D Pit Extension (South) in KBR Report BEE603-W-REP-005 Rev 2, and was investigated for seepage and stability compliance due to its proximity to the pit edge at that time (30 m bench from levee embankment toe to pit edge). The cross section using the Option 1 landform indicates a bench of 10 m from the levee toe to the edge of regrade embankment into the void, and hence represents a worst-case scenario in terms of proximity of levee to the final highwall profile. The soil subsurface profile shown on this section is in line with the description of materials in this area in the KBR report and as described earlier, as well as the profile used for analysis in the KBR report. Steady state and transient seepage models were undertaken for this section using SEEP/W. The steady state assumes a constant water level at the base of the Nogoa Anabranh (conservative assumption for steady state), while the transient model utilised the 0.1% AEP flood hydrograph in the vicinity of the levee to determine subsurface layer exposure to flood waters. The seepage results were imported into the SLOPE/W stability analysis, the results from which are shown in Figure 4-27 and Figure 4-28 below. High range permeability parameters were used for the seepage analysis.

These results indicate a FOS of 1.96 for both steady and transient states, and are in line with the KBR seepage and stability analysis undertaken previously, which found an overall stability FOS of 2.33 for a profile that included a wider 30 m bench. These FOS are greater than the required 1.5. The analyses assume that the key is effective, and subsurface conditions should be verified to confirm profiles adopted.
