**MILLENNIUM MINE**  
**RESIDUAL VOID SLOPE STABILITY STUDY**

**MILLENNIUM COAL PTY LTD**

**Report No. 170**  
**August 2017**

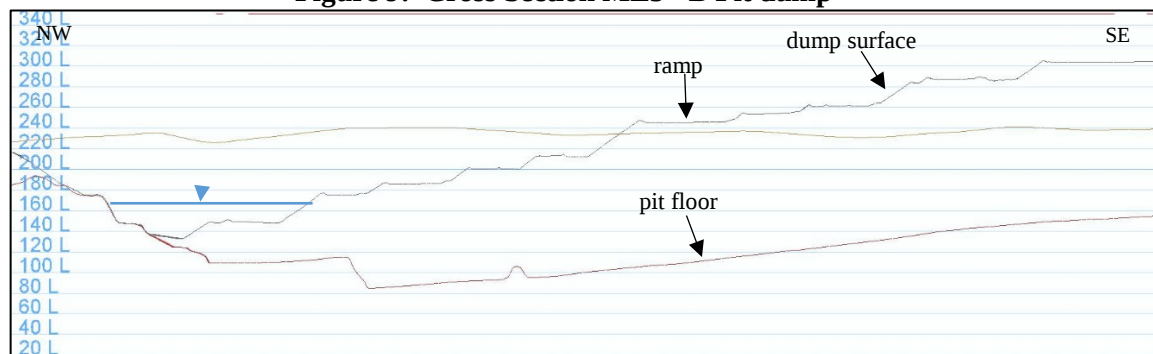
**Figure 9: Cross Section ML5 - B Pit dump**

Figure 9 shows the profile along Cross Section ML5 through the advancing in-pit dump face from pit bottom to the top of the Mountain Dump. This is as per the standard design although the overall slope is flatter due to the insertion of ramps at various levels across the dump face.

The in-pit standard analysis was based on this cross section from pit bottom to the elevated top height at RL305 on the 6° dipping floor but without the ramps. In practice there are ramps crossing the face of the dump which would reduce the overall slope angle so that the profile without ramps represents the worst case. The results indicate stable conditions for this hypothetical case with the inundated condition having a slightly less than desirable FoS for long term stability, noting however that the FoS for the as-constructed low wall would be higher with the inclusion of the ramps in the profile.

Irrespective of the analysis results however, Cross Section ML5 shows that the spoil dump extends to the opposite highwall and is buttressed against that and the Vermont Seam bench. This would preclude the possibility of mass failure for the current in-pit dump.

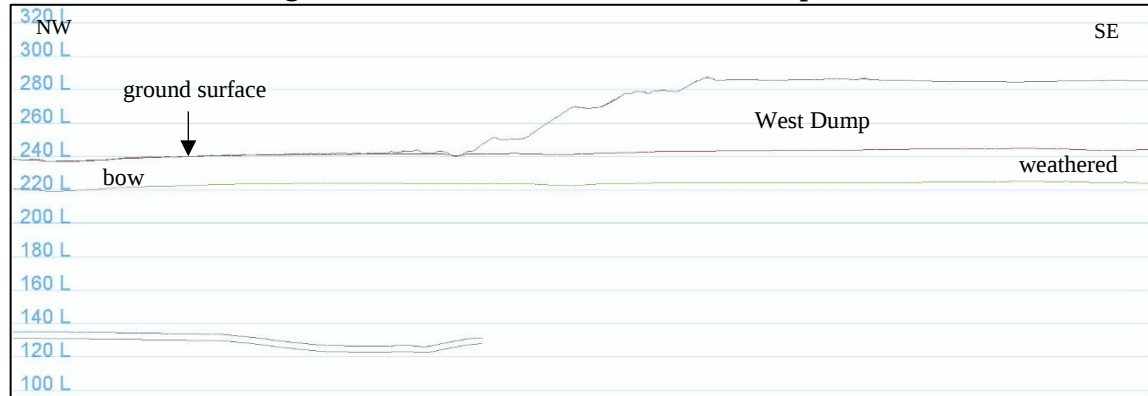
**Figure 10: Cross Section ML8 - West Dump**

Earlier out-of-pit dumps were steeper with narrower berms and this includes the North and West Dumps. Both of these have an as-constructed profile as they have not yet been re-graded, although technically they are in compliance with the EA requirements. Figure 10 below shows the profile for Cross Section ML8 through the northern side of the West Dump.

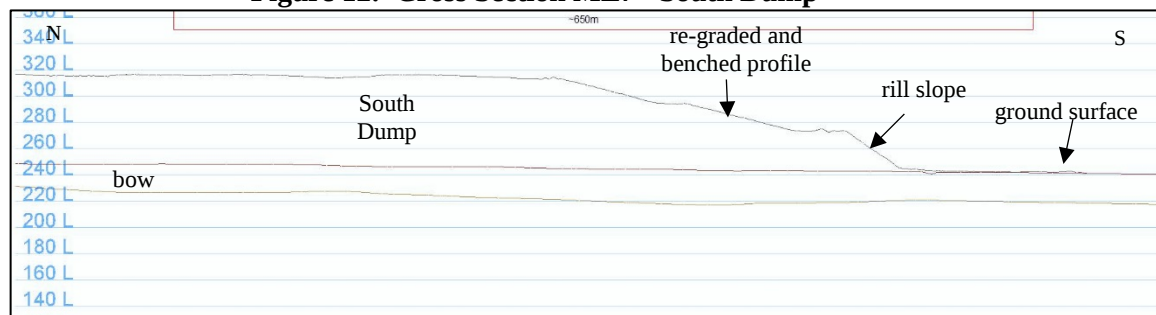
**Figure 12: Cross Section ML7 - South Dump**

The south side of the South Dump has also been re-graded as shown in Cross Section ML7 below. In this case however, final works have not been completed pending agreement to push material over onto the adjacent lease. As a consequence the bottom batter is still as-dumped at angle of repose.

Due to the shallow slope profile created by the re-grading, there is no risk of mass slope failure and rehabilitated slopes can be considered geotechnically stable over the long term.

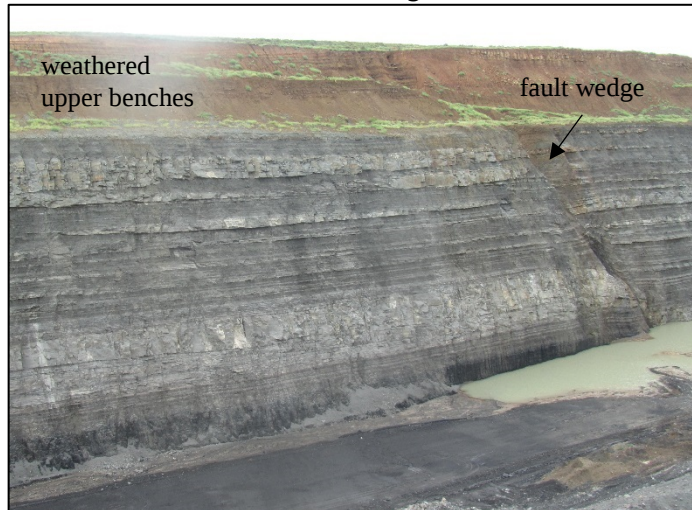
### ***E Pit north highwall***

The photo below shows a typical highwall face, together with a fault intersection.

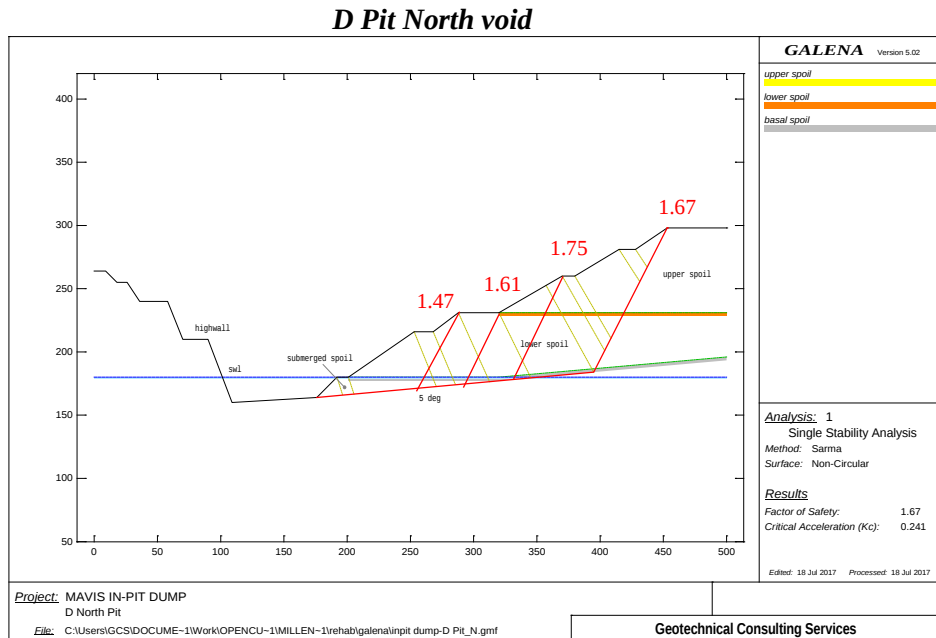
Analyses were made failure configurations ranging from the RL230 crest up to the top of the dump at the RL300 crest as shown above. The results show FoS from 1.73 to 1.90 for the as-constructed dry conditions, well in excess of the long term design value. The FoS for the inundated condition are shown on the model section; these are lower but still more than adequate for the most part.

The influence of the submerged spoil becomes more apparent towards the toe of the dump causing a reduction in the FoS. A minimum FoS of 1.47 was noted at the RL230 crest as indicated on the plot above.

These results would indicate that mass failure of the internal dump would be highly unlikely, with the worst case FoS of partial failure under inundation still more or less acceptable for long term stability. Although inundation to the predicted level would not prejudice the dump in terms of mass instability, it could possibly cause some shallow slumping if the slope was undercut by notching at the water line. The spoil is not dispersive but has a high potential for slaking from wetting and drying.

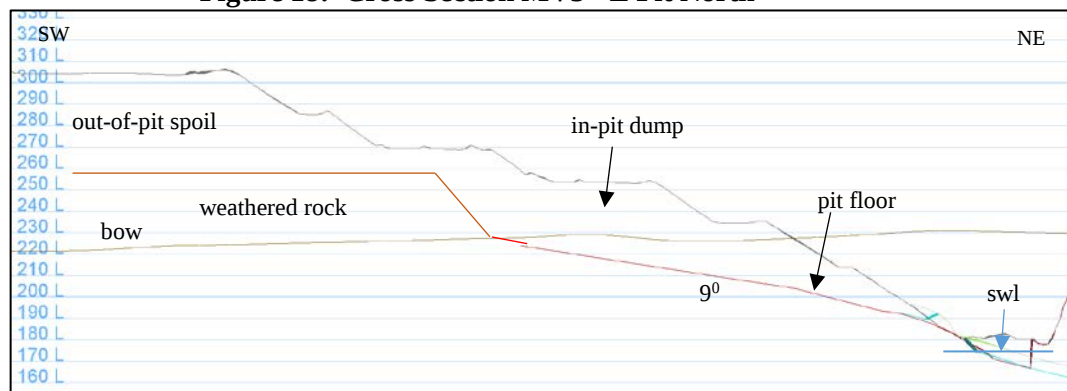
**Figure 18: Cross Section MV3 - E Pit North**

The analyses for E Pit North were based on the profile in Cross Section MV3, as illustrated in Figure 18 below, which extends to the full dump height but using the floor profile from Figure 17 (p.22).

The floor level in the void in this part of E Pit is generally above the predicted flood level so that inundation is not a factor in stability analysis. The other issue is the geometric constraint on failure due to the upper part of the dump being situated on insitu ground. This would preclude full height failure as bi-planar slippage would be limited to the front part only, where the spoil has been dumped on the pit floor. The farthest back for failure is thus on the RL270 bench. The Galena analysis model is presented below.

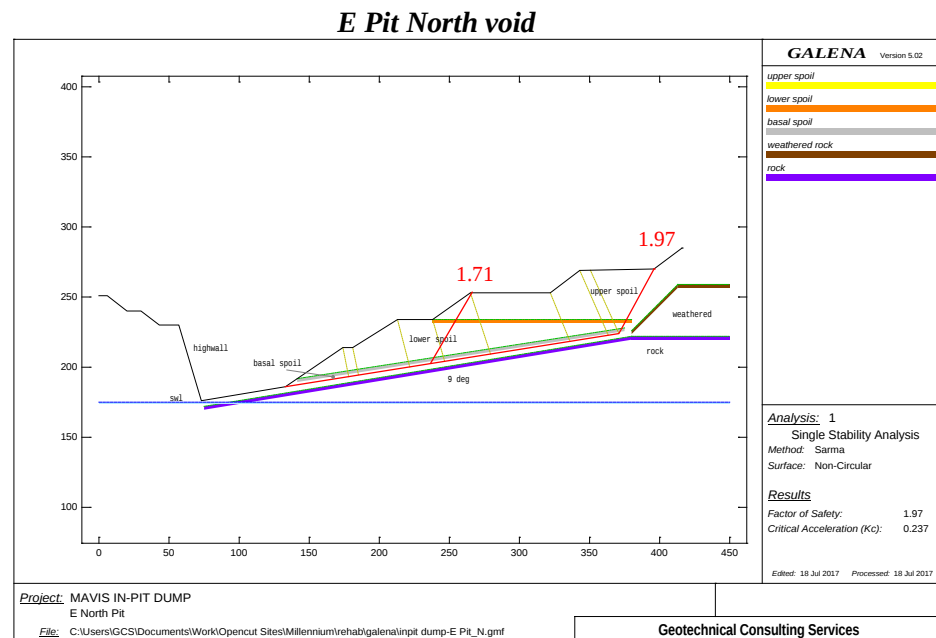
The FoS are high, despite the steeper dip, because of the lower dump height and the lack of submergence of the spoil. Mass failure of the in-pit spoil dump can be discounted in this instance. Notwithstanding the foregoing, the long term plan is to continue to infill E Pit North with spoil, which will mean that the low wall will be buttressed against the highwall. This will remove any possible risk of mass movement of the low wall.
