**MILLENNIUM MINE**  
**RESIDUAL VOID SLOPE STABILITY STUDY**

**MILLENNIUM COAL PTY LTD**

**Report No. 170**  
**August 2017**

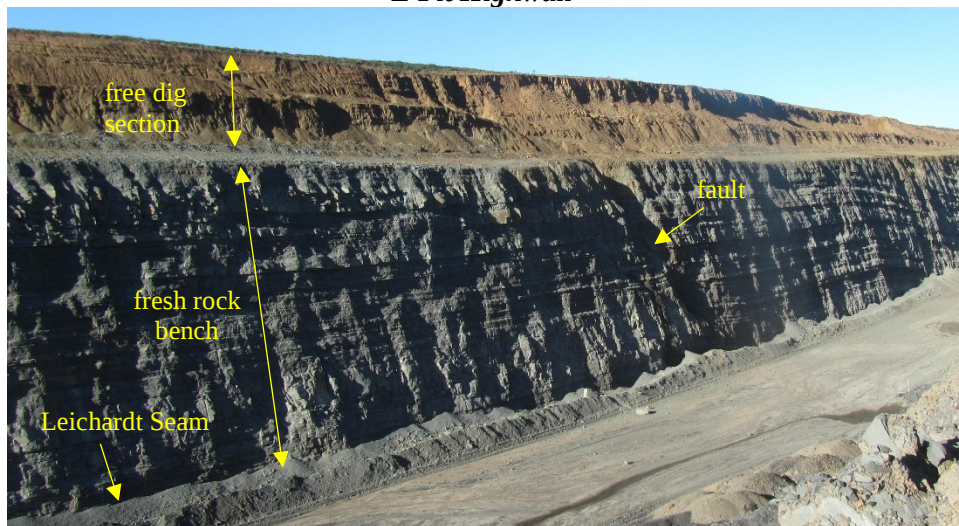
### *E Pit Highwall*

The photo below shows a typical highwall representation.

Photo taken 28/06/2016, looking ENE

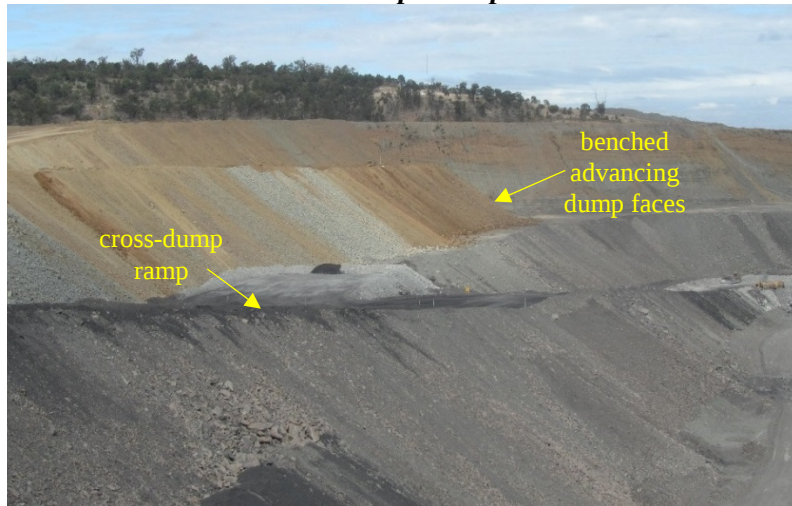
**B Pit in-pit dump**

The general aspect of the in-pit dump is illustrated in the photo below, which shows the face of the advancing dump in B Pit.

Photo taken 9/05/2017, looking SW

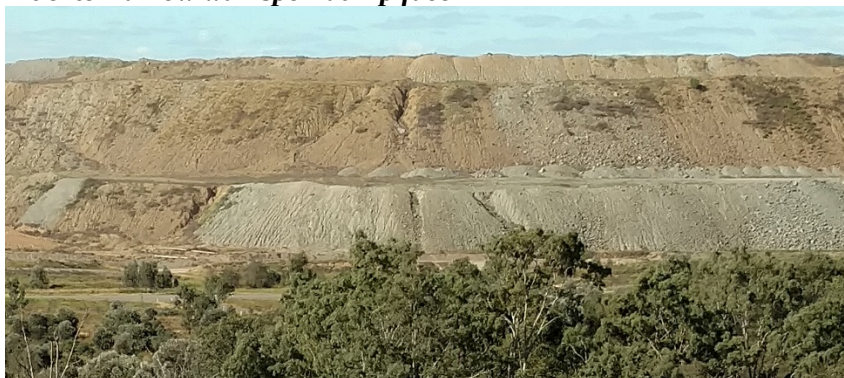
***Pit external low wall spoil dump face***

The photos below show as-constructed external slopes of the low wall spoil dump at D Pit and re-graded rehabilitated external slopes at E Pit.

Site photo 143458861 taken 18/07/2017, looking ENE

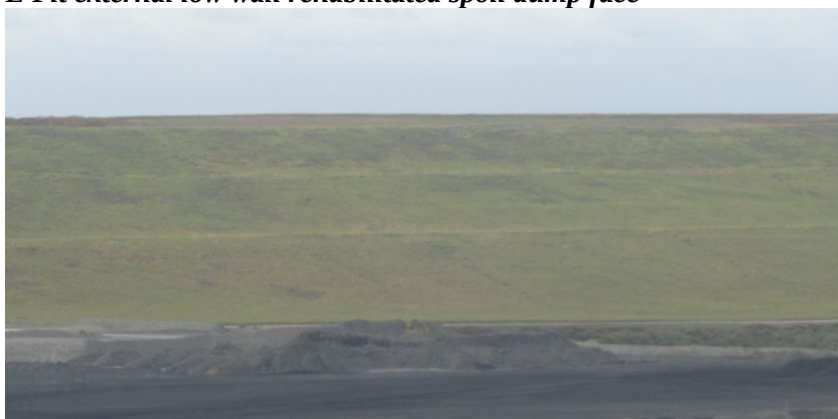
***E Pit external low wall rehabilitated spoil dump face***

Photo taken 9/05/2017, looking NE

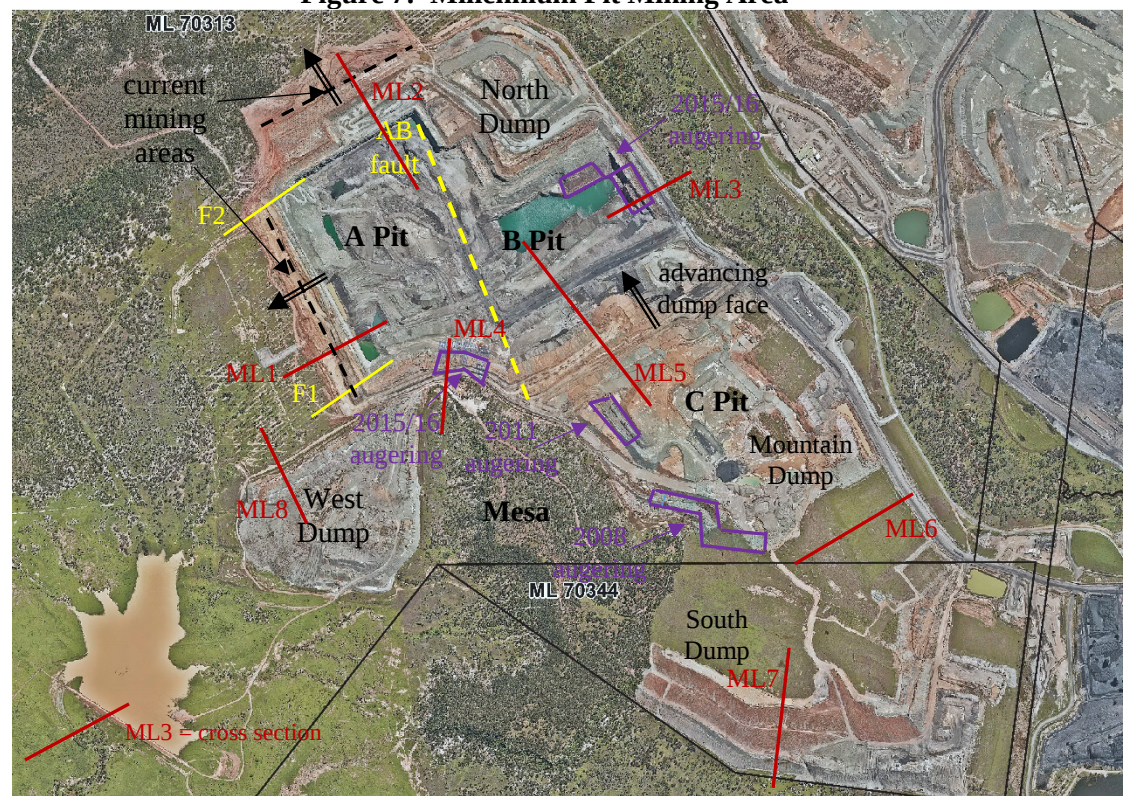
**Figure 7: Millennium Pit Mining Area**

The aerial photo below (Figure 7) shows the salient features of the Millennium Pit mining area. These include the designated pit areas A Pit, B Pit and C Pit and the out-of-pit dumps which are built above ground level. Also shown are the highwall augering blocks, the lease boundaries and the locations of cross sections (ML1 etc) referred to in the text.

Two other instances of potential fault-induced instability occur at each end of the west wall, marked as F1 and F2 on Figure 7. F1 appears to be a high angle fault running behind and sub-parallel to the south wall, dipping out of the wall. It has incurred some movement, manifest as a tension crack along the edge of the haul road and slumping of the lower bench. The tension crack enlarged significantly following inflow from cyclone Debbie in March 2017 as shown in the photo below.

Inspection of the face reveals that the movement is due to a slumping collapse of the feather-edging fault intersection with the wall – too much weight on too narrow a base – and that the main section of wall in front of the crack appears to be intact. The feather-edging tension crack is shown in the photo below cutting down across the upper weathered benches. The lower rock batter has incurred slumping collapse.

A spoil buttress has been placed against the wall and this has effectively buttressed the lower bench against any further slumping. The residual risk would be shallow slip failure through the top of the weathered material and haul road spoil at the top.

In terms of remedial action for final void, because the failure is fault controlled it will not extend any further back than the fault itself marked by the tension crack, the recommended action would be to leave as is with a rock bund along the haul road 15m from the tension crack. As the fault trend is moving further away from the wall the potential for mass failure should be reduced and it is unlikely to have any impact on the stability of the next strip endwall.

In either case the consequences of wall failure would be material movement into the residual void, with a failure extend defined by the fault line, hence the recommendation to bund off behind the line of the fault or tension crack to prevent access into a potentially failing edge area. The alternative would be to buttress the wall to ground level with the in-pit spoil dump.

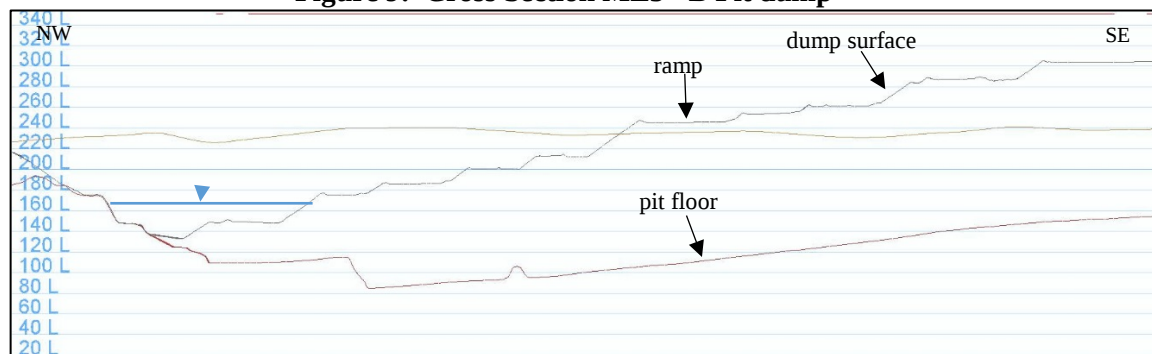
**Figure 9: Cross Section ML5 - B Pit dump**

Figure 9 shows the profile along Cross Section ML5 through the advancing in-pit dump face from pit bottom to the top of the Mountain Dump. This is as per the standard design although the overall slope is flatter due to the insertion of ramps at various levels across the dump face.

The in-pit standard analysis was based on this cross section from pit bottom to the elevated top height at RL305 on the 6° dipping floor but without the ramps. In practice there are ramps crossing the face of the dump which would reduce the overall slope angle so that the profile without ramps represents the worst case. The results indicate stable conditions for this hypothetical case with the inundated condition having a slightly less than desirable FoS for long term stability, noting however that the FoS for the as-constructed low wall would be higher with the inclusion of the ramps in the profile.

Irrespective of the analysis results however, Cross Section ML5 shows that the spoil dump extends to the opposite highwall and is buttressed against that and the Vermont Seam bench. This would preclude the possibility of mass failure for the current in-pit dump.

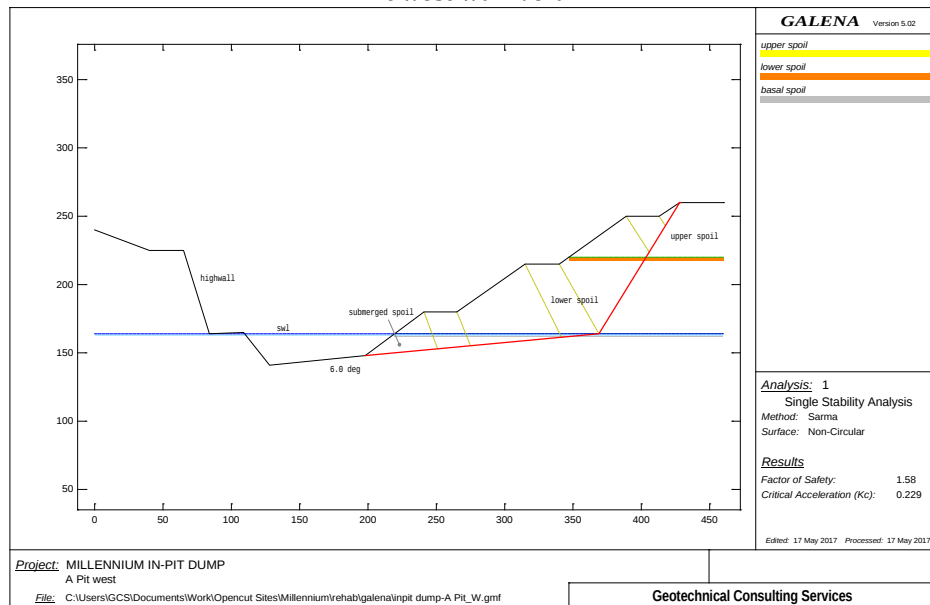
**A Pit west wall void**

Unbuttressed in-pit dump faces would be formed at the completion of mining in A Pit opposite the west and north walls. For these cases the standard dump design was applied to Cross Sections ML1 and ML2, assuming the A Pit dump is raised to ground level at RL260. Analyses were made for a presumed final void profile, allowing for inundation to RL164. The upper spoil forming the top bench may include some weathered material and has thus been treated as Category 2, with submerged spoil as Category 2 saturated. Failure mode is bi-planar with slippage on the pit floor and shearing back up through the spoil dump.

The results tabulated above show FoS in excess of the long term design value for both as constructed (drained) and inundated conditions. This would indicate that internal dump failure would be highly unlikely. Note that displaced material from failing slopes would in any case be contained within the pit void. The outputs from the Galena program are presented below. The FoS for the north facing dump are higher because of the shallower dip in that direction.

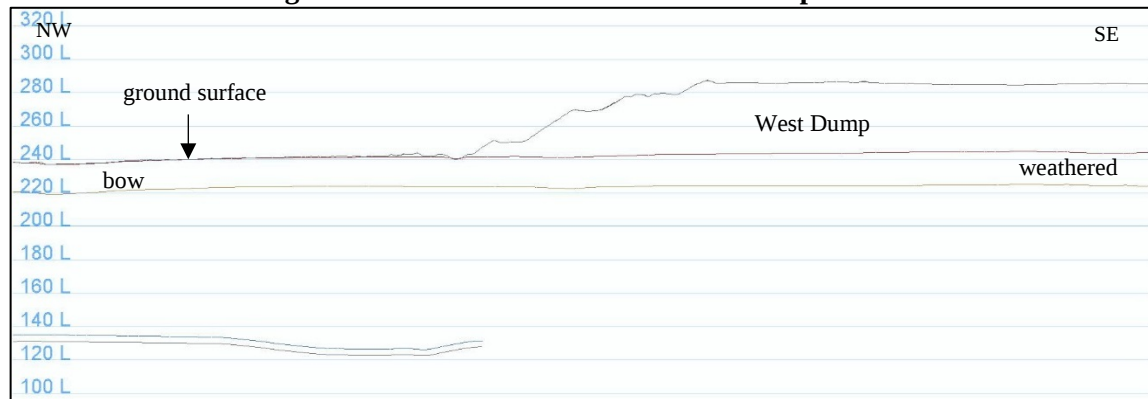
**Figure 10: Cross Section ML8 - West Dump**

Earlier out-of-pit dumps were steeper with narrower berms and this includes the North and West Dumps. Both of these have an as-constructed profile as they have not yet been re-graded, although technically they are in compliance with the EA requirements. Figure 10 below shows the profile for Cross Section ML8 through the northern side of the West Dump.

Analysis of this profile shows a high FoS of 2.44 for circular slip failure, with the most critical failure surface through to the third bench as illustrated on the Galena model below.

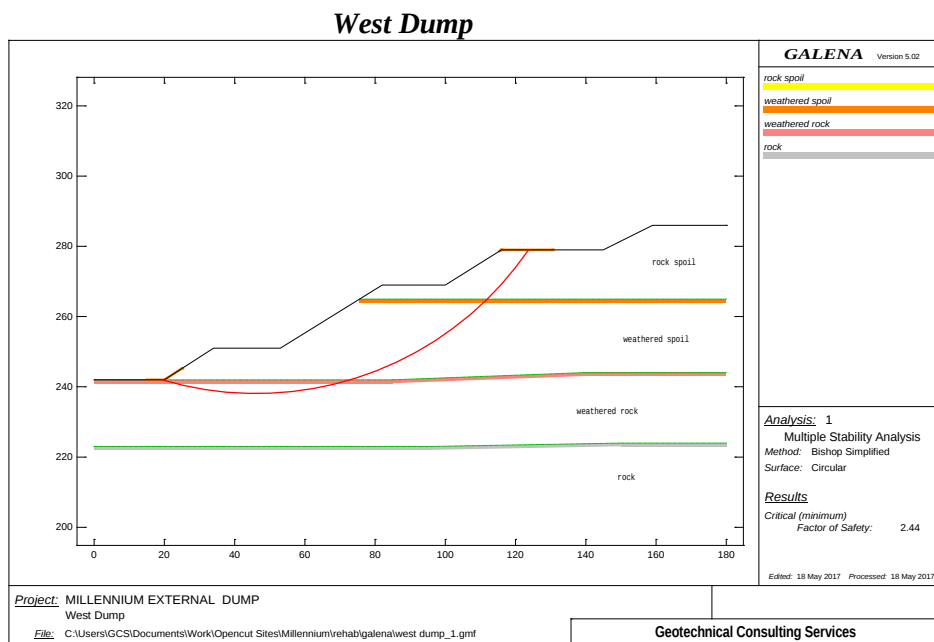
It can be concluded that the external dump faces with as-constructed profiles are geotechnically stable.

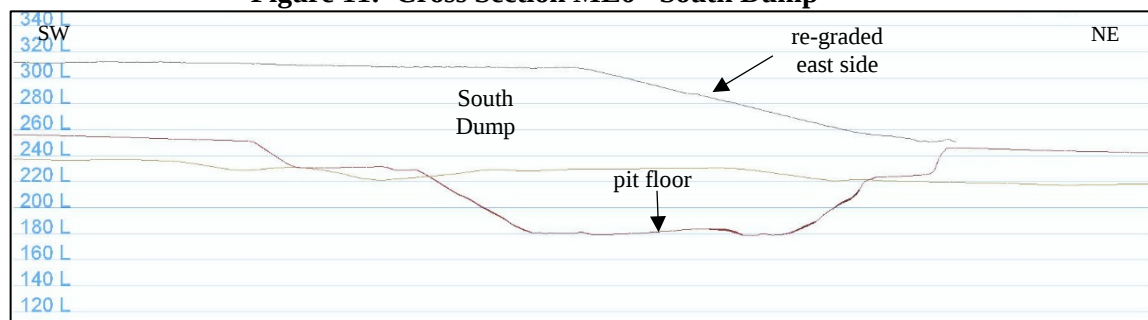
**Figure 11: Cross Section ML6 - South Dump**

Final external dump faces are re-graded to 1 in 4, covered in rock mulch and grassed for rehabilitation status (see Section 4.2). Cross Section ML6 below shows the profile through the east side of the old south dump. This is an example of early re-grading without any berms.

The top of the dump is flat to reduce run-off as per the requirements of the EA. In this respect it has been the practice to bury tailings in cells in the spoil – this causes differential compaction which tends to create temporary ponding on the surface over the cells.

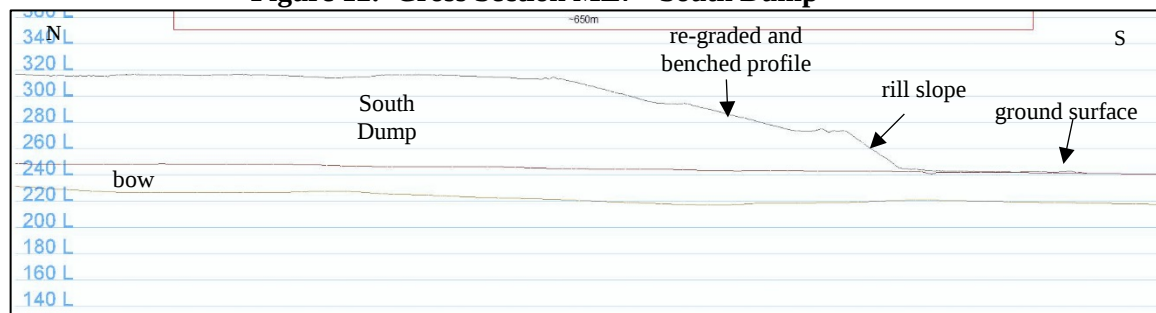
**Figure 12: Cross Section ML7 - South Dump**

The south side of the South Dump has also been re-graded as shown in Cross Section ML7 below. In this case however, final works have not been completed pending agreement to push material over onto the adjacent lease. As a consequence the bottom batter is still as-dumped at angle of repose.

Due to the shallow slope profile created by the re-grading, there is no risk of mass slope failure and rehabilitated slopes can be considered geotechnically stable over the long term.

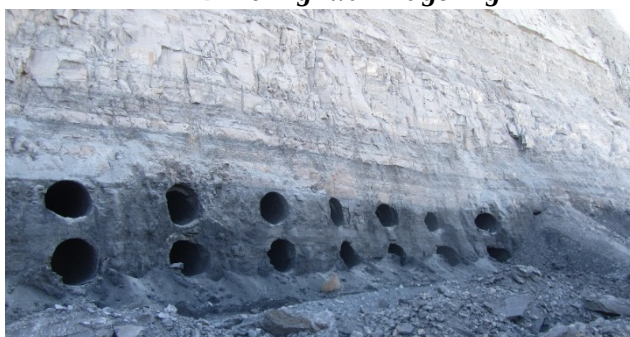
#### ***B Pit Highwall Augering***

In 2015/16 augering was undertaken in the next section of low wall in A Pit together with east and north walls in B Pit. The photo shows auger holes in the north wall of B Pit.

Photo taken 12/04/2016, looking E

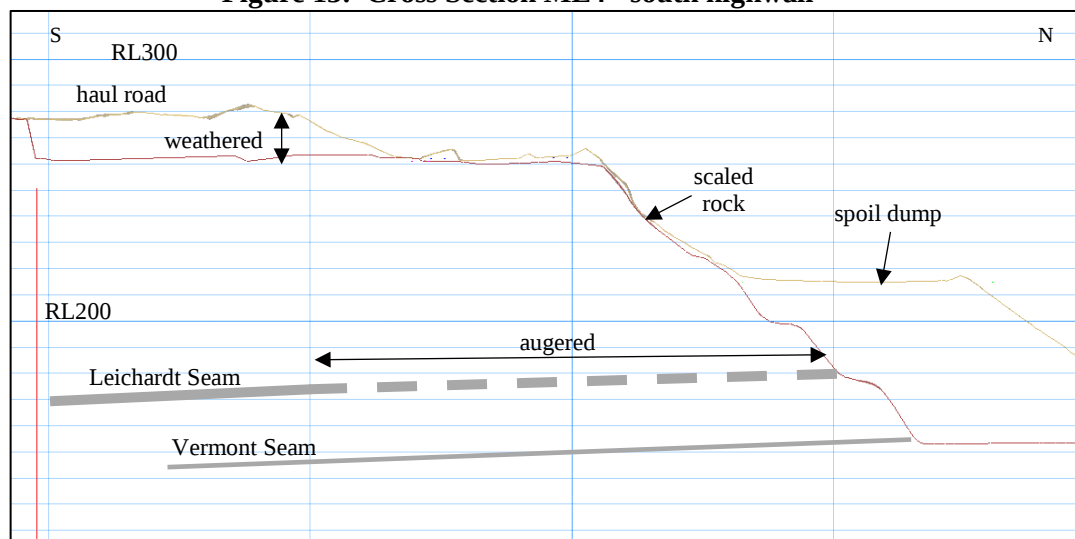
**Figure 13: Cross Section ML4 - south highwall**

A cross section through the south wall is shown in Figure 13 below. The auger holes generally penetrated between 80m and 160m, with a maximum of 200m in places, so did not penetrate further in than the haul road, which would not therefore be affected by any long term subsidence. The stability of the scaled 50° upper batters would not be affected by any subsequent pillar crushing and only the bottom rock bench would be at risk of face collapse. However the holes are now buried under a buttressing spoil dump which would offer greater confinement to the pillars under the face and reduce the opportunity for pillar failure.

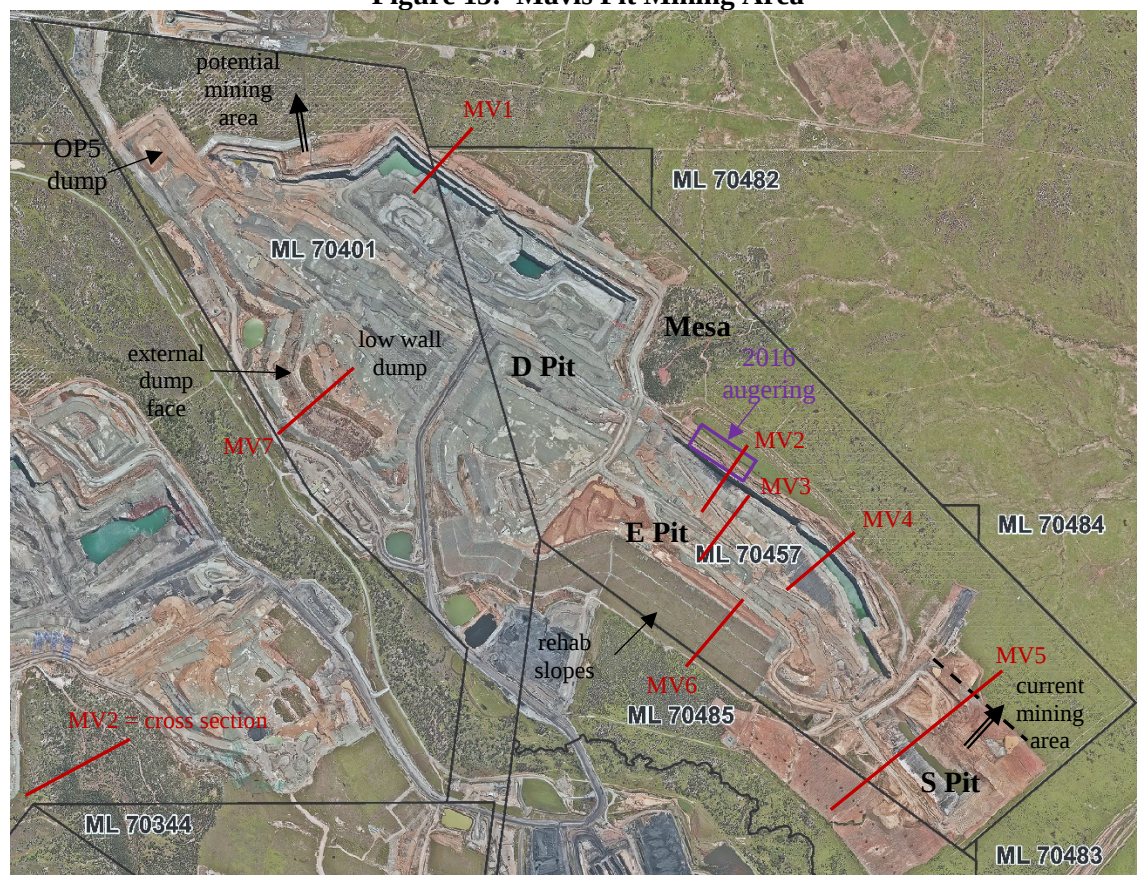
**Figure 15: Mavis Pit Mining Area**

Current opencut mining operations are restricted to D Pit and S Pit, with a potential to extend the pit to the north (D Pit North) towards the lease boundary. A small mesa forms high ground behind the D Pit southern endwall. Highwall augering is underway in the final E Pit highwall, as indicated in Figure 15 below, with plans to extend over the rest of the northern half of the pit. The seam dip in the southern half is too steep for auger mining.

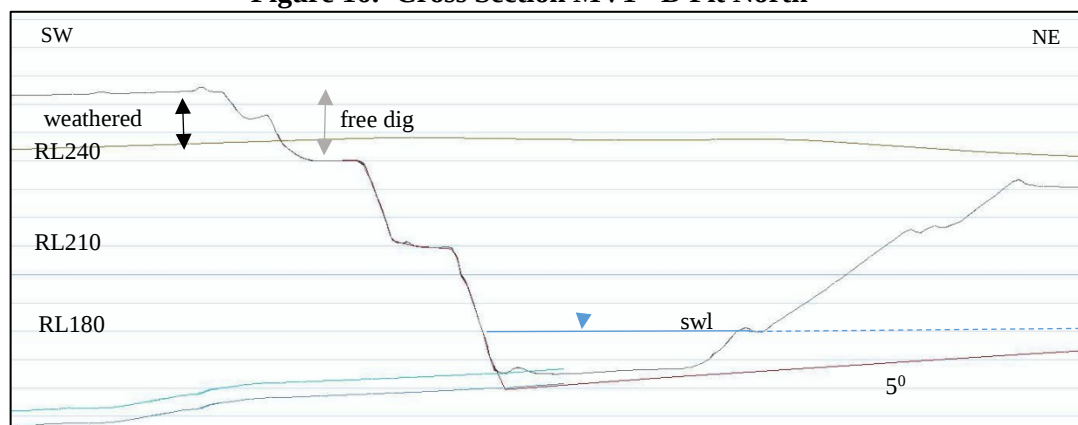
**Figure 16: Cross Section MV1 - D Pit North**

Cross Section MV1 at the northern end of D Pit is presented below. This shows the general configuration for an 80m high double bench highwall, with 70° pre-split benches and 15m berms at RL210 and RL240. It also illustrates the shape of the 'rough-cut' free-dig benches through the weathered material. The benched in-pit spoil dump is constructed on the pit floor up-dip of the mining void at angle of repose. The predicted long term water level is shown at RL180.

In terms of long term void water level, the predicted RL180 mark in D Pit would result in inundation of the lower rock benches to a height of about 20m above the Leichardt Seam. In E Pit only the southern part would accumulate water for a predicted long term level of RL175, again indicating a maximum submergence depth of 20m at the highwall. In each case only the lower part of the fresh rock bench would be impacted, and this would not be expected to induce any instability in the rock face.

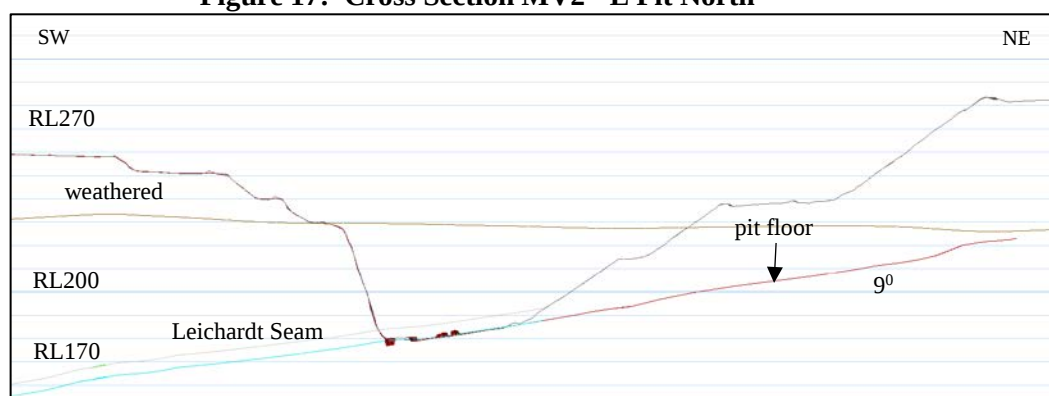
**Figure 17: Cross Section MV2 - E Pit North**

In E Pit the rock highwall is 50m to 60m high and has been cut as a single bench, as illustrated in Figure 17 below (Cross Section MV2). The pit floor in the northern part of E Pit is at RL180 or so and would be above the predicted long term water level.

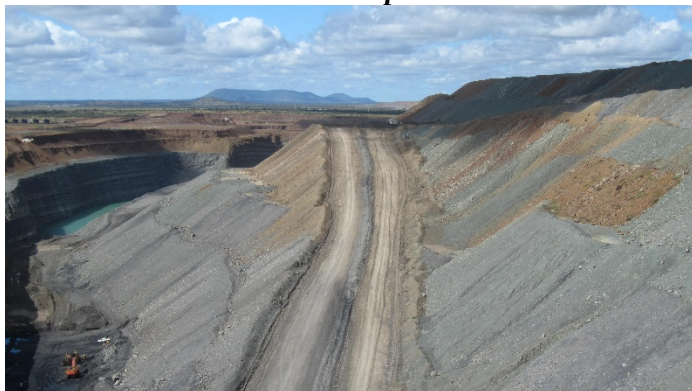
***E Pit low wall spoil***

Low wall dumps on a dipping floor are at risk of mass failure due to basal slippage, particularly if the floor contains weak or sheared horizons. In Mavis Pit the experience has been that dumps are stable on dips up to  $8^{\circ}$  in general, or  $12\frac{1}{2}^{\circ}$  on sound floor. No dump instability was apparent from the site inspection. The photo below shows the stable low wall configuration with good quality spoil forming the base.

Photo taken 11/05/2017, looking SE

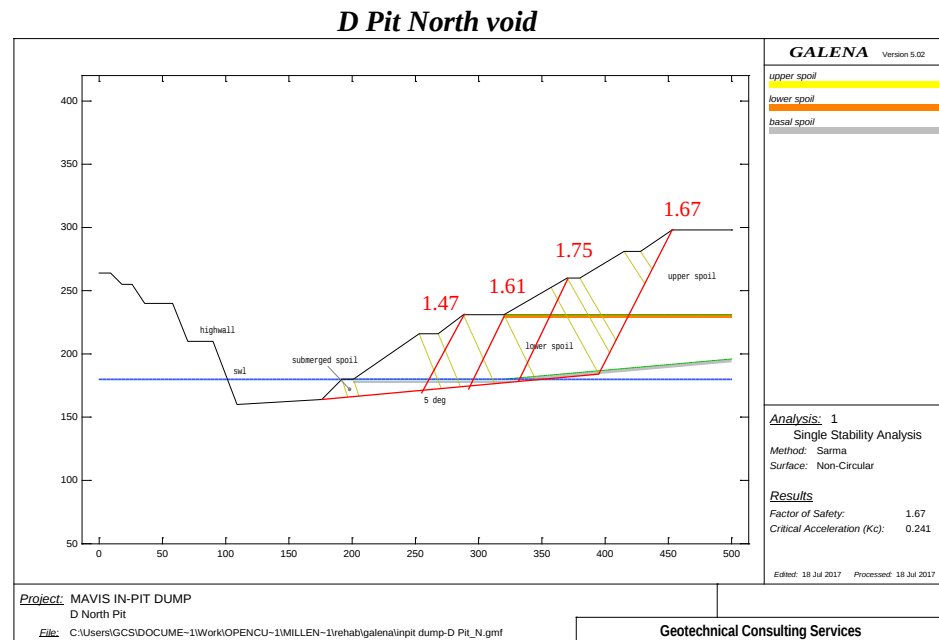
The analyses for D Pit North were based on Cross Section MV1 in Figure 16 (p.22), extended up to the full height of the dump at about RL300. The Galena analysis model showing the full profile is presented below.

Analyses were made failure configurations ranging from the RL230 crest up to the top of the dump at the RL300 crest as shown above. The results show FoS from 1.73 to 1.90 for the as-constructed dry conditions, well in excess of the long term design value. The FoS for the inundated condition are shown on the model section; these are lower but still more than adequate for the most part.

The influence of the submerged spoil becomes more apparent towards the toe of the dump causing a reduction in the FoS. A minimum FoS of 1.47 was noted at the RL230 crest as indicated on the plot above.

These results would indicate that mass failure of the internal dump would be highly unlikely, with the worst case FoS of partial failure under inundation still more or less acceptable for long term stability. Although inundation to the predicted level would not prejudice the dump in terms of mass instability, it could possibly cause some shallow slumping if the slope was undercut by notching at the water line. The spoil is not dispersive but has a high potential for slaking from wetting and drying.

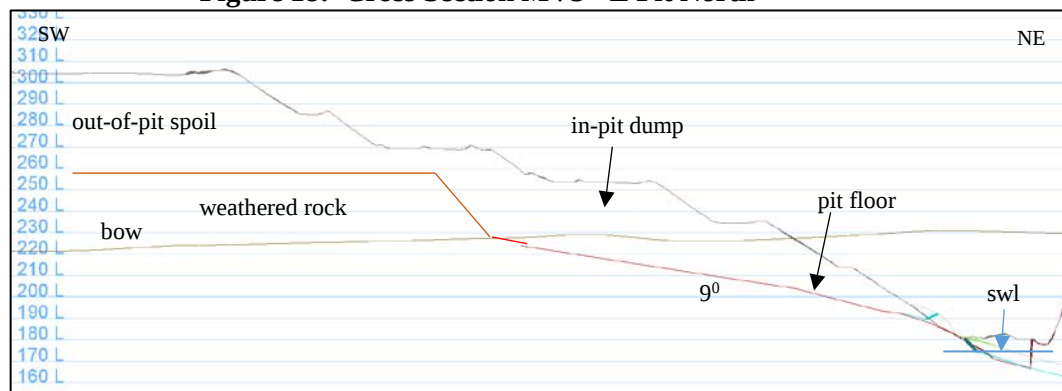
**Figure 18: Cross Section MV3 - E Pit North**

The analyses for E Pit North were based on the profile in Cross Section MV3, as illustrated in Figure 18 below, which extends to the full dump height but using the floor profile from Figure 17 (p.22).

The floor level in the void in this part of E Pit is generally above the predicted flood level so that inundation is not a factor in stability analysis. The other issue is the geometric constraint on failure due to the upper part of the dump being situated on insitu ground. This would preclude full height failure as bi-planar slippage would be limited to the front part only, where the spoil has been dumped on the pit floor. The farthest back for failure is thus on the RL270 bench. The Galena analysis model is presented below.

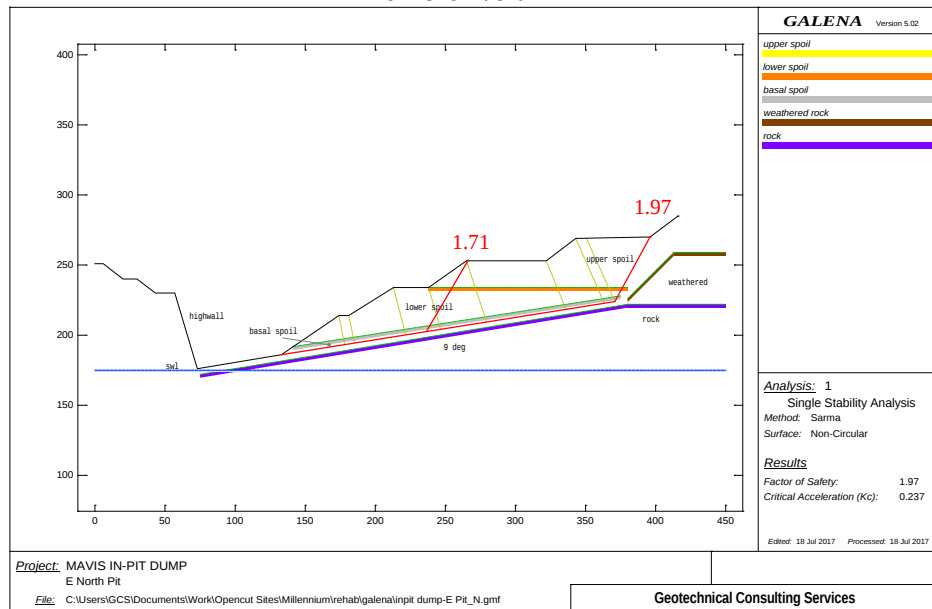
**E Pit North void**

The FoS are high, despite the steeper dip, because of the lower dump height and the lack of submergence of the spoil. Mass failure of the in-pit spoil dump can be discounted in this instance. Notwithstanding the foregoing, the long term plan is to continue to infill E Pit North with spoil, which will mean that the low wall will be buttressed against the highwall. This will remove any possible risk of mass movement of the low wall.

In both D Pit and E Pit North there will be a residual risk of downwash and scouring of fines but any displaced material would be contained within the pit void.

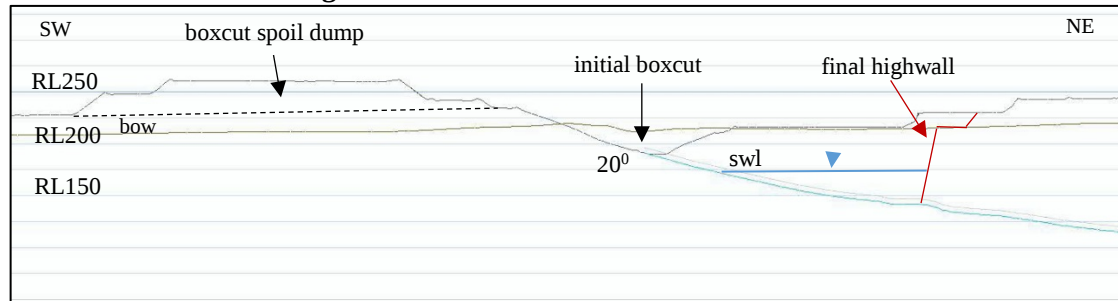
**Figure 20: Cross Section MV5 - S Pit**

S Pit was developed as a boxcut with all the spoil being dumped out-of-pit away from the low wall because of the high dip. After being used for water storage, mining has now been resumed. The cross section through S Pit and the boxcut spoil dump is shown below.

The initial insitu low wall was cut down at the dip angle so there is no material resting on the potential relict coal slip plane and the pit floor, which is effectively a footwall, is not steep enough to present any risk of slab failure. As a result the pit configuration is stable with no kinematic condition conducive to failure.

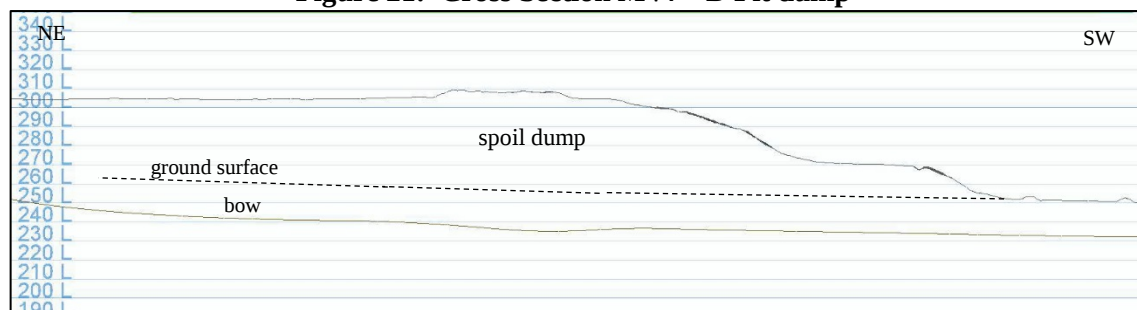
**Figure 21: Cross Section MV7 - D Pit dump**

Figure 21 below shows a cross section through the outer part of the D Pit dump, illustrating the shape of the benches and the flat top.

These slopes formed as per the standard design can be considered to be inherently stable for the long term in regard to potential mass failure. In terms of environmental stability they will be subject to ongoing surface erosion which will gradually over millennia flatten the batter angle of the faces.

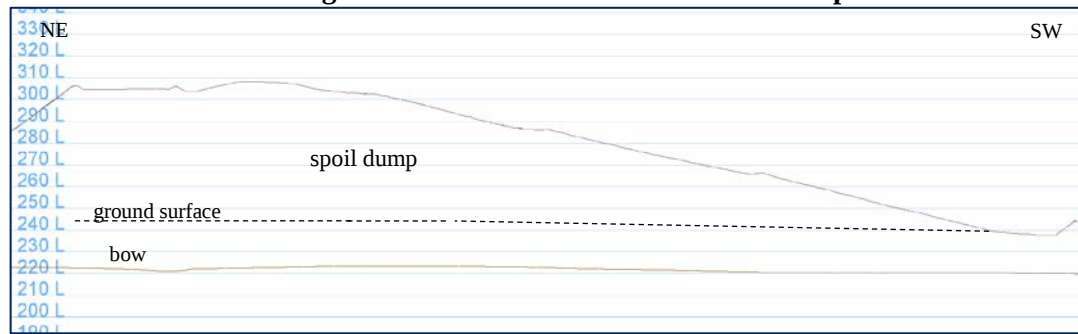
**Figure 22: Cross Section MV6 - E Pit dump**

The outer face of the E Pit dump has been re-graded and rehabilitated; Figure 22 below shows the final profile at 1 in 4 slopes with nominal 5m berm, giving an overall slope angle of 13°. There is no risk of mass failure with re-graded slopes at this angle.

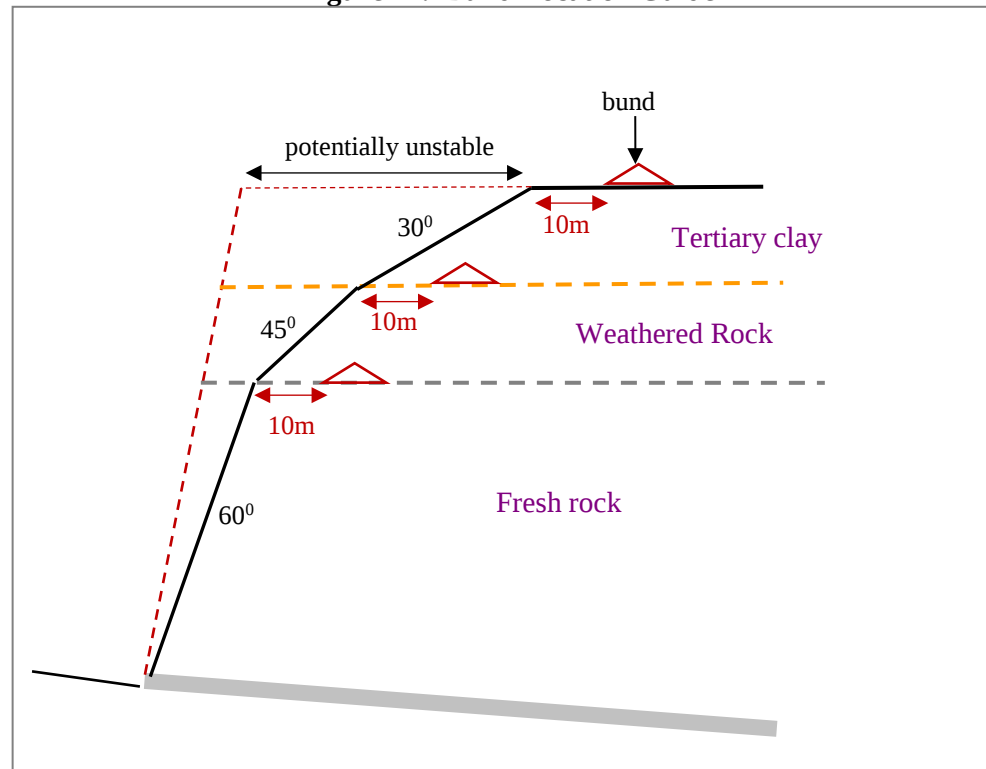
**Figure 24: Bund Location Guide**

This is illustrated diagrammatically in Figure 24 below. Any part of the highwall profile steeper than the projected lines is deemed potentially unstable with regard to the possibility of failures cutting back into the crest and the bund is to be located 10m back as shown.

The bund location relative to the actual crest is thus determined according to the thickness of the three material types present in the highwall, and the projected angles.
