Progressive Rehabilitation and Closure Plan

Fairhill Coal Project

Tenure number: ML 700043

Prepared by: Futura Mining Services Pty Ltd

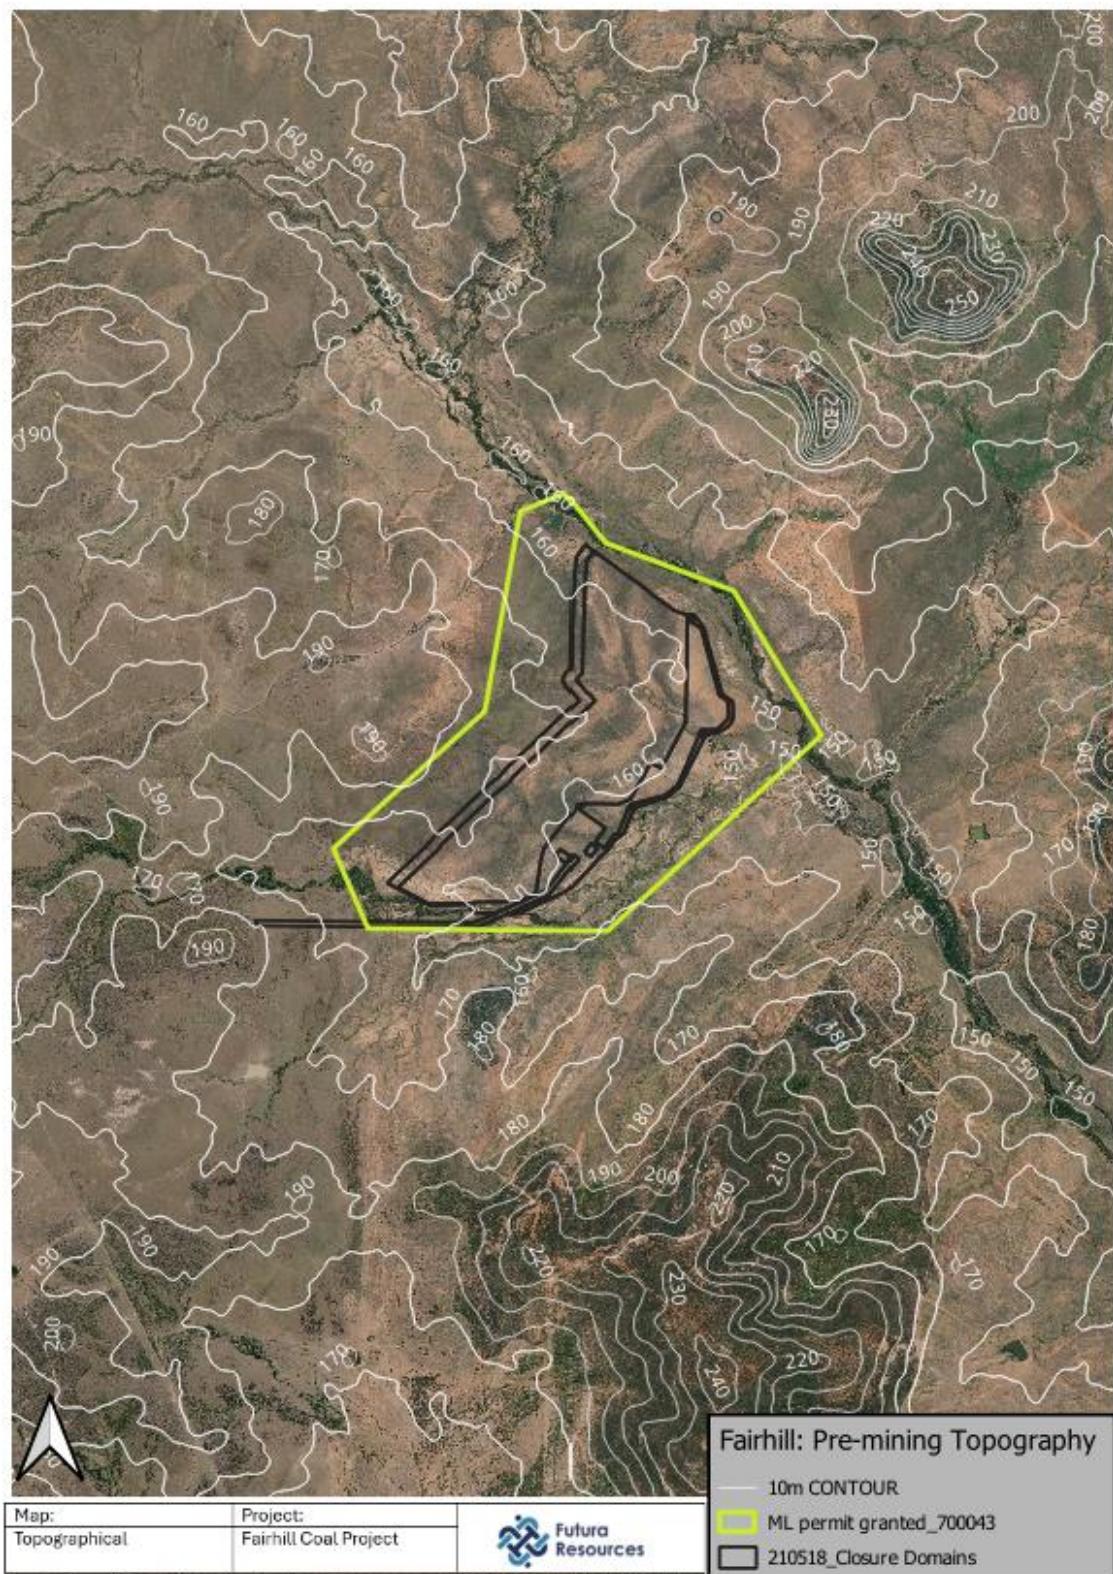
Figure 2. FHCP Topography

Figure 2, presents the topography at the FHCP.

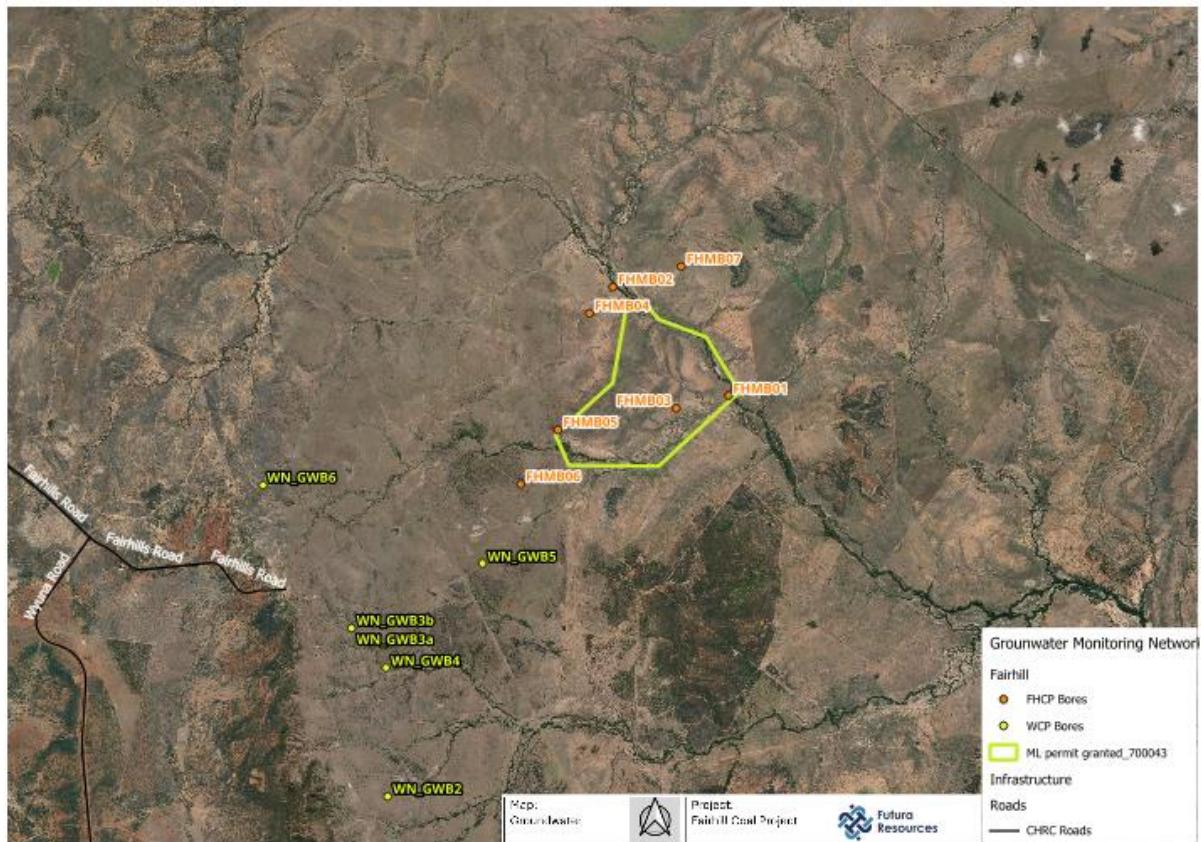
Figure 13. Groundwater Monitoring Network

At FHCP, all of the monitoring bores have been installed to monitor groundwater in the Fairhill Formation. The Burngrove Formation occurs only as a thin, weathered layer covering part of the western portion of the tenement which does not hold groundwater. Therefore, no aquifers of the Burngrove Formation are likely to be found within FHCP.

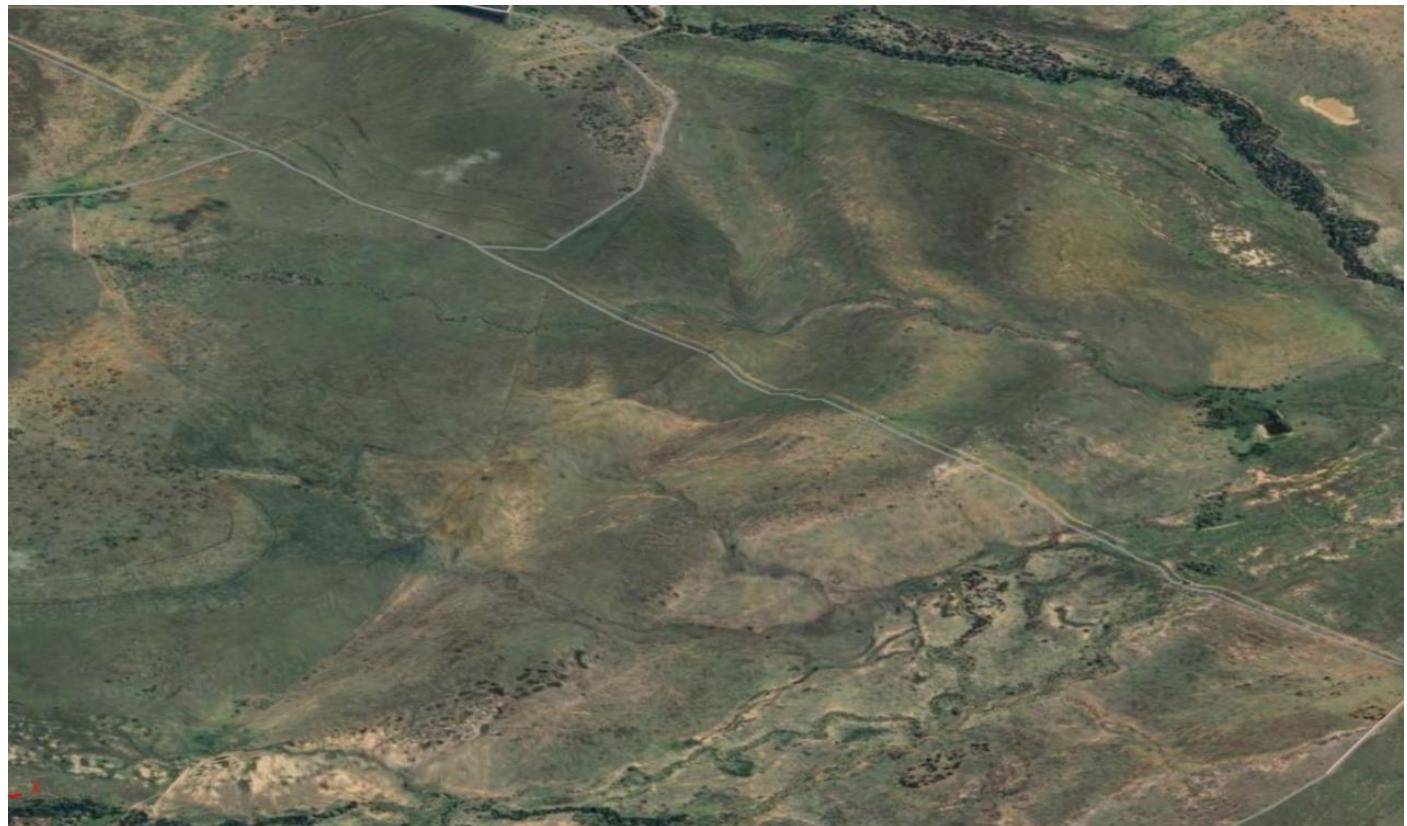
Figure 24. Topography of Post mining landscape – demonstrating final landform compatibility

Comparing the conceptual final landform with the existing elevated topographical features, it is clear that similar slope angles are present in both the conceptual and the natural land forms. This demonstrates the compatibility of the proposed final landform with the natural landscape.
