**A-PRCP-NEW-100665536 – Response to Information Request**

Please see response to the Information Request made by the Department on the 07/03/2025.  
Responses have been made to each item raised by the Department in the initial information request  
in Table 1 below.

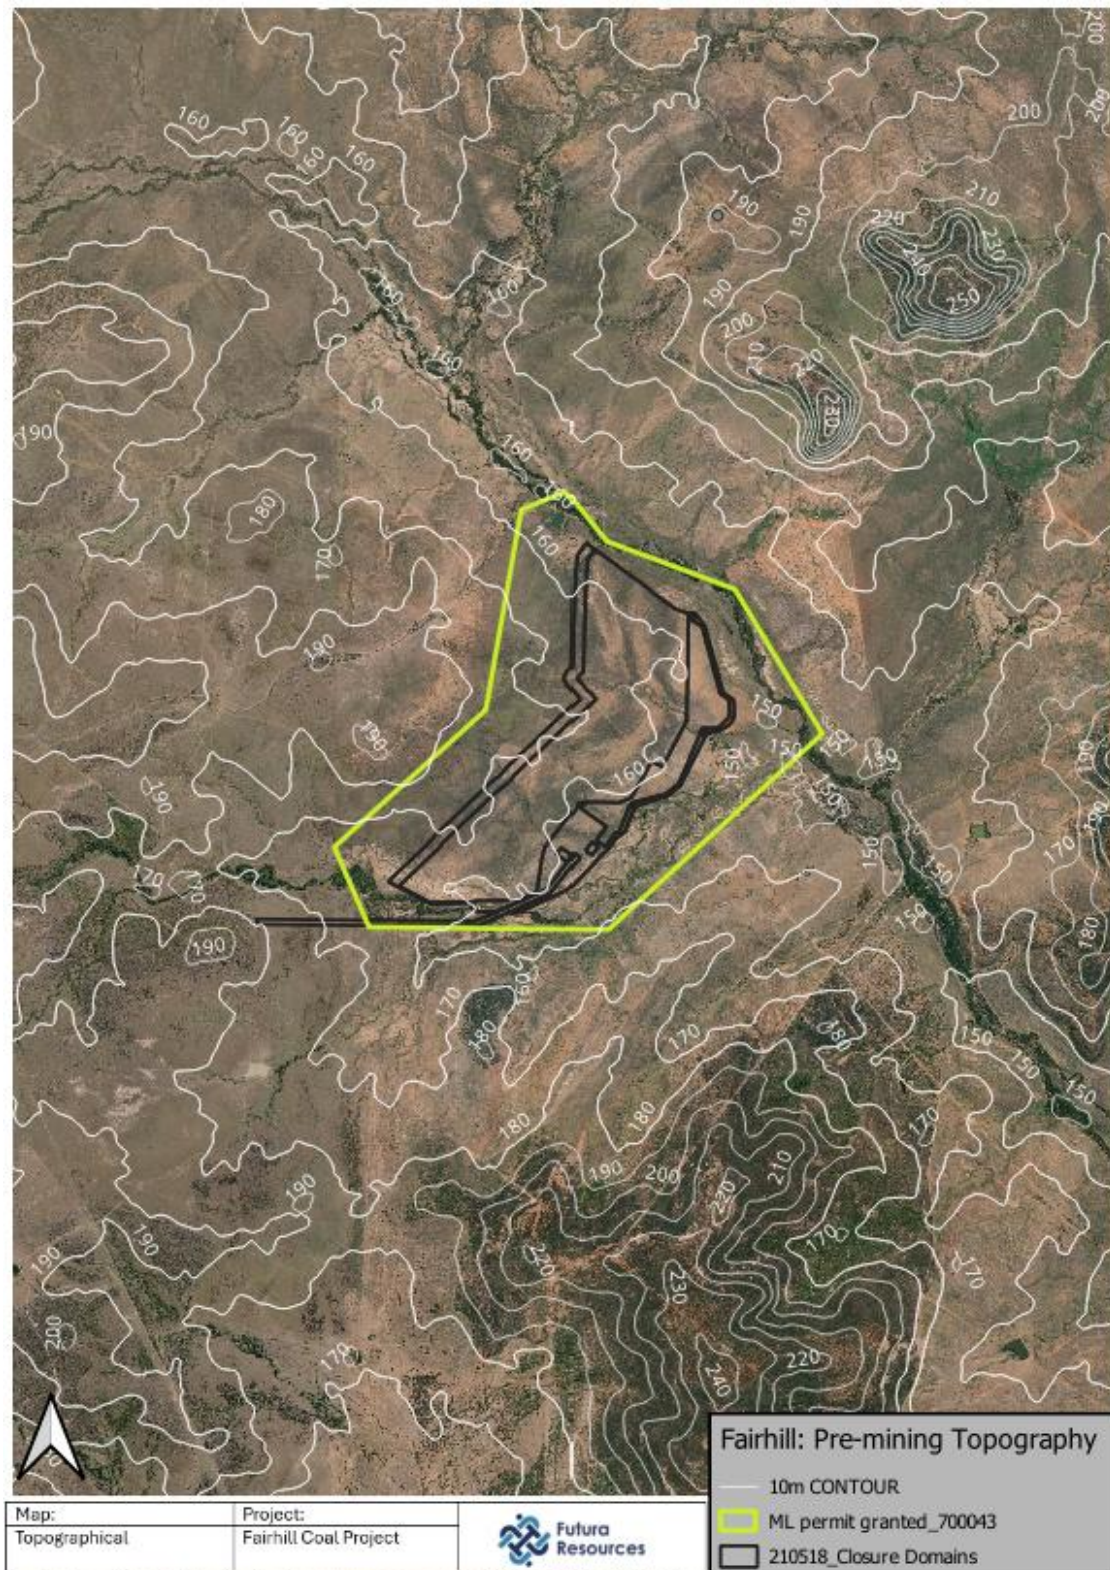
**Figure 2. FHCP Topography**

Figure 2, presents the topography at the FHCP.

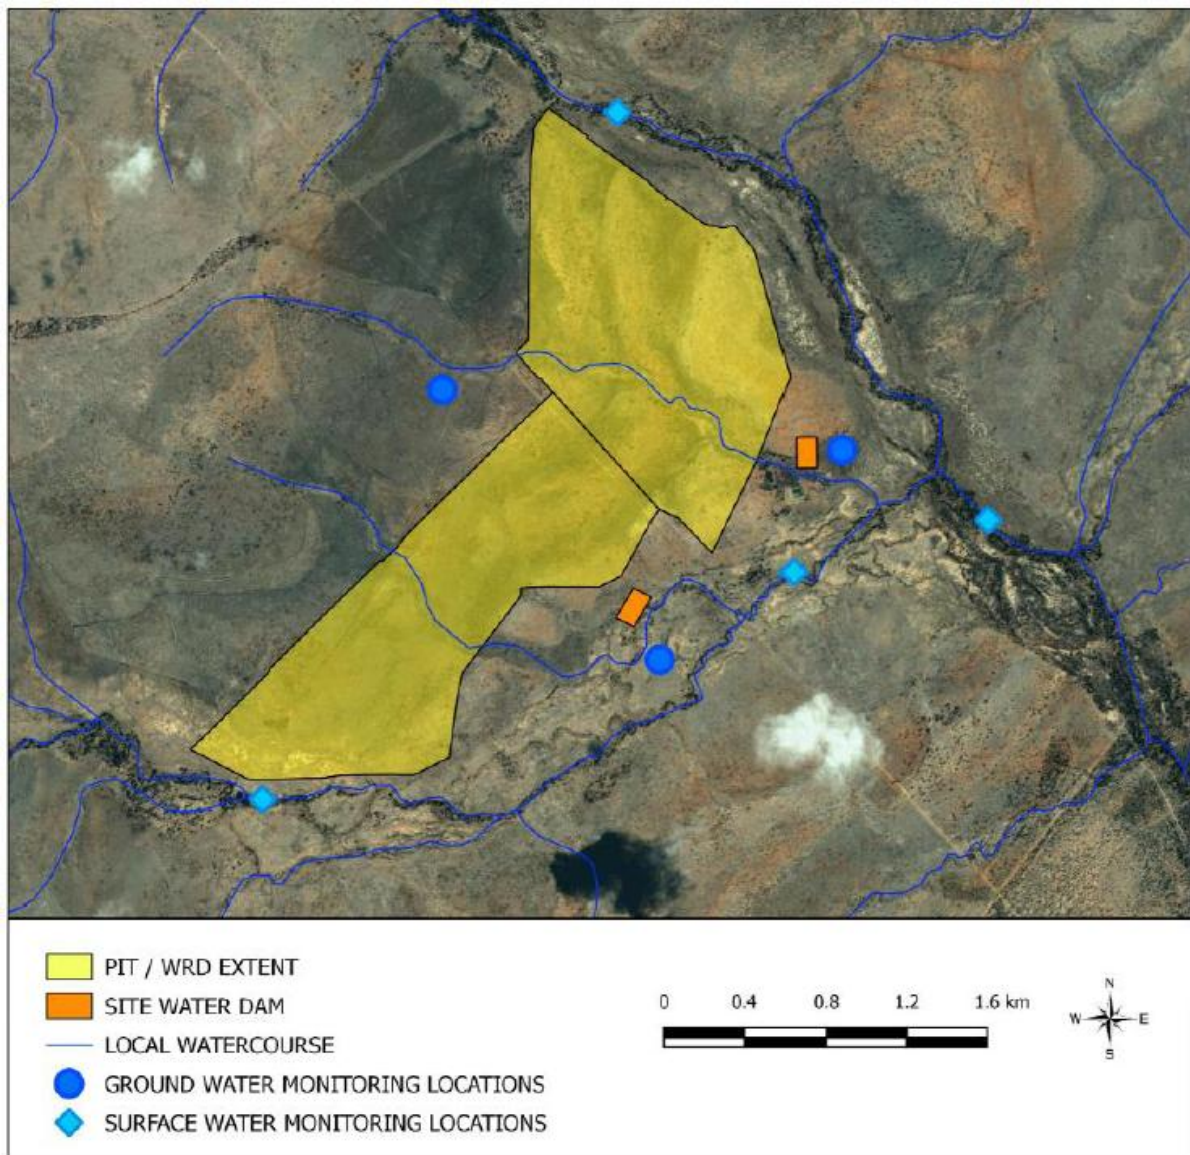
**Figure 12. Water Quality Monitoring Locations**

Water quality monitoring was undertaken by Northern Resource Consultants (NRC) in March 2018 at locations (Table 2) shown in Figure 12.

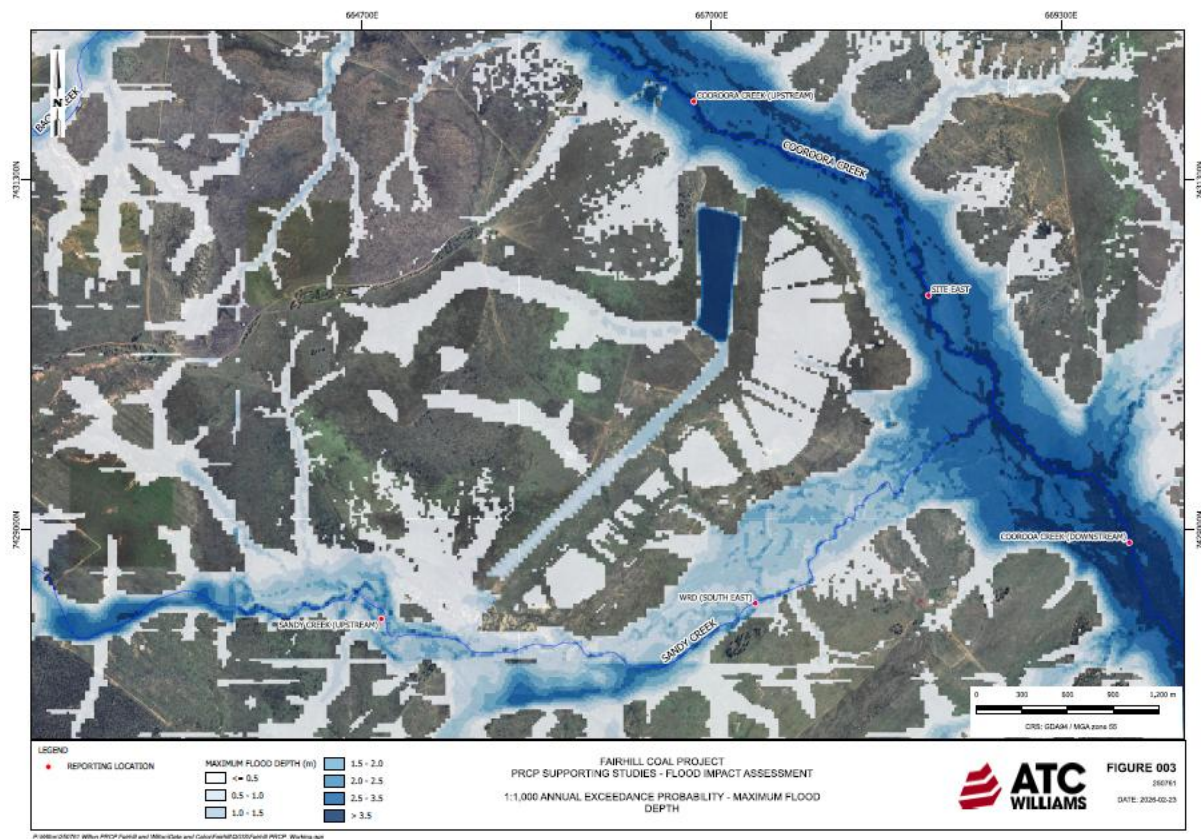
Flood modelling and an impact assessment carried out by ATC Williams (February 2026), confirms that the final landform is not impacted by ingress of floodwater from Cooroora Creek or Sandy Creek in the 0.1% AEP event and therefore is not within the extents of the 0.1% AEP floodplain.

**Figure 19. Final void depression and the 0.1% AEP Maximum flood depth**

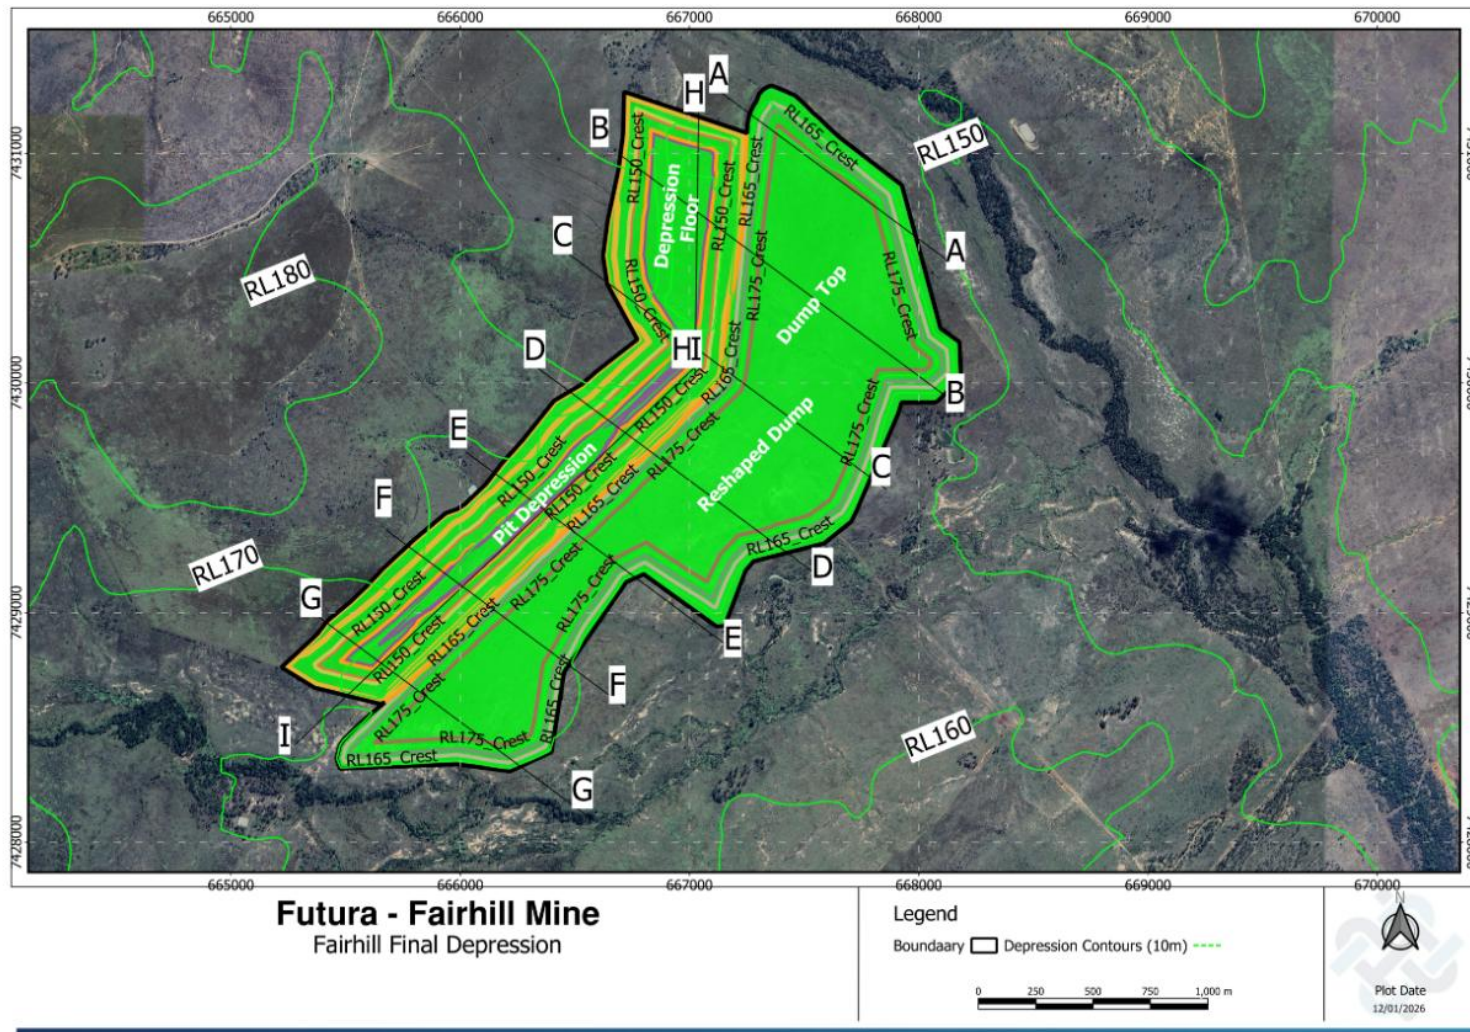
Figure 20. Modelled 3D Landform Design

A conceptual final landform has been modelled for the FHCP (year 7) and is shown in Figure 20, representing the extent of the rehabilitation associated with the proposed residual Landscaped depressions and out of pit overburden dump. The corresponding sections are shown in [Figure 22](#). The final landform will feature an elevated landform in the east and north in the location of the OOPDs, sloping down to form a depression in the west. Majority of slope angles are modelled to <10% except for battered slope angles achieving between 10% and 25%.

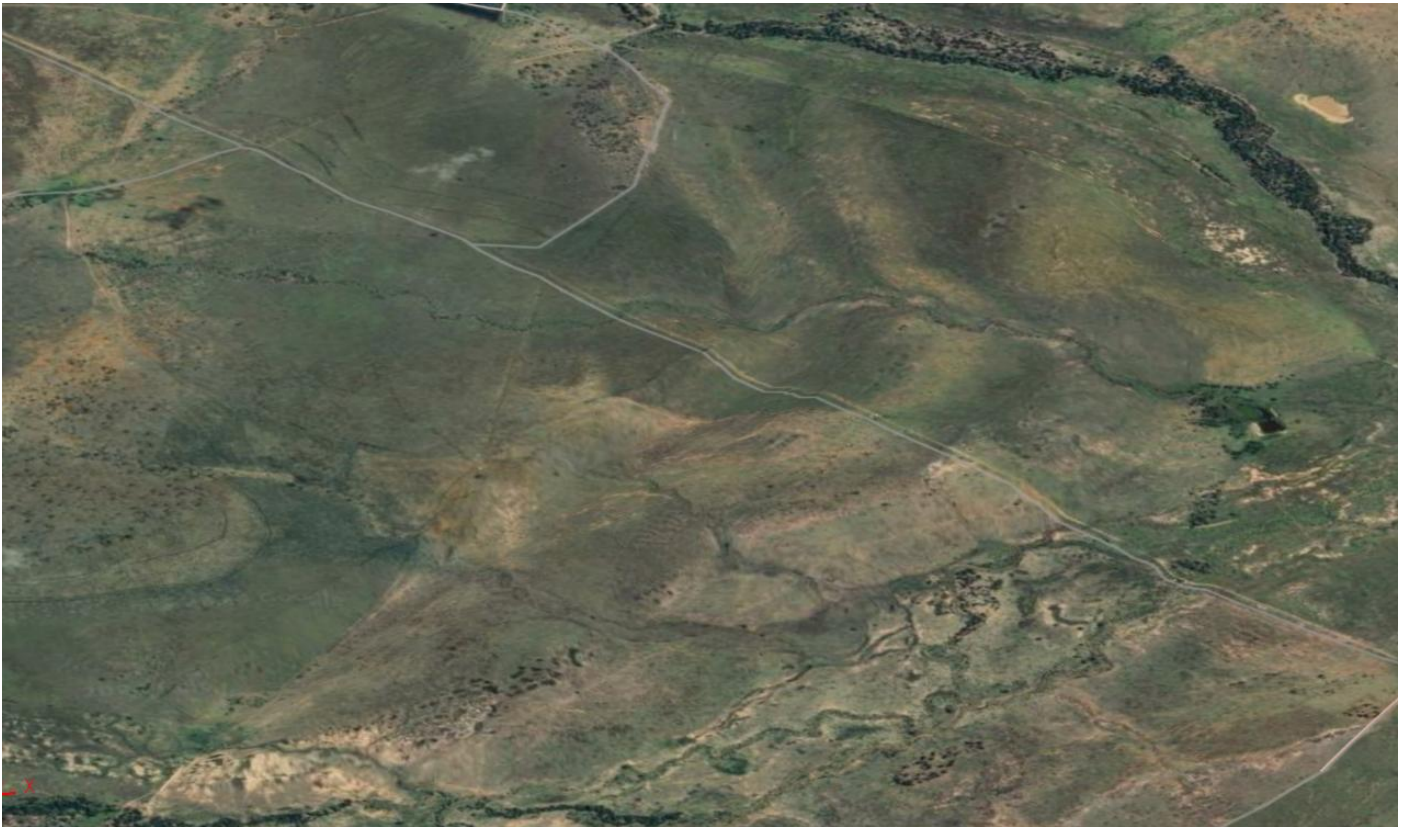
Comparing the conceptual final landform with the existing elevated topographical features, it is clear that similar slope angles are present in both the conceptual and the natural land forms. This demonstrates the compatibility of the proposed final landform with the natural landscape.

**Figure 23. Topography of Post mining landscape – demonstrating final landform compatibility**
