Hansen Bailey was commissioned by Batchfire Resources Pty Ltd (Batchfire) to prepare a Rehabilitation Management Plan (RMP) for the Callide Mine. This RMP has been prepared in accordance with the Callide Mine Environmental Authority (EA) conditions H2 and H3.

| Final Void Water Modelling | |

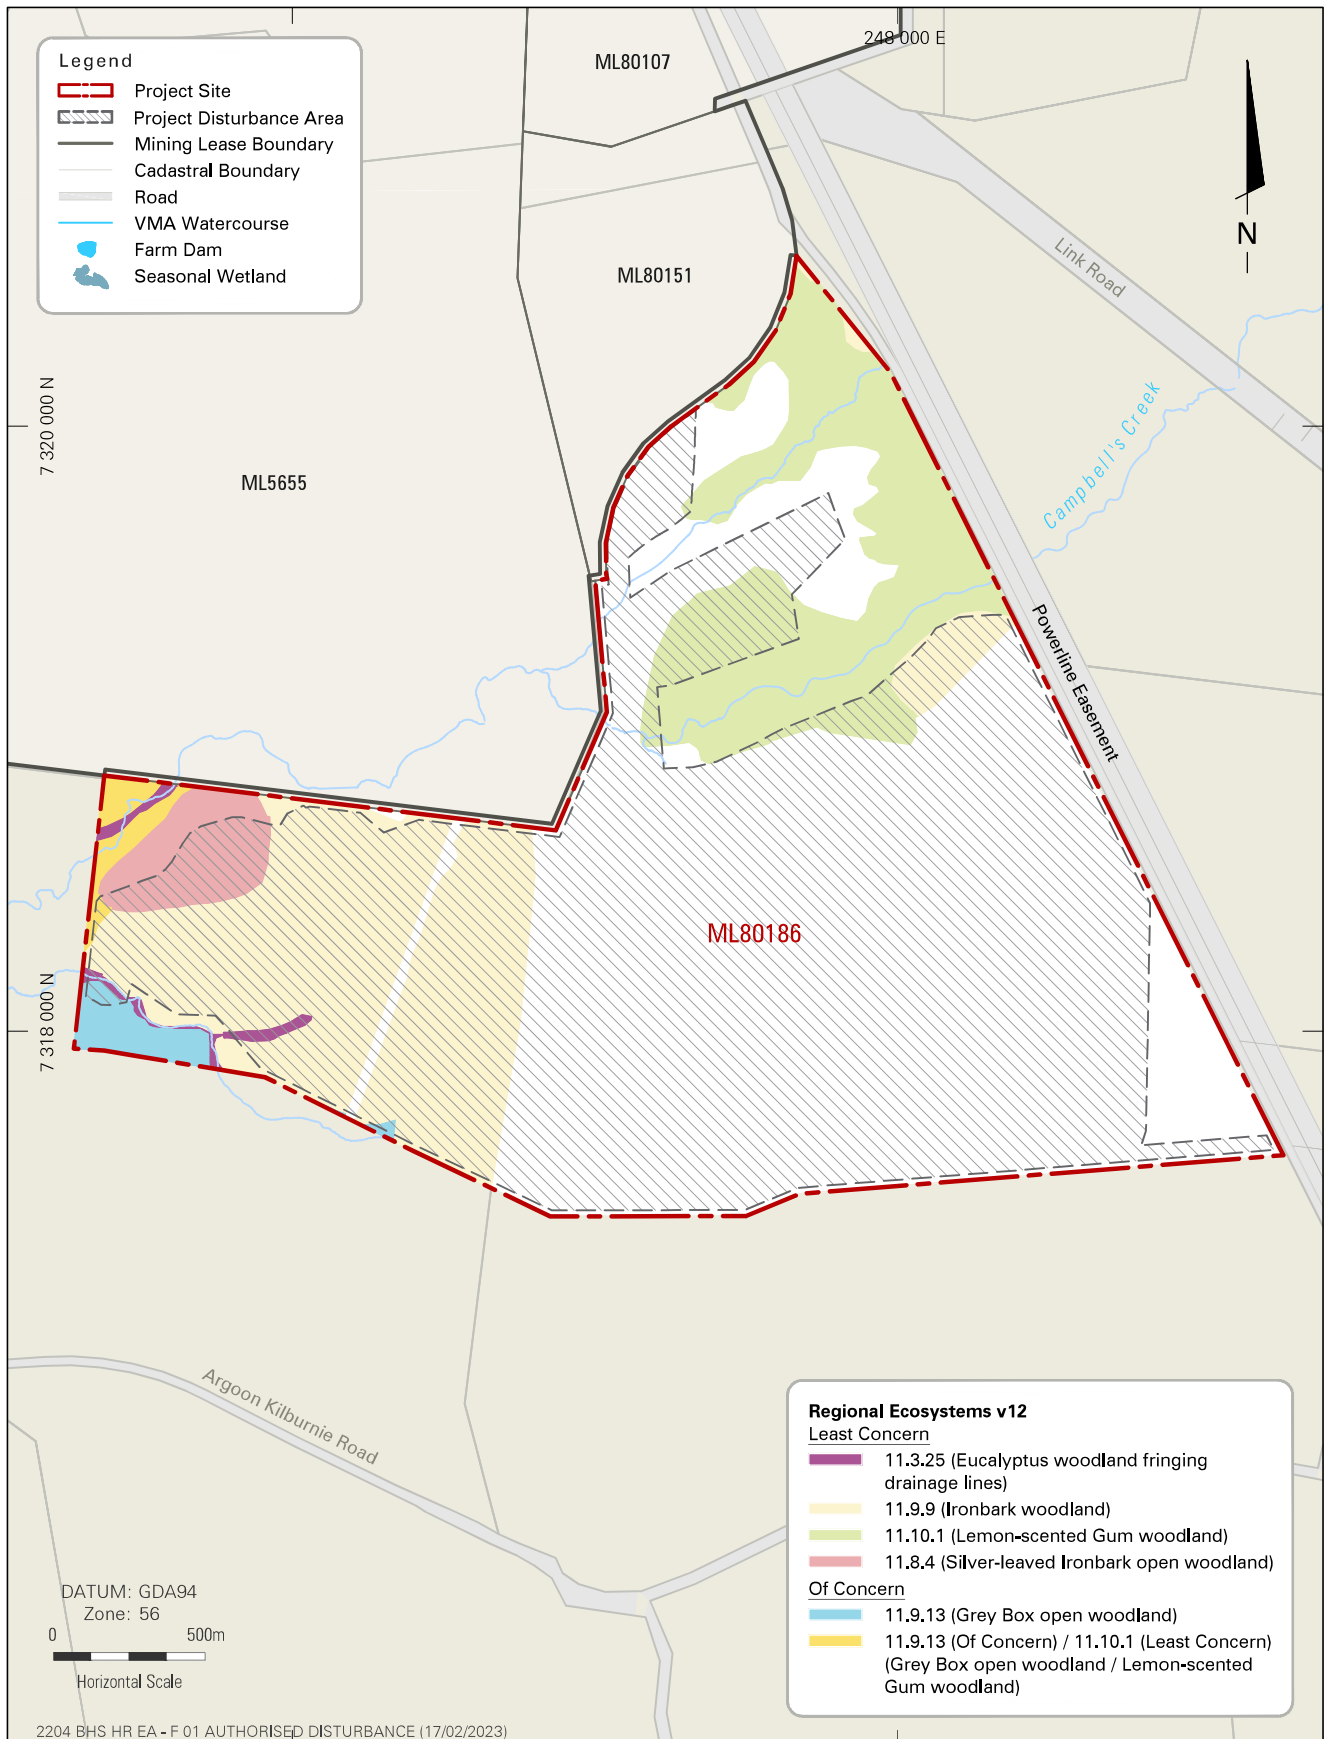
**FIGURE 1**

Boundary Hill South  
Authorised Disturbance Footprint

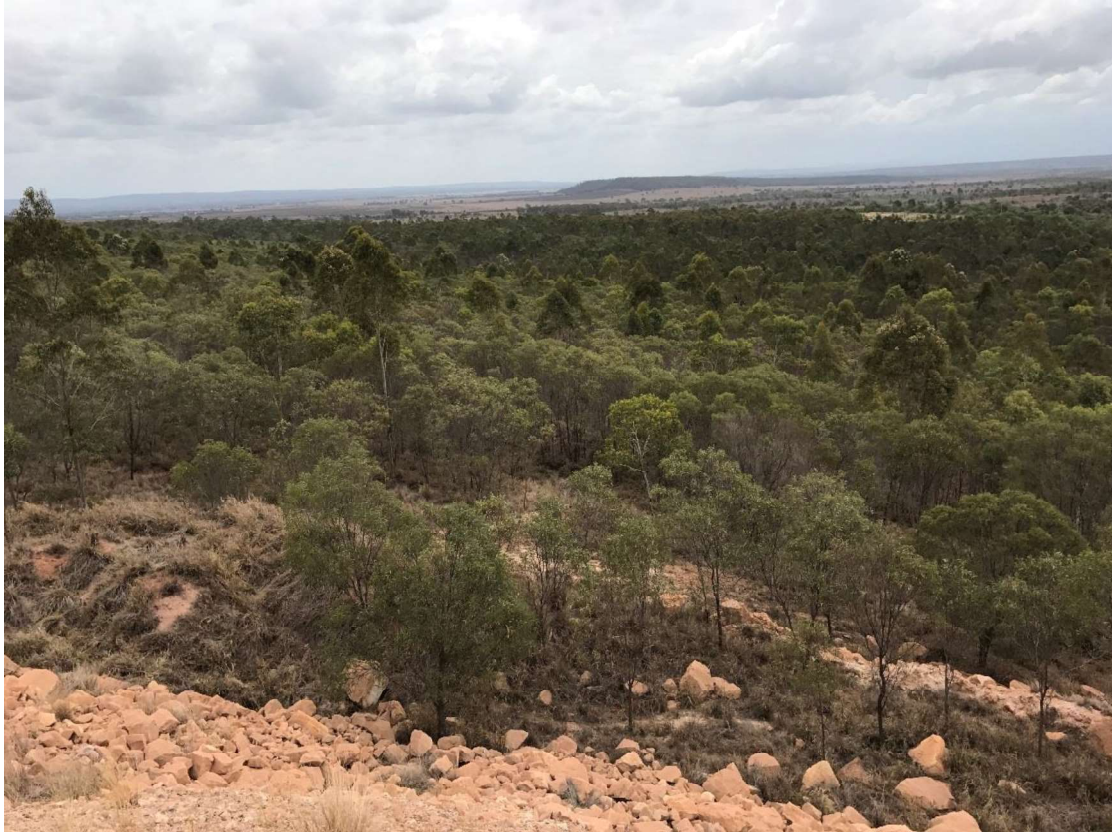
**Photo 1 Boundary Hill Mining Area - Established Rehabilitation Example**

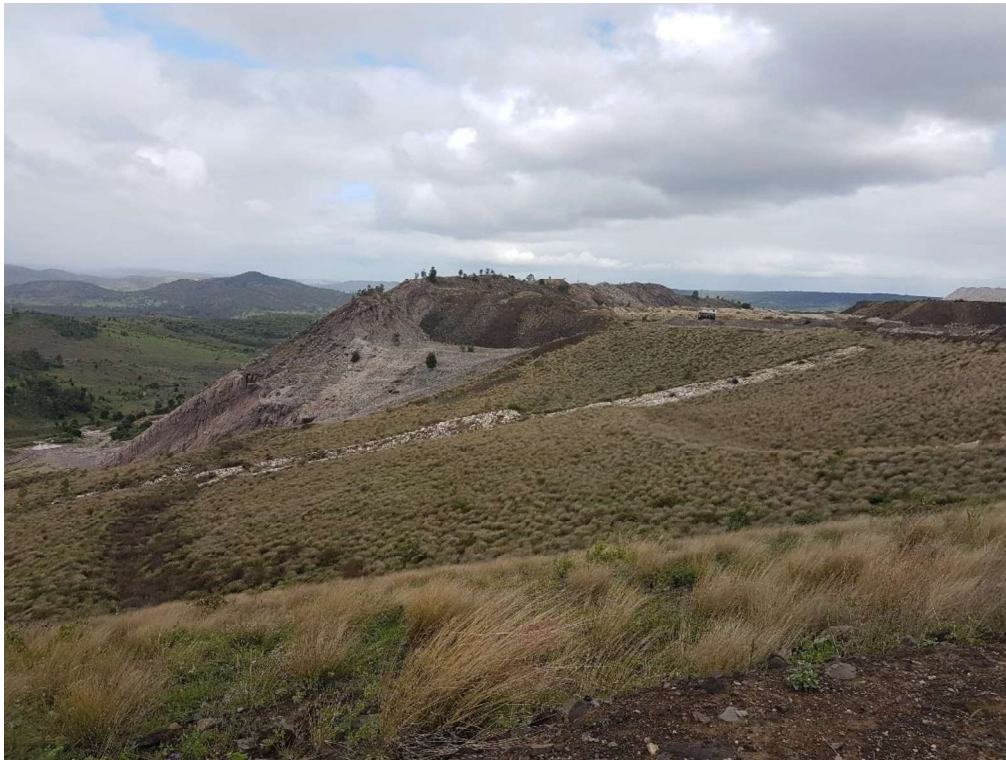
**Photo 2 Dunn Creek Mining Area – Trial Slope Rehabilitation Example**

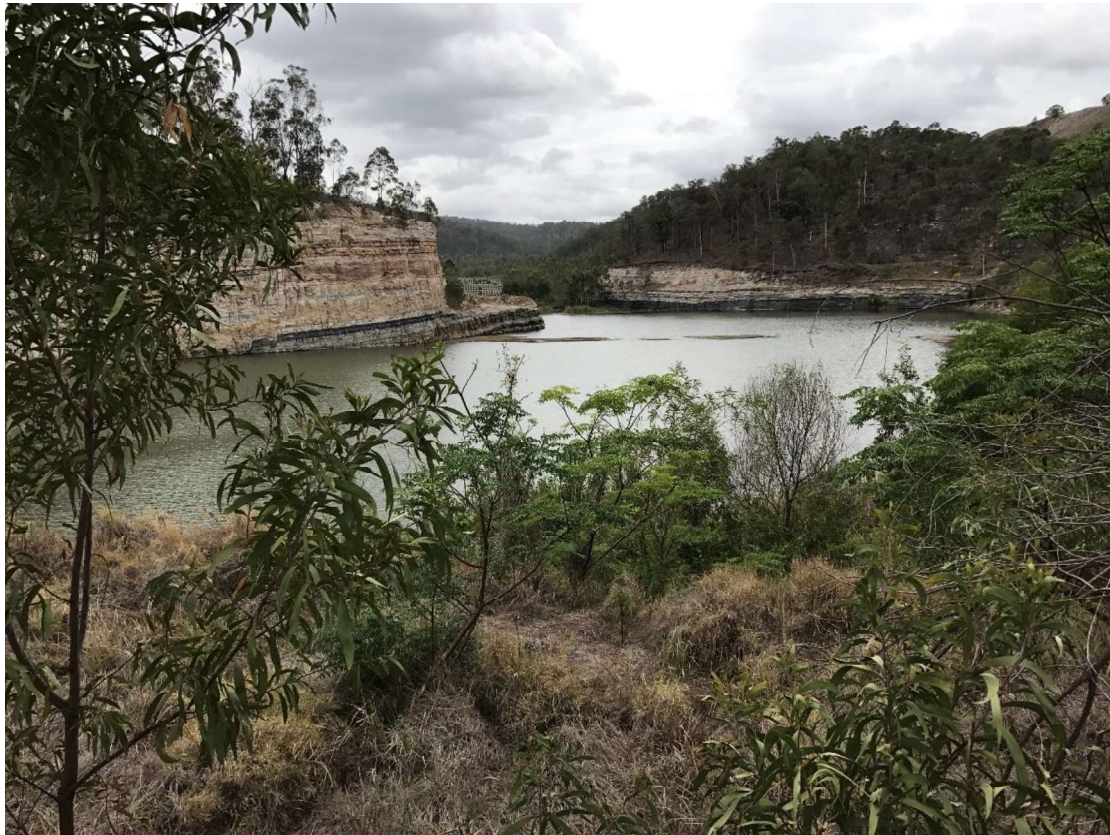
**Photo 3 The Hut Mining Area - Established Rehabilitation Example**

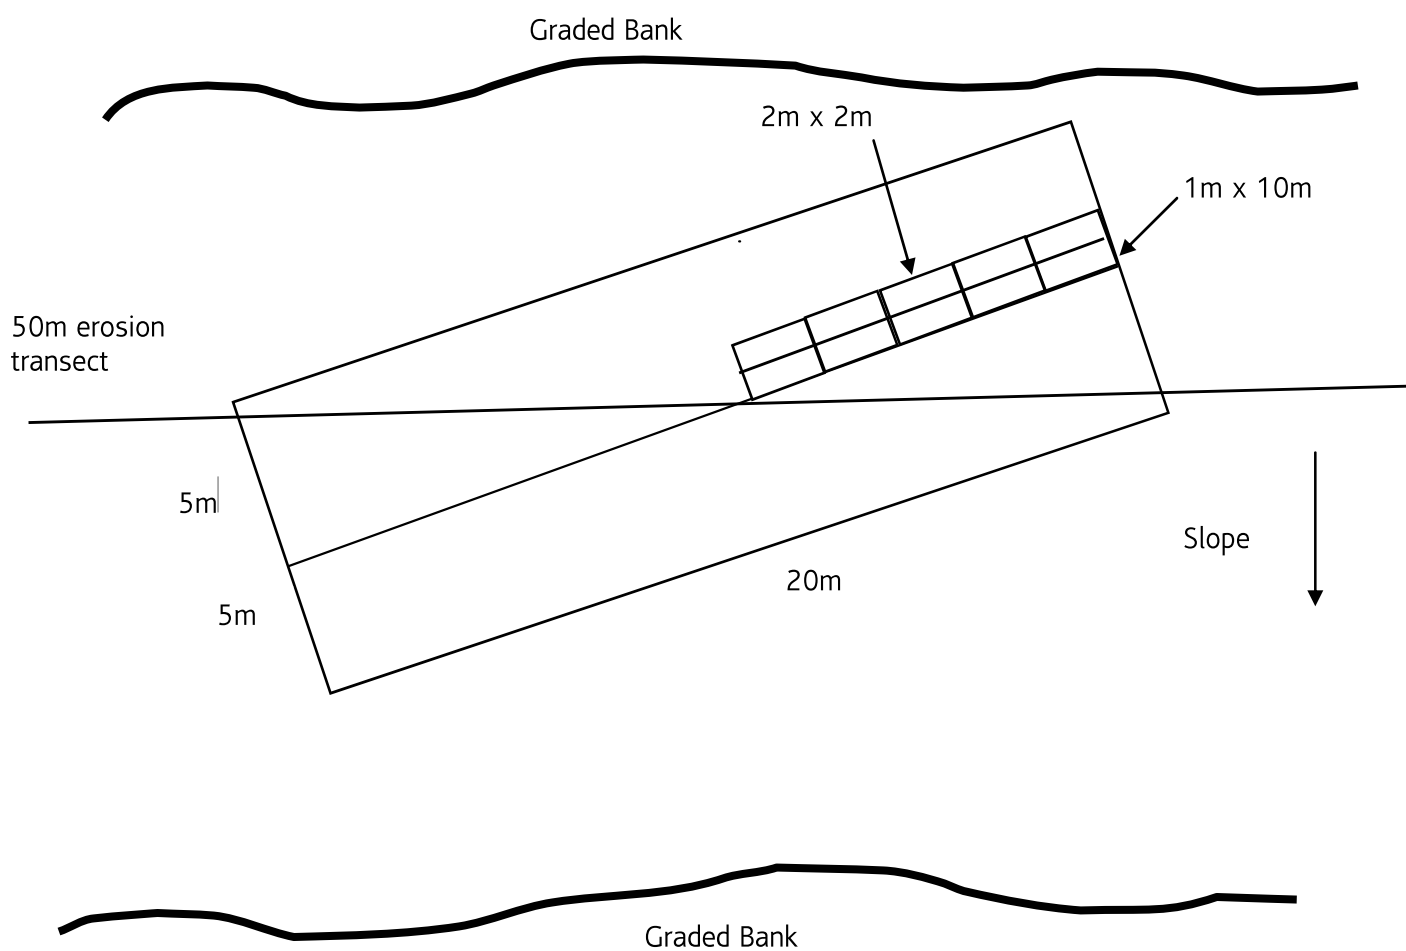
**Figure 7.1 - Recommended Monitoring Plot Design for use at Callide Mine**

The recommended revised monitoring design is shown in Figure 7.1. In a typical section of same-age rehabilitation, four plots should be established; two in the upper section of the slope, and two in the lower section. A smaller number of plots could be established in small rehabilitated areas, but it is important that several be used to give an indication of variability across a pit. The initial location of the plot should be selected at random, located in rehabilitation, which appears to be 'typical' of that particular rehabilitated area. The second plot should be sited at least 100m further along the slope. Where significant variation exists in a rehabilitated area, e.g. where some areas have a good tree cover and others have few trees and mainly grass, it may be necessary to stratify the sampling, to ensure that monitoring is a true reflection of the vegetation community. Thus, if site inspection or aerial photo interpretation reveal that  $\frac{3}{4}$  of the rehabilitated area has good tree cover and  $\frac{1}{4}$  has only grass, three of the four plots should be located in treed areas.

Each plot should be orientated at an angle to the contour to ensure that alternating strips of trees and grass are monitored.

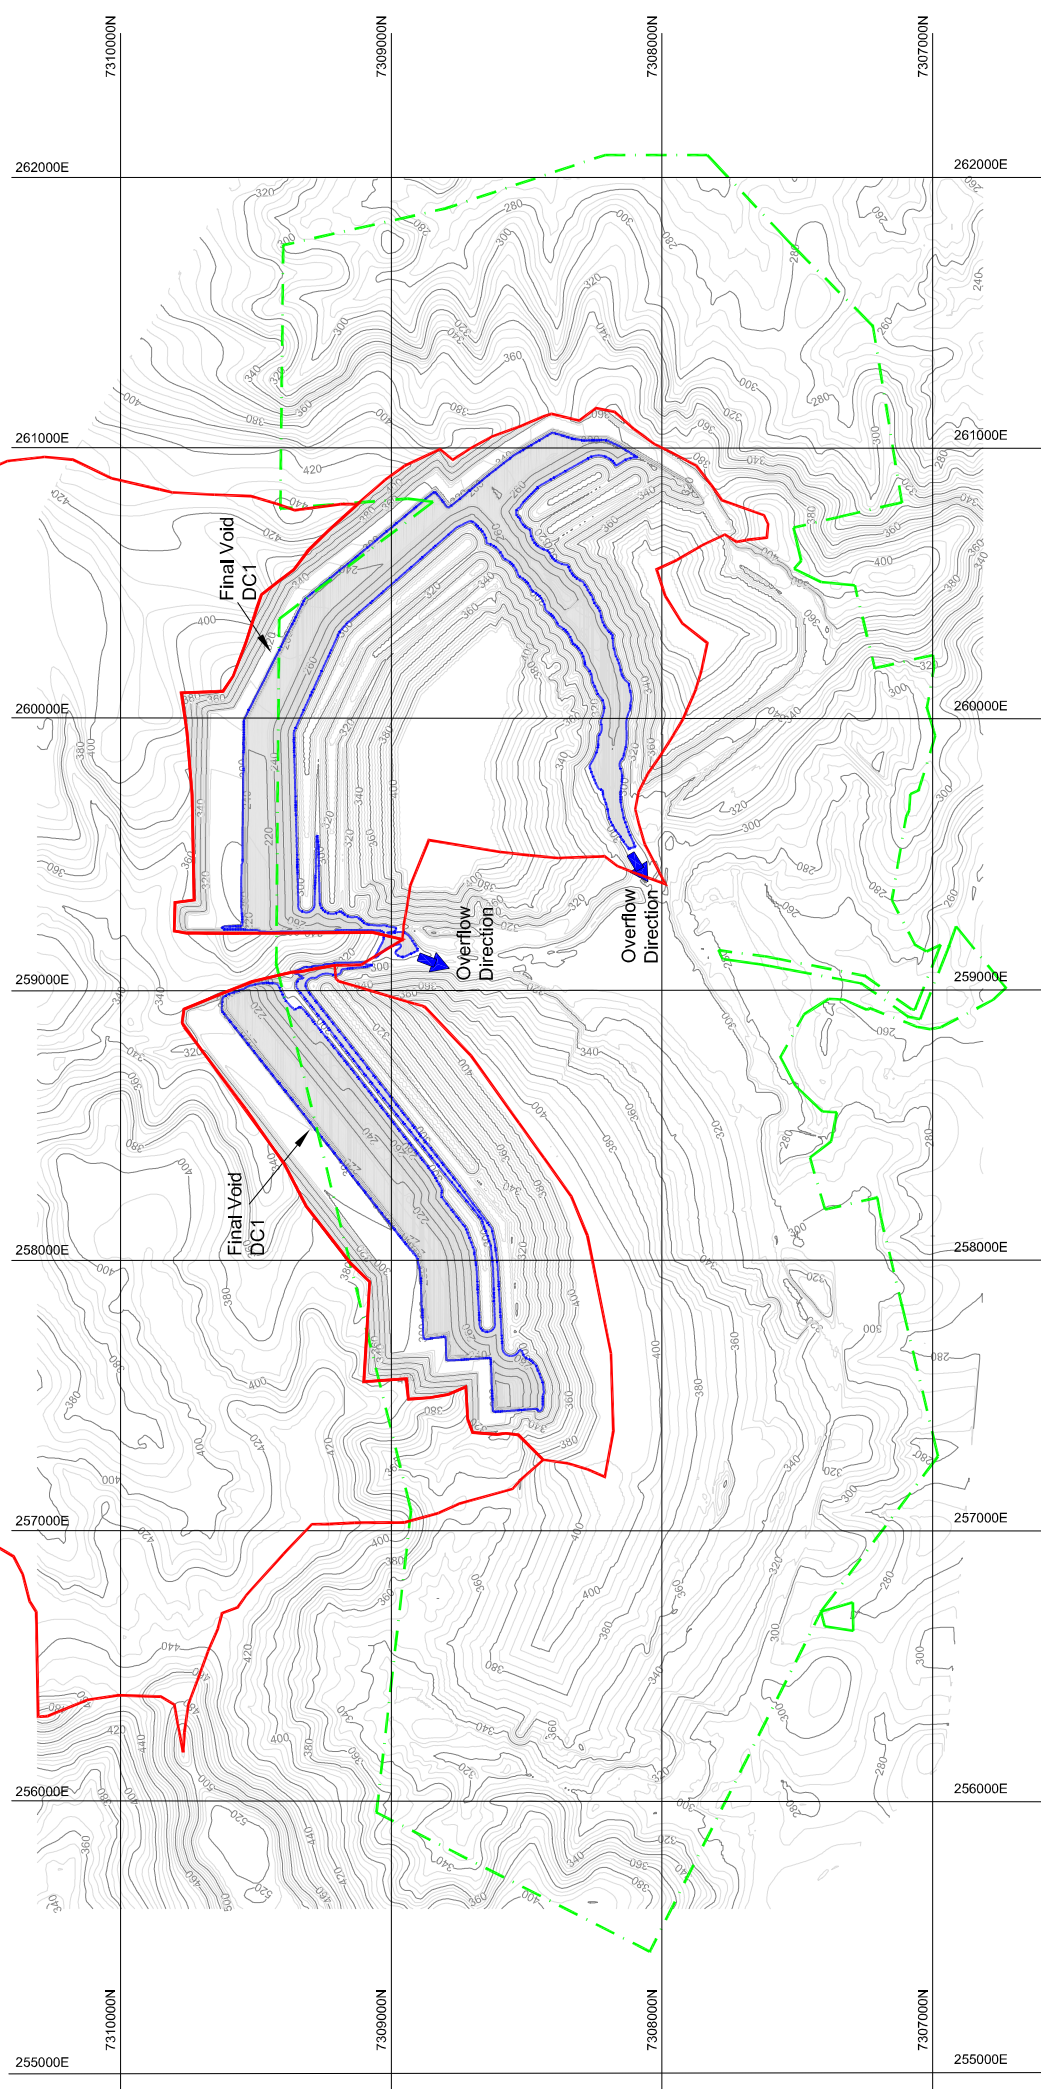
| Dunn Creek Mining Area - Proposed Final Landform | |

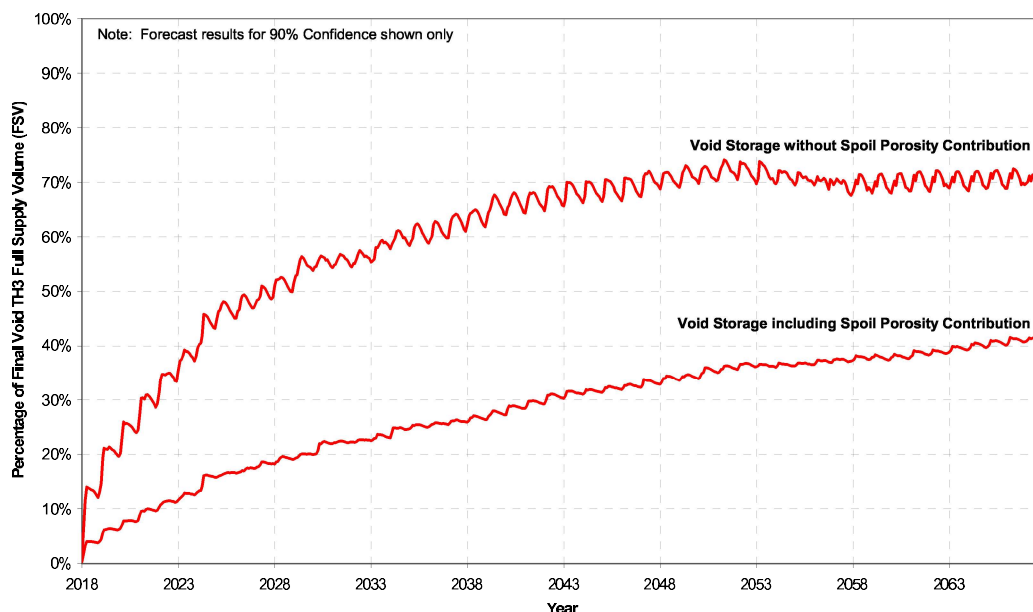
Figure 3.1 - Forecast Results for Final Void TH3

In order to assess the potential influence of spoil porosity on final void performance, a nominal spoil porosity of 35% was adopted and applied to The Hut Final Void TH3. Based on the final landform topography provided by Callide, it is estimated that an additional 1,800ML of void storage volume would be available within TH3 if spoil porosity was taken in account – that is, the assessed storage volume for TH3 would increase from around 700ML to around 2,500ML.

The influence of this increased final void storage volume on final void storage forecast is shown in Figure 3.1 below.

Review of Figure 3.1 shows an appreciable reduction in proposed final void storage volume over the 50 year forecast period reducing from 70% of the available void storage volume to around 40% of the available void storage volume when spoil porosity is considered for the 90% confidence level.

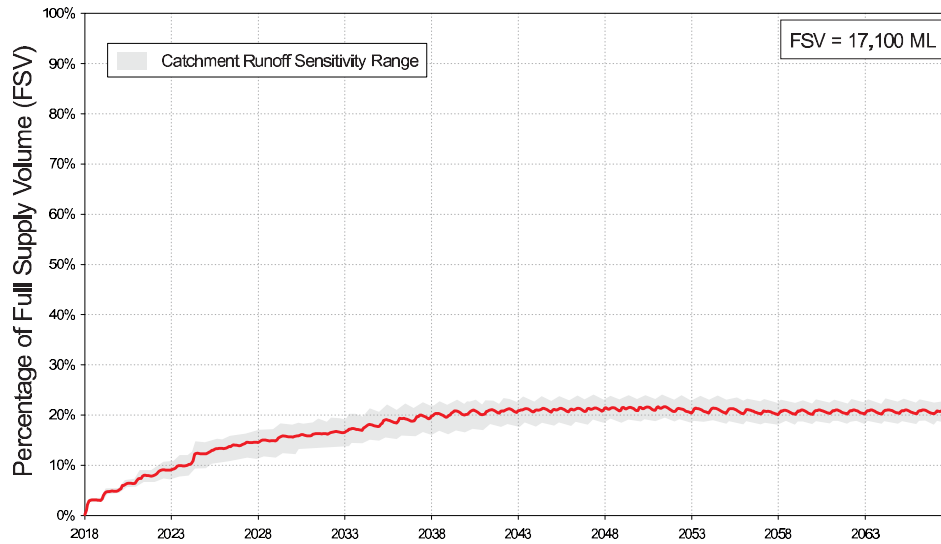
Forecast Results for 90% Confidence

Note: Sensitivity adopted a  $C_{av}$  range of 60mm - 100mm  
for Rehab Spoil Land Use Classification

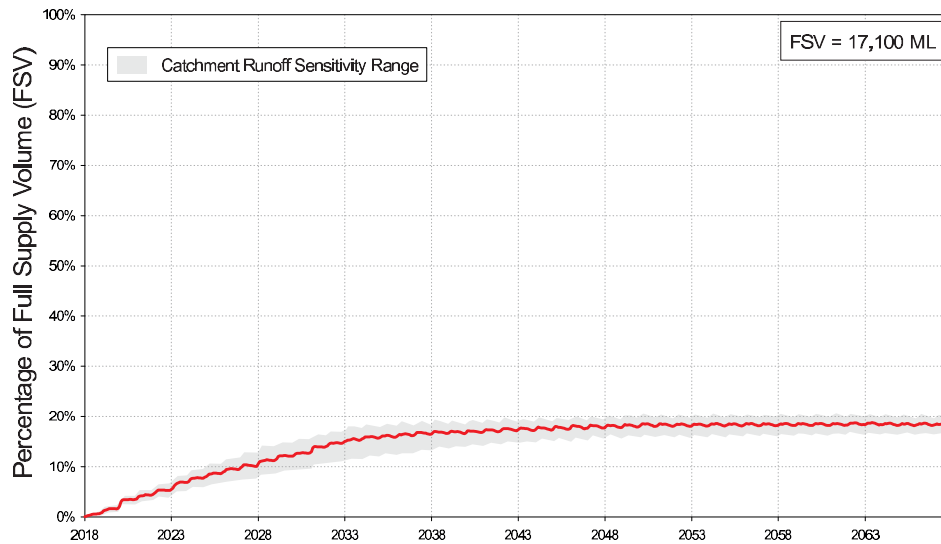
Forecast Results for 50% Confidence

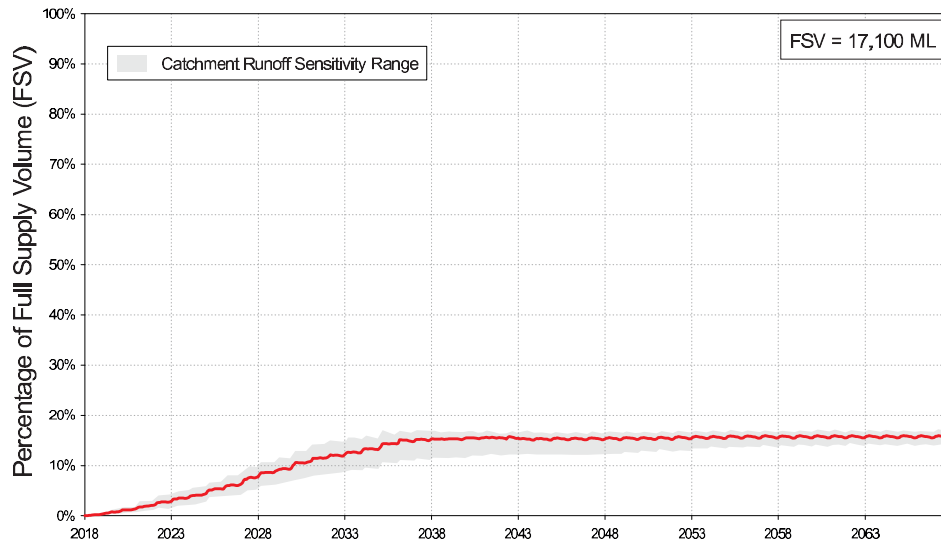
Forecast Results for 10% Confidence

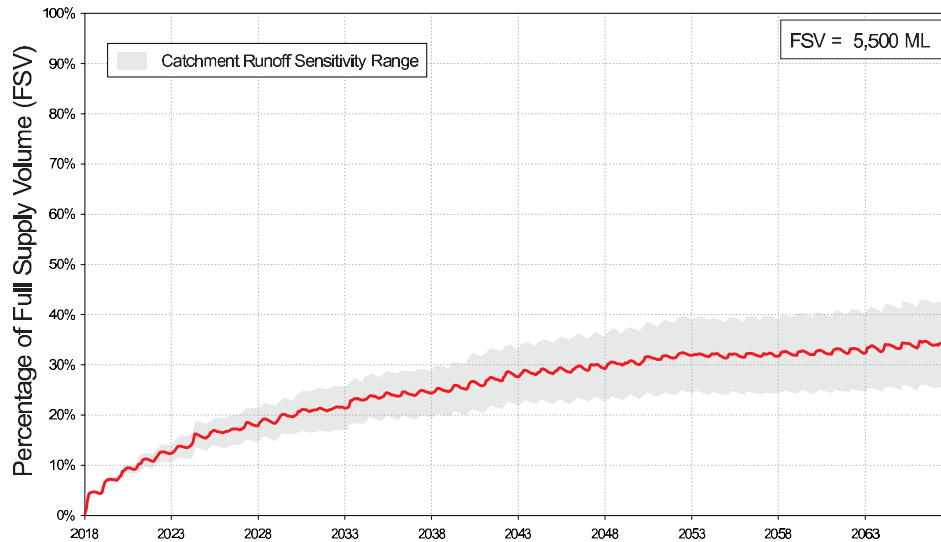
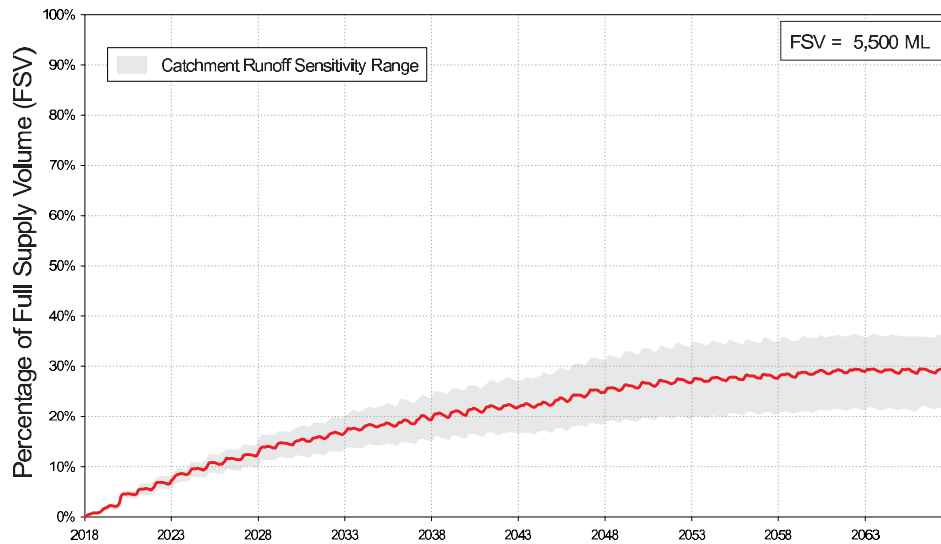
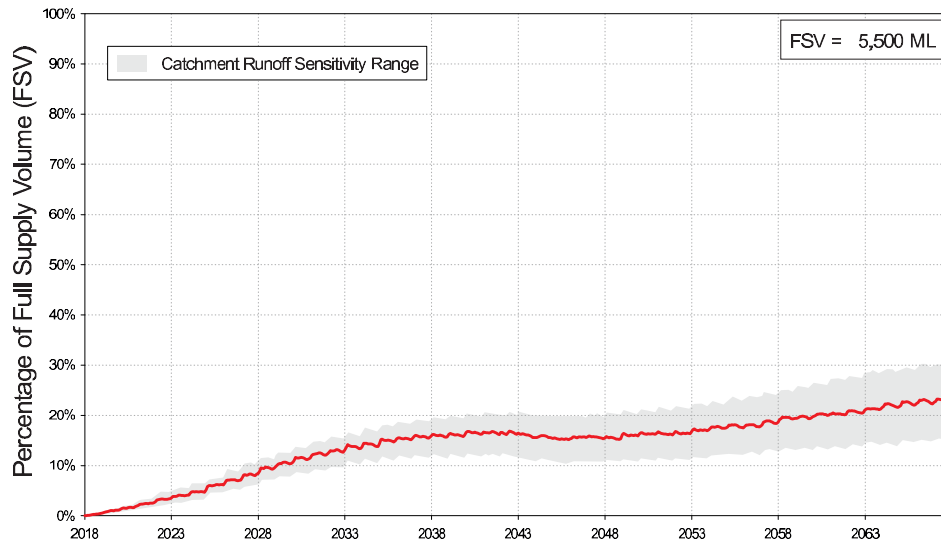
| | | Figure B5 |

Forecast Results for 90% Confidence

Forecast Results for 50% Confidence

Forecast Results for 10% Confidence

Note: Sensitivity adopted a  $C_{av}$  range of 60mm - 100mm for Rehab Spoil Land Use Classification

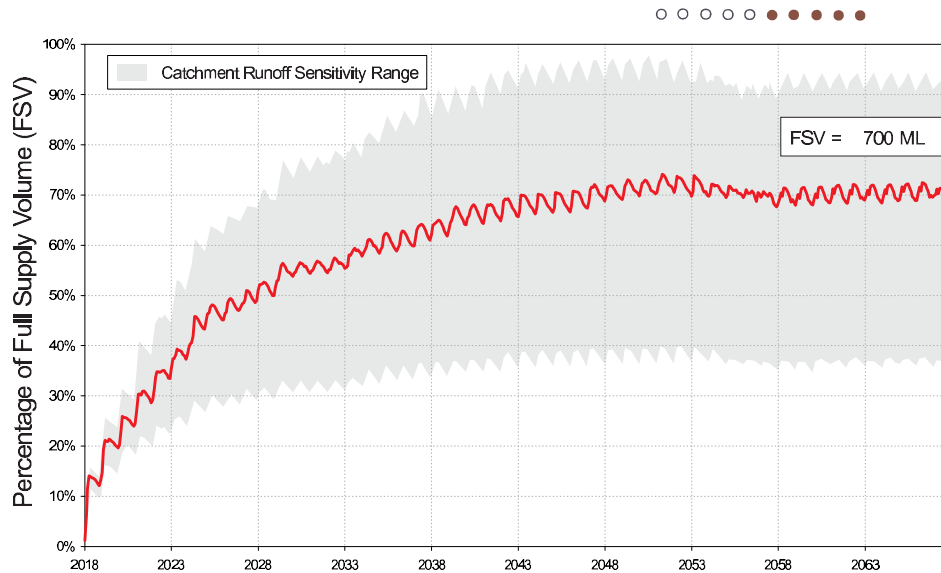
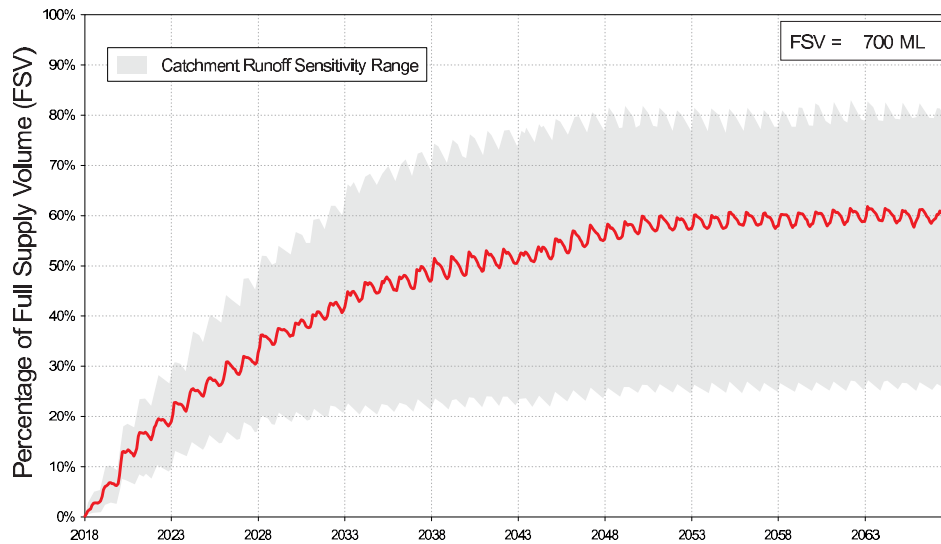
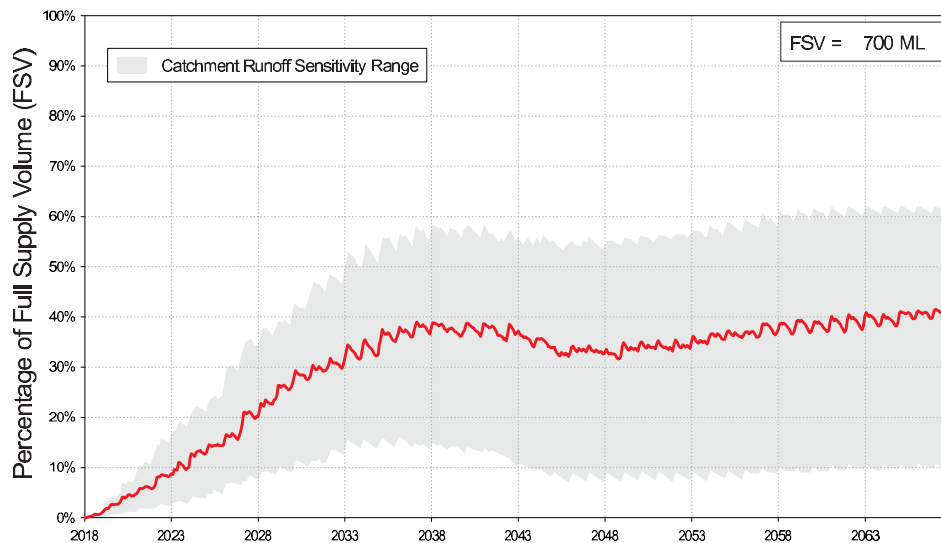
| | | Figure B6 |

Forecast Results for 90% Confidence

Forecast Results for 50% Confidence

Forecast Results for 10% Confidence

Note: Sensitivity adopted a  $C_{av}$  range of 60mm - 100mm  
for Rehab Spoil Land Use Classification

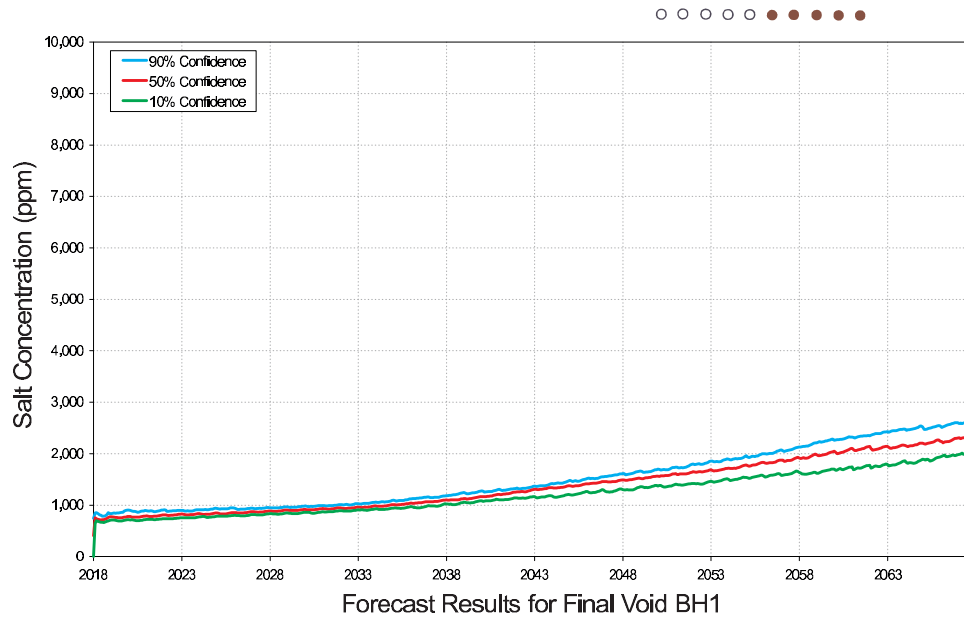
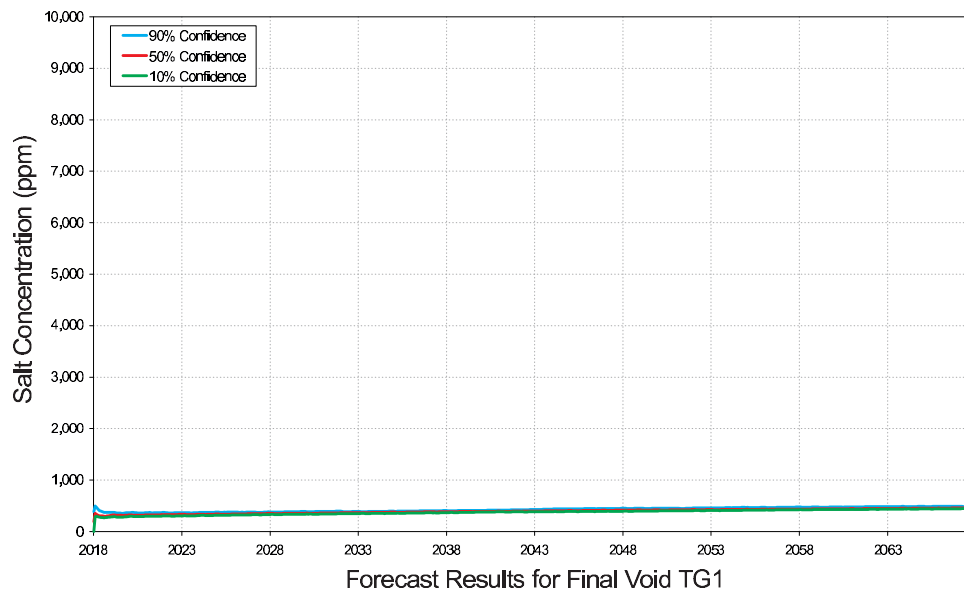
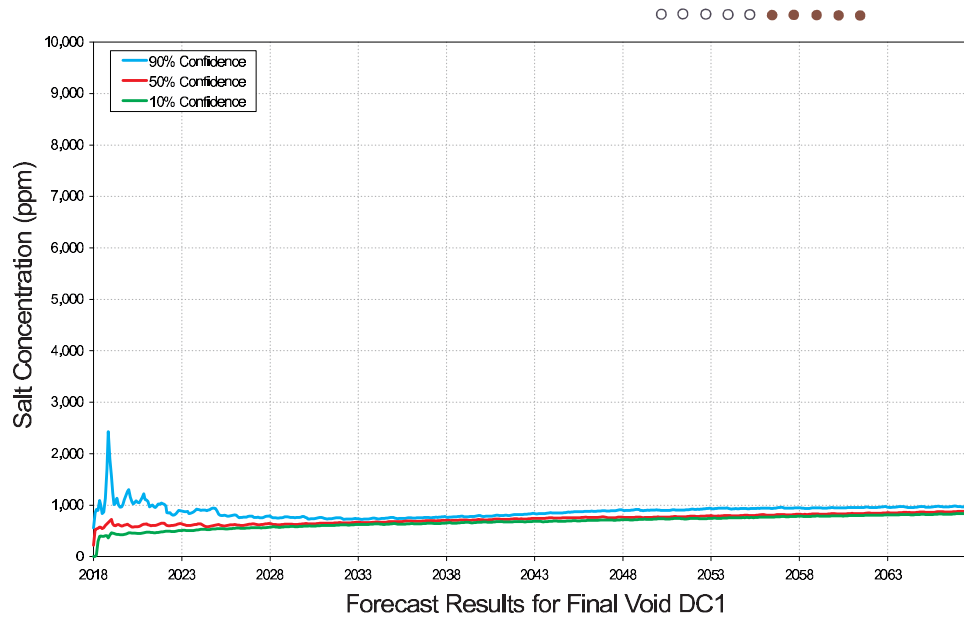
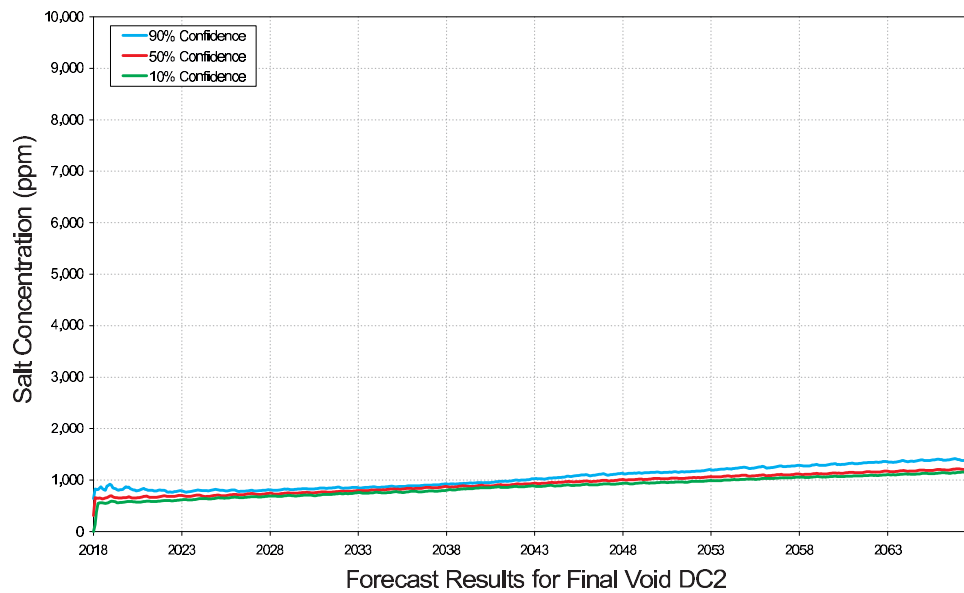
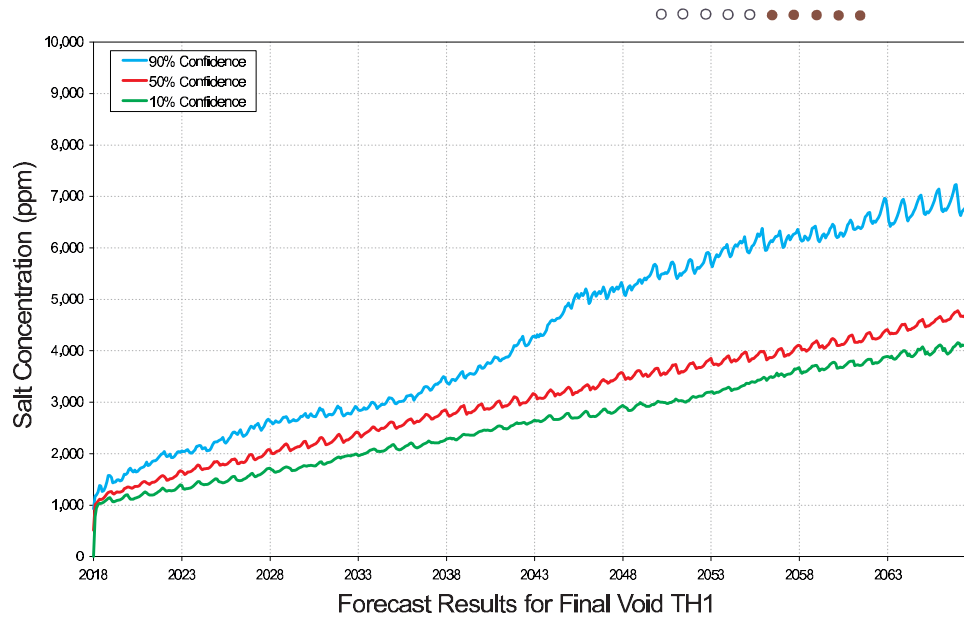
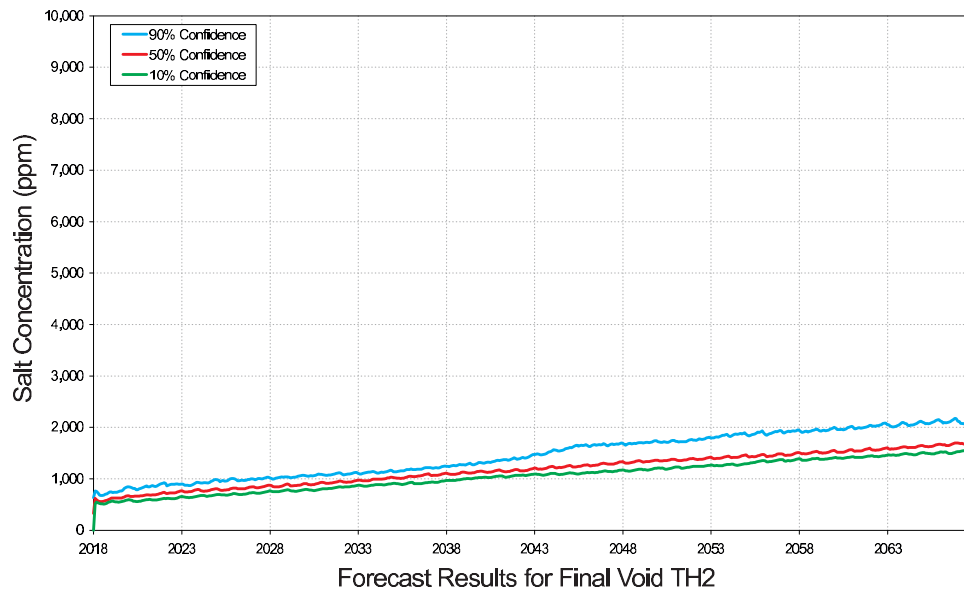
### Forecasted Void Salt Concentration Fluctuations

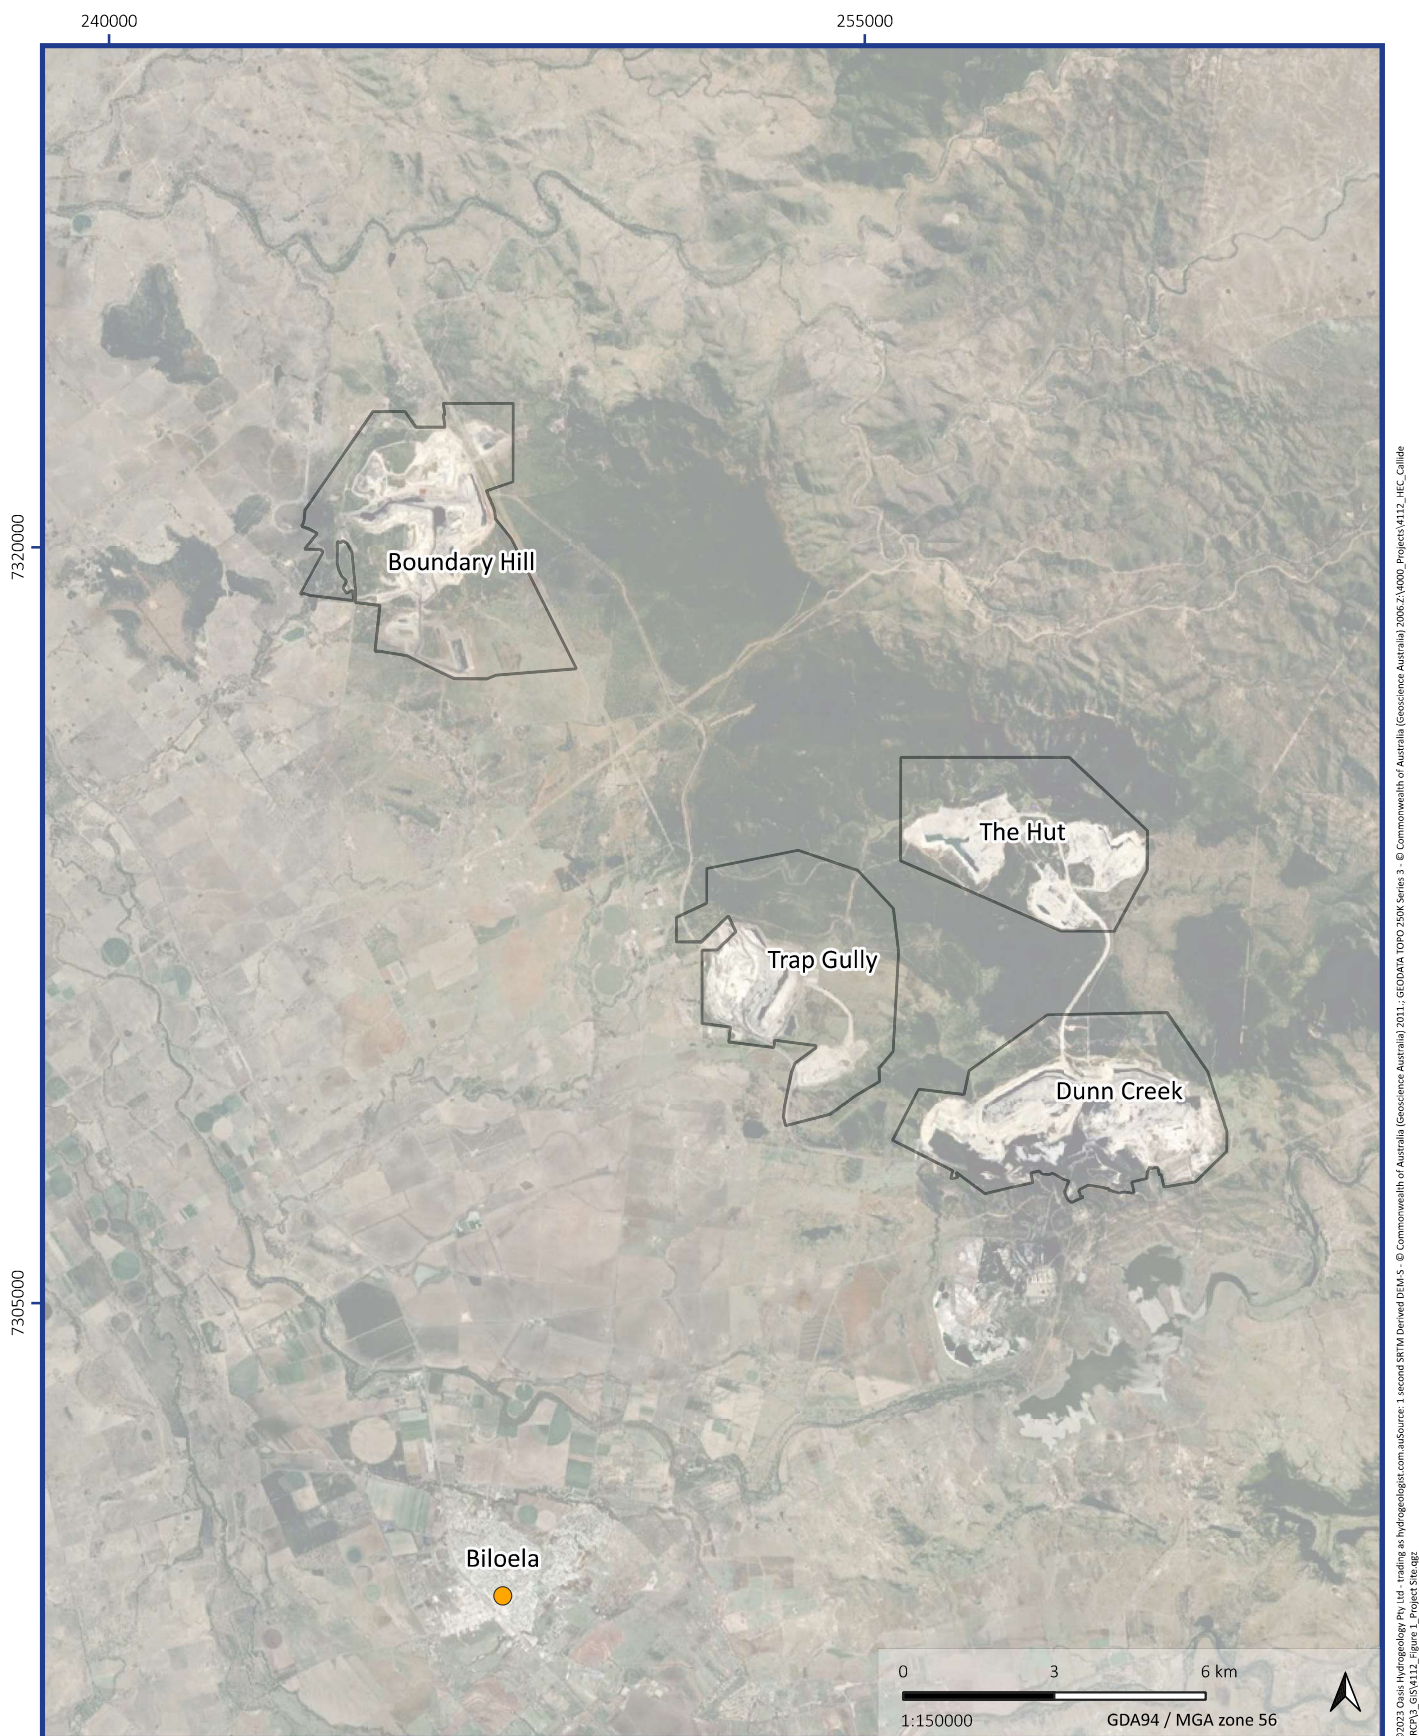
**Callide Mine layout**

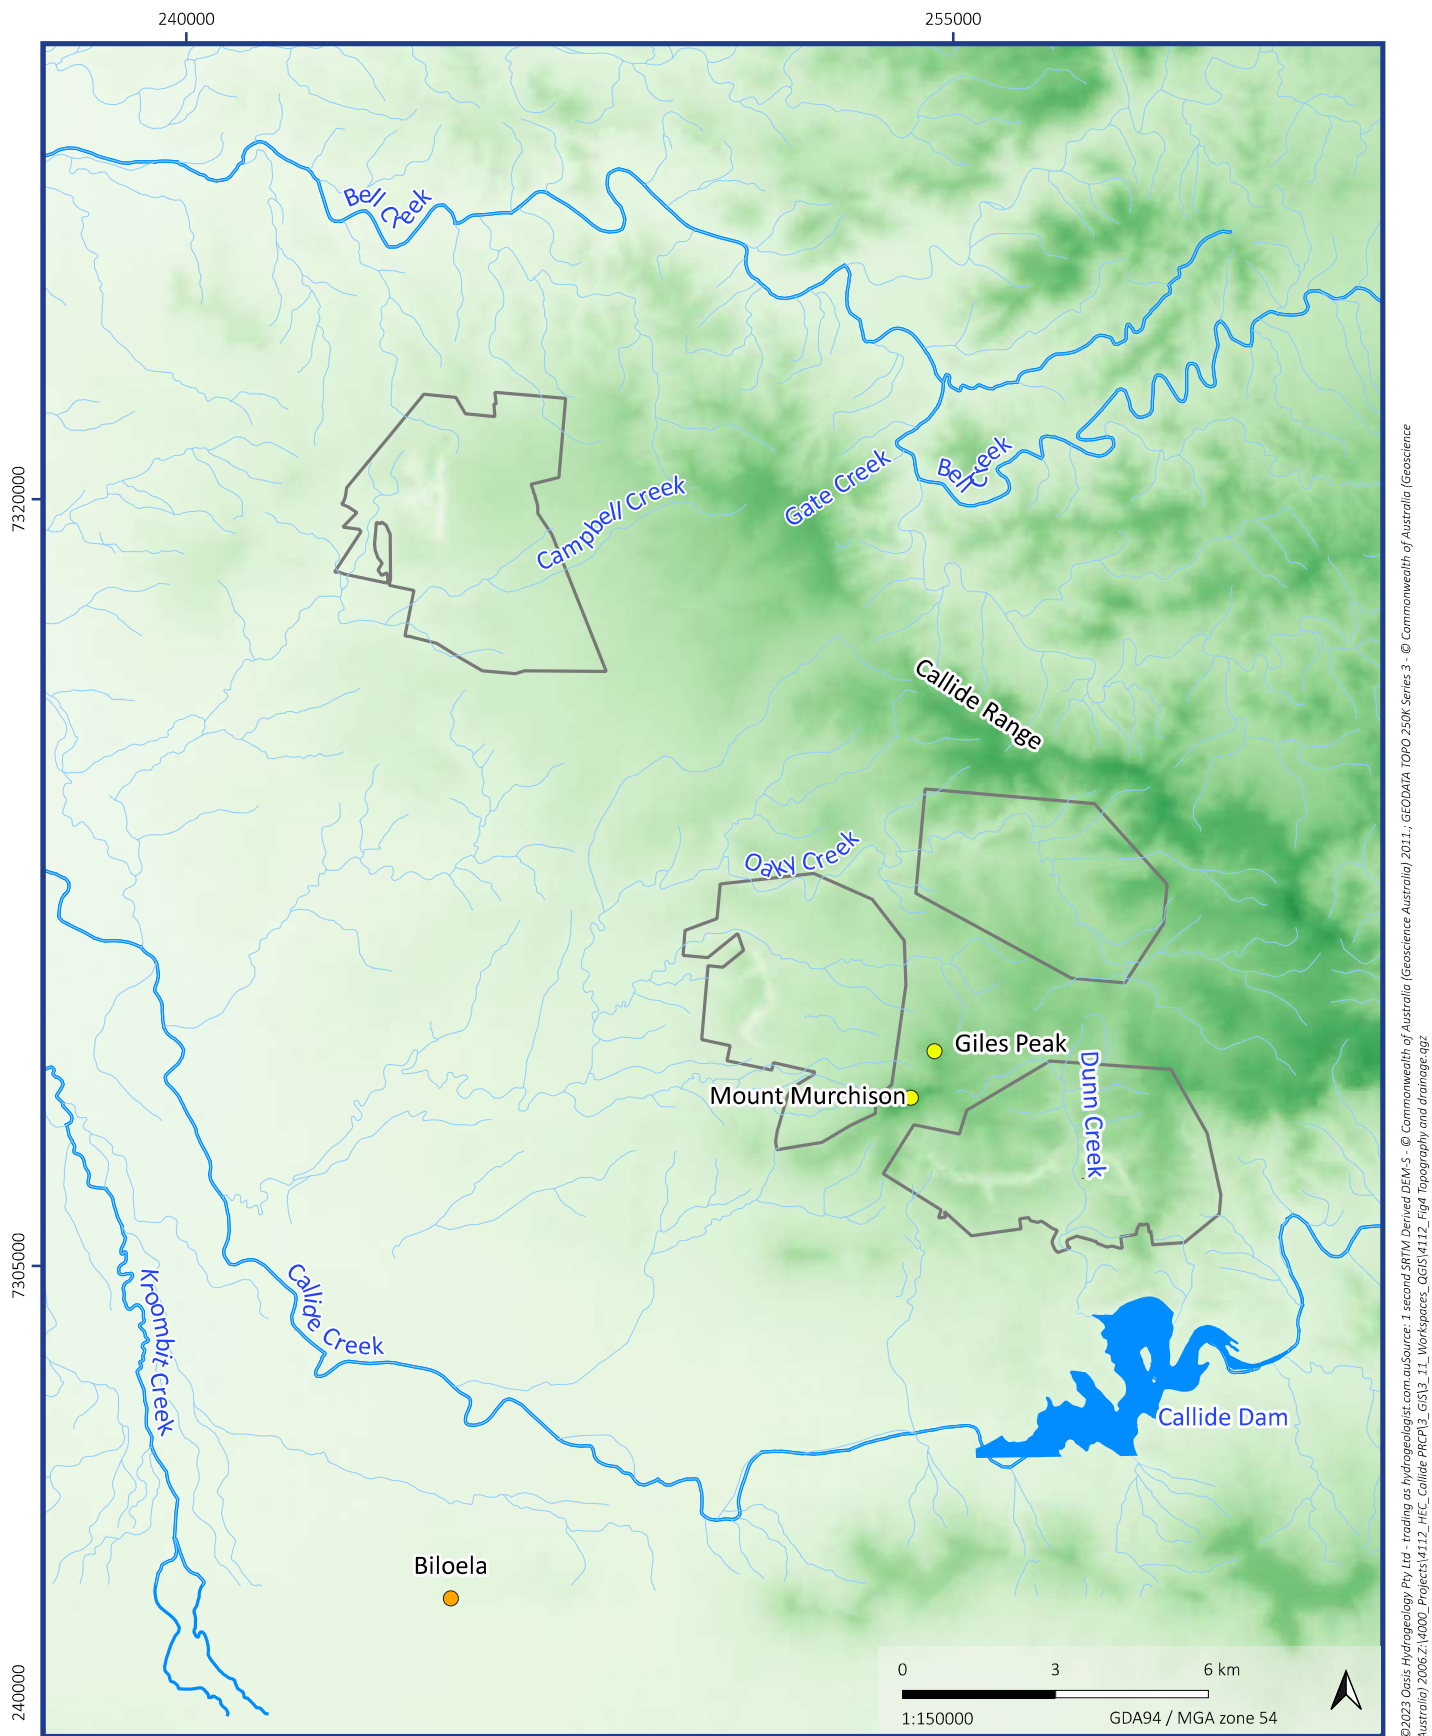
## Topography and drainage
