Hansen Bailey was commissioned by Batchfire Resources Pty Ltd (Batchfire) to prepare a Rehabilitation Management Plan (RMP) for the Callide Mine. This RMP has been prepared in accordance with the Callide Mine Environmental Authority (EA) conditions H2 and H3.

| Final Void Water Modelling | |

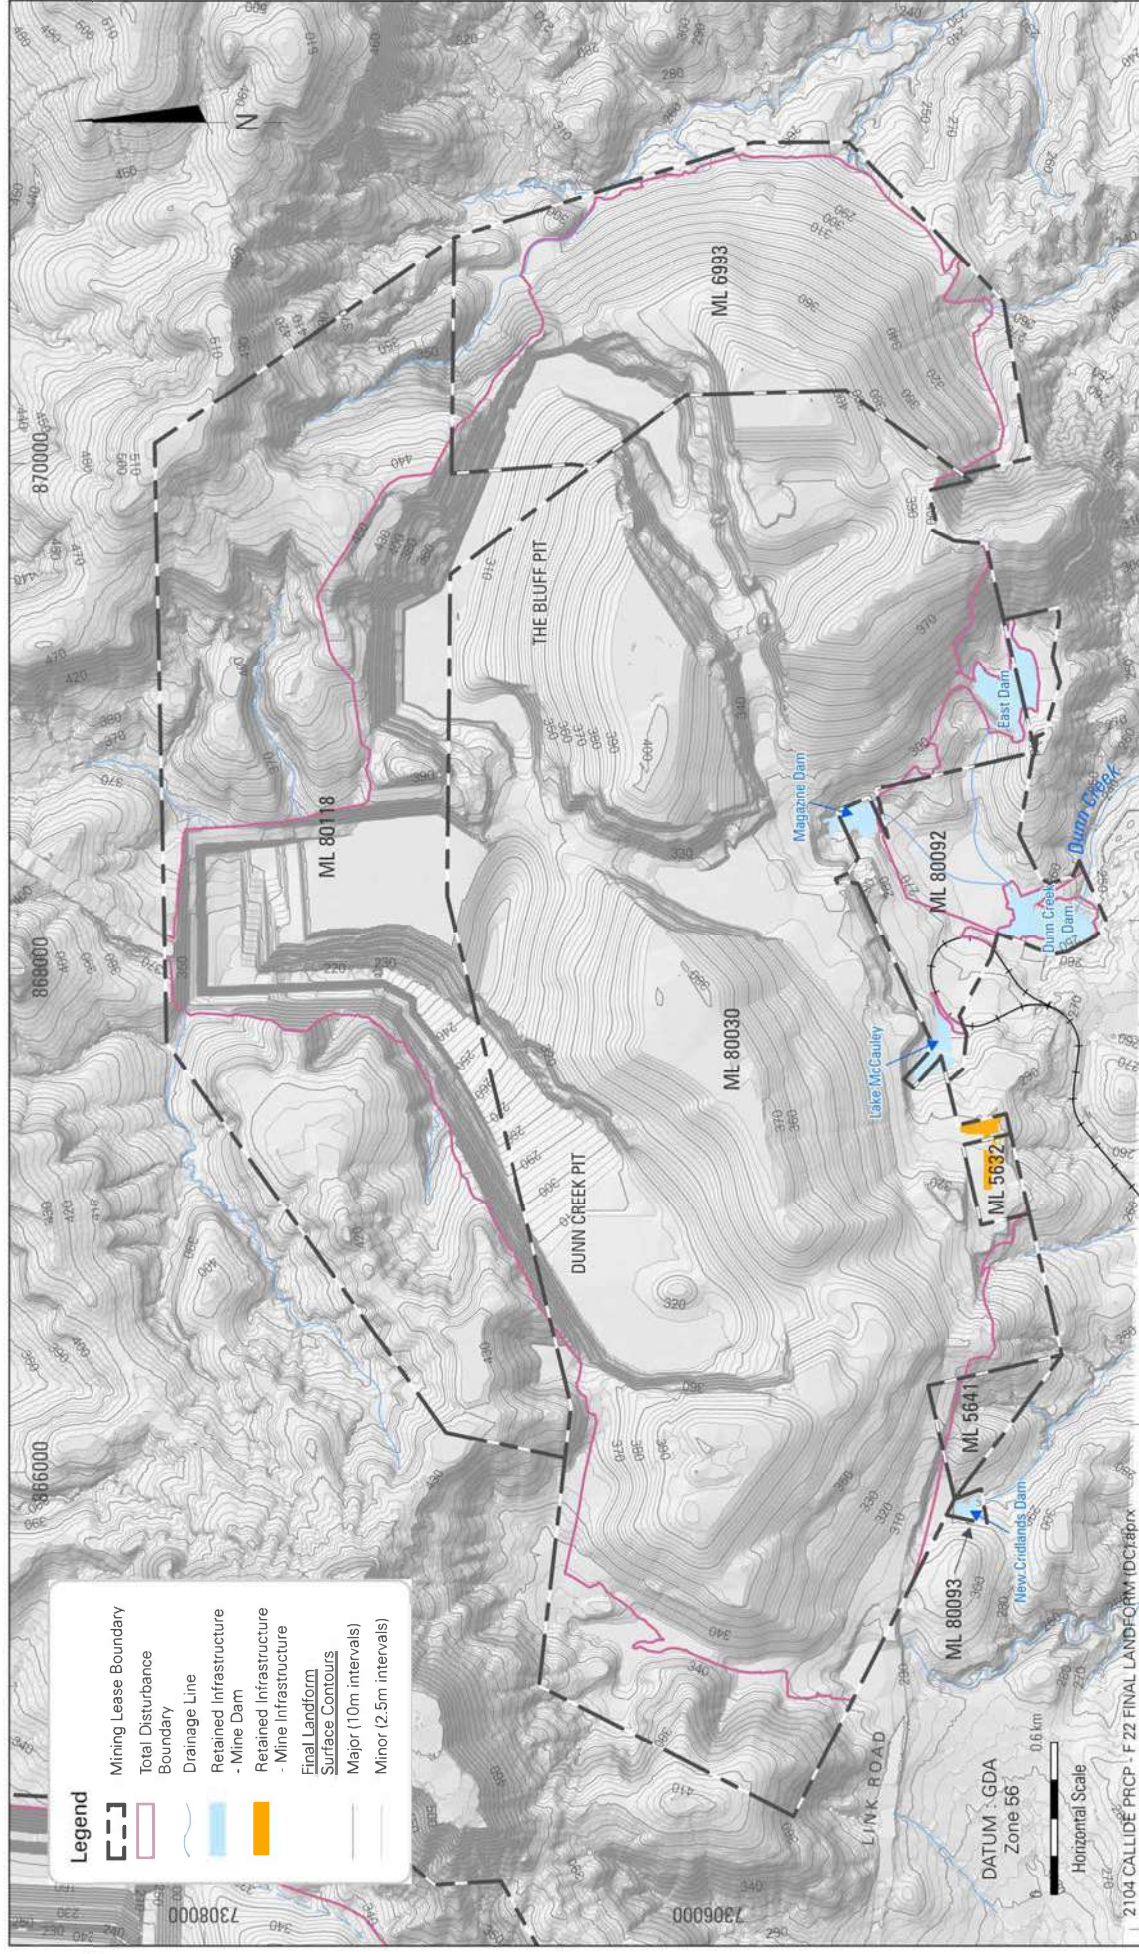
**Figure 6**

**CALLIDE MINE PRCP**  
**Dunn Creek Mining Area**  
**- Final Landform**

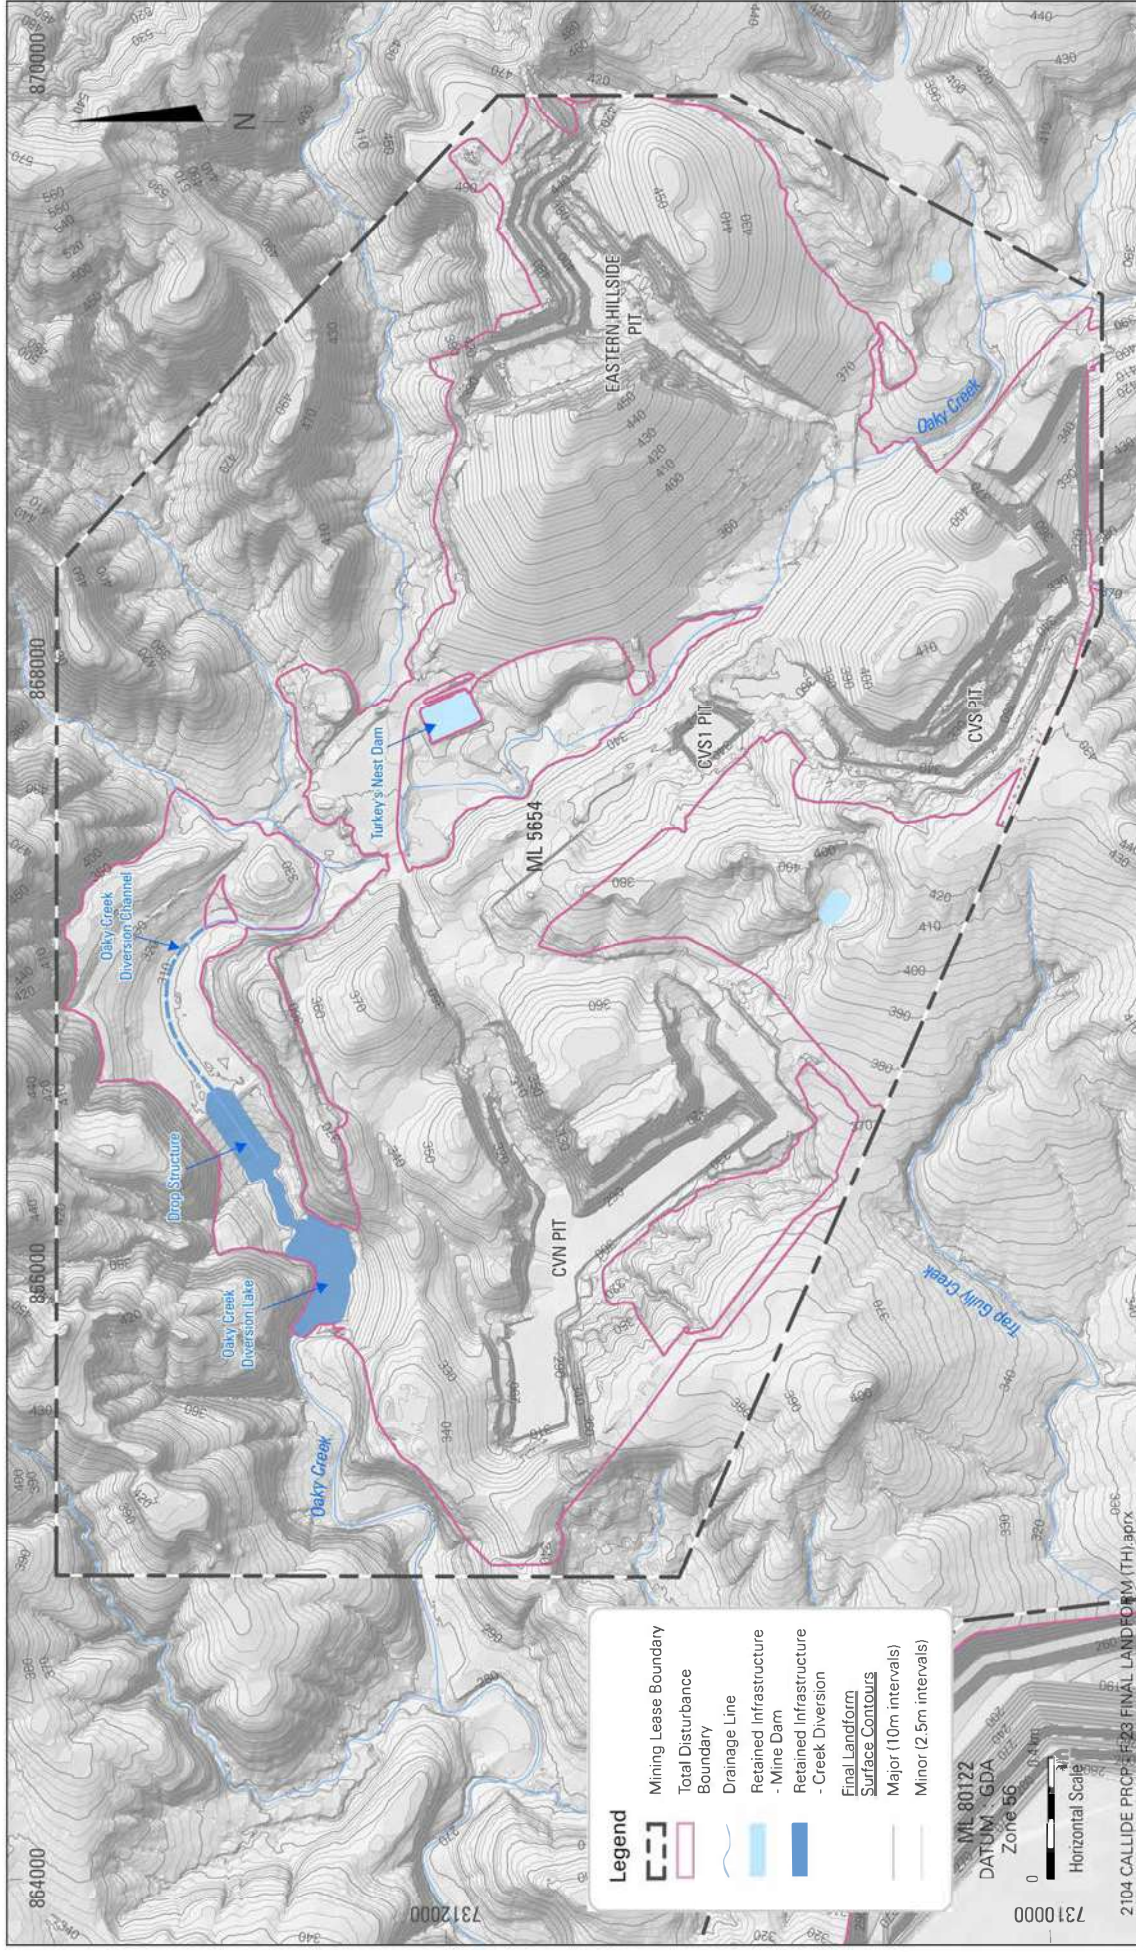
Figure 7

The Hut Mining Area  
- Final Landform

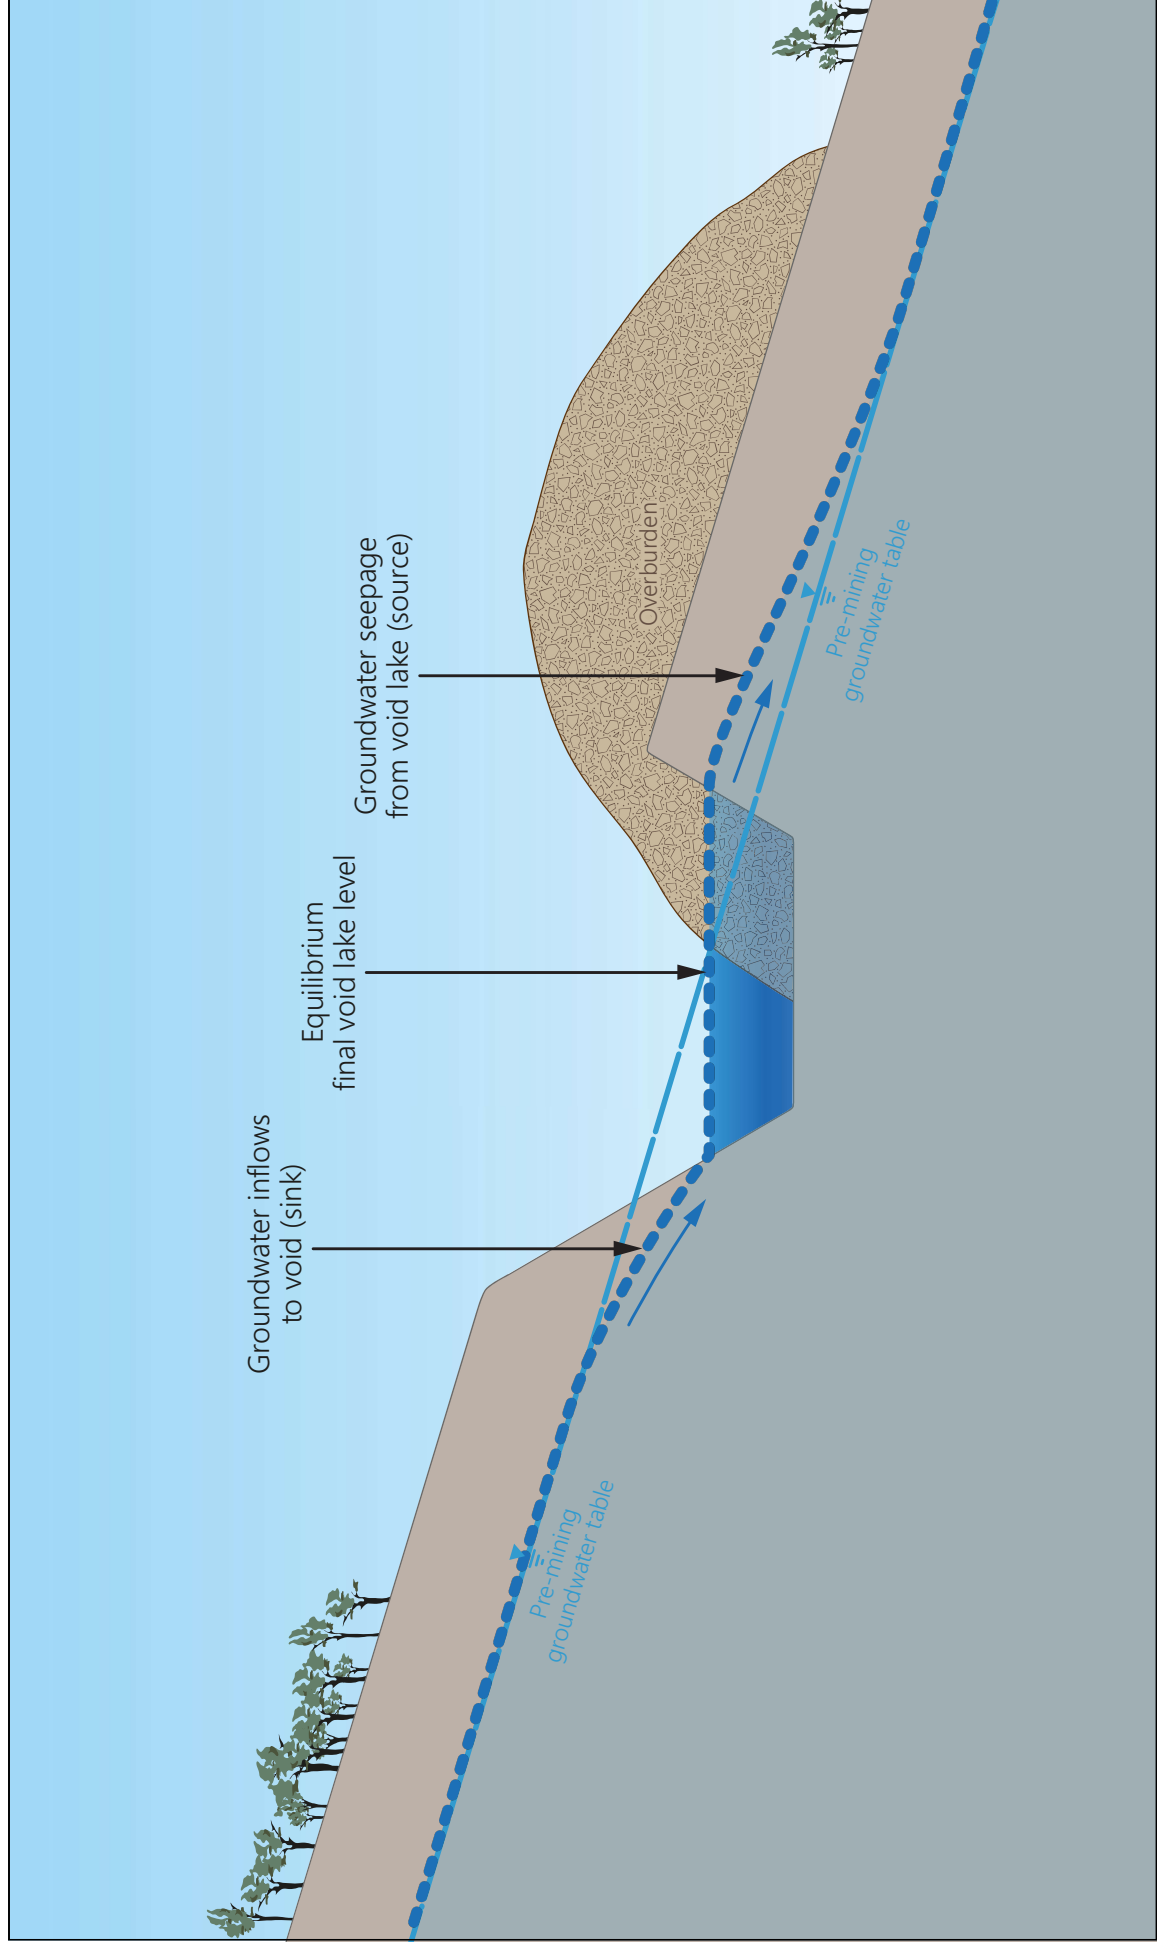
FIGURE 9

Conceptual Final Void Groundwater Source and Sink Schematic

- A combination of groundwater source and sink. This can occur under conditions when final voids may be located in an area with a steeply-sloping groundwater table. Under these conditions, the upgradient end of the void lake may be below the groundwater table (i.e., forming a groundwater sink) while the downgradient end of the void lake may be above the groundwater table (i.e., forming a groundwater source). Conceptually, groundwater would seep into the upgradient end of the final void lake and void lake water will seep out of the downgradient end of the final void to the surrounding groundwater regime. This scenario is illustrated in Figure 9.

- Trap Gully Pit and Boundary Hill South Pit voids will function as groundwater sinks.
- There are no uniformly elevated voids that could function as pure groundwater sources.
- The Boundary Hill East Pit, Eastern Hillside Pit, CVN Pit, CVS Pit, Dunn Creek Pit and Boundary Hill North Pit voids may function as a combination of groundwater source and sink (per the scenario described in Section 4 and shown in Figure 9).

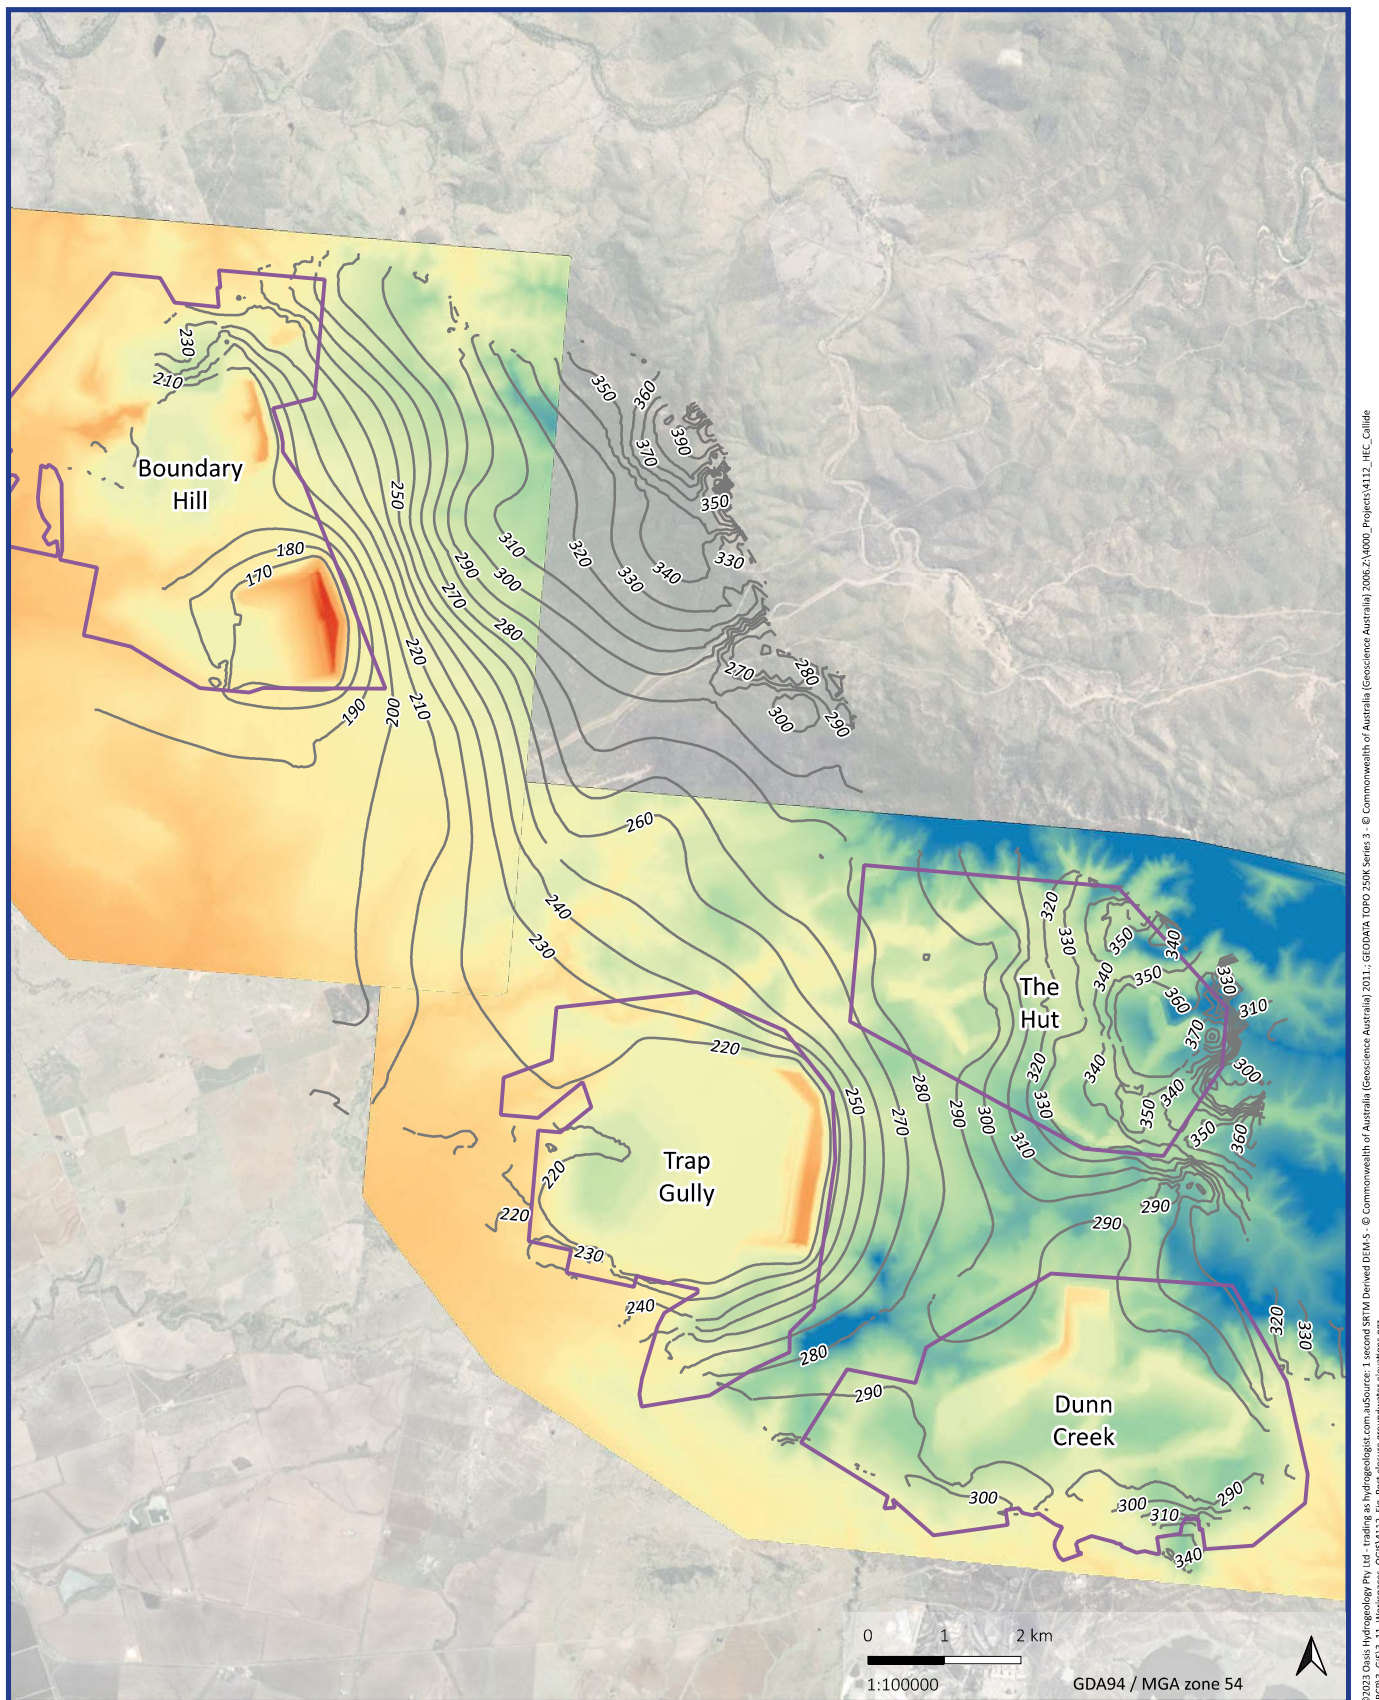
Post-closure groundwater elevation and flow - Callide Mine

Figure 10 shows the predicted post closure groundwater elevations across Callide Mine and its surrounds. Figure 11 to Figure 19 show cross sections of the predicted post closure voids and their interaction with the groundwater regime.

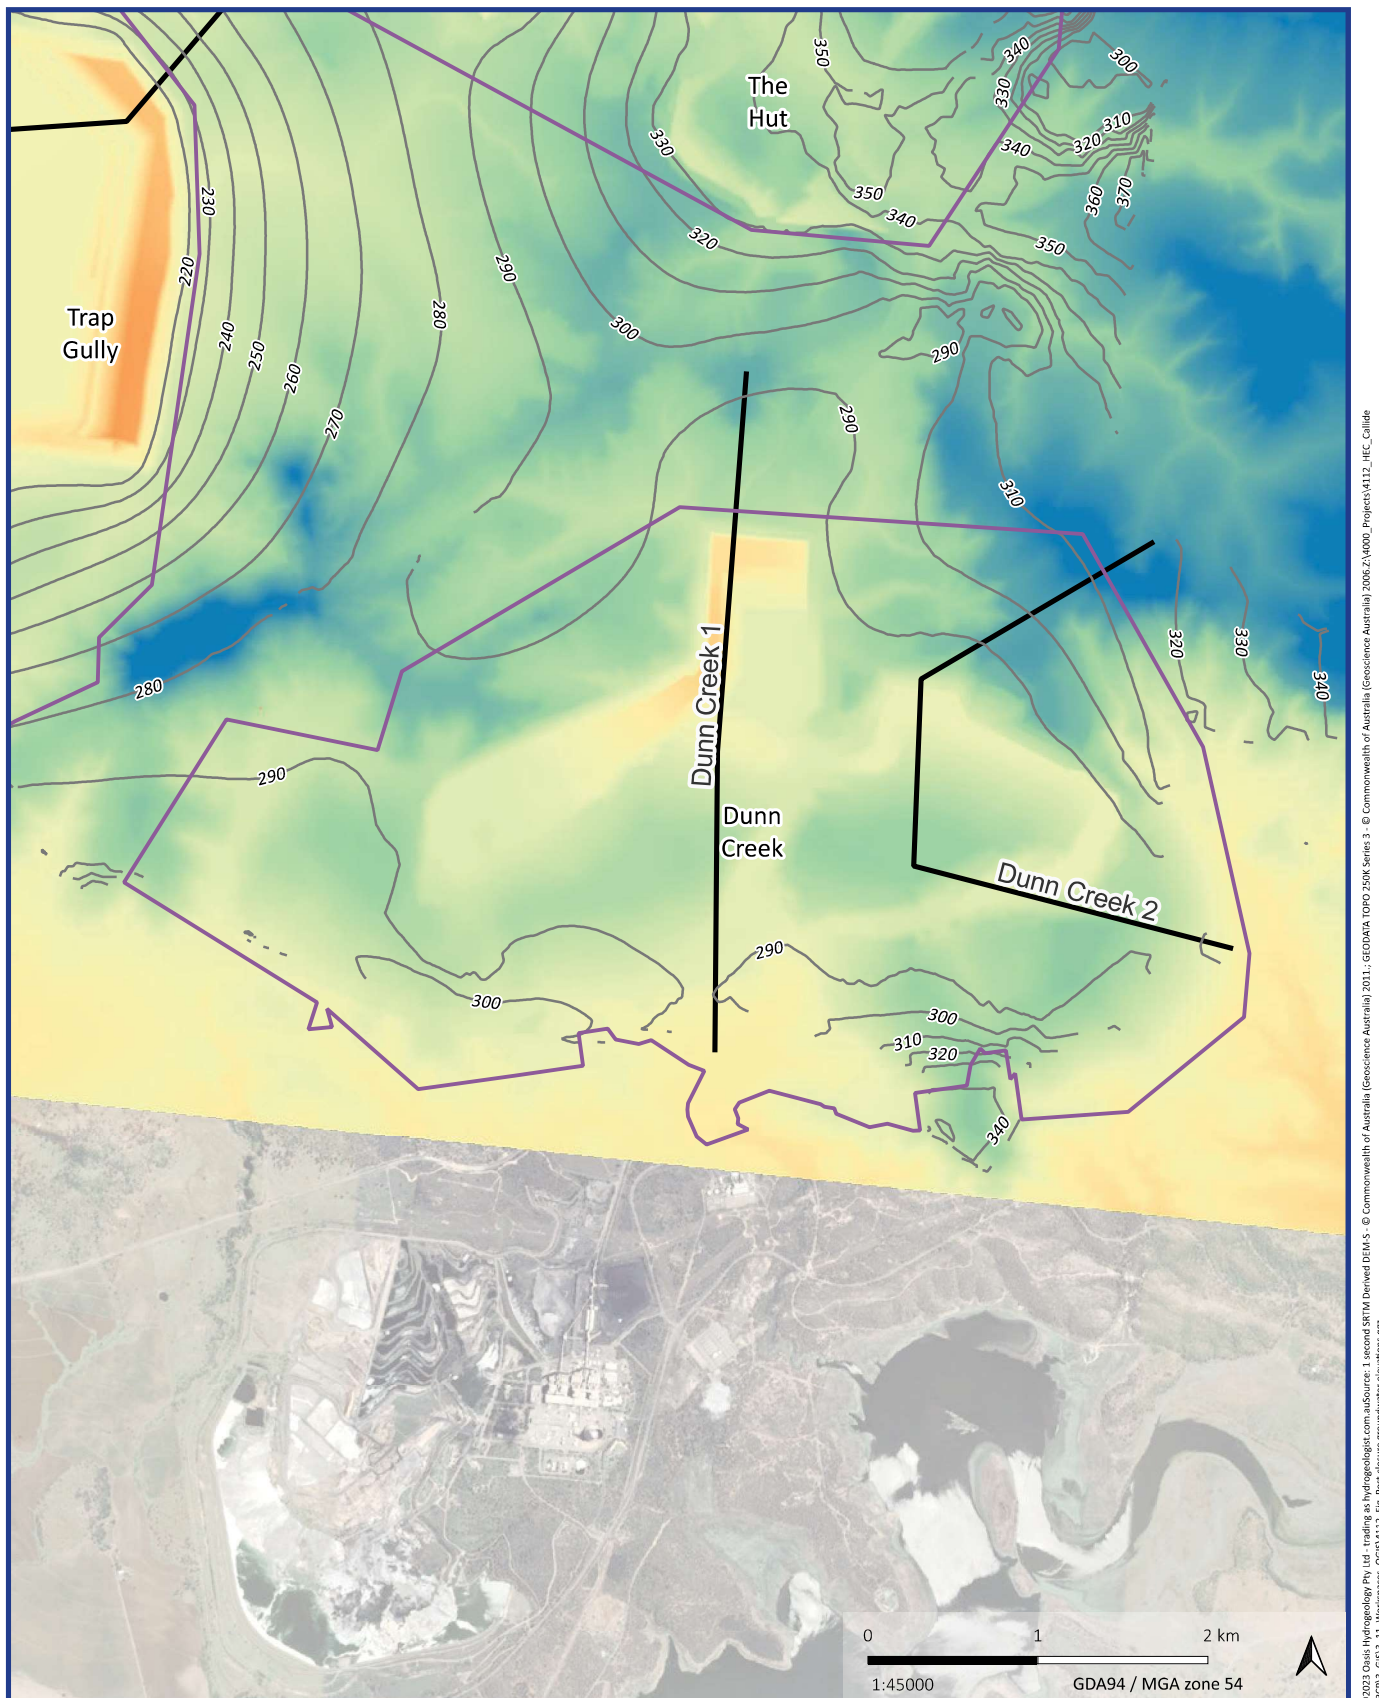
Post-closure groundwater elevation and flow - Dunn Creek mining area

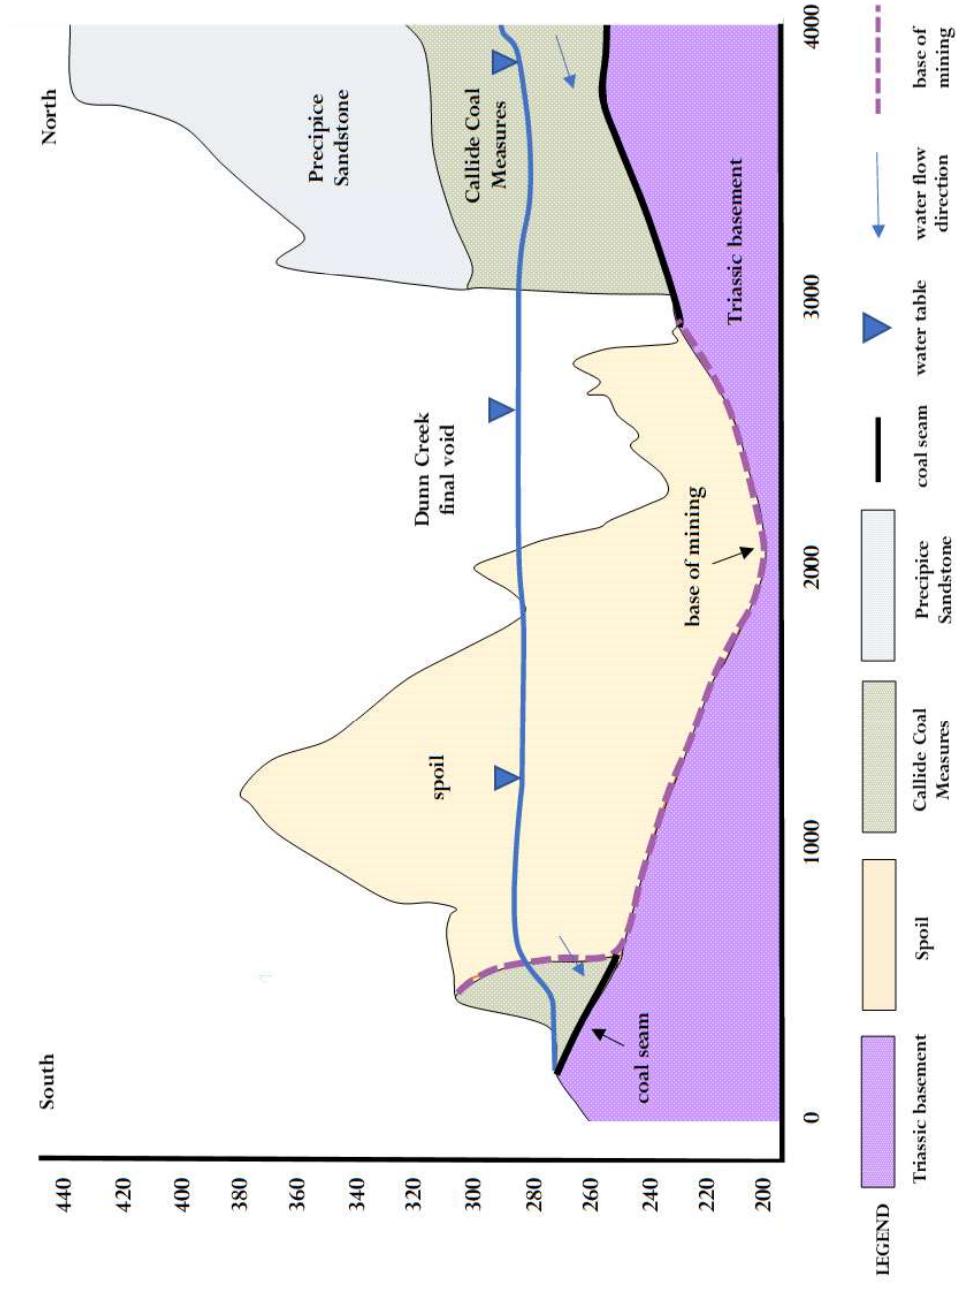
Figure 12 Dunn Creek mining area – post-closure groundwater regime cross-section 1

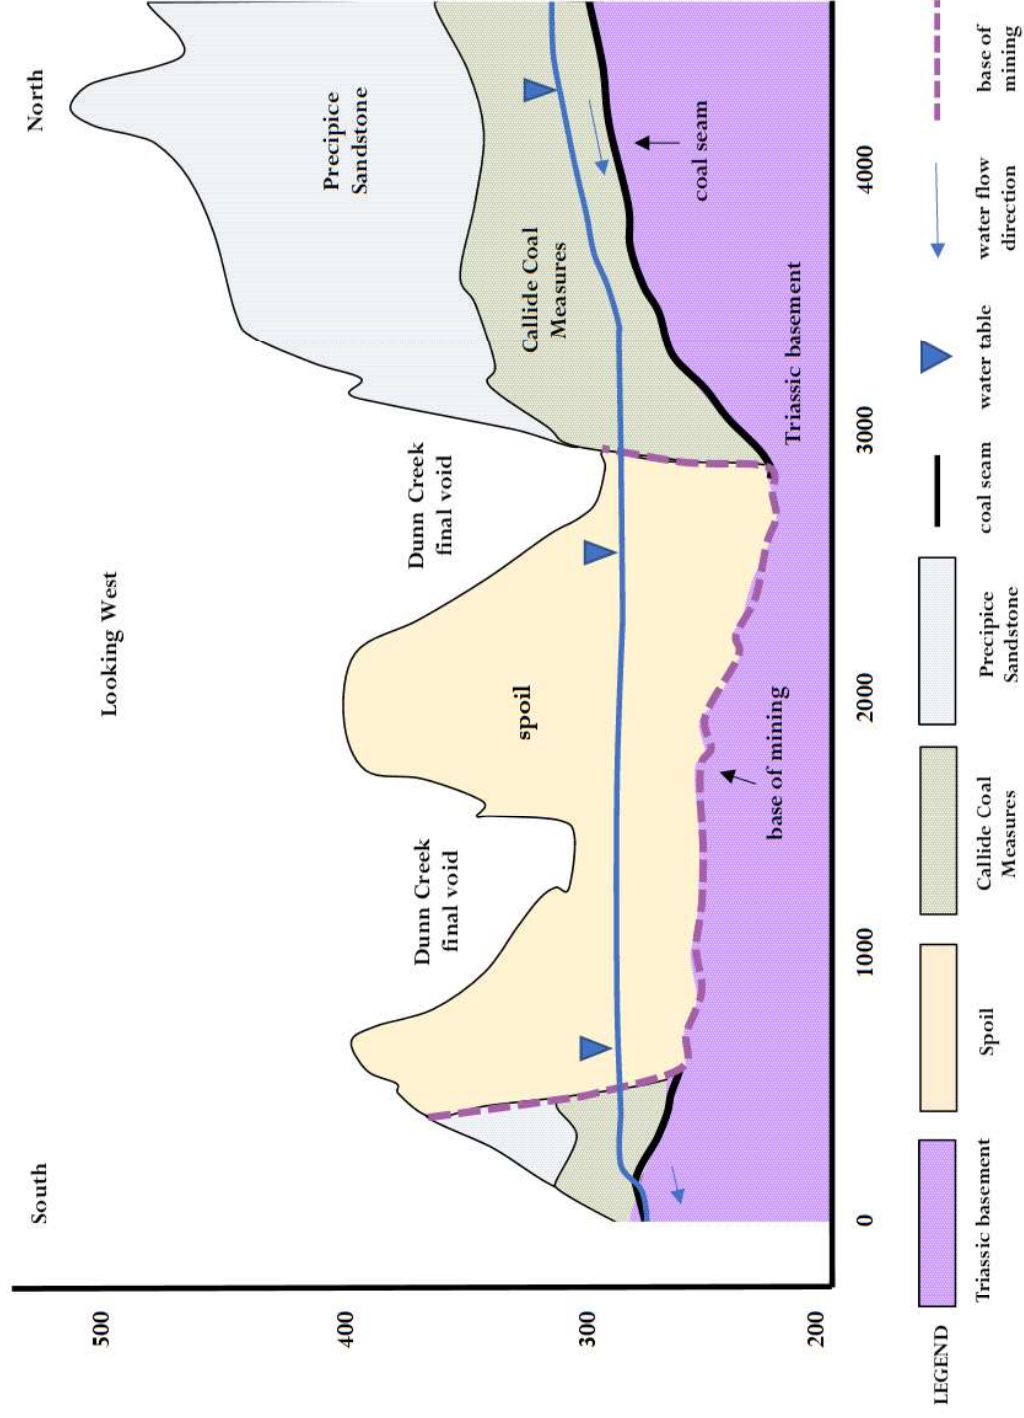
Figure 13 Dunn Creek mining area – post-closure groundwater regime cross-section 2

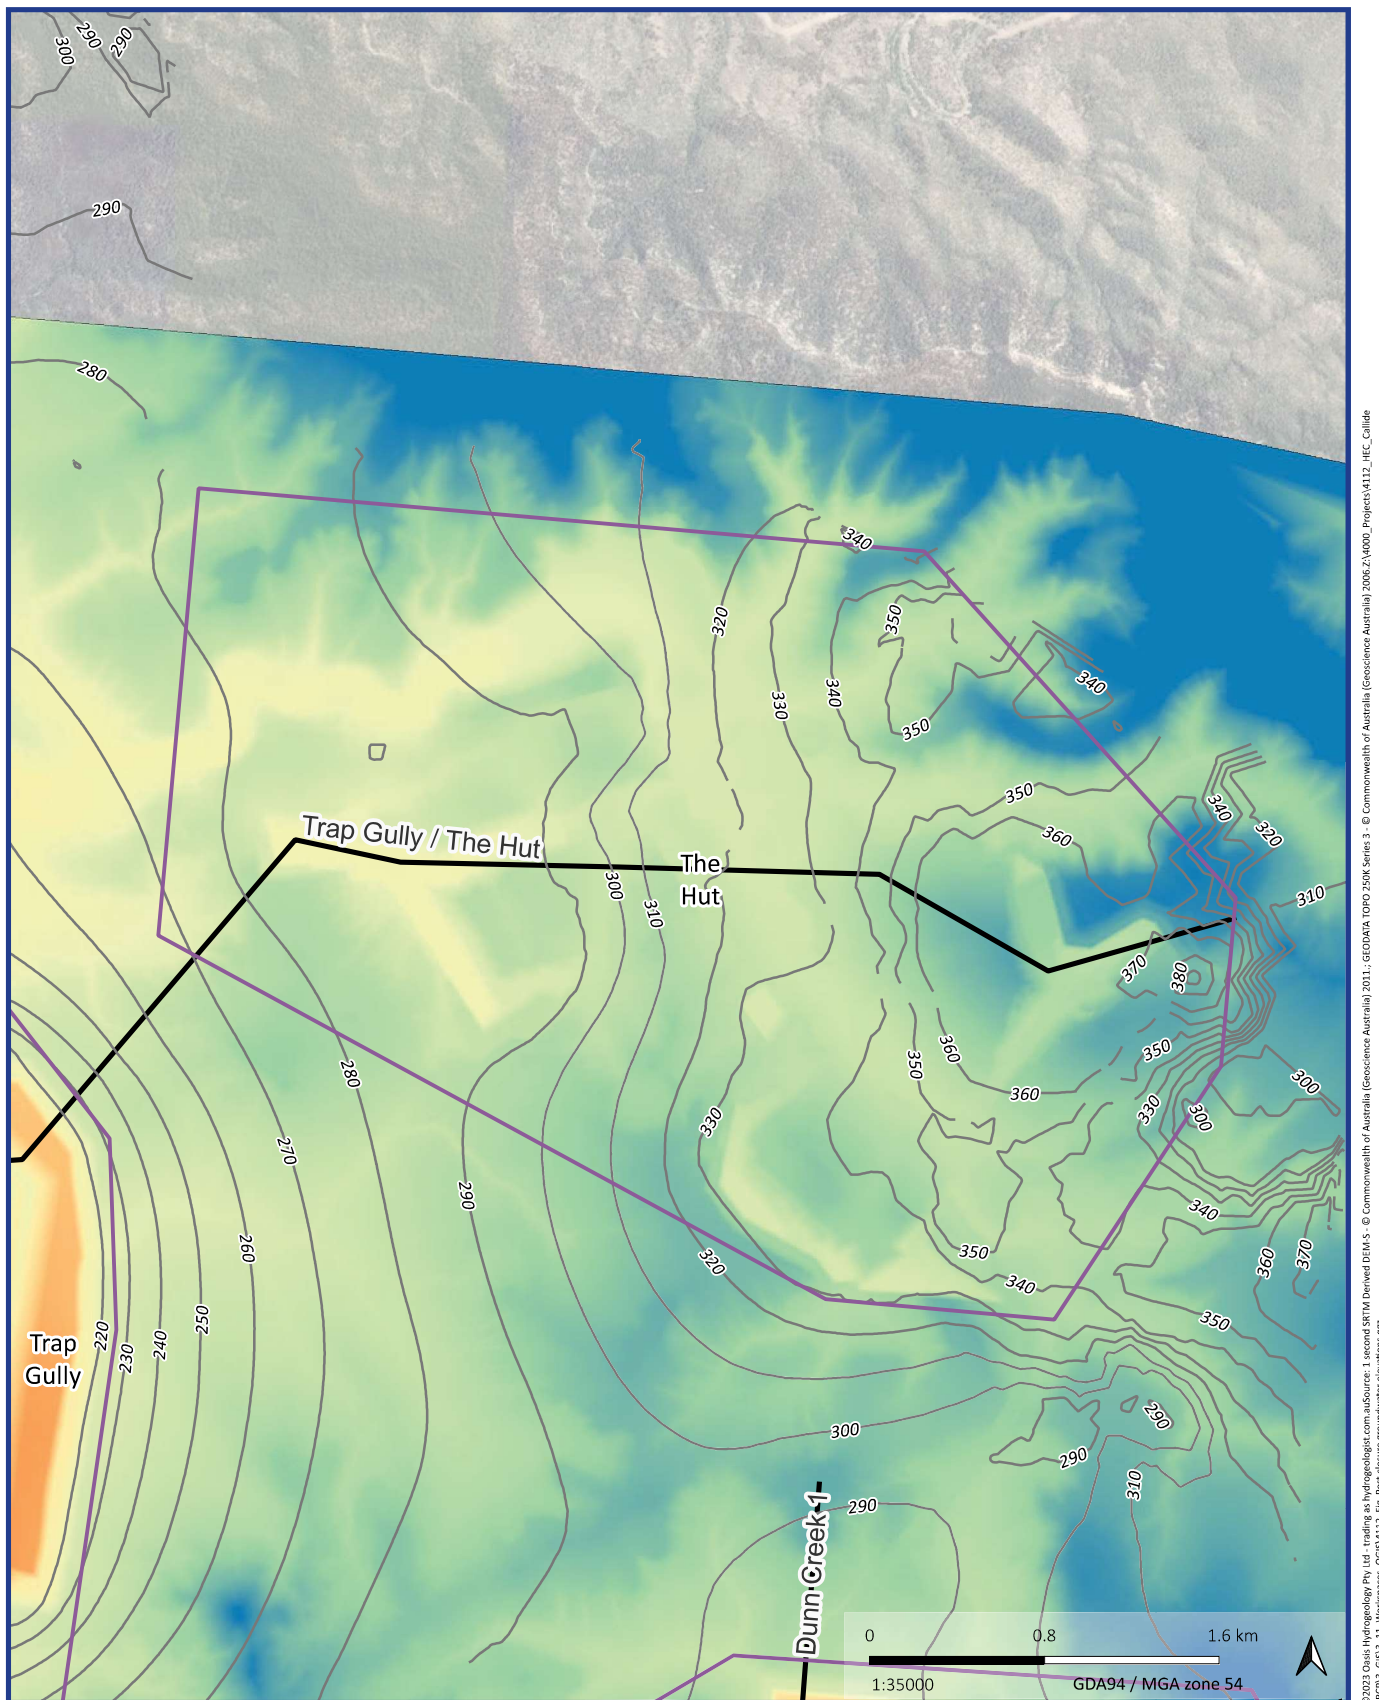
Figure 14

Post-closure groundwater elevation and flow - The Hut mining area

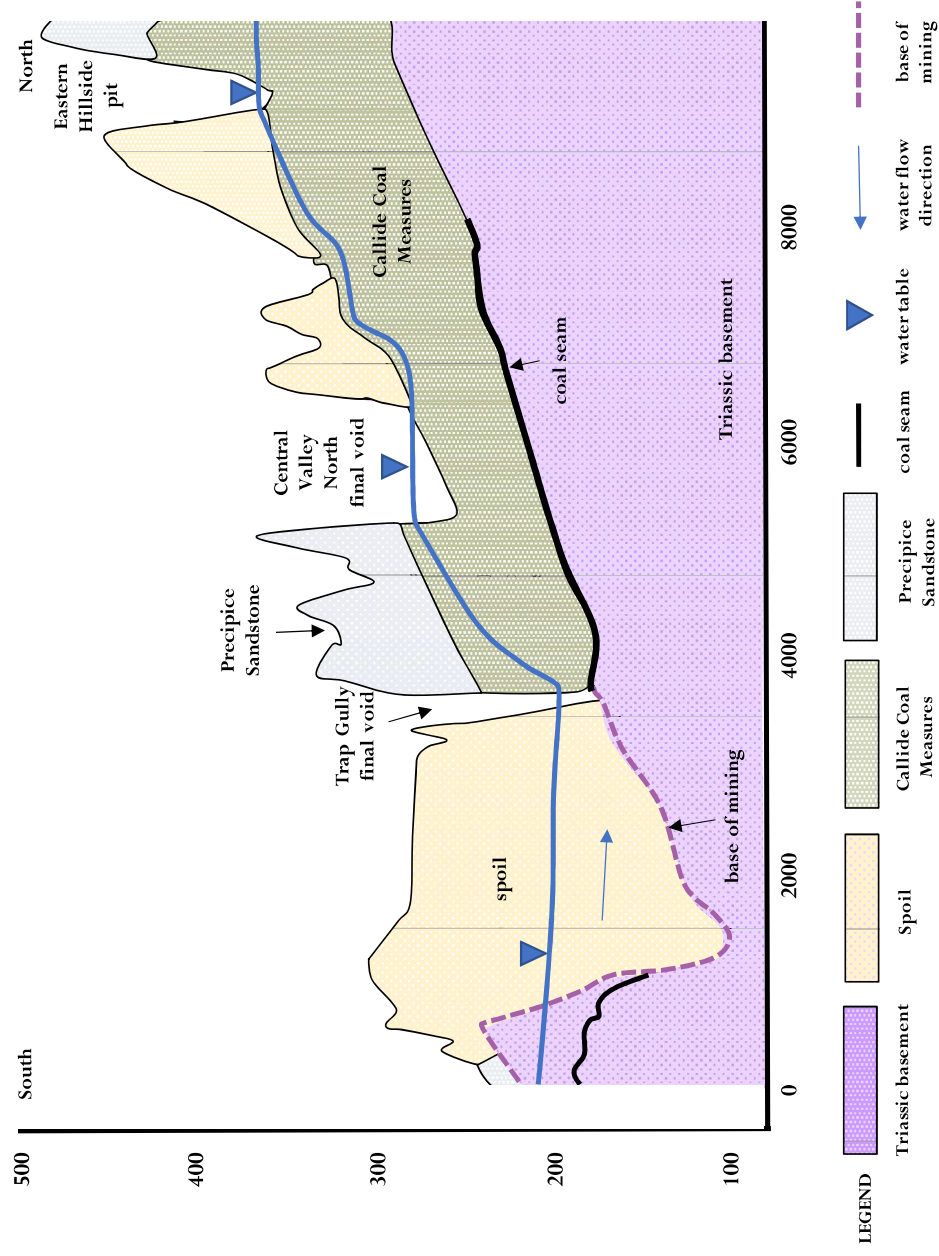
Figure 15 The Hut / Trap Gully mining area – post-closure groundwater regime cross-section

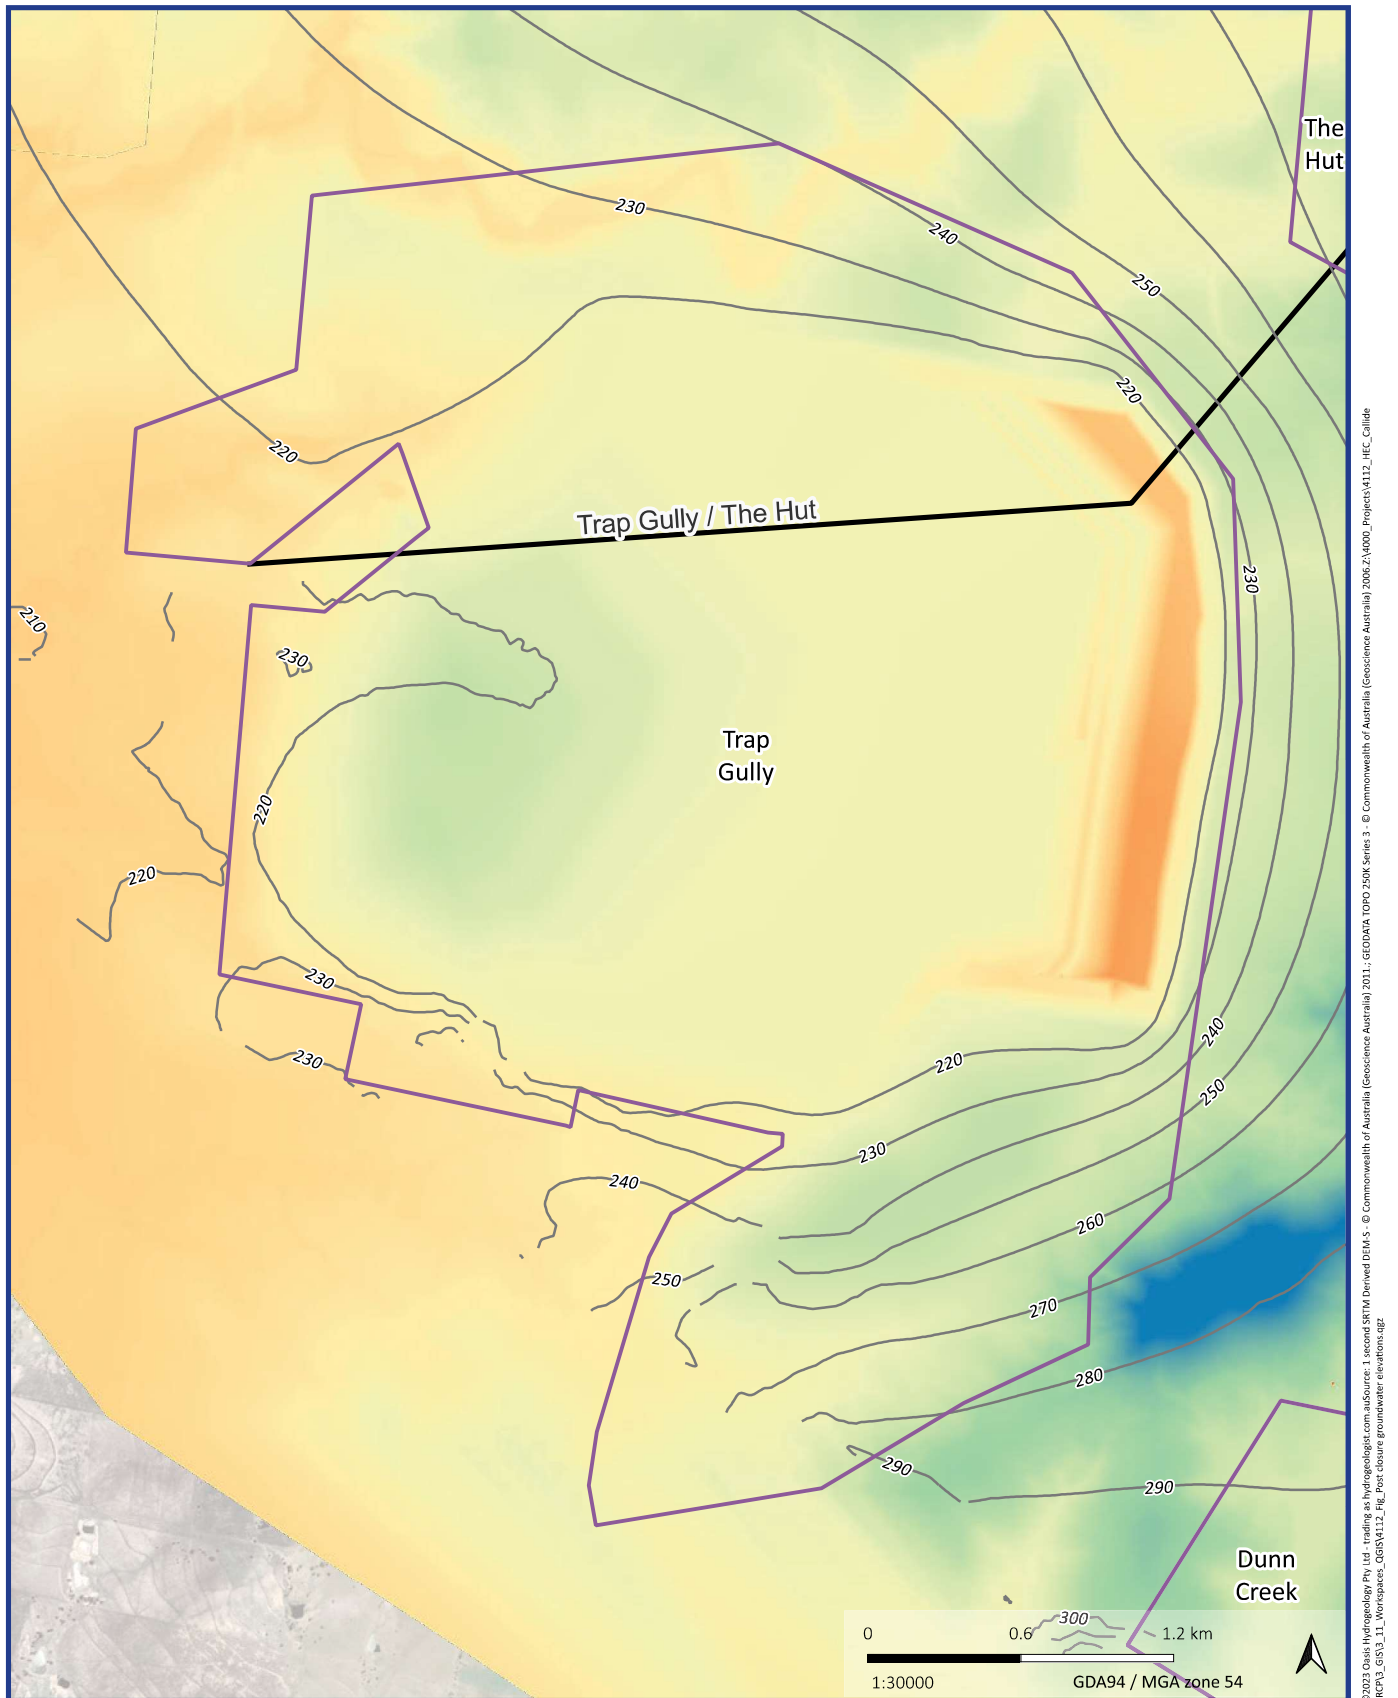
Figure 16

Post-closure groundwater elevation and flow - Trap Gully mining area

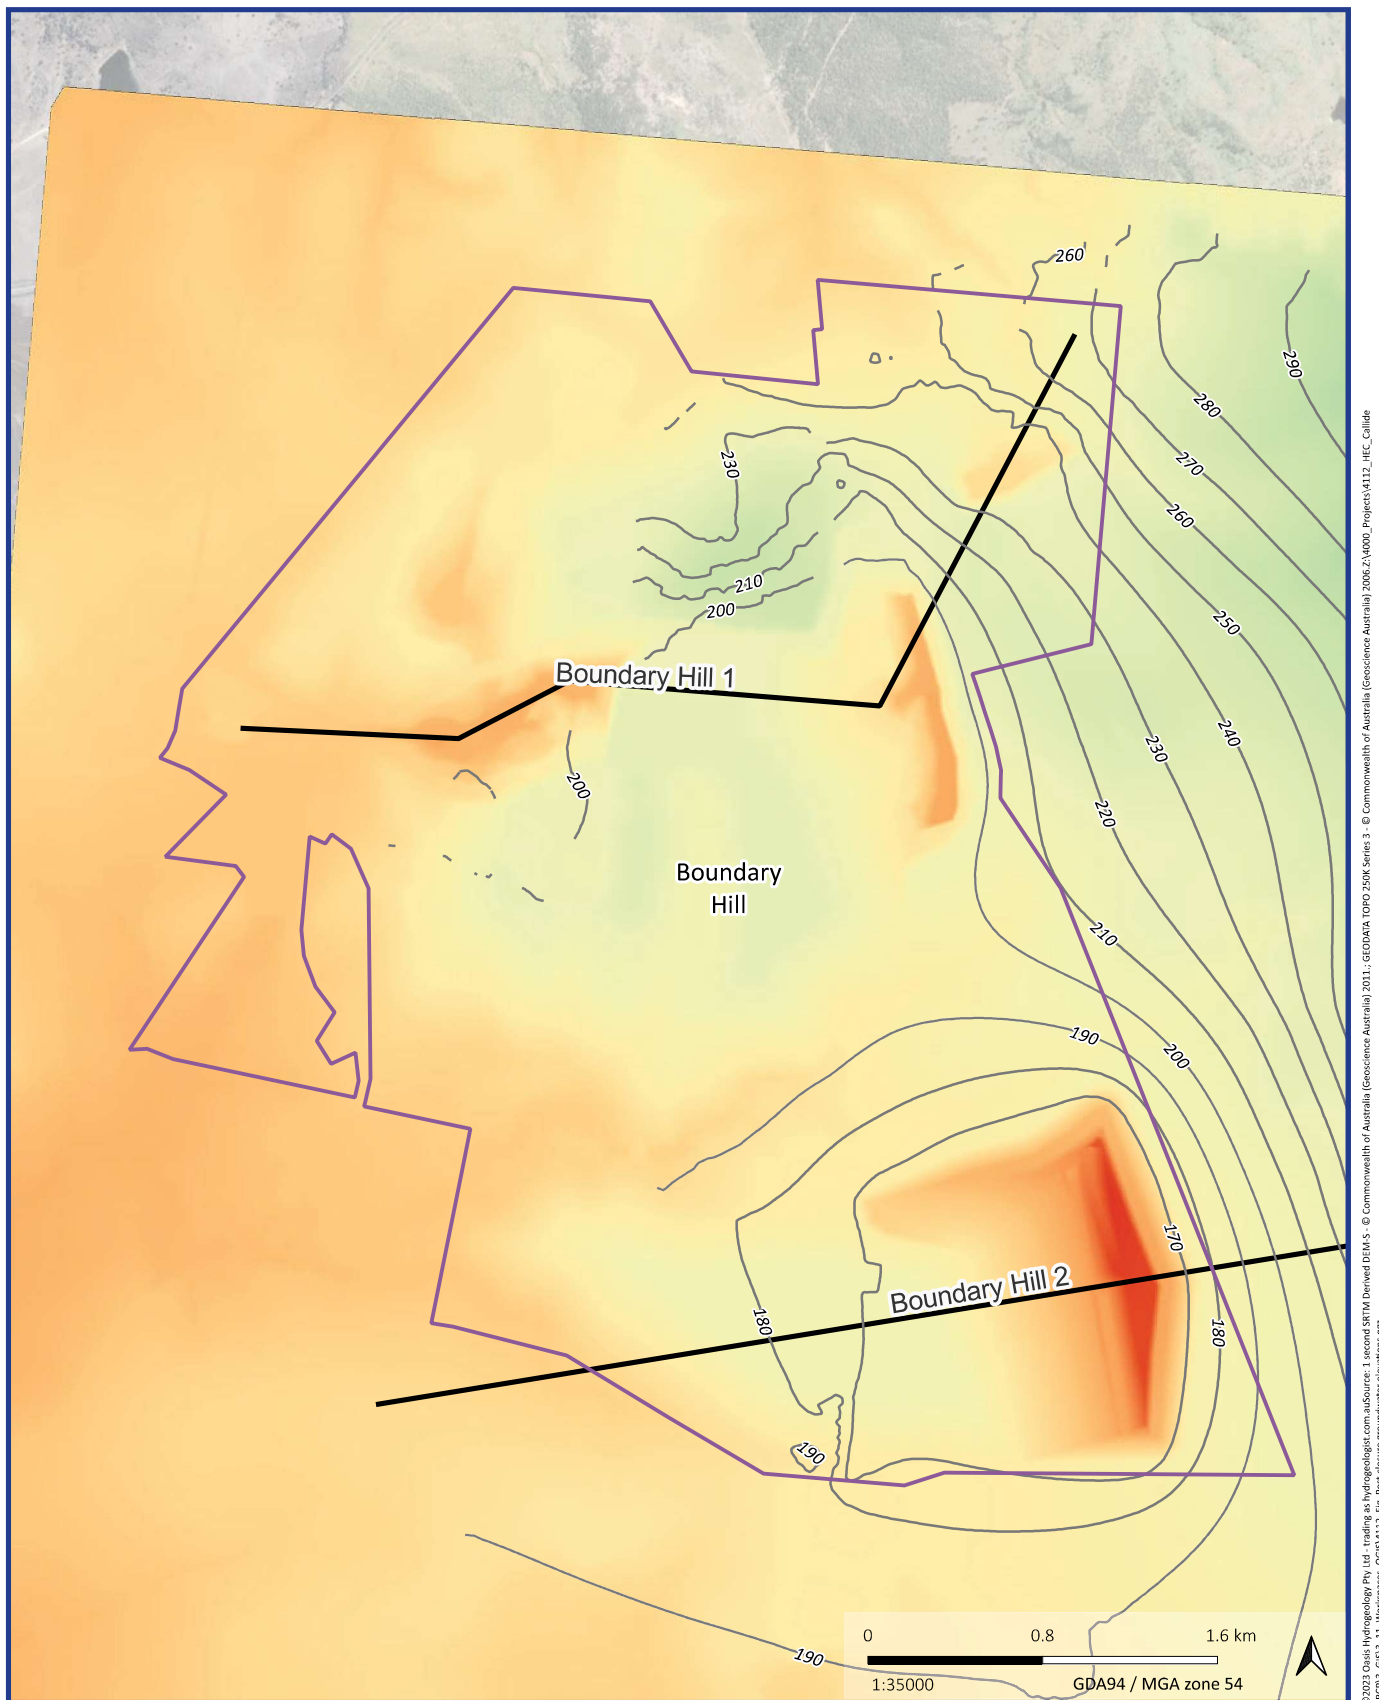
Post-closure groundwater elevation and flow - Boundary Hill mining area
