Hansen Bailey was commissioned by Batchfire Resources Pty Ltd (Batchfire) to prepare a Rehabilitation Management Plan (RMP) for the Callide Mine. This RMP has been prepared in accordance with the Callide Mine Environmental Authority (EA) conditions H2 and H3.

| Final Void Water Modelling | |

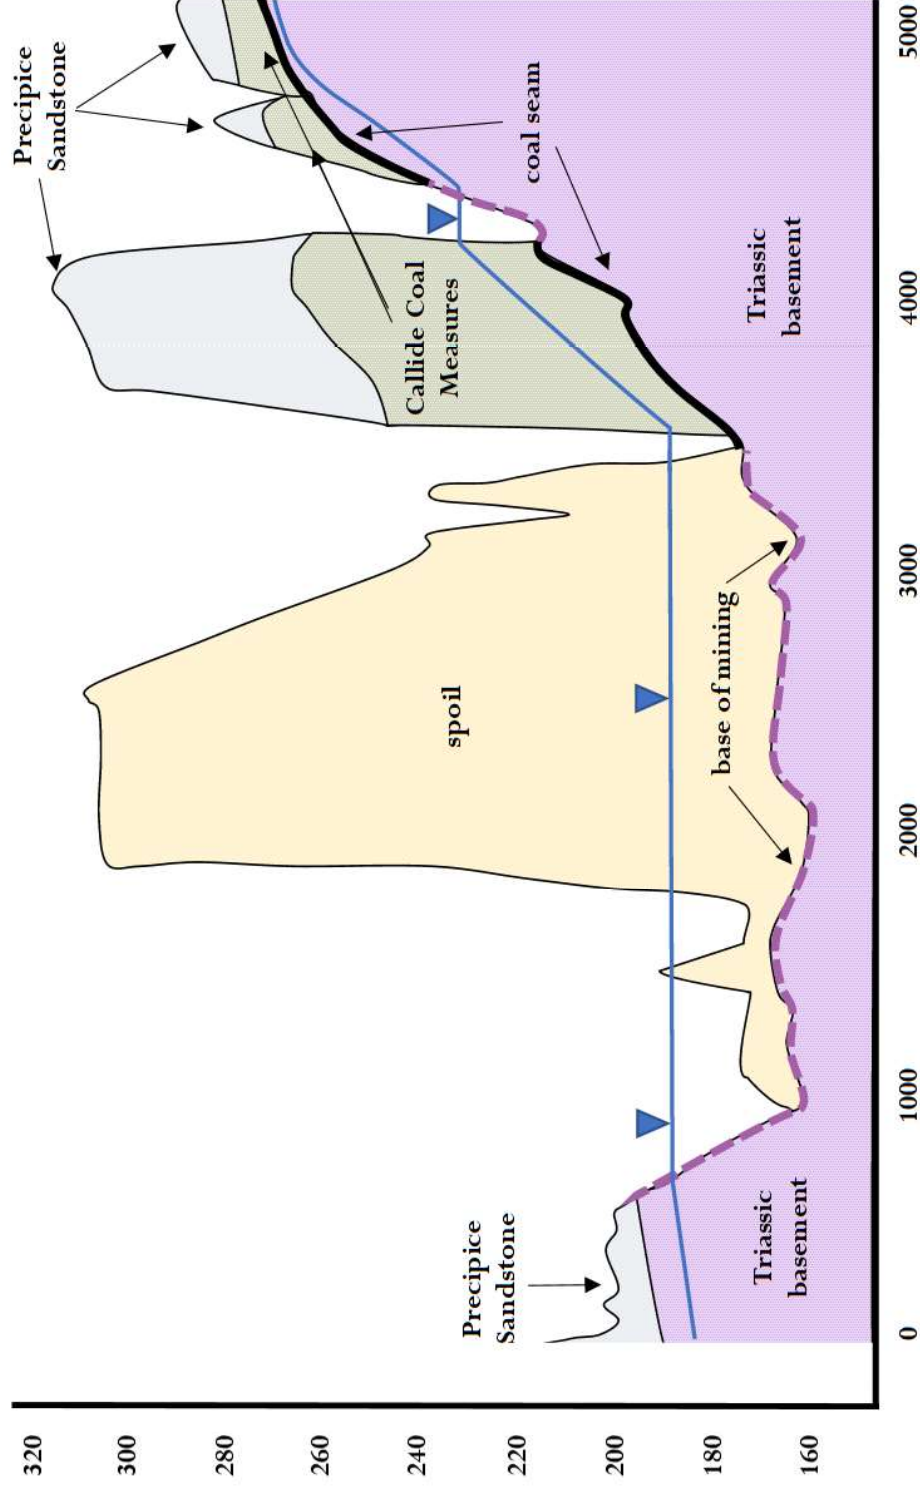
Figure 18 Boundary Hill mining area – post-closure groundwater regime cross-section 1

Figure 10 shows the predicted post closure groundwater elevations across Callide Mine and its surrounds. Figure 11 to Figure 19 show cross sections of the predicted post closure voids and their interaction with the groundwater regime.

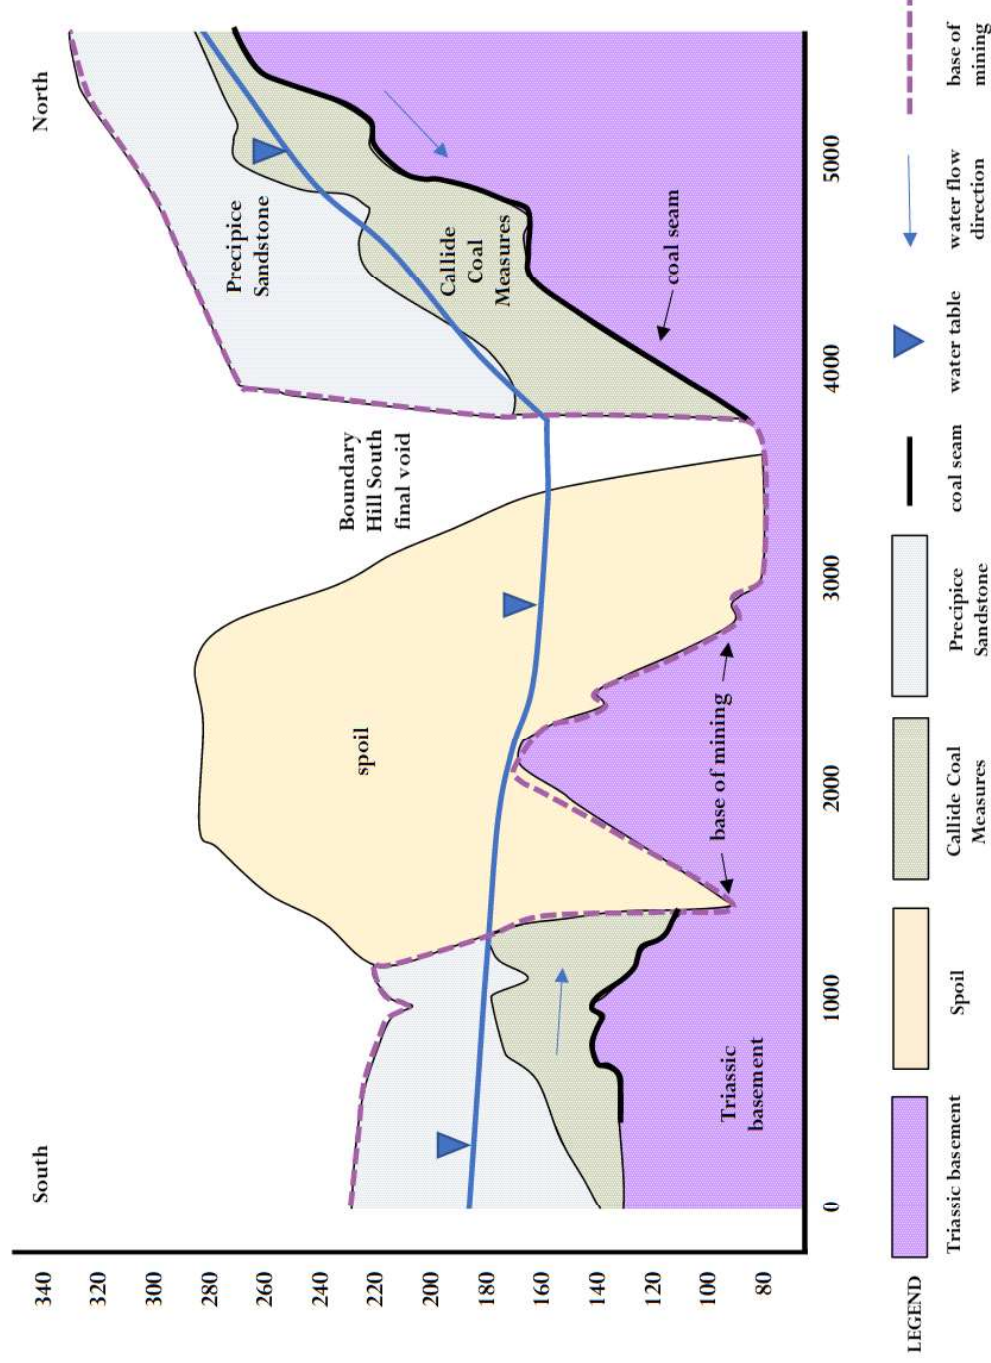
Figure 19 Boundary Hill mining area – post-closure groundwater regime cross-section 2

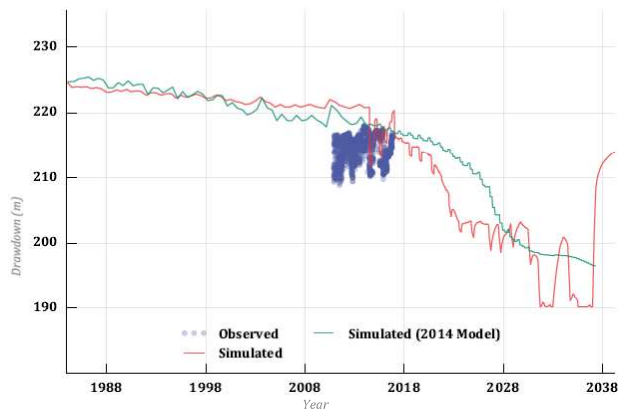
MB04

The groundwater flow model was calibrated to groundwater levels from the Callide Mine groundwater monitoring network. The calibration achieved a scaled root mean squared (SRMS) error within acceptable limits (i.e., 10%) as recommended by Barnett *et al.* (2012). Furthermore, the calibrated groundwater levels, vertical gradients, flow patterns and mine inflows are comparable to measured data and groundwater trends. The model calibration is therefore considered robust. The calibration hydrographs for the numerical model are presented in Appendix B.

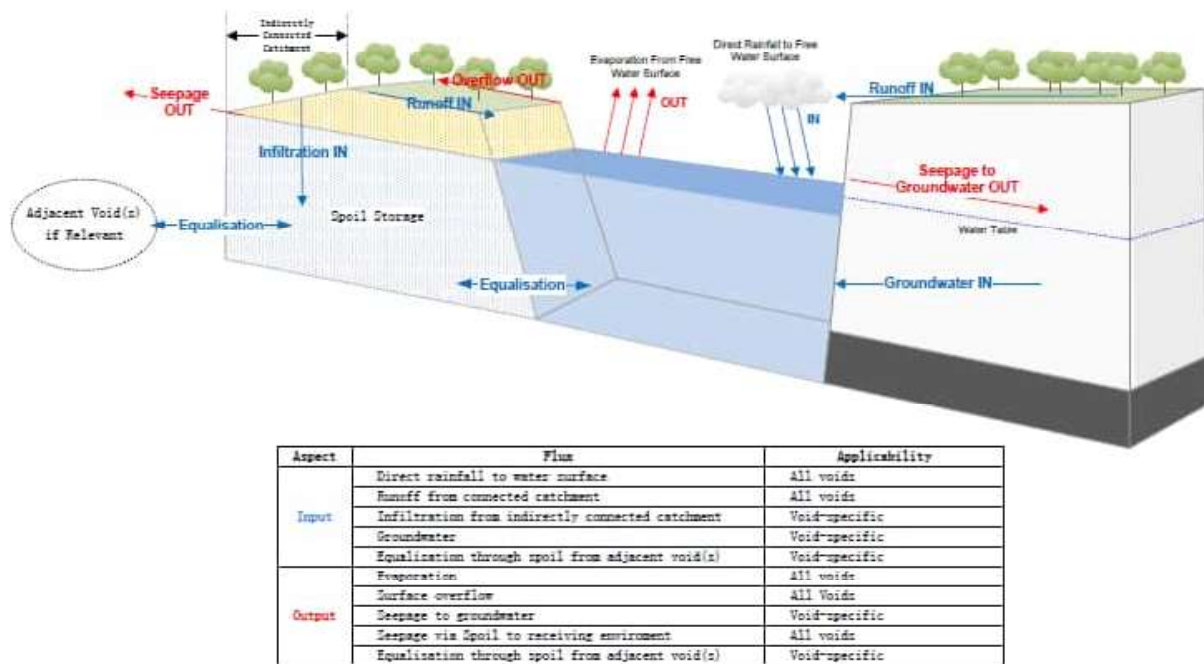
Figure 1-1 Water Balance Conceptual Model

Figure 1-1 shows the water balance conceptual model and considers the following key fluxes:

- Seepage losses through spoil – where void lake containment loss may occur to the receiving environment via backfilled spoil.
  - Infiltration through indirectly connected rehabilitated spoil catchments.

- Surface overflow if void storage capacity is exceeded.
  - Seepage through spoil to adjacent voids where relevant.

Section 1.3.1 provides additional details on the key assessment criteria adopted for the assessment. Table 1-1 below summarises the modelling approach adopted for each void. Voids have either been assessed independently as single voids or as multiple voids hydraulically connected through backfilled spoil. Where voids are assumed to be connected no allowance has been made for seepage transmission through spoil and equalisation is therefore assumed to occur instantaneously each timestep (daily).

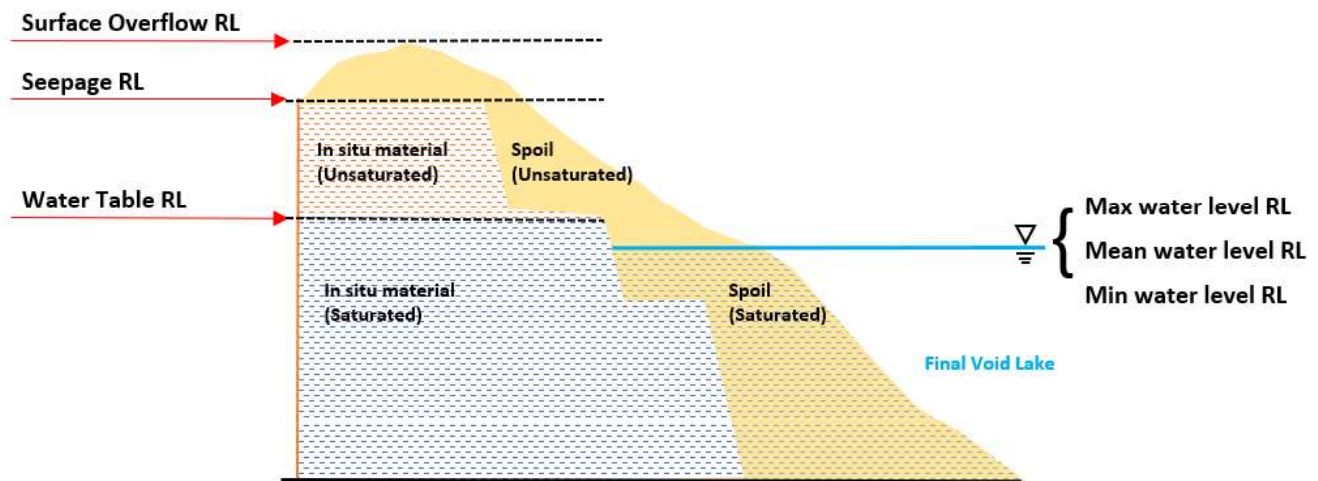
**Figure 1-2 Critical RLs – General Arrangement**

To assess the containment risk for each void three critical relative levels (RLs) were considered as summarised in Table 1-2 and shown in Figure 1-2. The locations of each critical RL are shown on Figure 2-1 to Figure 2-4 below, summarised in Table 2-2 below and shown on each final void storage curve (Appendix A.2).

| Critical RL | Description |
|---|---|
| Seepage | Elevation at which seepage loss from the final void may enter the receiving environment through any backfilled spoil. This is typically the lowest elevation on the mined-out pit shell crest. |
| Surface overflow | Elevation at which surface overflow to the receiving environment could occur i.e., the total storage capacity of the final void is exceeded. |

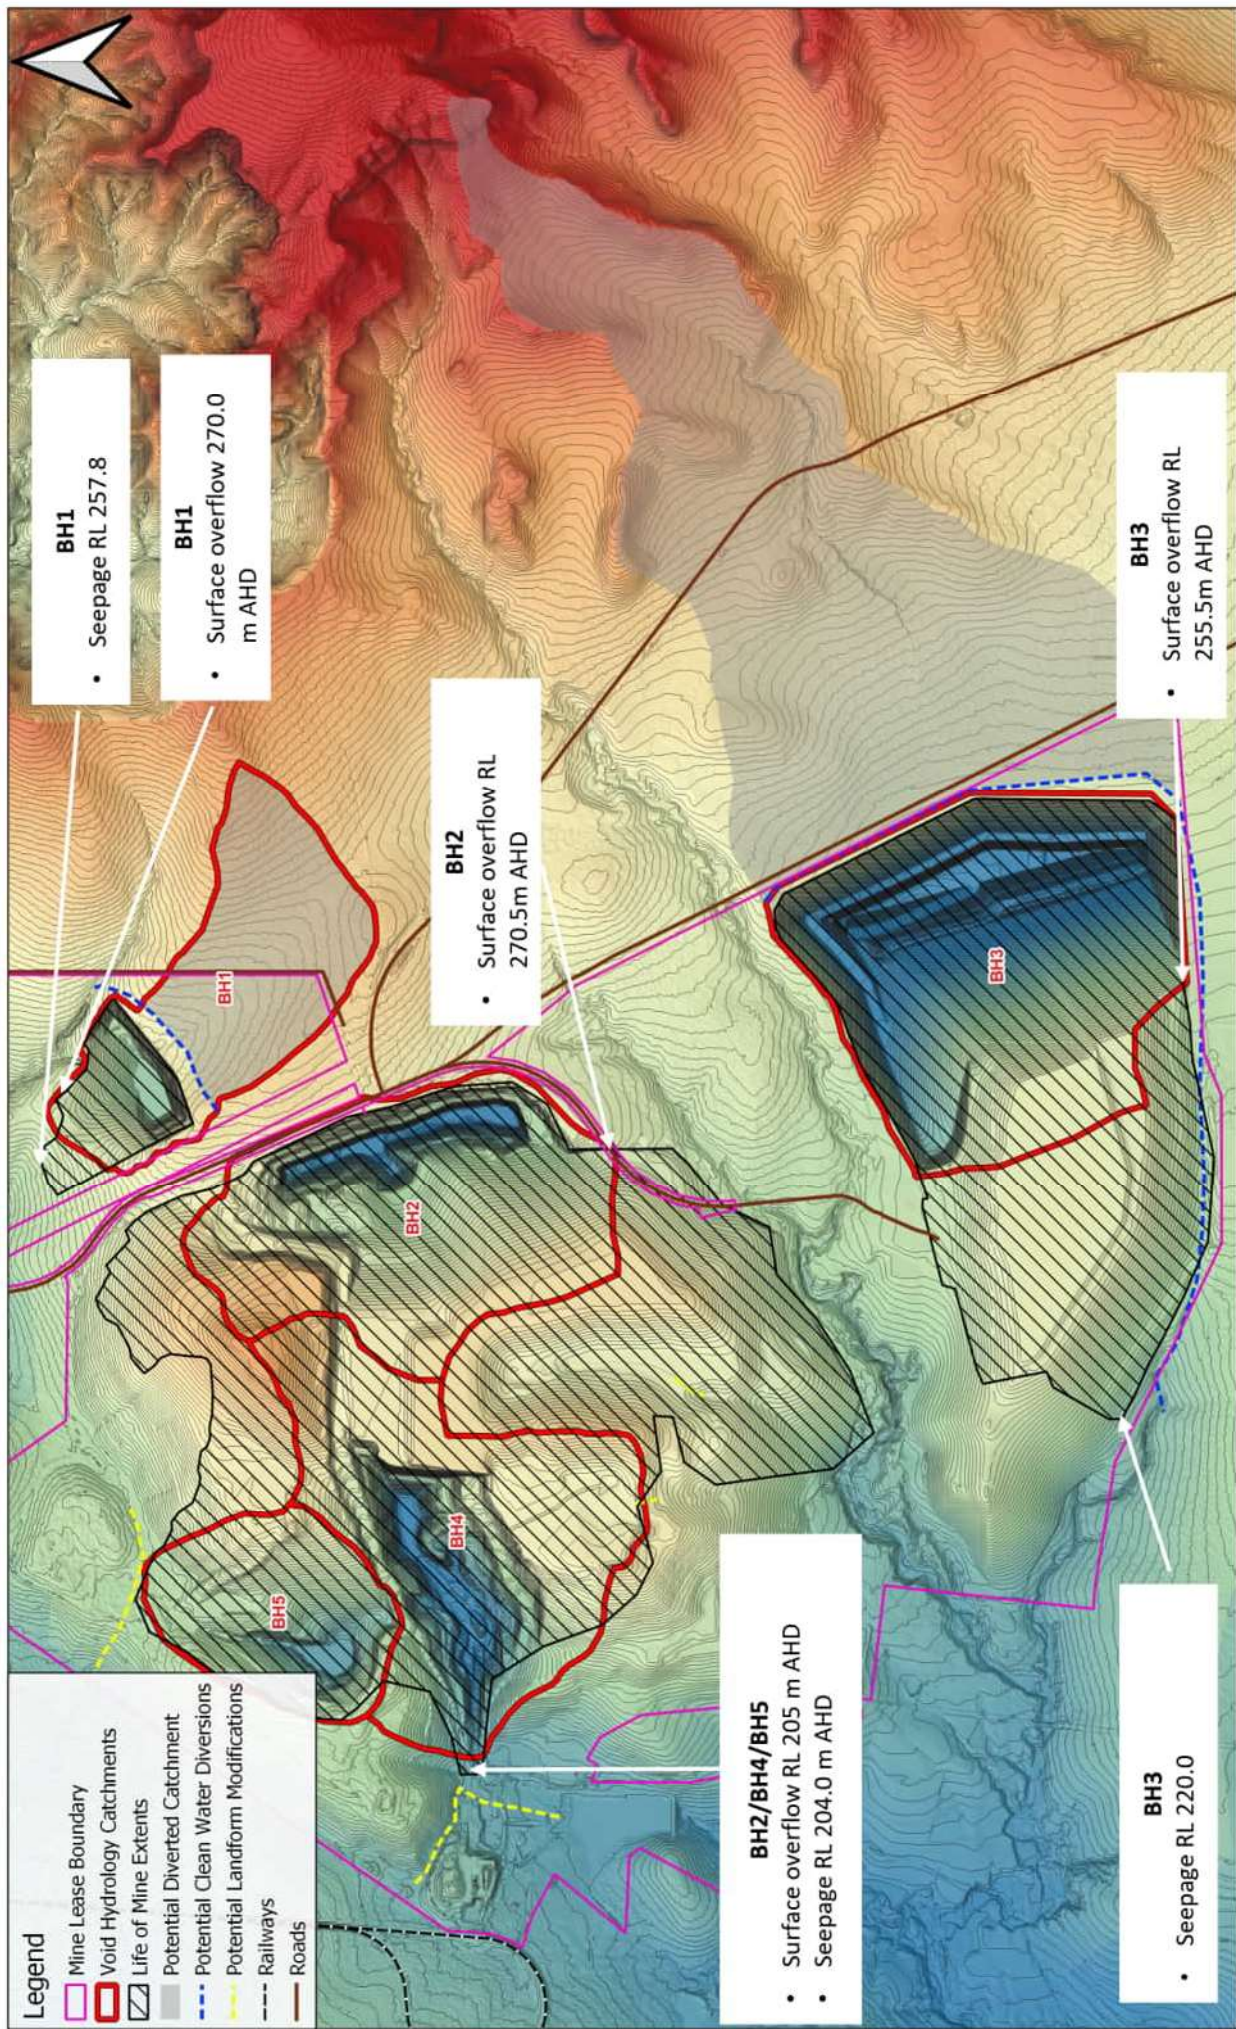
Batchfire - Callide PRCP  
Void Hydrology Catchments  
Figure 2-1 Boundary Hill

Job Number:  
M60000\_011  
Revision: 0  
Drawn: SW  
Date: 7 /10 /2022

Critical RLs for each final void are summarised below in Table 2-2 and Figure 2-1 to Figure 2-4.

| Final Void | Catchment Diverted | Comment |
|---|---|---|
| Boundary Hill – BH1 | 79 Ha | Catch drain to maintain stability of highwall (Figure 2-1) |
| Boundary Hill – BH3 | 391 Ha | Catchment diversion to reduce potential inflows (Figure 2-1) |

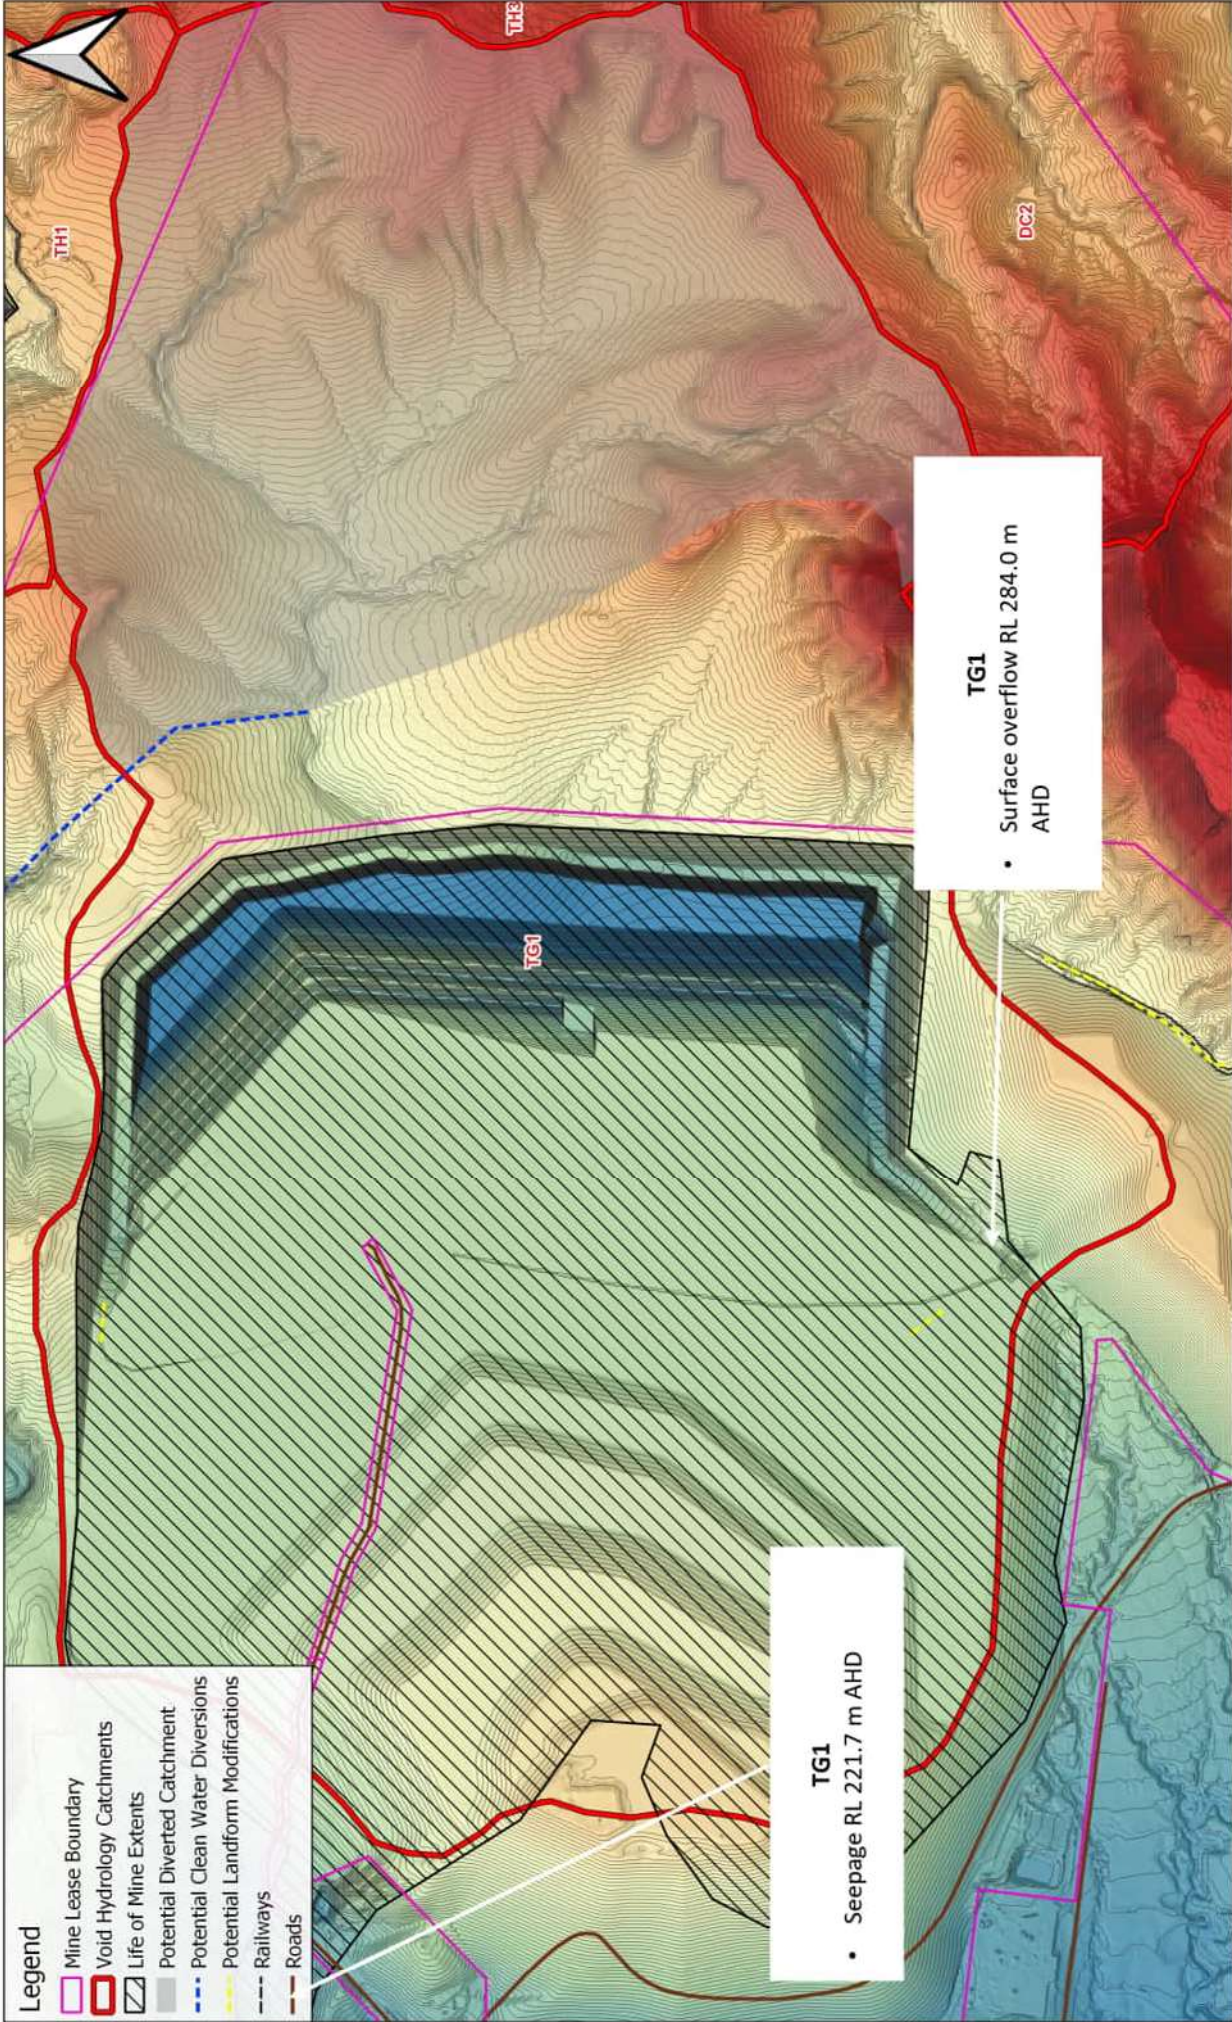
## TG1

- Seepage RL 221.7 m AHD

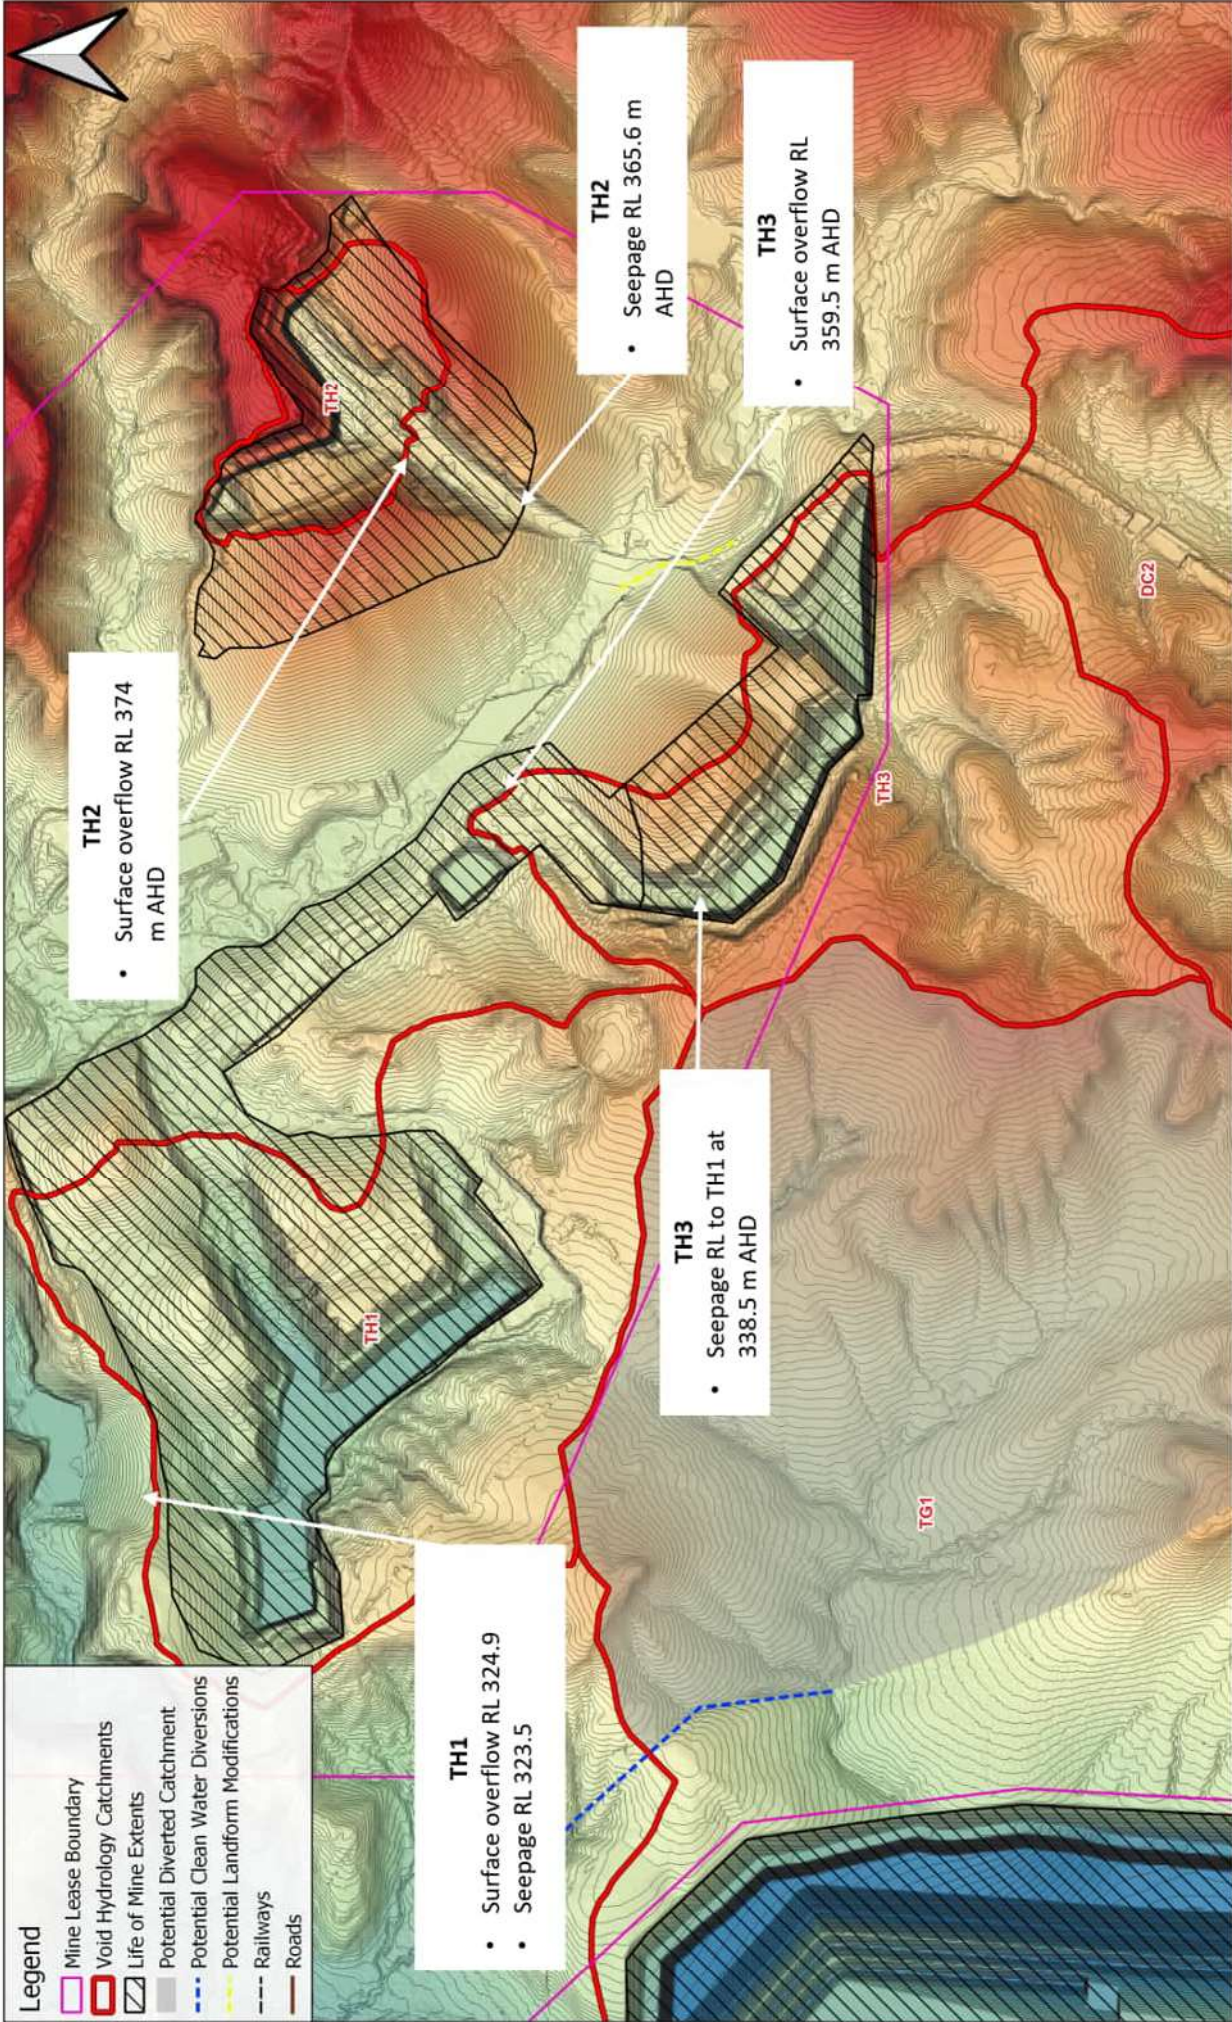
## TH1

- Surface overflow RL 324.9
- Seepage RL 323.5

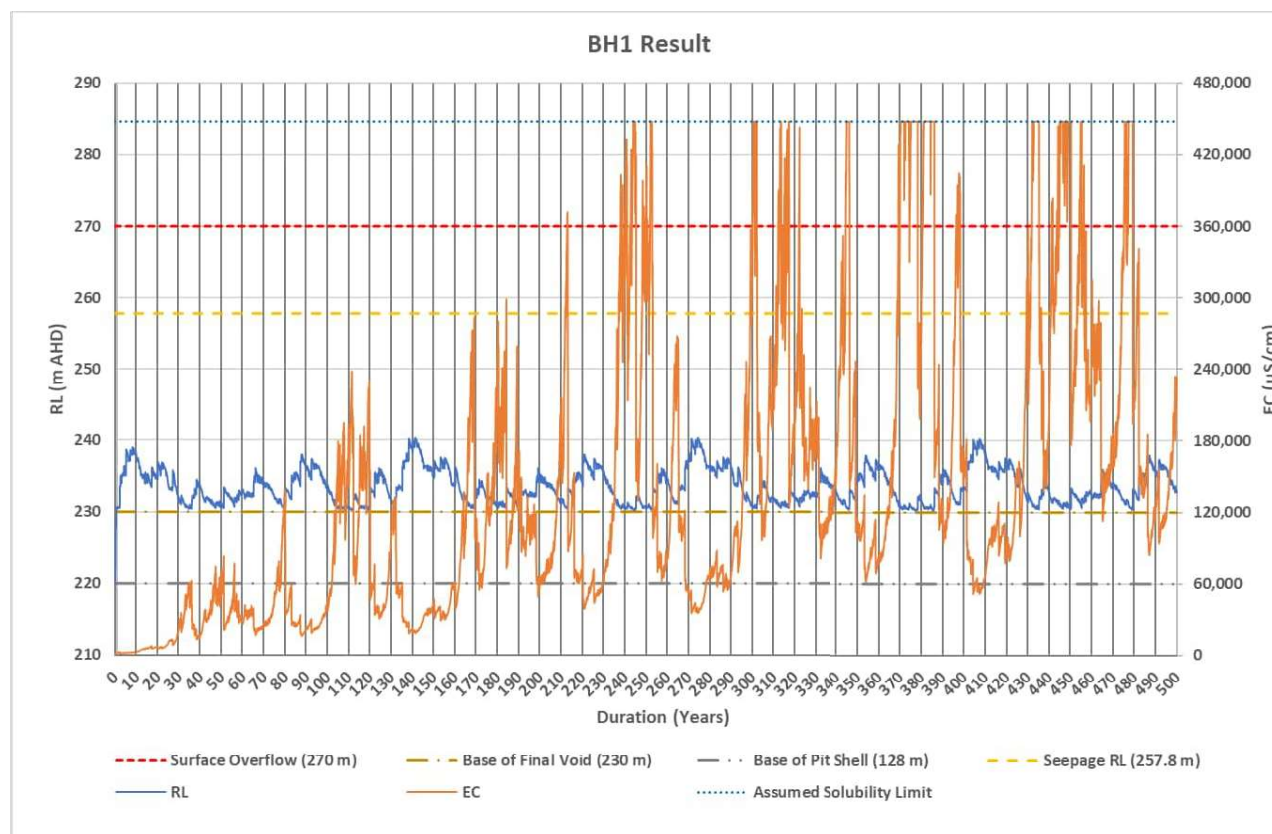
**Figure 4-1 Water Balance Result - BH1**

Modelling results are summarised in below in Table 4-1. Time series plots of final void water level and water quality are shown in Figure 4-1 to Figure 4-9:

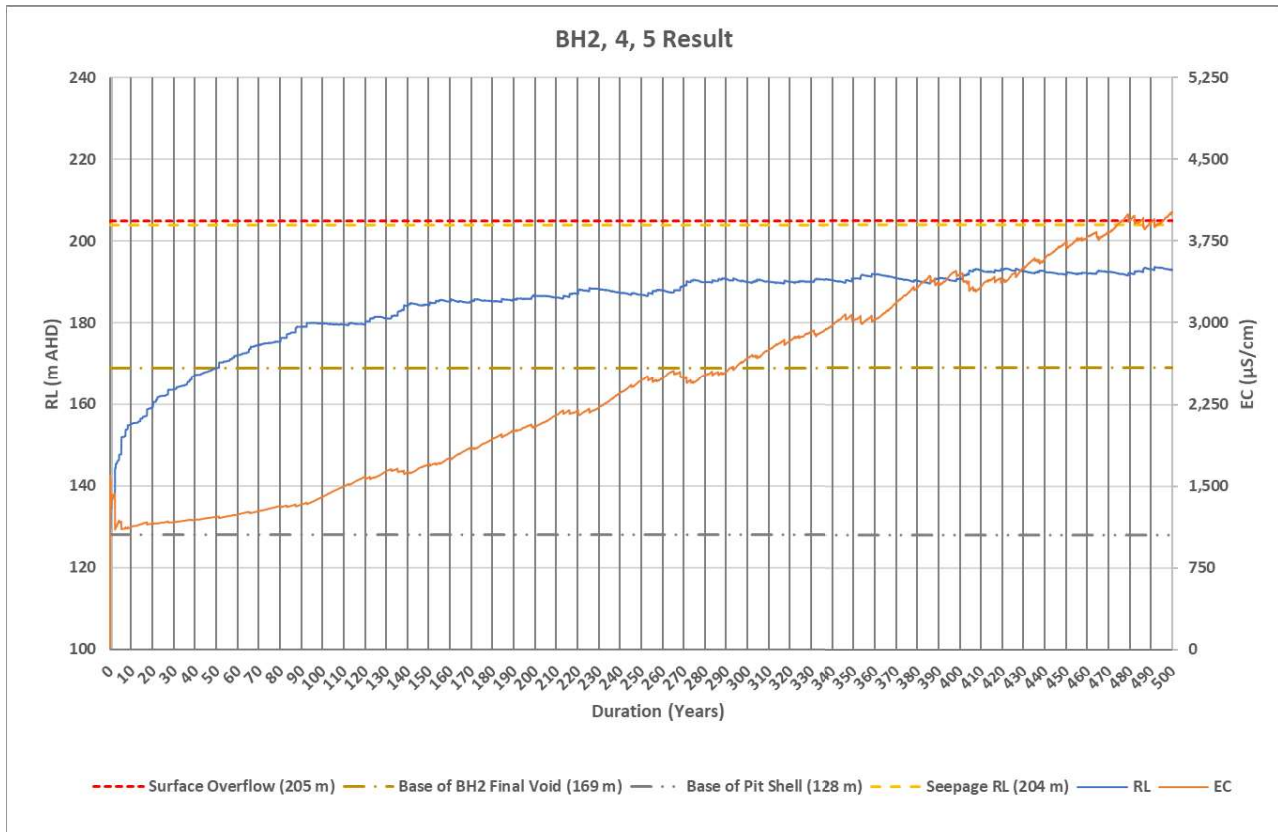
Figure 4-2 Water Balance Result – BH2, 4, 5

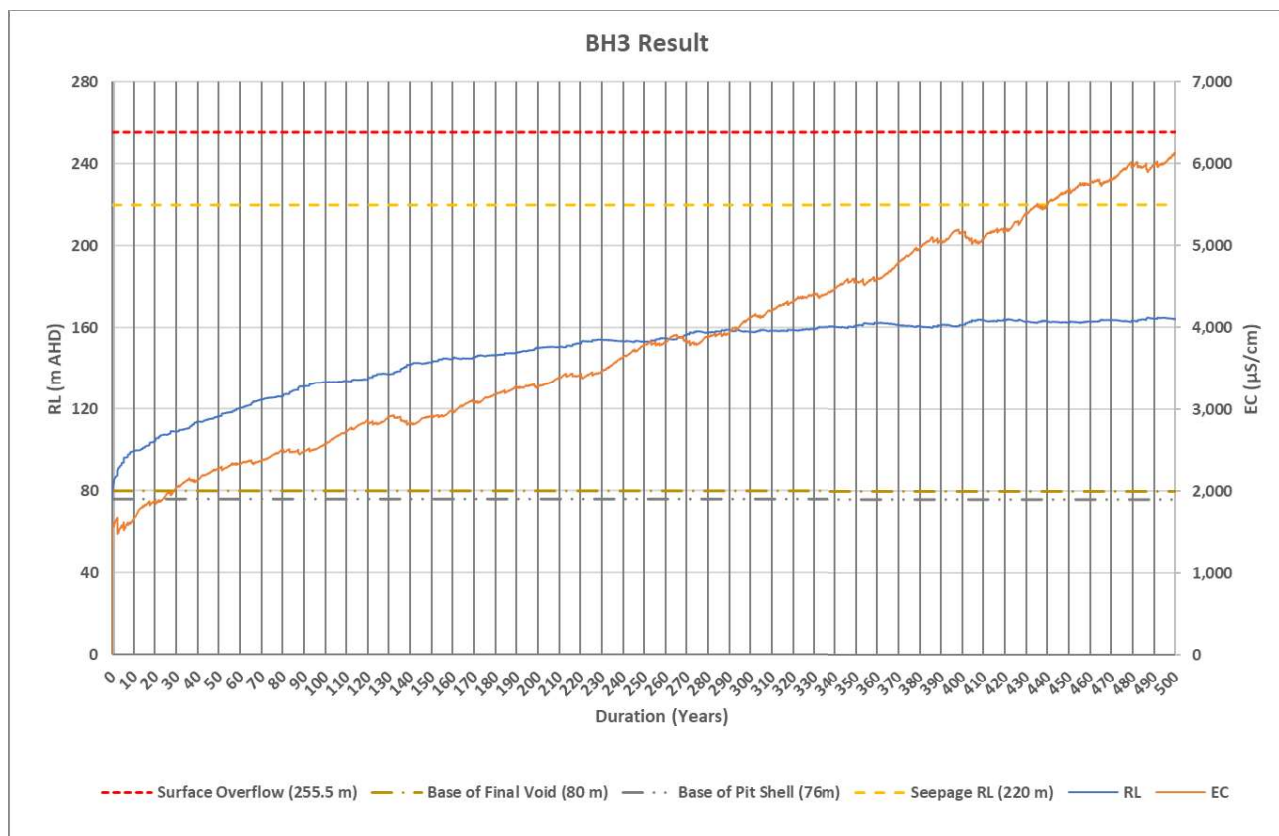
Figure 4-3 Water Balance Result – BH3

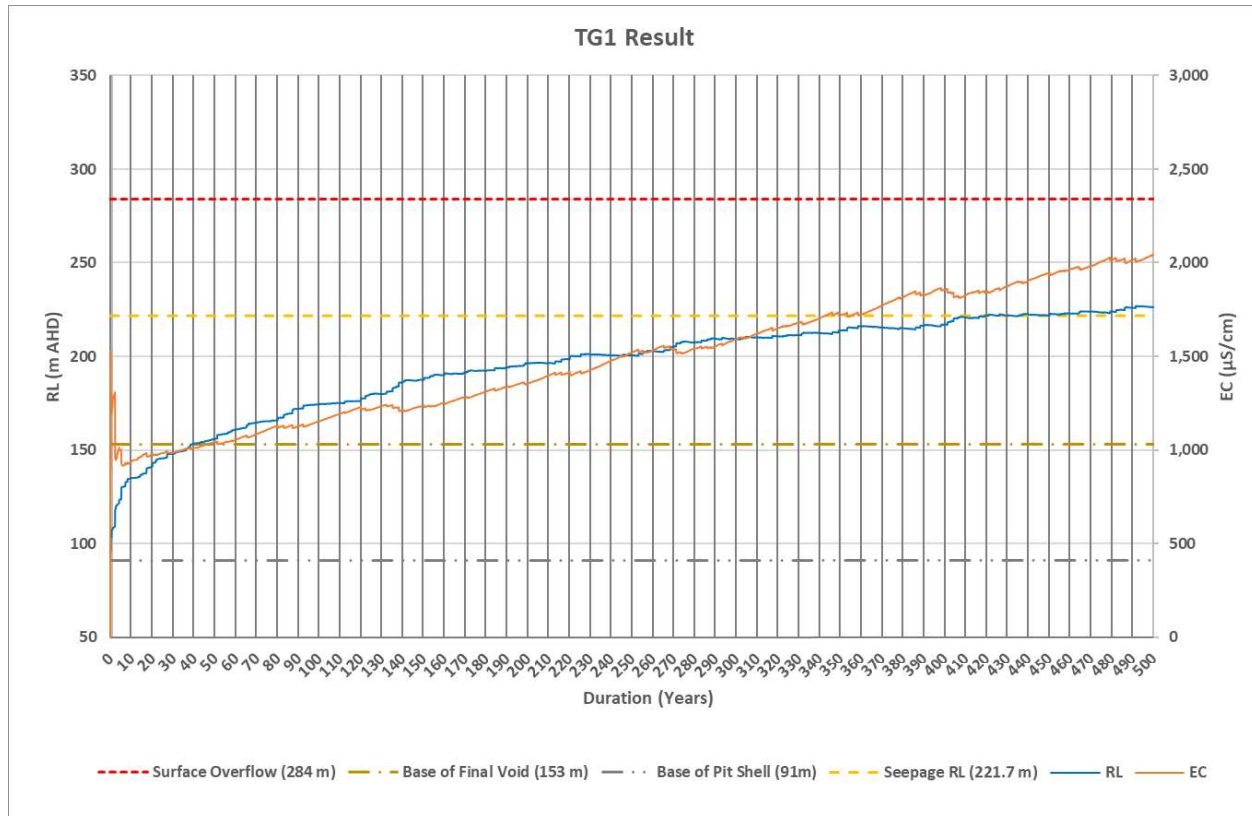
Figure 4-4 Water Balance Result – TG1 (Preliminary Result)

- TG1 (Figure 4-4) shows that the seepage level may be exceeded after approximately 410 years.
    - As noted in Section 2.4.1, TG1 has a large external catchment of 456 Ha (Table 2-3) that could potentially be diverted away from the void.

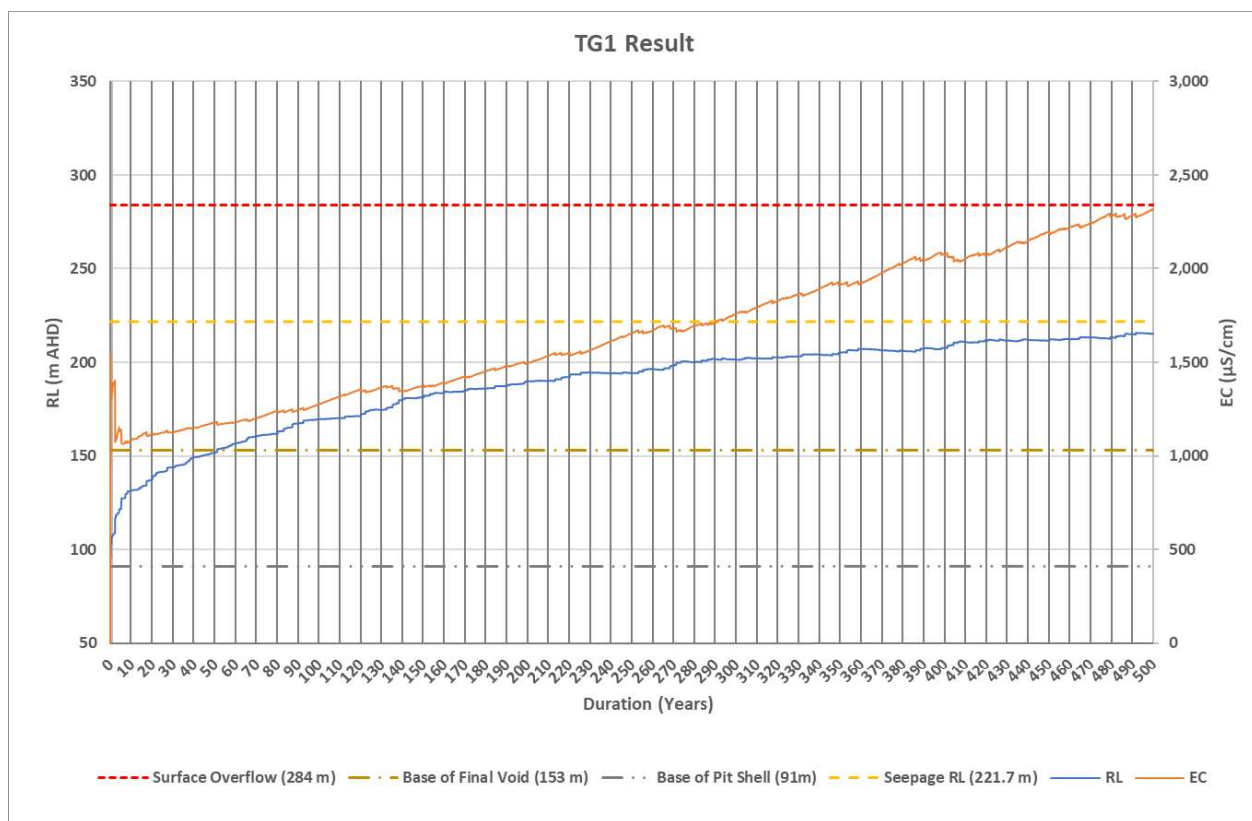
Figure 4-5 Water Balance Result – TG1 (With Diversion)

- An additional scenario was therefore considered for TG1 which assumed diversion of the external catchment. As a result of the diversion (Figure 4-5) the modelling indicates a lower final equilibrium level that does not exceed the seepage RL.

- BH1, TH1 and TH3 represent final voids with a high rate of evaporation loss relative to inflows and/or storage volume and therefore experience more rapid rises in EC over time as well as higher maximum EC.
  - These shallow void lakes which are generally subject to greater variability in water level periodically experience significant evaporative drawdown and evapo-concentration resulting in high EC levels which reach saturation (e.g., BH1, Figure 4-1)
- All remaining voids generally show relatively consistent, low to moderate increases in EC. Final ECs range from around 2,300  $\mu\text{S}/\text{cm}$  (TG1, Figure 4-5) to 11,000  $\mu\text{S}/\text{cm}$  (TH2, Figure 4-8)

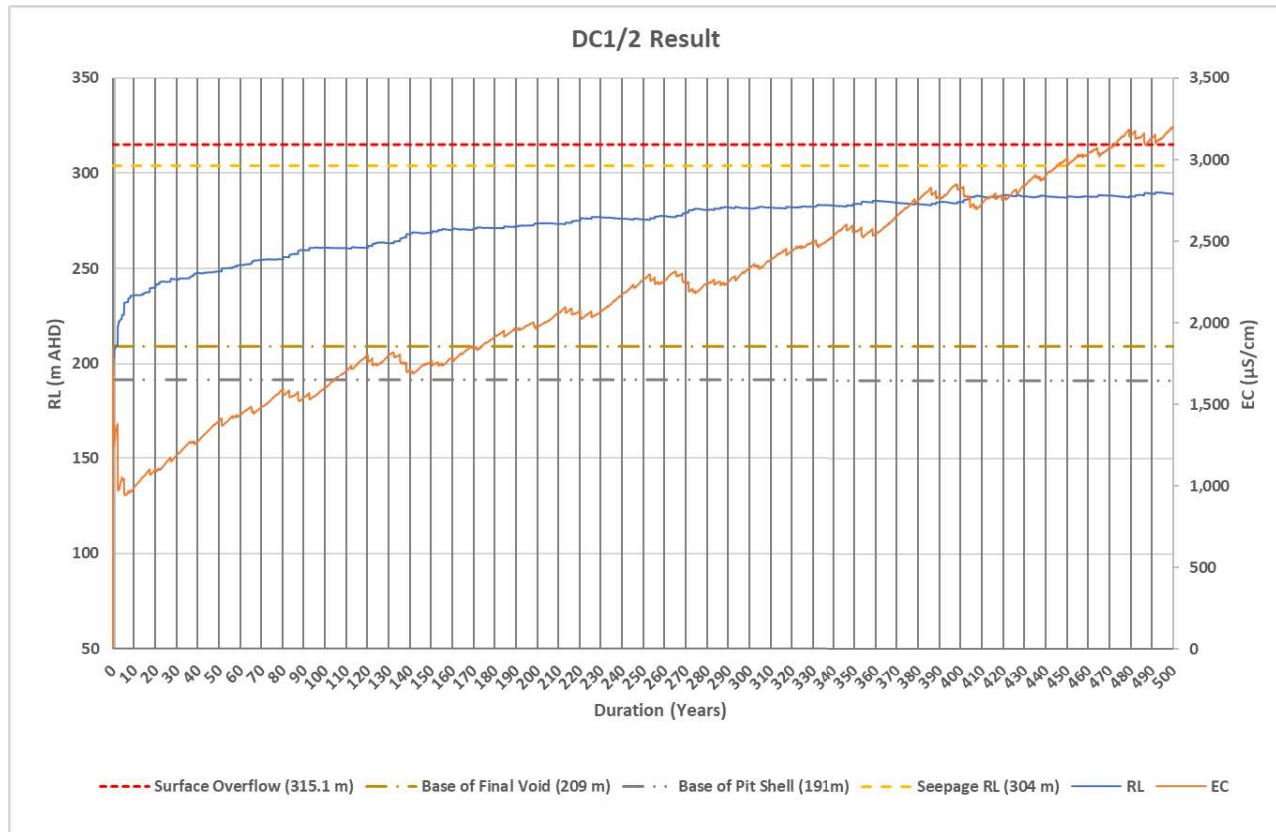
**Figure 4-6 Water Balance Result – DC1/2**

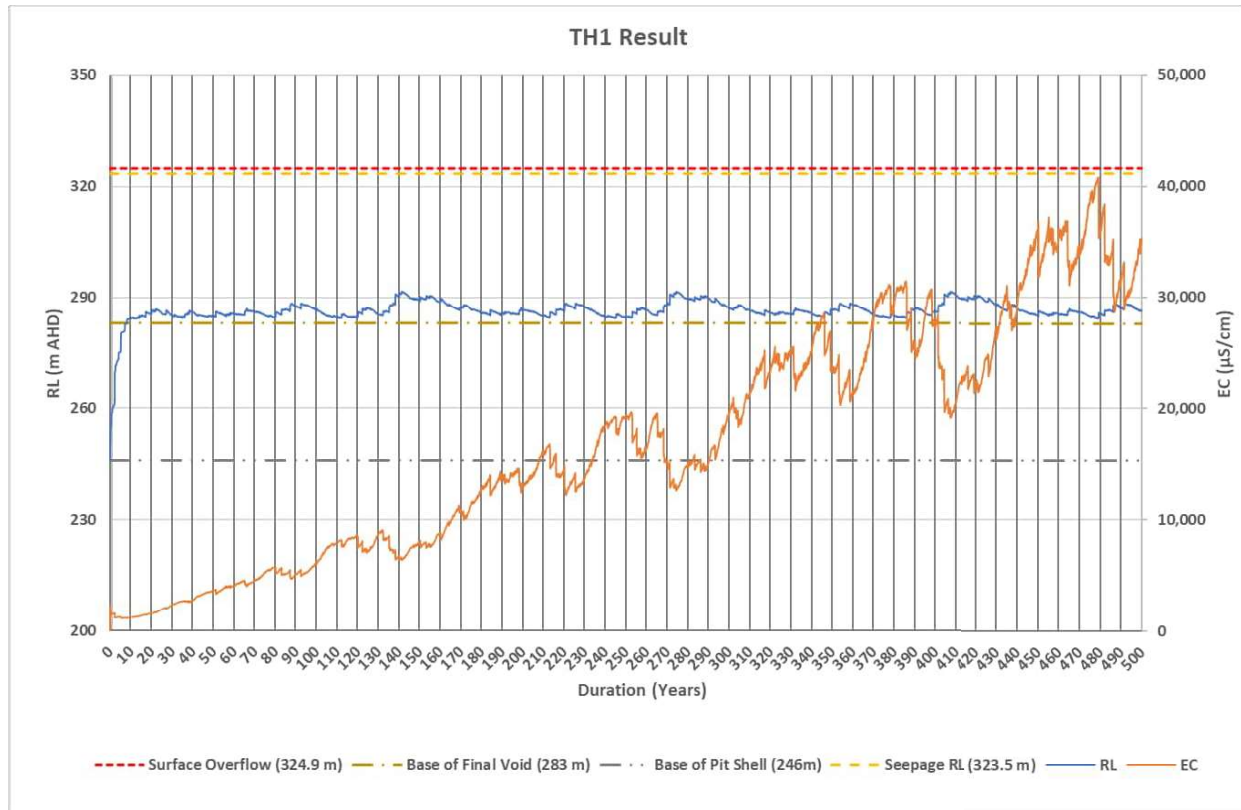
Figure 4-7 Water Balance Result – TH1

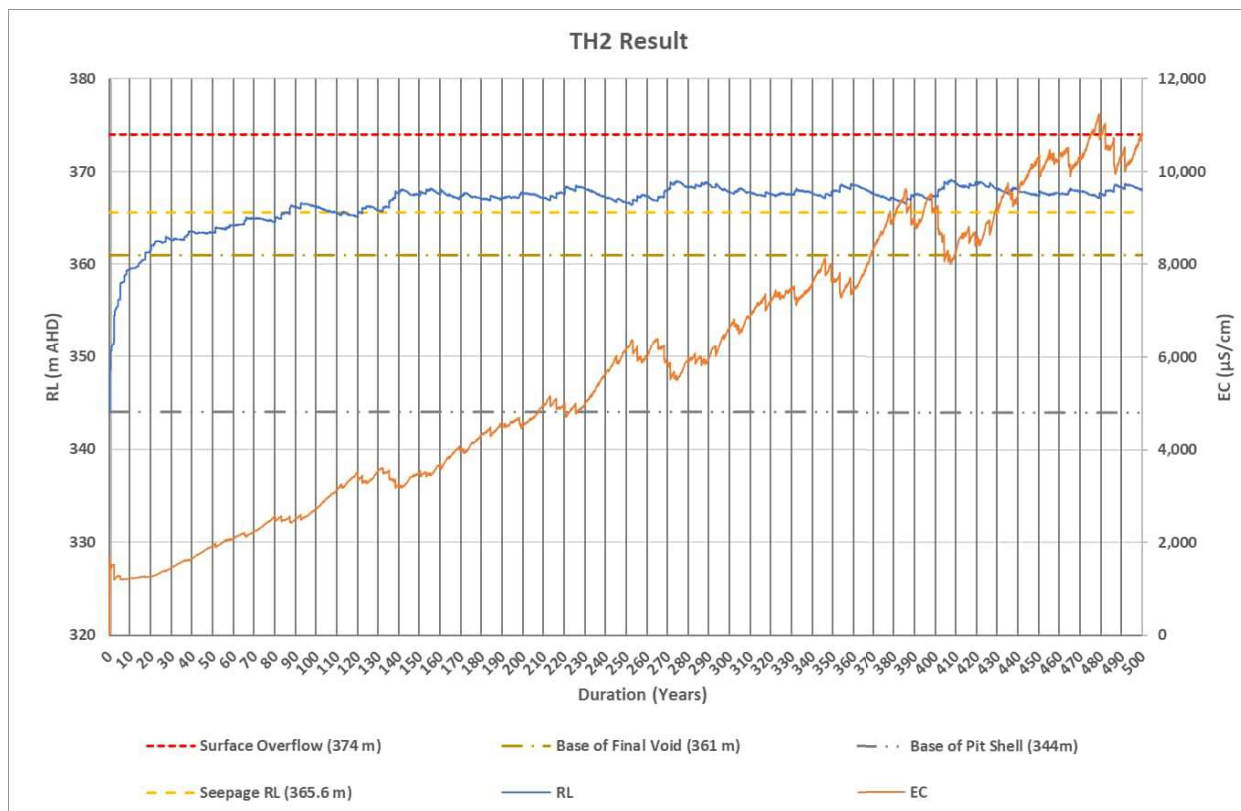
Figure 4-8 Water Balance Result – TH2

- TH2 (Figure 4-8) where the maximum water level reaches 3.5 m above the seepage RL (mean water level is 2.3 m above the seepage RL).
    - Further examination of this result indicates that this risk could be minimised through the placement of a levee structure located across the former pit entry ramp (refer to seepage RL location in Figure 2-4).

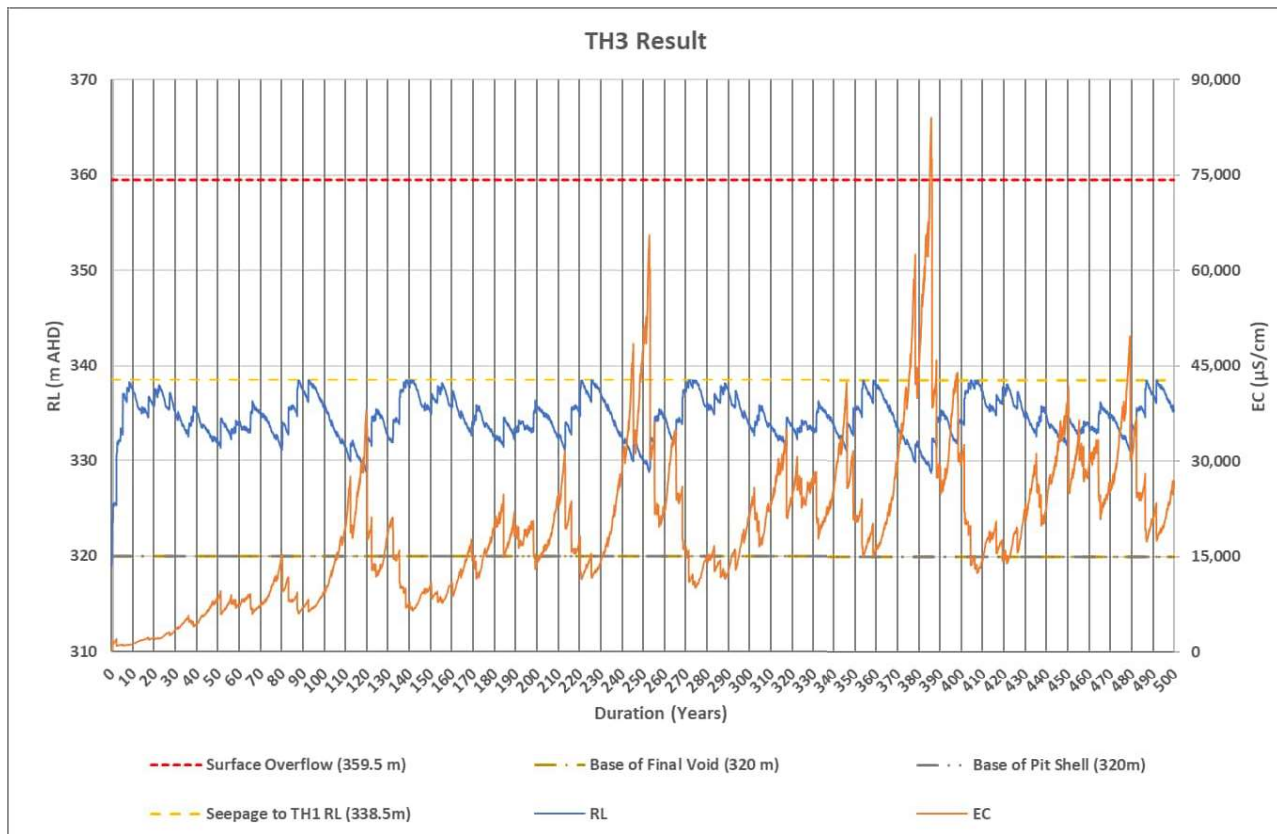
Figure 4-9 Water Balance Result – TH3
