Hansen Bailey was commissioned by Batchfire Resources Pty Ltd (Batchfire) to prepare a Rehabilitation Management Plan (RMP) for the Callide Mine. This RMP has been prepared in accordance with the Callide Mine Environmental Authority (EA) conditions H2 and H3.

| Final Void Water Modelling | |

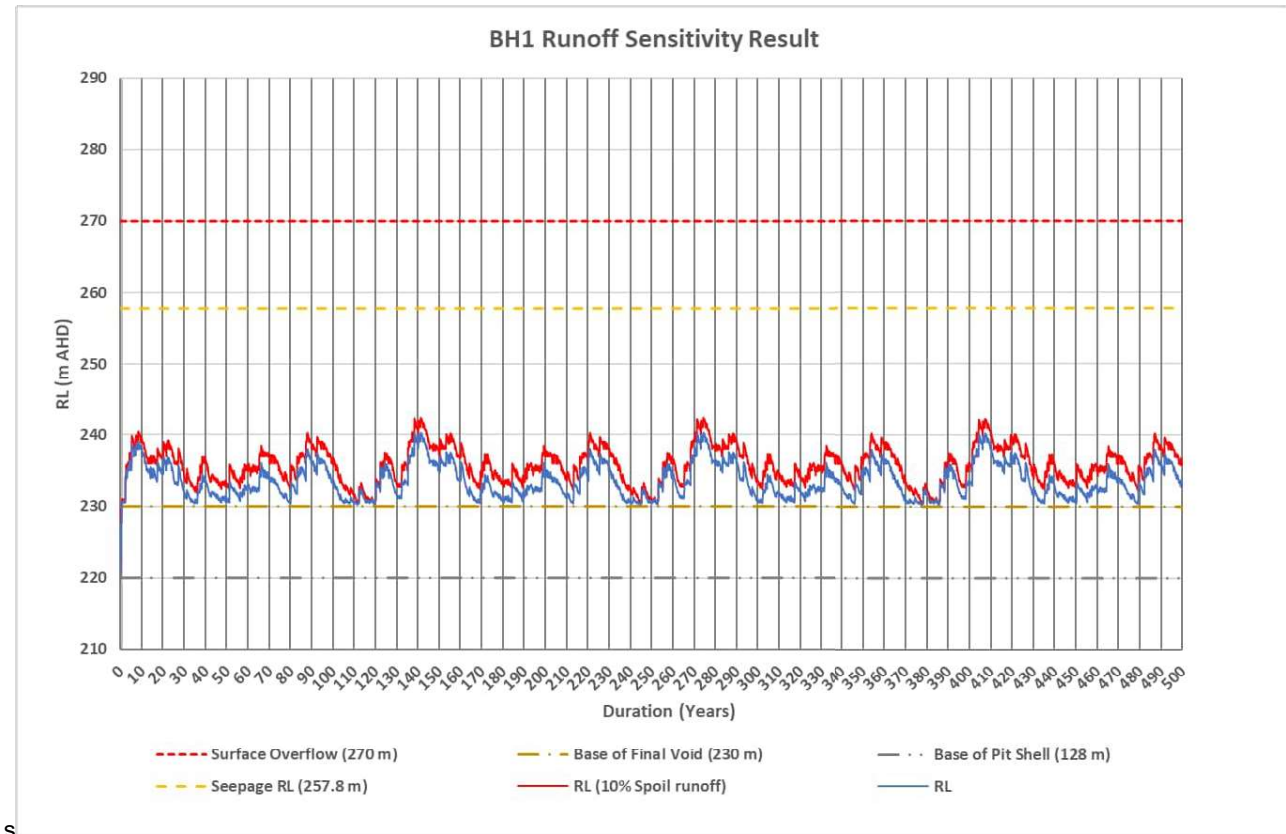
**Figure 4-10 Runoff Sensitivity Result - BH1**

In order to assess the sensitivity of estimated final void equilibrium water levels the AWBM parameters for the rehabilitated spoil landuse were adjusted to give a mean runoff coefficient of 10%, i.e., a 100% increase to the base case (5%). Table 4-2 to Table 4-4 and Figure 4-10 to Figure 4-17 show the results of the runoff sensitivity assessment.

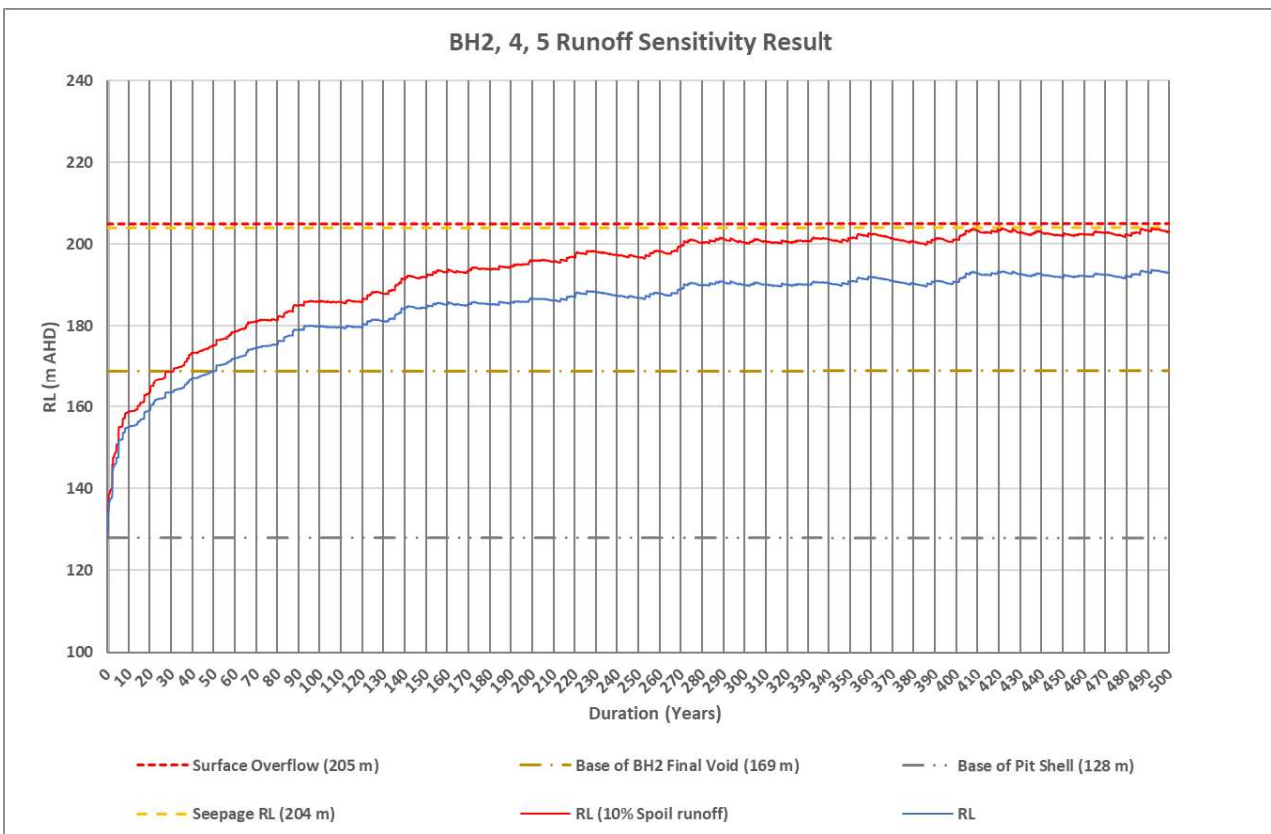
**Figure 4-11 Runoff Sensitivity Result - BH2, 4, 5**

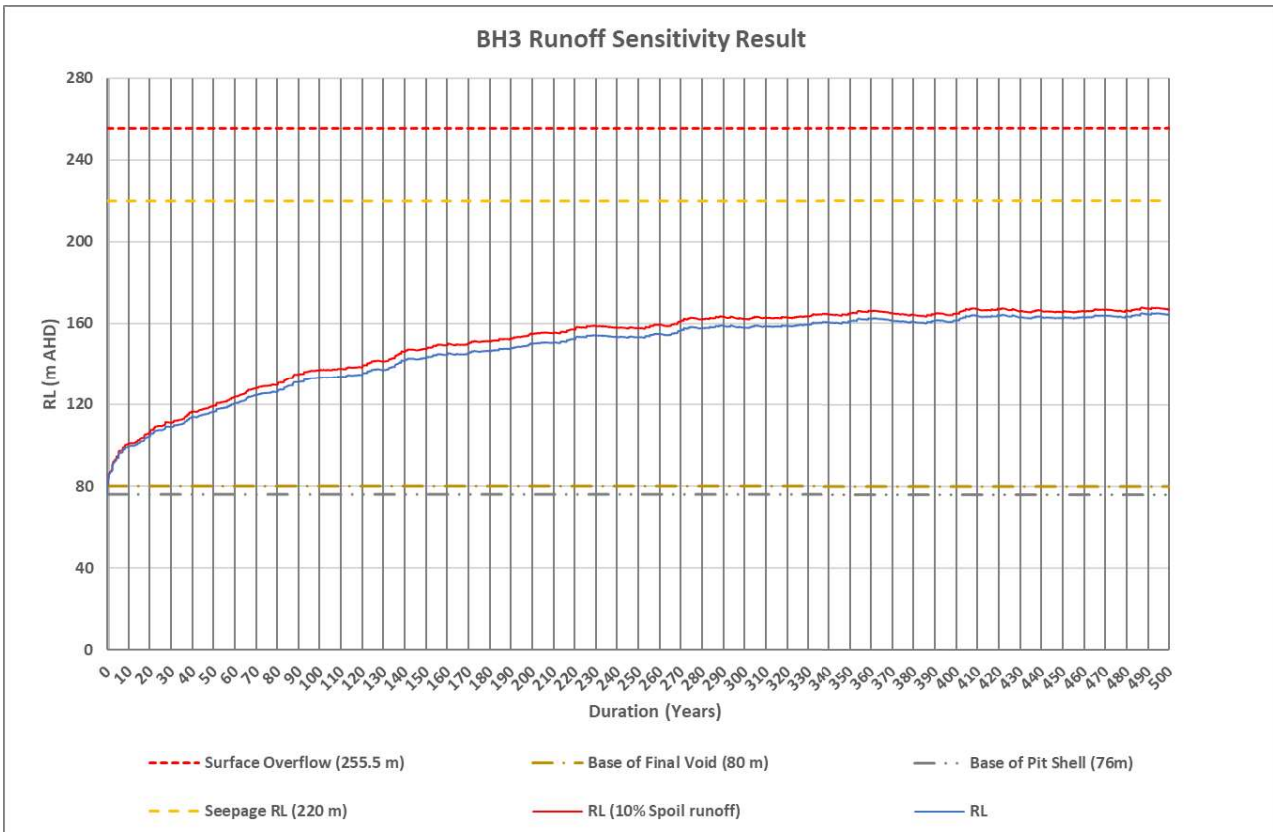
Figure 4-12 Runoff Sensitivity Result - BH3

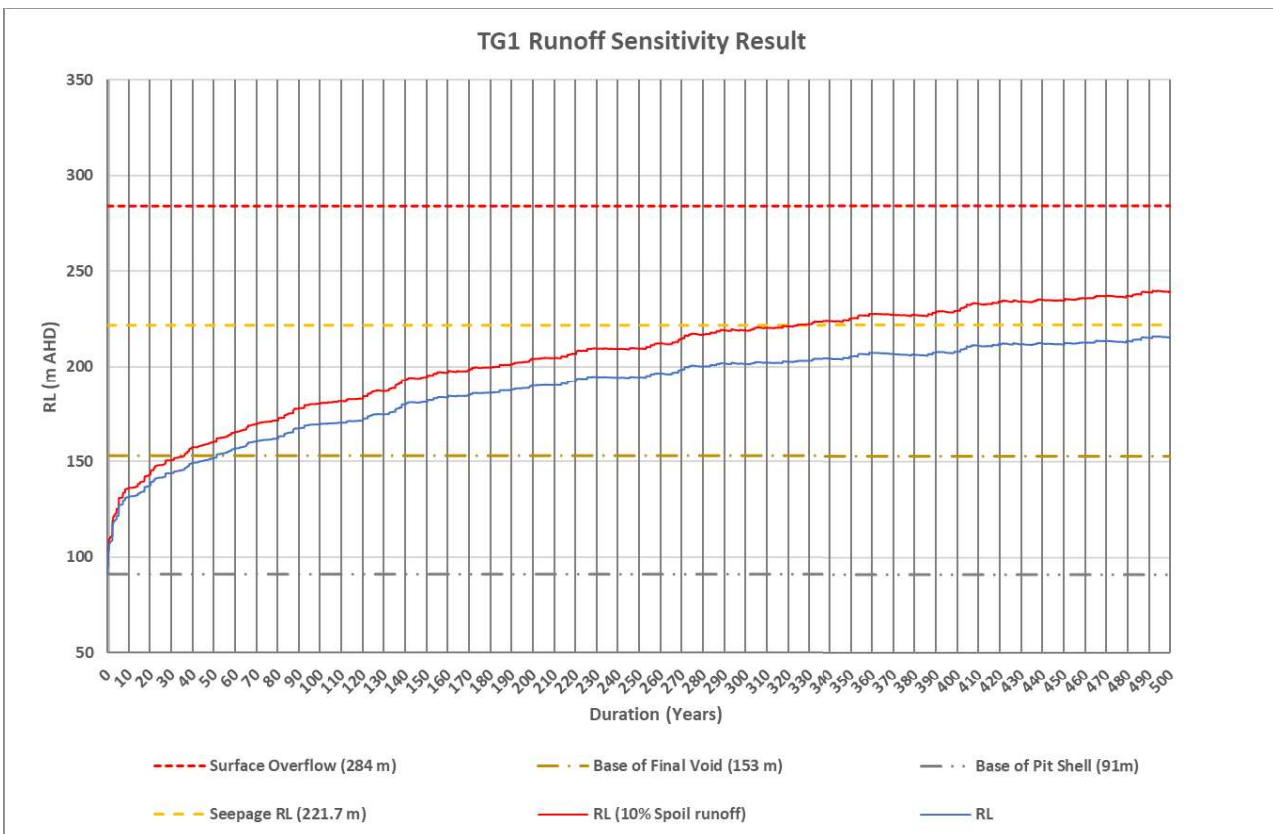
Figure 4-13 Runoff Sensitivity Result – TG1

- As a result of the additional runoff inflow the maximum water level for Trap Gully is 17.9 m above the seepage RL. The mean water level is 11.4 m above the seepage RL. From Figure 4-13 it can also be seen that it is estimated that the seepage RL will not be exceeded for approximately 320 years.

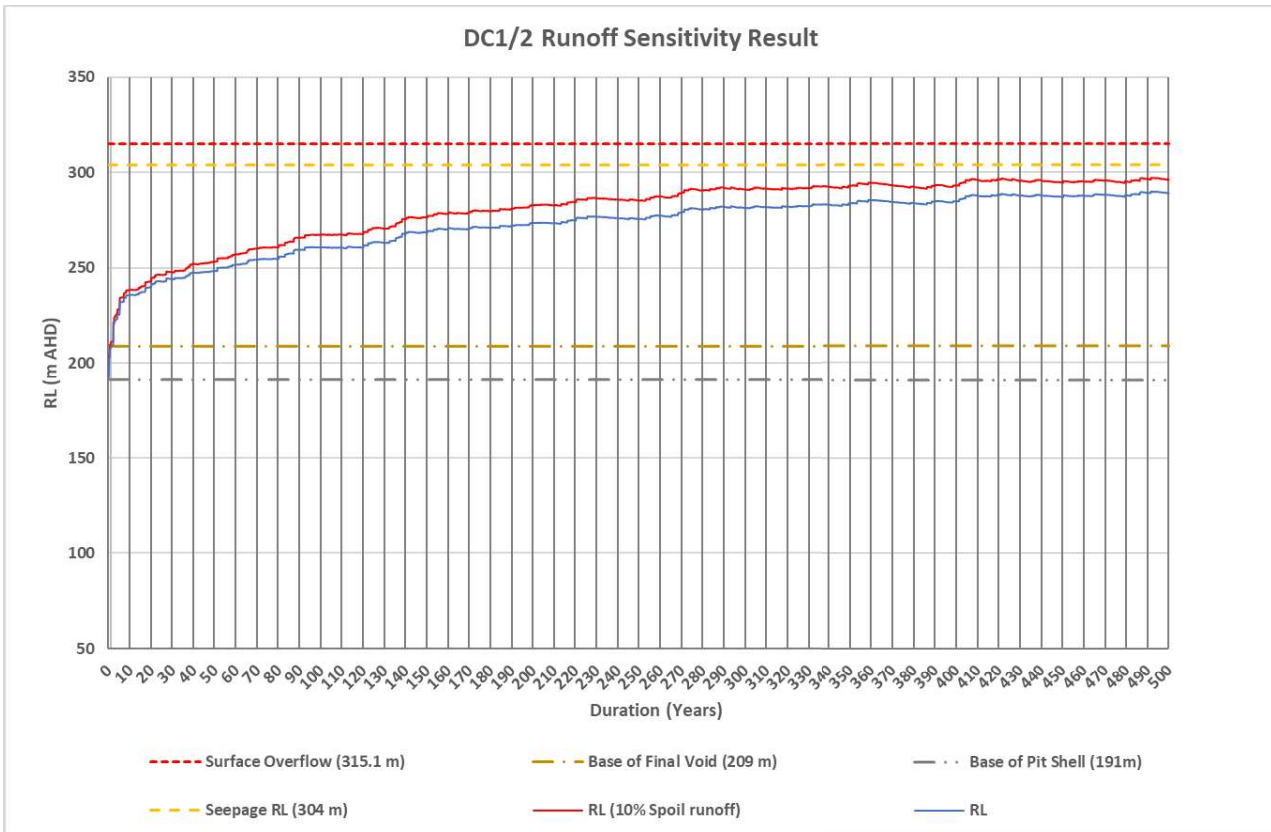
Figure 4-14 Runoff Sensitivity Result – DC1/2

- Dunn Creek (DC1/2 maintains a positive minimum freeboard of 6.8 m (Table 4-3 and Figure 4-14) with the additional runoff inflow.
- The maximum water level at TH2 increases 6.5 m above the seepage RL with the increased runoff scenario although this still remains 1.9 m below the surface overflow RL.

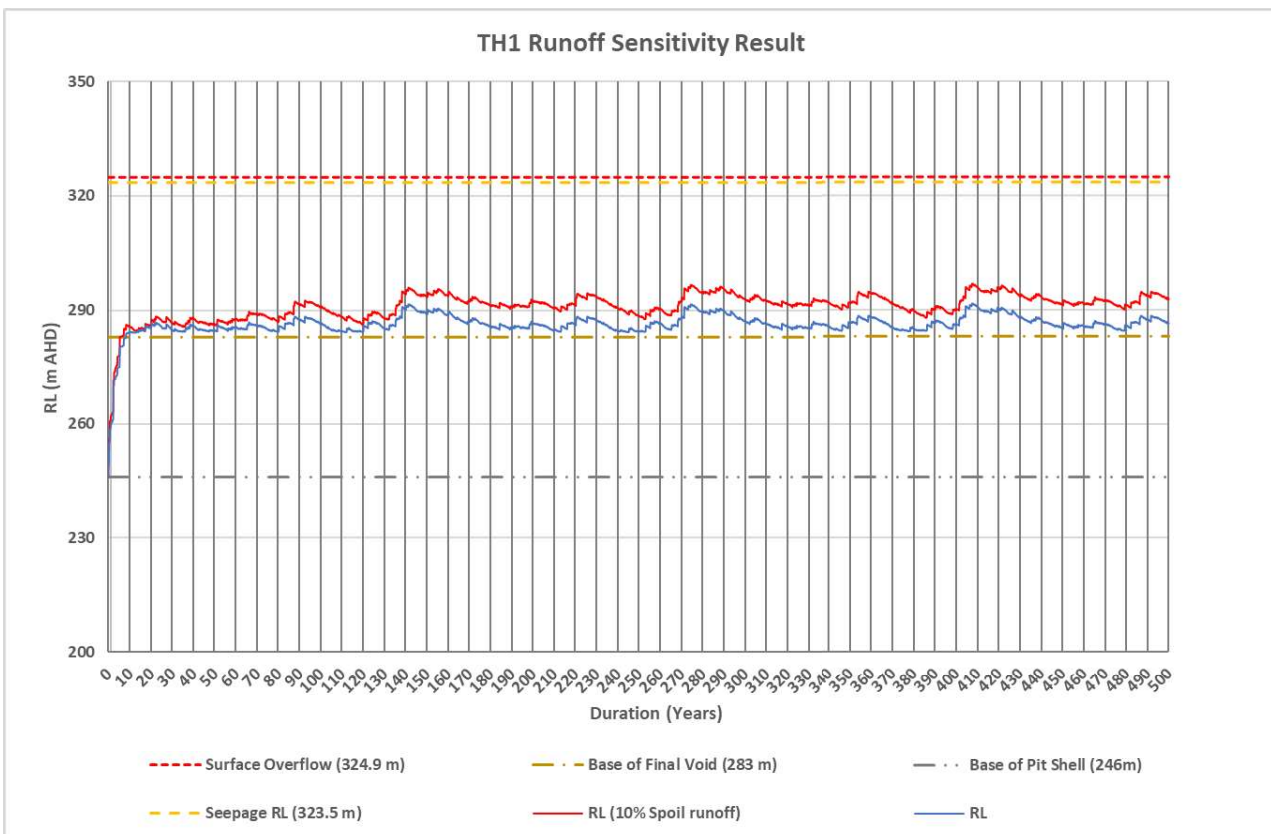
Figure 4-15 Runoff Sensitivity Result – TH1

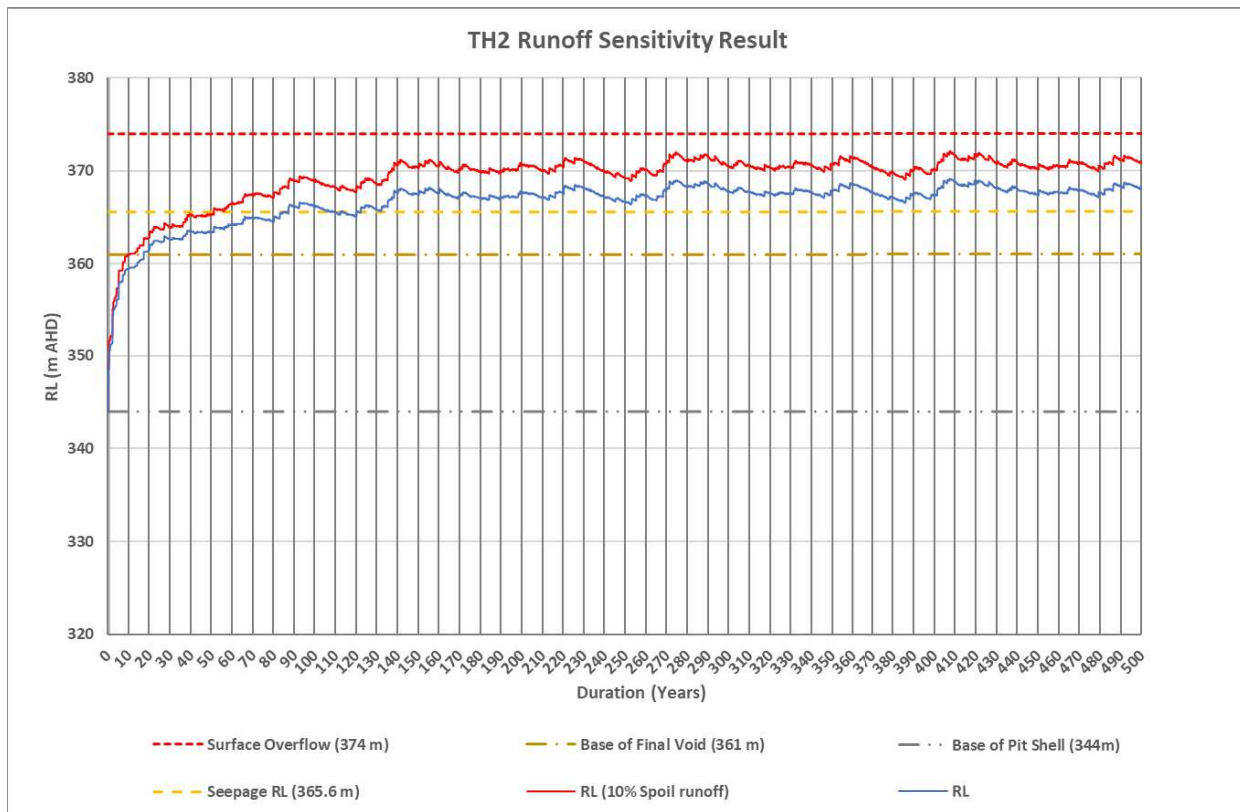
Figure 4-16 Runoff Sensitivity Result – TH2

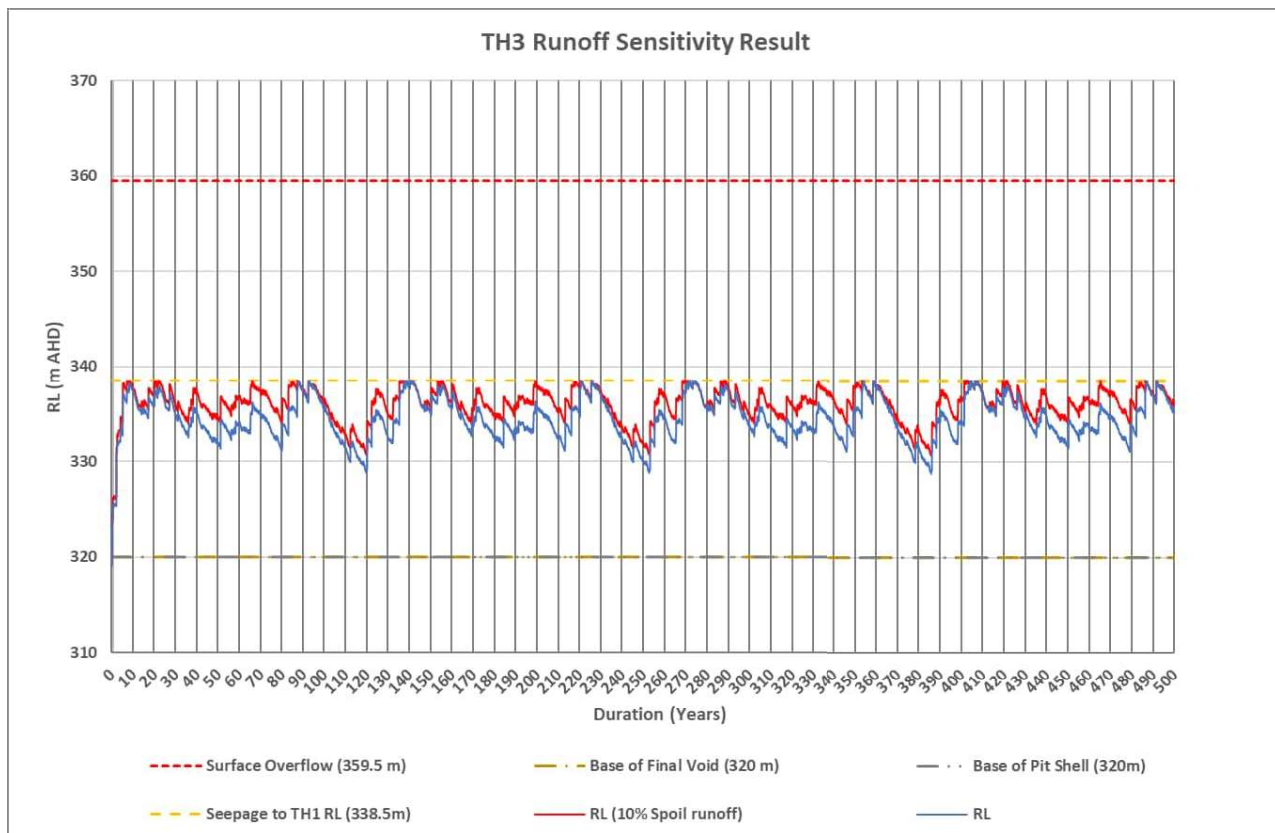
Figure 4-17 Runoff Sensitivity Result – TH3

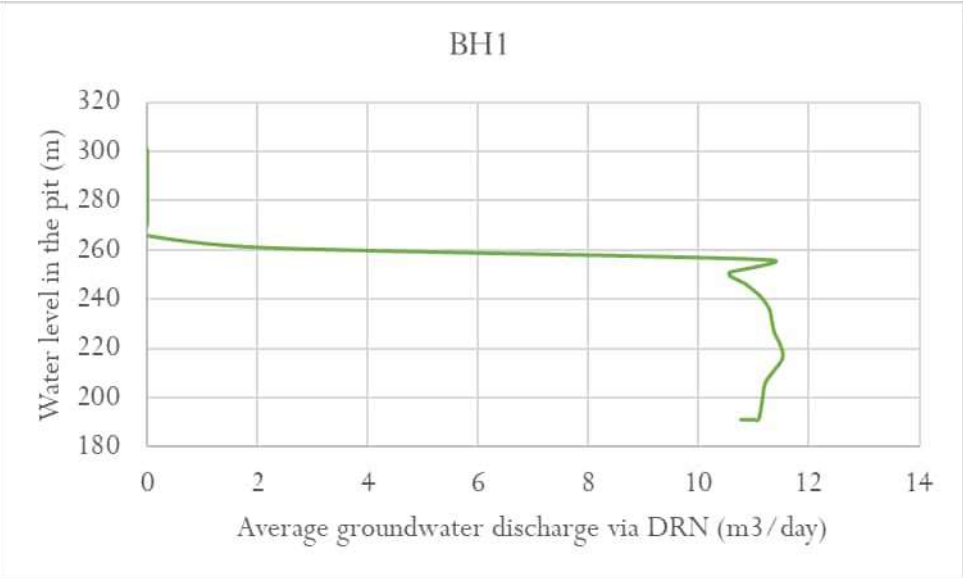
Note that the data reflects estimated groundwater inflows *prior* to application of a 40% loss factor

Figure 7-1 Groundwater Recovery Curve - BH1

| Residual Void | Groundwater Inflow | Assumed TDS (mg/L) | Assumed EC (µS/cm) |
|---|---|---|---|
| BH1 | Refer to Figure 7-1 | 1,072 | 1,600 |

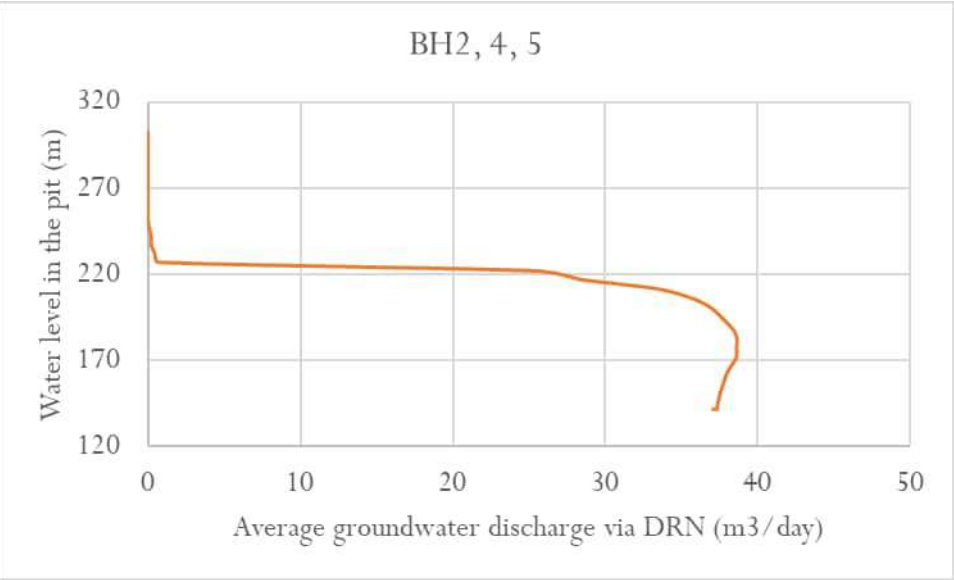
Figure 7-2 Groundwater Recovery Curve - BH2, 4, 5

| Residual Void | Groundwater Inflow | Assumed TDS (mg/L) | Assumed EC (µS/cm) |
|---|---|---|---|
| BH2, 4, 5 | Refer to Figure 7-2 | 1,072 | 1,600 |

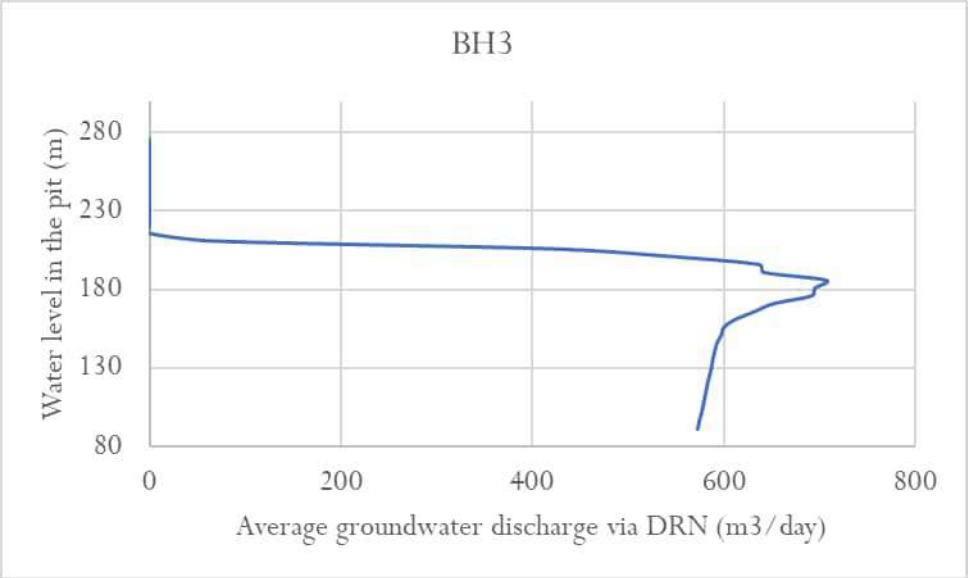
Figure 7-3 Groundwater Recovery Curve - BH3

| Residual Void | Groundwater Inflow | Assumed TDS (mg/L) | Assumed EC (µS/cm) |
|---|---|---|---|
| BH3 | Refer to Figure 7-3 | 1,072 | 1,600 |

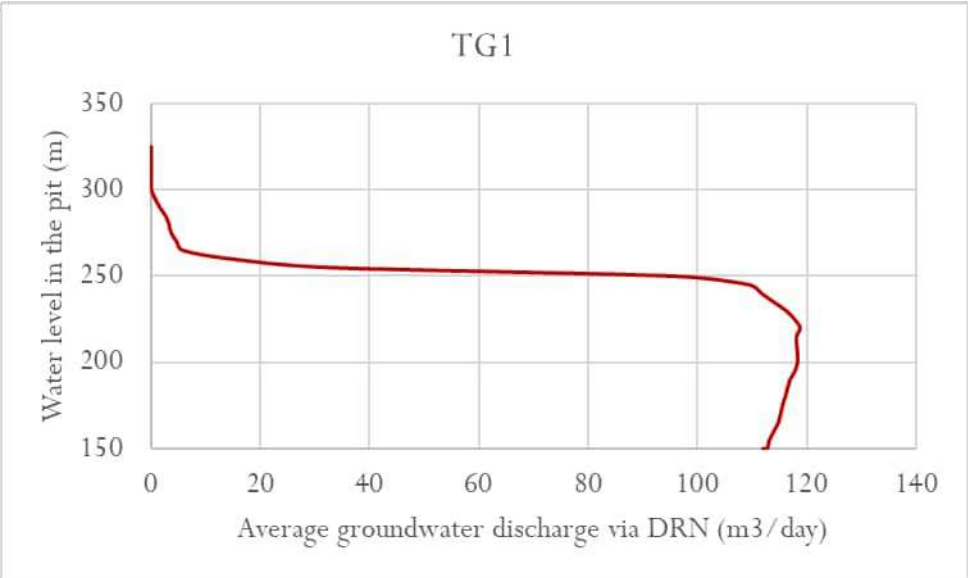
Figure 7-4 Groundwater Recovery Curve - TG1

| Residual Void | Groundwater Inflow | Assumed TDS (mg/L) | Assumed EC (µS/cm) |
|---|---|---|---|
| TG1 | Refer to Figure 7-4 | 637 | 950 |

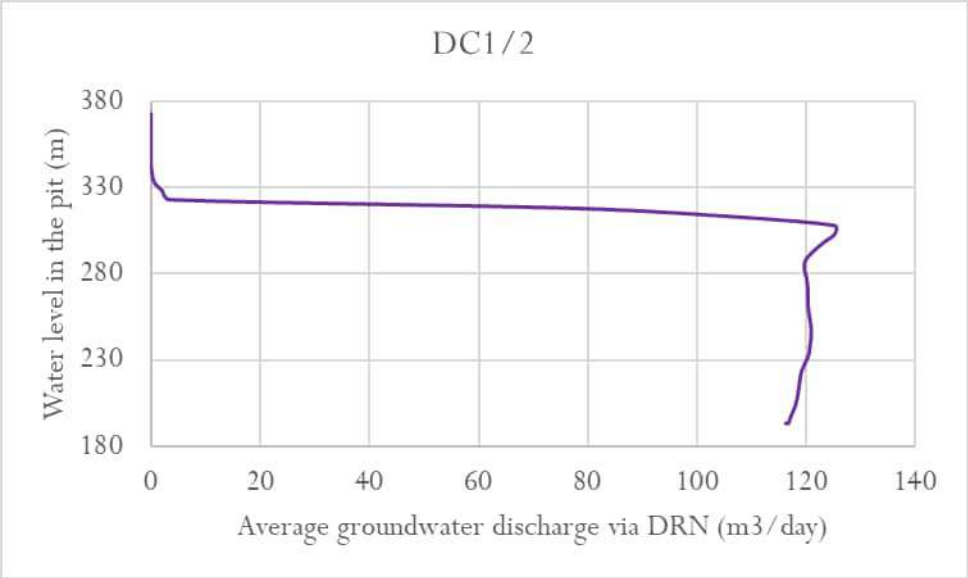
Figure 7-5 Groundwater Recovery Curve - DC1/2

| Residual Void | Groundwater Inflow | Assumed TDS (mg/L) | Assumed EC (µS/cm) |
|---|---|---|---|
| DC1/DC2 | Refer to Figure 7-5 | 1,240 | 1,850 |

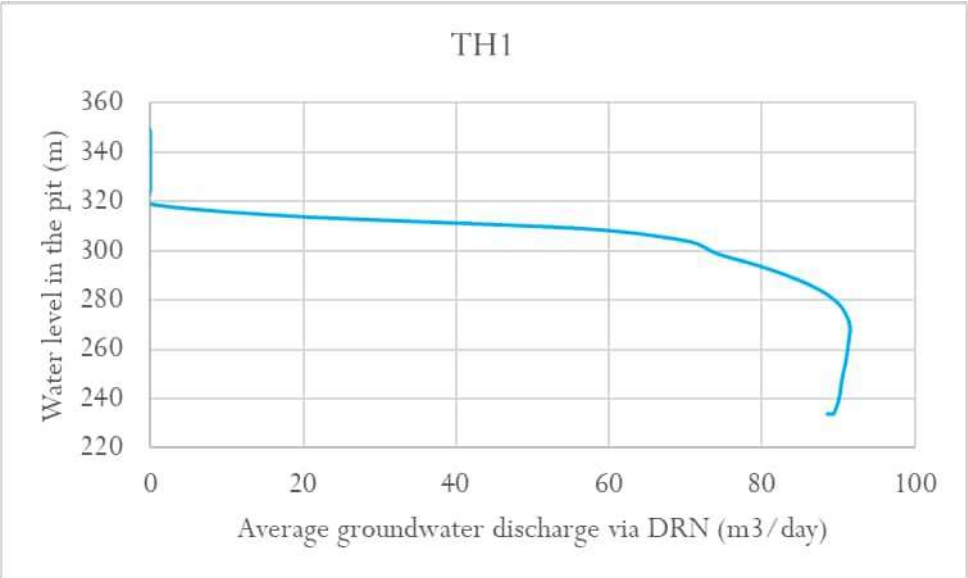
Figure 7-6 Groundwater Recovery Curve - TH1

| Residual Void | Groundwater Inflow | Assumed TDS (mg/L) | Assumed EC (µS/cm) |
|---|---|---|---|
| TH1 | Refer to Figure 7-6 | 1,541 | 2,300 |

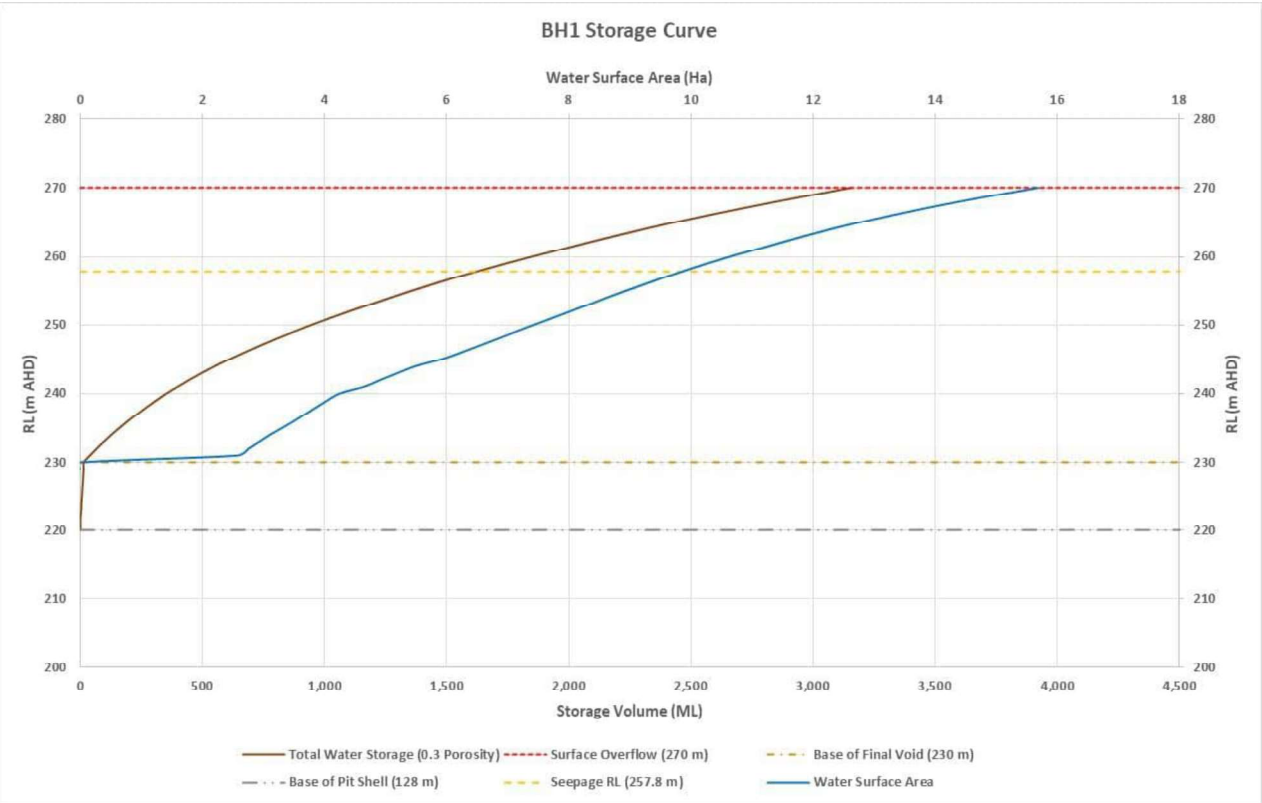
Figure 7-7 Storage Curve - BH1

- Catchment area (and subsequent runoff contribution) relative to final void storage capacity
- Potential spoil water storage capacity below the base of the final void – while the final void water level remains below the final void base (i.e., water is only contained in the saturated spoil and the water level has yet to reach the base of the final void) no losses (water surface evaporation) are applied. Consequently, voids with relatively small spoil storage volumes below the final void base (e.g., BH1 and TH3 (refer to storage curve Figure 7-7 and Figure 7-14 respectively) have relatively rapid fill times

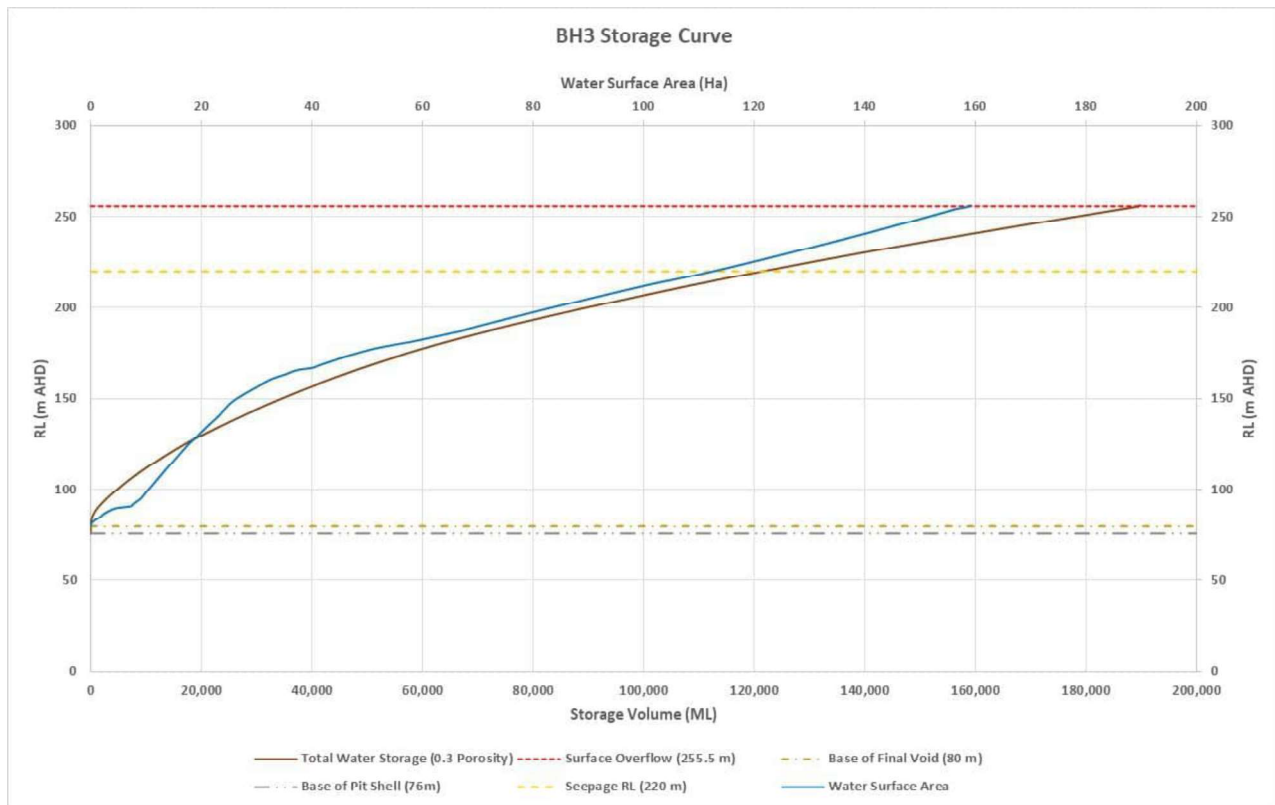
Figure 7-9 Storage Curve – BH3

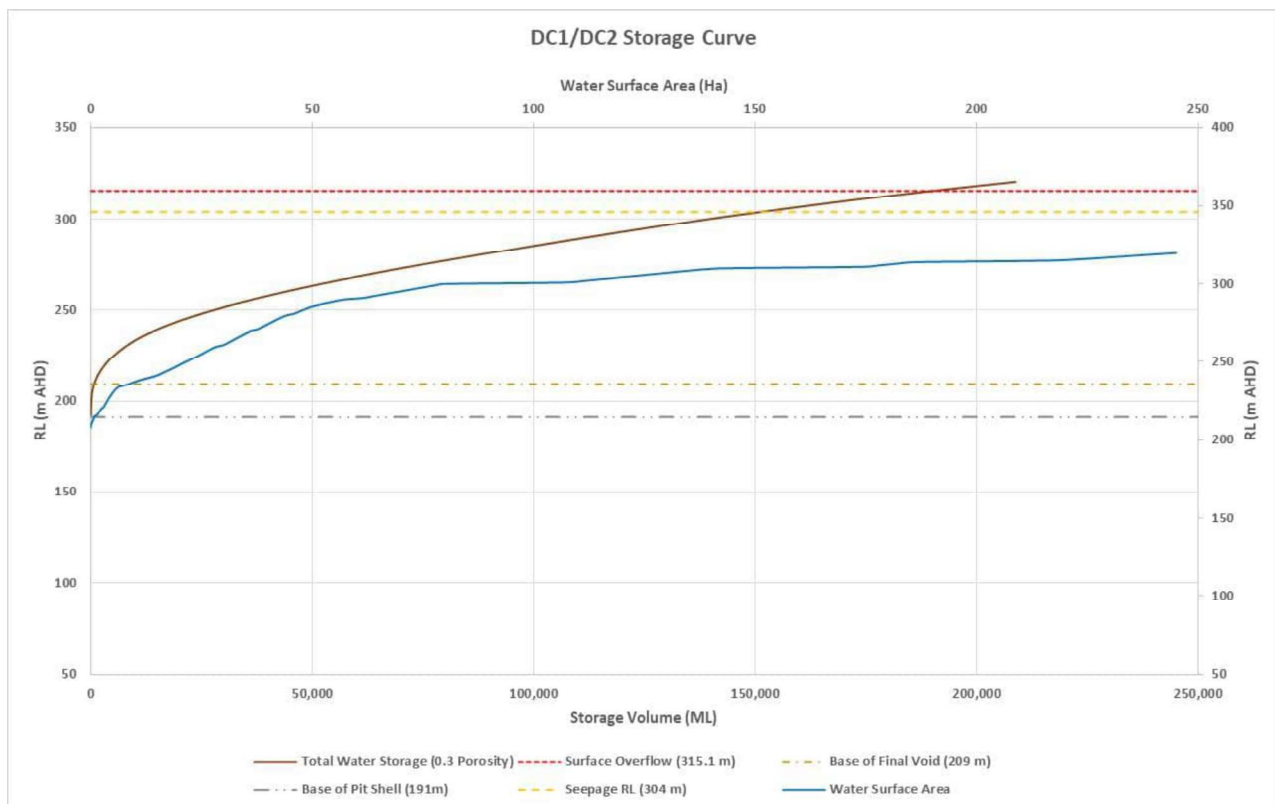
Figure 7-10 Combined Storage Curve – DC1, DC2

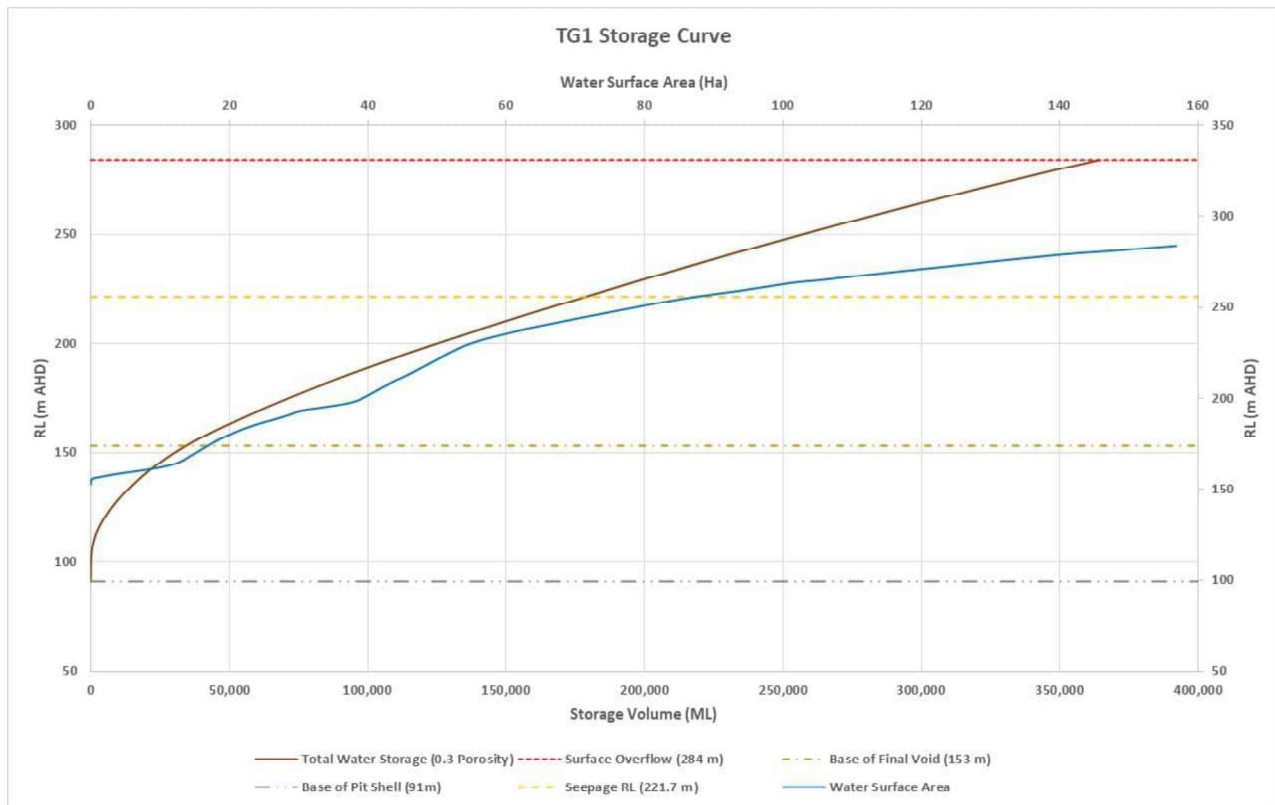
Figure 7-11 Storage Curve – TG1

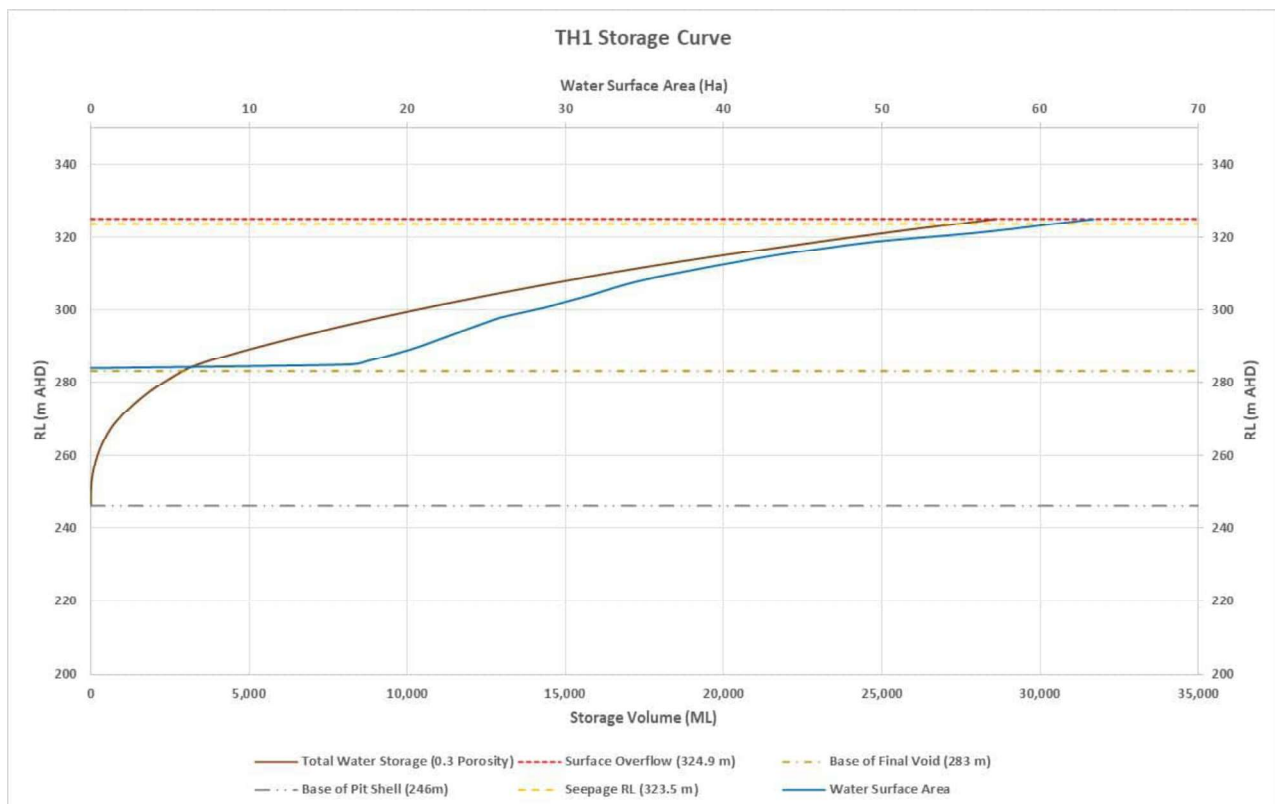
Figure 7-12 Storage Curve – TH1

- Storage geometry such as relationship between total storage volume and water surface area - where there is a large surface area relative to storage volume, equilibrium (balance between inflows and outflows) is reached more rapidly e.g., TH1 (refer to storage curve Figure 7-12)

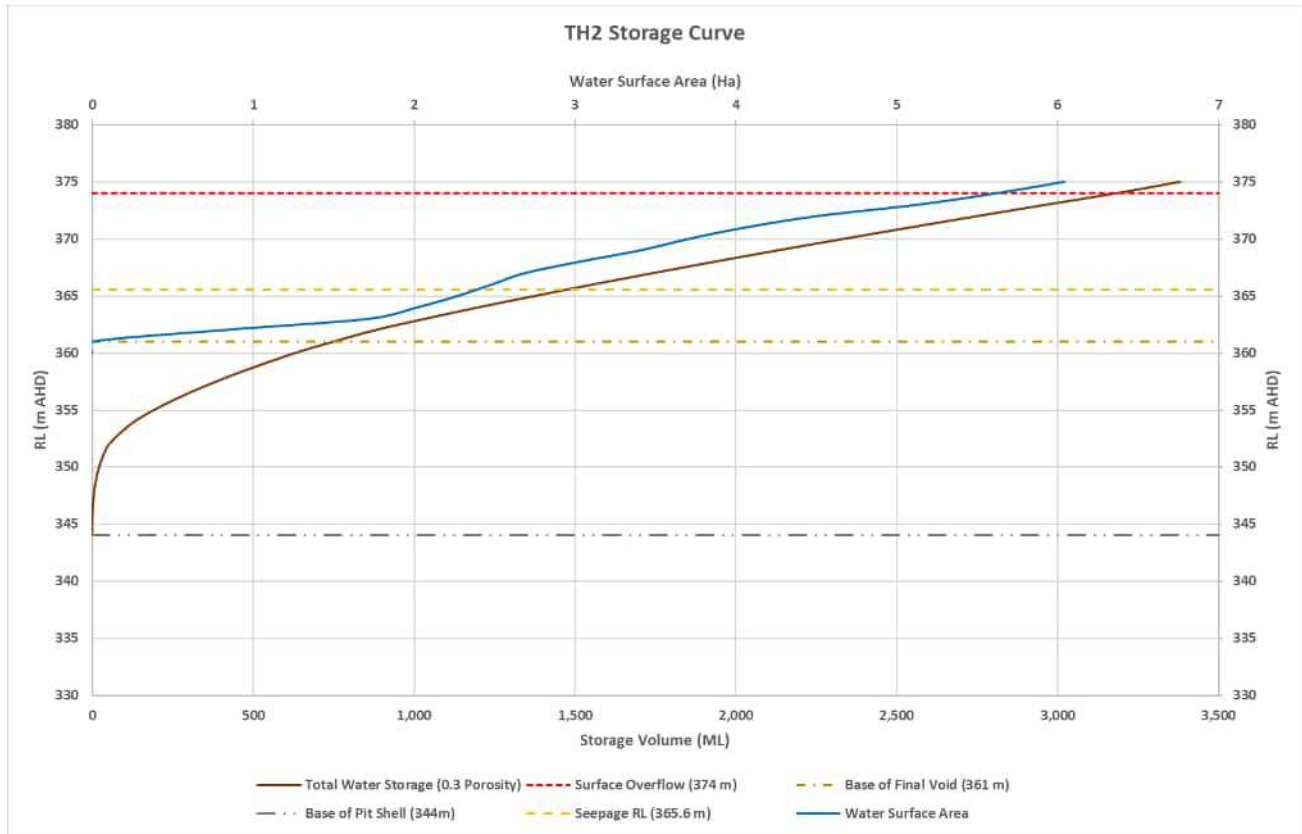
Figure 7-13 Storage Curve – TH2

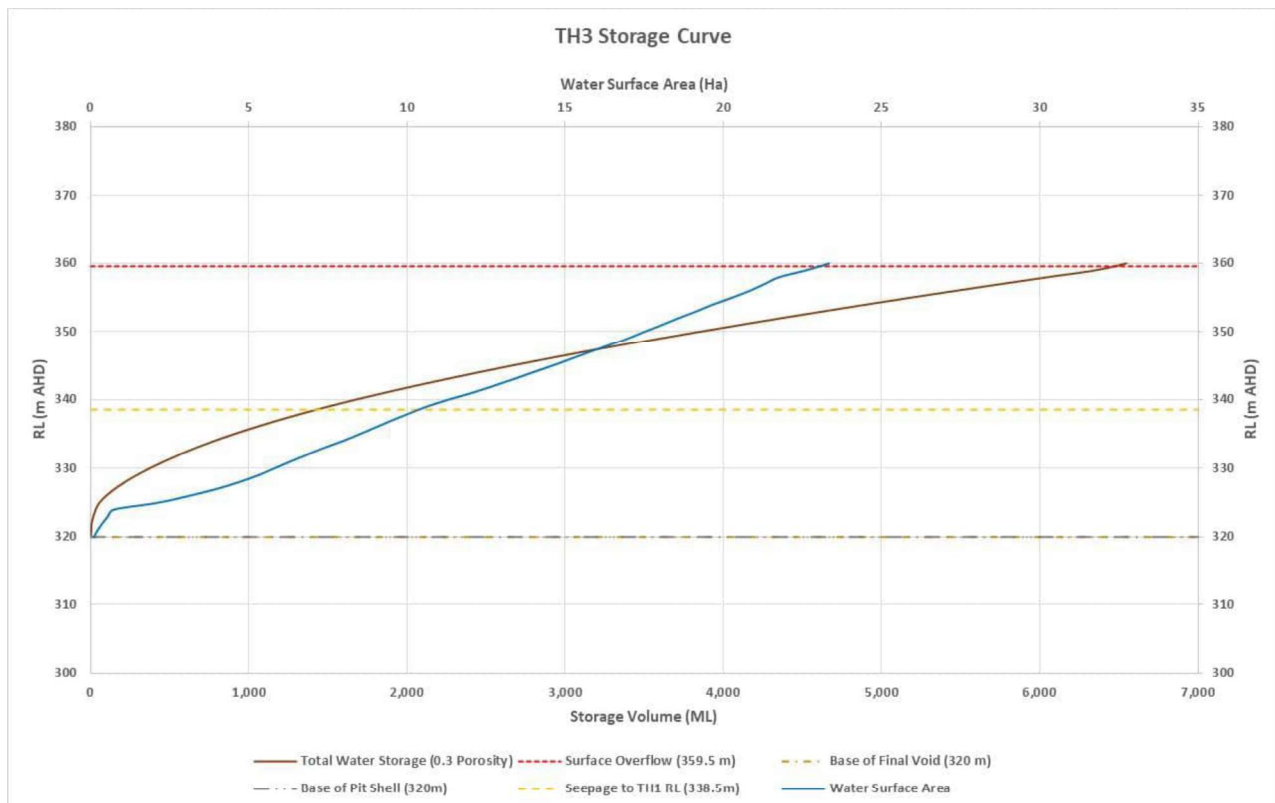
Figure 7-14 Storage Curve – TH3

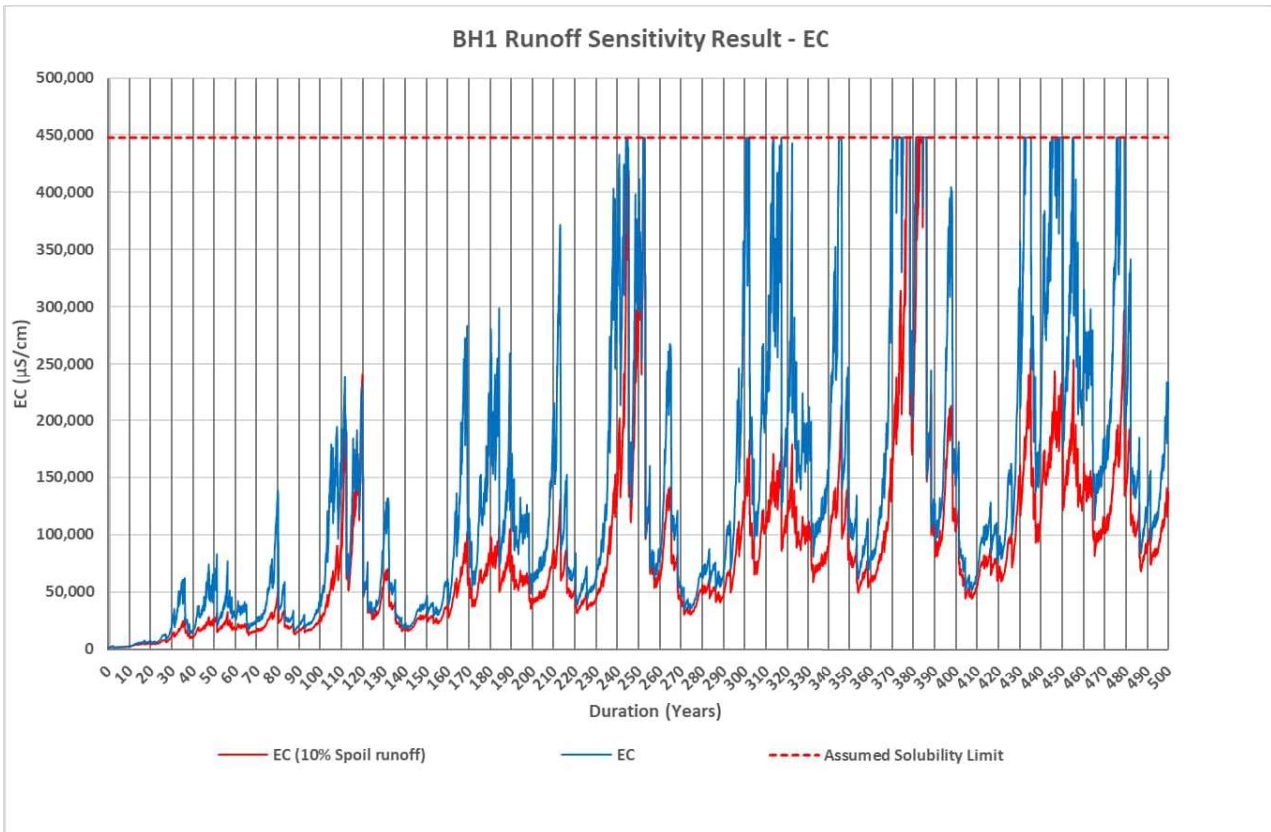
Figure 7-15 Runoff Sensitivity Result - BH1 EC

Water quality plots for the runoff sensitivity are shown in Appendix B (Figure 7-15 to Figure 7-22) and indicate that final void EC is lower for all final voids as a result of increased runoff. This results from the increased dilutionary impact the additional runoff inflow provides.

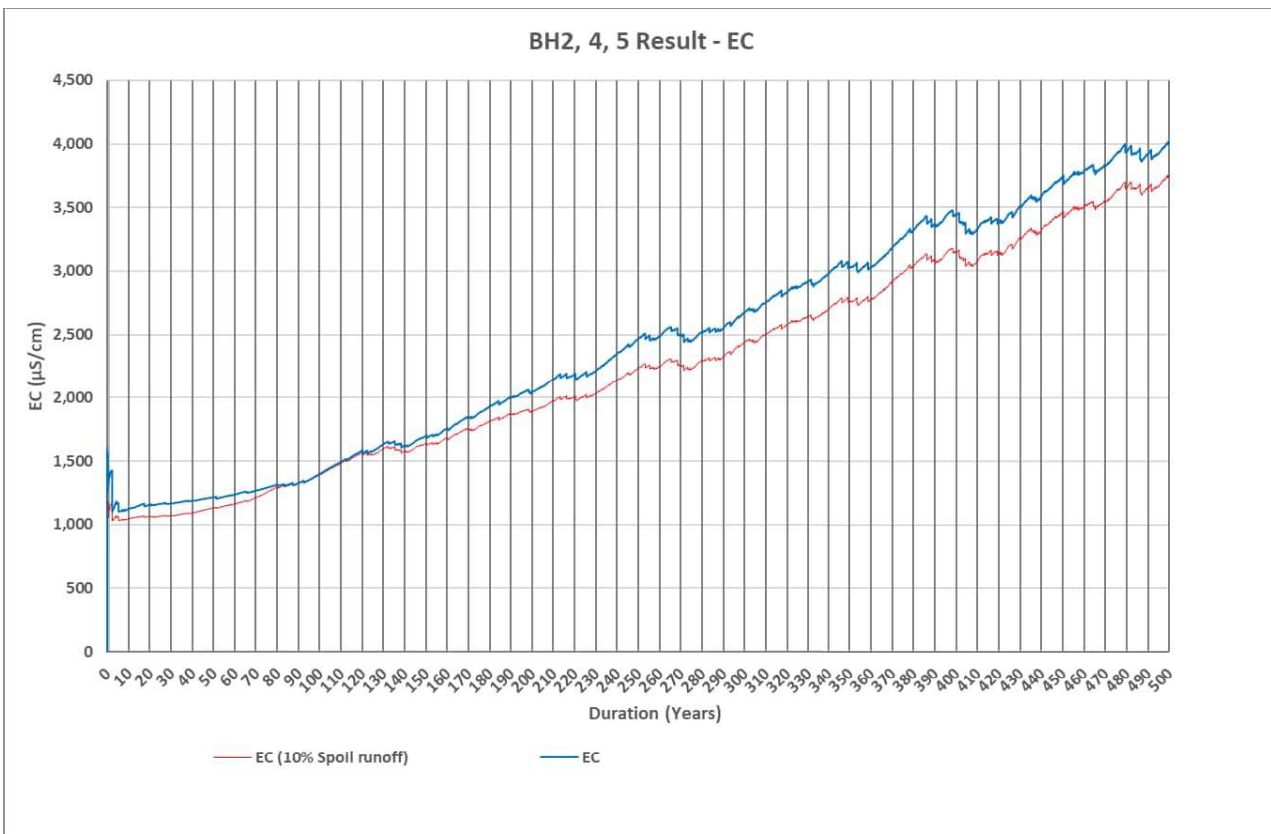
Figure 7-16 Runoff Sensitivity Result - BH2, 4, 5 EC
