Hansen Bailey was commissioned by Batchfire Resources Pty Ltd (Batchfire) to prepare a Rehabilitation Management Plan (RMP) for the Callide Mine. This RMP has been prepared in accordance with the Callide Mine Environmental Authority (EA) conditions H2 and H3.

| Final Void Water Modelling | |

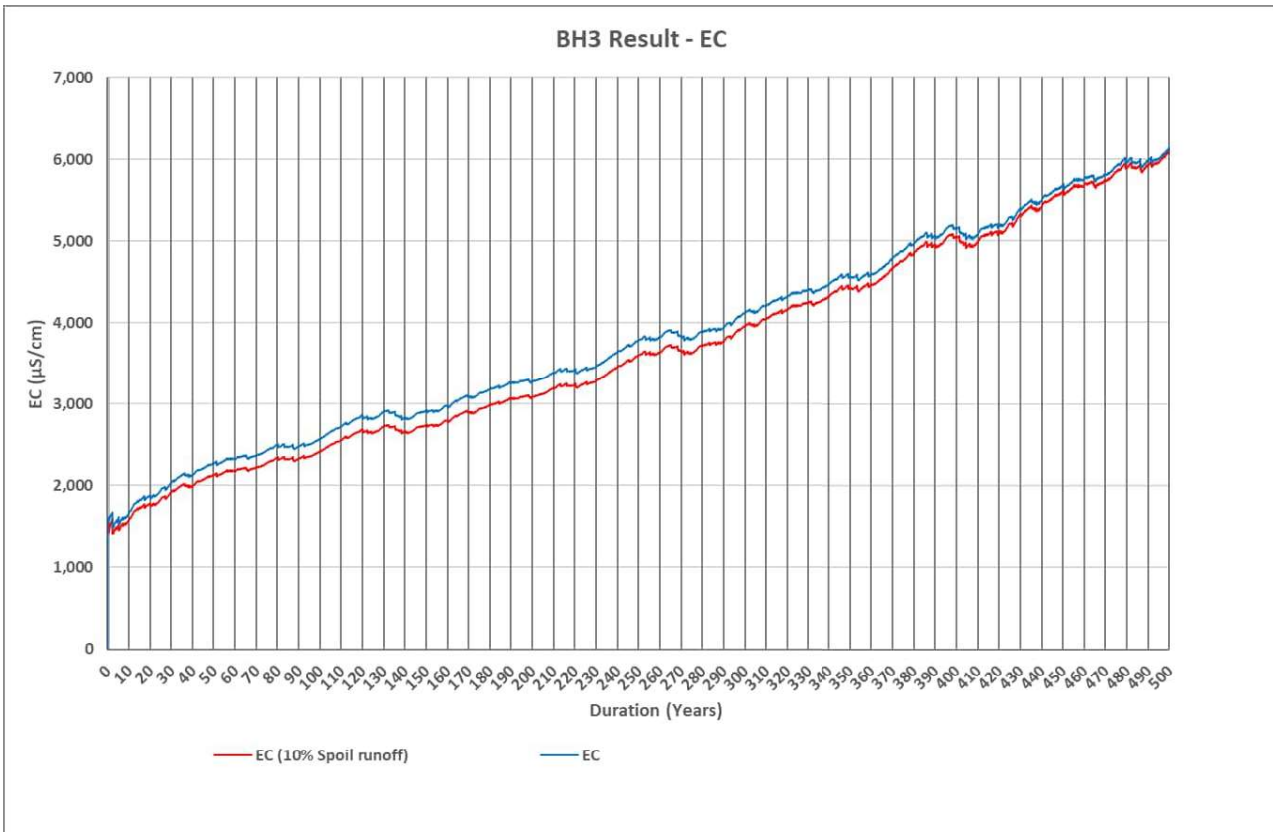
**Figure 7-17 Runoff Sensitivity Result - BH3 EC**

Water quality plots for the runoff sensitivity are shown in Appendix B (Figure 7-15 to Figure 7-22) and indicate that final void EC is lower for all final voids as a result of increased runoff. This results from the increased dilutionary impact the additional runoff inflow provides.

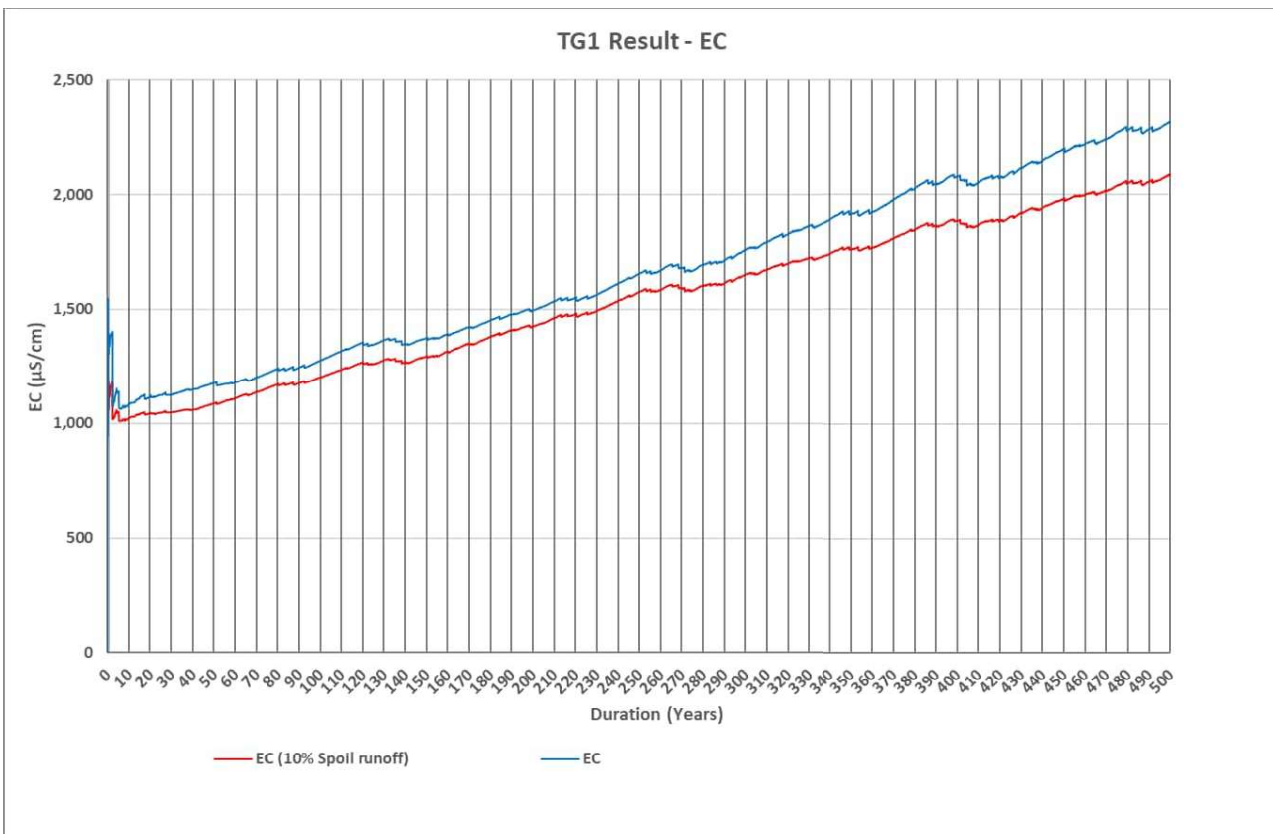
**Figure 7-18 Runoff Sensitivity Result – TG1 EC**

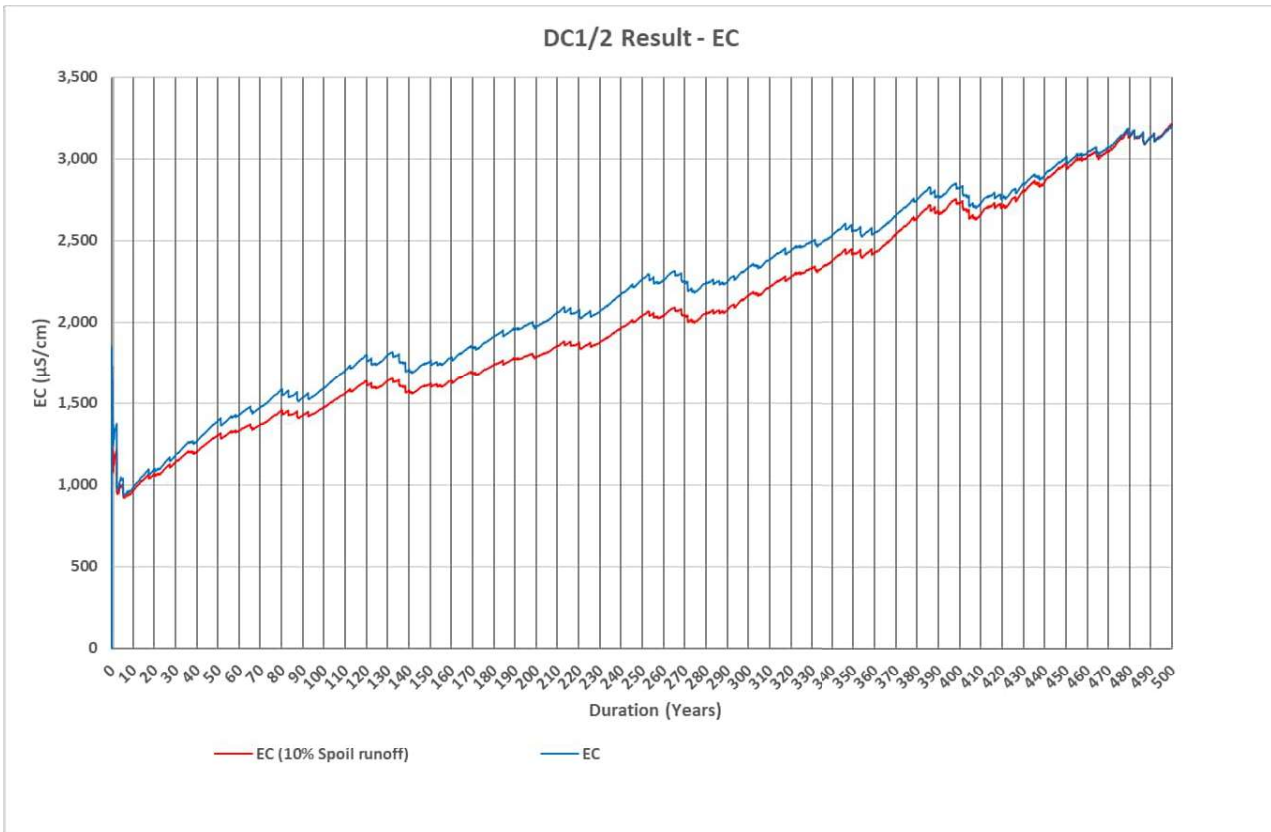
**Figure 7-19 Runoff Sensitivity Result – DC1/2 EC**

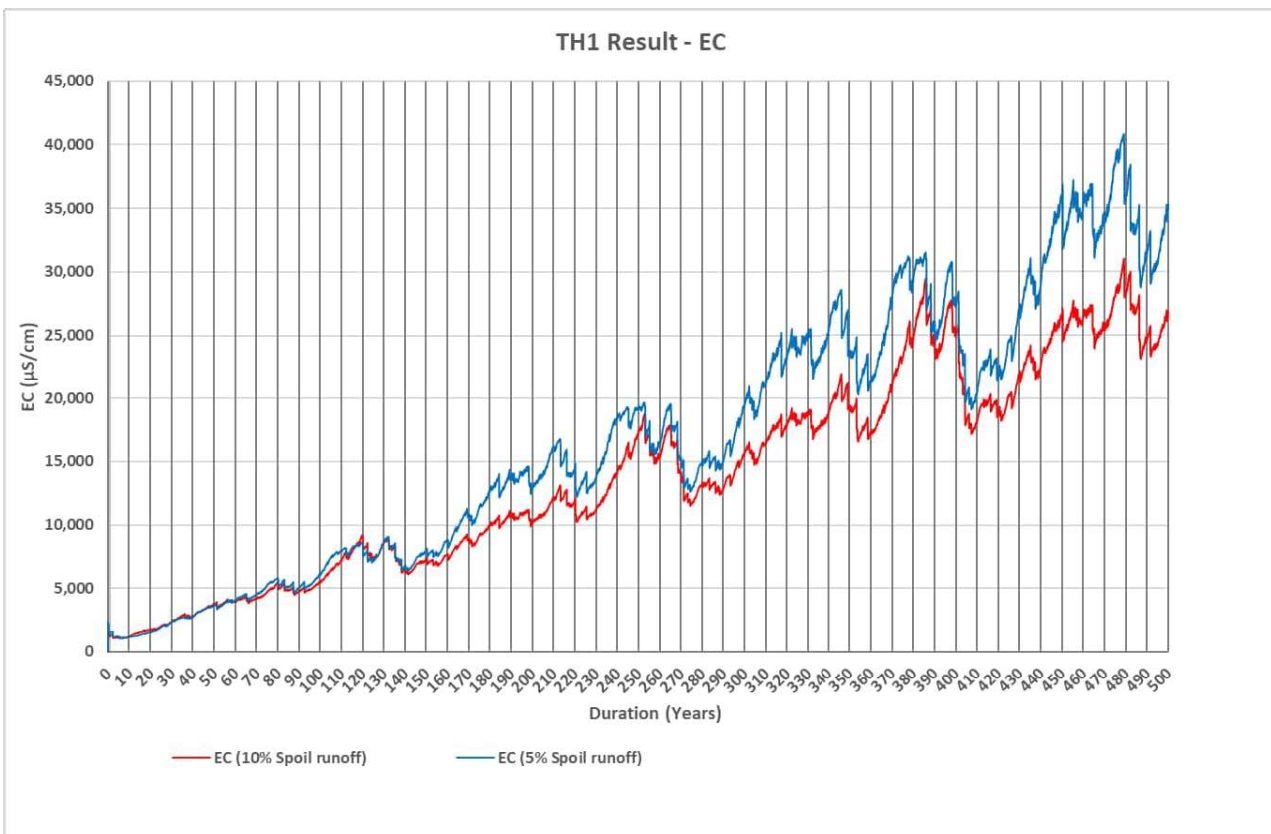
**Figure 7-20 Runoff Sensitivity Result – TH1 EC**

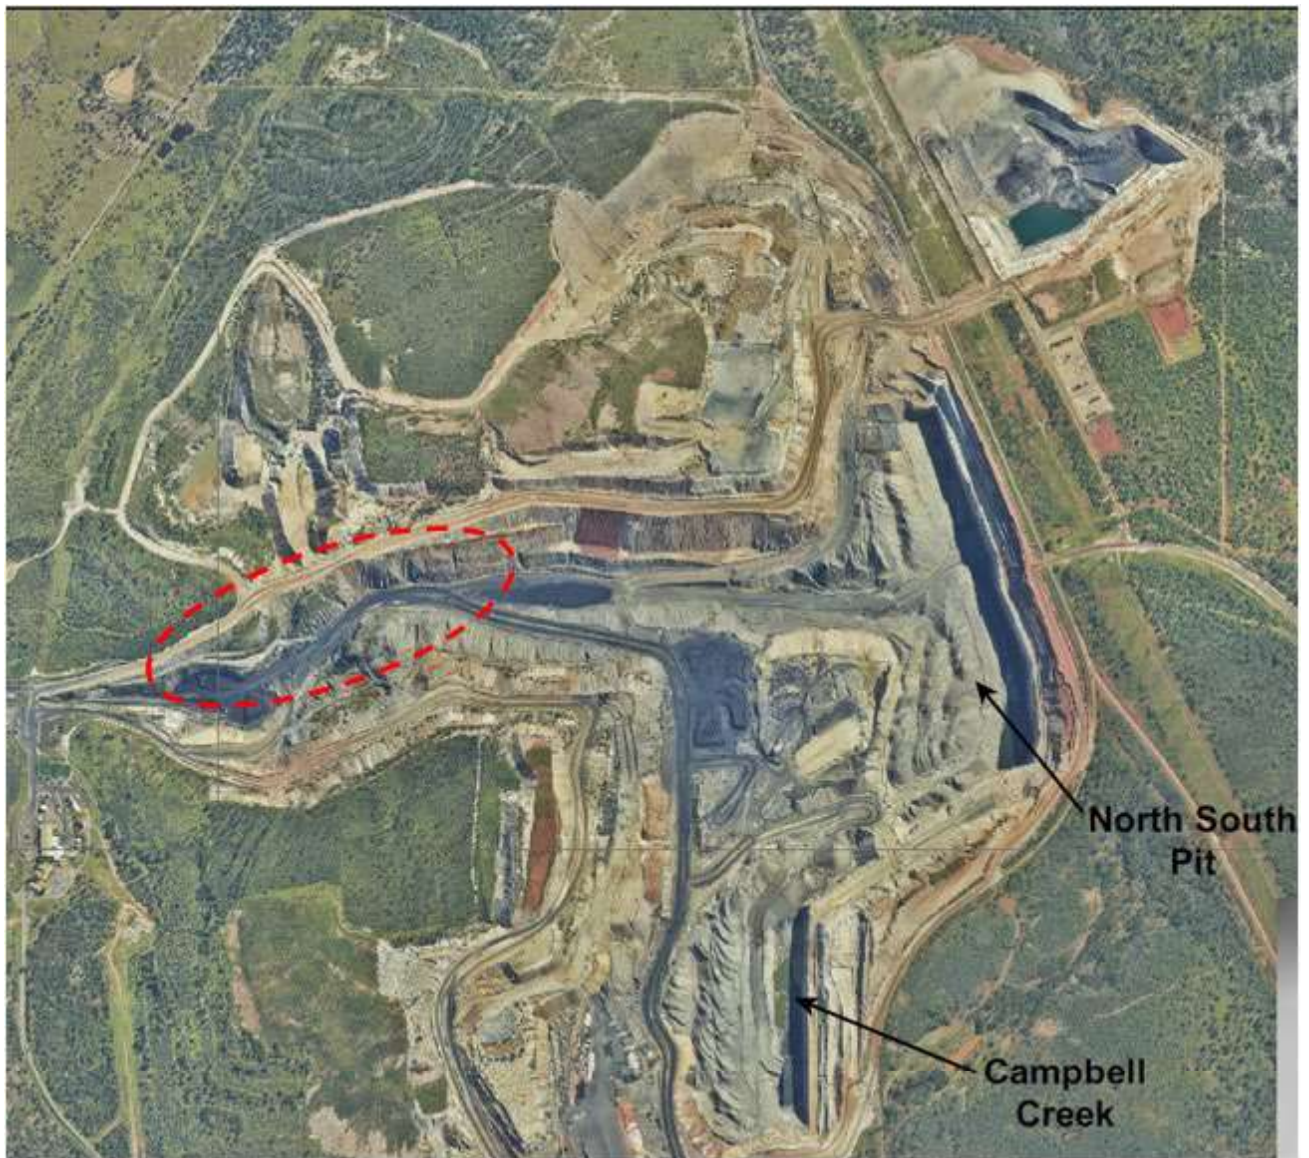
**Inset 2: Boundary Hill North Mining Area showing area where ramp batters have minor exceedances of  $40^{\circ}$**

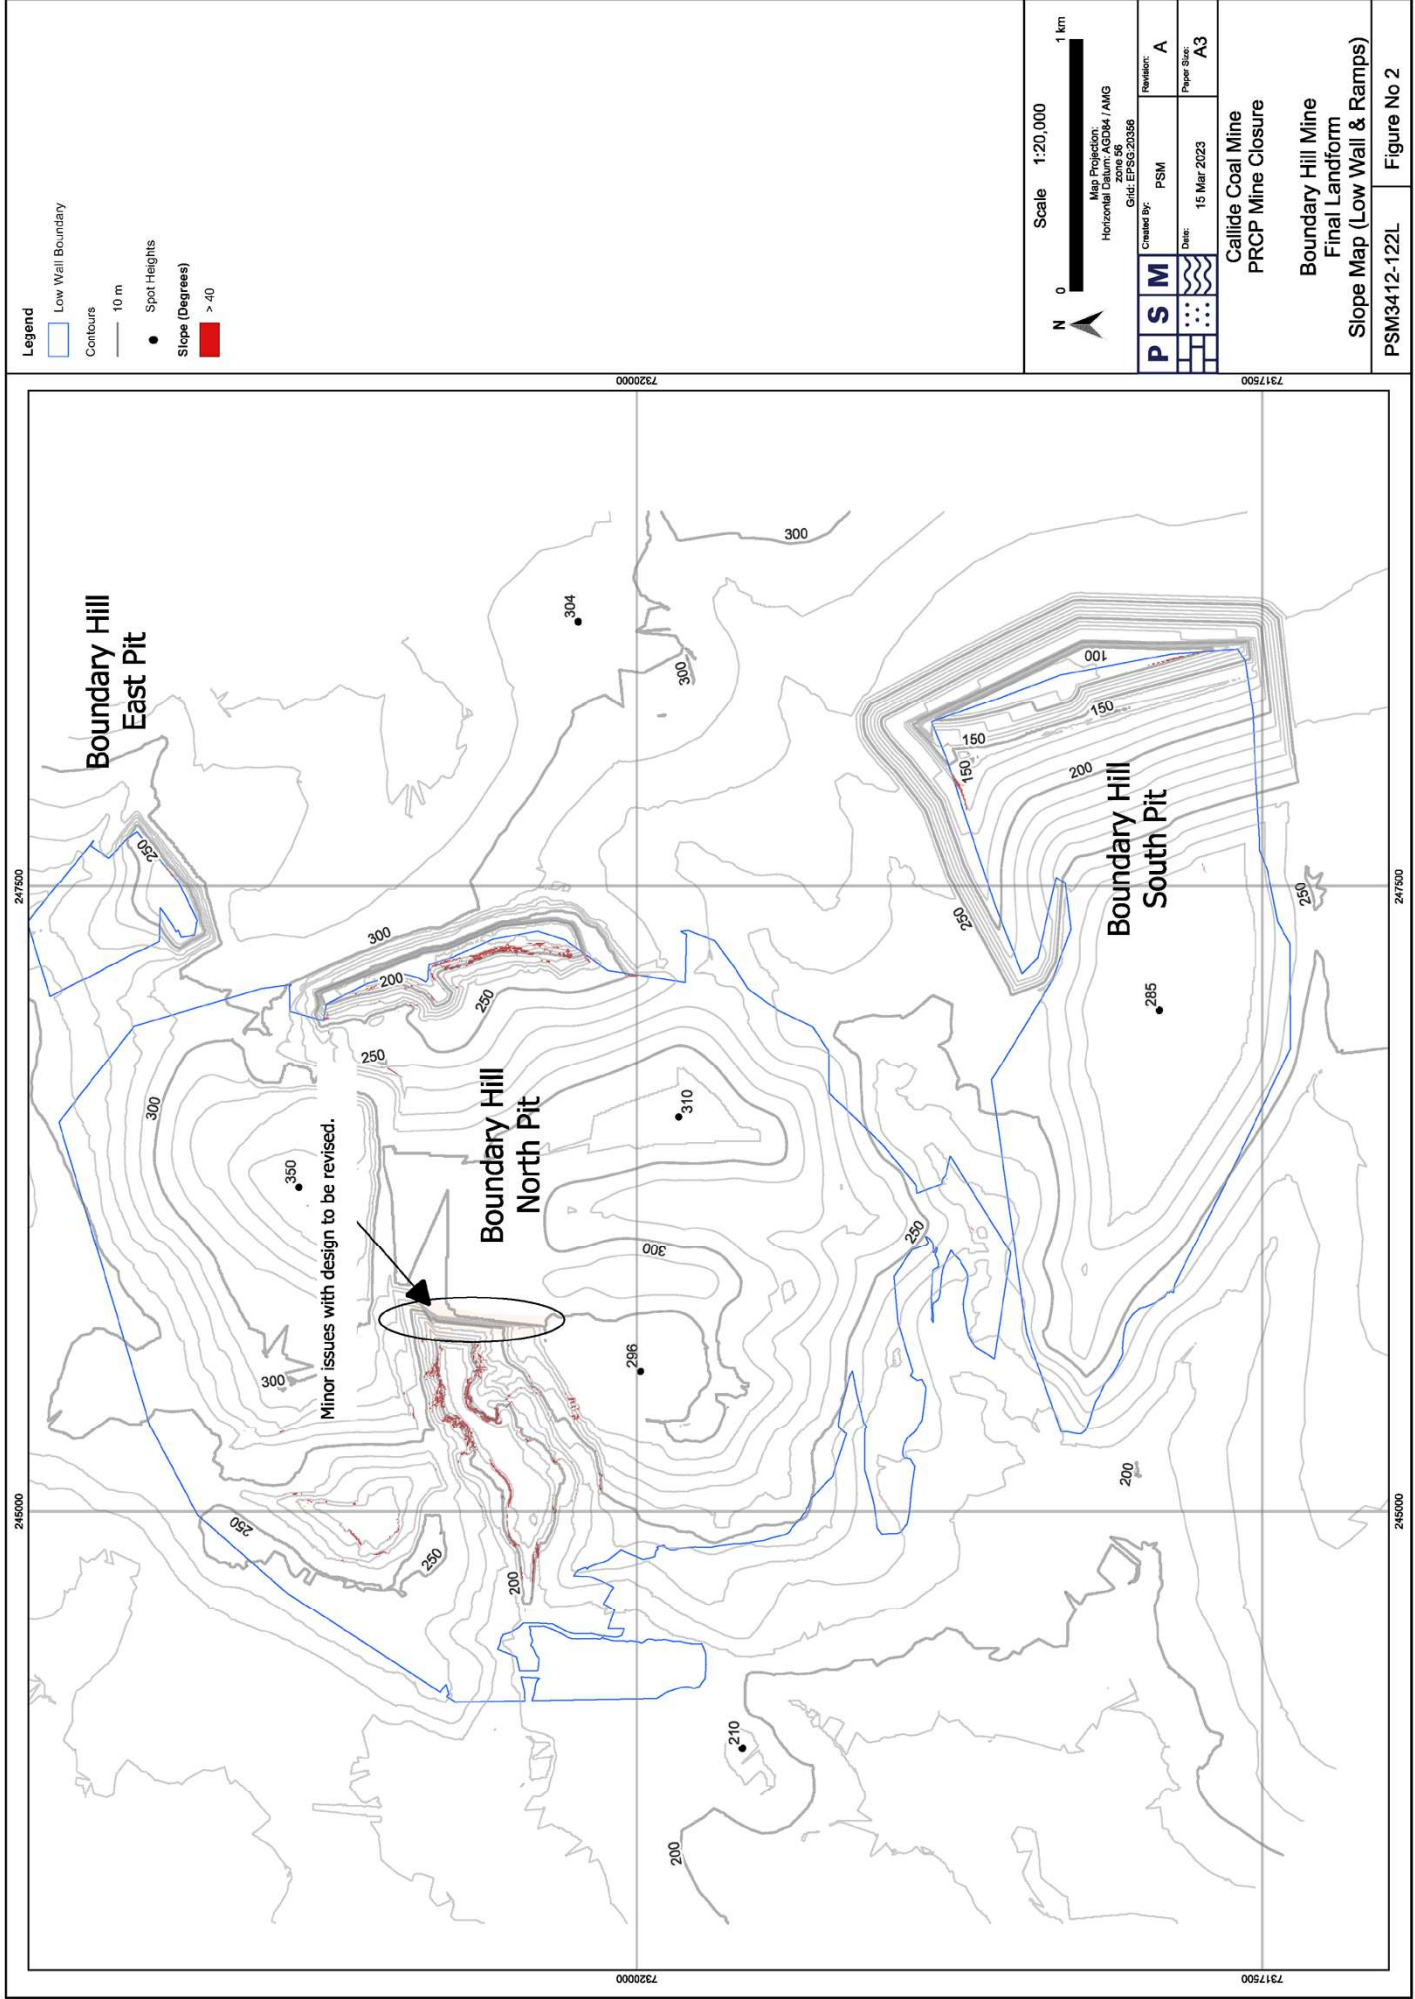
PSM3412-122L Figure No 2

Boundary Hill Mine  
Final Landform  
Slope Map (Low Wall & Ramps)

- PSM have noted areas in Boundary Hill South, south and east of above areas, where minor areas of the final landform appears to be overly steep, Figure 2. Batchfire have confirmed that this is due to a minor issue with the landform design geometry, and which will be addressed during construction to achieve a design slope in keeping with Table F3

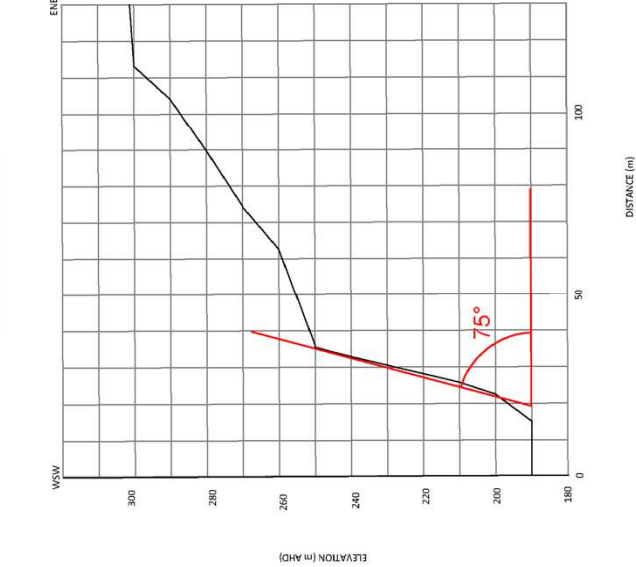
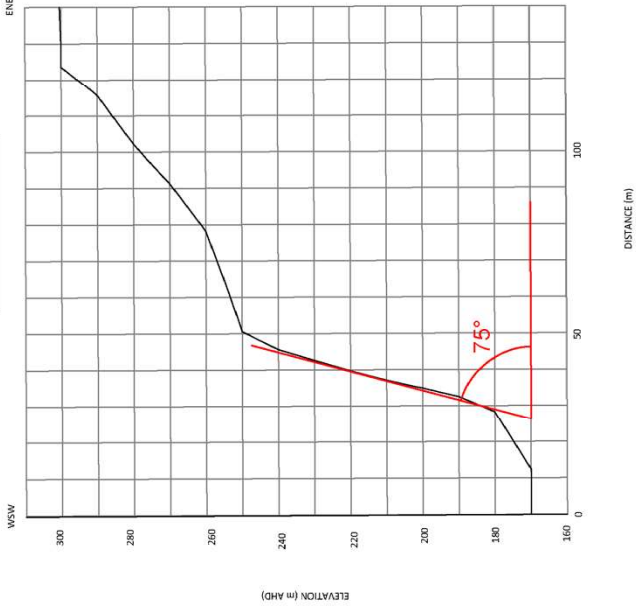
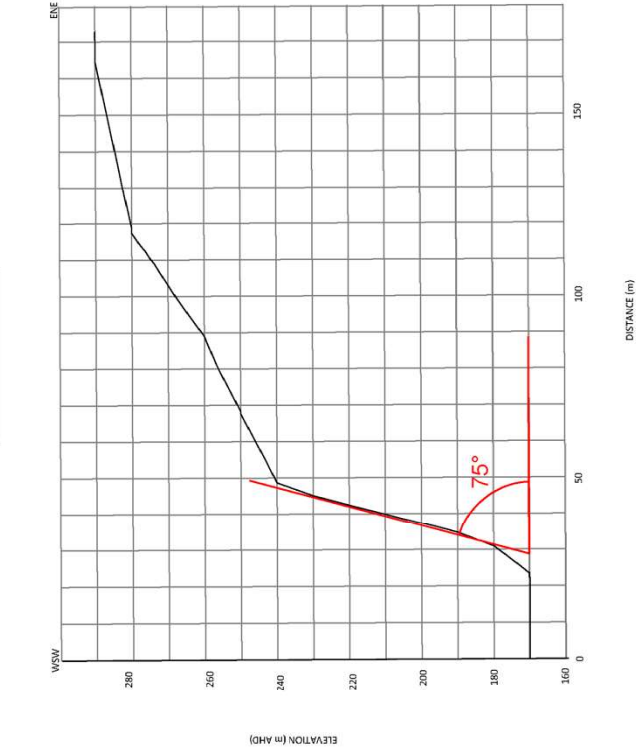
Section 1

Section 2

Section 3

Callide Coal Mine  
PRCP Mine Closure  
Boundary Hill Pit Sections  
(High Wall)

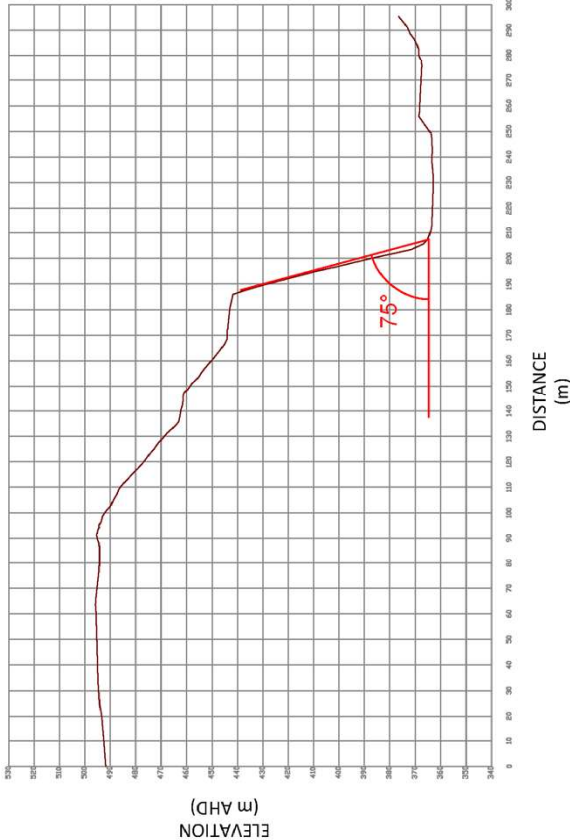
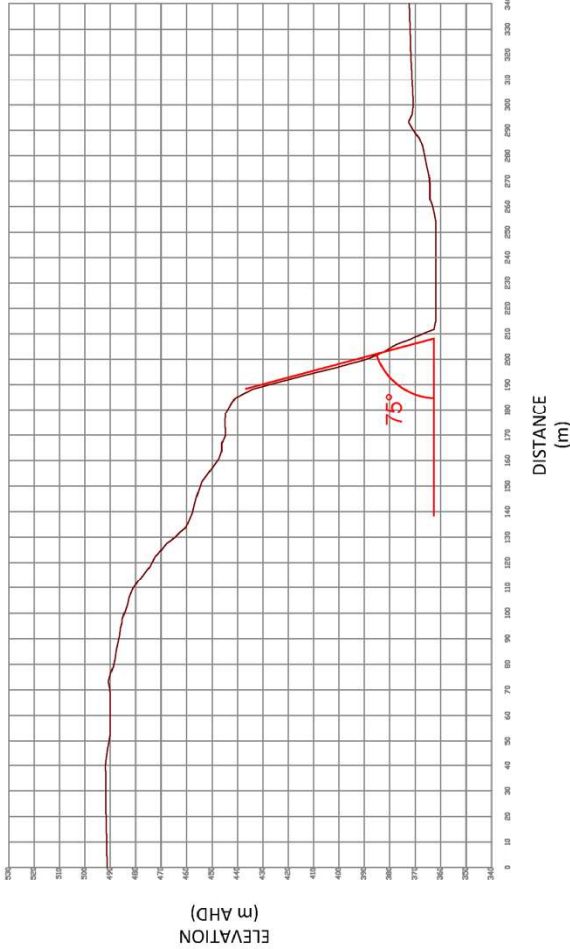
Section 1

Section 2

| Refer to Figure 3 for section location | Callide Coal Mine PRCP<br>Mine Closure<br>The Hut Pit Sections<br>(High Wall) | PSM | |

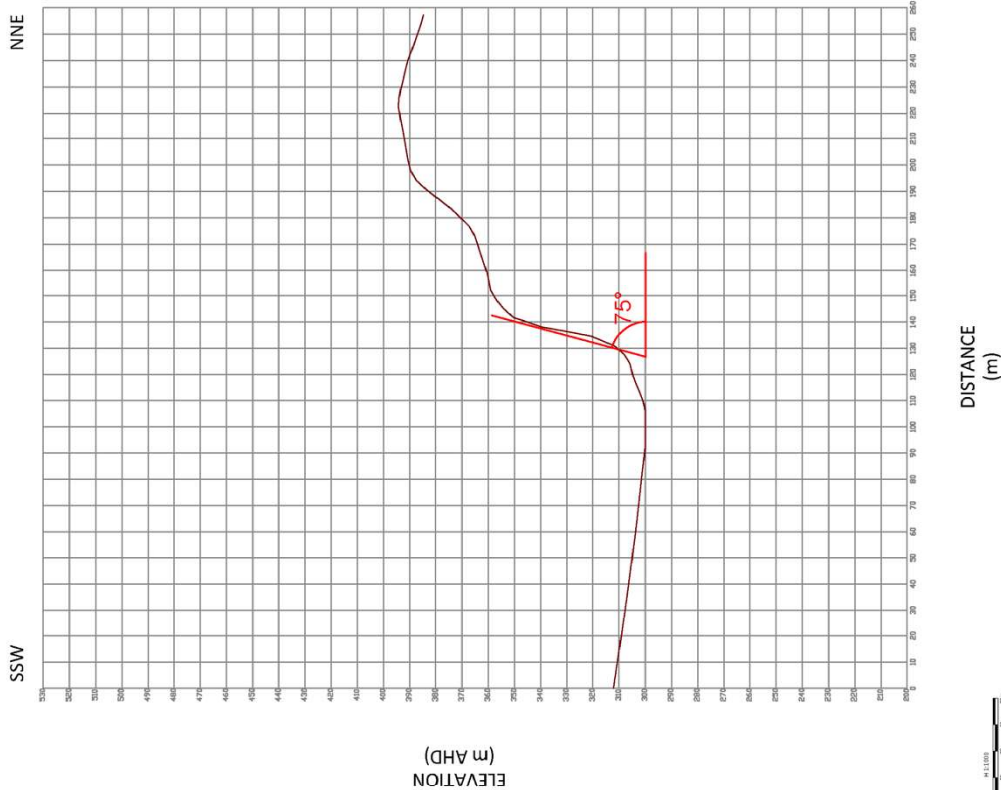
Section 1

| Refer to Figure 5 for section location | | Callide Coal Mine<br>PRCP Mine Closure<br>Dunn Creek Pit Section<br>(High Wall) | | DRAWN | PSM |

- For Dunn Creek (DC) mining there is one area where the highwall angle in the Bluff pit final void exceeds  $75^{\circ}$ , Figure 5. This is in an area of an existing highwall that has a slope failure. As shown in the Inset in Figure 5, a localised, relatively short section along strike of the upper part of the slope constitutes a scarp to the failure and where the slope angle exceeds  $75^{\circ}$ , Figure 11. It is understood that Batchfire is proposing to place windrows to restrict access to the area including the failure and the pre-strip benches immediately above. The failure material has buttressed the area and bunding on the pit bench also limits further access to the short scarp area. It is understood that Batchfire will continue to monitor this area and, if necessary, will consider remediation measures to stabilise the area
