# Appendices

# Appendix A

## PRCP Schedule

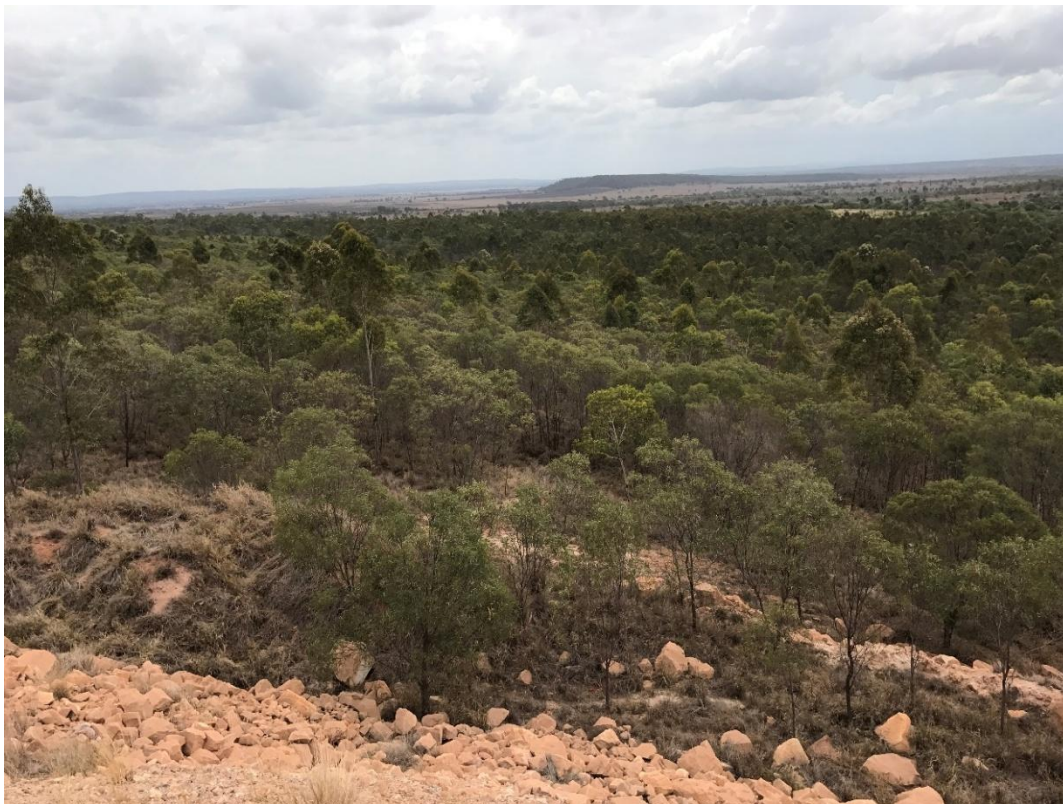
*Photo 1: Boundary Hill Mining Area - Established Rehabilitation Example*

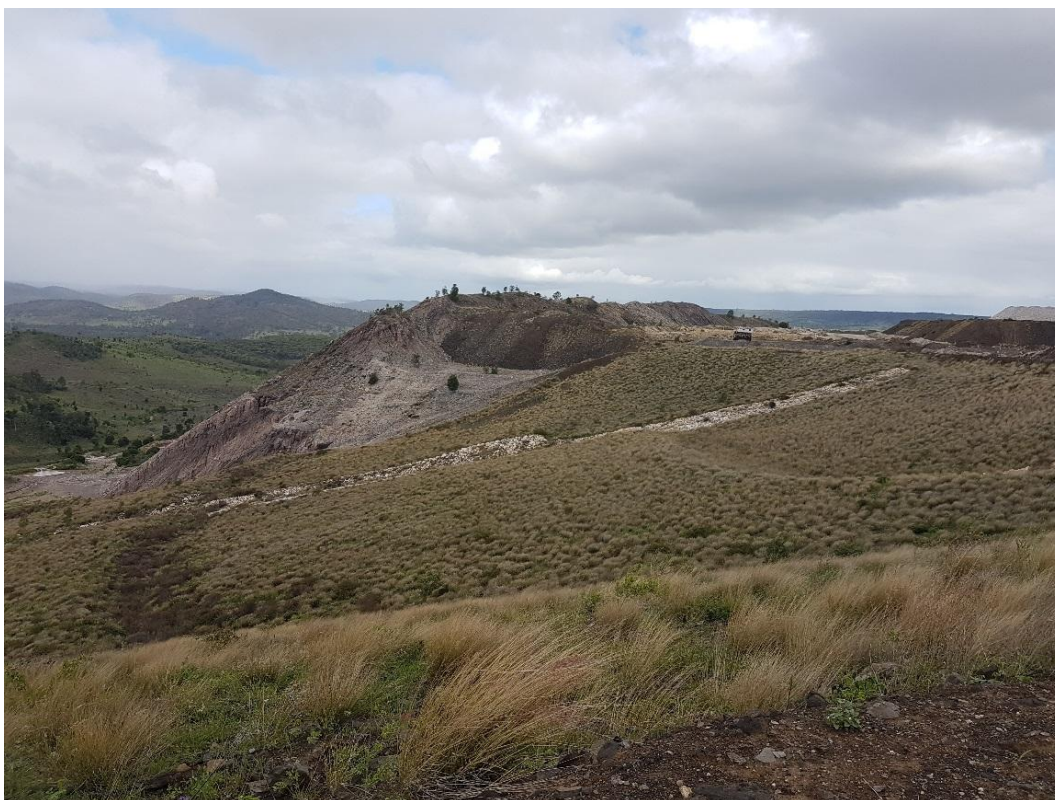
*Photo 2: Dunn Creek Mining Area – Trial Slope Rehabilitation Example*

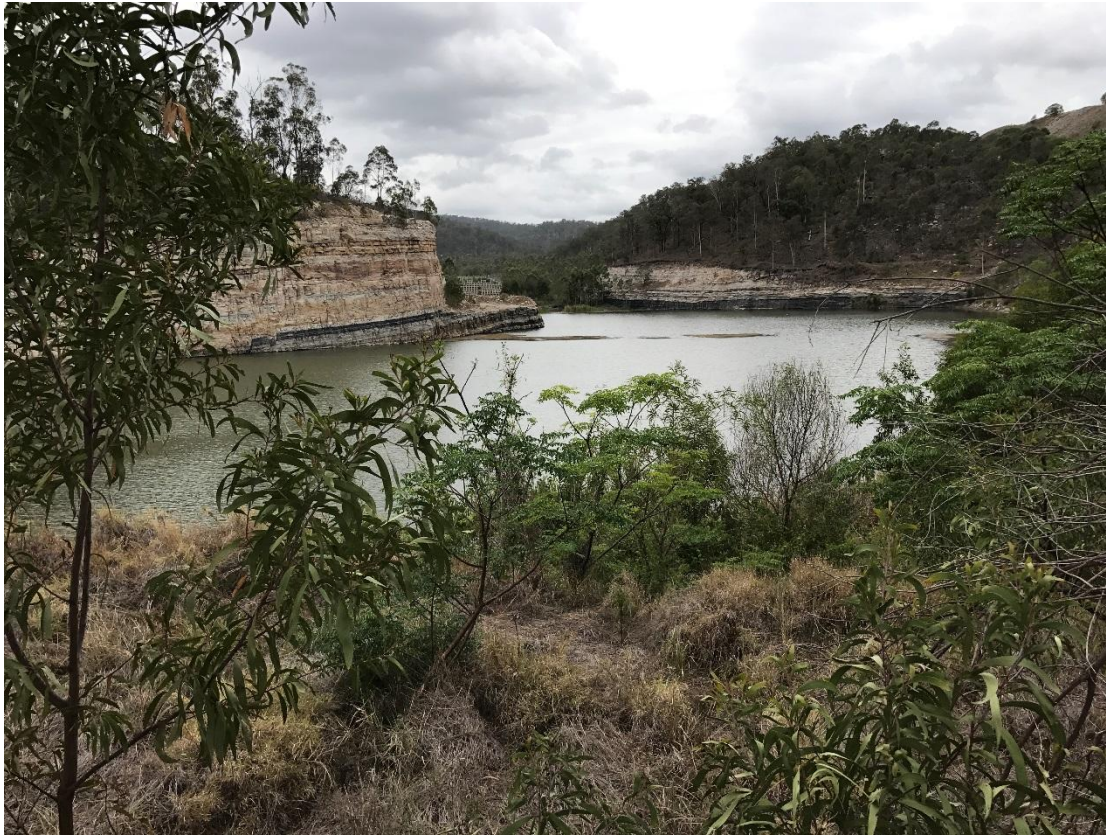
*Photo 3: The Hut Mining Area - Established Rehabilitation Example*
