# Progressive Rehabilitation and Closure Plan – Chum Street Pty Ltd

**Title of the Project:** Claypave

**Tenure Numbers:** ML 4553, ML 4559, ML 4714, ML 50077

**Document ID Number:** QPG003 PRCP

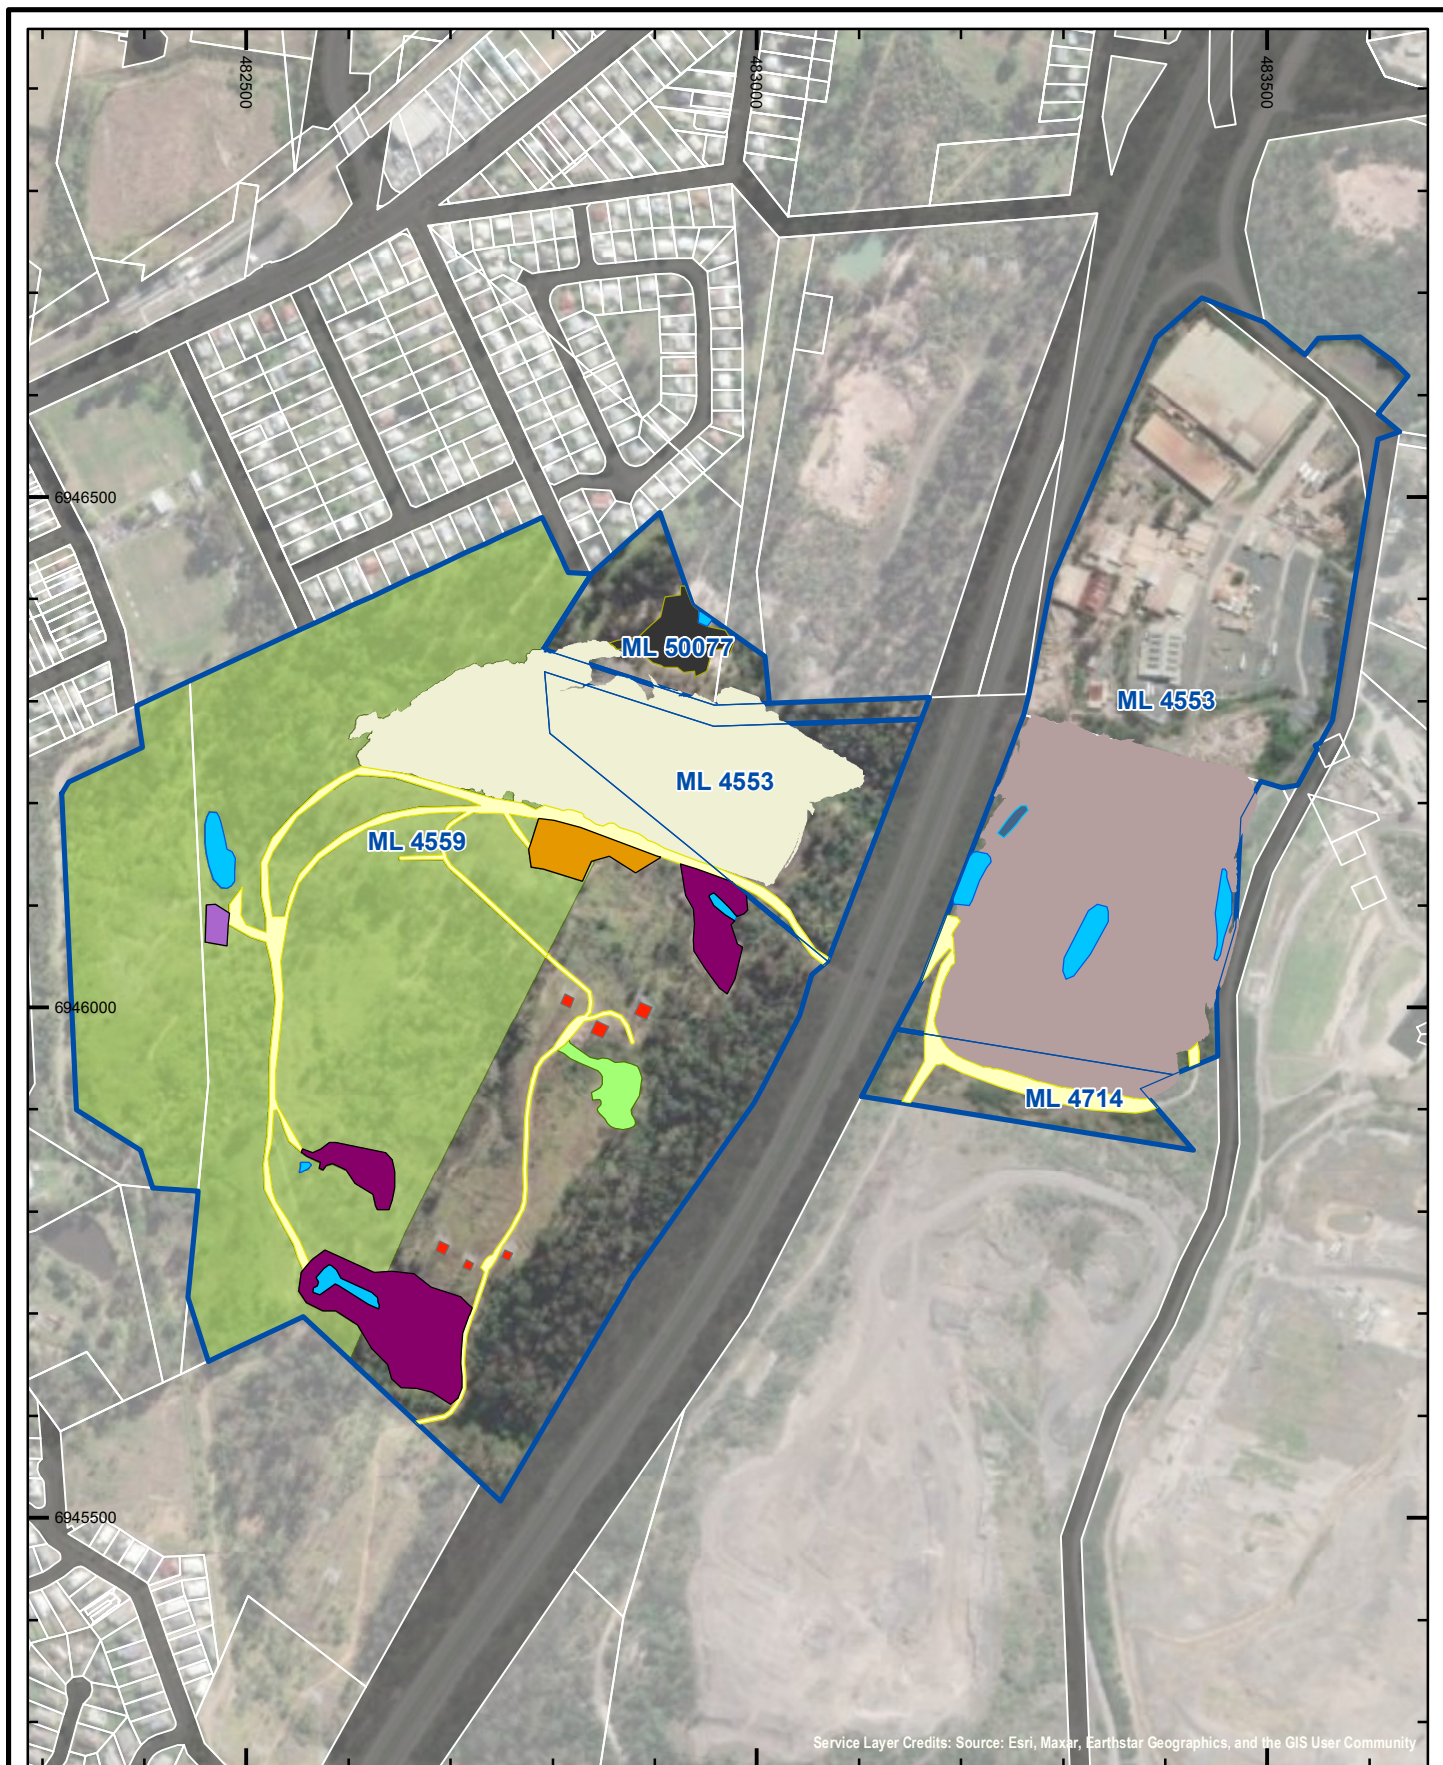
Figure 3  
Sheet No.

The disturbance footprint for the site as it existed prior to the commencement of rehabilitation works is depicted in Figure 3 below.
