## Stradbroke Rutile Pty Ltd - Glass Mine, Minjerribah

### Transitional Progressive Rehabilitation and Closure Plan (EPML00349813)

| Document Title: | Transitional Progressive Rehabilitation and Closure Plan – EPML00349813 |

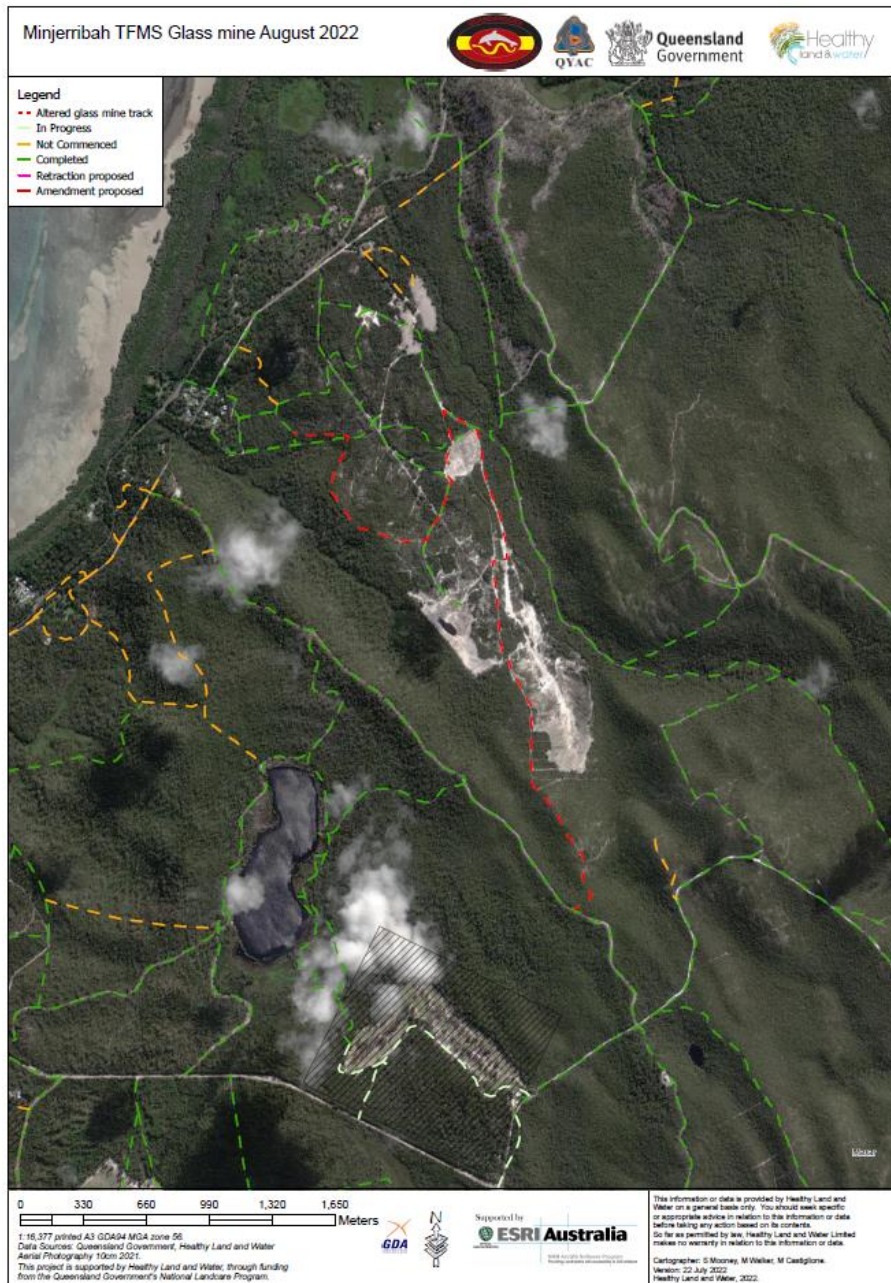
Figure 13 Access tracks to be retained, as provided by HLW on 9 August 2022

QYAC has advised SAPL of its intent to utilise and upgrade the existing but rehabilitated track network at Glass and Vance operations to meet fire trail prescriptions as part of the implementation of the Minjerribah Township Fire Management Strategy (Appendix M) to SAPL dated 09/08/2022). The map of the access tracks to be utilised is shown in Figure 13. QYAC now utilise and maintains the fire trail for this purpose.

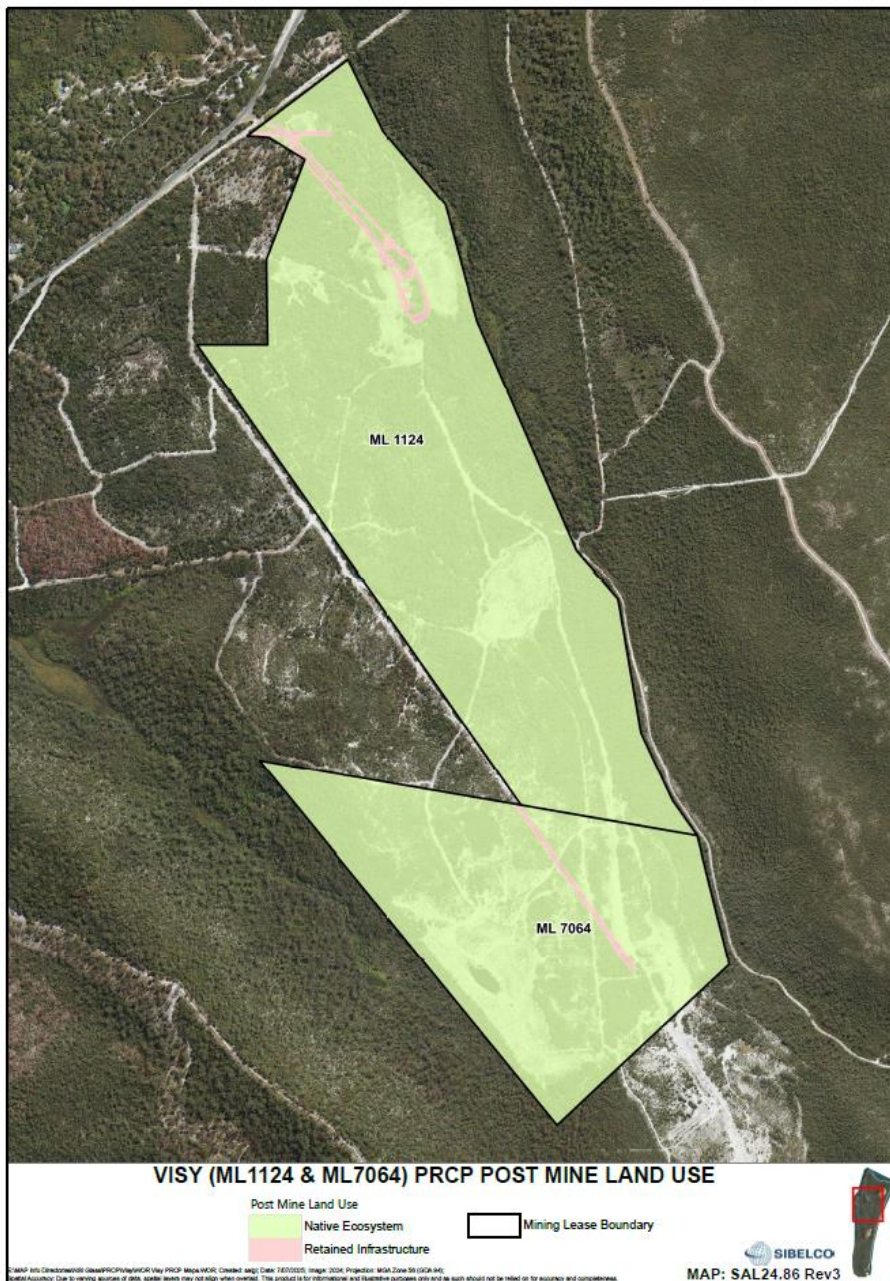
Figure 14 Post Mining Land Uses

The selected PMLUs are presented in Table 16 and Figure 14.

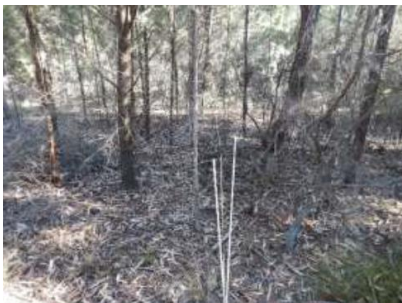
**Plate 9** Litter cover at rehabilitation monitoring site 'V5'

This is conservative as rehabilitation efforts by SAPL on older areas at Glass as well as other operations on Minjerribah have achieved canopy cover far in excess of 25%. Canopy cover and understory cover can be substantial in some areas of mature rehabilitation which both improve the C Factor. For example, litter cover >90% (equivalent to reference) has been achieved at older rehabilitation areas at Bayside (Lockhart, 2006) and is evident in older areas of rehabilitation at Glass (**Plate 9** and **Plate 10**).

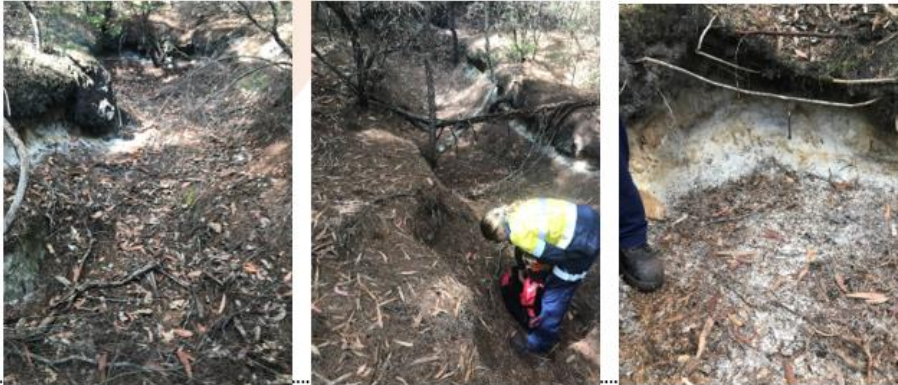
**Plate 11** Stabilised erosion features D (left and middle) and H (right)

The gully features identified in the Table 20 have stabilised and are not showing active erosion. They do not appear to convey water any more, have high litter and vegetation

cover and do not warrant management intervention or pose a risk to slope stability at Glass (see **Plate 11**).

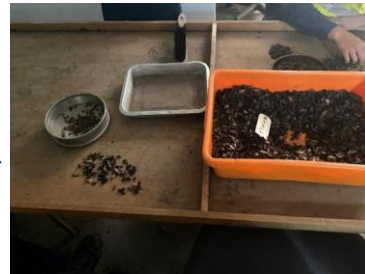
1. Cones and seed pods from banksias, eucalyptus and other species are collected

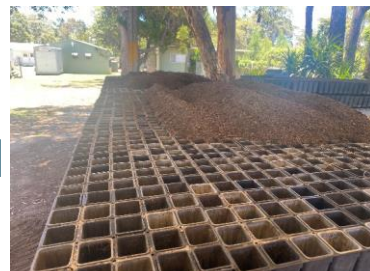
6. Plants are placed outside to harden and are ready to use when needed to stabilise reshaped and
