**UNIMIN AUSTRALIA LIMITED**

## **NORTH STRADBROKE ISLAND PROJECT**

REHABILITATION PLAN FOR DISTURBED AREAS

(EA NO. M2884)

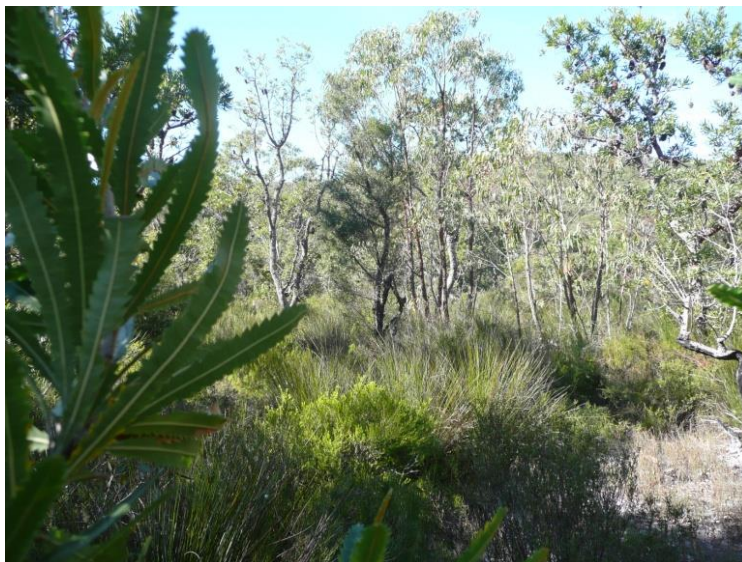
**V17**

## **APPENDIX C - Reference Transect Photographs**

Photographs of transects will be undertaken, with the same direction/orientation maintained for each recording period. GPS points for these locations shall be recorded. The locations of active reference transects, as determined by EA M2884, are displayed in Figure 3, and photographs are shown in Appendix C.
