# TRANSITIONAL PROGRESSIVE REHABILITATION AND CLOSURE PLAN

## YANDAN GOLD PROJECT

PREPARED FOR  
STRAITS GOLD PTY LTD

02 APRIL 2024

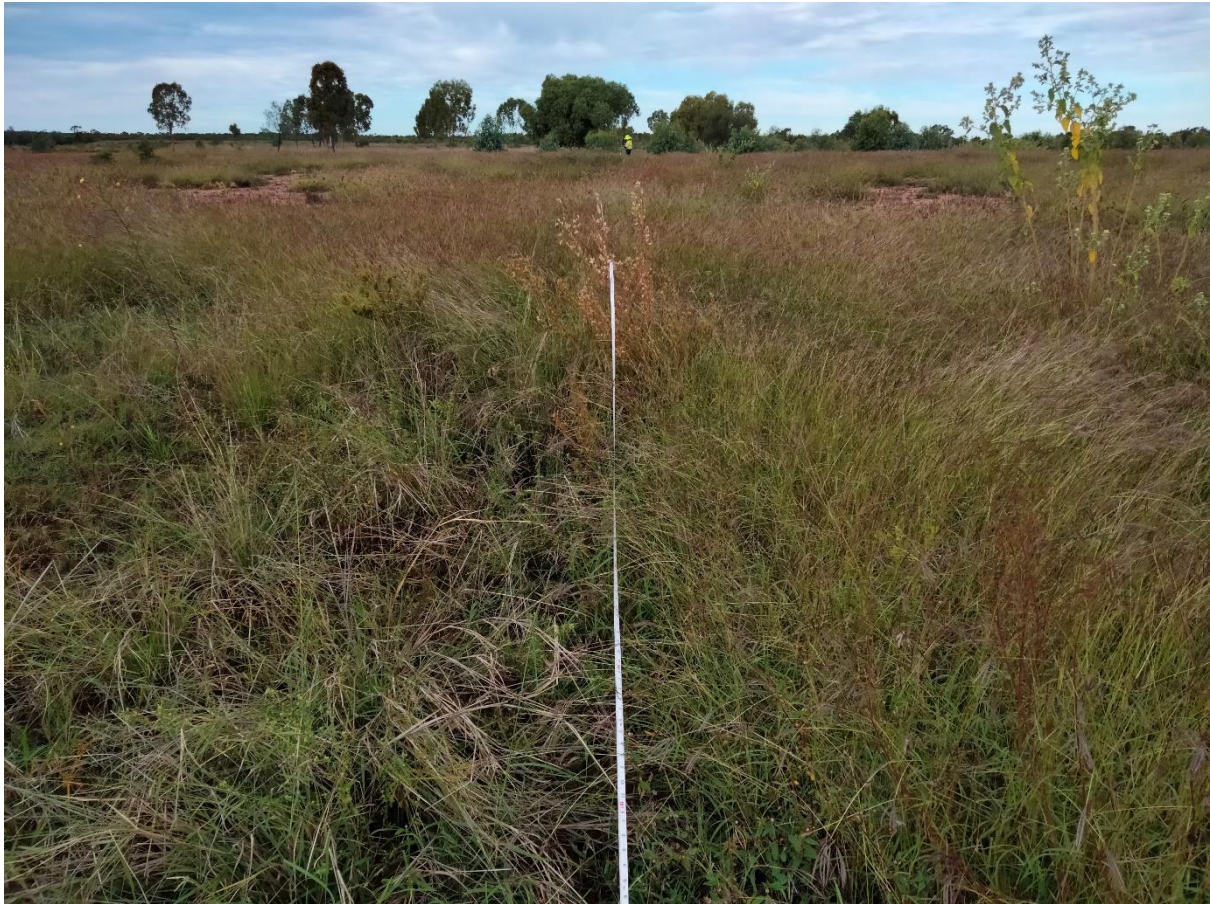
Figure 9: Gravel Topsoil cover trial site (400 mm) – June 2022

Rehabilitation monitoring undertaken during 2014 – 2021 identified that the 'Gravel Topsoil cover' trials sites have established vegetation characteristics most comparable to reference sites and are meeting relevant completion criteria (refer Figure 9)(AARC 2018; AARC 2019; AARC 2021b):

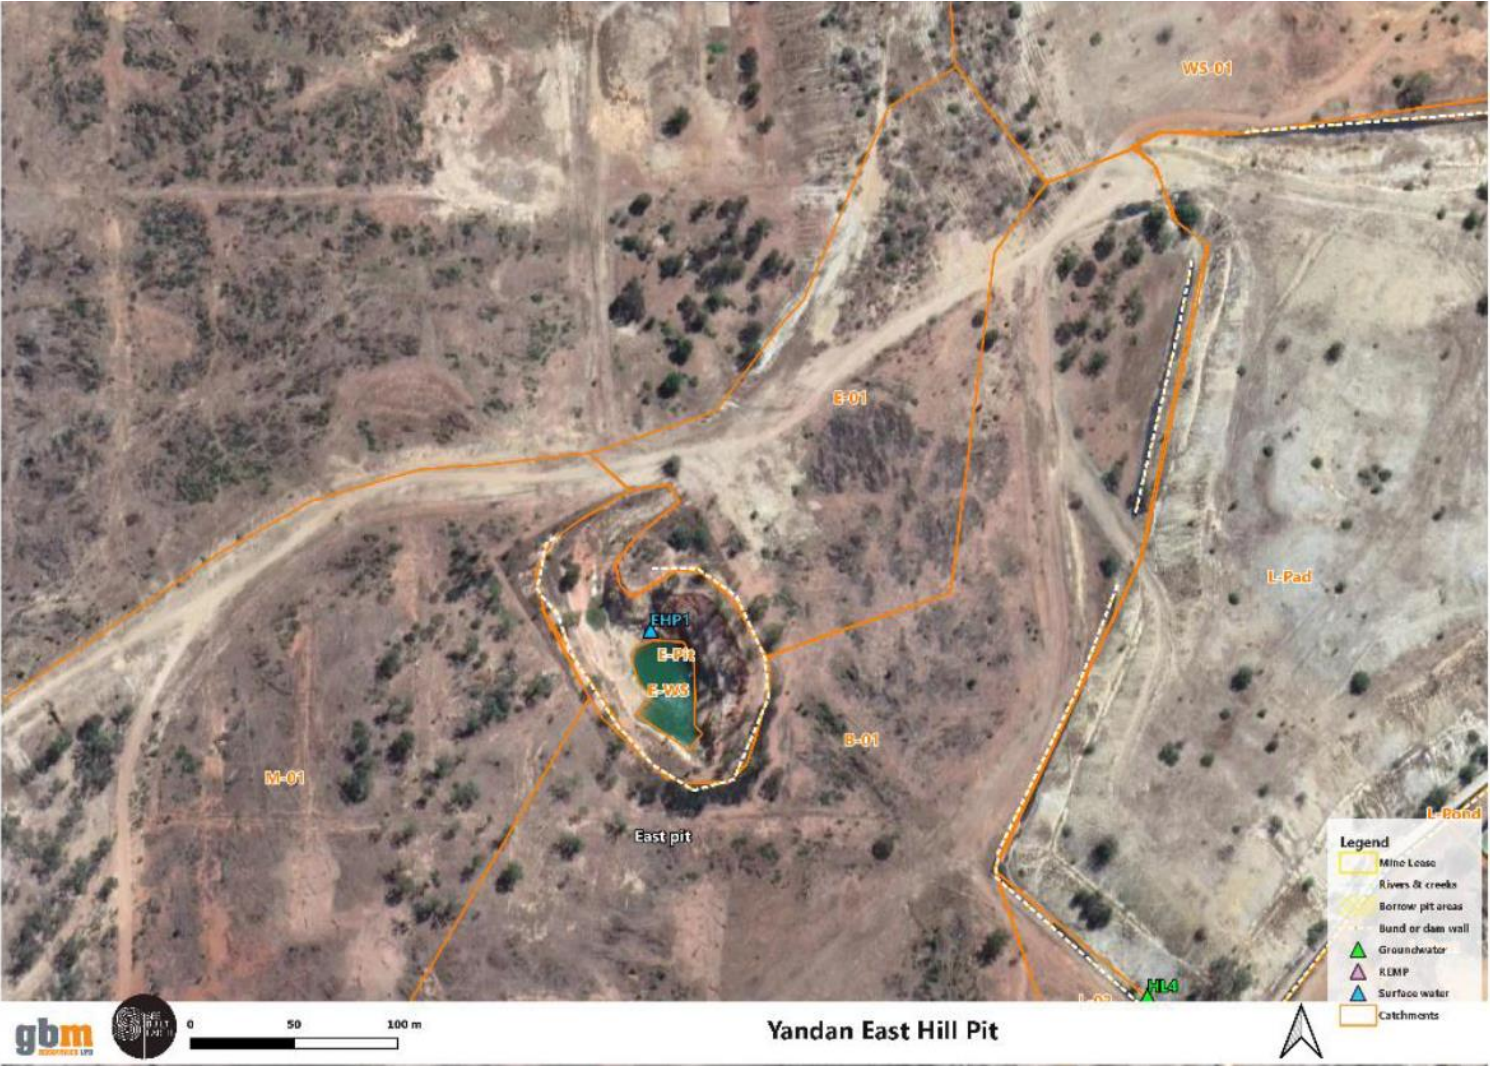
Figure 81: East Hill Pit domain (SBE 2022)

East Hill Pit is a small open cut pit with a limited footprint of only 0.9 ha, with pit walls reaching approximately 20 m above a small pit lake (Figure 81). The surface catchment reporting to East Hill Pit is 2.9 ha (refer to Section 3.1.5).

The catchment area draining to each residual void is shown on Figure 80 and Figure 81.

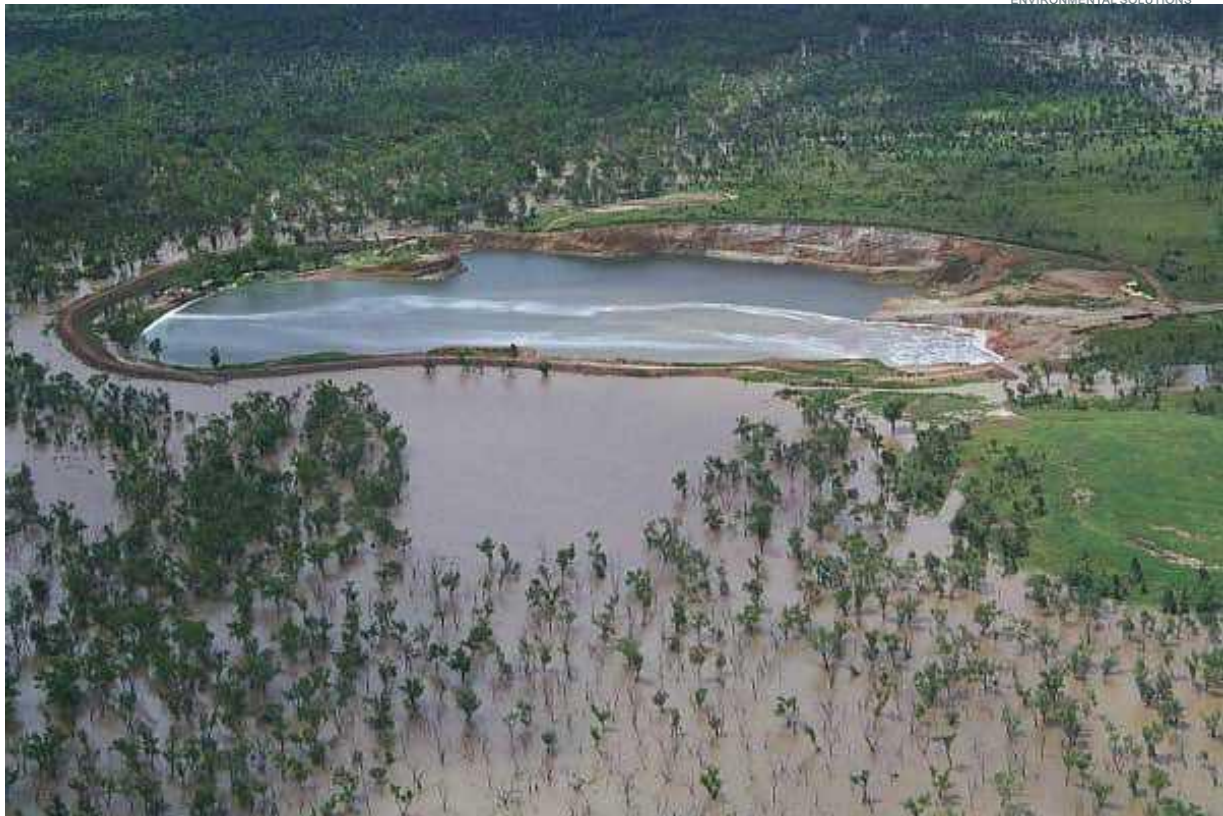
Figure 101: Main Pit inflows during flooding of the Suttor River in February 2020

River height records for the Project are inferred from the St Ann's gauging station, located downstream from the Project on the Suttor River. Based on a river height records, connectivity between Main Pit and the Suttor River has occurred eight times since the establishment of the flushing pit design (i.e. in 2001, 2003, 2004, 2007, 2011, 2023 and 2023) (SBE 2024c).

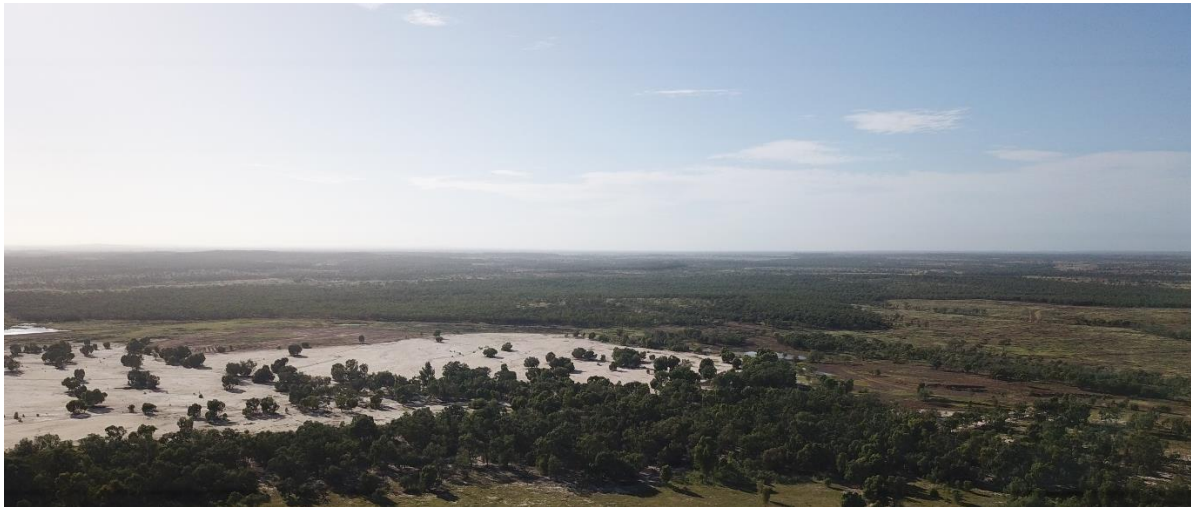
Figure 106: Established vegetation in the drainage channels of Cell B

RGS considered it unlikely that soluble concentrations of major ions and trace elements in the Cell B tailings material are causing chronic or acute eco-toxic impacts, noting that healthy vegetation has established in the drainage channels of the Cell B facility (RGS 2015) (Figure 106). RGS considered that the revegetation of the Cell B tailings, apart from along drainage lines (as per Figure 106 below) is likely limited by the availability of water (2015). Geochemical assessment indicates that the tailings material is of low permeability, limiting deep drainage (RGS 2015). Monitoring of the receiving environment also supports that there has been no observed contaminated seepage capable of causing environmental harm.
