# CLERMONT OPEN CUT

## Rehabilitation Management Plan

**Number:** CLEOC-520960306-2580

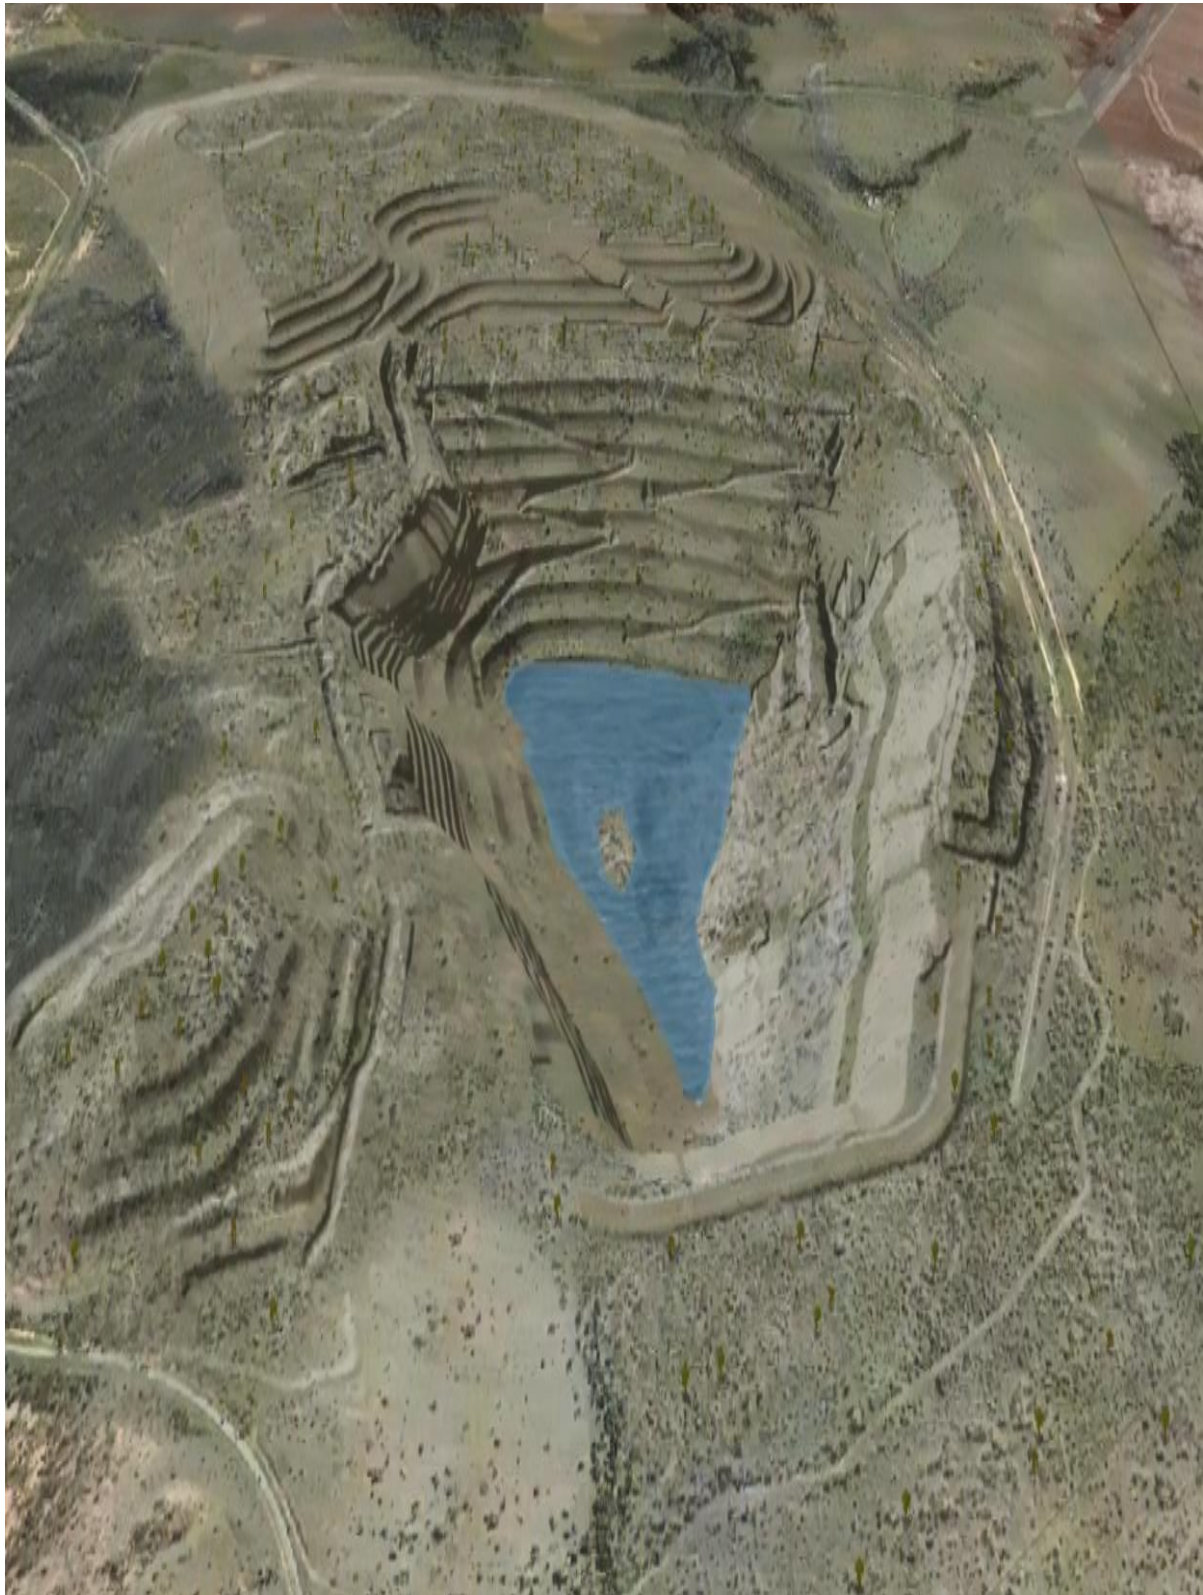
*Figure 7-1 – Final Landform Concept.*

LOM Rehabilitation Planning is an ongoing process which is updated at least annually following the overarching LOM planning process. The current final landform concept is provided as Figure 7-1. Once the LOM has been finalised, the rehabilitation schedule should be updated to accommodate any changes in dump scheduling. The current rehabilitation schedule is provided in Section 10.
