Kestrel SHMS - Report

Transitional Progressive Rehabilitation and Closure Plan

Project Name:	Kestrel
Report Title:	Progressive Rehabilitation and Closure Plan
Client:	Kestrel Coal Resources Pty Ltd
Project Manager:	Stuart Ritchie
Document ID/Ref.	20230914_KCR_KestrelMine_PRCP_v9.3.pdf
Date of Submission:	15 September 2023
Tenure Nos.:	ML 1978, ML 70301, ML 70302, ML 70330 and ML 70481
EA Reference:	EPML00693413
EA Holder Name:	Kestrel Coal Resources Pty Ltd and Mitsui Kestrel Coal Investment Pty Limited
EA Holder Contact Details:	Level 22, 10 Eagle Street, Brisbane QLD 4000 07 3557 3000

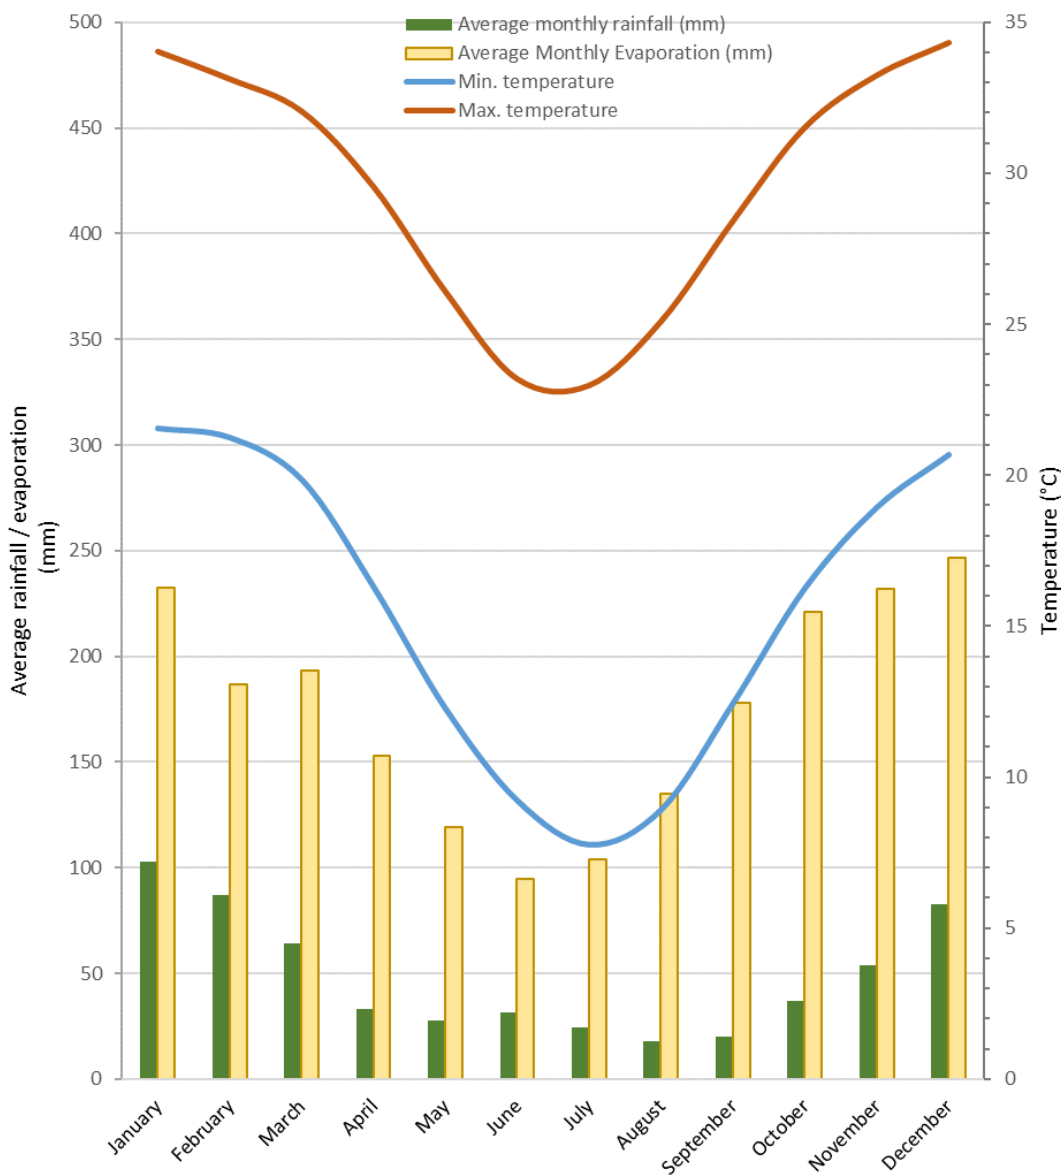
Figure 6: Average monthly climate data for Kestrel

The climate data presented in Figure 6 has been drawn from SILO (Queensland Government 2022). The climate of the region is described as subtropical with warm wet summers and mild, dry conditions in winter. The warmest months are November to February. Average temperatures range from 22.3°C to 34.6°C in January to 9.1°C to 23.4°C in July (Emerald Airport ID 035264). Average annual rainfall for the area is 582 mm (SILO -23.25, 148.35) with a wet season that generally aligns with the November to March period and accounts for over 65% of the region’s annual average rainfall.

Evaporation records are available from SILO (-23.25, 148.35) which estimates an annual average evaporation (Class A pan) of approximately 2,096 mm; approximately three to four times the average rainfall (Figure 6). Based on the available datasets, measured, monthly average potential evaporation is approximately three to four times higher than the average rainfall.

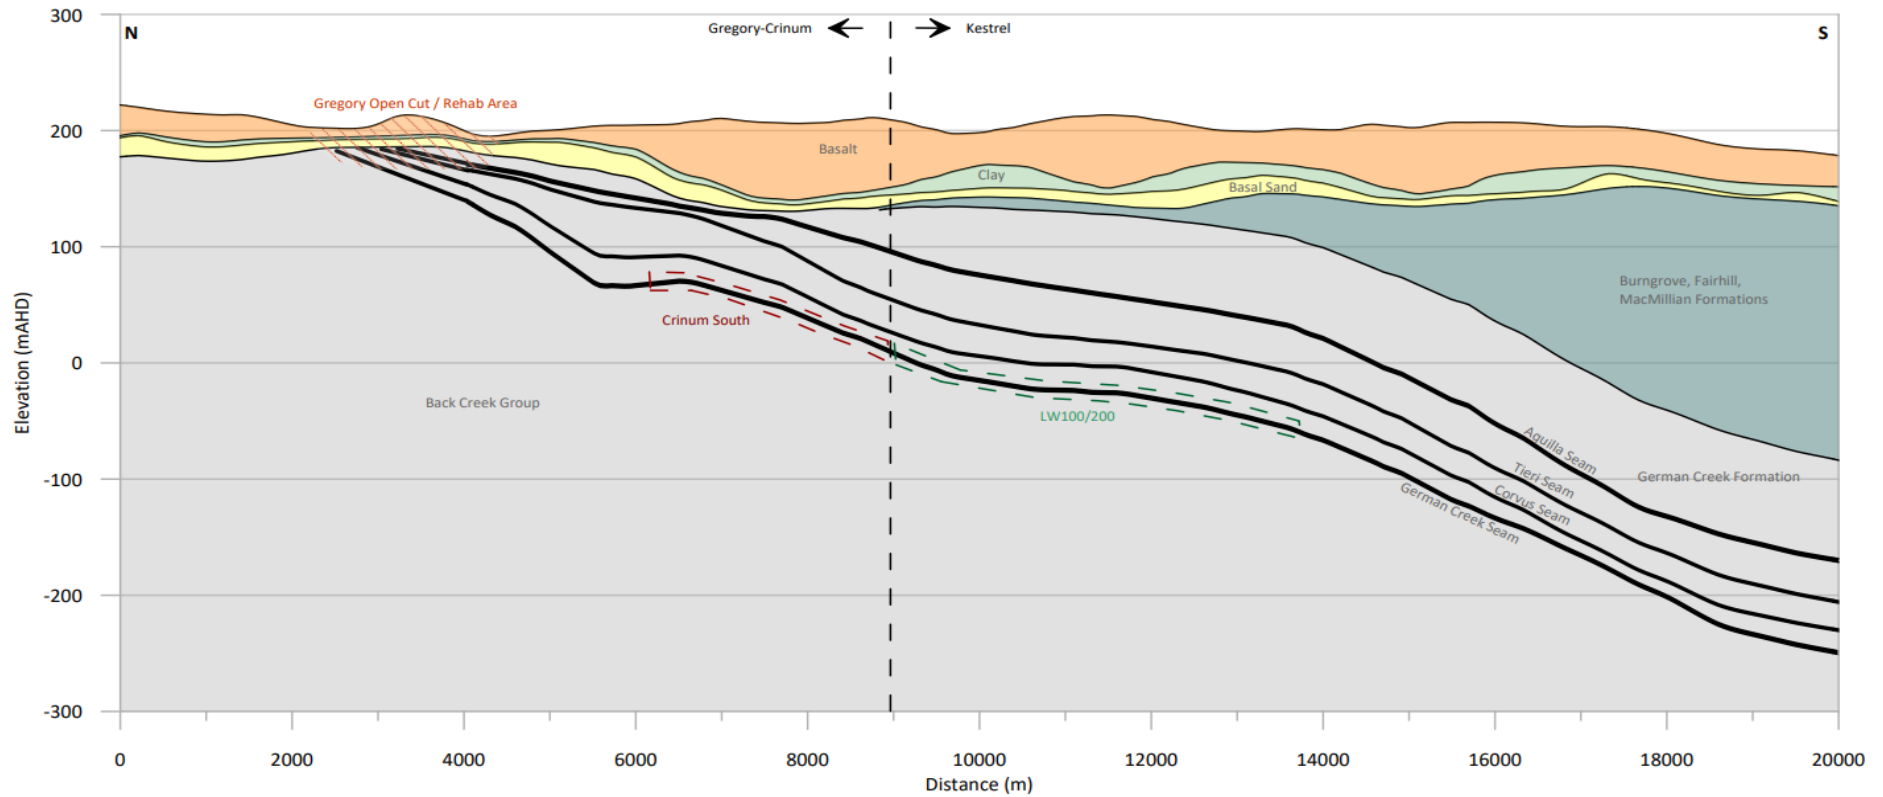
Figure 10: North-south geological section through Gregory-Crinum and Kestrel (KCB 2022a)

The hydrostratigraphic units are described in the Kestrel-Gregory-Crinum Groundwater Model Report (KCB 2022a) and are summarised below. The geological sections discussed are presented in Figure 10 and Figure 11.

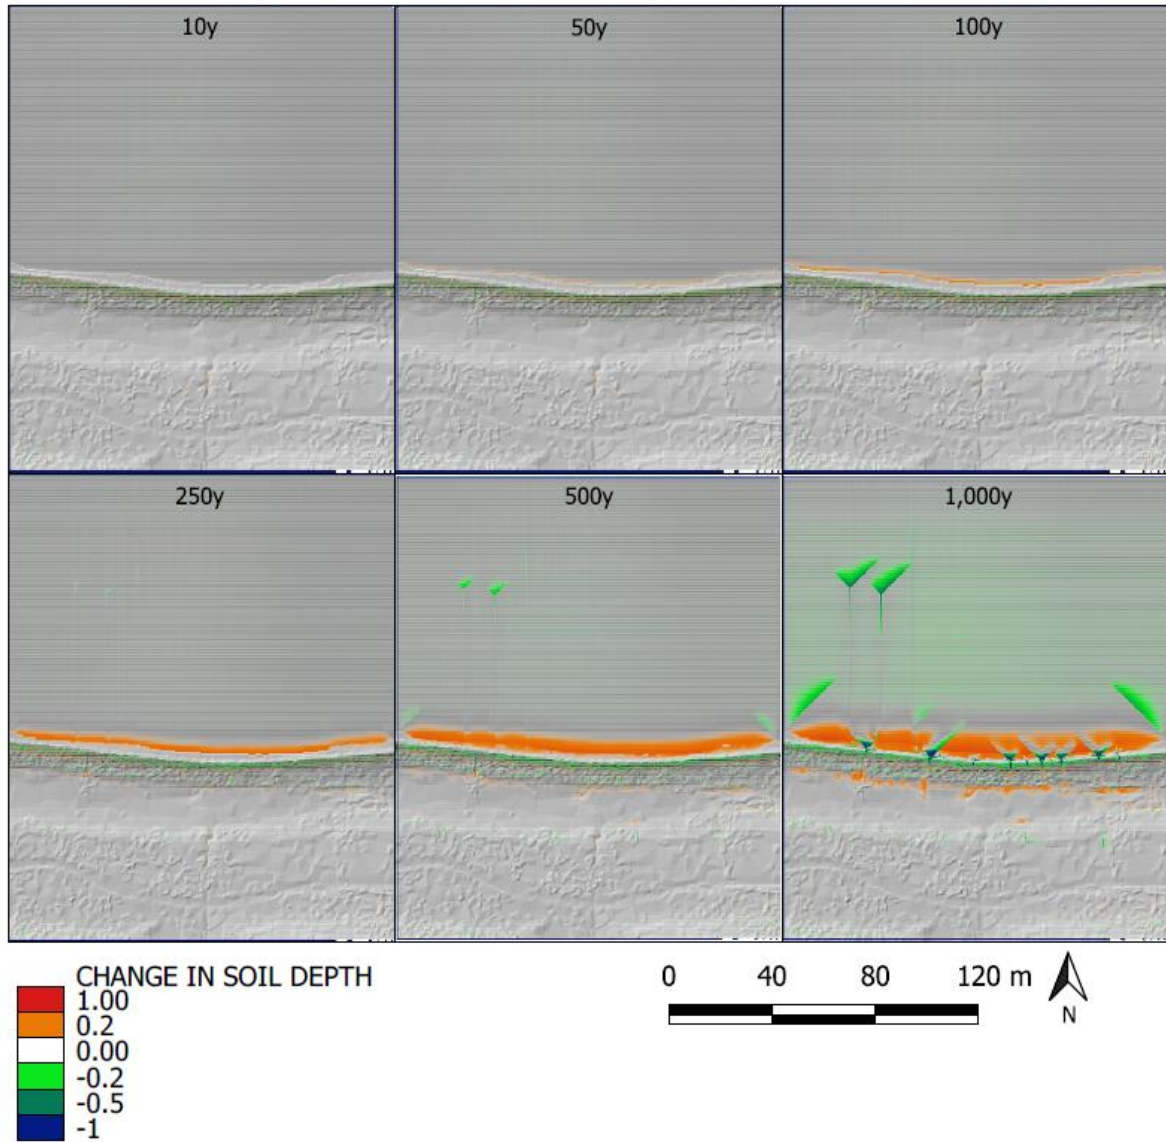
Figure 36: Change in soil depth (1V:6H slopes)

Modelling of the 1V:6H batter slopes indicate minimal erosion will occur for the first 100 years, with rilling commencing after 200 years approximately halfway up the batter. The rills propagate upslope in the 500 and 1,000 year results indicating that drains would be required at approximate intervals of 50 m to minimise rilling.

Figure 36 shows the CDSF from the plateau on the north side of the figure to the embankment toe on the south.
