# TRANSITIONAL PROGRESSIVE REHABILITATION AND CLOSURE PLAN JEEBROPILLY COAL MINE

PREPARED FOR  
NEW HOPE GROUP  
on behalf of JEEBROPILLY COLLIERIES PTY. LTD.

17 MAY 2024

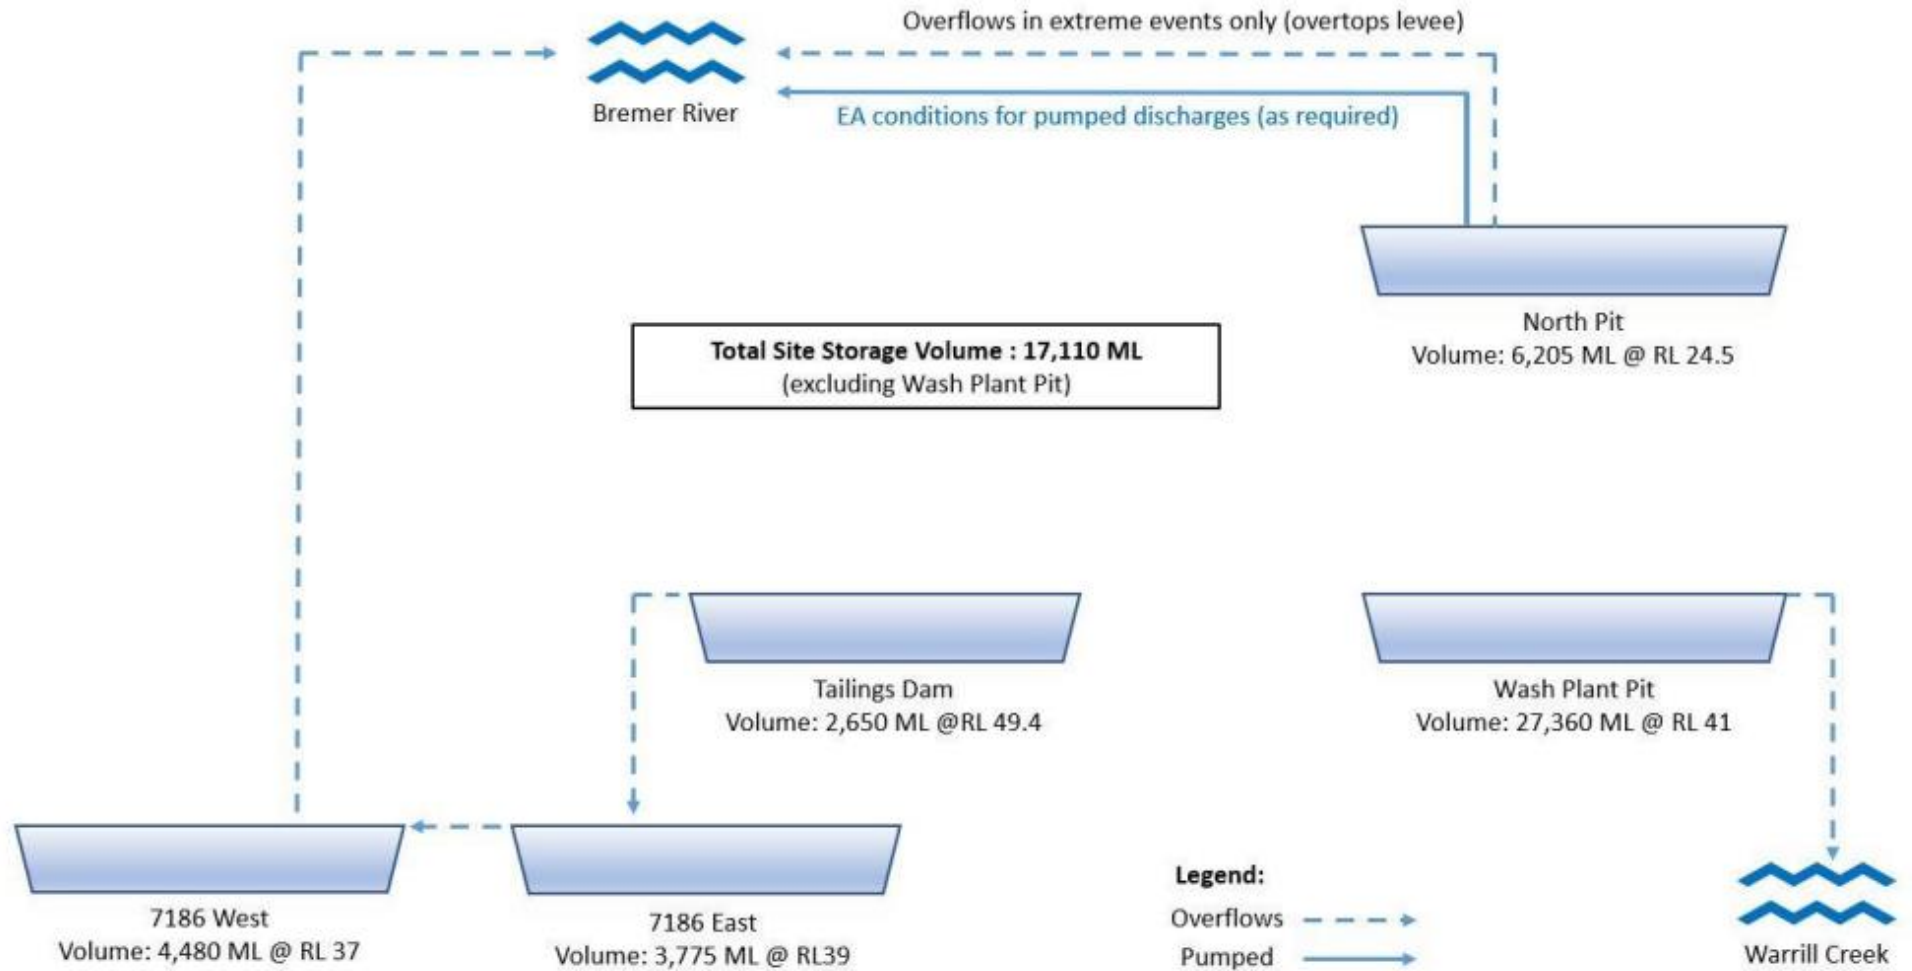
Figure 37: Site water management schematic

Key water storages are detailed in Table 26 and shown in Figure 36 along with corresponding catchment areas. The site water management balance schematic is shown in Figure 37.

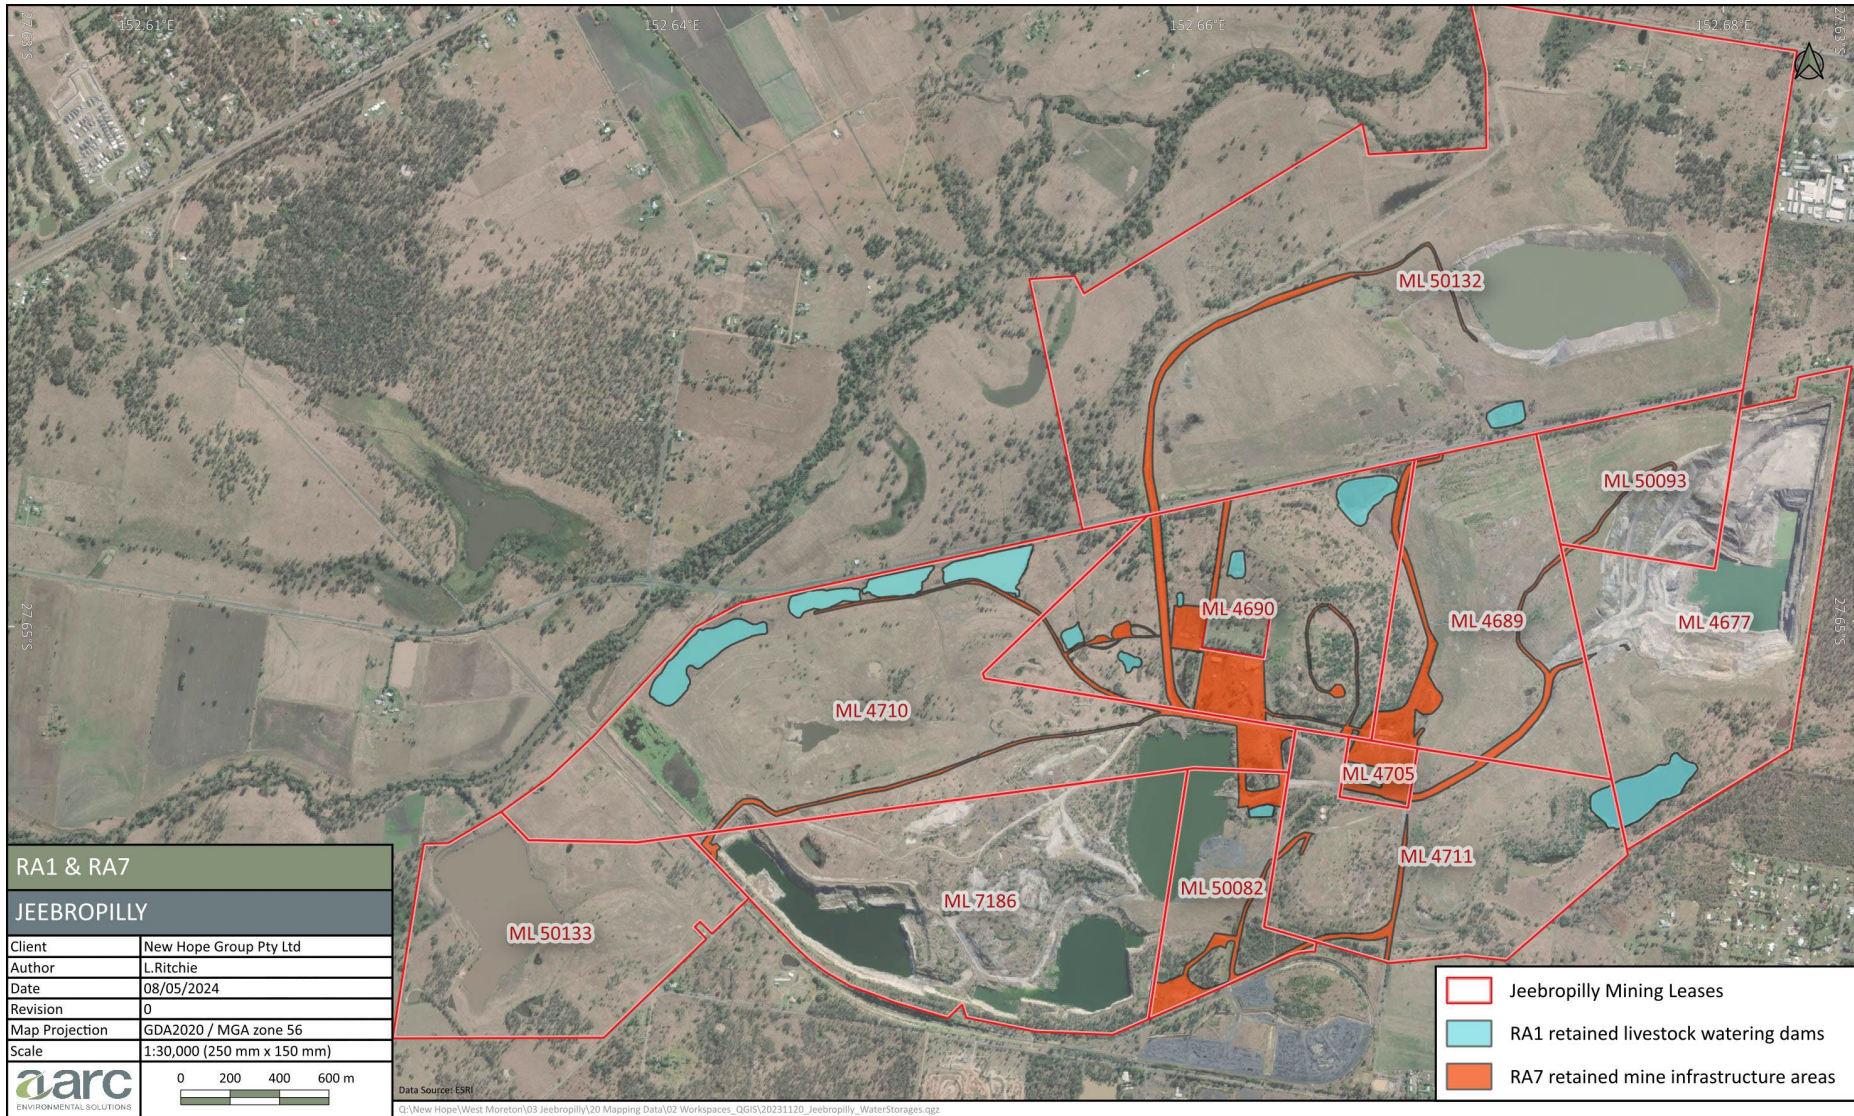
**Figure 1: Livestock Watering dams and Mine Infrastructure areas to be retained**

- Livestock watering dams (as shown in **Figure 1**) will be retained in a safe and stable condition as they are valuable resource for grazing activities. Dams generally contain water of appropriate quality for stock watering and are currently being used for that purpose. Livestock watering dams across site will store rainwater and surface runoff during wet seasons, providing a vital source of water during dry spells. This will help sustain livestock and help reduce the strain on natural water sources such as the Bremer river,
