# Thalanga Copper Mines Pty Ltd

## **Re: Transitional Environment Program (TEP) MAN17020**

In accordance with the commitments made in the above TEP please accept this report on the potential earthworks program for 2016 at the Highway Reward mine.

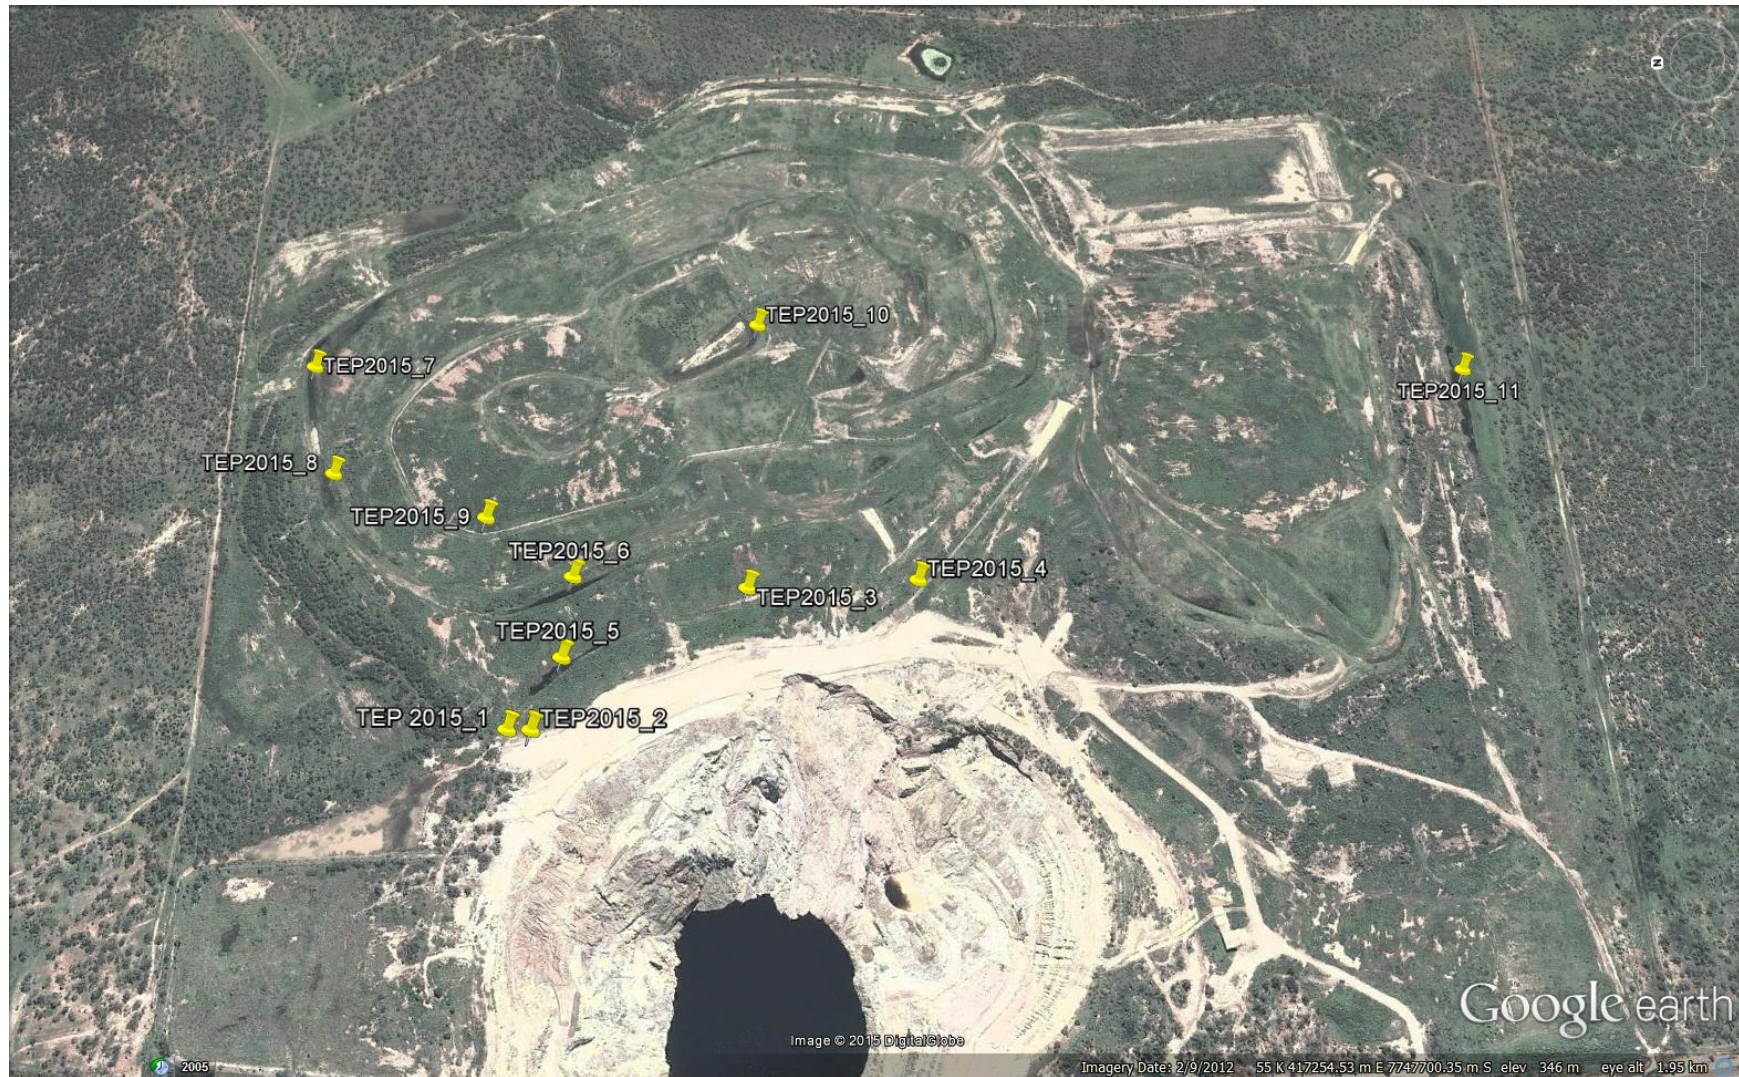
**Figure 5**      **Sample Locations**

The location of each proposed sample site is shown in Figure 5 below. Sampling is proposed in conjunction with SW sampling i.e. when there has been enough rain to get water flowing around the site and again one week later.

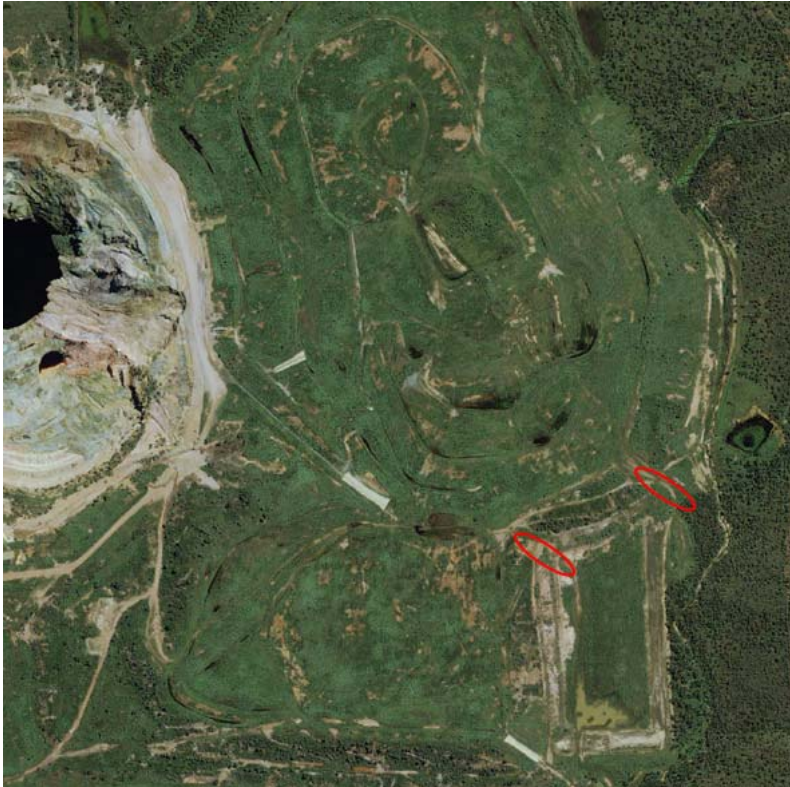
**Figure 6**                      **Currently Proposed Maintenance Earthworks**

The JV will also undertake maintenance earthworks to repair erosion lines and scours which could expose sulphidic material and lead to AMD formation. Areas currently marked for capping and repair are shown in Figure Figure 6 below. The site will be inspected in May 2016 to determine whether any further maintenance earthworks are required.
