# Progressive Rehabilitation and Closure Plan – Chum Street Pty Ltd

**Title of the Project:** Claypave

**Document ID Number:** QPG003 PRCP

**Version Number:** 03

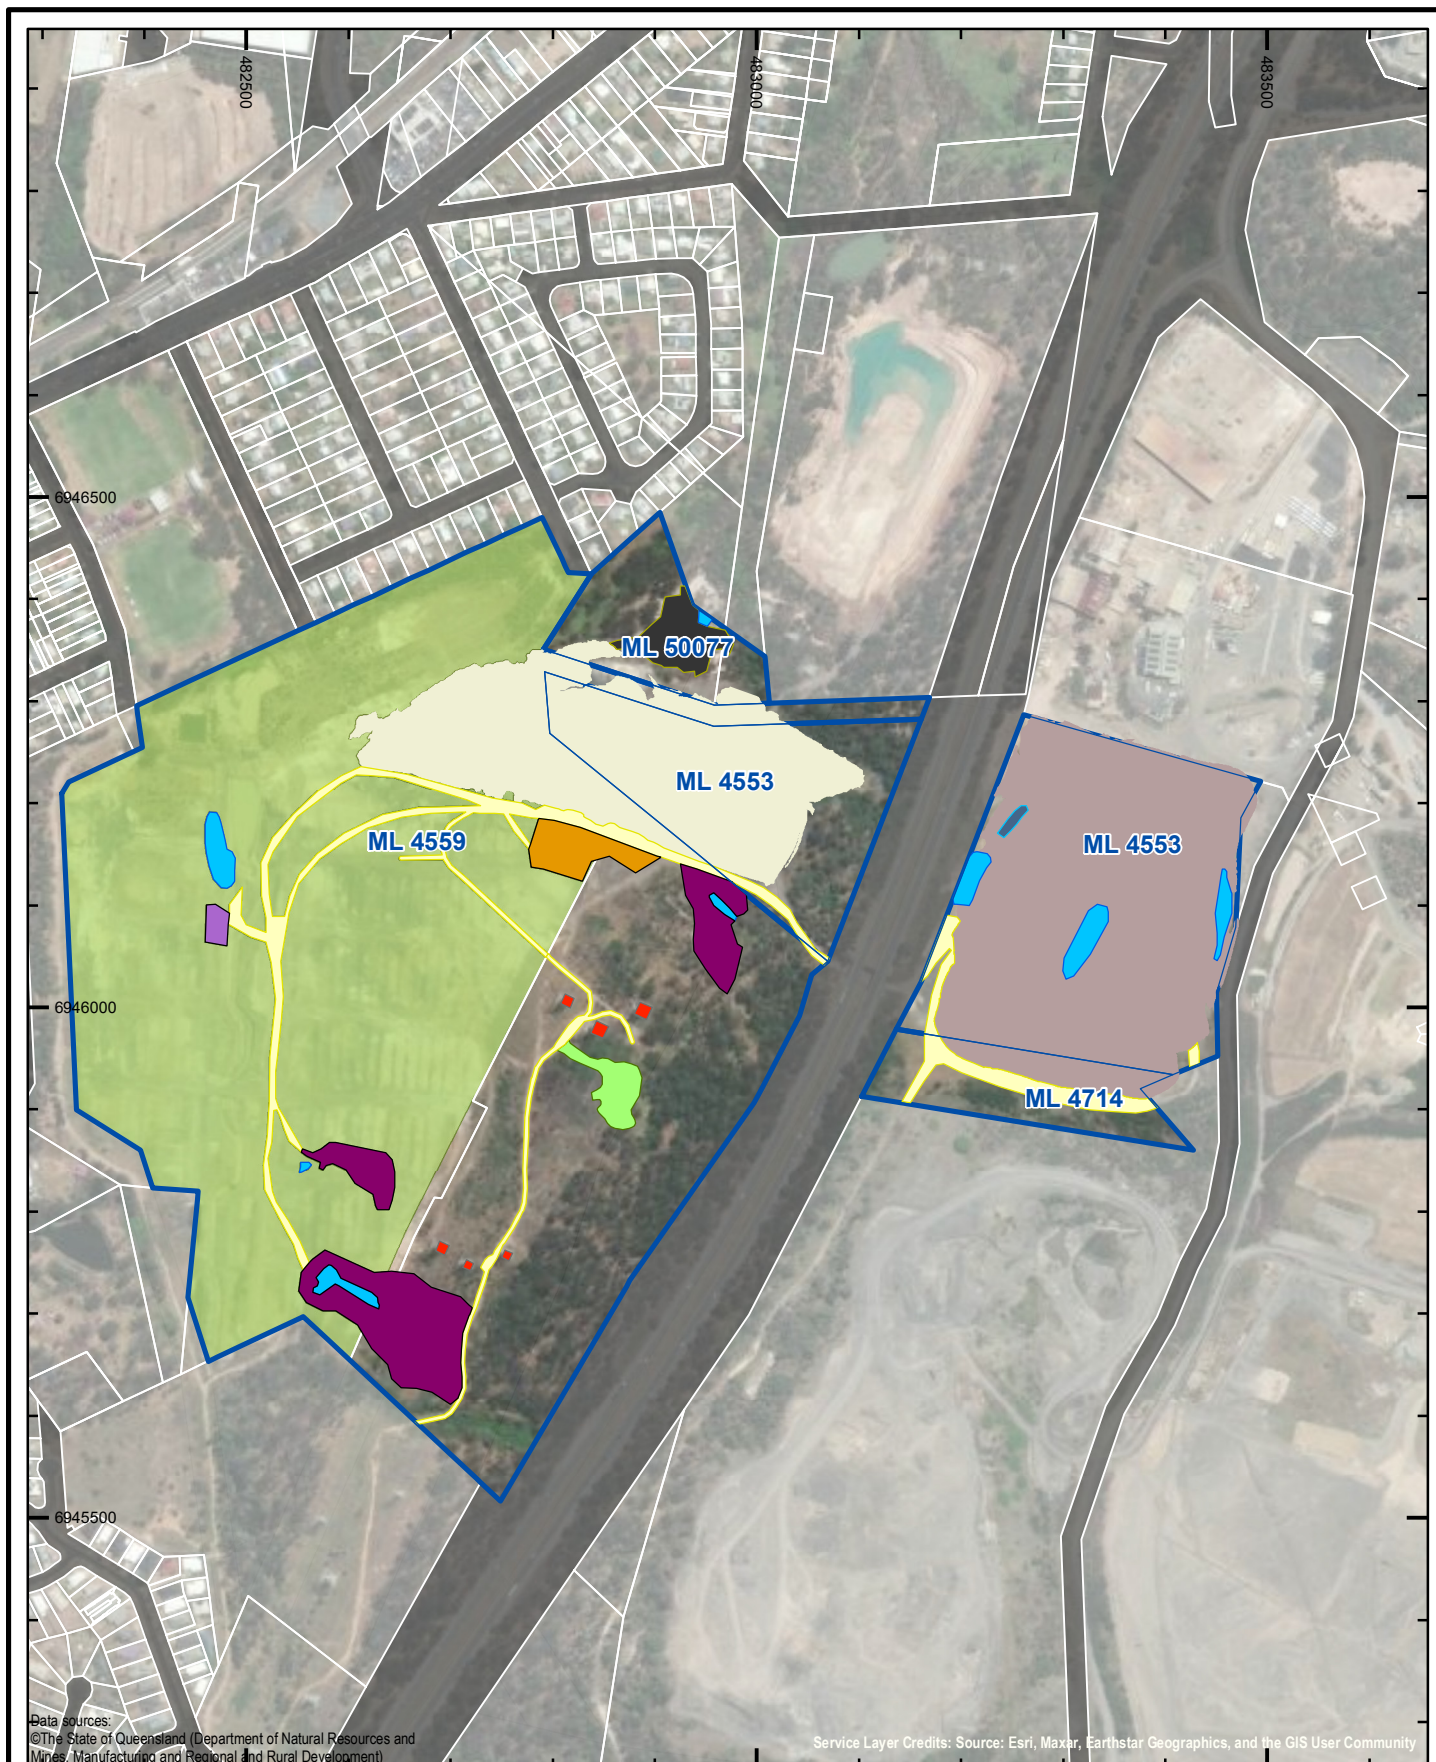
Figure 3  
Sheet No.

The disturbance footprint for the site as it existed prior to the commencement of rehabilitation works is depicted in Figure 3 below.
