ENSHAM  
RESOURCES  
PTY LIMITED

# PROGRESSIVE REHABILITATION AND CLOSURE PLAN

Version 8

11 March 2025

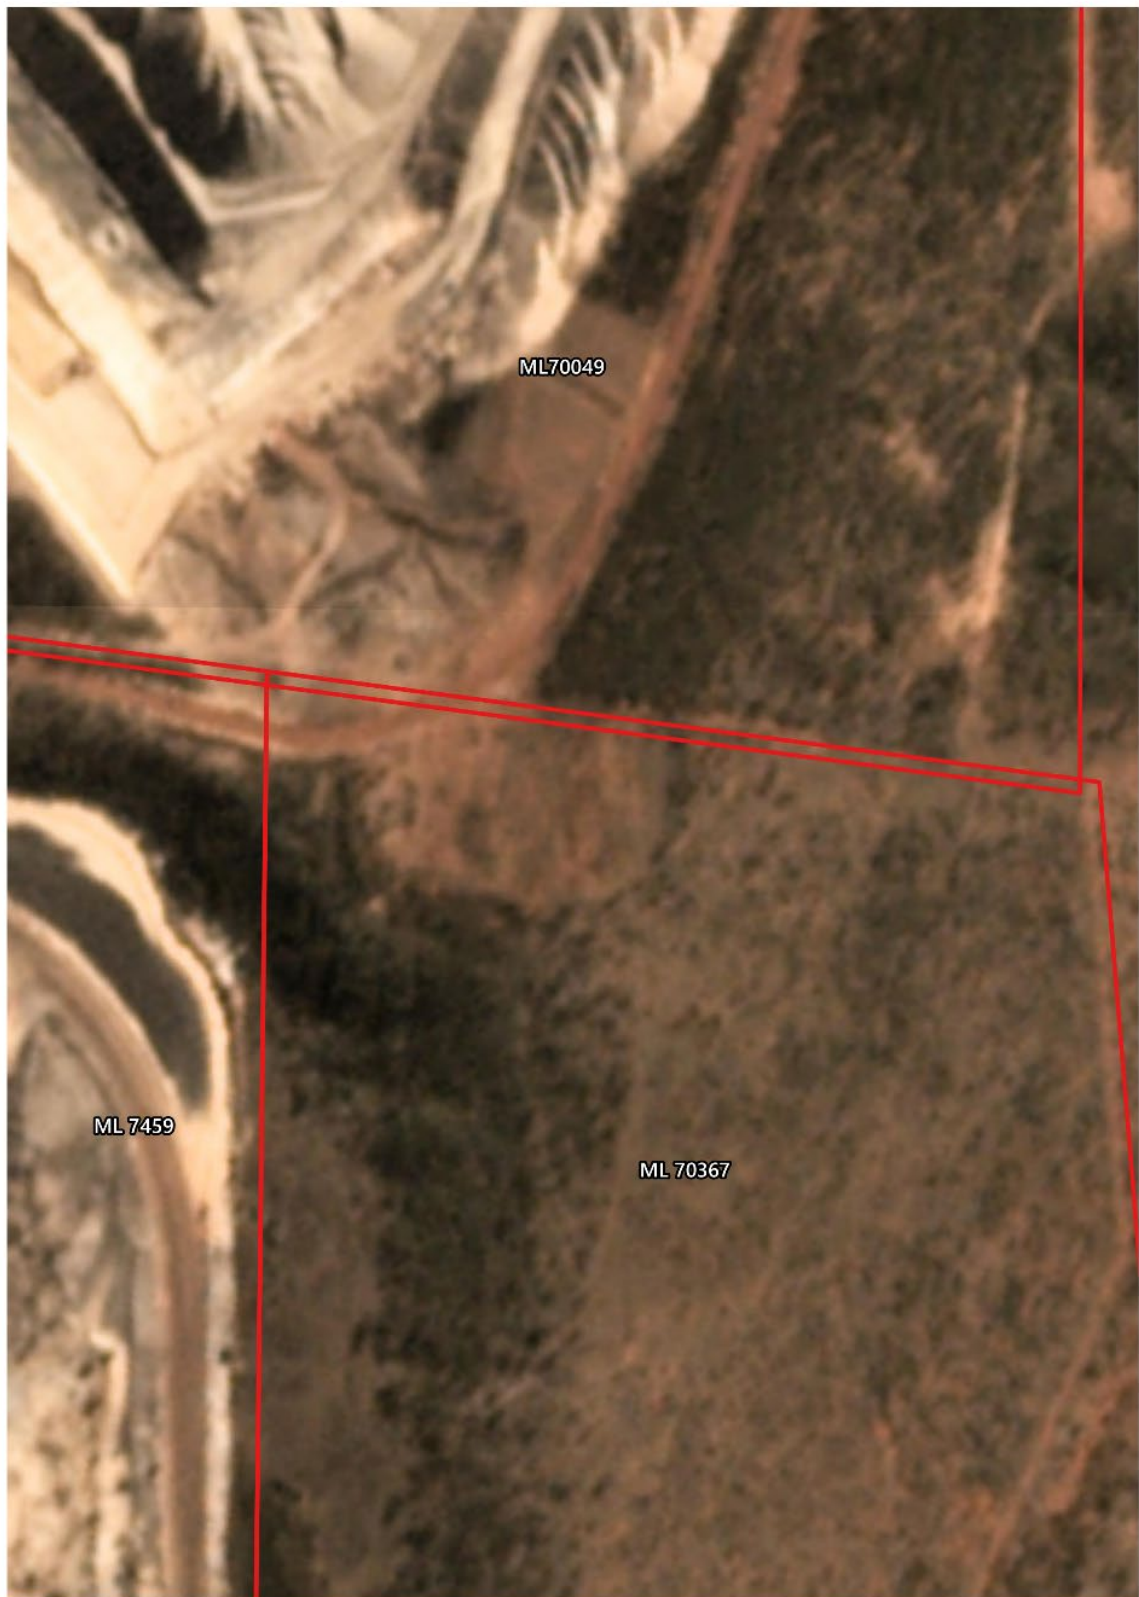
Figure P0-1 Example of spatial data inaccuracies in QSpatial

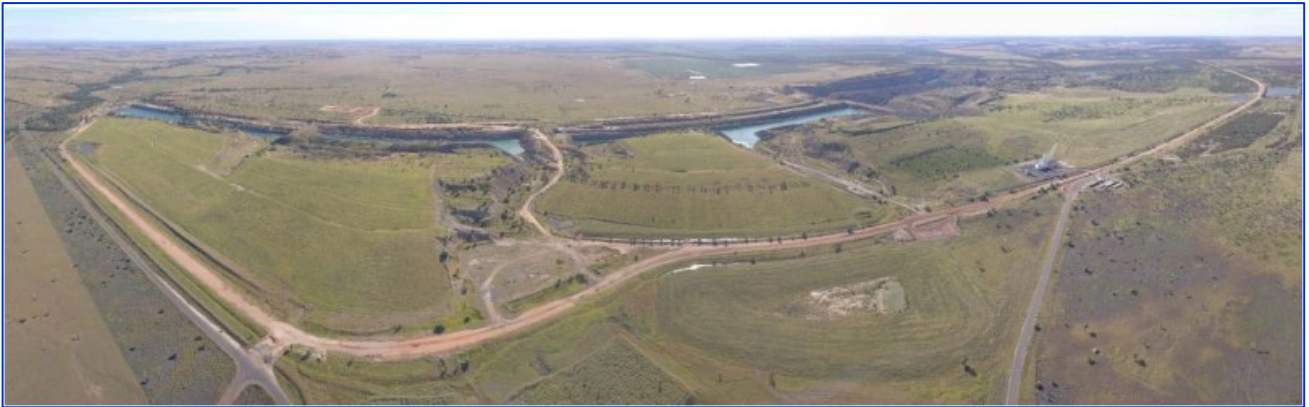
**Figure 1-5 Existing rehabilitation at AB Pit (ML7459)**

These areas are currently used for beef cattle grazing.

Ensham has completed more than 1,600 ha of opencut mine rehabilitation since 2001 (Figure 1-5, Figure 1-6, Figure 1-7 and Figure 1-8). This equates to approximately one third of total mining disturbances. Most existing rehabilitation has a target PMLU of beef cattle grazing. Portions of existing rehabilitation have been approved as certified under the EP Act (Table 1-4) or not yet applied for.

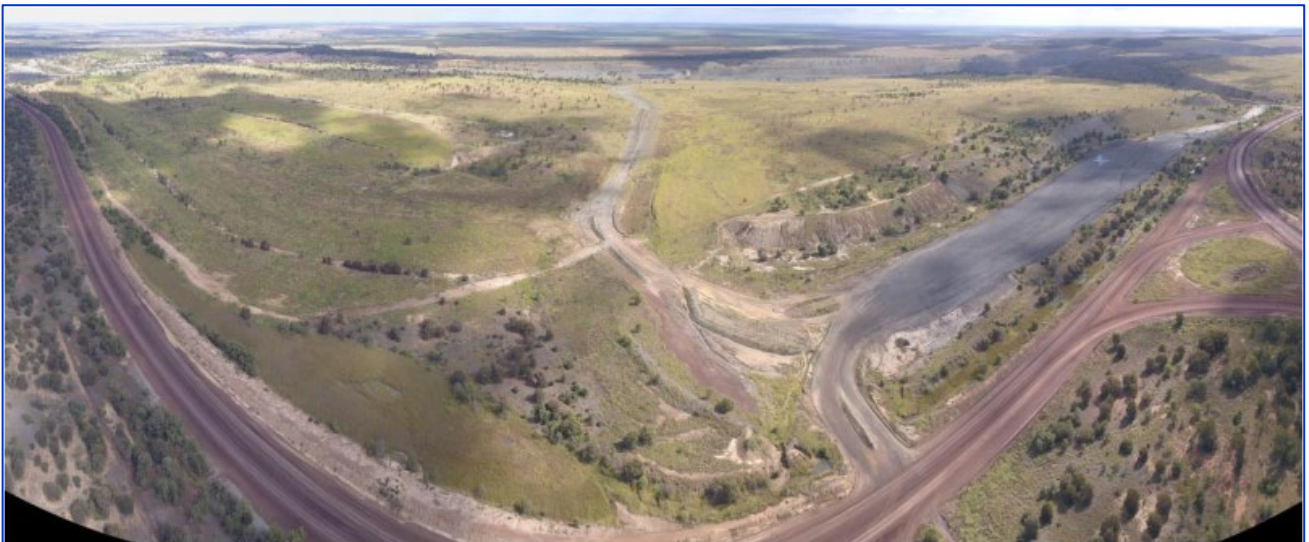
**Figure 1-6 Existing rehabilitation at CDE Pit (ML7459)**

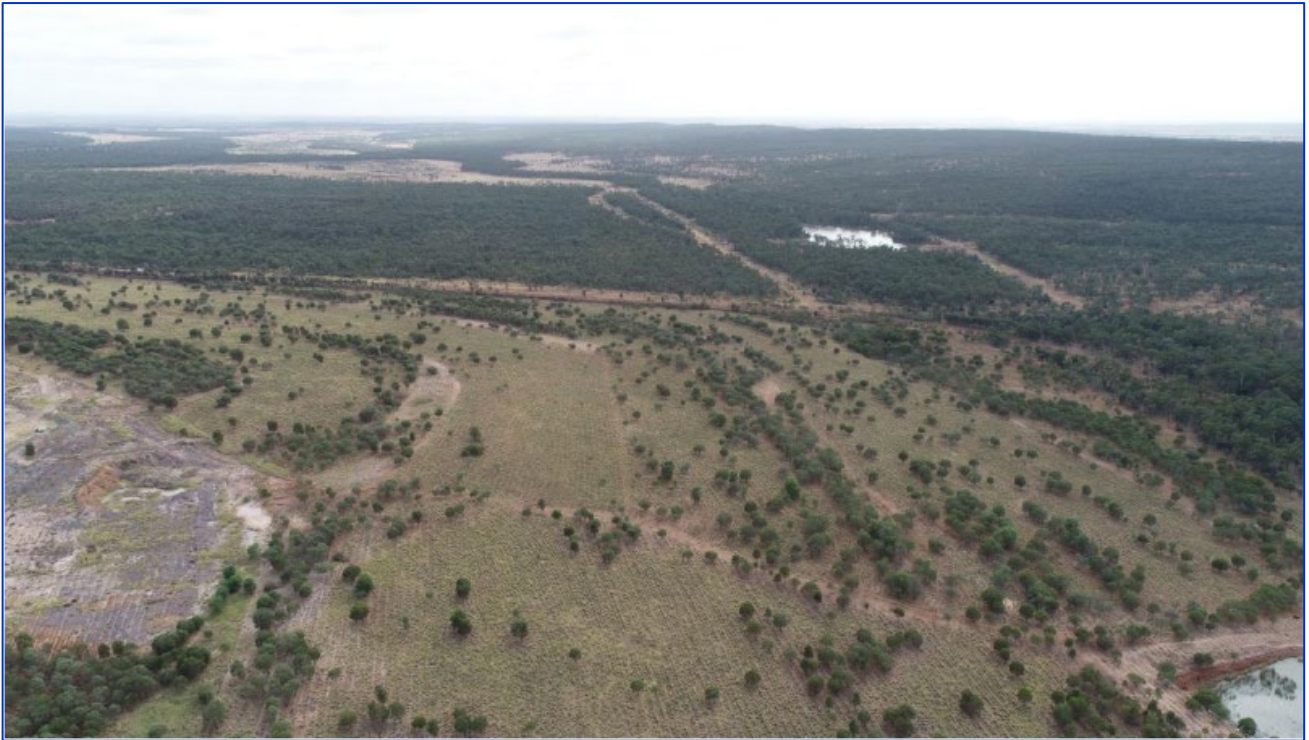
**Figure 1-7 Existing rehabilitation at Y Pit (ML70049)**

This area was certified in 2019 and is currently used for beef cattle grazing.

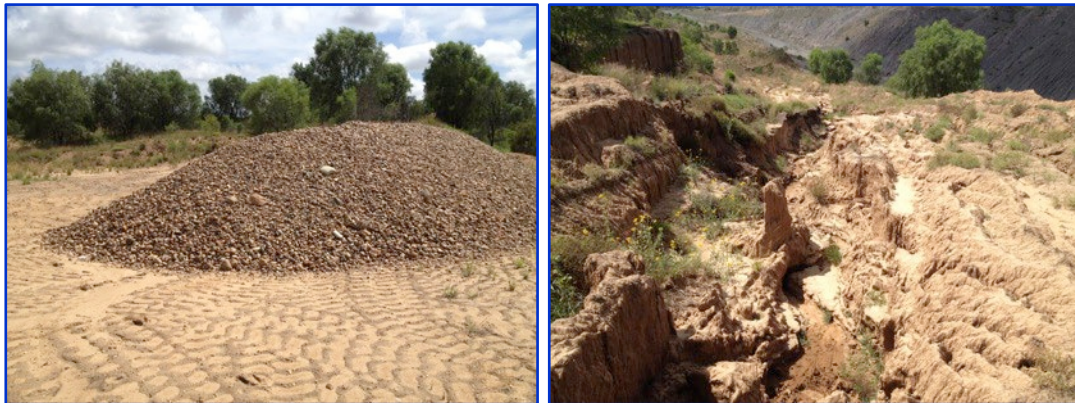
Pale brown to yellow alluvial sands and gravels (Figure 5-3). Low clay content means material has little water or nutrient holding capacity. Non-saline but sodic with low surface cohesion, this overburden is highly dispersive and prone to excessive erosive when exposed to rainfall.

Figure 5-3 Quaternary spoil in B Pit is screened for gravel and sand for use around site (left) and erosion in situ Quaternary spoil in B Pit endwall (right)

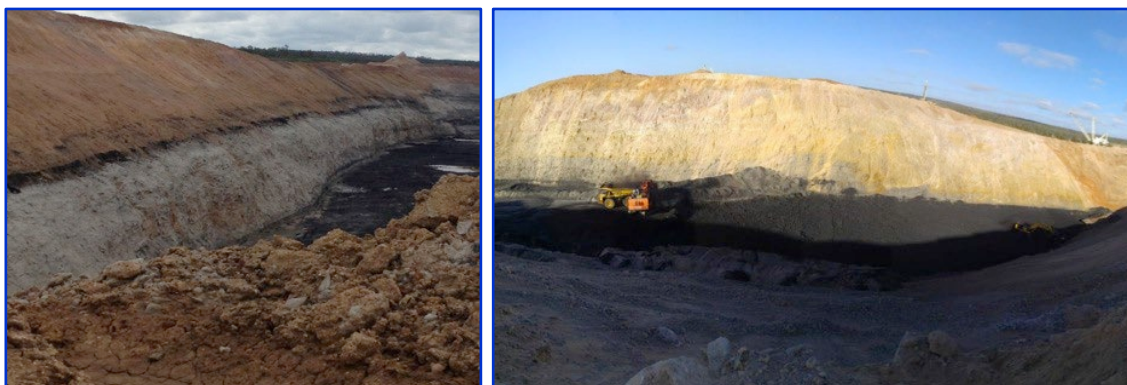
Overlying the Permian overburden, this material is derived from Tertiary age alluvium or colluvium (Figure 5-4). It is consistently saline to extremely saline, with chloride levels toxic to plants at Y Pit, and consistently sodic to extremely sodic. This material is extremely dispersive.

Figure 5-4 Tertiary spoil overlying Permian spoil in Y Pit (left) and F Pit (right)

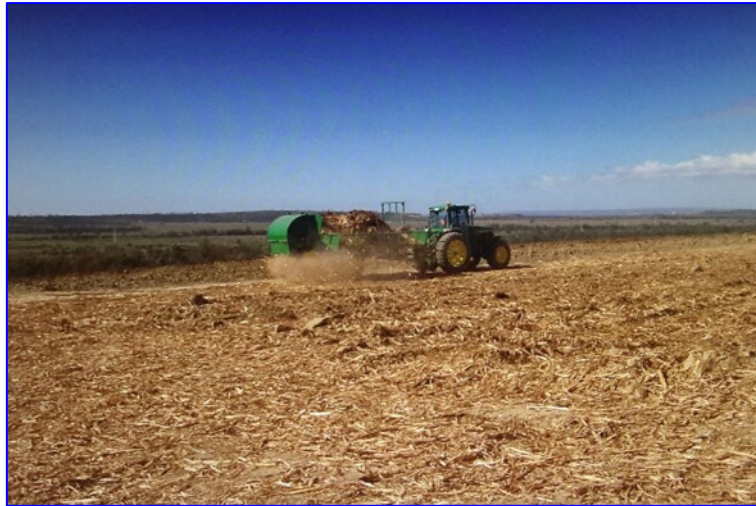
Ensham applies hay mulch immediately after sowing to provide instant groundcover and close the window of erosion risk (Figure 5-10). This is particularly important for any slopes greater than 20%. Hay mulch applied at a minimum rate of 20 round bales or 12 large square bales / ha (approximately 5 t/ha) is a quick and effective erosion hazard control. It also promotes germination and establishment of sown species by assisting to retain soil moisture through reducing evapotranspiration and lowering soil temperatures in the hotter months.

**Figure 5-10 Spreading hay mulch for erosion control in rehabilitation at Ensham**

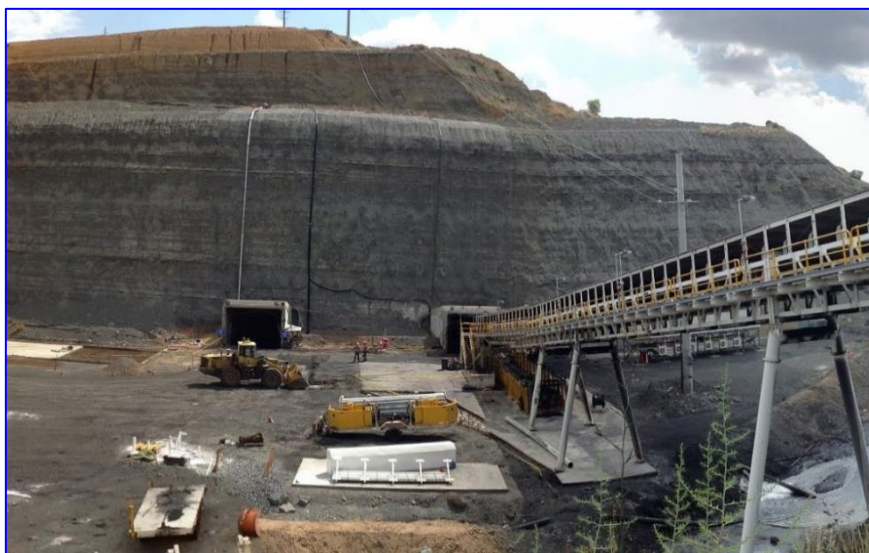
Underground mining at Ensham has negligible surface impacts because, unlike longwall mining, bord and pillar mining does not cause discernible surface subsidence. The underground workings are accessed from a section of C Pit highwall (Figure 5-11).

**Figure 5-11 Entrances to the existing Ensham underground mine.**
