# TRANSITIONAL PROGRESSIVE REHABILITATION AND CLOSURE PLAN LUCKY BREAK PROJECT

PREPARED FOR  
AUSTRALIAN MINES LIMITED

| <b>Report Title:</b> | Progressive Rehabilitation and Closure Plan |

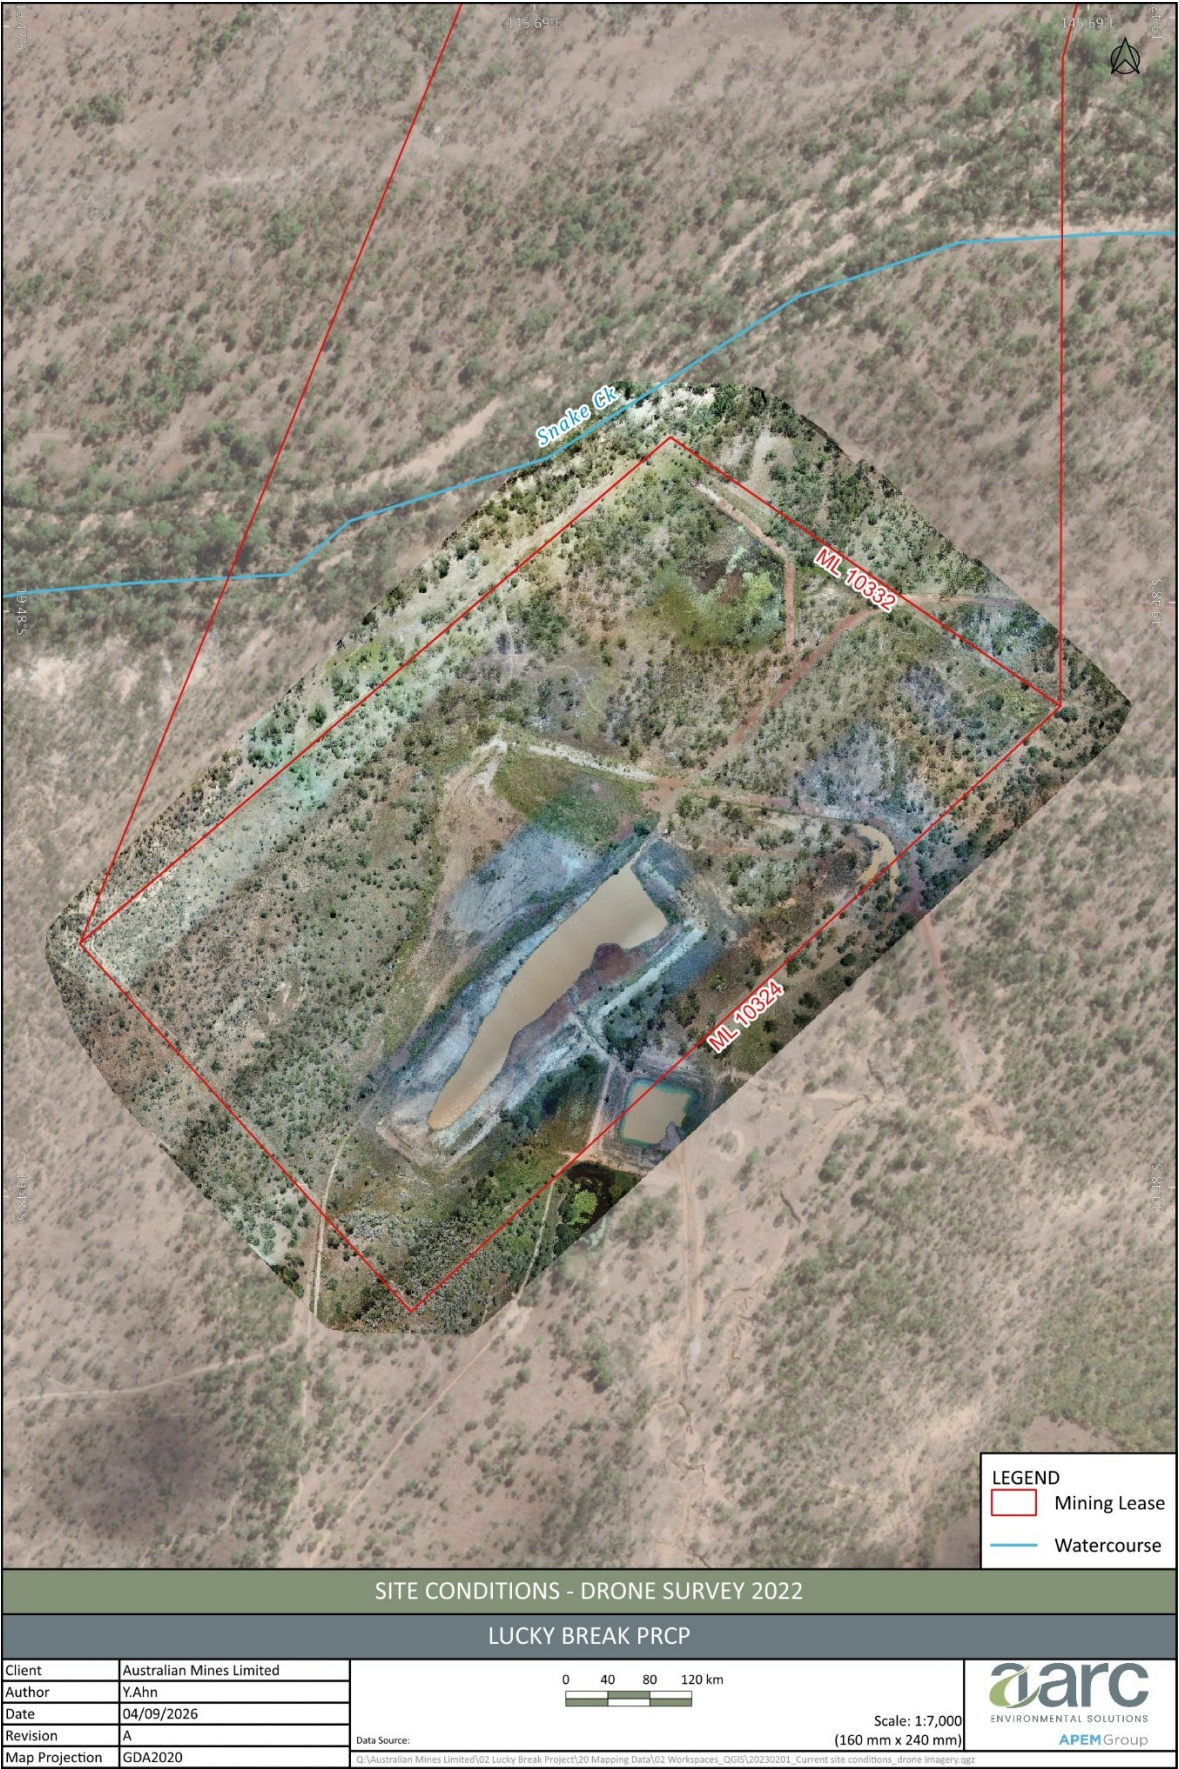
Figure 3: Drone survey of current site conditions 2022 (drone imagery overlain global imagery)

Field-based assessments of rehabilitation progress have been undertaken in September 2018 and then again in March 2022, to provide a broad assessment of final landform stability and the success of past rehabilitation activities. The assessments involved surface water, stream sediment, topsoil quality sampling and analysis and a visual assessment of vegetation establishment and erosion to determine environmental values on the Project site and surrounding receiving environments. Drone imagery capturing the current condition of the site was collected in 2022 and is shown in Figure 3.

For the most part, final landforms were found to be stable with minor and moderate areas of erosion occurring infrequently on the slopes of the WRD and final void. Rehabilitation success in terms of vegetation cover was limited across the Project site in 2018 with the western portion of the WRD supporting the most prominent area of established groundcover vegetation. Groundcover species identified in rehabilitation areas included *Heteropogon contortus*, *Melinis repens*, *Aristida spp.*, *Chloris gayana*, *Stylosanthes scabra*, *Urochloa mosambicensis* and *Sclerolaena spp.* A small number of pioneering Acacia shrubs were scattered across the rehabilitation areas.

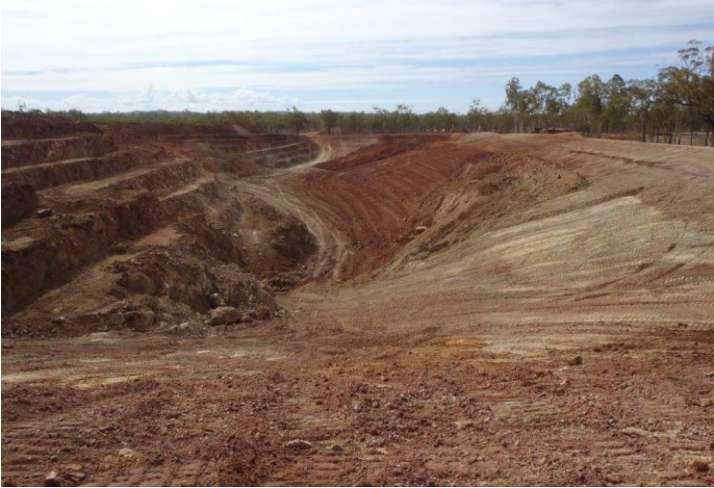
| Mine Domain | Rehabilitation in Progress | Current Rehabilitation Status |
|---|---|---|
| Residual Void | <p data-bbox="383 1342 824 1374">Void – partially rehabilitated (June 2015)</p> | <p data-bbox="1205 1342 1798 1374">Northern void embankment – facing WSW (April 2023)</p> |

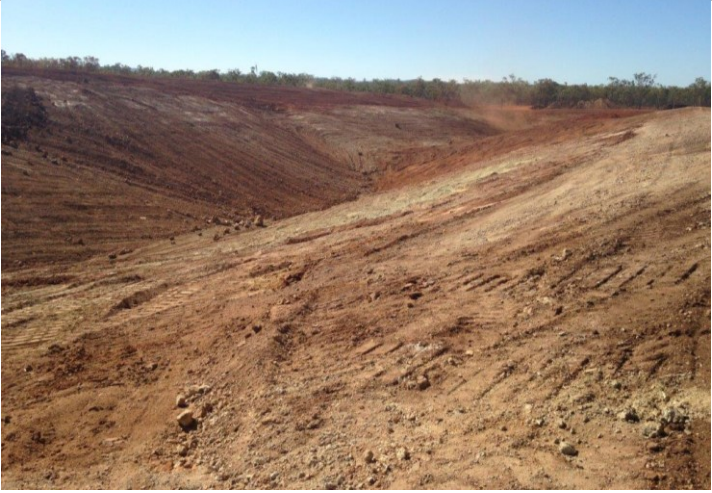
| Mine Domain | Rehabilitation in Progress | Current Rehabilitation Status |
|---|---|---|
| | <p data-bbox="383 783 1093 815">Void – rehabilitation complete (July 2015)</p> | <p data-bbox="1205 783 1921 815">Northern void embankment – facing ESE (April 2023)</p> |

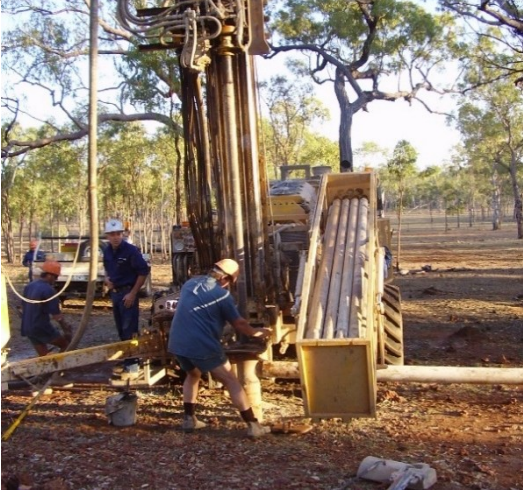
| Mine Domain | Rehabilitation in Progress | Current Rehabilitation Status |
|---|---|---|
| <p>Exploration area<br/>(ML 10322)</p> | <p>Drill rig set up at Dingo Dam (2005)</p> | <p>Rehabilitation monitoring transect (ML 10322) (March 2022)</p> |

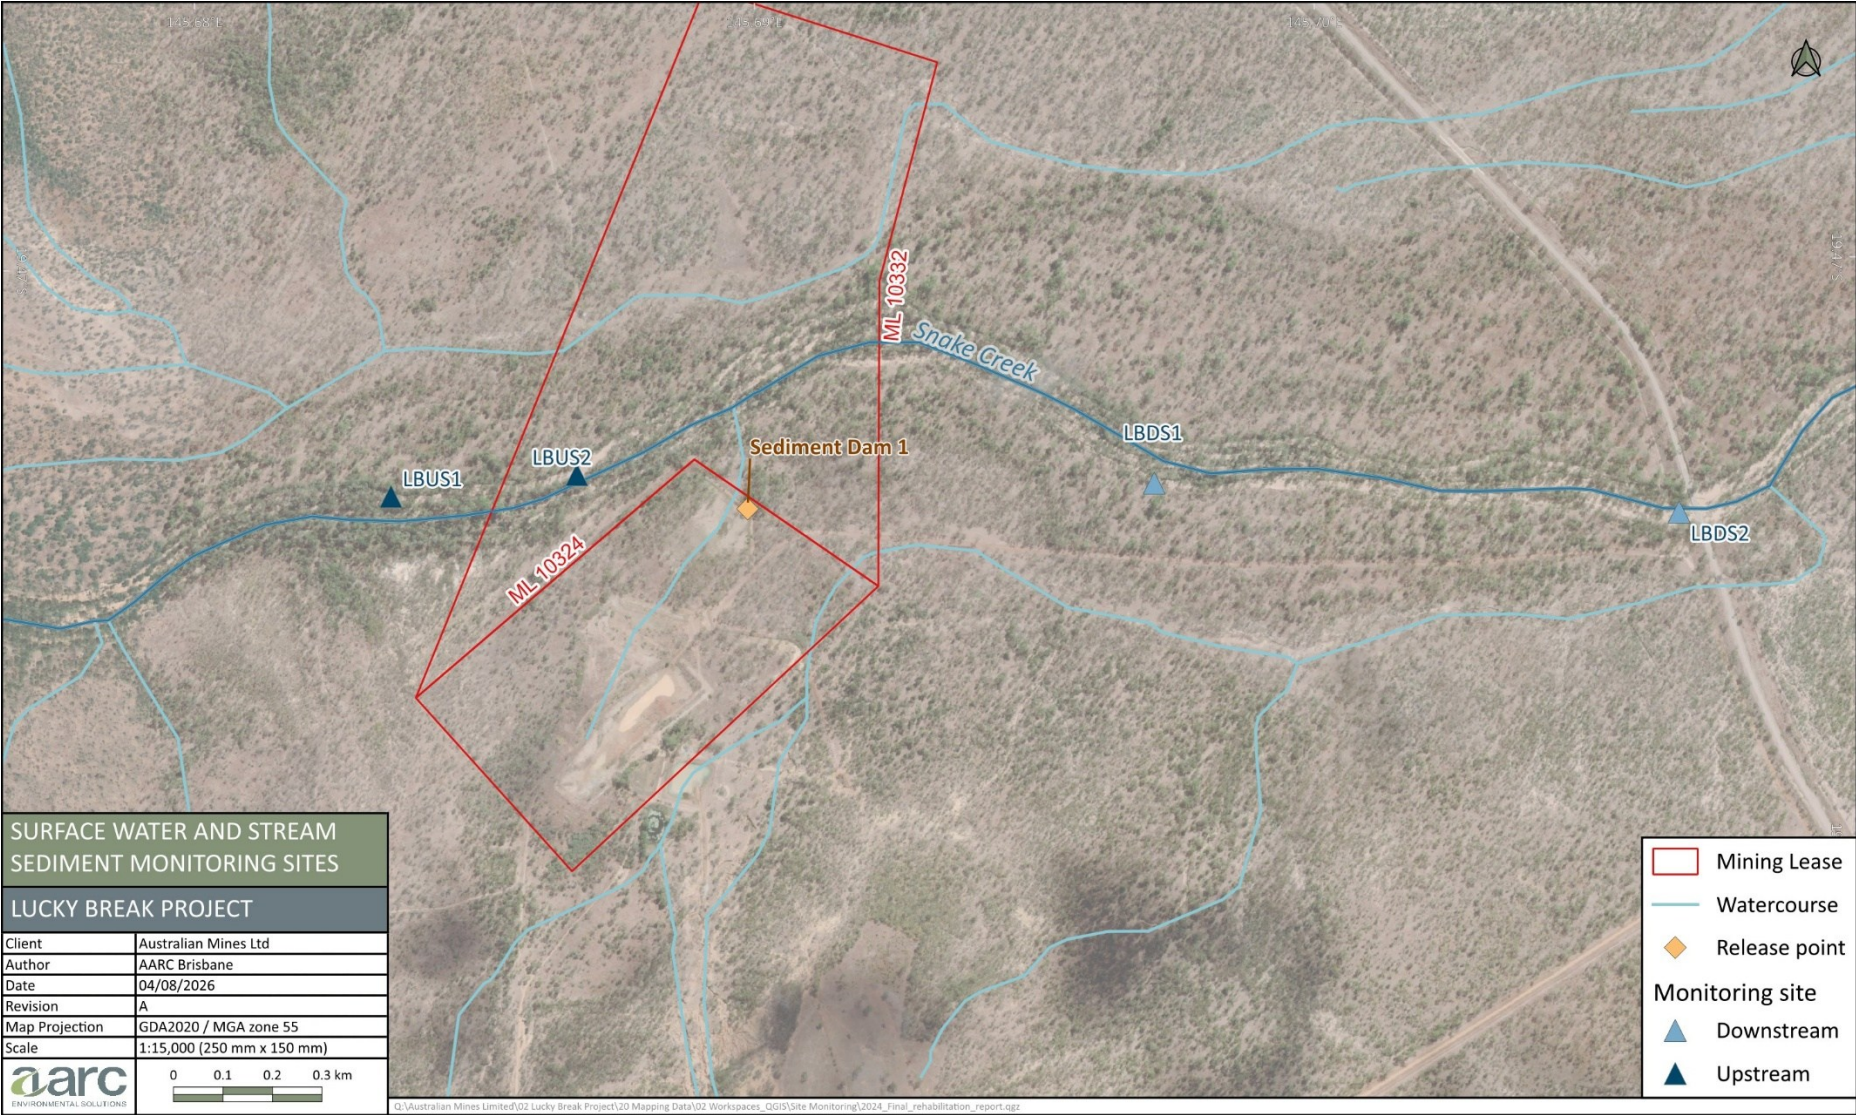
Figure 15: Figure 3: Surface Water and Stream sediment Monitoring Sites

| Monitoring Points | Location Description | Latitude (GDA94) | Longitude (GDA94) |
|---|---|---|---|
| LBDS1 | Snake Creek approximately 1000 metres downstream of RP1 (Sediment Dam 1) | -19.47549 | 145.69960 |
| LBDS2 | Snake Creek approximately 2000 metres downstream of RP1 (Sediment Dam 1) | -19.476218 | 145.709432 |

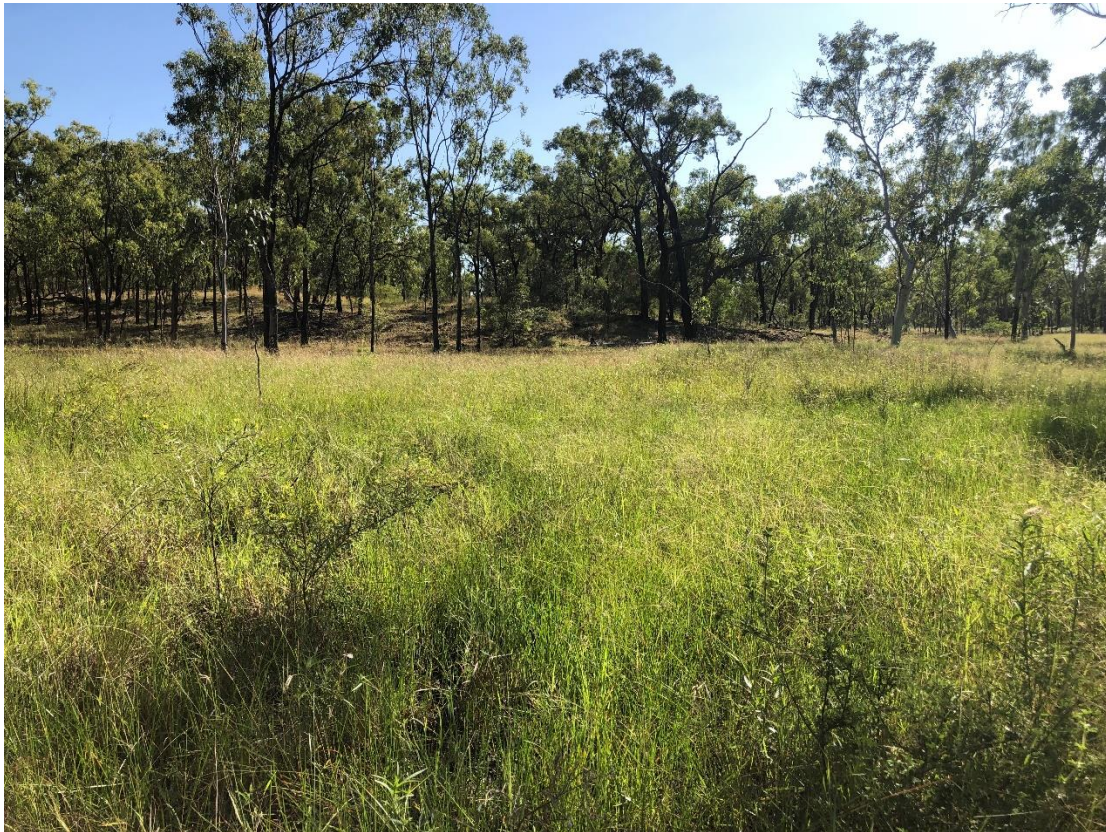
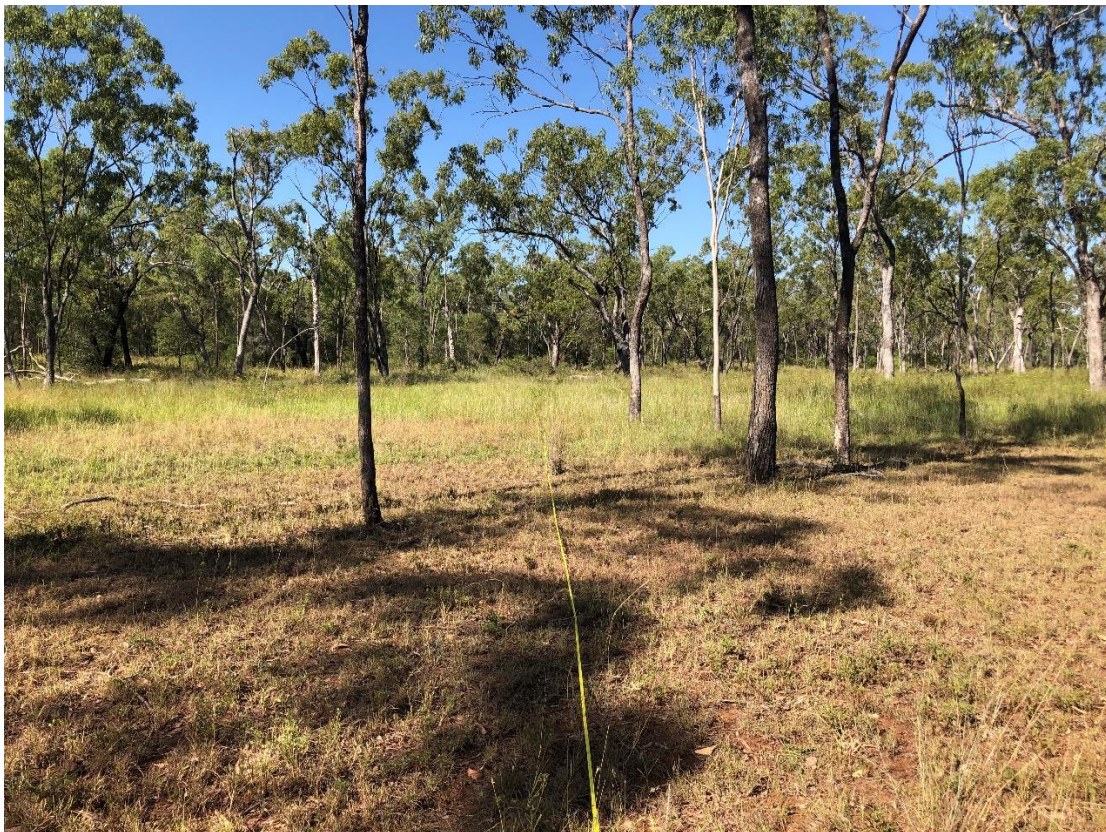
*Figure 17: DRILL 1 monitoring location 2022*

Disturbance on the Lucky Break ML has been limited to historic exploration activities in 2004 and 2005. Areas disturbed by exploration activities have been rehabilitated and show good vegetation cover. Aerial imagery and field photographs indicate that vegetative cover is representative of the surrounding environment. No evidence of drillhole location or residual drilling disturbance was noted.
