# GUMIGIL CHRYSOPRASE MINE'S PROGRESSIVE REHABILITATION AND CLOSURE PLAN

Version 02

Document ID – Gumigil Chrysoprase Mine's PRCP

Tenure 5769, 5770, 5781, 5782, 5791, 5792, 5795, 5802, 7197 and 7198

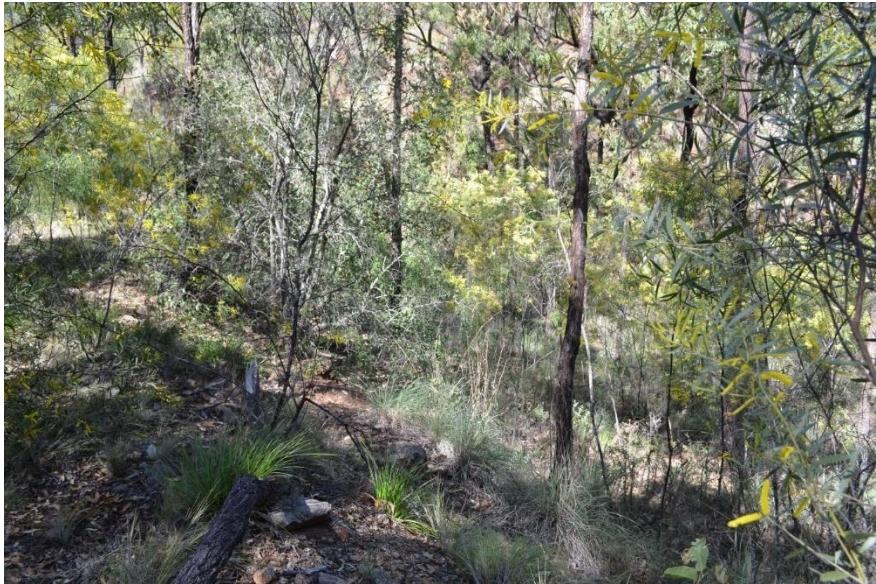
Figure 10: Downstream Wall Dam 2 – November 2022

Further sediment basins were built on gully 1, gully 2, gully 3 and gully 4 commencing 1999 to 2002 with further basins constructed at the toe of the slopes in gullies 5,6 and 7 in 2003. Basins were constructed with downstream walls at 4:1 (Figure 10) and upstream walls at 3:1 with a 5m wide berm on top out of the local material. Basins were constructed with a small dozer with the by-wash constructed in natural material on one side of the wall (see Figure 11). No further incidents of large quantities of sediment being captured in sediment basins have been recorded since 1999 or failure of the drainage system on either Western Tops or Eastern Tops have been reported. It is likely that the site may have received isolated falls >100mm/day since 1999 as Marlborough Helipad regularly receive daily falls exceeding 100mm/day (see Table 4). The nearby Marlborough Creek monitoring station recorded 169mm on 31/3/2025. This is the first recorded time sediment basin 4 on gully 4 has by-washed since construction in 1999. Inspections after the event have not identified any observable erosion with all sediment basins functioning as planned. Minor maintenance will be required on sediment basin 3 and 4 on gully 4.

The natural revegetation on the Western Cut has had two bushfire events in 2003 and 2016 since the mid-1990s demonstrating resilience akin to the surrounding natural vegetation. The resultant landform has endemics volunteering in the rehabilitated area. No reshaping or rehabilitation was conducted on gully 6 or gully 7 Face. Following the construction of the sediment basins on gullies 1 to 4 in 1999 to 2002, select walls of the sediment basins were planted with tube stock grown onsite from locally collected seed (see Figure 10).

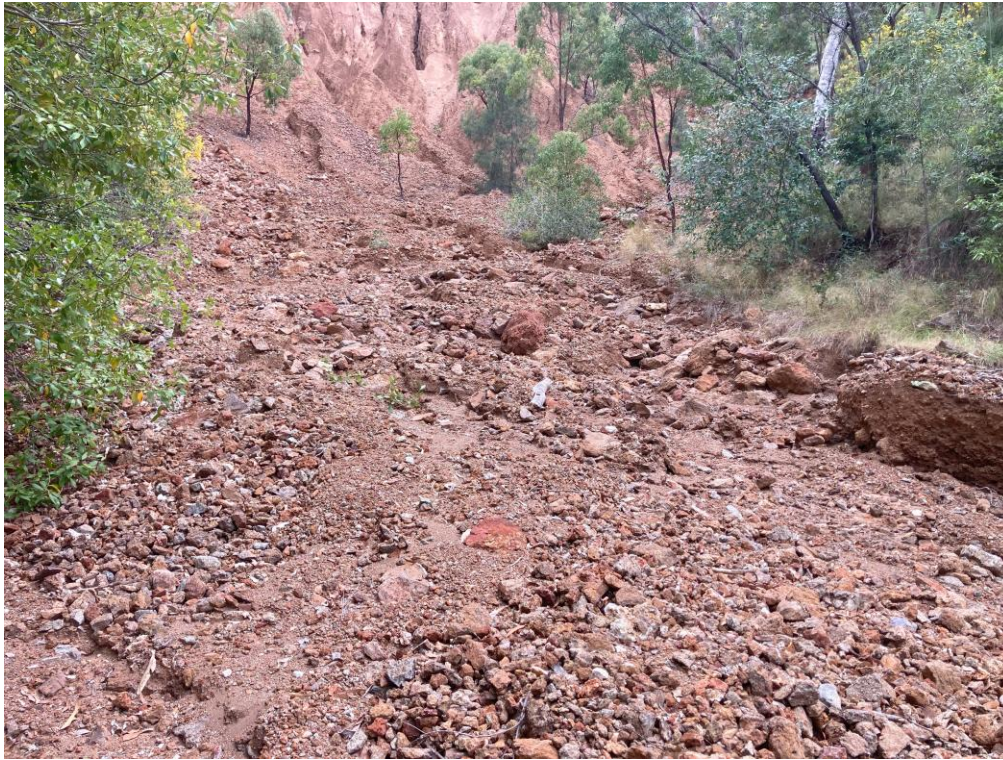
**Figure 13: Active Colluvial Apron – November 2022**

Deposition of sediment at the toe of the Faces is a natural process mimicking the toe of surrounding slopes with a steeper colluvial slope (see Figure 13) initially in the gully followed by finer sediment on the lower slopes. All 7 gullies have sediment basins downstream of the Face. Where stable sediment layers are established, free from intermittent, short duration flows, natural regeneration of native trees and shrubs occurs rapidly (see Figure 13).

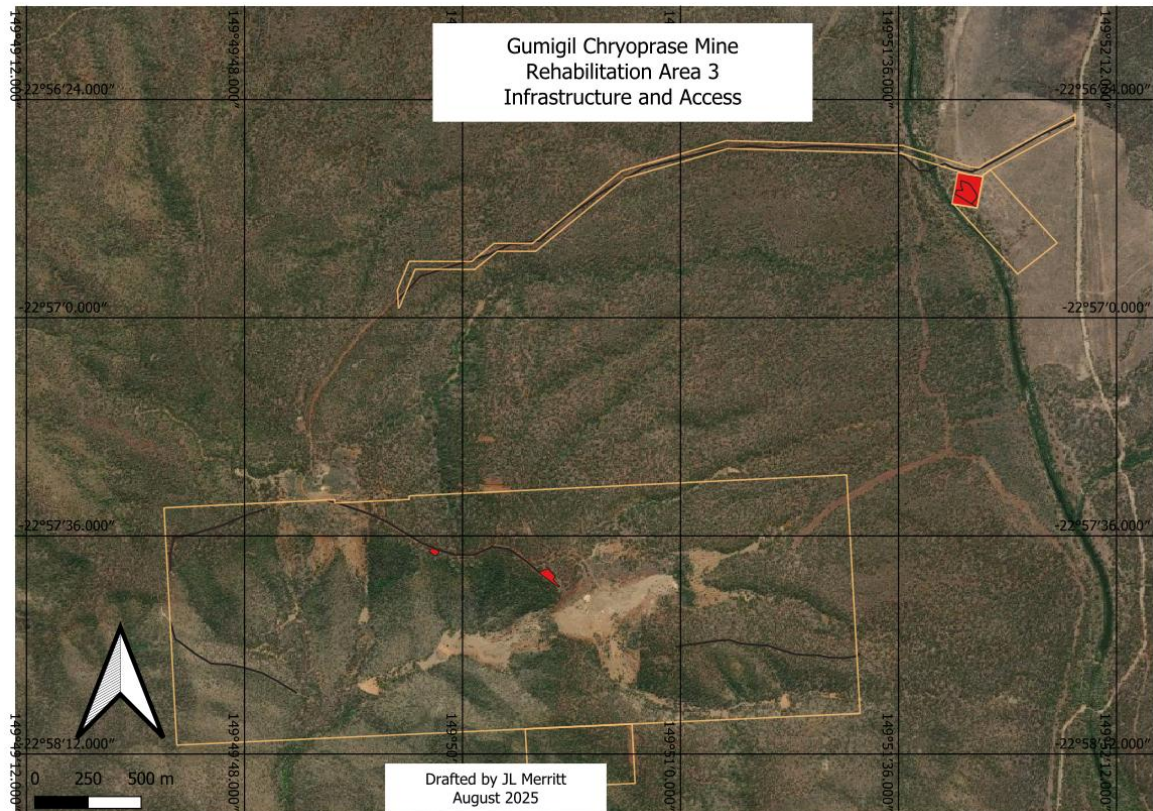
Figure 17: RA3

### Rehabilitation Area 3 (Figure 17)

Infrastructure on leases 5781 and 5795 are being progressively decommissioned and the area rehabilitated. Rehabilitation of the remainder of ancillary structures and tracks will commence at the cessation of mining.

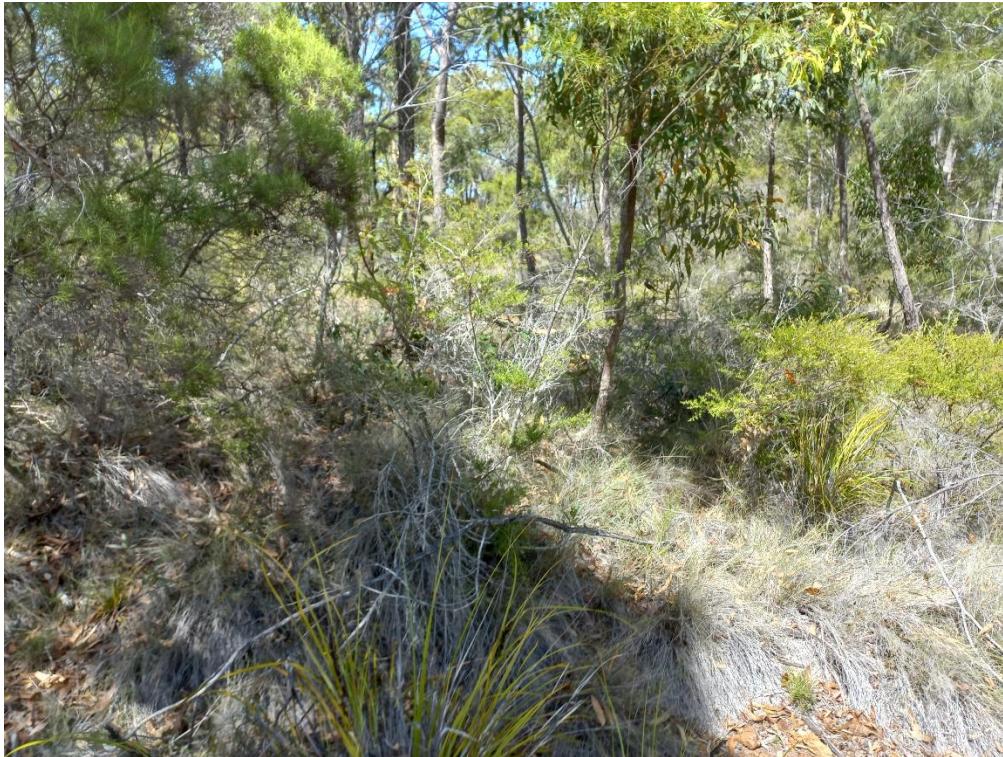
**Figure 23: Revegetation of Western Cut Tops – November 2022**

Figure 23 taken in the Western Cut Tops is typical of the successful natural regeneration of the domain.

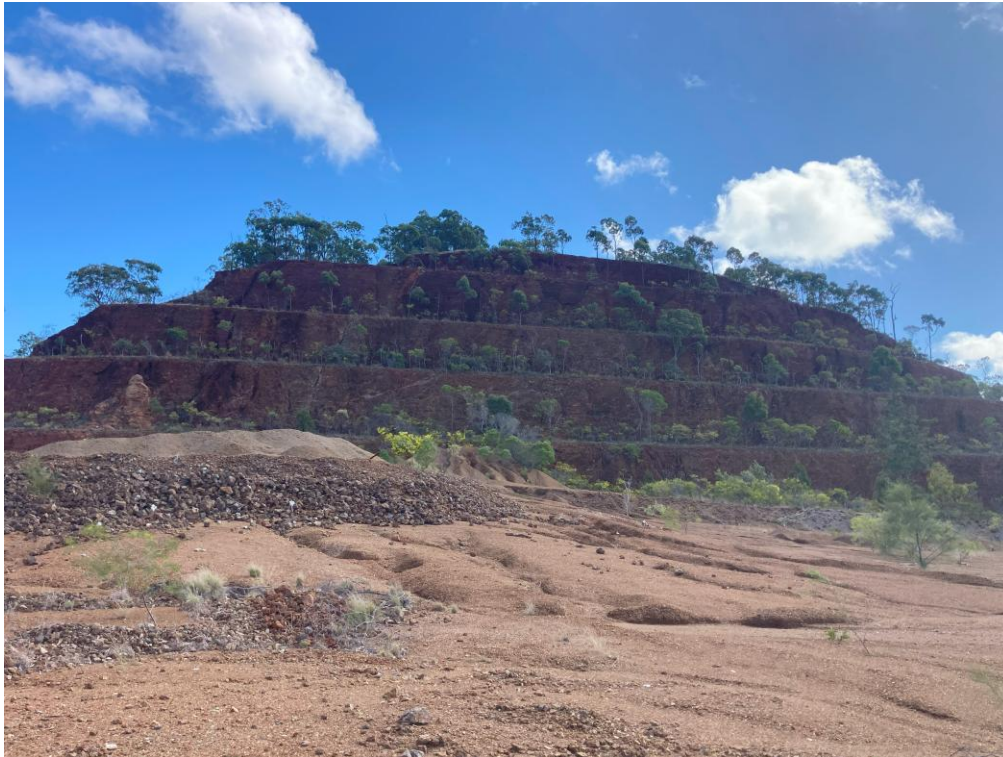
Figure 24: Terraced Pit Wall on bench 1 – July 2022

Terraced Pit Walls have maintained geotechnical stability over time. The upper terraces on the pit wall on bench 1 (Figure 24) were covered with a layer of overburden to promote vegetation growth. This action occurred in the early 1990's when the terraces were accessible from the mining face. Isolated native tussocks can be observed on the vertical batters and low open woodlands growing on the terraces.

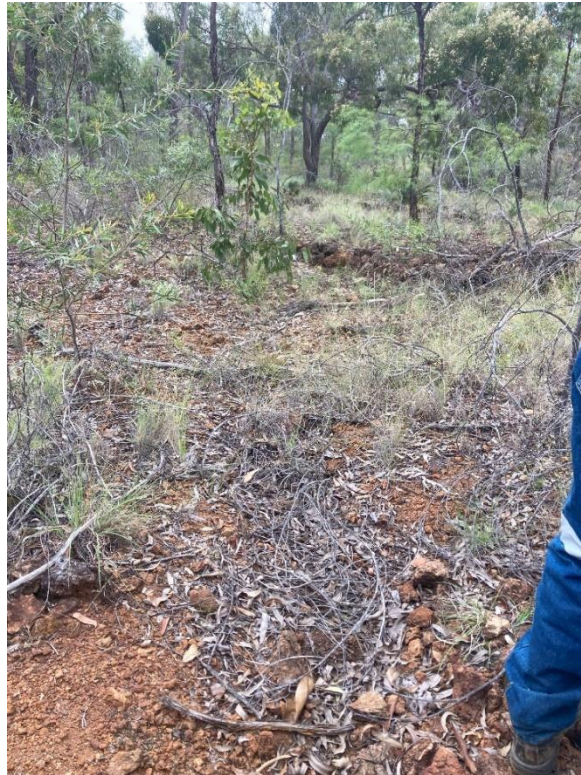
**Figure 25: Fuel Storage Area – April 2023**

Figure 25 shows the decommissioned fuel storage area and is an example of an industrial area that has naturally revegetated.

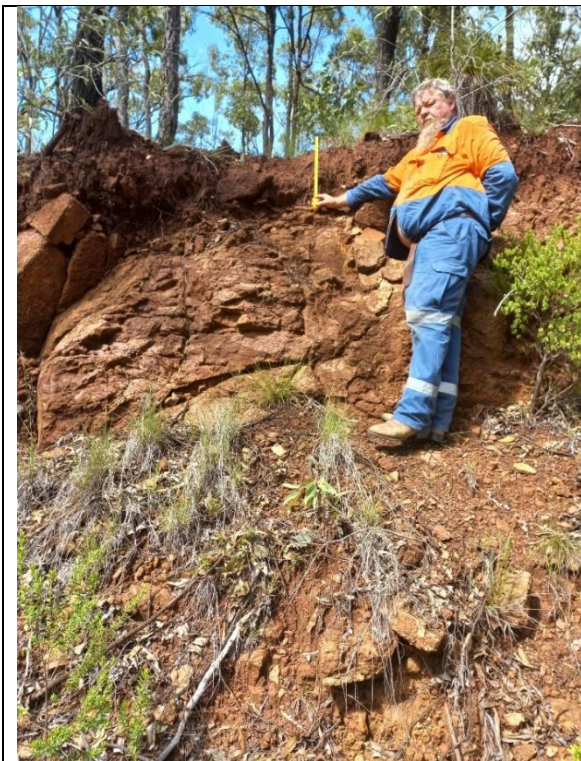
Figure 29: Topsoil depth 752303E 7444852N GDA 94

The topsoil over the undisturbed area planned to be mined was surveyed in January 2023. Topsoil depth averages 300mm in depth. Figure 29 has 300mm of topsoil over rocky

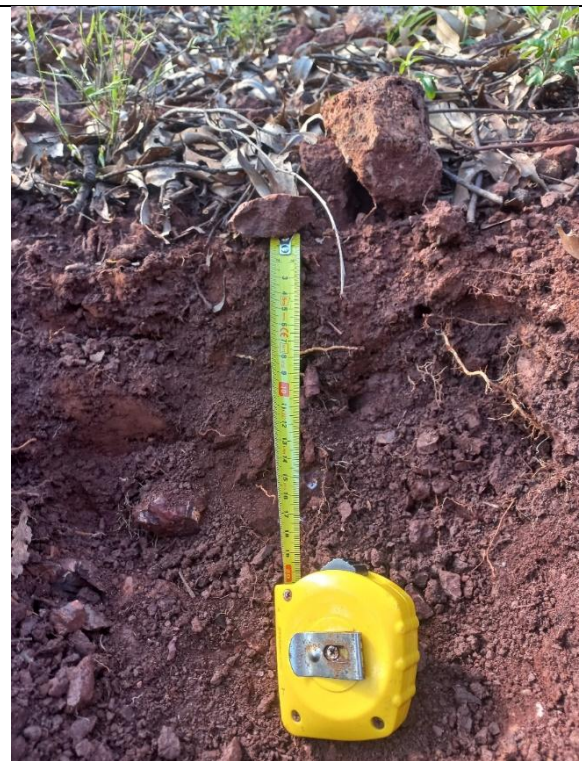
Figure 30: Topsoil depth 791579E 7457924N GDA 94

subsoil. Figure 30 has 200mm of topsoil depth. Table 22 lists the nutrient levels of topsoil and subsoil in the future mining area and a soil sample from a rehabilitated site.

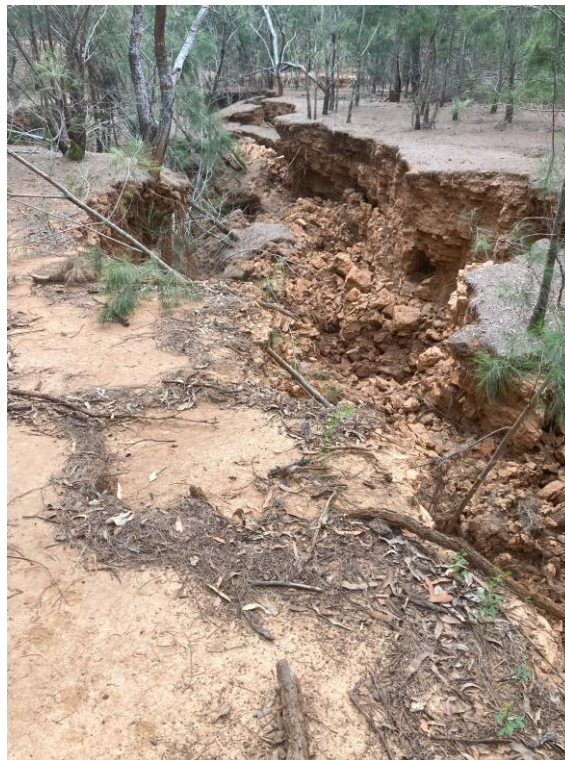
**Figure 31: Head cut on Basin 1 Gully 4 – April 2023**

A risk with the stability of the landform is that head cuts (see Figure 31) migrating upstream through the accumulated sediment in sediment basins that are failing may result in the release of basin sediments over time at levels more than the downstream gully can

assimilate. As observed in Figure 31, the sediment's structure limits remobilisation with manageable impact downstream.

Basin 1 and basin 2 on Gully 4 (Poacher's Gully) have over-topped with a head cut working its way upstream through the basin wall and deposited sediment (see Figure 31). Sediment basins 3 and 4 have been constructed below basins 1 and 2. 3 and 4 continue to function and remain at >90% of the original capacity. Basin 4 first overflowed in April 2025.

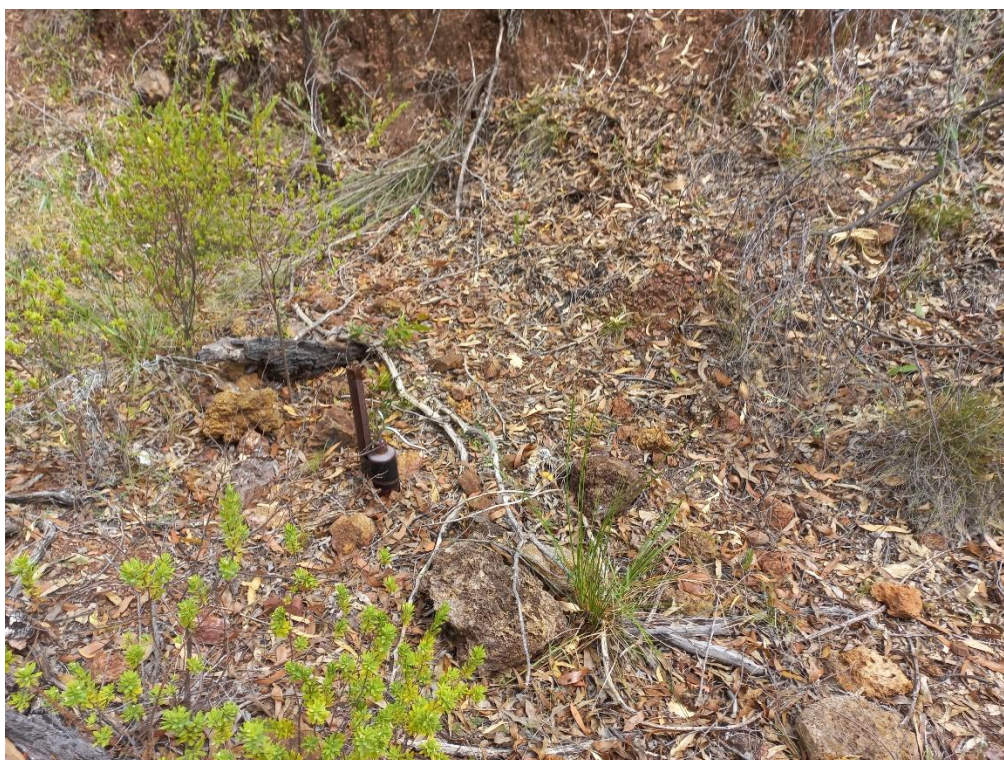
**Figure 32: Gully 4 Rising Stage Sampler – November 2022**

Rising Stage Samplers (RSS) have been installed on Gullies 1,3, 4 and the Devlin Creek catchment at suitable locations downstream of the lease boundary as required by Condition WA3 of the EA (see Figure 32). Samplers have only 1 bottle that will collect flows greater than 200mm. Monitoring of Gully 2 was abandoned as gully 2 flows into Gully 1 upstream of the Gully 1 monitoring point. No samples have been collected since monitoring commenced in 2014.

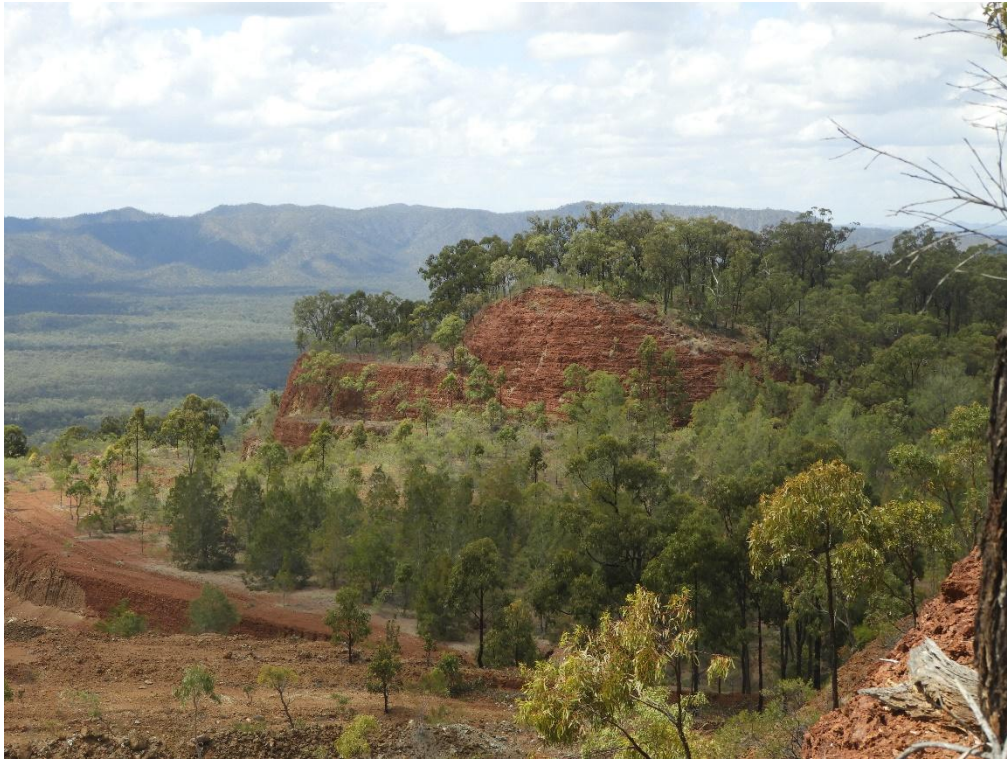
Bench 2 Terraced Pit Wall - 1975

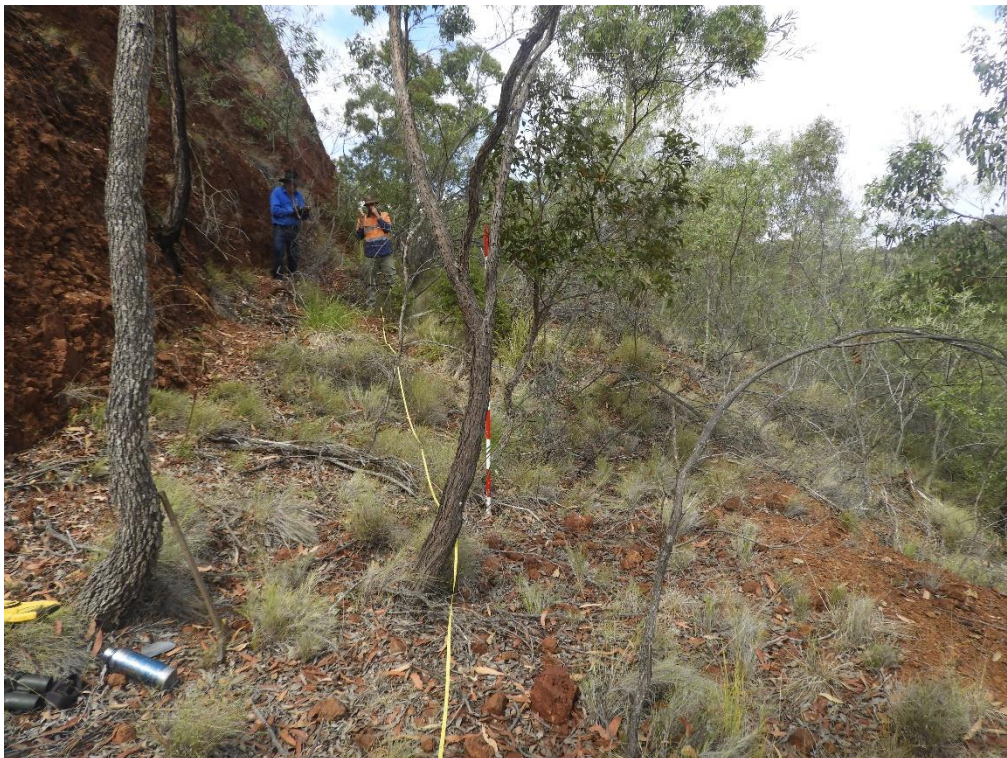
Pit Wall Terrace - 2023

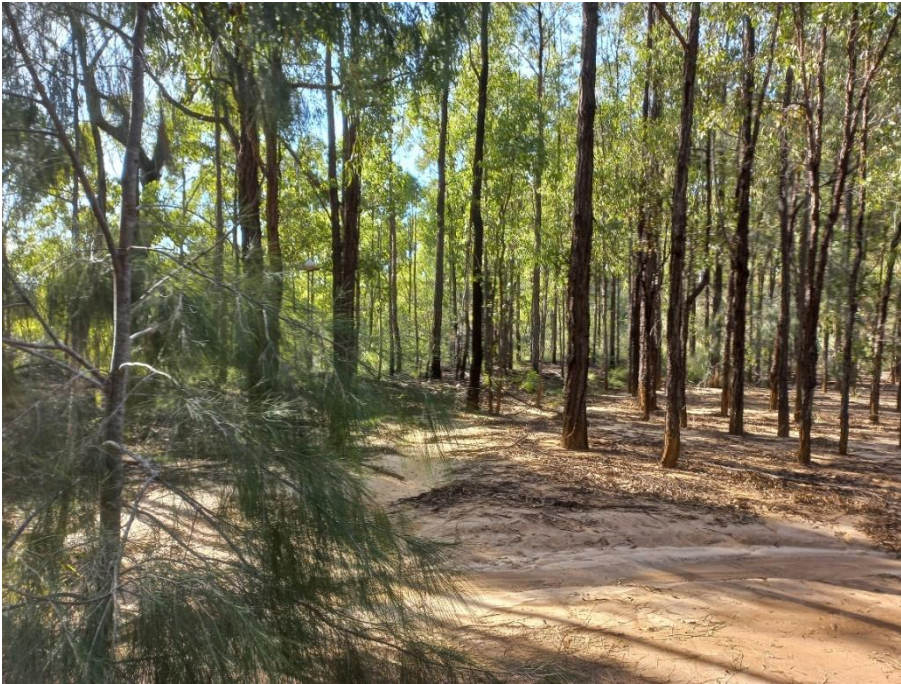
Tubestock on Sediment Basin wall – November 2022

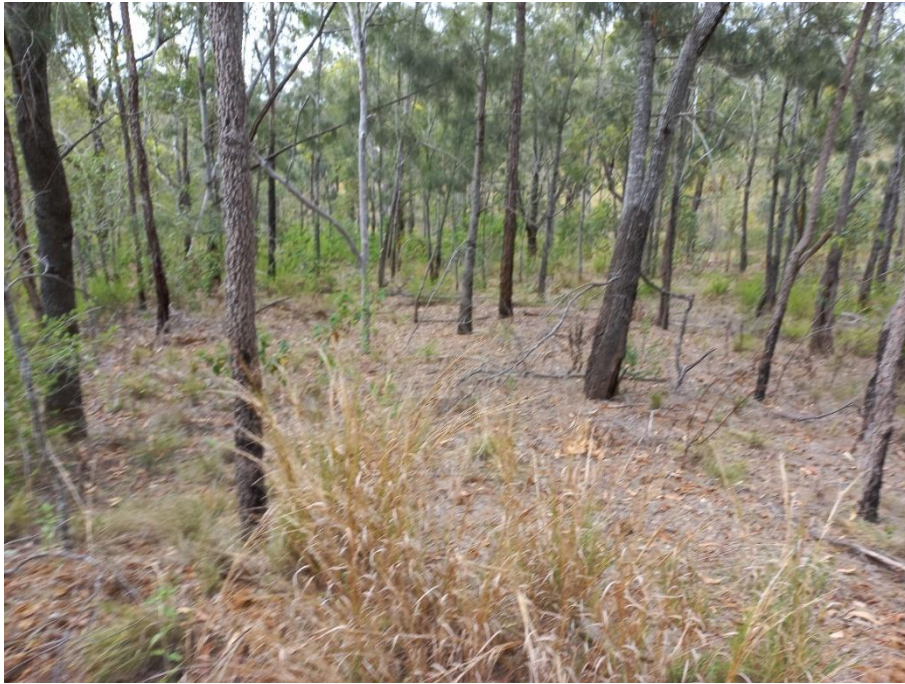
Rehabilitated Colluvial Apron Western Cut – November 2022

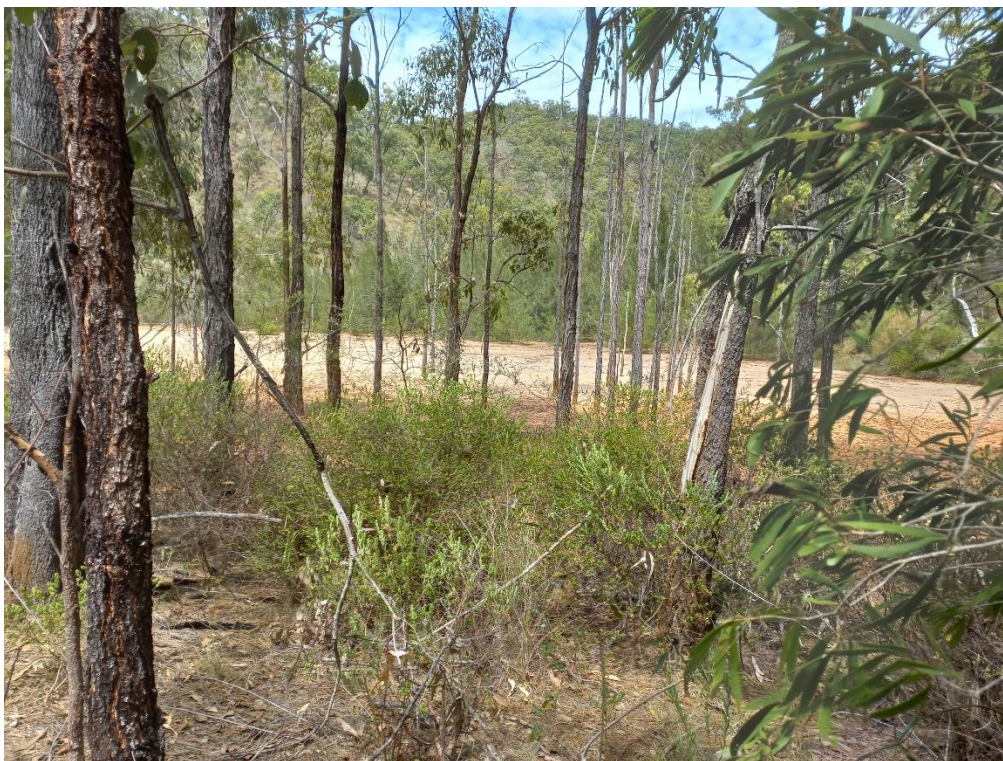
Gully 4 Sediment Basin 2 sediment in basin – November 2022

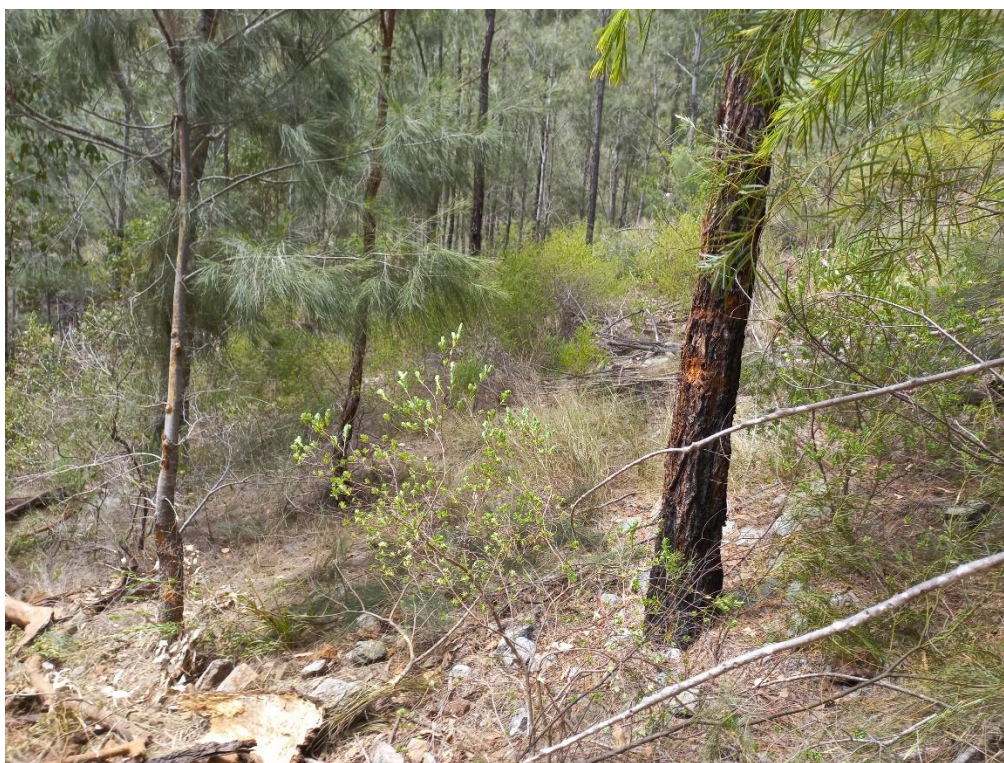
Gully 4 Sediment Basin 2 d/s slope wall – November 2022
