MIDDLEMOUNT COAL MINE
PROGRESSIVE REHABILITATION AND CLOSURE PLAN

February 2026
Document No. FMMP 003.18
Version 5.0

Title of the Project	Middlemount Coal Mine
Document Title	Progressive Rehabilitation and Closure Plan
Document ID Number	FMMP 003.18
Tenure Number(s)	ML 70379, ML 700014, ML 700027 and ML 70417
EA Number	EPML00716913
EA Holder Name	Ribfield Pty Ltd and Middlemount Coal Pty Ltd
EA Holder Contact	Henning Boshoff
EA Holder Contact Details	(07) 4985 0059

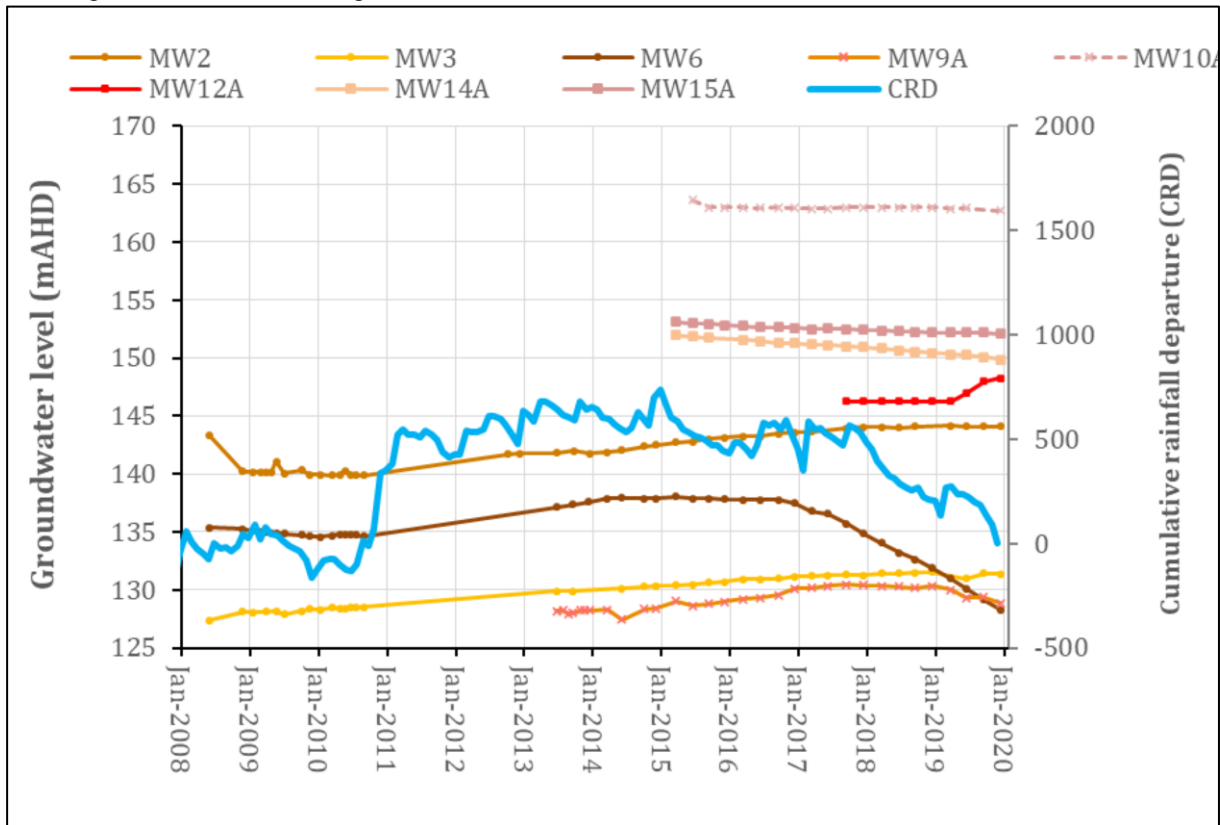
Plate 1 - Groundwater Level Hydrographs

Groundwater level data has been collected from the groundwater monitoring bores within the vicinity of the Middlemount Coal Mine from 2008 to present. Plate 1 presents the groundwater level hydrograph for the groundwater monitoring bores.

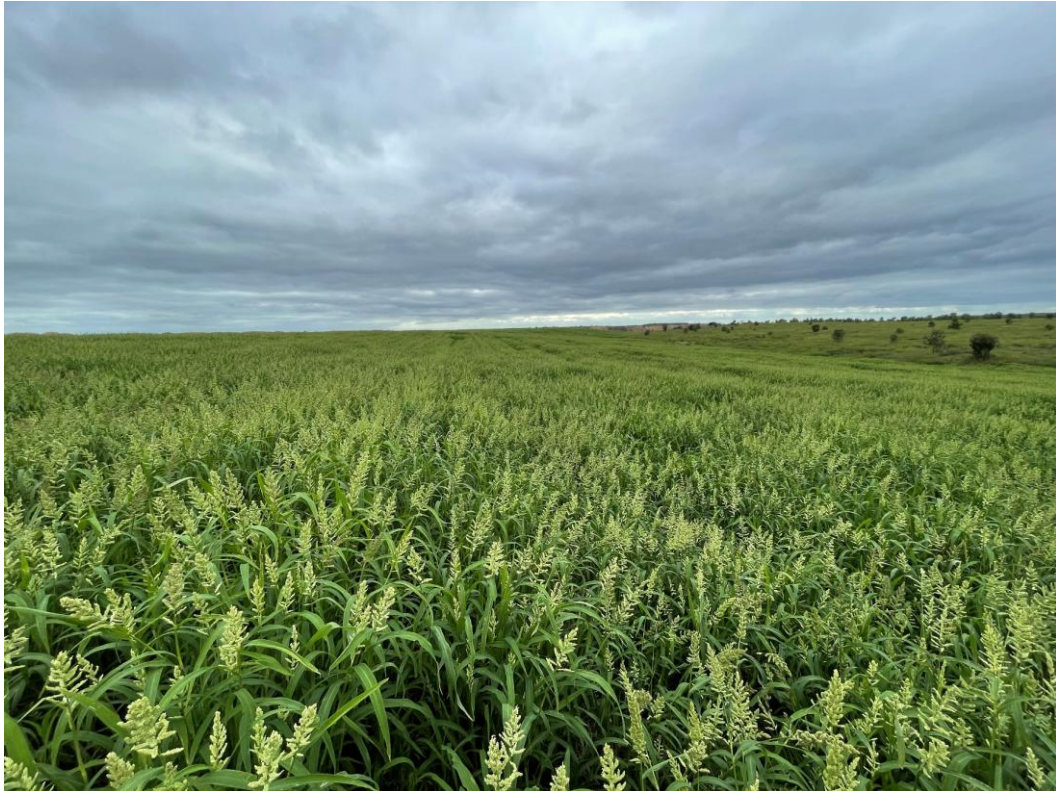
Plate 2: Cover Crop species present on 5 month old rehabilitation at the Middlemount Coal Mine.

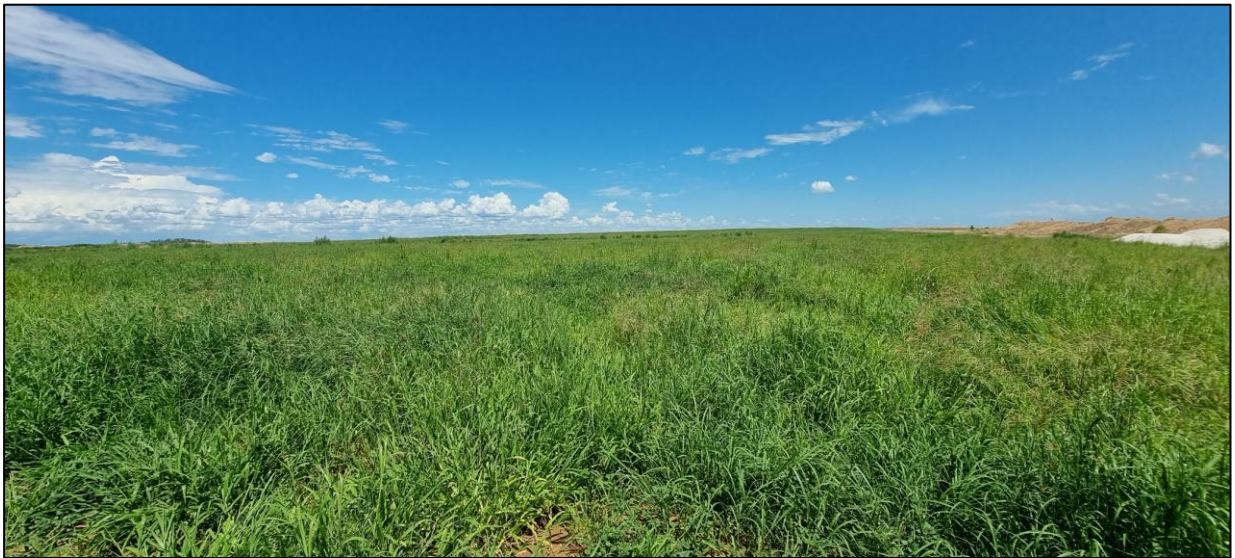
Plate 3: Intermediate pasture with emerging Acacia species present at the Middlemount Coal Mine.
