# Marmor Operations Progressive Rehabilitation and Closure Plan

## Marmor Operations Progressive Rehabilitation and Closure Plan – Rehabilitation Planning Part

| <b>Document reference:</b> | 22MUD3257 |

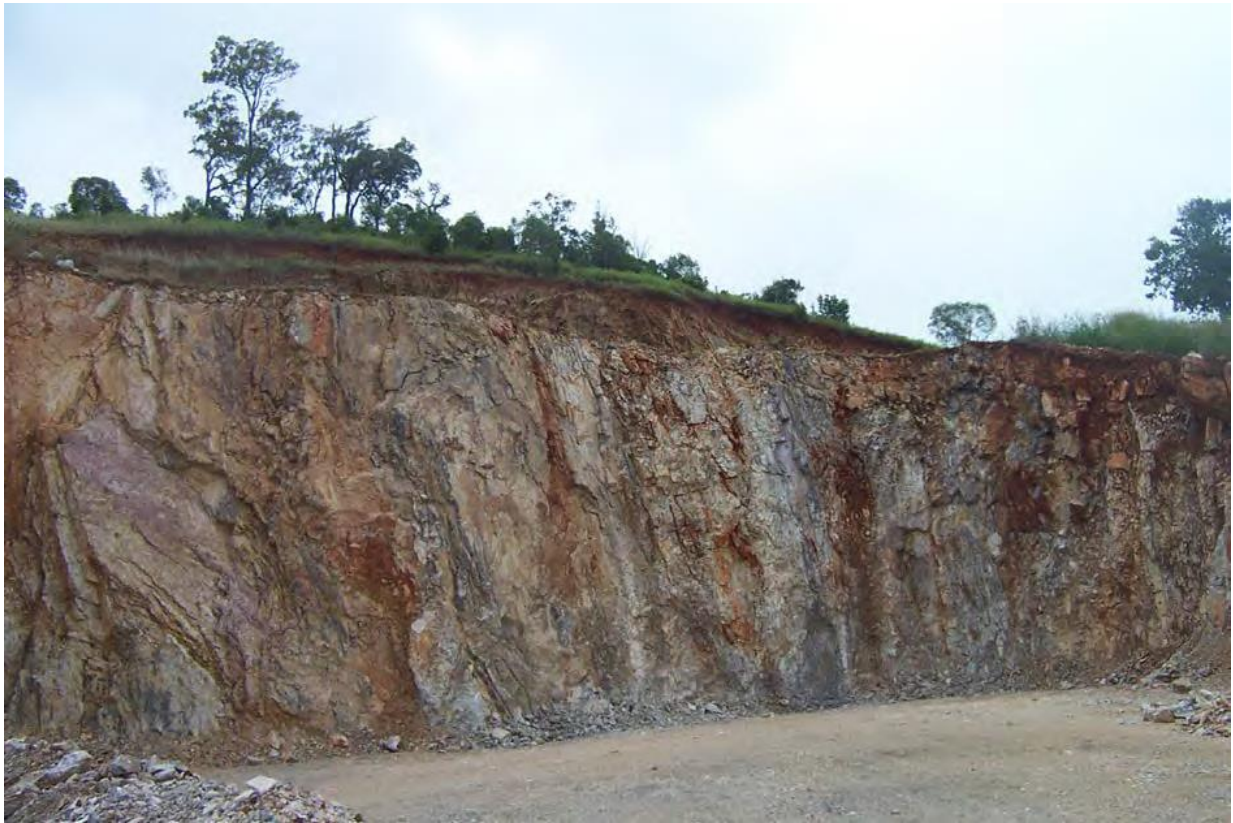
**Figure 7: Photograph of the void showing a cross section of the shallow red-brown clay soil profile over partially weathered parent material**

Given the background geology of the project area, the uniform or gradational clay loams to clays would be classified as Red or Brown Dermosols under the current Australian Soil Classification (ASC) system (see the soil profiles exposed above the void walls in Figure 7). It is possible that deeper clay rich soils (Grey or Brown Vertosols under the ASC) occur in flatter areas outside the main area of disturbance. Where topsoil depths have been provided in *Land Systems of the Dawson-Fitzroy area, Queensland* (CSIRO 1968), they are generally 100 to 150 mm deep. This has guided the proposed topsoil depth to be used in site rehabilitation.

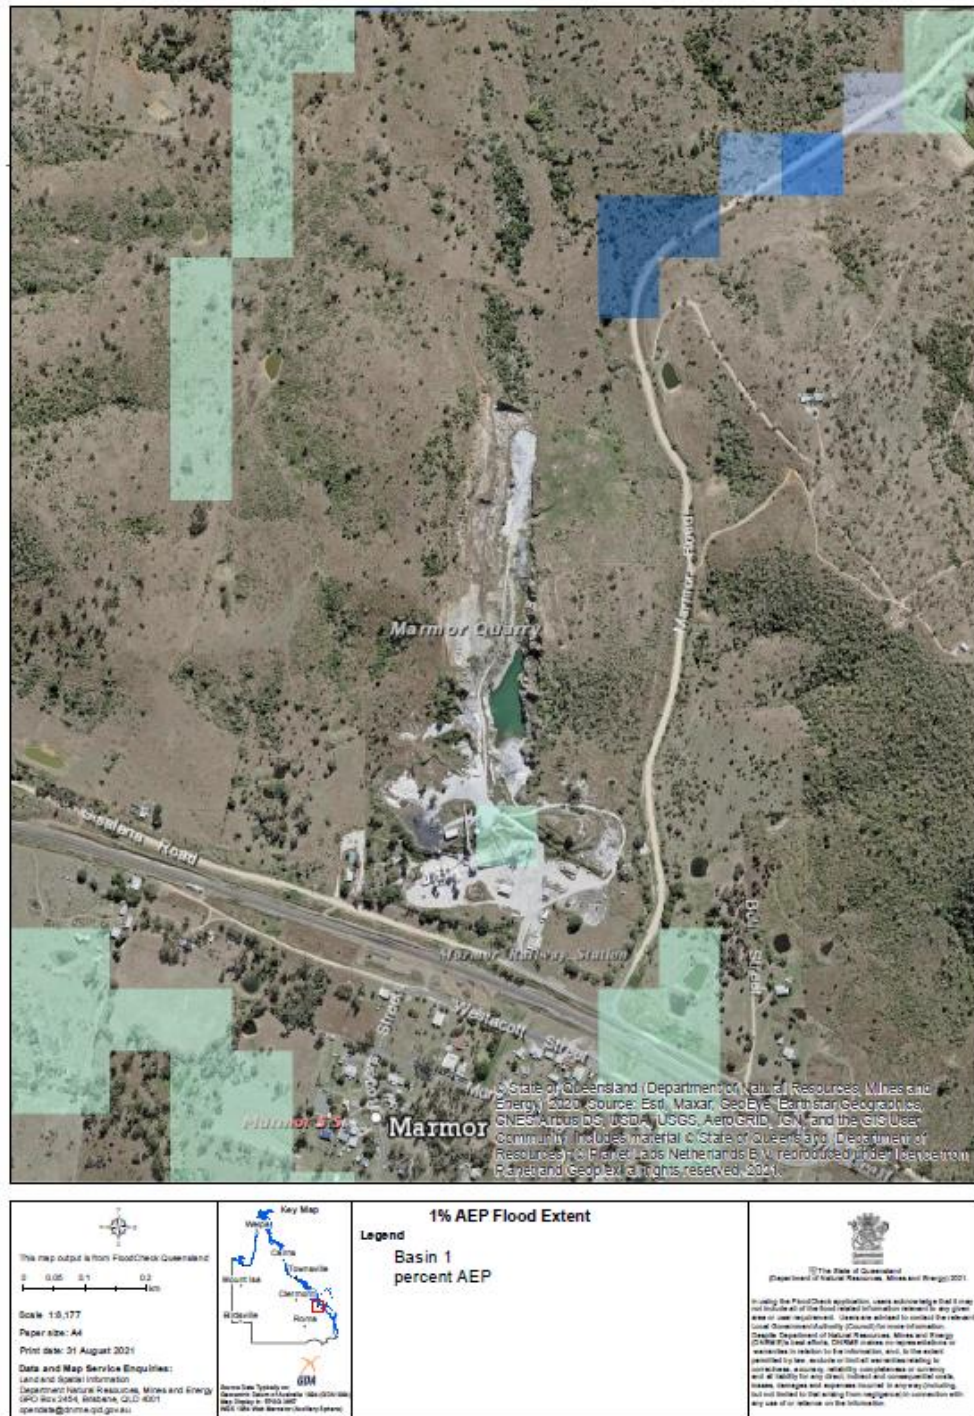
Figure 14: 1% AEP flood extent around the Marmor Operations<sup>6</sup> where variants of blue blocks on the map indicate depth of water

Available flood information showed that there is the potential for some flooding on site during a 1% Annual Exceedance Probability (AEP) flood event (Figure 14) and during more extreme events (Figure 15) that approximate the probable maximum flood (PMF). These results show that some isolated flooding may occur during the 1% AEP event with more broadscale flooding occurring only in more extreme events. Combining the flood information with the contours of the site (Figure 16) indicates that the localised flooding identified would largely drain to the south of the site or into the residual void. The potential flooding even for the PMF does not result in the whole of the void being flooded and there is no direct connection between flooding in the void and surrounding water courses, there is no direct continuity between flooding within the void. Therefore, flooding is not anticipated to impact the surrounding users or the downstream EVs. The likelihood of water spilling from the former mining pit is discussed in Section 3.5.11.3.

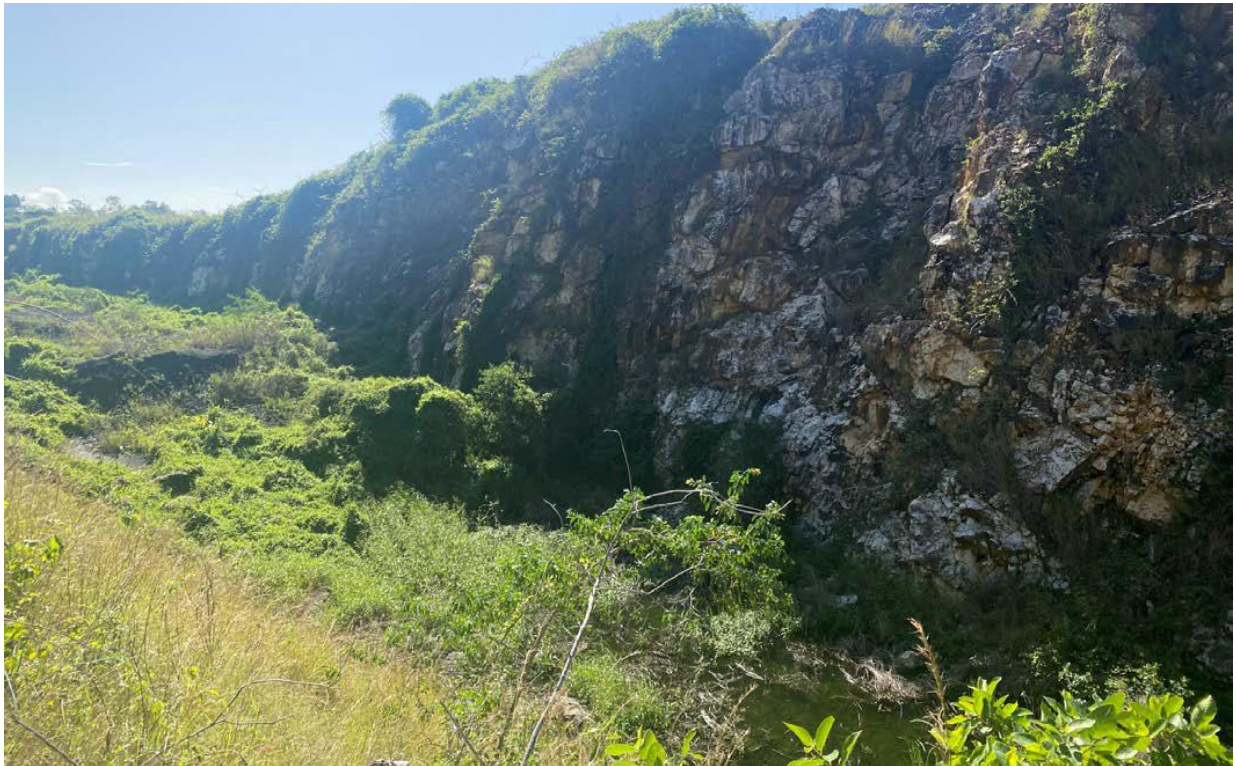
**Figure 22: High vegetation cover on the floor of the void at the Marmor Operations adjacent to the Pit Lake with good cover on the east wall in the background**

The observations of the rapid regeneration of vegetation within the void (particularly between 2014 and 2022), as shown in Rocktest (2022) and examples reproduced in Figure 22 and Figure 23, is consistent with the benign nature of the limestone parent material and the recognised ability of vegetation to passively regenerate in mined-out limestone quarries/pits in many other parts of the world under varying climatic conditions (Davis 1979, Thompson & Green 2010, Tropek et al. 2010, Gilardelli et al. 2015).

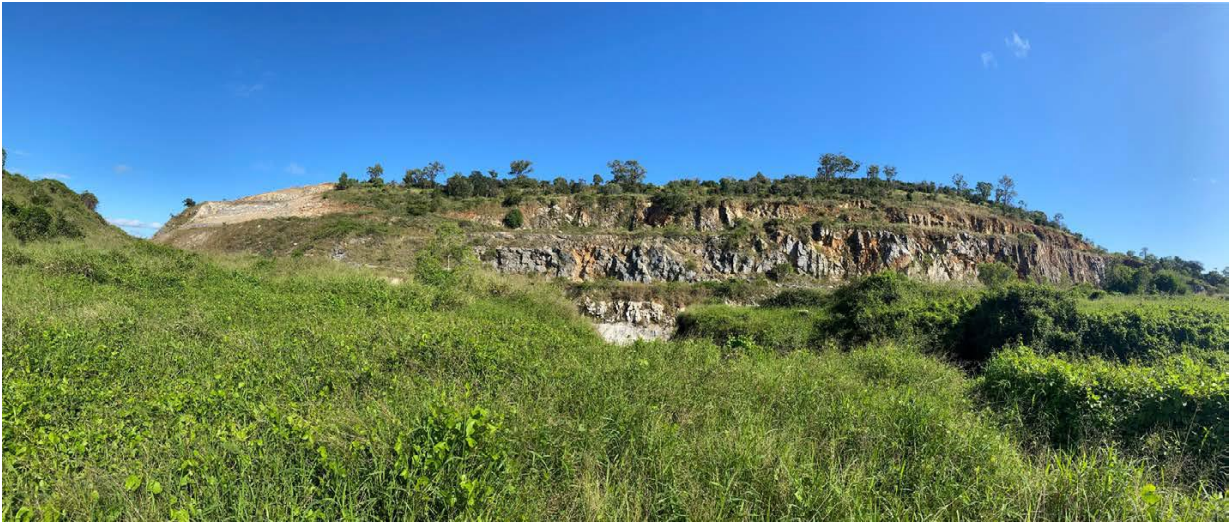
**Figure 23: Good vegetation in disturbance areas at the crest of the west wall of void at the Marmor Operations with groundcover, shrub and tree establishment on benches and good groundcover establishment in areas reworked in 2014 to the left**

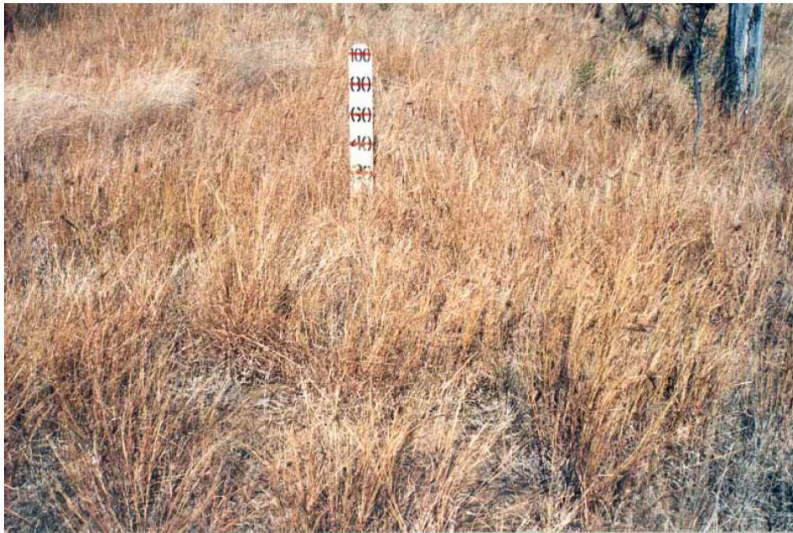
**Figure 28: Example of a photo standard of Black Speargrass with a pasture yield of 2,450 kg DM/ha**

Once this has been done several times, it should be possible to establish a series of photo standards (like the one in Figure 28) using the plot photos and corresponding standing biomass measurements. These can then be used for subsequent estimates of standing biomass rather than the cut and weigh method.

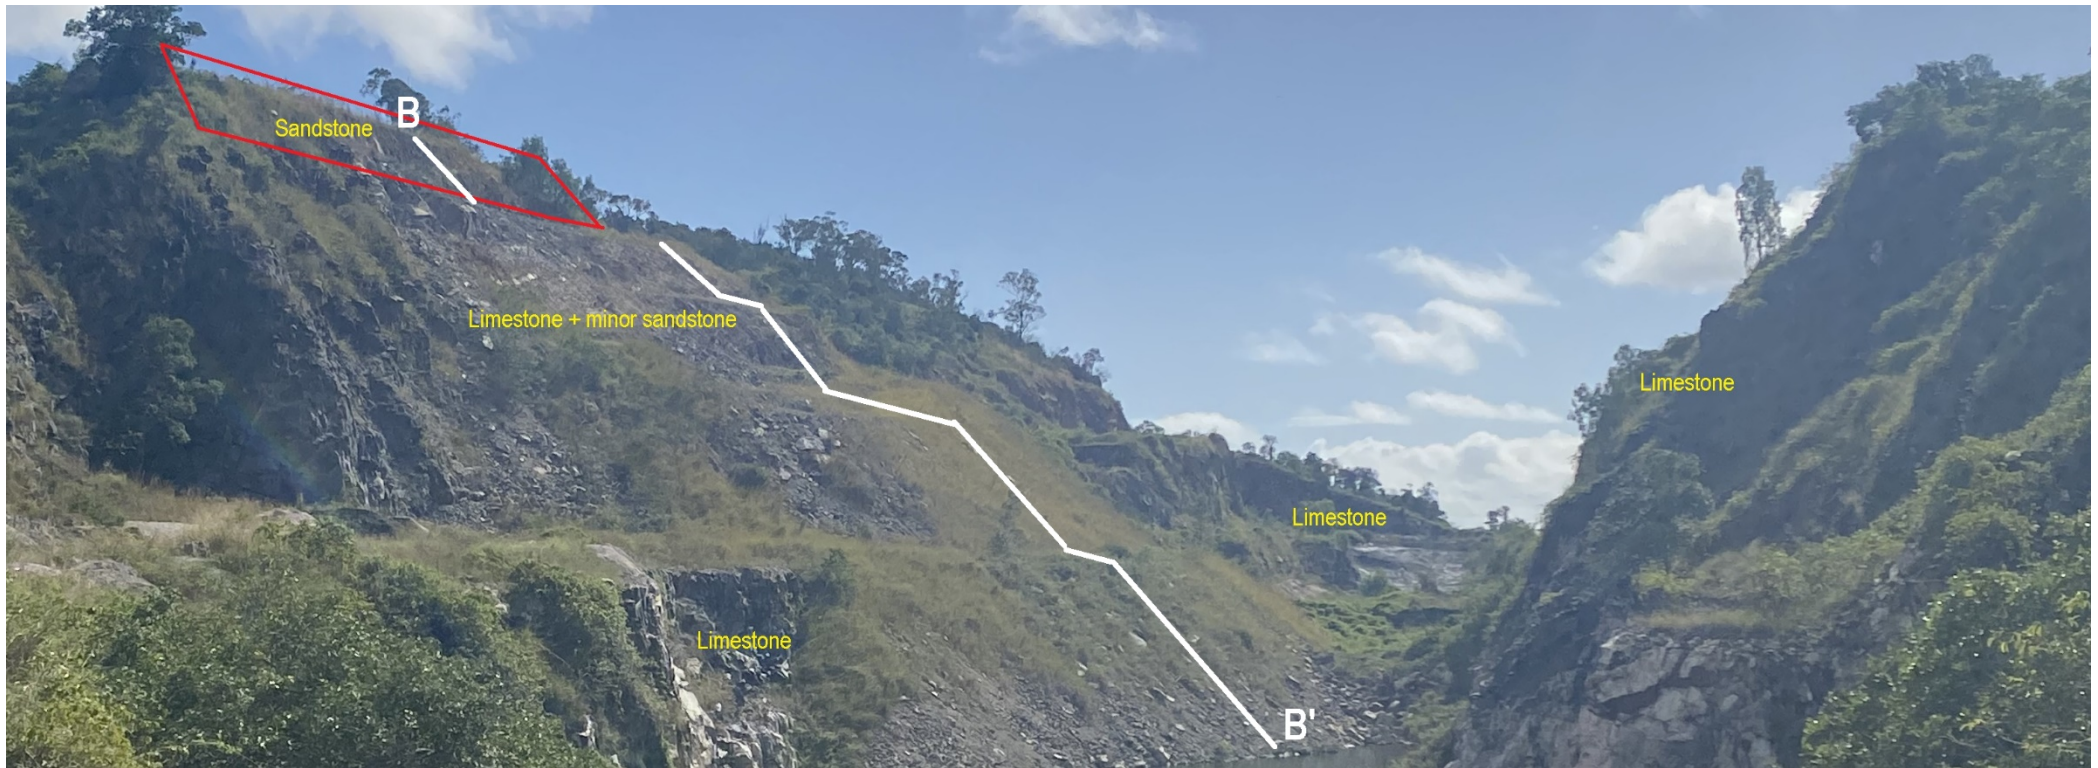
Figure 2. General rock types exposed in the pit walls. Vegetation density is high behind the crests and sparse to moderate on the walls and the pit floor. The stabilities of the east and west walls along cross-section B-B' is considered in Section 4.2.2.

The east, north and south walls of the pit comprises limestone (Figure 2). The uppermost benches midway along the west wall comprise sandstone from surface to RL80: approximately 10 m. The sandstone is fine grained, predominantly light grey to dark grey and has high to very high-strength<sup>6</sup> even where weathered<sup>7</sup>. The benches below the sandstone are predominantly in limestone to the pit floor with some interbeds of sandstone. The sandstone does not contribute significantly to the overall performances of the pit walls.

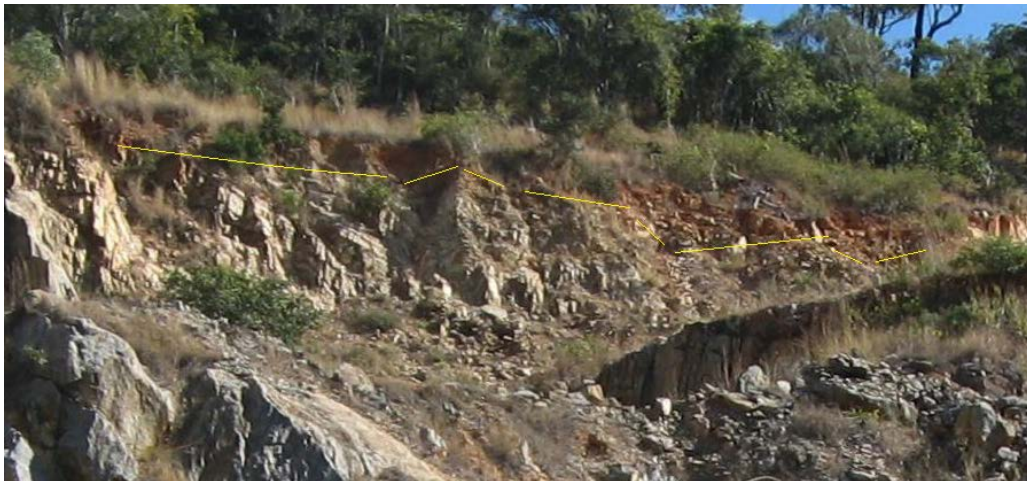
Figure 6. Highlighted is the base of the shallow cover of soil above highly- to extremely-weathered limestone at the north end of the west wall. Vegetation density is high behind the crest.

The average thickness of the soil is less than 1 m (Figure 4 to Figure 7). Being thin, it has negligible influence on the performances of the walls of the pit. Its main influence is to reduce the shear strengths of karst features and infilled dilated discontinuities<sup>9</sup> in the weathered limestone. These features occur predominantly to depths up to approximately 10 mBGL in the north, south and east walls.

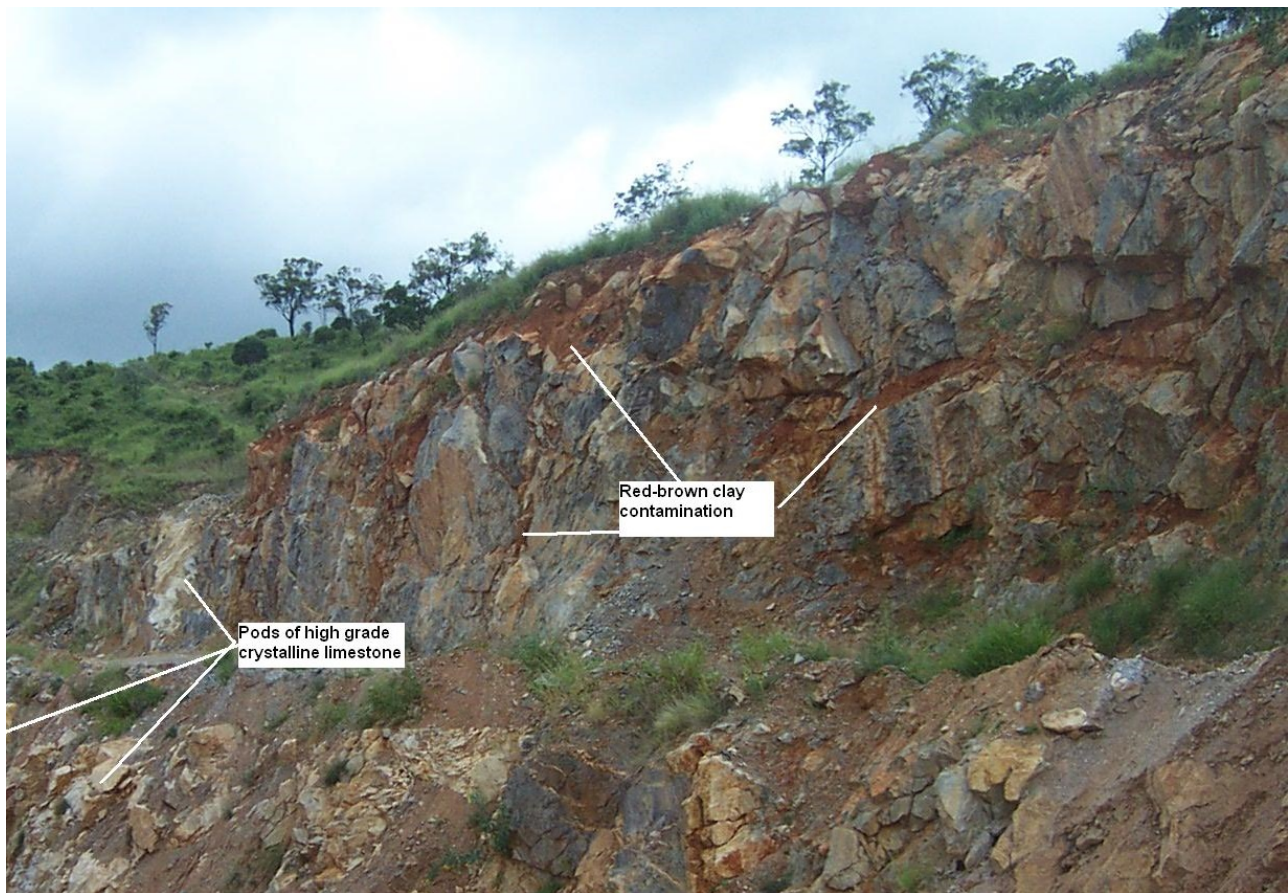
Figure 10. Examples of karst features in limestone on the west wall infilled with red-brown clay.

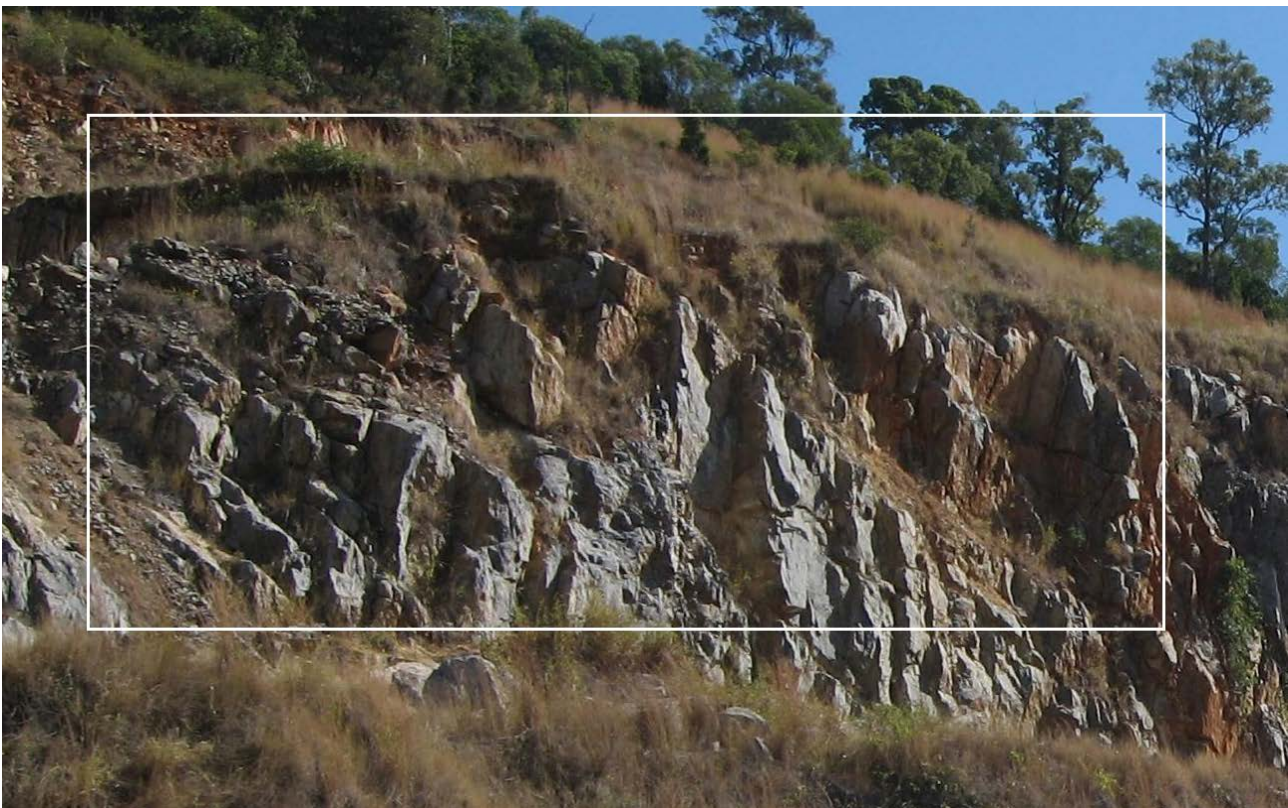
Figure 11. Weathering of clay infill within karst has contributed to the irregular sawtooth surface below the crest at the north end of the west wall.

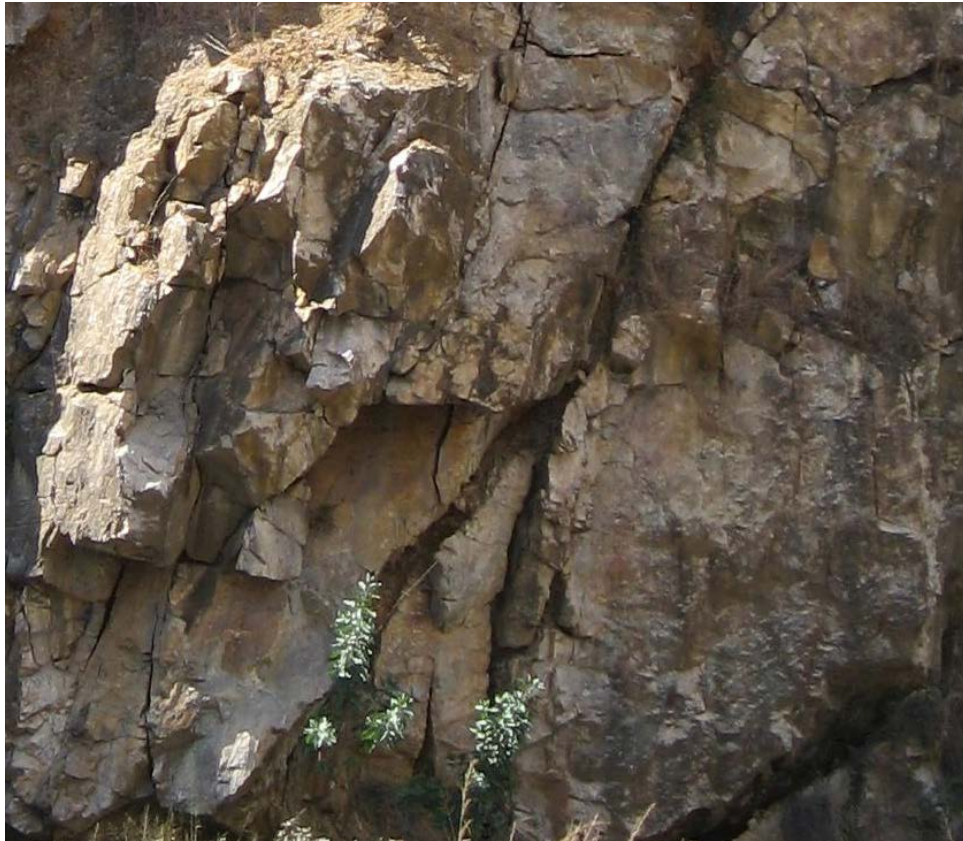
Figure 15. Most blocks of limestone are less than 50 cm in size, consistent with the results of rock size analyses in Section 2.6.5. The surfaces of the discontinuities in the direction of sliding (i.e. down) are slightly rough and undulating. These characteristics contribute positively to their shear strengths.

- Joint Roughness Coefficients<sup>49</sup> (JRC), which quantifies the roughness of the discontinuities. The coefficient was quantified by comparing the surfaces of the discontinuities to a standard chart of roughness profiles. Most discontinuities are slightly rough (Figure 15). Most surfaces undulate in the directions overlying rocks are likely to slide. A high proportion of the discontinuities above 10 mBGL have a sandy clay coating. Surfaces at greater depths are unaltered with some surface staining.

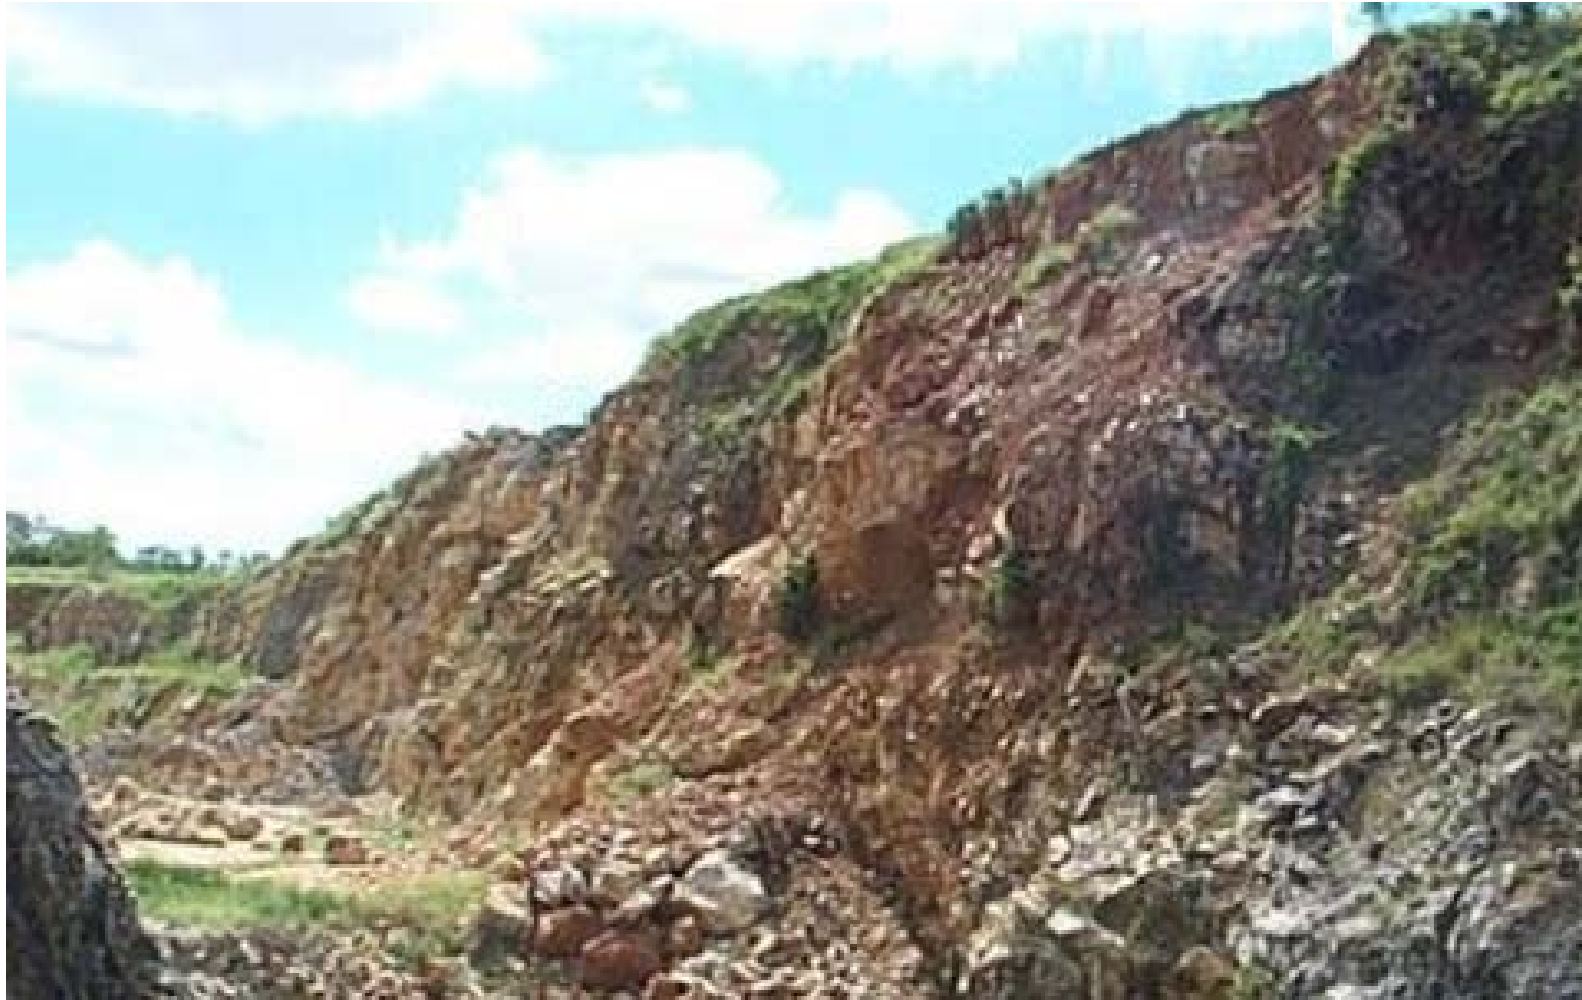
Figure 20. Rocks pushed over the crest of the east wall during the 2014 cutback triggered instabilities of individual rocks and masses of rocks on the wall that had marginal capacities. Doing so, and subsequent scaling, reduced the number of hazards.

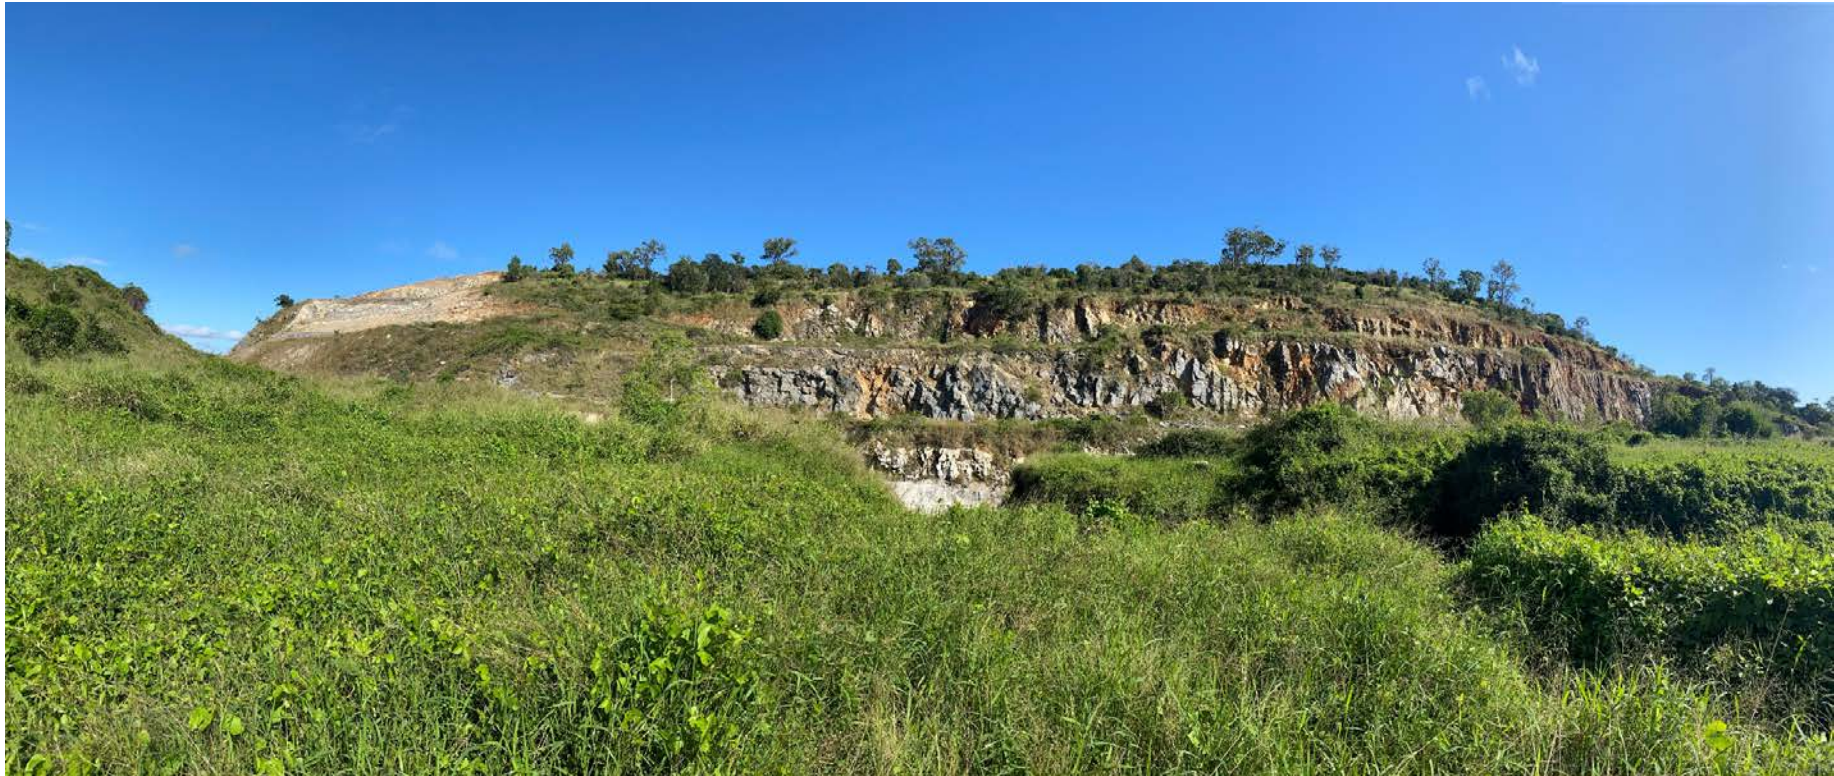
Figure 21. View from behind the crest of the east wall looking towards the west wall. The density of vegetation behind the crests of all walls is high. It is moderate to high on the berms.

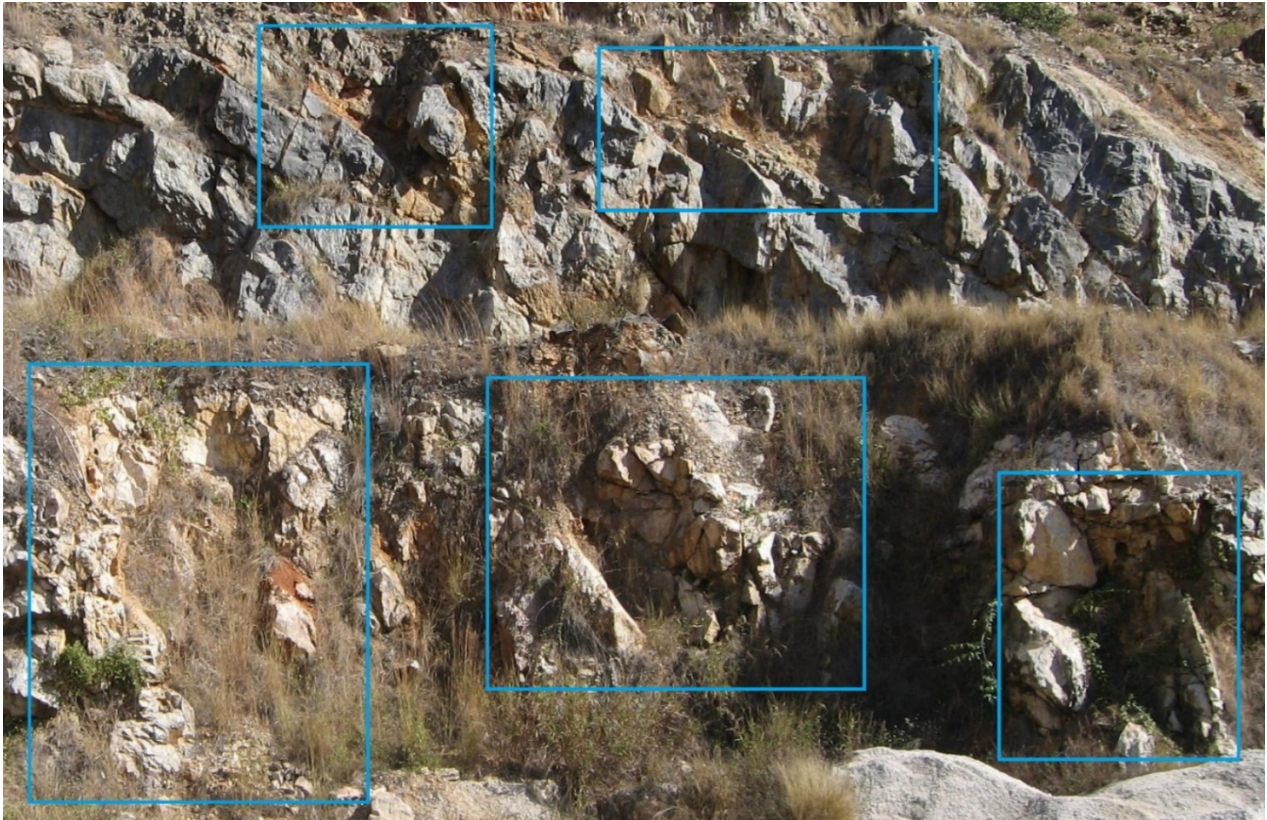
Figure 25. Highlighted at the north end of the west wall are examples of bench scale masses of rocks that have detached by toppling from, and sliding along, one or two discontinuities, predominantly from Sets 3, 5 and 7. Multibench (i.e., inter-ramp) scale instabilities have not occurred on this wall.

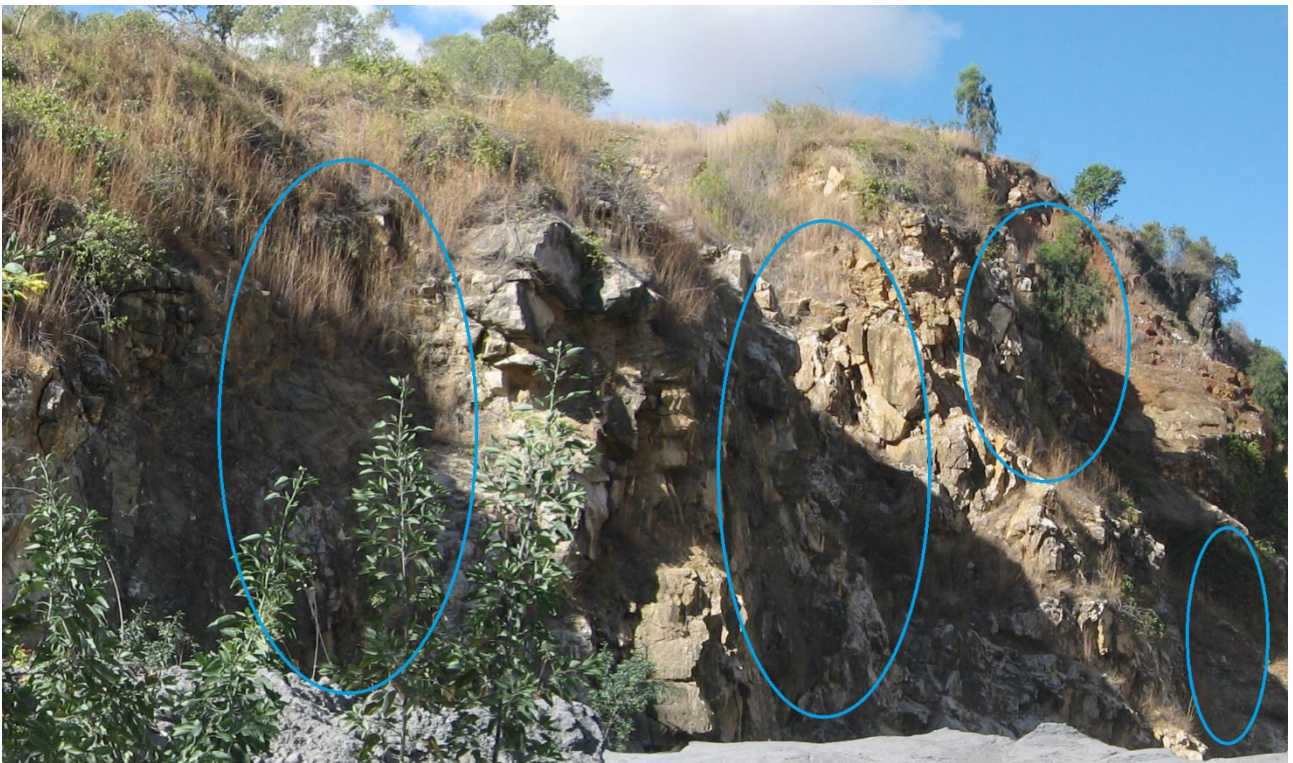
Figure 26. Highlighted midway along the east wall are examples of multi-bench (i.e., inter-ramp) and overall scale masses of rocks that have detached by toppling from, and sliding along, one or two discontinuities, predominantly from Sets 1, 4 and 5.

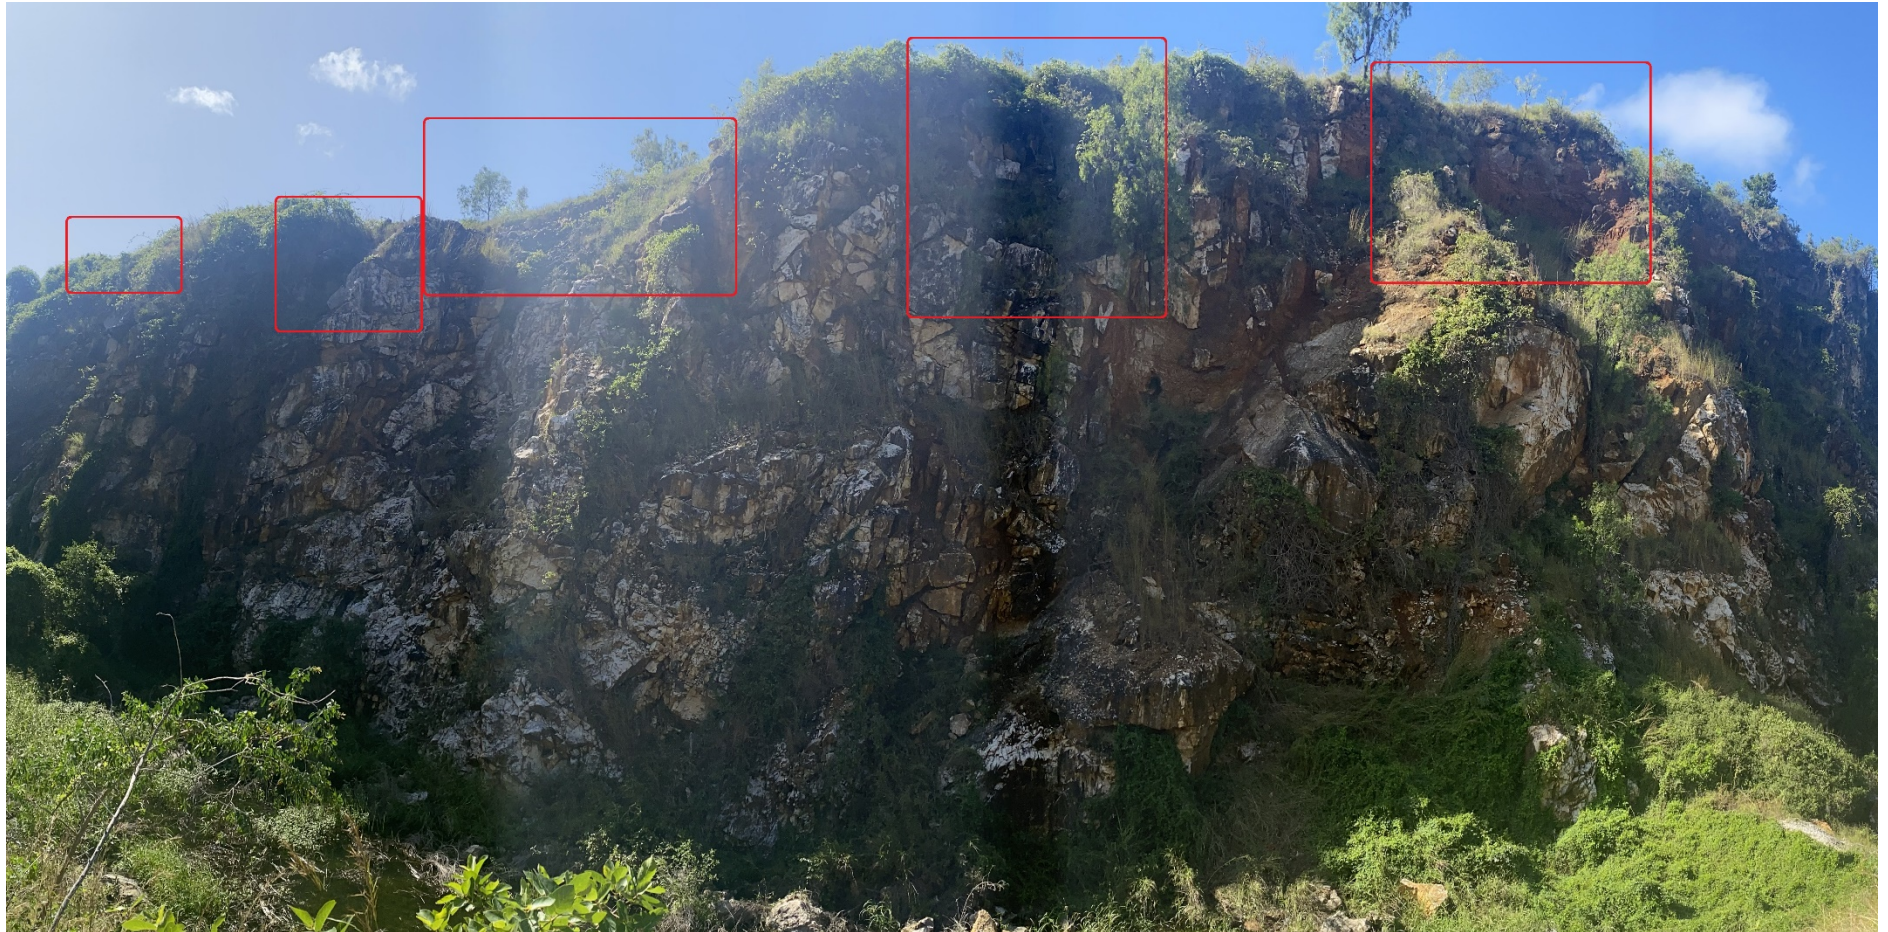
Figure 27. Example of locations along the crest of the east wall where detachments of rocks of inter-ramp and overall scales resulted in the crest breaking back by up to 6.3 m.

- The offsets recommended by the guideline exceed the maximum break-back distances experienced to date of 6.3 m on the east wall and 8.5 m on the west wall (Figure 27 and Figure 28).
- The maximum offset recommended by the guideline along the east wall is unrealistic as it exceeds significantly the 16 m distance at which the lowest strength overall scale surfaces daylight behind the crest (Figures A3.3). It is also inconsistent with the performance of the wall since mining ceased.
- The recommended offset applicable to west wall is less than the 41 m distance the lowest strength overall scale surfaces daylight behind the crest (Figures A3.2).

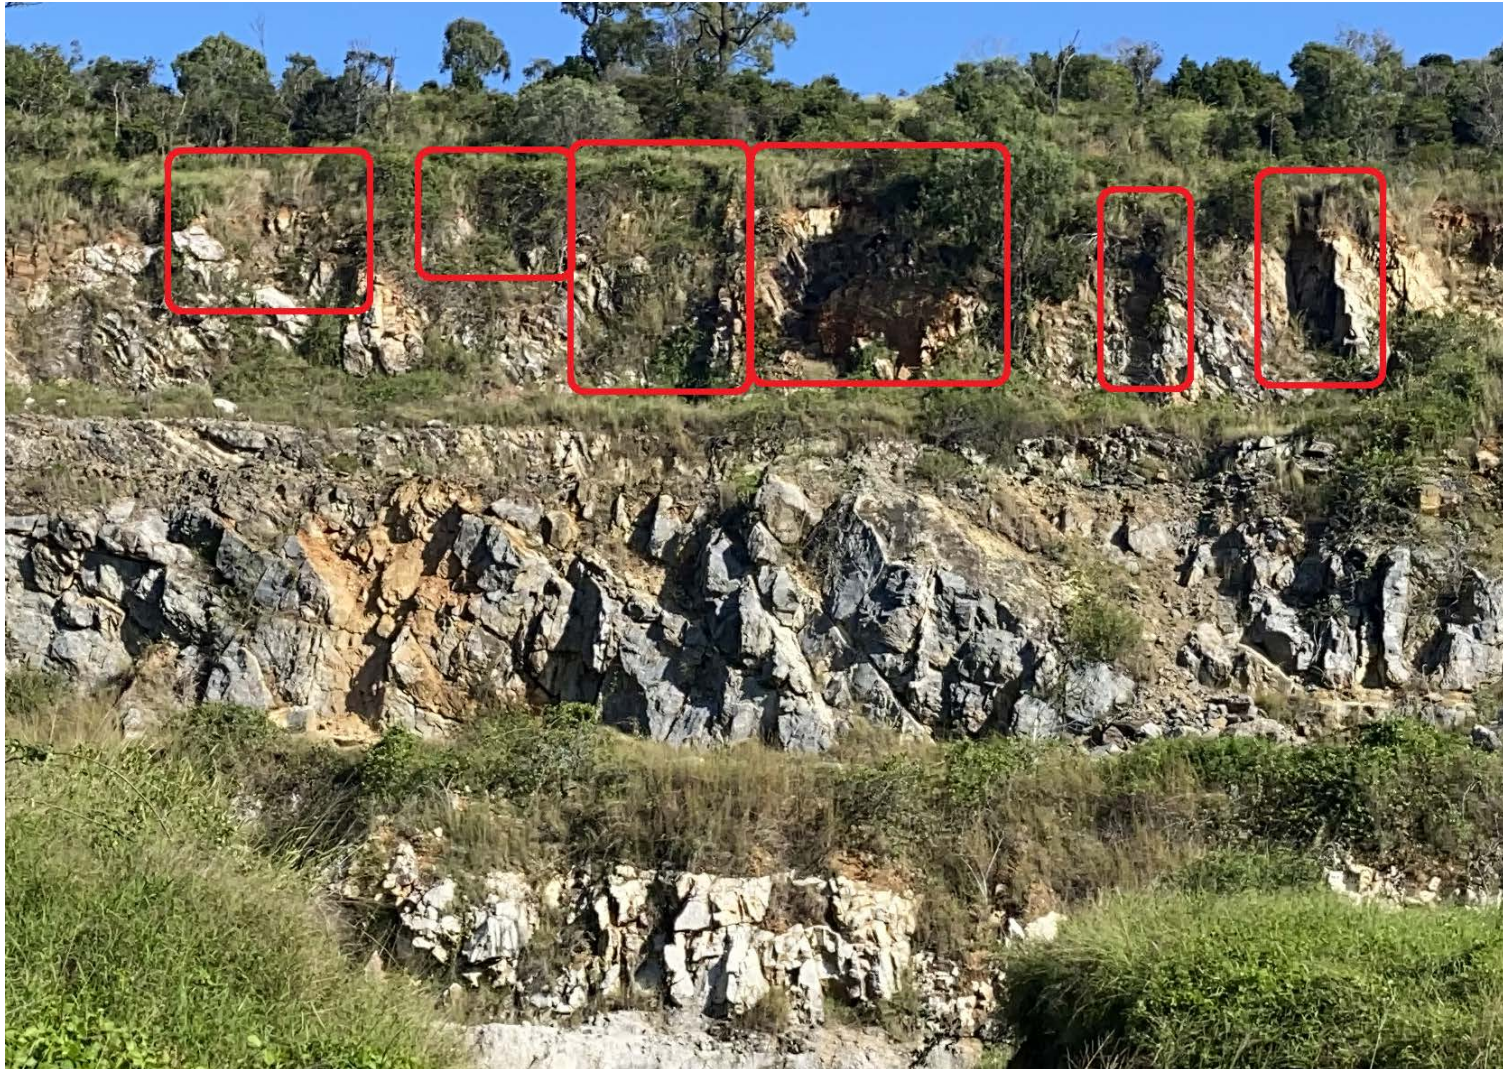
Figure 28. Examples of locations along the crest of the west wall where detachment of masses of rocks of bench scale resulted in the crest breaking back by up to 8.5 m.

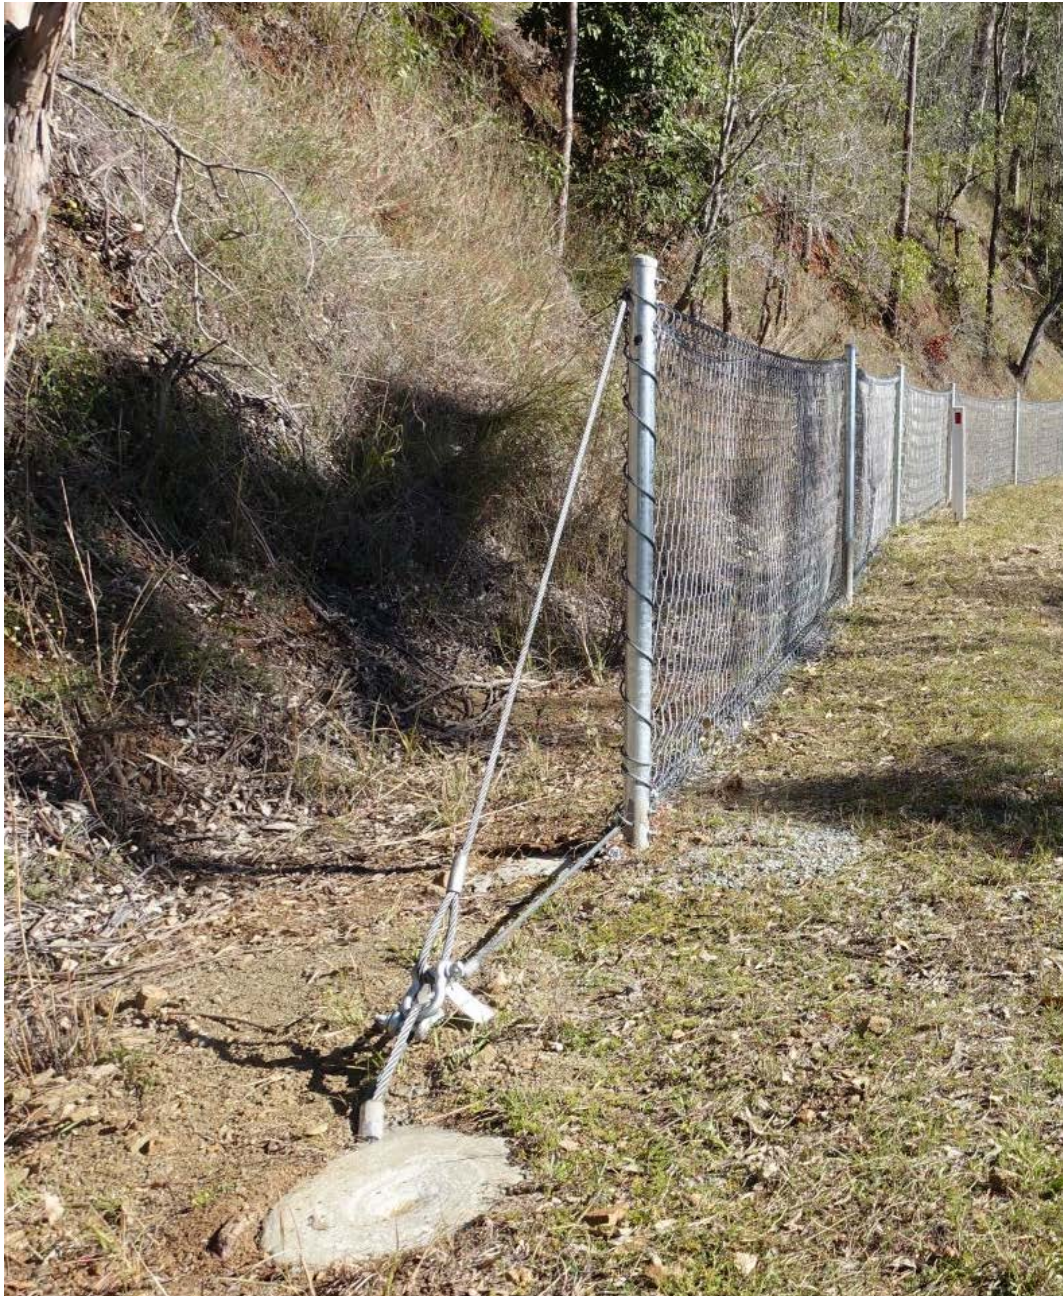
Figure 30. Example of a 1.5m high, 10 kJ capacity, proprietary rockfall barrier. This style of barrier can have a 100 year design life.

Alternatively, a proprietary rockfall barrier (i.e. fence) (e.g., Figure 30) can provide a 100 year design life without significant maintenance or the need for replacement. A suitable barrier would be 1.5 m high and have a 10 kJ capacity. Post spacings can be up to 5 m, which minimises the number of posts required compared to a farm style fence. The style of barrier is suitable for stock control. Sturdy locked gates should be installed within the barrier where access to the site is required.
