# Marmor Operations Progressive Rehabilitation and Closure Plan

## Marmor Operations Progressive Rehabilitation and Closure Plan – Rehabilitation Planning Part

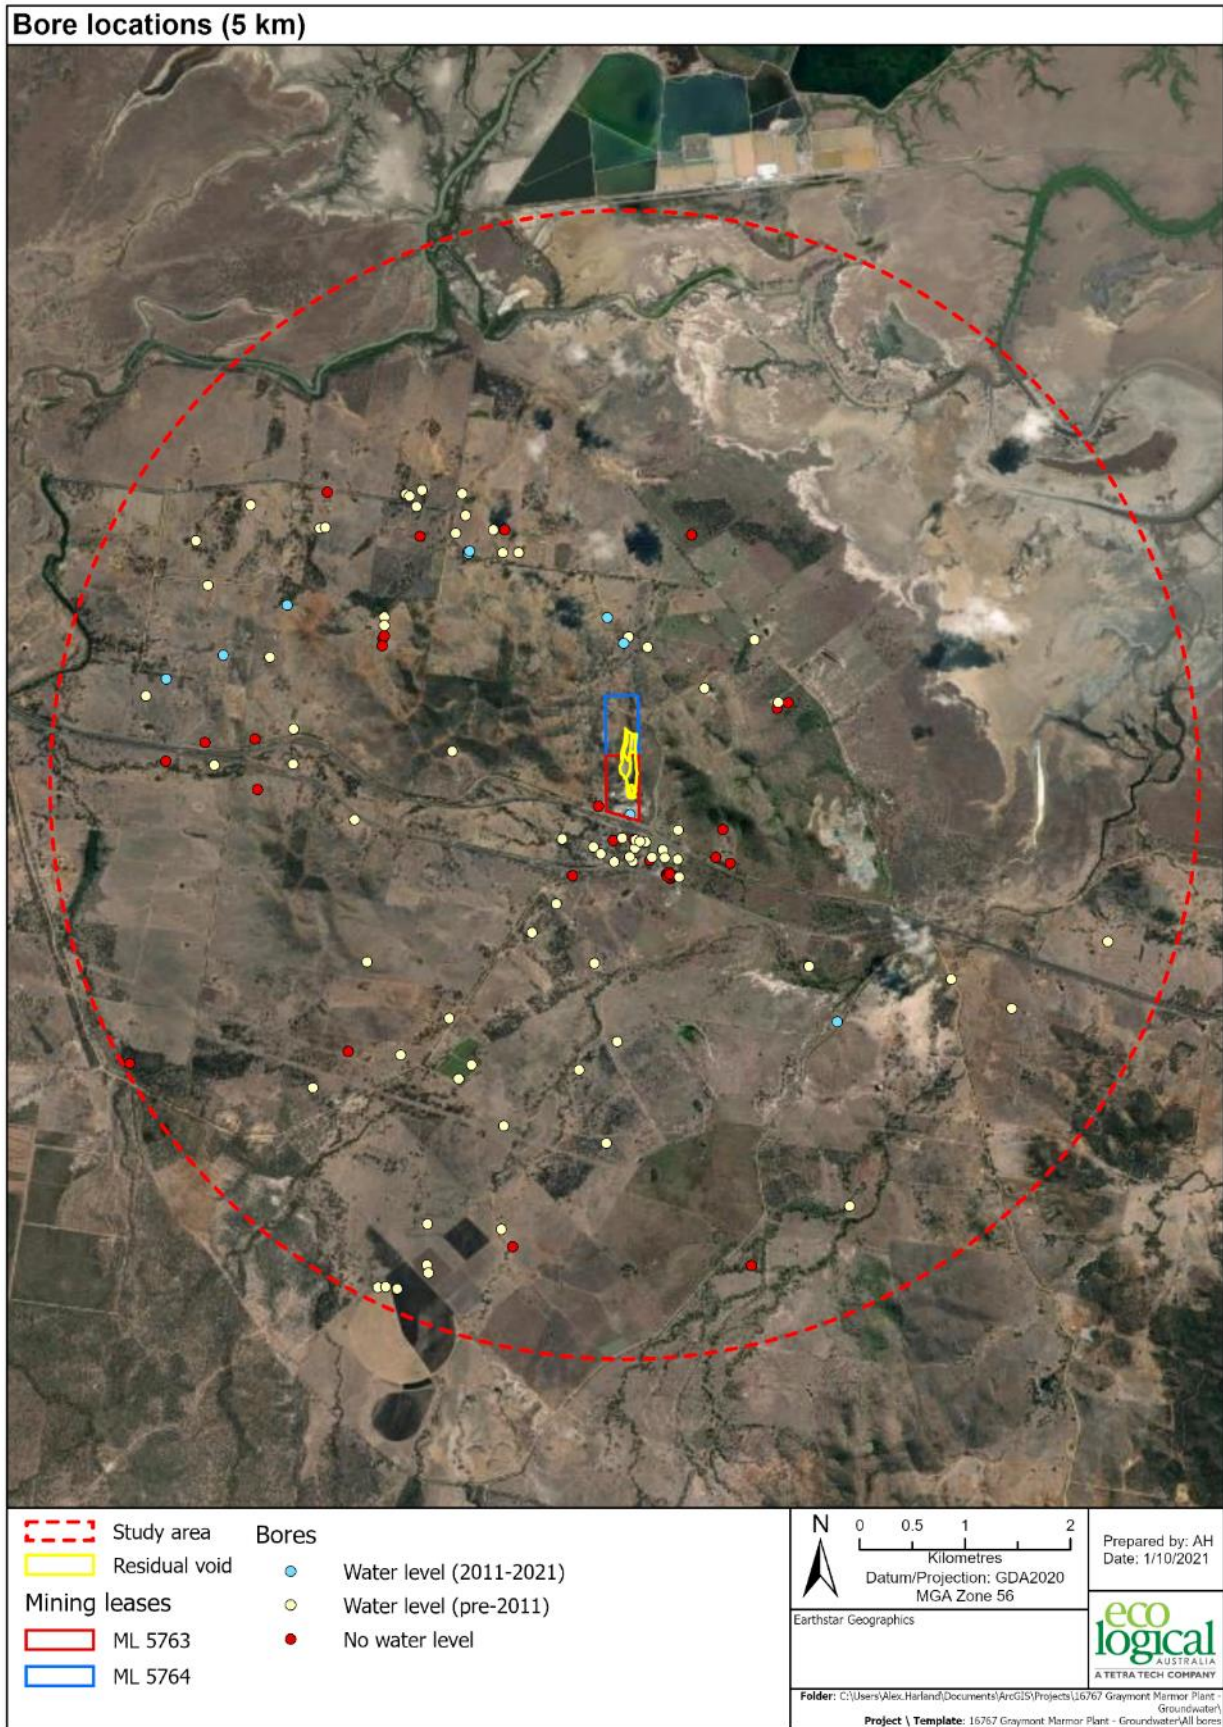
Figure 4: All bores found within the study area and information about availability of bore depth data (no water level data (red), water level data pre-2011 (yellow) and water level data between 2011-2021 (blue)).

The depth of the bores with recent depth readings ranged from 6.4 to 56.7 (mbgl). All bores were screened within the Mount Alma Formation and Mount Holly Formation/Erebus Bed fractured rock aquifers and were either primarily drilled for water supply, stock use or monitoring.

- 12.0 and 33.4 mAHD within the Mount Alma Formation; and
- 10.4 and 30.8 mAHD within the Mount Holly Formation.

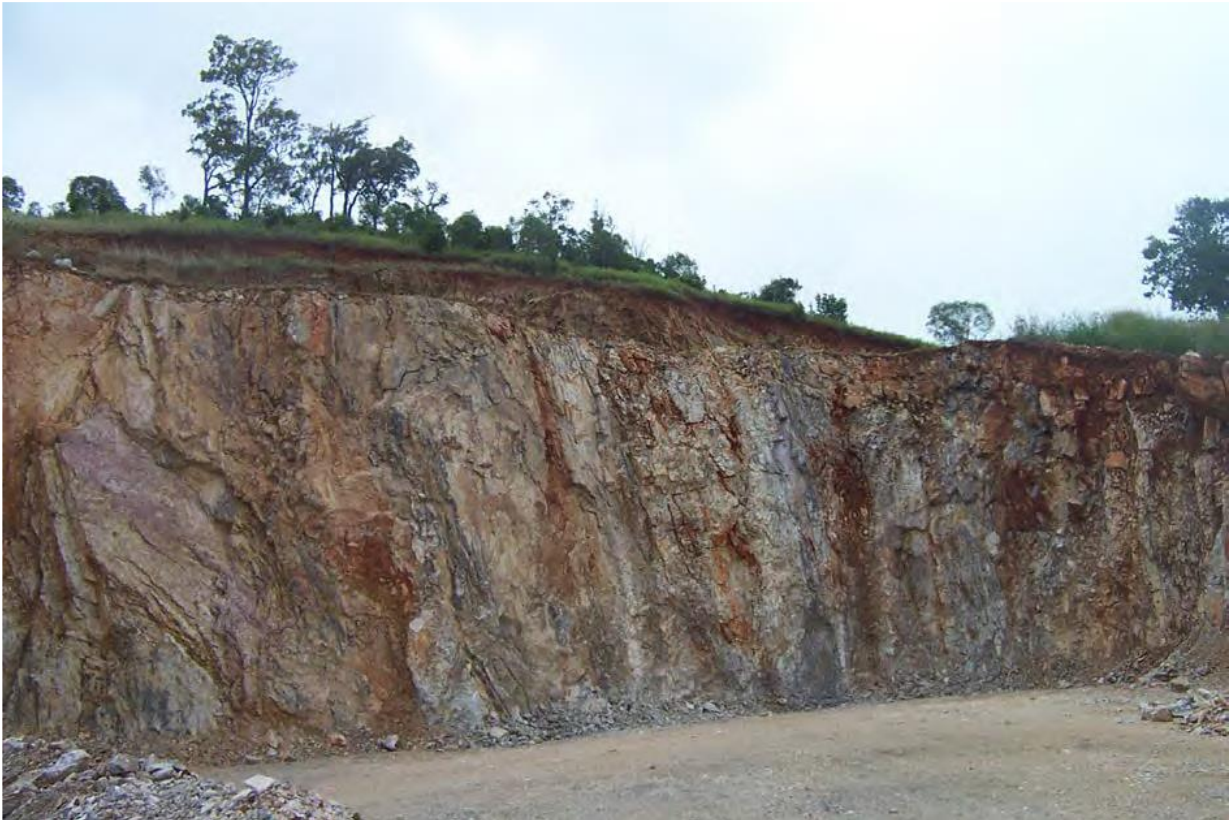
**Figure 7: Photograph of the Marmor pit showing a cross section of the shallow red-brown clay soil profile over partially weathered parent material**

Given the background geology of the project area, the uniform or gradational clay loams to clays would be classified as Red or Brown Dermosols under the current Australian Soil Classification (ASC) system (see the soil profiles exposed above the pit walls in Figure 7). It is possible that deeper clay rich soils (Grey or Brown Vertosols under the ASC) occur in flatter areas outside the main area of disturbance. Where topsoil depths have been provided in *Land Systems of the Dawson-Fitzroy area, Queensland* (CSIRO 1968), they are generally 100 to 150 mm deep. This has guided the proposed topsoil depth to be used in site rehabilitation.

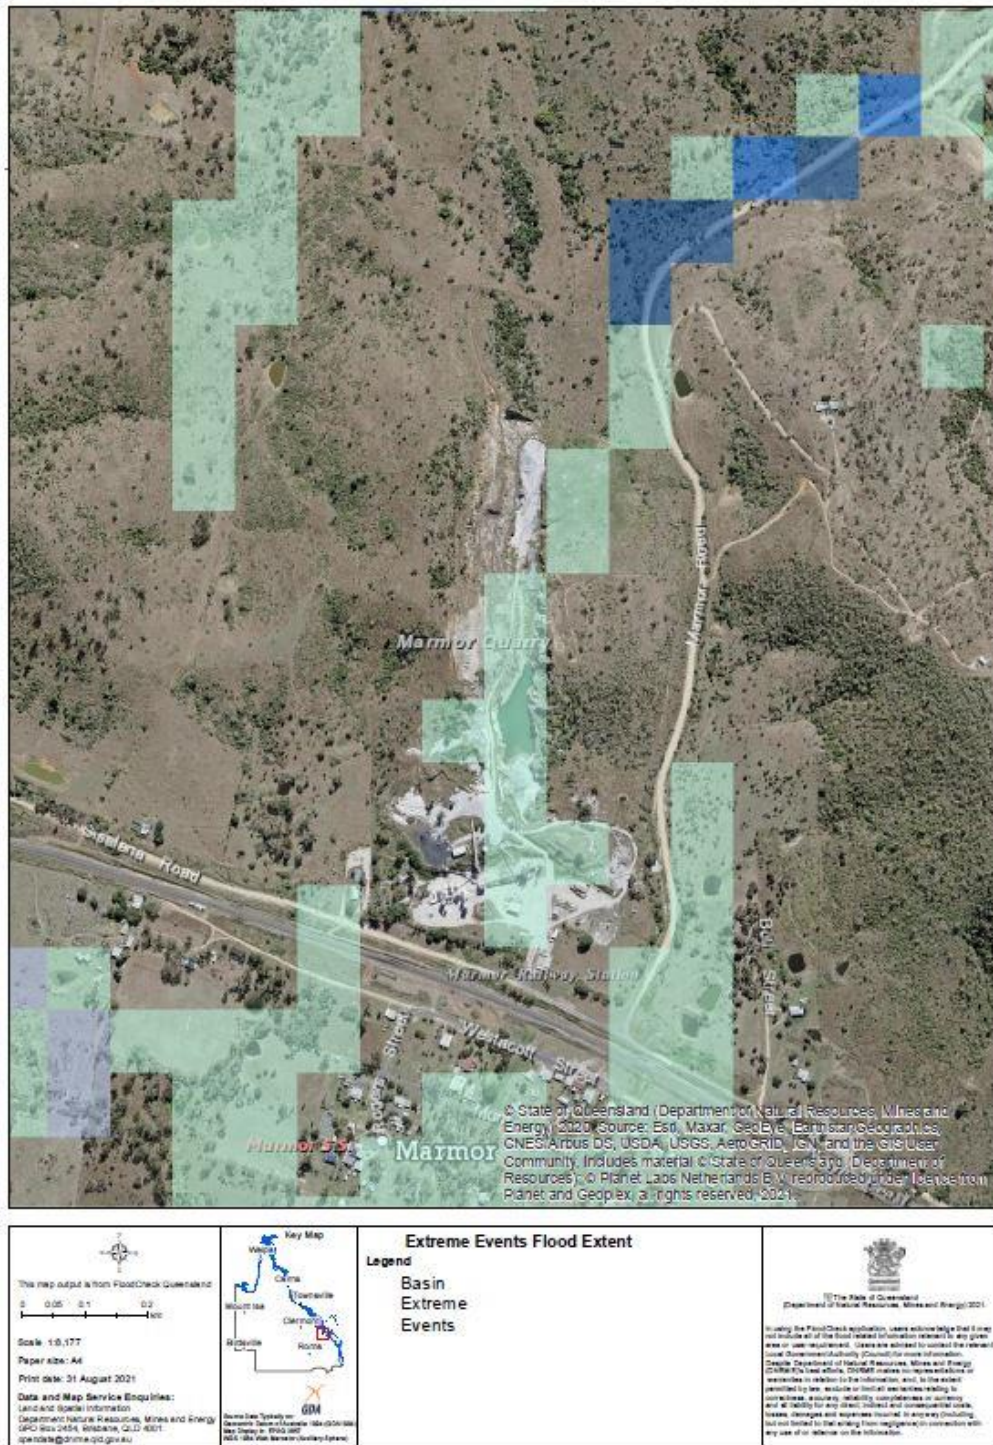
Figure 15: Extreme events (approximation of the PMF) flood extent around the Marmor Operations<sup>7</sup> where variants of blue blocks on the map indicate depth of water

Available flood information showed that there is the potential for some flooding on site during a 1% Annual Exceedance Probability (AEP) flood event (Figure 14) and during more extreme events (Figure 15) that approximate the probable maximum flood (PMF). These results show that some isolated flooding may occur during the 1% AEP event with more broadscale flooding occurring only in more extreme events. Combining the flood information with the contours of the site (Figure 16) indicates that the localised flooding identified would largely drain into the residual void. The potential flooding even for the PMF does not result in the whole of the void being flooded and there is no direct connection between flooding in the void and surrounding water courses, there is no direct continuity between flooding within the void. Therefore, flooding is not anticipated to impact the surrounding users or the environment. The likelihood of water spilling from the former mining pit is discussed in Section 3.5.11.3.

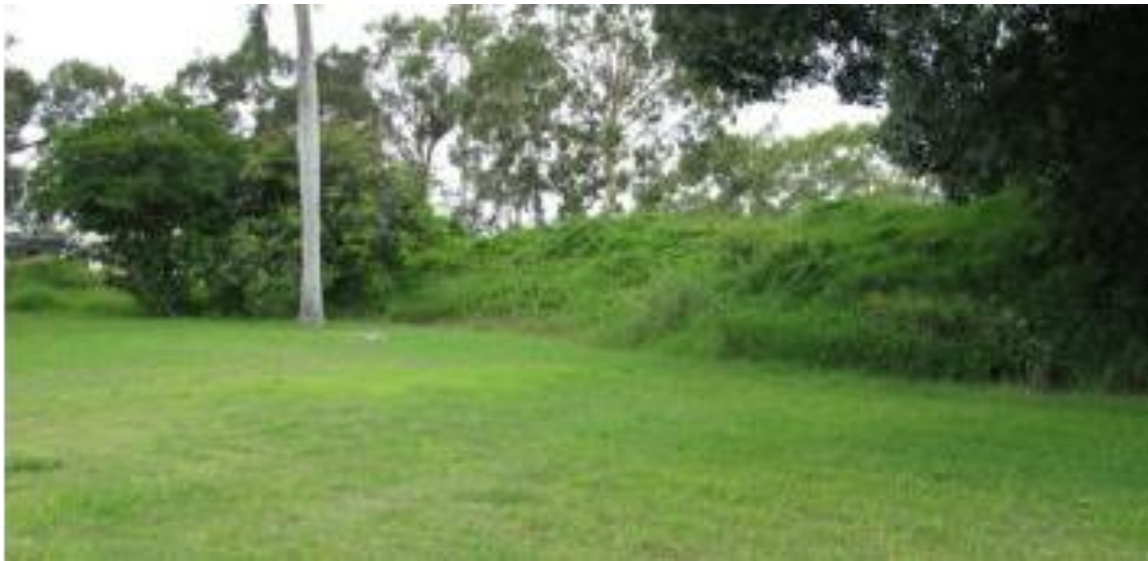
**Figure 17: View of the well vegetated topsoil stockpile at the Marmor Operations**

No additional disturbance is planned at Marmor and no further topsoil stripping will be undertaken. All existing stripped topsoil has been placed in low stockpiles awaiting re-spreading. The stockpile is currently well vegetated and supports mature trees which will have assisted in maintaining biological activity (Figure 17).

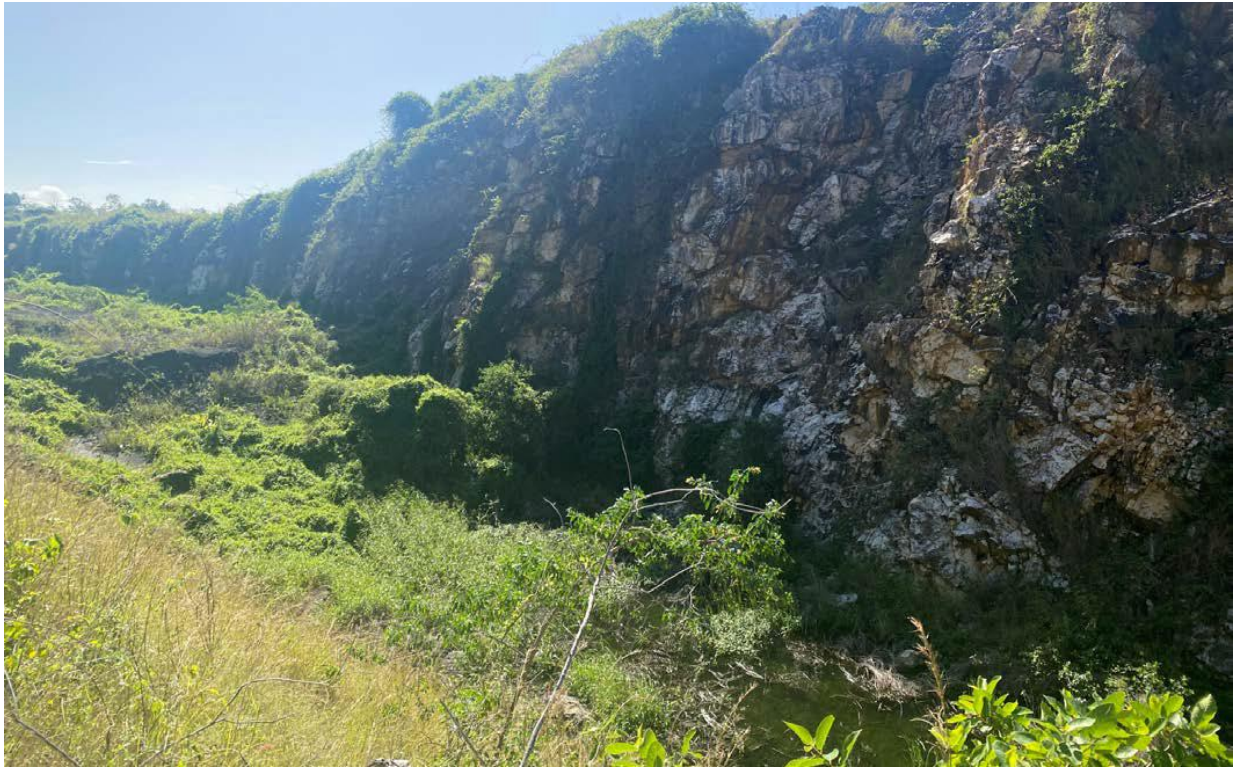
**Figure 22: High vegetation cover on the floor of the Marmor void adjacent to the Pit Lake with good cover on the east wall in the background**

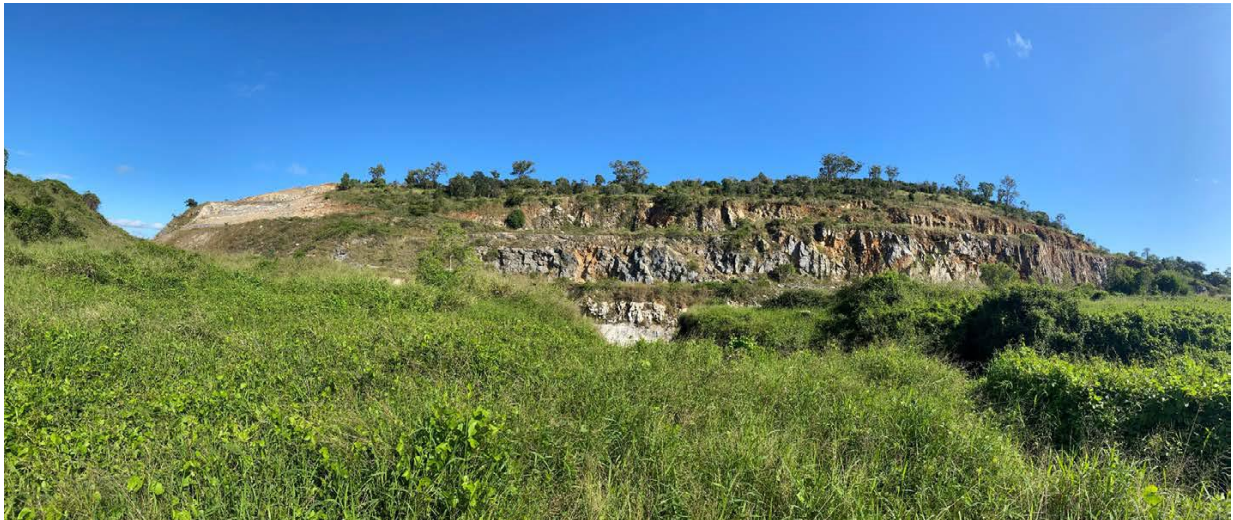
**Figure 23: Good vegetation in disturbance areas at the crest of the west wall of the Marmor void with groundcover, shrub and tree establishment on benches and good groundcover establishment in areas reworked in 2014 to the left**

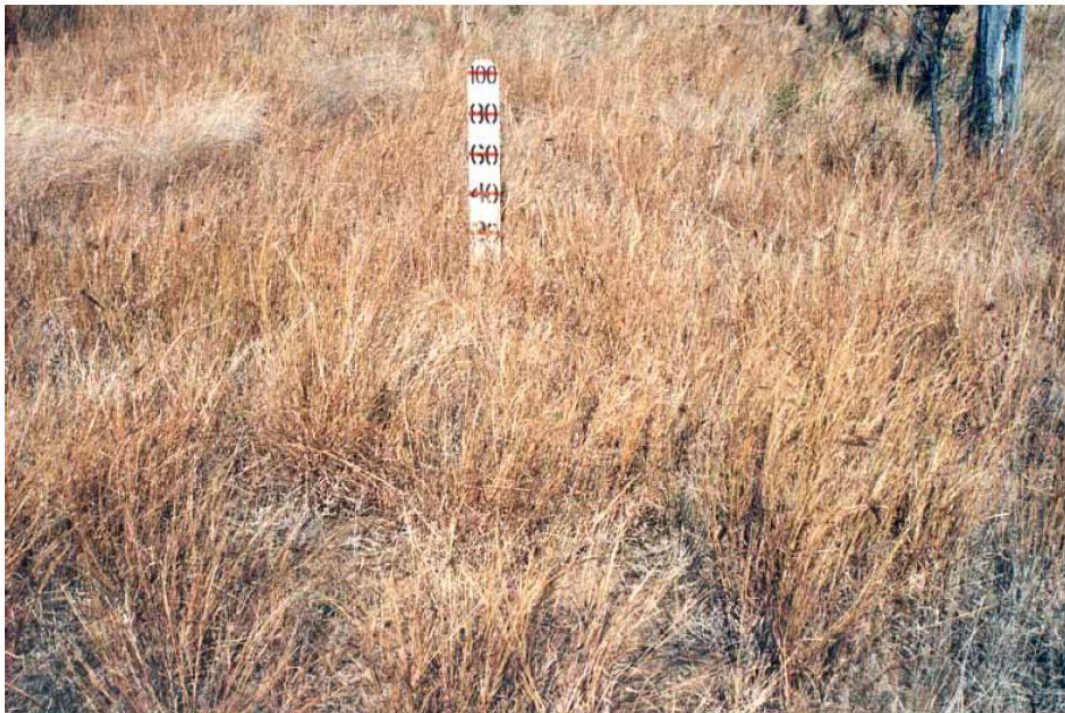
**Figure 28: Example of a photo standard of Black Speargrass with a pasture yield of 2,450 kg DM/ha**

Once this has been done several times, it should be possible to establish a series of photo standards (like the one in using the plot photos and the standing biomass measurements to be used for future estimates of standing biomass.

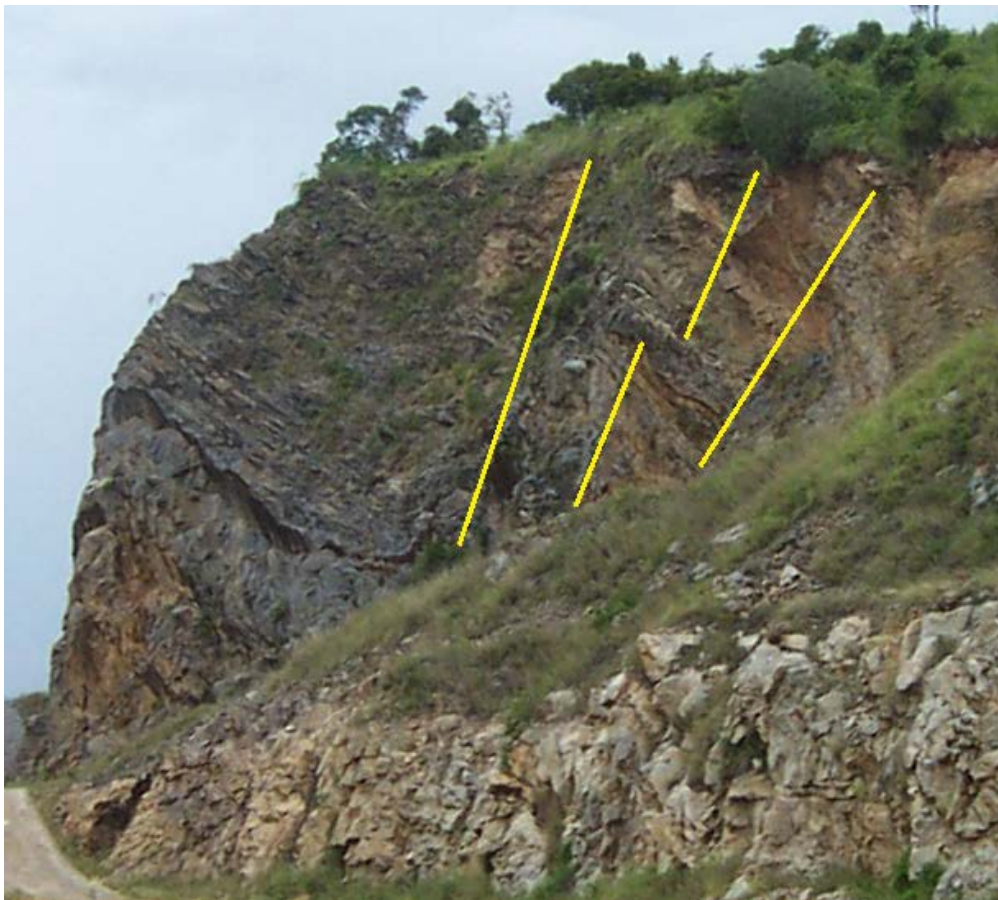
Figure 4. Examples of north-south striking faults in the west wall associated with fault F1 (refer Figure 3).

Figure 3 highlights the approximate locations of some of the larger faults that traverse the site. North-south striking fault F1 (Figure 4) is parallel to two major regional thrust faults, 300 m east and 2.7 km west of the site. Northeast striking faults F2 to F6 (Figure 5) may be synthetic faults<sup>8</sup> associated with displacements along the more persistent faults. Localised shear zones and distorted beds (e.g., drag folds) resulting from displacements along the faults have not significantly reduced the performances of sections of the walls they intersect. These performances have been associated more with the characteristics of the discontinuities (i.e., bedding partings and joints) discussed in Section 2.6.3.

The average thickness of the soil is less than 1 m (Figure 4 to Figure 7). Being thin, it has negligible influence on the performances of the walls of the pit. Its main influence is to reduce the shear strengths of karst features and infilled dilated discontinuities<sup>9</sup> in the weathered limestone. These features occur predominantly to depths up to approximately 10 mBGL in the north, south and east walls.

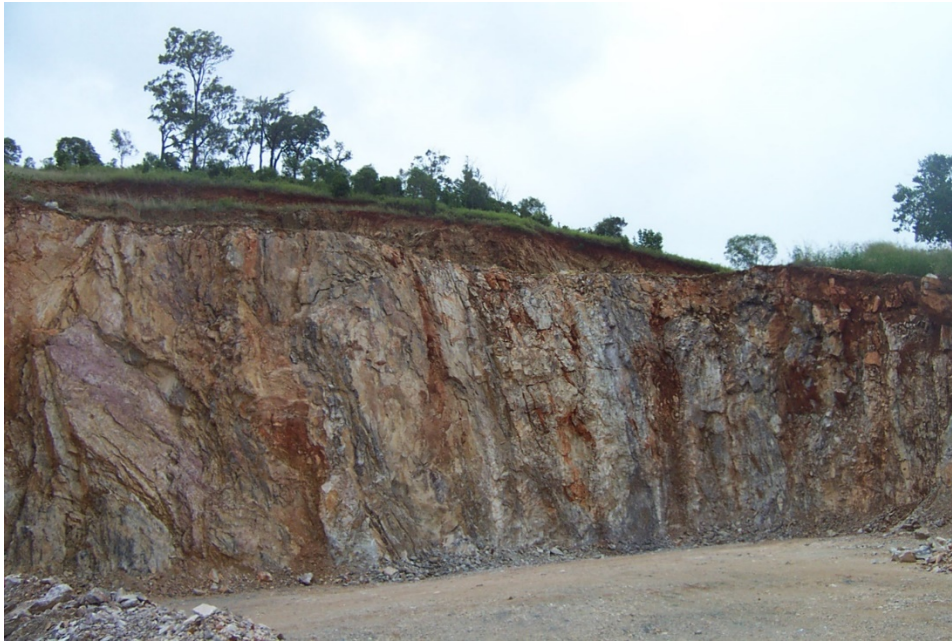
Figure 5. Mottling of moderately weathered limestone exposed in the north wall results from shearing along east-west striking fault F4 (refer Figure 3). Note the shallow cover of soil.

The intact limestone is fine to coarse grained. Some (i.e., <40%) is recrystallised to marble. It is predominantly white to cream and light grey to dark grey. Less typical are other colours, including pink, purple, brown, and green. These colours can be banded or mottled, particularly in area where the rockmass has been sheared by movements along faults (Figure 5).

At depths less than ≈10 mBGL in the north, south and east walls, and adjacent to faults and karst structures, the surfaces of individual rocks are highly- to extremely-weathered (Figure 5 to Figure 7). At greater depths,

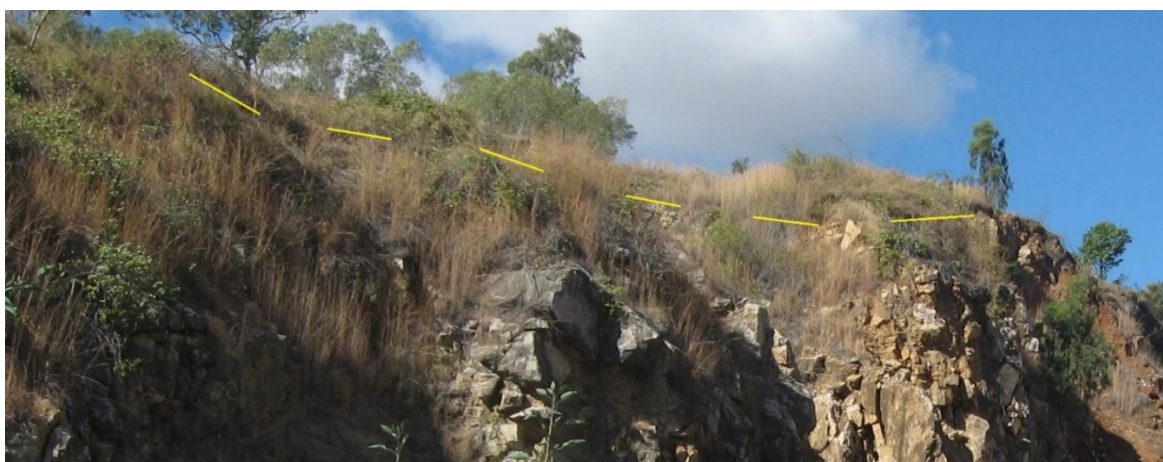
Figure 7. Highlighted is the base of the shallow cover of soil above moderately- to highly-weathered limestone midway along the east wall. Vegetation density is high behind the crest.

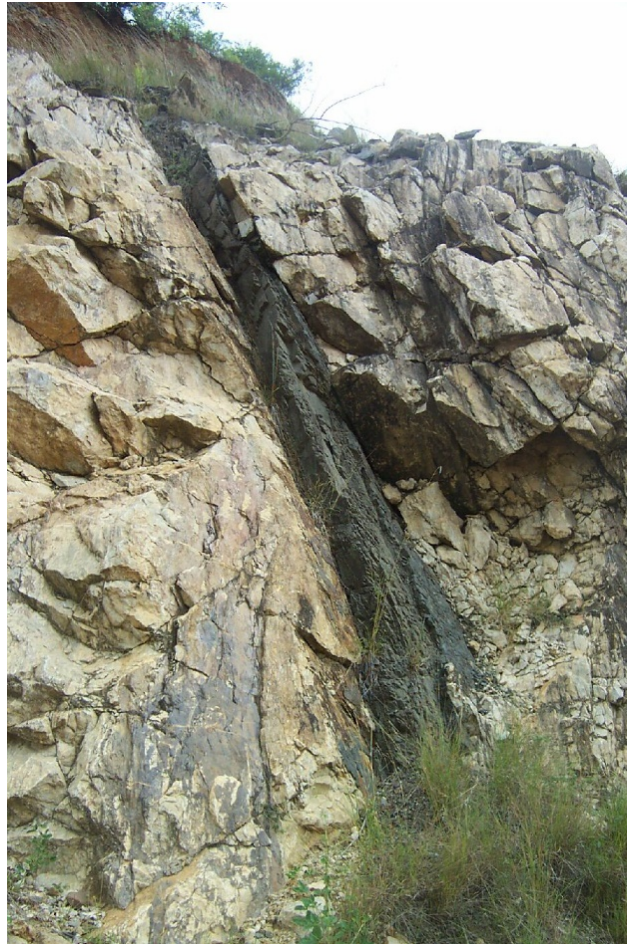
Figure 8. Example of andesite dyke intruded along a joint in the east wall.

The andesite occurs generally as steep dipping dykes (Figure 8) up to 2 m thick associated with vertical to sub-vertical bedding, faults, and joints within the limestone. It can occur as large irregular shaped lenses and sills (Figure 9).

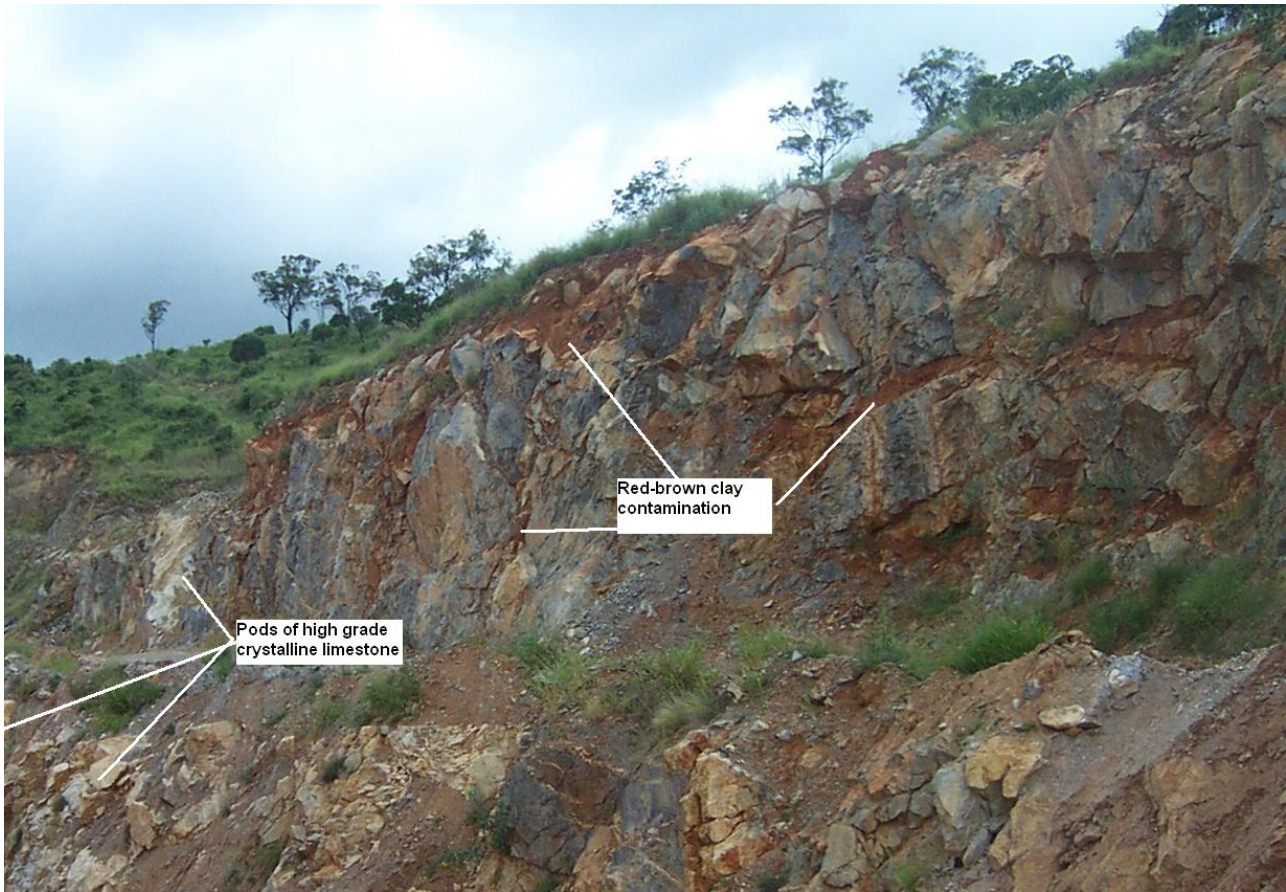
Figure 10. Examples of karst features in limestone on the west wall infilled with red-brown clay.

Karst features are extensive in the upper benches of all walls (Figure 10). They comprise predominantly cavities, sinkholes and solution widened discontinuities. All karst is clay filled. The features can extend to  $\approx 10$  mBGL although they are most prevalent at shallower depths. With depth, karst become less prevalent and the apertures of the discontinuities become tight and clean.

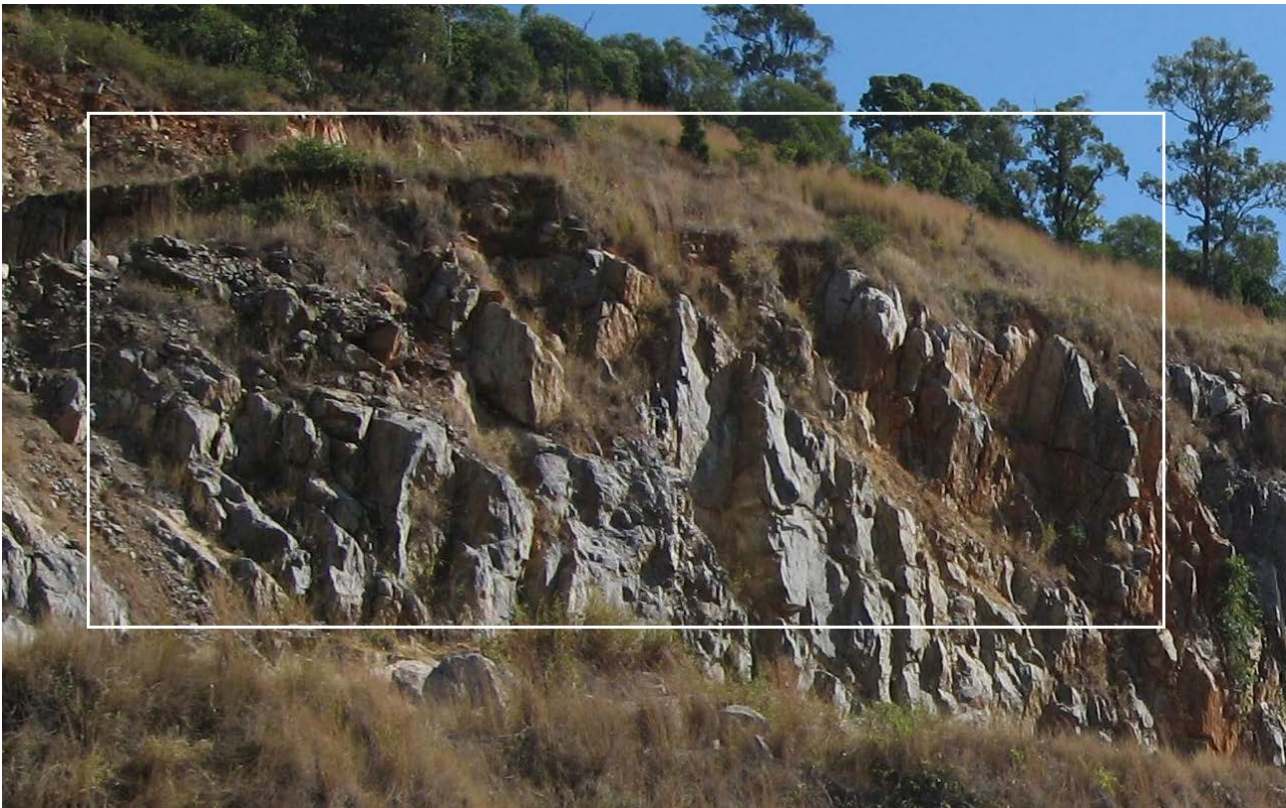
Figure 11. Weathering of clay infill within karst has contributed to the irregular sawtooth surface below the crest at the north end of the west wall.

Karst has influenced the performances of the benches above 10 mBGL (Figure 11); bench scale instabilities have occurred below the crests of all walls. These events have had, and will continue to have, insignificant influence on the performances of the overall walls (i.e., crest to toe).

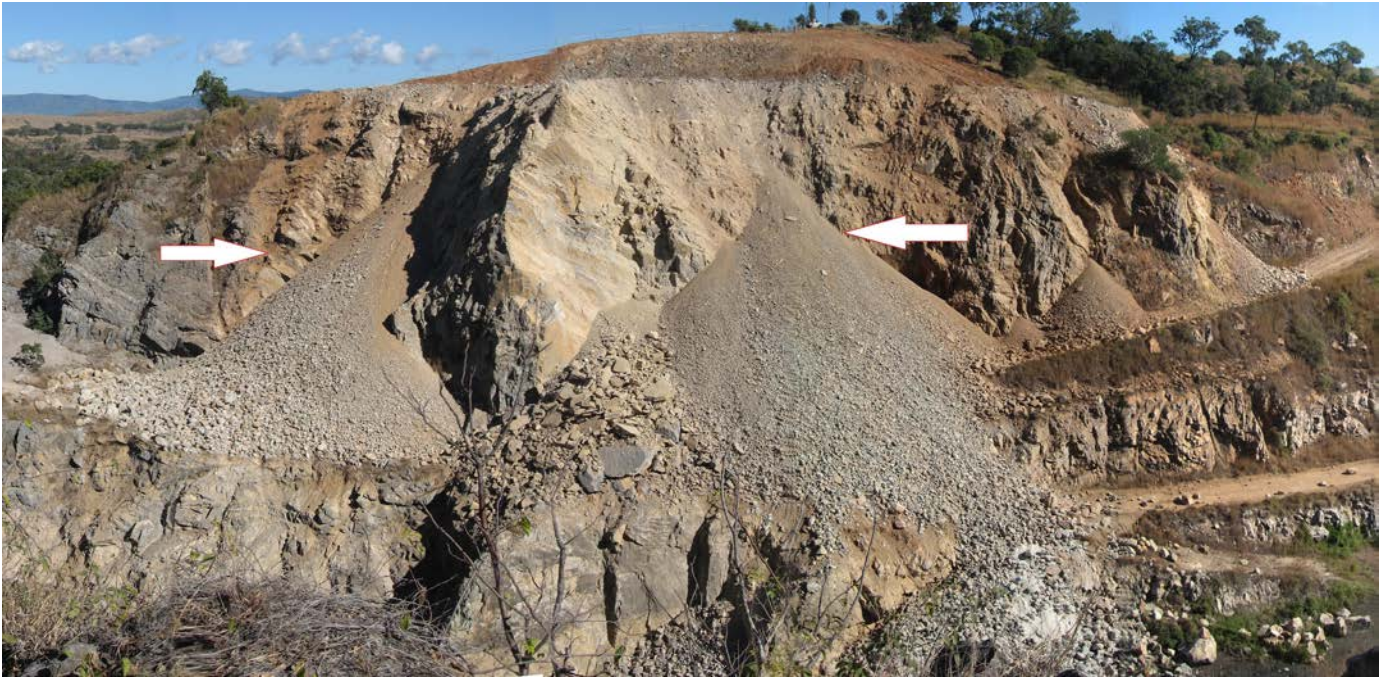
Figure 18. In 2014, a protrusion of limestone and sandstone on the west wall was excavated and the wall benched to reduce risk applicable to vehicles traversing along the haulroad during proposed mining. Some of the loose material was used to form a short section of the haul road and to cover the lower bench.

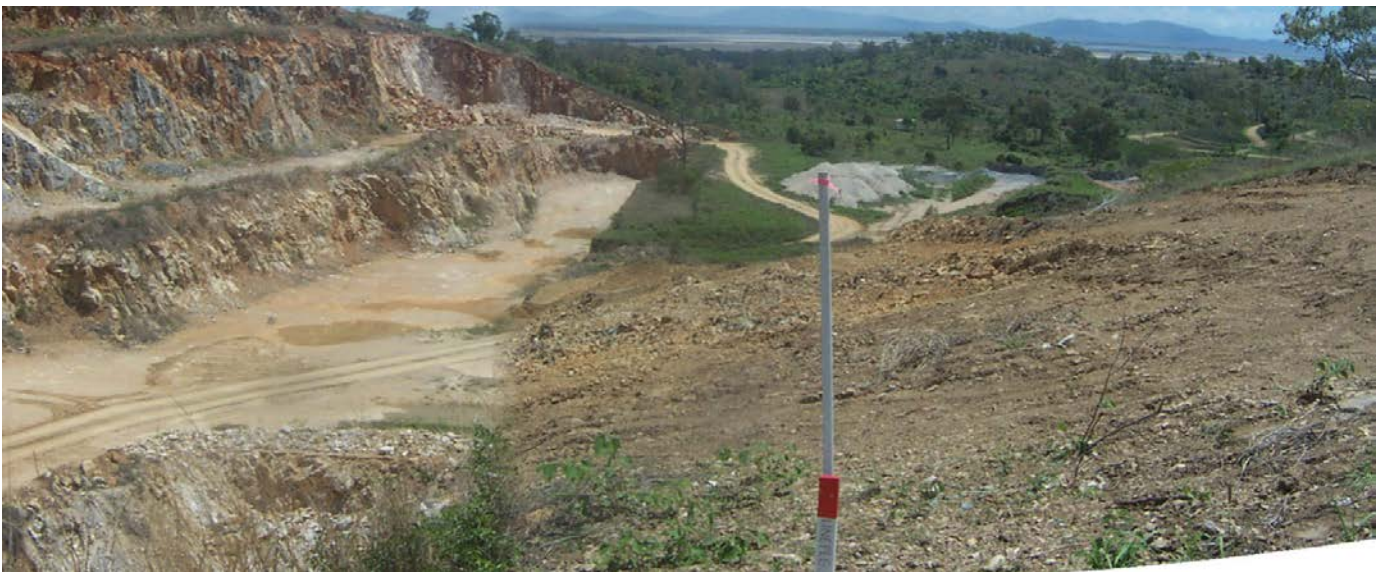
Figure 19. In 2014, the crest of the east wall was cut back to ensure the risk applicable during proposed mining on the pit floor would be acceptable.

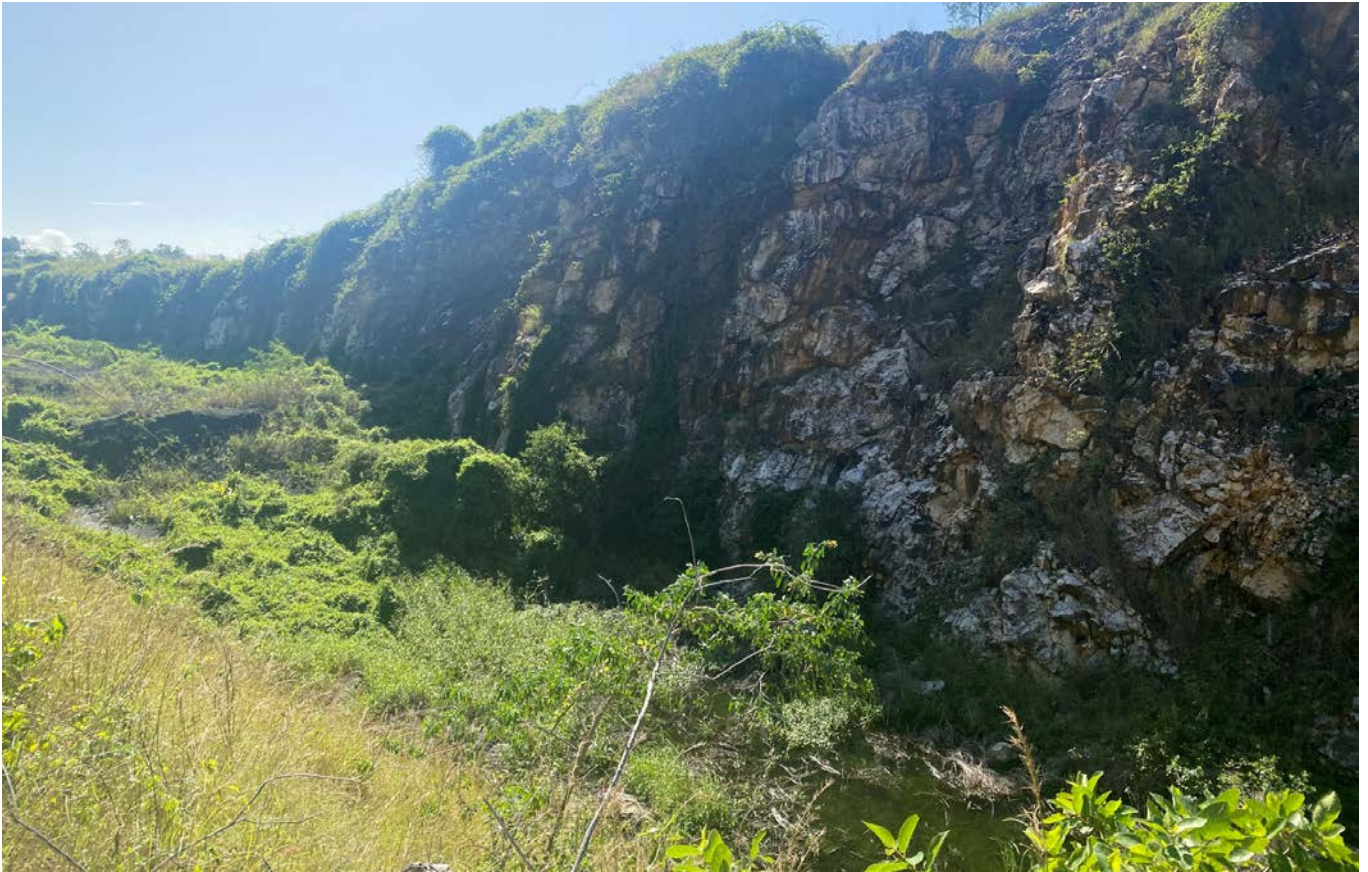
Figure 22. Pit floor looking north. The density of vegetation on the floor is moderate to high. It is sparse to moderate on the east wall.

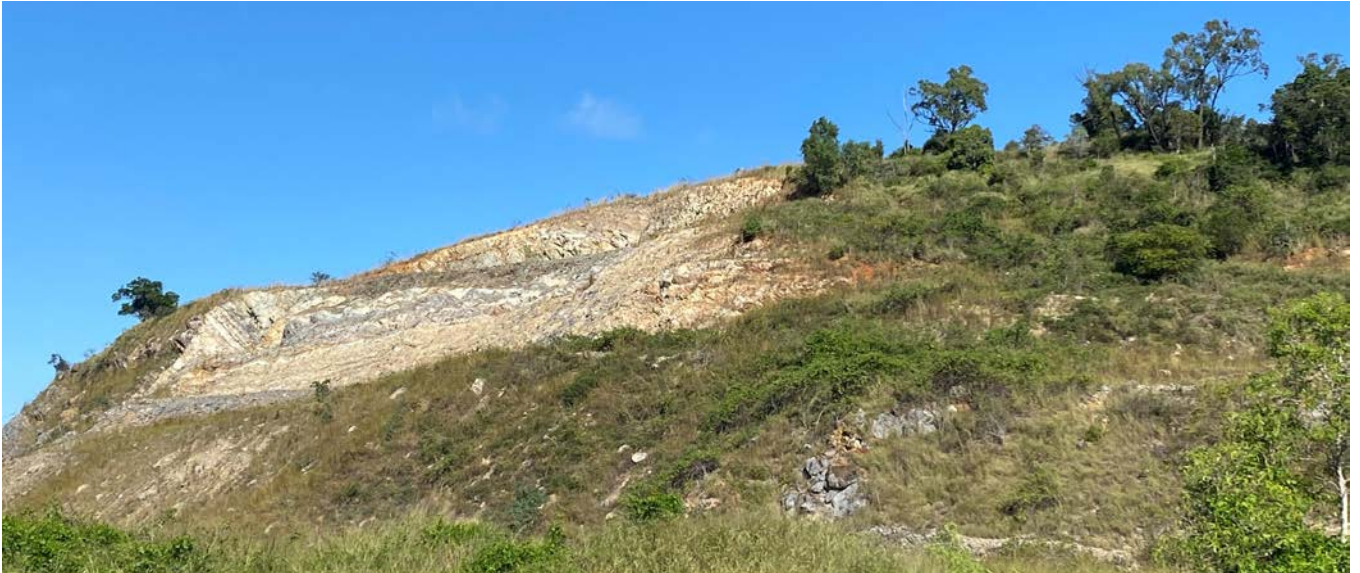
Figure 23. Vegetation is sparse below the crest of the section of the west wall where earthworks were undertaken in 2014.

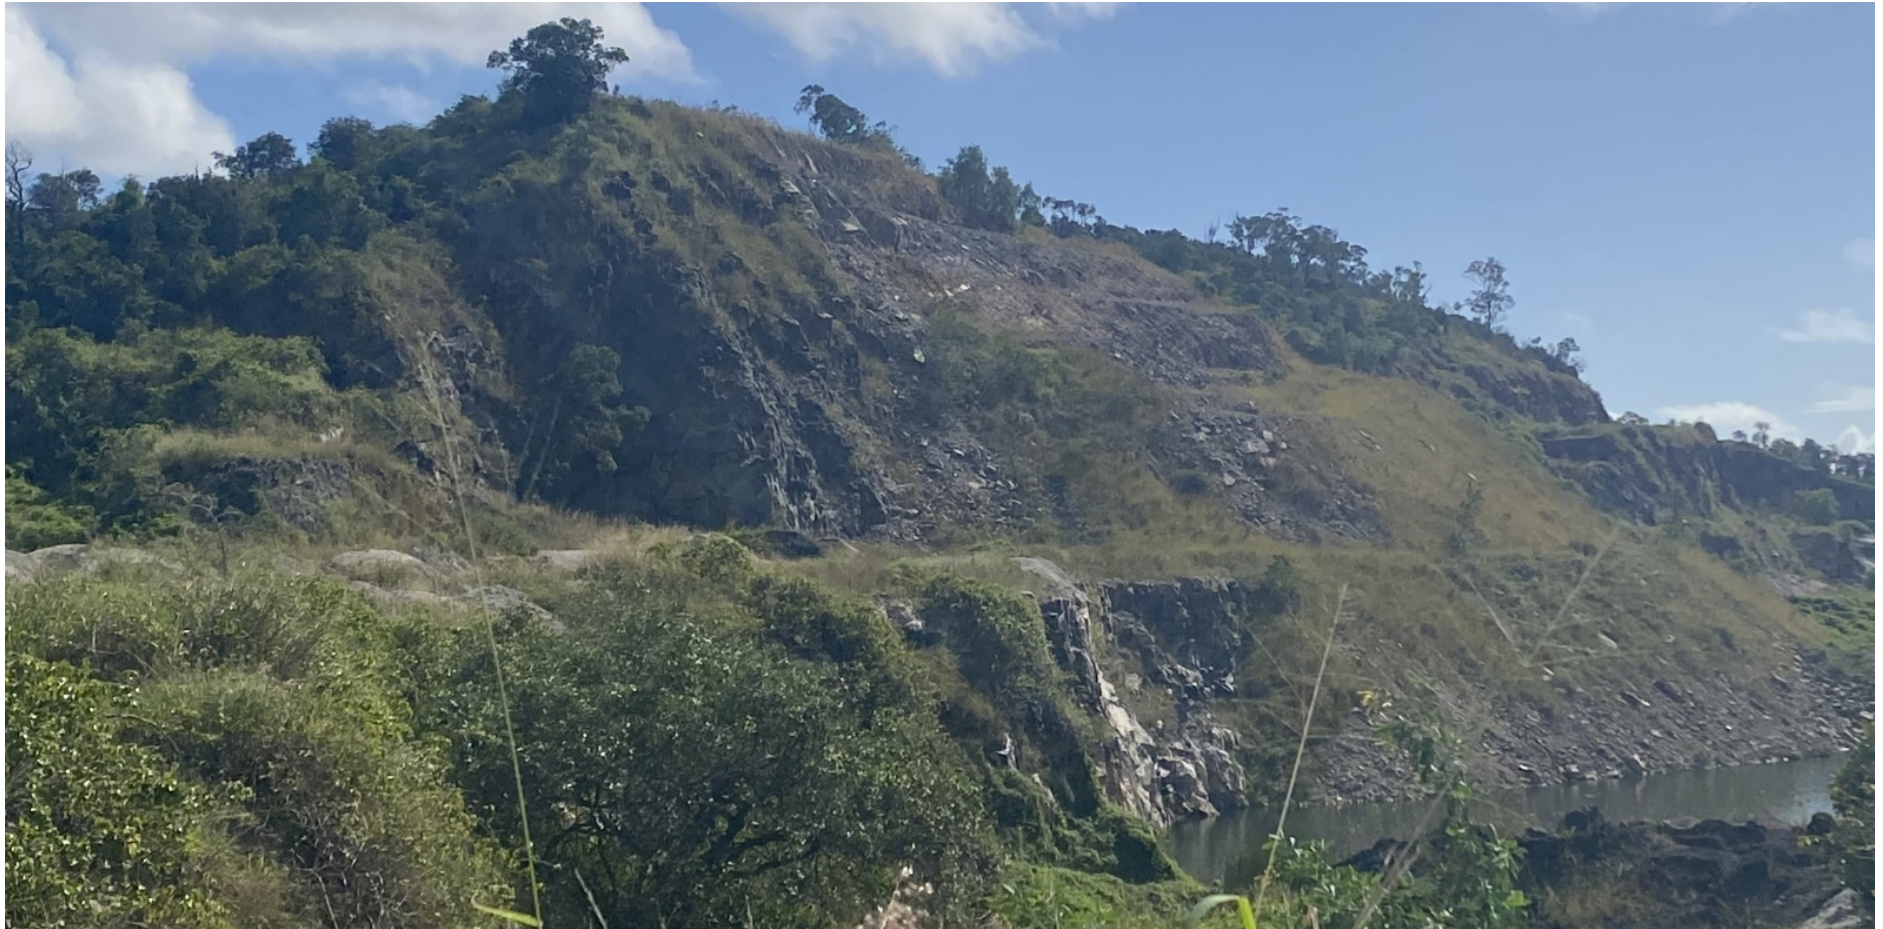
Figure 24. West wall looking north. The density of vegetation on the berms is moderate to high. It is sparse to moderate on the batters.

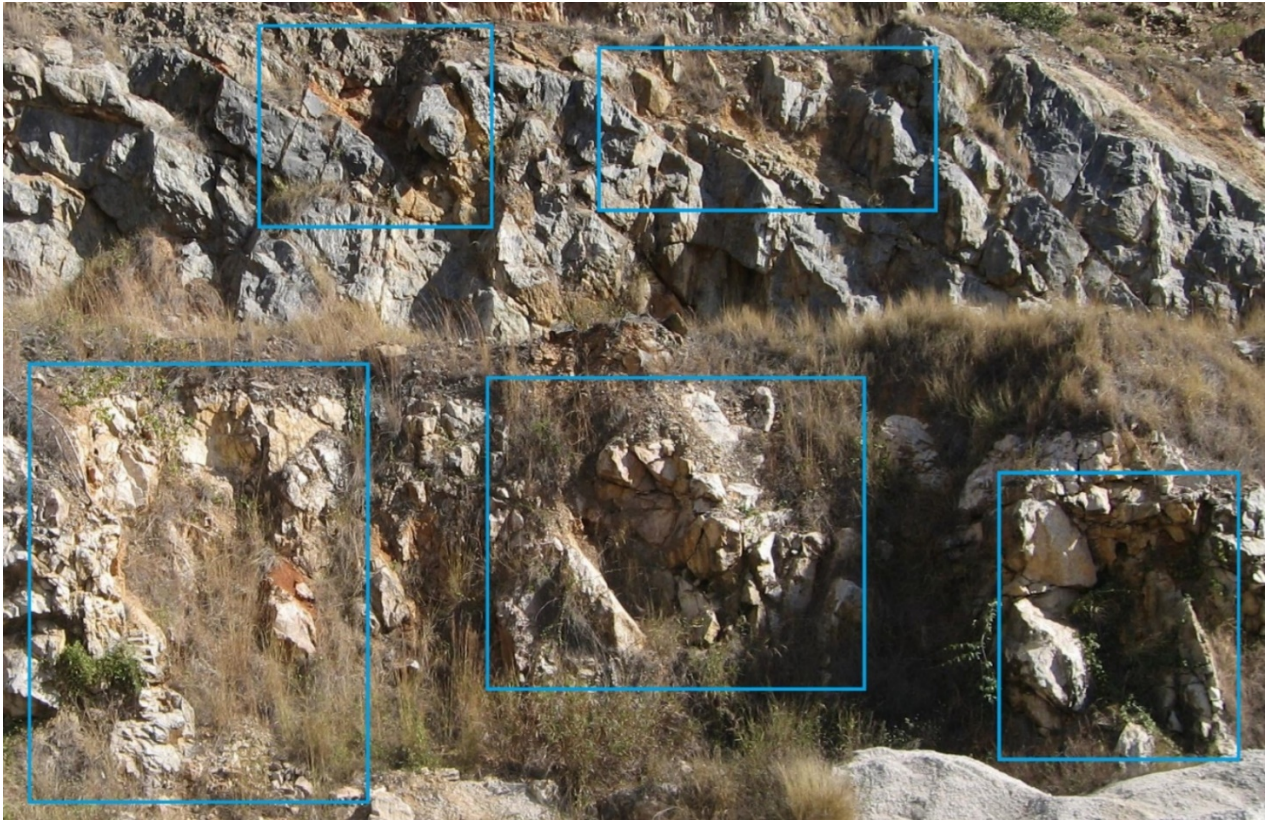
Figure 25. Highlighted at the north end of the west wall are examples of bench scale masses of rocks that have detached by toppling from, and sliding along, one or two discontinuities, predominantly from Sets 3, 5 and 7. Multibench (i.e., inter-ramp) scale instabilities have not occurred on this wall.

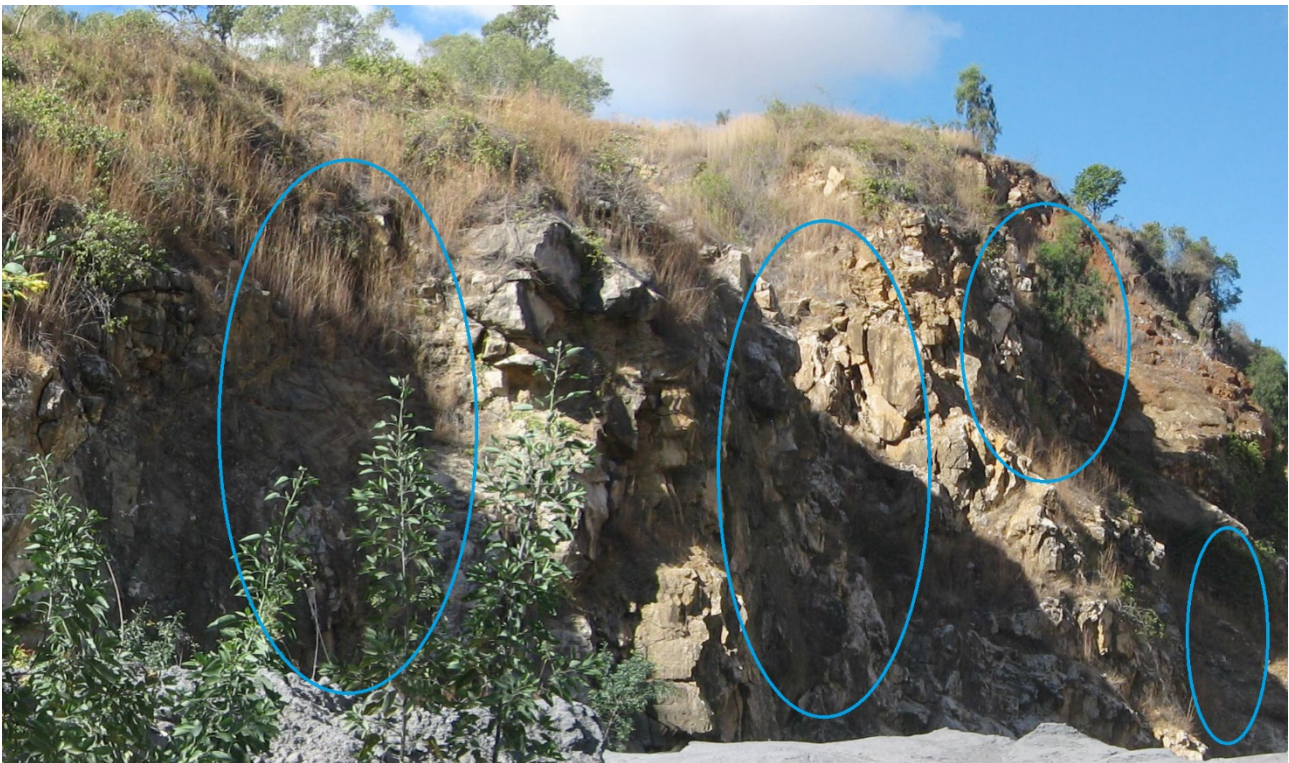
Figure 26. Highlighted midway along the east wall are examples of multi-bench (i.e., inter-ramp) and overall scale masses of rocks that have detached by toppling from, and sliding along, one or two discontinuities, predominantly from Sets 1, 4 and 5.
