# Marmor Operations Progressive Rehabilitation and Closure Plan

## Marmor Operations Progressive Rehabilitation and Closure Plan – Rehabilitation Planning Part

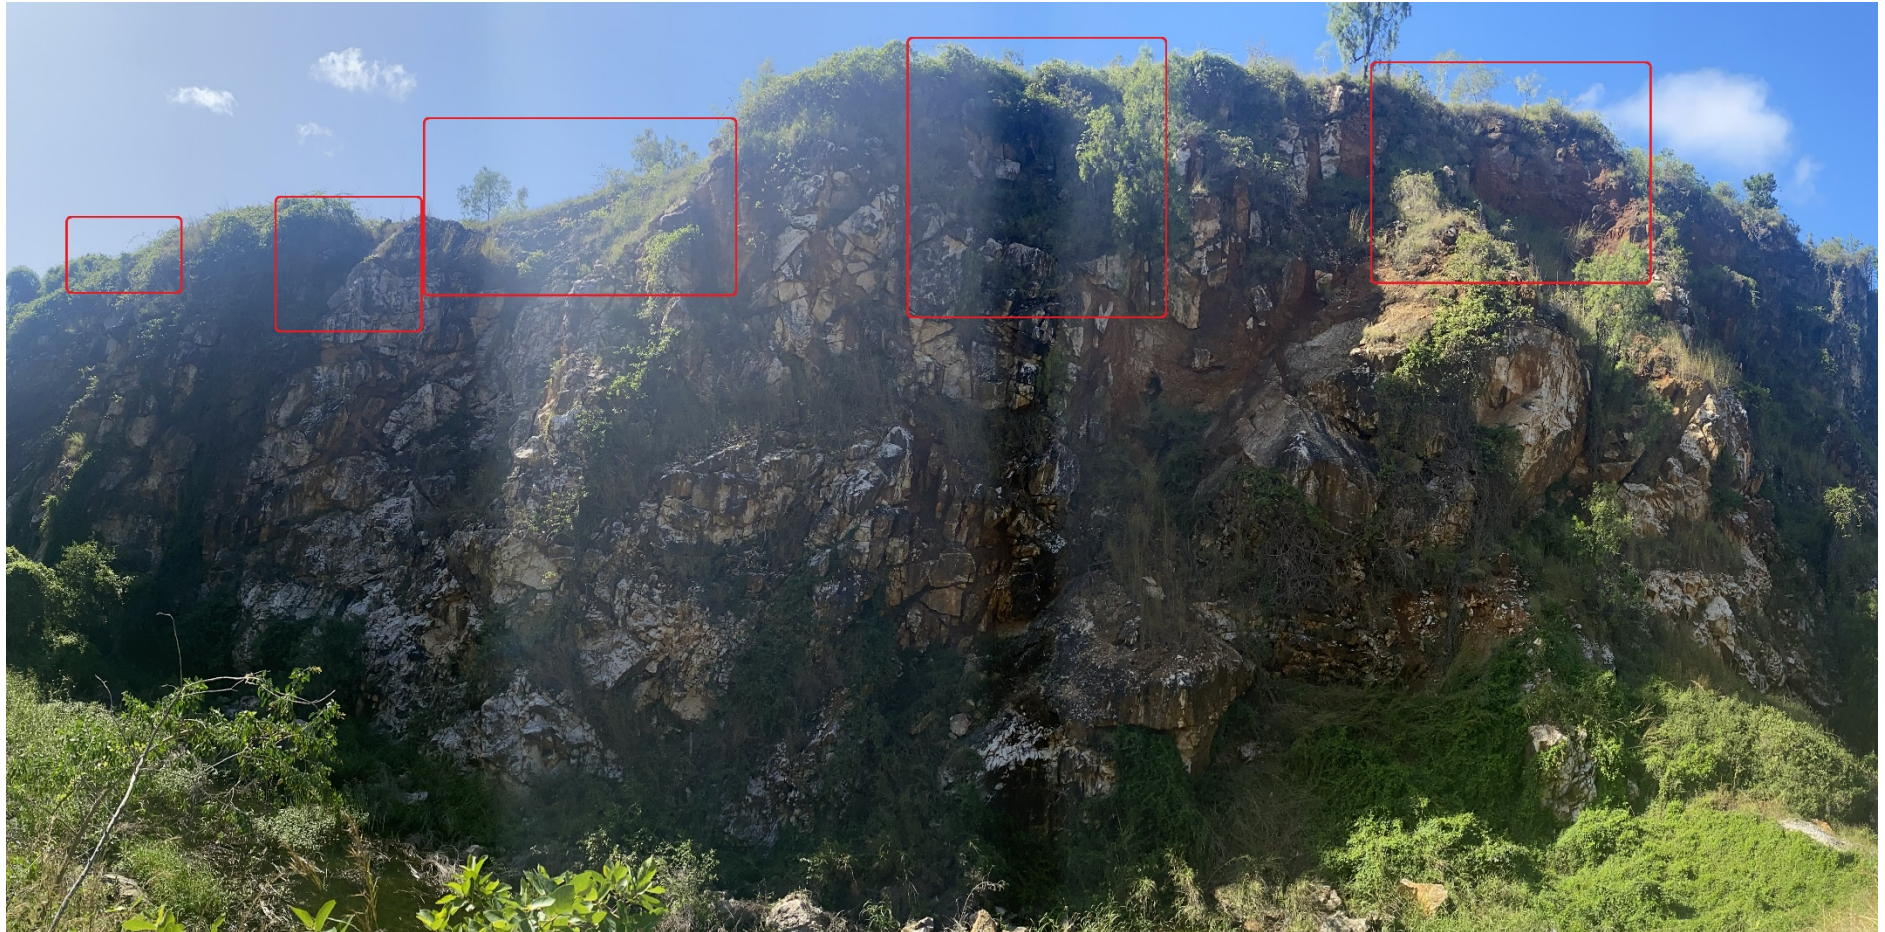
Figure 27. Example of locations along the crest of the east wall where detachments of rocks of inter-ramp and overall scales resulted in the crest breaking back by up to 6.3 m.

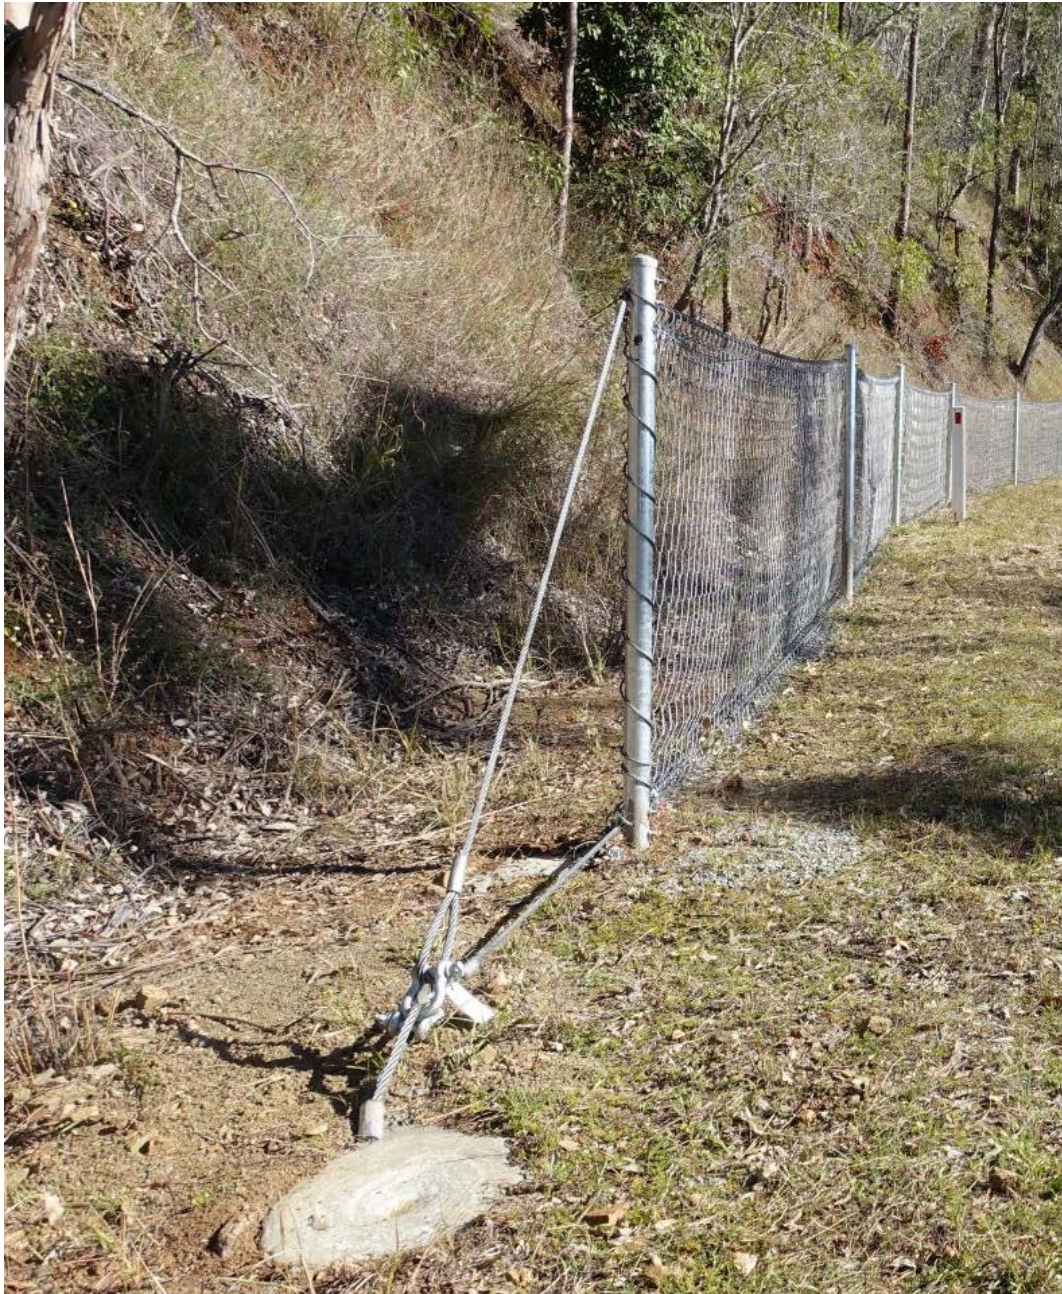
Figure 30. Example of a 1.5m high, 10 kJ capacity, proprietary rockfall barrier. This style of barrier can have a 100 year design life.
