# New Oakleigh Normanton Pit and East and North Drains

Summary Design Report

BEN862-TD-EV-REP-0001 Rev. 0

The sole purpose of this document and the associated services performed by Kellogg Brown & Root Pty Ltd (KBR) is to provide a Design and Documentation for the final landforms for the Normanton Pit and East and North Drains components of former New Oakleigh mine.

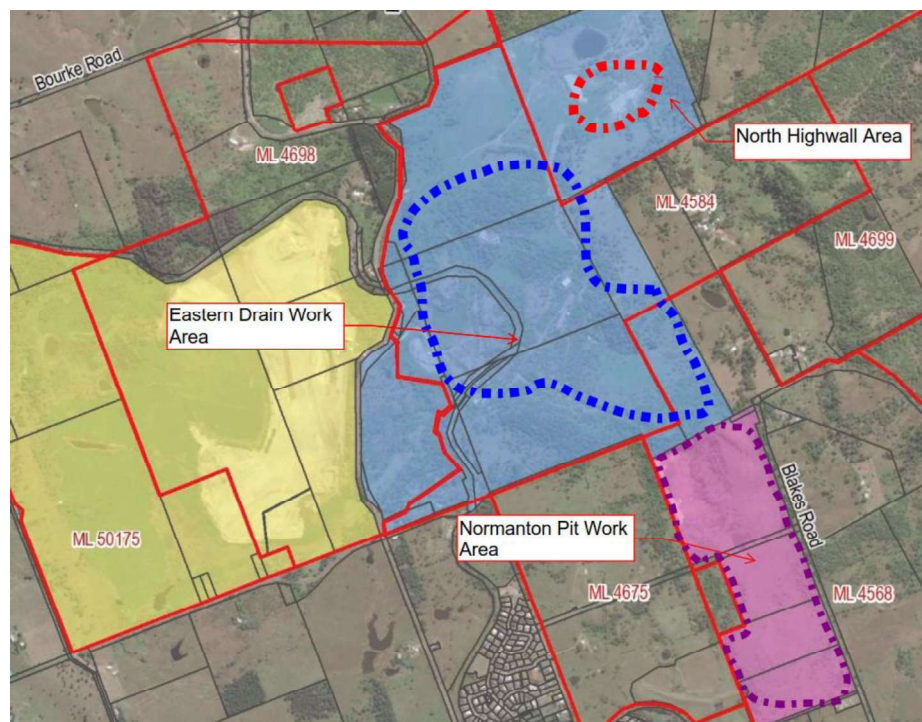
Figure 2.1 Priority areas

- Northern Highwall
- Eastern Drain
- Normanton Pit (refer Figure 2.1)

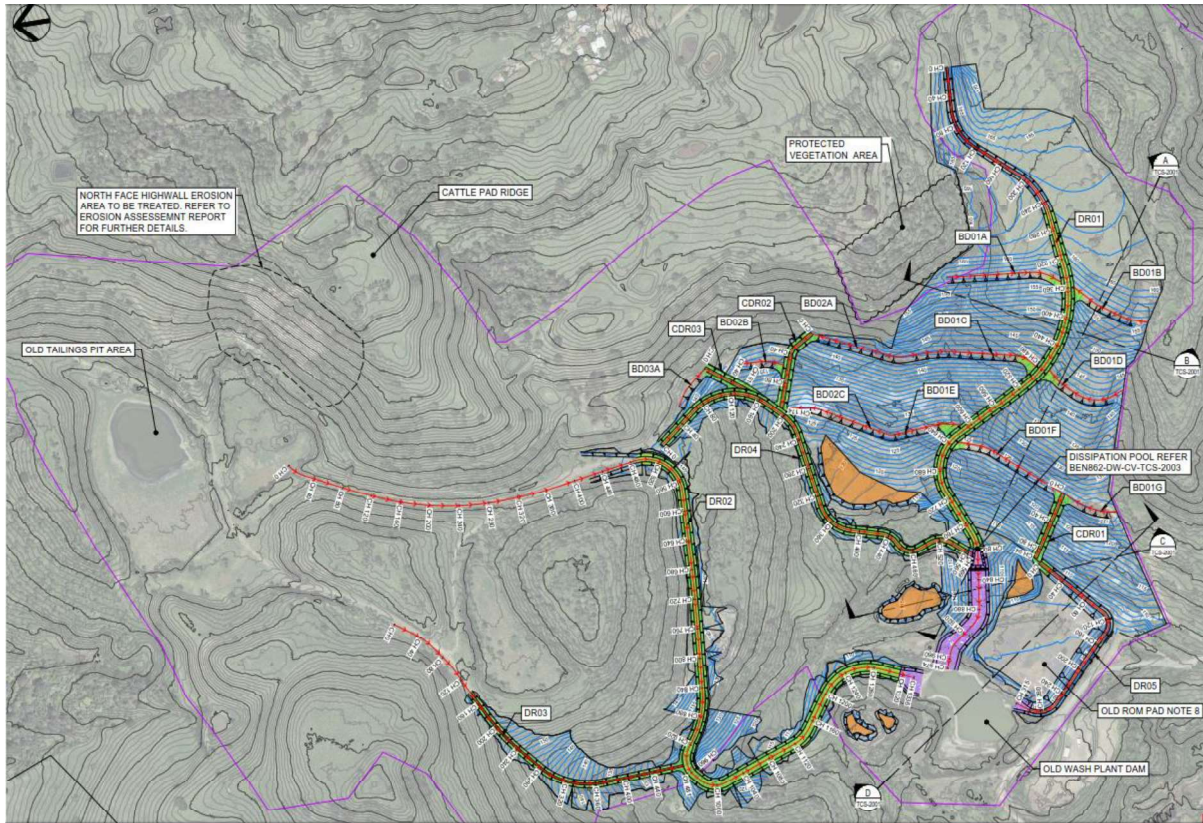
**Figure 4.1 Eastern Drain Area (East and North Drains) General Arrangement**

The drainage strategy has two main trunk drains, eastern drain DR01 and northern drain DR02 that outflow into the existing wash plant dam which will act as a settling pond. Minor branch drains DR03, DR04 and DR05 along with Chute and berm drains are used to further manage the natural runoff of the site and control erosion in accordance with the BOD parameters.

The area currently drains to an existing pond adjacent to the tailings dam infill area which then discharges south into the East Drain works area. Refer to Figure 4.1 in Section 4.

A number of iterations of the drainage design in this area have been undertaken to reduce the need for drop structures and minimise disturbance to the adjacent land, especially in those areas where rehabilitation and regrowth has already been established. A detailed layout of the proposed drainage layout for the eastern and northern sub-catchments (referred to as the East and North Drains) is detailed in drawing BEN862-DW-CV-GAR-2001, Appendix G and detail in Figure 4.14.1.

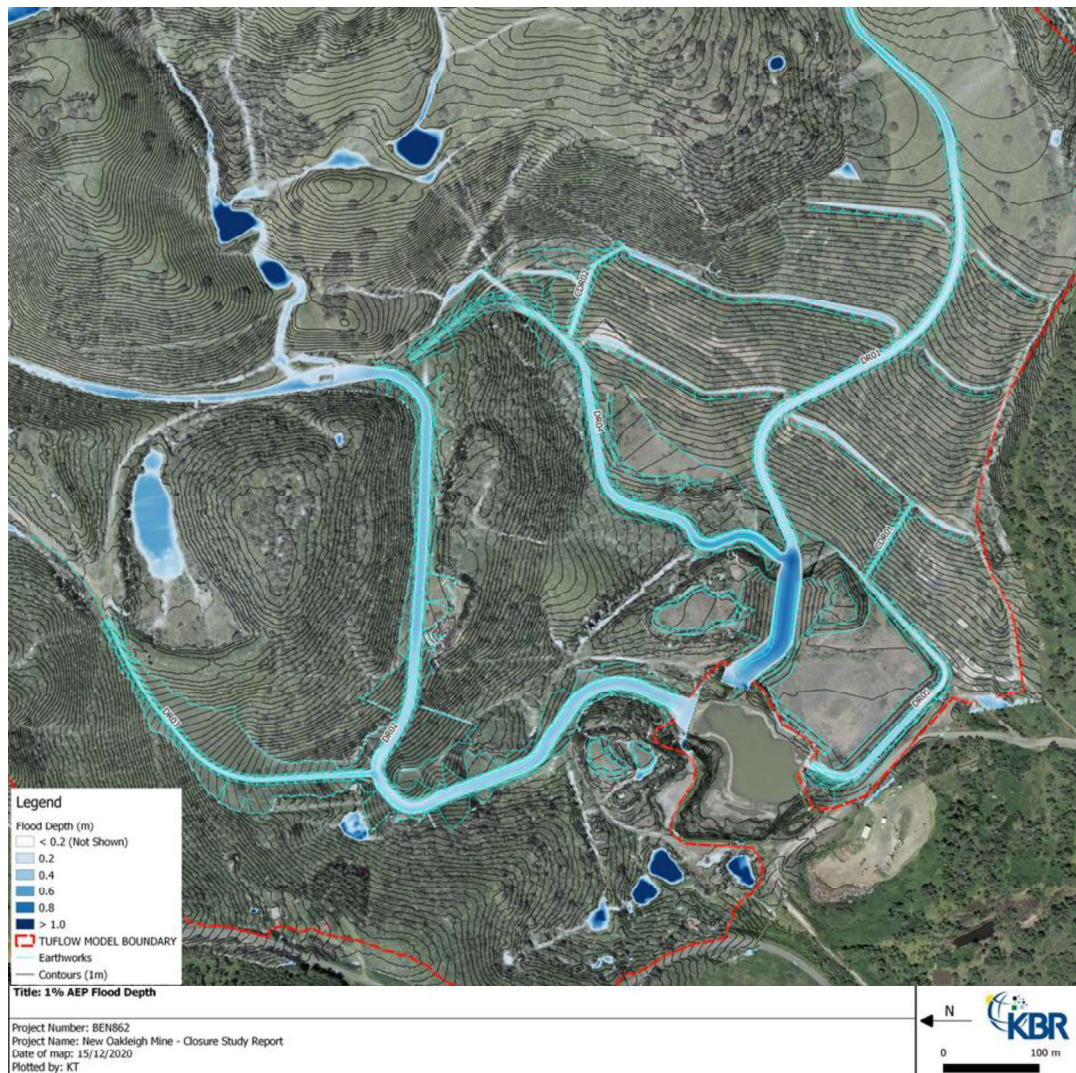
**Figure 4.2 Modelled 1 in 100 year flood depths**

It is noted that no assessment of changes in flow to points of discharge or stakeholders outside the mine lease has been conducted as part of this drainage assessment. The Old Wash Plant Dam was considered mostly dry in the hydraulic assessment as this would create a 'worst case' scenario for bed shear stresses and velocities at the drains. Volumes and storage at Old Wash Plant Dam weren't considered as part of this assessment.

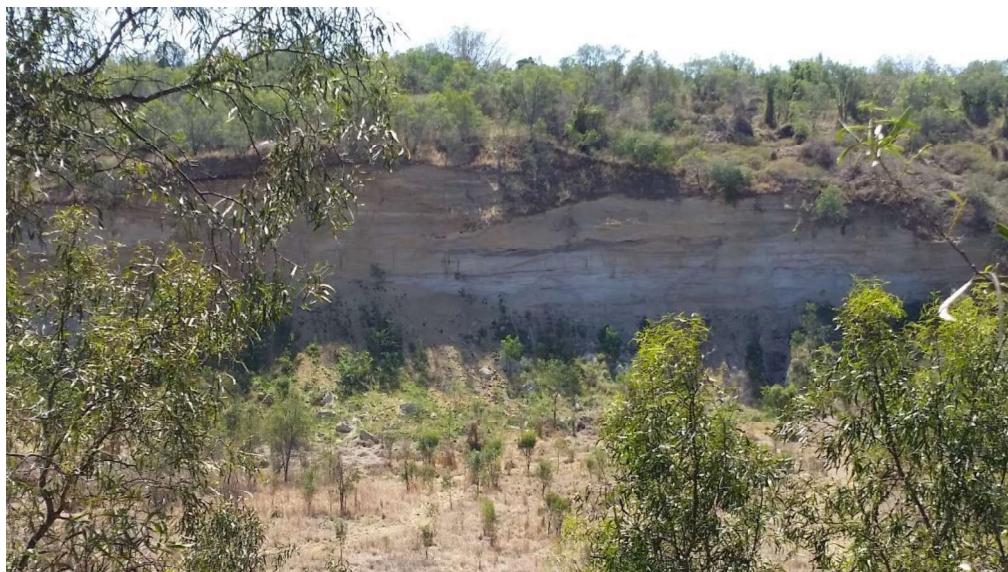
**Figure 5.1** Normanton Pit Cliff

The top of the cliff area is generally flat and has previously been rehabilitated and shows significant tress, shrub and pasture growth—refer Figure 5.1.

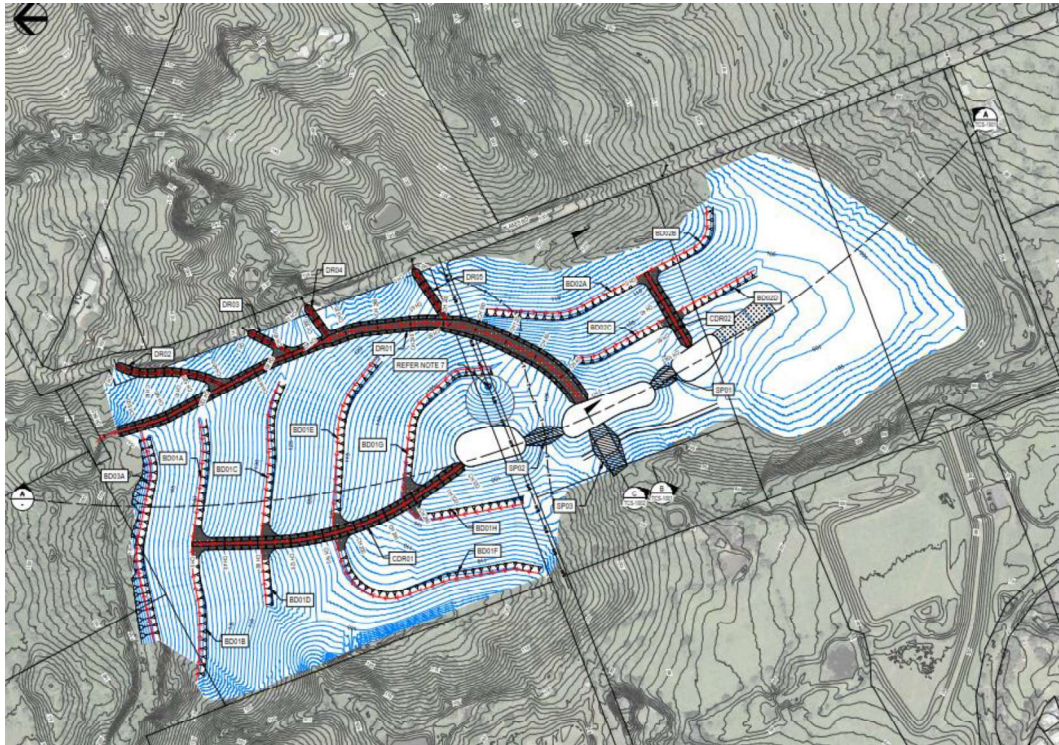
**Figure 5.2 Normanton Pit General layout**

Adoption of the 1:5 slope in the main area of the pit addresses the issue of long term erosion and scour of the main face of the cliff. By grading the slope to a channel on the eastern edge of the area the existing drainage channel can be reinstated and realigned to effectively convey existing runoff from the north and four existing road culvert crossings on Blakes Rd to the pond. Runoff from the surrounding bulk earthworks is managed via berm drains and chutes which ultimately discharge into a series of ponds before release into the existing downstream network at the western edge of the lease boundary. Rock armouring has been applied to chutes and the main drain to help control erosion. Refer to Figure 5.2 for the general layout.

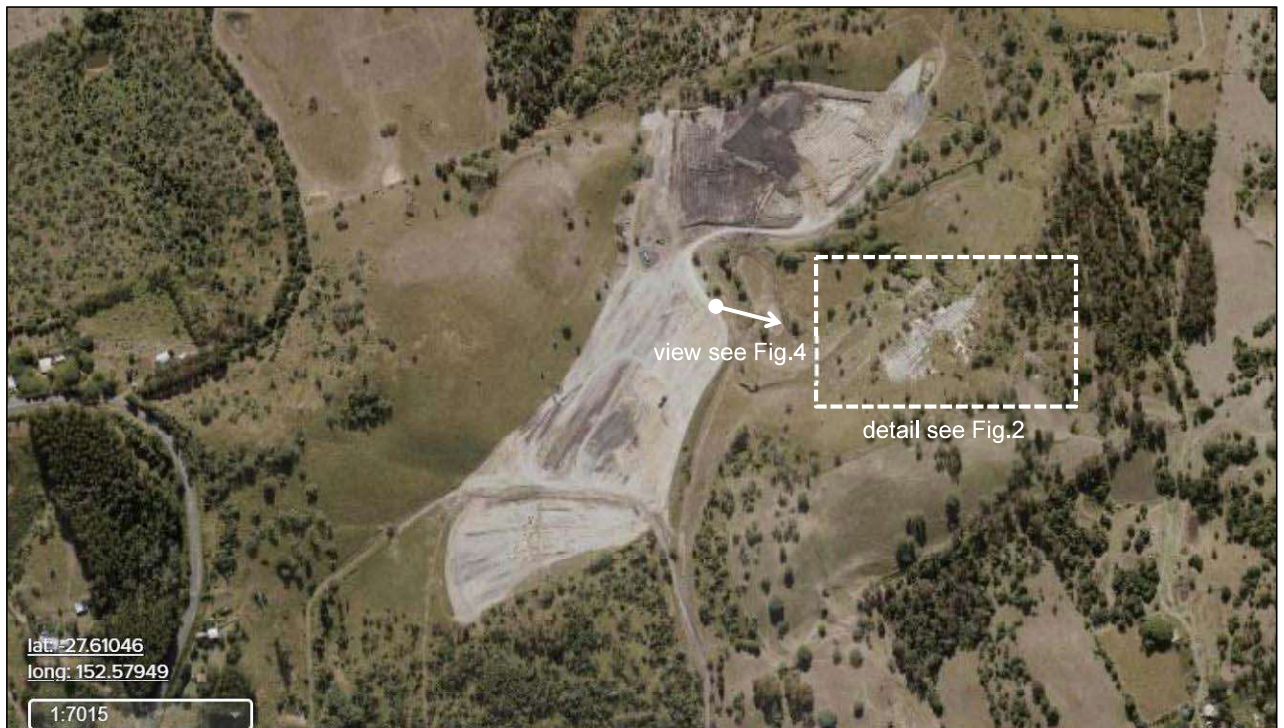
**Figure 1** New Oakleigh North Cut overall aerial view of site with inset showing exposed highwall strata [QldGlobe imagery, accessed 3/02/2020]

Final post-mining landform and rehabilitation works are being undertaken for the New Oakleigh Colliery North Cut area located a few km to the north of Rosewood. **Figure 1** is an overall view of the North Cut site, with imagery from mid-2019 when capping of the tailings dam was in progress. Marked on this figure are the extent of the more detailed aerial view in **Figure 2** and the location and direction of view of the oblique view in **Figure 3**.

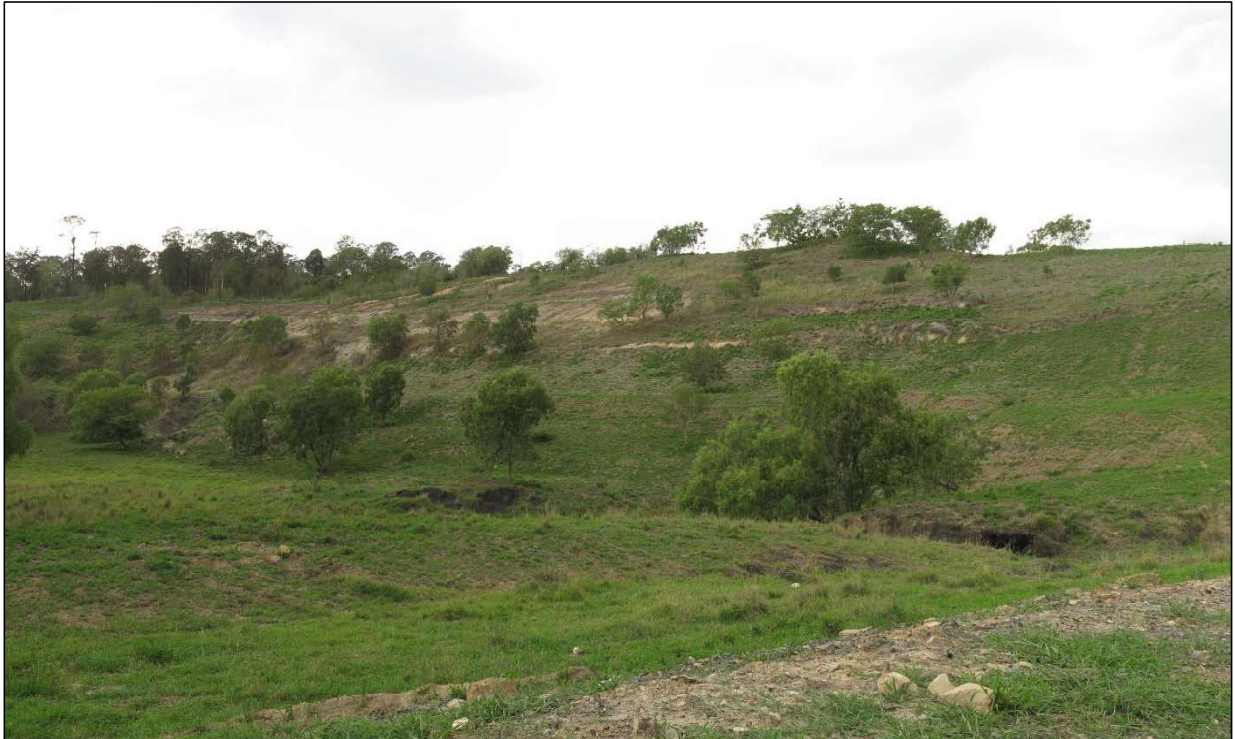
**Figure 3 North Cut exposed strata on old highwall, viewed towards east-southeast**

The shear strength parameters tabulated in **Figure 4** are much lower than WMO parameters recognised by SGRS, and are considered to be unrealistically low given the observed condition of the rock materials exposed in **Figure 2** and **Figure 3**. For many of the materials described as rocks, the listed shear strengths are lower than the listed shear strengths for soil materials. Other analysis results, for undrained (short-term) conditions, utilised SHANSEP or  $\Phi=0$  strength models which SGRS considers to be inappropriate for the conditions.

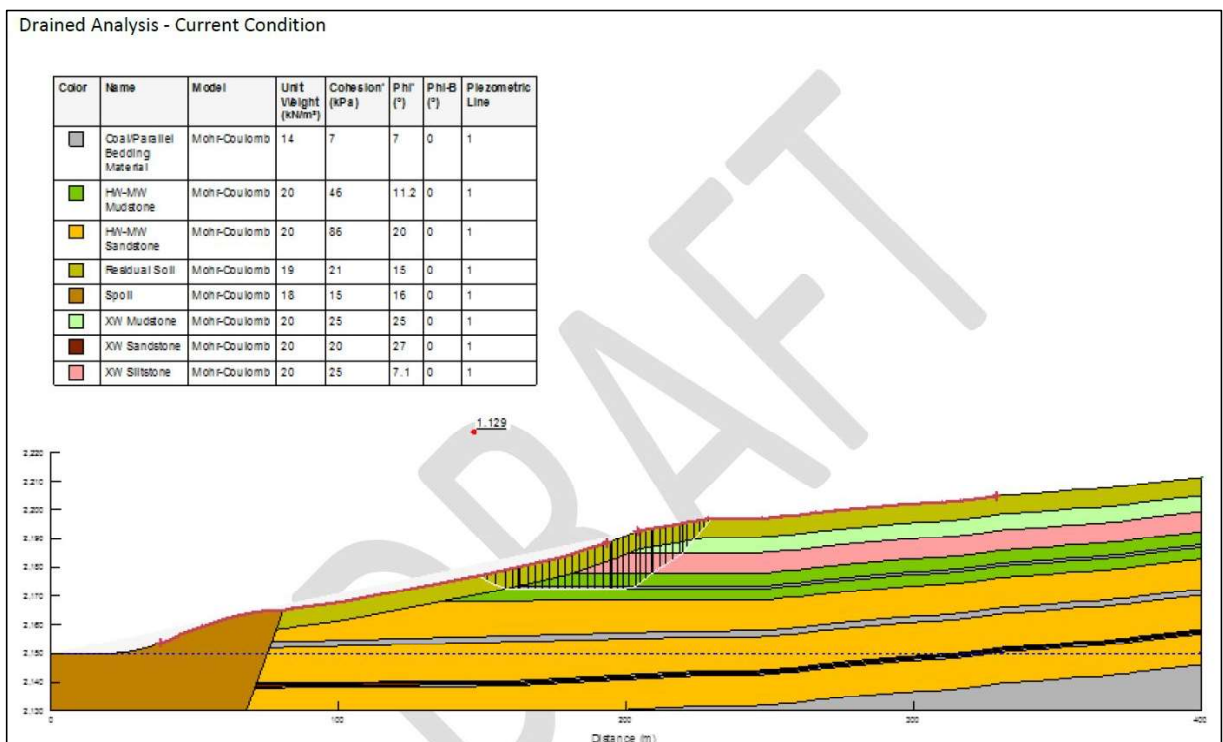
**Figure 4 Example current highwall profile stability analysis provided for review with tabulation of shear strength parameters for drained strength mobilisation condition**

The original assessment was based on a nominal highwall section. For the current slope condition, and considering long-term (drained) shear strength parameters, **Figure 4** shows an example of an original assessment critical potential instability mechanism involving sliding on a weak bedding-parallel tuffaceous clay band. SGRS adopted this nominal highwall section, which includes modelled geological layers, and applied shear strength parameters that SGRS has adopted for Jurassic coal measures rocks and related spoil materials at WMO sites.

The geometry of **Figure 4** was scanned by SGRS and remodelled using a selection of material layers that SGRS considers reasonable for WMO materials generally and specifically the North Cut highwall. SGRS groundwater pressures were modelled using a phreatic surface commencing at ground level in the spoil at the slope toe and then rising to follow a contour about 15m below current ground surface. This is a guesstimate but considered to be reasonably cautious based on prior Normanton and Washplant conditions.

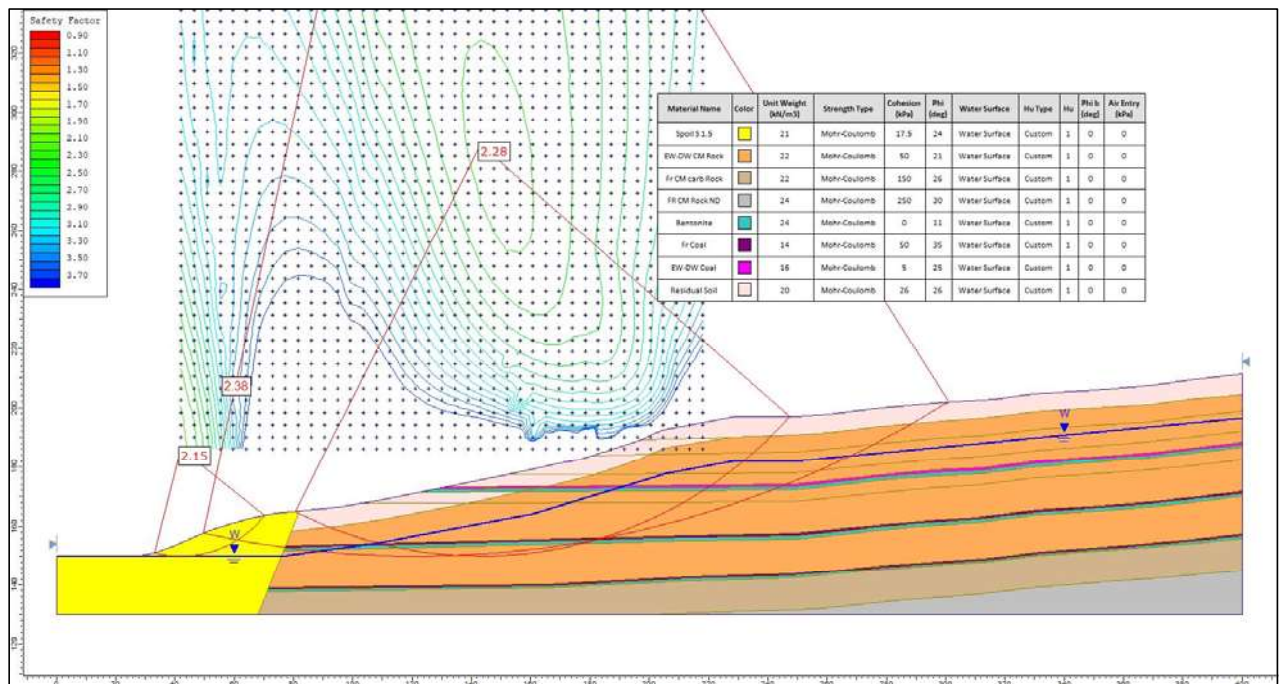
**Figure 5 Adapted current highwall profile analysis for potential rock mass strength-controlled instability, with tabulation of drained strength mobilisation parameters adopted by SGRS for West Moreton Operations**

- (1) Circular arc sliding with stability controlled by rock mass strength: the minimum computed FOS was 2.15 within the spoil backfill in the lower part of the slope, and the minimum computed FOS was 2.28 for the highwall overall. **Figure 5** shows the SGRS analysis outcome and lists the applicable shear strength parameters on which it was based.
- (2) Block sliding along a weak tuffaceous clay band was also considered. In addition to the slope phreatic surface, potential tension cracking to a depth of 5m was also considered. For the tension crack completely filled with runoff water, an extreme case, the minimum computed FOS was 1.83 as shown in **Figure 6** along with the list of applicable shear strength parameters on which it was based.

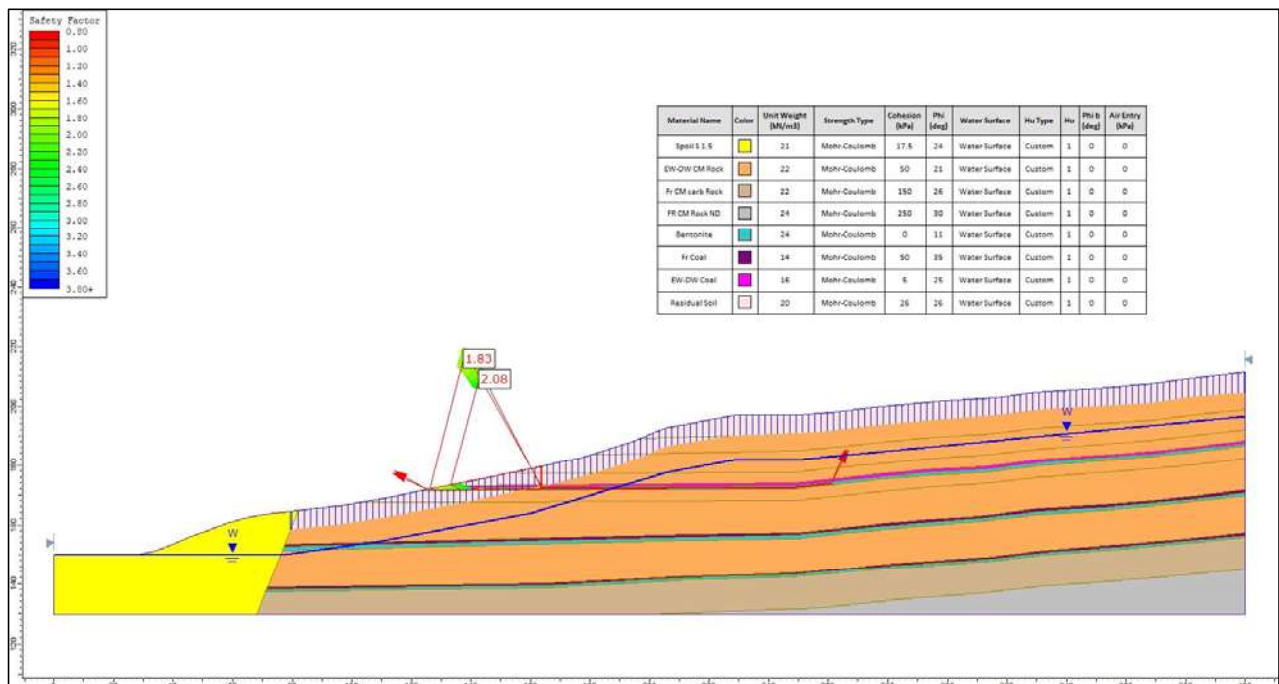
**Figure 6 Adapted current highwall profile analysis for potential block sliding instability including water-filled tension crack loading, with tabulation of drained strength mobilisation parameters adopted by SGRS for West Moreton Operations**

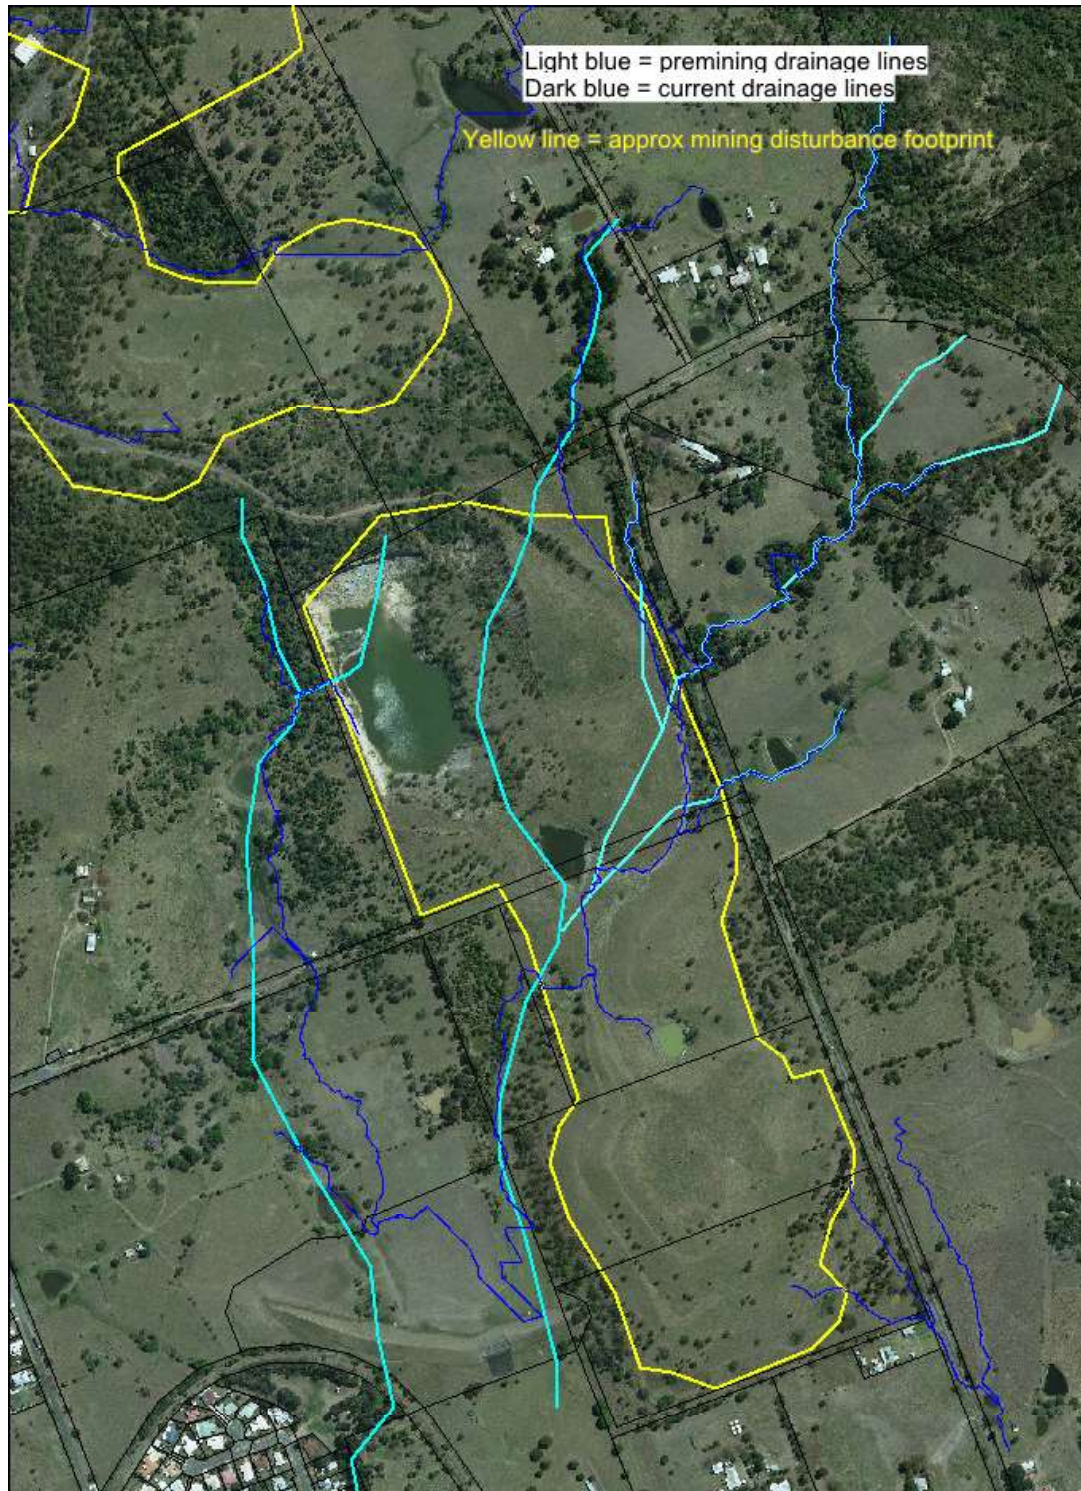
**Figure 2.1 Normanton Pit (bottom area outlined in yellow) showing pre and post mining drainage. Residual void is in north-west corner of pit**

The Normanton Pit section of ML 4568 west of Blakes Road was operated as an open cut until closure in 2000. The earlier underground workings to the east of this area were not intercepted by the open cut operations and do not constitute part of the proposed rehabilitation requirements. The extent of Normanton Pit is shown in Figure 2.1.

The pre-mining and post-mining drainage are also shown in Figure 2.1 Normanton Pit (bottom area outlined in yellow) showing pre and post mining drainage. Residual void is in north-west corner of pit. A significant part of the catchment of what eventually becomes Masons Gully that runs through Rosewood township, is external to the Normanton Pit and drains across Blakes Road (road along the eastern side of the mine site) where it discharges into a gully that has formed along the eastern boundary of the mine site. All drainage on the former mine is now artificial and bears no relationship to the pre-mining drainage until it exits the site along the central western boundary at the original discharge point. From this point downstream to the Council-constructed bund wall, the gully is incised and has at least two significant active headcuts. To some extent, past mining and stockpiling now dictate the general drainage layout to be established by this rehabilitation process.

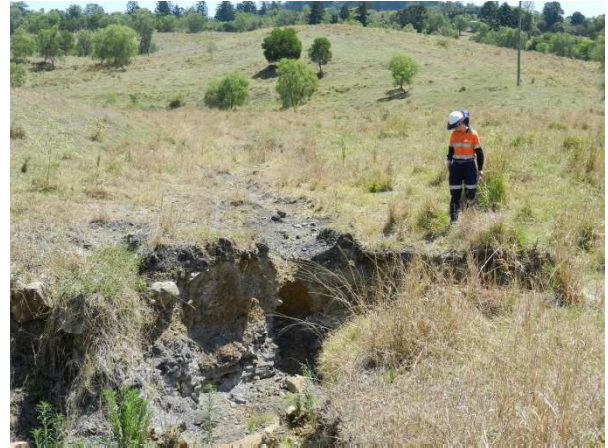
**Figure 2.3** Headcut advancing upstream into fill

Gullying along the eastern side of the ML is particularly unstable and is characterised by a series of headcuts (also known as knickpoints (Figure 2.3 Headcut advancing upstream into fill) and intervening deposition sites that are progressively moving sediment downslope. This drainage is incised into fill. For the purposes of this report, this is referred to as Blakes Gully (Figure 2.4). The two confluences with the main drainage lines that cross Blakes Road are seriously unstable with the gully at the confluences >4 m deep (Figure 2.5). There is evidence of the inflows overtopping Blakes Road as the under-capacity culverts are silted up (Figure 2.6) and upstream inlets to the culverts are higher than the road invert. Managing these external catchment inflows (Figure 2.7) is a major component of the final landform planning as shown looking towards Normanton Pit where discharge joins Blakes Gully.

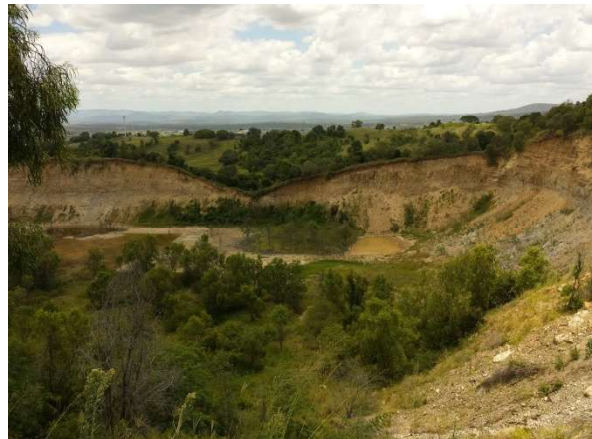
**Figure 2.9** Unstable highwalls in north-western corner of site

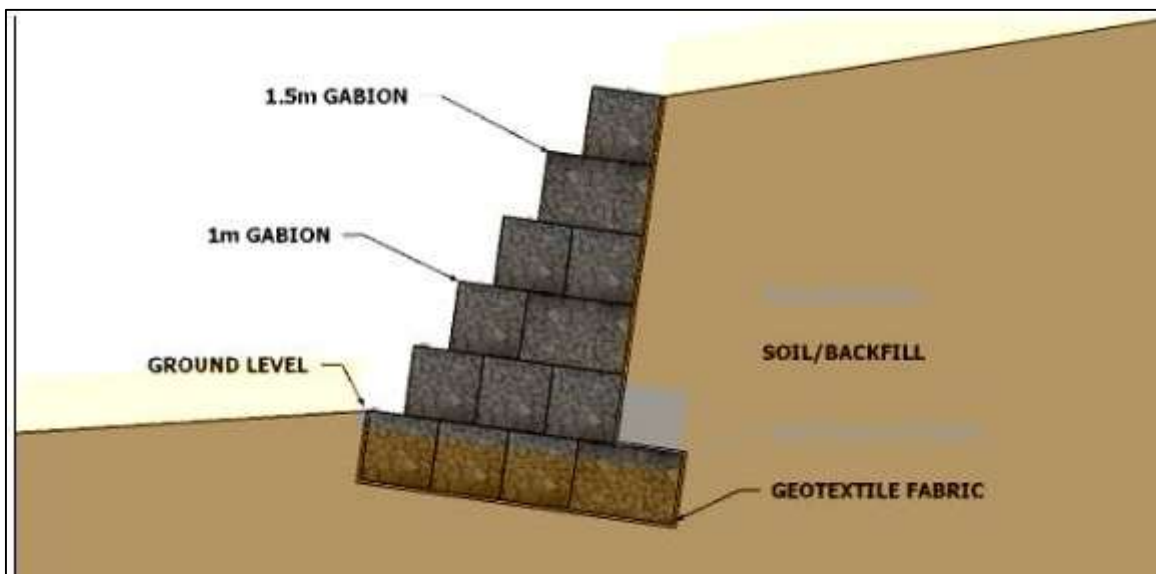
Figure 4.1 Schematic of design of gabion drop structures (not showing upstream and downstream gabion mattresses)

A 6 m drop structure will require at least 7 m (high) of gabions (or similar structures) for construction. A gabion is required to be keyed on both abutments and into the gully floor into the surrounding fill material to develop a rigid base for the structure to be developed and reduce the risk of flows bypassing the structure. Geofabric is also required on the upstream and abutment sides, as well as under the downstream apron, to prevent the ingress of fines in seepage that will restrict the permeability of the structure and impede its long-term effectiveness (Figure 4.1). This figure does not show the upstream and downstream gabion mattress components of the proposed design. Details on the use of gabions are presented in Appendix B Gabion drop structure information.

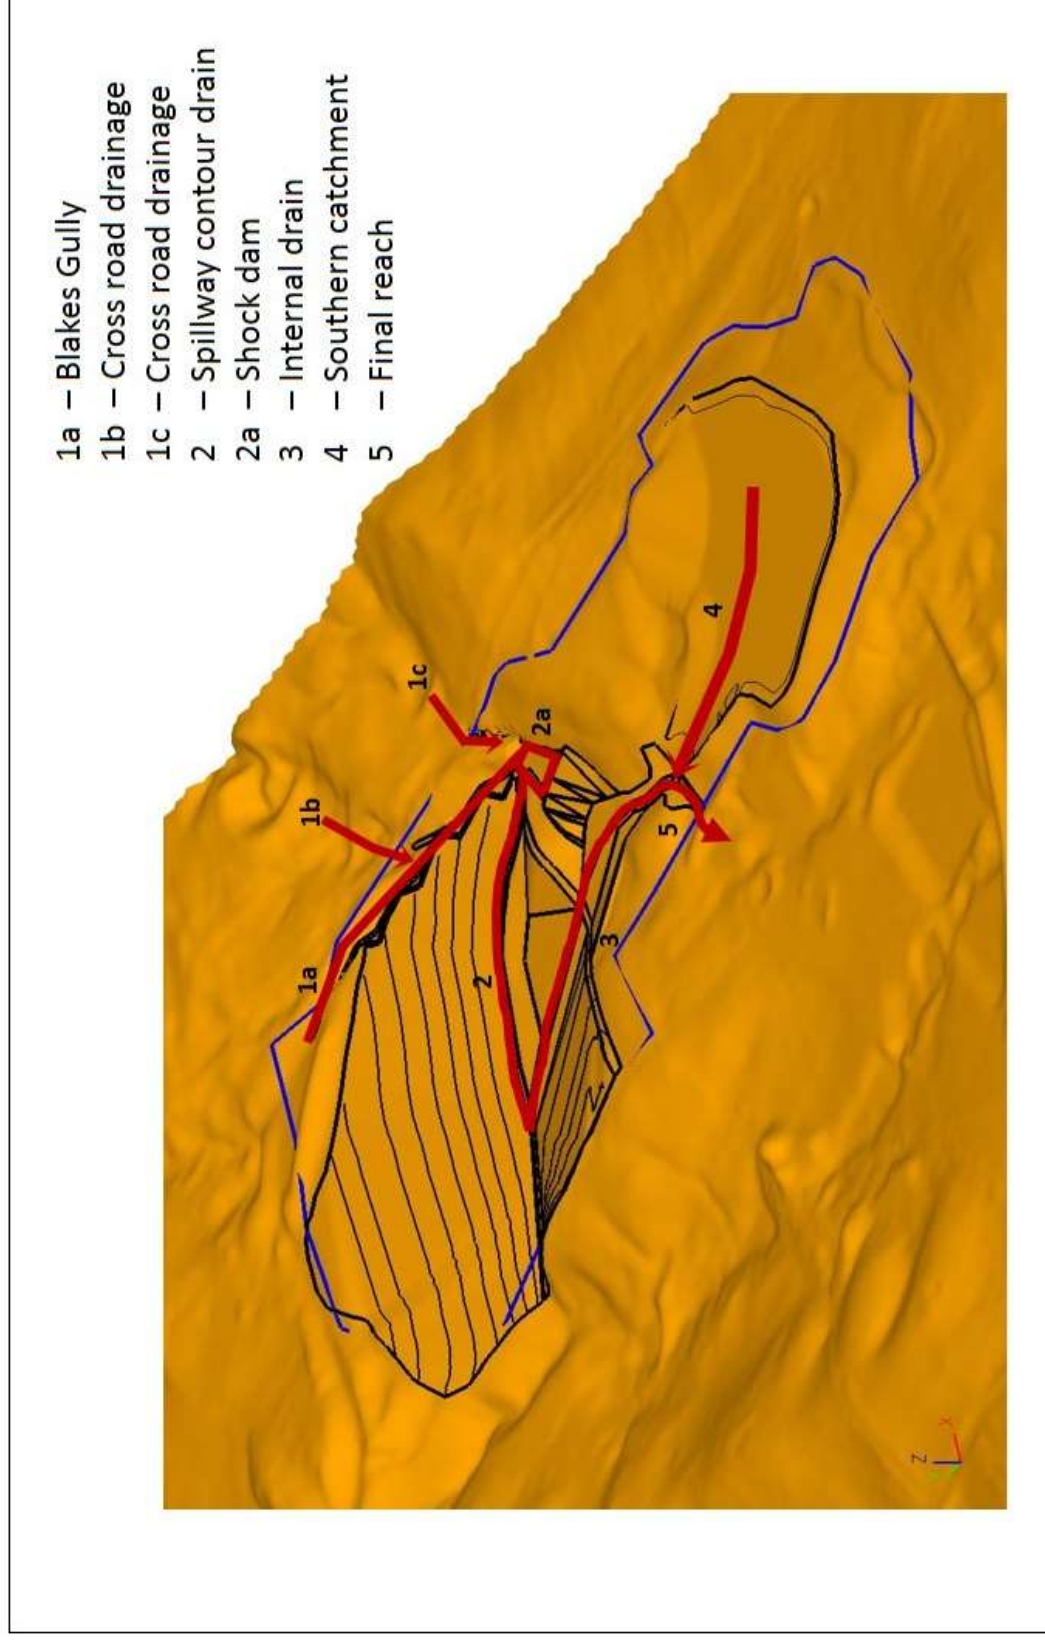
Figure 4.2 Internal drainage schematic

The self-draining southern catchment (Figure 4.2; 4) (Stream Order 1) created by removal of spoil (and potentially excavation of unmined land under the out-of-pit dump) will drain at <1% to the north to a confluence with the discharge from the mattress-protected drop structure described above at the start of reach 5. This depression is designed to have slopes of <10% and will also receive flows via a diversion channel from the land above the shock dam on its southern side. The current plan for this borrow area is to leave a small, deeper, central depression that will temporarily hold some water for stock purposes. This may require a constructed grassed spillway to drain to the top of reach 5. The preferred option though is not to create any permanent waterbodies and rather to provide for a cattle trough to which water is piped from a domestic source (or bore) for stockwater supply. This trough can then be established in a site that will not impact the integrity of the constructed drainage and lead to future erosion risk.

The final reach (Reach 5) from the foot of the final drop structure is a grassed drain designed to have a 10 m base width to reduce erosion risk during peak flow. This drain flows at low grade (<1%) to the western boundary where it leaves the mine site. The discharge point to the adjacent land from the pit site will be constructed as a level crest to spread the water at a non-erosive velocity as it leaves the site.

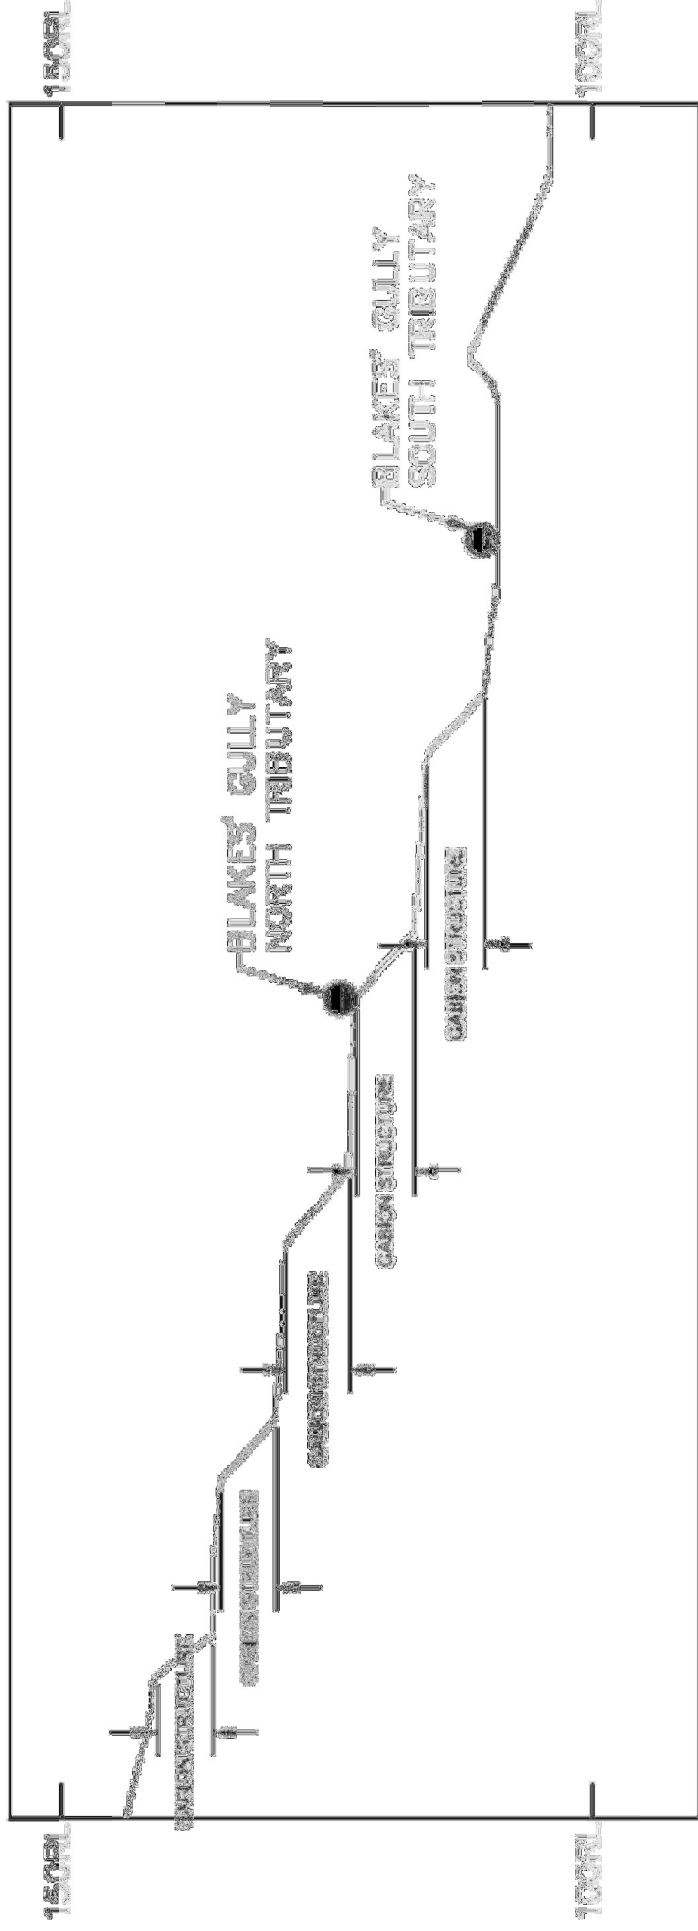
Figure 4.3 Long-section of re-formed Blakes Gully to shock dam

It is recommended that drop structures, required to maintain grassed channel sections at grades likely to minimise erosion potential, be constructed of gabions or similar (Figure 4.3) with additional gabion mattresses upstream and downstream of those forming the near-vertical structures. In this context, gabions are rectangular woven wire mesh boxes, generally constructed of heavily zinc galvanised wire with or without additional coatings, and filled with competent rock. Galmac or galfan wire units are recommended as the coating is zinc and aluminium which has a much longer design life than zinc galvanising alone.

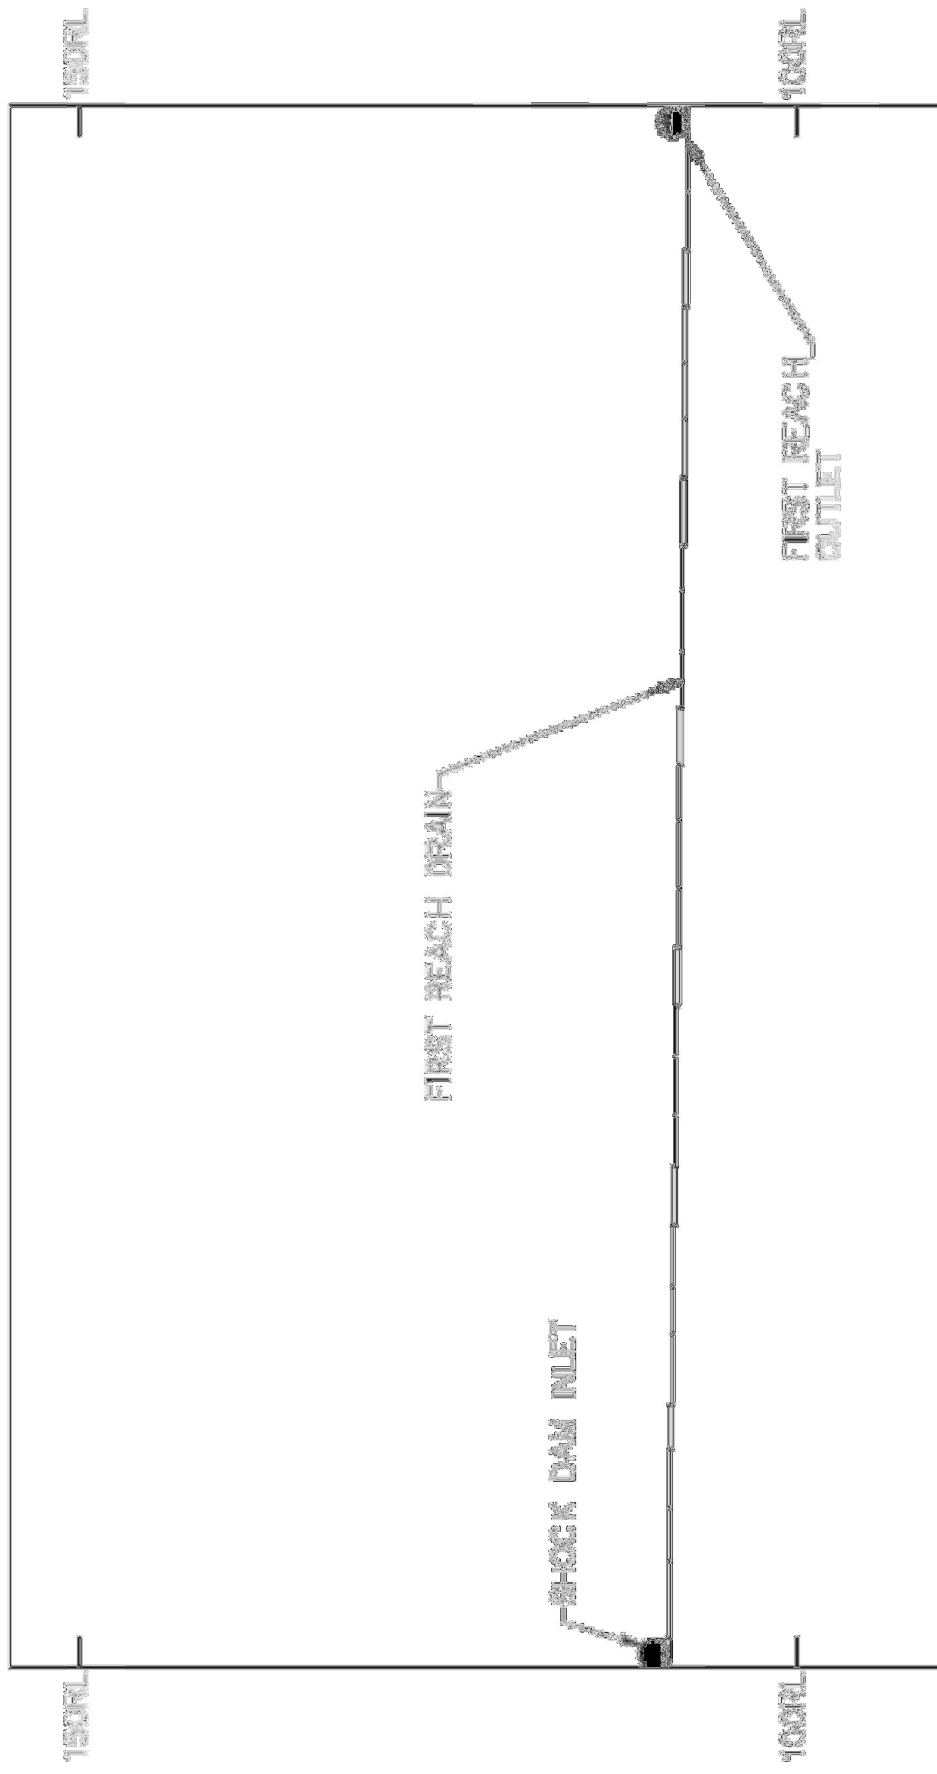
Figure 4.4 Long-section of drainage profile from shock dam to furthest north-west point

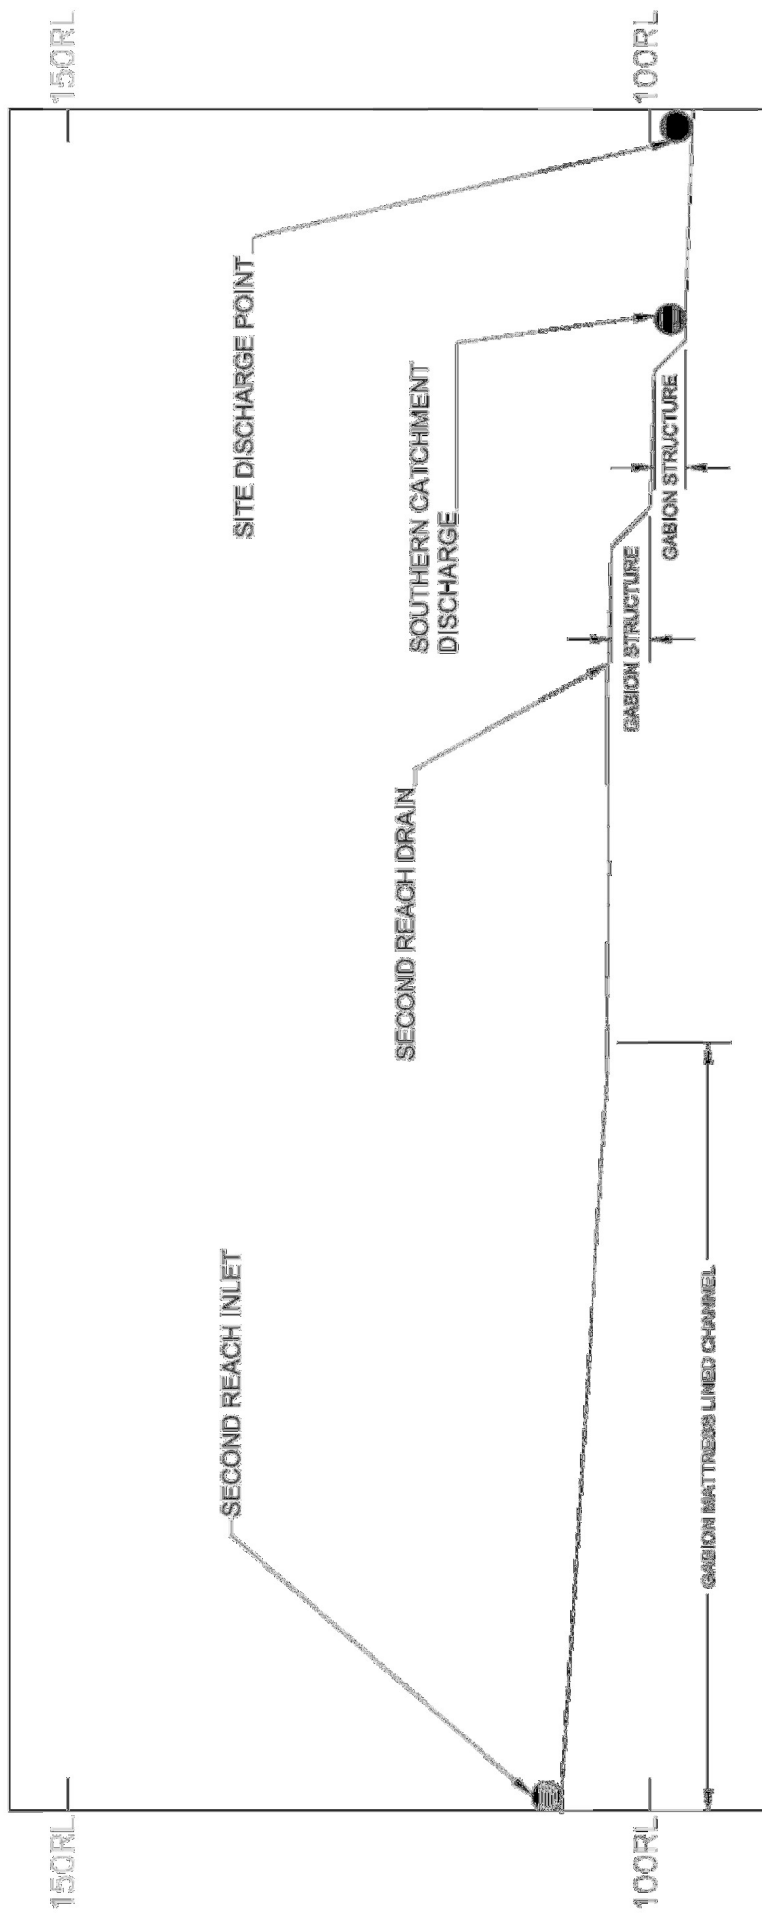
Figure 4.5 Long-section of drainage profile from furthest north-west point

Site inspection shows that this reach of the gully/creek on the neighbouring land (that ultimately becomes Masons Gully) is strongly incised from past events. This will continue to function as a defined channel and will continue to headcut back to the discharge point from the mine site unless treated. Any further headcutting would eventually threaten the integrity of the stormwater management design implemented on the mine site, negating the functionality of the structures and ultimately slope stability. The timeframe over which this would occur cannot be predicted as it is dependent on the time of the year at which landforming is undertaken, timing and frequency of erosive events, the time taken to re-establish effective groundcover and the level of groundcover at the time (e.g. drought conditions perhaps). Further, any lack of channel maintenance and management of riparian vegetation in this reach just upstream of the Council bund but downstream of the point of discharge from the mine site could also compromise the ability of the creek to operate at non-erosive velocities.
